Subject: Draft Environmental Assessment (DEA) for Conservation District Use Application (CDUA) OA-3589 for the Repair and Reconstruction of a Seawall at Kaluahole, Waikiki, Oahu, TMK (1) 3-1-003:001

**Environmental Assessment**

**Conservation District Use Application  
Kainalu Seawall, Diamond Head  
Honolulu, Hawaii**

TMK (1) 3-1-003: 001

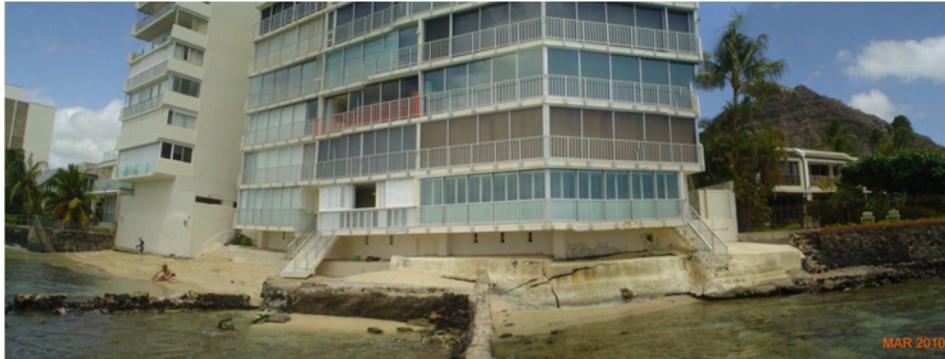
Shoreline along Southern property boundary.

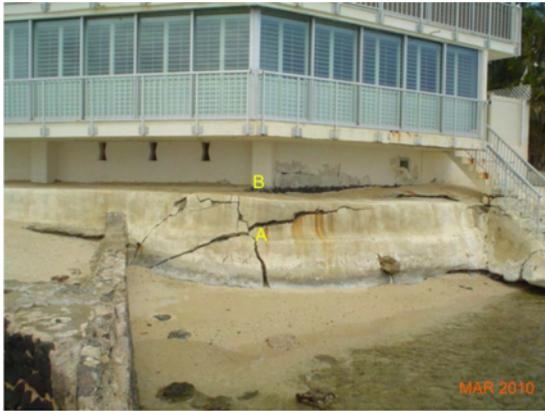
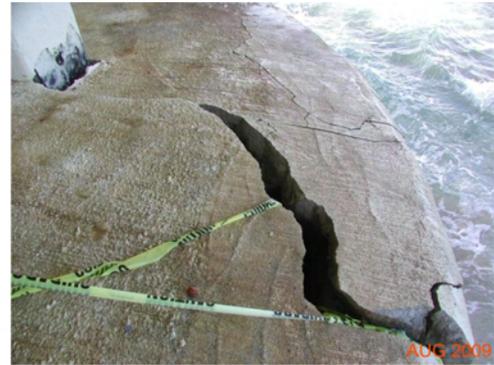
The continued erosion of sand appears to be causing differential settling, which in turn, is causing the wall and gunite to crack and pull away from the apartment building. It is feared that if erosion continues, the wall will collapse and seawater inundation of the Kainalu support pilings may cause the building to become unstable and collapse.

Crack on top surface. Wall is hollow under surface.

The proposed solution is to replace the existing CRM wall with a more appropriate CRM barrier that would deflect wave energy back towards the ocean and be designed to withstand the test of time. The replacement CRM wall would have a foundation that is to be laid on the existing bedrock below the surface to provide stability in an area of erosion. The wall face itself would be rough surfaced due to the CRM construction, dissipating energy, and the top of the wall would include a re-curved wave deflector sending remaining wave energy back towards the ocean. Construction methods can be seen in **appendix 3**.

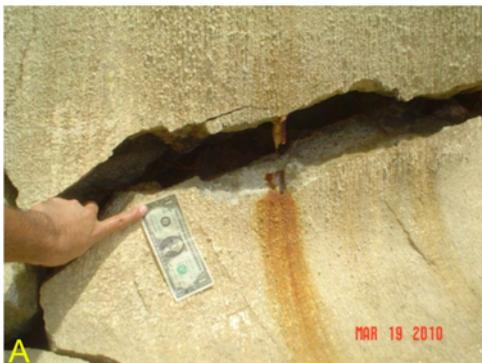
**A** Cracking in gunnite coating. Wall is hollow behind surface.

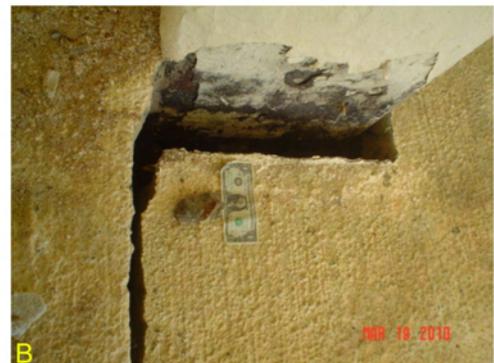
**B** Separation from building face.

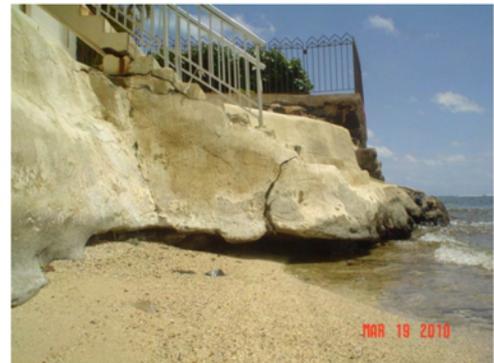
Erosion under encroaching section to be removed

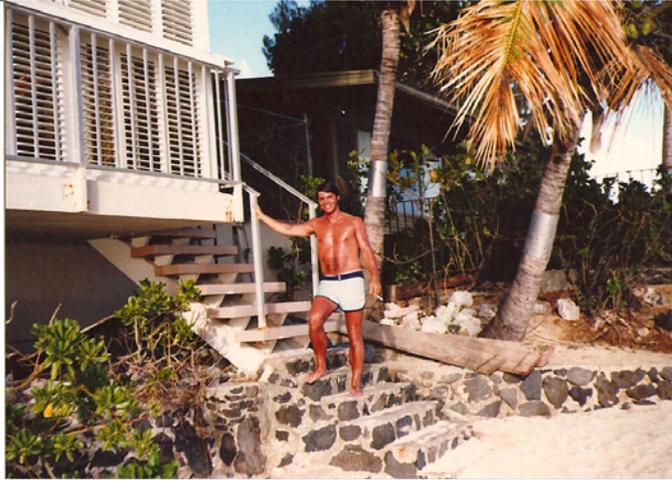
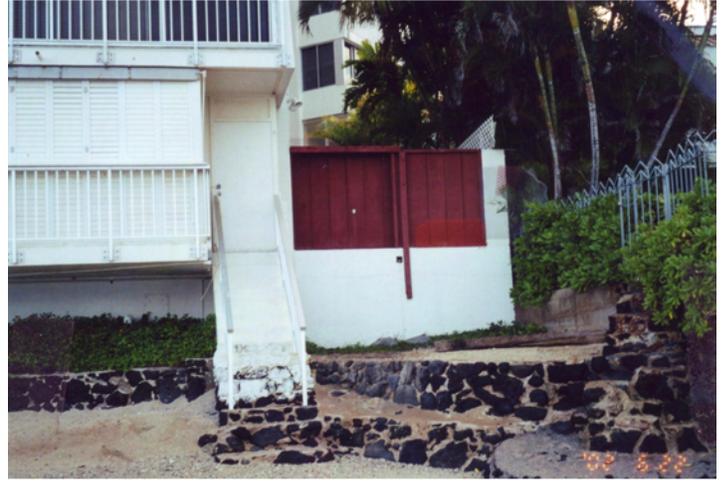
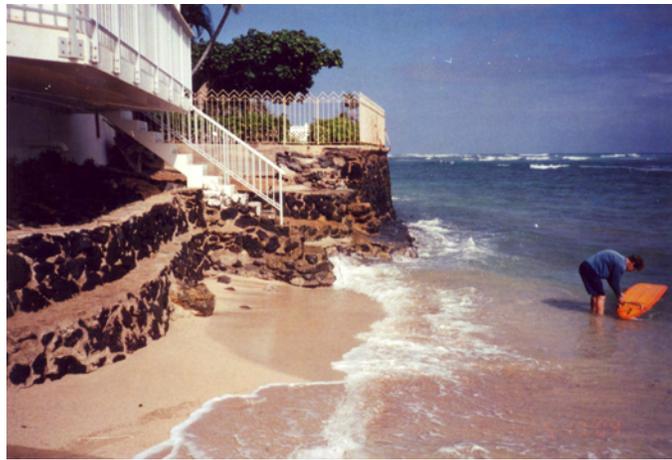
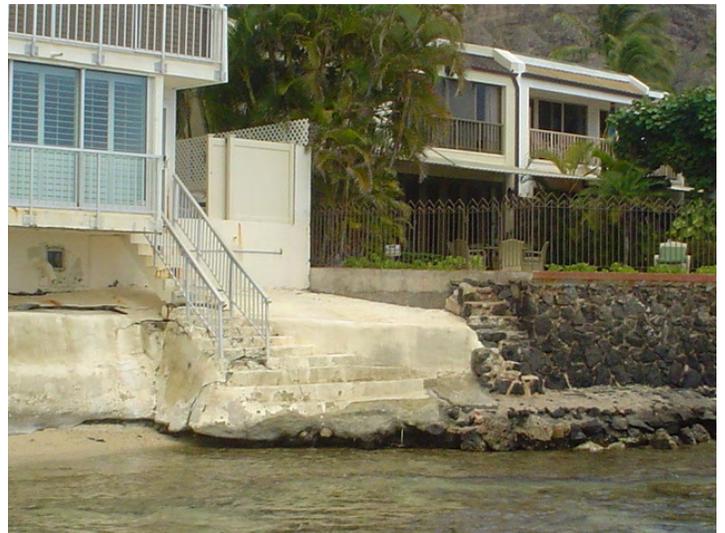
**Figure 5. Eastern Beach Erosion**

shoreline still retains sand suitable to be a comfortable beach, however another has eroded to the point where the waves consistently connect with the wall, resulting in a bedrock and sand mixture as well debris from the failing section of the wall.

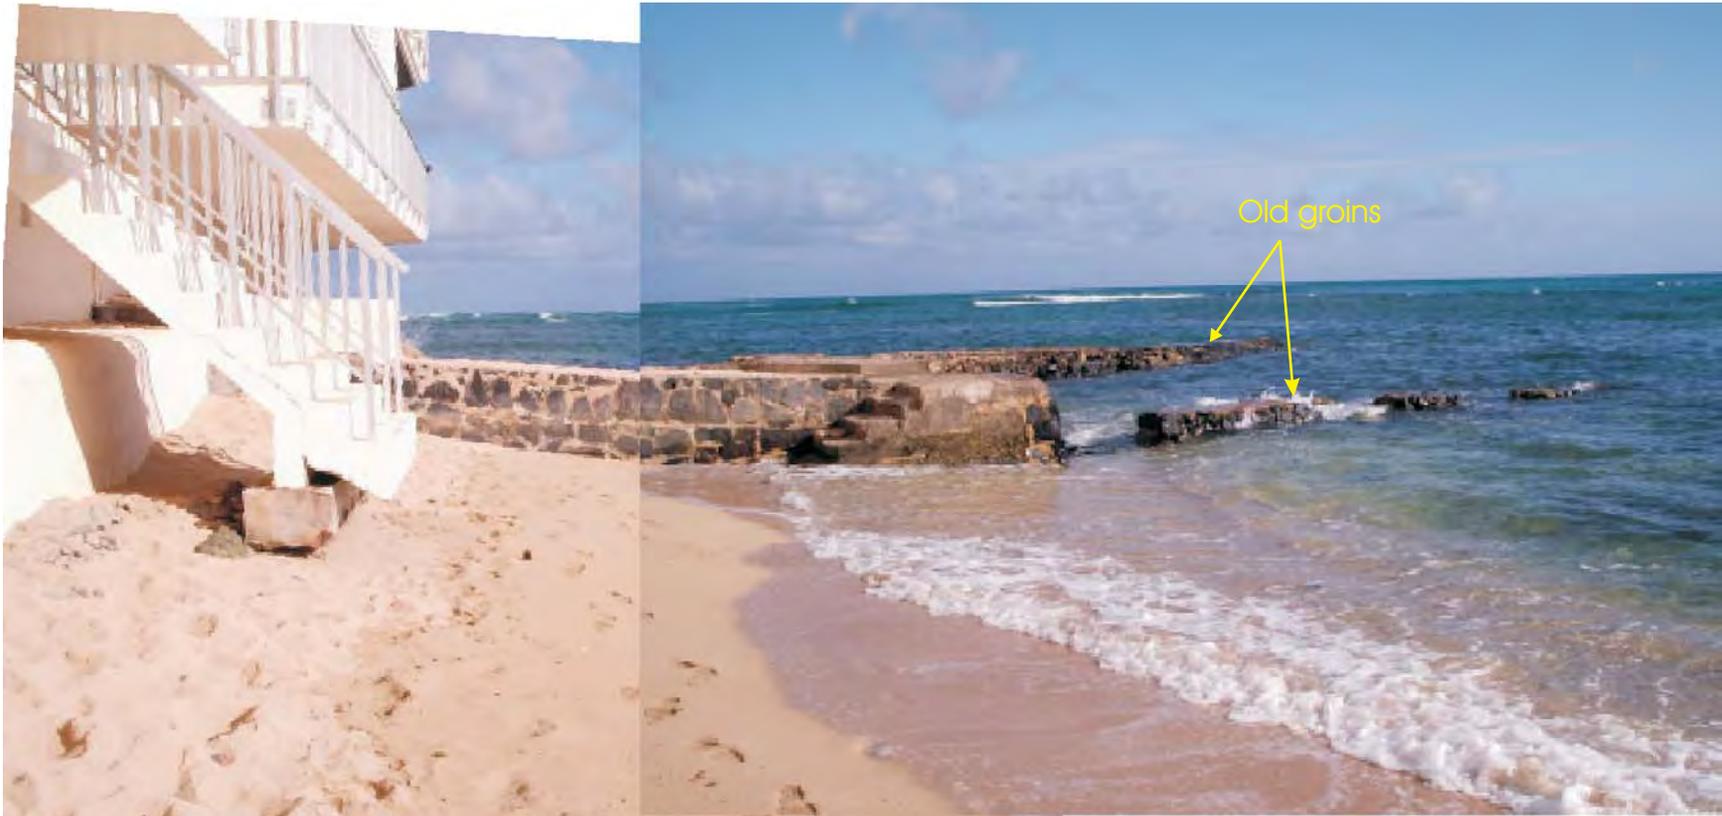
Property shorefront on north side of old groins. A narrow beach fronts this half of the building. Stairs lead to first floor apartment.

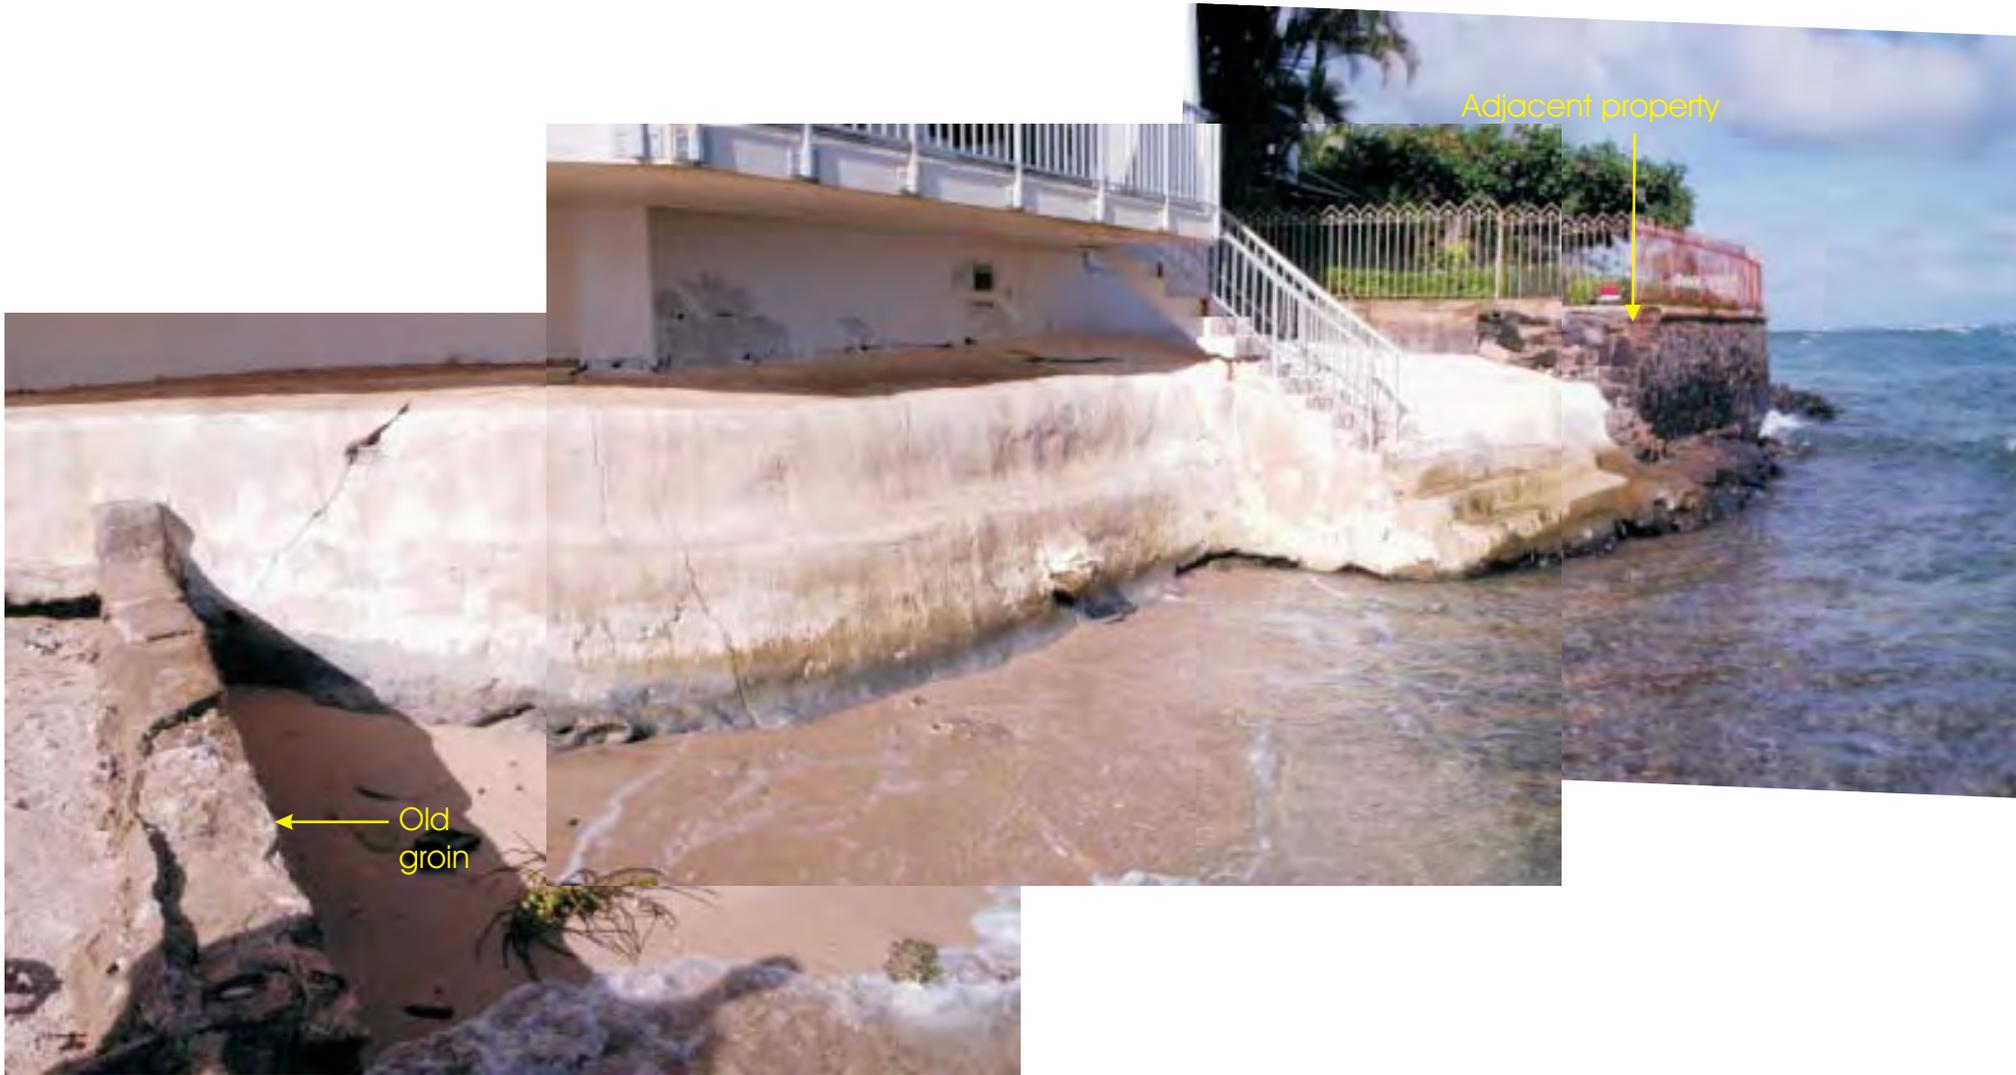
Property shorefront on south side of old groin. Gunitite covers old planter boxes adjacent to the building, formerly fronted by a narrow beach. Stairs lead to first floor apartment.

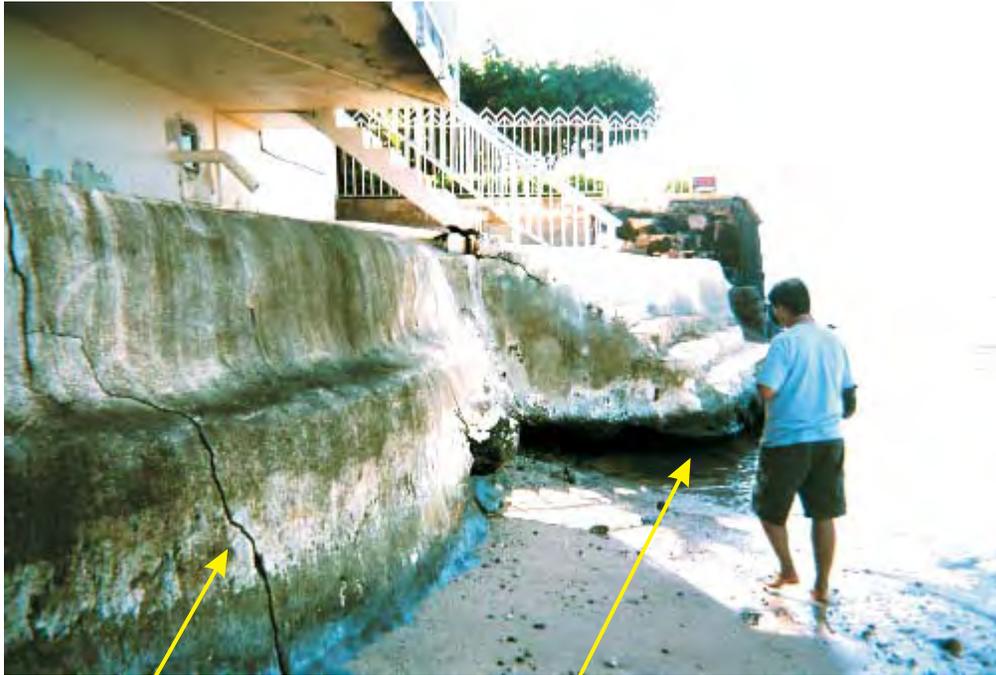
Cracks in gunite

Erosion of the remaining sand covering the reef flat fronting the building is causing continued damage to the gunite-covered structures. There is presently a scoured gap between the limestone reef and the base of the gunited stairs, and large cracks are developing in the gunite surface covering the planter boxes due to differential settlement.

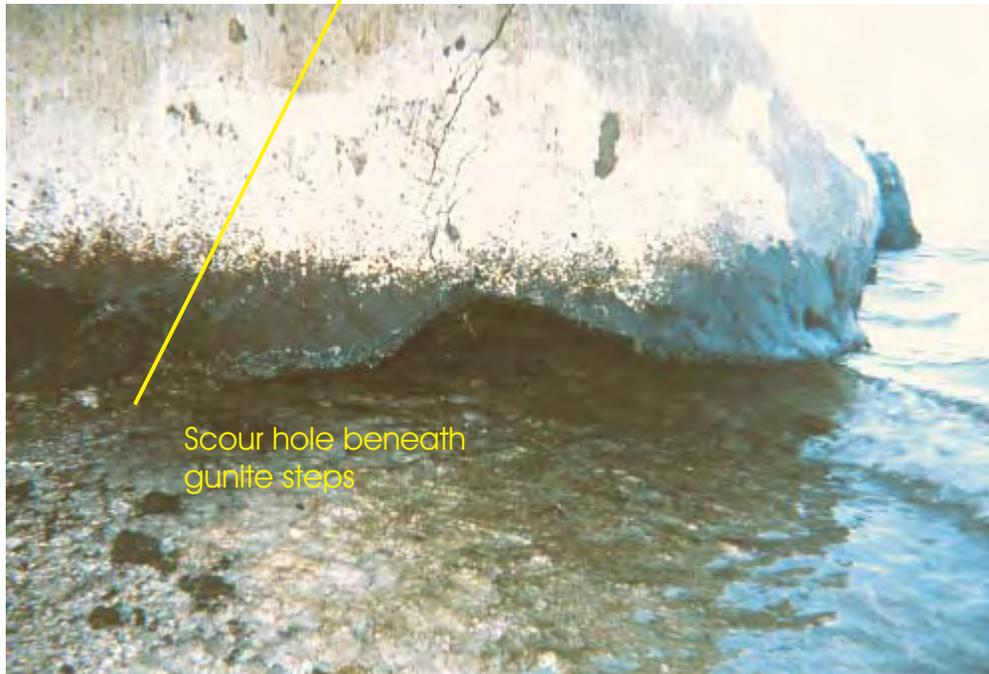
Scour hole beneath  
gunite steps
