COUNTY OF KAUAI
HOUSING AGENCY

Subject: Final Environmental Assessment for the Waimea
Theater Rehabilitation Project

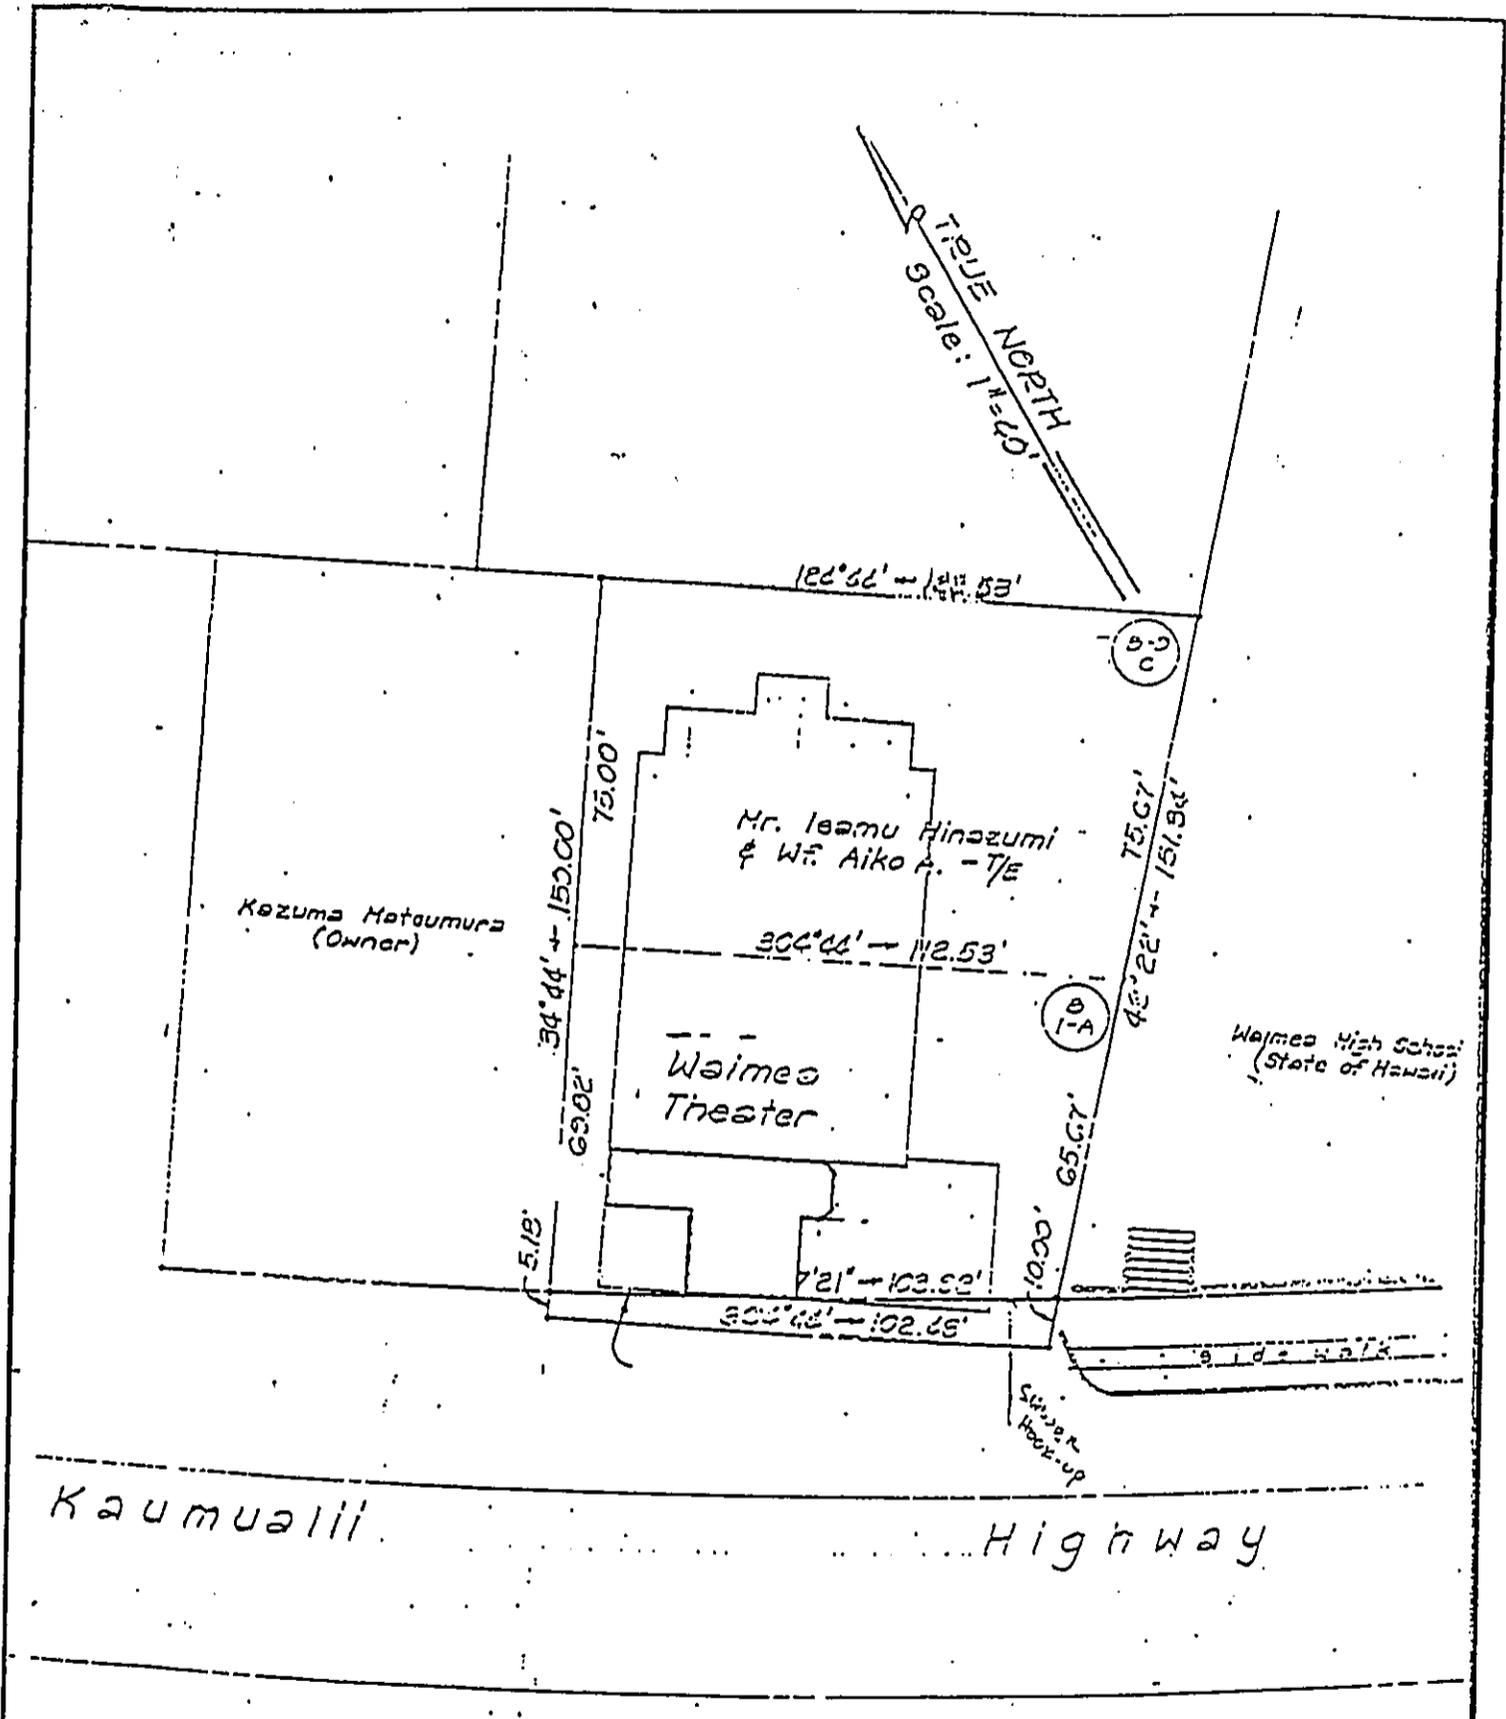
FIGURE
B

A small sink hole occurs northeast of the kitchen extension on the front east side of the theater. The sink hole appears to be in alignment with a sewer easement (Fig. B), but may be caused by an insignificant geologic condition. NEXUS recommends hand excavating the sink hole to see if it is caused by a utility line break.

TAX MAP KEY 1-06-09:8
WAIMEA THEATER, WAIMEA, KAUAI

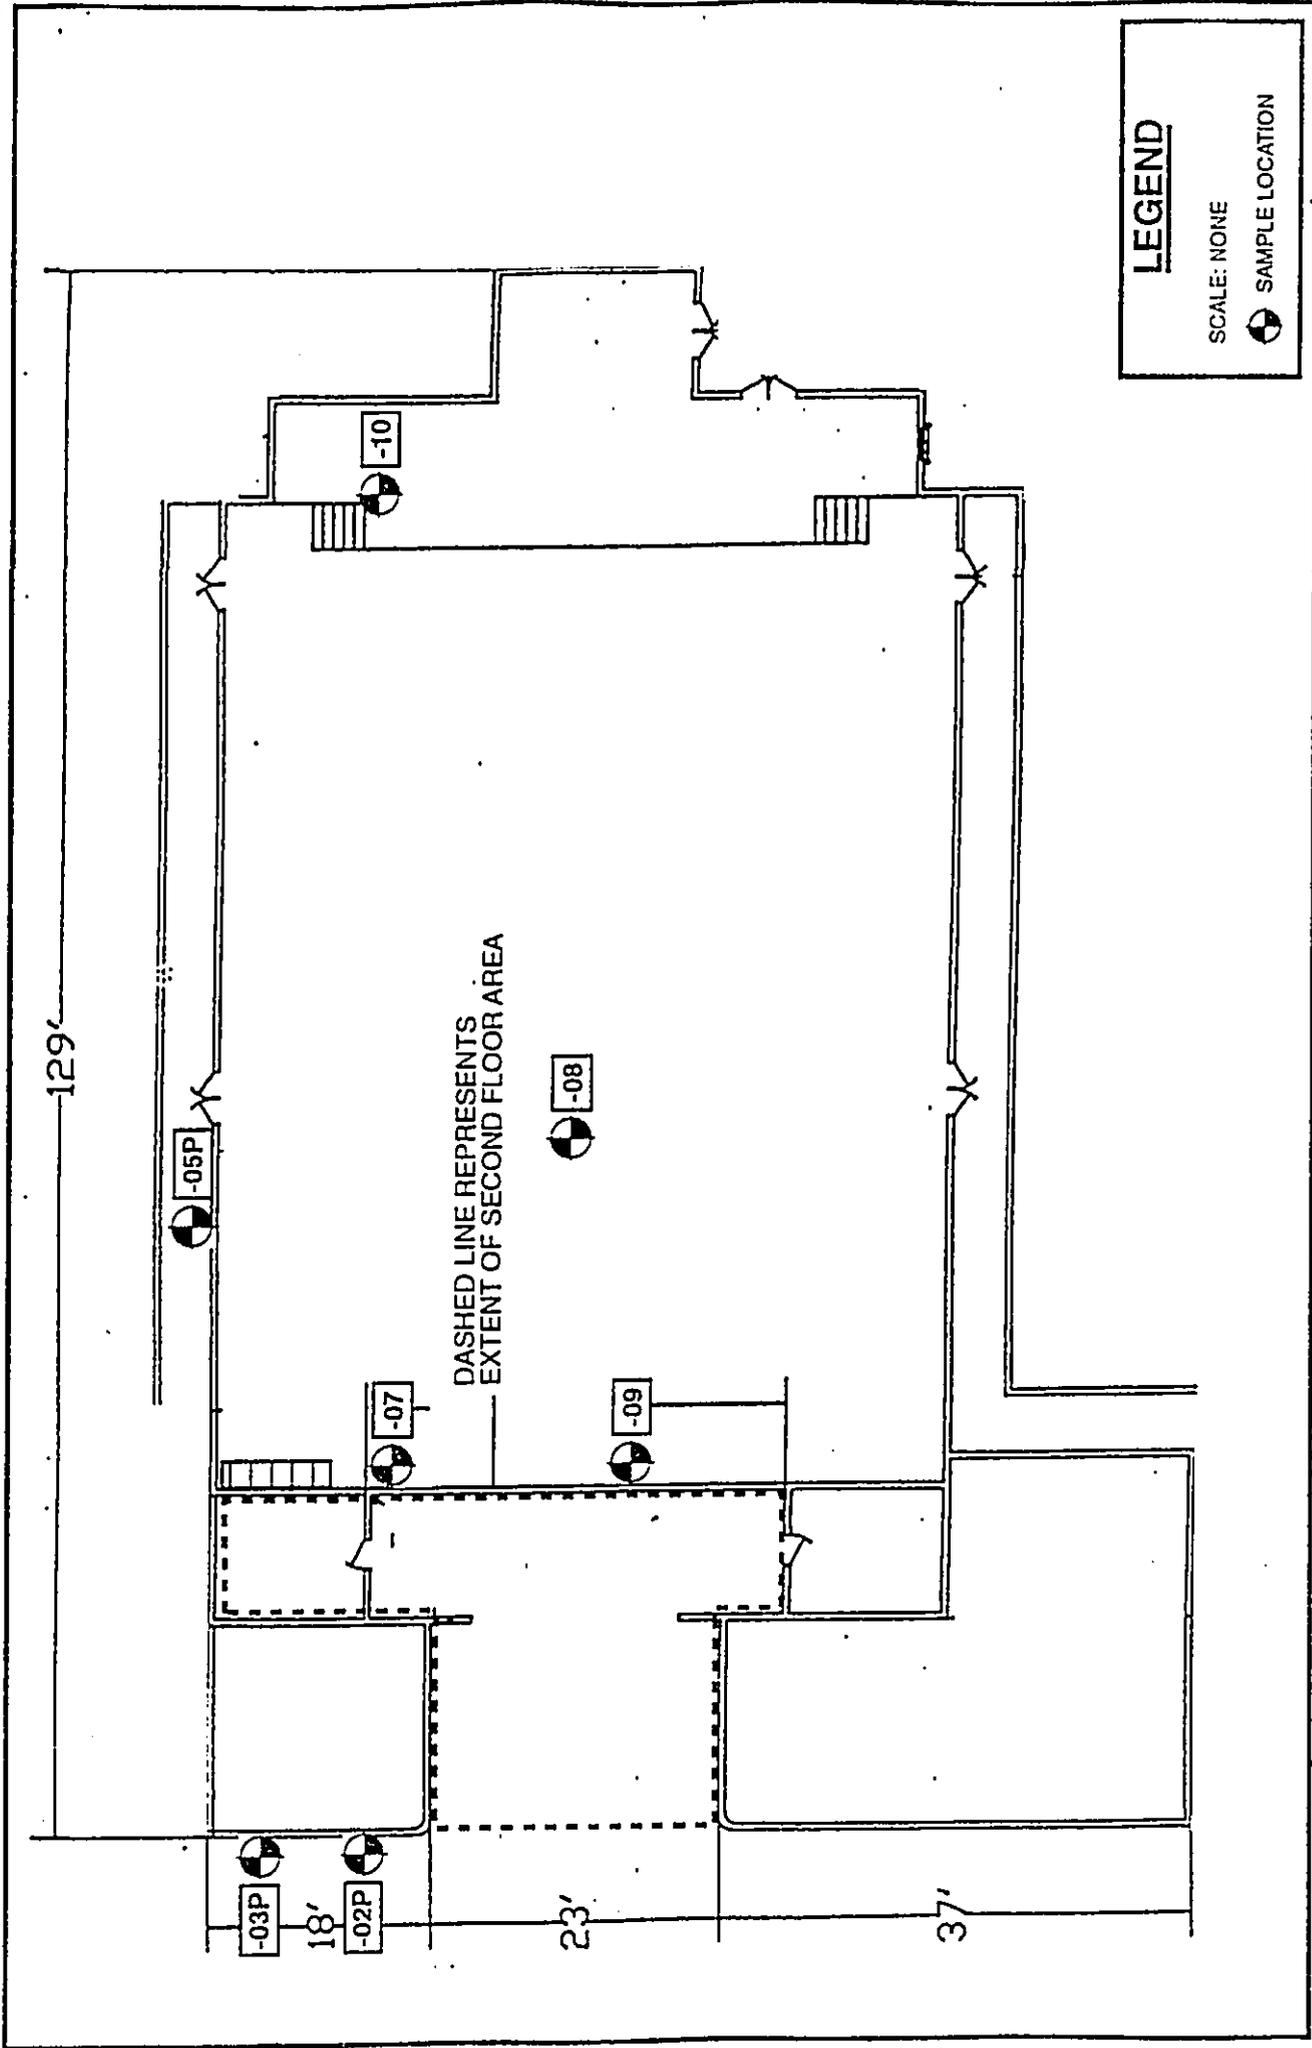
FIGURE
 D

SITE LAYOUT SHOWING GROUND FLOOR
 ASBESTOS & PAINT SURVEY SAMPLE LOCATIONS
 WAIMEA THEATER, WAIMEA, KAUAI

The recommended methods for the abatement of LBP's and ACBM in the attached Nexus report must be carefully adhered to prior to and during the rehabilitation of the Waimea Theater. It is recommended that Nexus be retained to prepare a scope of work for the removal of these materials as well as to certify that said removal and disposal has been conducted in accordance with applicable Federal, State and County regulations. It is suggested that their services be incorporated into the design/build Request for Proposal.
