Shoreline Setback Variance
Chapter 343, Hawaii Revised Statutes
Environmental Assessment (EA)/Determination
Finding of No Significant Impact

FINAL ENVIRONMENTAL ASSESSMENT

**RECONSTRUCTION OF A FAILING RETAINING
WALL AT 46-035 LILIPUNA ROAD
Kaneohe, Oahu, Hawaii**

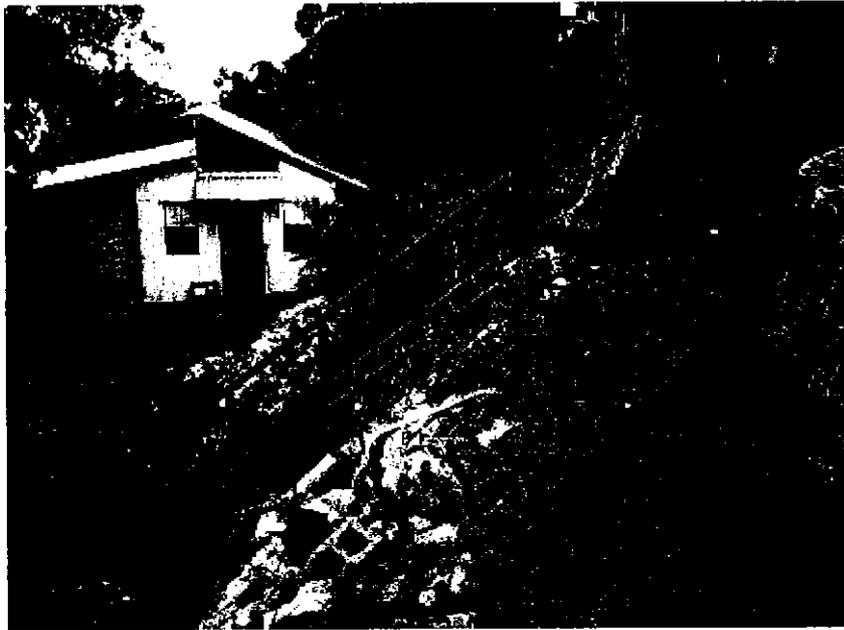
Although the wooden stair was originally in good condition when the EA was originally drafted in 2002, regrading of the area required the removal of the top 1/3 of the stair. The bobcat also struck and damaged the bottom section. The stair and wall sections in the design are attempts to construct a less visual but integrated system. These stairs are on a diagonal and in 3 short sections vs. the visually prominent 20-foot straight run (from the ocean) raised wooden stair.

Figure 15: Photo of Remaining Portion of The Original Stair

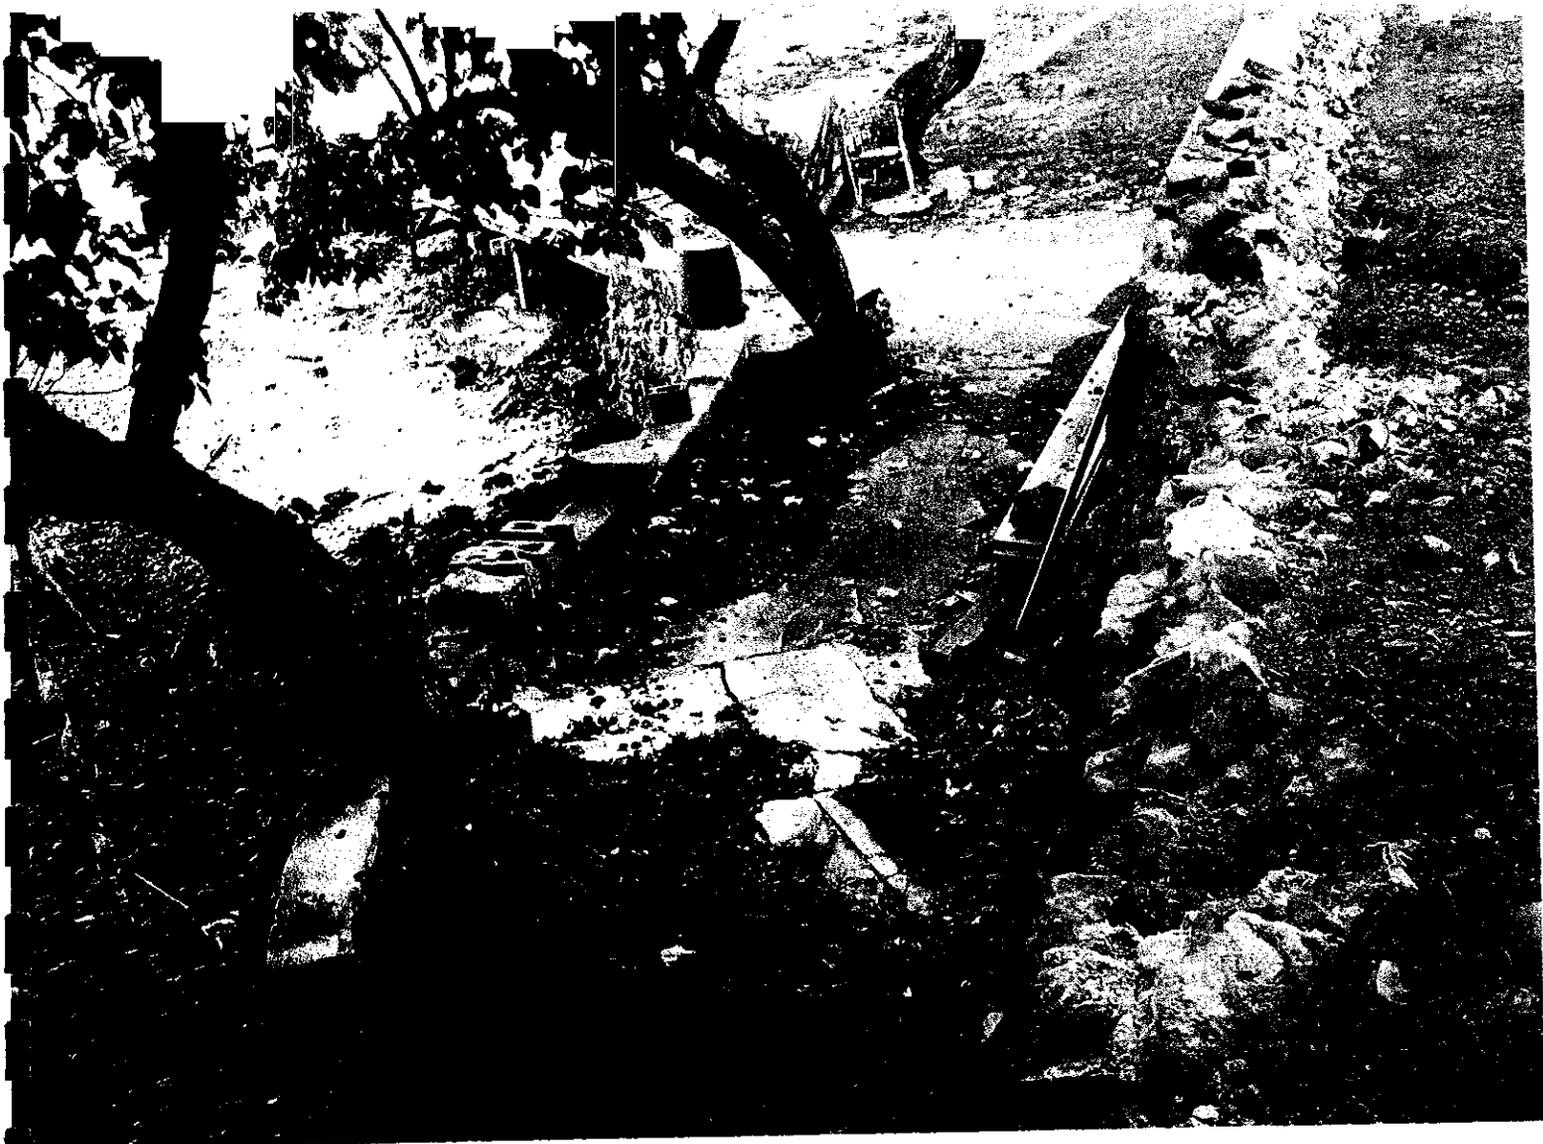
EXISTING SLAB SEAWARD OF
THE REMAINDER RETAINING WALL

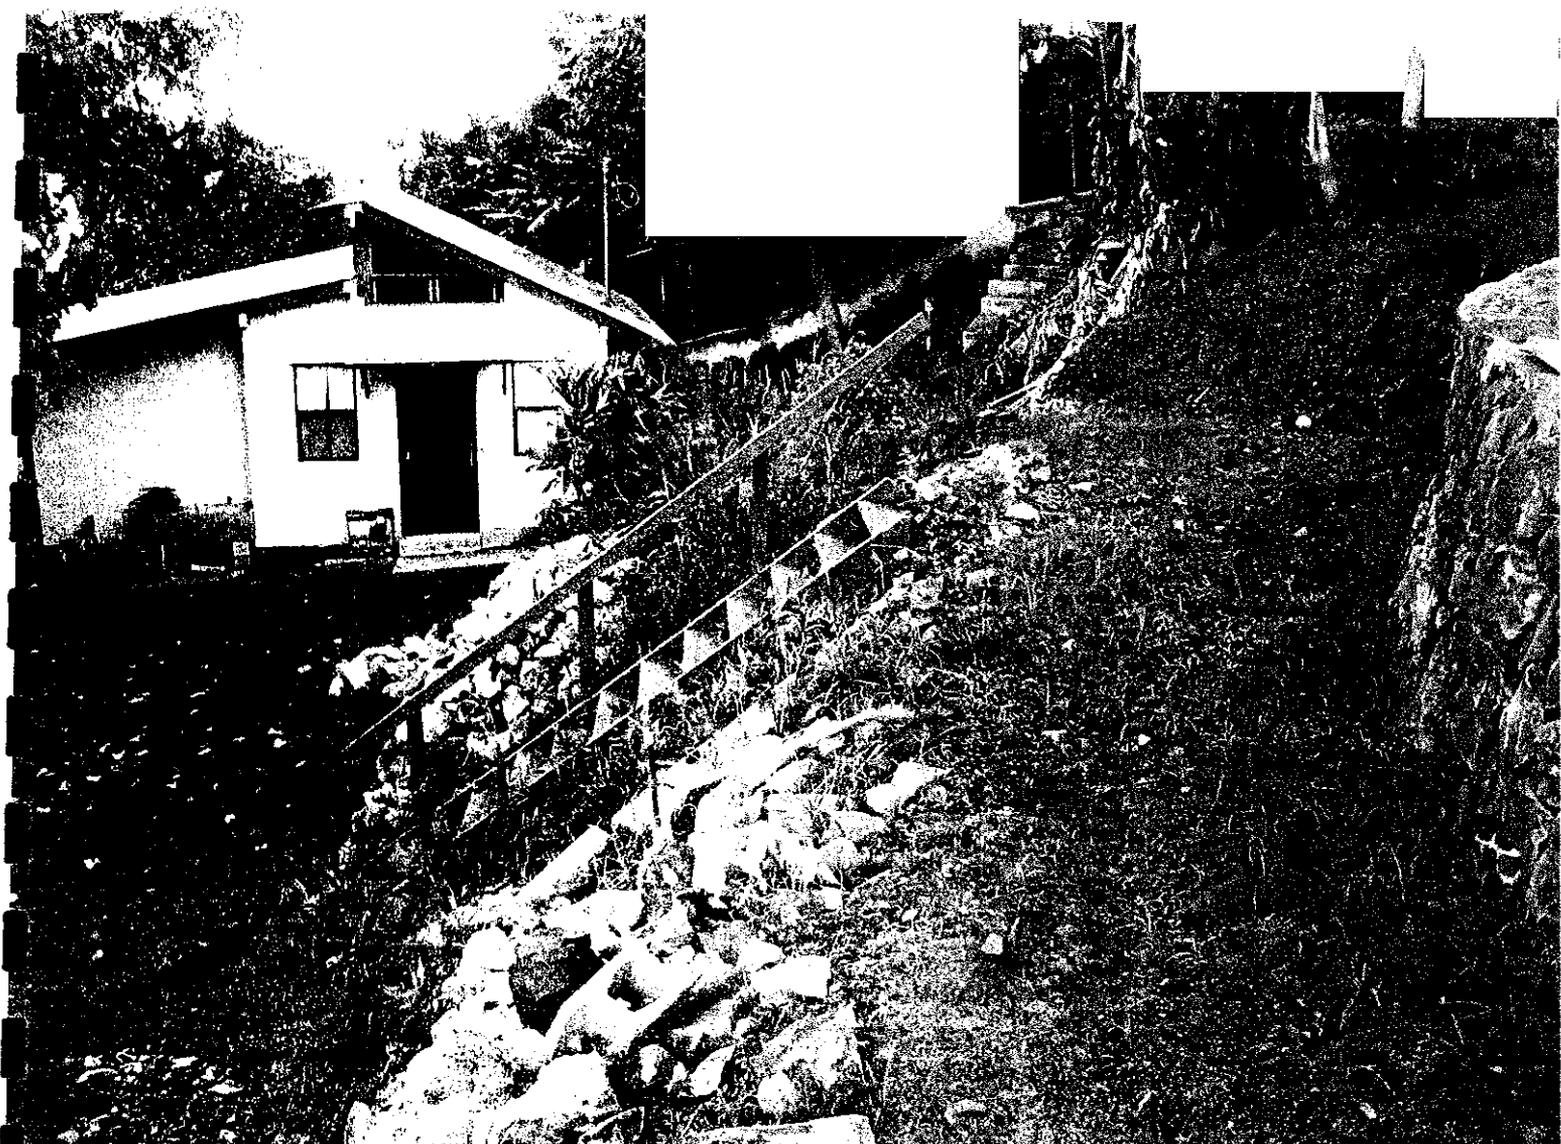
REMAINING PORTION OF
THE ORIGINAL STAIR

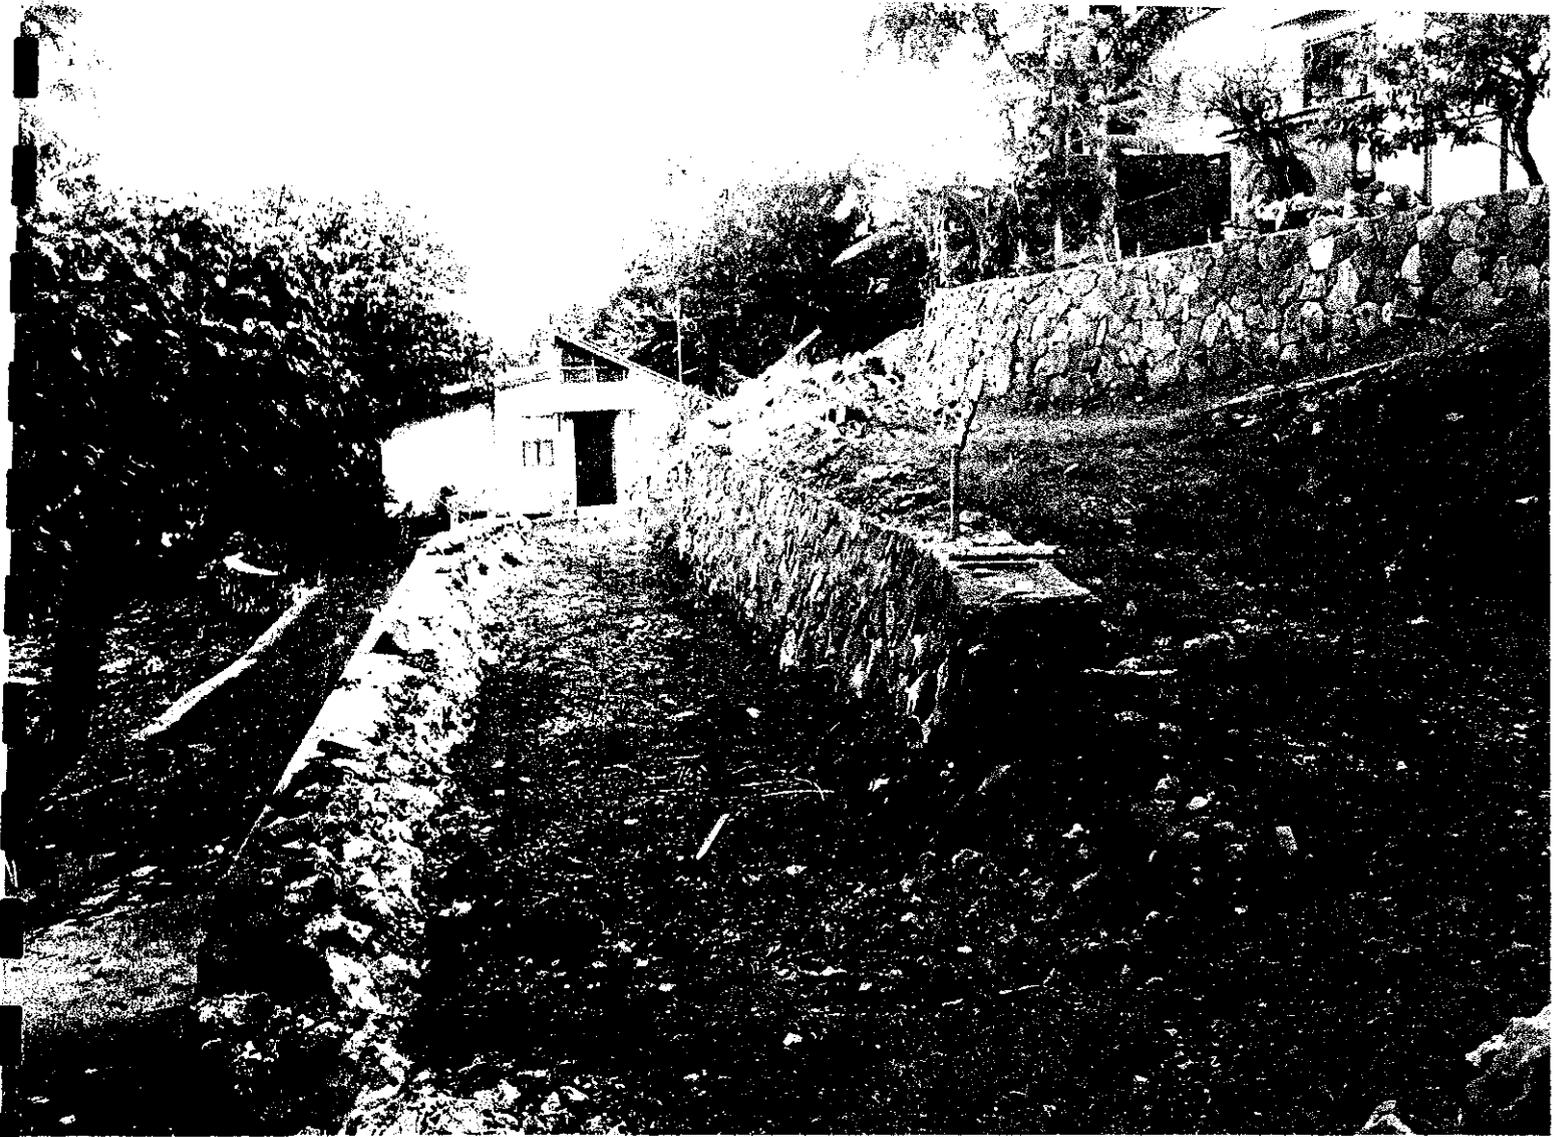
NEW SLOPE RETAINING WALLS
REINFORCED AND CUT DOWN
EXISTING RETAINING WALL
AND NEW GRADING.
