ENVIRONMENTAL ASSESSMENT FOR A SHORLINE
SETBACK VARIANCE APPLICATION

RETAINING WALL

47-079 Kamehameha Highway, Kaneohe, HI

TMK: 4-7-019-049

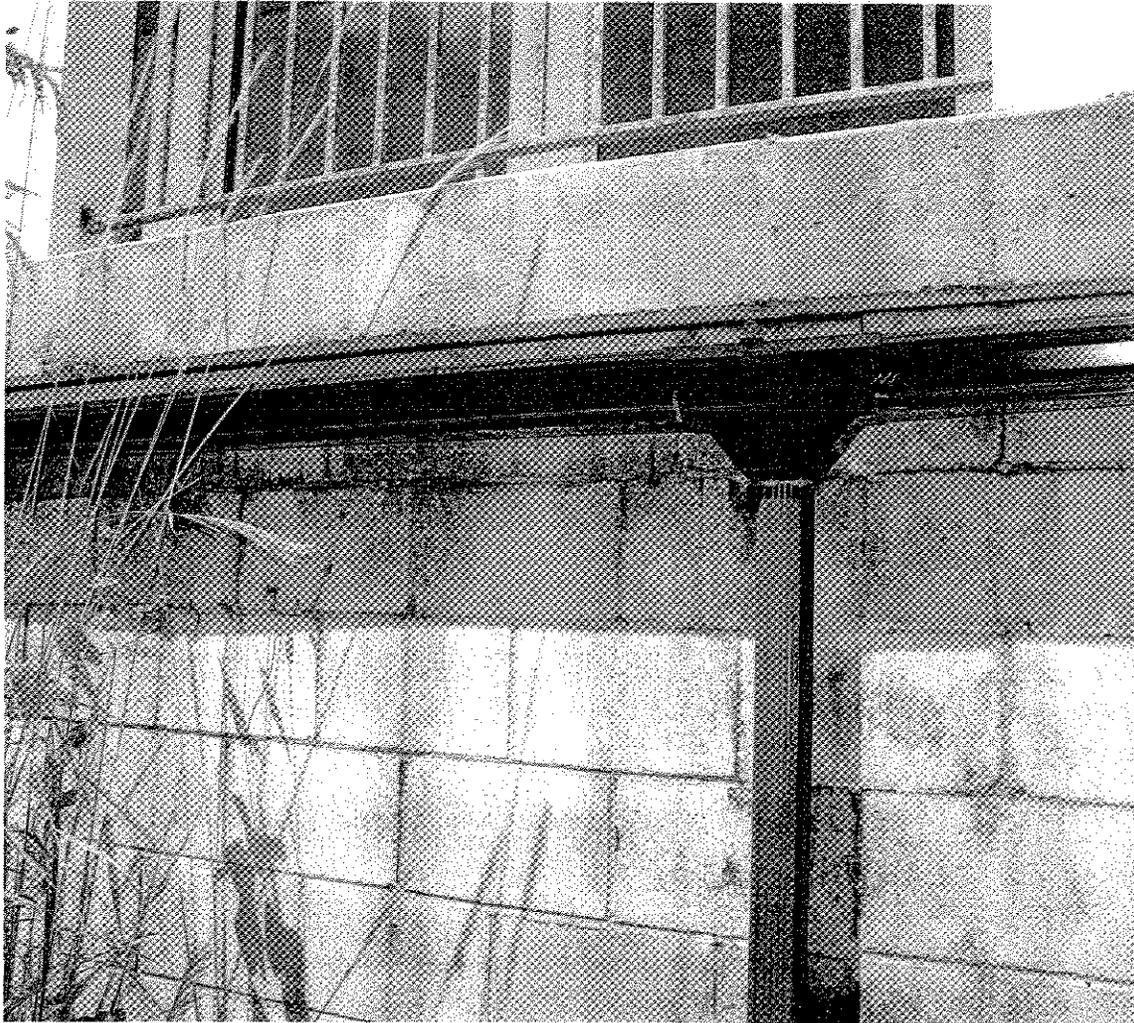
Exhibit 1

CMU wall with gutter system. Below this structure is dirt and weeds. There is about 2 feet some areas are less and some are a bit bigger of dirt and weeds before the cliff to the water.

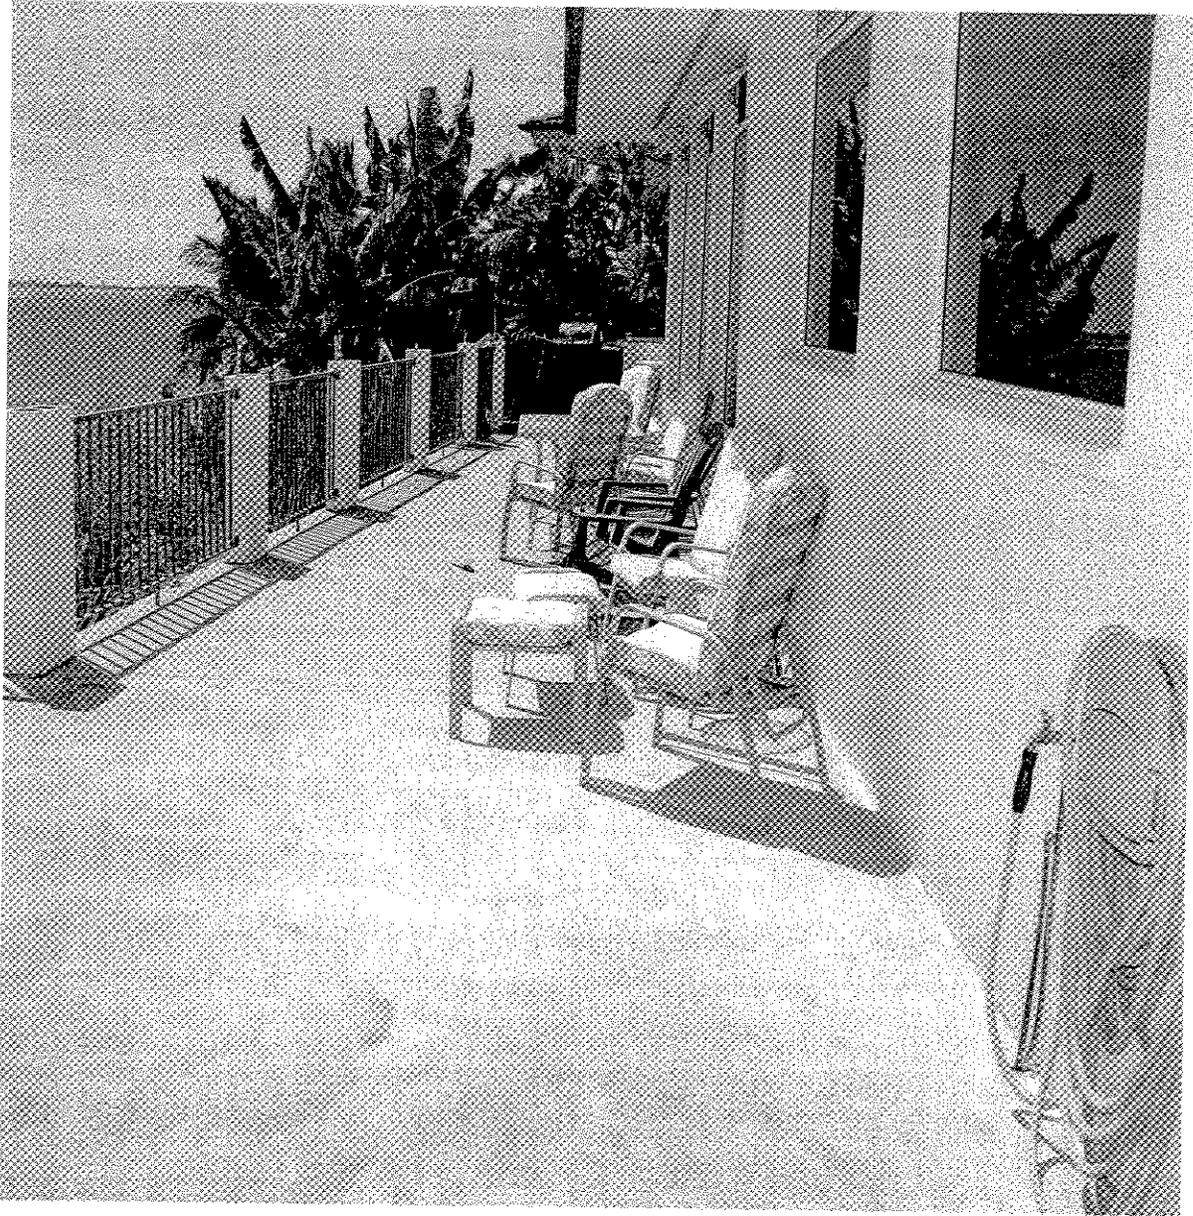
Exhibit 2

Proposed retaining wall with back fill and concrete. South View.

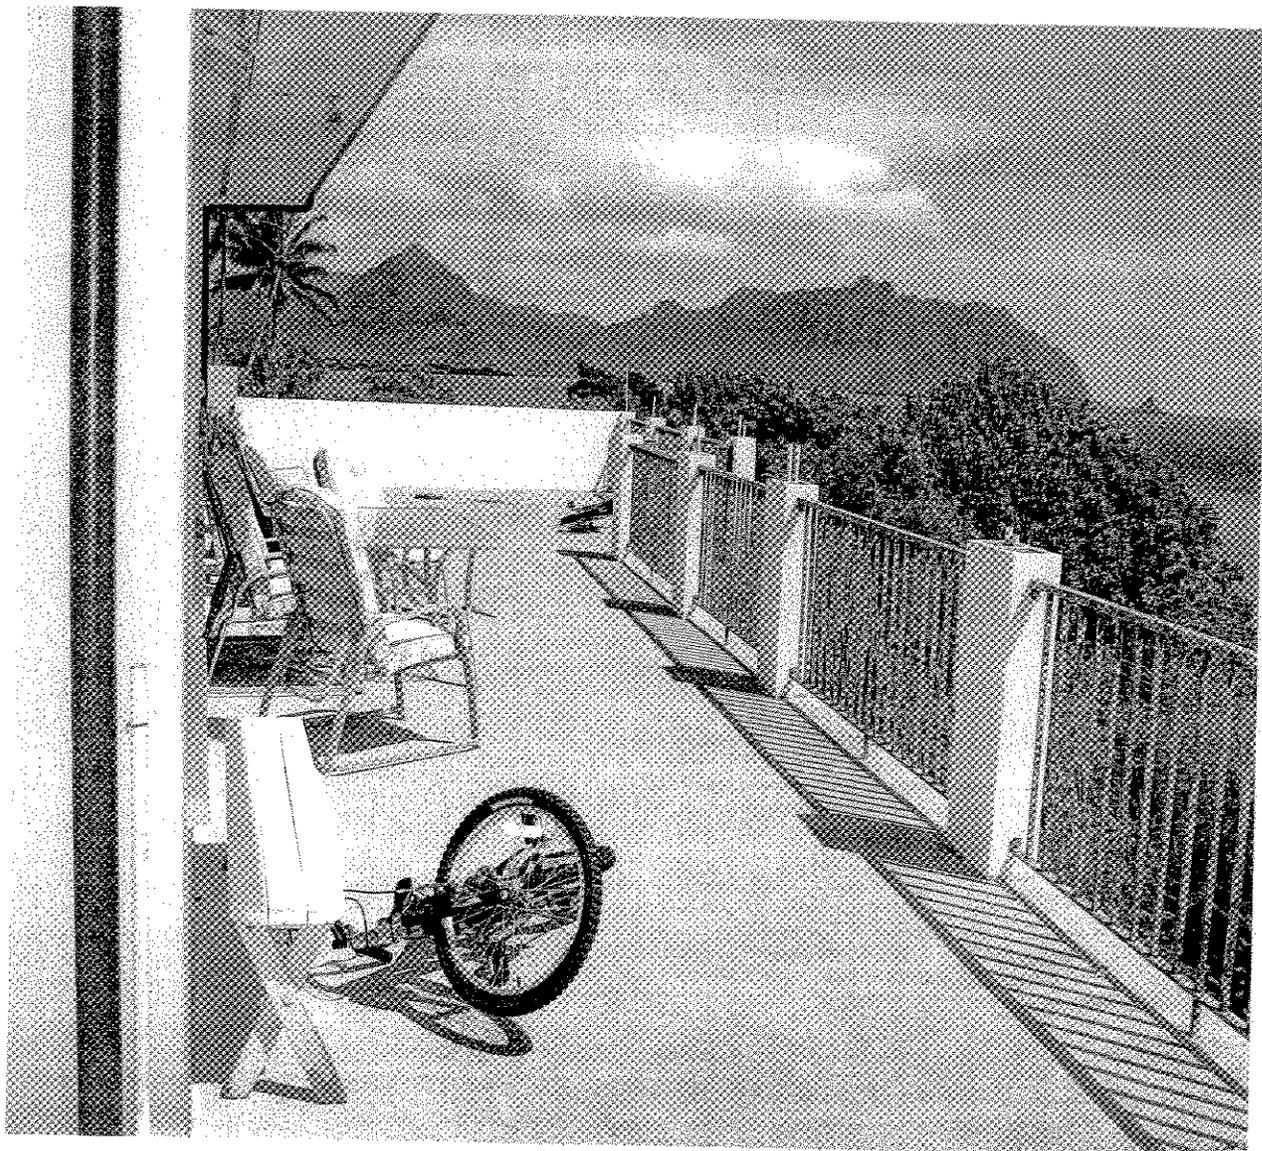
Exhibit 3

Proposed retaining wall with back fill and concrete

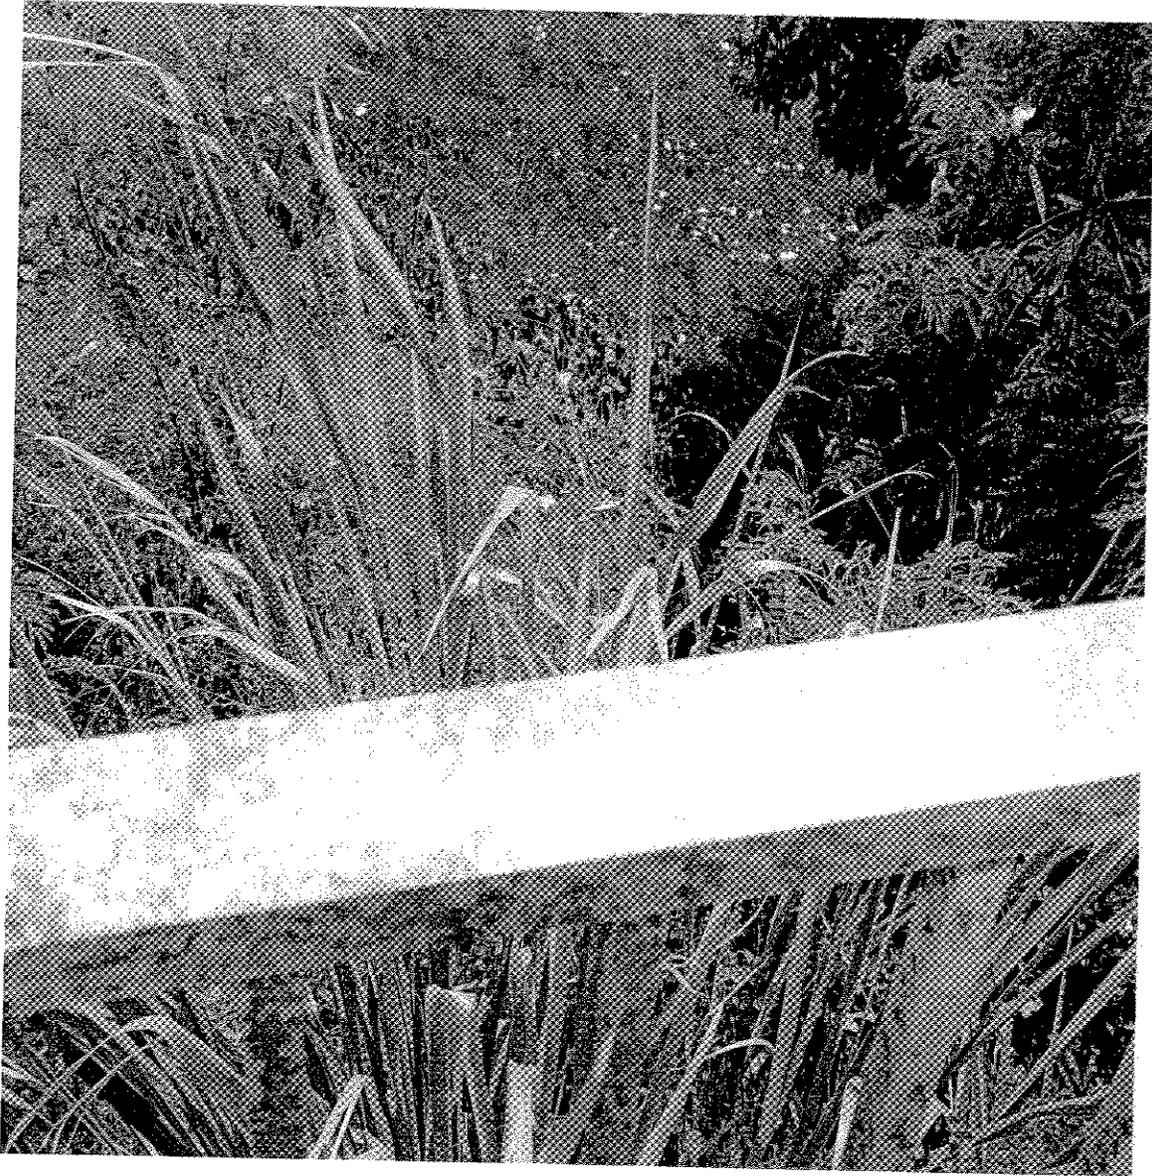
Exhibit 4

This is a photo of the cliff looking down from the retaining wall. Please take note on how dangerous it could be if there was no type of railing or retaining wall.

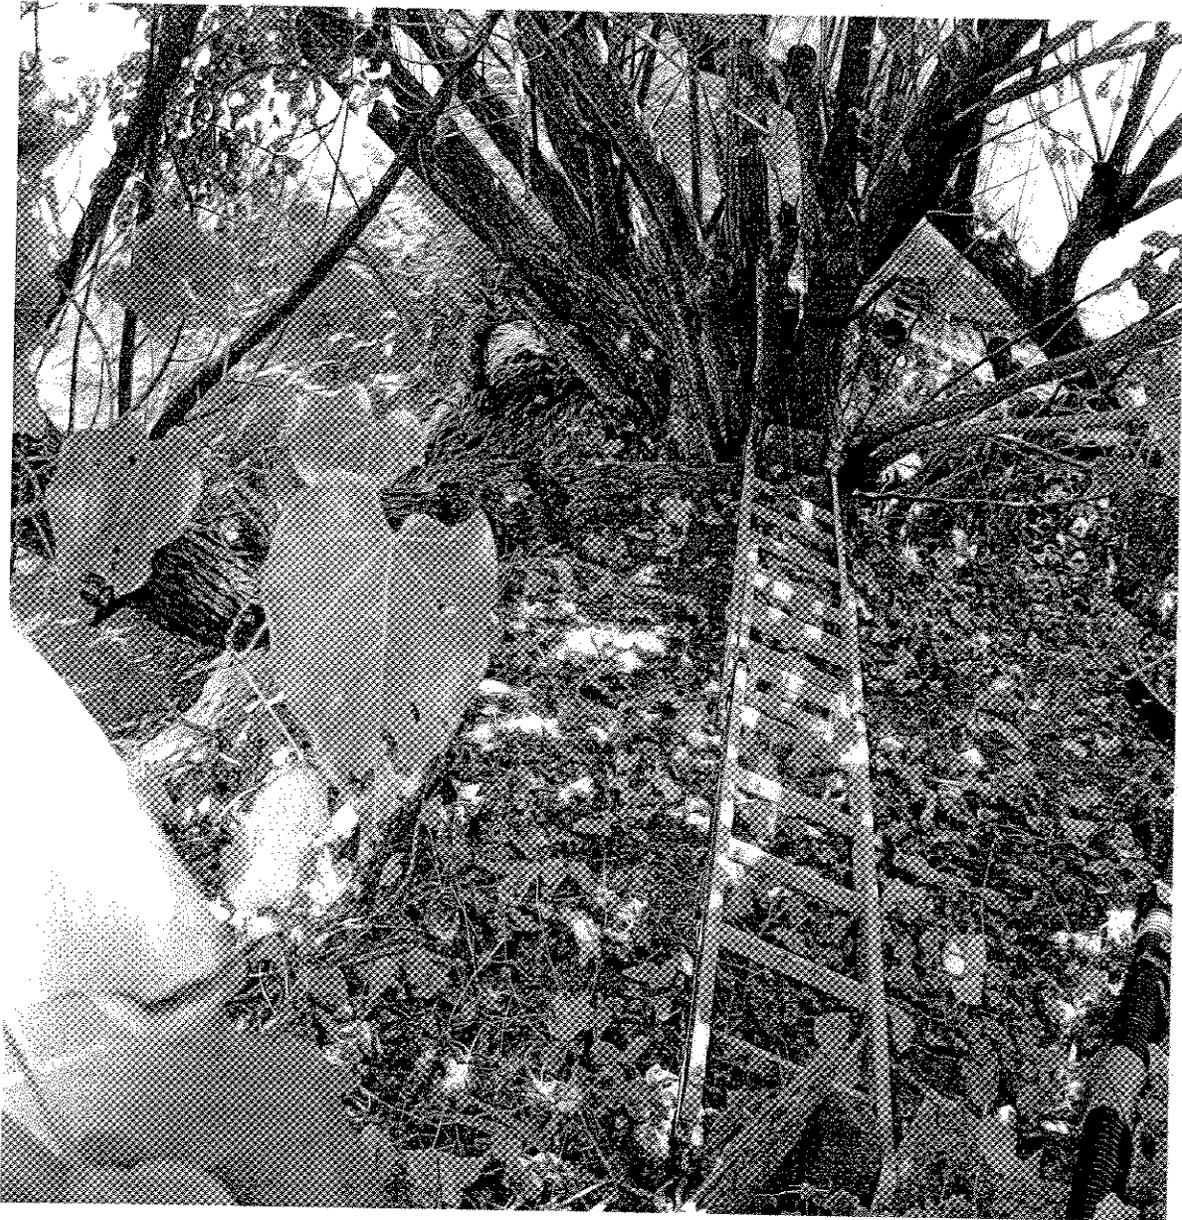
Exhibit 6

Front view of cliff from about half way up to the retaining wall from the water line. The erosion as you are well aware of will not stop until we control the slope and situation. Any large rains just create more danger and eat away at our property.

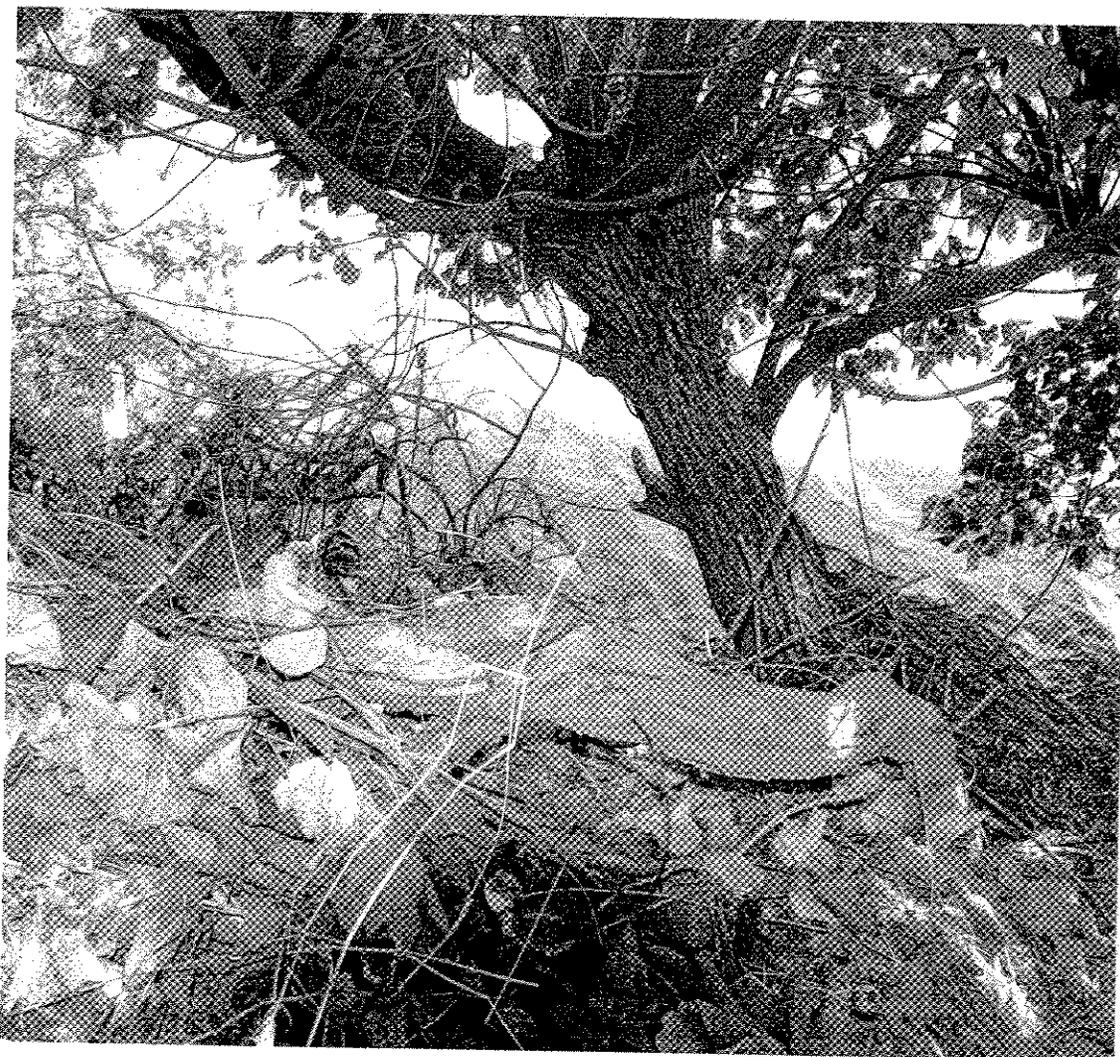
Exhibit 8

This is a very large span of land. This is another front view straight down (about 20 feet) from retaining wall. There is one large Milo tree on the proposed property. There is shrubbery along the hillside.

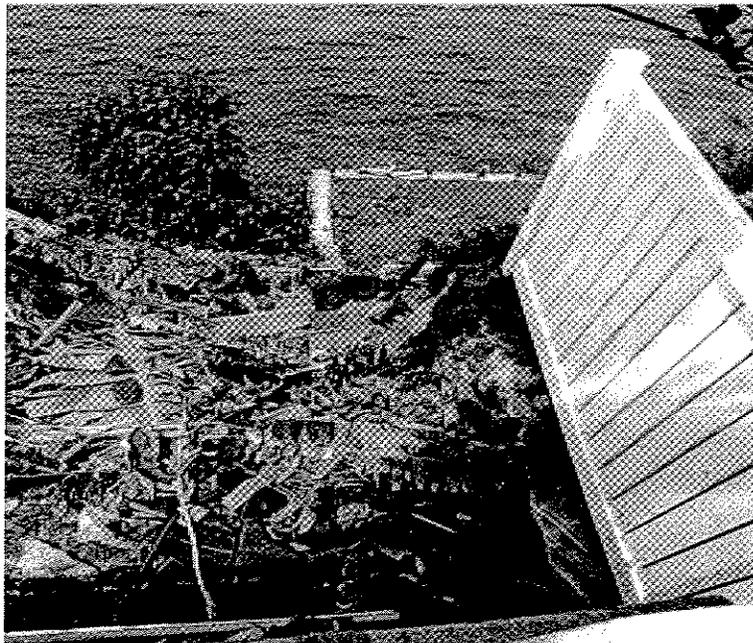
Exhibit 14

The photo is taken from the far right (Kaneohe side) of our property next to Wallace Ho. The white fence and rock wall is their property. Please note the severity of height elevation. This is 35' high.

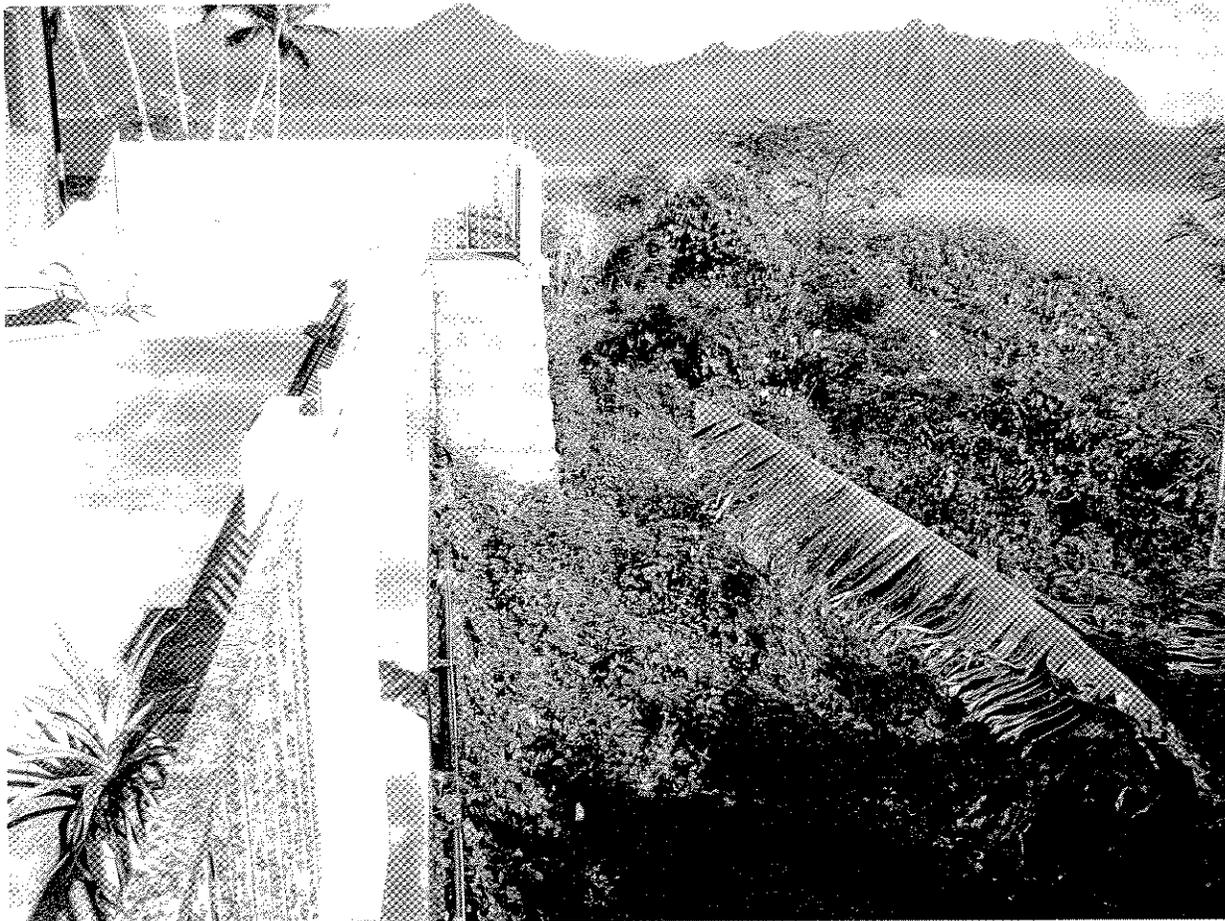
Figure 2. Rear portion of property with steep seaward cliff on the right.

At the base of the cliff is a narrow shore bench that is underlain by calcareous sand and reef limestone. High tides and storm surges from Kaneohe Bay can submerge all of the shoreline and reach the base of the cliff. Fill material to a depth of 2 to 3 feet extends from the edge of the cliff backward beneath the porch (Figure 2). Blue-gray rock, characteristic of dike formations, is exposed along a portion of the toe of the slope. Some of this rock is very hard and essentially un-weathered. However, the bulk of the exposed steep face that descends to sea level consists of highly to moderately weathered reddish volcanic

flows and sapolite. These materials are fractured, loose and unstable. In many places the soil is held in place only tenuously by vegetation. It is clear that substantial erosion and shallow sliding have taken place in the past, contributing unwanted volcanic soils to the waters of Kaneohe Bay. This process is exacerbated by ocean tides that wash directly against the toe of the cliff and are therefore contributing to its progressive undermining. Continued erosion and sliding are causing progressive headcutting at the top of the slope, which may soon start to undermine the porch area and even the residential foundation.

The steep slope that constitutes the seaward edge of the elevated cliff is unstable and in dire need of stabilization. Clearly the seaward cliff is undergoing progressive soil loss, mainly in the form of surface erosion and shallow sliding. These processes can be expected to continue, while a more serious deep-seated failure is not out of the question. Presently the exposed soil on the slope is loose, fractured and much of it is on the verge of descending toward the ocean. In many places soil material is barely held in place by weak root systems and the vegetation that covers the slope. This type of quasi-retention is unreliable and not acceptable from an engineering perspective.

Sooner or later the continued loss of soil will begin to undermine the porch and begin to compromise the structural integrity of the house. Aside from structural concerns regarding the porch and the house, the continued transport of volcanic soil from the cliff area into the waters of Kaneohe Bay is undesirable from an environmental perspective. Kaneohe Bay is a fragile ecosystem that in the past has suffered from excessive inflow of volcanic soils. Of particular concern is the underwater reef ecosystem that exists nearby which can easily be damaged by volcanic soils that wash into the bay and are then transported by nearshore currents and tides. The potential negative environmental consequences from soil transport into Kaneohe Bay are sufficient to warrant the construction of an effective retention system.

A single retaining wall on the order of 30 feet in height may be quite expensive and unsightly. A set of tiered walls would appear to be a more reasonable choice. However, the details of the retention system need to be designed with care and should be reviewed by Applied Geosciences to insure that it is stable and compatible with the site conditions and this report. Design parameters for retaining walls are presented below.

After obtaining the proper permits and installing suitable erosion control measures, all loose soils, vegetation, concrete and other debris should be removed from the slope to expose firm soil or rock materials. Clearing and grubbing should be observed by a qualified geotechnical engineer. Utilities, if any, should be located and shut off prior to any grading. If existing utilities are to be abandoned, they should be removed, and the resulting excavation should be properly backfilled with select granular fill material compacted to a minimum of 90 percent relative compaction. The final grade prior to commencing backfilling and/or construction of the new retention system should be approved by a qualified geotechnical engineer.

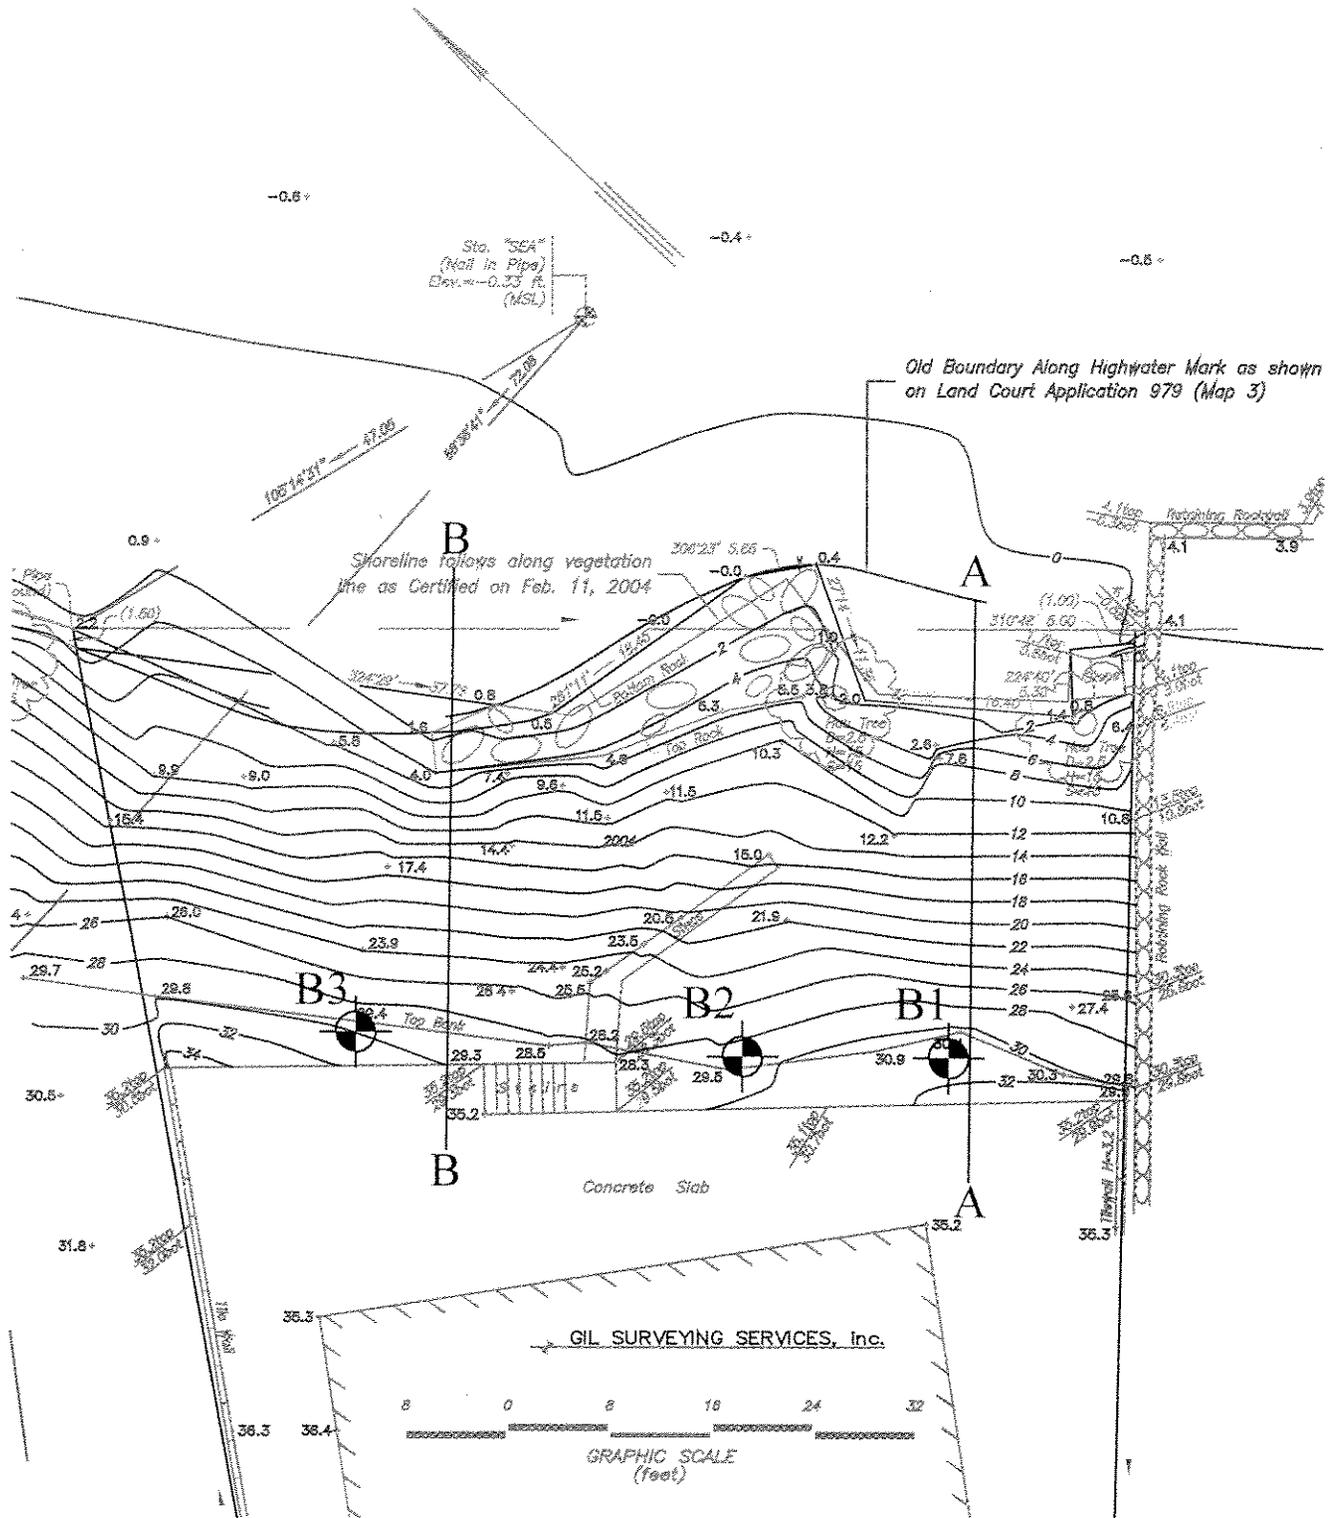
Figure 3

Figure 4 indicates a minimum factor of safety of 1.19 for line AA. The calculations assume hard rock at a relatively shallow depth, as determined from surface outcrops and borings taken both on this property and the neighboring one on the left. A high water elevation is assumed, as shown in Figure 3. This accounts for substantial ground saturation under extenuating circumstances. Although the computed factor of safety is larger than 1.0 and therefore indicates a stable condition, values less than 1.50 are generally deemed potentially hazardous and unacceptable. A deep-seated failure would be limited in depth by the hard basalt rock beneath. Since the depth and extent of this basalt is expected to be non-uniform, the potential for substantial soil movement in the case of a large failure cannot be discounted with confidence. It is therefore conceivable that under severely adverse condition such a failure could compromise the structural integrity of the existing porch and the main house. A similar conclusion can be drawn from considering the stability analysis results depicted in Figure 5 for section BB. Here the factor of safety is much too close to the threshold of 1.0 for the initiation of deep sliding. Both analysis cross
