Subject: Chapter 343, Hawaii Revised Statutes (HRS)
Final Environmental Assessment (EA) Determination
Finding of No Significant Impact (FONSI)

Final Environmental Assessment

Heinz Sea Wall Repair Kane'ohe Bay, O'ahu, Hawai'i

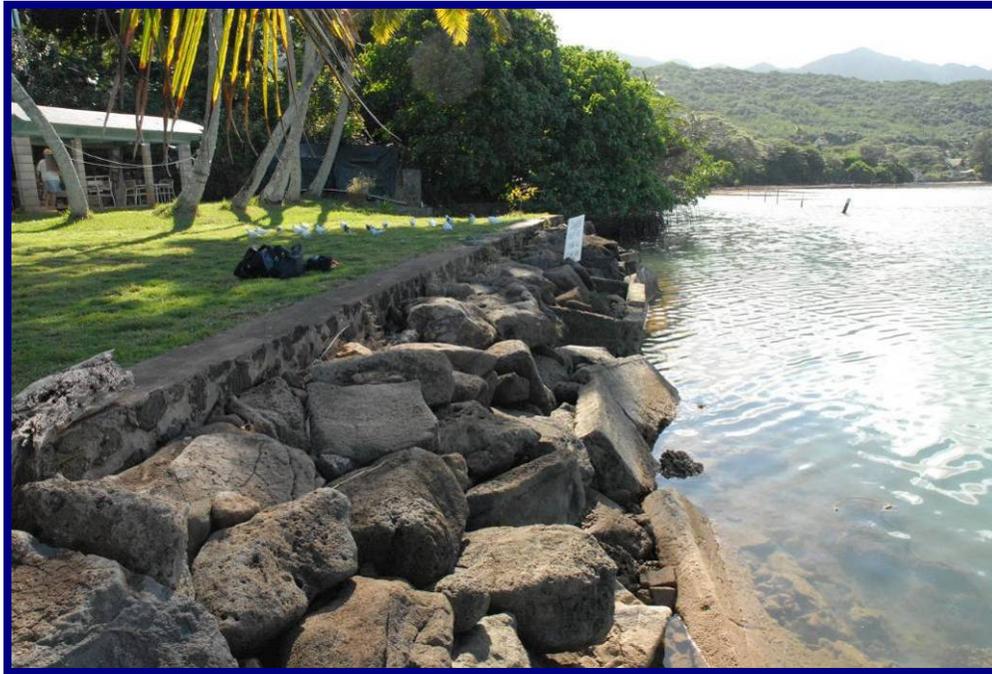
Figure 5. West Side of Central Double Wall System (taken 1/25/07)

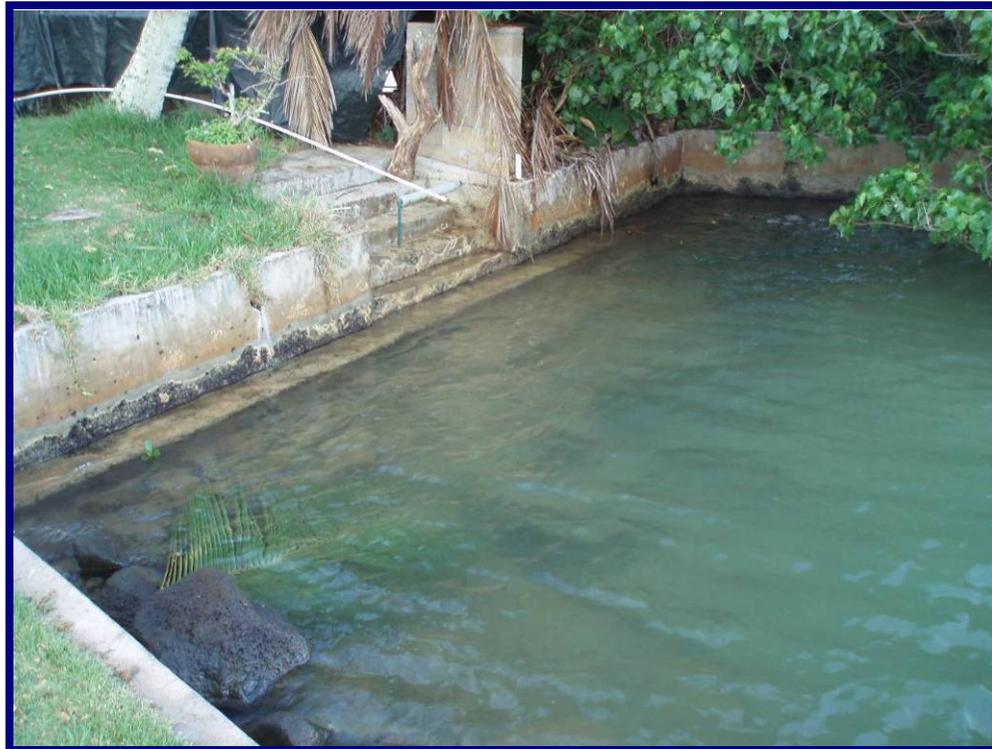
Figure 6. Concrete Wall on West Section of the Wall System (taken 1/25/07)

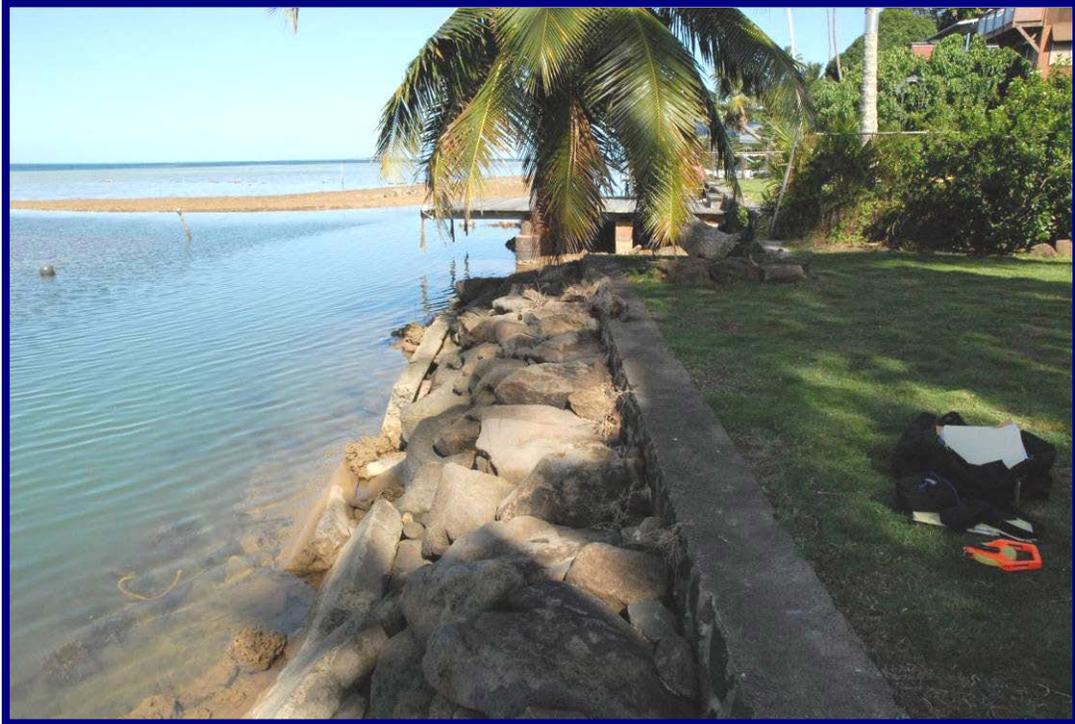
Figure 7. Eastern Portion of the Heinz Wall System (taken 1/25/07)

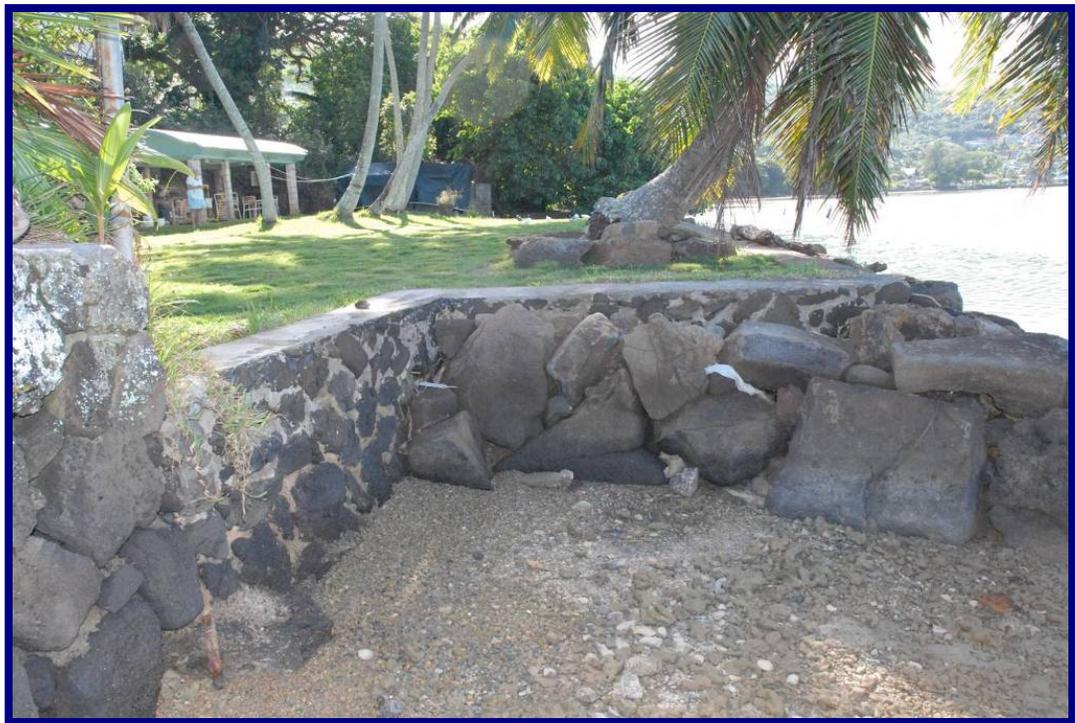
Figure 8. CRM Wall on Eastern Side of Lot (taken 1/25/07)

3. The seawall on the east side of the property is a CRM wall that ties into the inner CRM wall and extends to the property line. No information on the foundation depth and type has been found. Coral gravel has built up along part of the east wall. The design consultant recommends that this wall be replaced with sheet piles when the remaining walls are replaced.
4. The seawall on the west side of the property is made with concrete. It has a visible foundation (not buried) with scour gaps beneath the wall. The wall does not appear to extend far enough below the surface to prevent the scouring. The concrete has deteriorated over its life. The design consultant's recommendation is to replace the wall with a new sheet pile wall rather than try to repair it. Repair would be expensive, would require excavation of the land inside the wall, and would likely require dewatering.

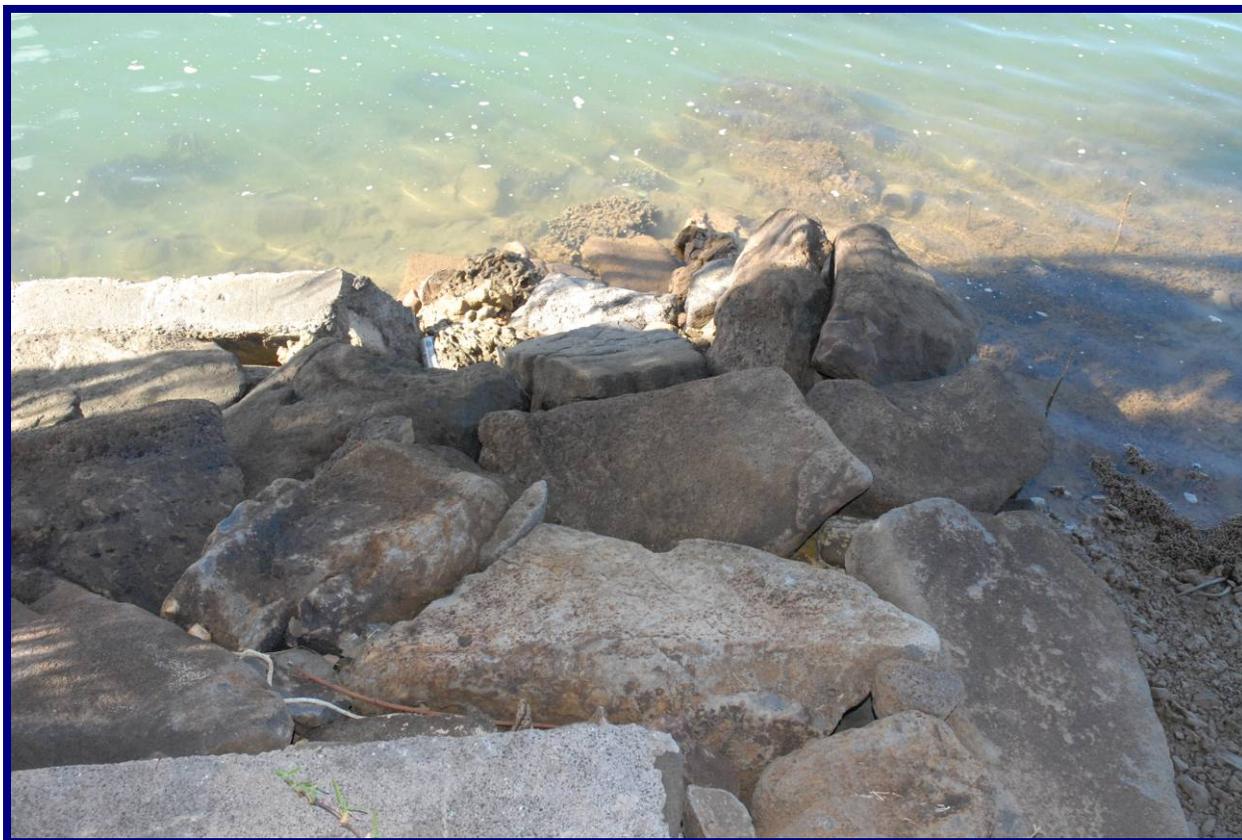
Figure 9. Rocks Encroaching in State Waters (taken 1/25/07)

The history of the existing walls along the property shoreline is not completely known. An old shoreline map shows the outer and inner seawalls in place on January 15, 1963, which does make them nonconforming. Dr. Heinz does not have copies of the original plans for the existing walls. Dr. Heinz hired a structural engineer to draw plans of the existing walls as they appeared in 2006. These plans are shown in Figures 10 through 12. The shape of the buried parts of the walls was assumed based on what is typical. CRM wall depths below grade are not known. Reinforced concrete wall dimensions based on measurements are shown. Some of the rock areas around the walls are labeled: “new rip rap slope protection.” These rocks were added in January 2006 and have been addressed in discussions with DLNR/OCCL regarding a new shoreline certification. These rocks and the broken outer seawall will be removed as a condition of the shoreline certification.

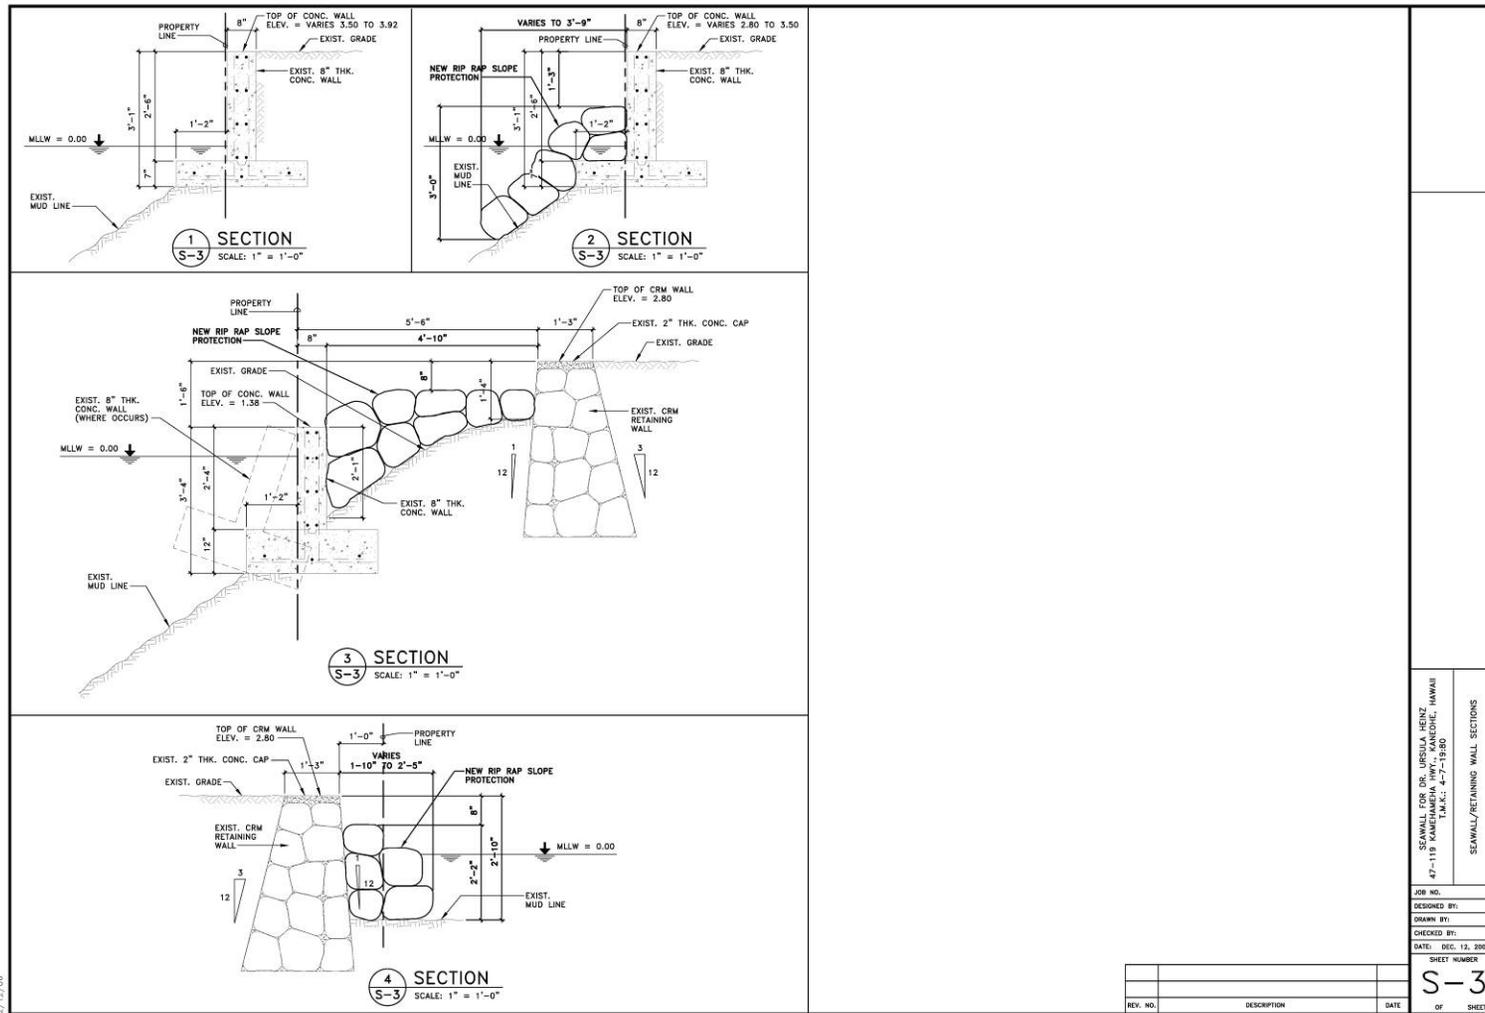
1. A section of the seawall system was a double wall. The outer wall was a seawall that was undermined by erosion along the adjacent shoreline boat channel and has mostly collapsed. The outer wall is damaged beyond the practical possibility of repair. Therefore, the design consultant initially recommended replacement. The certified shoreline formerly ran along the outer wall, but the Department of Land and Natural Resources determined that the ocean had passed through the location of the shoreline and that the shoreline would have to be moved inland to the inner wall, thereby making the outer collapsed wall and the rock fill encroachments into state waters, which would have to be removed before a certified shoreline could be approved and any repairs made.

2. Since the outer seawall must be removed, the inner CRM wall would have to work as a seawall if left in place. The CRM wall does not appear to the design consultants as properly designed or constructed to be a seawall. There is no available information on the foundation depth or type. The inner wall is a retaining wall for the dredged fill that was used to construct the property originally.

Figure 12. Existing Seawall Sections

The outer wall and the rocks placed between the two walls currently support the inner wall. When the encroaching material is removed, this support will be gone. To prevent inner wall collapse, the design consultant's recommendation is to replace the CRM wall with a properly designed and constructed sheet pile wall.

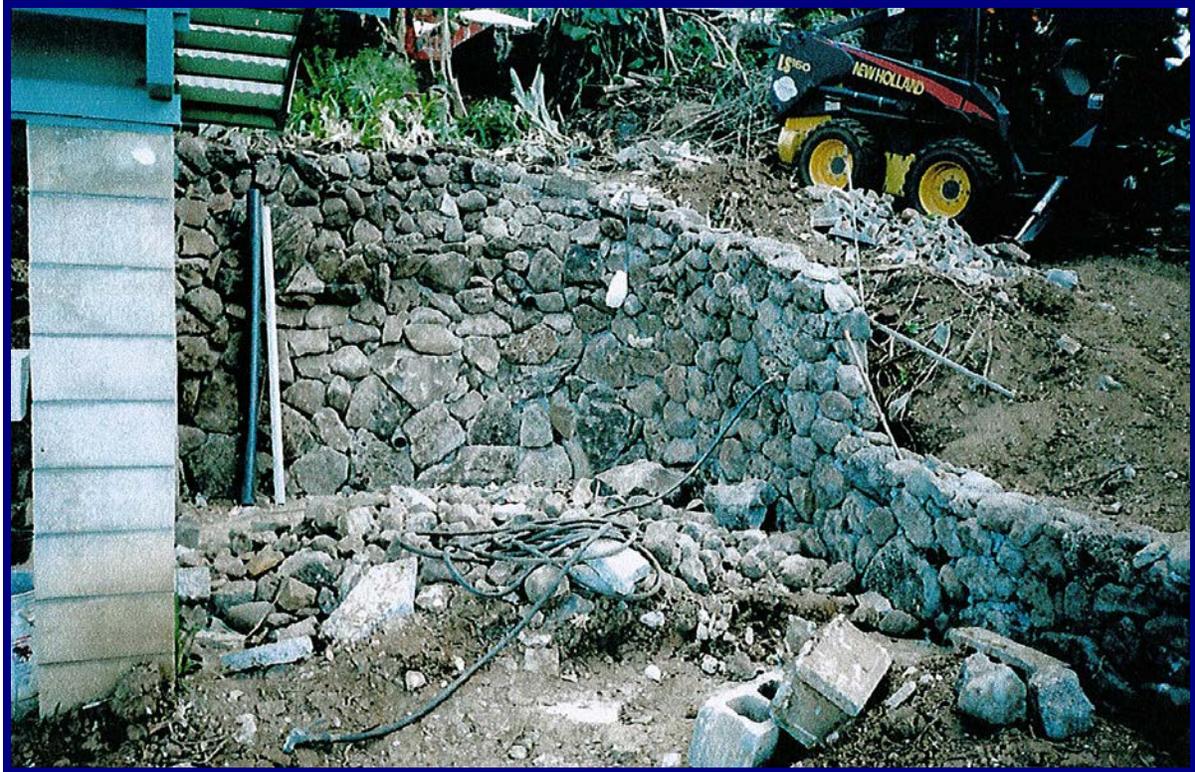
Figure 14. Reconstructed Side and Back CRM Wall

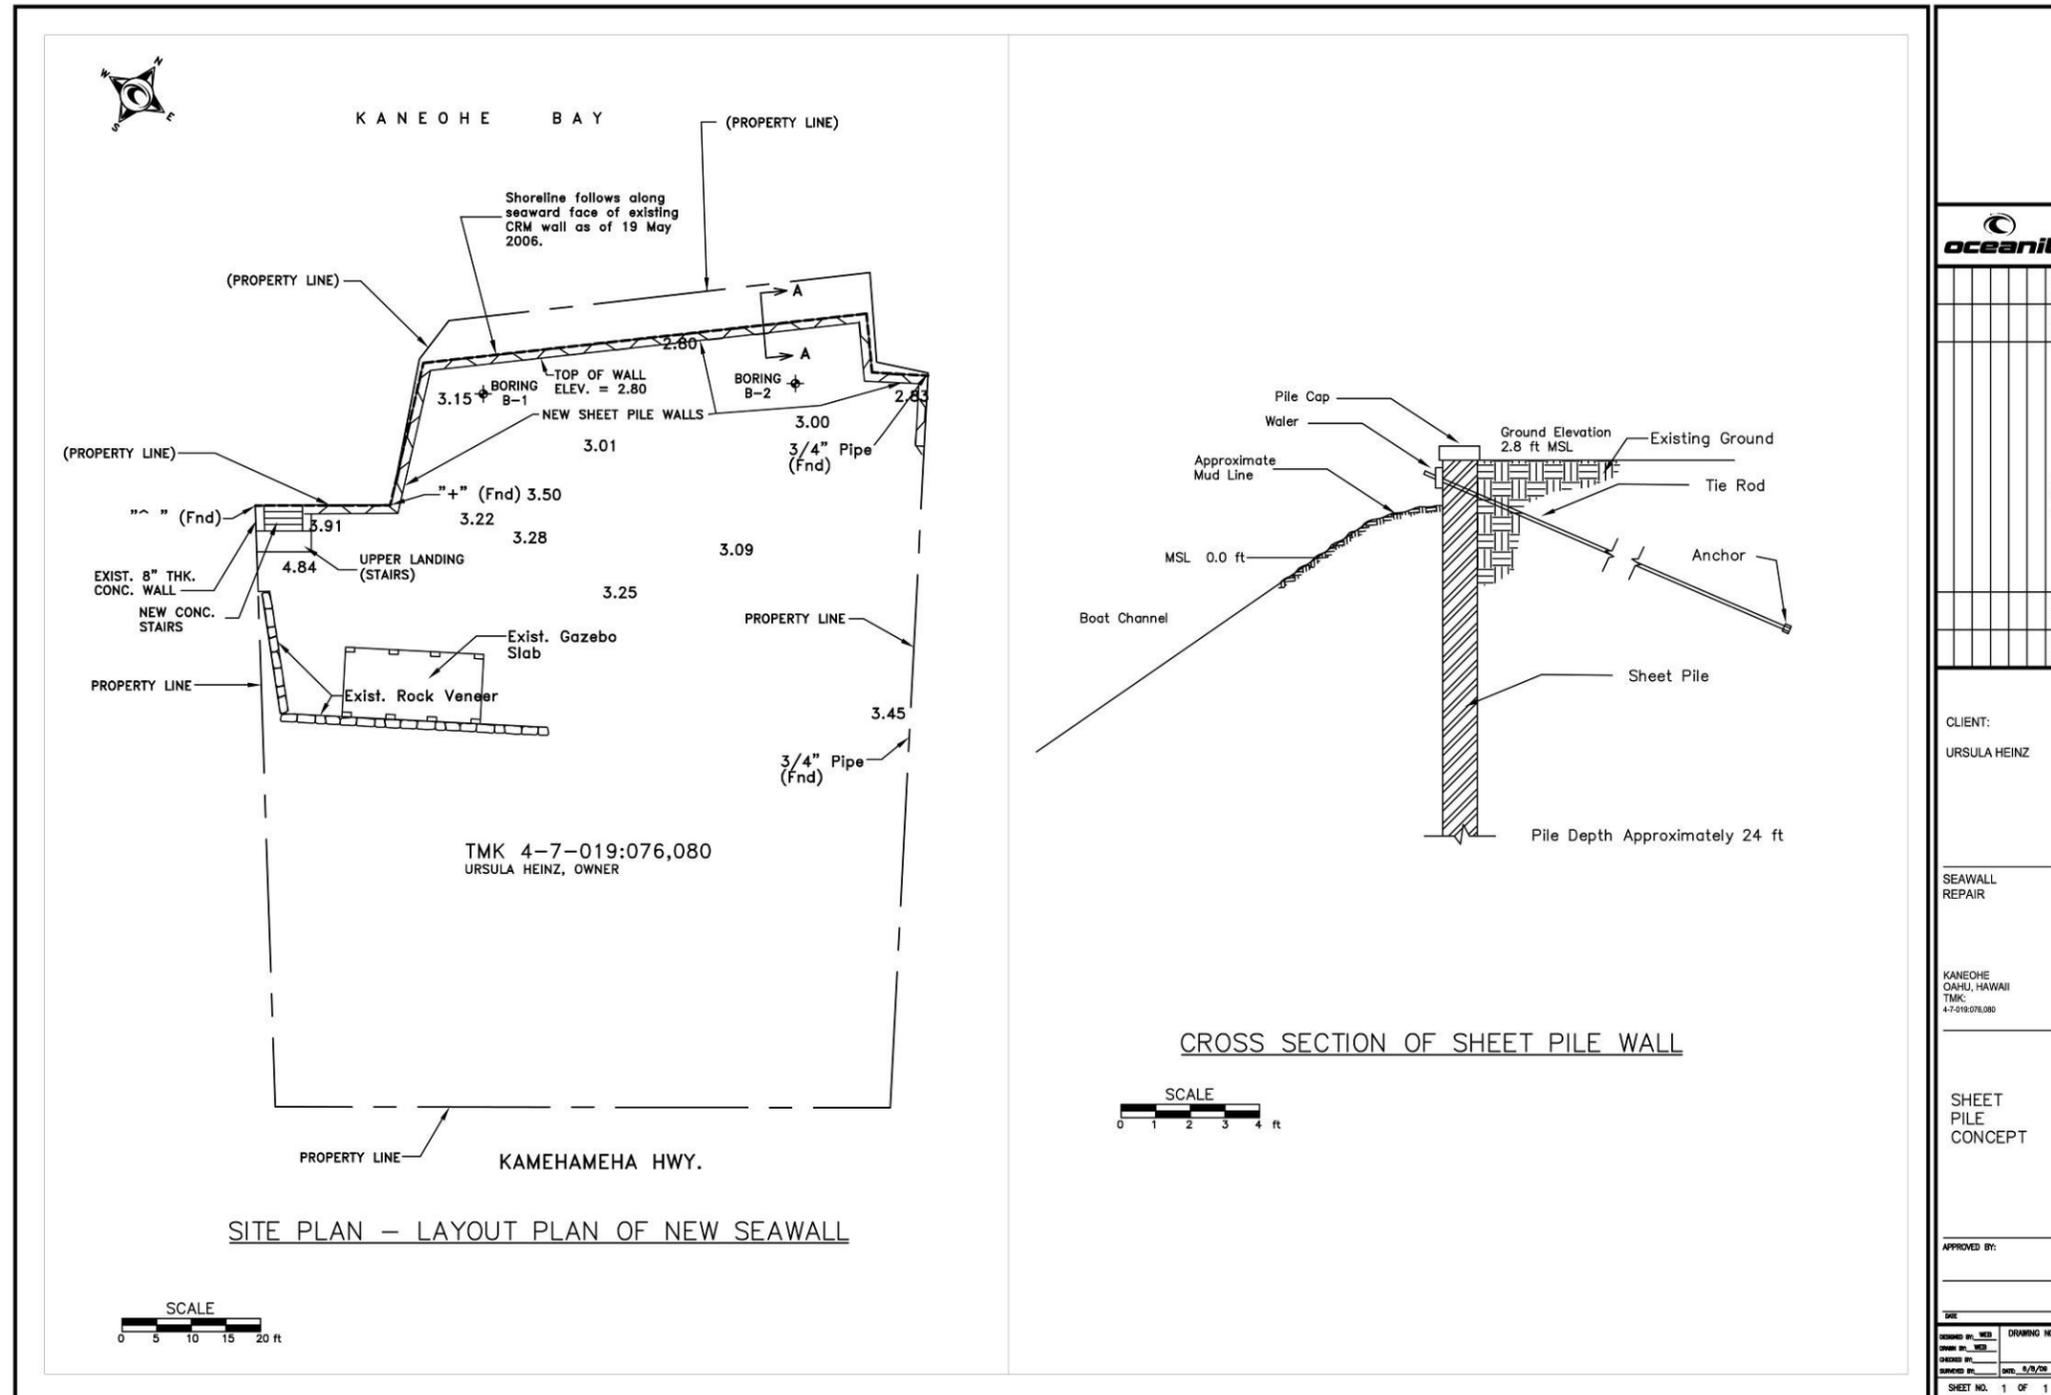
Figure 15. Sheet Pile Concept Design

The proposed solution is to replace the existing CRM and concrete seawalls with a sheet pile wall that follows the shoreline/property line. Sheet piles are driven into the ground to a depth sufficient for stabilization and to prevent scour under the wall. Sheet piles have an advantage over other wall systems in that no toe excavation and therefore no dewatering are needed. So the environmental impact is less than for other wall systems. Sheet piles are made of steel, aluminum, concrete, vinyl, or fiber reinforced plastic. Vinyl sheets will be used because they do not corrode. Tiebacks will be attached to hold the sheets against soil pressure. A typical sheet pile design is shown in Figure 15.

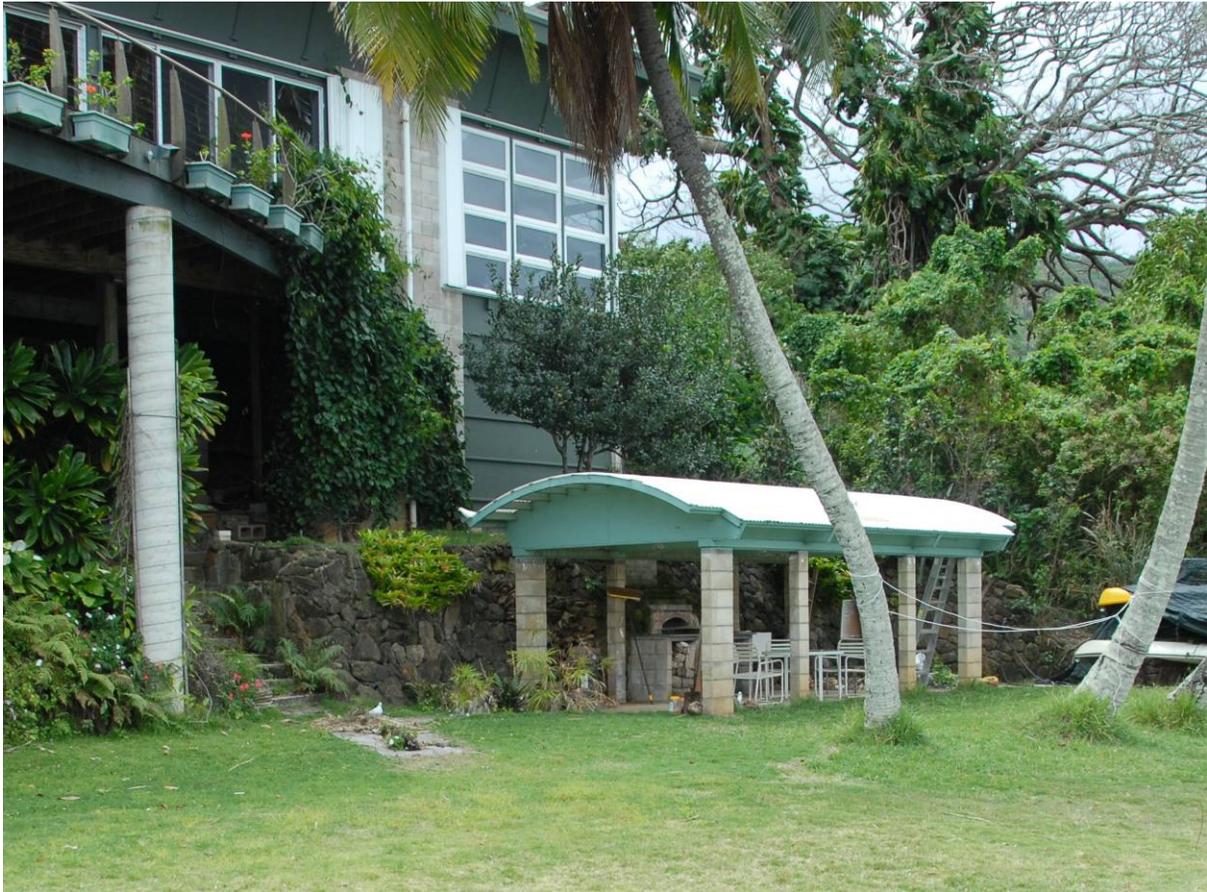
In addition, Dr. Heinz received a Notice of Violation (NOV) 2006/NOV-02-033 issued February 6, 2006 and a Notice of Order (NOO) 2007/NOO-145 issued June 18, 2007 from the Department of Planning and Permitting (DPP) for the unauthorized repair of a portion of a hollow tile retaining side wall (See Appendix D). A section of the side wall was removed to allow construction equipment to conduct repairs on the property. Additional parts of the hollow tile wall collapsed. After construction was completed and the equipment removed, the retaining side wall was partially reconstructed as a CRM wall and partially reconstructed as a rock-veneered hollow tile wall that formed an “L” shape along the side and back of the lower property. (See Figures 13-14) This portion of the side wall is within the 40-foot shoreline setback zone and is subject to an SV from the City and County of Honolulu, DPP. An SV for the new seawall, the reconstructed side wall, the replacement of the gazebo roof, and landscaping inside the seawall will be submitted to the DPP for approval. Figure 13 shows the relationship of the 40-foot setback line in relation to the house, seawall, side wall, and gazebo foundation. This side wall is a retaining wall that retains the soil where the foundation of the house is situated and retains the soil from the neighboring property. This wall ranges from 4 to 6 feet high and about one foot wide. The area between the retaining wall and the seawall was filled in with gravel and rock when the house was constructed. The “L” shaped wall is located behind the gazebo (see Figure 17).

Figure 17. Photo of Retaining Wall Adjacent to the Gazebo with New Roof
