SUBJECT: FINAL ENVIRONMENTAL ASSESSMENT  
HAWAII BELT ROAD, KUPAPAU LIA BRIDGE WIDENING,  
DISTRICT OF HAMAKUA, ISLAND OF HAWAII  
FEDERAL-AID PROJECT NO. BR-019-2(38)

**FINAL ENVIRONMENTAL ASSESSMENT**

**HAWAII BELT ROAD  
KUPAPAUlua BRIDGE WIDENING**

District of Hamakua, Island of Hawaii  
Project No. BR-019-2 (38)

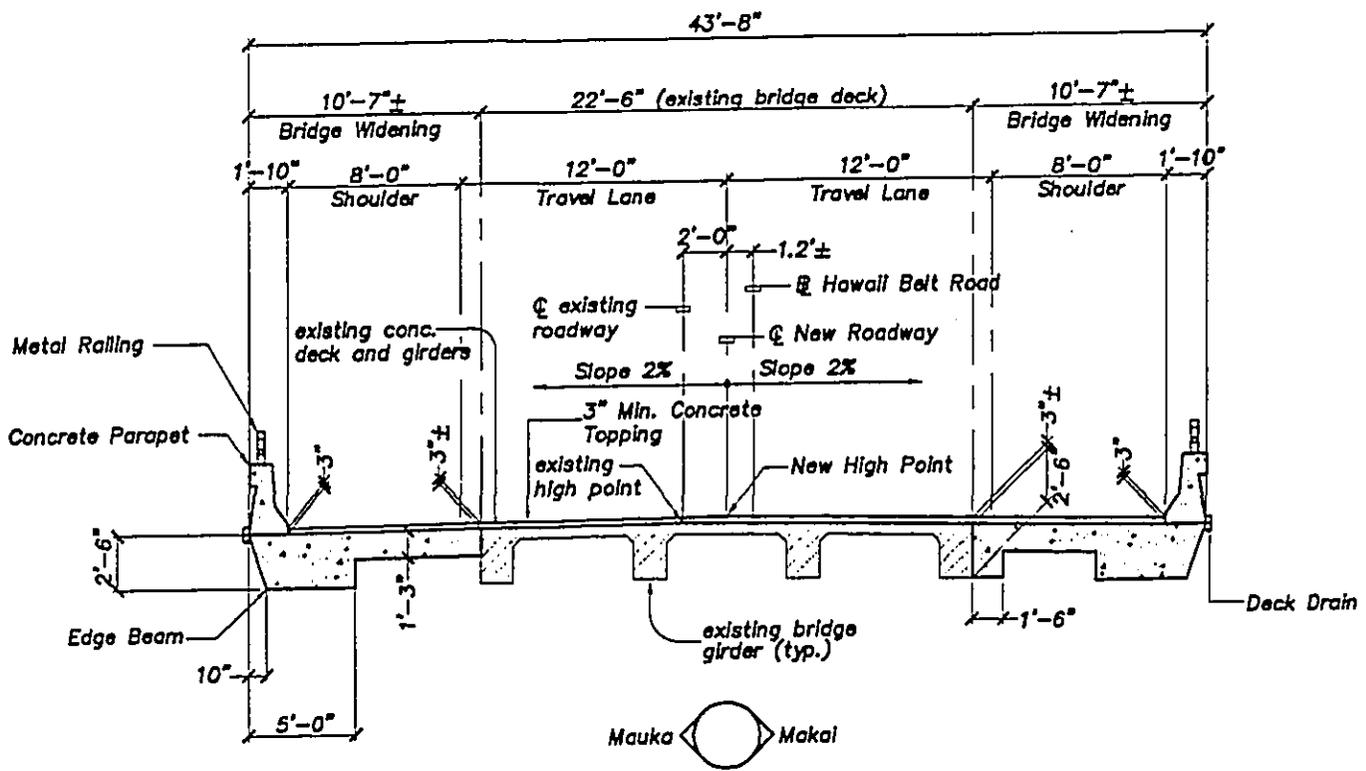
**Figure 6**  
**Bridge Cross-Section**  
 Final Environmental Assessment

TYPICAL NEW DECK SECTION

The existing 29 foot 11 inch wide bridge is proposed to be widened to approximately 44 feet to accommodate two 12-foot wide travel lanes and two 8-foot wide shoulders. The existing molded concrete railings are proposed to be replaced with American Association of State Highway and Transportation Officials (AASHTO) approved Jersey-type barriers. Metal railings extending 4 feet 6 inches above the bridge deck are proposed to be added on the concrete barriers to conform to bicycle traffic requirements.

Profiles and a cross section of the existing bridge and the proposed improvements are provided in Figures 4, 5 and 6. In conformance with the current AASHTO design specifications and increased loads due to widening of the existing bridge, all sections of the existing open-spandrel arches and piers will be increased in size by building up with new concrete and reinforcing steel. New footings bearing on drilled shaft foundations will be added at each end of the central open-spandrel arch span. The girder spans on each end of the arch span are proposed to be modified such that the existing bridge deck bears on new structural fill material. New reinforced concrete retaining walls are proposed extending from the existing abutments to the new abutments located at each end of the arch span.

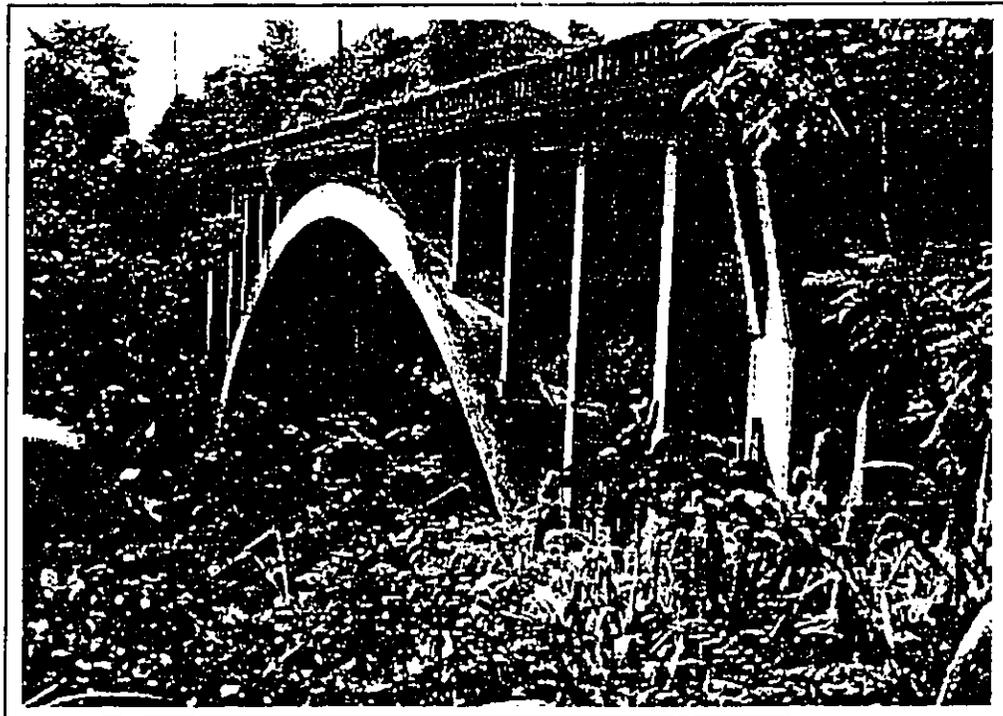
Figure 8. Underside of Kupapaulua Bridge,  
View to Southeast.

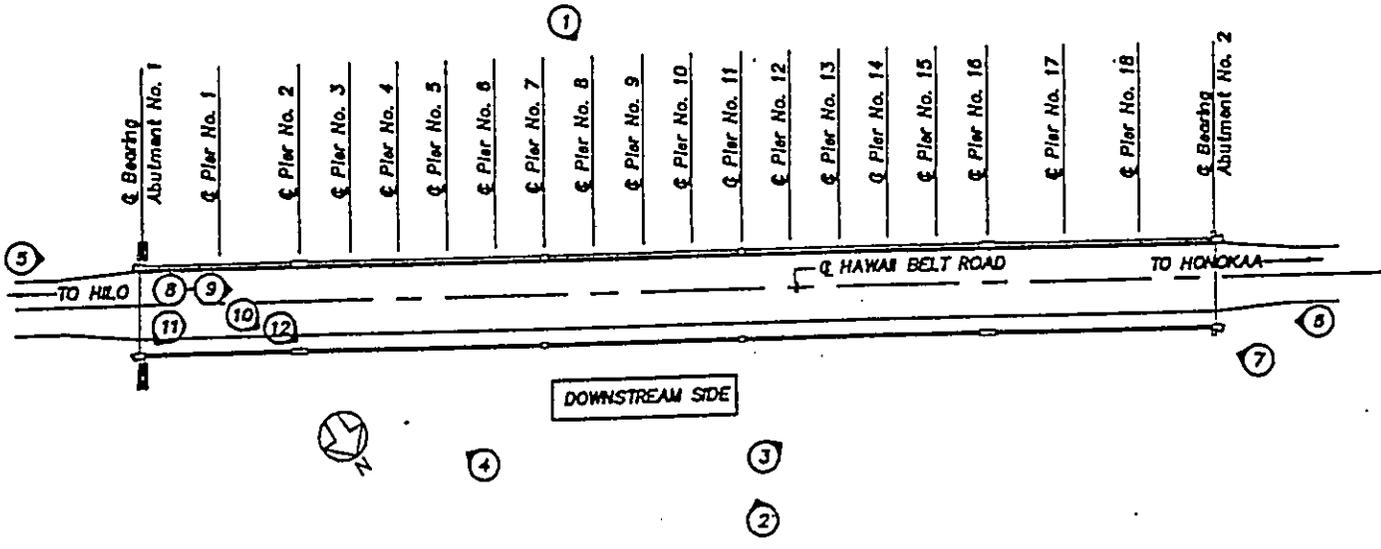
BRIDGE PLAN / PHOTO KEY  
 NOT TO SCALE

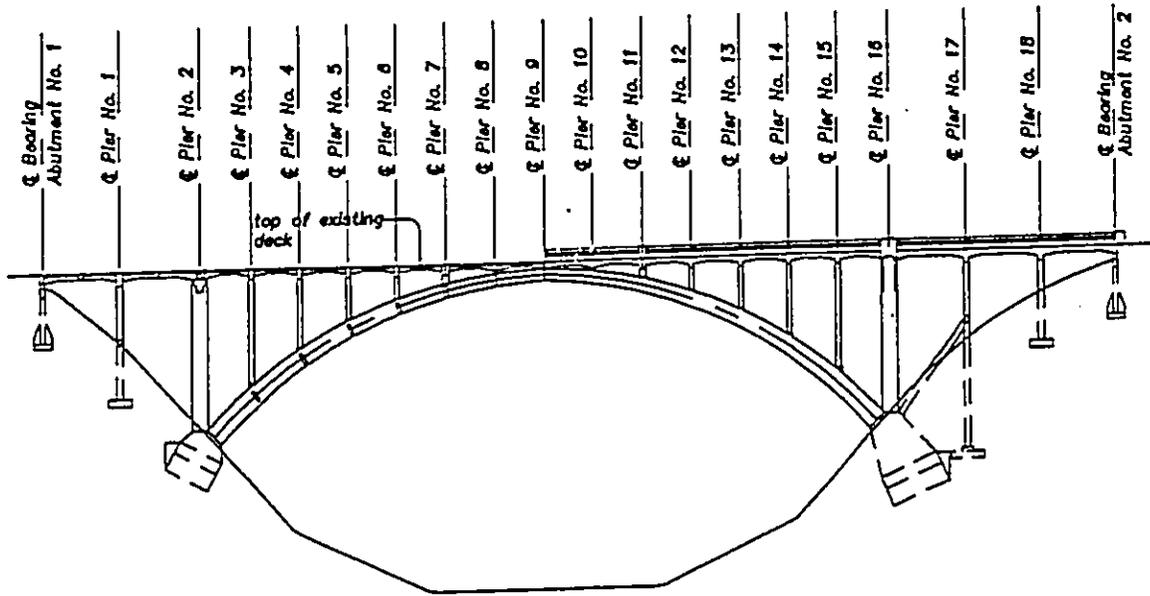
BRIDGE HALF SECTION / ELEVATION  
 NOT TO SCALE

The bridge deck is proposed to be widened to approximately 44 feet outside edge to outside edge to accommodate two 12-foot travel lanes and two 8-foot shoulders. The existing molded concrete railings will be replaced with American Association of State Highway and Transportation Officials (AASHTO) approved Jersey-type concrete barriers. In conformance with the current AASHTO design specifications and increased loads due to widening, all sections of existing concrete arches and piers will be increased in size by building up with new concrete and reinforcing steel. New footings bearing on drilled shaft foundations will be added at each end of the central open-spandrel arch span. The girder spans on each end of the arch span are proposed to be modified such that the existing bridge deck bears on new structural fill material. New reinforced concrete retaining walls are proposed extending from the existing abutments to the new abutments located at each end of the arch span.
