Subject: Finding of No Significant Impact for Kalaheo Water System –
0.5 Million Gallon Reservoir, Booster Pump and Connecting Pipelines
T.M.K. 2-4-04: por. 5 and 49
Kalaheo, Koloa, Kauai, Hawaii

FINAL ENVIRONMENTAL
ASSESSMENT

(KALAHEO WATER SYSTEM)
0.5 MILLION GALLON
RESERVOIR,
BOOSTER PUMP AND
CONNECTING
PIPE LINES

Department of Water
County of Kauai
P.O. Box 1706
Lihue, Hawaii 96766-5706

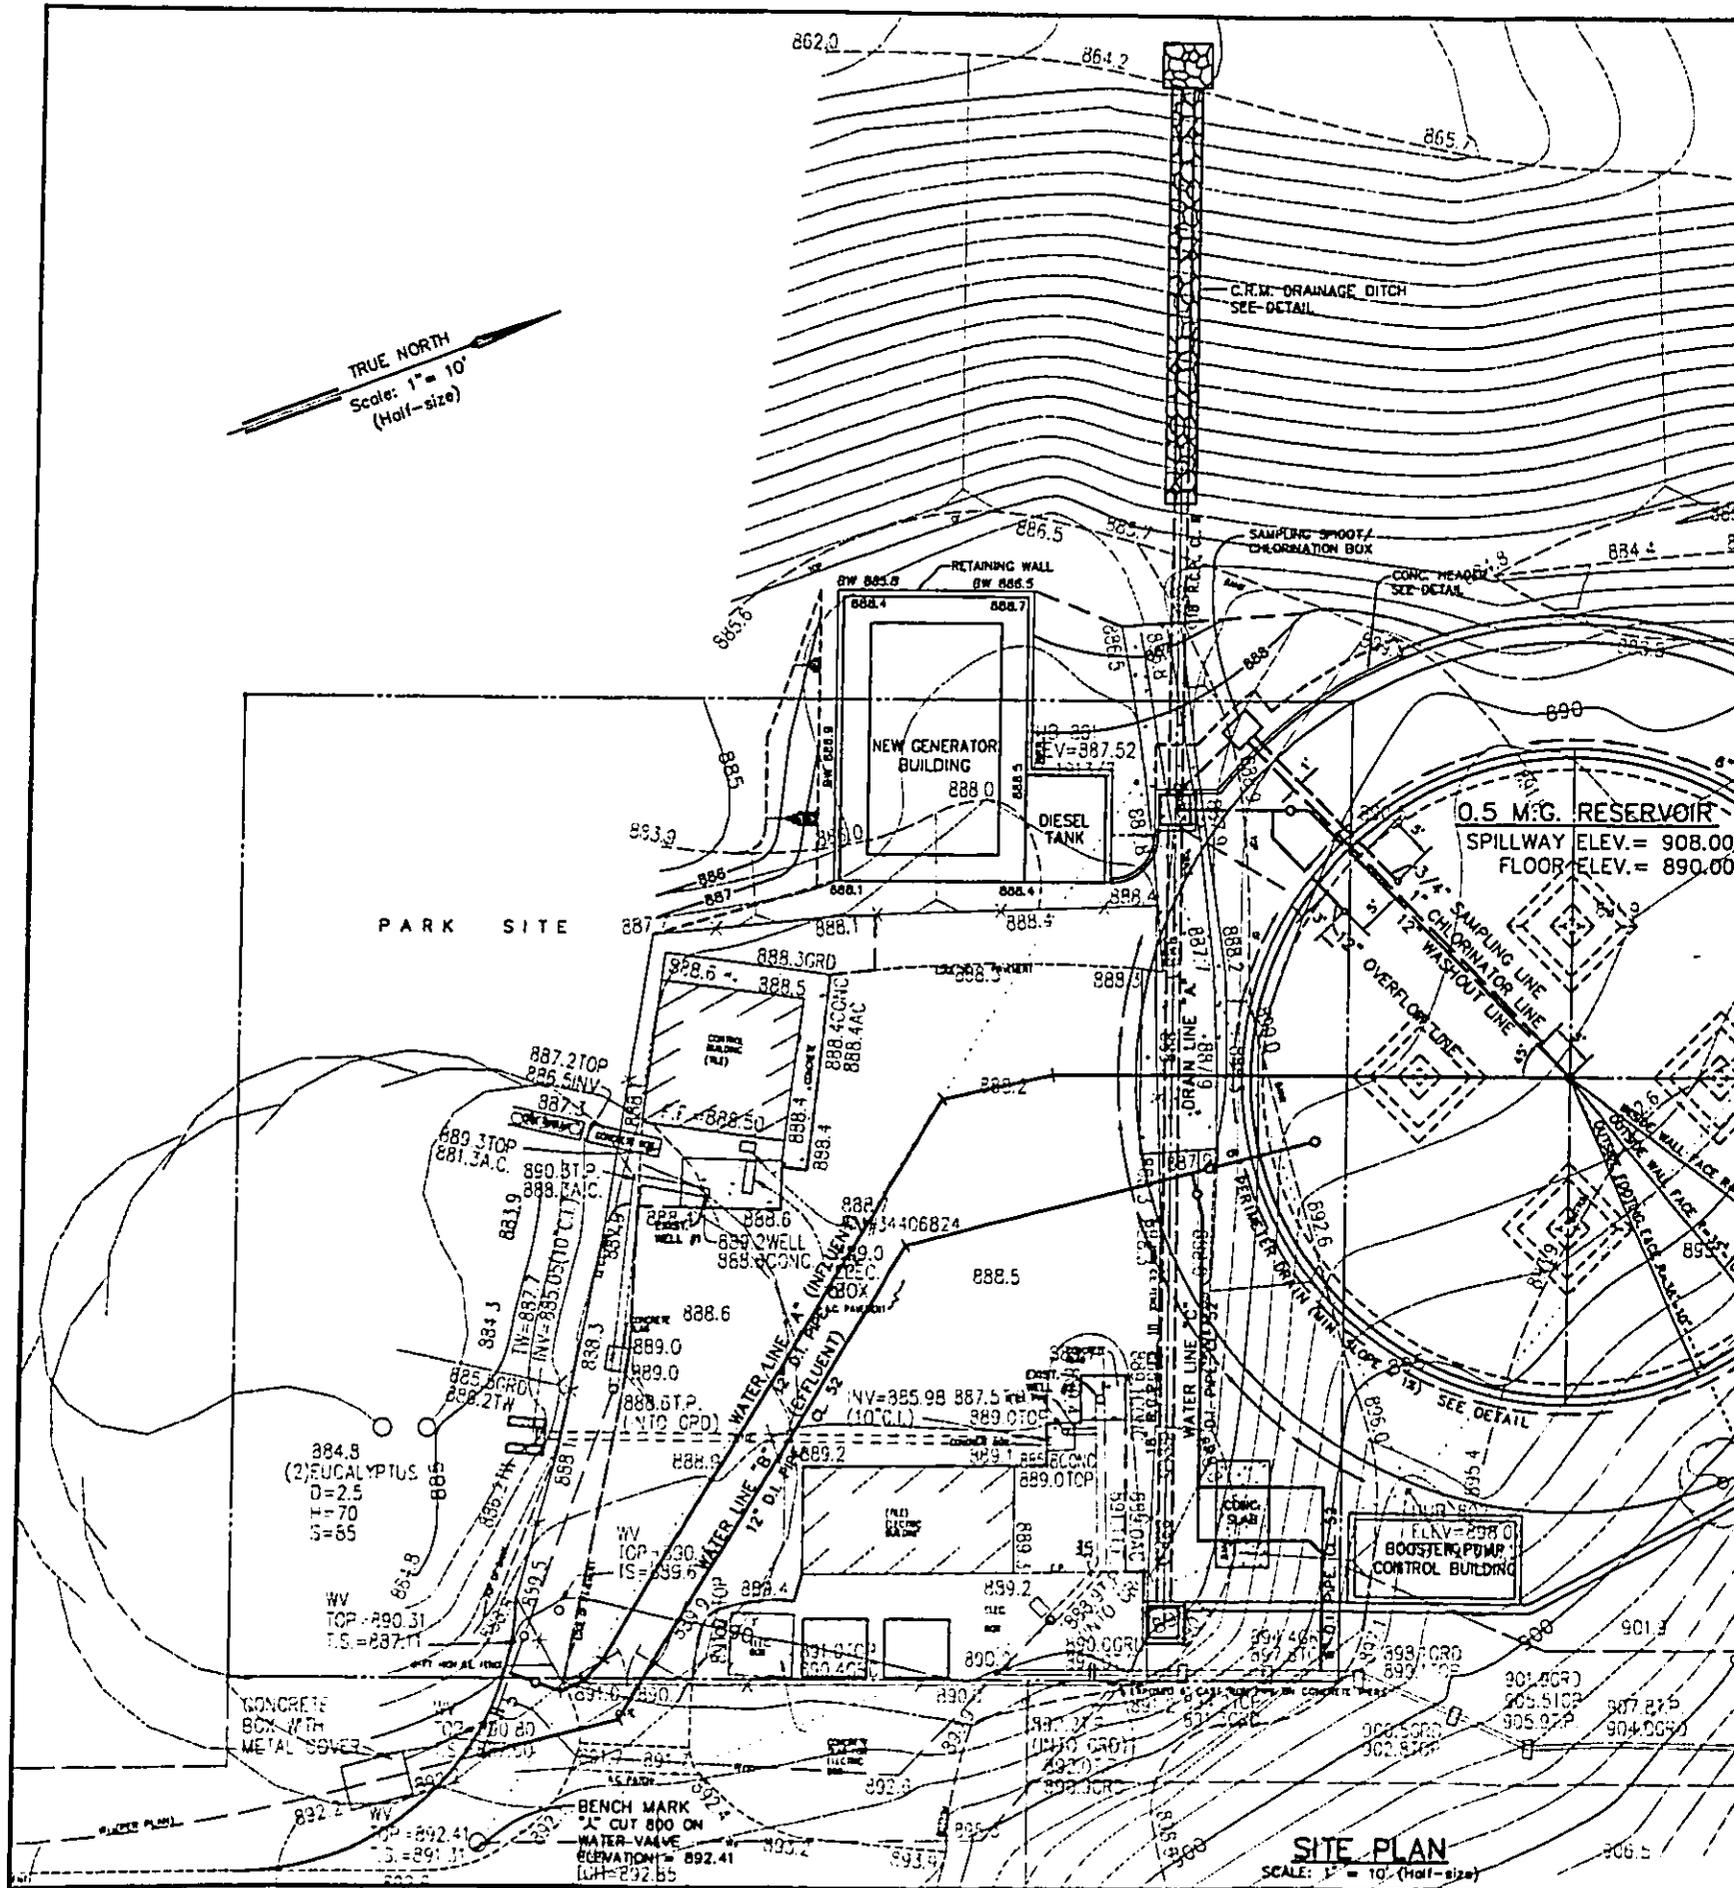
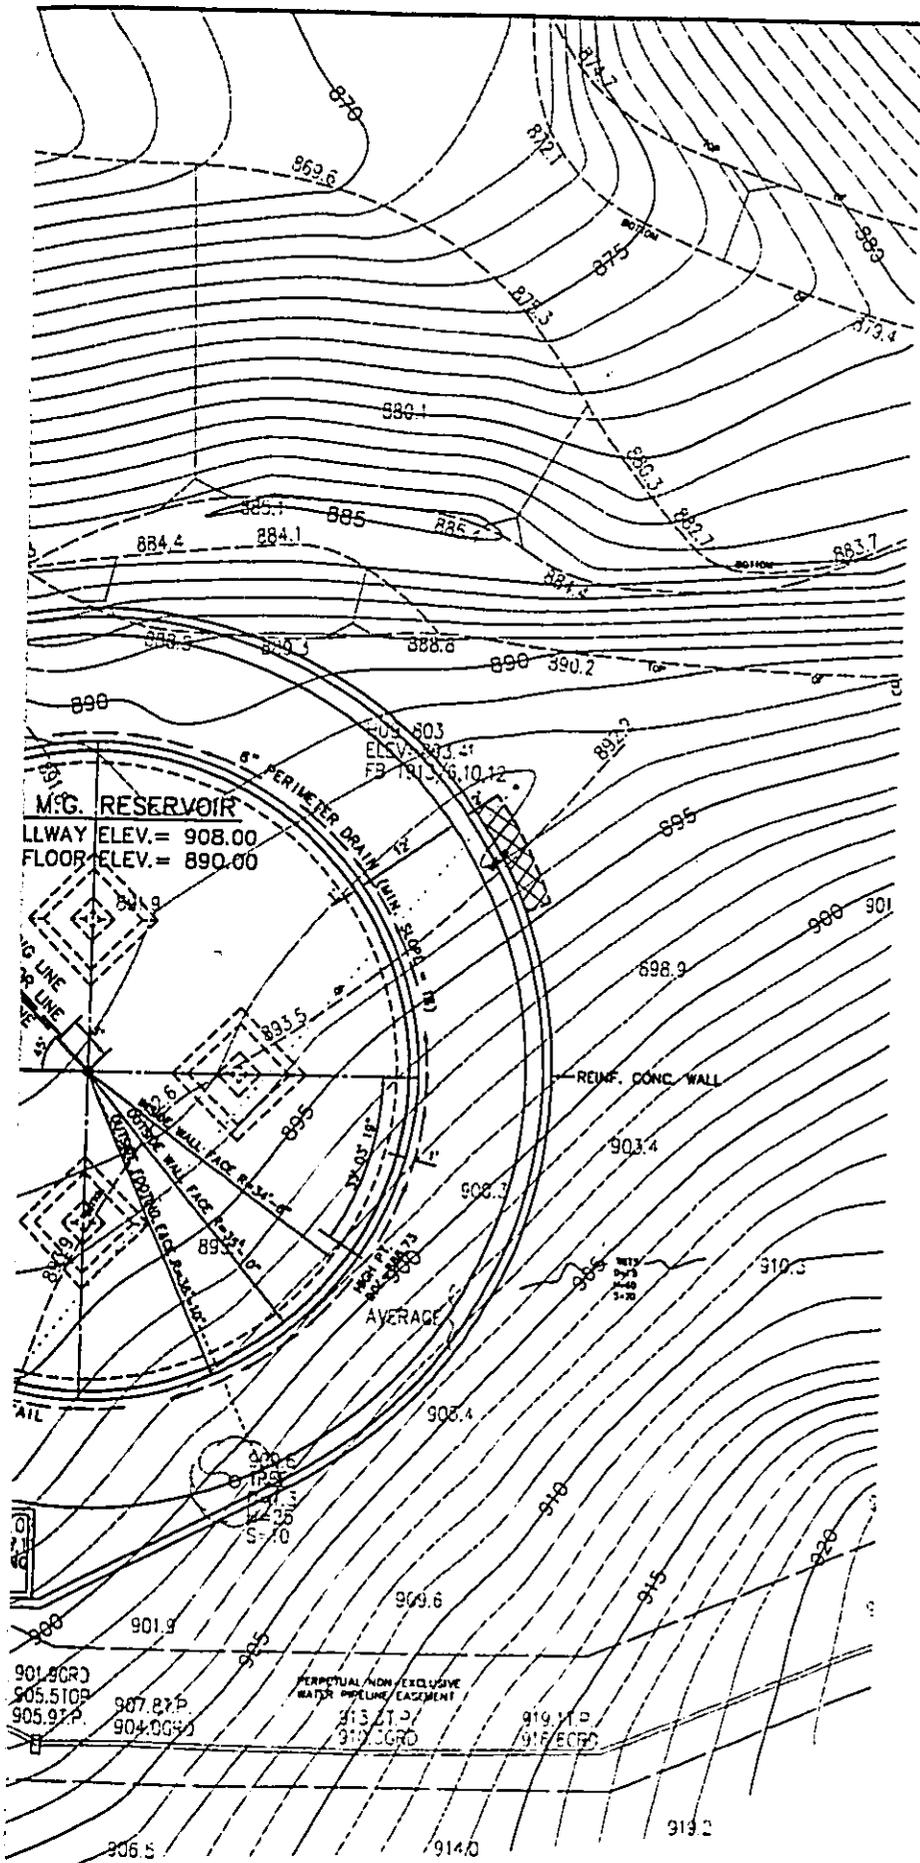
SITE PLAN
SCALE: 1" = 10' (Half-size)

The associated water piping system will consist mainly of 12-inch ductile iron lines, dedicated influent and effluent lines, overflow and washout lines. A new 6-inch ductile iron line will connect the new 12-inch line to an existing 6-inch main east of the proposed reservoir. A ¾-inch sampling line and a 1-inch chlorinator line will also be installed as part of this project.

Site improvements include a perimeter drain around the reservoir and a 12-foot wide asphalt concrete (ac) access road around the reservoir. The road will be bordered by a reinforced concrete retaining wall approximately 160 feet in length. Surface runoff will be conveyed to a perimeter drain system installed around the reservoir. Flows from the washout and overflow lines will be directed to on-site drainage inlets and then to an 18-inch reinforced concrete pipe (rcp) which discharges into a proposed concrete rubble masonry (crm) ditch about 50 feet in length. The outlet for the ditch will consist of a grouted riprap apron enclosed by a cutoff wall. The design of the outlet will minimize the impact of runoff water into a man-made drainage ditch located west of the proposed reservoir. See Figure 3.

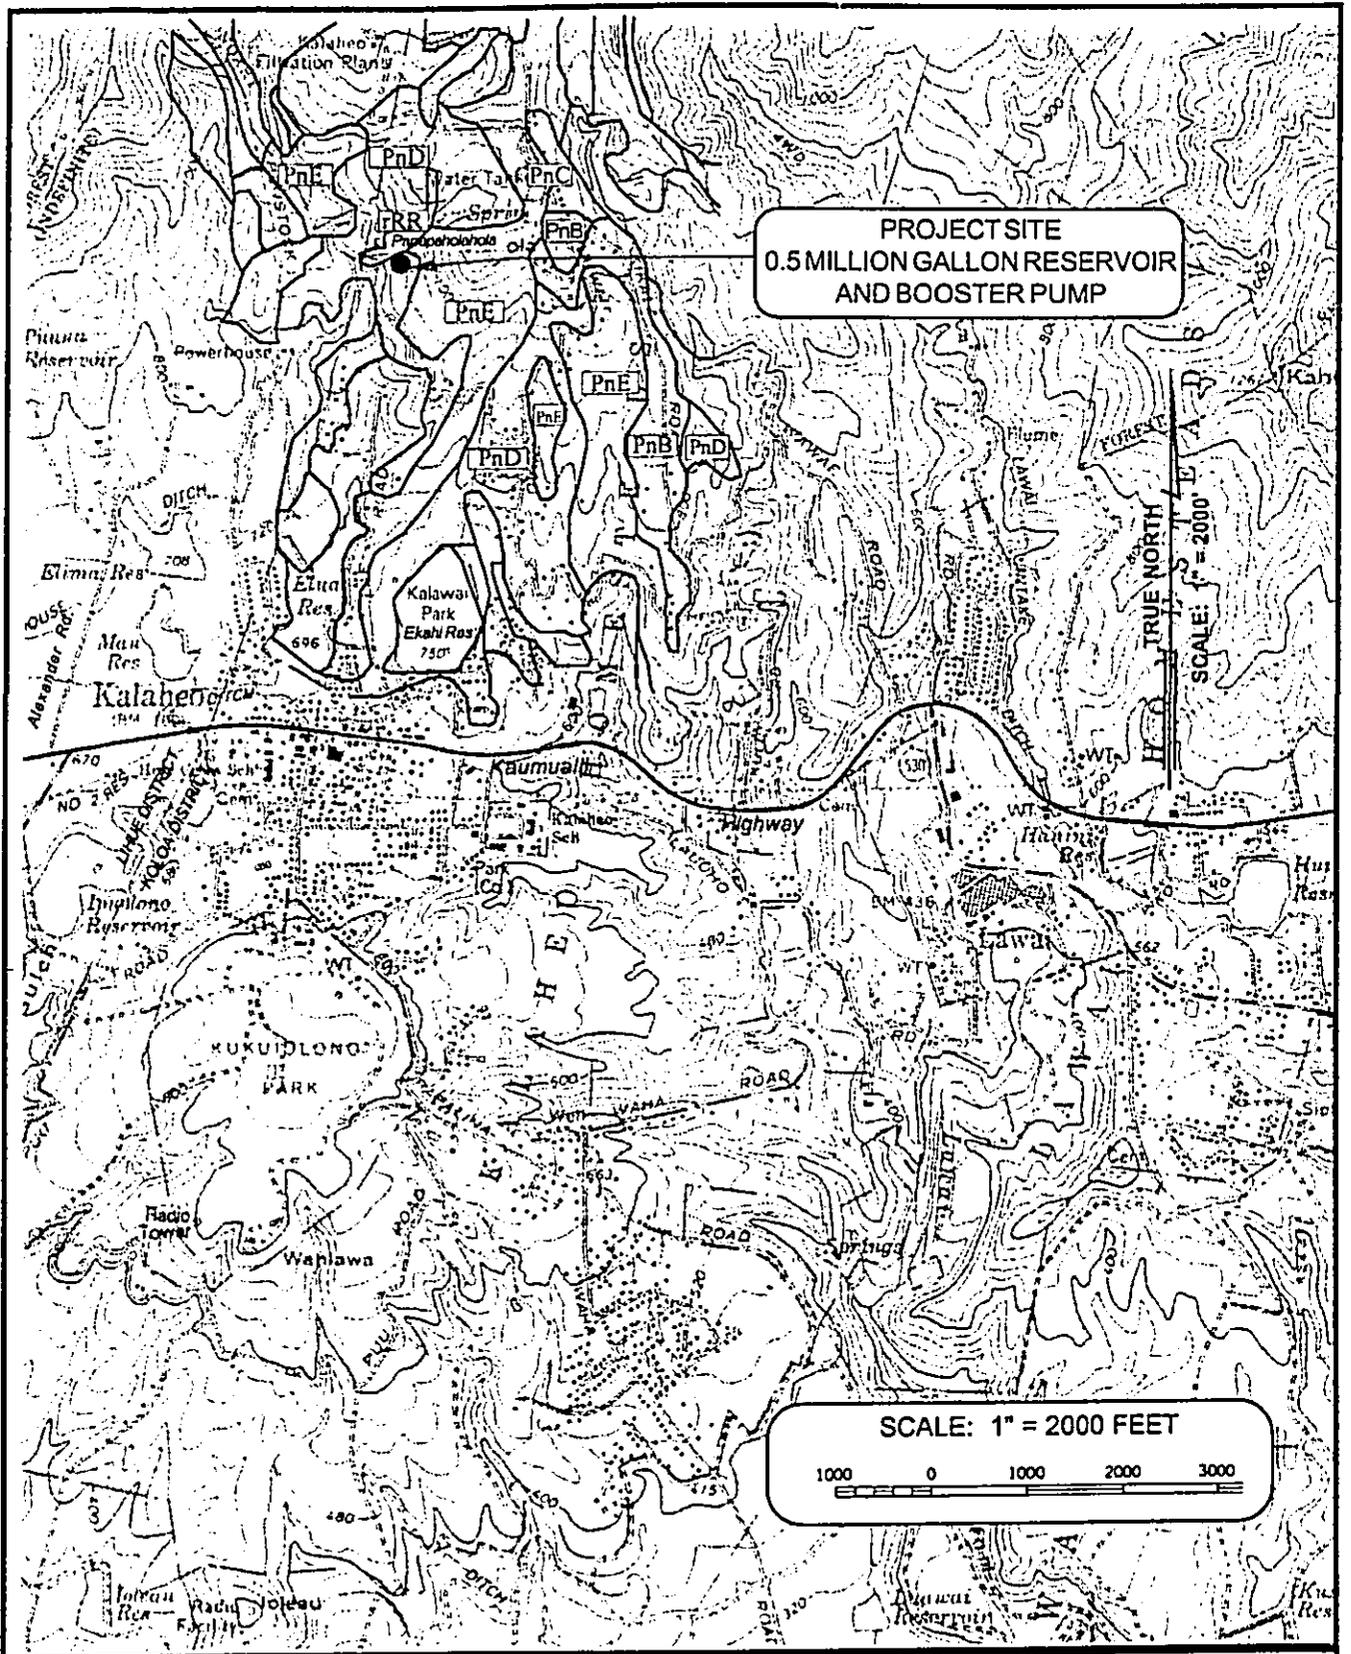
KALAHEO WATER SYSTEM
KALAHEO, KOLOA, KAUAI, HAWAII
SOILS MAP

In the vicinity of the reservoir site are soils belonging to the Puhi series as classified as by the U.S. Department of Agriculture Soil Conservation Service (SCS). These soils are well drained and generally found on the uplands of Kauai. A section of Rough Broken Land occupies the area to the north of the site. These soils are typically used for sugarcane, pineapple, orchards, pasture, woodland, wildlife habitat and water supply. See Figure 4.

Puhi (PnE) - Silty clay loam and silty clay, 25 to 40 percent slopes. Runoff is rapid and and the erosion hazard is severe.

Puhi (PnD) - Silty clay loam and silty clay, 15 to 25 percent slopes. Runoff is medium and and the erosion hazard is moderate.

Puhi (PnC) - Silty clay loam and silty clay, 8 to 15 percent slopes. Runoff is slow and and the erosion hazard is slight.

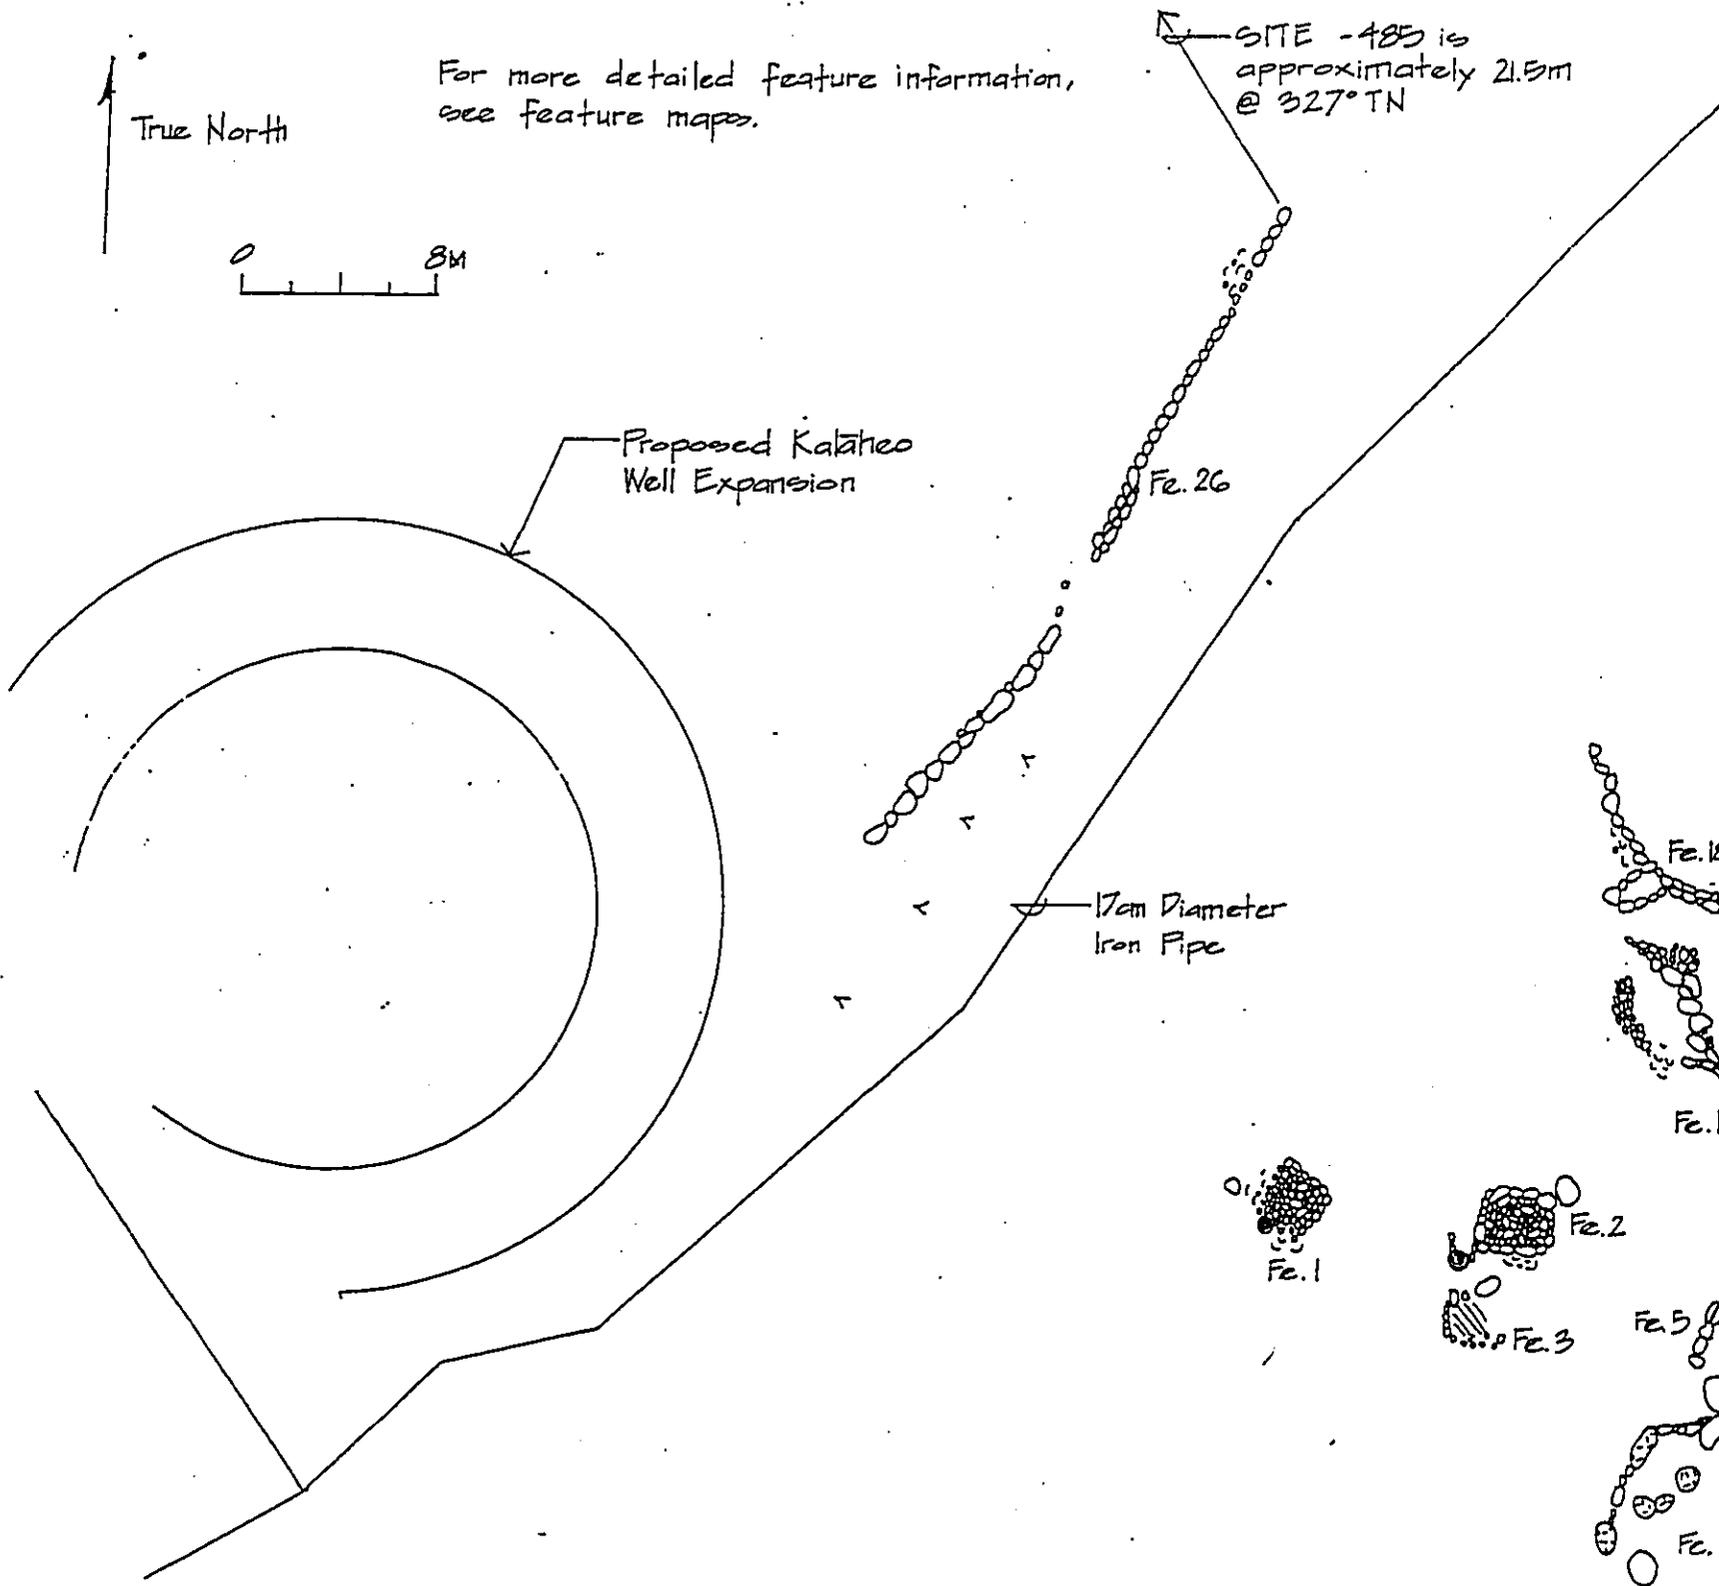
Figure 5 Map of State Sites 50-30-10-406 and -485 Showing Features 1-26 and Proposed Water System Expansion.

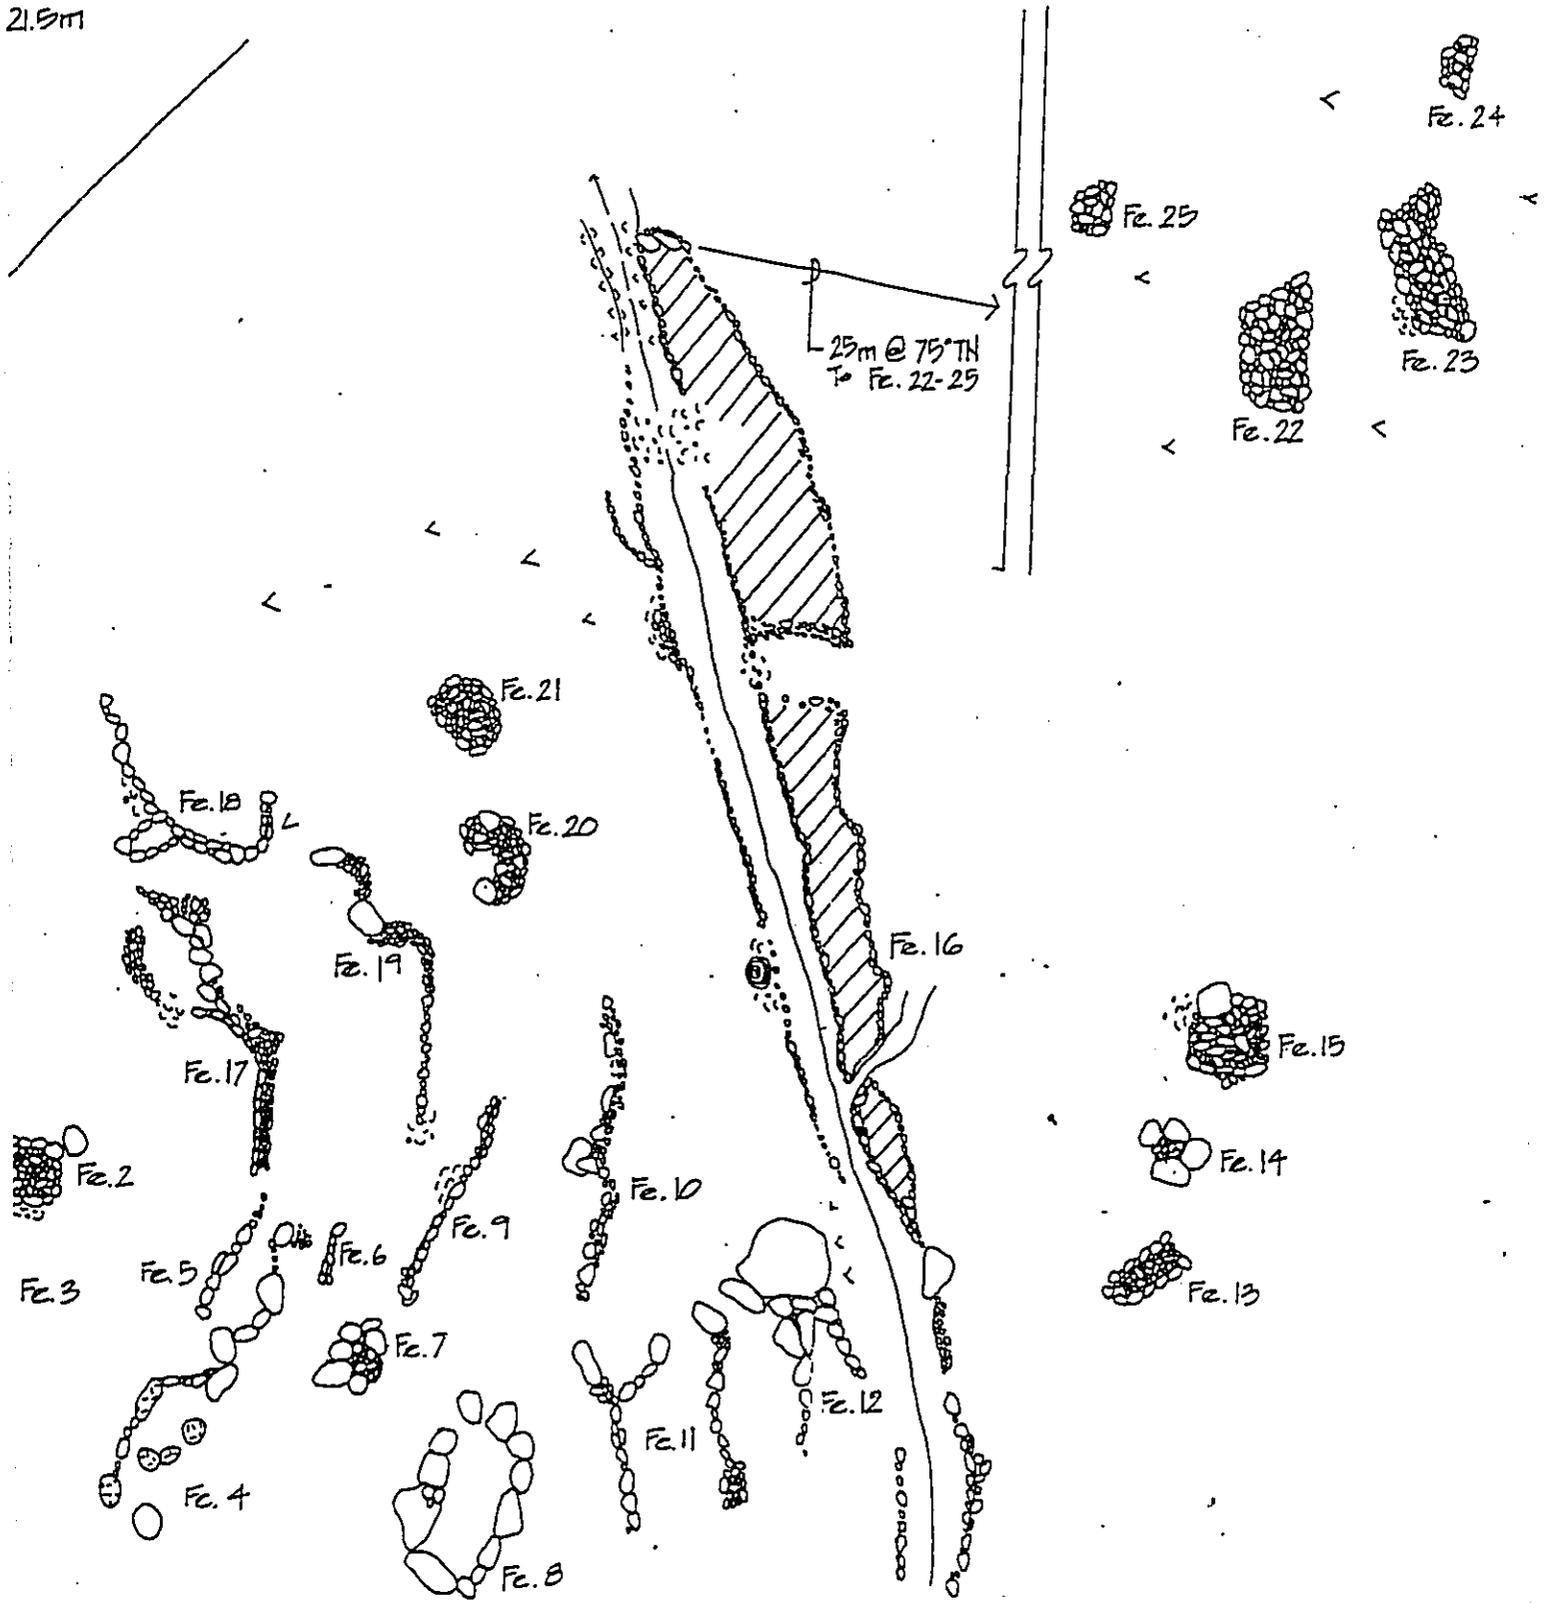
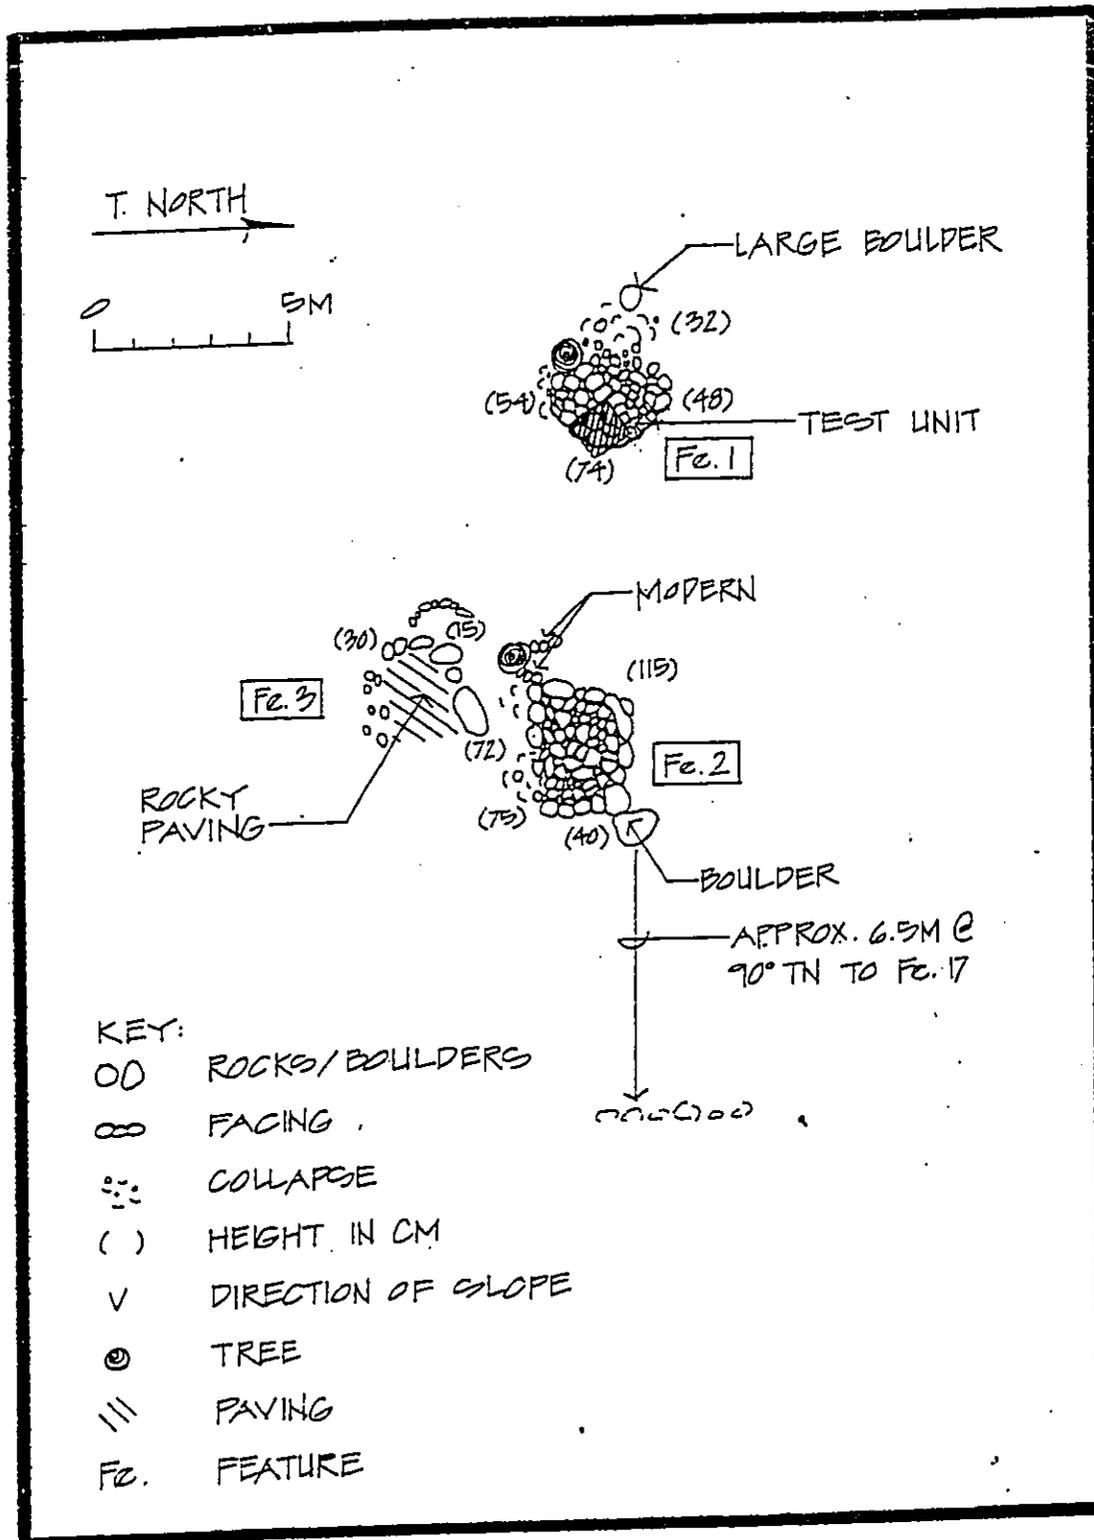
Figure 6 Close-Up of Site 50-30-10-406 Showing Platforms and Agricultural Feature, Features 1, 2, and 3.

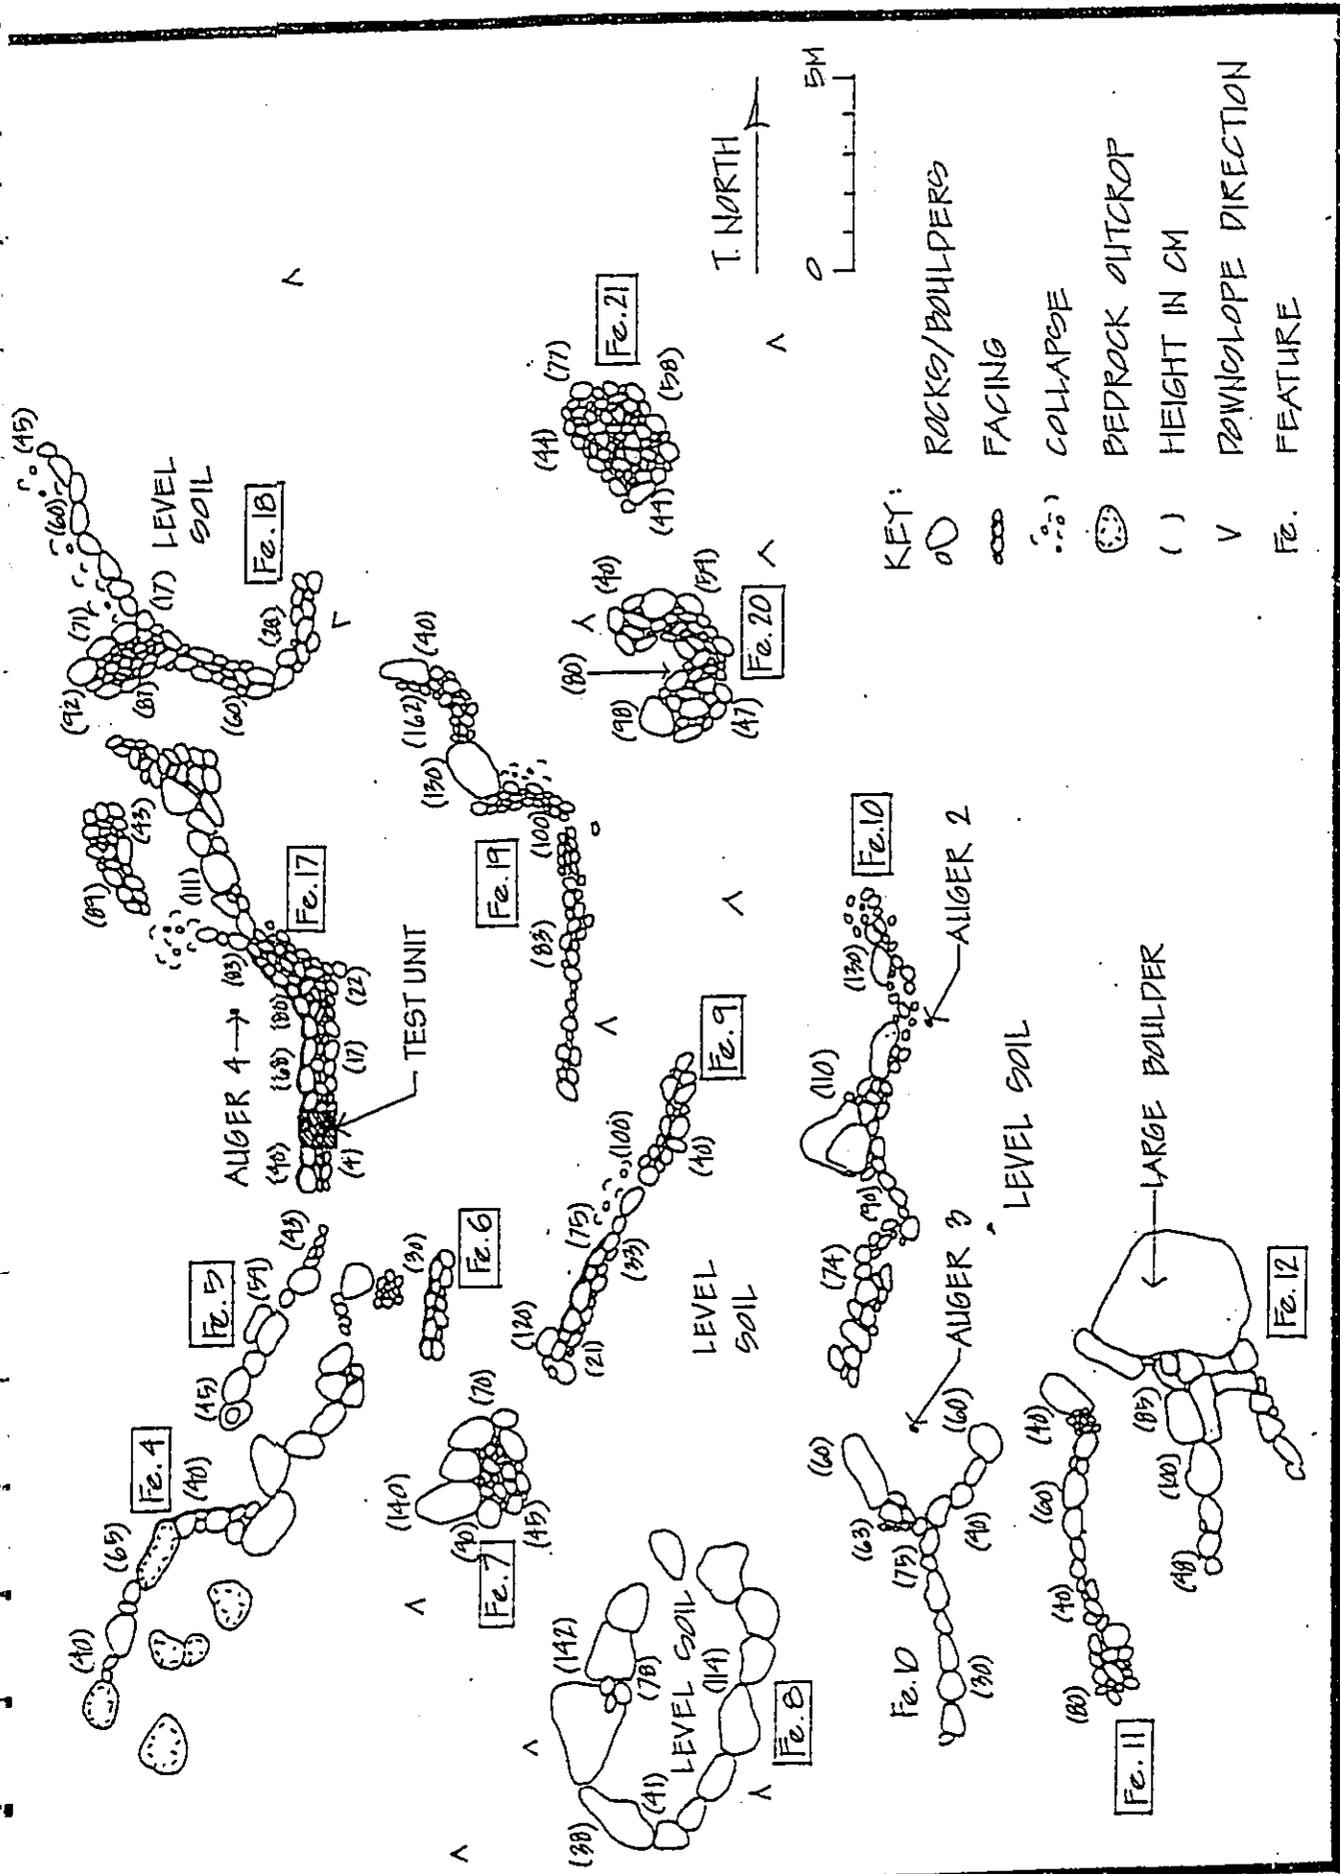
Figure 7 Close-Up of Site 50-30-10-406 Showing Agricultural Features, Features 4-12 and 17-21.

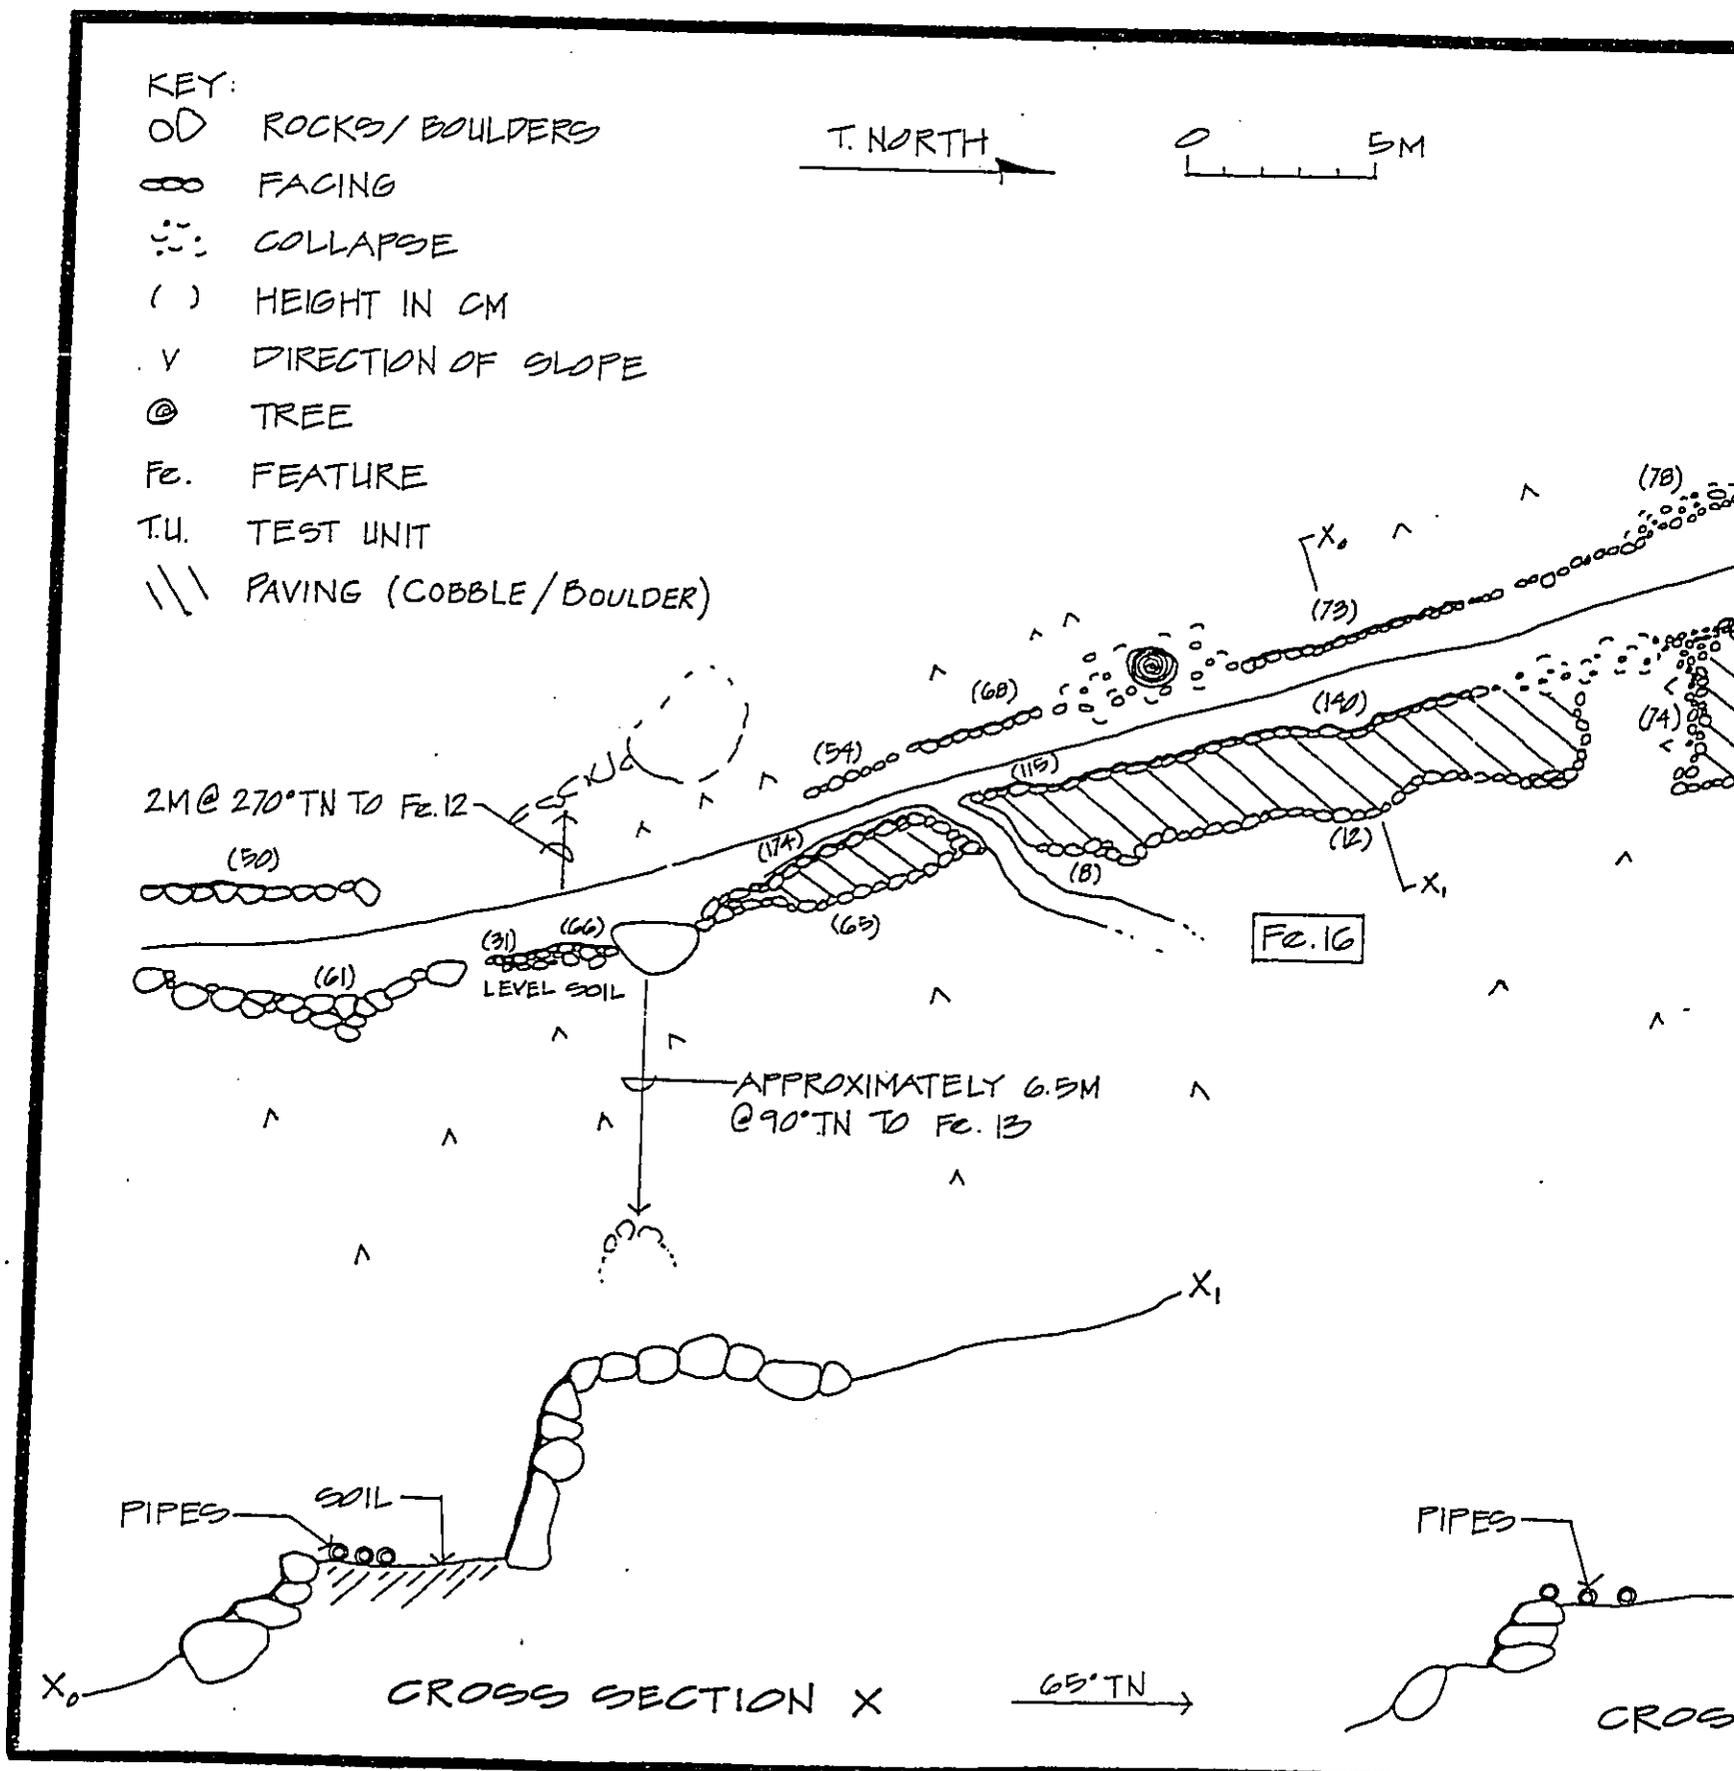
Figure 8 Map of State Site 50-30-10-406 Showing Multi-Tiered Terrace, Feature 16, Test Units, and Cross Sections.

Feature 16 of site -406 is a massive multi-tiered terrace located up-slope from most of the features that make up the site. Feature 16 represents a substantial labor investment. The large boulders that make up most of the feature construction are very dense and heavy and are skillfully stacked. The terrace's largest tier has a well constructed vertical face measuring between 1 and 1.9 m in height. The boulders on the surface of the structure are moss covered and show no scarring or other marks from mechanical earth moving equipment or chain dragging. Based on this evidence, the boulder and cobble construction material appears to have been collected and placed by hand.
