Subject: Finding of No Significant Impact for Kalaheo Water System –
0.5 Million Gallon Reservoir, Booster Pump and Connecting Pipelines
T.M.K. 2-4-04: por. 5 and 49
Kalaheo, Koloa, Kauai, Hawaii

FINAL ENVIRONMENTAL
ASSESSMENT

(KALAHEO WATER SYSTEM)
0.5 MILLION GALLON
RESERVOIR,
BOOSTER PUMP AND
CONNECTING
PIPE LINES

Department of Water
County of Kauai
P.O. Box 1706
Lihue, Hawaii 96766-5706

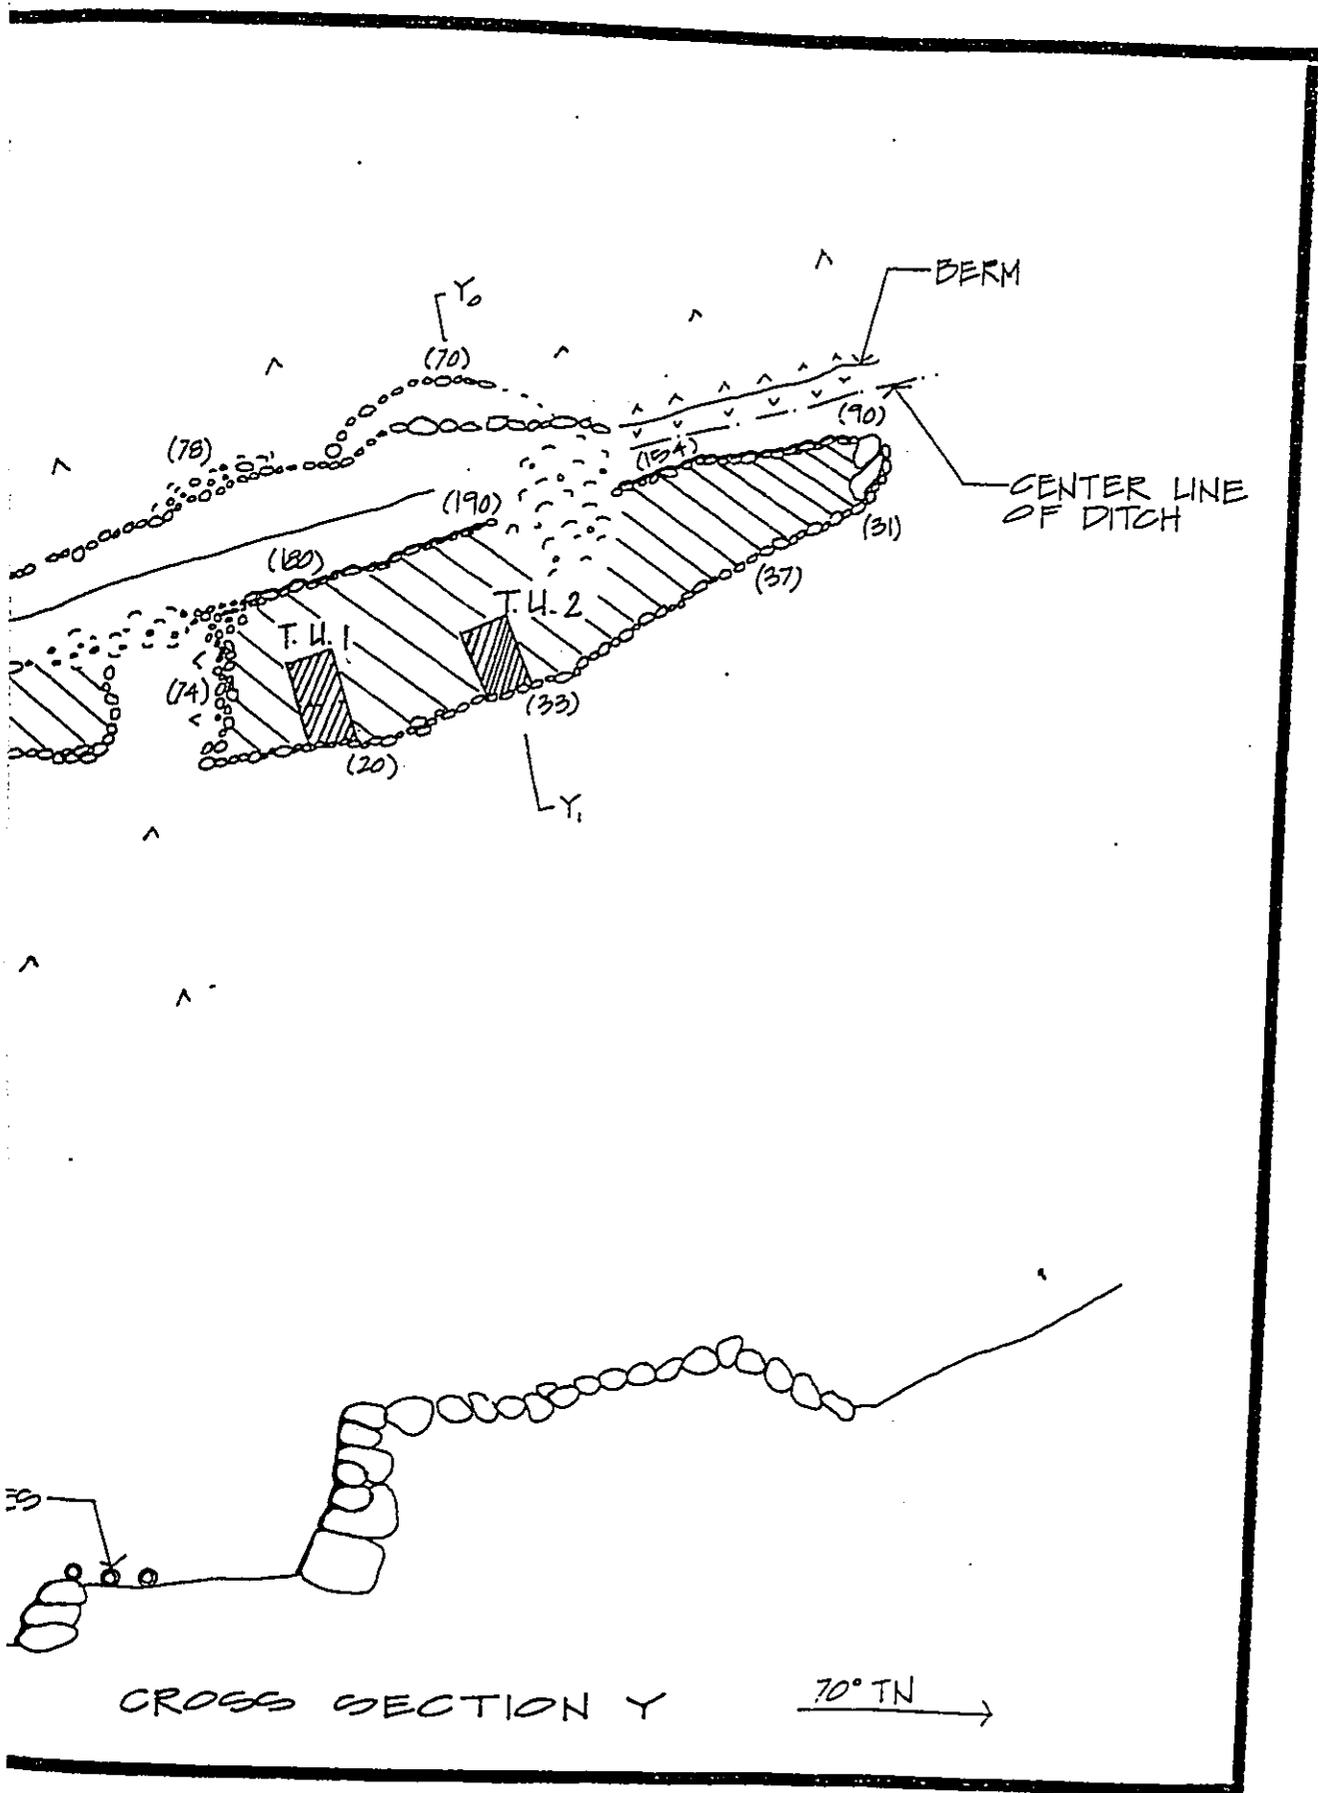
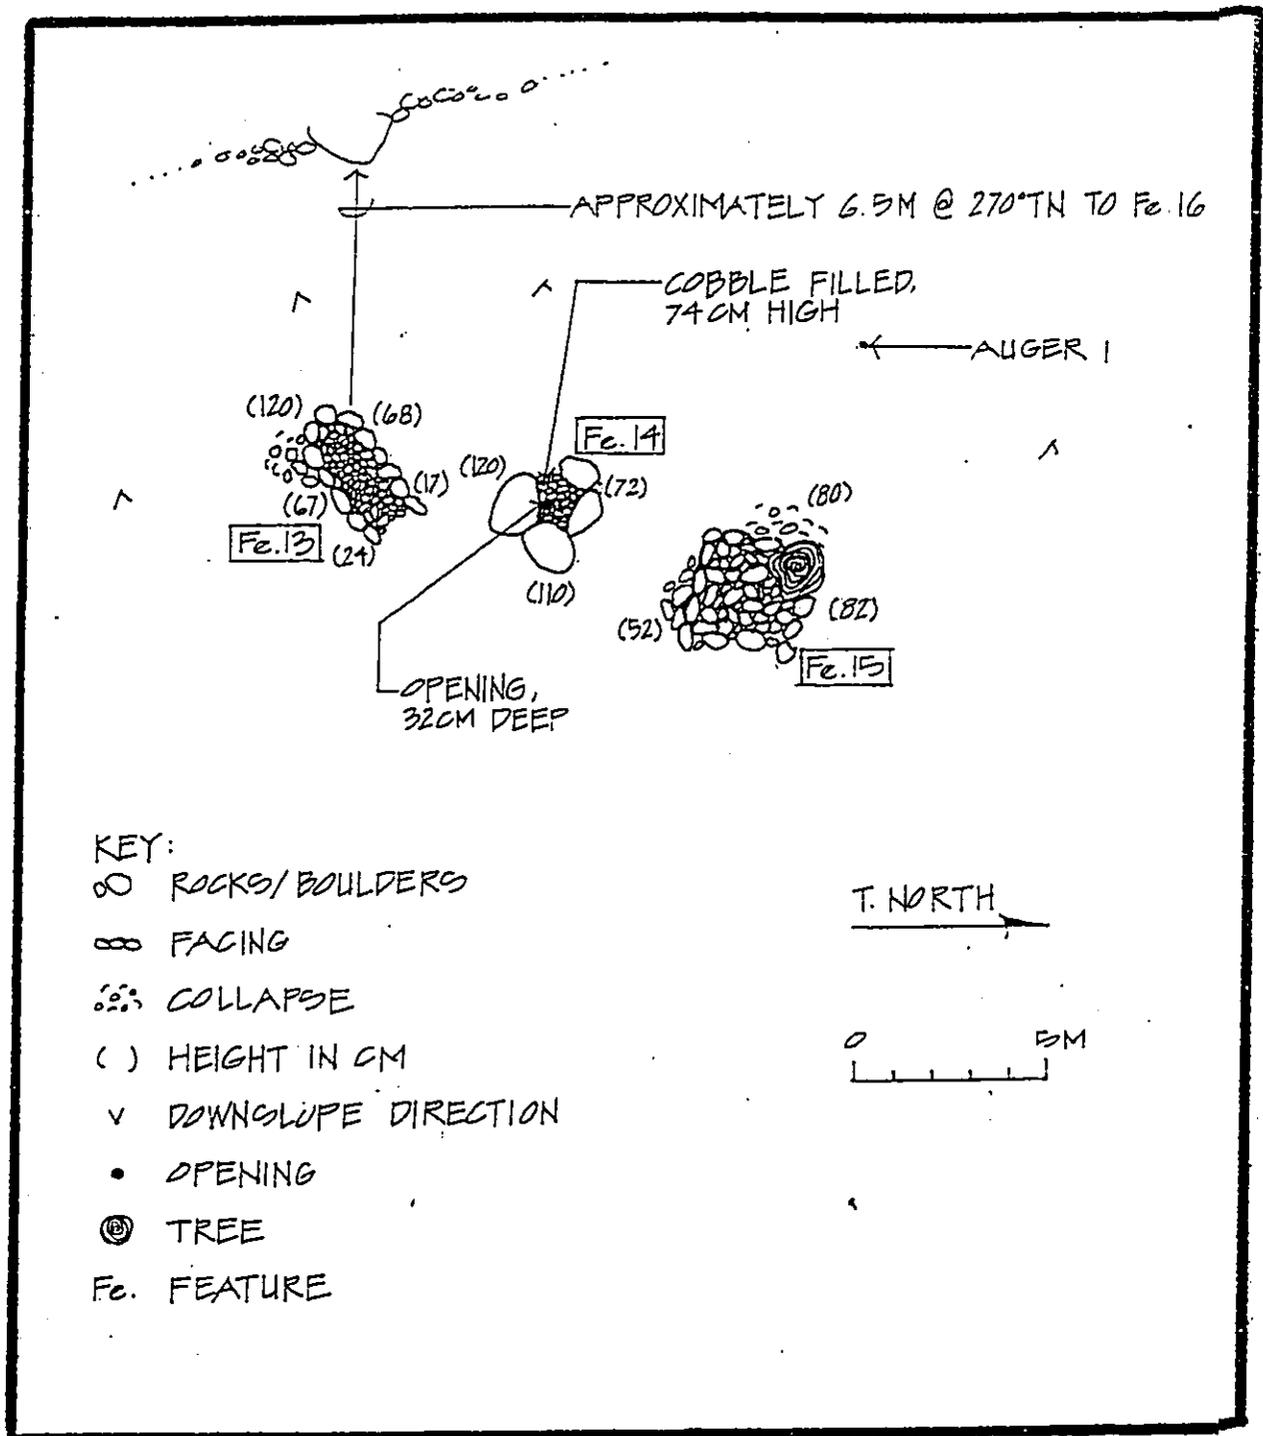
Figure 9 Map of State Site 50-30-10-406 Showing Mounds and Filled Crevice, Features 13, 14, and 15.

- 4) Features 13, 14, and 15 include two mounds and a filled crevice located on the east side of the southern end of Feature 16 (Figure 9). Feature 13 consists of a basalt boulder mound with a bedrock base (see Photograph Appendix, Figures 25 and 35). The perimeter of the mound consists of rounded-subangular basalt boulders stacked 4 courses high. The interior is cobble filled. Feature 15 is a roughly rectangular mound which consists of a basalt boulder perimeter stacked 1-3 courses high with a cobble-filled interior. Feature 15 has been disturbed by tree roots which have dislodged some of the boulders. Feature 14 consists of a basalt cobble and boulder filled crevice within a natural bedrock outcrop (see Photograph Appendix, Figure 36). An auger hole (#1) was excavated on the west side of Feature 15 which revealed small pieces of opaque sheet plastic at a depth of 0-15 cmbs. The material may be related to historic pineapple or truck crop agriculture. Therefore, Features 13-15 were likely used for historic agriculture or clearing.

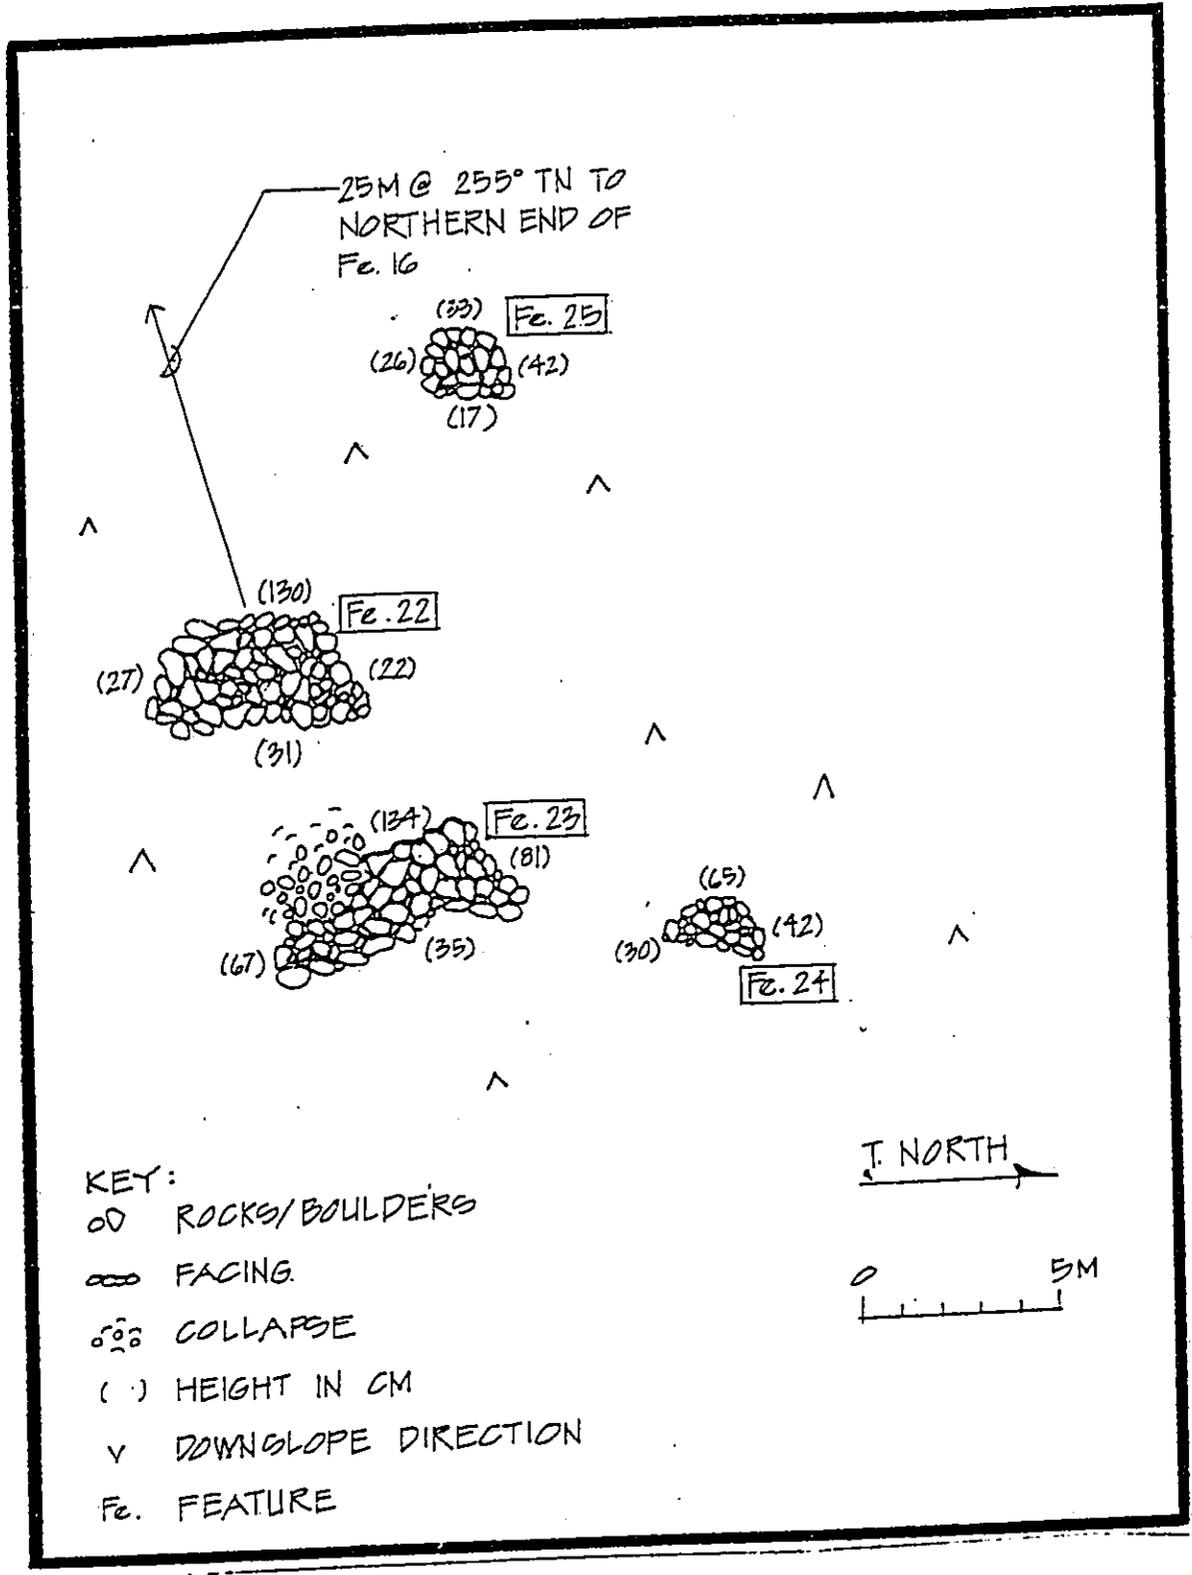
Figure 10 Map of State Site 50-30-10-406 Showing Boulder Clearing Mounds and Platforms, Features 22, 23, 24 and 25.

- 5) Features 22-25 consists of a cluster of rock clearing mounds within the upper elevation area, 25 meters east-northeast of Feature 16's northern extent (Figure 10). No test units were conducted. The rock mounds all appeared to be agricultural clearing piles, likely constructed by European settlers in the early 1900s. Features 22 and 23 were better constructed mounds/platforms (see Photograph Appendix, Figure 37). Feature 23 displayed facing on its western side. No cultural material was observed.

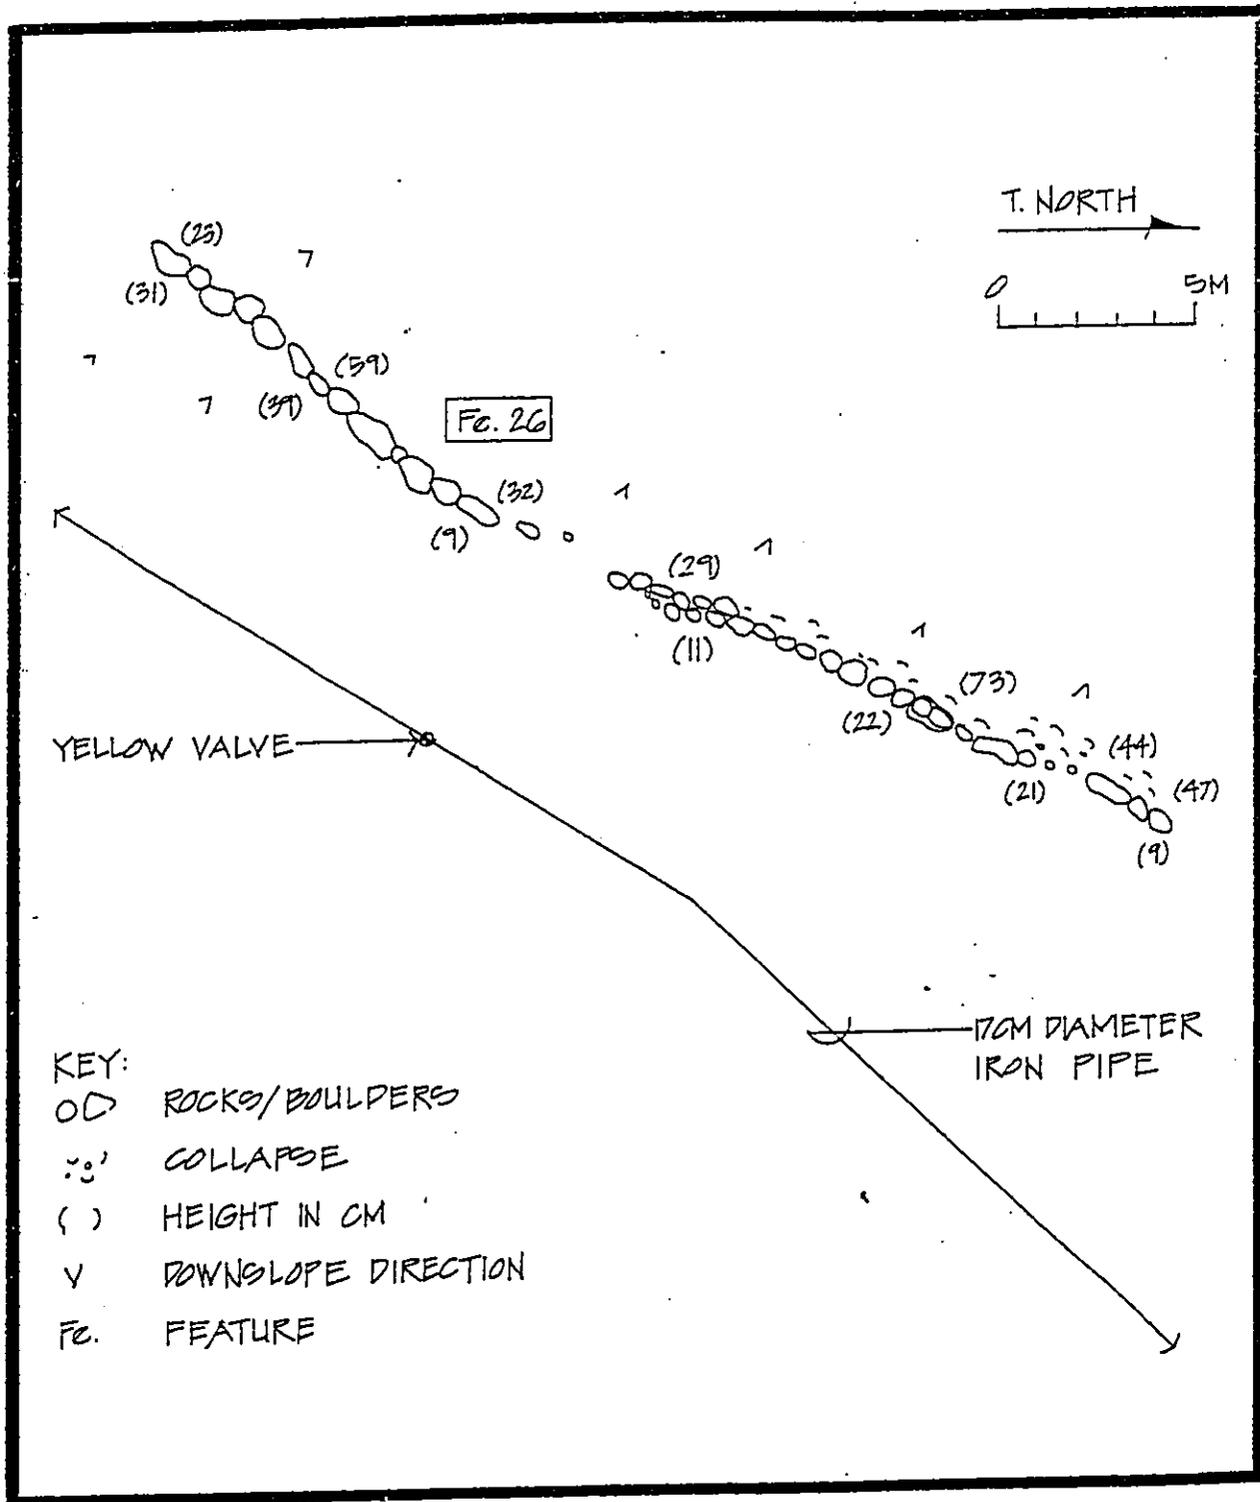
Figure.11 Map of State Site 50-30-10-406 Showing Agricultural Terrace, Feature 26.

- 6) Feature 26 consists of a historic terrace retaining wall located on the west side of the functioning 17 cm diameter iron water pipe which transects the project area (Figure 11). The terrace measures 31 meters long in an NE/SW alignment. The terrace is in poor condition and truncated in several places (see Photograph Appendix, Figure 38). No test units were conducted. Due to crude, informal construction techniques this feature is likely historic and functions to minimize erosion to drainage canal. No artifacts or cultural material was observed.

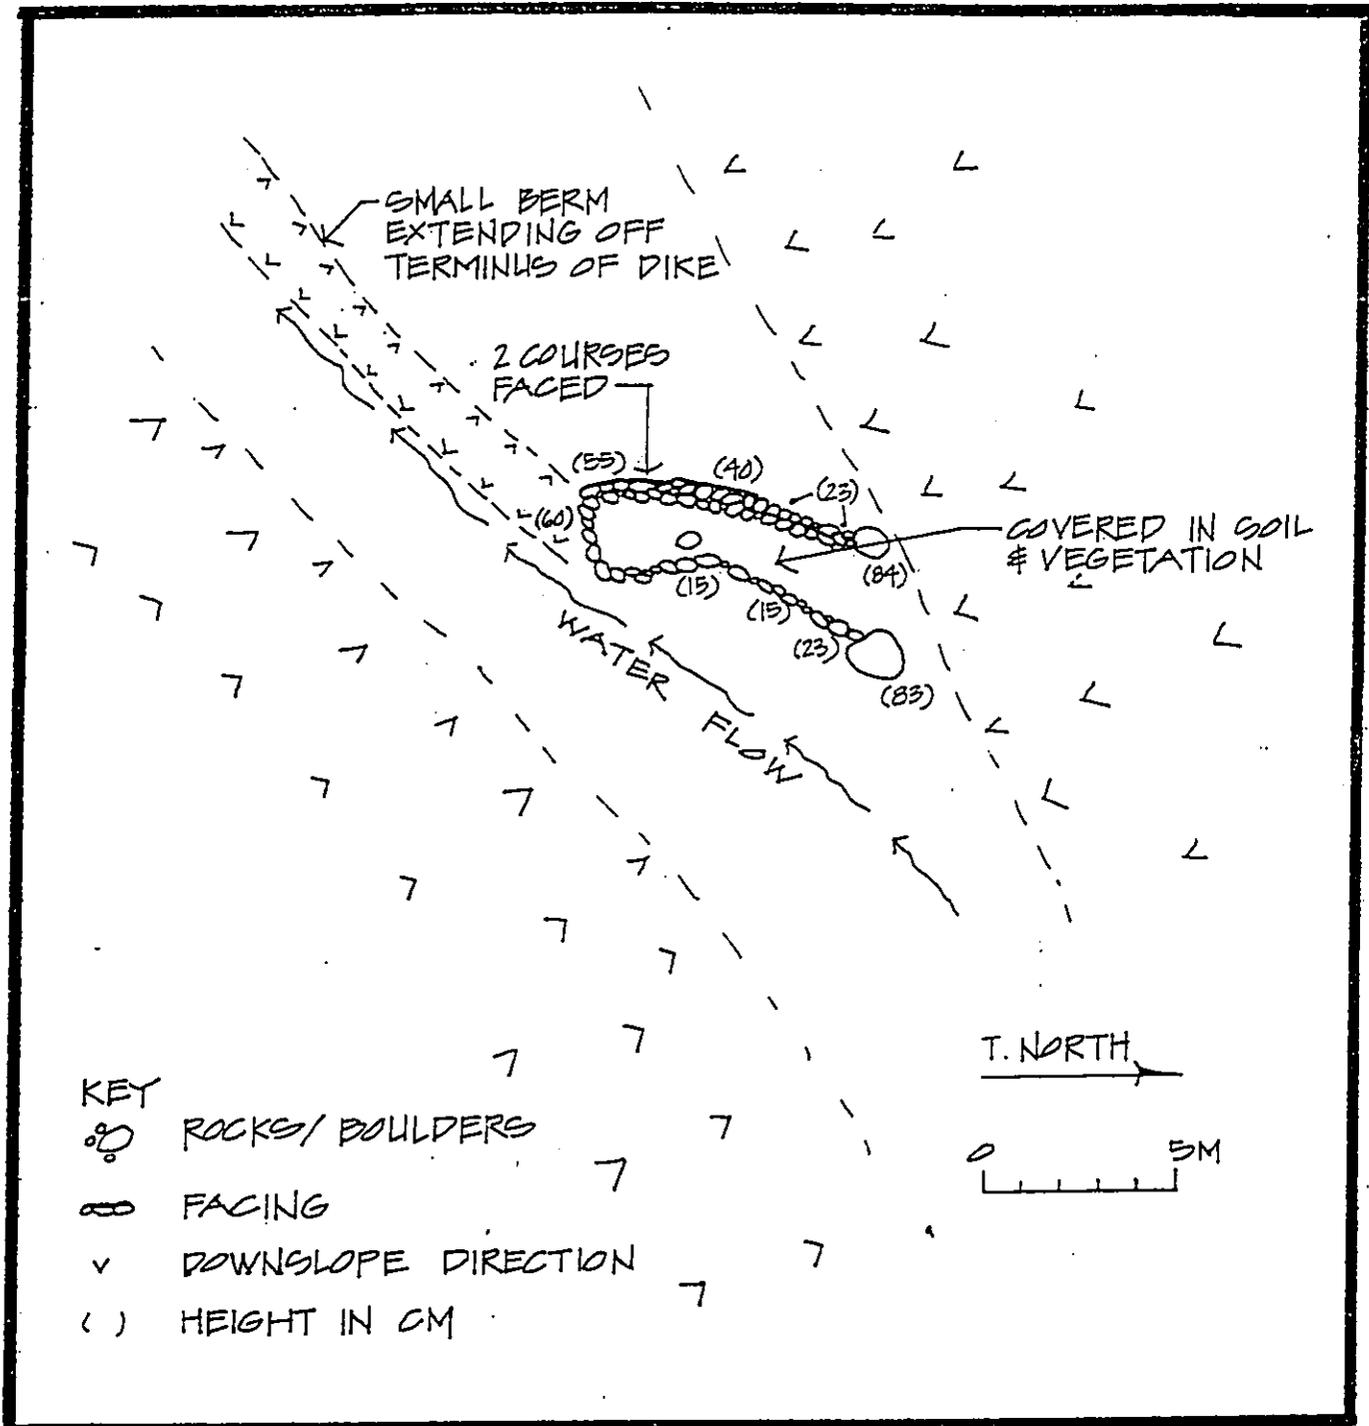
Figure 12 Map of State Site 50-30-10-485 Showing Agricultural Water Dike and Surrounding Topography.

- 7) State Site 50-30-10-485 consists of a single water dike feature located on the north end of the project area, west of site -406 (Figure 12). The historic water dike consists of a 7.6 meter long dike shaped slightly concave to the flow of the water. The max width of the feature is 2.7 meters and is faced on the down-flow side of the feature. The northeast, or up-flow, side consists of a 3.5 meter long, straight, single course of subangular basalt boulders. The faced side consists of subangular basalt boulders stacked 1-2 courses high. The up-slope side of the feature is concave-shaped to form a small pool, although it is currently filled in with accumulated sediment and organic refuse. A low 80-100 cm high berm extends off of the terminus of the dike further constricting the flow of water. The area surrounding site -485 is heavily vegetated with guava, eucalyptus, swamp mahogany, and young Norfolk pines.

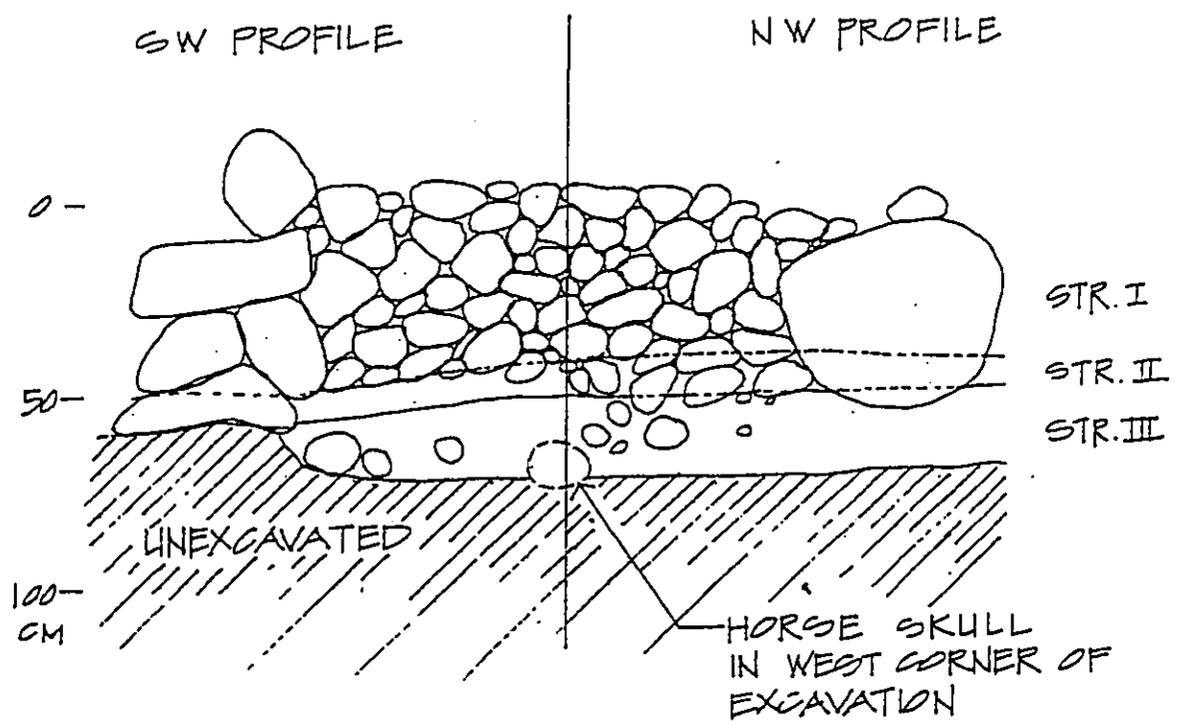
Figure 13 Southwest and Northwest Profile of Site -406 Feature 1, Unit 1, Post-Excavation.

Test unit 1 (1 by 1 m) was excavated in the eastern corner of the Feature 1 platform. Feature 1 is a well constructed, roughly rectangular, platform consisting of a perimeter of large basalt boulders, 2-4 courses high, with an interior fill of smaller boulders and cobbles. The platform has the appearance of a traditional Hawaiian burial feature, but may also have been constructed for agricultural land clearance. Based on surface observations, the age of construction for the platform was not apparent. No artifacts or midden were visible on the platform surface, or in the immediate vicinity. Test unit 1 was excavated to better determine the function of the mound, its age of construction, and to investigate the mound's stratigraphic relationship to the surrounding land surface.

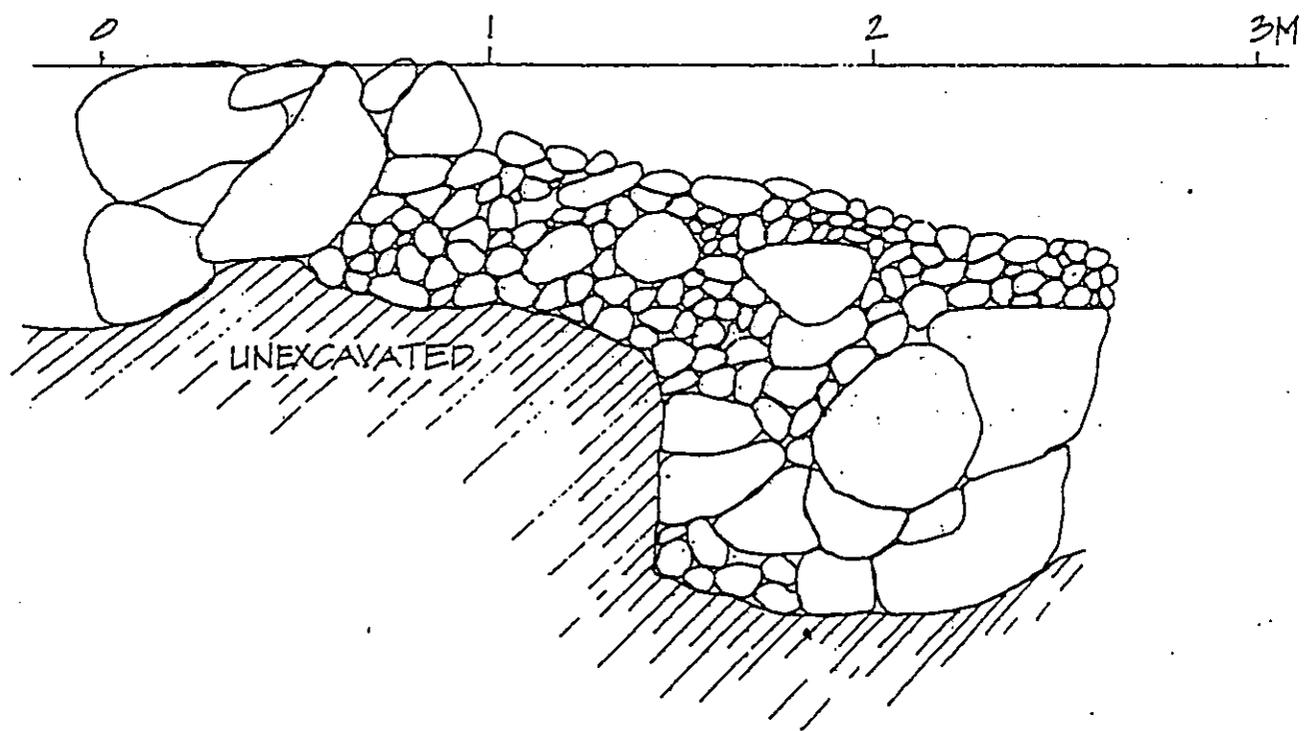
Figure 14 South Wall Profile of Site -406, Feature 16, Test Unit 1.

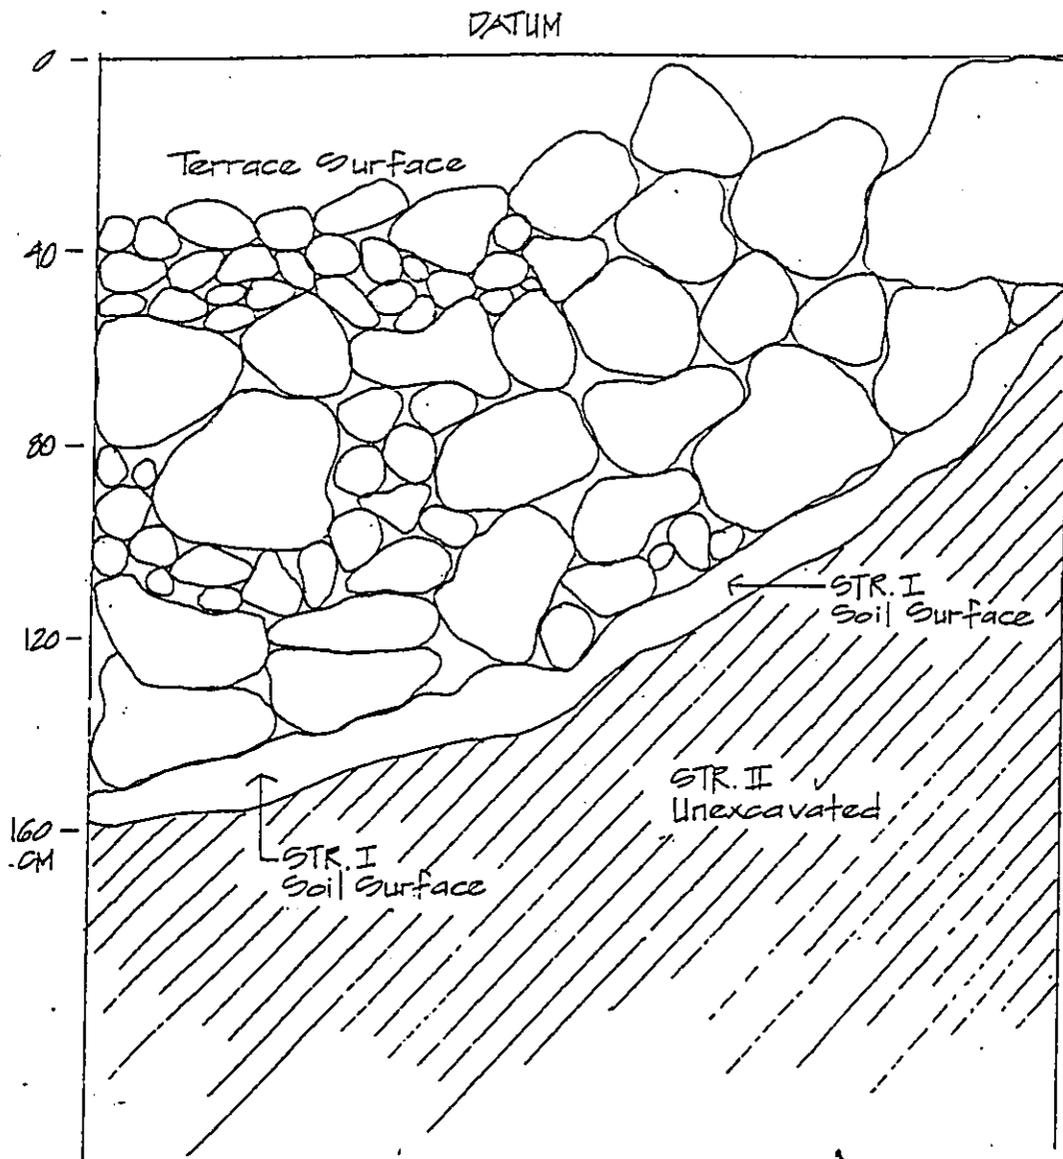
Figure 15 North Wall Profile of Site -406, Feature 16, Test Unit 2.

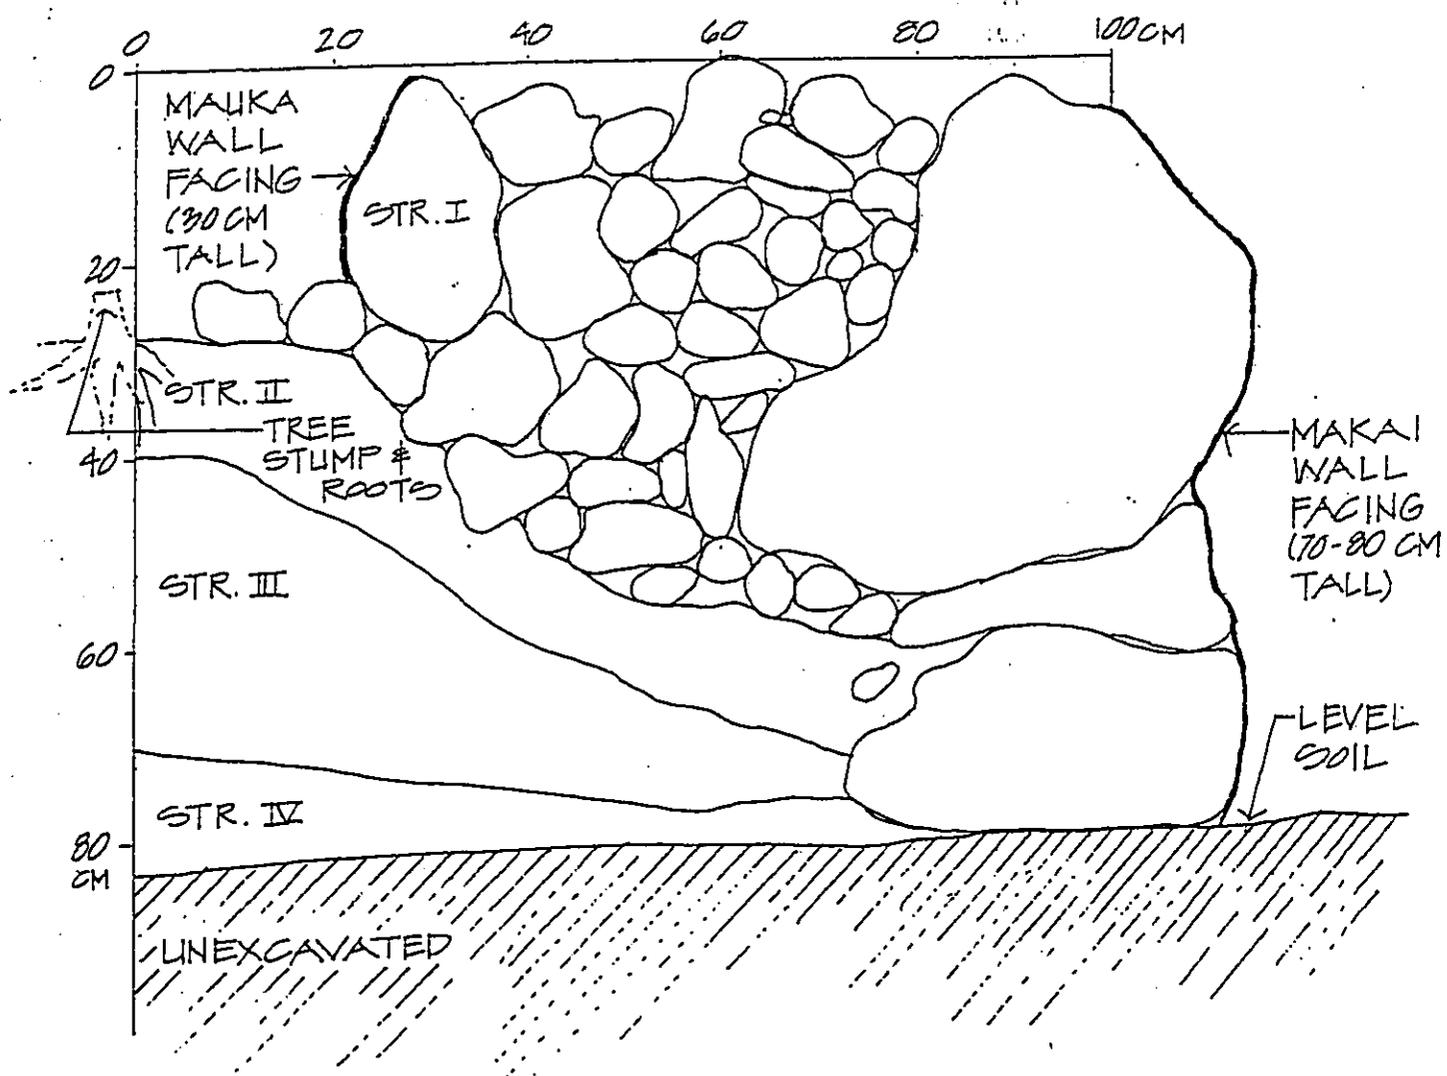
Figure 16 South Wall Profile of Site -406, Feature 17, Test Unit 1.

Test unit 1 in Feature 17 was excavated to bisect the terrace retaining wall, to document the feature's construction style, and to search for cultural material associated with the feature. The excavation was intended to help establish the age of construction and function of the retaining wall. The retaining wall is constructed of stacked boulders three to five courses high on the up-slope side and two to six courses high on the down-slope side. The retaining wall clearly has a core-fill of cobbles, see Figure 16. Based on general morphology, the retaining wall appeared to be an agricultural retaining wall that
