**FINAL
Environmental Assessment**

**KEO
EMERGENCY SHELTER
AND
TRANSITIONAL HOUSING PROGRAM
Lihue, Kauai, Hawaii
Tax Map Key: (4) 3-8-5:1**

Phase I Environmental Site Assessment

Agor Architecture retained Clayton Group Services, Inc. (Clayton) to conduct a Phase I Environmental Site Assessment of the Proposed Kauai Homeless Shelter property located at 2804 Wehe Road in Lihue, Kauai, Hawaii, the "subject property," also described as Tax Map Key (TMK) Numbers: (4) 3-8-005: Parcel 1. The objective of the assessment was to provide an independent, professional opinion regarding recognized environmental conditions, as defined by ASTM, associated with the subject property. The objective of the assessment was in association with a real estate financial transaction.

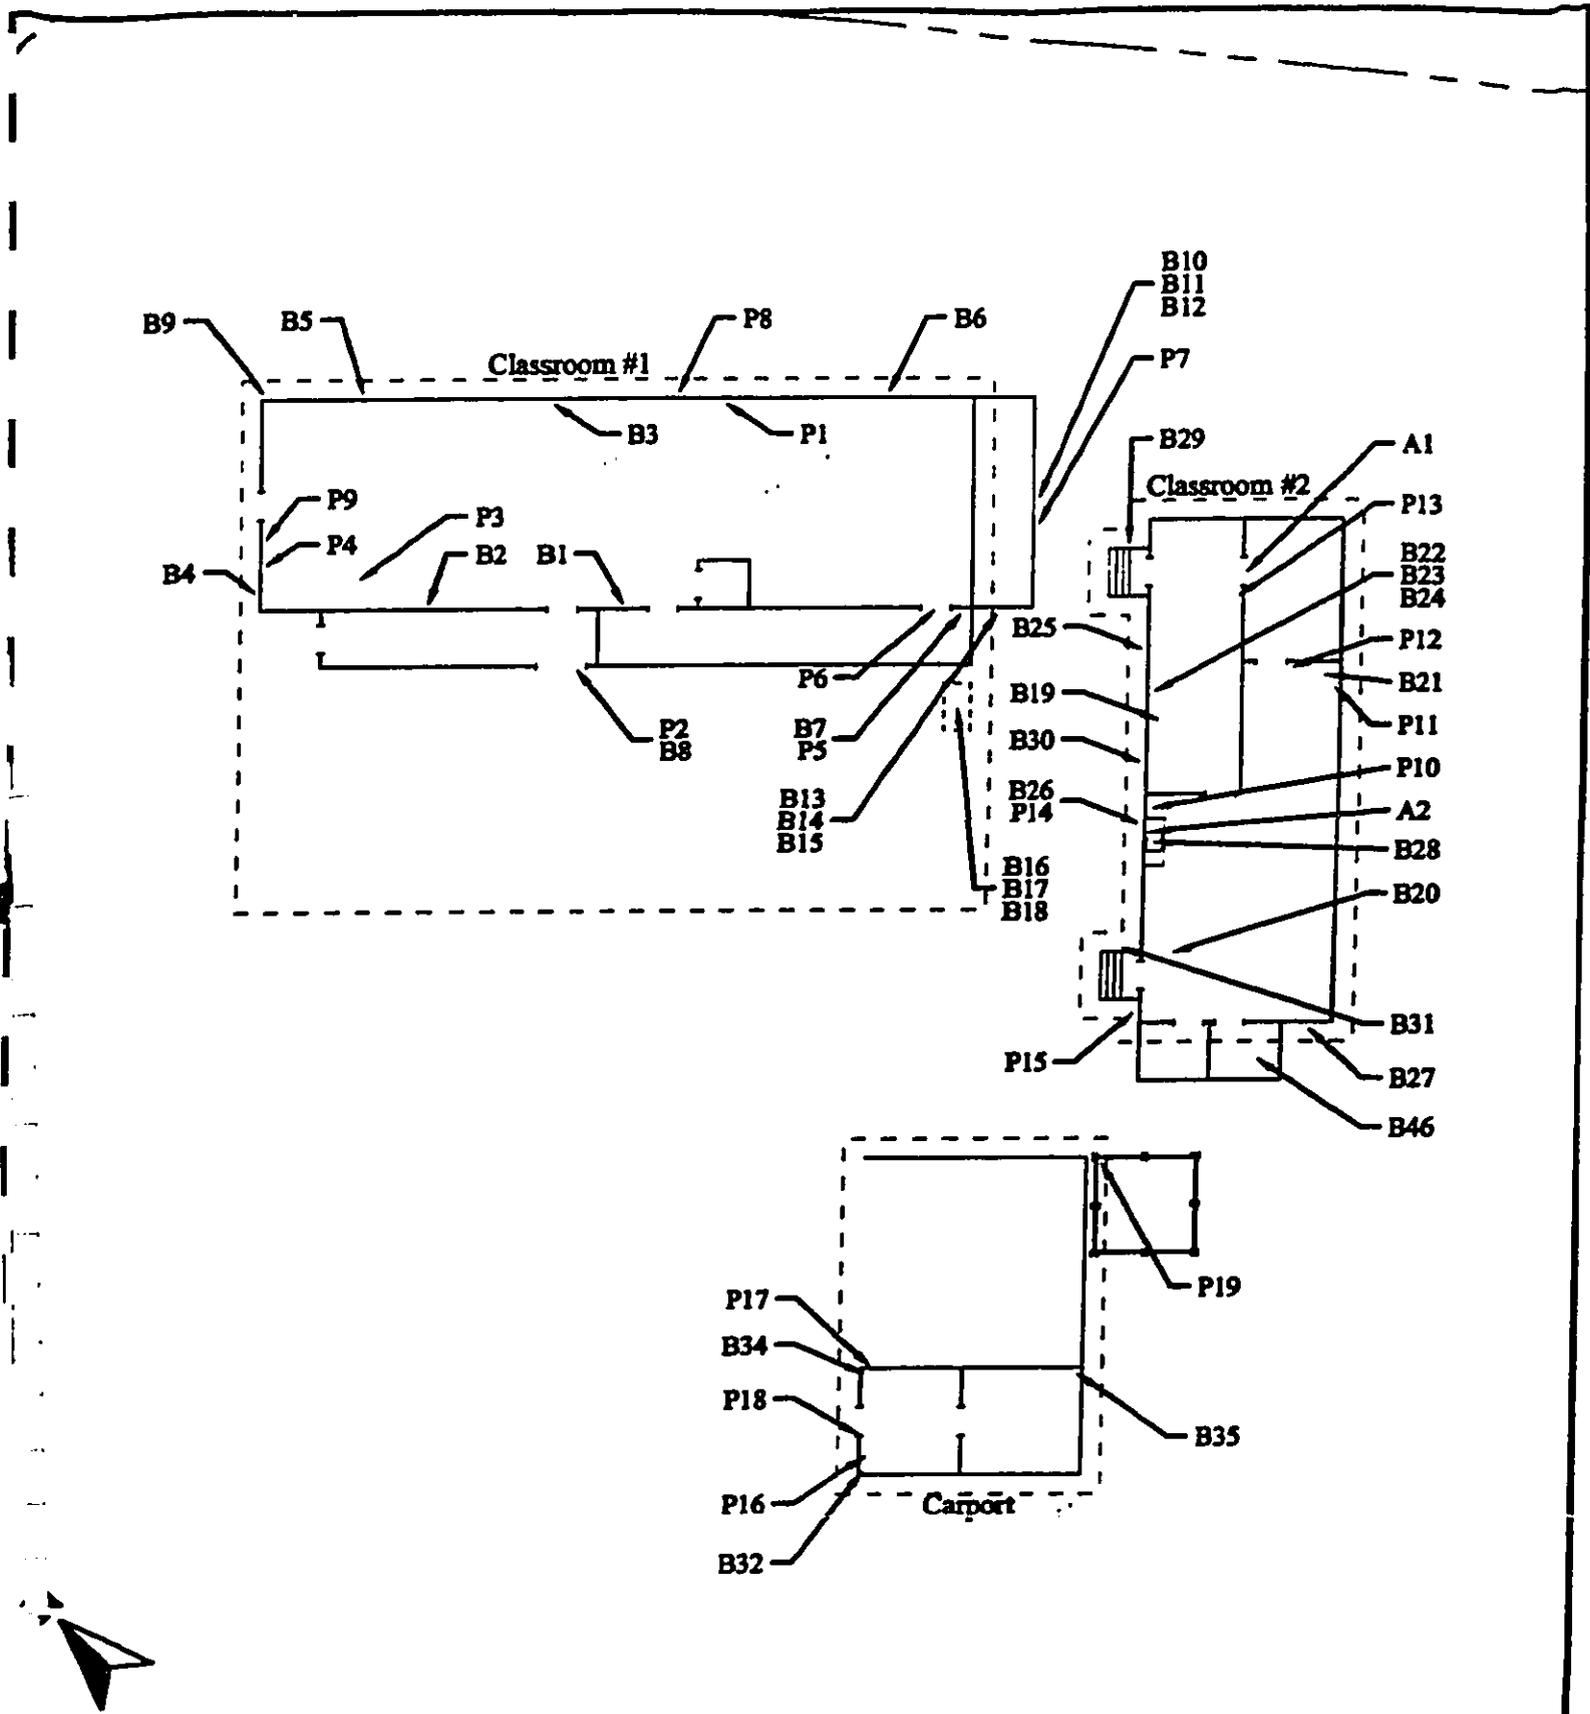
Project No.	85-05262.00	Title	Lead and Asbestos Sampling Locations	FIGURE 3
	Date	04/05/2005		TMK [4] 3-8-005:001	
	Prepared by:	JT		Lihue, Kauai, Hawaii	
	Checked by:	JW		Agor Architecture

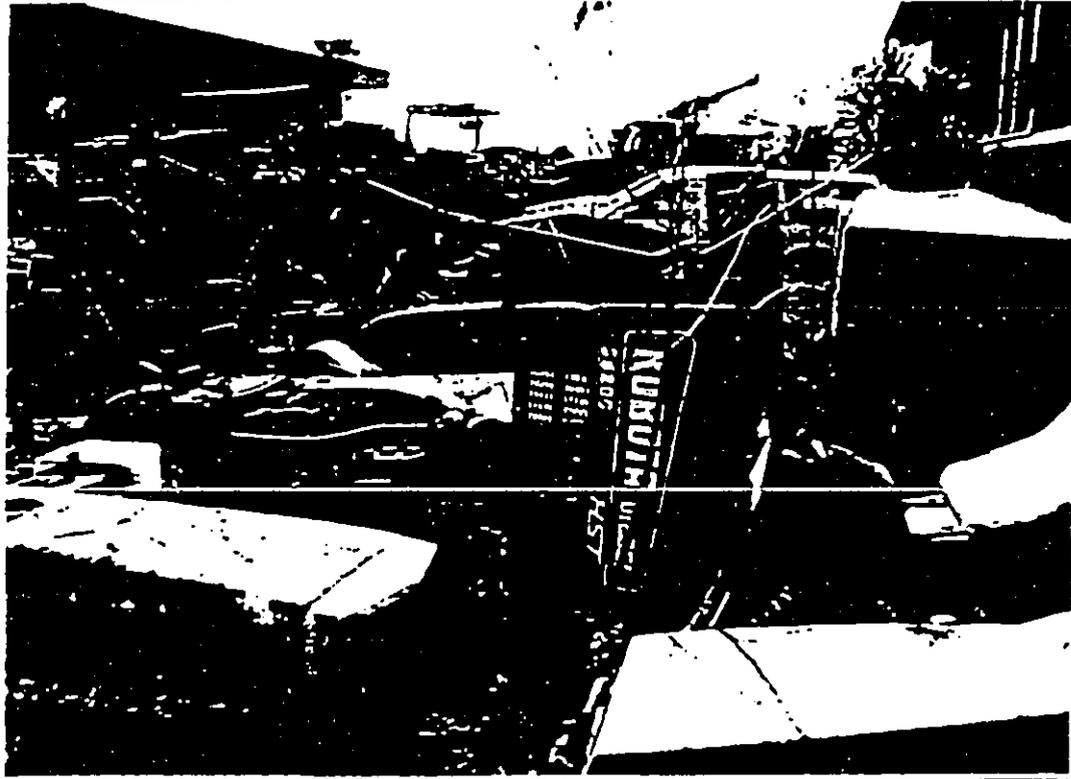
- Evidence of fugitive dumping, including heavy machinery, vehicles, and *de minimis* staining, was observed in the area of the subject property's former baseyard.

Clayton Project Number 85-05262.00	Description	View of discarded equipment located in the former baseyard area	Photo 2
	Site Name	Kauai Homeless Shelter, 2804 Wehe Road, Lihue, Kauai, Hawaii	Photo Date
	Client	Agor Architecture	3-22-2005

The former baseyard and the abandoned machinery and vehicles are considered a recognized environmental condition because of the site activities (i.e., oil changes, fueling) normally associated with these types of operations. Clayton recommends that the discarded items should be removed and properly disposed of prior to development of the property.

After removal of the refuse, the underlying ground surface should be inspected for stains or releases of suspect hazardous materials. If staining is observed, the impacted soil and/or rocks should be sampled prior to being removed and sent to a proper disposal facility. *De minimis* stains in the former baseyard area should be removed from the area.

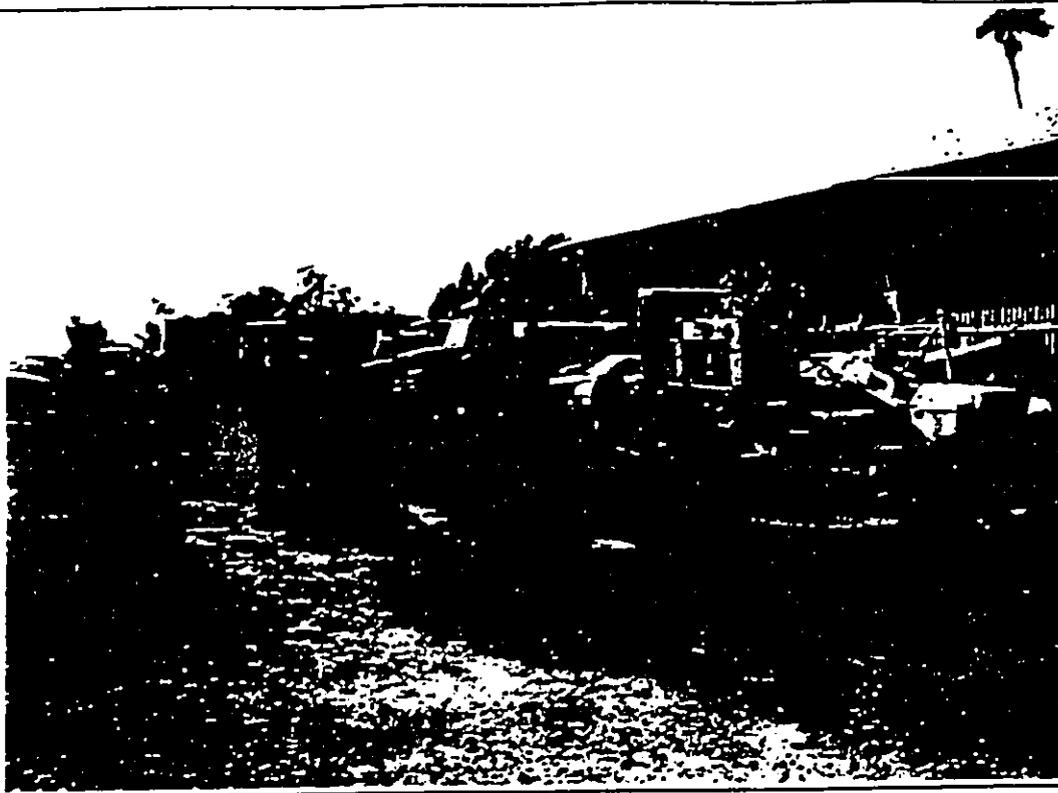
Clayton Project Number 85-05262.00	Description	View of the subject property's former baseyard area	Photo 11
	Site Name	Kauai Homeless Shelter, 2804 Wehe Road, Lihue, Kauai, Hawaii	Photo Date
	Client	Agor Architecture	3-22-2005

Clayton also recommends that the baseyard portion be surveyed with ground penetrating radar to confirm the presence or absence of underground storage tanks at the subject property.

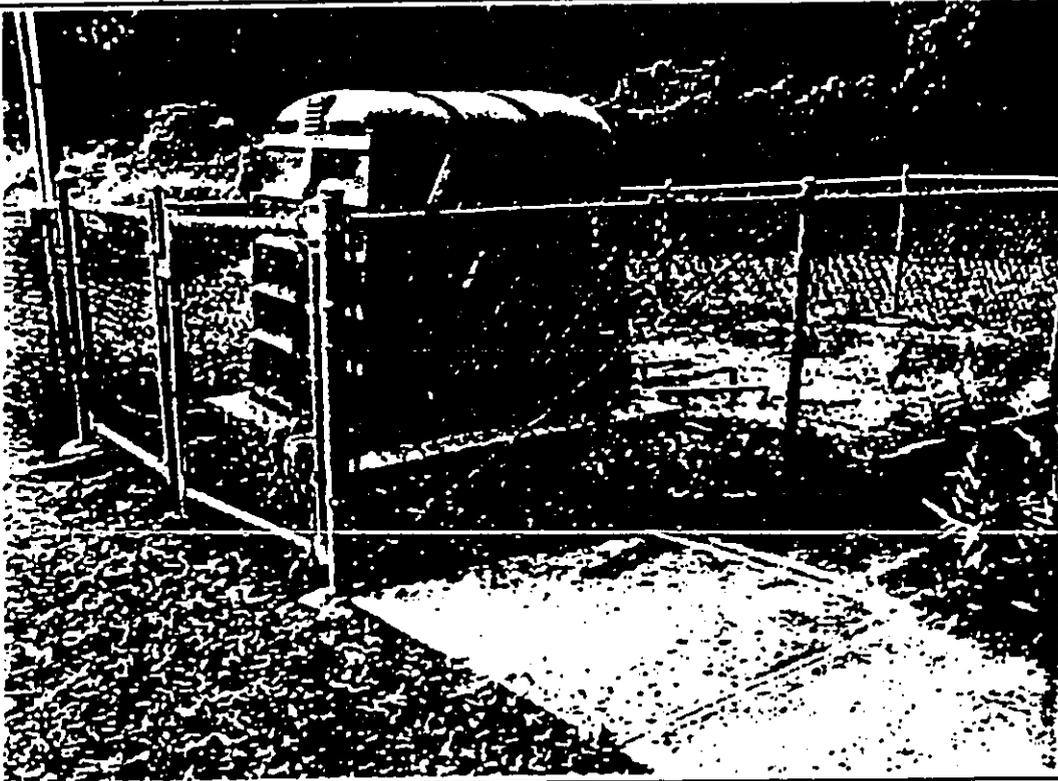
- The subject property maintains an aerobic wastewater system, which is located directly behind the KEO building and is utilized to handle wastewater generated from the KEO building's sinks and toilets. Due to defective issues related to the system's associated irrigation field, it is currently linked to an onsite abandoned cesspool, which was utilized by the former Lihue Grammar School. According to the State of Hawaii Department of Health-Wastewater Division, the onsite system in its current operational state has not been approved for use.

The subject property's wastewater system is not considered a recognized environmental condition because there is no evidence of hazardous materials releases into the system. However, according to the federal regulations published in Federal Register 68546, dated December 7, 1999, existing large capacity commercial cesspools are required to be closed by April 5, 2005.

Clayton Project Number 85-05262.00	Description	View of the subject property's aerobic wastewater system located to the rear of the KEO building	Photo 12
	Site Name	Kauai Homeless Shelter, 2804 Wehe Road, Lihue, Kauai, Hawaii	Photo Date
	Client	Agor Architecture	3-22-2005
