SUBJECT: PEAHI ROAD, BRIDGE REPLACEMENT AT KAUPAKULUA STREAM
FEDERAL AID PROJECT NO. BR-0900(48)
FINAL ENVIRONMENTAL ASSESSMENT
NEGATIVE DECLARATION
TMK: 2-1-13:8
HAIKU, HAWAII

**Kaupakulua Bridge Replacement
Final Environmental Assessment**

The original structure was constructed in 1911, although various components have been replaced since then. With a posted weight limit of six tons, the existing bridge structure measures 15 feet wide by 34-1/2 feet long. Therefore, the bridge currently does not meet minimum strength requirements to accommodate standard highway truck loads, or two lanes of traffic. The bridge has a timber deck, metal guardrails on either side, concrete rubble masonry (CRM) abutments, and a wooden center brace system supported by a concrete foundation within the streambed (See Photographs 1 through 5).

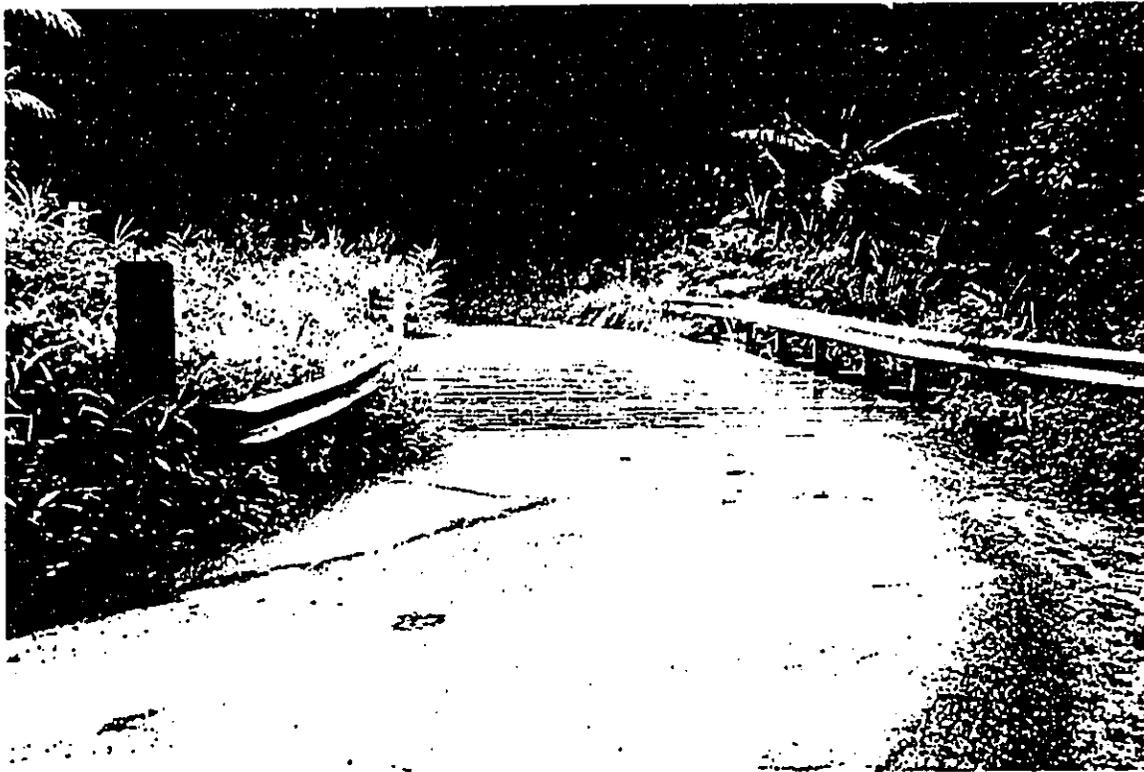
Photograph 1. Peahi Road at Kaupakulua Bridge facing east.

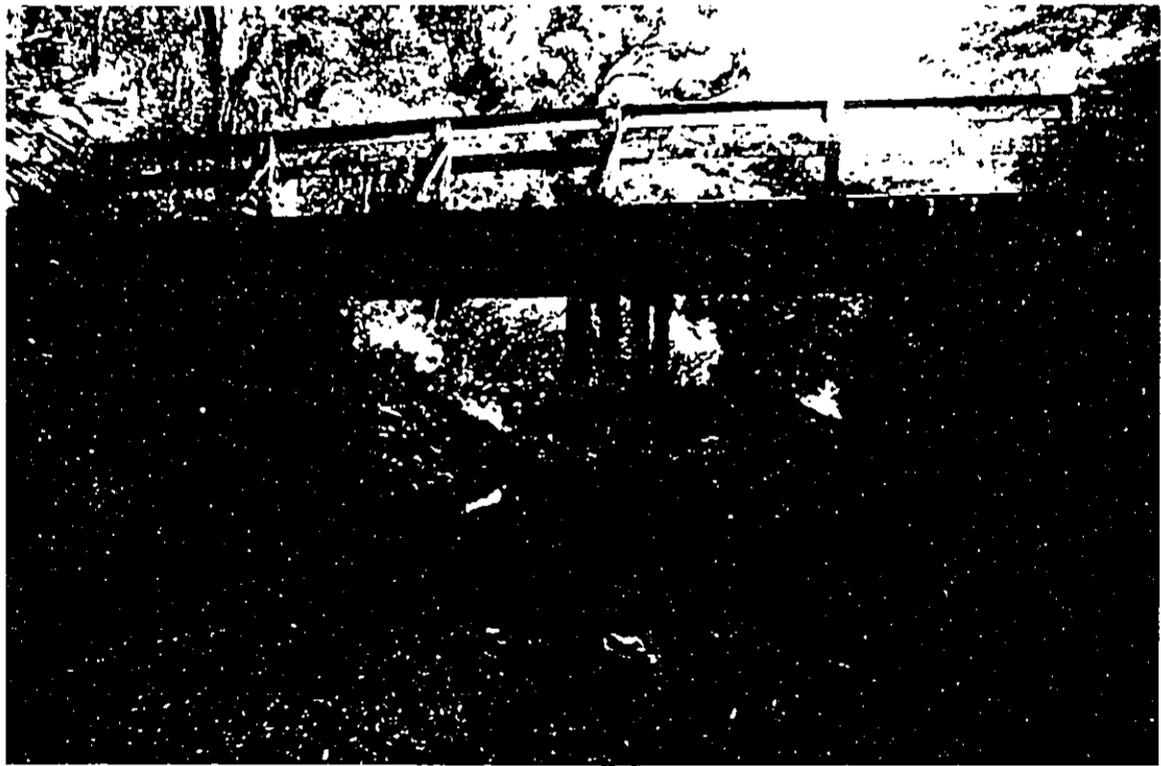
Photograph 4. Kaupakulua Bridge mauka elevation facing downstream (north).

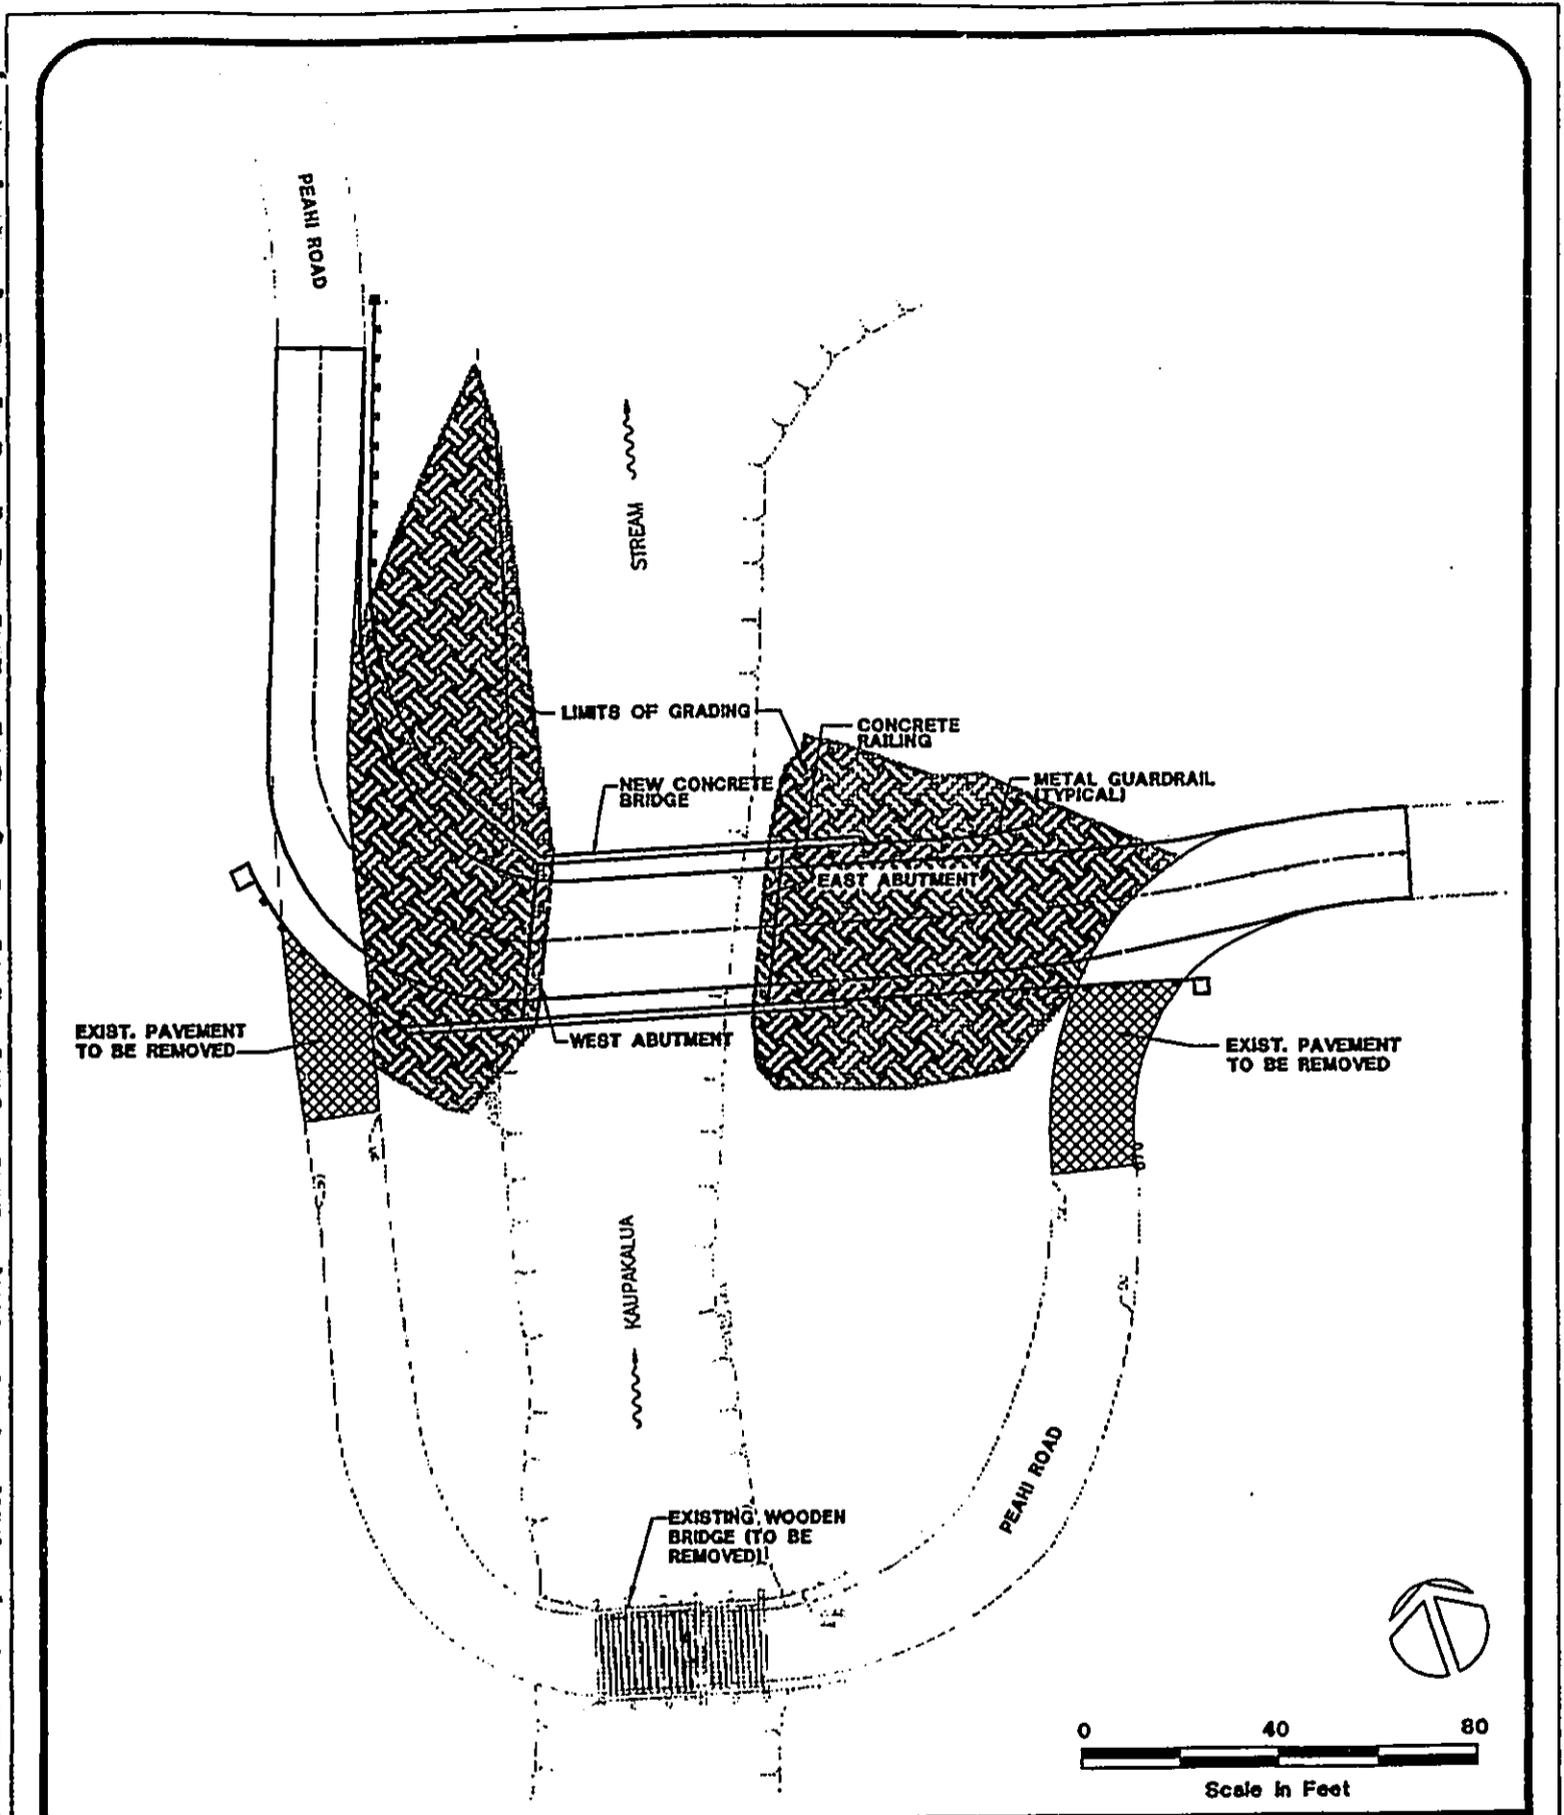
**Fig. 2
Existing &
Proposed Site Plan**

Measuring approximately 35 feet wide by 44 feet long, the proposed replacement bridge will cross Kaupakulua Stream approximately 150 feet downstream of the existing bridge (See Figure 2). The new bridge will be constructed of a cast-in-place concrete deck supported by five pre-cast, prestressed concrete girders, cast-in-place concrete abutments and spread footings. Approximately 3-foot high

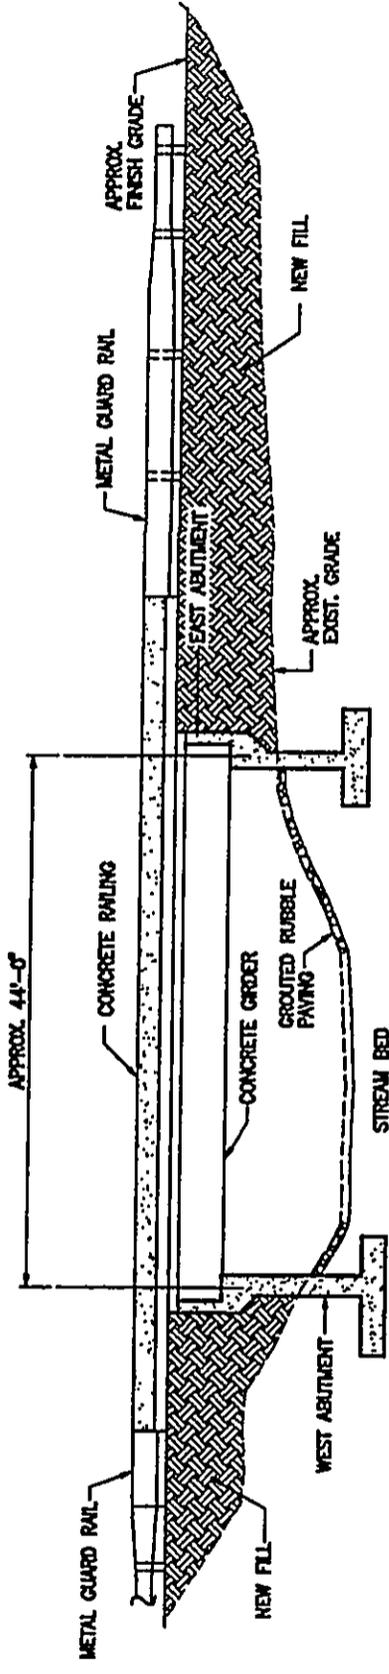
Figure 3
Proposed Longitudinal Section

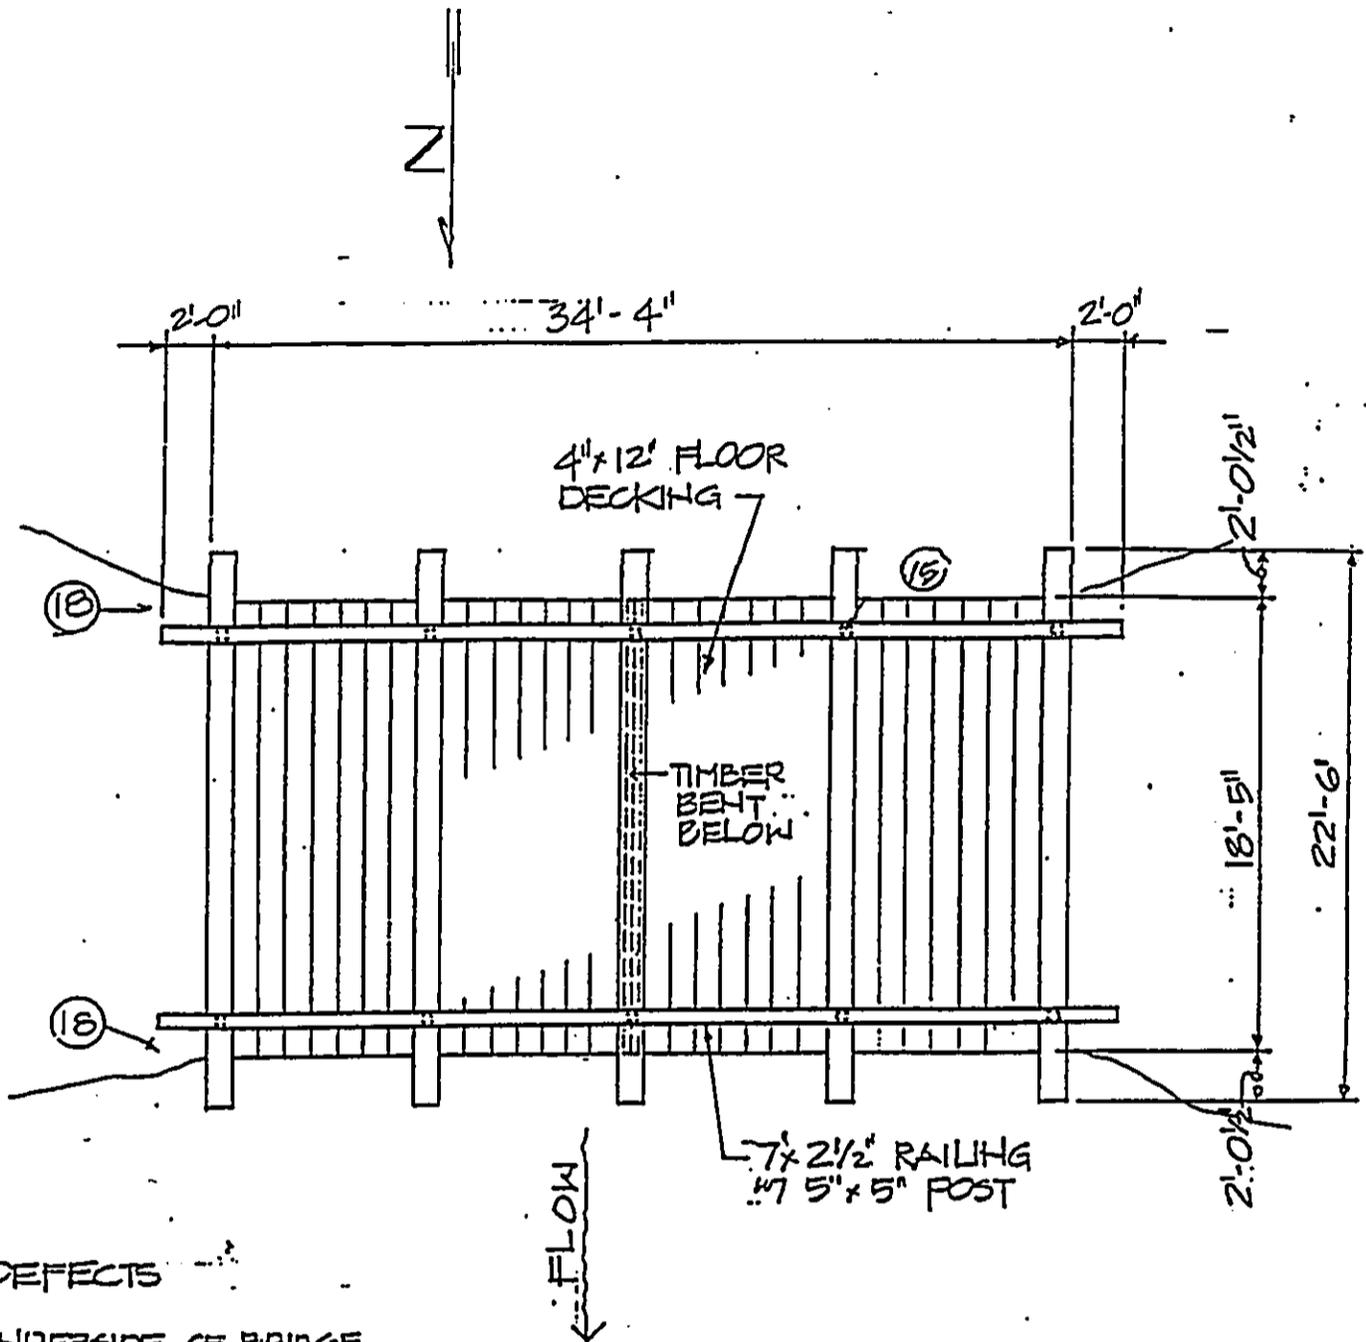
- DEFECTS
- * UNDERSIDE OF BRIDGE

PLAN
SCALE 1/16" = 1'-0"

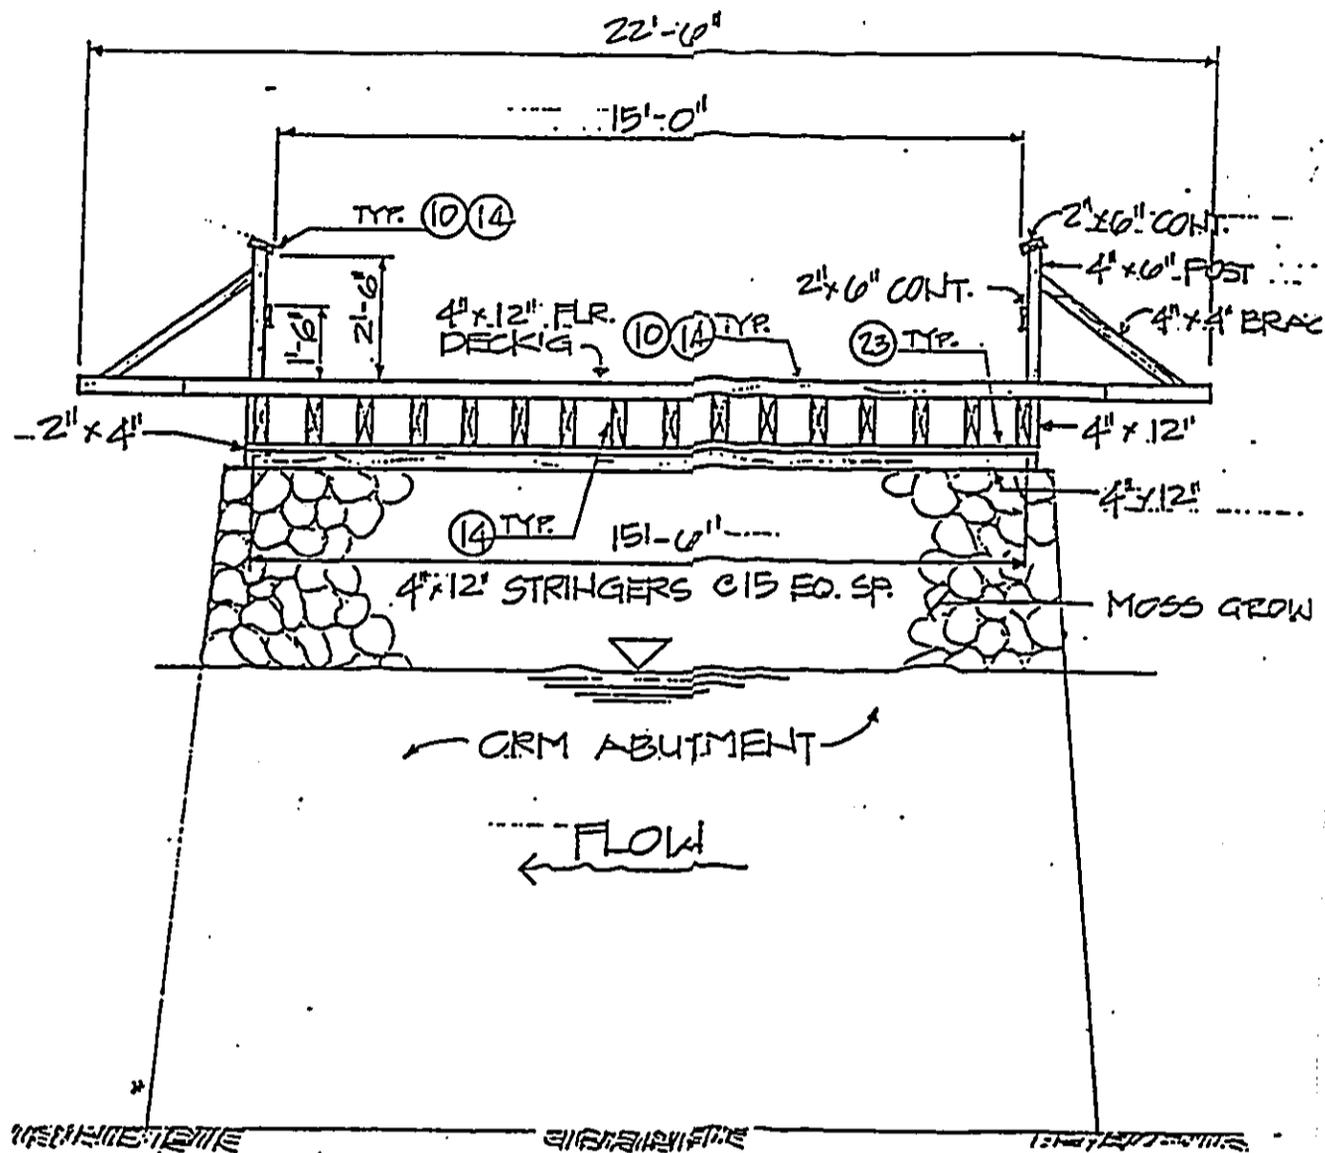
ABUTMENT ELEVATION. LOOKING EAST.

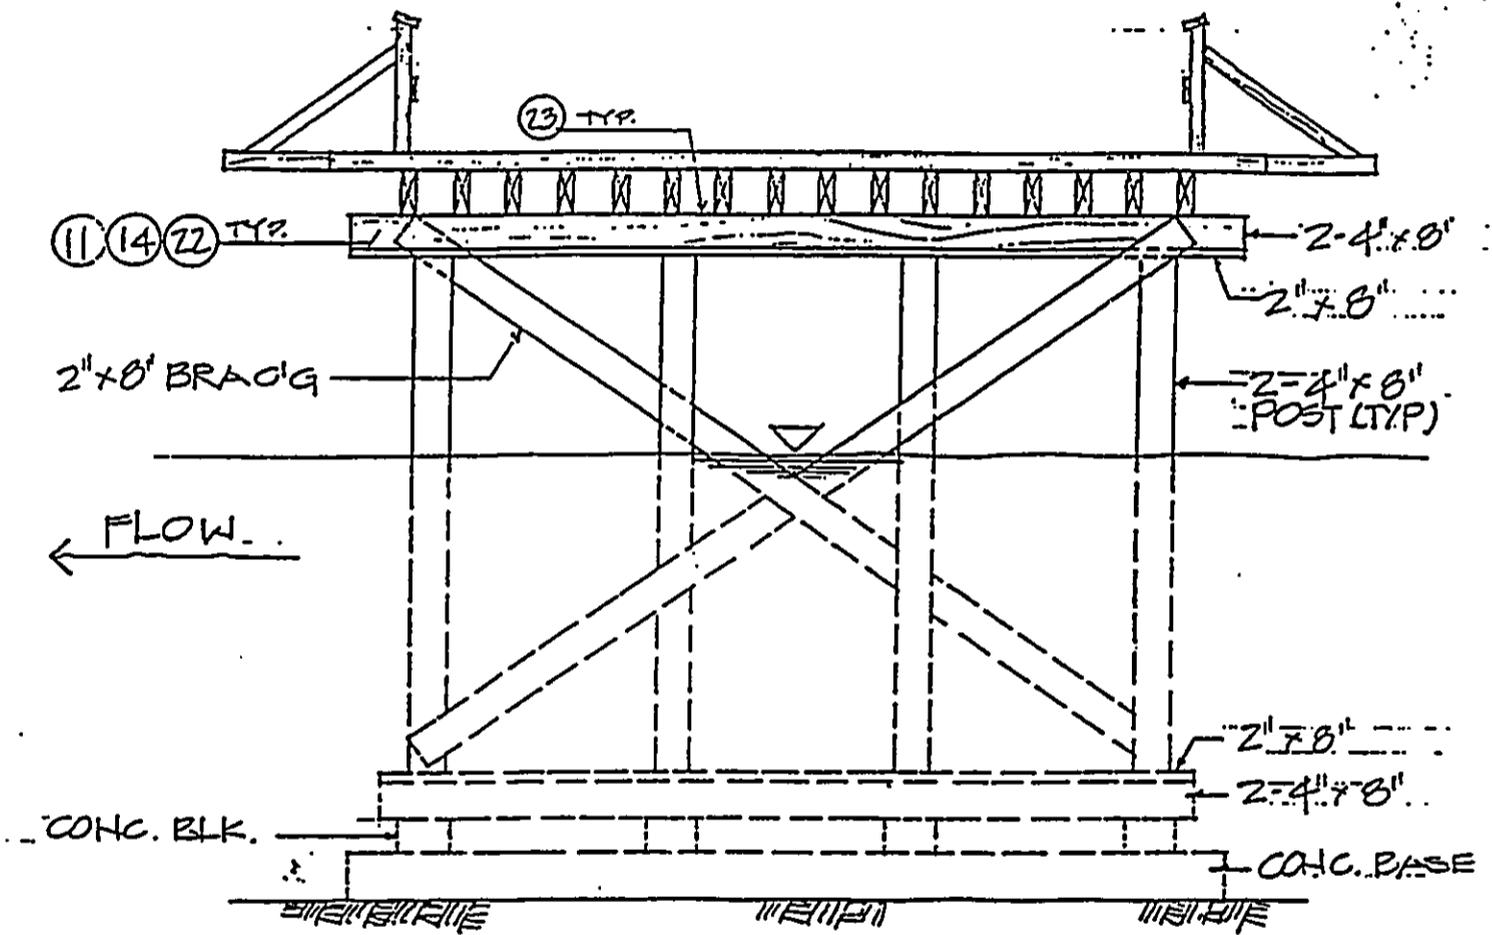
ELEVATION AT TIMBER BENT LOOKING EAST

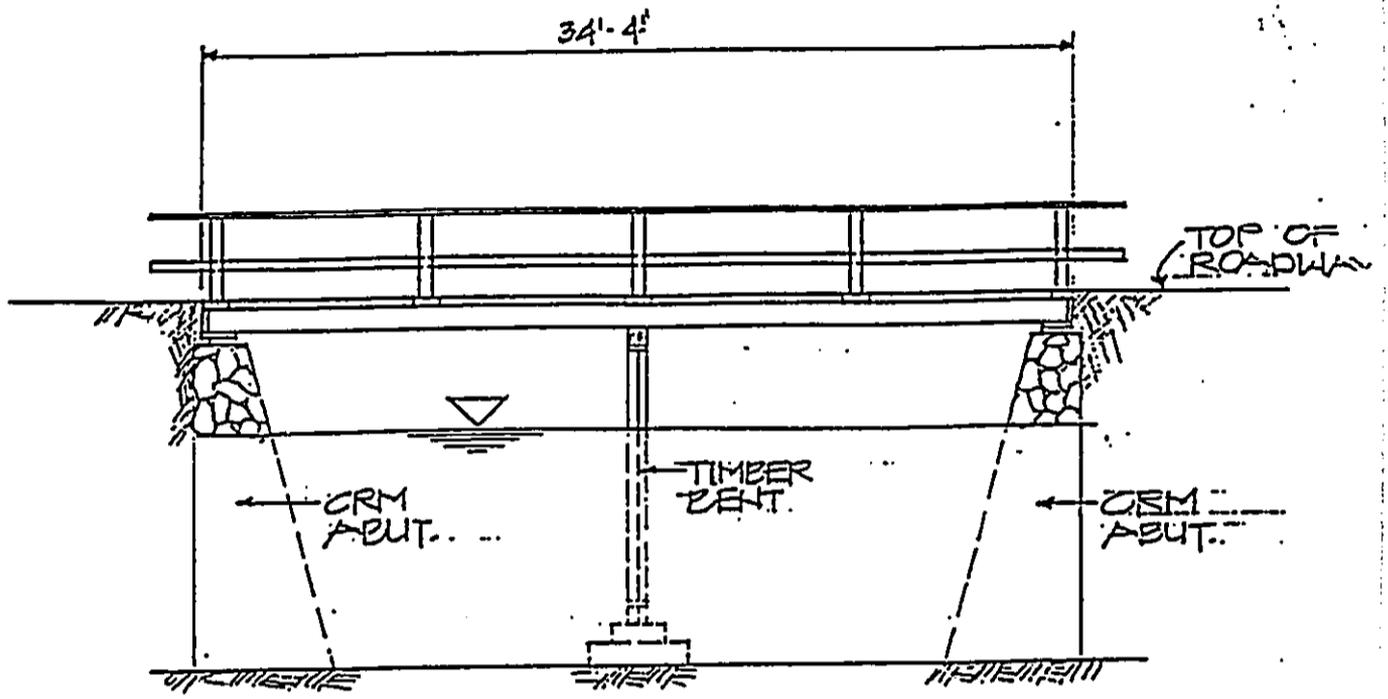
ELEVATION LOOKING NORTH
 SCALE: 1/8" = 1'-0"

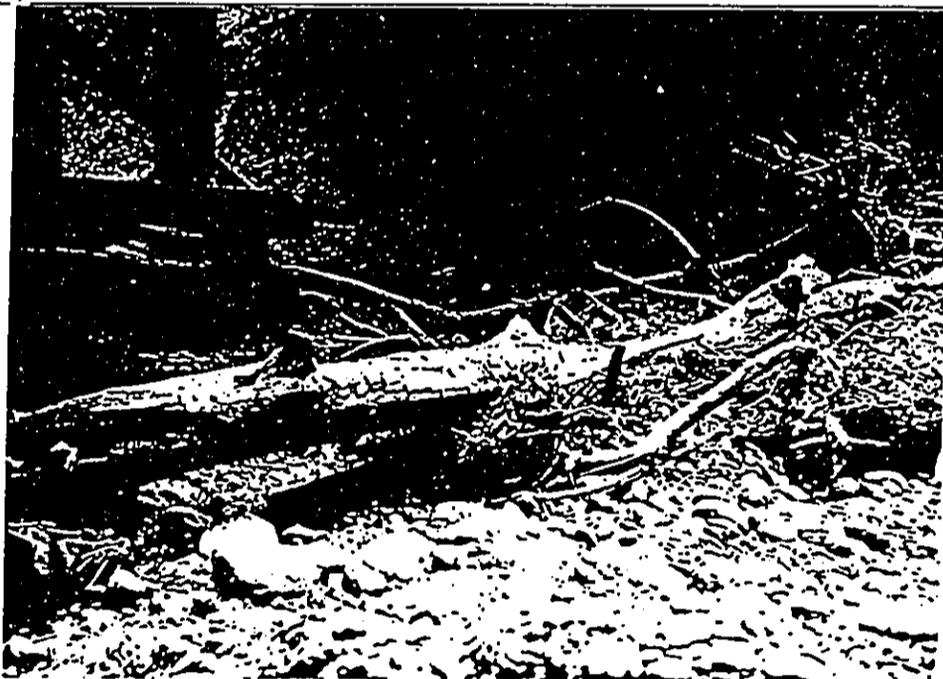
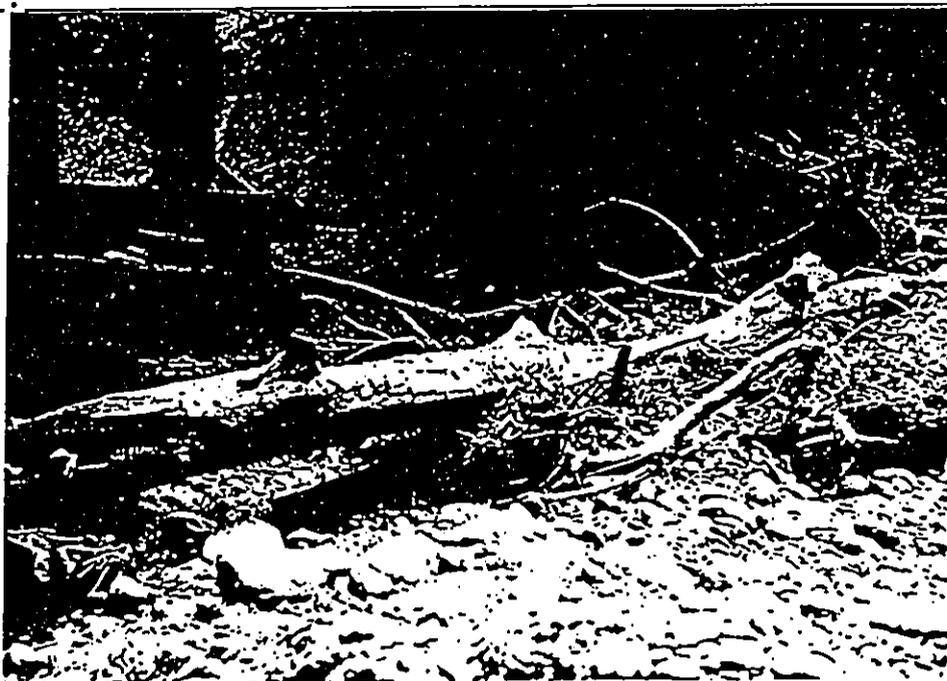
6. Upstream, mid channel, debris.

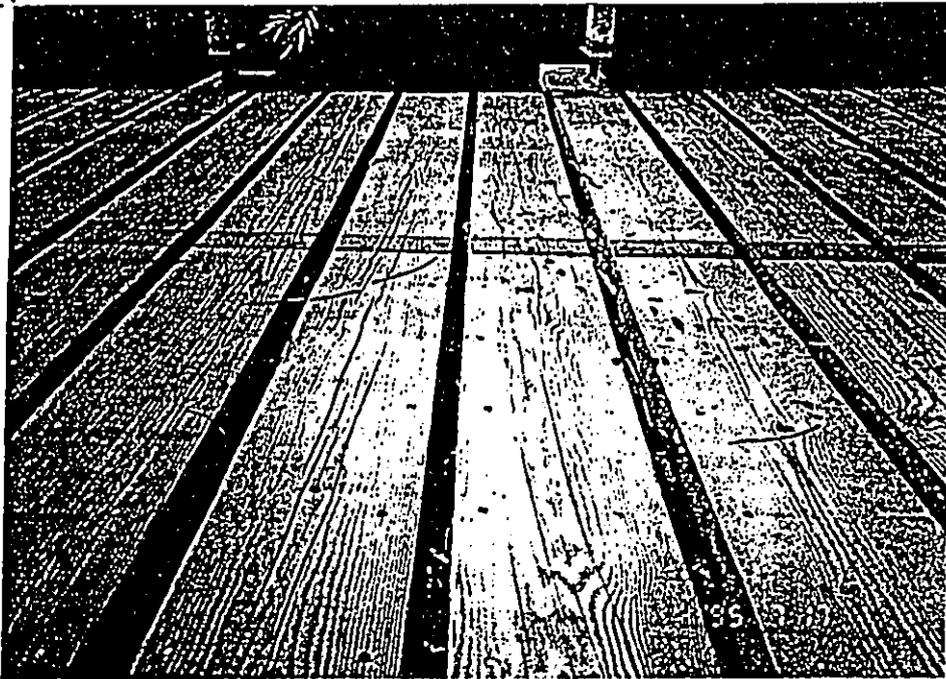
3. New deck planks.

"This bridge is in structurally fair condition. Although county crews have done a very good job replacing the deck, stringers, guardrails, etc., this bridge, due to its location and weather conditions, will require ongoing repairs on a yearly basis. The location is in a rainy area and is usually shaded for the better part of the day, this is conducive to rot and prolific decay to a wooden structure. A replacement structure of concrete construction, would be most desirable."

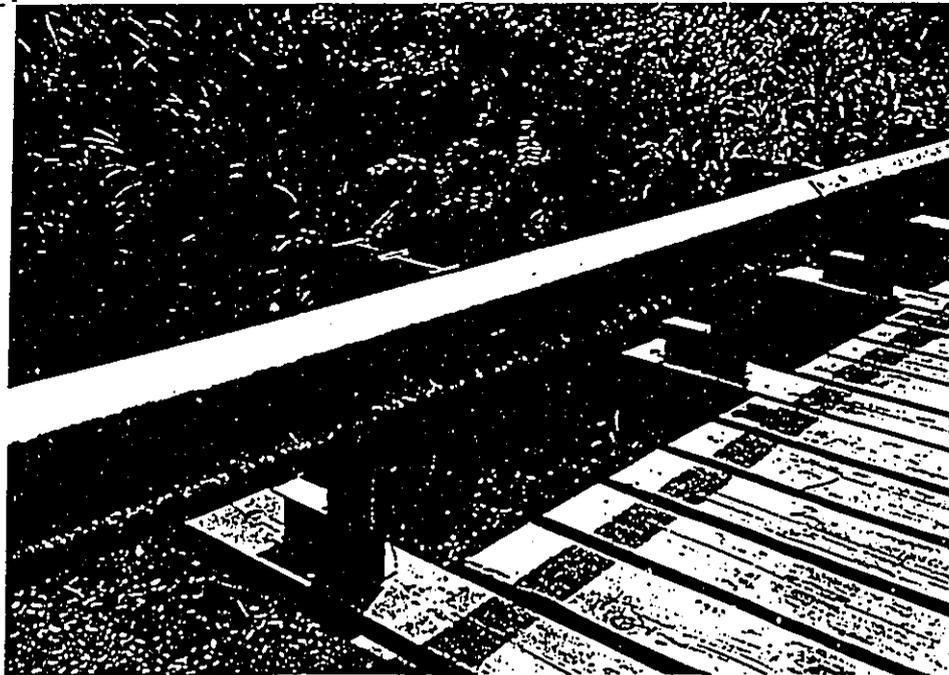
4. New guardrails.

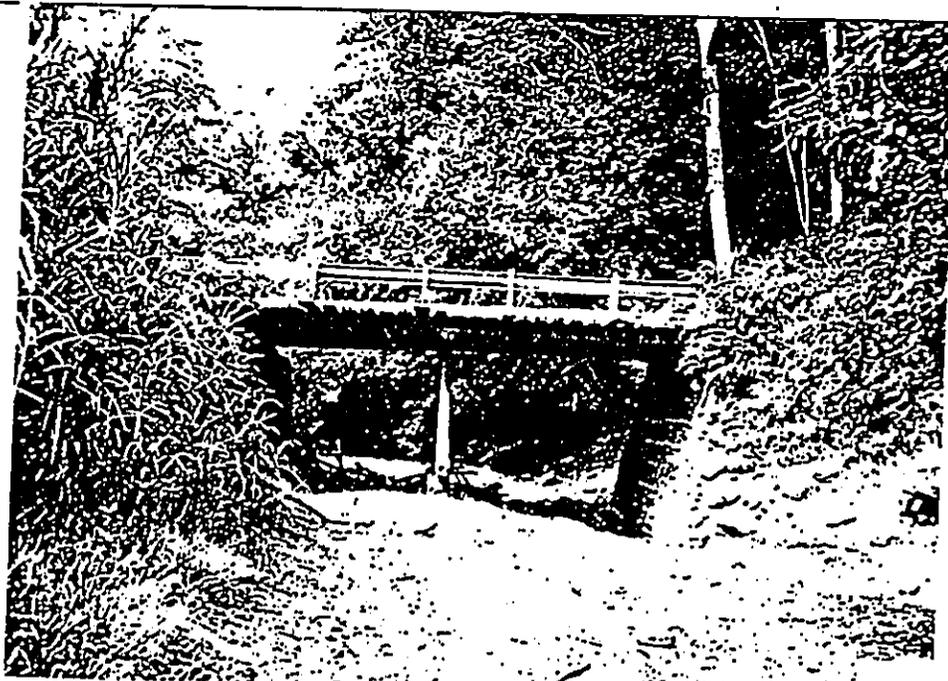
2. Elevation, looking upstream.

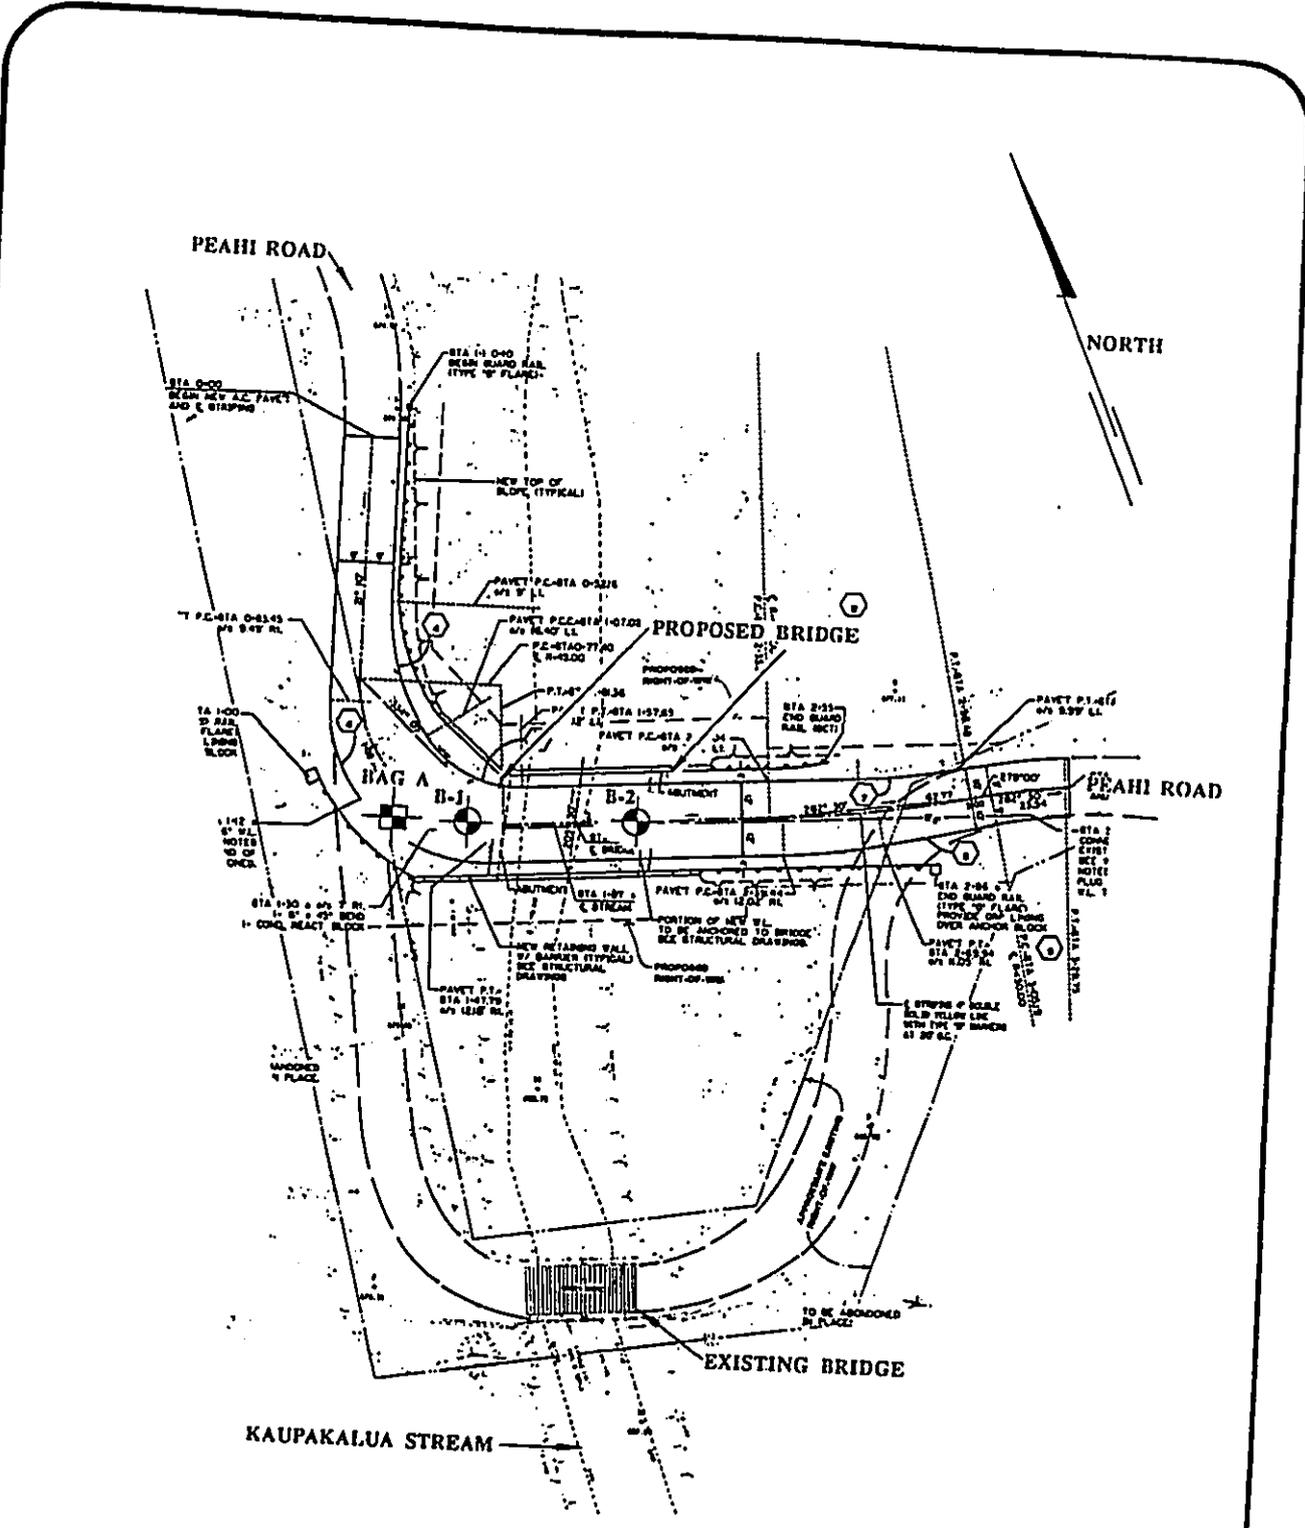
- LEGEND**
- FGE BORING LOCATION
 - FGE BULK SAMPLE LOCATION

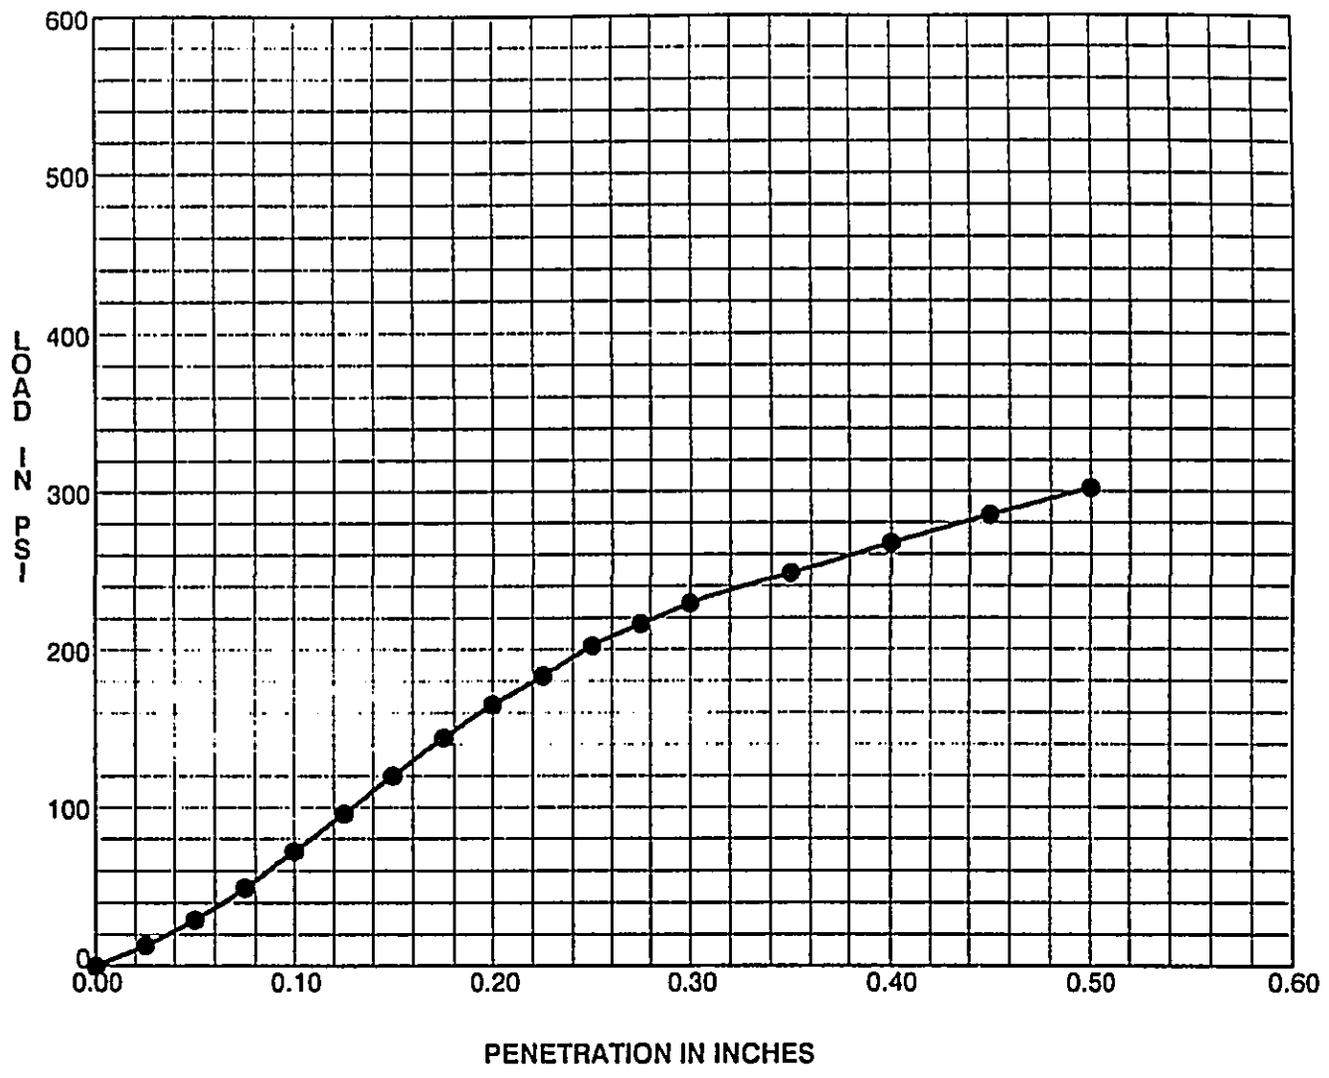
Figure 11

| Sample Identification | Classification | CBR | % Comp. | Max. Den. | Opt. % MC | % Swell | LL | PI |
| ● BAG A | Brown Clayey SILT (MH) | 12.0 | 93 | 100 | 26 | 2.8 | 62 | 20 |

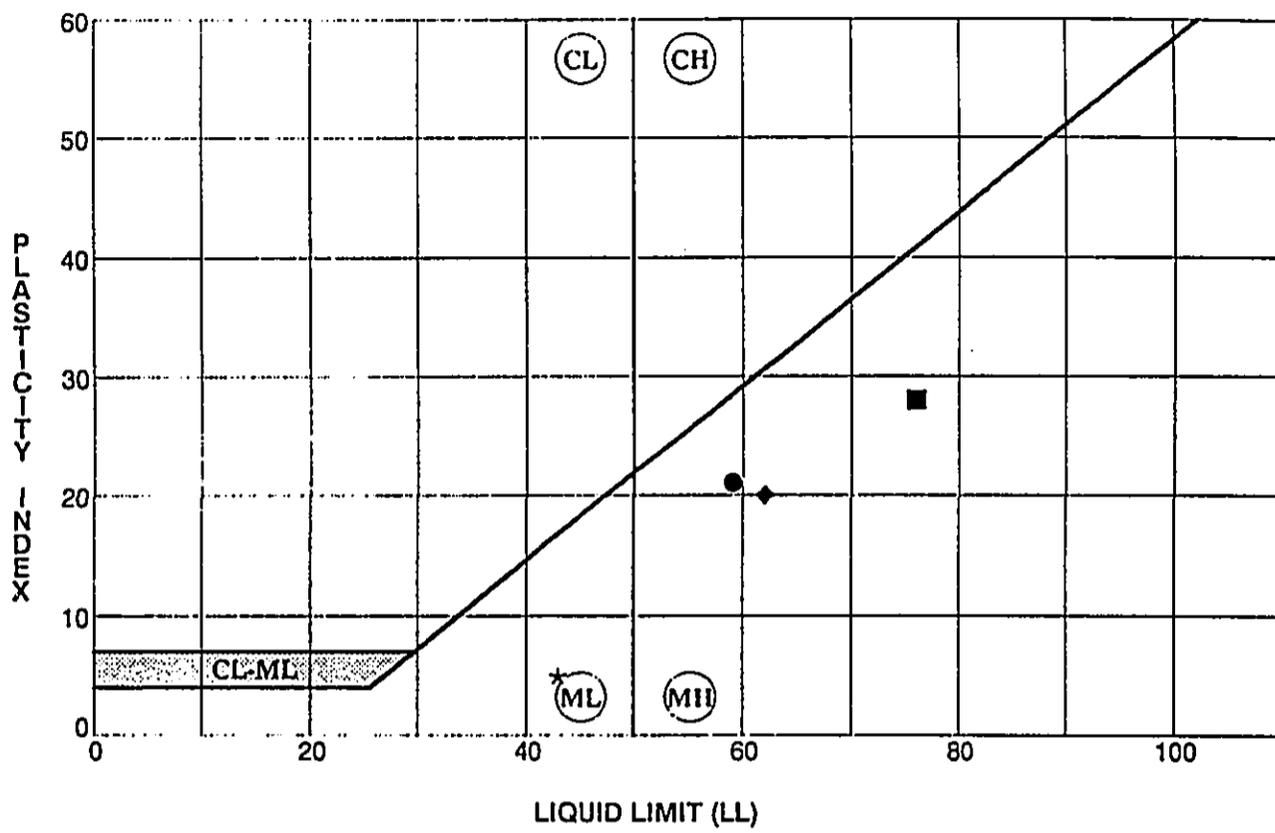
| Sample Identification | Depth in Feet | LL | PL | PI | Classification |
| ● 1-3 | 6.0 | 59 | 38 | 21 | Brown Clayey SILT (MH) |

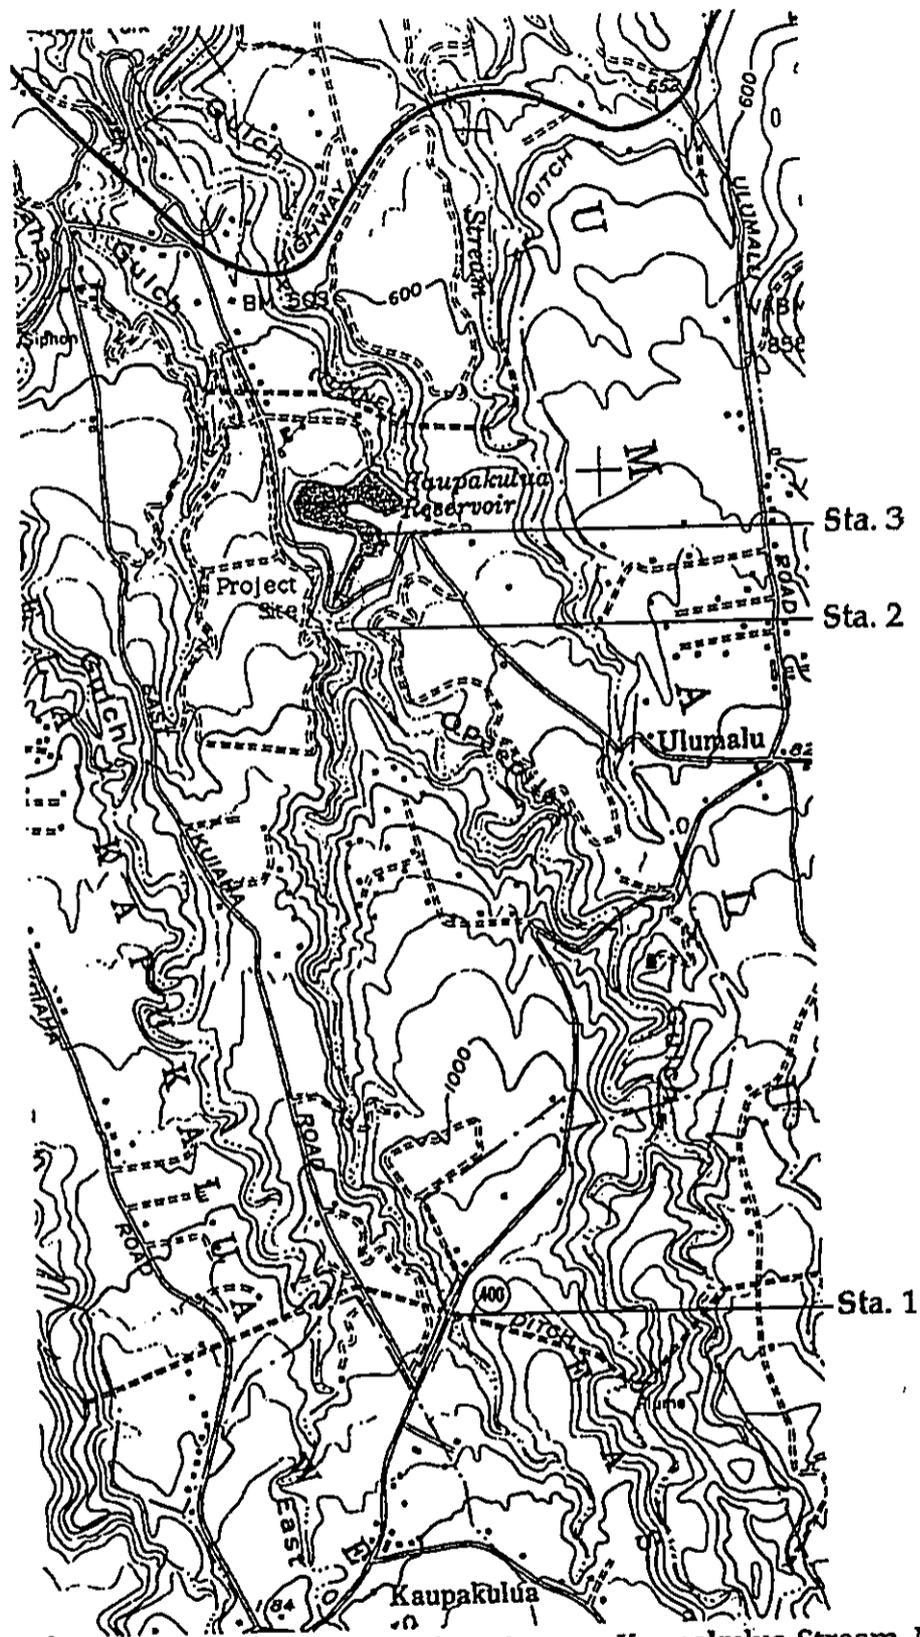
FIGURE 3. Water quality station locations on Kaupakulua Stream, Maui.

Three samples of water were collected from the Kaupakulua Stream system (Figure 3) for measurements of several common water quality parameters (see Table 4). Station 1 was located on the unnamed gulch where the stream passes under Kaupakulua Road (State Highway 400). Station 2 was located on Kaupakulua Stream about 50 m upstream of the Peahi Road bridge (i.e., just above the project area). Station 3 was located in Kaupakulua Reservoir near the upper end but downstream of the proposed bridge crossing point.
