SUBJECT: PAPA'AHAWAHAWA BRIDGE REPLACEMENT
FEDERAL AID PROJECT NO. BR-0900(49)
FINAL ENVIRONMENTAL ASSESSMENT
NEGATIVE DECLARATION
TMK: 1-5-06:1 AND 1-5-07:1
HANA, MAUI, HAWAII

**Papaahawahawa Bridge Replacement
Final Environmental Assessment**

APPENDIX A	Bridge Inspection Report for Papaahawahawa Bridge County of Maui Department of Public Works and Waste Management, August 1995
APPENDIX B	Geotechnical Site Reconnaissance Report, Papaahawahawa Stream Bridge Replacement, Fewell Geotechnical Engineering, Inc., August 1995
APPENDIX C	Environmental Reconnaissance Survey for Papaahawahawa Bridge. AECOS, Inc., December 1995
APPENDIX D	Archaeological Assessment of the Proposed Bridge Replacement Site at Papaahawahawa, Hana District, Cultural Surveys Hawaii, December 1995

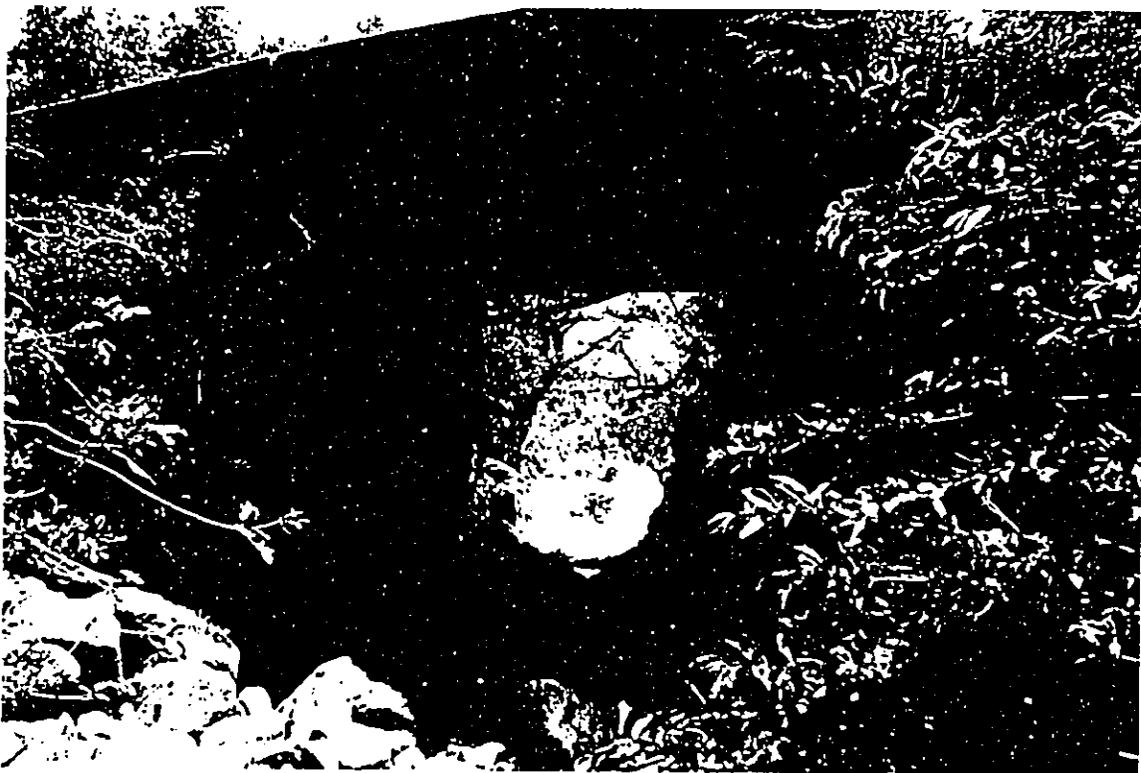
Photograph 6. Papaahawahawa Bridge mauka elevation facing downstream (south).

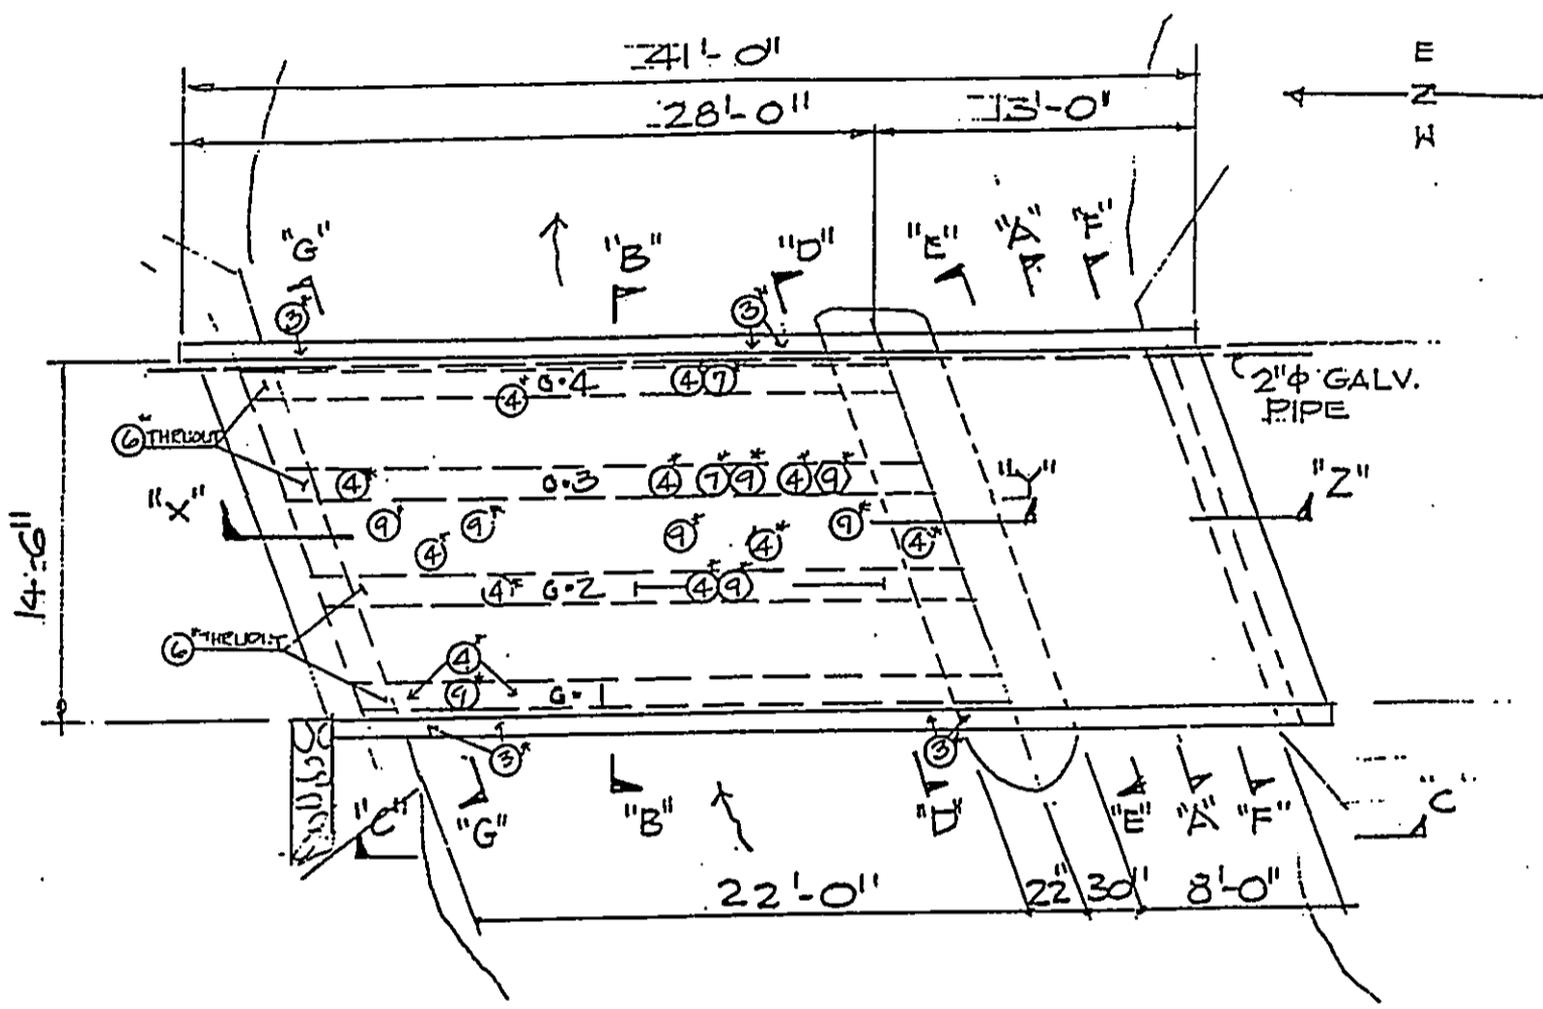
P L A N
SCALE: 1/8" = 1'-0"

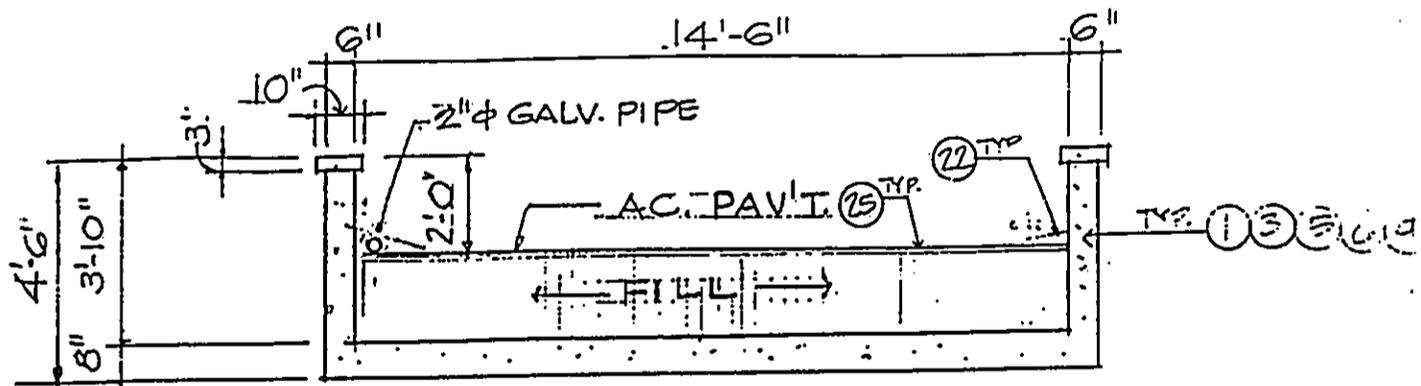
SOUTH BRIDGE CROSS-SECTION "A-A"
 SCALE: 1/4" = 1'-0"

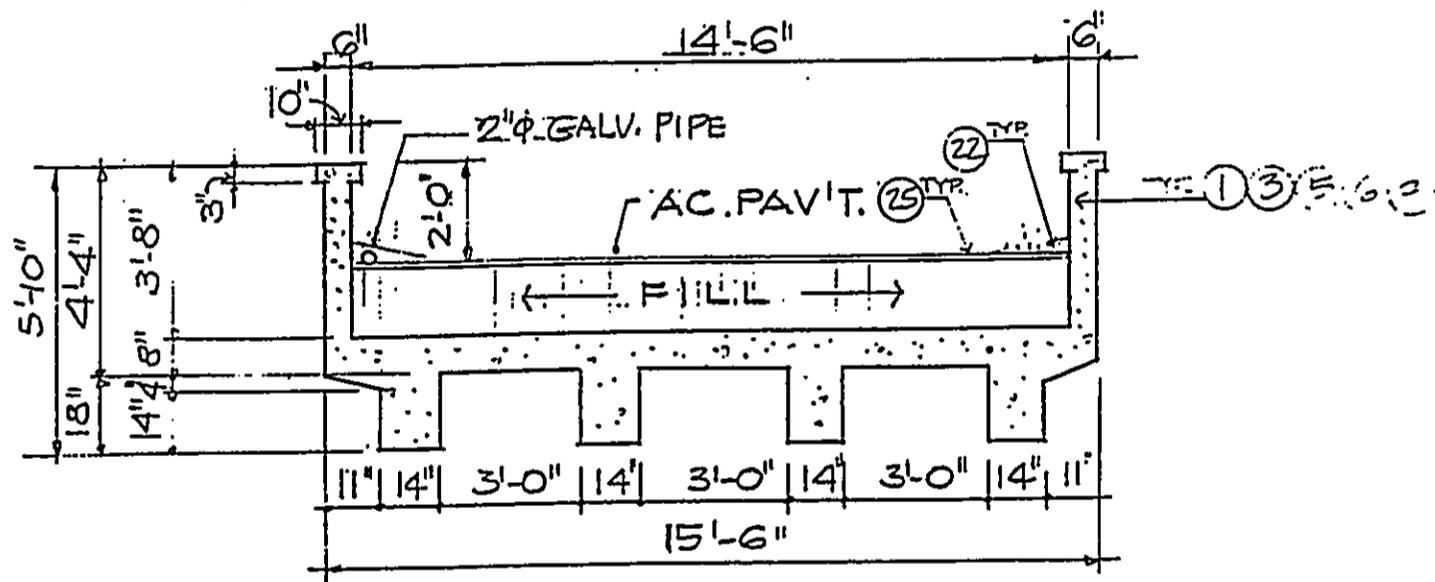
NORTH BRIDGE CROSS-SECTION "B-B"
 SCALE: 1/4" = 1'-0"

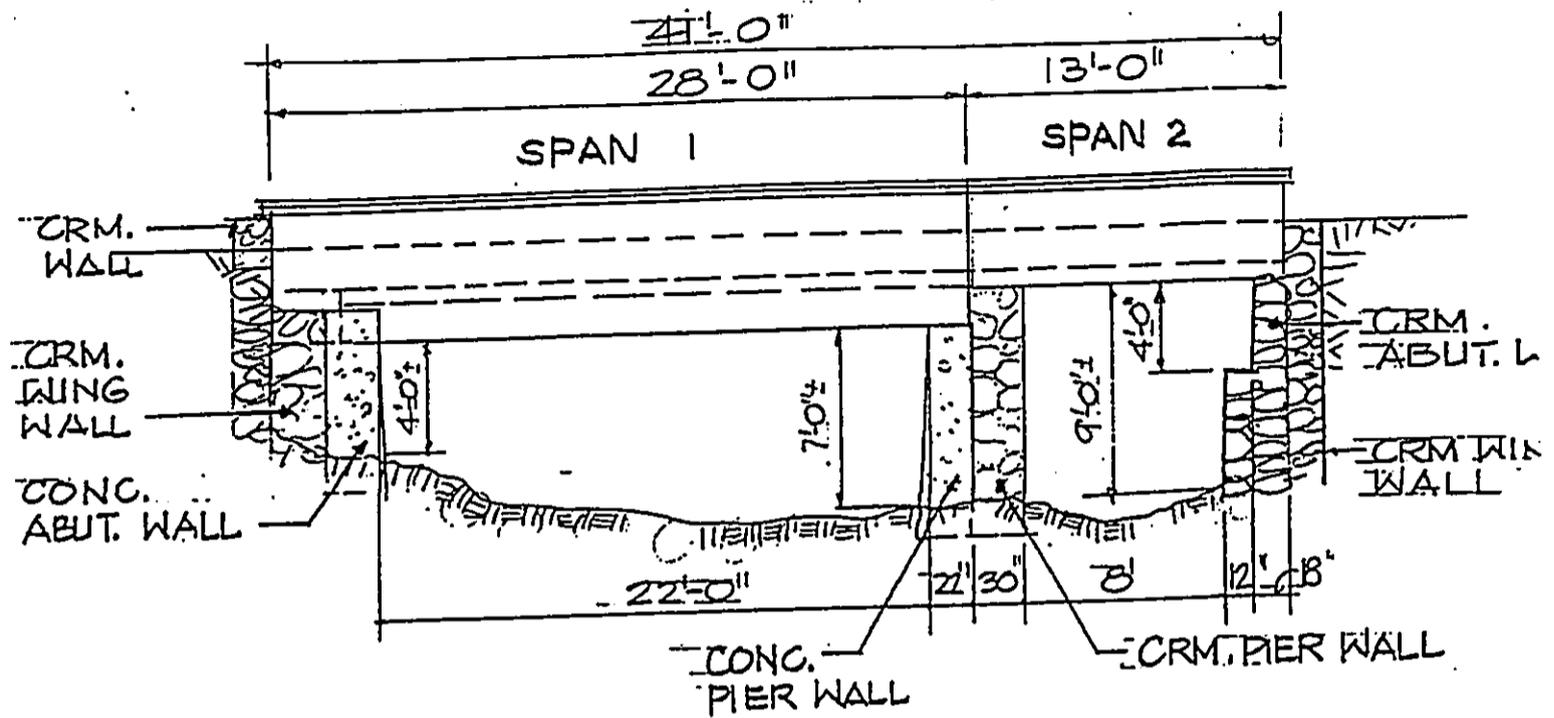
WEST ELEVATION "C-C"

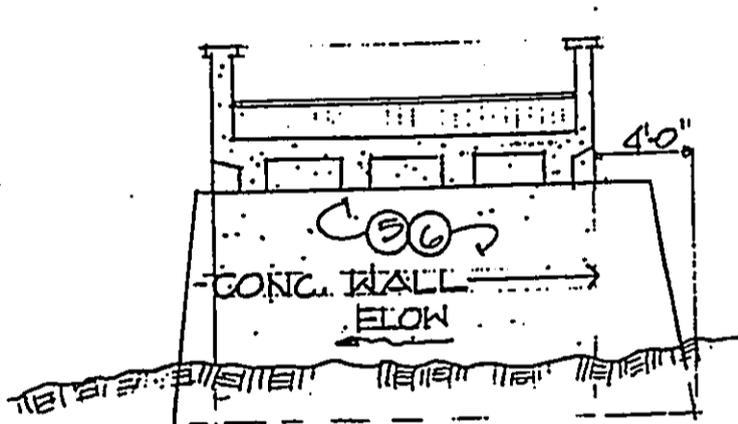
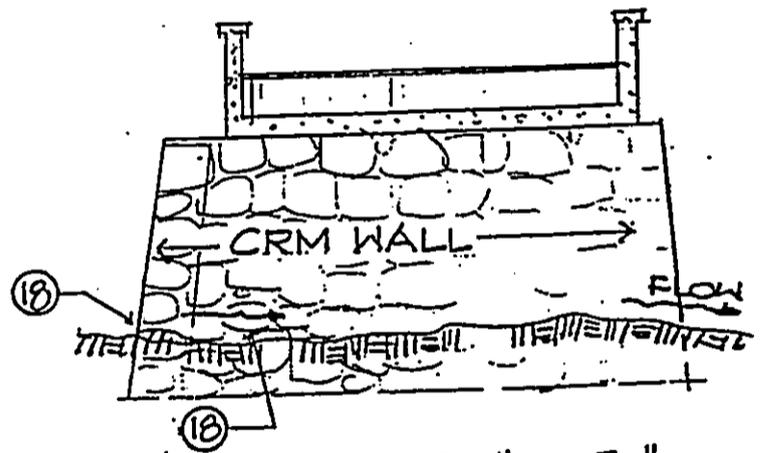
PIER SECTIONS

LOOKING SOUTH "D-D"

LOOKING NORTH "E-E"

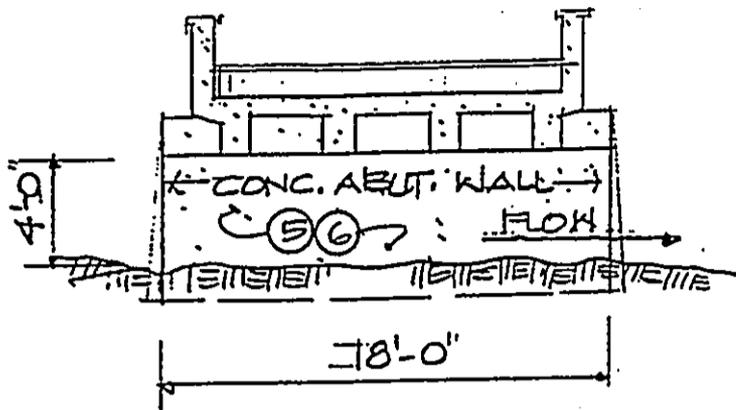
NORTH ABUT. SECTION "G-G"
SCALE: 1/8" = 1'-0"

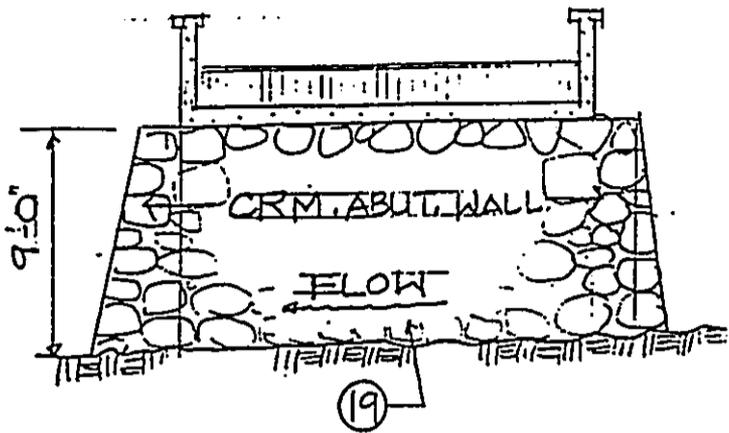
SOUTH ABUT. SECTION "F-F"
SCALE: 1/8" = 1'-0"

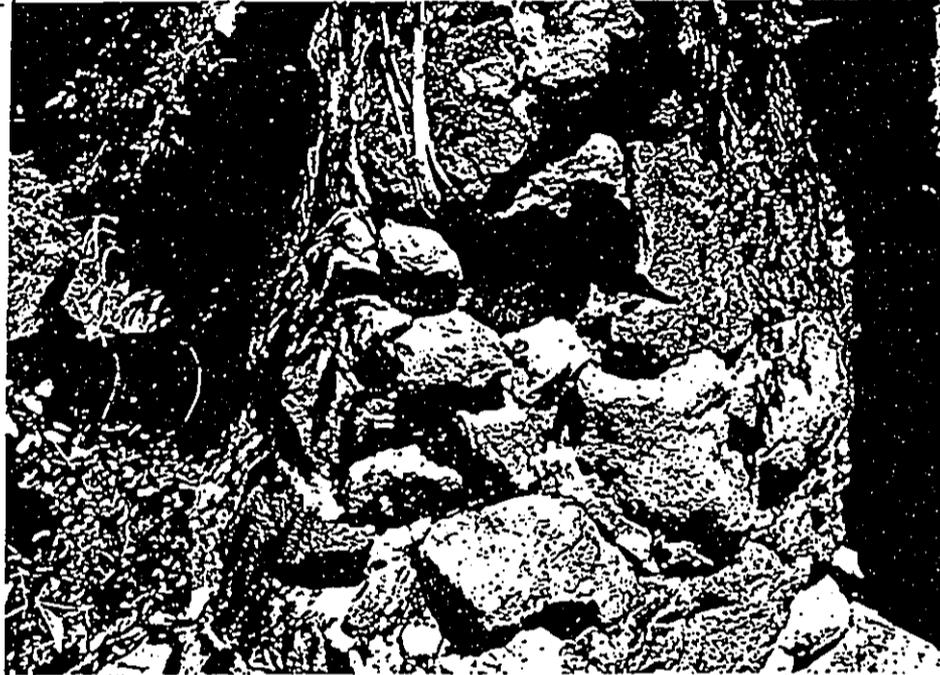
7. Upstream, nose of CRM pier, section loss.

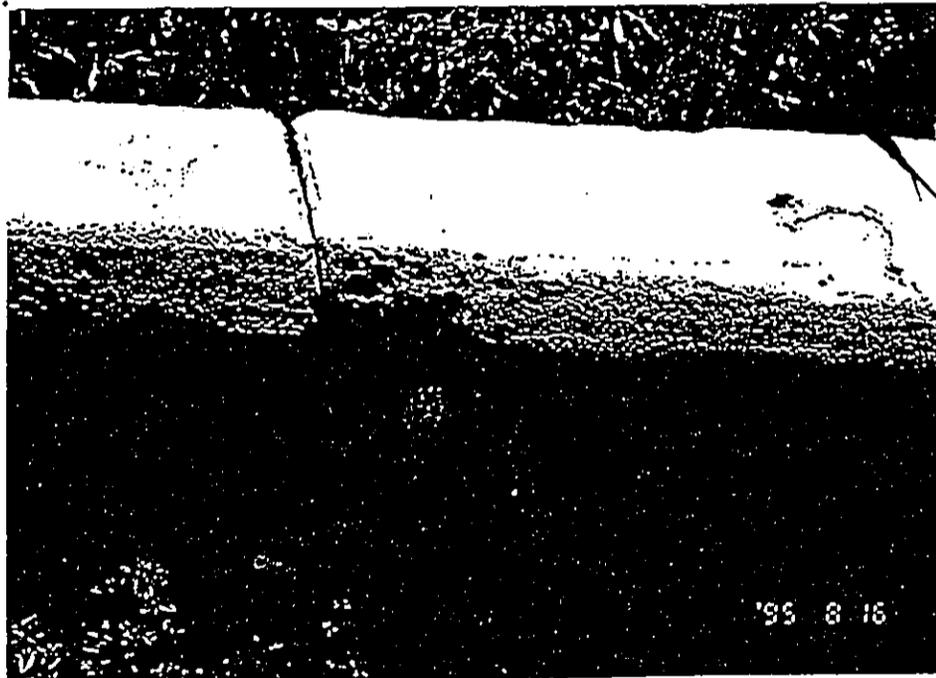
4. Downstream parapet, honeycomb, and scaling to chamfer of parapet.

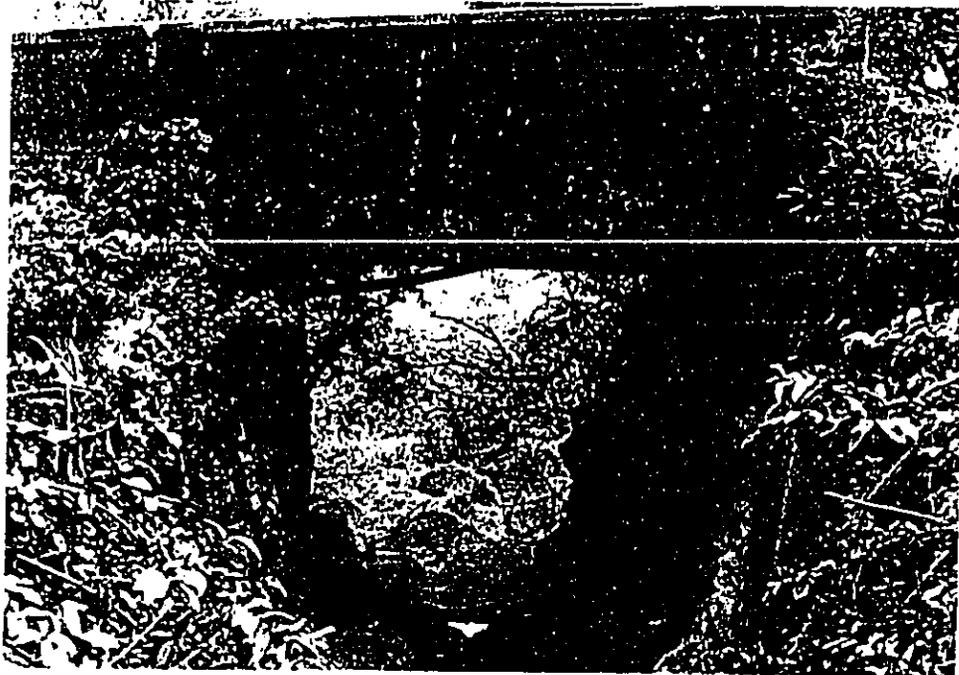
Figure 8 Underside of Papaahawahawa Bridge, view to *mauka*
