**FINAL ENVIRONMENTAL ASSESSMENT
and FINDING OF NO SIGNIFICANT IMPACT
for the**

**BARGE TERMINAL IMPROVEMENTS
KAHULUI HARBOR
Job H.C. 3281**

**STORAGE YARD PAVING AND UTILITY IMPROVEMENTS
KAHULUI HARBOR
Job H.C. 3280**

MAUI, HAWAII

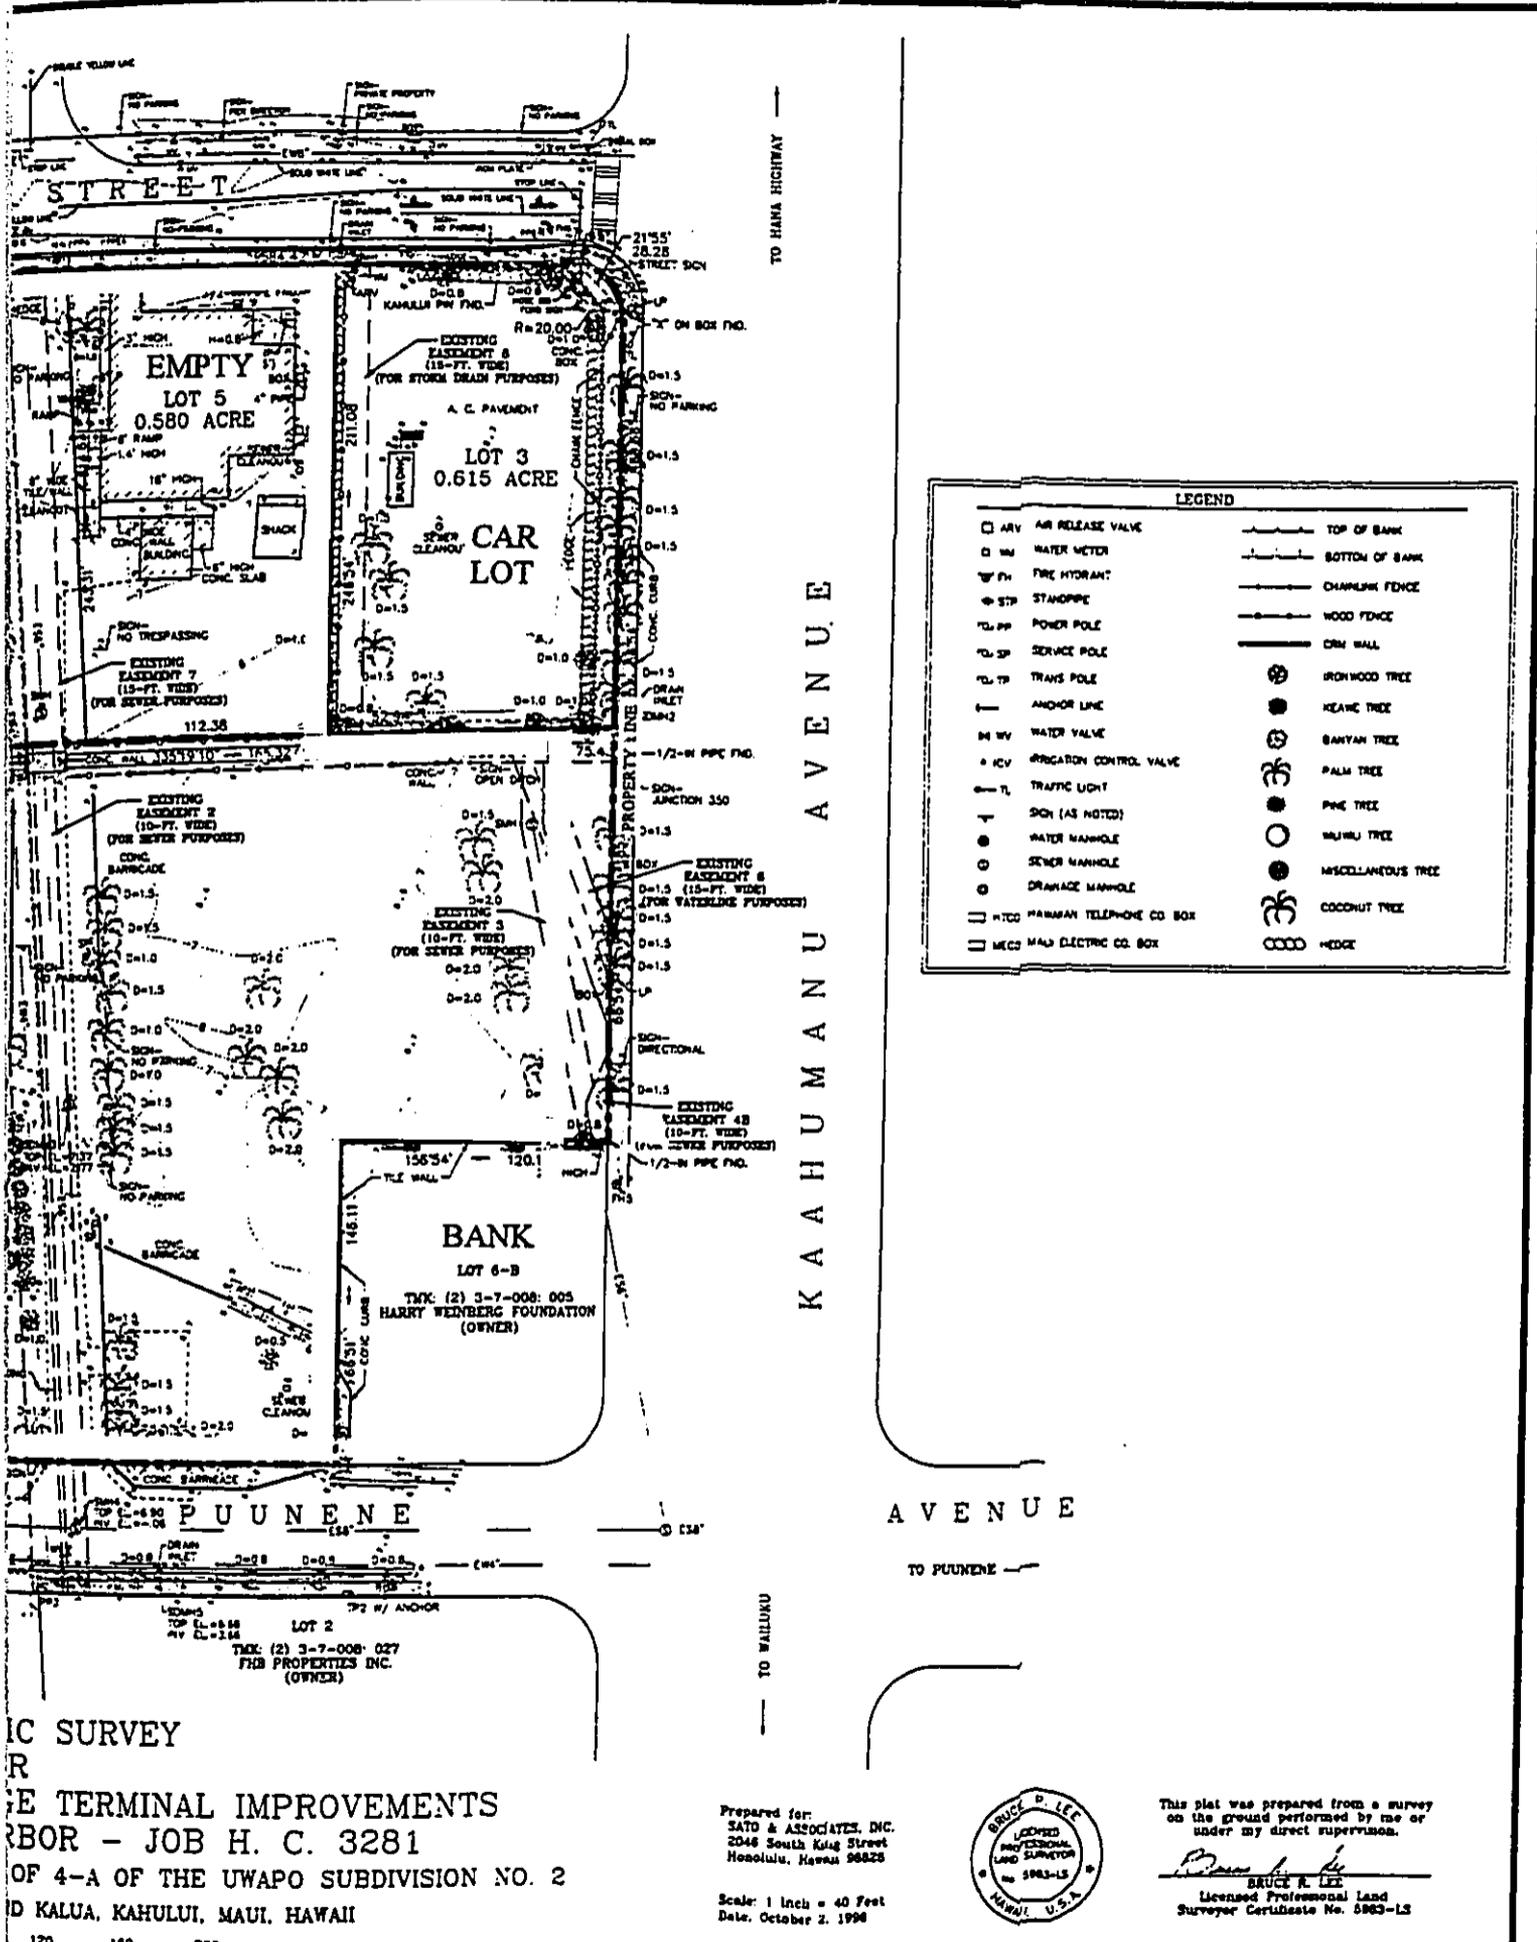
FIGURE 1-2

EXISTING TOPOGRAPHIC MAP

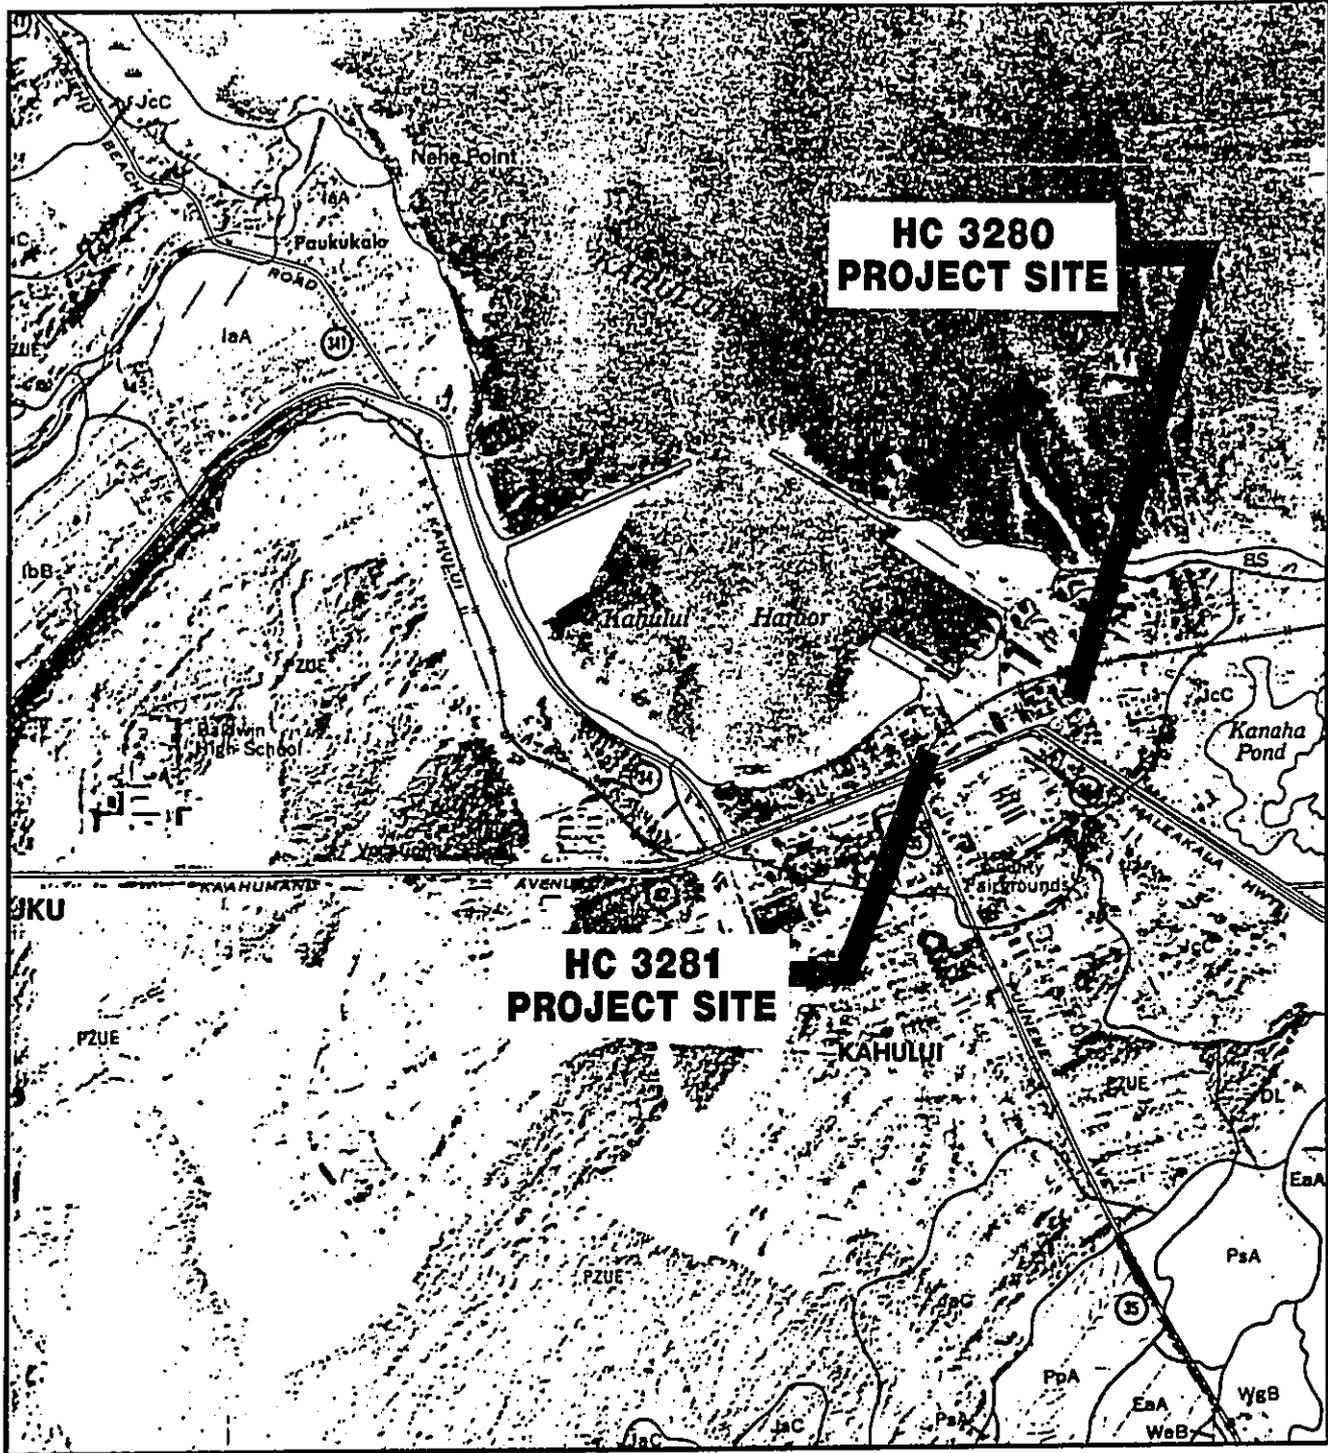
SOILS MAP

The soils at the site are described as fill land (Fd) by the United States Department of Agriculture. The existing topography of the site ponds excess runoff within the property along Kaahumanu Avenue and the existing ground is stabilized by its topping of A.C. pavement and gravel. The contractor will be required to keep the graded areas moist by means of waterwagons or temporary sprinkler systems and to have all exposed areas paved, grassed or landscaped immediately upon completion of finished grading. A NPDES General Permit Notice of Intent for construction dewatering will be obtained. No adverse environmental impact is anticipated due to soil erosion.

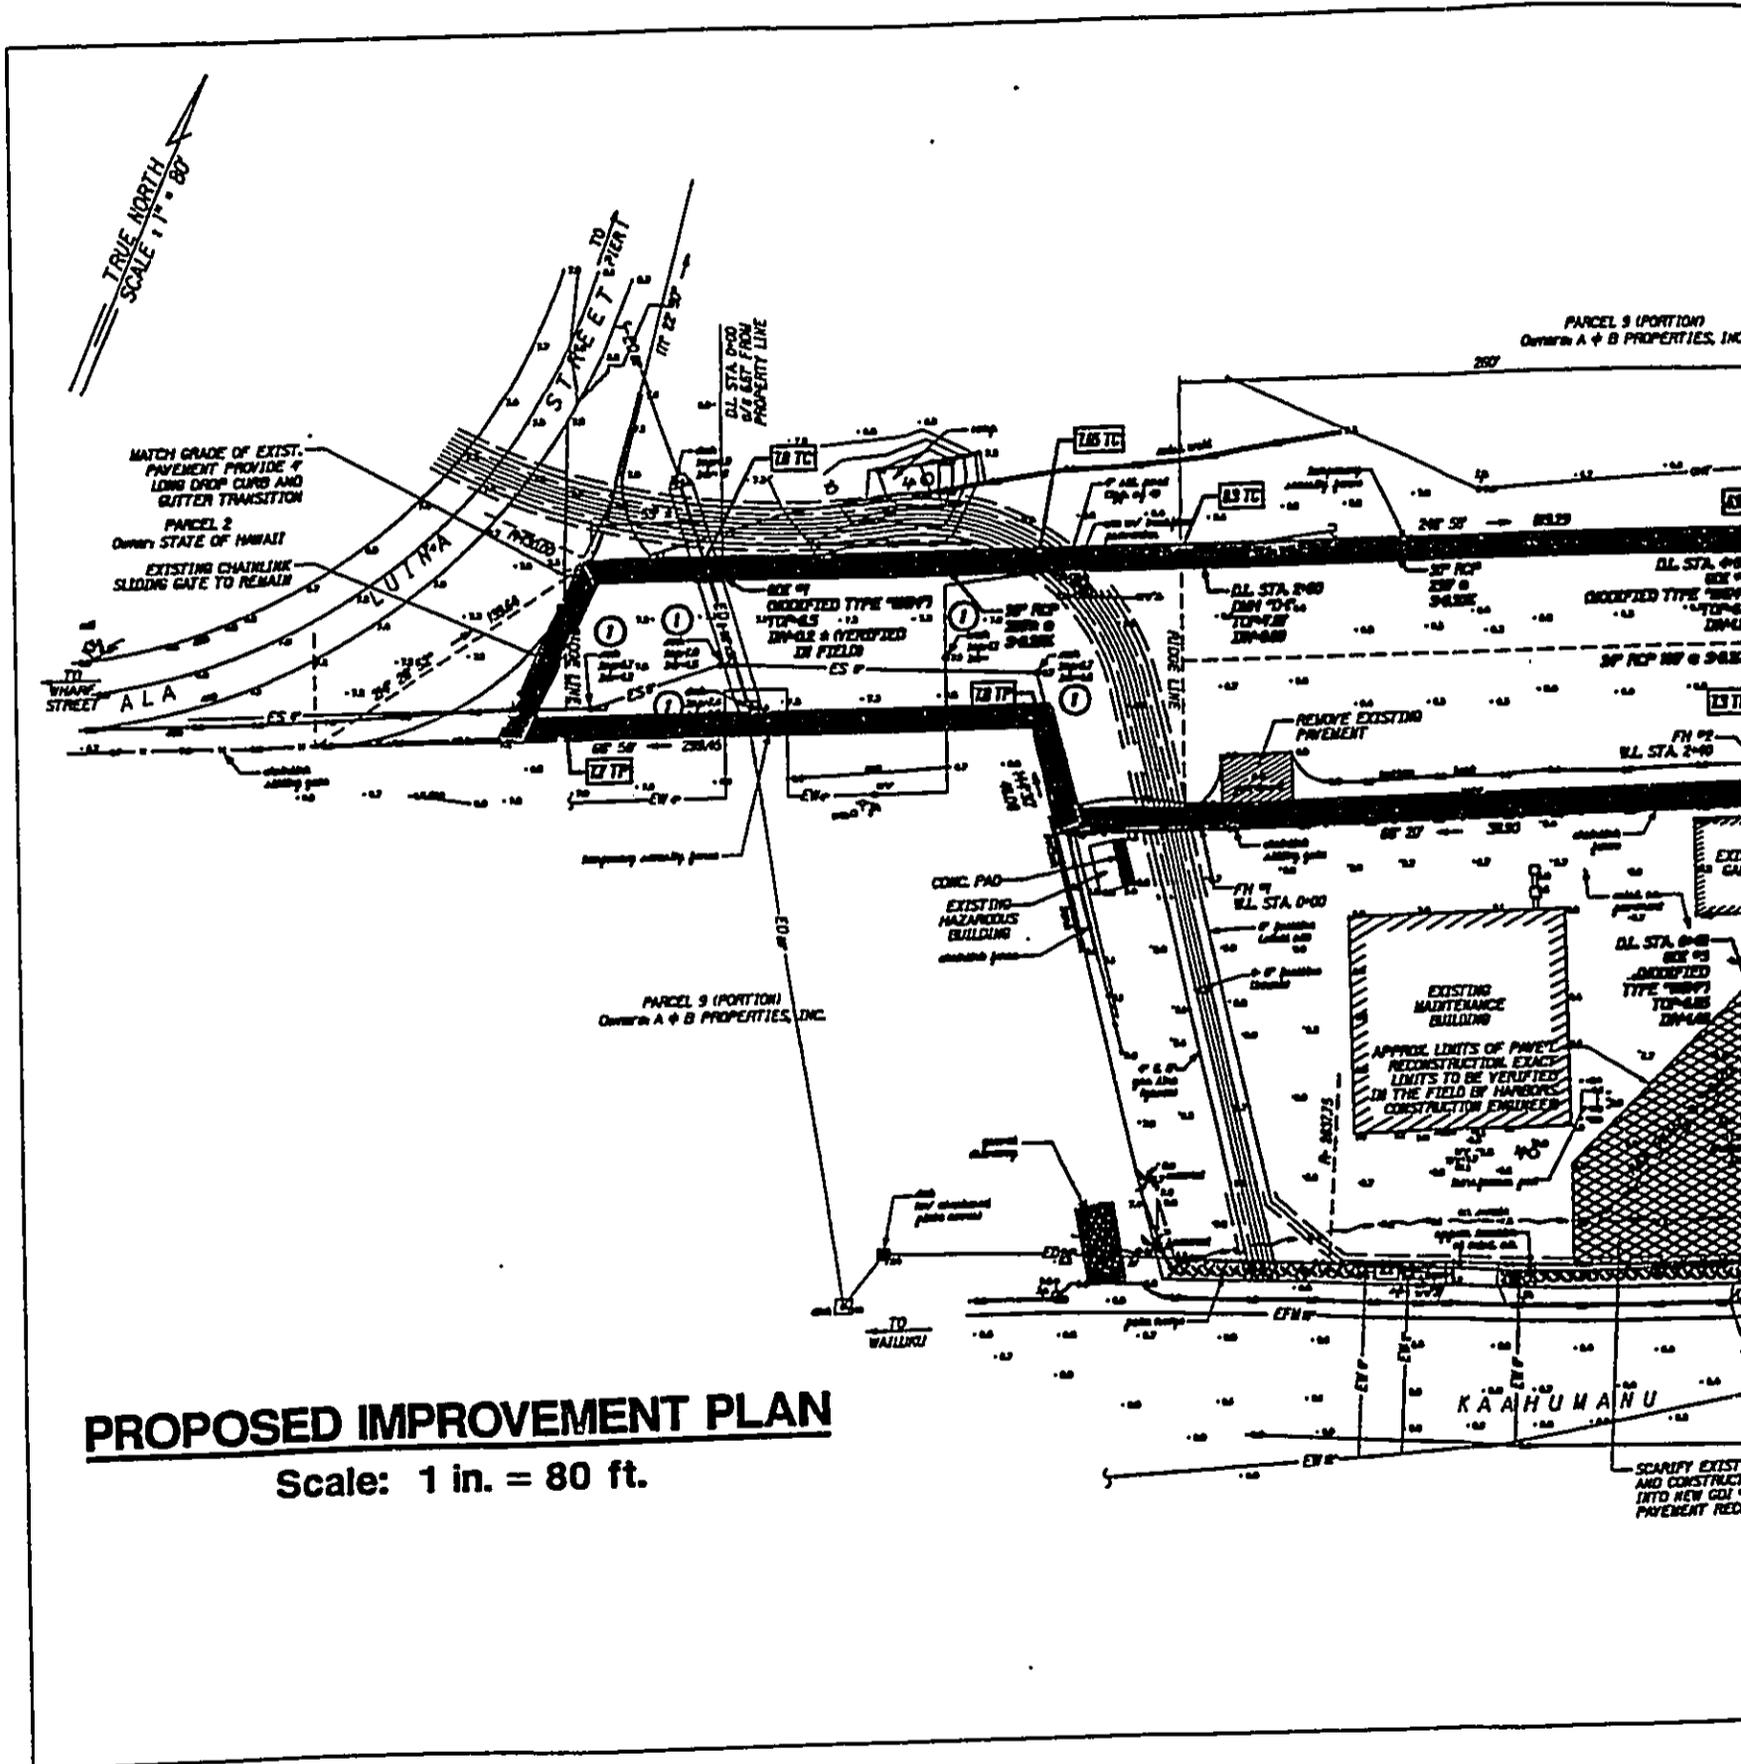
PROPOSED IMPROVEMENT PLAN
 Scale: 1 in. = 80 ft.

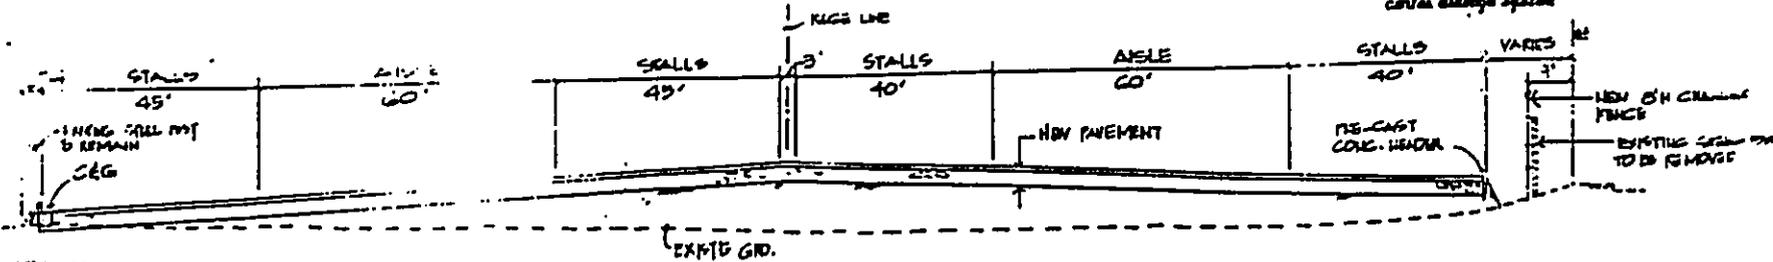
SECTION A-A
N.T.S.

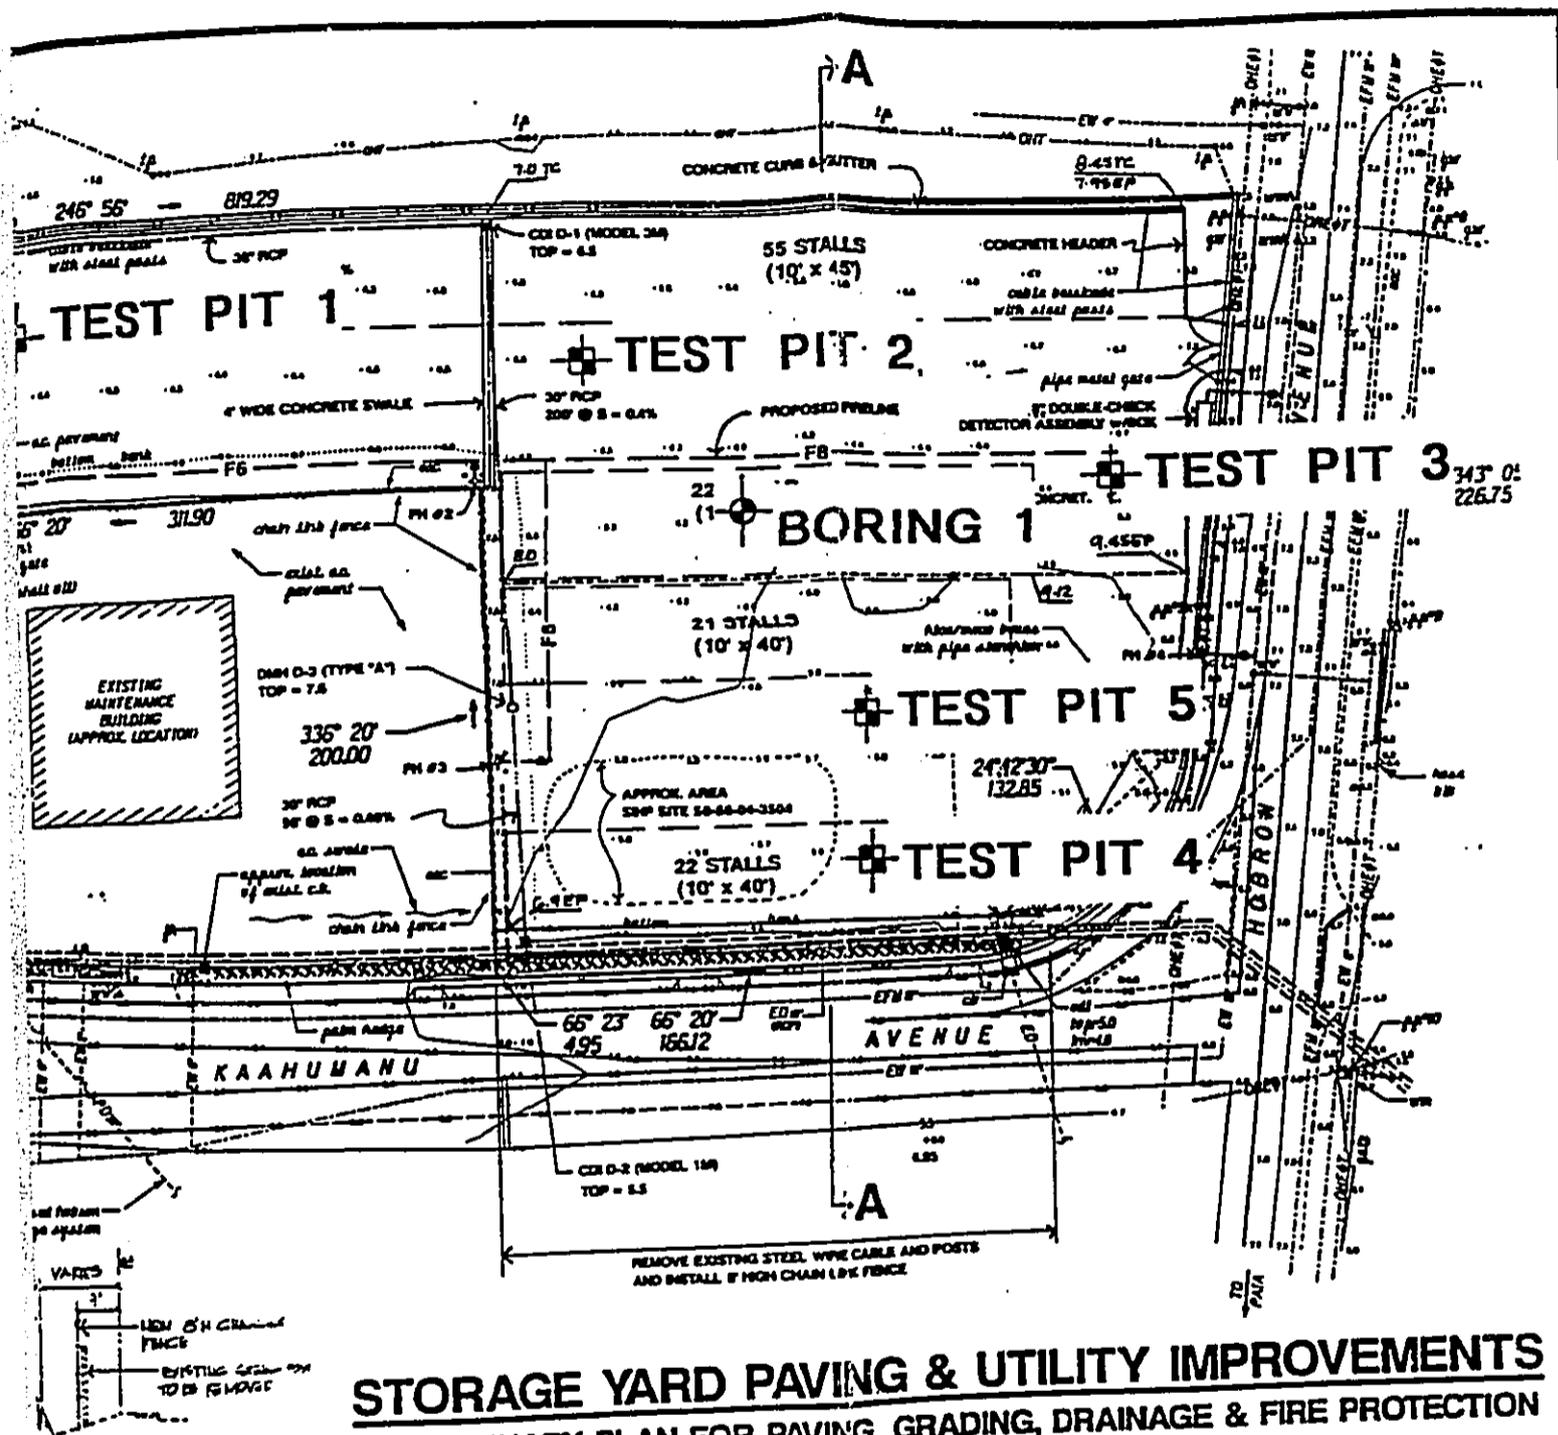
PLOT PLAN		
SCALE: 1"=80'	APPROVED BY:	DRAWN BY
DATE: AUG., 1996		REVISED
KAHULUI HARBOR STORAGE YARD		
SOILS INTERNATIONAL PROJECT NO. M-2686-F		Plate 2

The subsurface conditions at the site were explored by excavating five (5) test pits to depths of 2 to 4.5 feet, and drilling one (1) test boring to a depth of 10 feet. The locations of the explorations are shown on the Plot Plan, Plate 2. Detailed logs of the explorations are presented in the Appendix to this report.

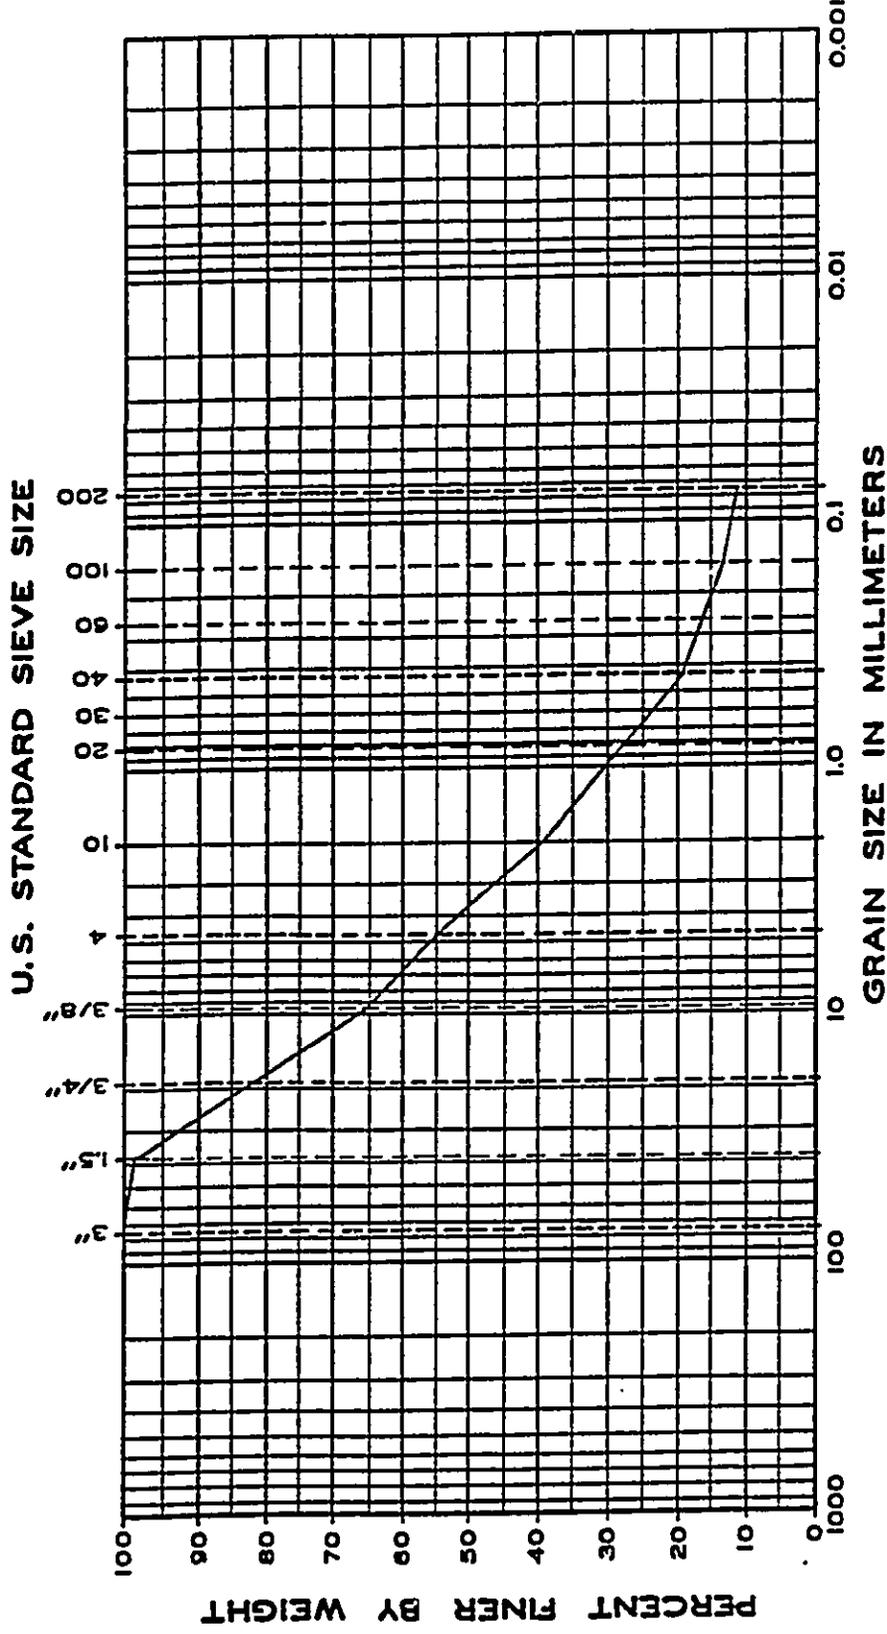
GRAIN SIZE DISTRIBUTION

LOCATION	DEPTH	GROUP SYMBOL	GRAVEL			SAND			SILT OR CLAY			ATTERBERG LIMITS		
			COARSE	FINE	CO	MEDIUM	FINE	MOISTURE CONTENT	LL	PL	PI			
TP-3, S-1	0'	GW-GM	GRAVEL; with sand and fines			CLASSIFICATION			4.9%					
KAHALUI HARBOR STORAGE YARD												PROJECT NO. M-2686-F		
SOILS INTERNATIONAL												PLATE 9

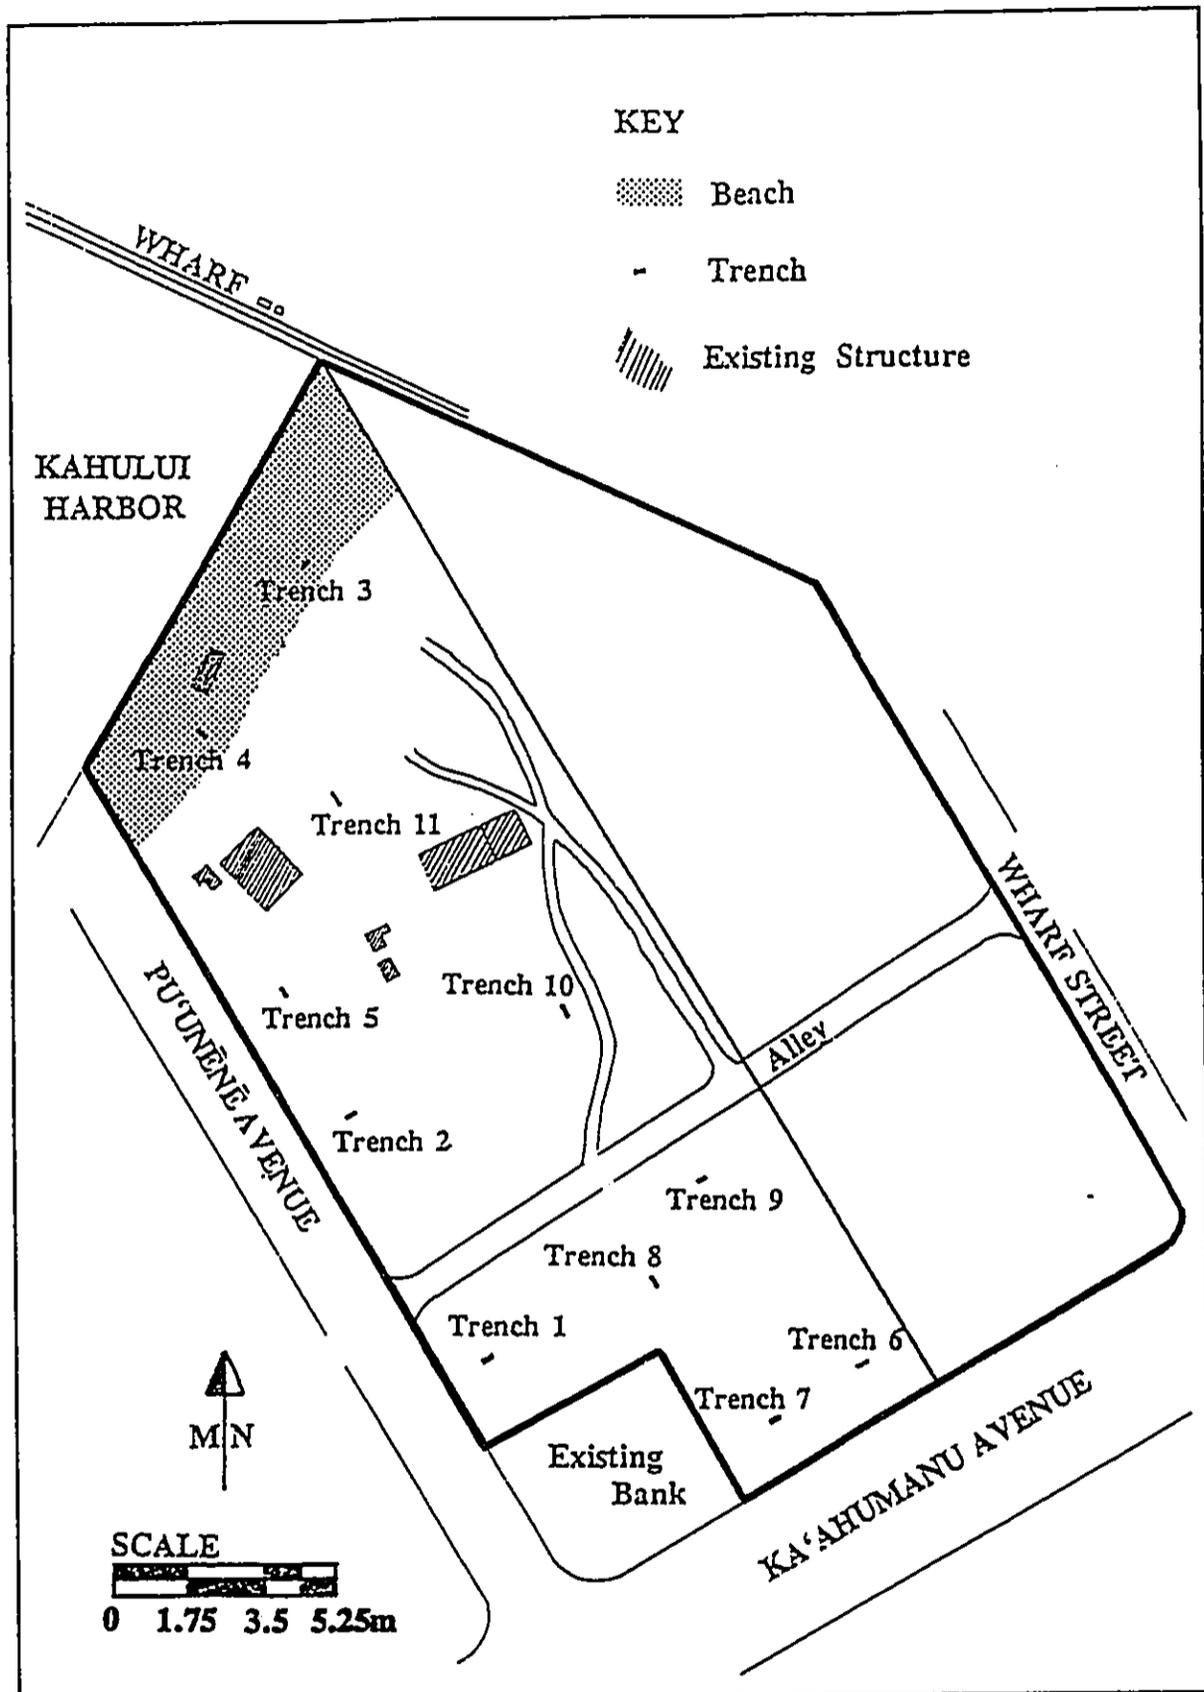
Figure 5. Map of project area and trench locations.

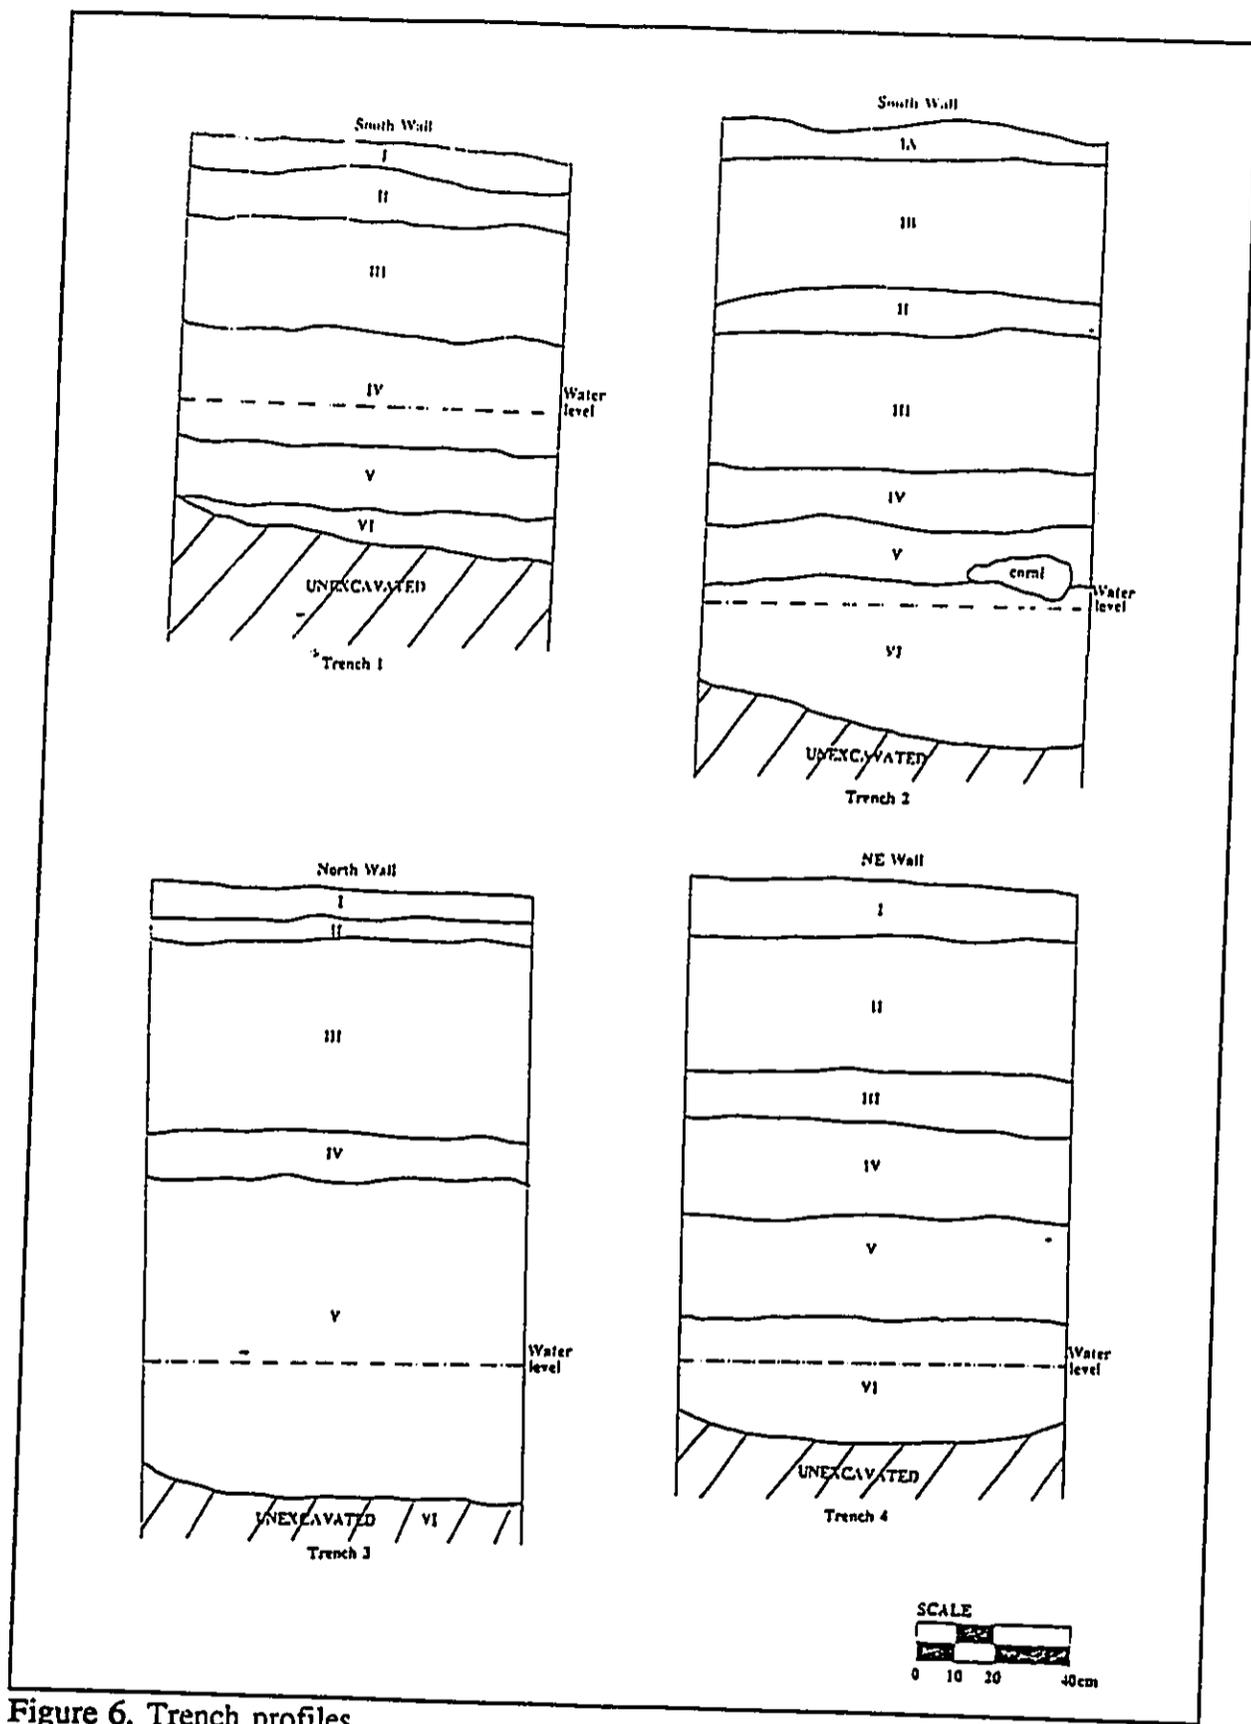
Figure 6. Trench profiles.

brownish sand to 90 cm below surface. This overlaid three layers of dark gray sand containing varying percentages of waterworn basalt pebbles. A fragment of white porcelain was recovered from the backdirt. Ground water was encountered at 1.25 m below surface. Excavation of Trench 2 was terminated at 1.61 m below surface (Figs. 6 and 11).

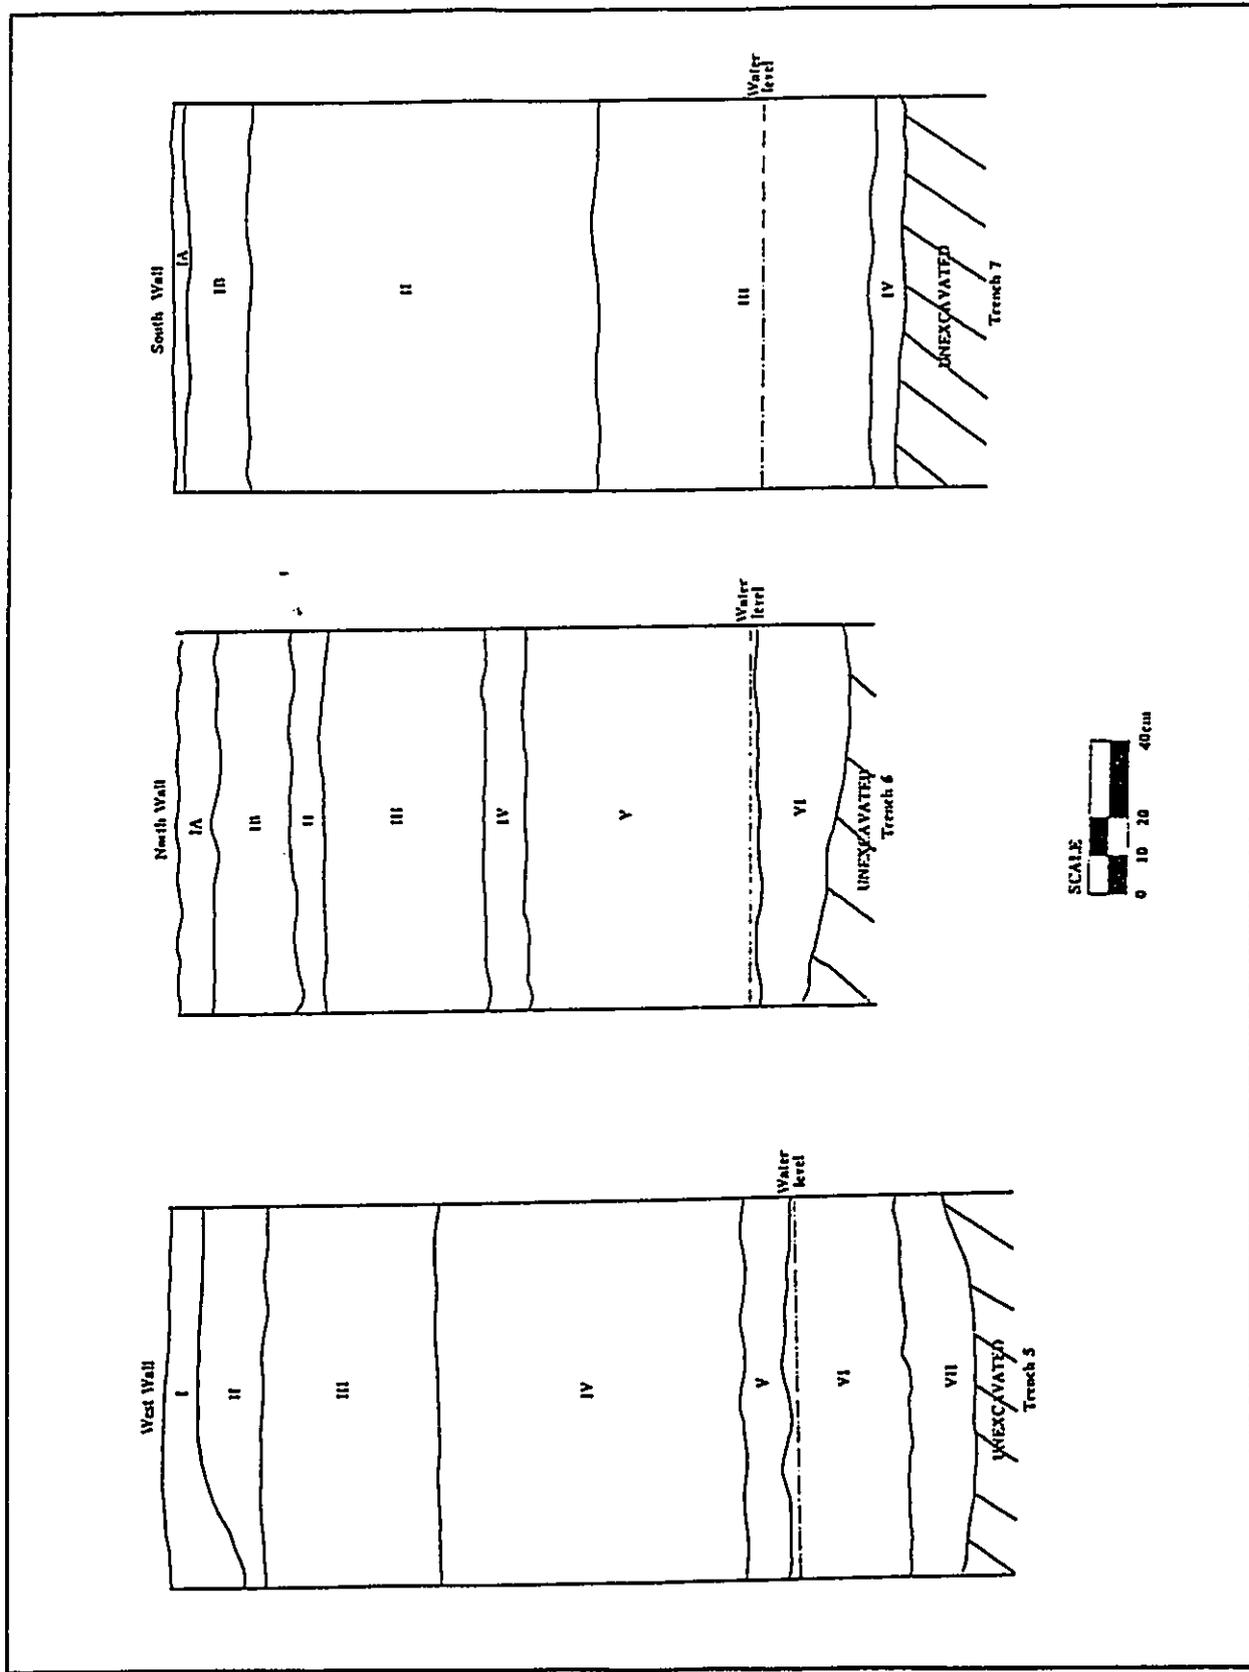
Figure 8. Trench profiles.

Trench 6, oriented 230° magnetic and 1.74 m deep, was located in the southeast corner of the project area. Six layers were revealed during testing, including three layers of sand fill. This overlaid a 10-cm-thick layer of clay loam fill. Two natural sand layers (Layers V and VI), ranging from 90 cm to 1.74 m below surface, were encountered. Layer VI consisted of 5-10 percent waterworn basalt pebbles. Ground water was encountered at 1.5 m below surface. Excavation of Trench 6 was terminated at 1.74 m below surface (Fig. 8).

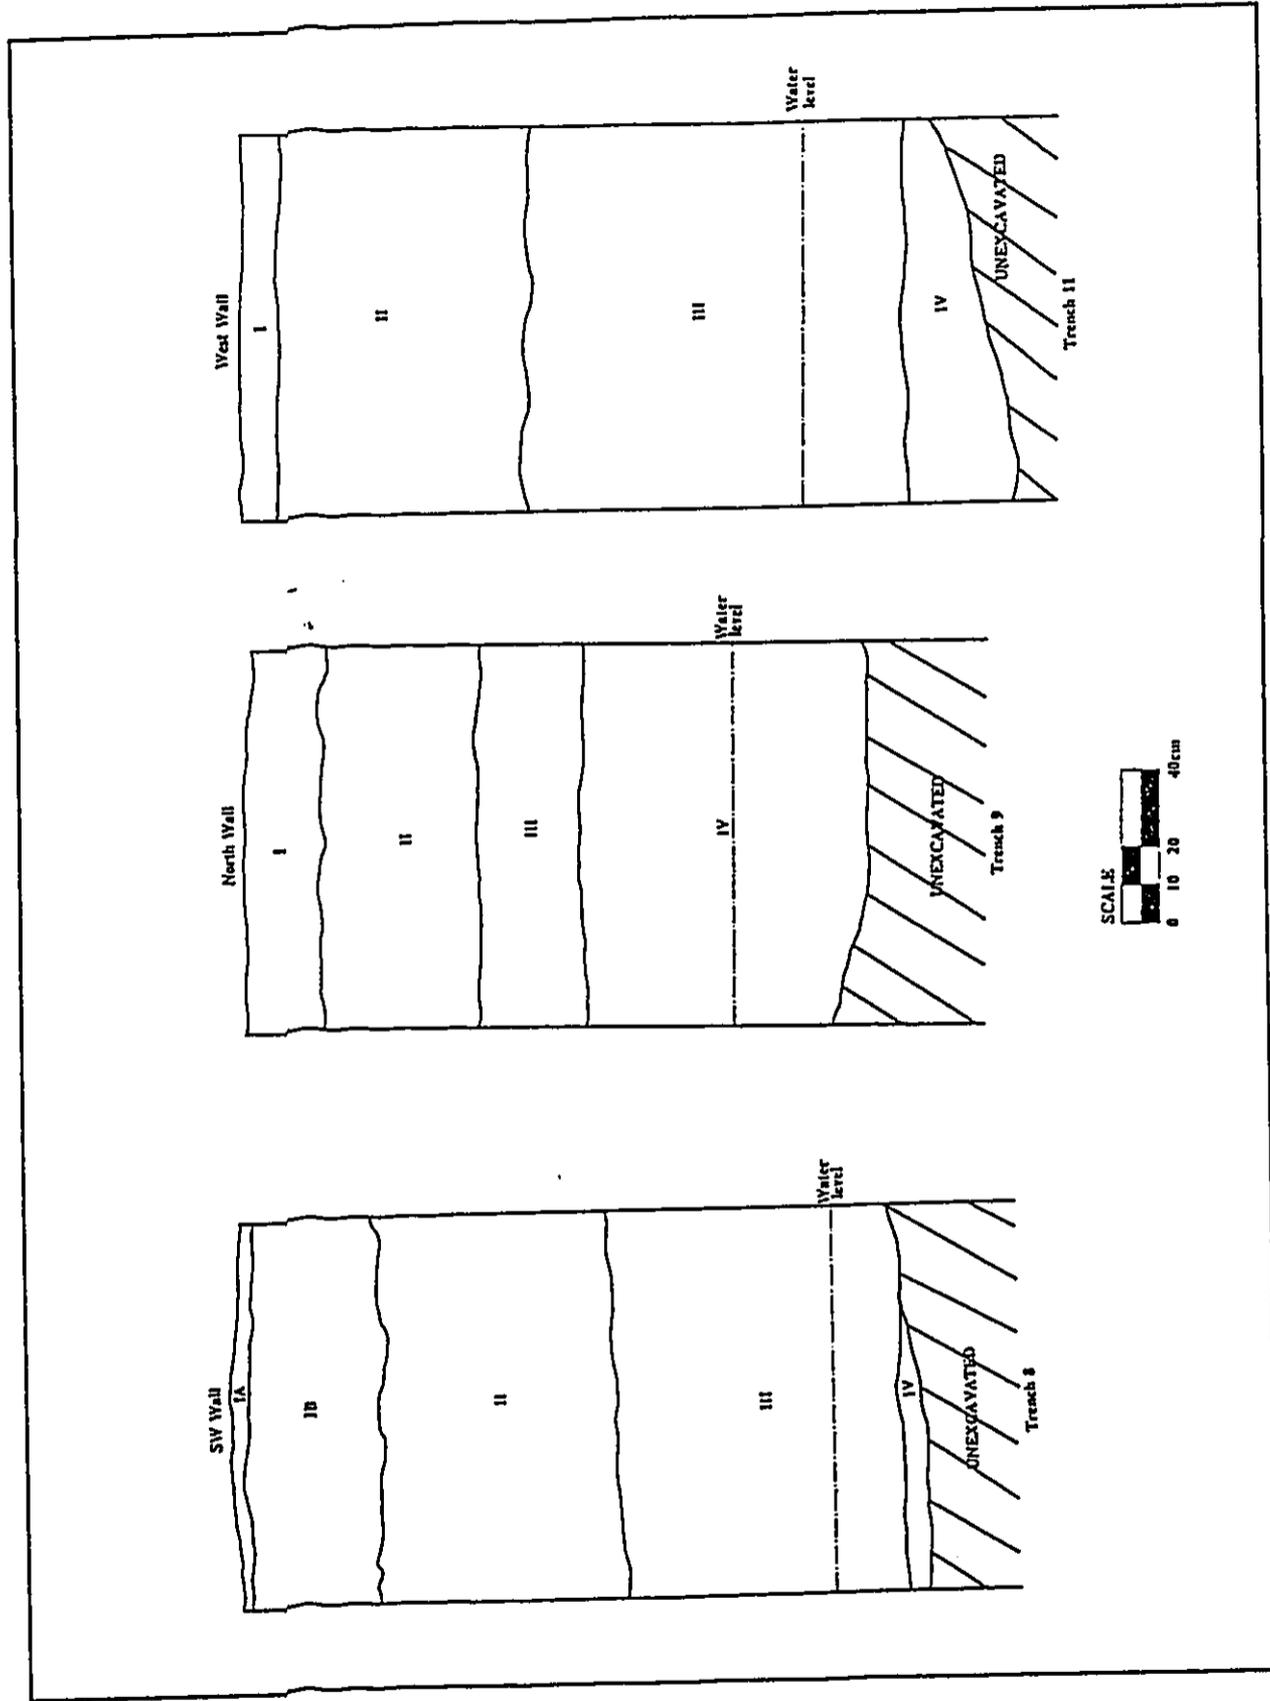
Figure 9. Trench profiles.

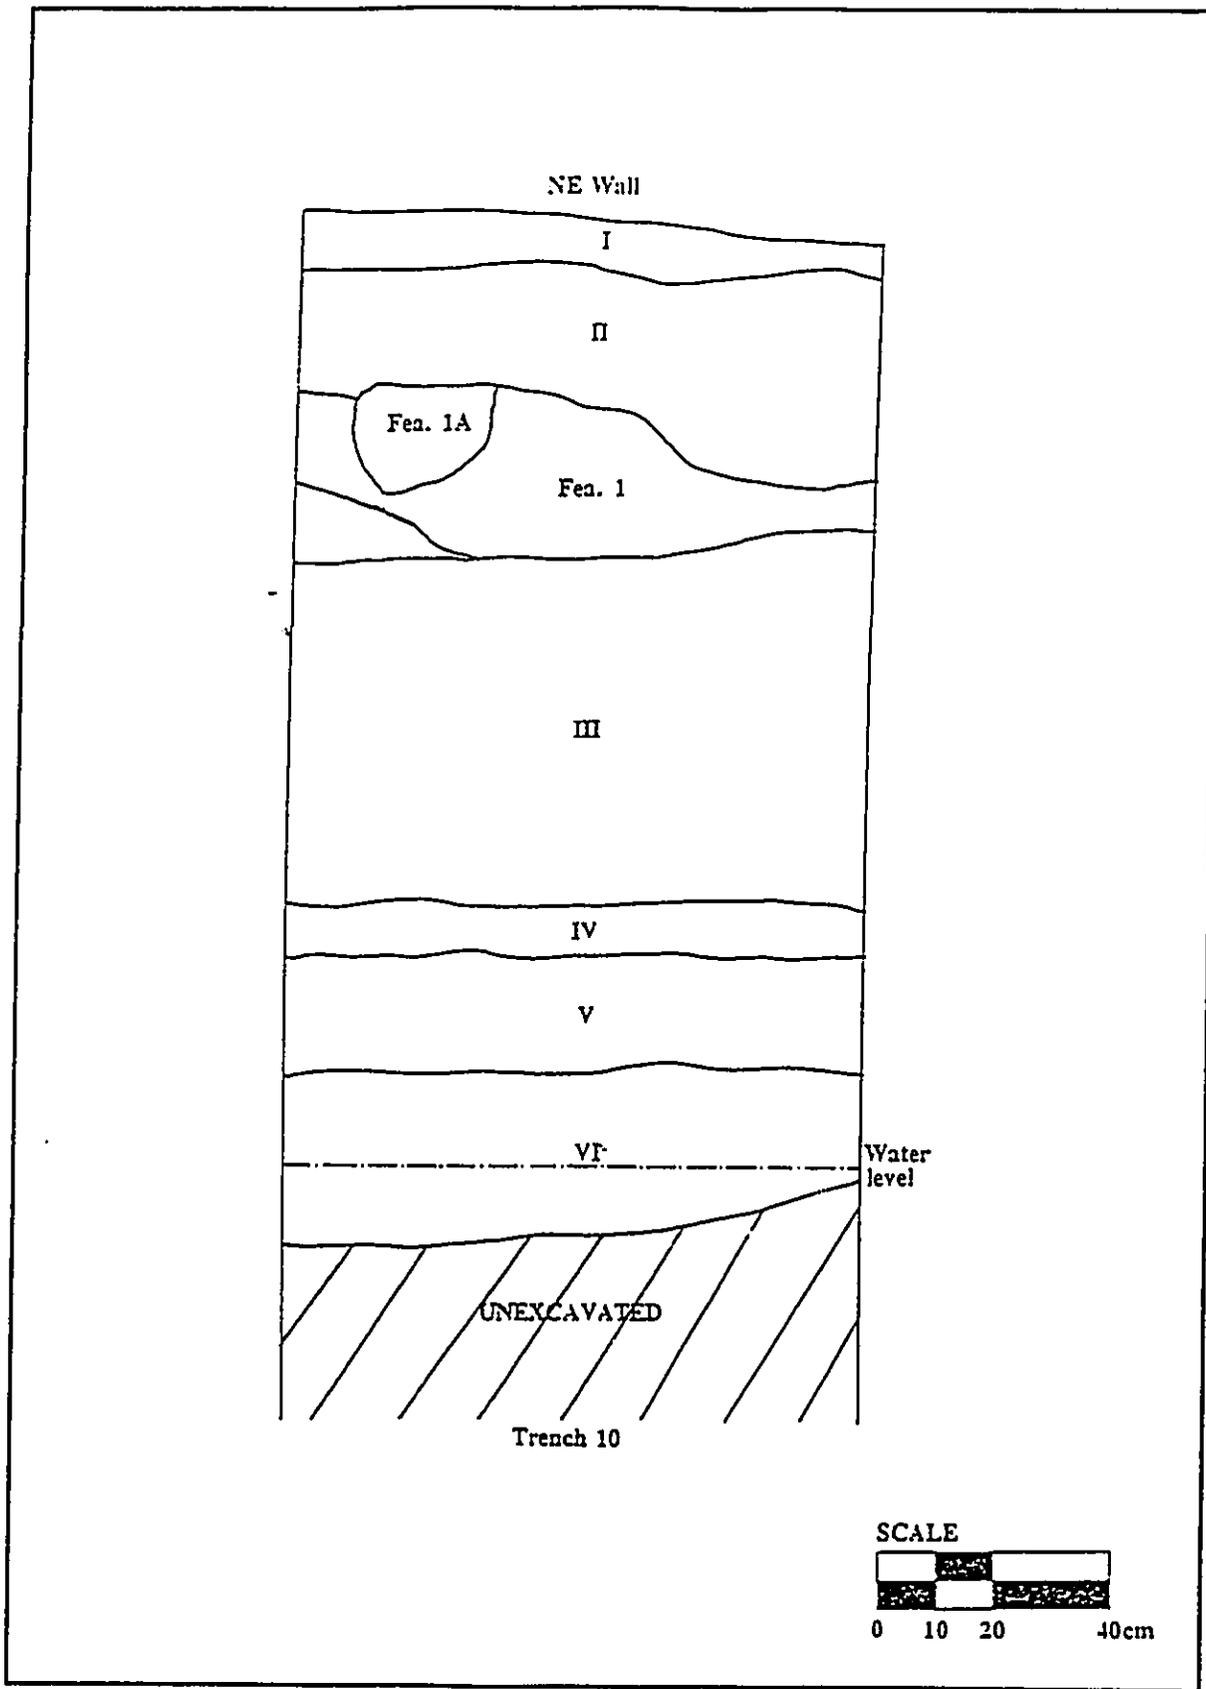
Figure 10. Trench 10 profile, NE wall.
