**FINAL ENVIRONMENTAL ASSESSMENT
and FINDING OF NO SIGNIFICANT IMPACT
for the**

**BARGE TERMINAL IMPROVEMENTS
KAHULUI HARBOR
Job H.C. 3281**

**STORAGE YARD PAVING AND UTILITY IMPROVEMENTS
KAHULUI HARBOR
Job H.C. 3280**

MAUI, HAWAII

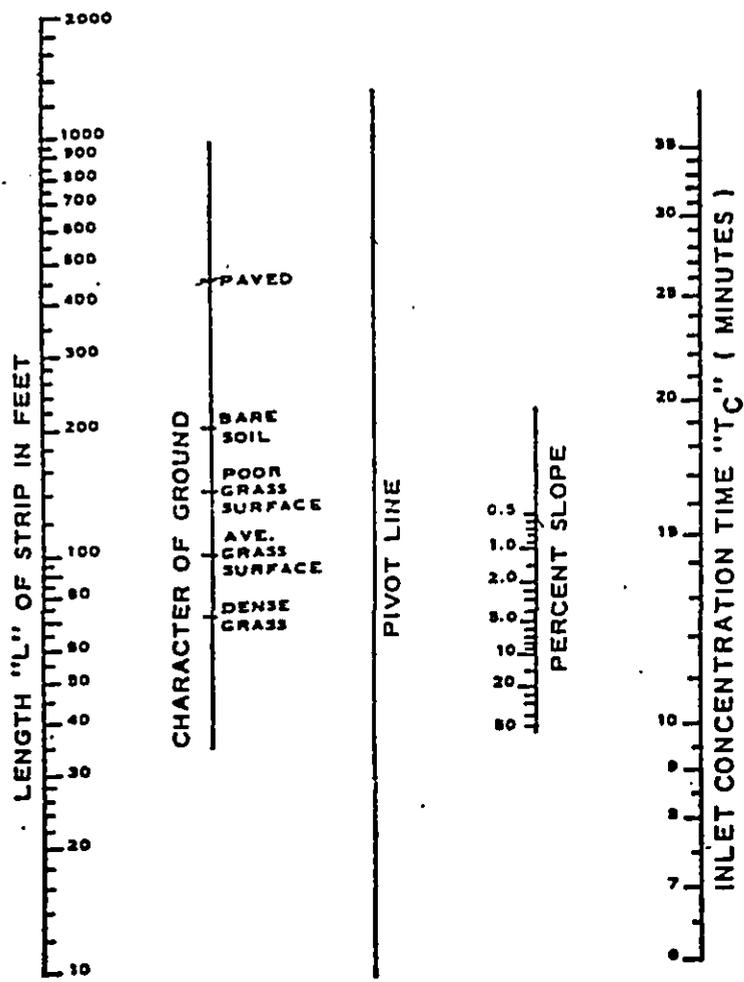
Plate 3
Overland
Flow
Chart

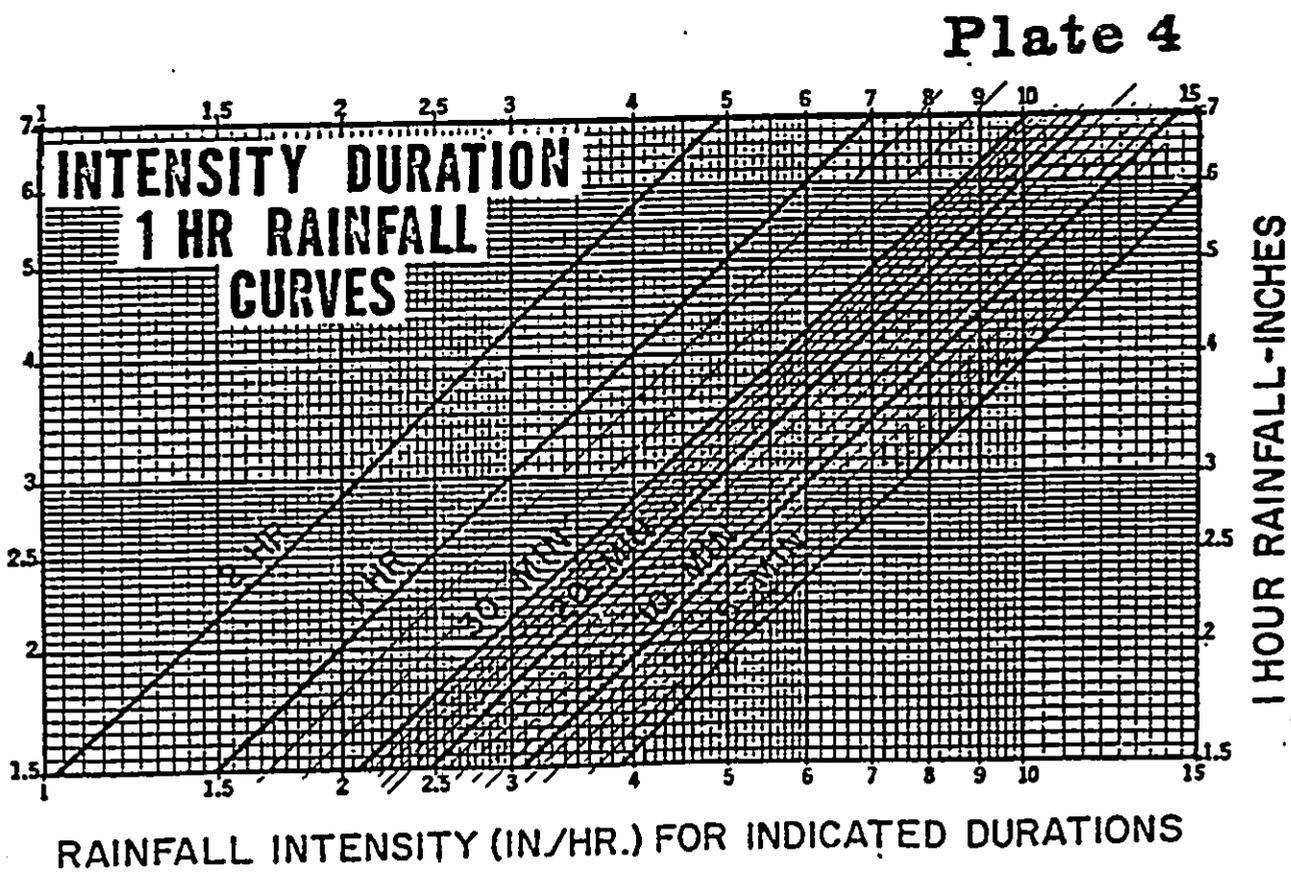
RAINFALL INTENSITY (IN/HR.) FOR INDICATED DURATIONS

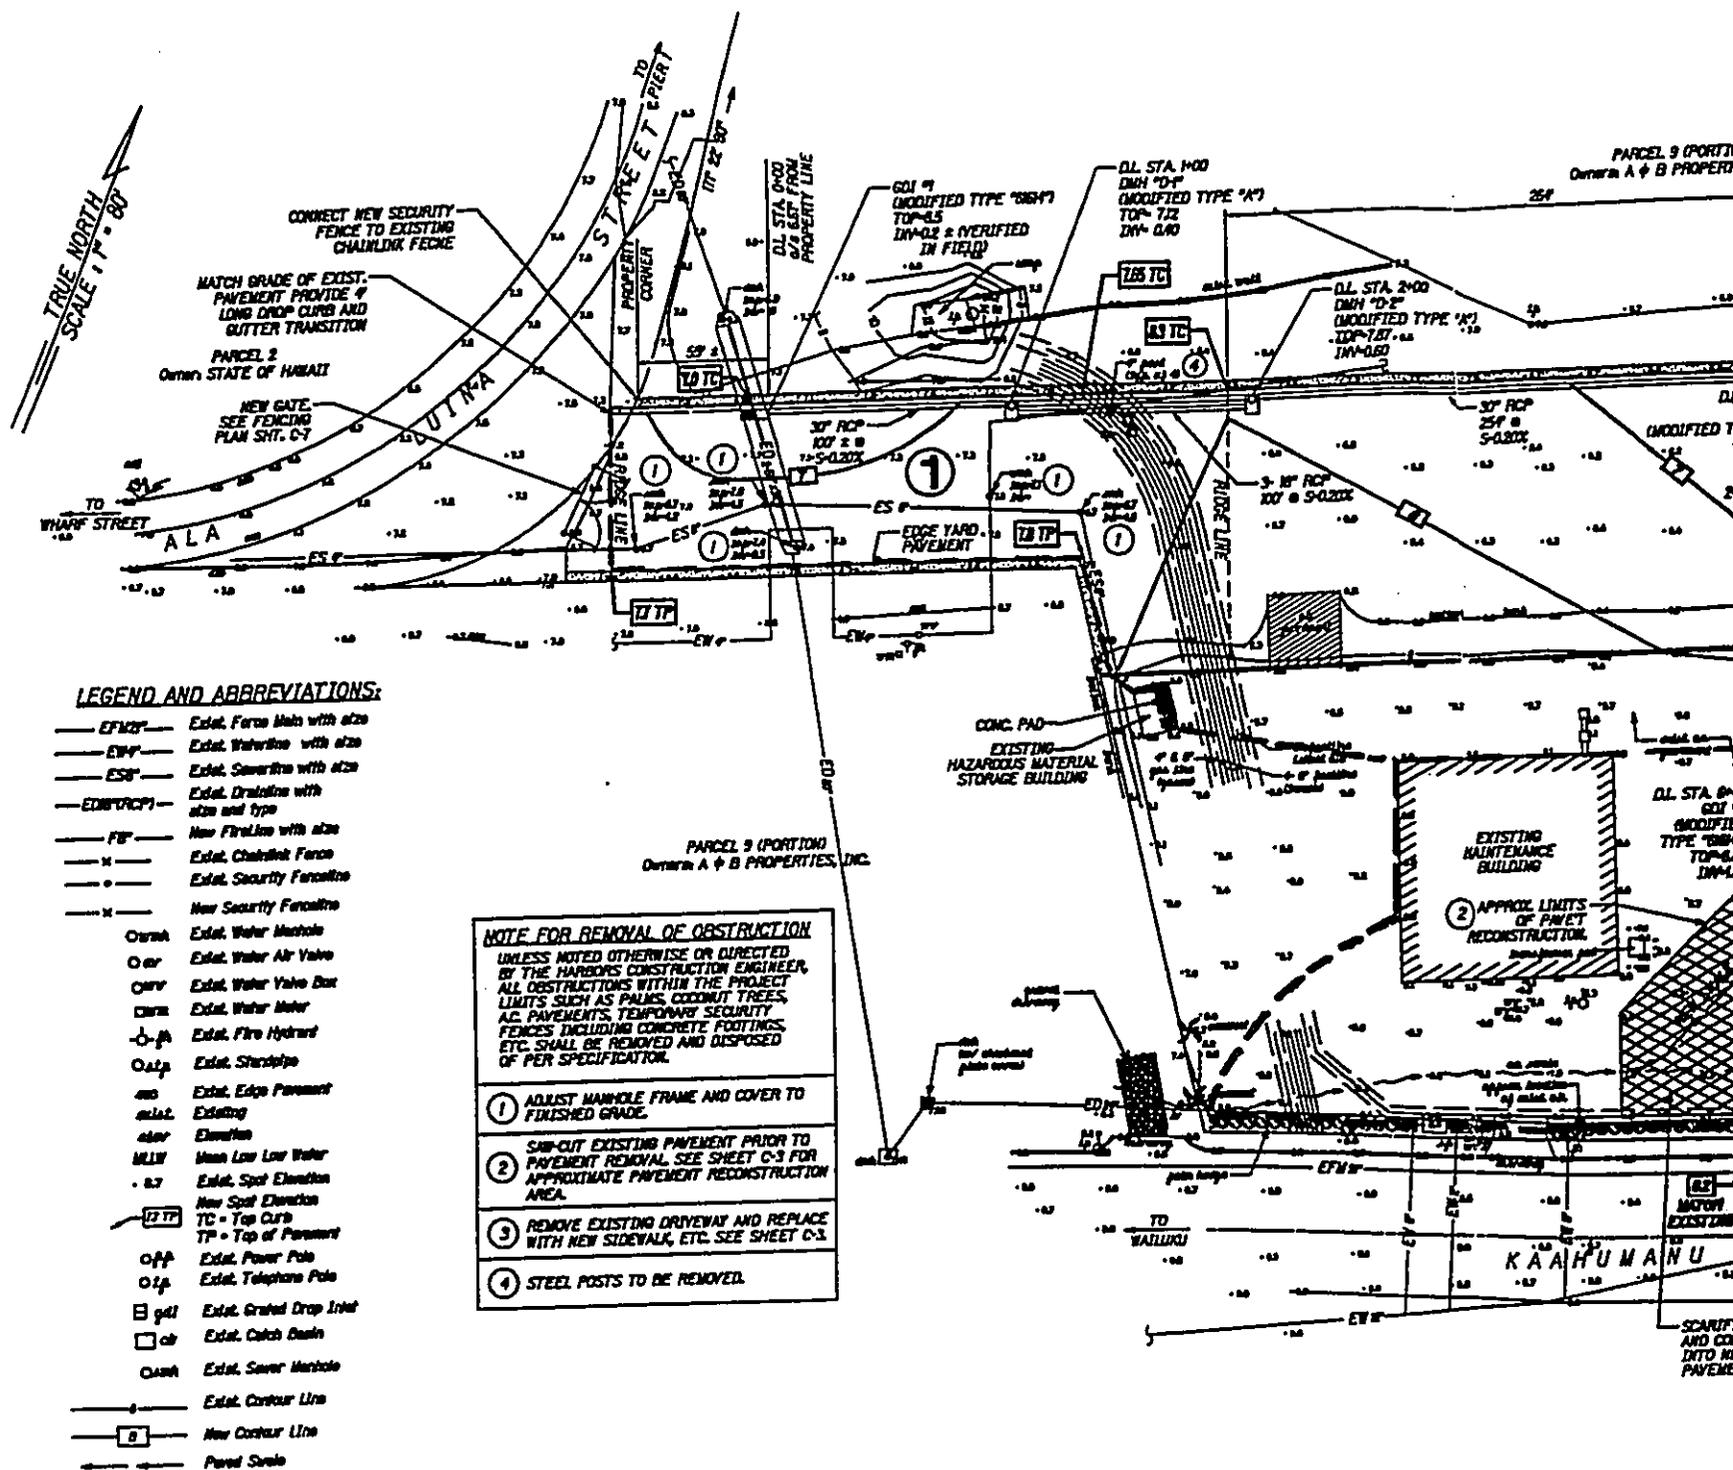
GRADING AND DRAINAGE

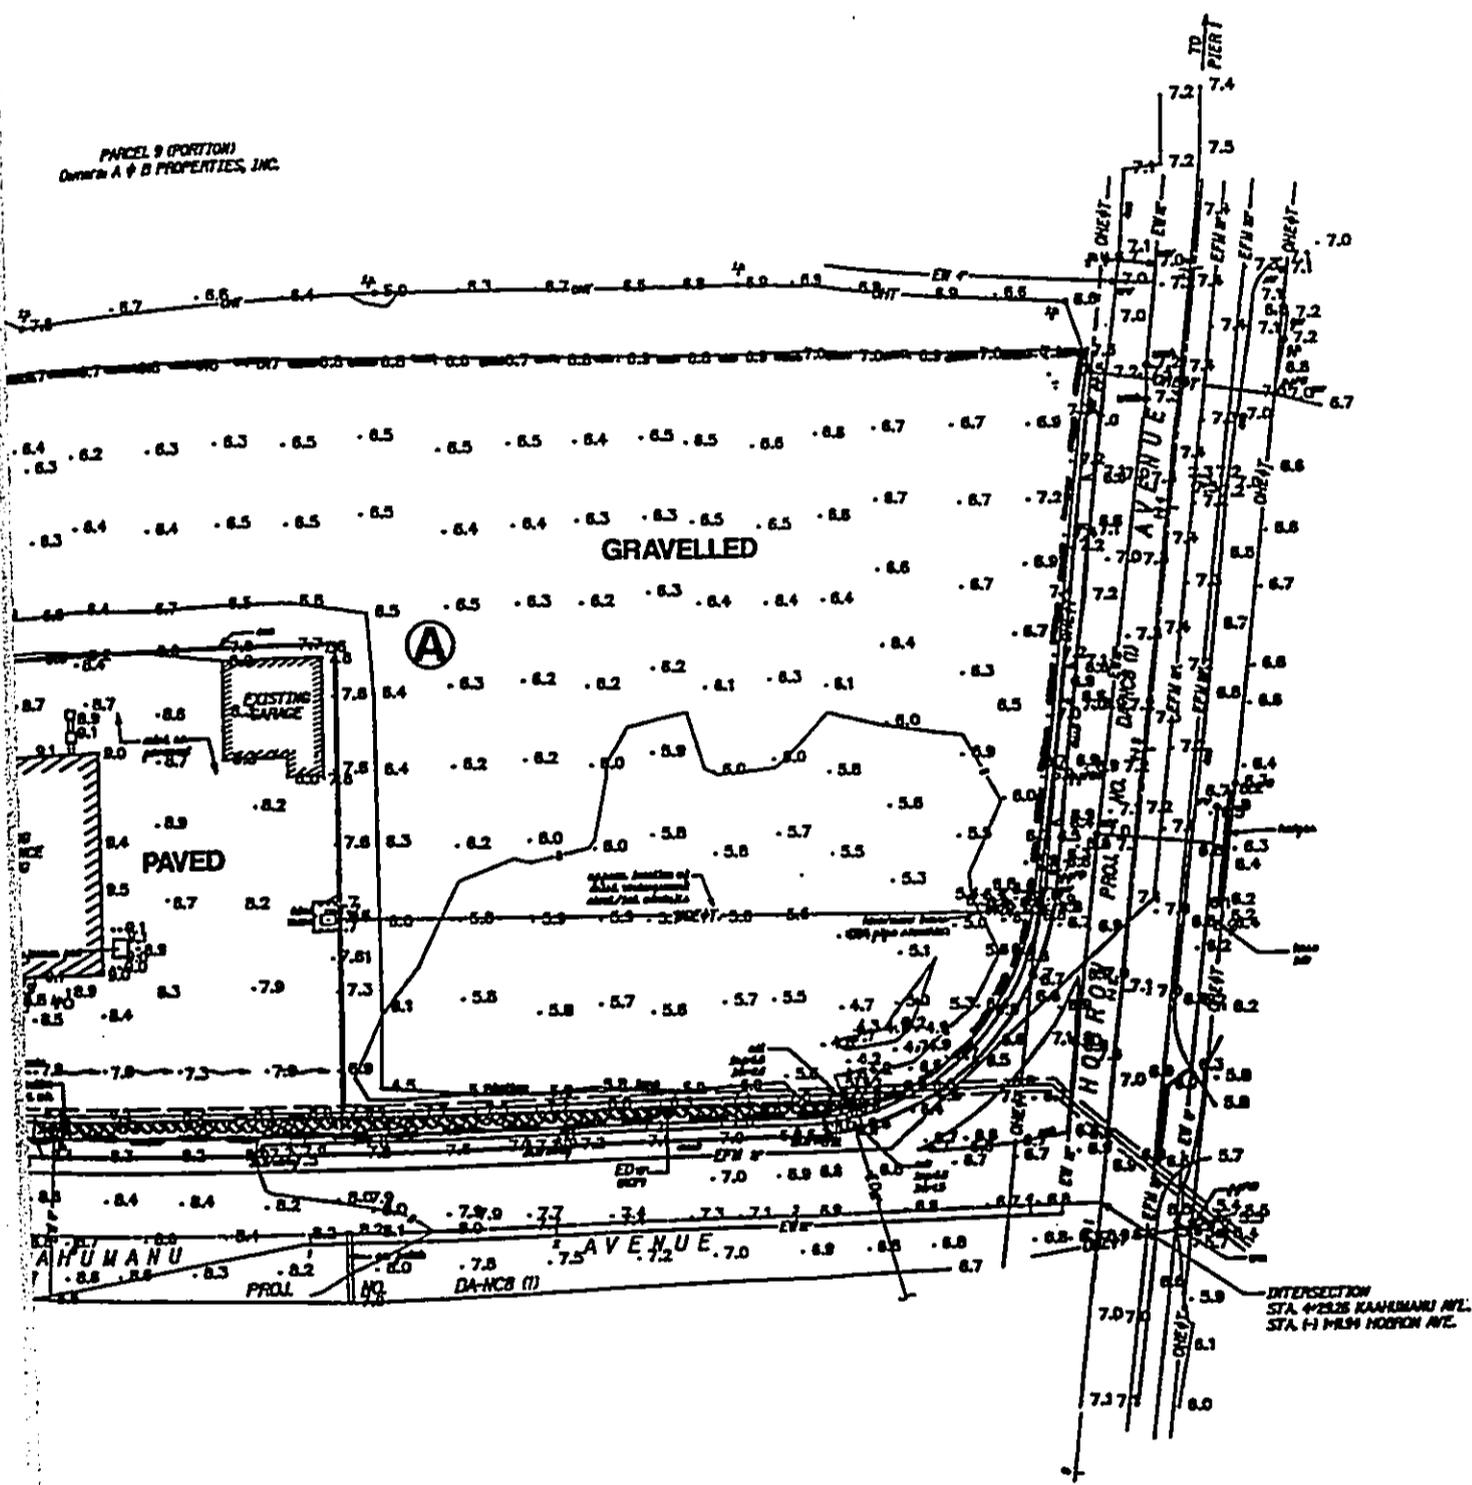
HYDROLOGY MAP EXISTING CONDITIONS
