**Subject:** Draft Environmental Assessment (EA) for Permanent Shore Protection of the Hololani Resort Condominiums Located at 4401 Lower Honoapiilani Road, Lahaina, Maui, TMK: (2) 4-3-010:009.

**Project Name: Permanent Shore Protection of the Hololani Resort  
Condominiums**

The proposed shore protection is a structure consisting of a sloping rock revetment that rises to a crest at +6 ft MSL, backed by a vertical seawall that rises to grade at +12 ft. The rock revetment will minimize wave reflection to help allow accretion of sand, and the vertical wall will minimize the horizontal extent of the structure. The revetment crest will help provide lateral access during seasonal low sand conditions.

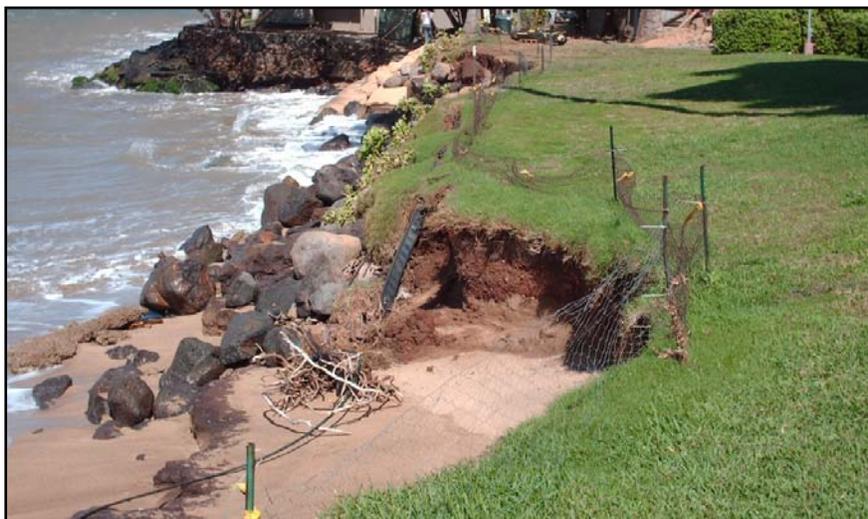
**Figure 1-2. Severe erosion, January 2007**

Since the lot was originally partitioned in 1959, it has eroded almost 40 feet, moving the active erosion scarp to within 15 feet of northern building's corner in 2007. Nearly 5,000 square feet of property has eroded between the two buildings and the shoreline. This has significantly reduced the buffer area between the inhabited structures and the shoreline that affords protection from potential damage due to large wave events.

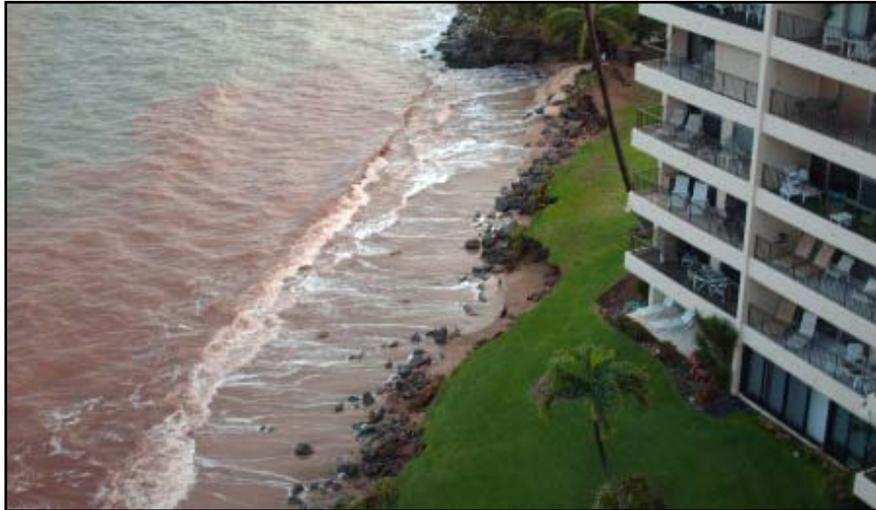
**Figure 1-3. Erosion conditions threatening the north building in January 2007**

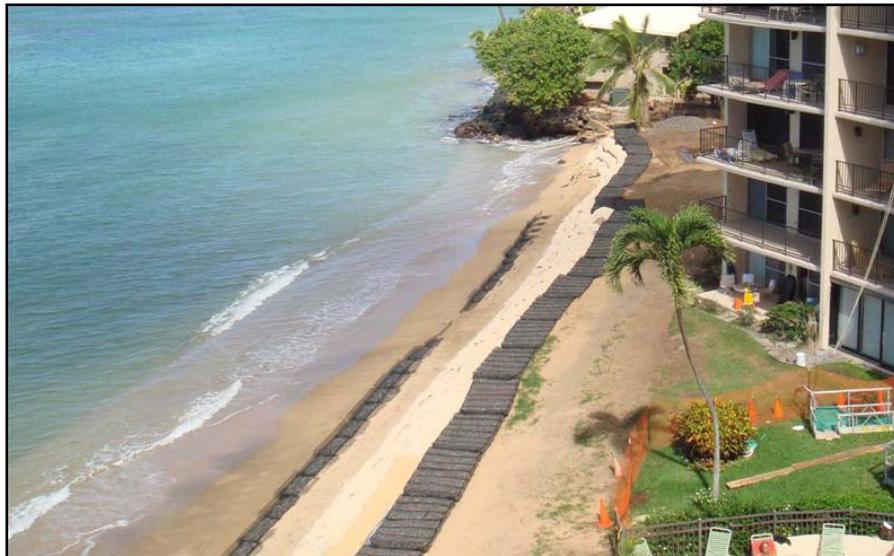
**Figure 1-4. Freshly installed temporary shore protection, January 2008**

The need to stabilize this coastline has been apparent for some time. Temporary shoreline stabilization structures were authorized by County and State agencies as far back as 1988. The most recent temporary structure, a combination of geotextile sand bags and rock mattresses, has not shown any apparent impacts on the seasonal behavior of the beach, though it has helped in slowing the ongoing, chronic erosion and has provided a more durable coastline for mitigating coastal natural hazards. However, the temporary measures are not an adequate long-term solution, as highlighted in the winter of 2010/2011 when wave damage to the temporary structure resulted in repairs costing nearly 1/3 of the total structure's value. In addition, failure of any individual sand bag has the ability, and a history at this location, for destabilizing entire sections of the structure.

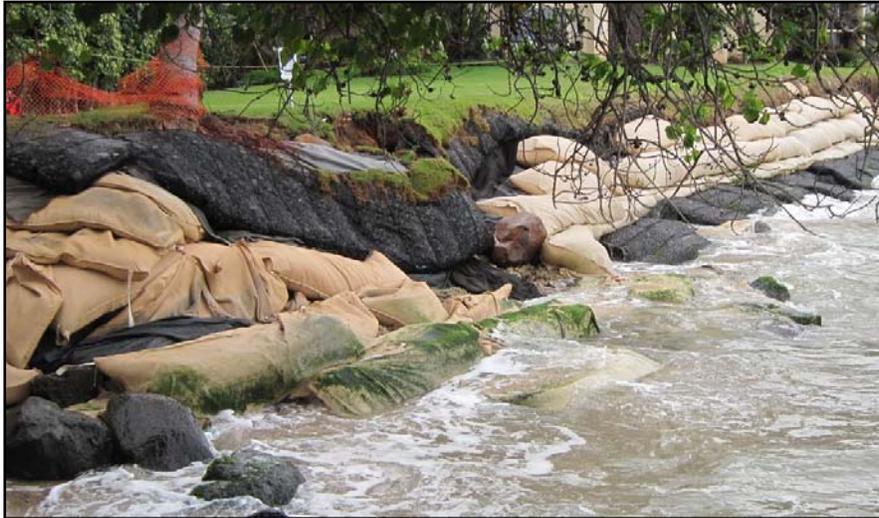
**Figure 1-5. Extensive damage caused by high waves, January 2011**

The 2009-2010 winter wave season was one of the more energetic on record, and the presence of the temporary structure certainly prevented continued shoreline erosion and saved the Hololani from possible irreparable structural damage. Although a robust structure, the temporary emergency revetment has suffered damage. The 2010-2011 winter wave season was particularly damaging, and repairs to the temporary structures totaled \$140,000. Some of the damage is shown in Figure 1-5.

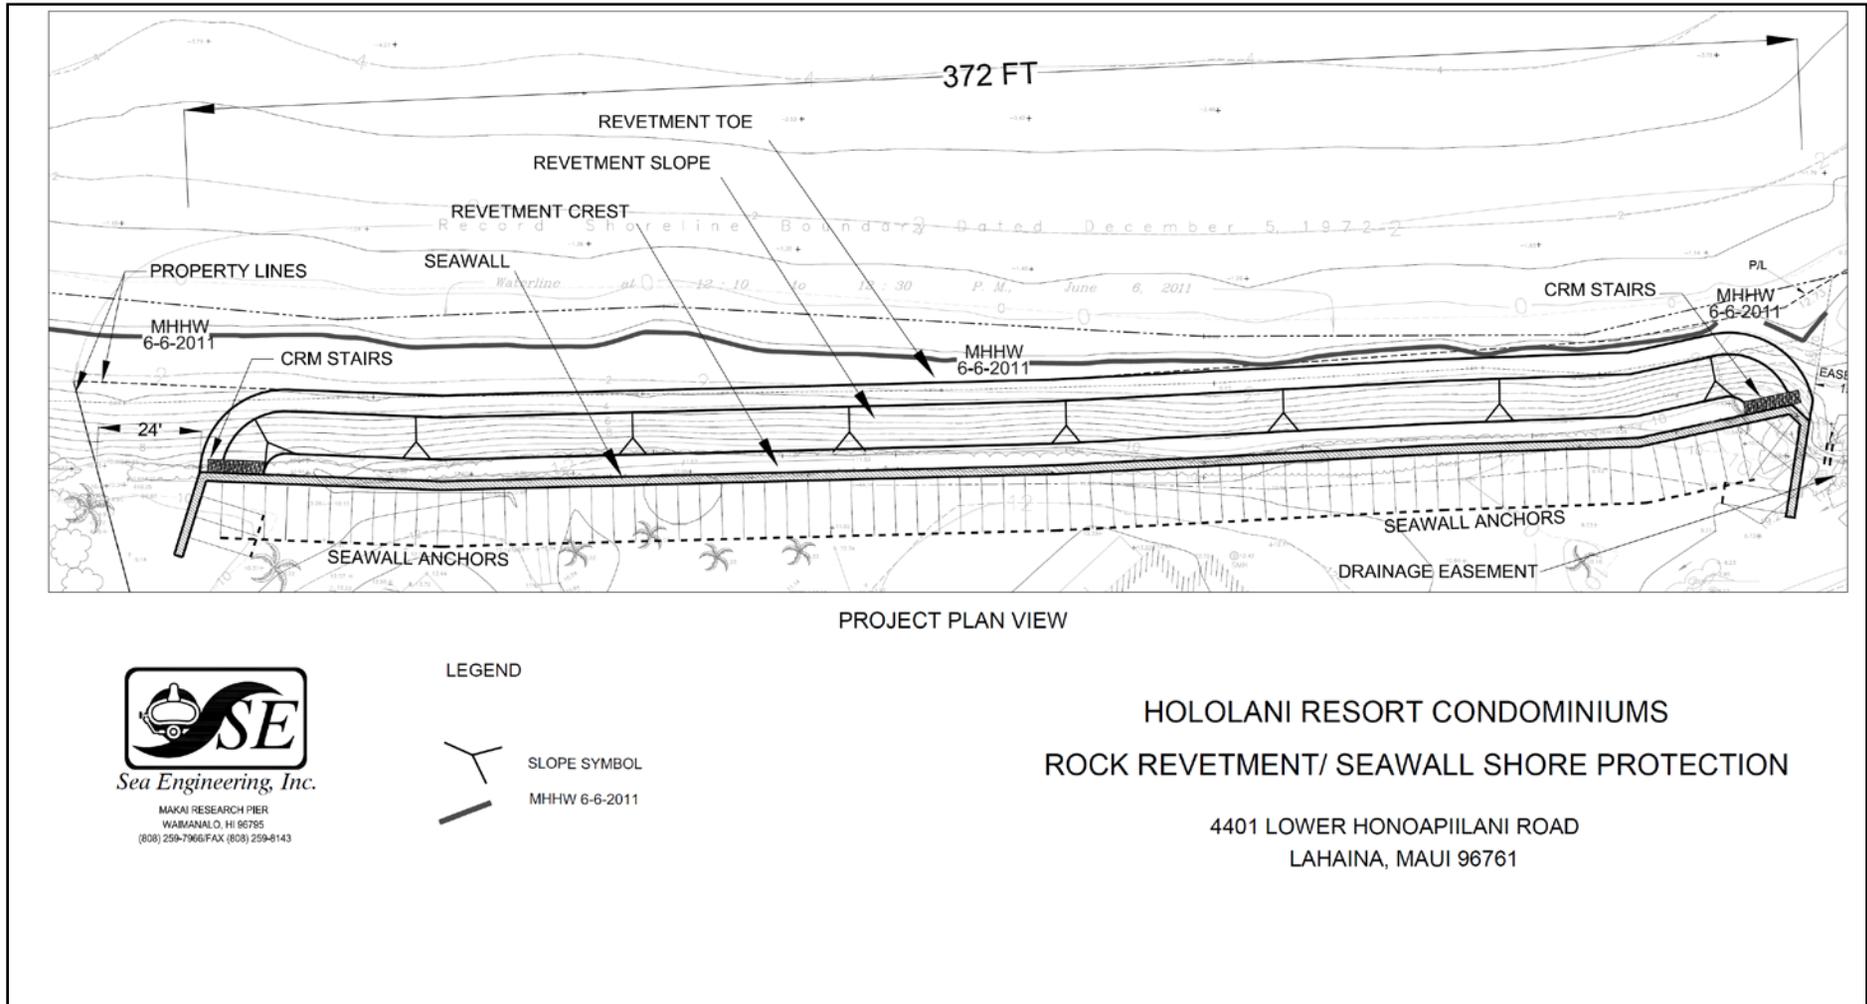
Figure 1-6. Layout of proposed hybrid revetment and seawall

The wall will be constructed of vinyl sheet pile, with a concrete cap at an elevation of approximately +12 ft, and driven to a depth of -10 ft or rock refusal. The sheet pile wall will have a line of soil anchors spaced at 5-ft centers for reinforcement. The vinyl product will not corrode, is resistant to degradation from ultra-violet sunlight, and is typically guaranteed for 50 years. The product is new to Hawaii, but has been used on mainland projects for over 20 years.

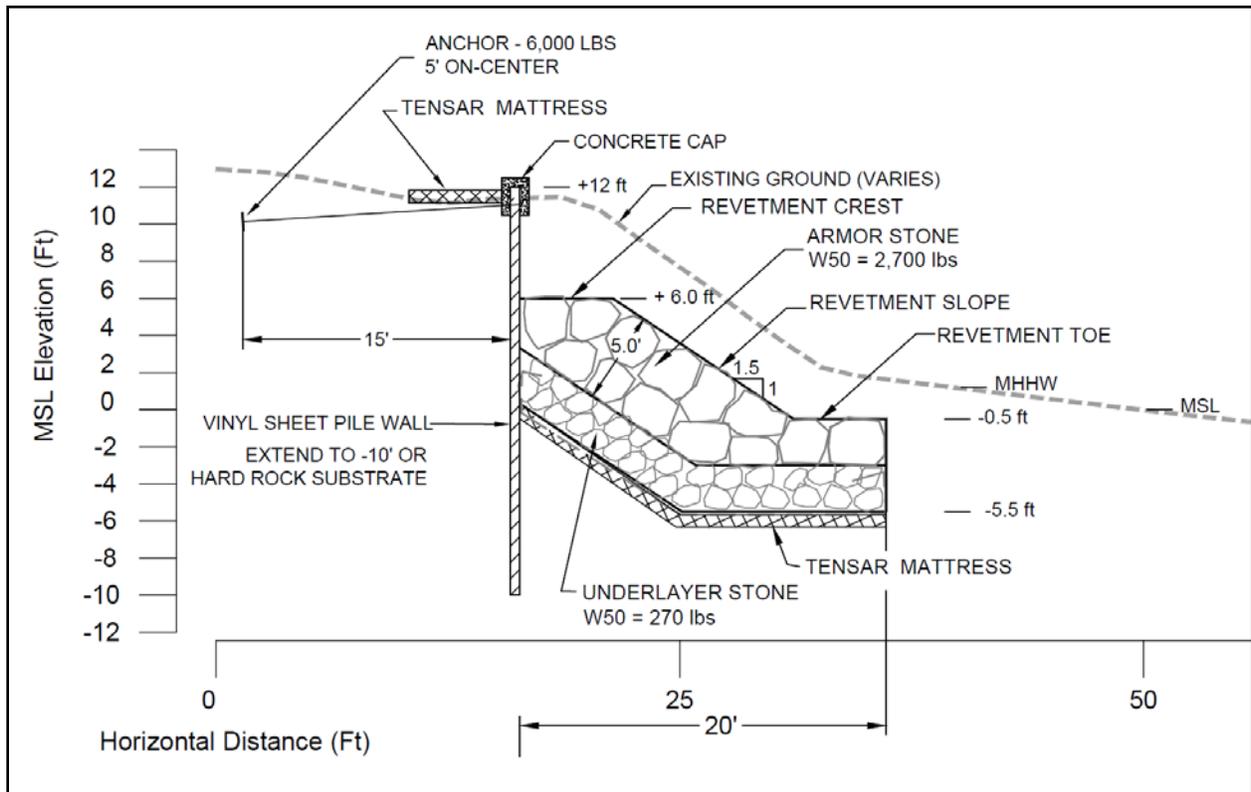
Figure 1-7. Cross-section of the proposed shore protection structure

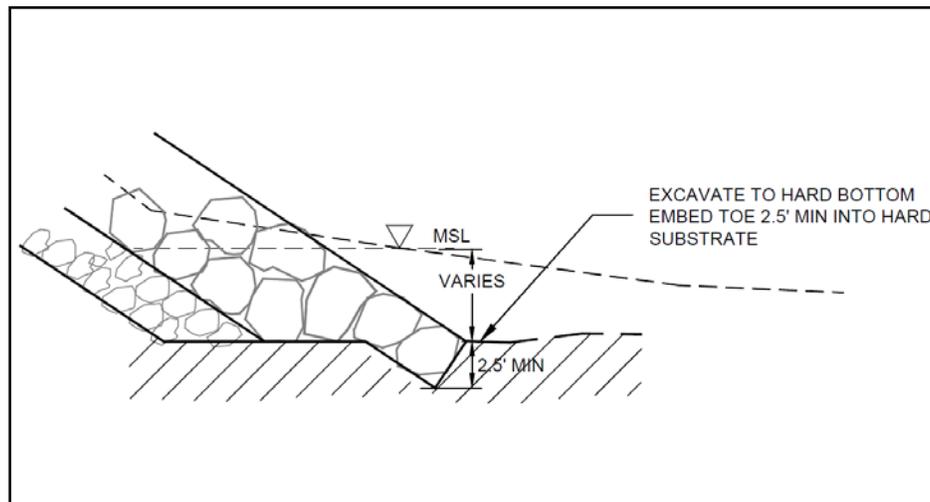
The revetment toe is the revetment section at the base of the structure. The toe design is dependent on the substrate type. Substrate conditions, based on the geotechnical report by Island Geotechnical, are discussed in Section 4.1.14. Most of the structure will require a toe designed for soft substrate conditions, with excess stone contained in a 5-ft apron for protection from scour (see Figure 1-7). The top of the toe is located at an elevation of  $-.5$  ft MSL. The geometry of the armor stone and underlayer stone size requires excavation to a depth of  $-5.5$  ft MSL in order to properly place the toe. Another foot of excavation will be necessary in areas where Tensar mattresses are used to reinforce the soil. The presence of rock shown in some of the boring results (see Section 4.1.14), may allow an alternative toe configuration. If the substrate is competent rock, the revetment can be keyed into it for protection and stability. Figure 2-1 illustrates the toe design for a hard bottom.

Figure 2-1. Toe configurations for hard substrate

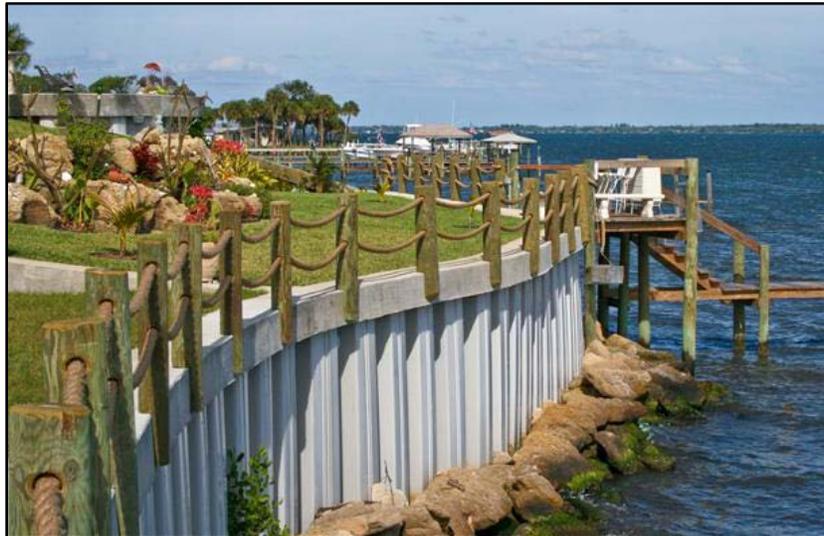
Figure 2-2. Example of vinyl sheet pile wall with a concrete cap (from manufacturer's website)

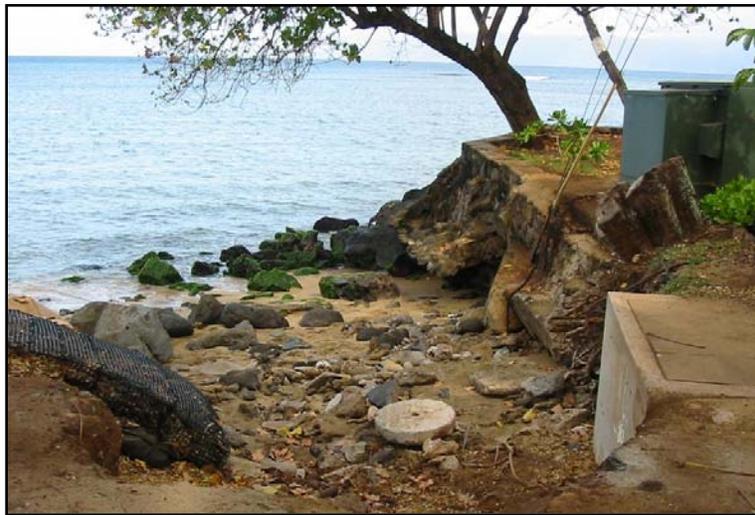
**Figure 2-4. Photograph of the drainage easement showing utilities and seawall undermining**

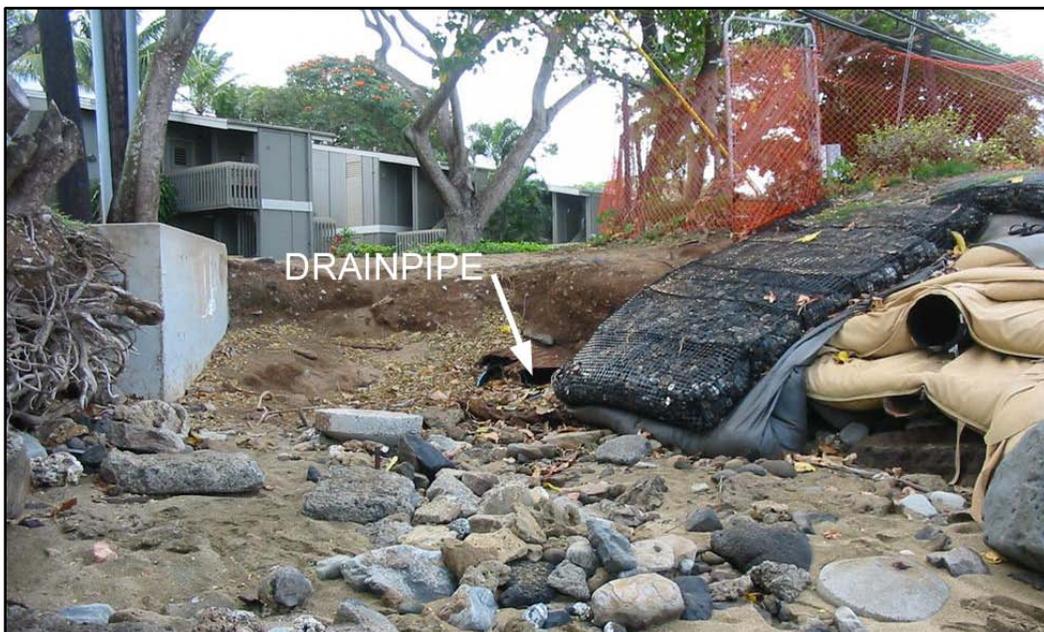
Figure 2-5. Photograph of the drainage easement showing buried drain line

A drainage easement in favor of the County of Maui exists at the north end of the Hololani Property. As discussed in Section 2.5.1 (page 25) of the report, the easement area is severely eroded and the drainline is damaged and blocked. Figure 2-5 in the report shows the present design configuration for shore protection at the north end. The north side of the Hololani property (the south side of the easement) will be protected by a seawall approximately 12.5 ft in elevation (although the final design may vary). A low-crested revetment will front the seawall on the the makai side of the Hololani property, however this will return and end at the south easement boundary, as shown in the figure. The seawall will allow future repairs to the drainline and modifications of the easement area to be done as necessary and on a schedule set by Maui County.

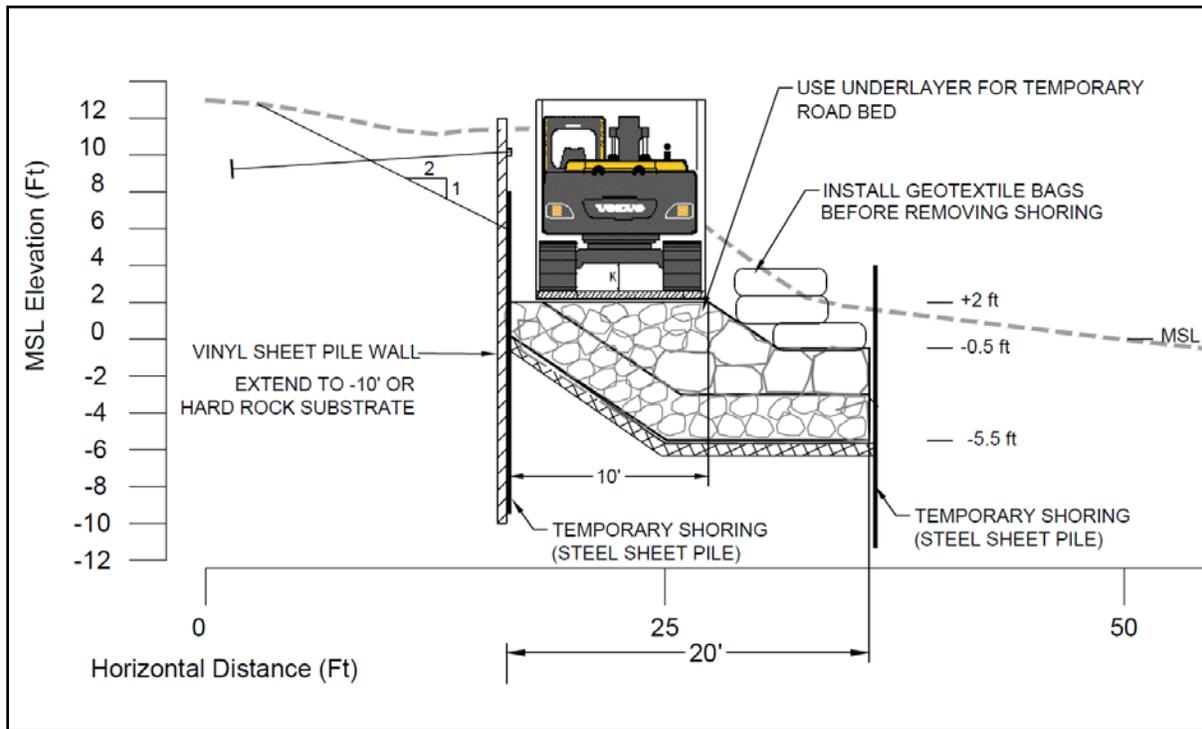
Figure 2-8. Construction of temporary road bed and structure toe – Phase 1, construction moving south.

3. Move forward on the road bed and emplace shoring for the next section.
4. (Phase 2) When the south end is reached, build armor stone slope and crest. Move back north – remove roadbed (excess underlayer stone) and progressively complete revetment. Remove geotextile sand bag berm before moving north to new section. Back-fill and compact top surface excavation, install Tensar mattress and landscaping.

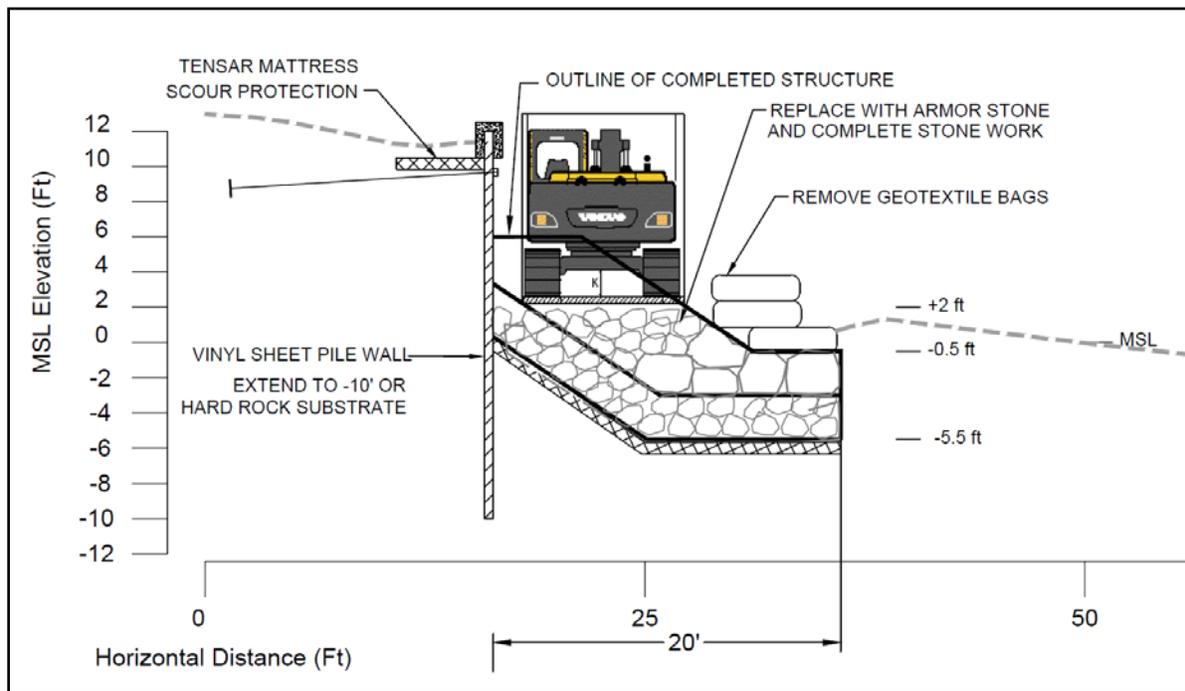
Figure 2-9. Construction of remainder of structure, removal of temporary shoring – Phase 2, construction moving north.

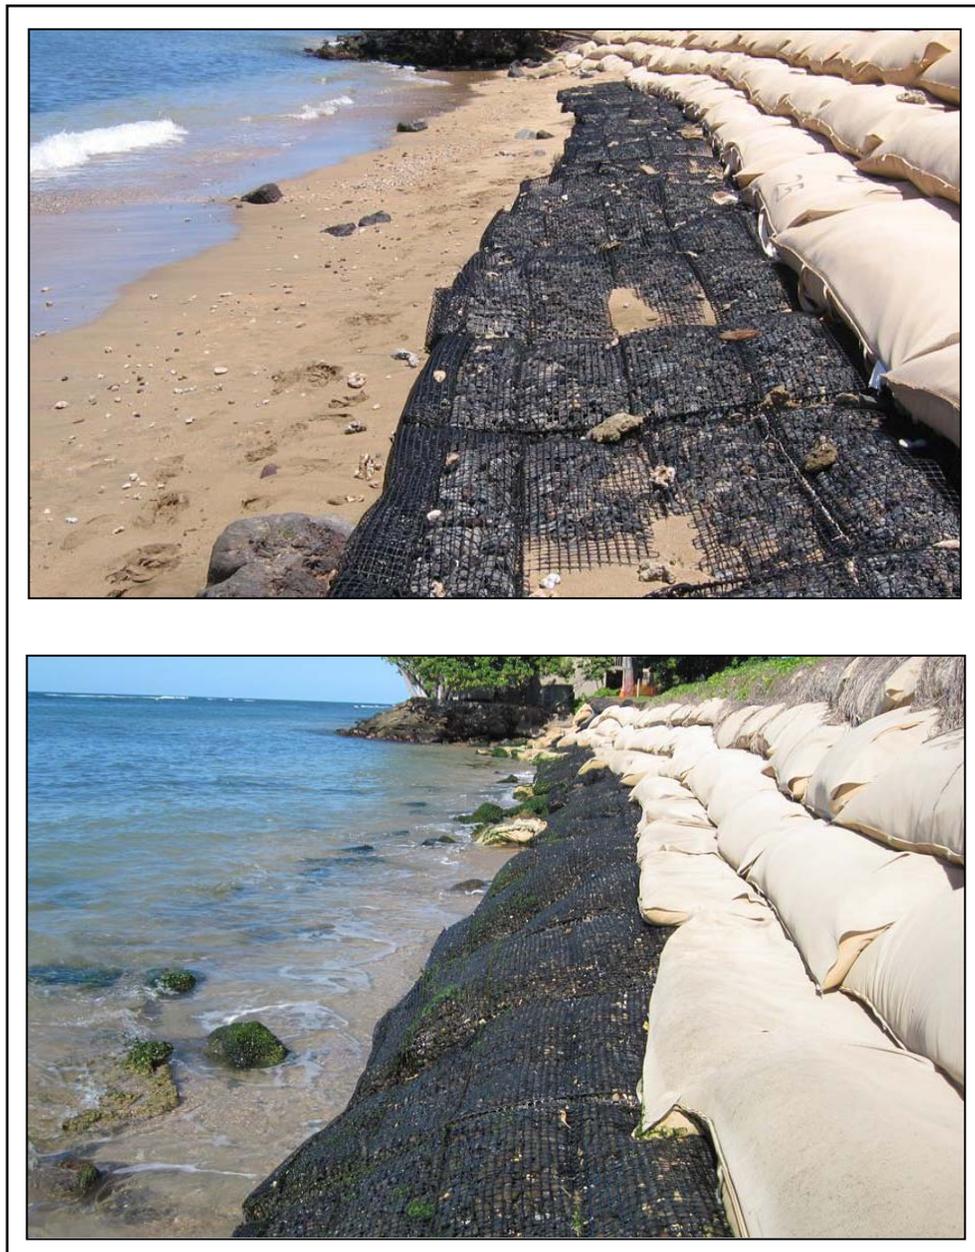
During the winter of 2010/2011 the substrate in front of the temporary shore protection was scoured and eroded. The marine mattress toe protection for the temporary structure articulated down as designed to protect the integrity of the structure (Figure 3-1). The structure was repaired in January, 2011 at a cost of \$140K. Repairs to the temporary structure are not only expensive, they are difficult to do, requiring significant on-site mobilization of pumps and fill material for the sand bags and marine mattresses.

**Figure 3-1. Articulation of marine mattresses in response to erosion of the substrate: April 2008 (top), January 2011 (bottom)**

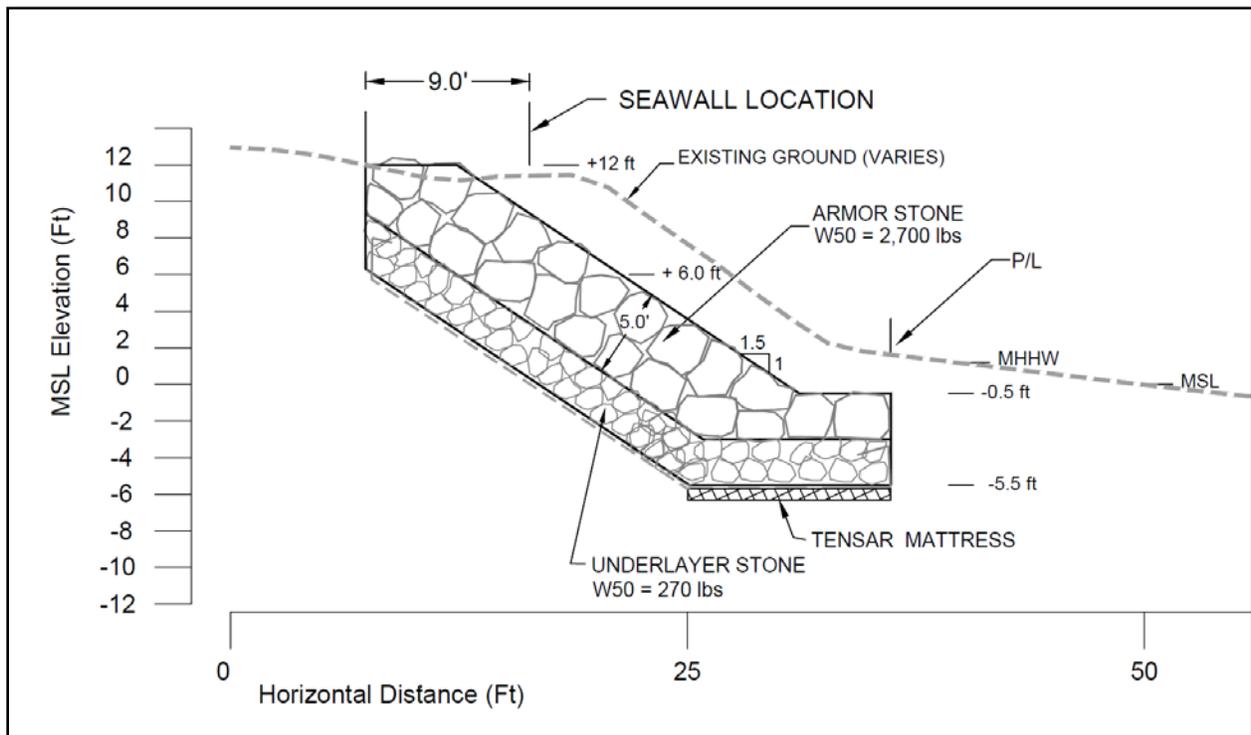
Figure 3-2. Design cross-section for full revetment structure

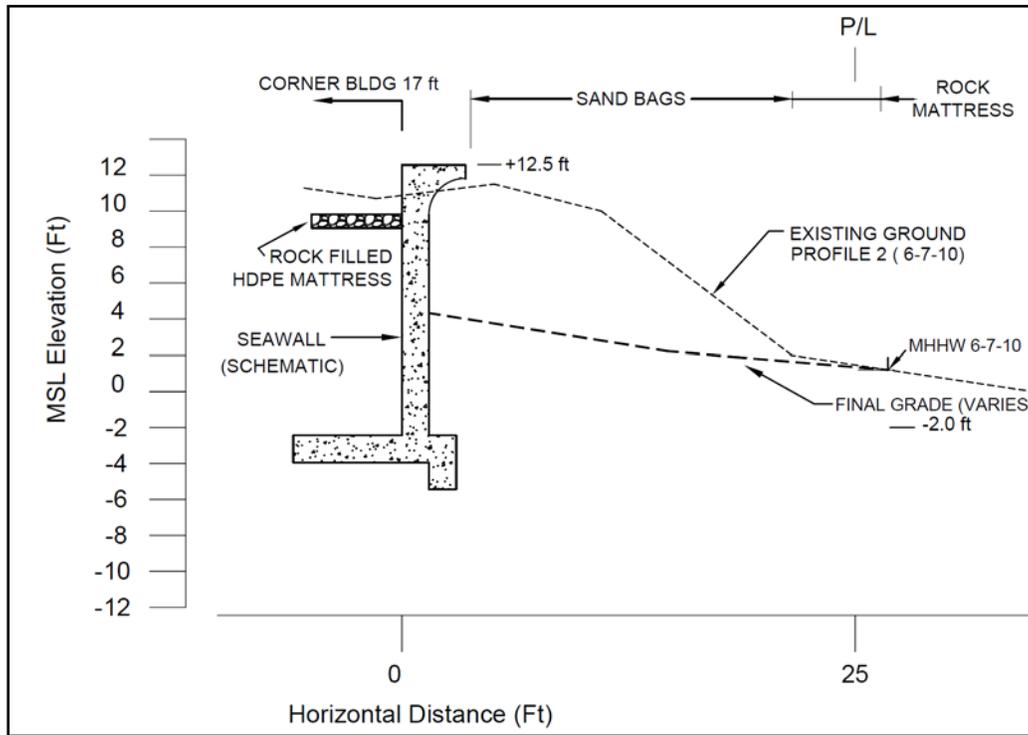
**Figure 3-3. Cross-section for a typical seawall structure at the Hololani**

- The vertical wall face will increase wave reflection, which inhibits sand accretion and degrades the beach;
- During conditions of low sand, the vertical seawall face will be an imposing edifice with a potentially dangerous vertical drop;
- A properly designed and built seawall will require extensive excavation.

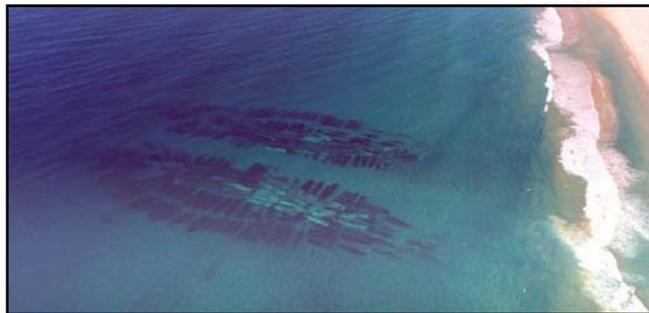
Figure 3-5 is a photograph of an existing artificial reef in Queensland, Australia. The reef is constructed of large geotextile sand bags. Despite the large footprint of the structure, positive effects of the reef on shoreline stability have not been conclusively demonstrated.

Figure 3-5. Narrowneck Reef, Queensland, Australia (photo from ASR - [www.asrltd.com](http://www.asrltd.com))

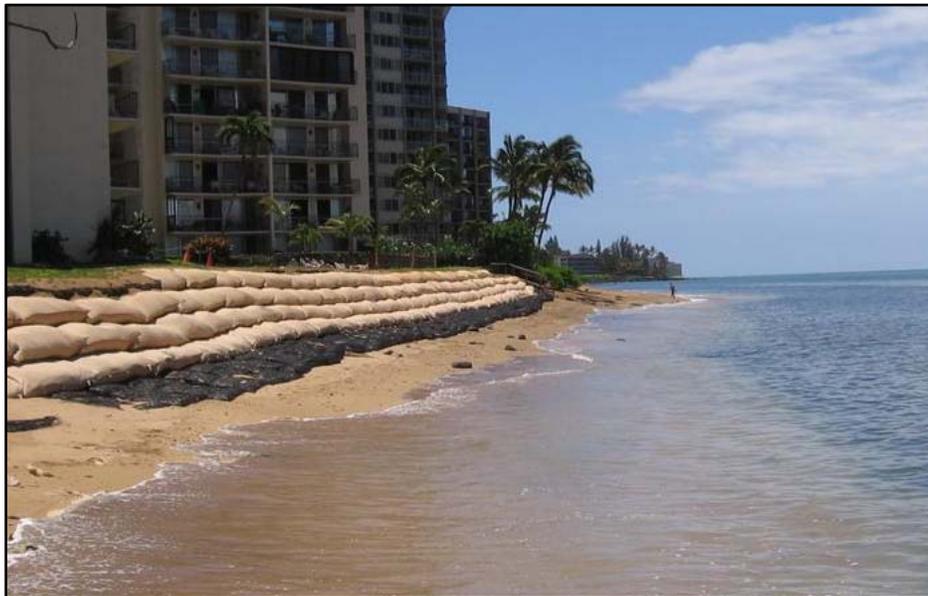
**Figure 4-2. Shoreline at Hololani showing the existing shoreline bluff with temporary shore protection**

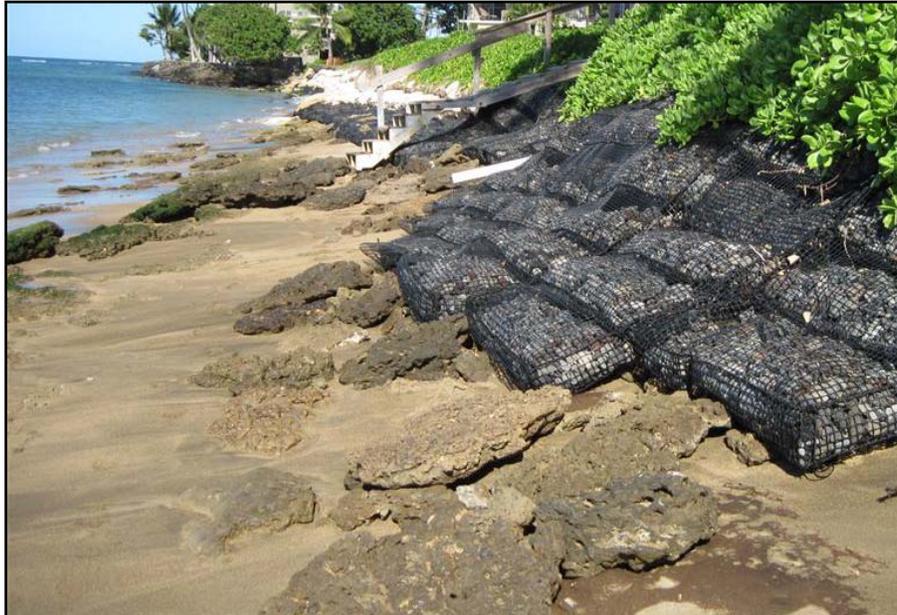
**Figure 4-3. Beach rock fragments exposed during low sand conditions; note draped rock mattress shore protection at adjoining Royal Kahana property**

During conditions when the beach sand has migrated away from the area fronting the Hololani, the substrate is littered with stony plates of beach rock (Figure 4-3). Beach rock is formed by weakly cemented beach sand, and there are linear outcrops visible in many nearshore areas of West Maui. The presence of the beach rock fragments – and the apparent onshore migration of these fragments during high surf conditions – are an indication of offshore sources. The beach rock fragments are difficult and uncomfortable to walk on, and have been destructive to the existing temporary emergency shore protection. The substrate underlying the sand and beach rock, and also existing behind the temporary shore protection structure is red clay that is typical of much of the Maui shoreline (Figure 4-4). The red clay is easily suspended in the water column when eroded, and can lead to significant turbidity issues when exposed (see Figure 4-5).

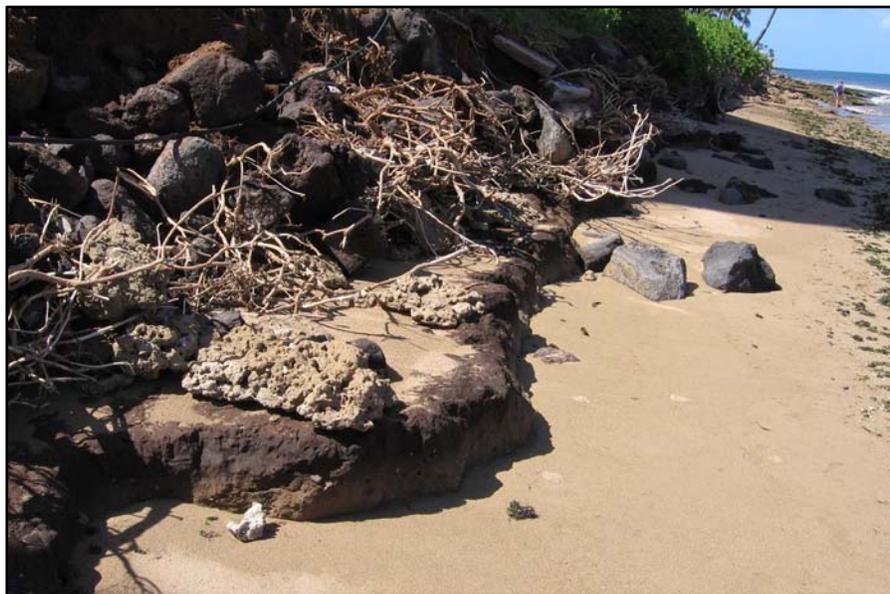
**Figure 4-4 Native substrate at Hololani showing red clay layer**

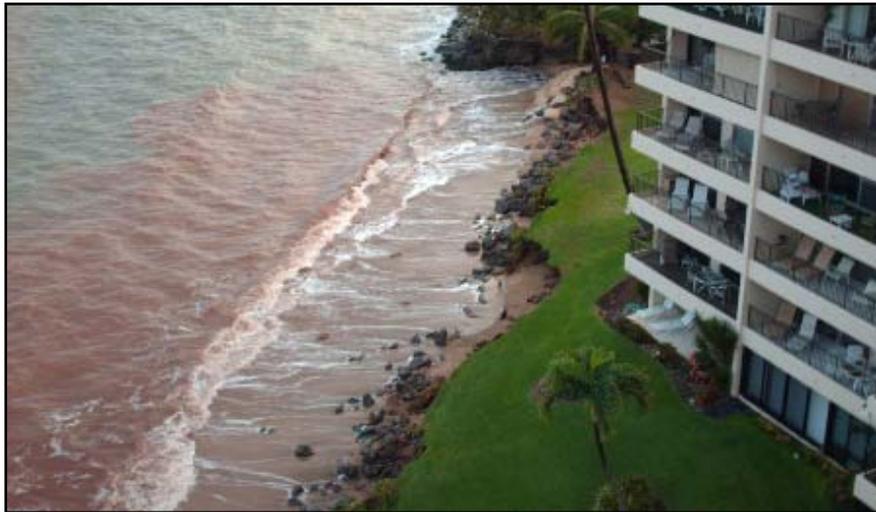
**Figure 4-5. Turbidity caused by erosion of red clay substrate**

In addition, it should be noted that the temporary shore protection that is in place has improved the water quality in the area by preventing the erosion of the red clay substrate and suspension of the resulting fine particulates in the water column. Damage inflicted on the temporary protection since December 2007 is indicative of the severe shoreline erosion that would have occurred if the protection were not in place. Looking forward, there is no doubt that serious erosion and property damage will occur if the proposed project is not implemented. A dangerous shoreline escarpment would migrate mauka, and eventually both buildings would be structurally threatened and would probably need to be abandoned and condemned. All of these things would entail serious and negative impacts on the shoreline and cause loss of use. A portion of Lower Honoapiilani Road is already threatened by coastal erosion near the drainage easement, and this condition will become worse if the shoreline erosion is allowed to continue.

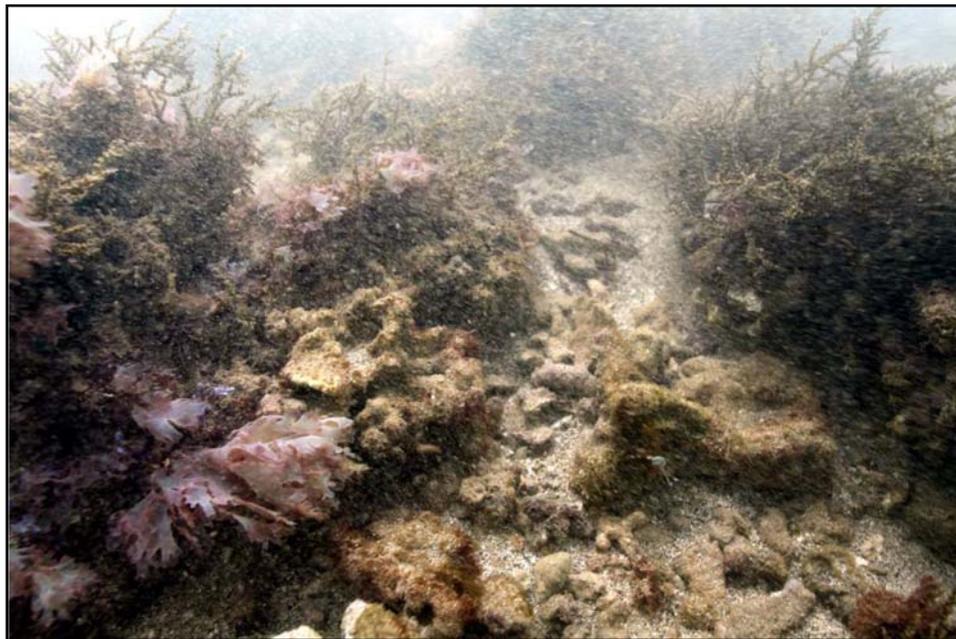
**Figure 4-6. Sand, rubble and red alga in the nearshore zone**

The sand, rubble, and algal cover that typifies the nearshore zone are shown in Figure 4-6 of Section 4.1.4.

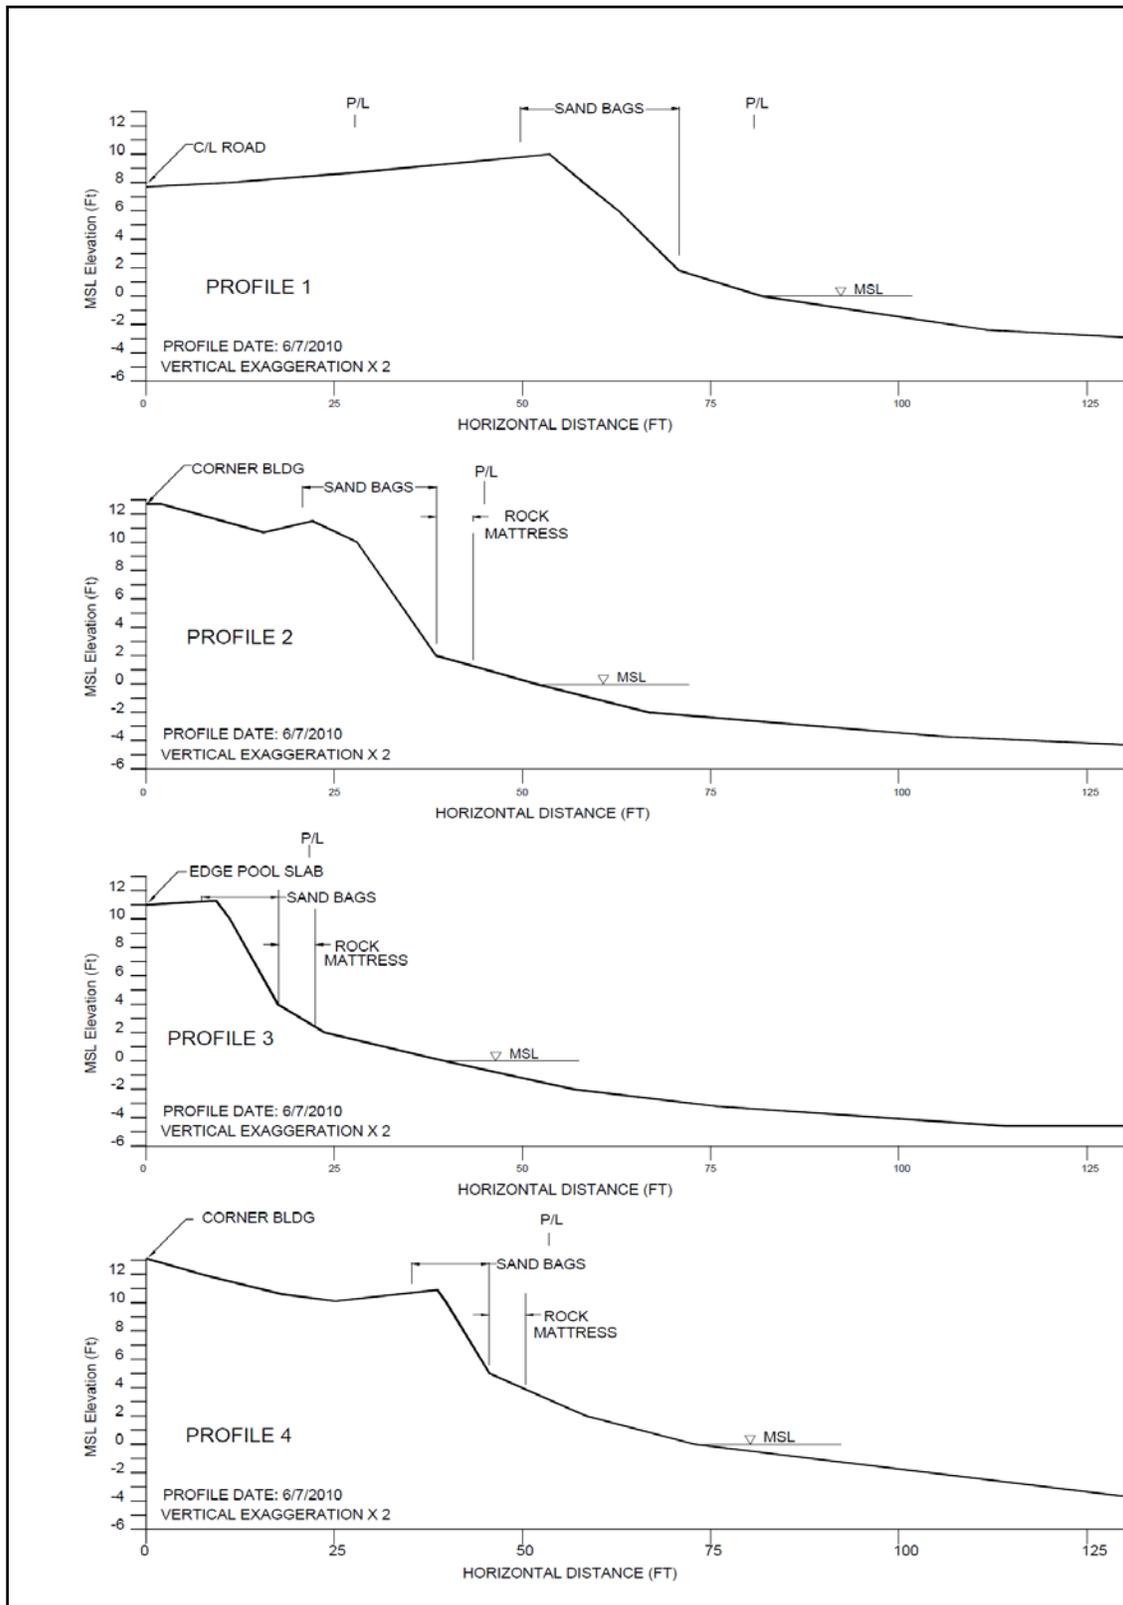
Figure 4-7. Shoreline profiles from June, 2010

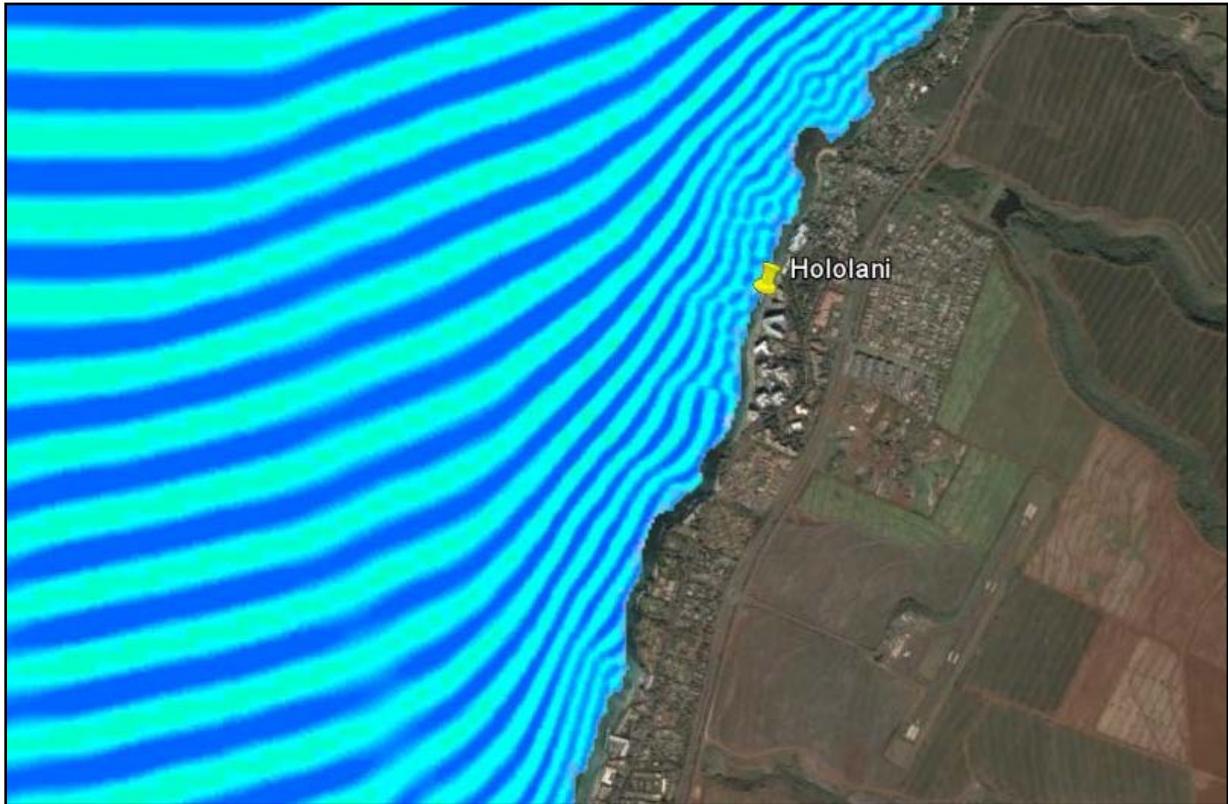
Figure 4-10. North swell wave approach at Kahana (background image from Google Earth)

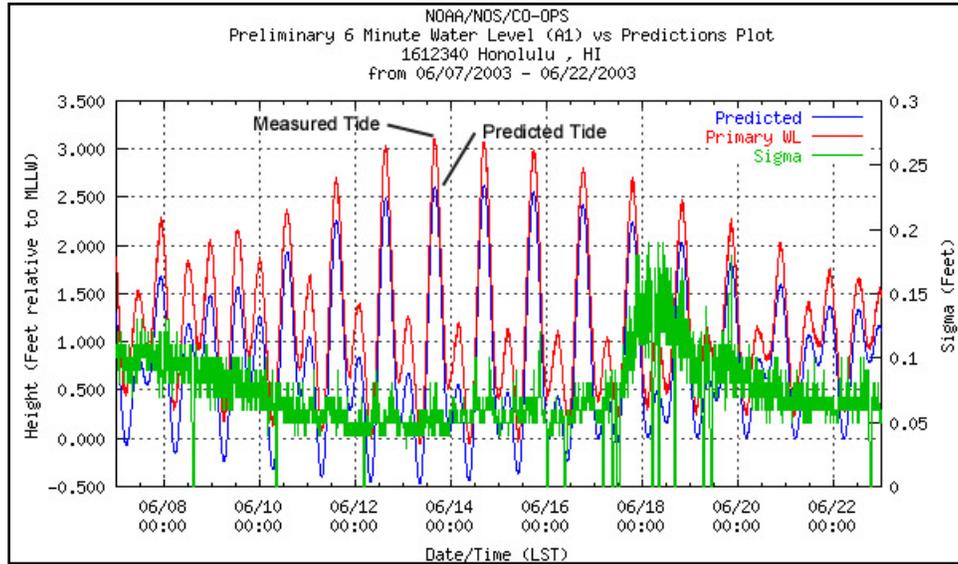
Nearshore waves are typically depth limited, meaning that the amount of wave energy that reaches the shoreline is directly tied to the water level at the shoreline. As wave energy increases exponentially with wave height, a water level increase of 0.5 ft can dramatically change the coastal processes at a particular shoreline. The existing equilibrium can be suddenly modified and large amounts of beach and shoreline sediment can be transported away in a relatively short period of time.

Figure 4-12. NOS tide record for June, 2003 showing influence of a mesoscale eddy

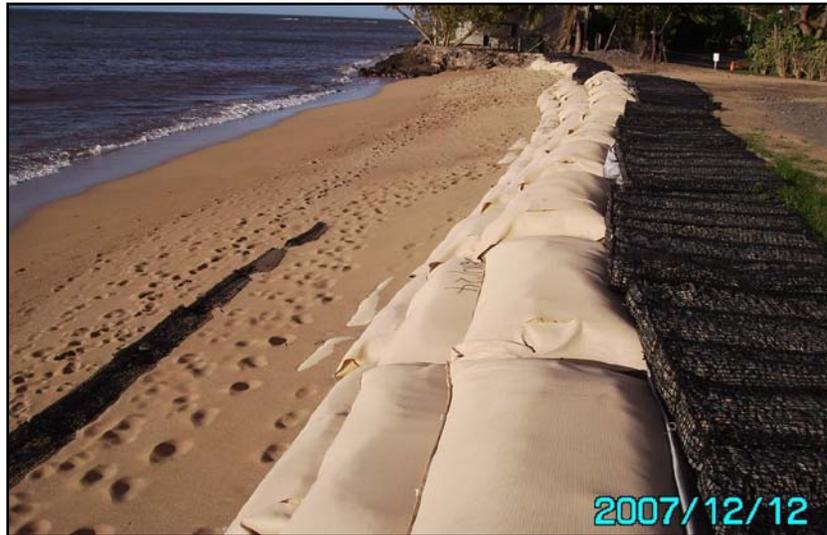
**Figure 4-13. Accretion of sand due to the occurrence of a Kona storm soon after construction of the temporary emergency structure**

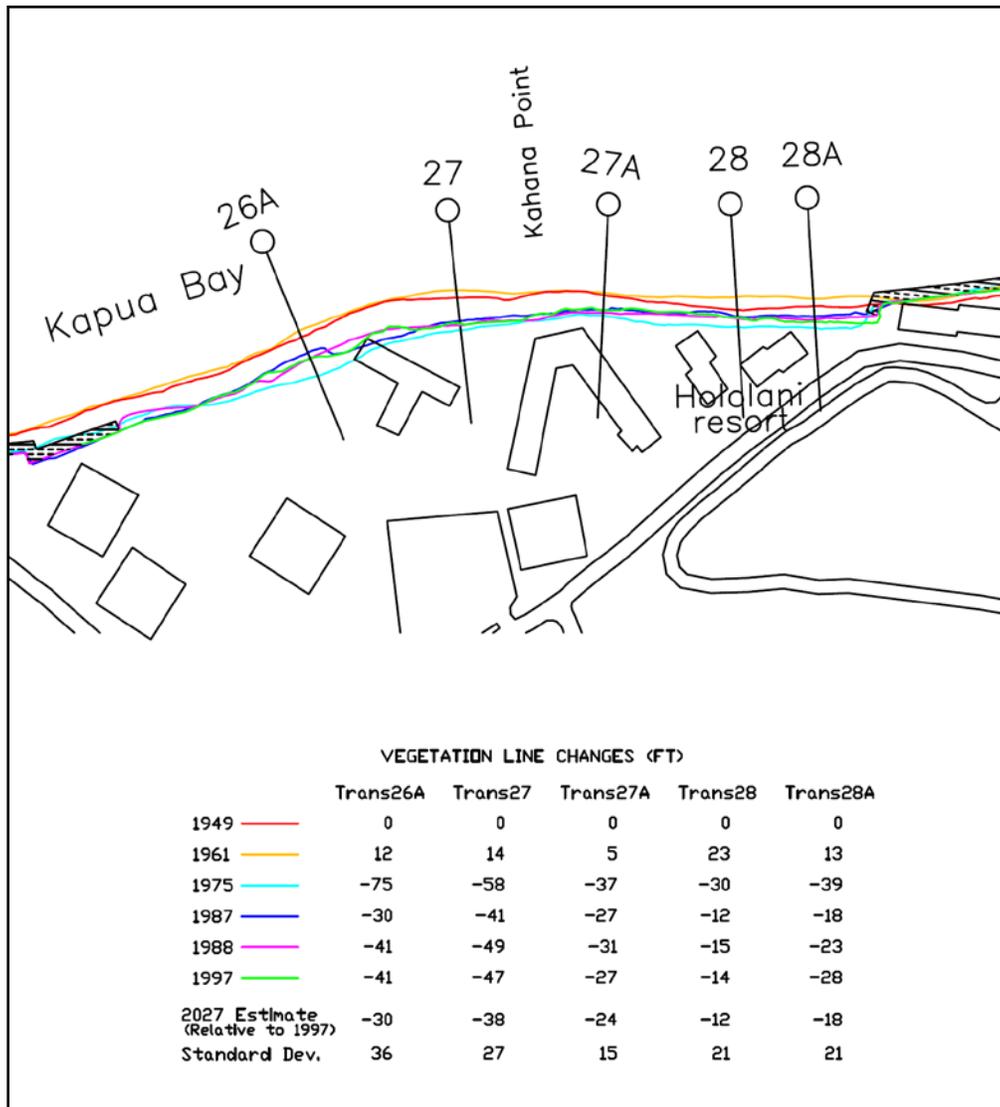
Figure 4-14. SEI 2001 study of shoreline erosion at Kahana

- The shoreline has been dynamic in the 48 years of the study, showing episodes of both strong erosion and accretion, with erosion dominating in recent years
- Aerial photographs reveal beach narrowing and an apparent loss of sand volume in the beaches in front of and adjacent to the Hololani resort
- Due to the prevailing erosion trend and loss of beach width, the shoreline will likely continue to erode in the absence of shore protection.
