**Subject:** Draft Environmental Assessment (EA) for Permanent Shore Protection of the Hololani Resort Condominiums Located at 4401 Lower Honoapiilani Road, Lahaina, Maui, TMK: (2) 4-3-010:009.

**Project Name: Permanent Shore Protection of the Hololani Resort  
Condominiums**

The proposed shore protection is a structure consisting of a sloping rock revetment that rises to a crest at +6 ft MSL, backed by a vertical seawall that rises to grade at +12 ft. The rock revetment will minimize wave reflection to help allow accretion of sand, and the vertical wall will minimize the horizontal extent of the structure. The revetment crest will help provide lateral access during seasonal low sand conditions.

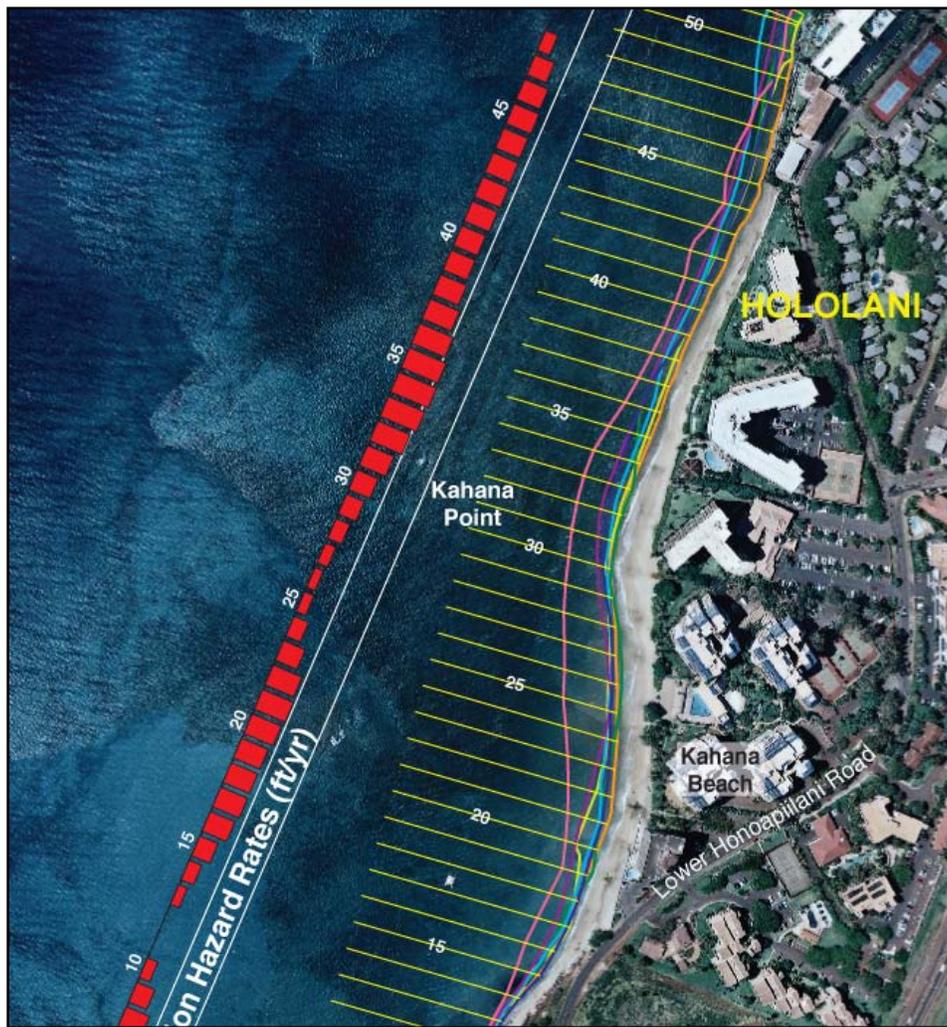
Figure 4-15. University of Hawaii Coastal Geology Group erosion rates at the Hololani

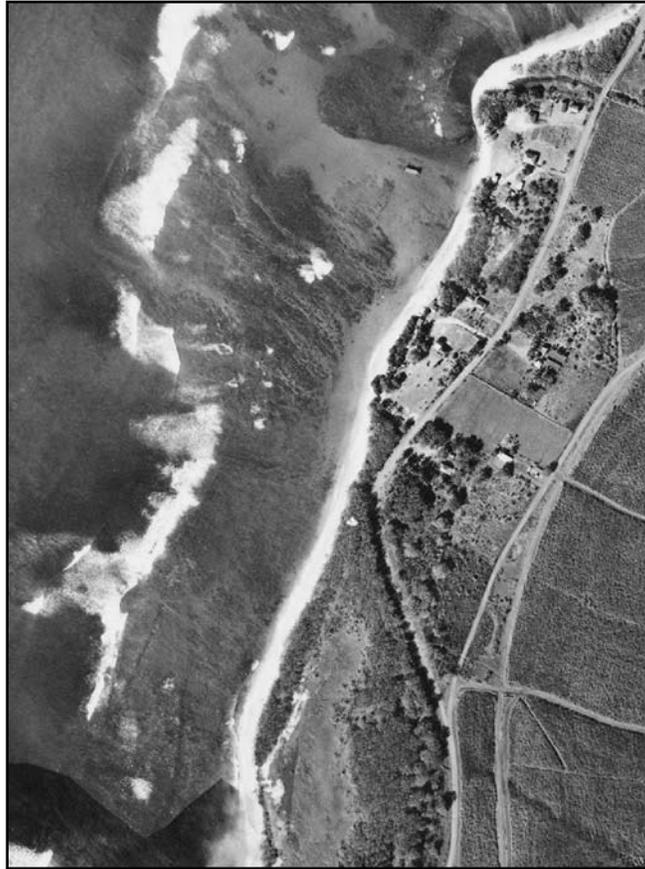
**Figure 4-16. 1949 aerial photograph showing sand from Kahana beaches to Kahana Stream**

What is striking when comparing the 1949 aerial photograph (Figure 4-16) with those of more recent years is the apparent change in the volume of sand. The 1949 photograph shows a healthy ribbon of sand offshore and adjacent to the beach along all of the Kahana coast all the way to Kahana Stream. It is possible that the loss of beach sand is the primary factor driving the erosion at Hololani in the Kahana area in general. The actual mechanism for the beach sand loss is difficult to quantify.

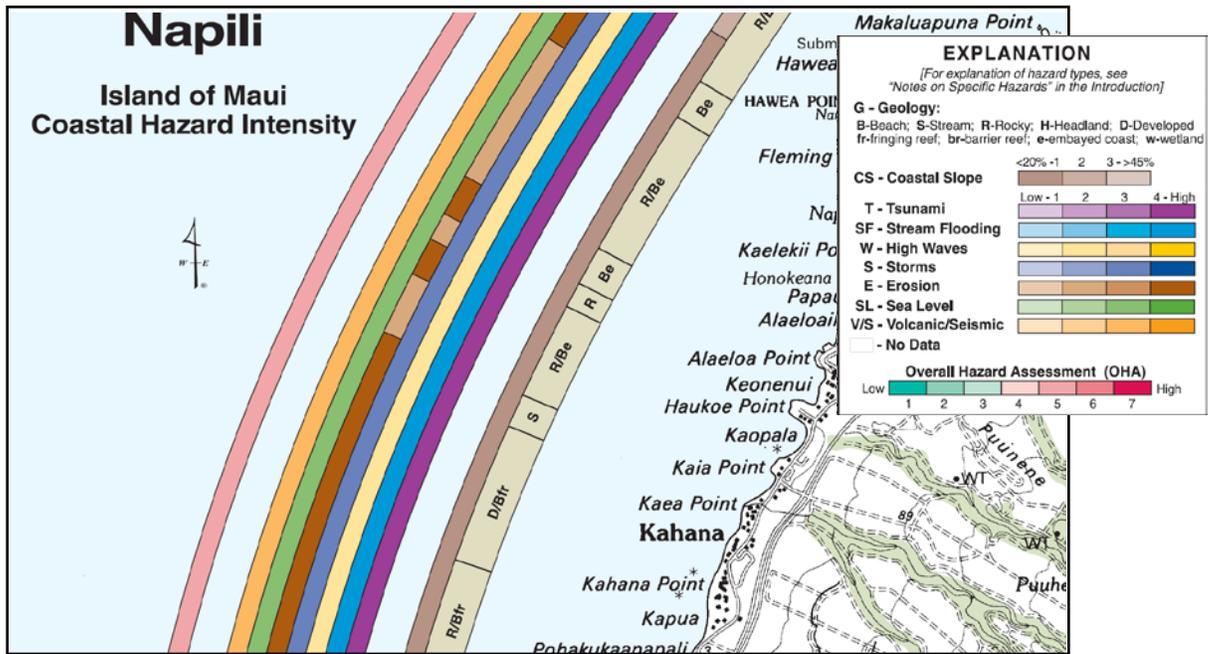
Figure 4-17. Coastal Hazards in the Kahana to Napili region of West Maui (modified from Fletcher et al, 2002)

A comprehensive report by the UH Coastal Geology Group and the U. S. Geological Survey gave a regional Overall Hazard Assessment for the project area as “moderate to high” (Fletcher *et al* 2002). The regional assessment is shown in cartographic form in Figure 4-17, taken from the report. The high tsunami hazard is due to the 1946 tsunami inundation of 15 ft (reported as 24 ft by Loomis, 1976). Other hazards include flash flooding caused by the steep terrain of the West Maui Mountains and the potential for heavy precipitation, as well as the chronic erosion conditions that are prevalent along the coast. Exposure to storms (in particular Kona storms), and moderately high wave conditions is intensified by projected global sea level rise. The region is also seismically active and is classified as a seismic hazard zone 2.

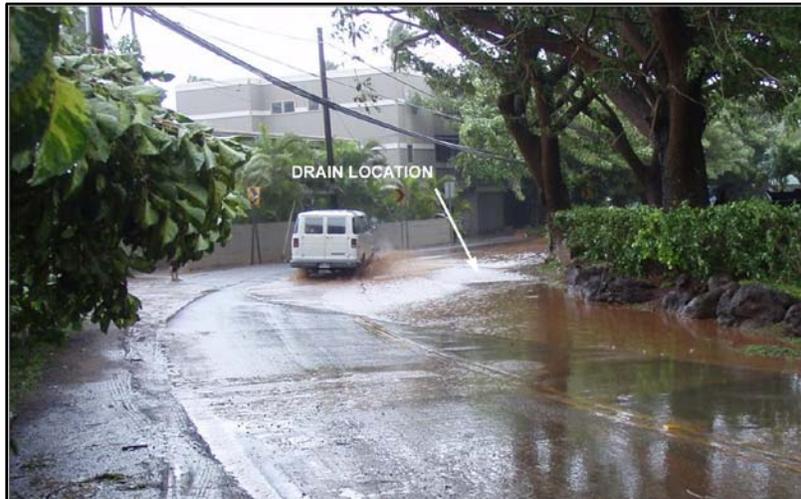
Roadway flooding can occur on the Honoapiilani Highway in the vicinity of the Hololani (Figure 4-18) during heavy rain events. In part this is due to restriction of the drainline north of the Hololani.

**Figure 4-18. Flooding of Honoapiilani highway during heavy rain**

Access to the Hololani is provided by Lower Honoapiilani Road, a two-lane County-owned road that runs just mauka of the shorefront developments such as the Hololani that characterize the area. The road has a meandering character, and has its closest local approach to the shoreline on a tight curve near the drainage easement between the Hololani and Pohailani condominiums (see Figure 4-18).

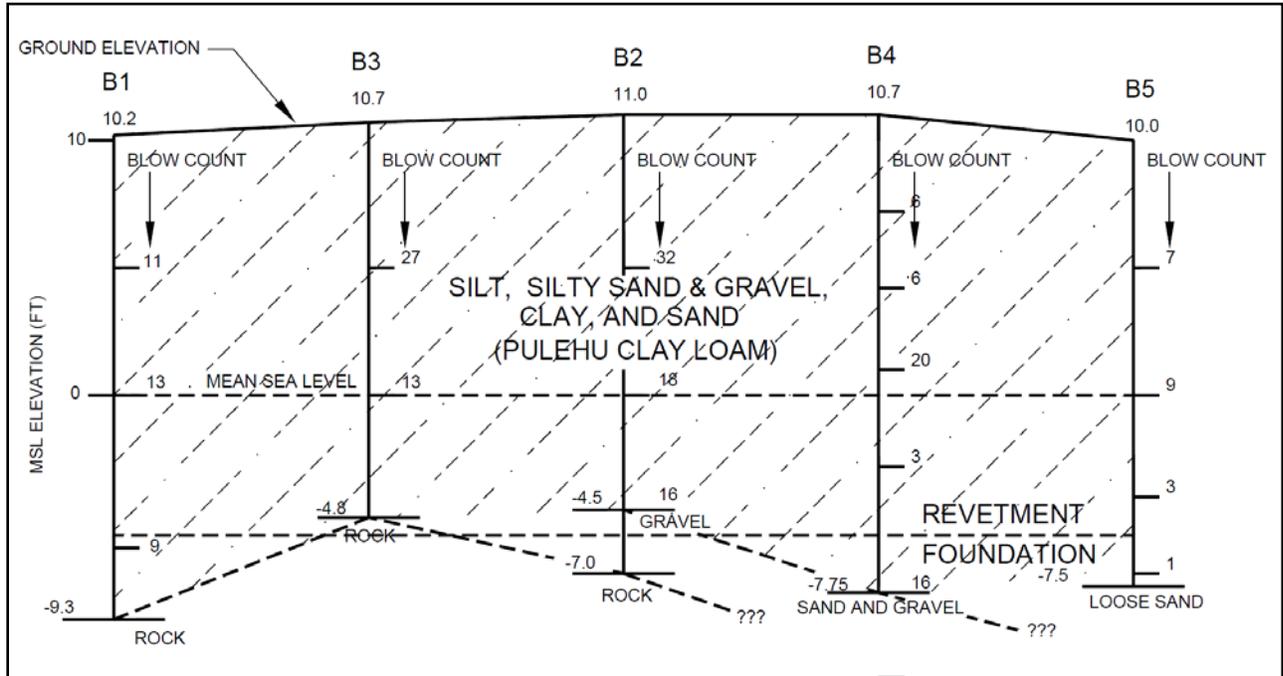
Figure 4-19. Schematic of foundation conditions (note: B1 is at the north end of the property)

The weak substrate found at Borings 4 and 5 at the southern end of the property have necessitated design revisions with the use of sheet pile and stabilization of the substrate with Tensar mattresses. The allowable bearing capacity of 1,500 lbs per sq ft (see Appendix B) is deemed by the project structural engineer as not enough to support a CRM retaining wall.

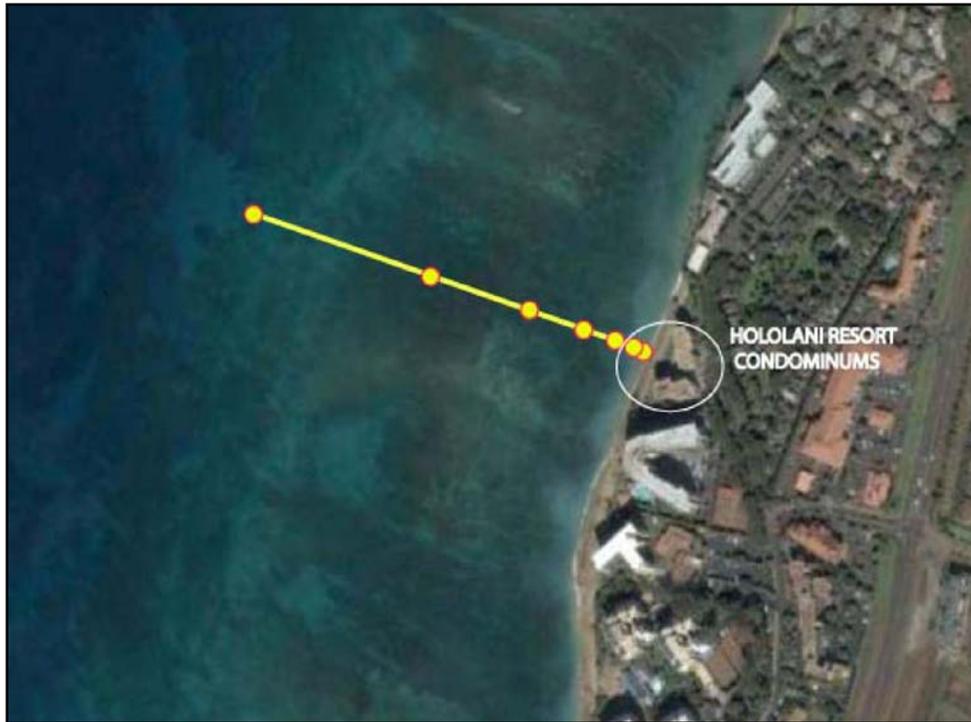
Figure 4-20. Approximate location of water sampling stations off the Hololani

MRC conducted a baseline study of the biological resources at the project site. The investigators swam the transect shown in Figure 4-20 in a zig zag pattern to encompass an approximate 100 yd corridor. The full MRC report, *Baseline Assessment of Marine Water Chemistry And Marine Biotic Communities, Hololani Resort Condominium, West Maui, Hawaii* is attached as an appendix. Italicized excerpts are used in this section to describe the offshore environment.

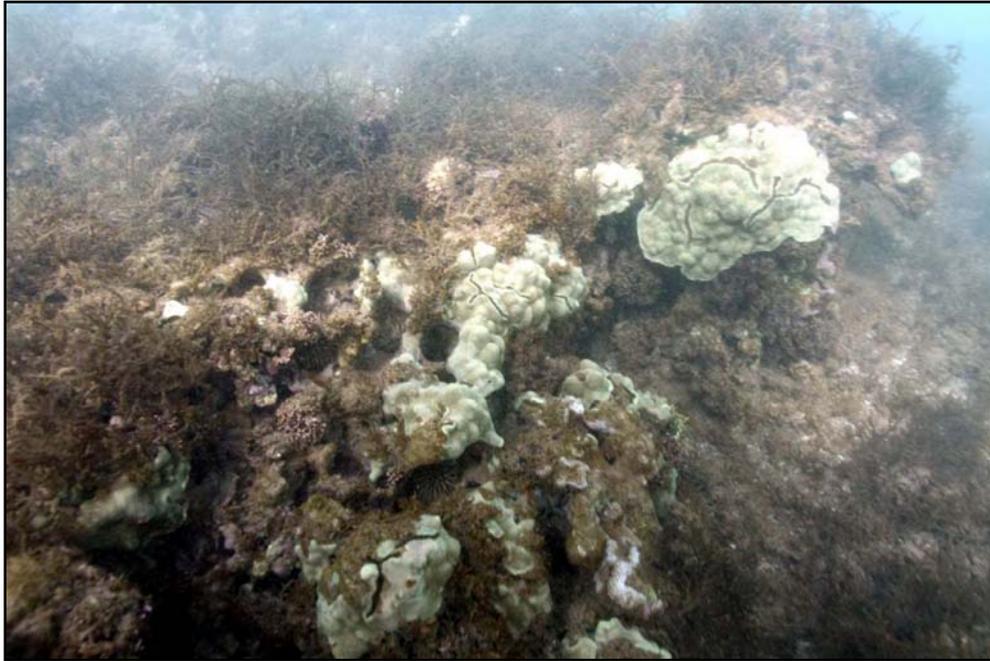
Figure 4-21 shows the still-abundant red alga and encrusting corals that dominate the mid-reef zone.

**Figure 4-21. Red alga and encrusting coral on elevated surfaces in the mid-reef zone.**

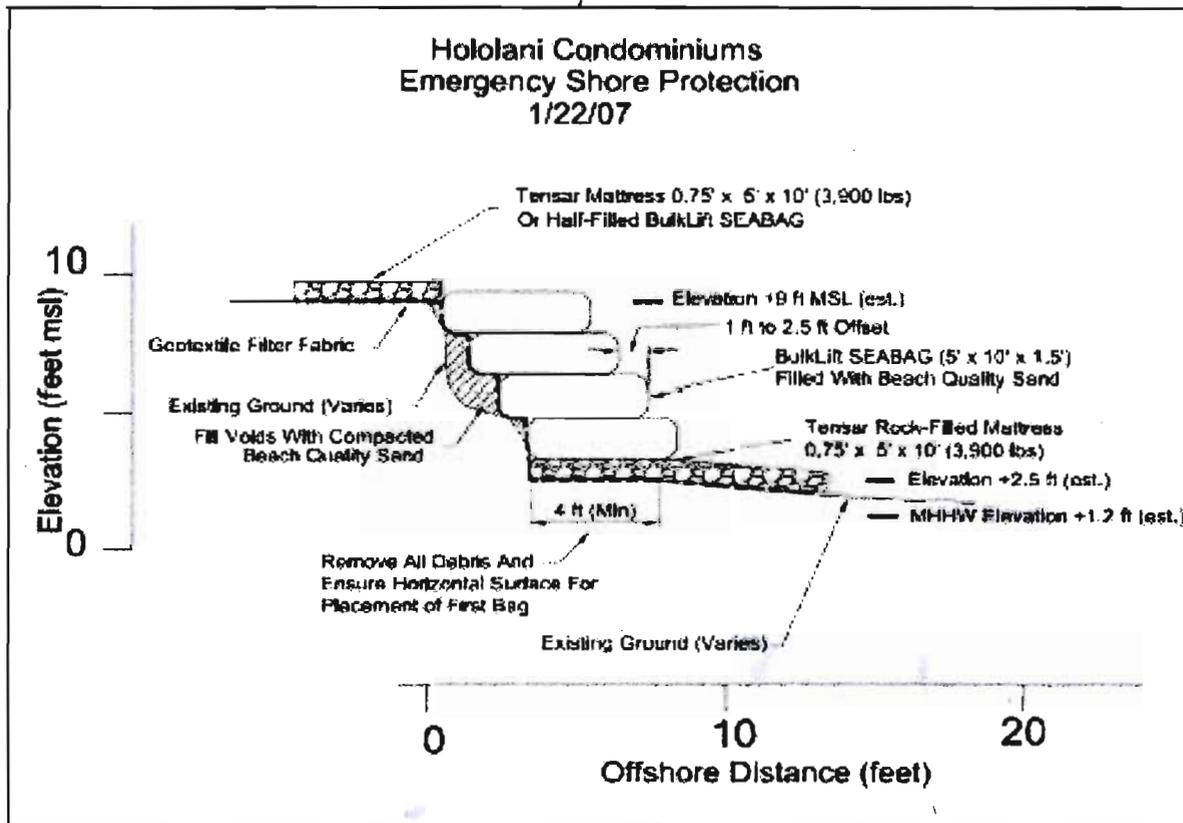
Figure 2. Cross-section of proposed temporary emergency shore protection.

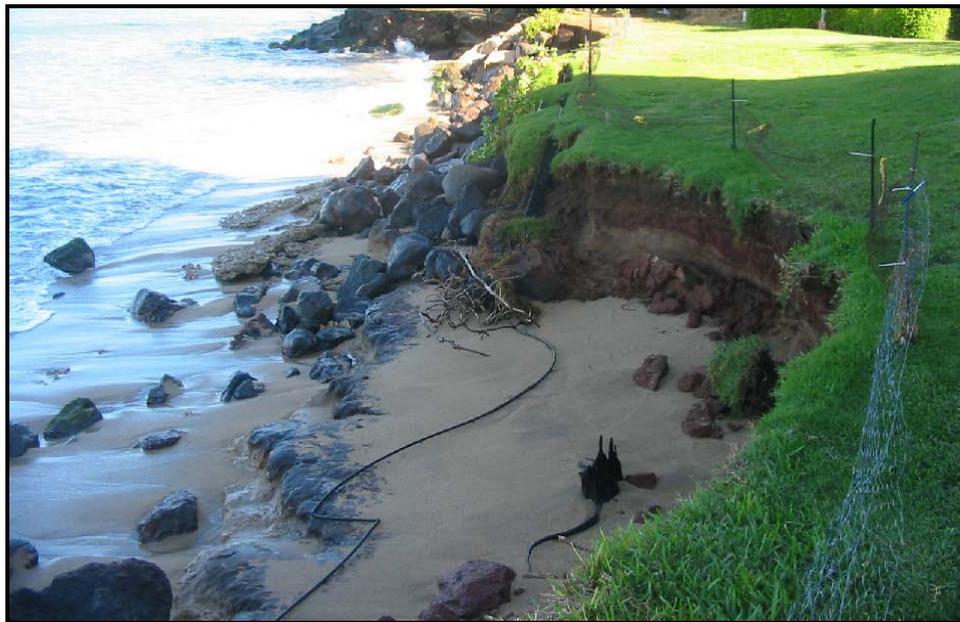
Figure 2. Project site shoreline, 1-11-07

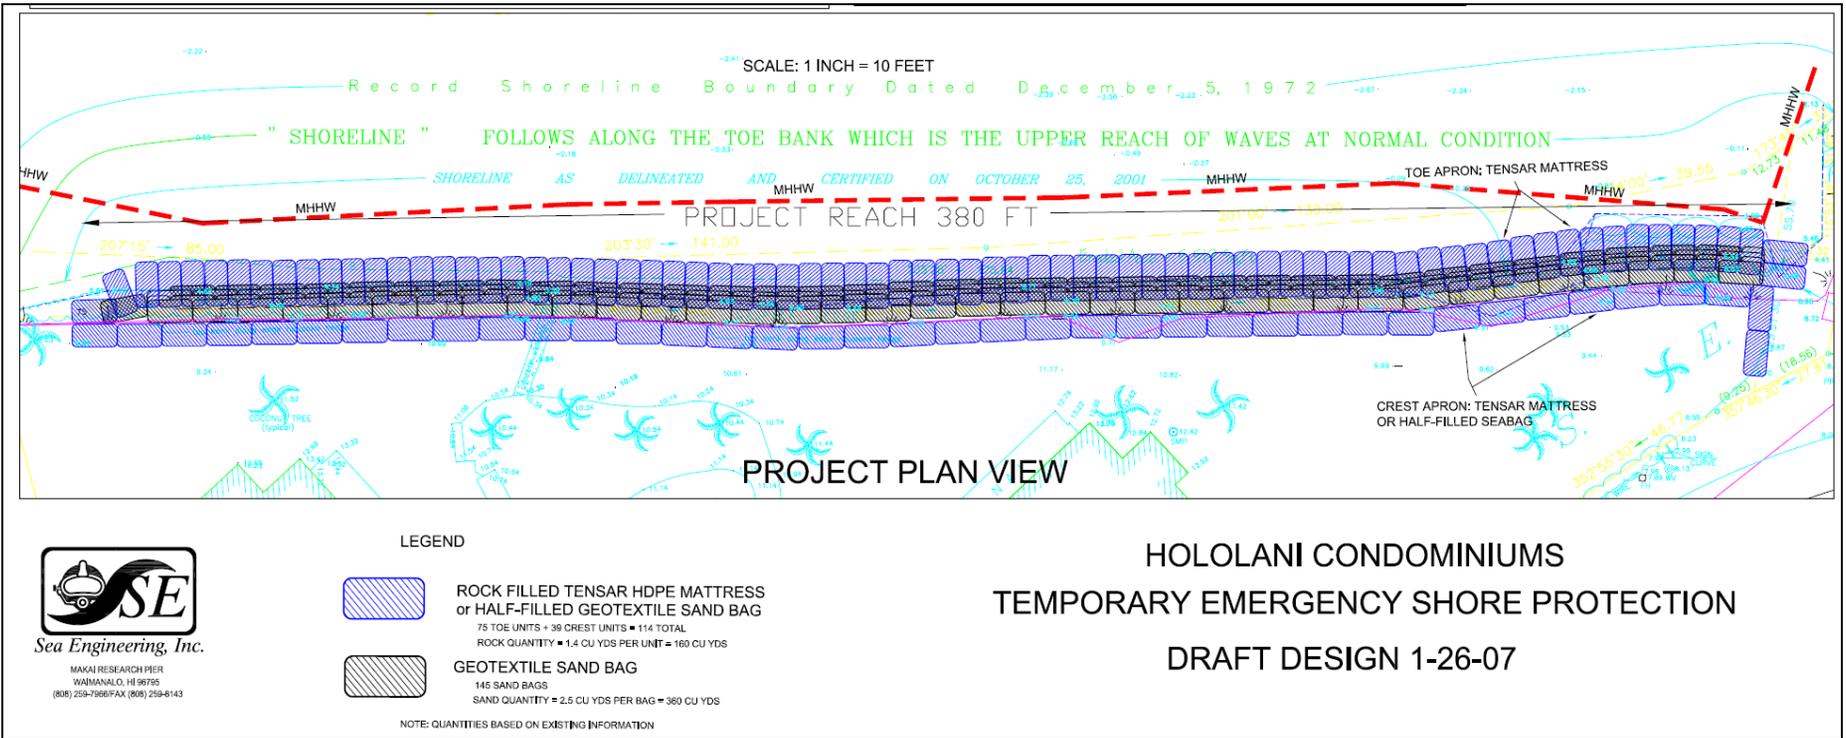
Figure 3. 2007 temporary shore protection plan, showing location of January 2007 MHHW level

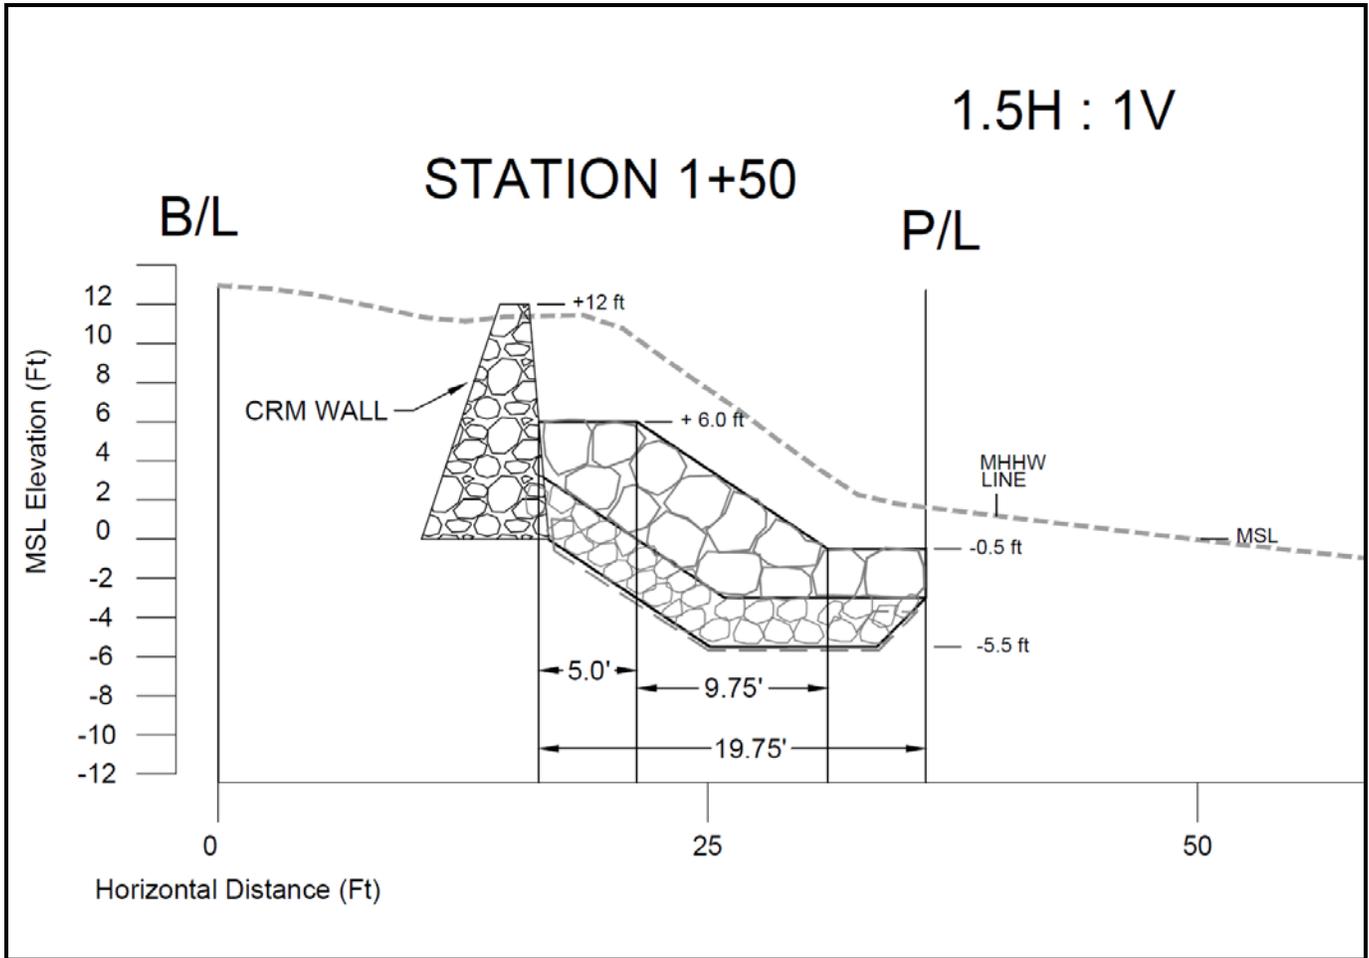
Figure 4. Permanent shore protection section, showing dimensions of the hybrid structure

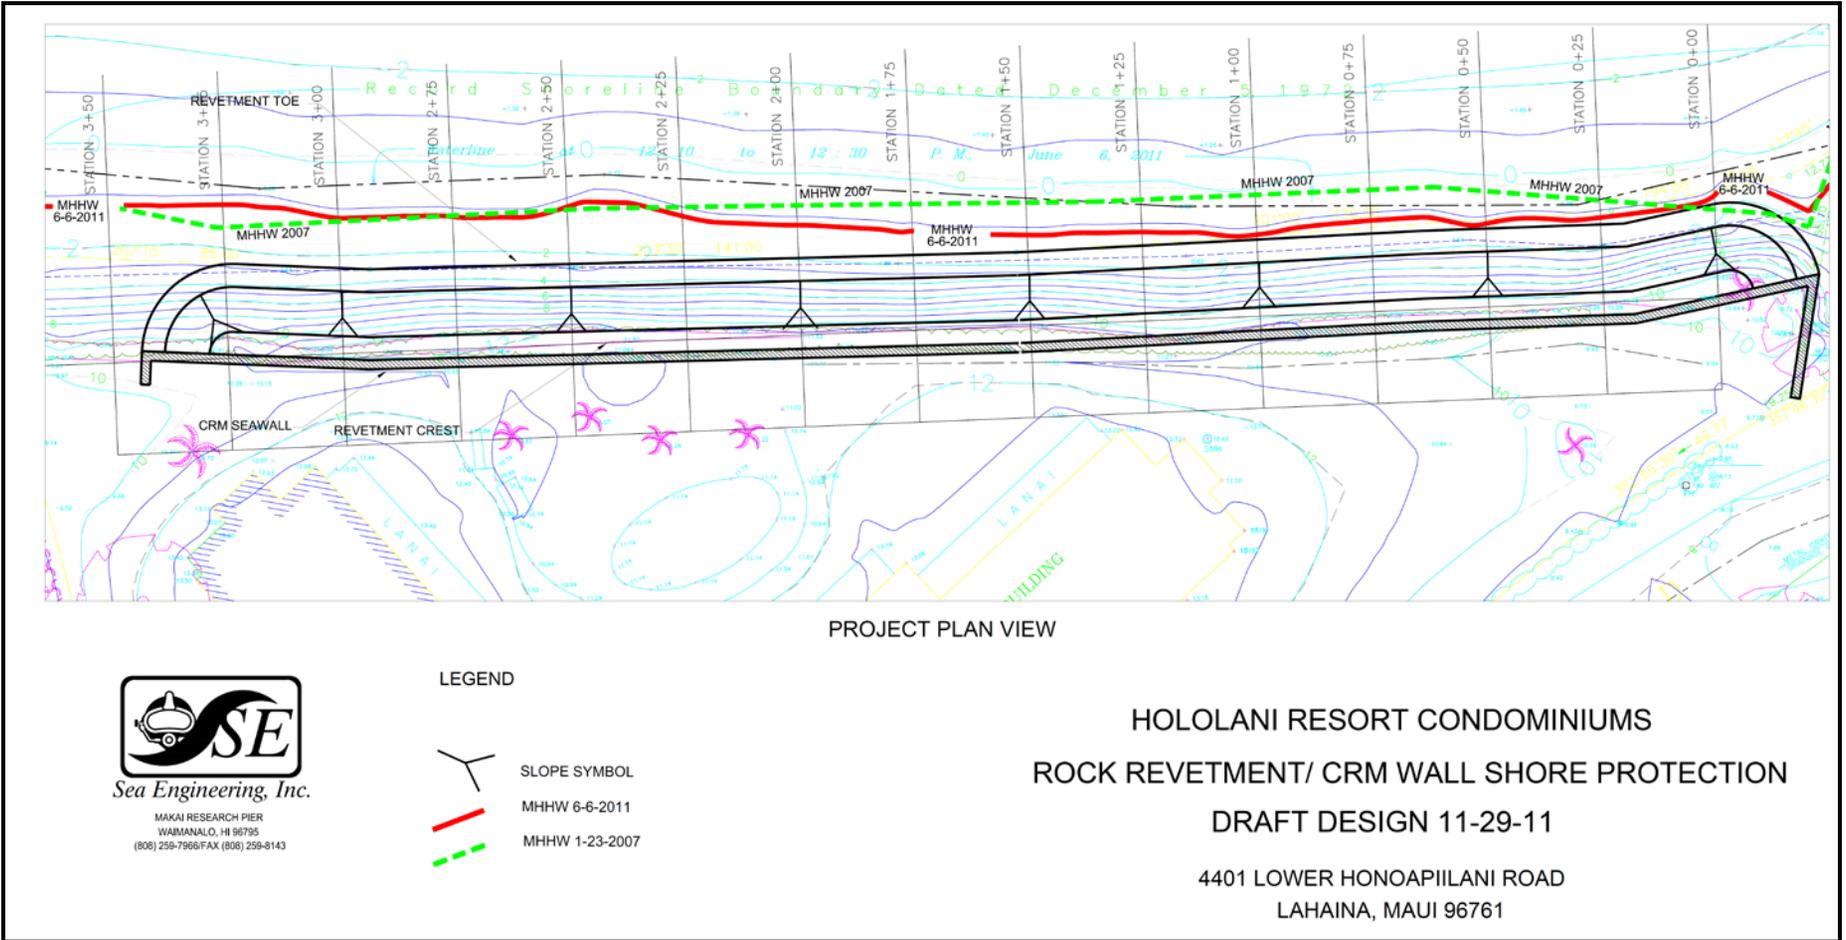
Figure 4. Permanent shore protection plan, with 2007 and 2011 MHHW levels

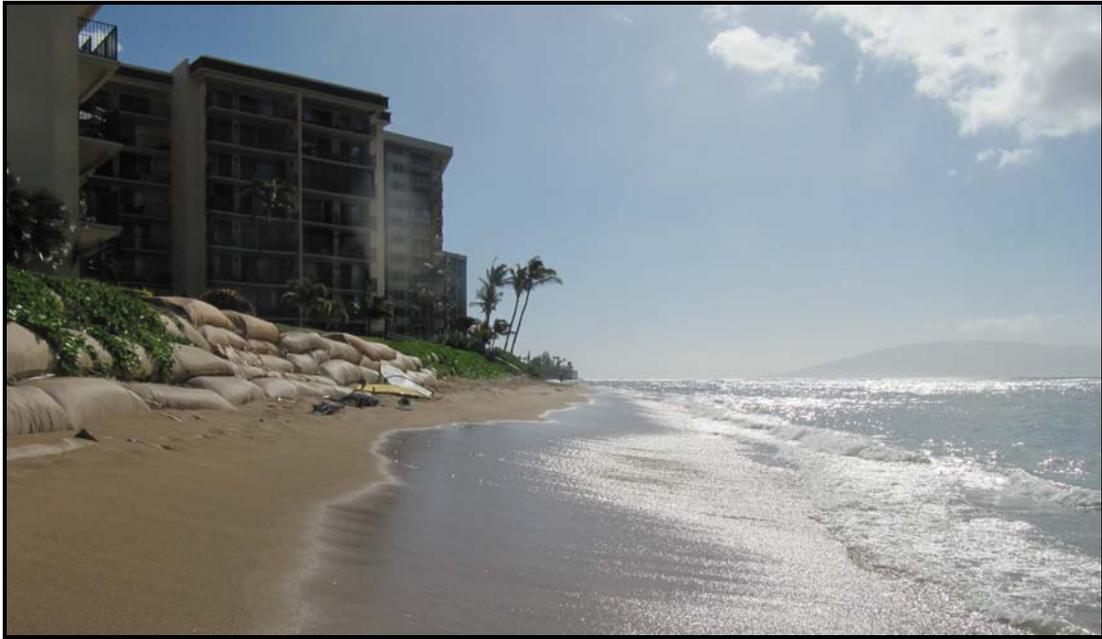
Figure 5. Hololani beach, 11-25-2011

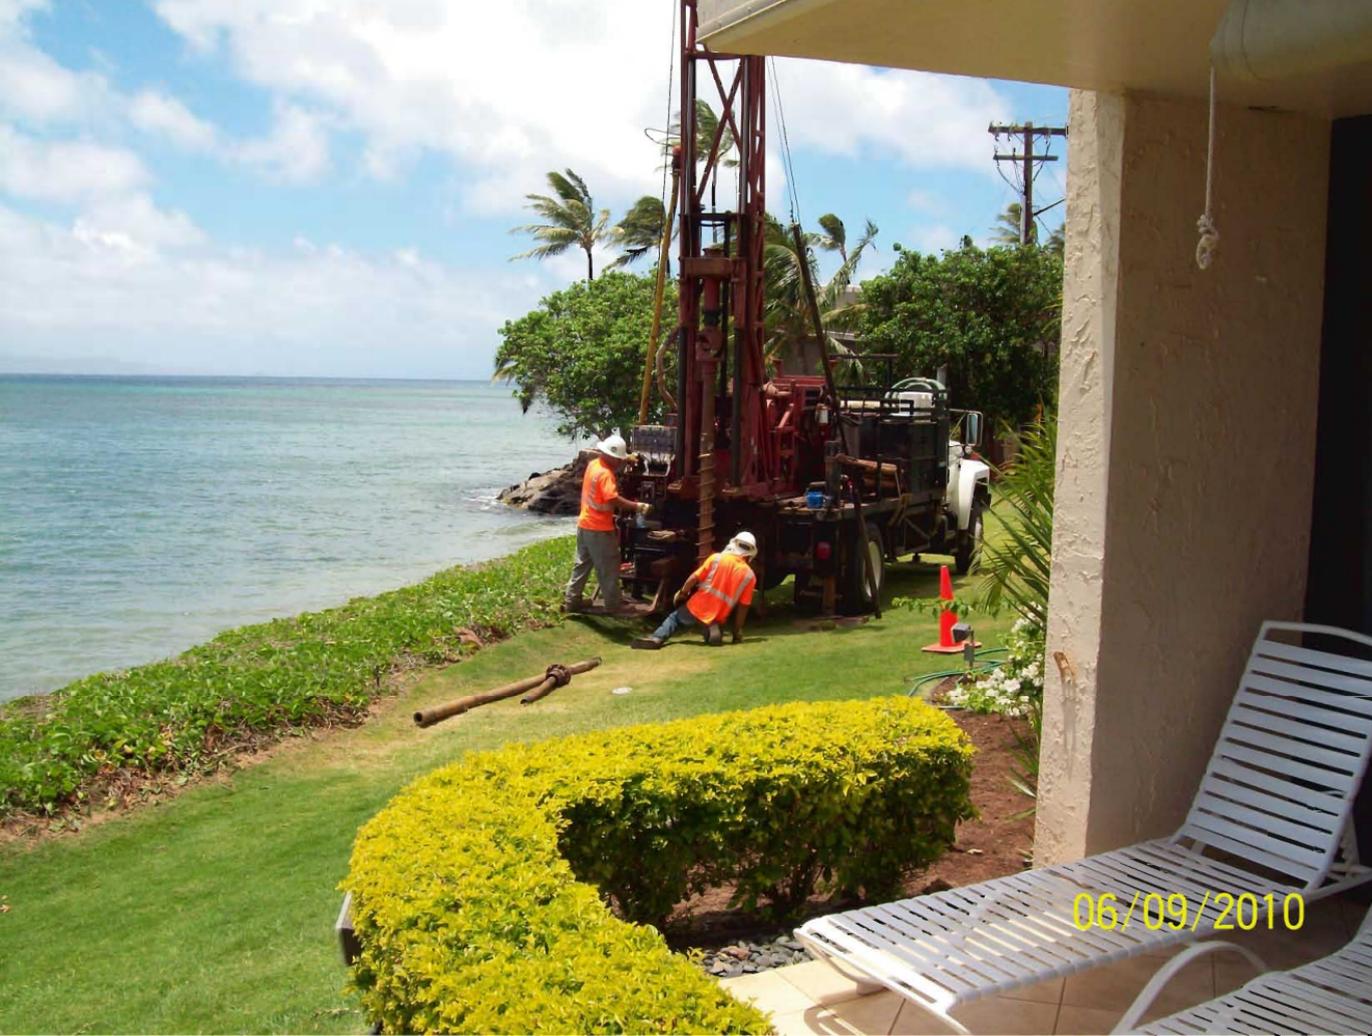
<u>Boring</u>	<u>Estimated MSL Elevation of Rock (*)</u>
1	-9.5'
2	-8'
3	-5.5'
4	?
5	?

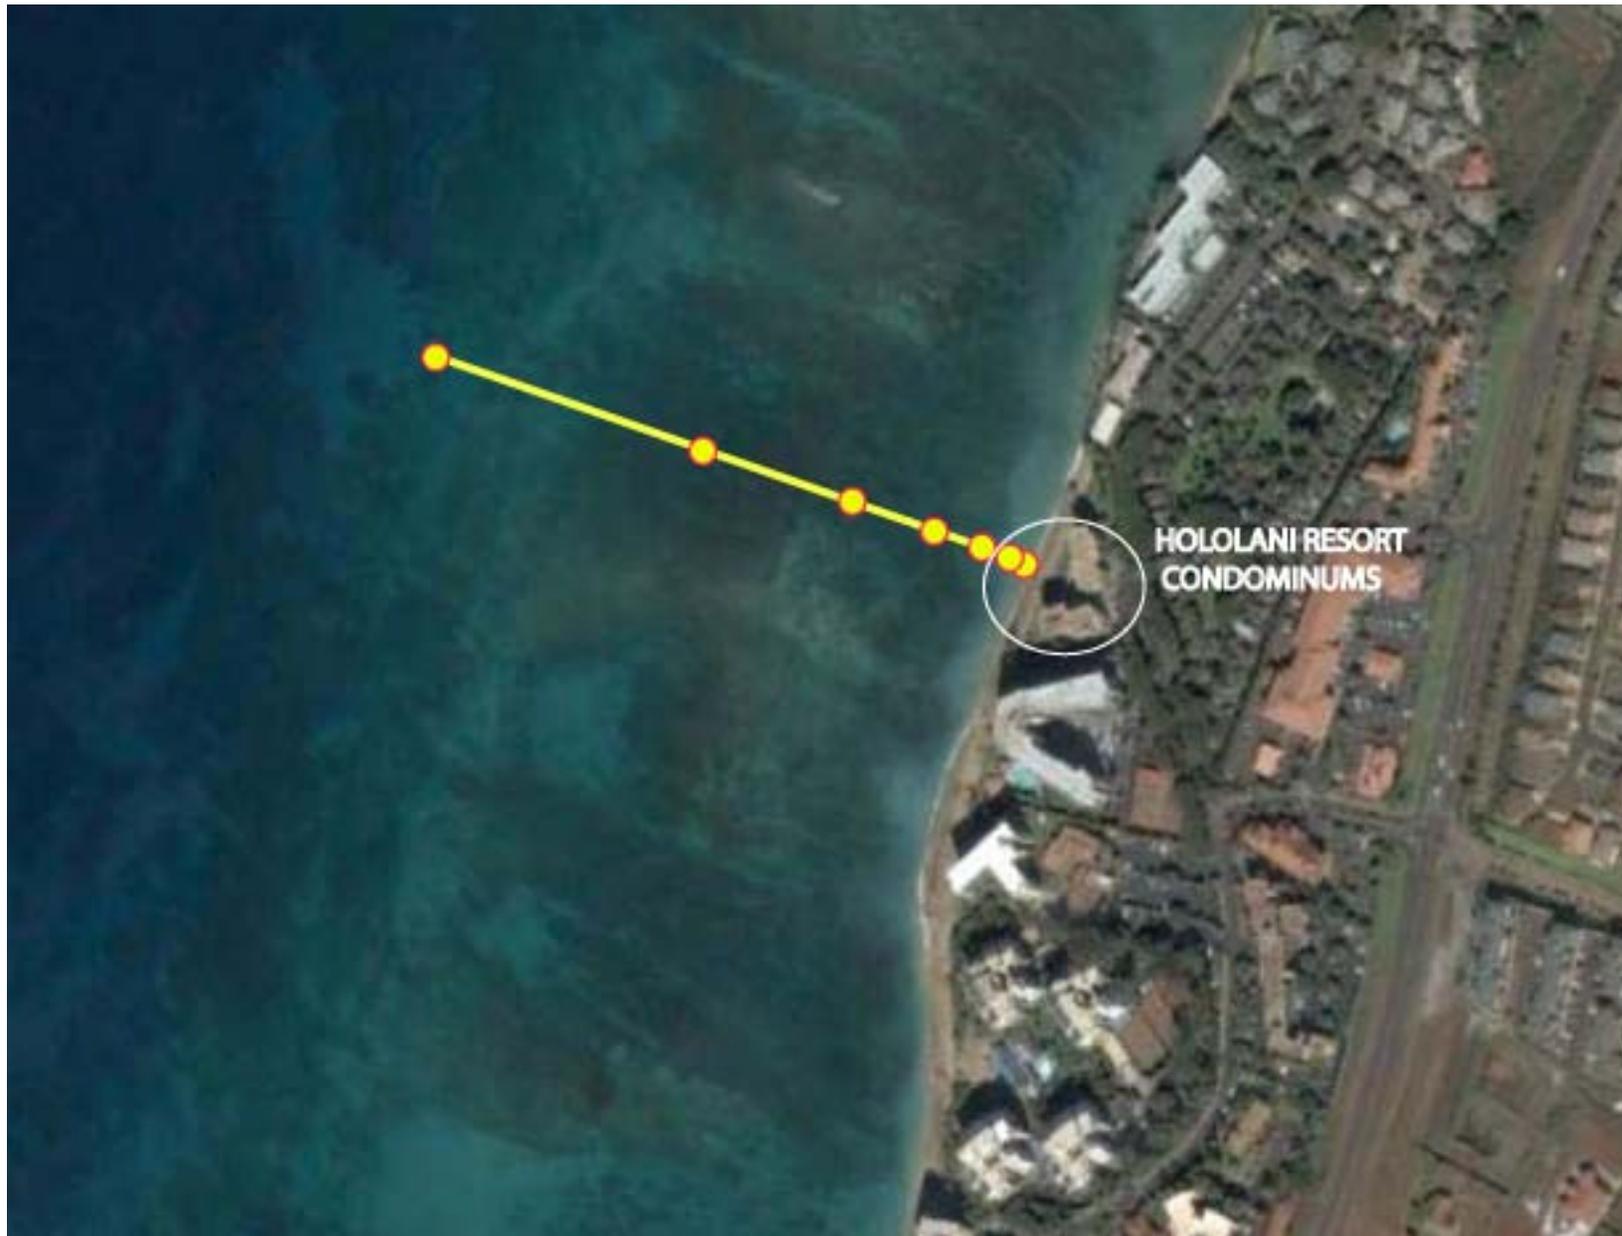
FIGURE 1. Aerial photograph of coastal region of west Maui showing location of Hololani Resort Condominiums in white circle. Yellow circles are approximate water sampling locations. Benthic reconnaissance surveys were conducted along a corridor approximately 50 m wide on either side of yellow line from the shoreline to an offshore depth of approximately 25 feet.

TABLE 1. Results of water chemistry analyses from ocean sampling stations off of the Hololani Resort in West Maui, Hawaii. Nutrient concentrations are shown in micromolar ( $\mu\text{M}$ ) units. Samples were collected on August 15, 2010. See Figure 1 for locations of sampling stations. "S" indicates surface samples; "D" indicates deep sample approximately 0.5 m above the ocean floor. Also shown are DOH WQS for "open coastal waters" under "dry" conditions, "not to exceed more than 10% and 2% of the time" criteria. Shaded values indicate exceedance of DOH "not to exceed more than 10% of the time" criteria and "not to exceed more than 2% of the time" criteria.

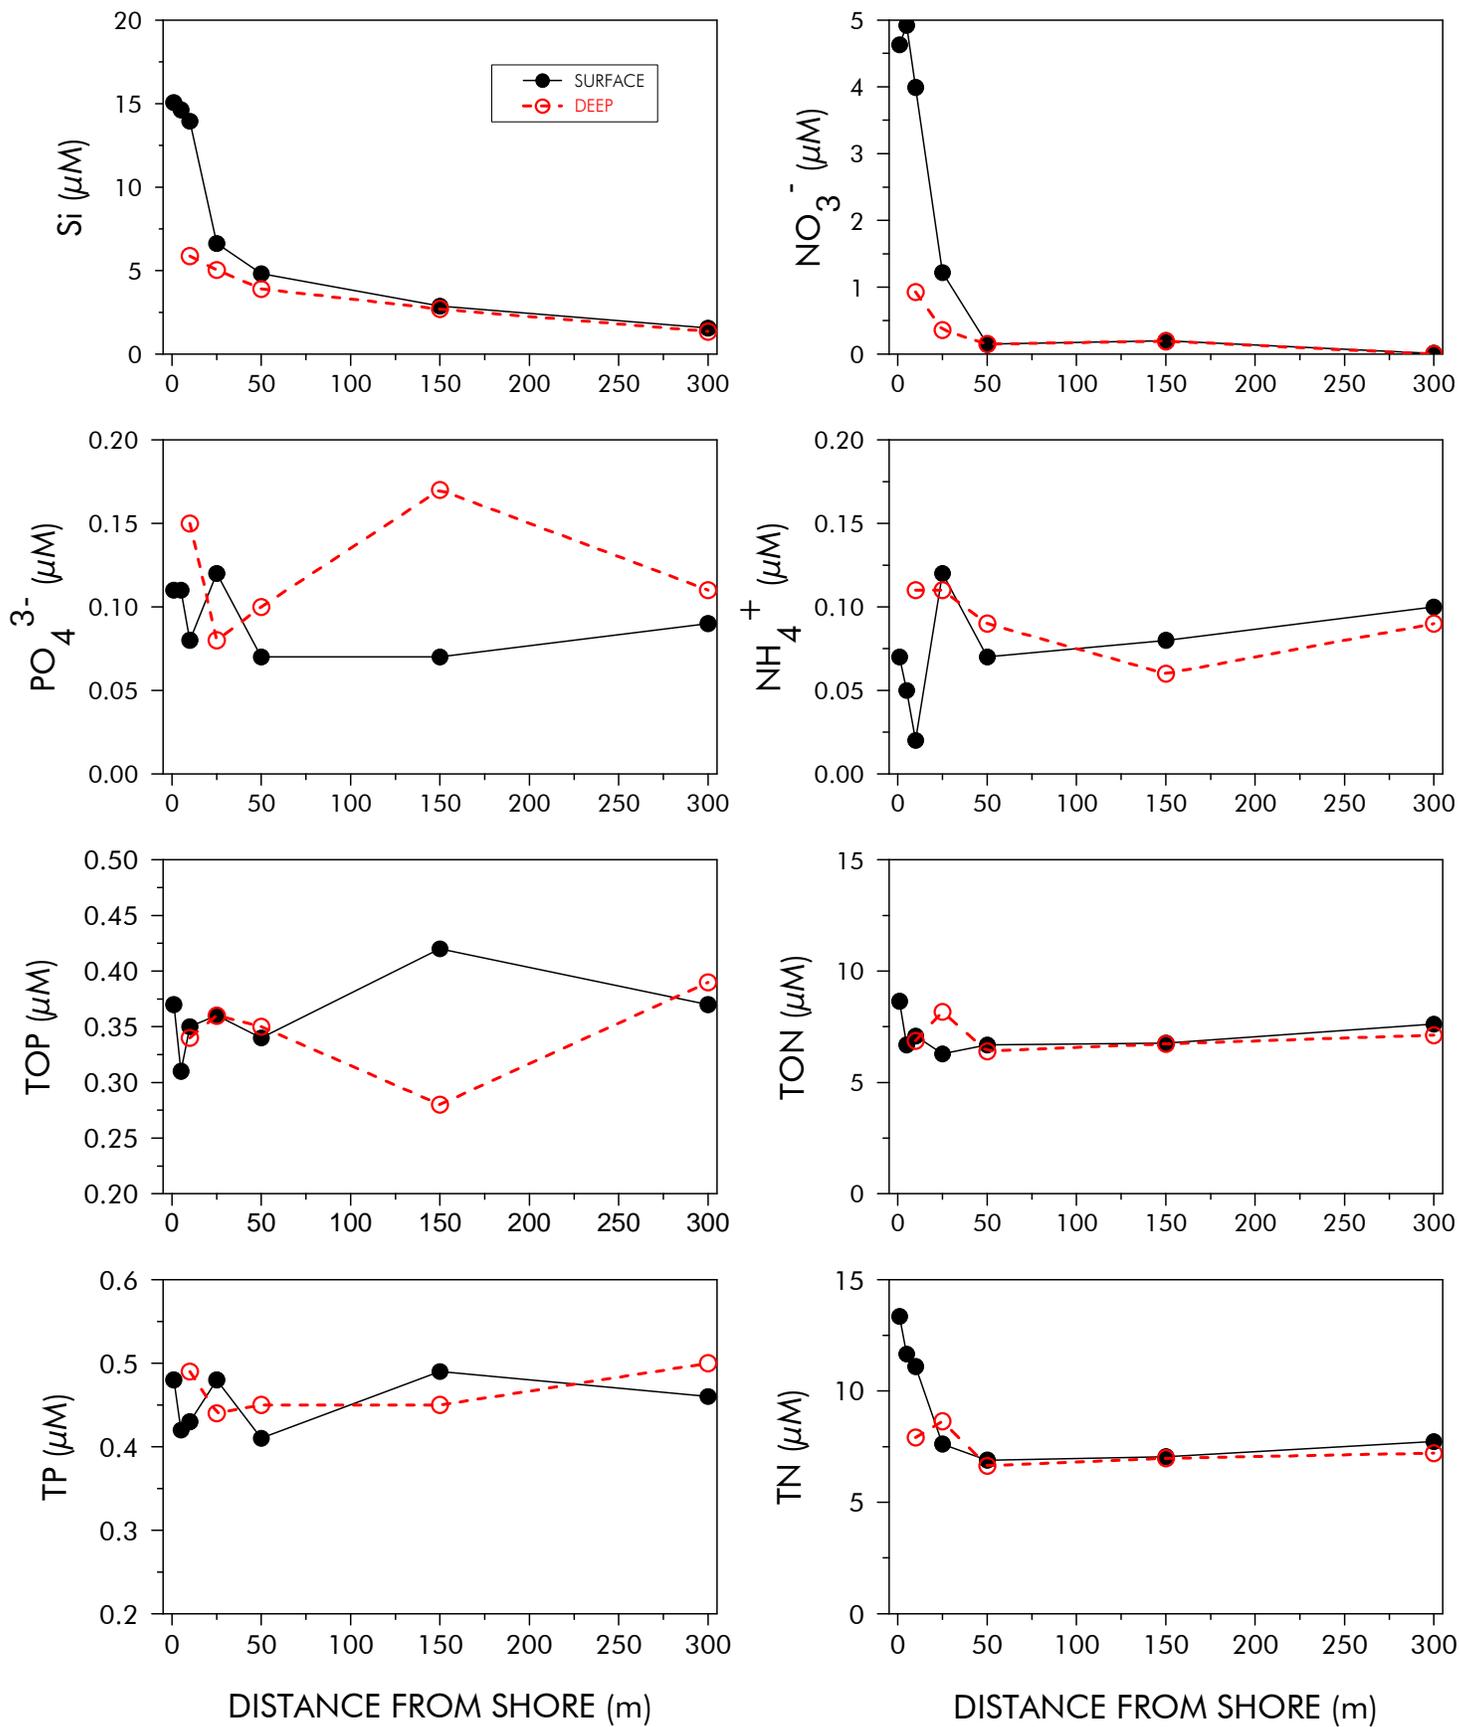
FIGURE 2. Plots of dissolved nutrients in surface (S) and deep (D) samples collected on August 15, 2010 at stations extending from the shoreline to a distance of 300 m offshore of the Hololani Resort Condominium in West Maui, Hawaii. For sampling site locations, see Figure 1.

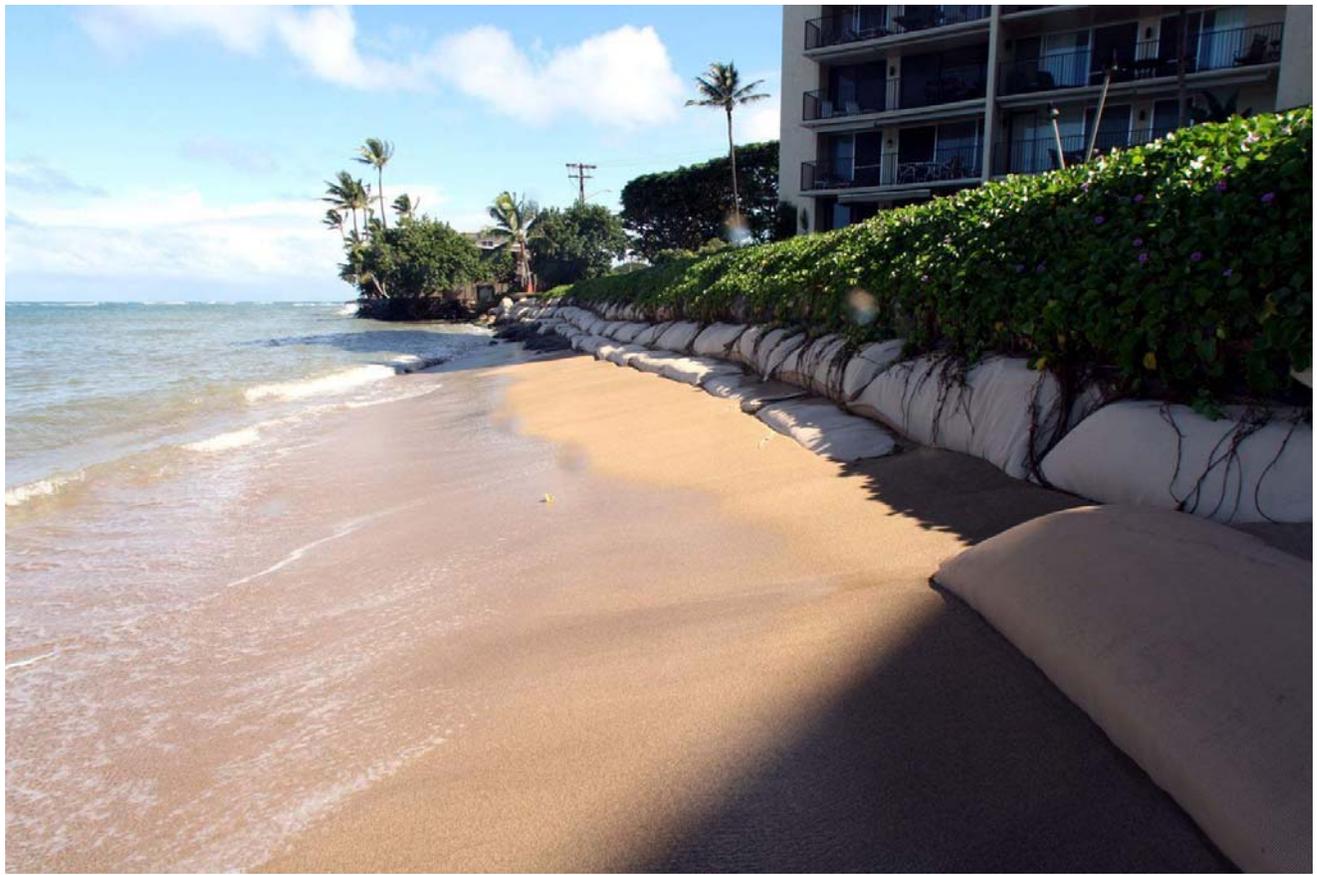
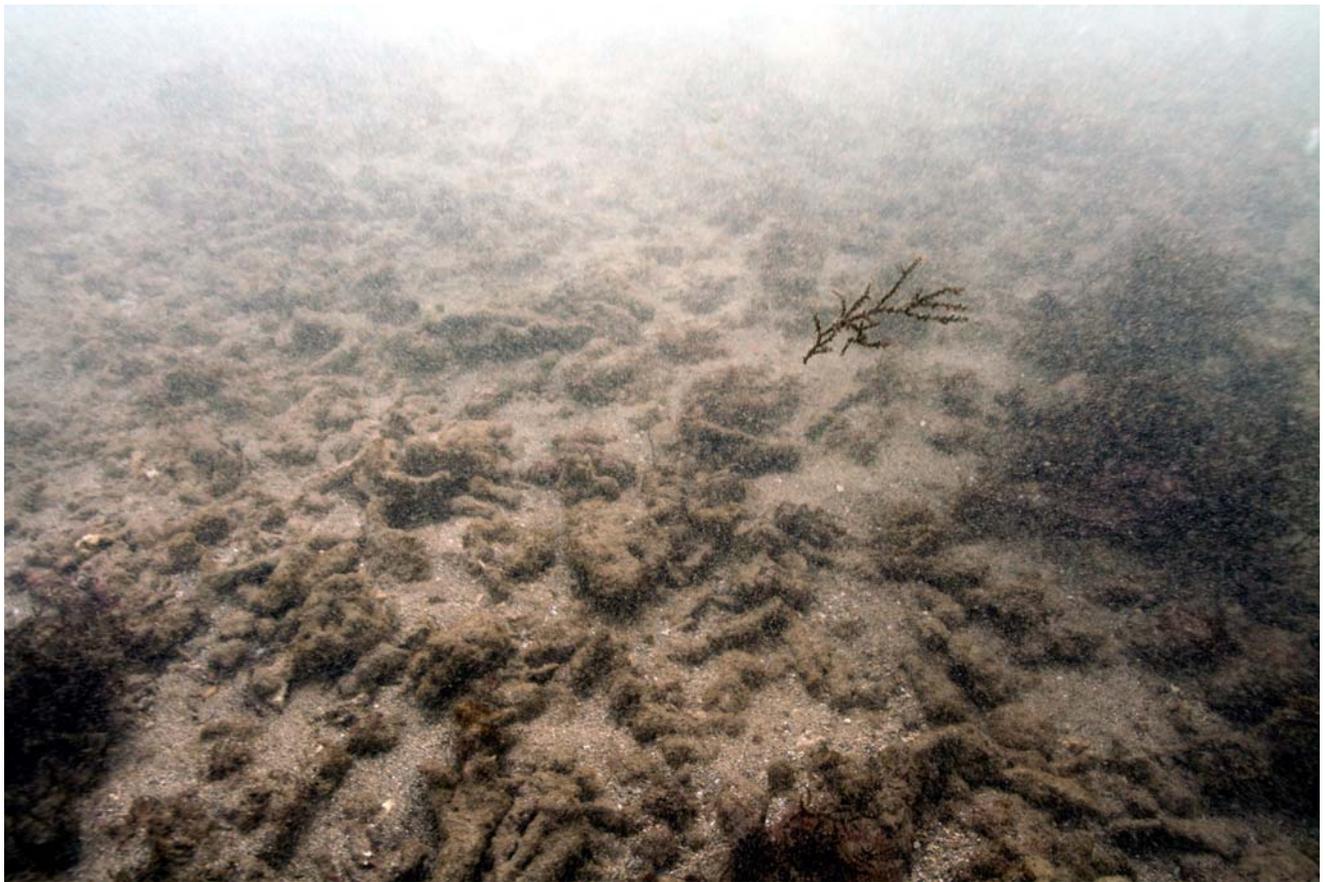
FIGURE 4. Upper photo shows sand-bags at base of shoreline wall of the Hololani Resort Condominium property. Bottom photo shows sand-rubble bottom in the subtidal zone just off the beach.

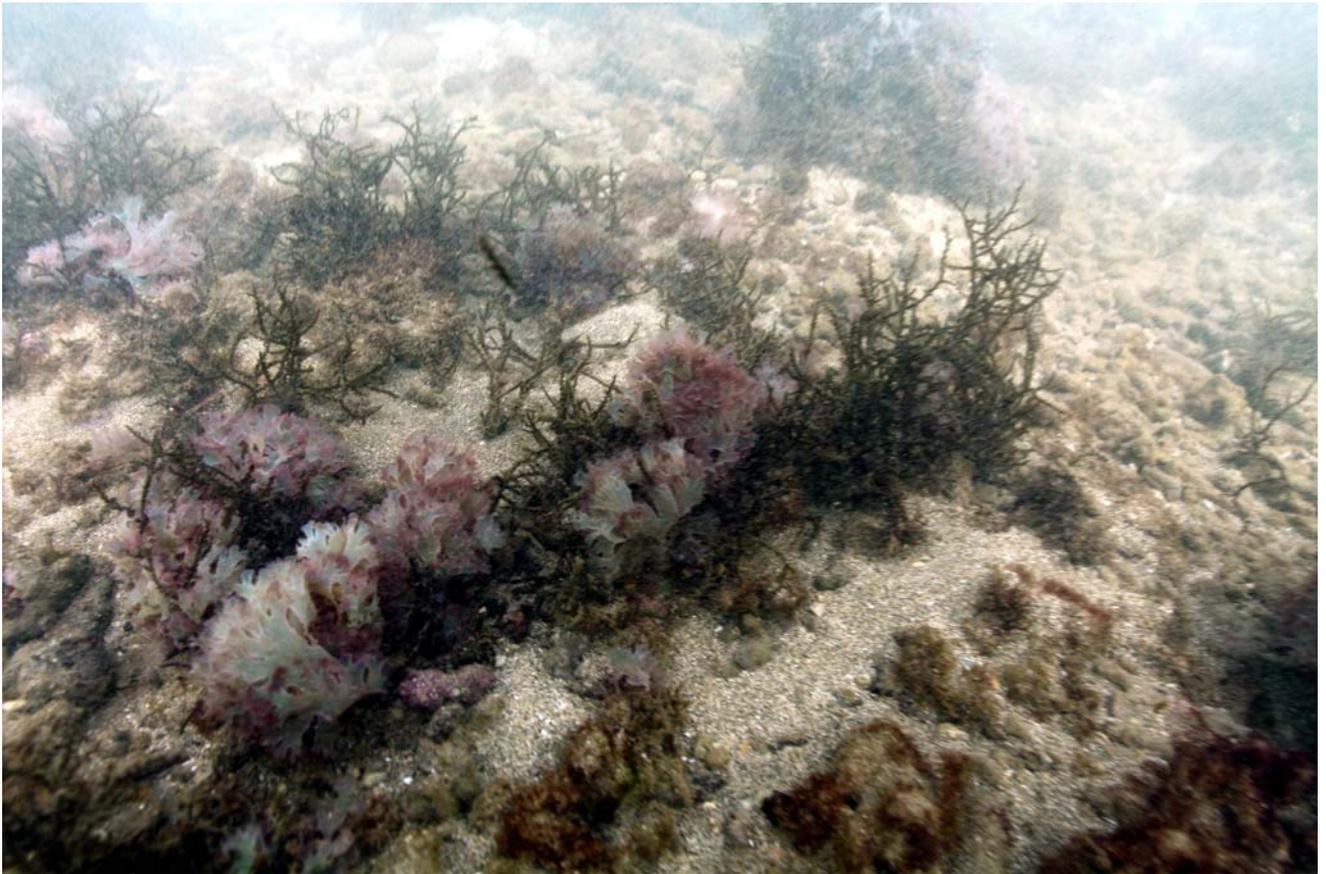
FIGURE 6. Mixed algal communities of red spiny branching alga *Acanthophora specifera*, and red alga *Grateloupia hawaiiiana* that has the appearance of translucent pink blades growing on sand and rubble substratum in the nearshore area fronting the Hololani Resort Condominiums. West Maui.

The physical composition of the nearshore algae zone consists of a pitted and eroded limestone platform of biotic origin covered with a veneer of calcareous sand and rubble. Within a depth range of 1 to 4-5 feet, and within a distance of approximately 50 feet from the shoreline, the limestone platform is devoid of living corals, but rather is covered with dense growth of the invasive red alga *Acanthophora specifera* (Figure 5). While *A. specifera* was by far the dominant alga, several other species of red alga were also noted, primarily *Hypnea musciformis* and *Halymenia formosa* (Figure 6).
