**Subject:** Draft Environmental Assessment (EA) for Permanent Shore Protection of the Hololani Resort Condominiums Located at 4401 Lower Honoapiilani Road, Lahaina, Maui, TMK: (2) 4-3-010:009.

**Project Name: Permanent Shore Protection of the Hololani Resort  
Condominiums**

The proposed shore protection is a structure consisting of a sloping rock revetment that rises to a crest at +6 ft MSL, backed by a vertical seawall that rises to grade at +12 ft. The rock revetment will minimize wave reflection to help allow accretion of sand, and the vertical wall will minimize the horizontal extent of the structure. The revetment crest will help provide lateral access during seasonal low sand conditions.

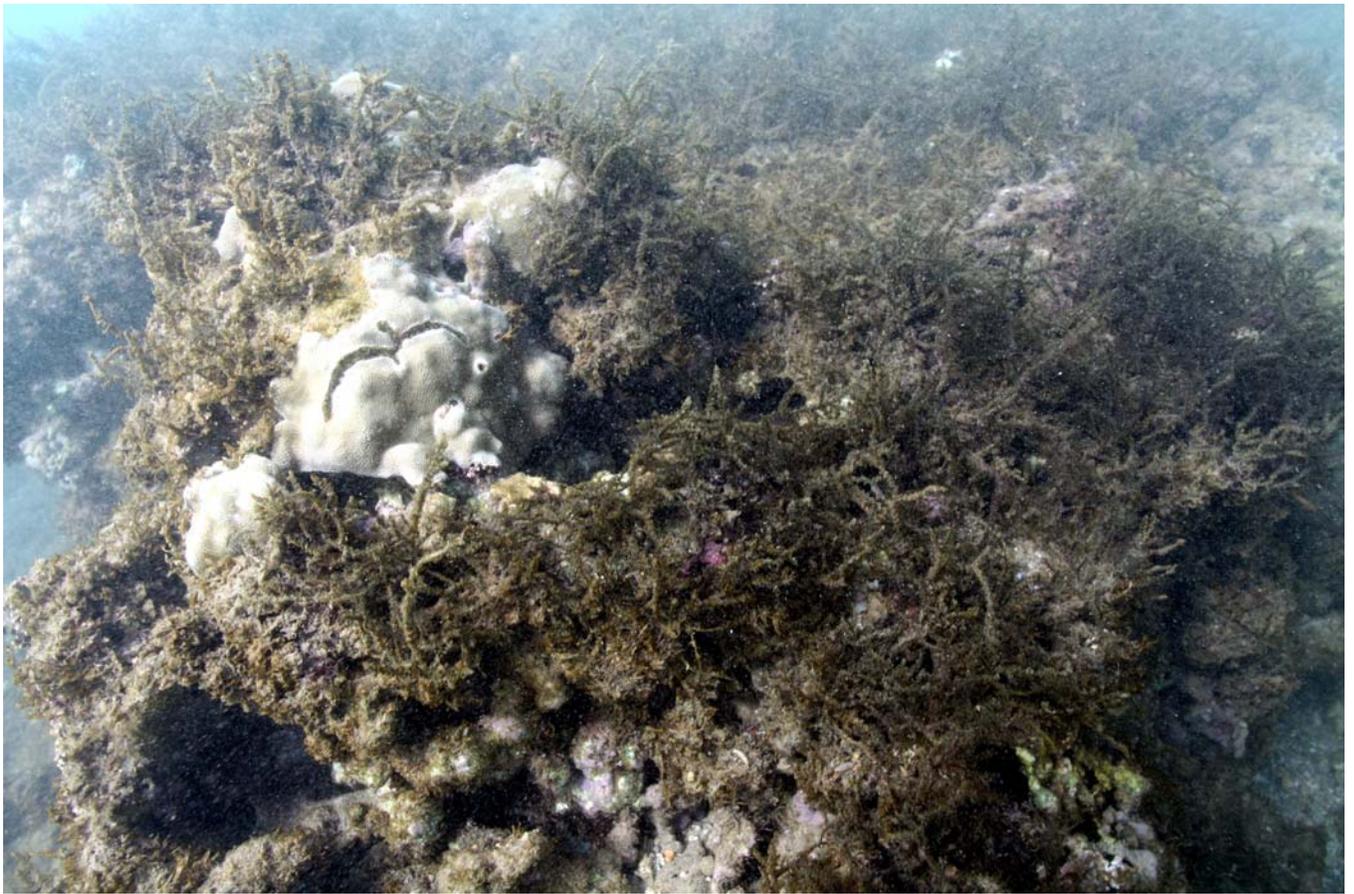
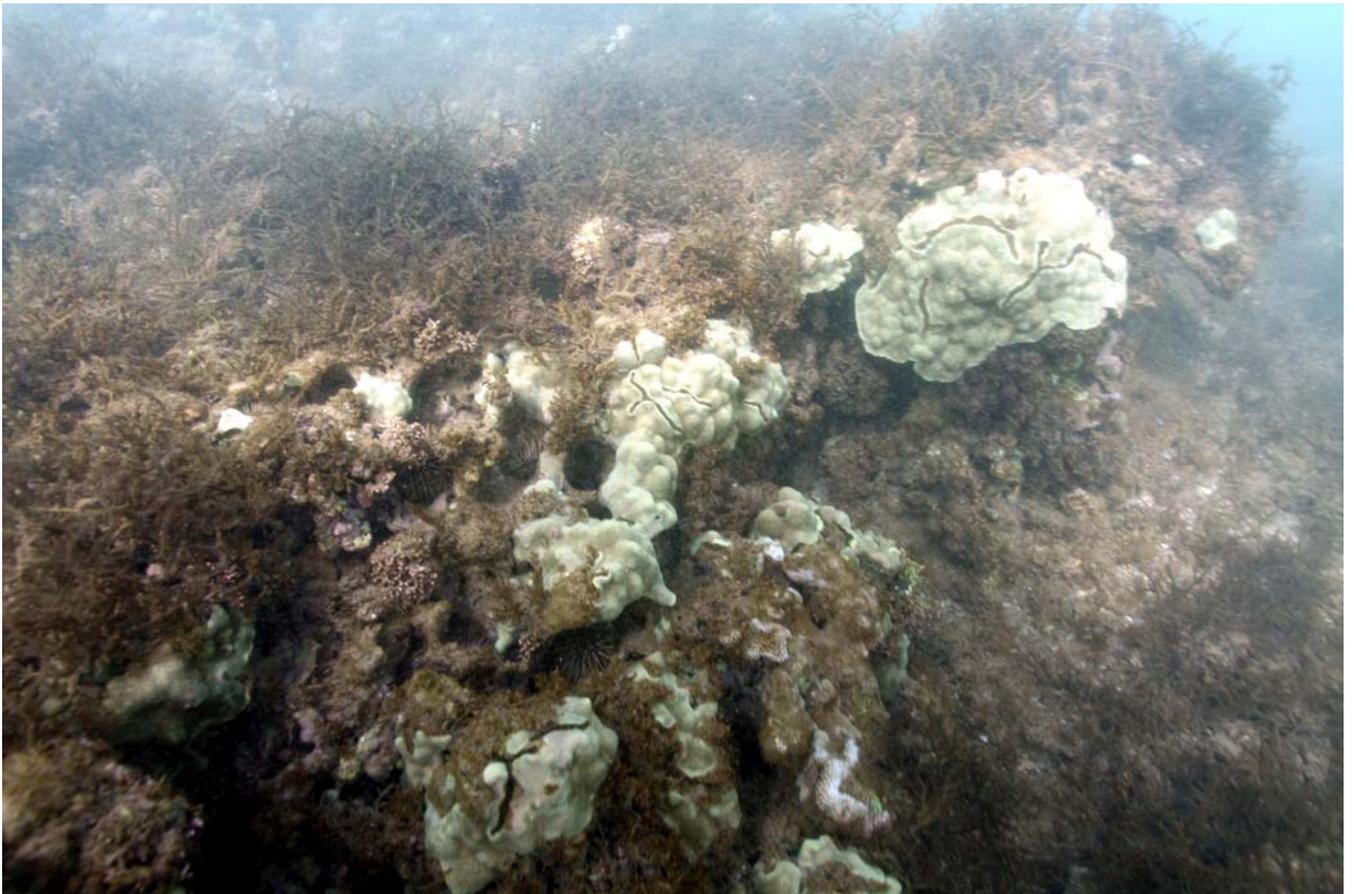
FIGURE 7. Dense growth of red spiny alga *Acanthophora specifera* interspersed with encrusting coral *Porites lobata* growing on limestone substratum in the nearshore area fronting the Hololani Resort Condominiums, West Maui.

With slightly increasing depth and distance from shore, dense algal coverage of the bottom persists, although isolated living coral heads begin to occur, primarily on the upper surfaces of rocky projections that are elevated above the limestone platform (Figures 7 and 8). Elevation of the reef surface increases the resiliency of these coral from the effects of sediment scour, and the competitive abilities of these corals is apparently sufficient to prevent them from being completely overgrown by algae. The predominant coral species occurring within the mid-reef area are *Porites lobata* (Figure 7) and *Montipora patula* (Figure 8). Within both the nearshore algal zone and the mid-reef algal-coral zone motile macrobenthos, particularly sea urchins, were extremely scarce, likely as a result of the force of breaking waves which is sufficient to prevent these unattached organisms to remain stable on the reef surface.

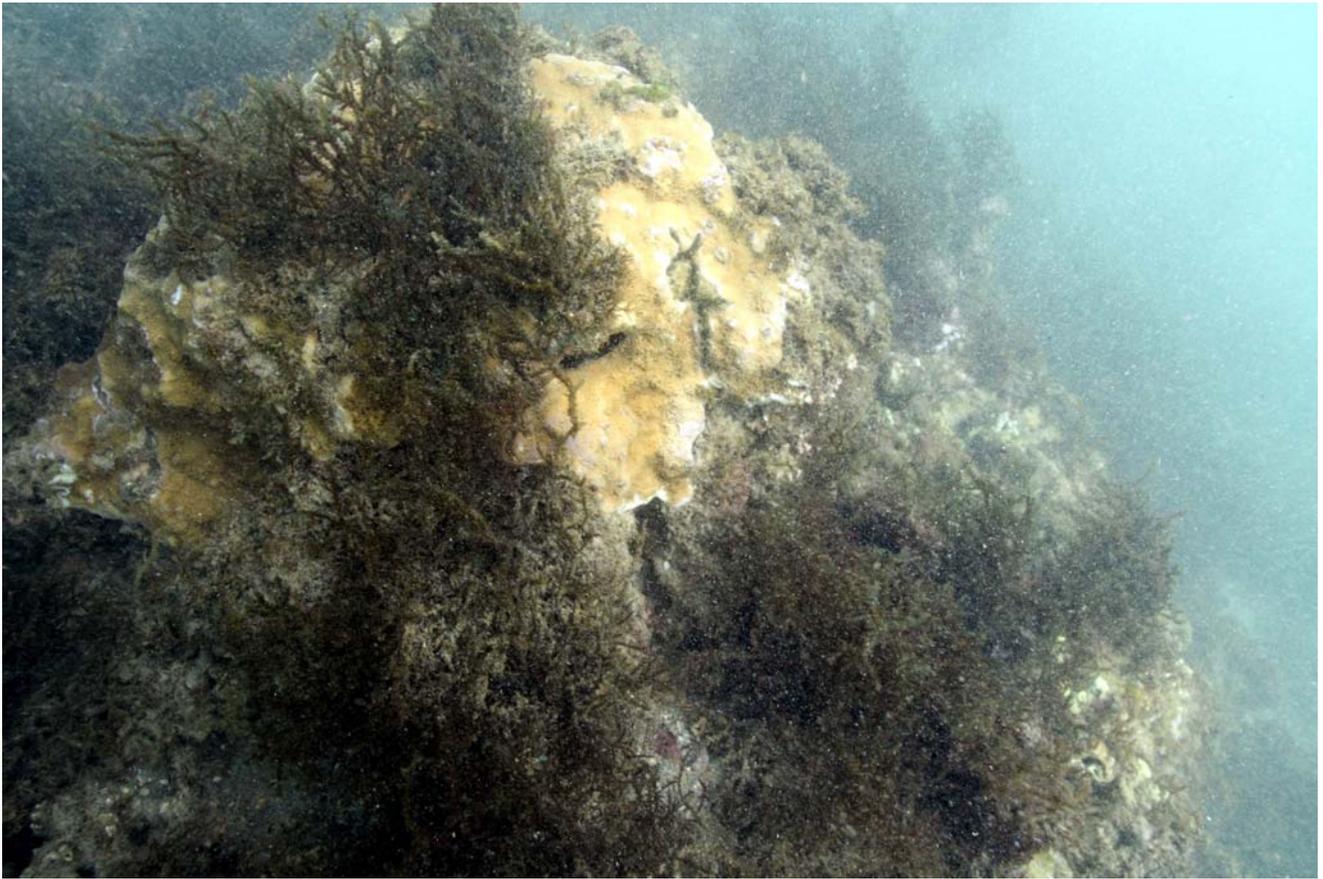
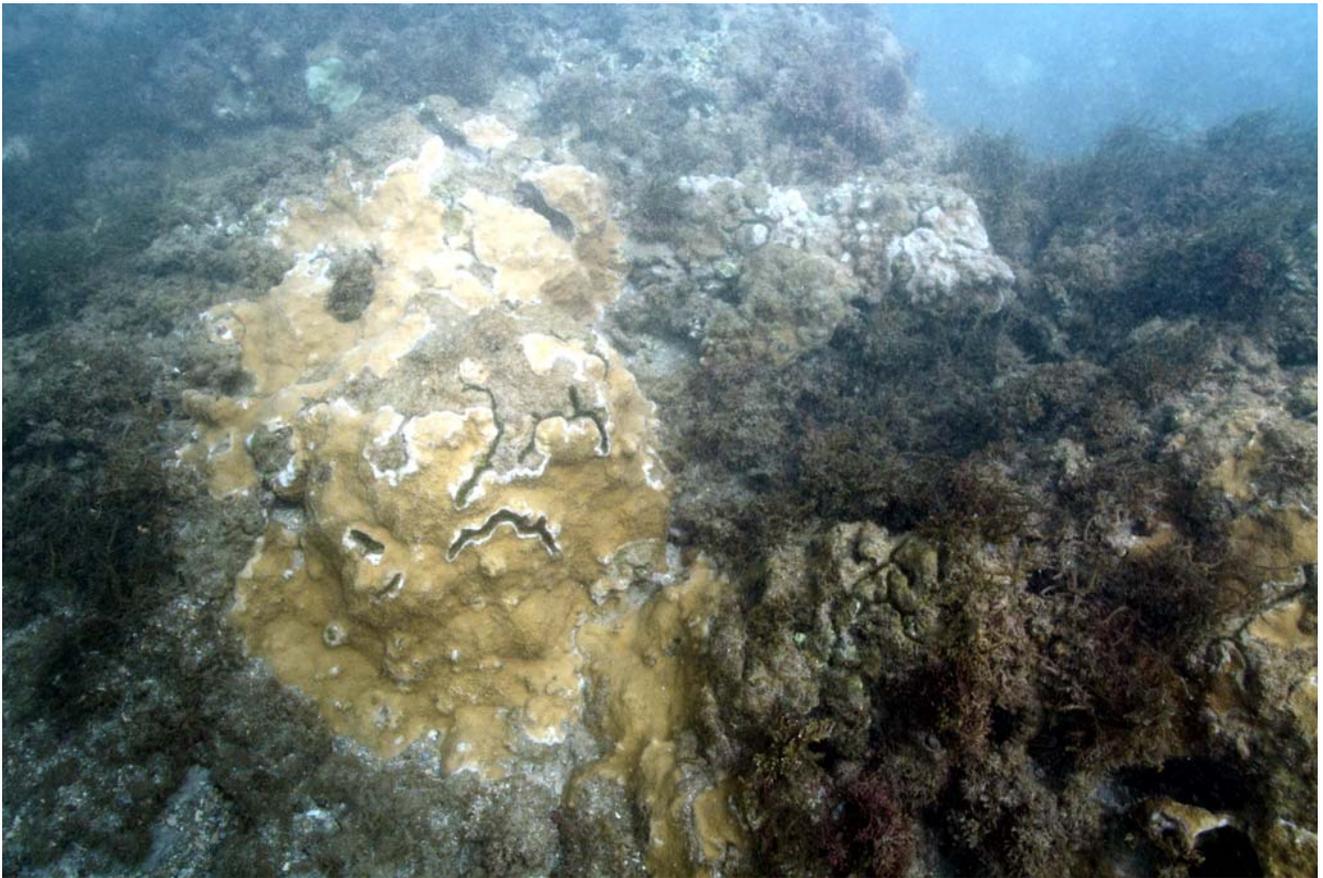
FIGURE 8. Dense growth of red spiny alga *Acanthophora specifera* interspersed with encrusting coral *Montipora patula* growing on limestone substratum in the nearshore area fronting the Hololani Resort Condominiums, West Maui.

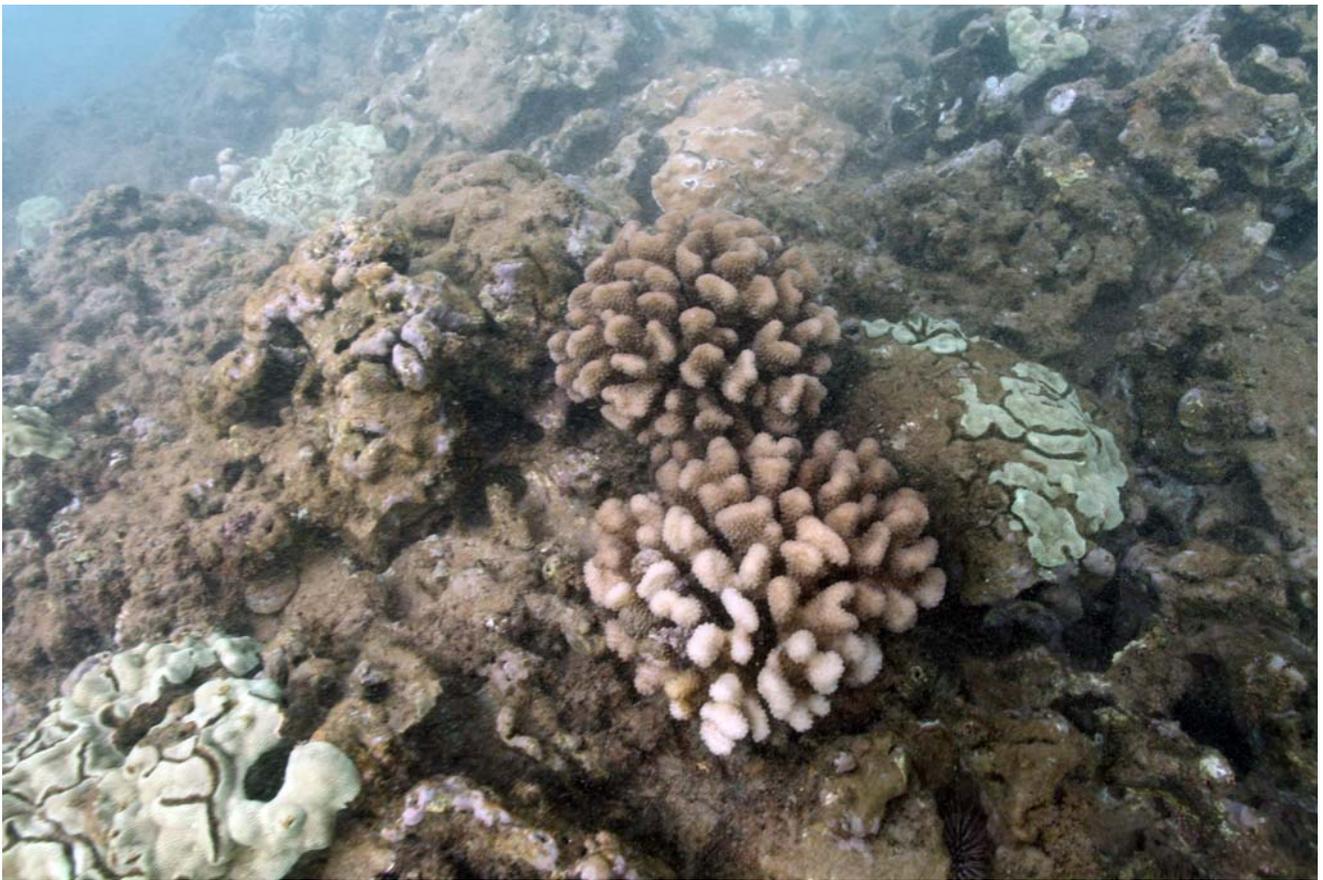
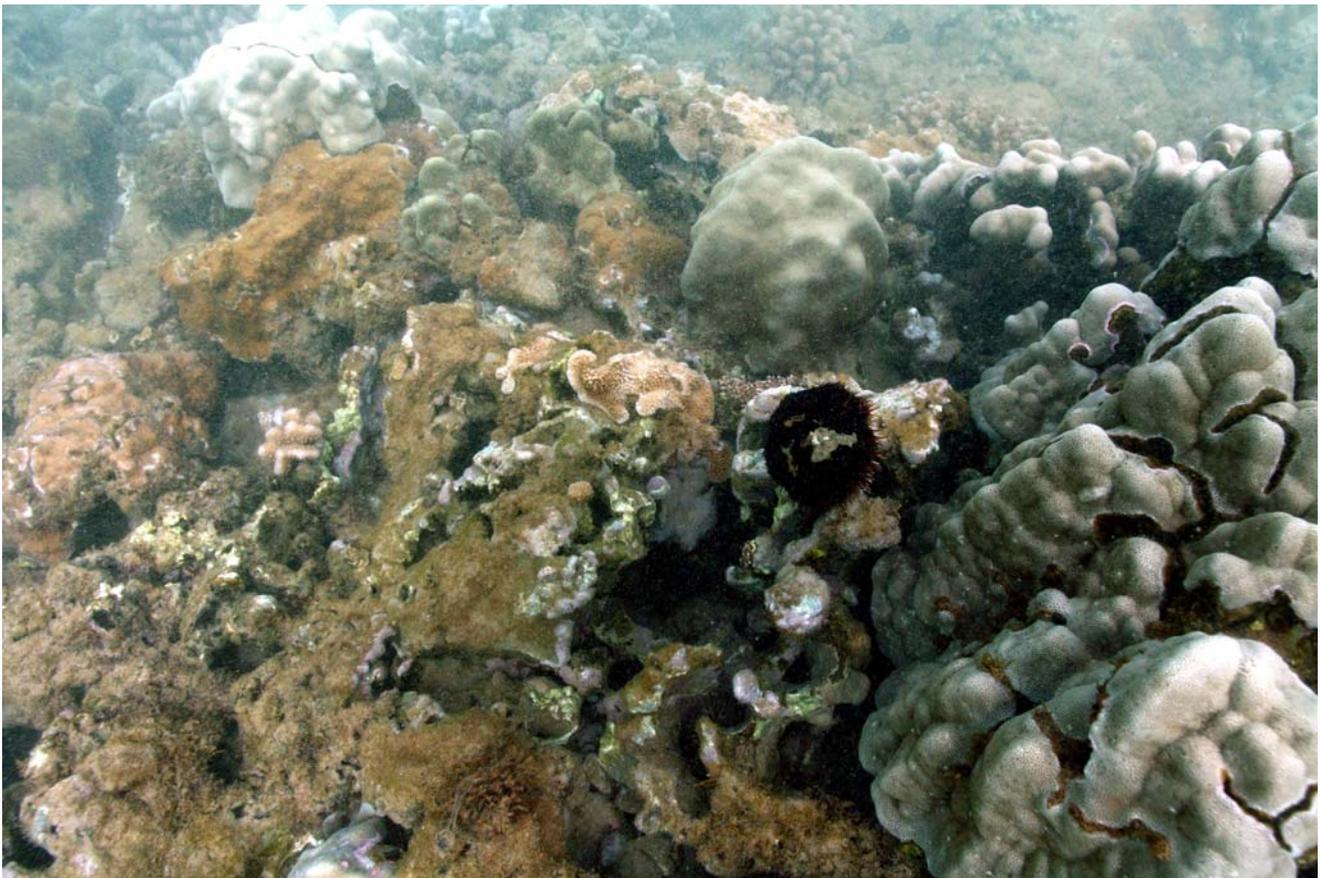
FIGURE 9. Reef corals on limestone platform on outer reef zone fronting the Hololani Resort Condominiums, West Maui. Hemispherical short-branched species in upper photo is *Pocillopora meandrina*. Variegated corals in upper and lower photos are *Porites lobata*. Tan colored encrusting coral in bottom photo is *Montipora patula*. Black sea urchin in bottom photo is *Tripneustes gratilla*.

The seaward boundary of the mid-reef algal-coral zone and the inshore boundary of the outer reef zone is demarcated by the boundary where extensive beds of algae no longer occur, and the bottom consists of either living corals or relatively bare turf-covered limestone (Figures 9-11). This zone extends across the reef platform from a distance of approximately 200 feet from shore to the seaward edge of the reef platform, and spans the depth range of approximately 10 to 25 feet. The primary coral species occurring in the outer reef zone were *Pocillopora meandrina*, commonly called "cauliflower coral" (Figures 9 and 11), *Porites lobata*, commonly called "lobe coral" (Figures 9-11), and *Porites compressa*, commonly called "finger coral" (Figure 10). Many of these colonies were up to several feet in diameter indicating that they are on the order of several decades old. The growth form of *Porites compressa* consists of elongated fingers, which are substantially more delicate and susceptible to breakage compared to the other corals. Hence, *P. compressa* is not found in areas that are routinely subjected to wave energy. The occurrence of large, intact colonies of *P. compressa* in the outer reef zone off of Hololani indicates that the outer reef zone has not sustained wave stress substantial enough to destroy these coral colonies over at least a decadal time interval.

Other macro-invertebrates that were observed on the surface of the outer reef were several species of sea urchins (*Echinometra matheai*, *Echinothrix diadema*, *Tripneustes gratilla*, and *Heterocentrotus mammilatus*) (Figures 9 and 12). None of these urchins were particularly abundant, but were found most commonly on the bare limestone reef platform rather than on living corals. It is well known that these urchins graze on benthic algae, and may be responsible for the absence of dense algae in the outer reef zones where wave energy is not sufficient to remove the urchins from the reef.

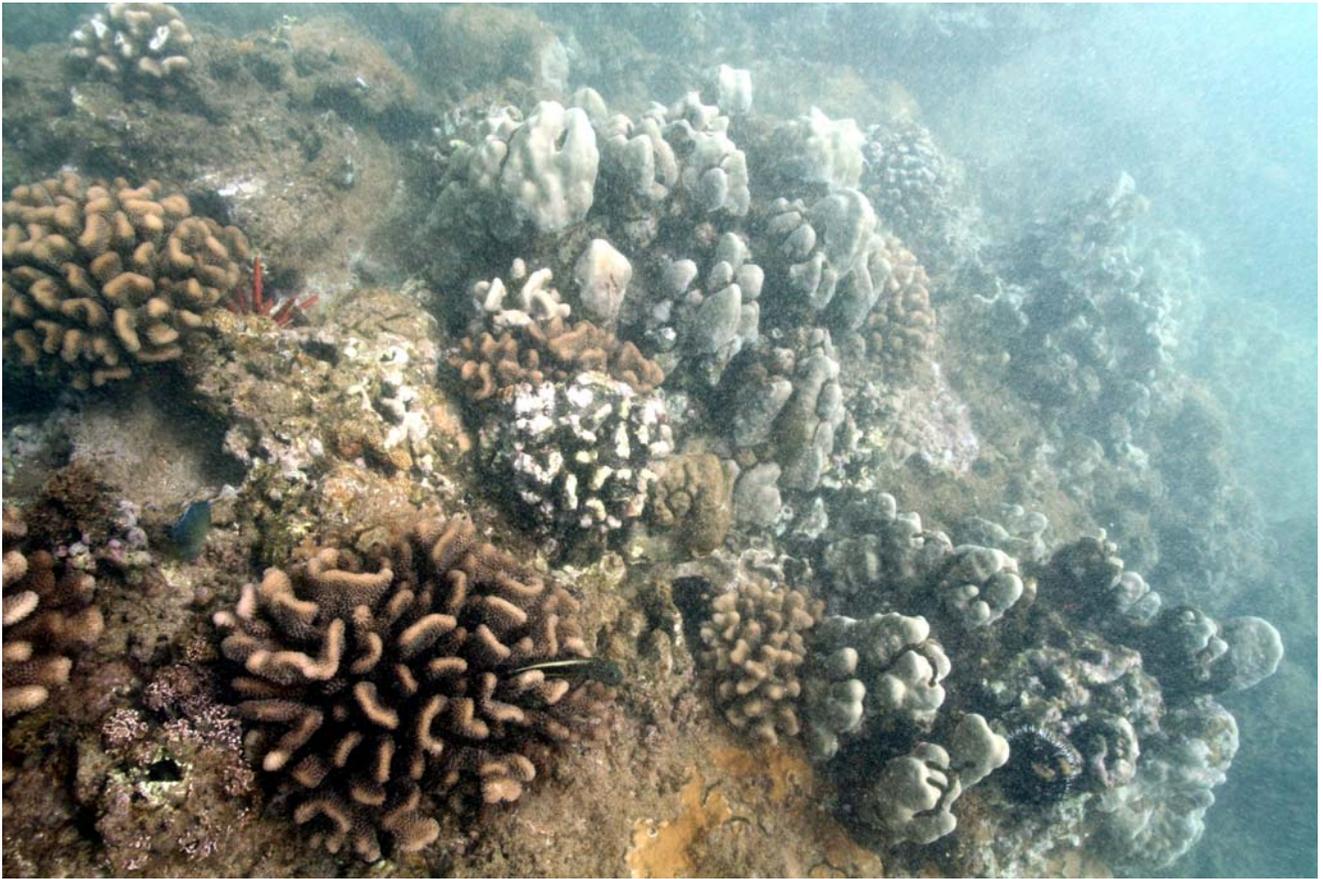
FIGURE 11. Reef corals on limestone platform on outer reef zone fronting the Hololani Resort Condominiums, West Maui. Hemispherical short-branched species in upper photo is *Pocillopora meandrina*. Variegated grey-green corals in upper and lower photos are *Porites lobata*. Water depth is approximately 20 feet.

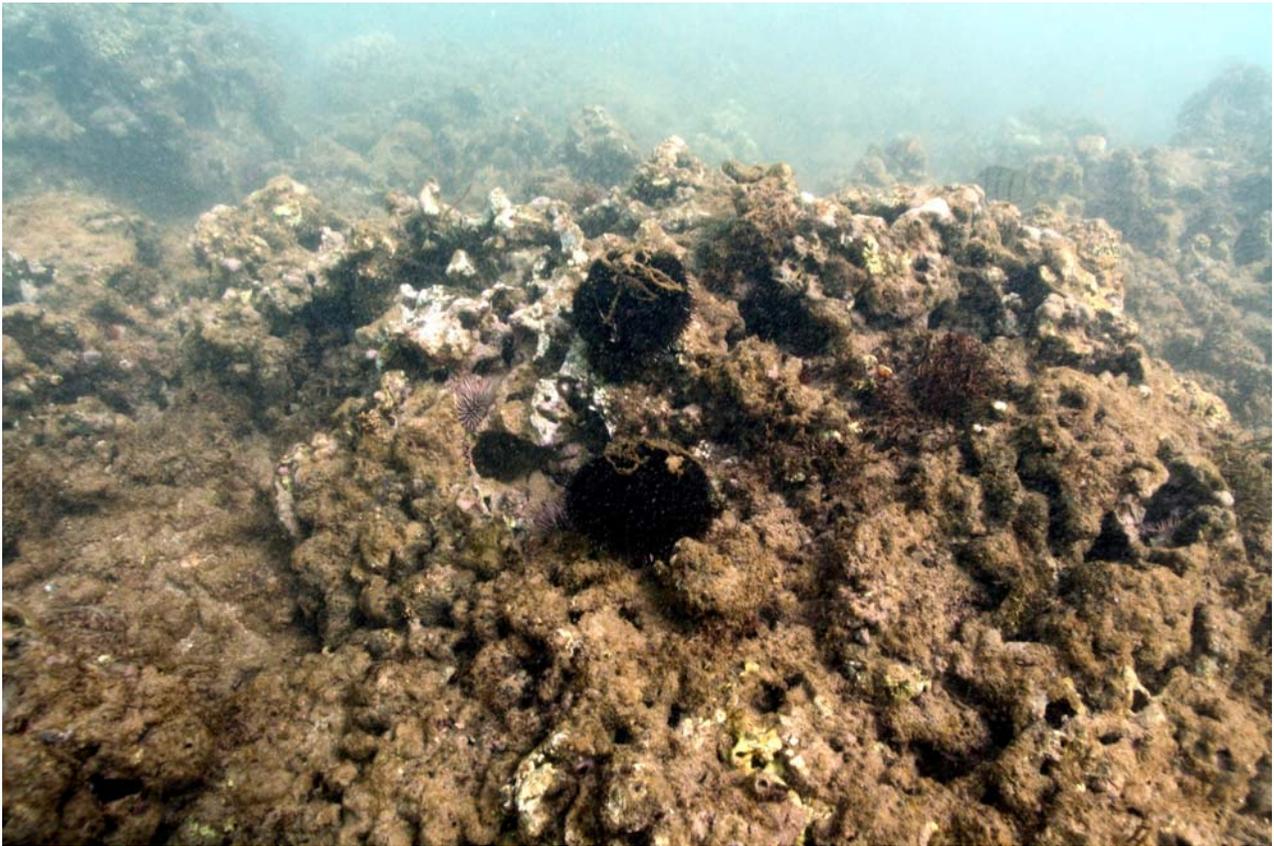
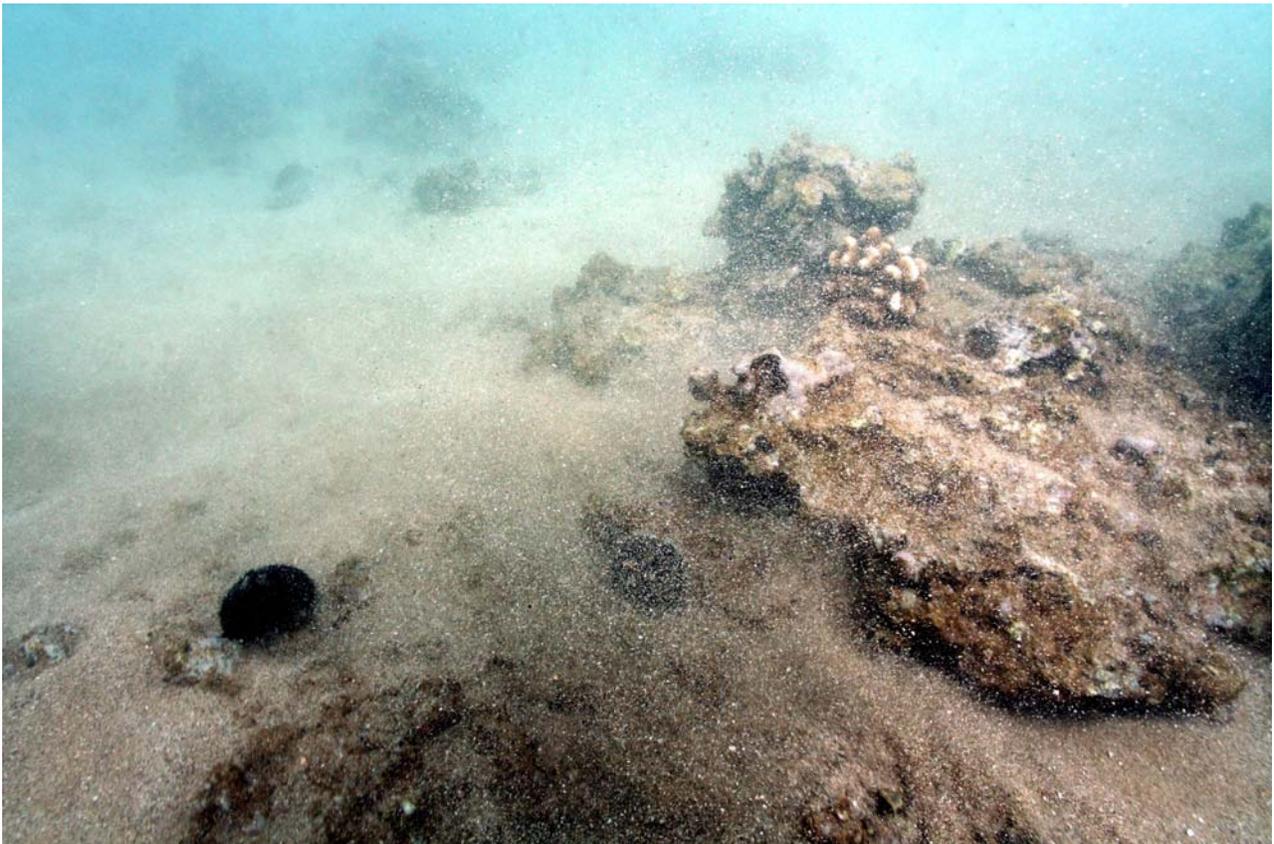
FIGURE 12. Upper photo shows portion of outer reef platform devoid of corals or algae. Bottom photo shows seaward edge of outer reef platform adjacent to sand plain fronting the Hololani Resort Condominiums, West Maui. Black sea urchins in both photos are *Tripneustes gratilla*. Water depth is approximately 25 feet.

The outer reef zone terminates at a depth of approximately 25 feet in a margin between the limestone platform and sand plain (Figure 12). Seaward of the outer reef margin bottom composition consisted of a flat, gently sloping sand plain. In many areas of West Maui, the sand plains beyond the reef platform are colonized with vast pastures of the calcareous green alga *Halimeda*. No such pastures of *Halimeda* were observed during the present study off of the Hololani area.
