**STATE OF HAWAII
DEPARTMENT OF LAND AND NATURAL RESOURCES
OFFICE OF CONSERVATION AND COASTAL LANDS**

MEMORANDUM

Subject: Draft Environmental Assessment (EA) for Temporary Shoreline Erosion Control at the Hyatt Regency Maui Resort Located at 200 Nohea Kai Drive, Lahaina, Maui, TMK: (2) 4-4-013:008.

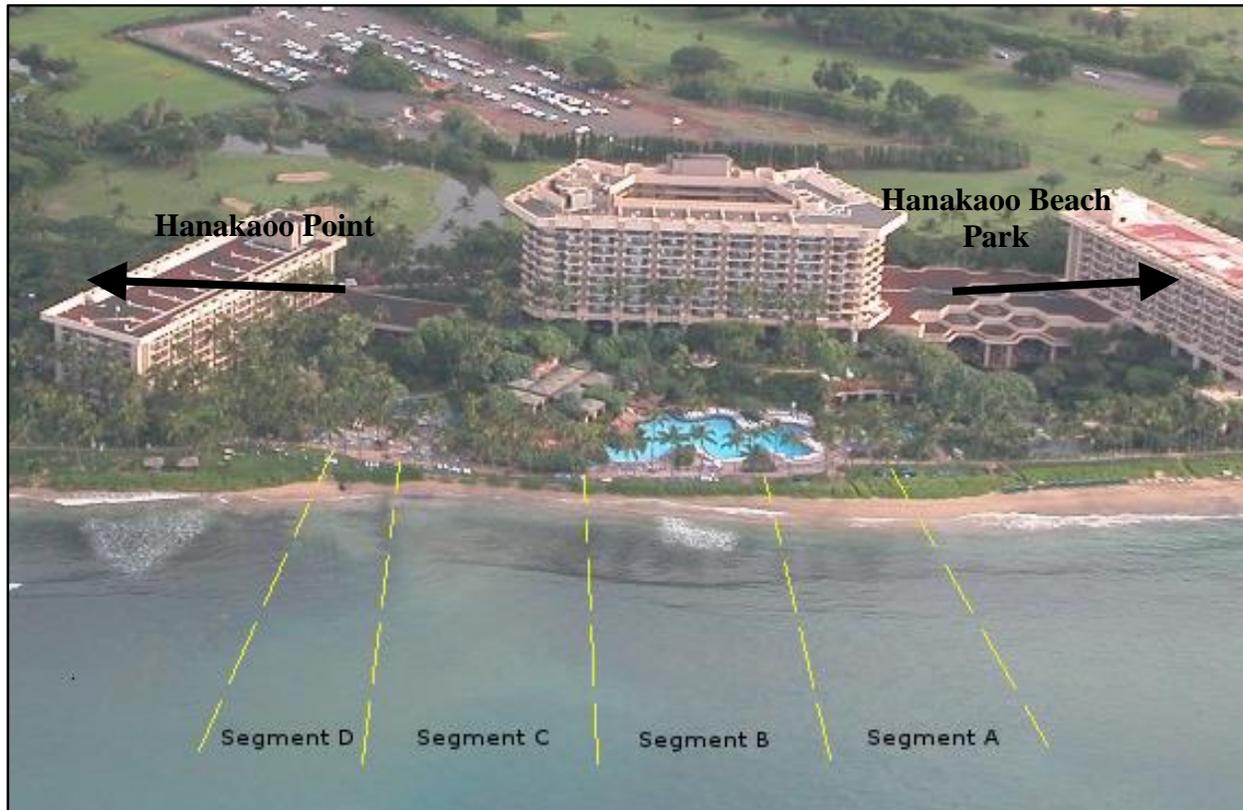
Figure 2-2 Shoreline segments (Photo Source: University of Hawaii Coastal Geology Group, Photo Date: N/A)

The condition of the shoreline varies from south to north, and is divided into four segments for discussion as illustrated in Figure 2-2.

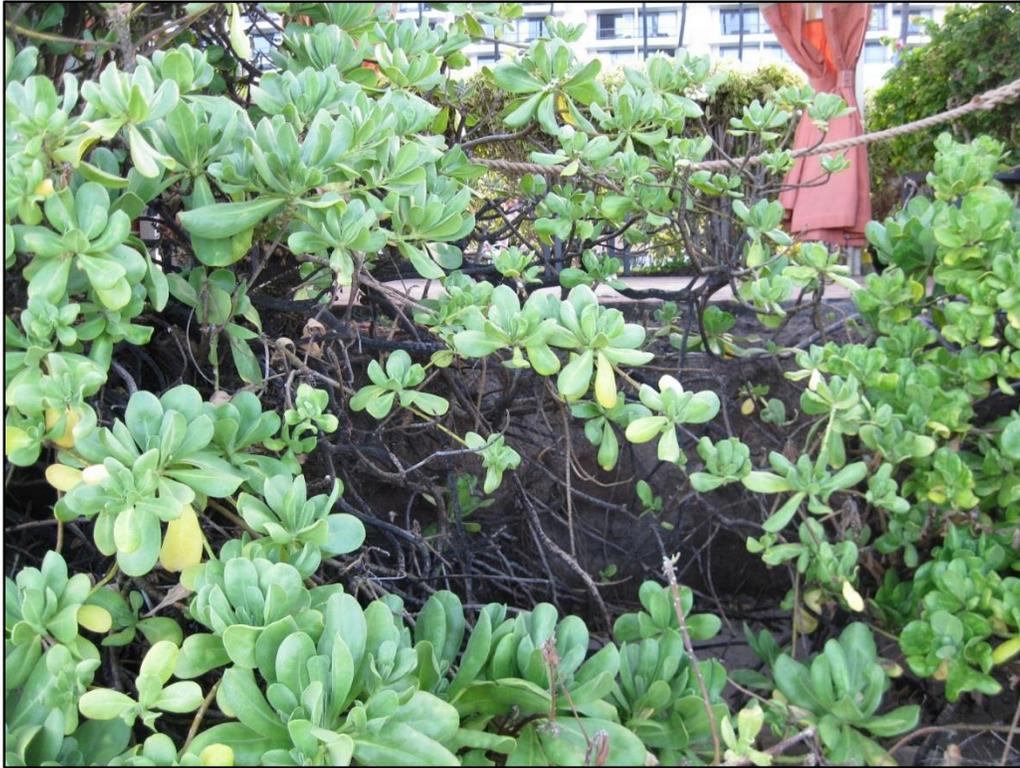
Figure 2-3 Erosion scarp in vegetation (SEI, 08/11/2015)

Segment A is the southernmost section of critically-eroding shoreline and is approximately 110 feet in length. The segment is vegetated with Beach Naupaka (*scaevola taccada*) that shows significant saltwater damage, and a 2 foot high erosion scarp is present in the Naupaka hedges (Figure 2-3). A shower that is part of the Beachwalk and beach access is undermined and barricaded (Figure 2-4). Backshore resort infrastructure and hardscape located seaward of the Beachwalk is threatened to the point that some has been removed (Figure 2-5).

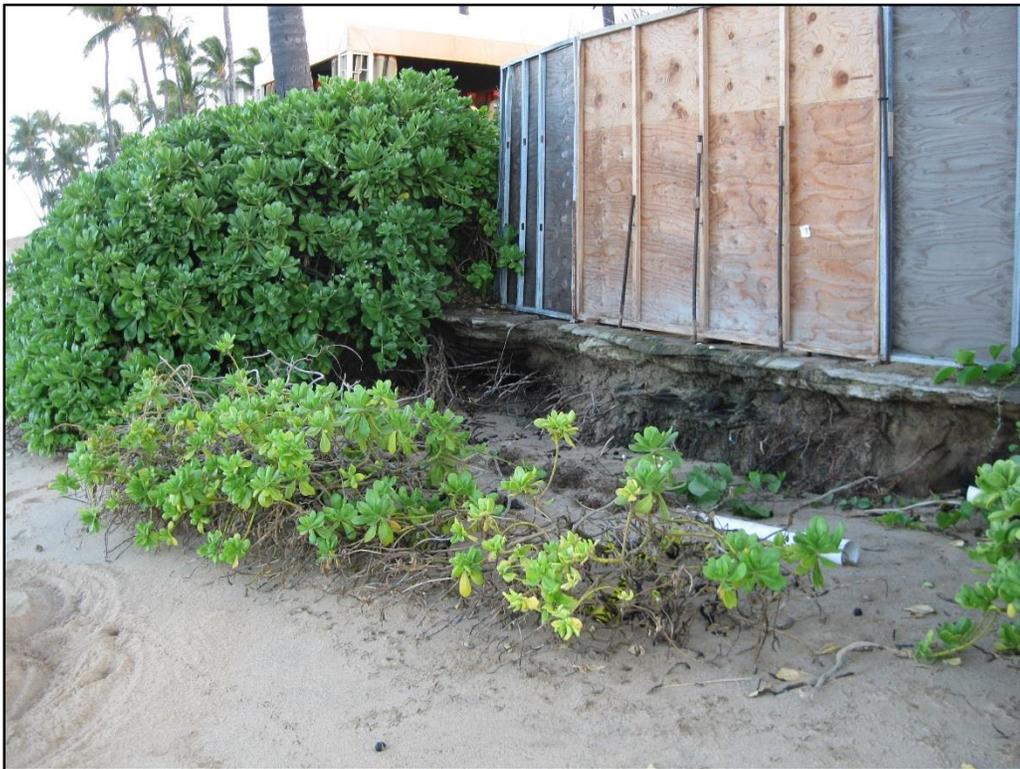
Figure 2-4 Undermined and barricaded beach access (SEI, 08/11/2015)

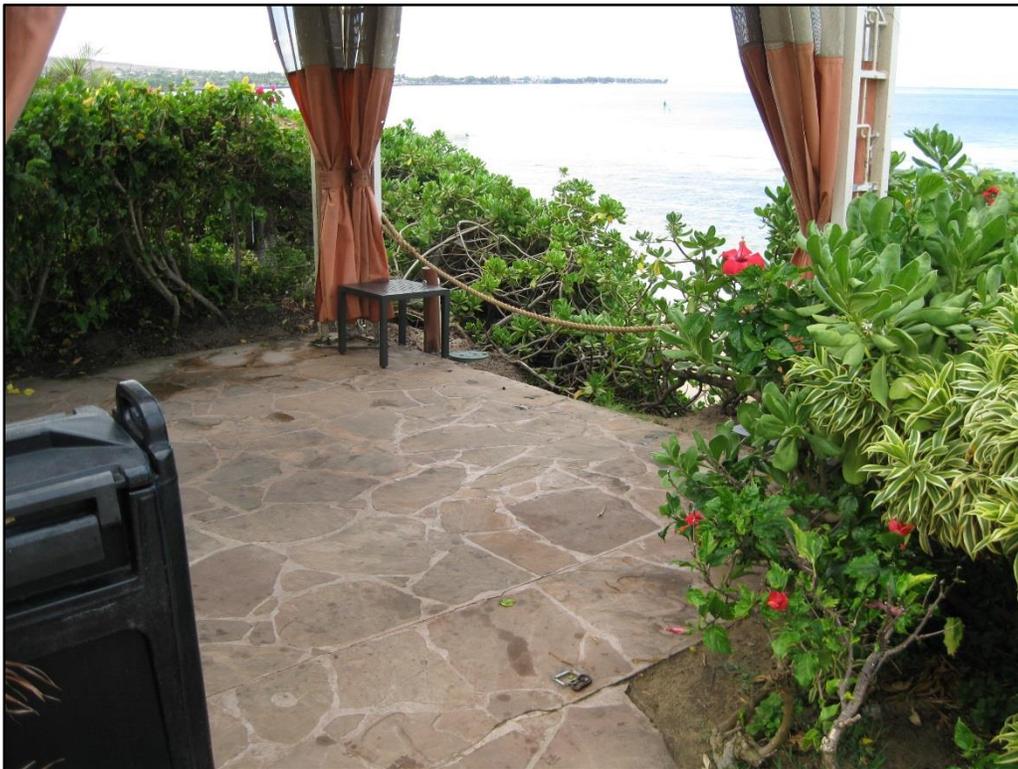
Figure 2-5 Erosion scarp threatening backshore amenities. Portions of the amenities have since been removed. (SEI, 08/11/2015)

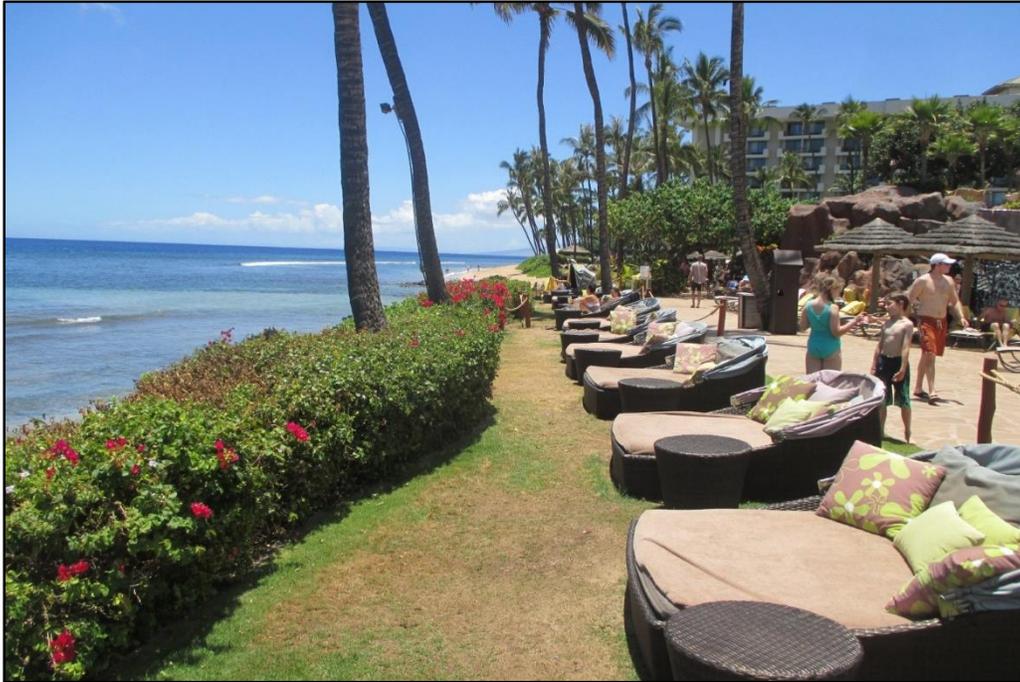
Figure 2-6 Vegetated backshore along Segment B (SEI, 06/08/2015)

Segment B is approximately 150 feet in length and has noticeably less vegetation than Segment A. A photograph from June 2015 (Figure 2-6) show a healthy Naupaka hedge and Palm trees along this segment, but the vegetation has since been damaged and removed (Figure 2-7 and Figure 2-8). The erosion scarp in this segment is 4 feet high. The erosion scarp was as close as 10 feet from Beachwalk in this segment (Figure 2-8) in August 2015 and continues to move landward (Figure 2-9).

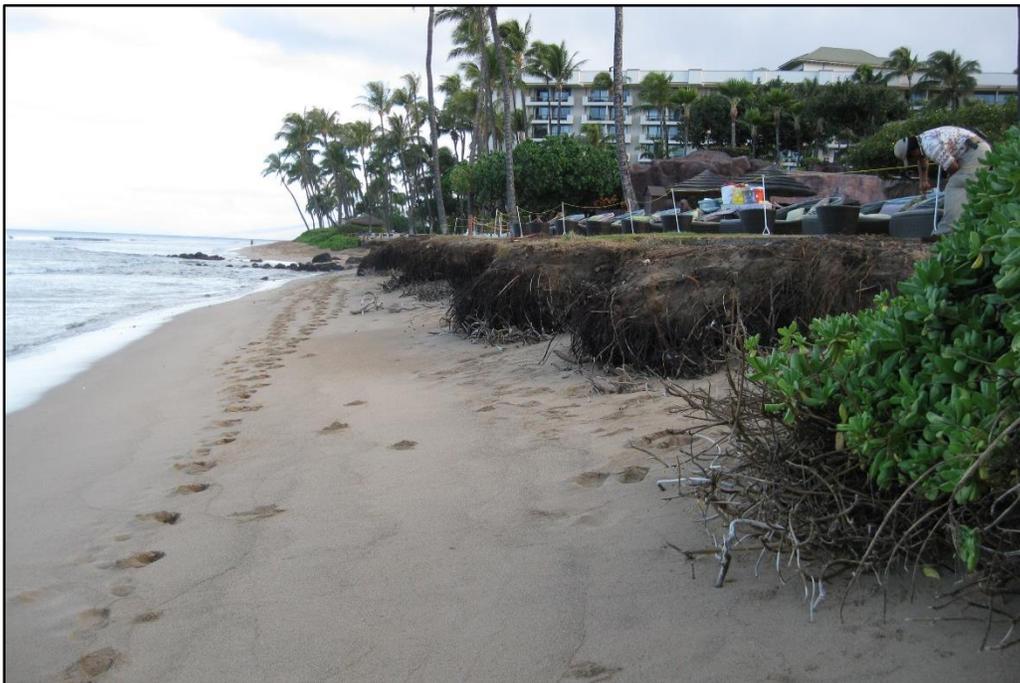
Figure 2-7 Erosion scarp at Segment B (SEI, 06/27/2015)

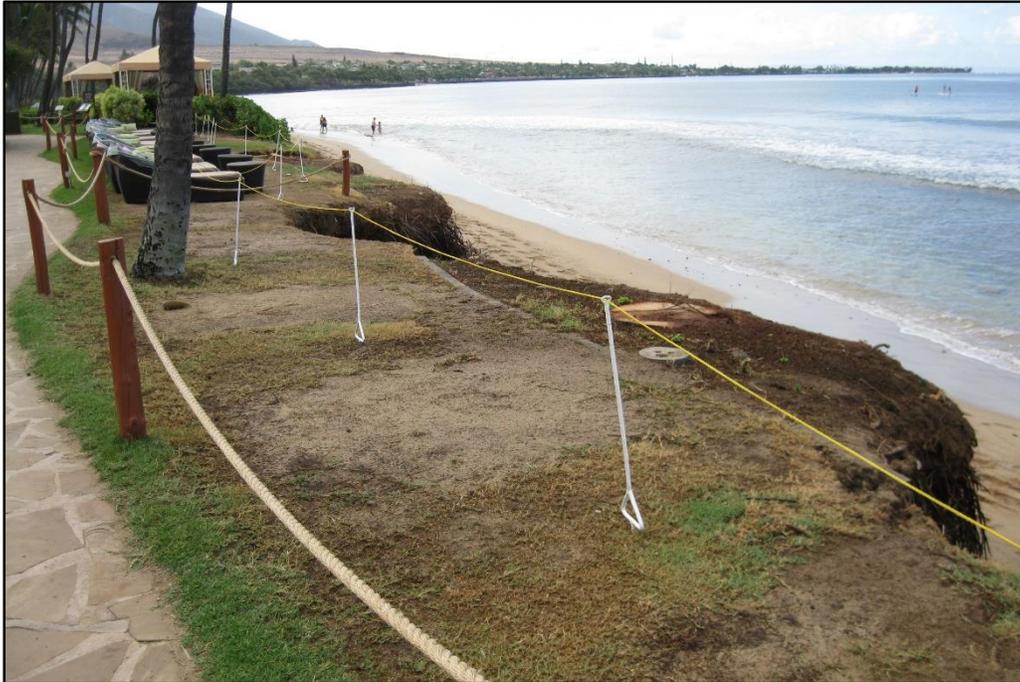
Figure 2-8 Erosion scarp at Segment B with Coconut tree stumps and Naupaka hedge remnants on the mauka side (SEI, 08/11/2015)

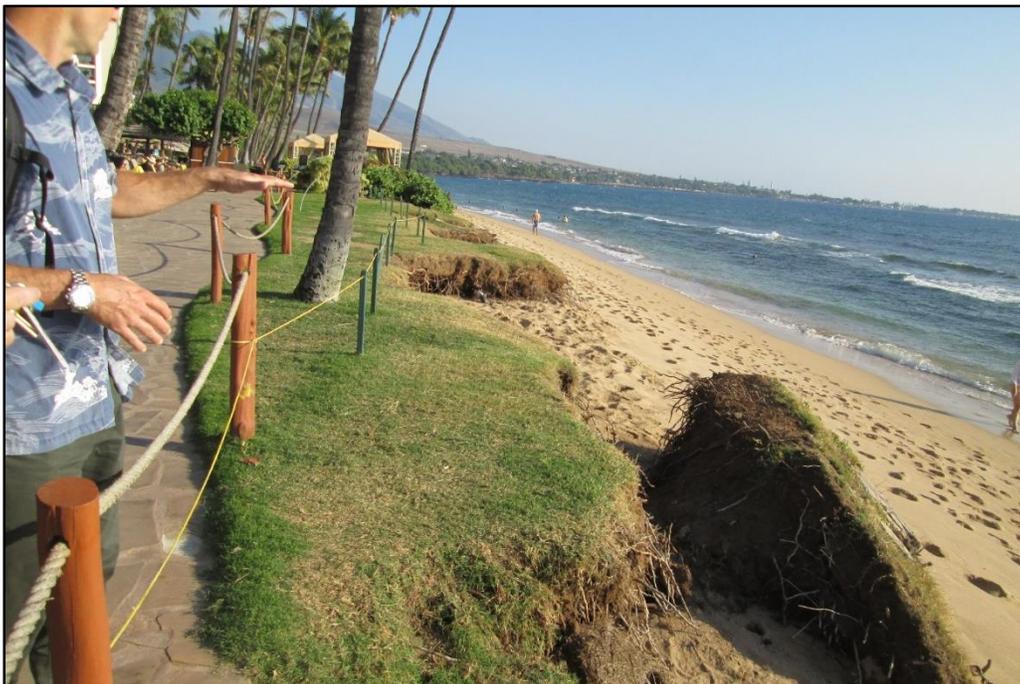
Figure 2-9 Erosion scarp at Segment B (SEI, 01/14/2016)

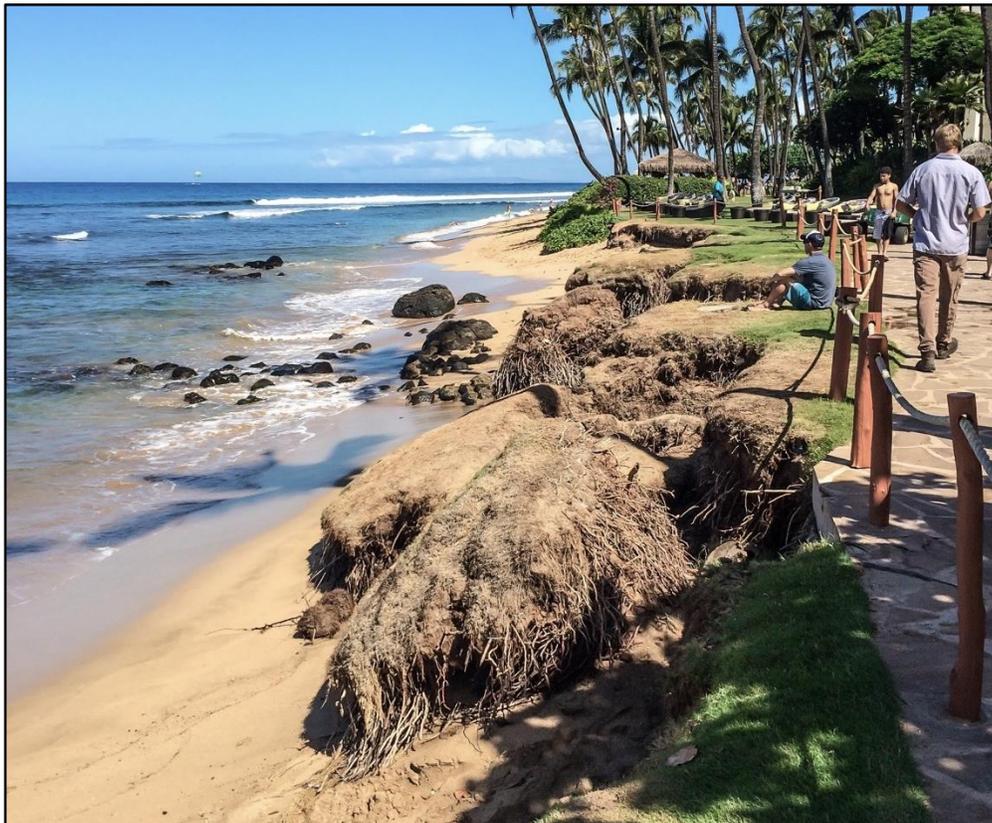
Figure 2-10 Segment C before Emergency Erosion Protection Skirt installation (SEI, 07/27/2015)

Segment C is approximately 180 feet in length. In early 2015, a combination of south swell and high tides caused critical undermining of the Beachwalk in several locations (Figure 2-10 and Figure 2-11). In response to that erosion and upcoming higher high tides, an Emergency Erosion Protection Skirt (EEPS) was deployed in July of 2015 over the 5 foot high erosion scarp to slow the retreat of the shoreline. The EEPS, discussed later in Section 2.2.7.1, provides a barrier between the erosion scarp and the erosive wave attack.

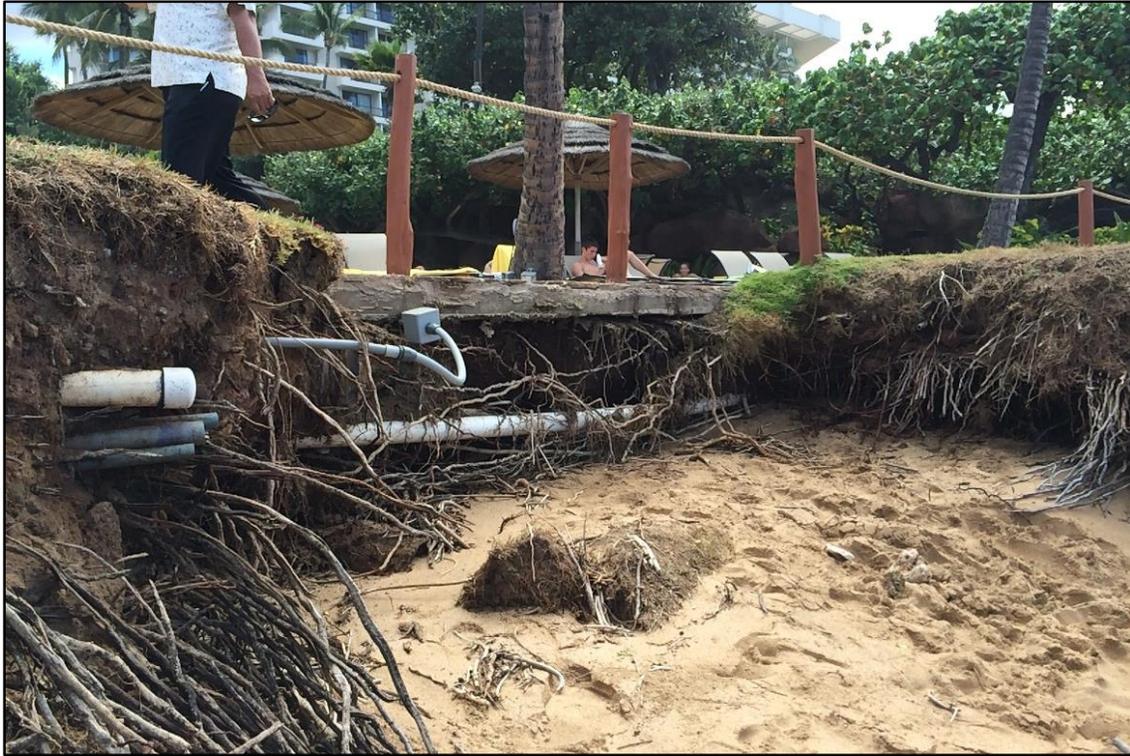
Figure 2-11 Path undermined and electrical conduit exposed (SEI, 07/27/2015)

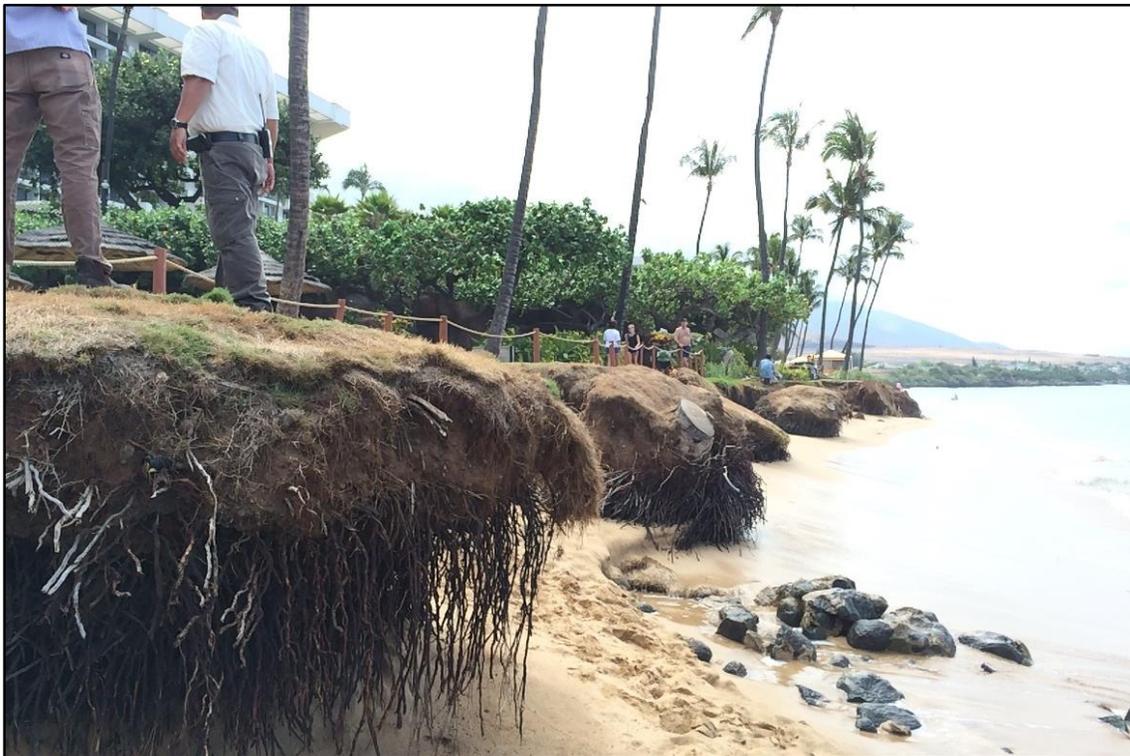
Figure 2-12 Segment C, pre-skirt installation (SEI, 07/27/2015)

Like Segment B, this section of shoreline no longer has vegetation cover (Figure 2-12); Naupaka hedges and Palm trees were damaged or removed as the erosion scarp migrated landward. Removal of undermined sections of the Beachwalk in this segment have made a pinch point in shoreline access (Figure 2-13). The remaining width of Beachwalk at this pinch point is currently threatened, and removal would disrupt coastal access along the Beachwalk. This segment has experienced the highest erosion rates in the project area, with some spots eroding at rates over 2.0 feet per year.

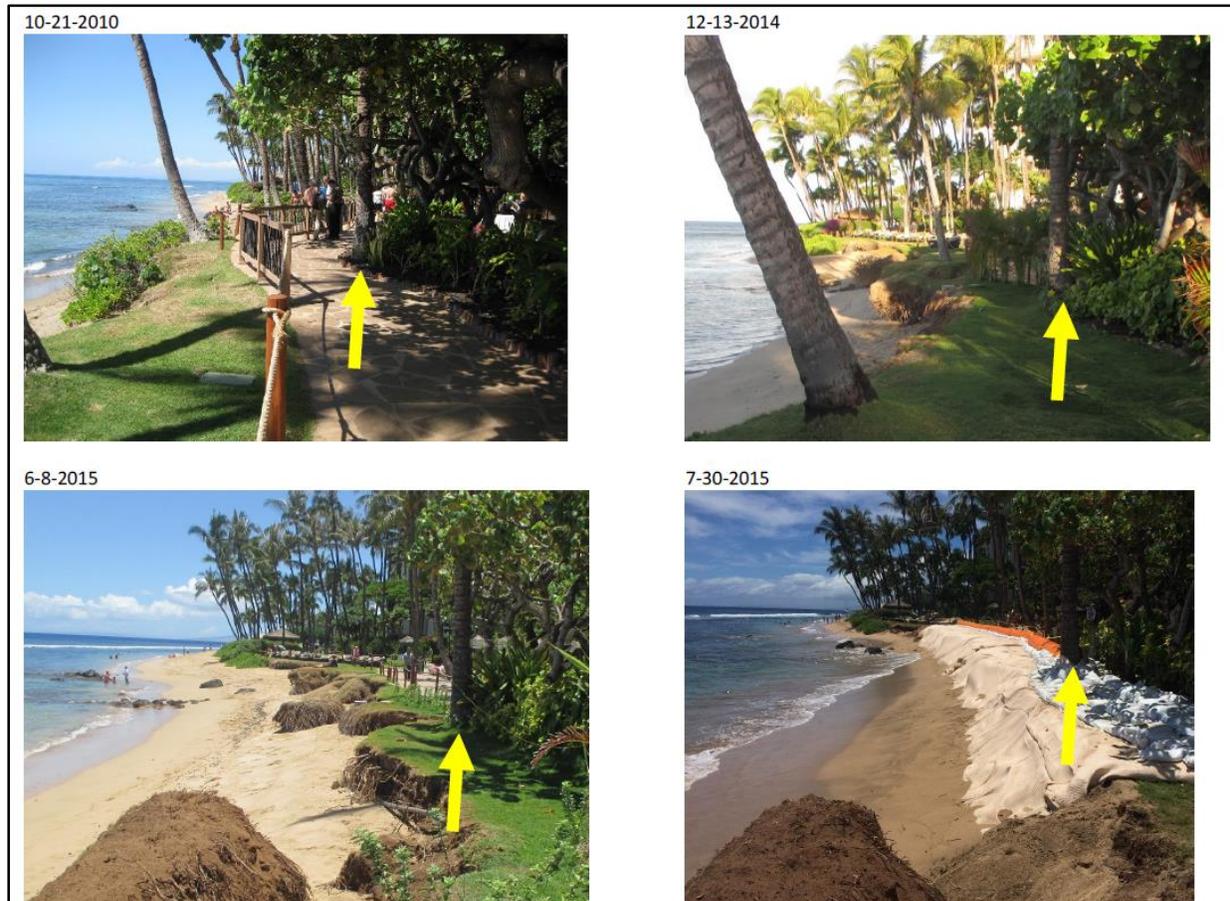
Figure 2-13 Shoreline progression in Segment C with yellow arrow indicating reference coconut tree in each image. The Beachwalk originally split and had a segment mauka of the reference tree (SEI, 2010)

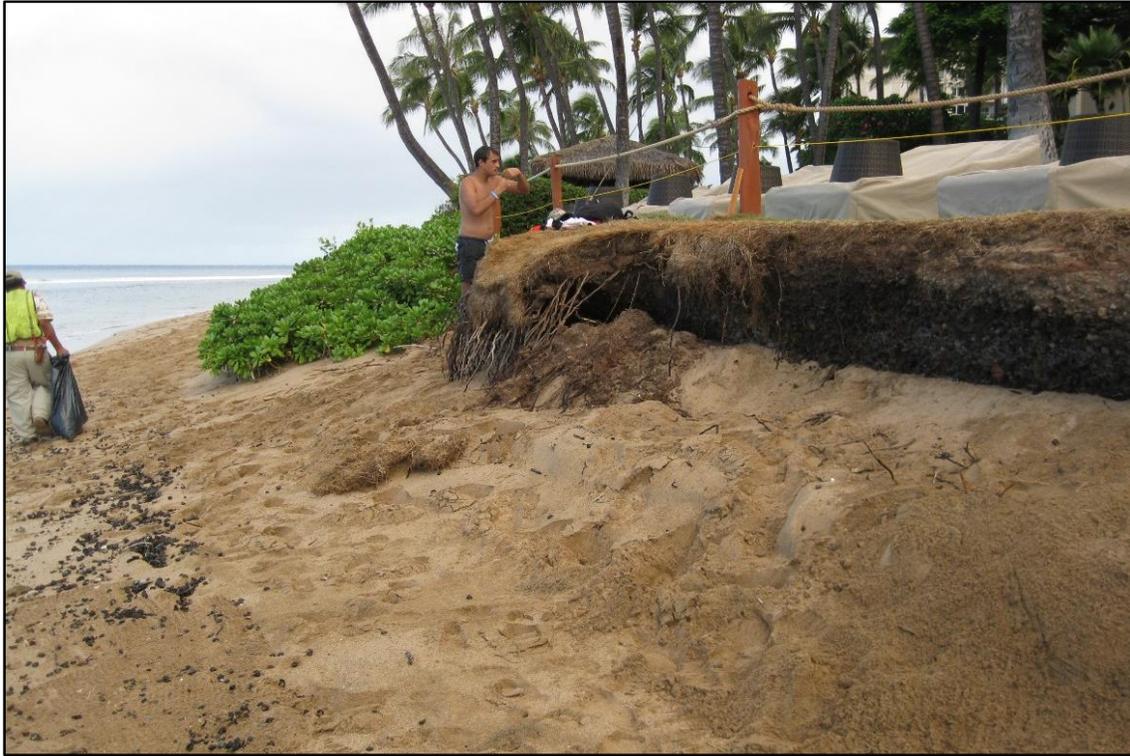
Figure 2-14 Erosion scarp in Segment D (SEI, 08/11/2015)

Segment D is the northernmost section of critically-eroding shoreline and is approximately 60 feet in length. This segment has a 3 foot erosion scarp that is covered by patches of vegetation (Figure 2-14). The vegetation can be seen in Figure 2-15 to have been significantly damaged by saltwater intrusion and wave attack.

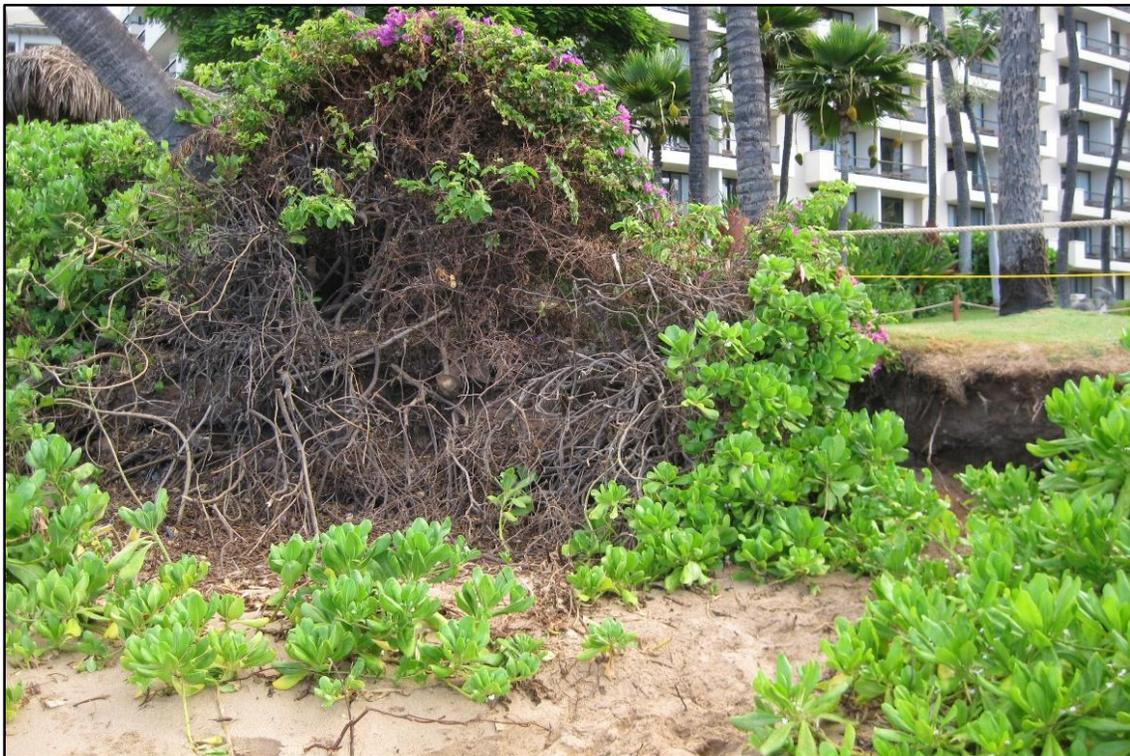
Figure 2-15 Erosion scarp and damaged vegetation in Segment D (SEI, 08/11/2015)

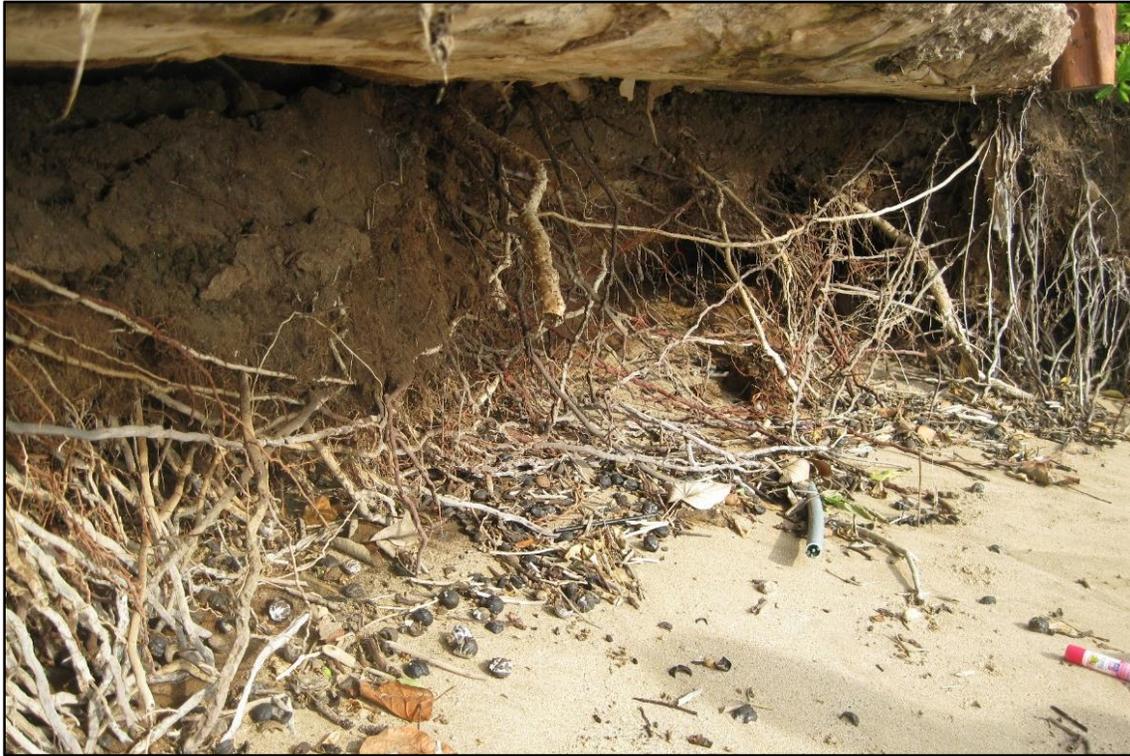
Figure 2-16 Exposed fill material in the erosion scarp below Beachwalk opposite the Grotto (SEI, 08/11/2015)

Investigation of the shoreline erosion scarp generally confirms the findings of the trenching. An exposed clay bank can be seen fronting the Grotto where the Beachwalk has been undermined (Figure 2-16). This bank has been seen to erode during high water level events, when wave action allows water to impact the bank, releasing material into the nearshore waters. The release of this material may be slow and steady, or in areas containing palm tree root balls, the release may be sudden when the rootball collapses. This general condition is found along the shoreline fronting the main swimming pool and Grotto. To the west of the Grotto, the erosion scarp contains fill material that appears to be composed of loam and gravel (Figure 2-17), consistent with the findings of the trenching. This erosion scarp is also unstable and the material is released into the nearshore waters as erosion progresses landward.

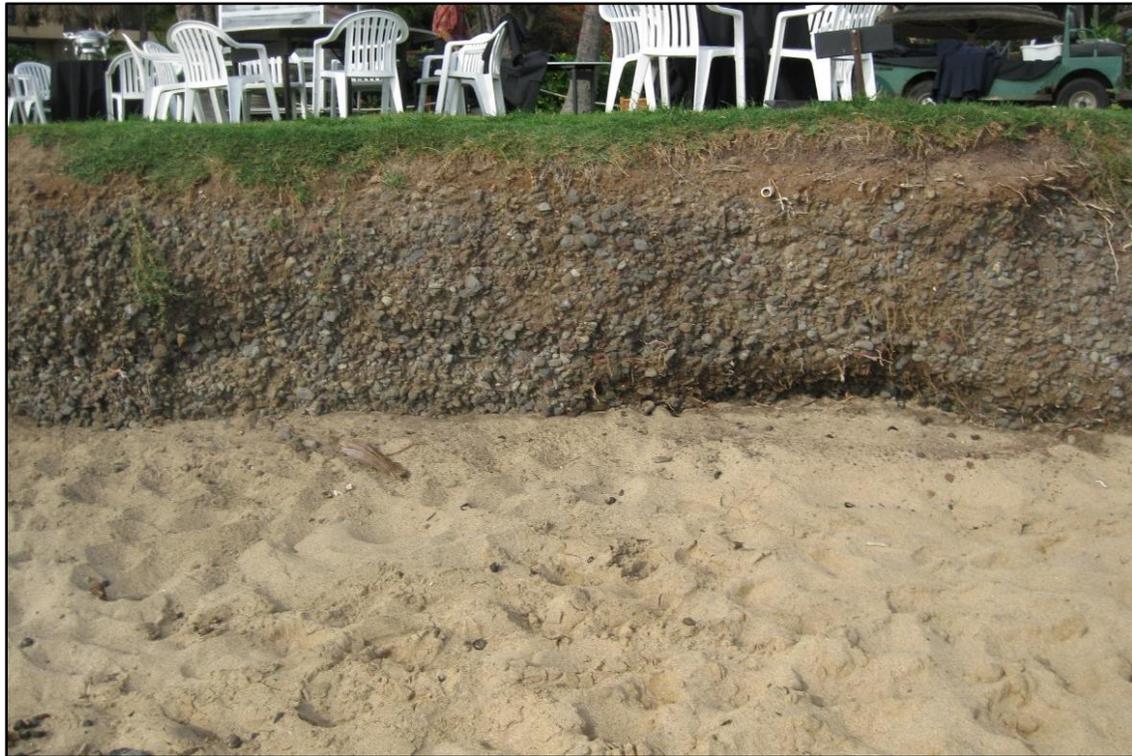
Figure 2-17 Exposed loam and gravel fill material in the erosion scarp to the west of the Grotto SEI, 08/11/2015)

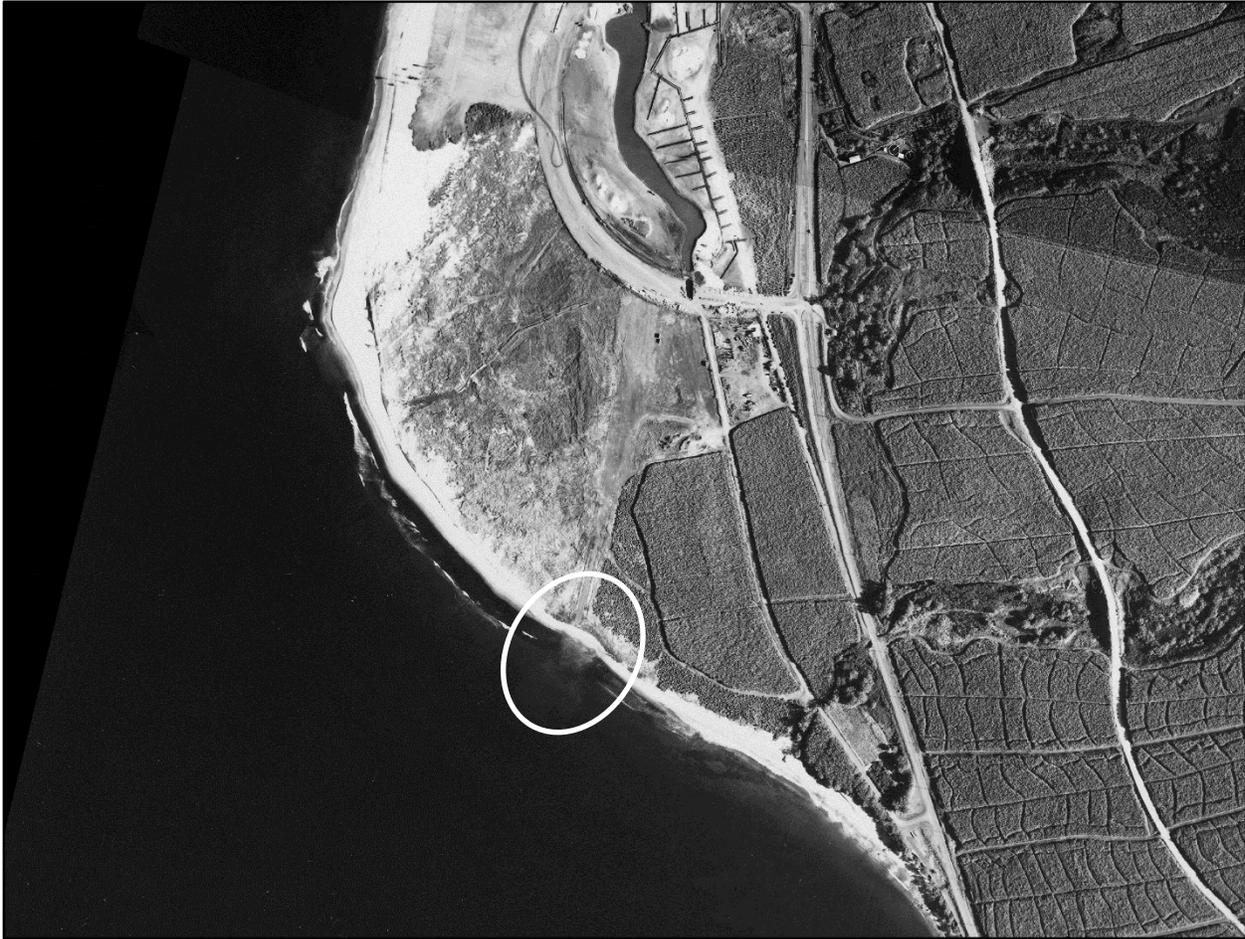
Figure 2-20 1961 aerial mosaic showing significant clearing/grubbing and expansion of the stream/floodway, indicated by the white ellipse

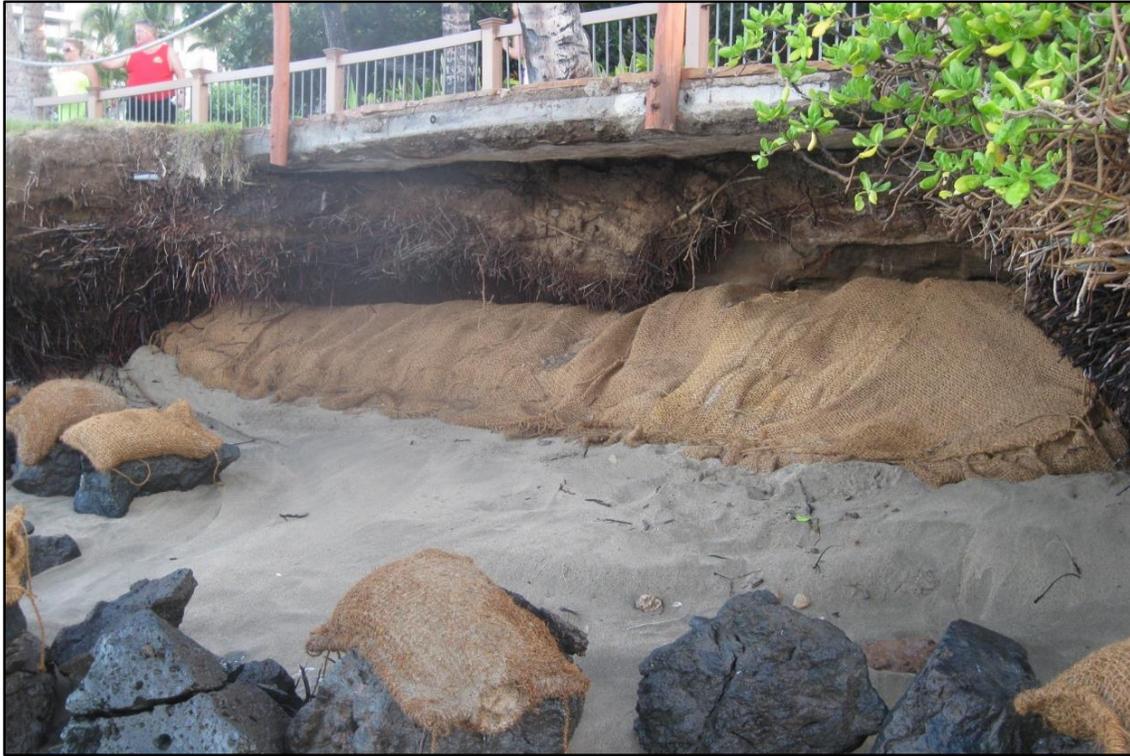
Figure 2-24 Photo of coir sandbag bank protection (SEI, 10/15/2013)

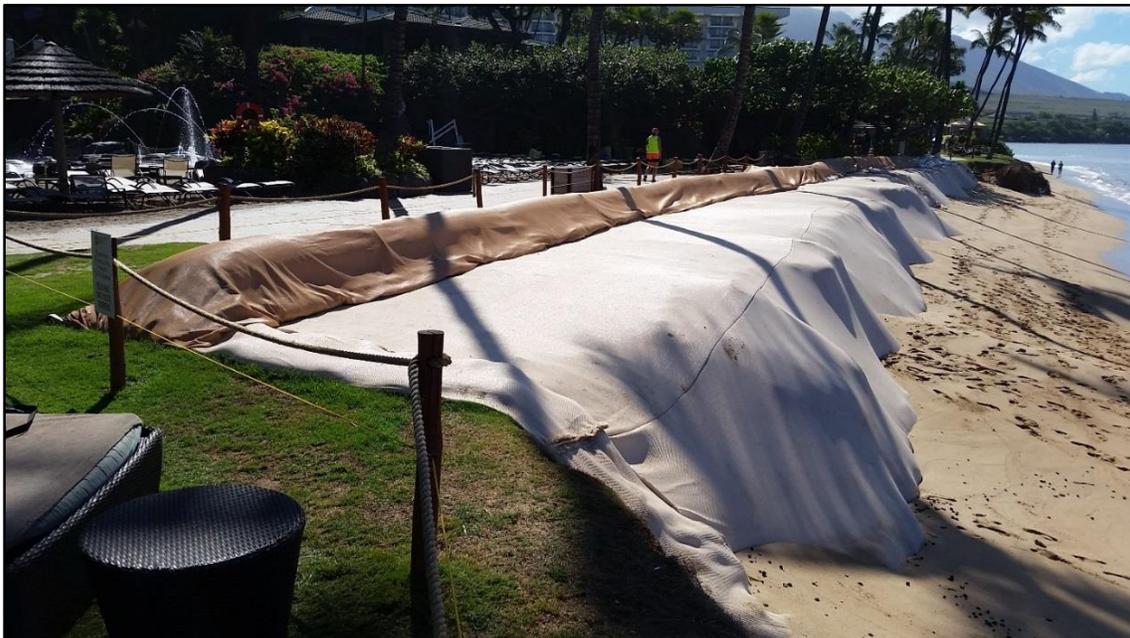
Figure 2-25 Photo of existing Emergency Erosion Protection Skirt (SEI, 08/08/2015)

The EEPS consists of a geotextile blanket that is laid across the erosion scarp and anchored in the backshore. The geotextile blanket protects the erosion scarp from wave attack, particularly during periods of high tides and high surf. The use of durable, geosynthetic materials facilitated rapid deployment and better protected the fragile and already undermined erosion scarp beneath and adjacent to the Beachwalk.. The EEPS design is intended for eventual recovery, ideally allowing for future re-use of the materials. The EEPS is performing adequately, requiring only minor adjustments since installation.

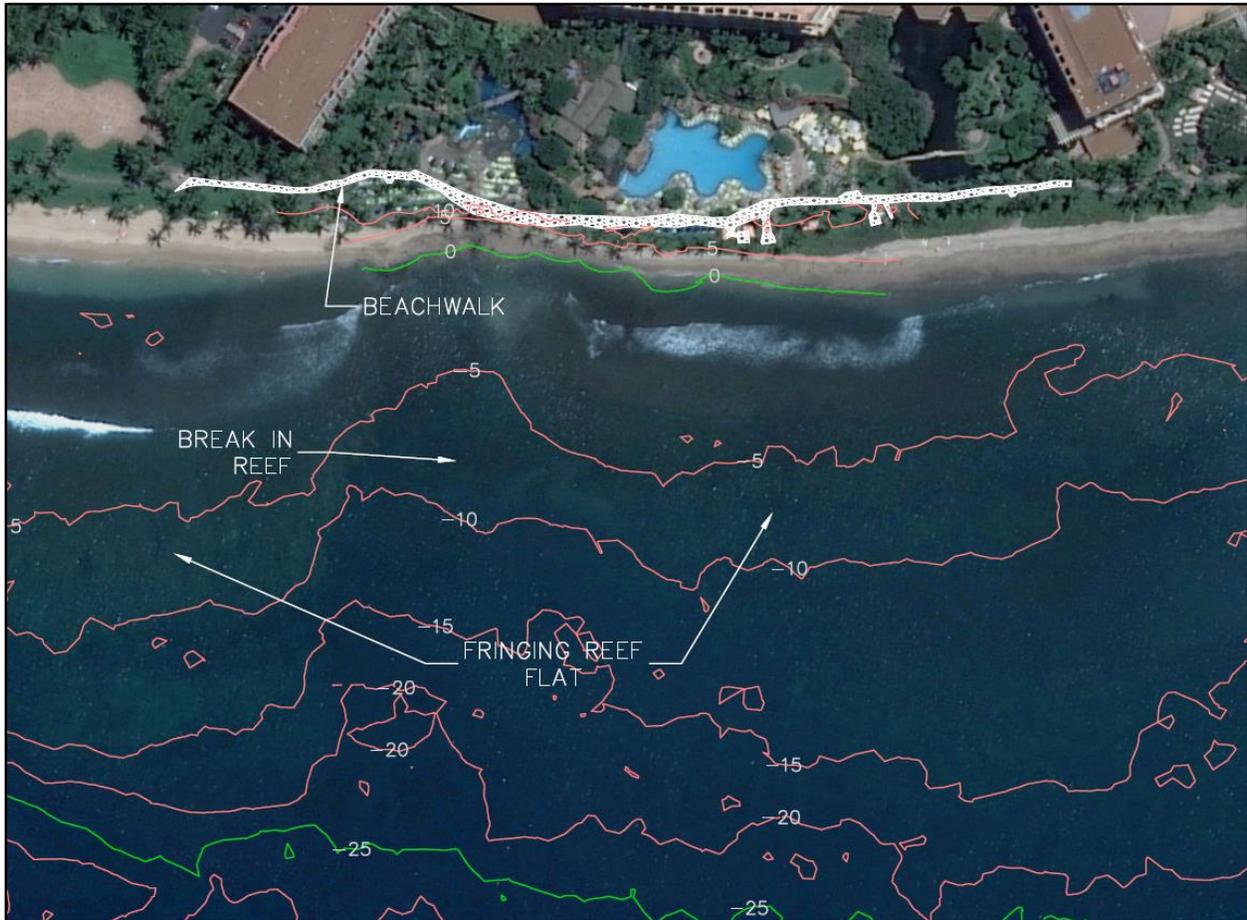
Figure 2-27 Project area bathymetry (elevation contours in feet MSL)

fronting Segments A, B, and D. The deeper water fronting this segment has a significant effect on the waves as they approach the shore, and is further discussed in Section 2.2.13.

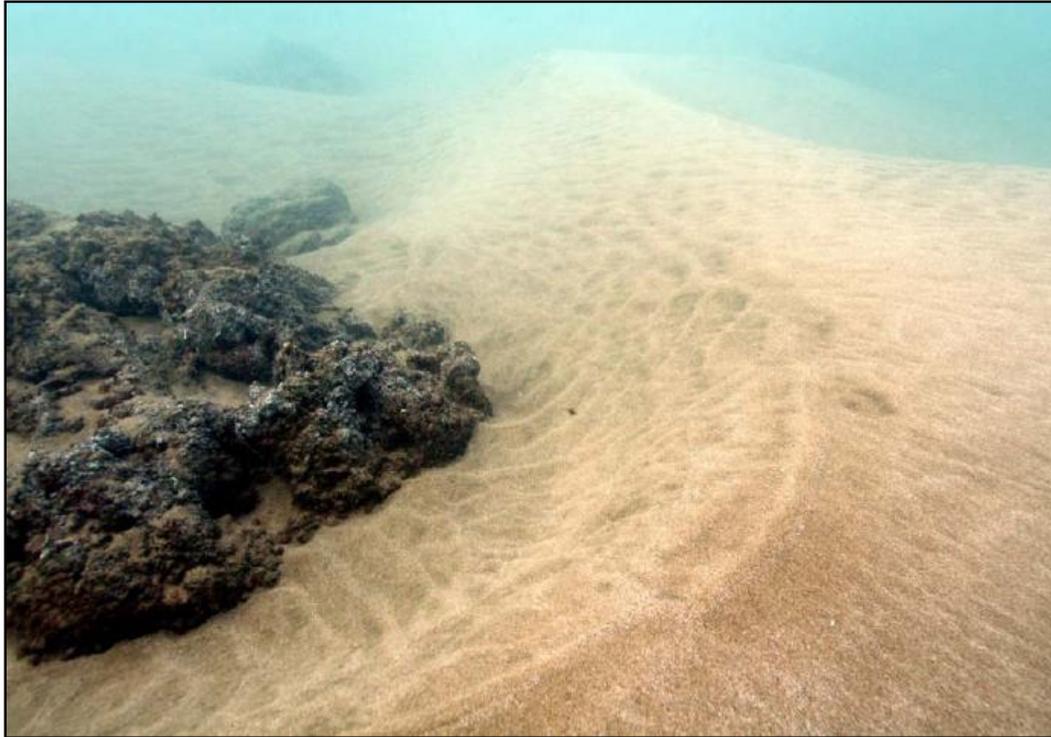
Figure 3-1 Fore-reef zone nearshore, with no coral growth due to sediment suspension and scour (Depth < 10 feet)

The nearshore reef can be roughly divided into three zones, based primarily on coral species cover and diversity that also reflect the bottom morphology. The Fore-reef and Mid-reef Zones are morphologically similar, with outcrops and ridges of coralline limestone interspersed with sand channels and sand flats. The Fore-reef Zone is in water depths of 0 to 10 feet, with shallow areas being devoid of coral due to scour (Figure 3-1), and deeper parts of the zone containing coral opportunistically colonizing on the higher projections of the reef (Figure 3-2). The Mid-reef Zone, starting at about 10 feet of water depth, is where sediment re-suspension due to wave forces is no longer observed, and typically shows increased opportunistic colonization (Figure 3-3). The Outer-reef Zone is marked by the presence of large (and ancient) colonies of *porites lobata* as well as other species with almost 100 percent coral cover, more continuous hard substrate, and less sand channels and pockets (Figure 3-4). The preferred alternative is not anticipated to have significant negative impacts on marine substrate.

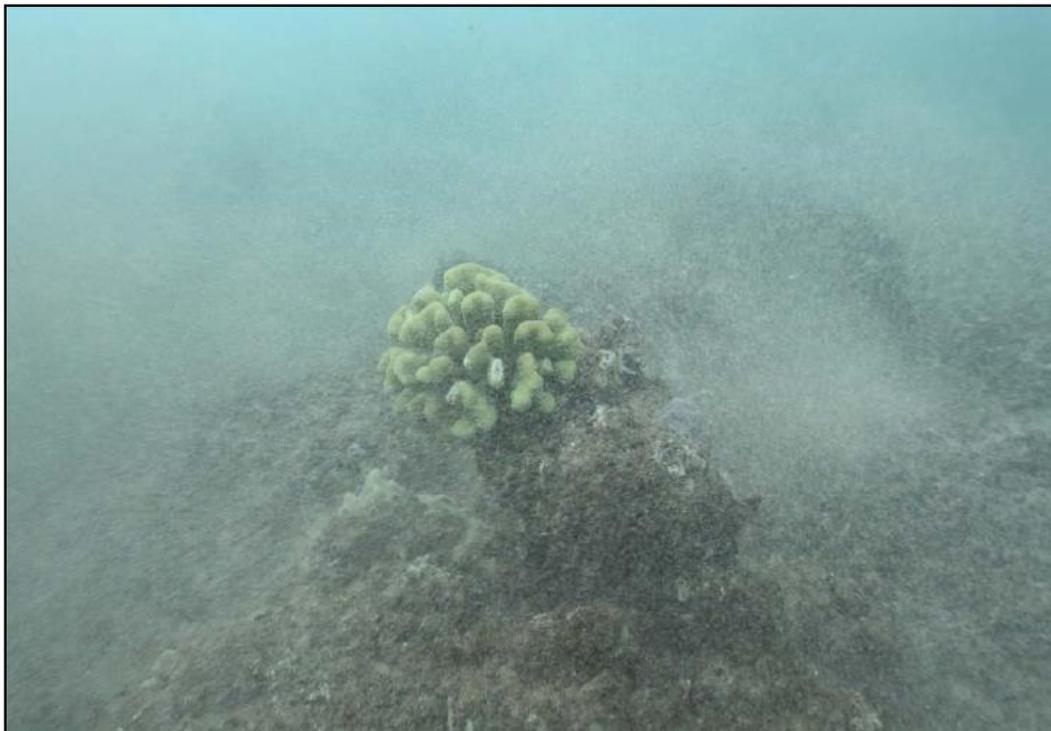
Figure 3-2 Fore-reef Zone showing opportunistic colonization of elevated outcrops (Depth < 10 feet)

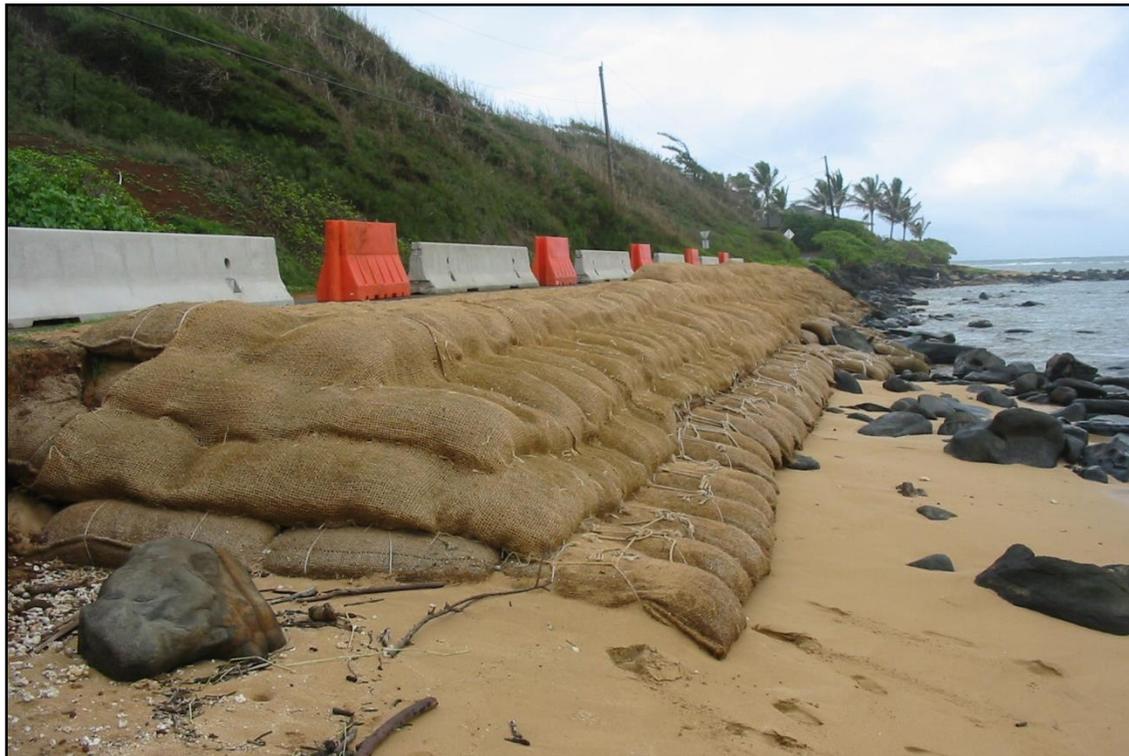
Figure 4-1 Shore protection using natural fiber bags, Anahola, Kauai (SEI, 2014)

Sandbags constructed from natural, biodegradable materials have been increasingly used for temporary emergency protection in Hawaii over the last ten years. A common sandbag configuration is a jute (burlap) sand bag with a coir weave on the outside. When filled, the bags weighed approximately 50 lbs and can be placed by hand. This configuration was used as bank protection in 2013 at the Hyatt Regency Maui. Similar installations include Maalaea (Maui), Anahola (Kauai), and Honolulu (Oahu). An example of a roadside installation of natural fiber sandbags is shown in Figure 4-1, using larger coir sand bags with a protective blanket. The 2013 installation of sandbags at the Hyatt Regency Maui as slope stabilization was described in Section 2.2.7.1.
