**STATE OF HAWAII
DEPARTMENT OF LAND AND NATURAL RESOURCES
OFFICE OF CONSERVATION AND COASTAL LANDS**

MEMORANDUM

Subject: Draft Environmental Assessment (EA) for Temporary Shoreline Erosion Control at the Hyatt Regency Maui Resort Located at 200 Nohea Kai Drive, Lahaina, Maui, TMK: (2) 4-4-013:008.

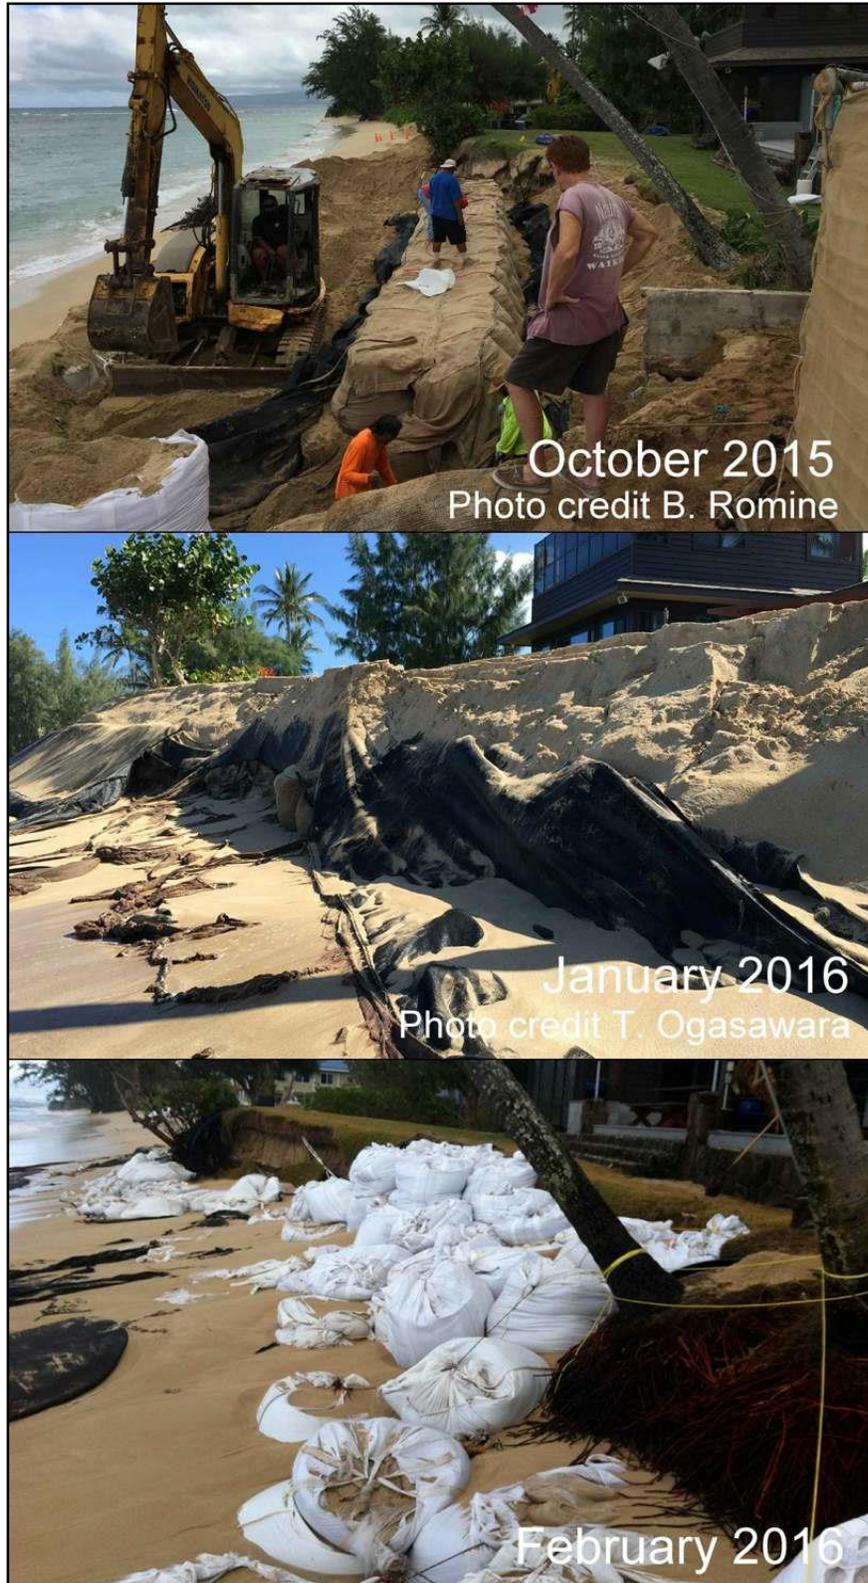
Figure 4-2 Photo comparison of 2015/2016 jute bag protection

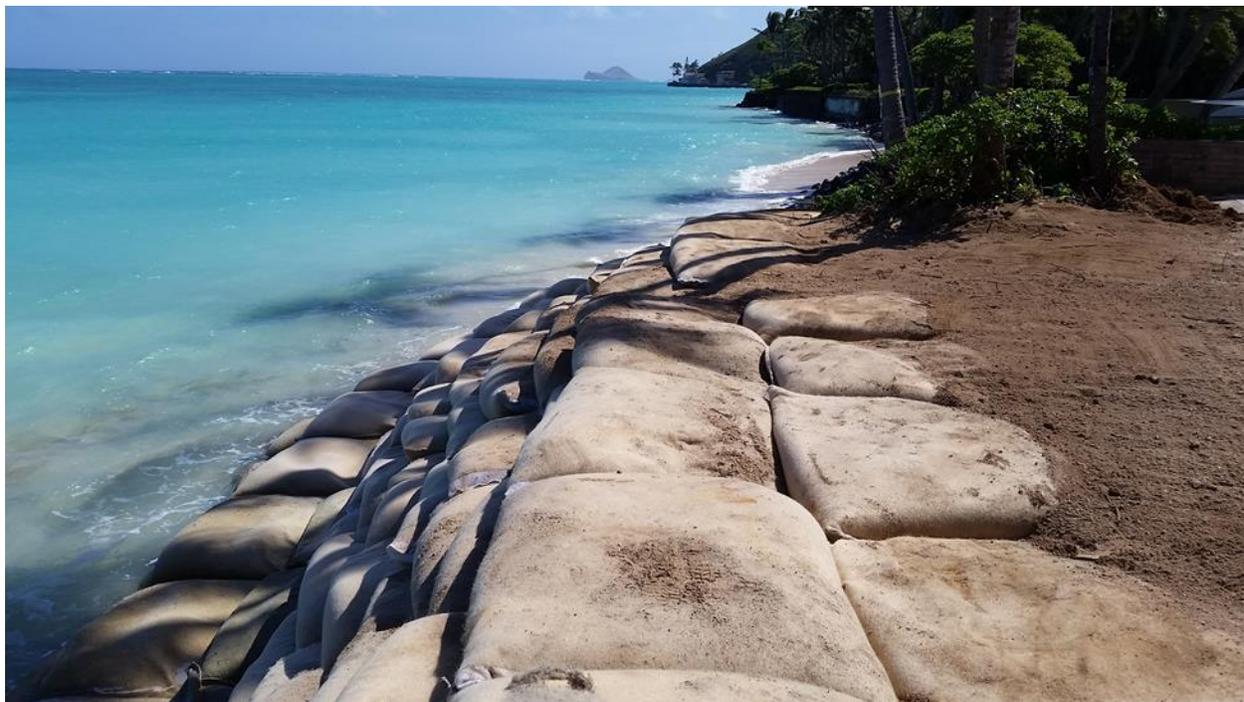
Figure 4-3 ELCOROCK[®] sandbags deployed as shore protection on Oahu, Hawaii (SEI, 2015)

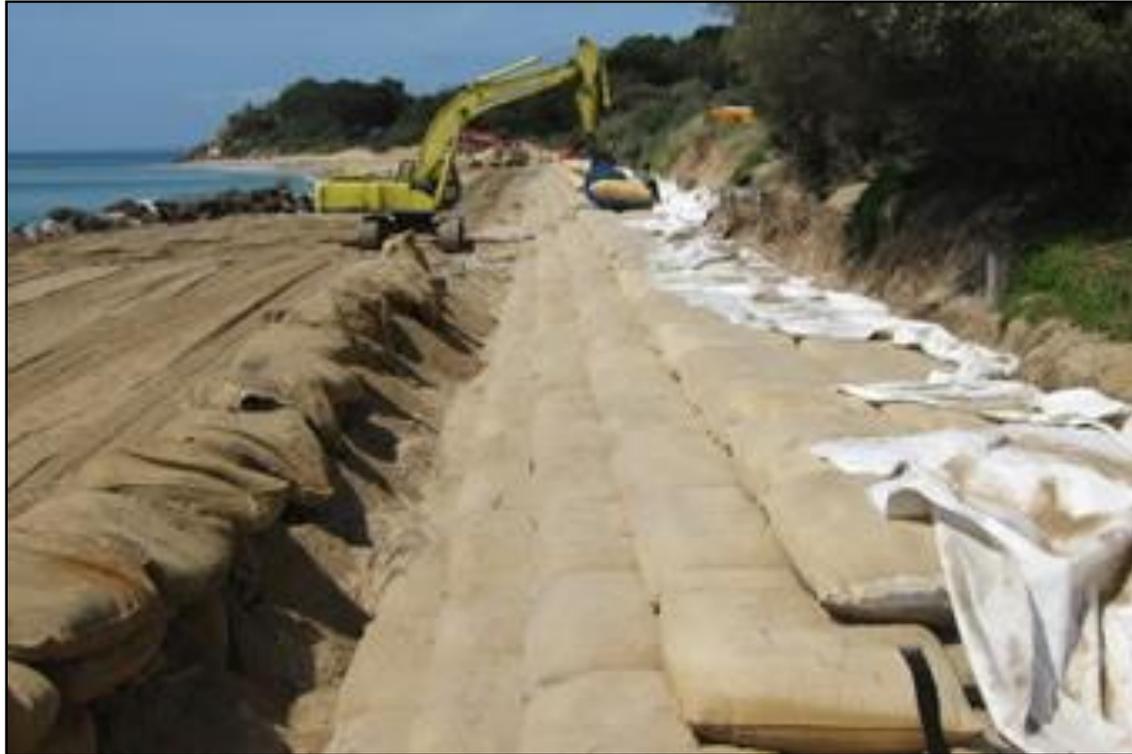
Figure 4-4 ELCOROCK® sandbags during placement (ELCOROCK® brochure, 2015)

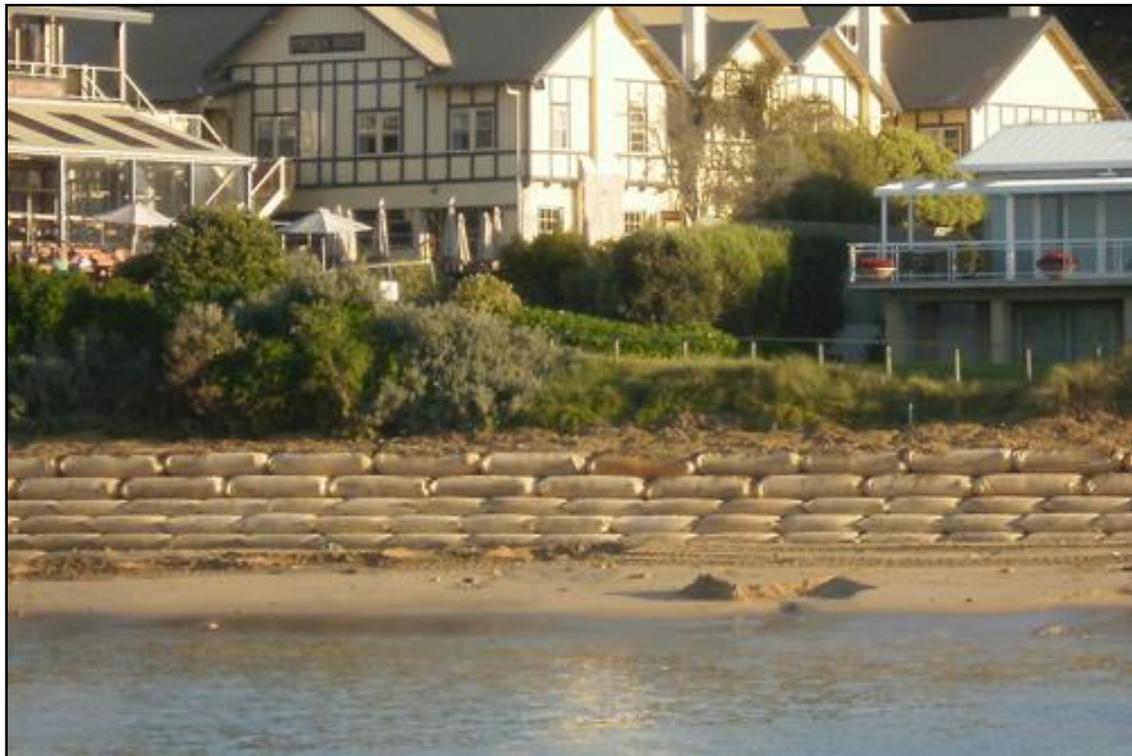
Figure 4-5 ELCOROCK® sandbag structure following completion (ELCOROCK® brochure, 2015)

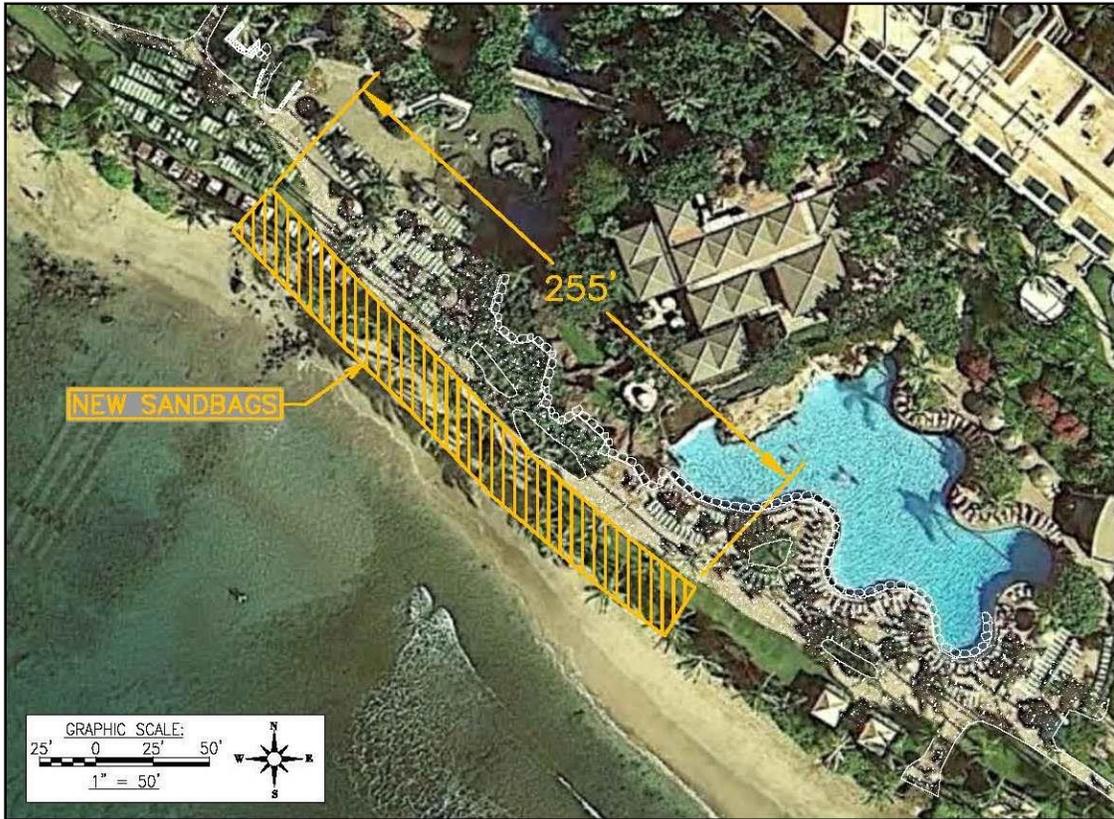
Figure 4-6 Footprint of proposed sandbag slope stabilization

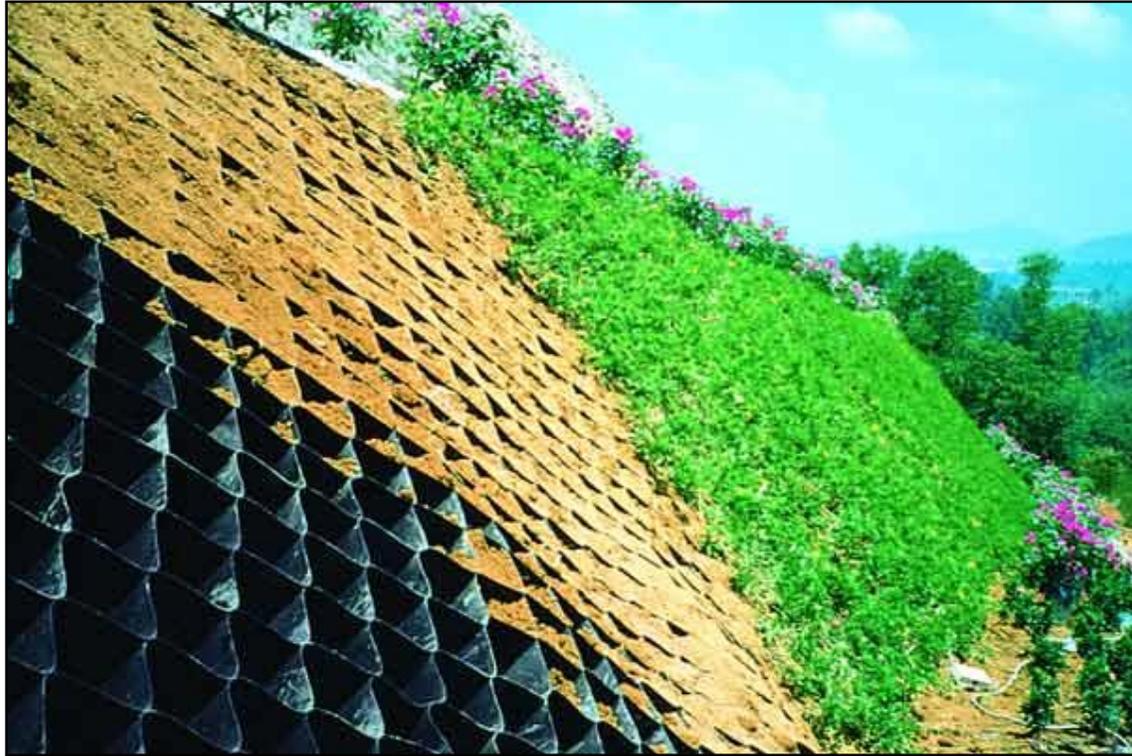
Figure 4-8 Geoweb used as bank stabilization (Brochure)

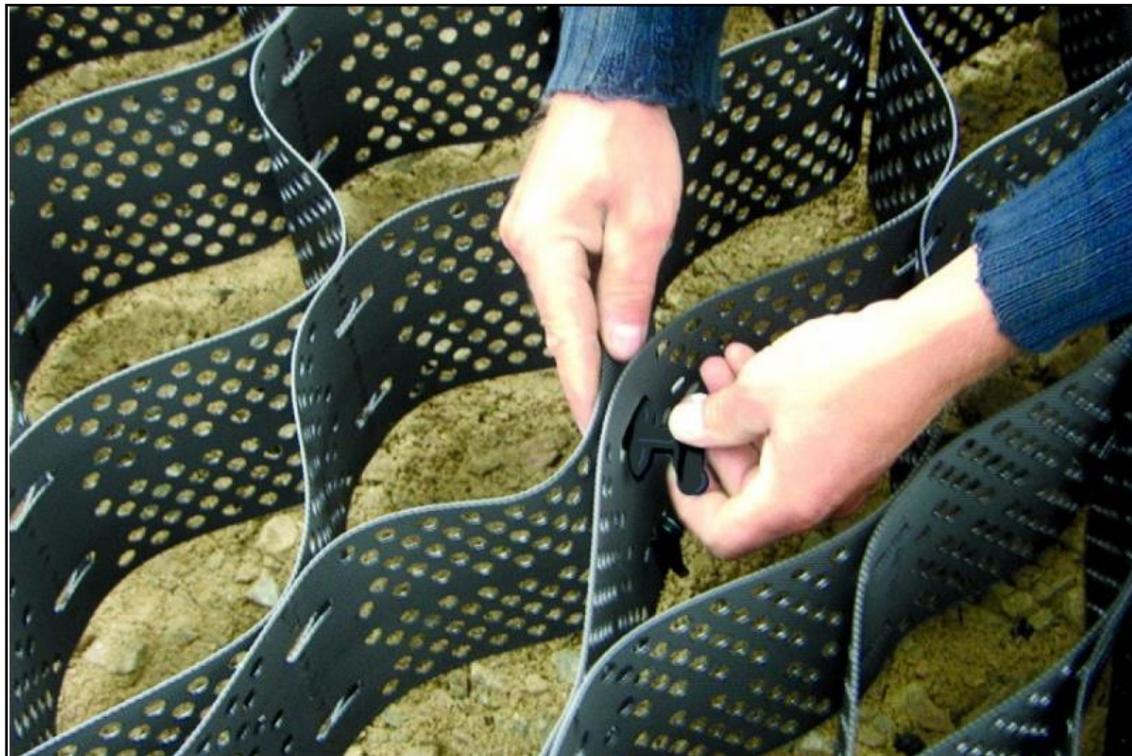
Figure 4-9 Geoweb interconnections (Brochure)

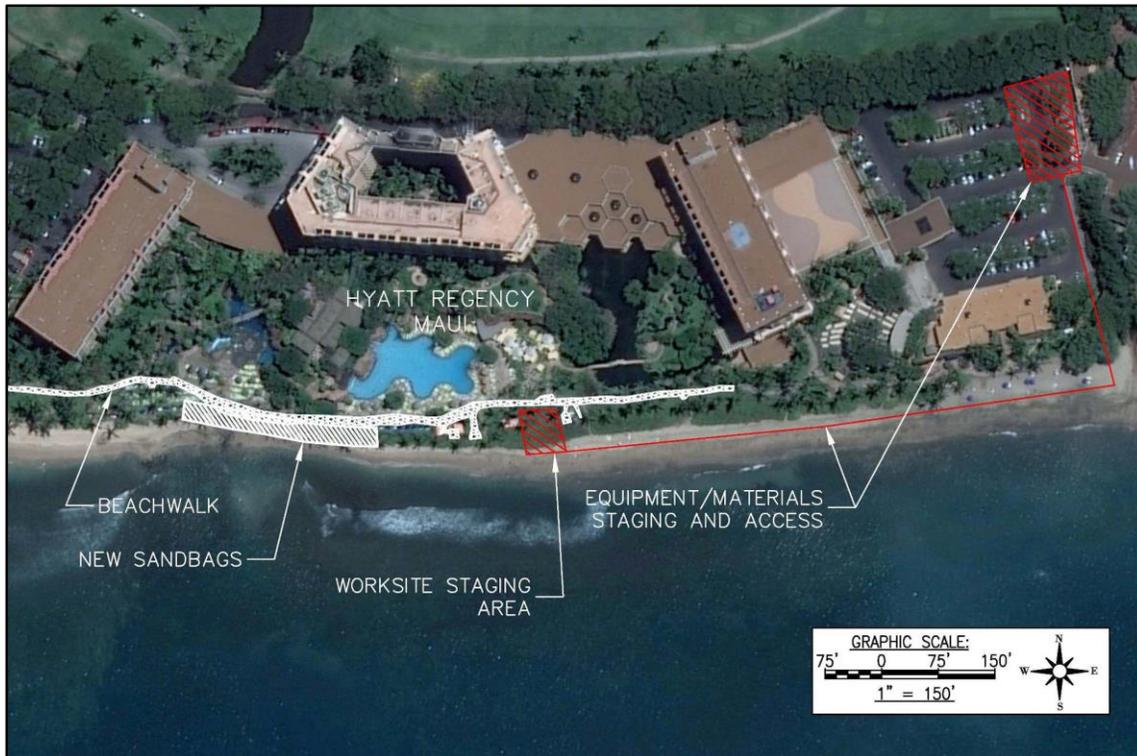
Figure 4-10 Proposed construction access and staging areas

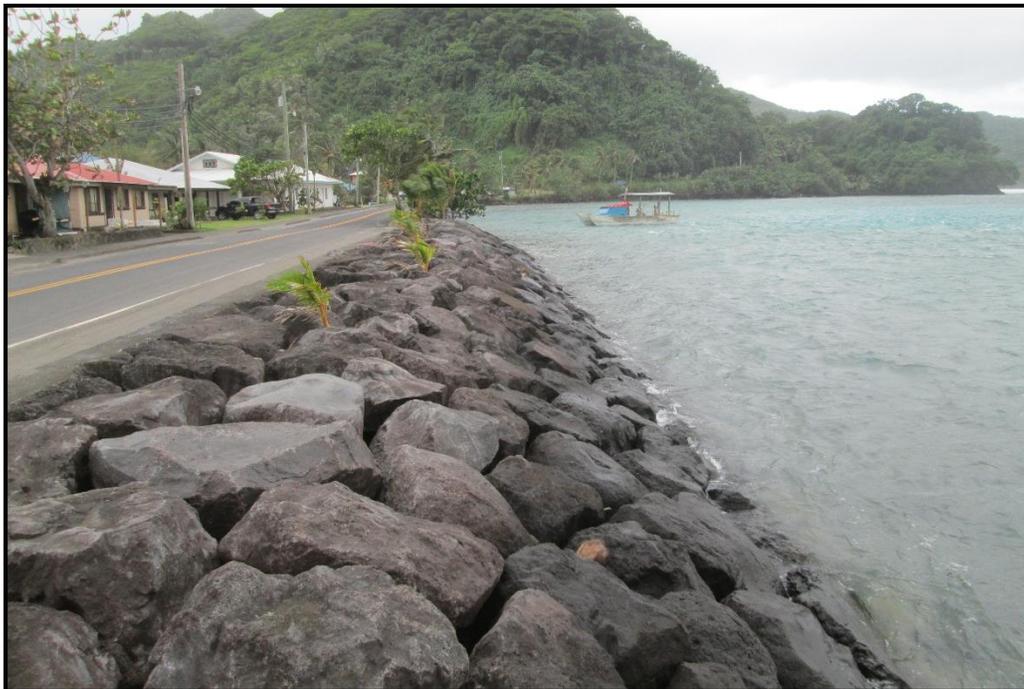
Figure 4-11 Example of a rock revetment in American Samoa (SEI, 2015)

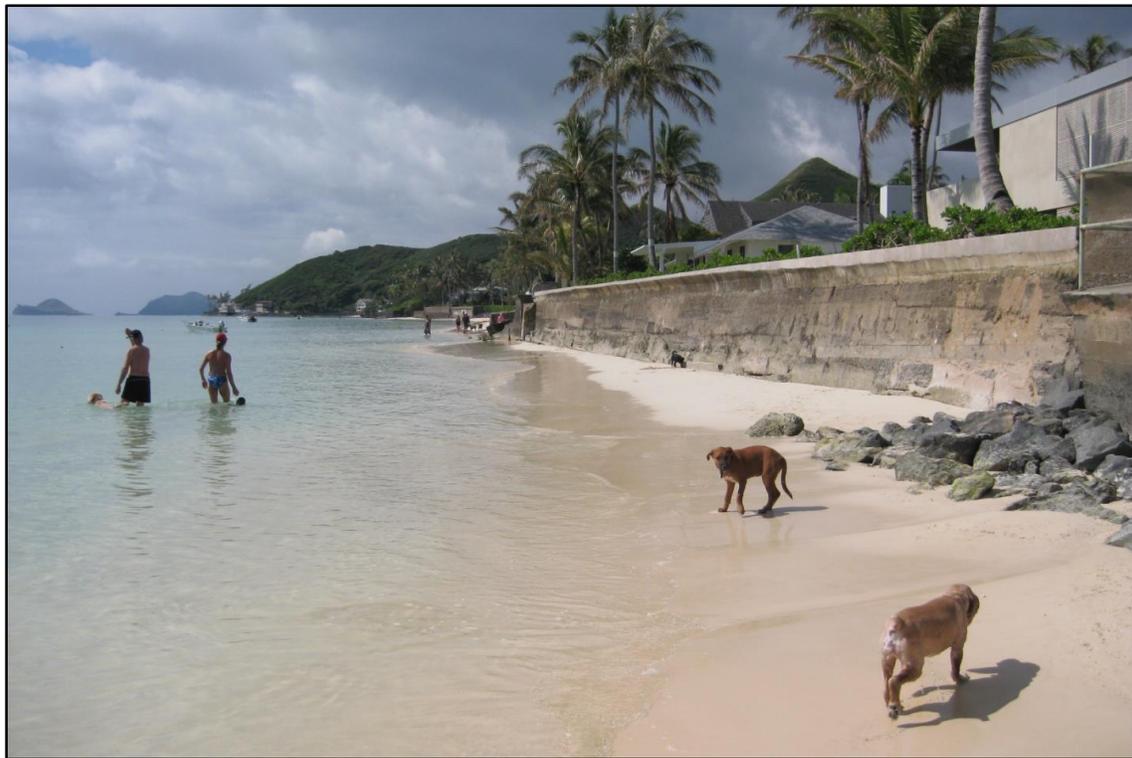
Figure 4-15 Concrete seawall fronting a private home in Lanikai (SEI, 2015)

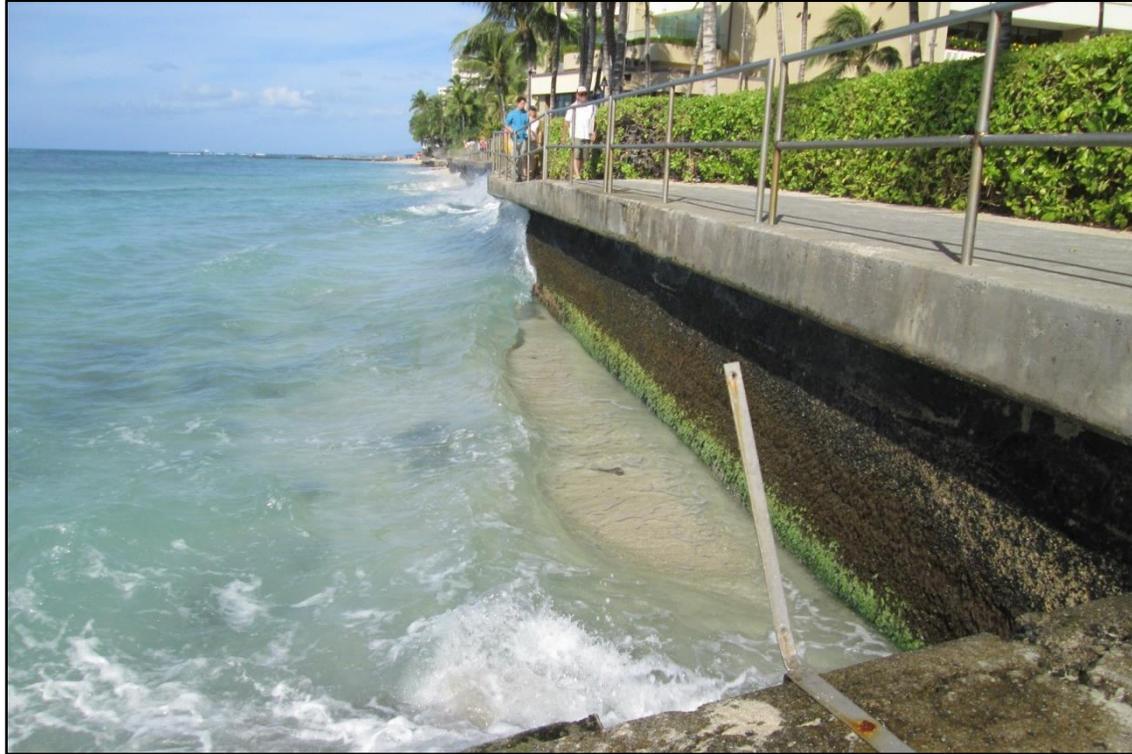
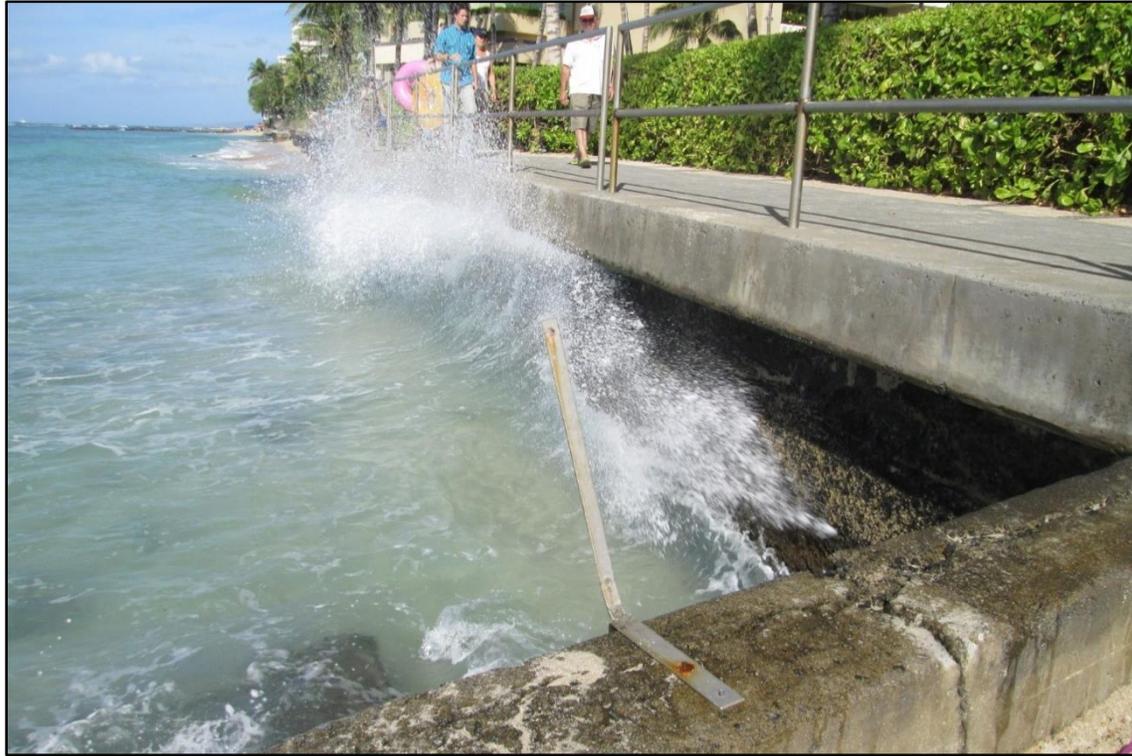
Figure 4-16 Concrete seawall fronting the Sheraton Waikiki (SEI, 2015)

Figure 4-17 Concrete seawall fronting the Sheraton Waikiki (SEI, 2015)

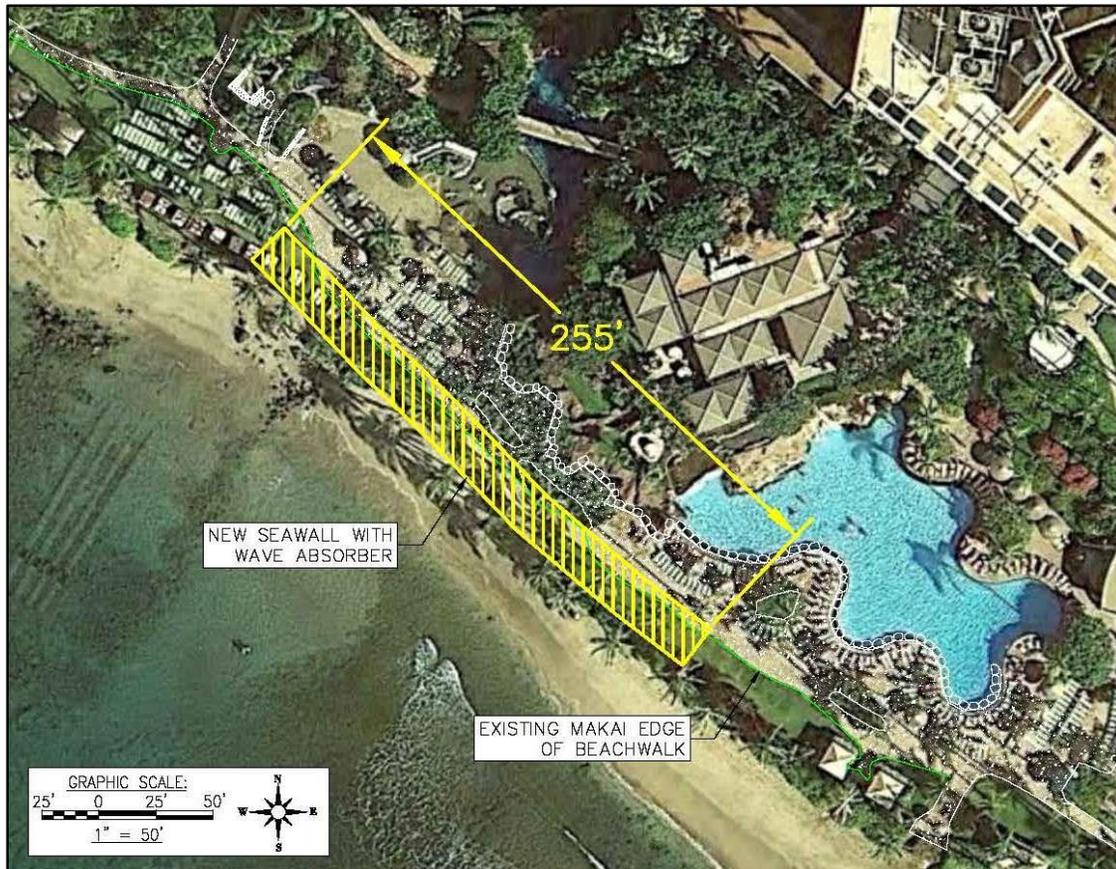
Figure 4-20 Concept seawall and wave absorber footprint (maximum width shown)

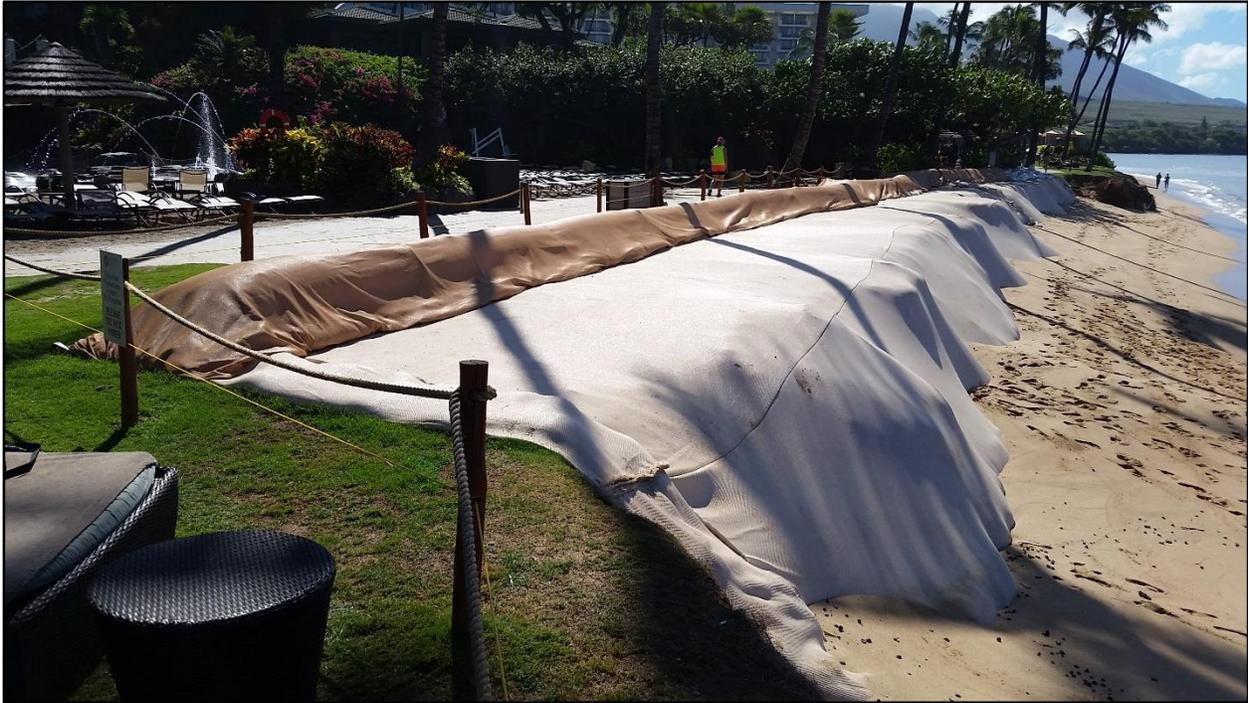
Figure 4-21 Photo of existing Emergency Erosion Protection Skirt (SEI, 11/08/2015)

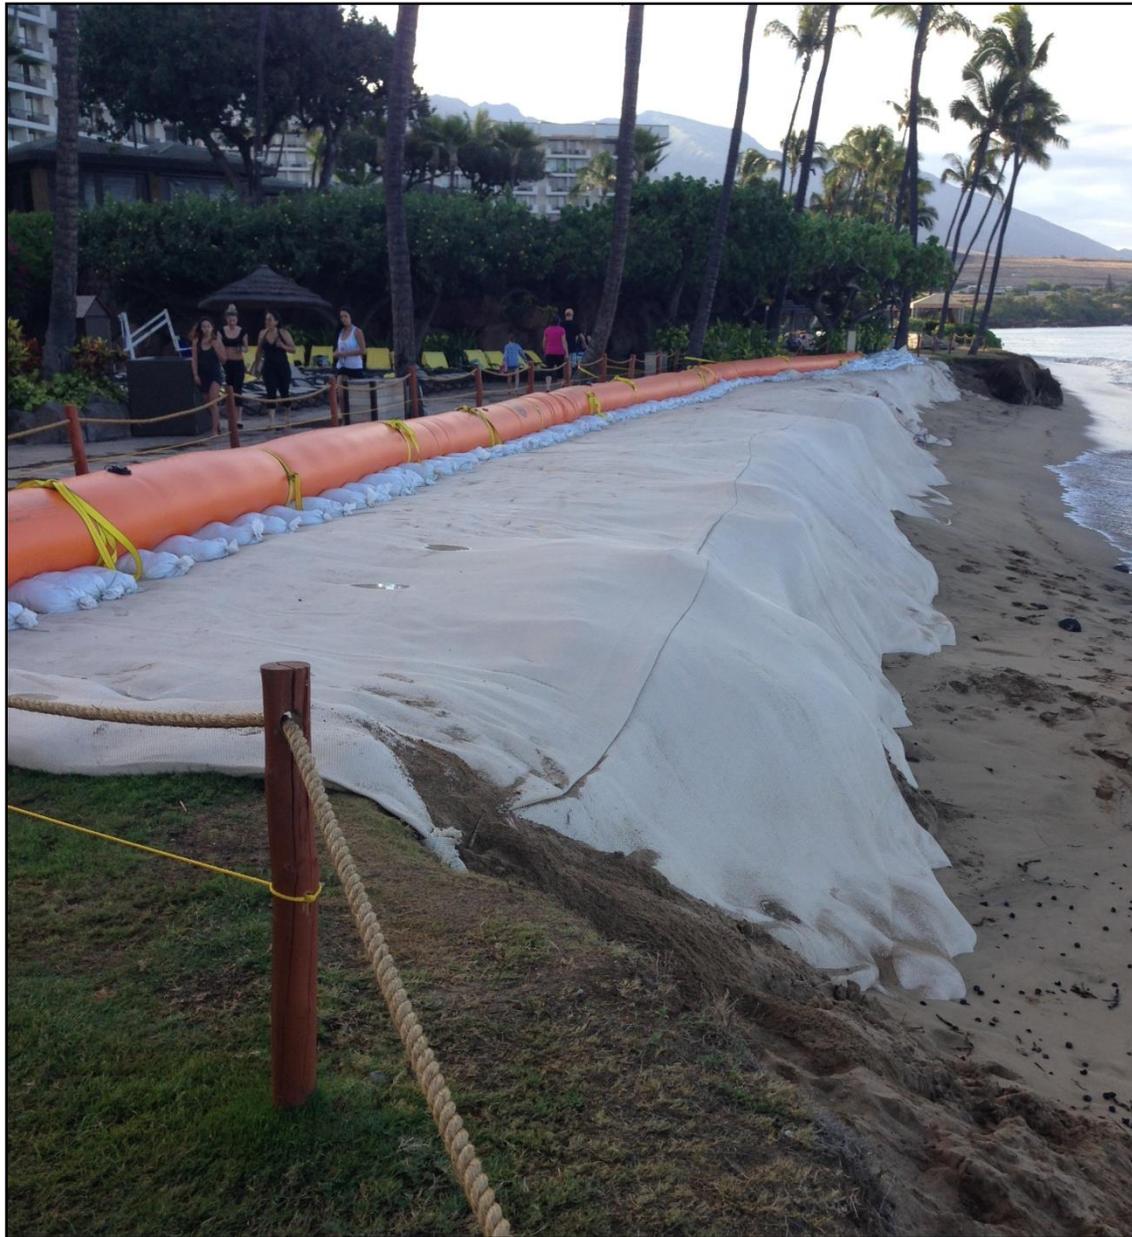
Figure 4-23 Tiger Dam installation and anchoring (SEI, 2015)

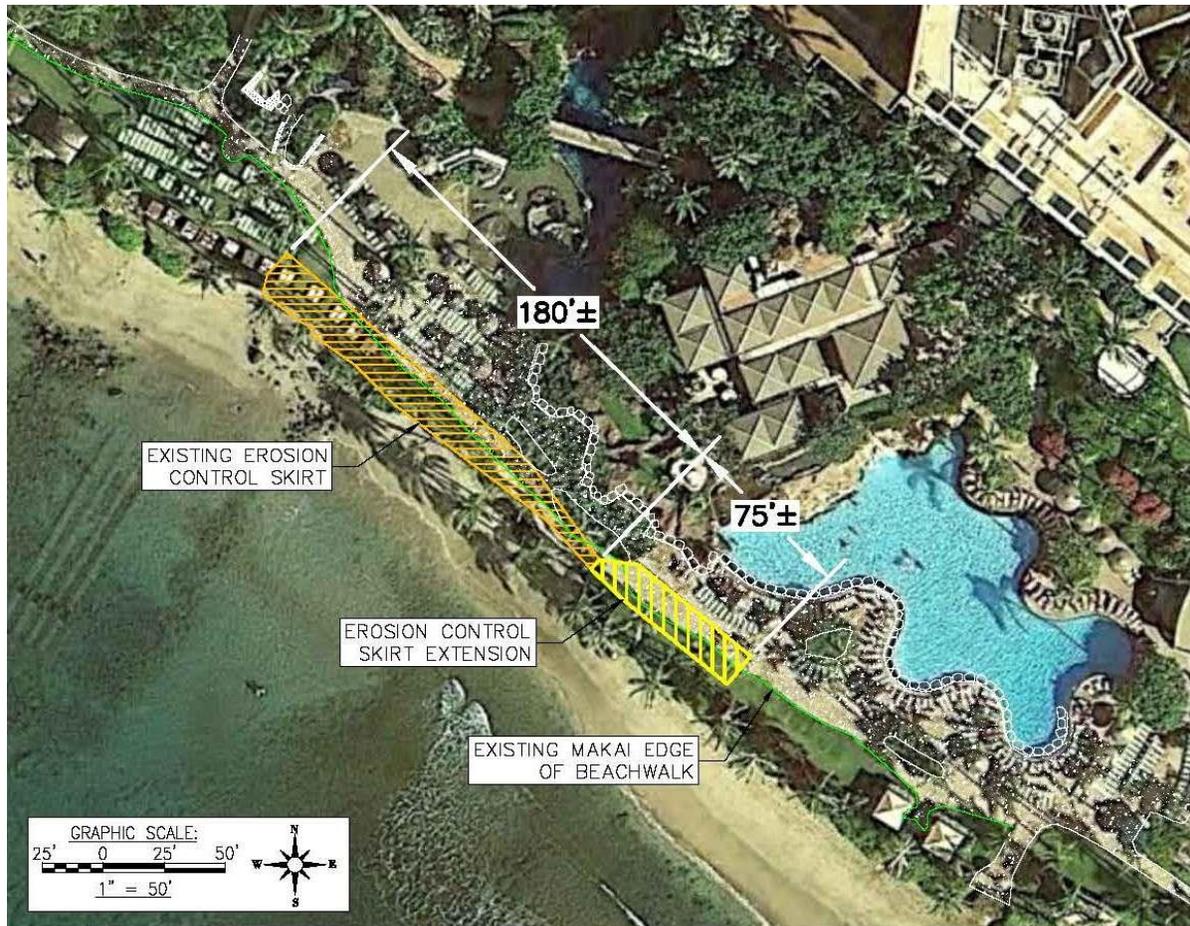
Figure 4-24 Emergency Erosion Protection Skirt deployment plan

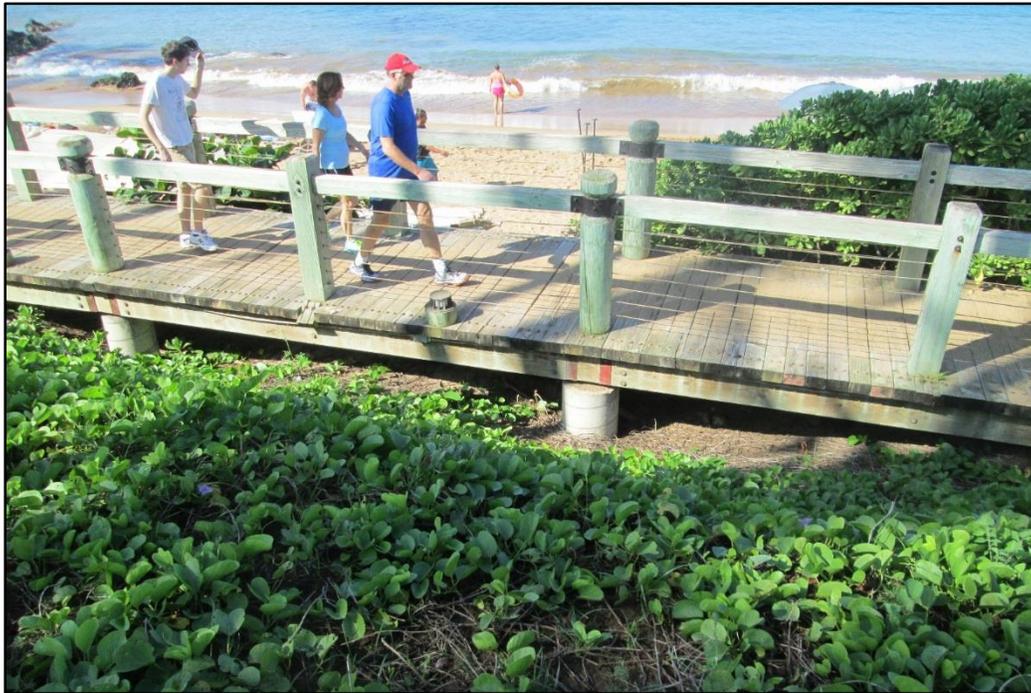
Figure 4-27 Elevated shoreline boardwalk at Wailea, Maui (SEI, 2016)

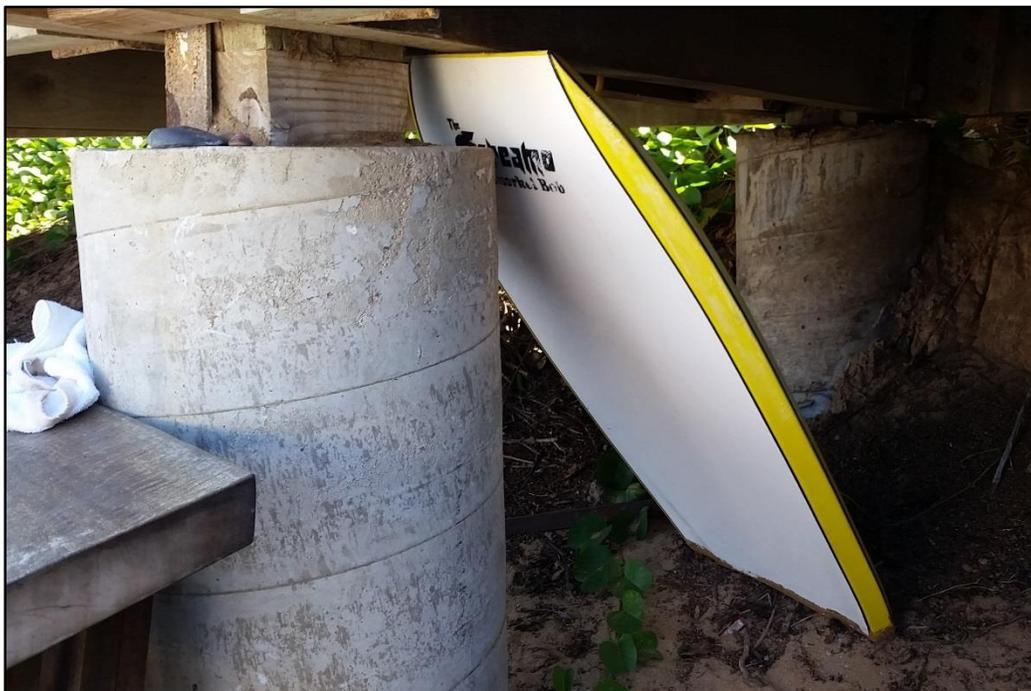
Figure 4-28 Concrete supports under elevated boardwalk, Wailea, Maui (SEI, 2016)

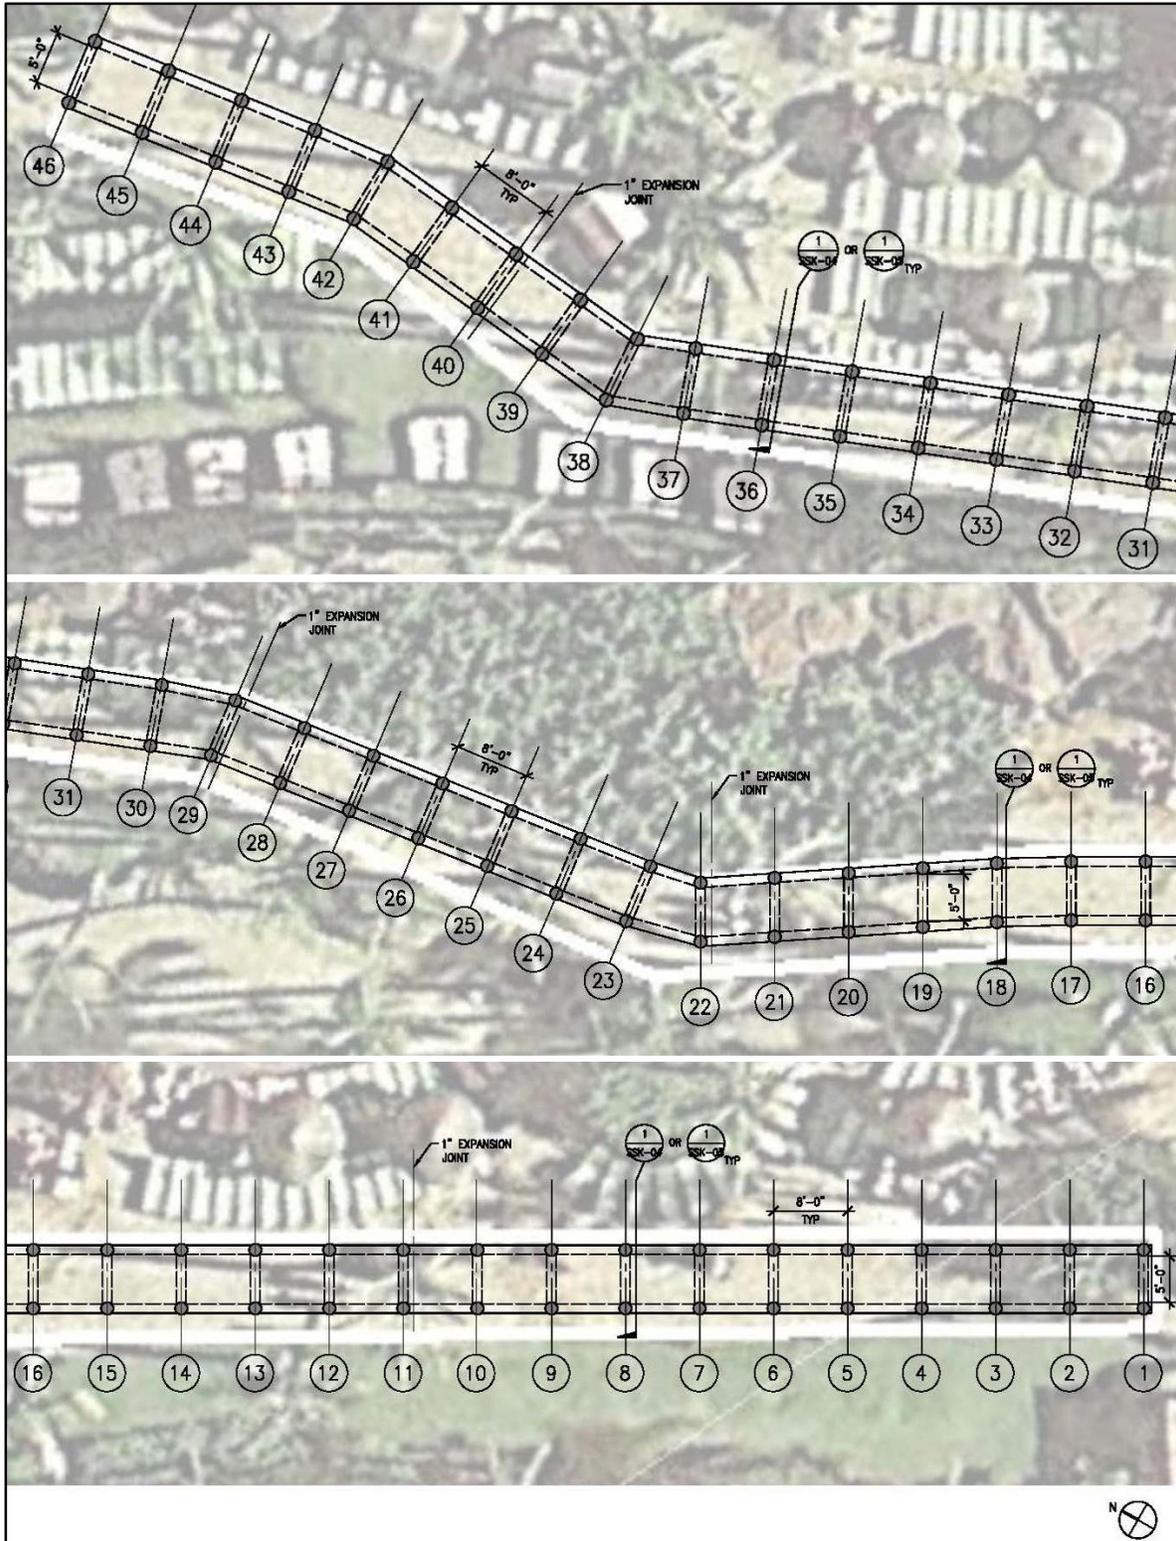
Figure 4-29 Overview of Hyatt boardwalk plan

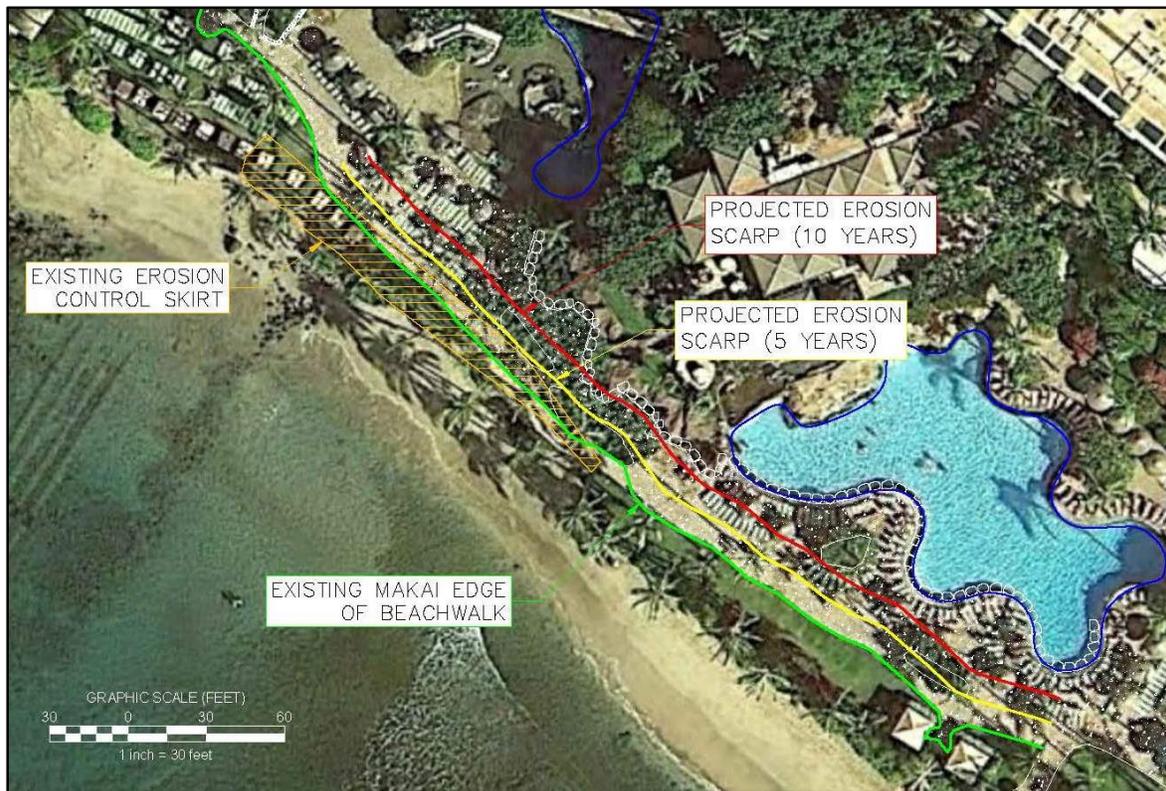
Figure 4-34 Projected future shoreline positions – Hyatt Regency Maui
