ENVIRONMENTAL IMPACT STATEMENT KALAUPAPA INFIRMARY

R E V I S E D
ENVIRONMENTAL IMPACT STATEMENT
FOR THE
PROPOSED KALAUPAPA INFIRMARY
KALAUPAPA, MOLOKAI
MOLOKAI TMK 6-1-01:01

Prepared by: Urban 9

March 1978

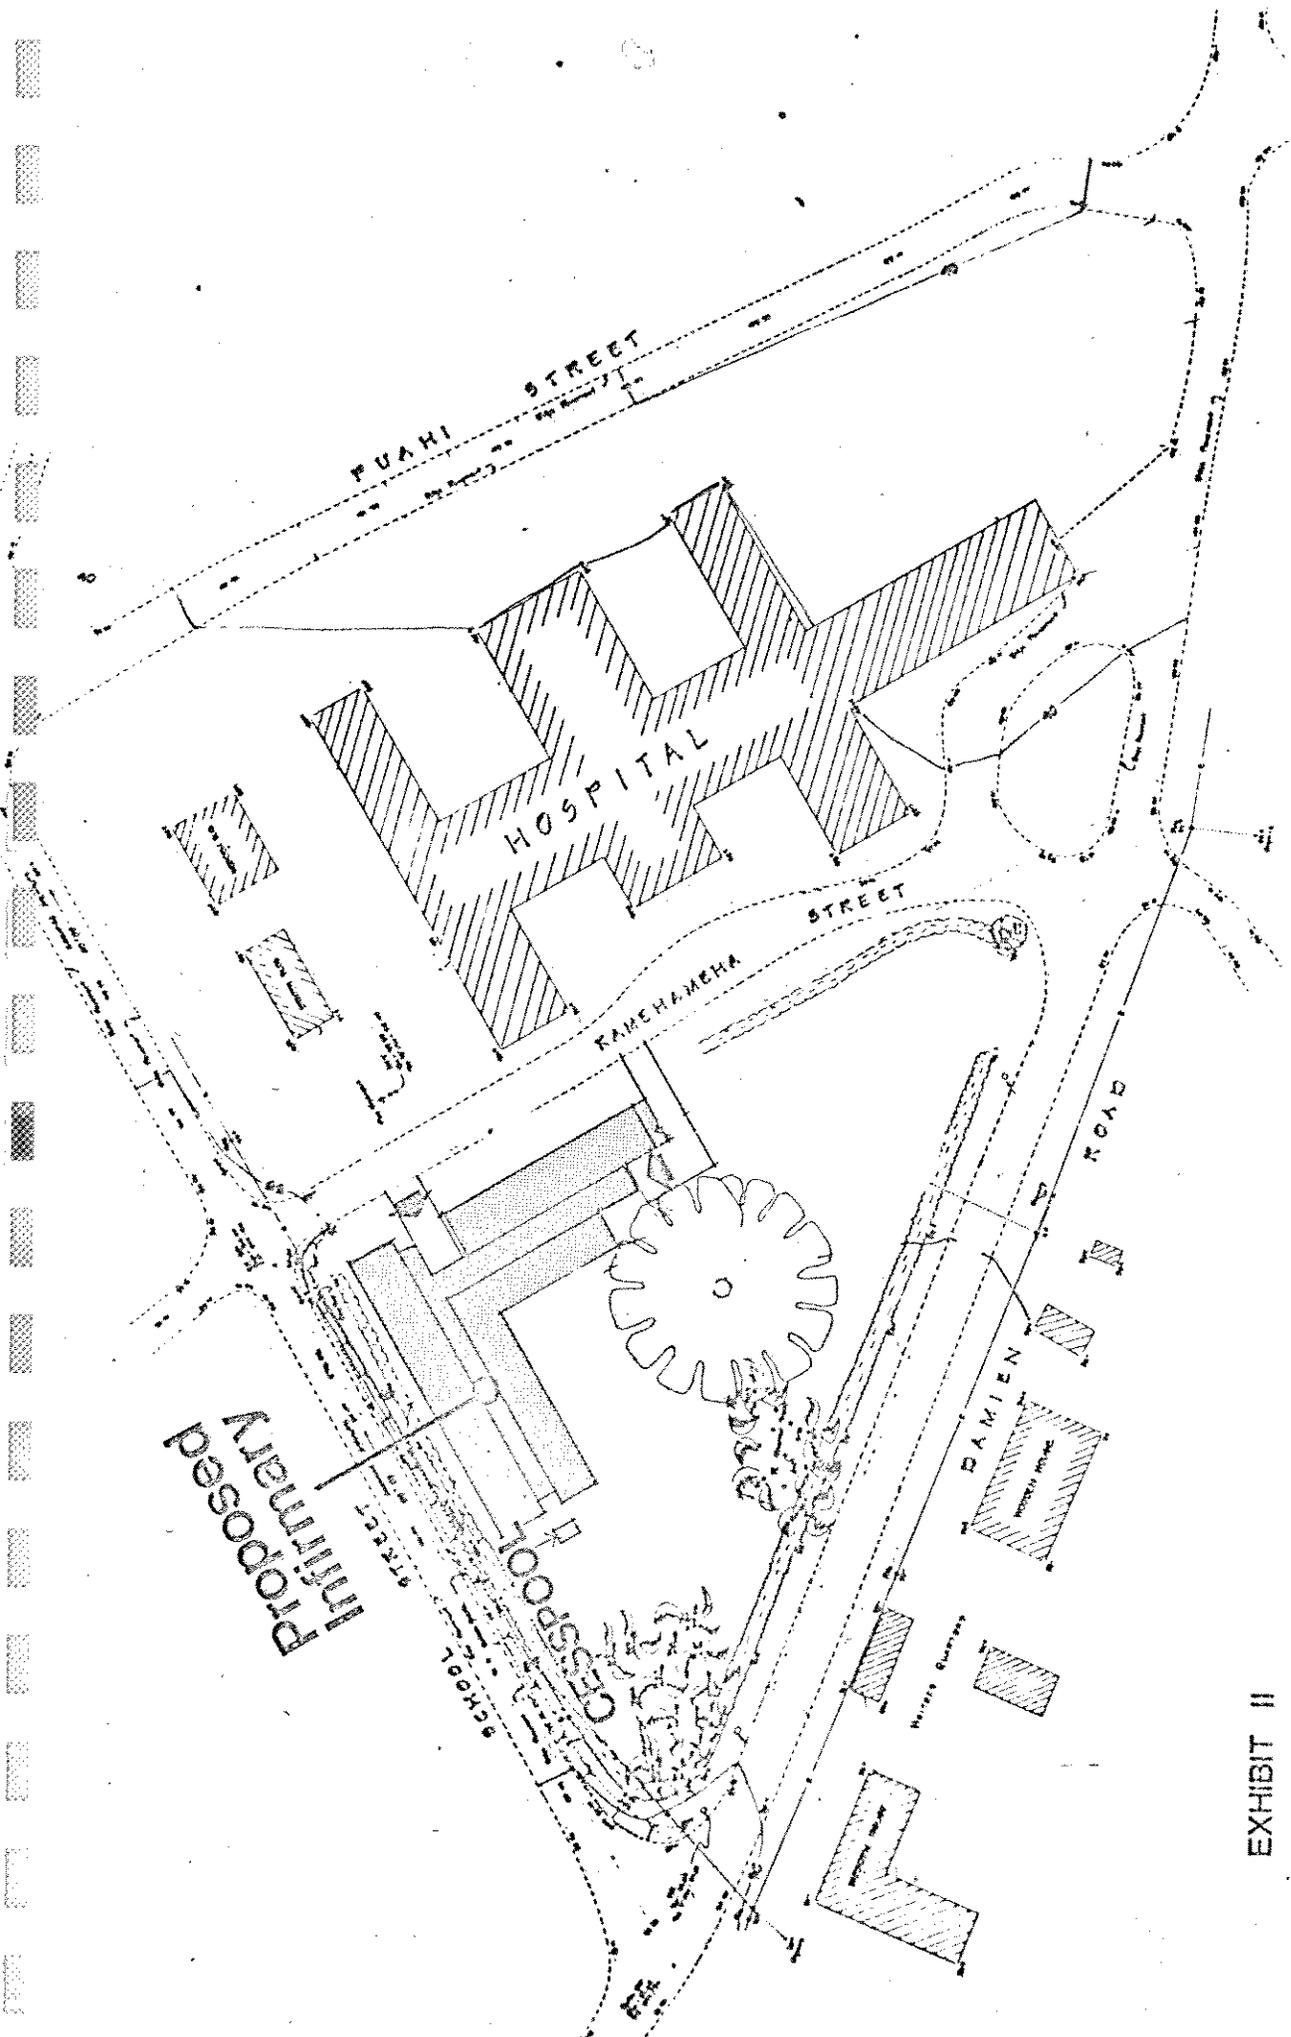
EXHIBIT II

PROPOSED SITE PLAN

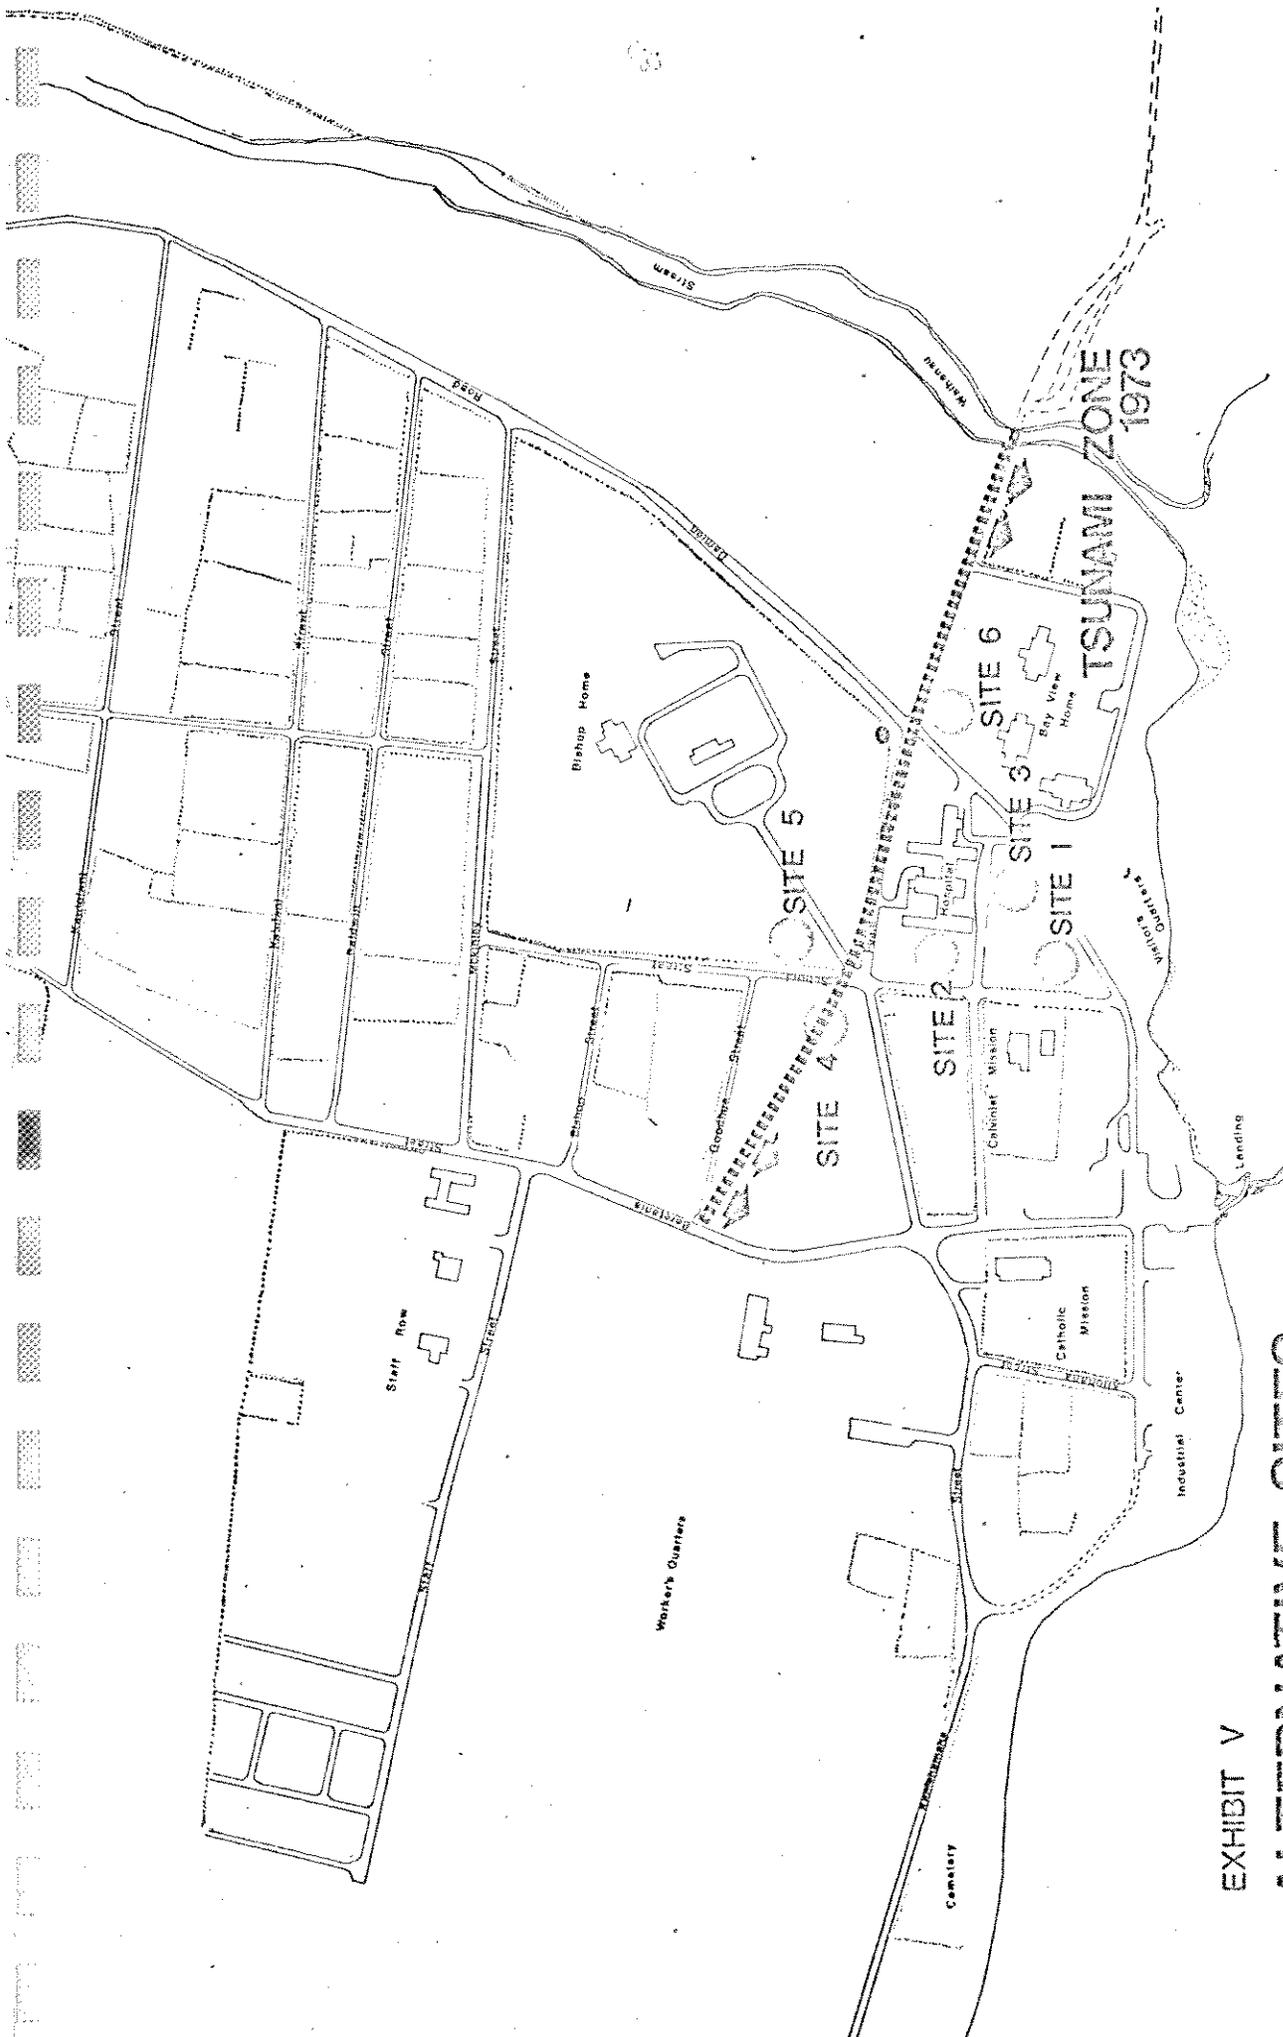
EXHIBIT V
 ALTERNATIVE SITES
 & TSUNAMI ZONE

Updated potential tsunami hazard analysis, obtained from Army Corps of Engineers, University of Hawaii Environmental Center and others, indicated that the 1946 tsunami had a run-up height at 28 ft. and the 1957 tsunami at 22 ft. at Kalaupapa. The 1946 tsunami was the highest in the last 31 years, and there is no evidence that any tsunami (local or distant) was higher in the last 100 years. The present hospital is at approximately 36 ft. and the lowest part of the proposed Infirmary site would be at 32 ft. elevation. It is therefore, concluded that all alternative sites are safe from tsunami hazard based on 100-year occurrence (see Chapter IX-1 for various comments on potential tsunami hazard).

* D.A.G.S. initially selected five sites and one additional site was added at a later date. When tsunami hazard was analyzed, only the initial five sites were considered. (For detailed discussion, see chapter VI on page 36).

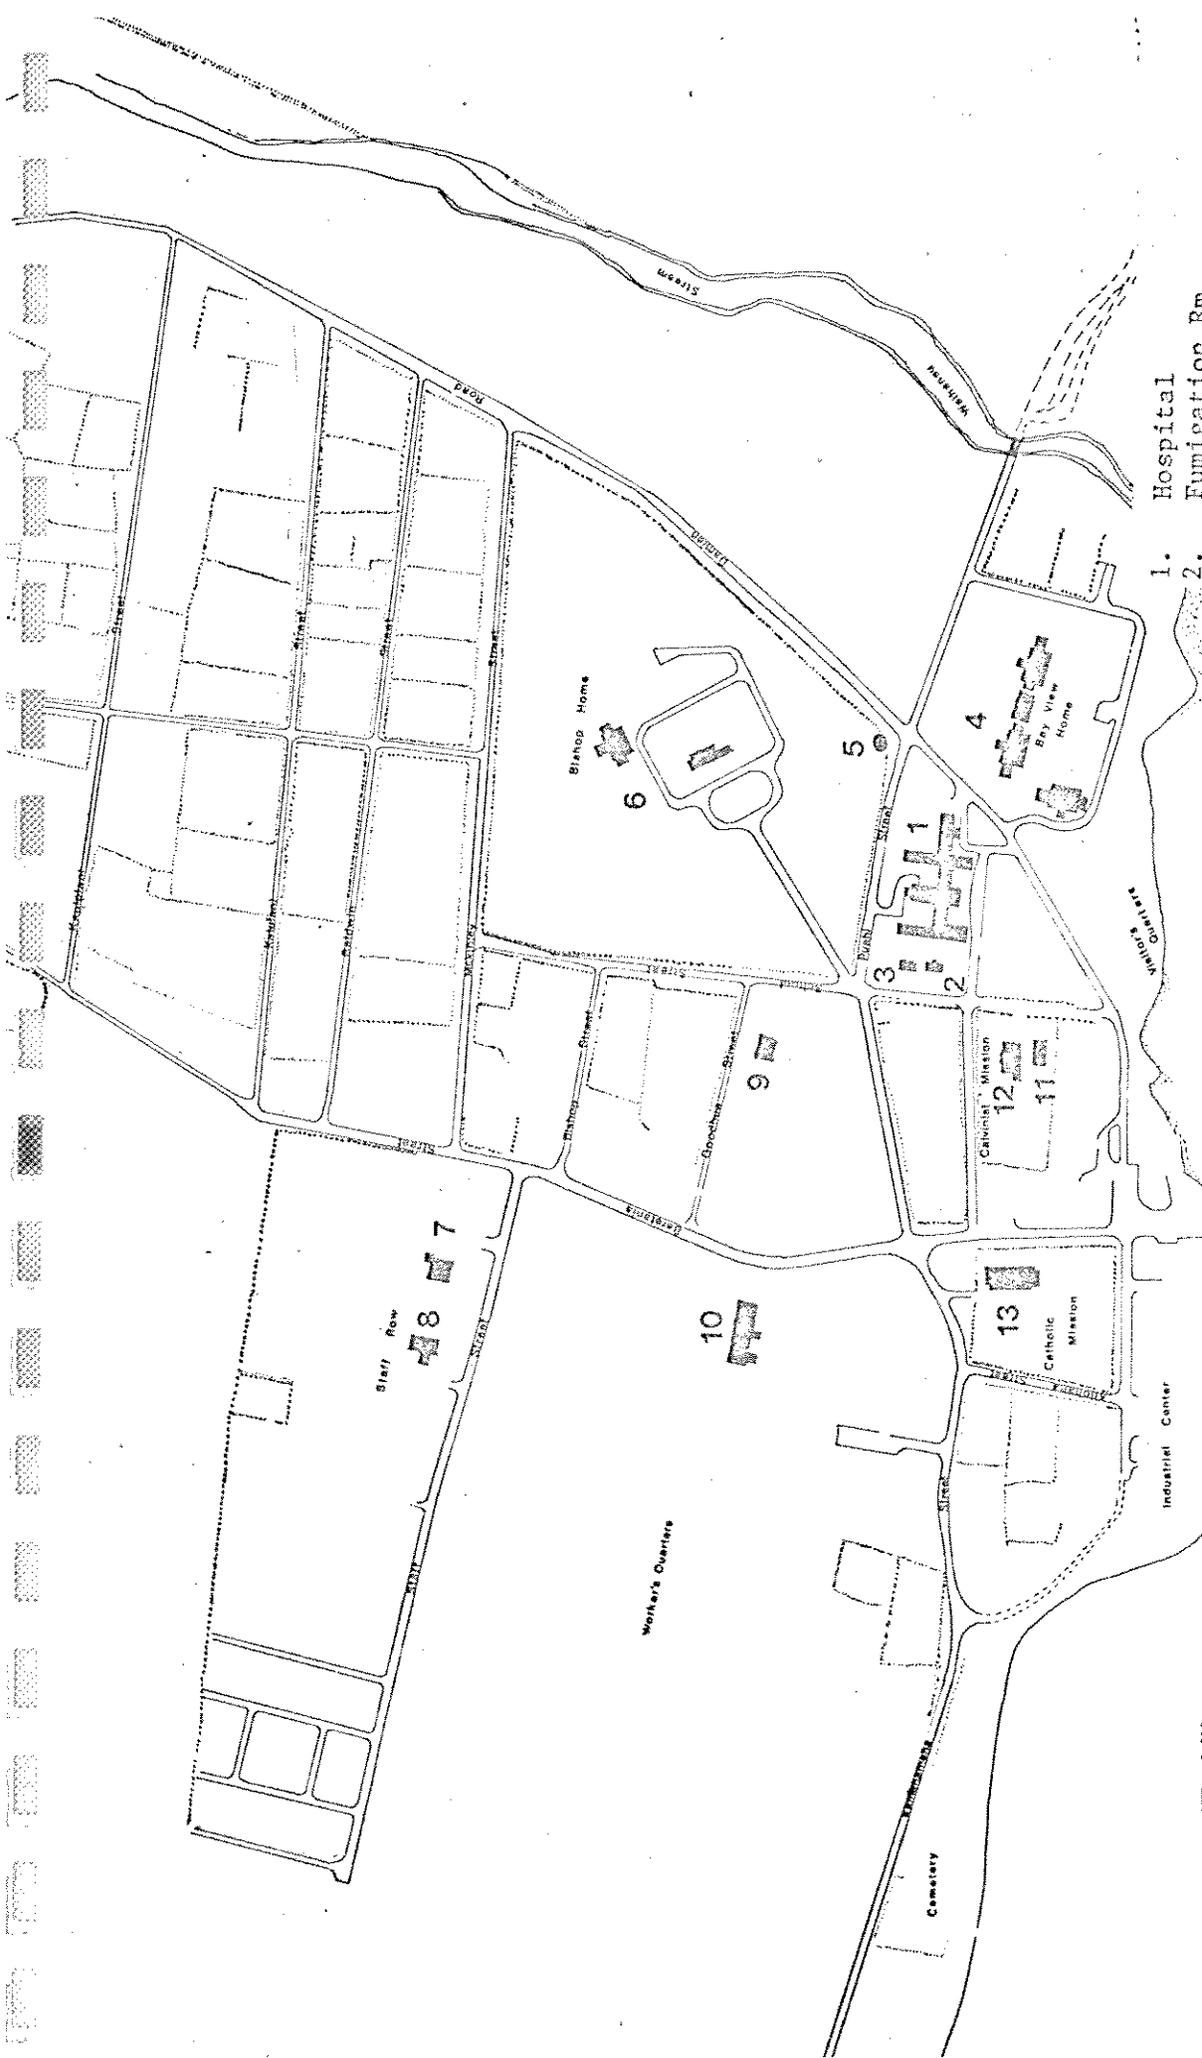
EXHIBIT VII
**HISTORIC STRUCTURES
 IN KALAUPAPA SETTLEMENT**

Of these structures the following thirteen (13) buildings are specified as historic structures in the National Register of Historic Places and Exhibit VII indicates their location within the Settlement (see the Appendix 3 for the detailed building description).

1. Hospital
2. Fumigation Rm
3. Former Out-Patient Clinic
4. Bay View Home
5. Damien Monument
6. Bishop Home for Girls
7. Former Doctor's House
8. Administrator's Home
9. Goodhue Street Residence
10. Paschaol Community Hall
11. Protestant Church
12. Kanaana Hou Church
13. St. Francis Church

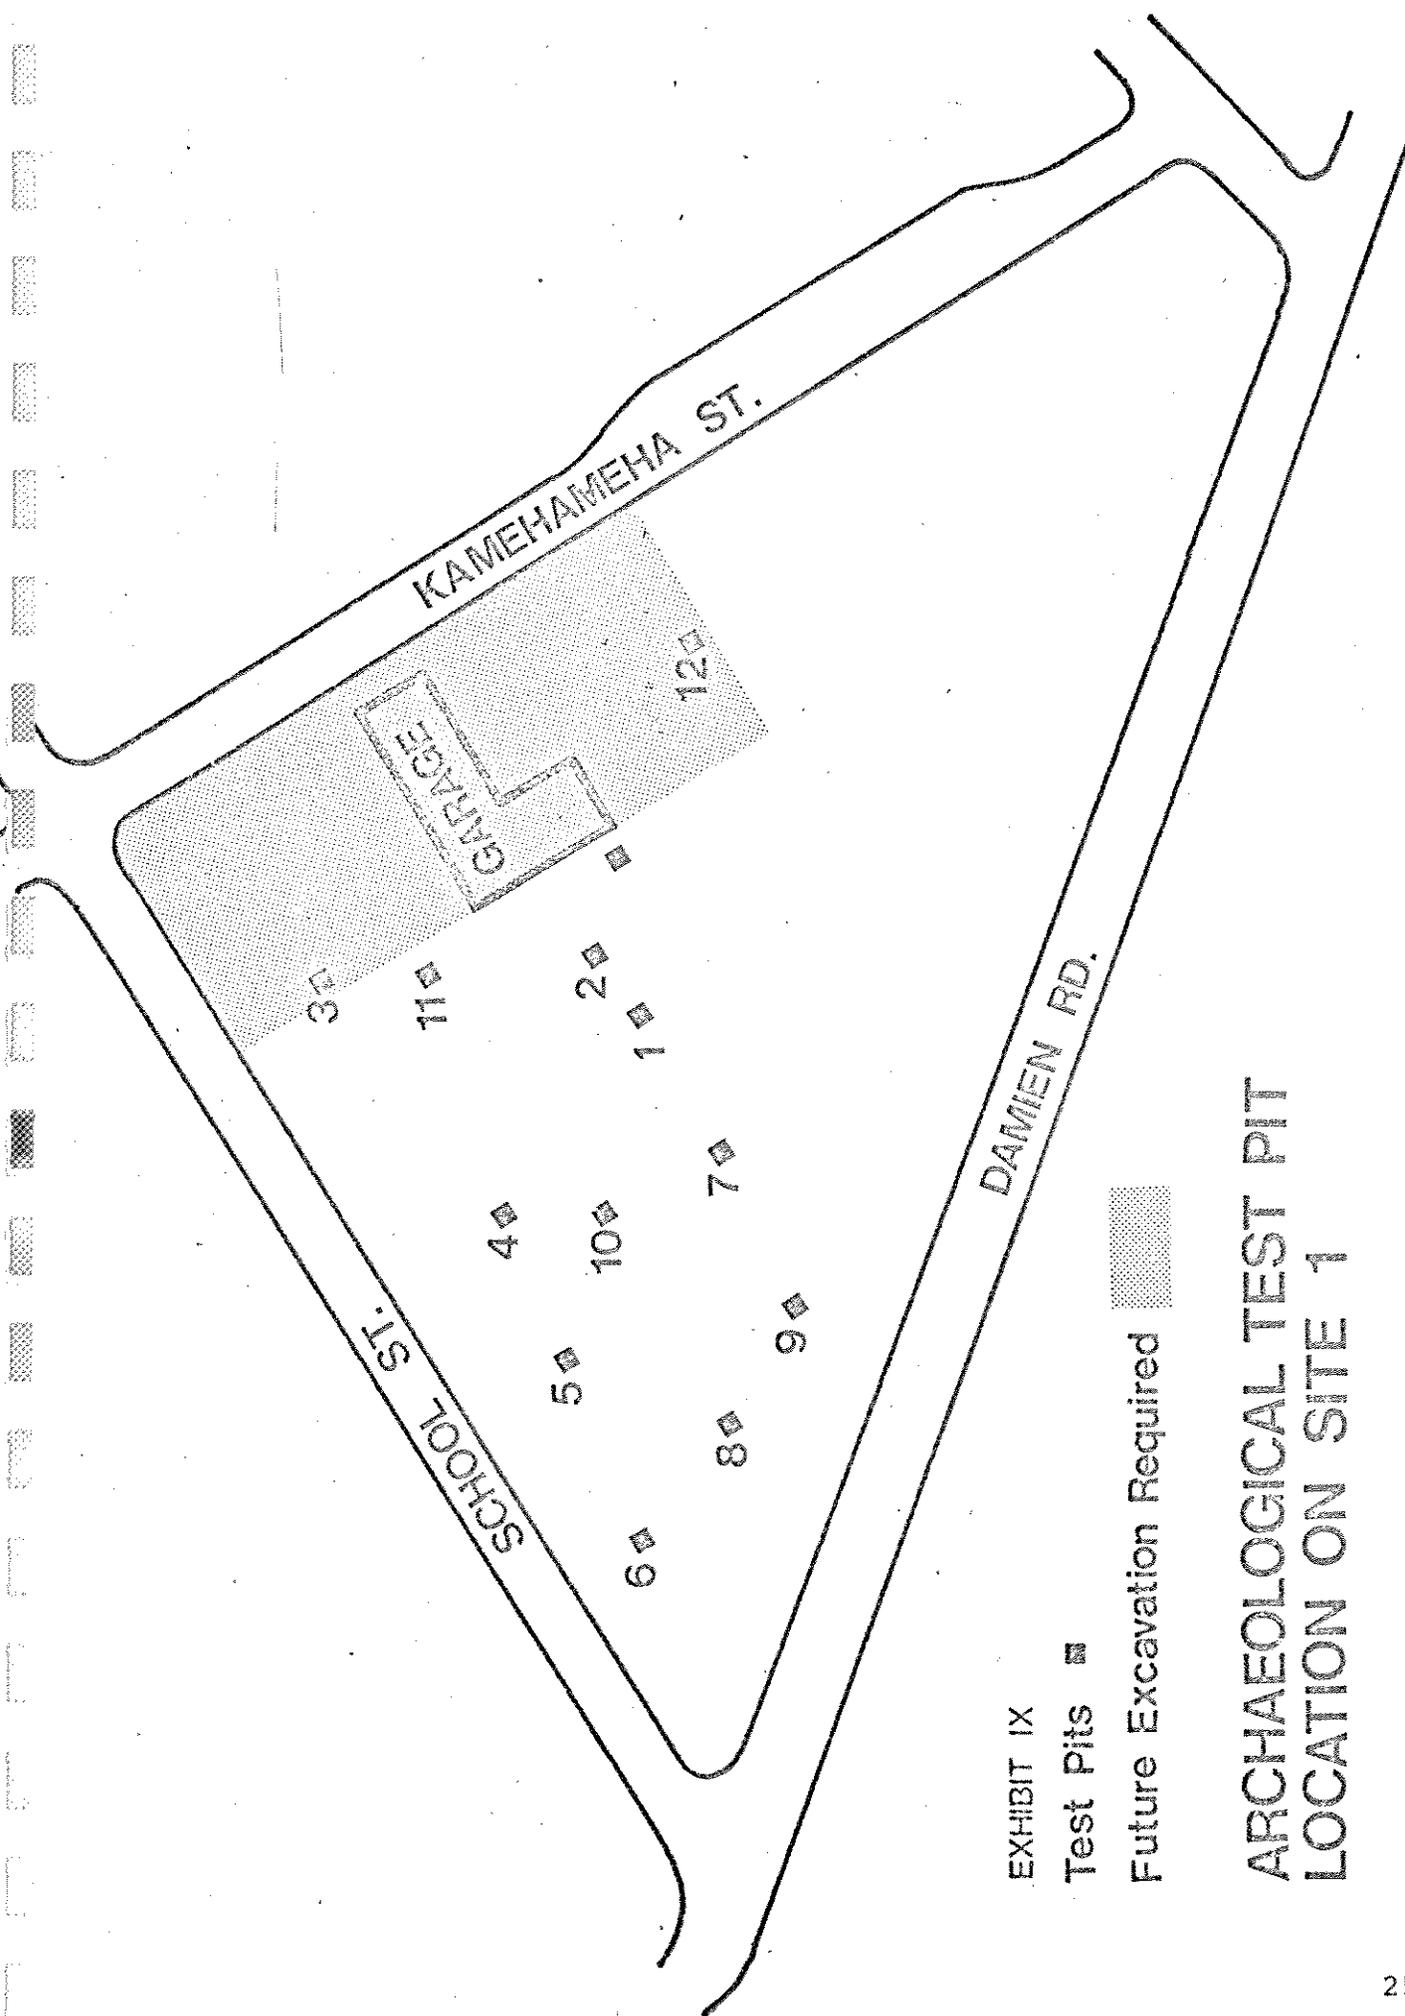
EXHIBIT IX

Thirteen (13) test pits were excavated (Exhibit IX). Due to the disturbed and mixed nature of the deposits on the west side of the survey, little of scientific value would result from an archaeological excavation in that area. Findings of Pit #12, however, indicates that the area may have been a site of historic building which was destroyed by fire. Therefore, it is recommended that no further work be done on the area other than between test pits between #3 and #12. This particular area should be the subject of further archaeological investigations before any construction activities take place (see Appendix 4 for a detailed report). This recommendation would be carried out and the findings would be supplemented at a later date.

Test Pits ■

**ARCHAEOLOGICAL TEST PIT
LOCATION ON SITE 1**

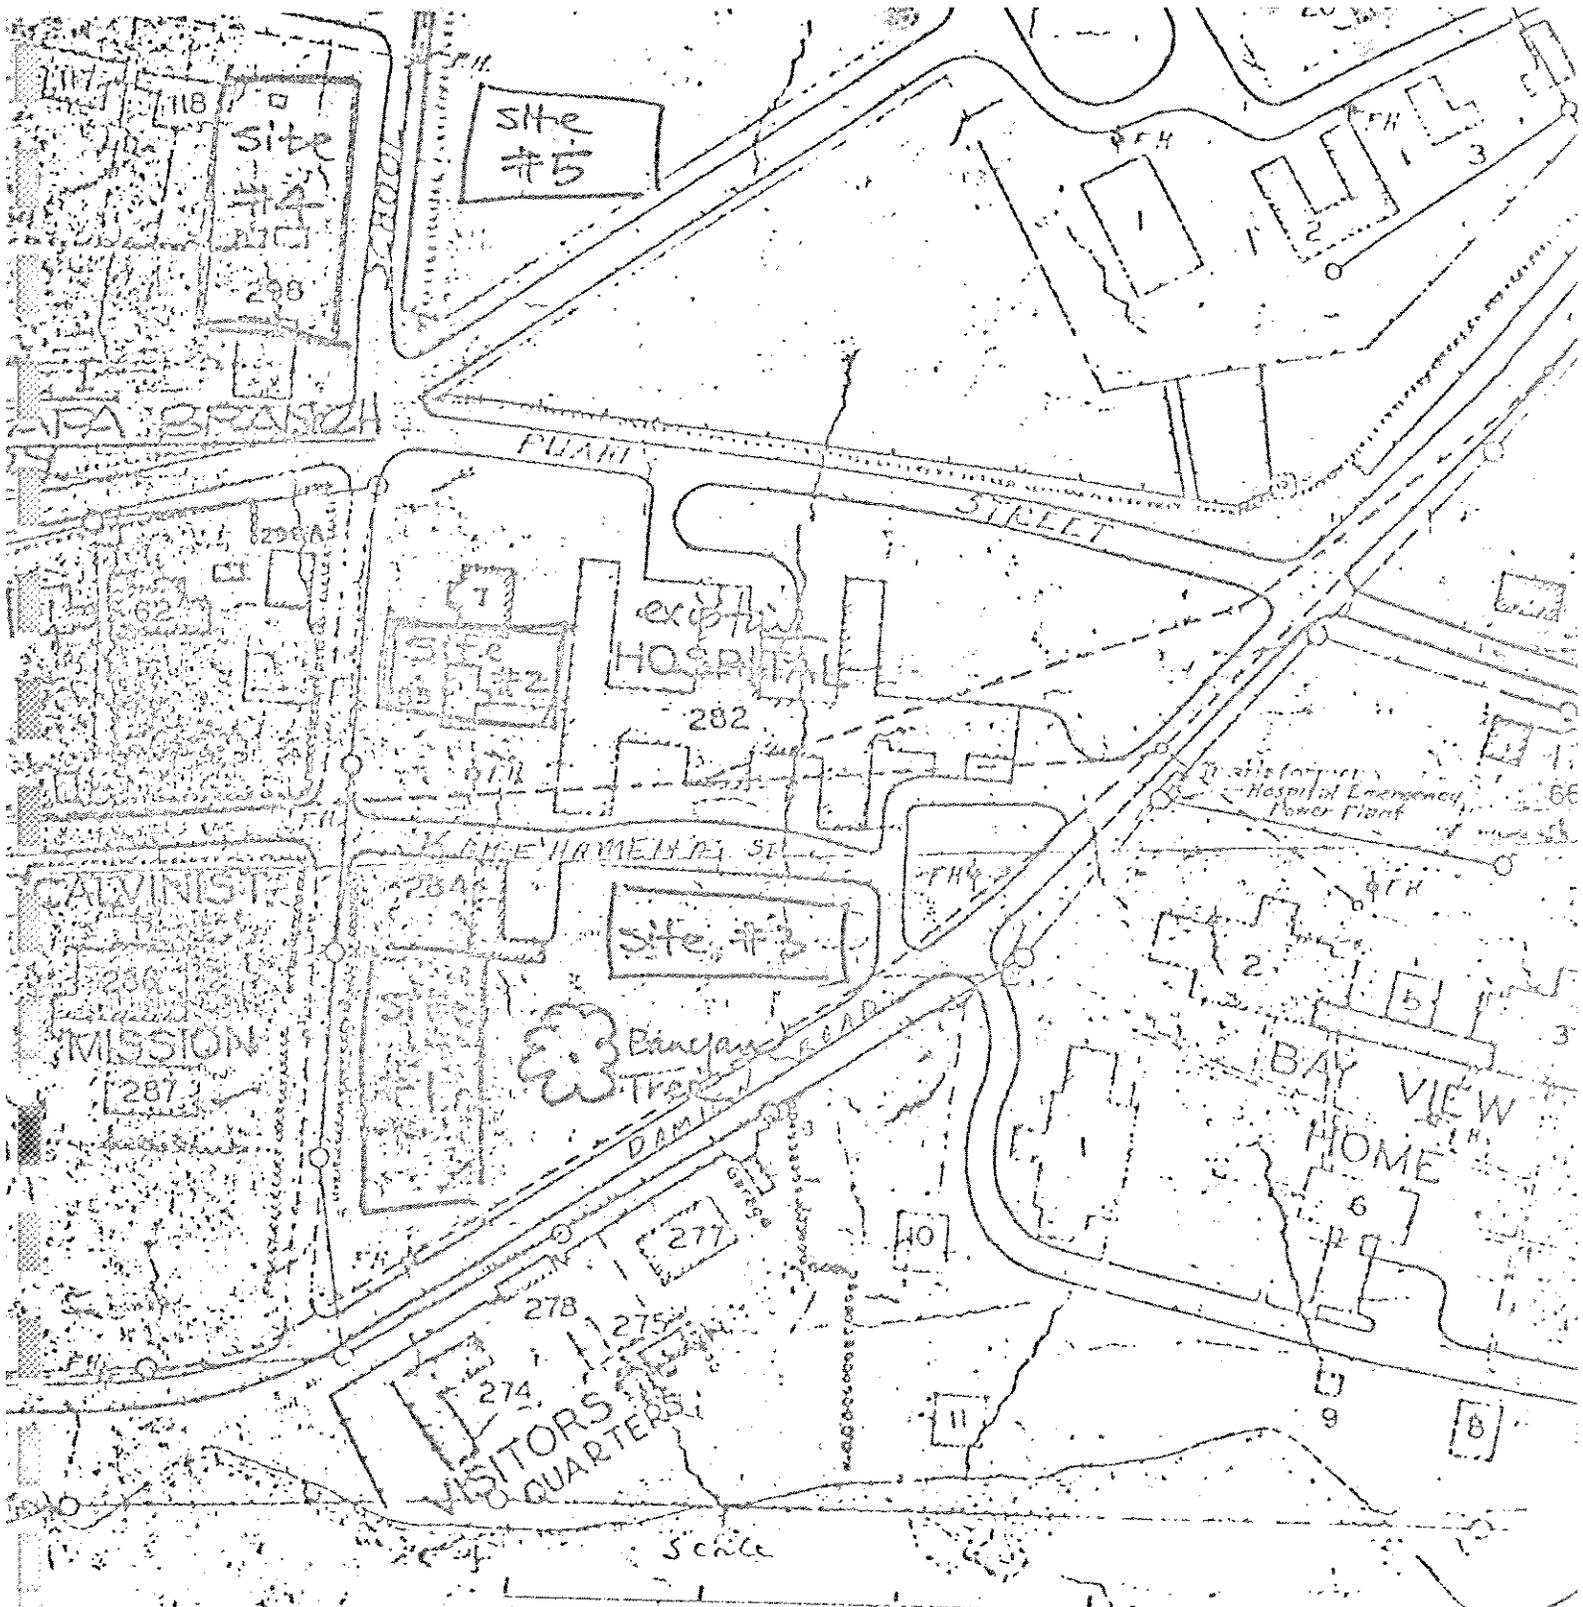
Kalaupapa Infirmery
Alternative Sites

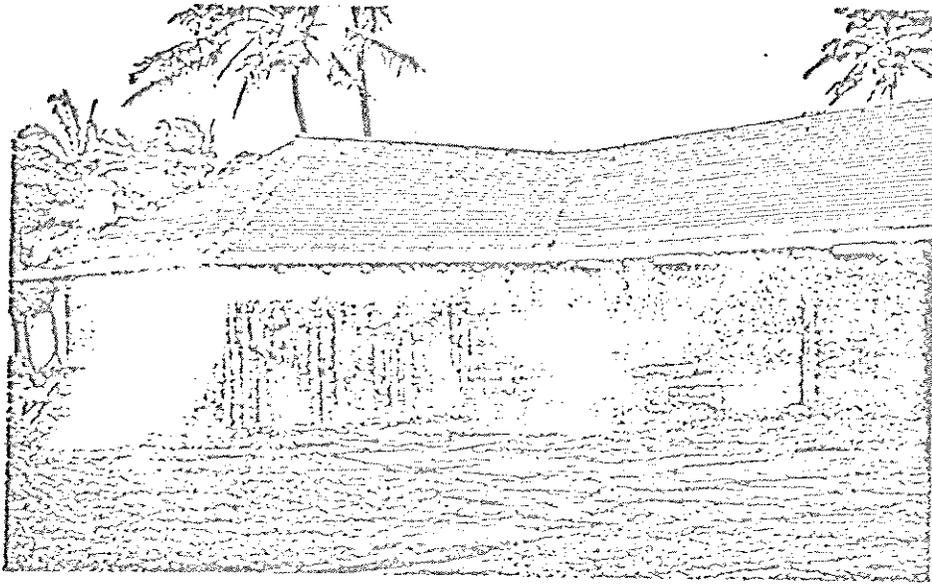
STRUCTURE: Building 284

DESCRIPTION: The structure is a frame building of single wall construction. The walls consist of vertical plank siding. The foundation consists of a concrete slab, and concrete footings. The hip roof of the L-shaped structure is finished with composition shingles. One wing of the "L" is completely enclosed and is used for storage. The other wing is divided into two large garage bays (two cars in each bay) and is completely open on the south side. The building is in poor condition. The structure is riddled with termites and the eaves are warped badly on the north side of the building. To keep the structure serviceable, the building should be fumigated and painted. Termite damage should be repaired. Vegetation should be cleared away from the base of the building.

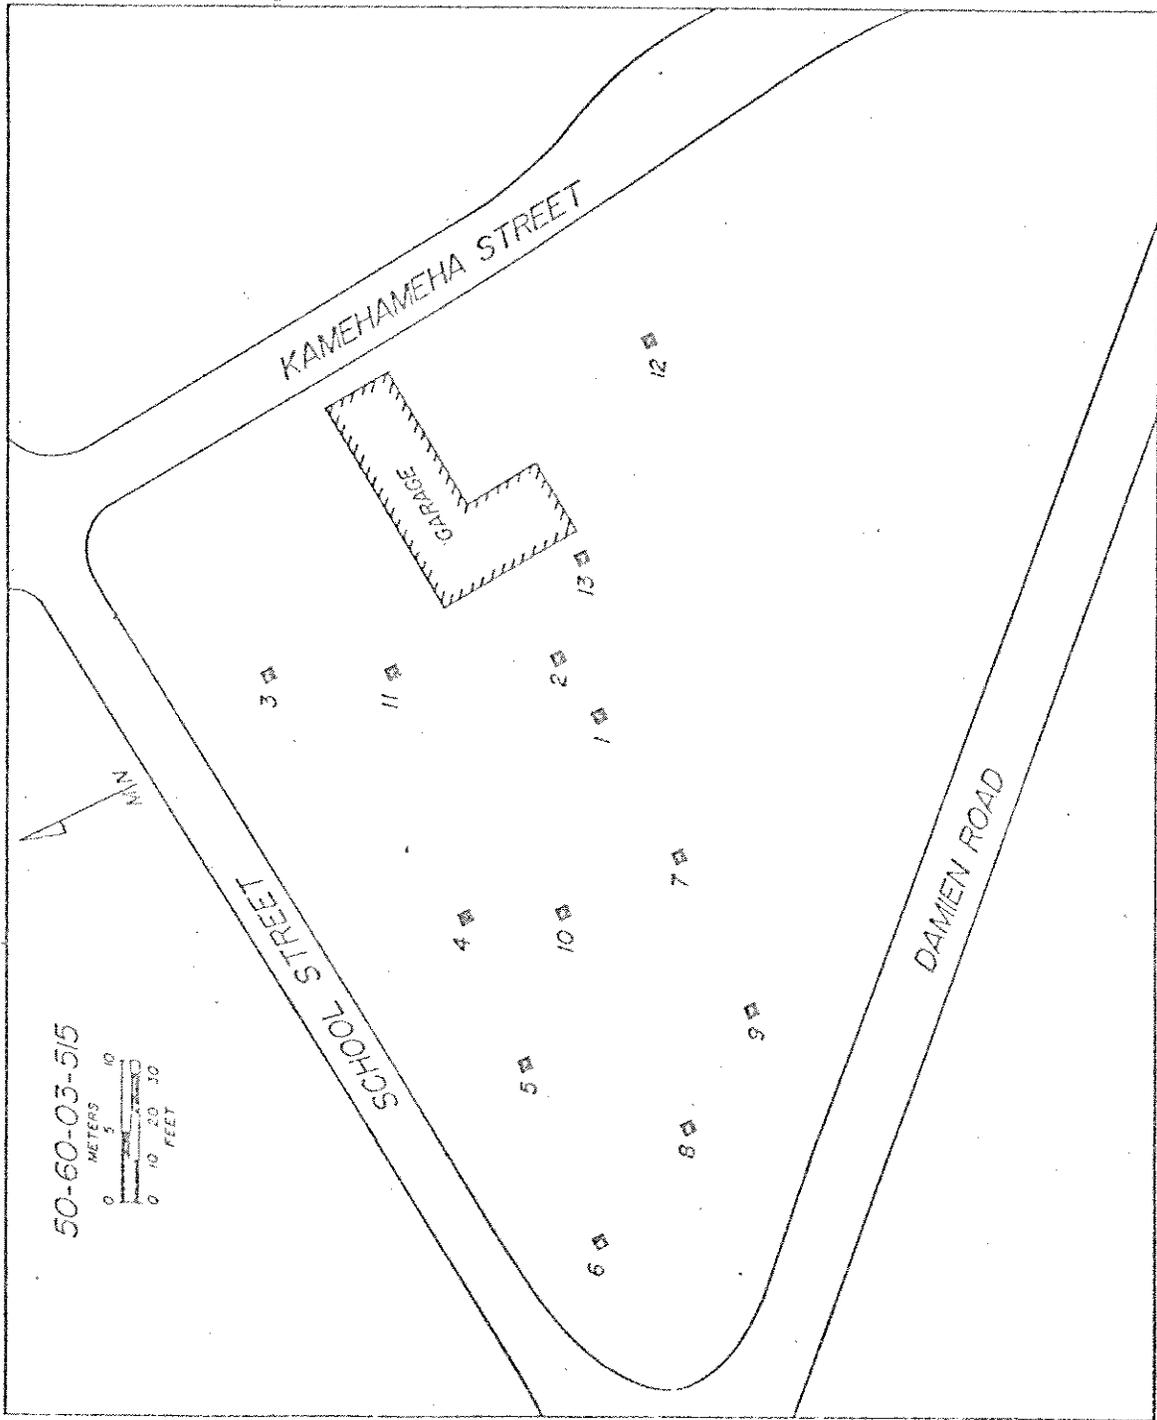
Figure 2. Map of Project Area, Showing Locations of Test Pits

Thirteen test pits were excavated. All materials were sifted through 0.25-inch mesh and the residue of artifacts and midden materials was saved and quantified. These are presented in Appendices I and II. Bone material from the excavations has been separated and will be submitted to a zoologist for identification, and these results will be made an appendix to this report at a later date.

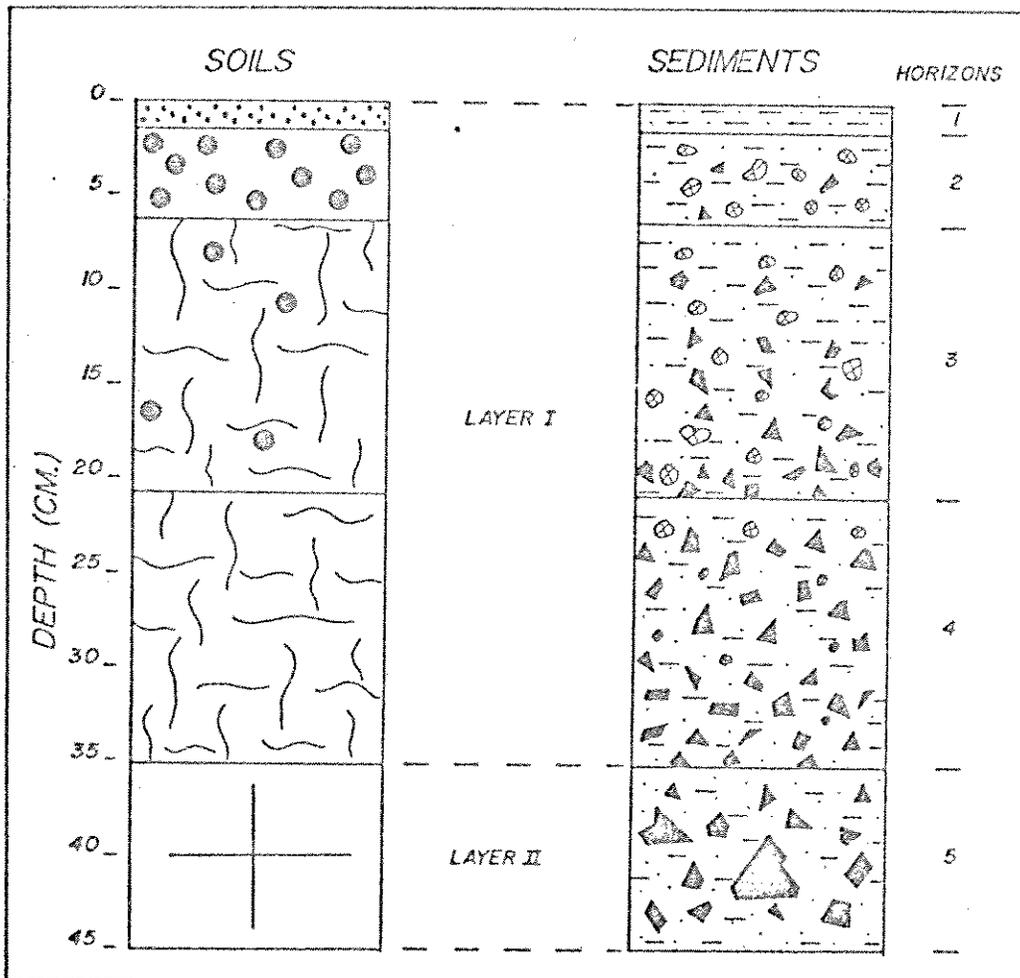
Figure 1. Profile of Square Six

0.1 cm.] strong blocky to slightly granular, sub-angular peds, slightly sticky, slightly plastic with common medium horizontal roots and rare small vertical roots, bioturbated by roots. Bottom contact gradational and drawn because of change in ped structure,

LAYER II - 35-45 cm. Aeolian and in situ basaltic boulder sediment, with boulders indicative of talus derivation and naturally sourced from pahoehoe lava flows, bimodal sediment, 7.5YR 4/2, dry 10% moisture content at 40 cm., homogeneous matrix with 5YR 5/1.5 and 7.5YR 4.5/2 common sub-angular to angular pebbles to cobbles and moderately common large cobble to boulders [rare].

Soil Horizon 5: 35-45 cm., C horizon, apedal to very weak angular blocky peds when broken, slightly sticky, slightly plastic, with rare root tube bioturbation. Unmodified, aeolian matrix with basalt is locally derived. Designated a C soil horizon which is developing into a B horizon - transitional. No evidence of churning or disturbance. No bottom contact.
