**DEPARTMENT OF TRANSPORTATION
FEDERAL AVIATION ADMINISTRATION**

**ENVIRONMENTAL IMPACT STATEMENT
PART 2 OF 2**

**KALAUPAPA AIRPORT, ROADWAYS AND WHARF IMPROVEMENTS
KALAUPAPA, MOLOKAI, HAWAII**

**STATE OF HAWAII
DEPARTMENT OF TRANSPORTATION
AIRPORTS DIVISION**

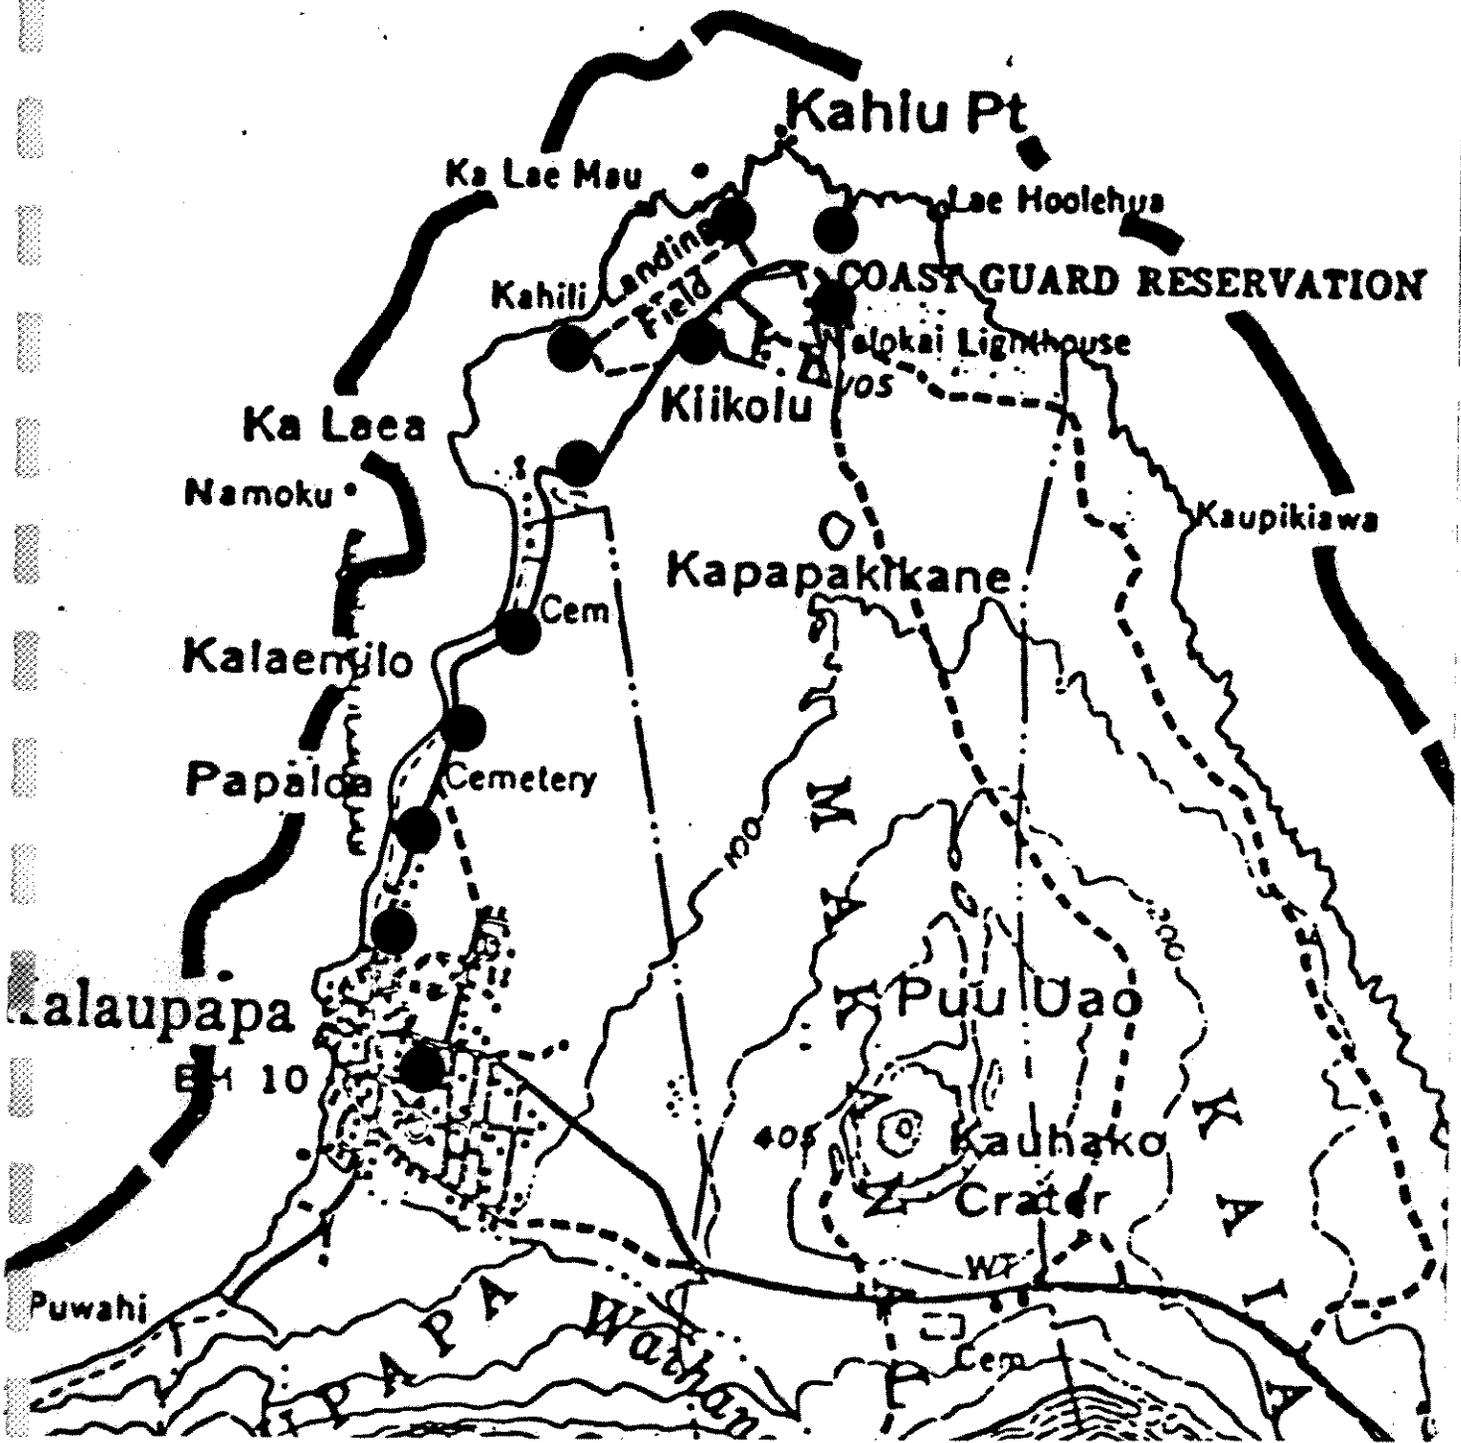
Fig. 1. Project site with locations of eight minute count stations indicated by solid circles.

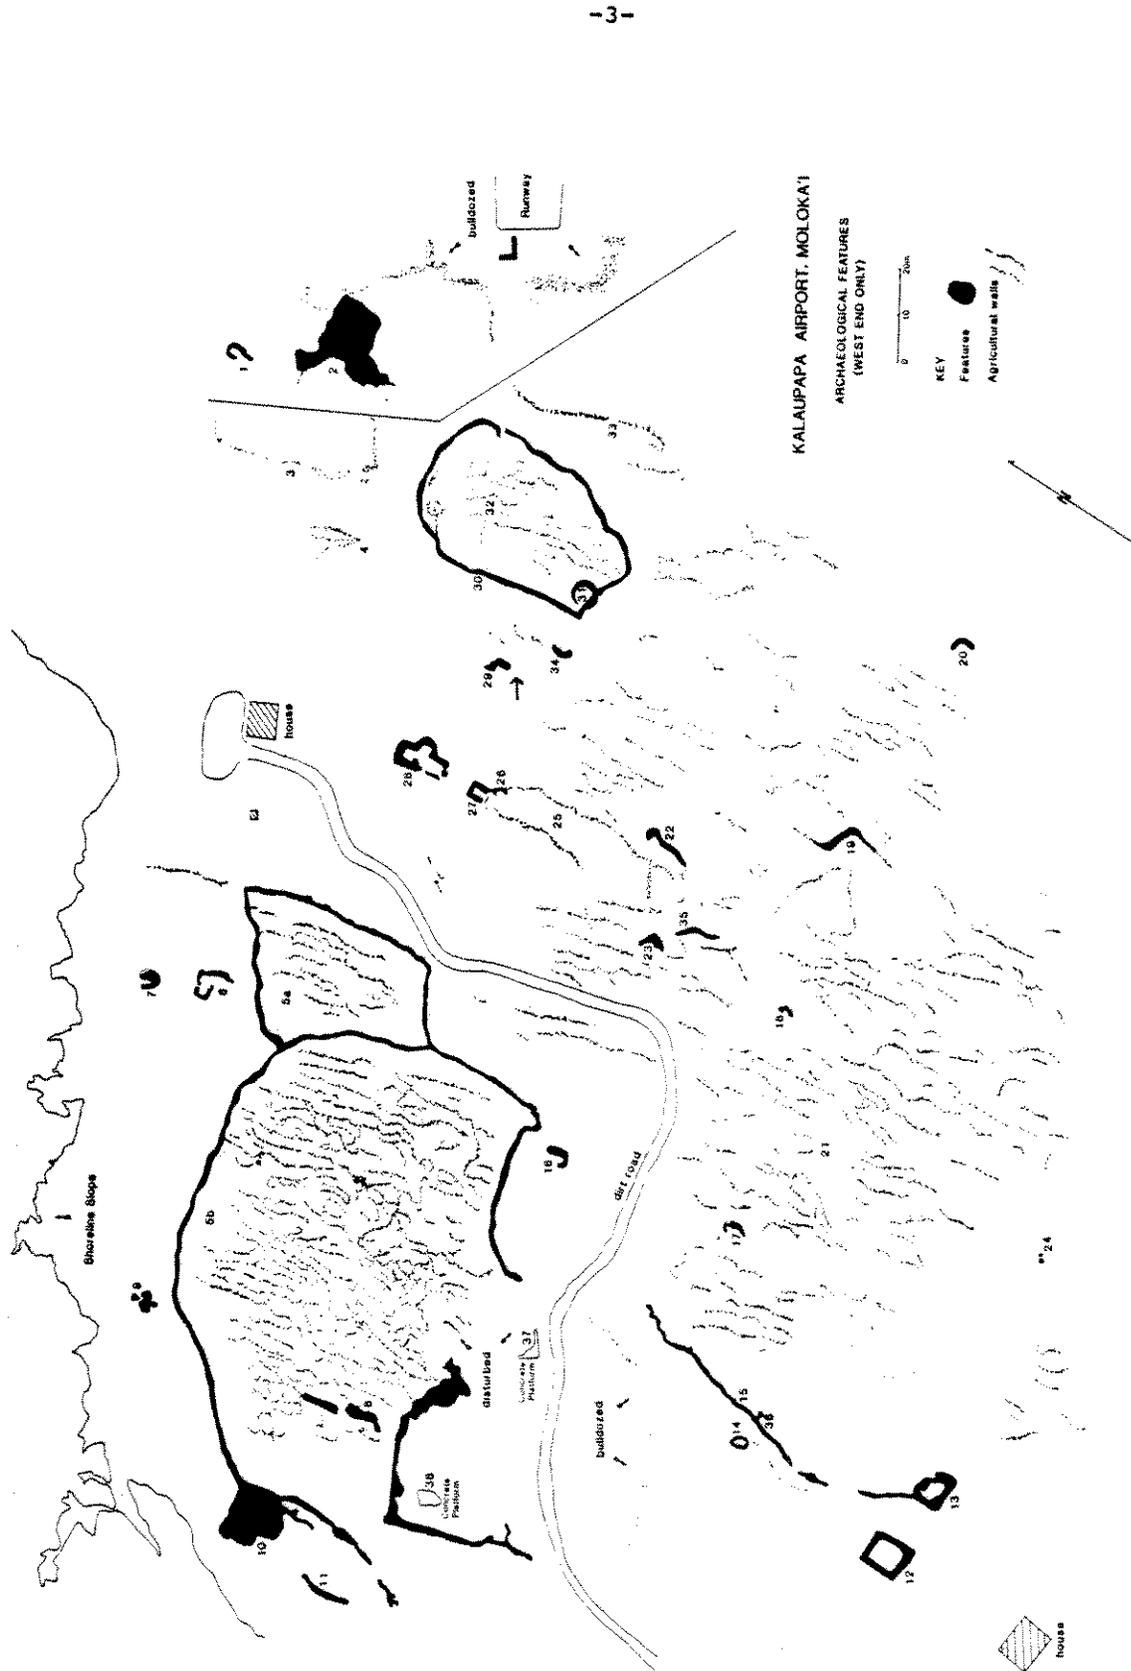
Figure 2. Map of west end of project area showing the spatial distribution of the archaeological features.

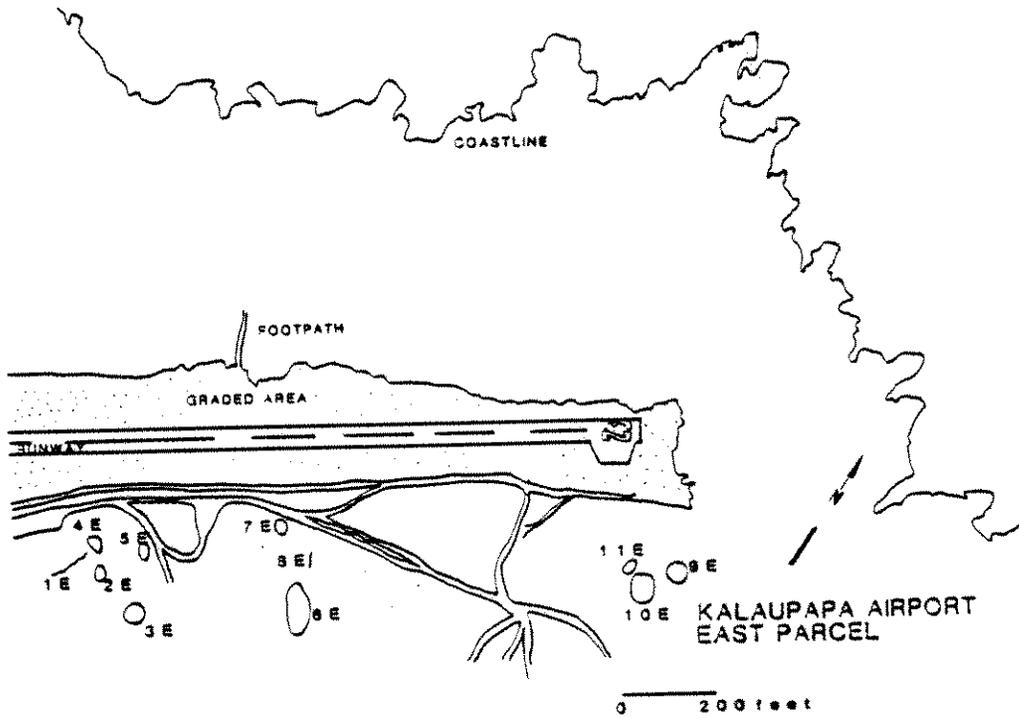
Figure 3. Map of east end of project area showing the spatial distribution of the archaeological features.

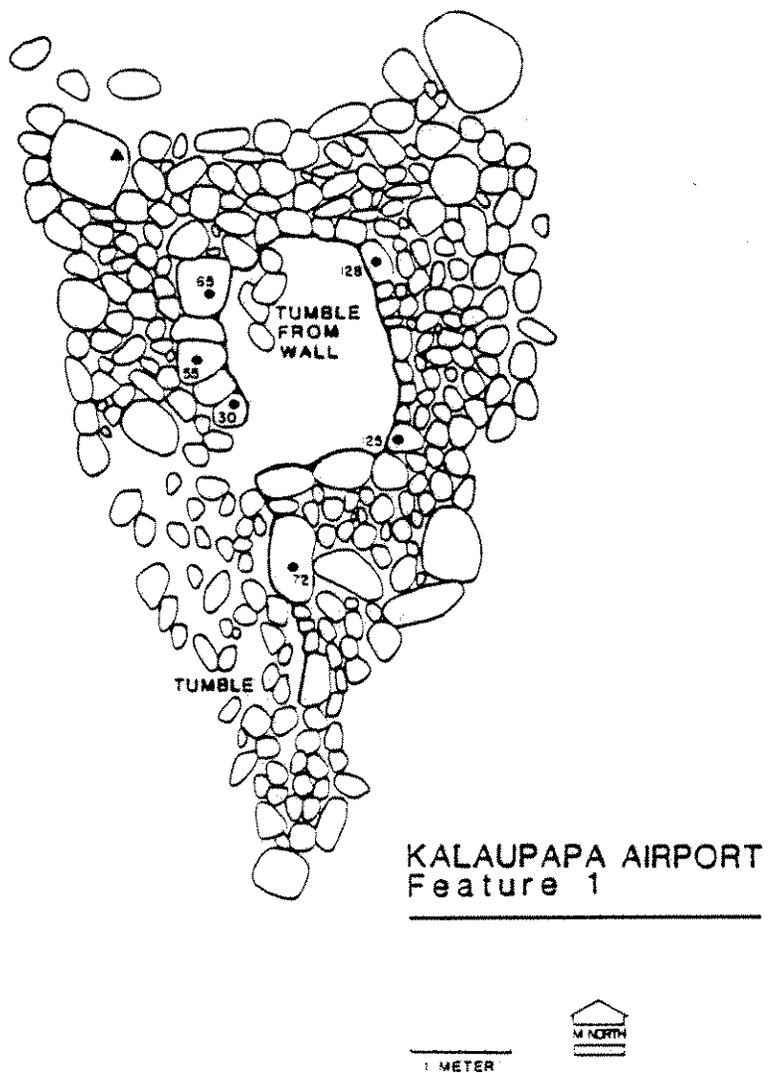
Figure 7. Map of Feature 1.

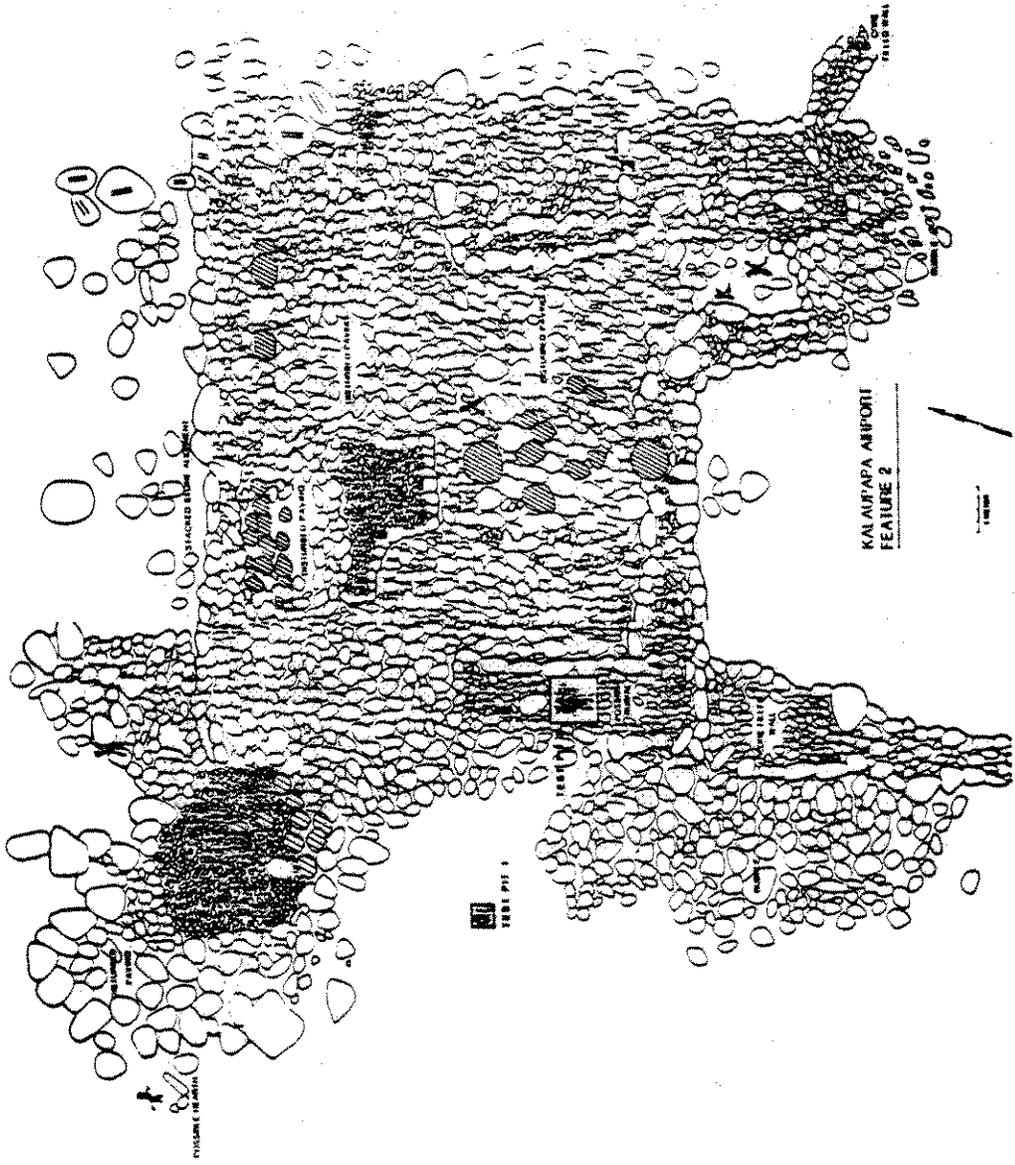
Figure 8. Map of Feature 2.

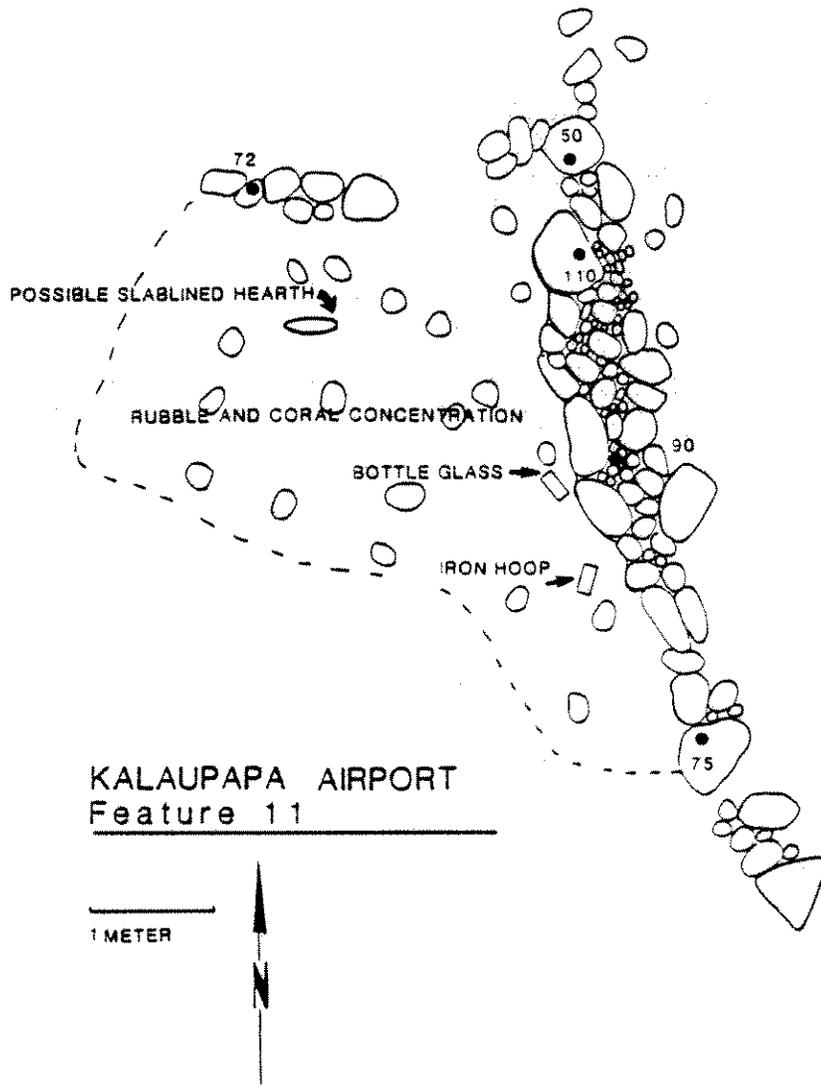
Feature 11 is a disturbed L-shape with an interior paving (Fig. 15). The windward wall of the L-shape is ca. 8.7 m long, 1 m high, and has a maximum height of 1.1 m. A portion of the wall is core-filled and the rest of it is stacked stone. The currently disturbed portion that is stacked stone might have been core-filled at one time. The side wall is stacked stone. The interior of the feature consists of 30 to 70 cm boulders intermixed with coral paving and ili ili stones. There is a possible slablined hearth in the paving. Two fragments of historic dark green glass, 2 fragments of violet glass, and several pottery sherds are on the surface of the paving. The violet glass is similar to pieces found in the enclosure next to Feature 10. Feature 11 probably functioned as a shelter or residence. Subsurface testing was not conducted at this feature.

Figure 15. Map of Feature 11.

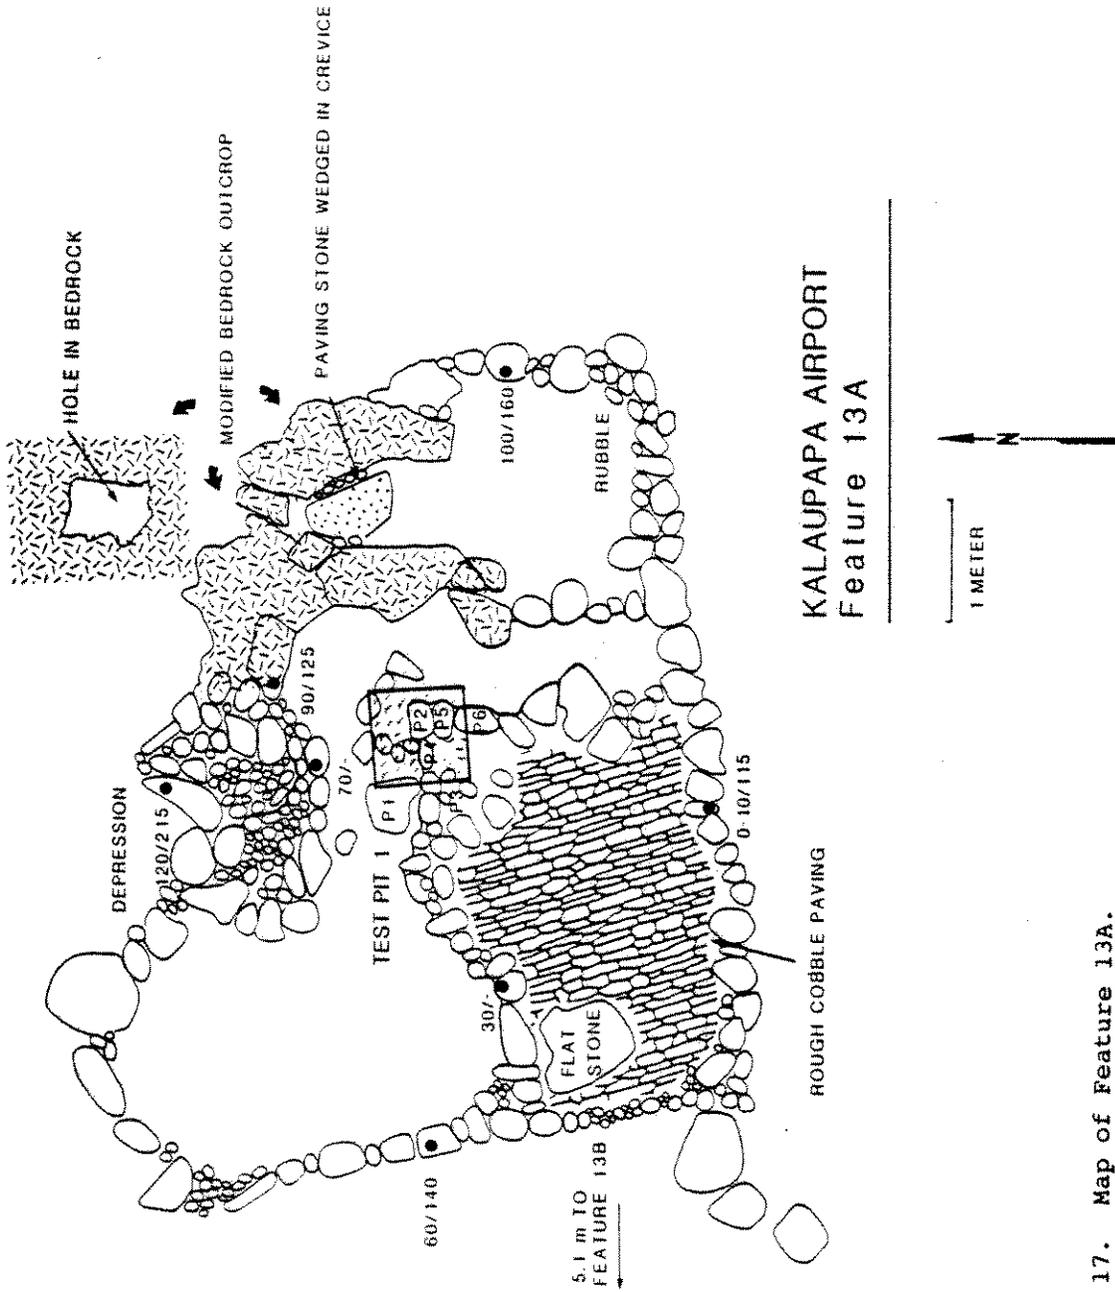
Feature 13 is a hill-top enclosure with 2 interior terraces and a small, faced depression (Figs. 17 and 18, and Photos 12 and 13). From the floor of the feature to the base of the outcrop is ca. 5 m. The south wall is 8 m long and the west wall 6.1 m long. The east wall is approximately 4.25 m, and the north wall is somewhat irregular in shape. An entrance step approximately 80 cm high is located in the northeast corner. The interior wall height is 90 to 140 cm and the exterior has a vertical drop of 1 to 3 m. The enclosure wall is stacked stone and incorporates a number of bedrock outcrops. There is a roughly paved terrace in the southwest corner of the unit. It is 4.2 by 2.6 m, and the height of the terrace face is 30 cm. The paving cobbles range in size from 10 to 40 cm. A 1 by 1 m test pit was excavated at the northeast corner of this terrace. The test pit uncovered a cultural deposit containing quantities of Sus scrofa (Pig), other mammal, fish, and bird bone. A second terrace is located in the southeast corner. It is not nearly as well constructed. A small, walled depression was incorporated into the north wall of the enclosure. It may have functioned as a storage area. Just outside of the enclosure there was a small man-made depression built into the bedrock outcrop. In between Feature 13 and Feature 12 there was a small terrace. It is 6 m long, 2.6 m wide, and the height of the terrace face is 1.6 m. The precise function of feature 13 is unknown, but several hypotheses are presented in the excavation section of this report.

Figure 17. Map of Feature 13A.

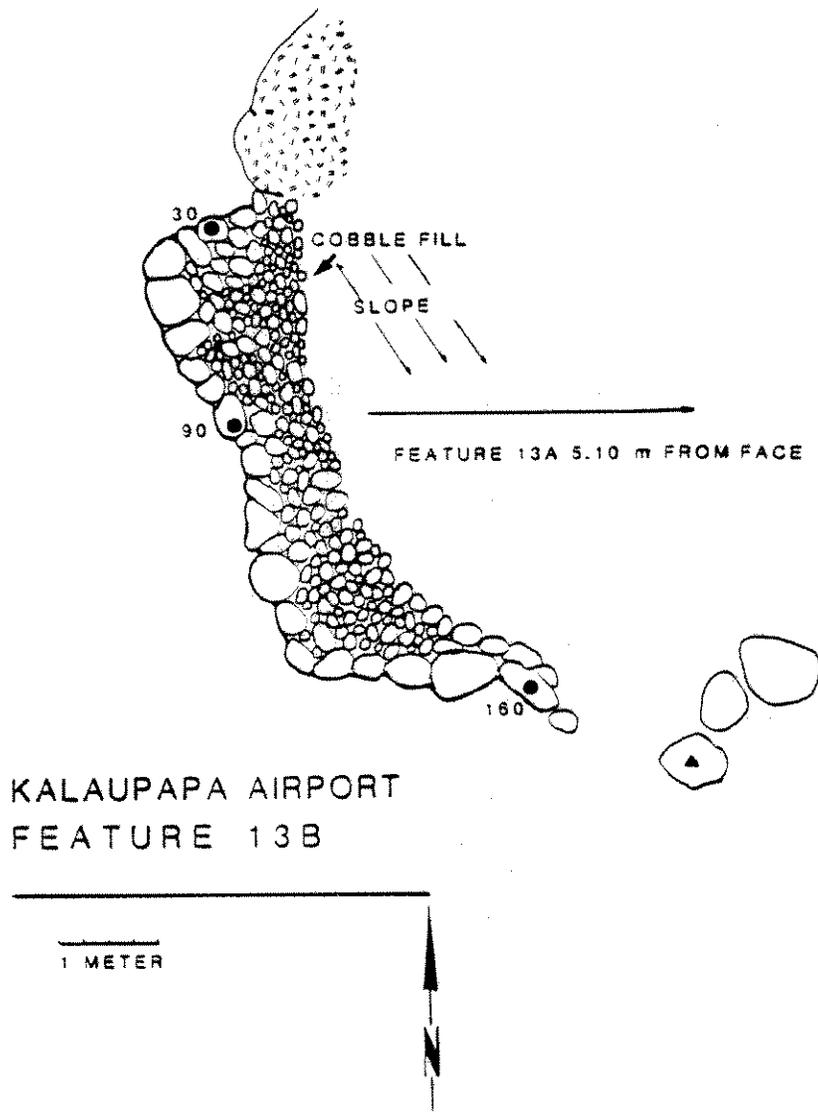
Figure 18. Map of Feature 13B.

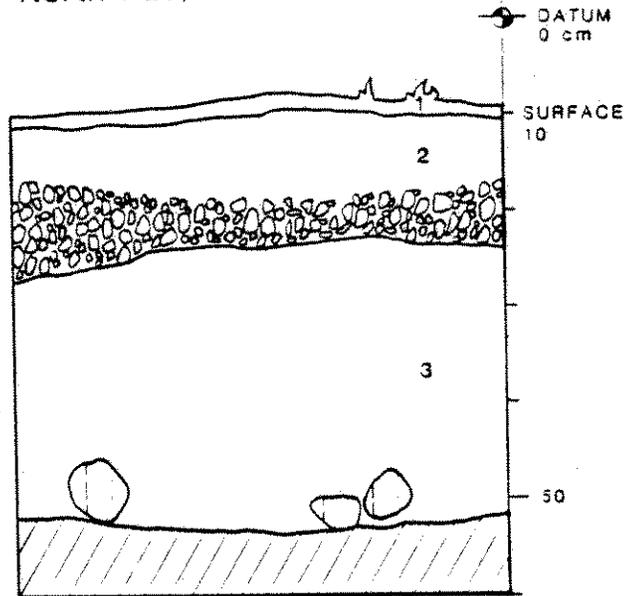
FEATURE 2 Test Pit 1
North Face

Layer	Munsell Color	Boundary	Description
1	-	abrupt (smooth)	silt loam, with wave washed shell and coral, lots of roots and vegetation
2	10YR 2/2 (very dark brown)	abrupt (smooth)	silt loam, with wave washed shell and coral; basalt pebbles
3	10YR 3/3 (dark brown)	-	silt loam, with wave washed shell and coral

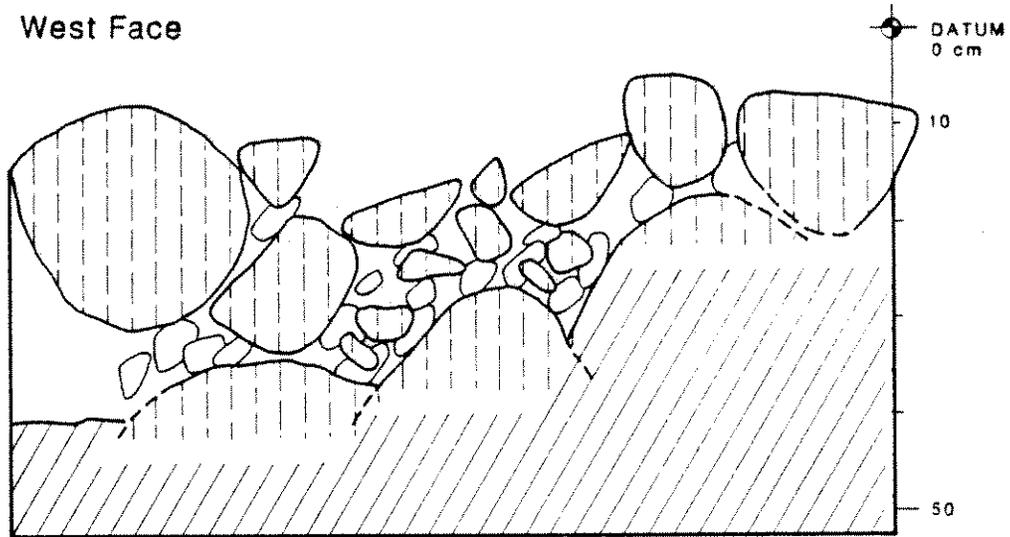
FEATURE 2 Test Pit 2
West Face

Layer	Munsell Color	Boundary	Description
1	-	-	pebble, cobble, boulder fill

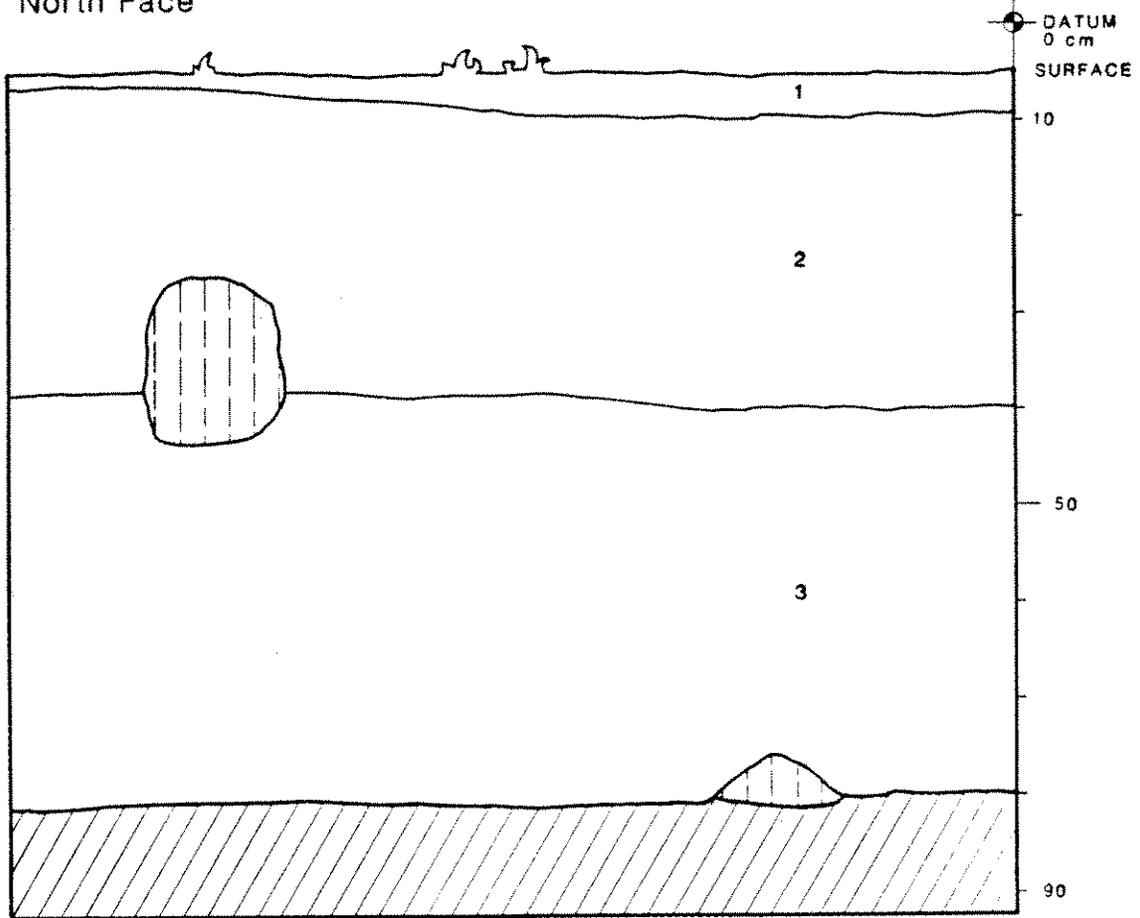
FEATURE 5B Test Pit 1
North Face

Layer	Munsell Color	Boundary	Description
1	10YR 2/2 (very dark brown)	abrupt (smooth)	sandy loam with wave washed shell and coral
2	10YR 3/3 (dark brown)	abrupt (smooth)	loam with wave washed shell and coral
3	10YR 3/3 (dark brown)	-	loam with wave washed shell and coral

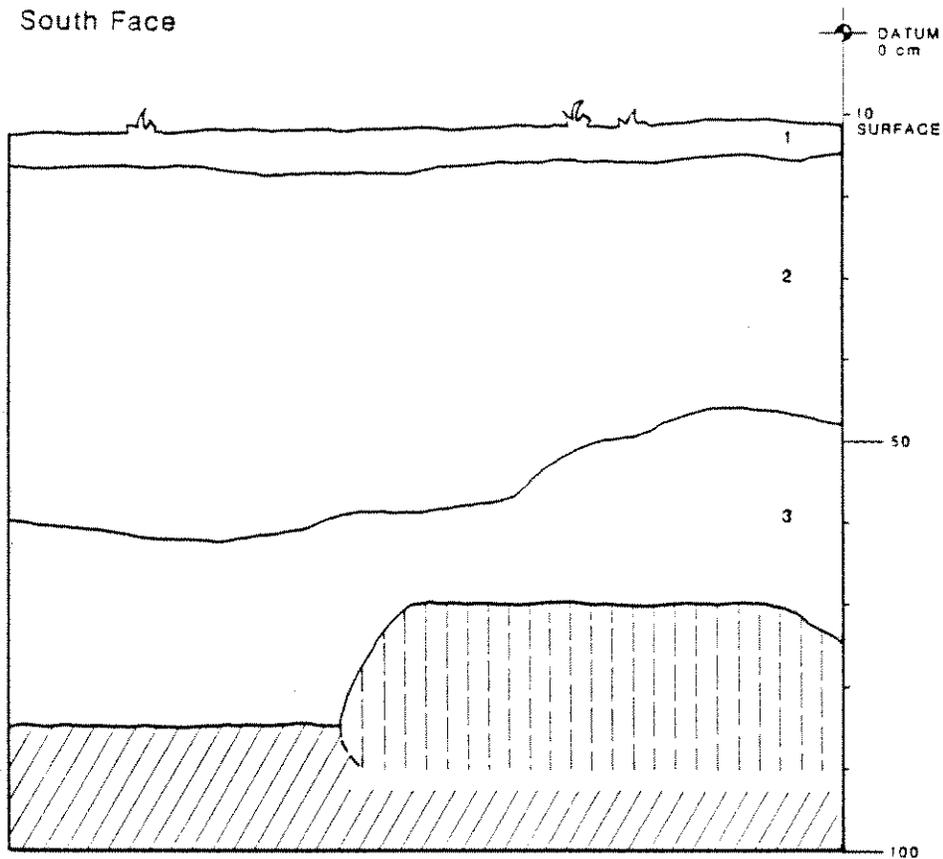
FEATURE 8 Test Pit 1
South Face

Layer	Munsell Color	Boundary	Description
1	10YR 8/2 (white)	abrupt (wavy)	silt loam with wave washed shell and coral
2	5YR 3/1 (very dark gray)	abrupt (wavy)	sandy loam with wave washed shell and coral, charcoal and ash flecking
3	10YR 3/3 (dark brown)	-	silt loam with wave washed shell and coral

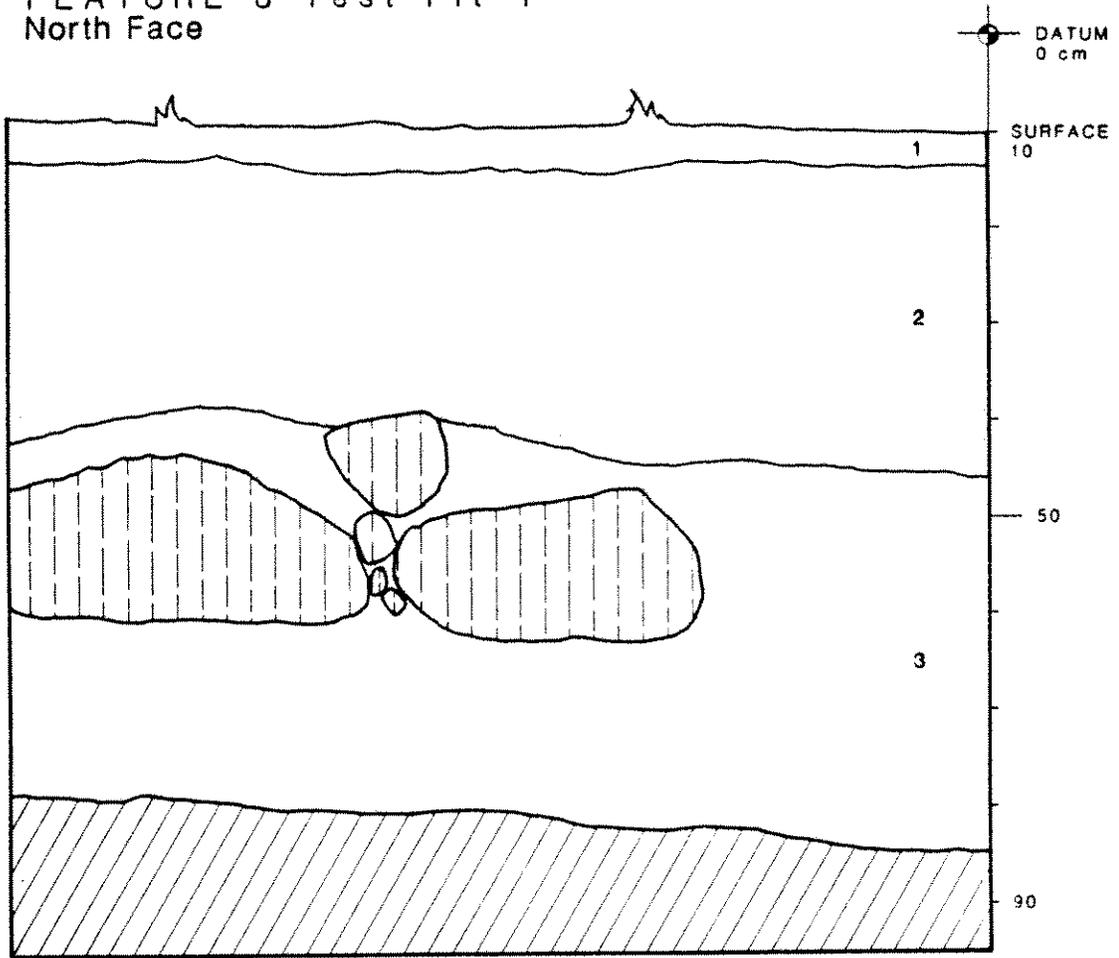
FEATURE 8 Test Pit 1
North Face

Figure 47. Profile of Feature 8, TP-1.

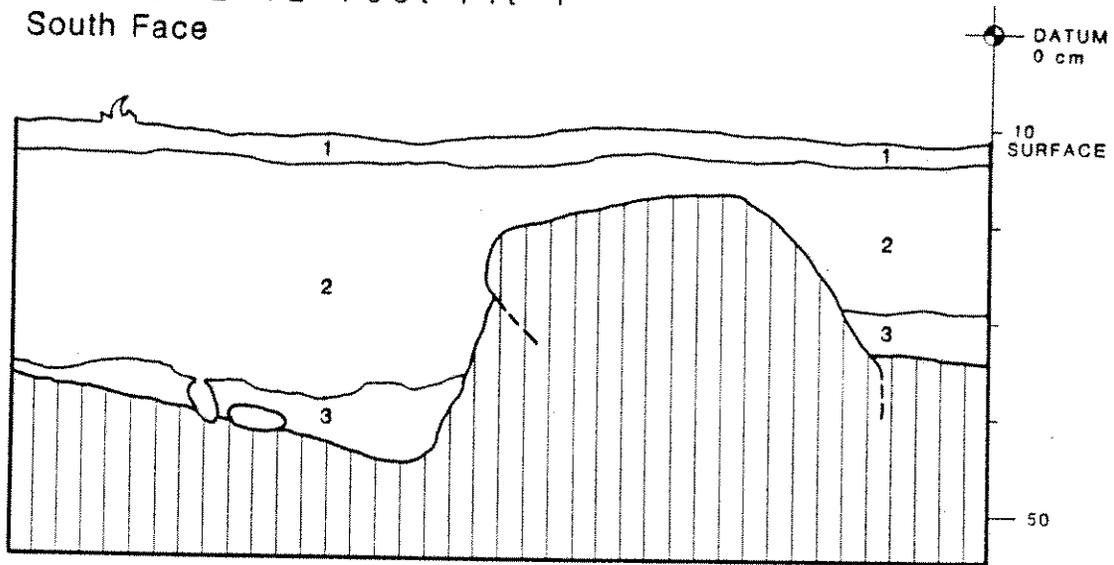
FEATURE 12 Test Pit 1
South Face

Layer	Munsell Color	Boundary	Description
1	10YR 4/2 (dark grayish brown)	abrupt (smooth)	sandy loam
2	10YR 3/3 (dark brown)	clear (irregular)	sandy loam
3	10YR 3/4 (dark yellowish brown)	-	silt loam

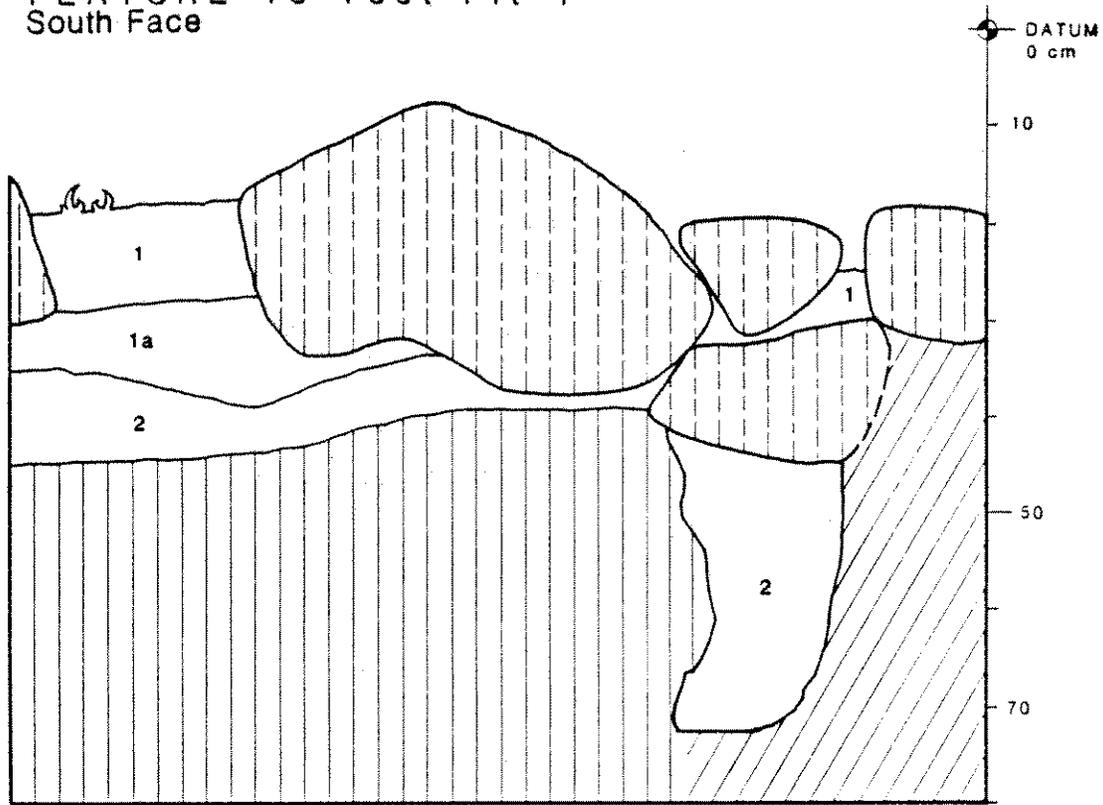
FEATURE 13 Test Pit 1
South Face

Layer	Munsell Color	Boundary	Description
1	10YR 2/2 (very dark brown)	abrupt (wavy)	silt loam
2	10YR 3/1 (very dark gray)	abrupt (wavy)	silt loam
3	10YR 2/2 (very dark brown)	abrupt (wavy)	silt loam
4	10YR 5/1 (gray)	-	silt

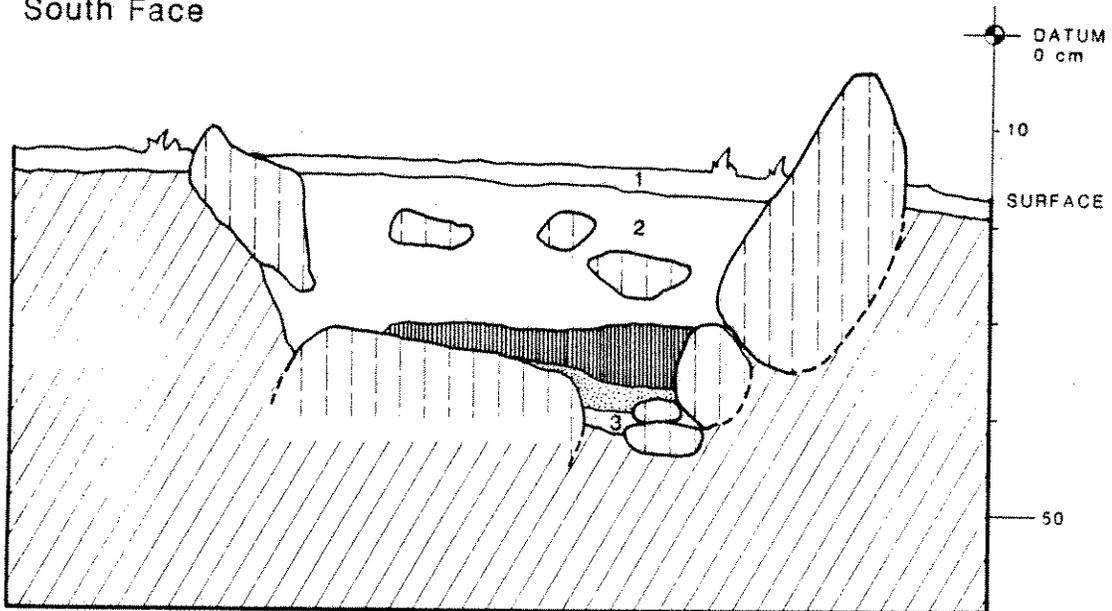
Feature 18 Test Pit 1
South Face

Layer	Munsell Color	Boundary	Description
1	5YR 2.5/2 (dark reddish brown)	abrupt (smooth)	silt loam
2	10YR 3/2 (very dark grayish brown)	abrupt (wavy)	silt loam
2 (char-coal)	7.5YR 2/0 (black)	-	silt ash loam
2 (ash)	10YR 4/1 (dark gray)	-	silt ash loam
3	10YR 4/4 (dark yellowish brown)	-	silt loam

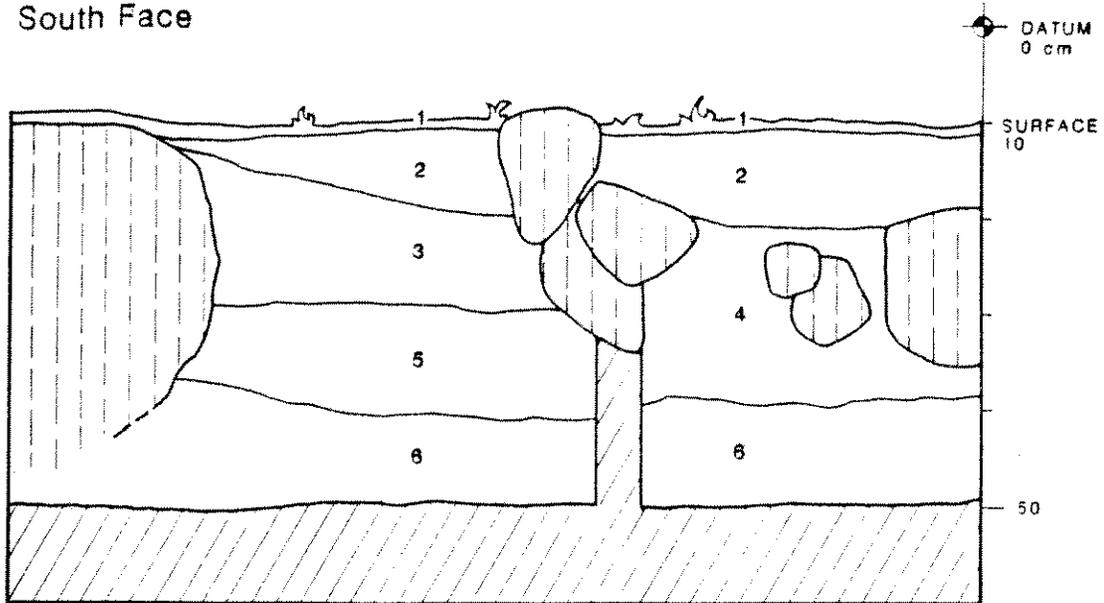
FEATURE 23 Test Pit 1
South Face

Layer	Munsell Color	Boundary	Description
1	-	clear	silt loam
2	10YR 2/1 (black)	abrupt (smooth)	silt loam
3	10YR 2/2 (very dark brown)	clear (smooth)	silt loam
4	10YR 2/2 (very dark brown)	clear (smooth)	silt loam
5	10YR 3/2 (very dark grayish brown)	clear (smooth)	silt loam
6	10YR 4/4 (dark yellowish brown)	-	silt loam

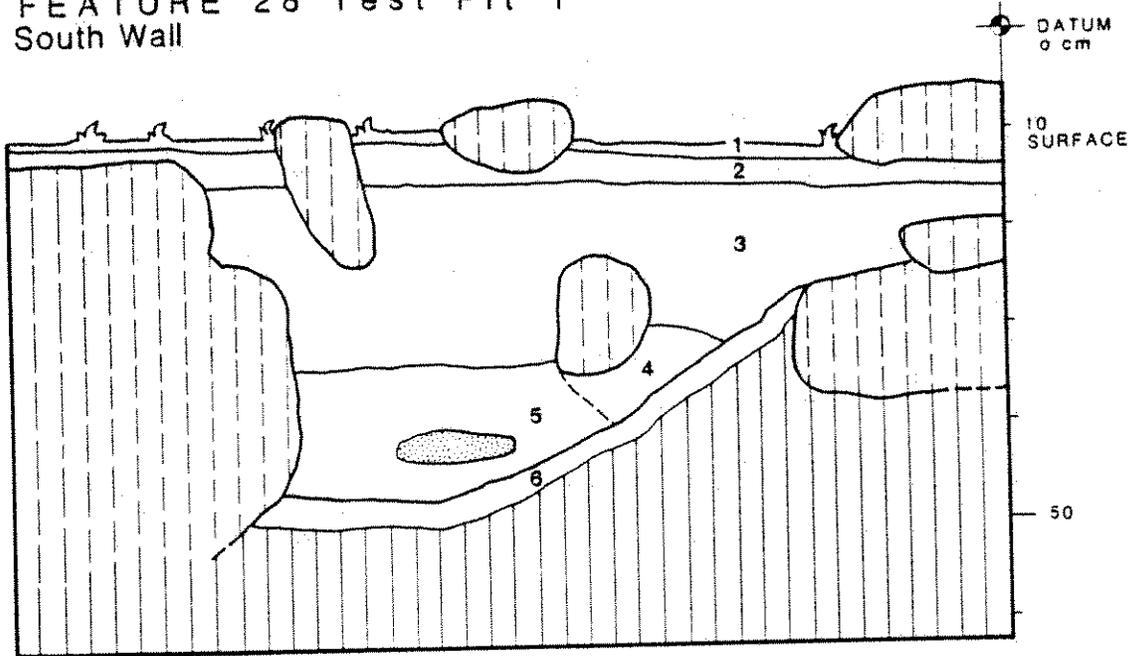
FEATURE 28 Test Pit 1
South Wall

Layer	Munsell Color	Boundary	Description
1	10YR 2/2 (very dark brown)	abrupt (smooth)	silt loam
2	10YR 2/2 (very dark brown)	abrupt (wavy)	silt loam
3	10YR 3/3 (dark brown)	abrupt (wavy)	silt loam
4	10YR 2/2 (very dark brown)	abrupt (clear)	silt ash loam
5	10YR 2/1 (black)	abrupt (wavy)	silt ash loam
6	10YR 4/6 (dark yellowish brown)	-	silt loam

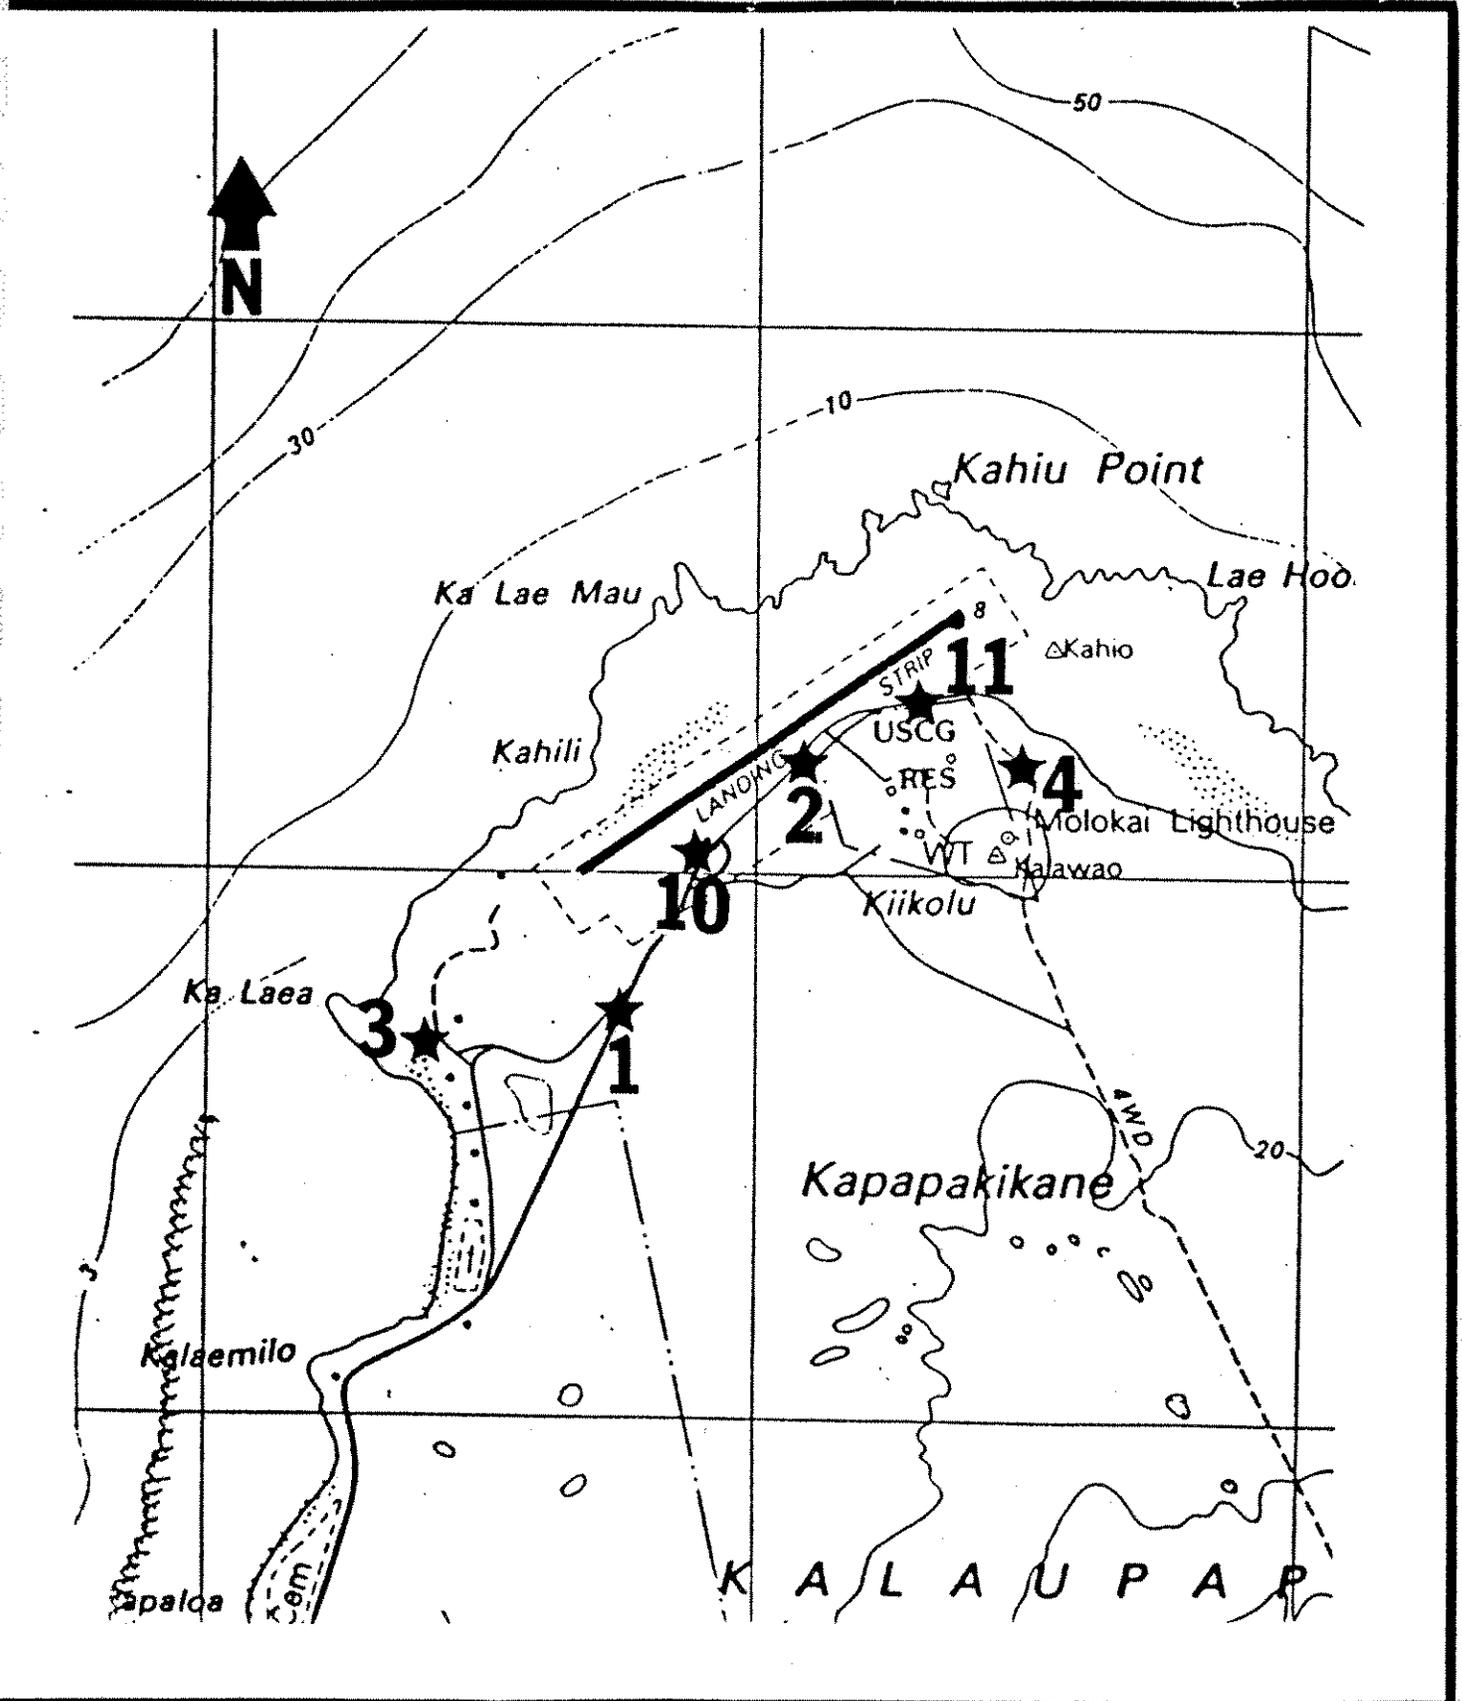
FIGURE 2A. LOCATION OF MEASUREMENT POSITIONS IN THE VICINITY OF KALAUPAPA AIRPORT
MAP NOT TO SCALE
