**DEPARTMENT OF TRANSPORTATION
FEDERAL AVIATION ADMINISTRATION**

**ENVIRONMENTAL IMPACT STATEMENT
PART 2 OF 2**

**KALAUPAPA AIRPORT, ROADWAYS AND WHARF IMPROVEMENTS
KALAUPAPA, MOLOKAI, HAWAII**

**STATE OF HAWAII
DEPARTMENT OF TRANSPORTATION
AIRPORTS DIVISION**

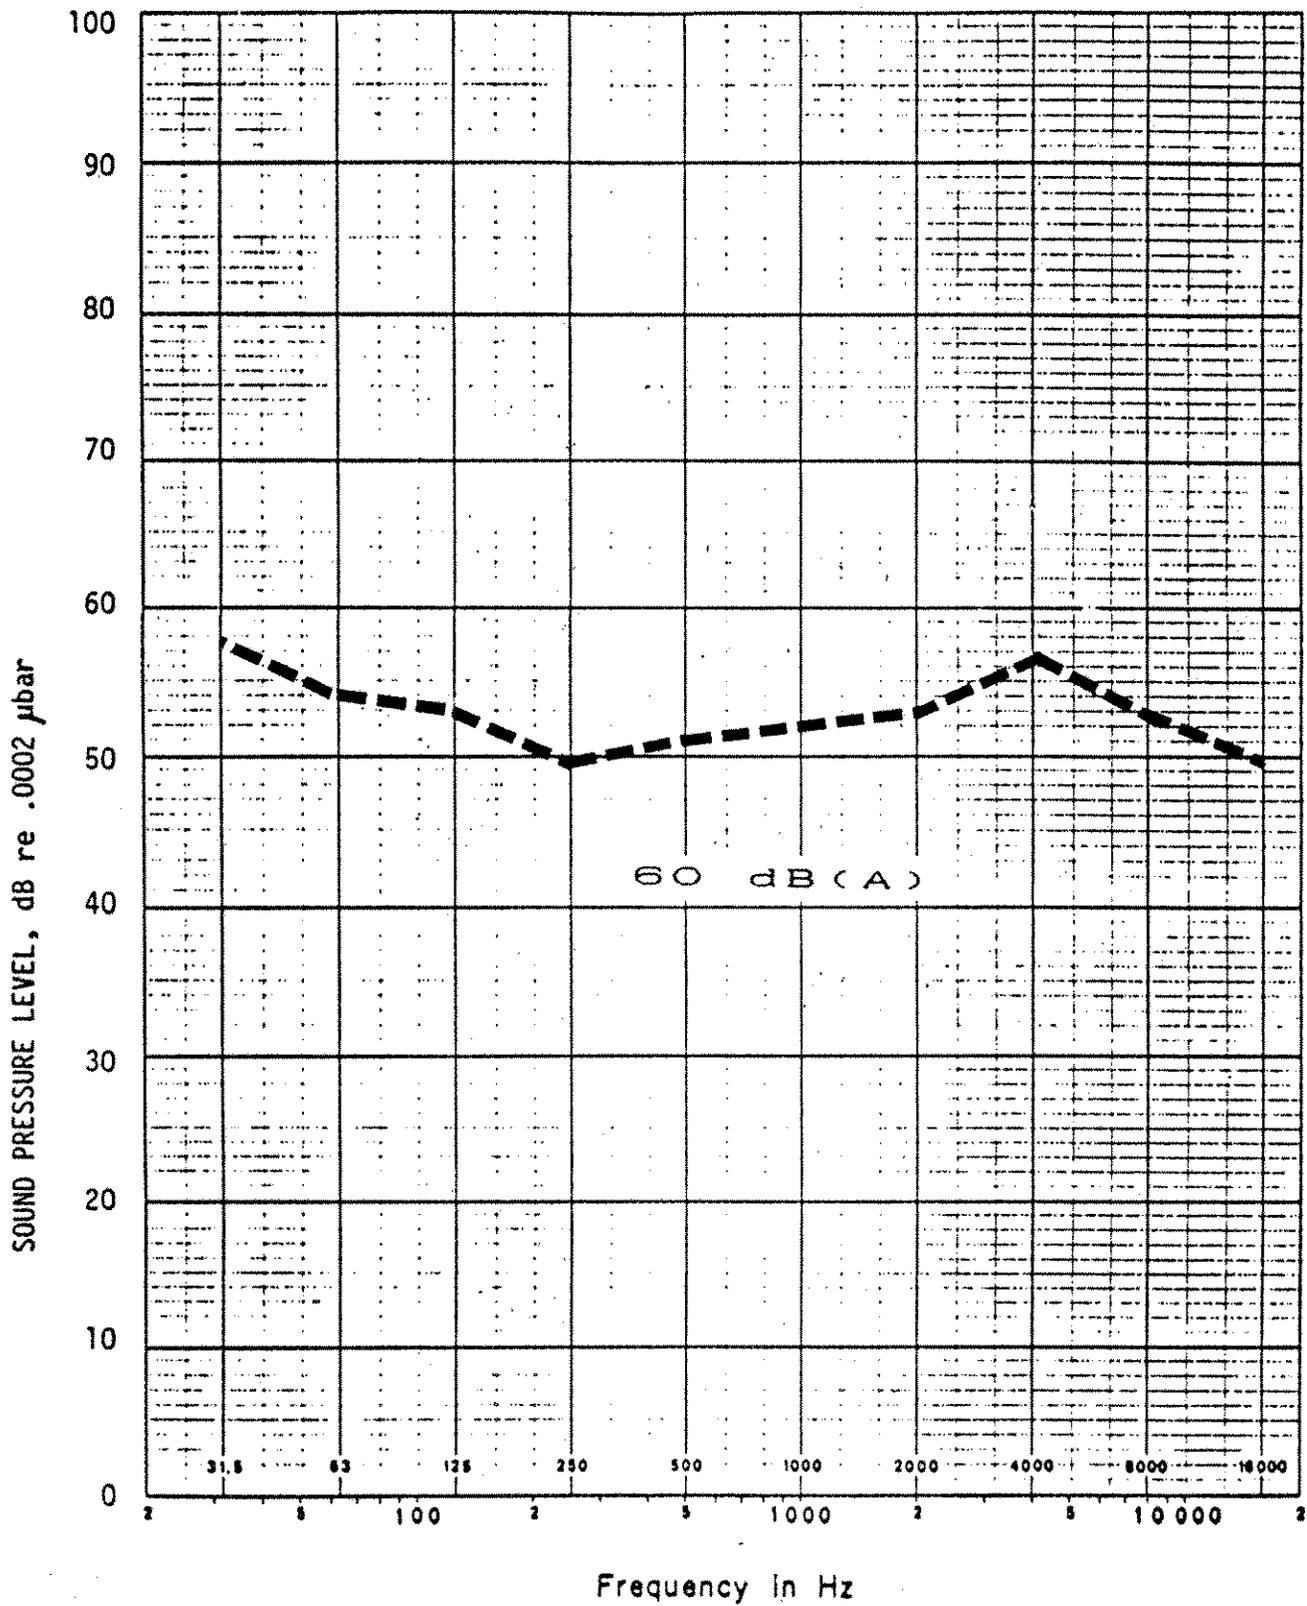
FIGURE 3B. AMBIENT OCTAVE
 FREQUENCY MEASUREMENT
 POSITION 5
 WIND: NE, 15-20 KNOTS

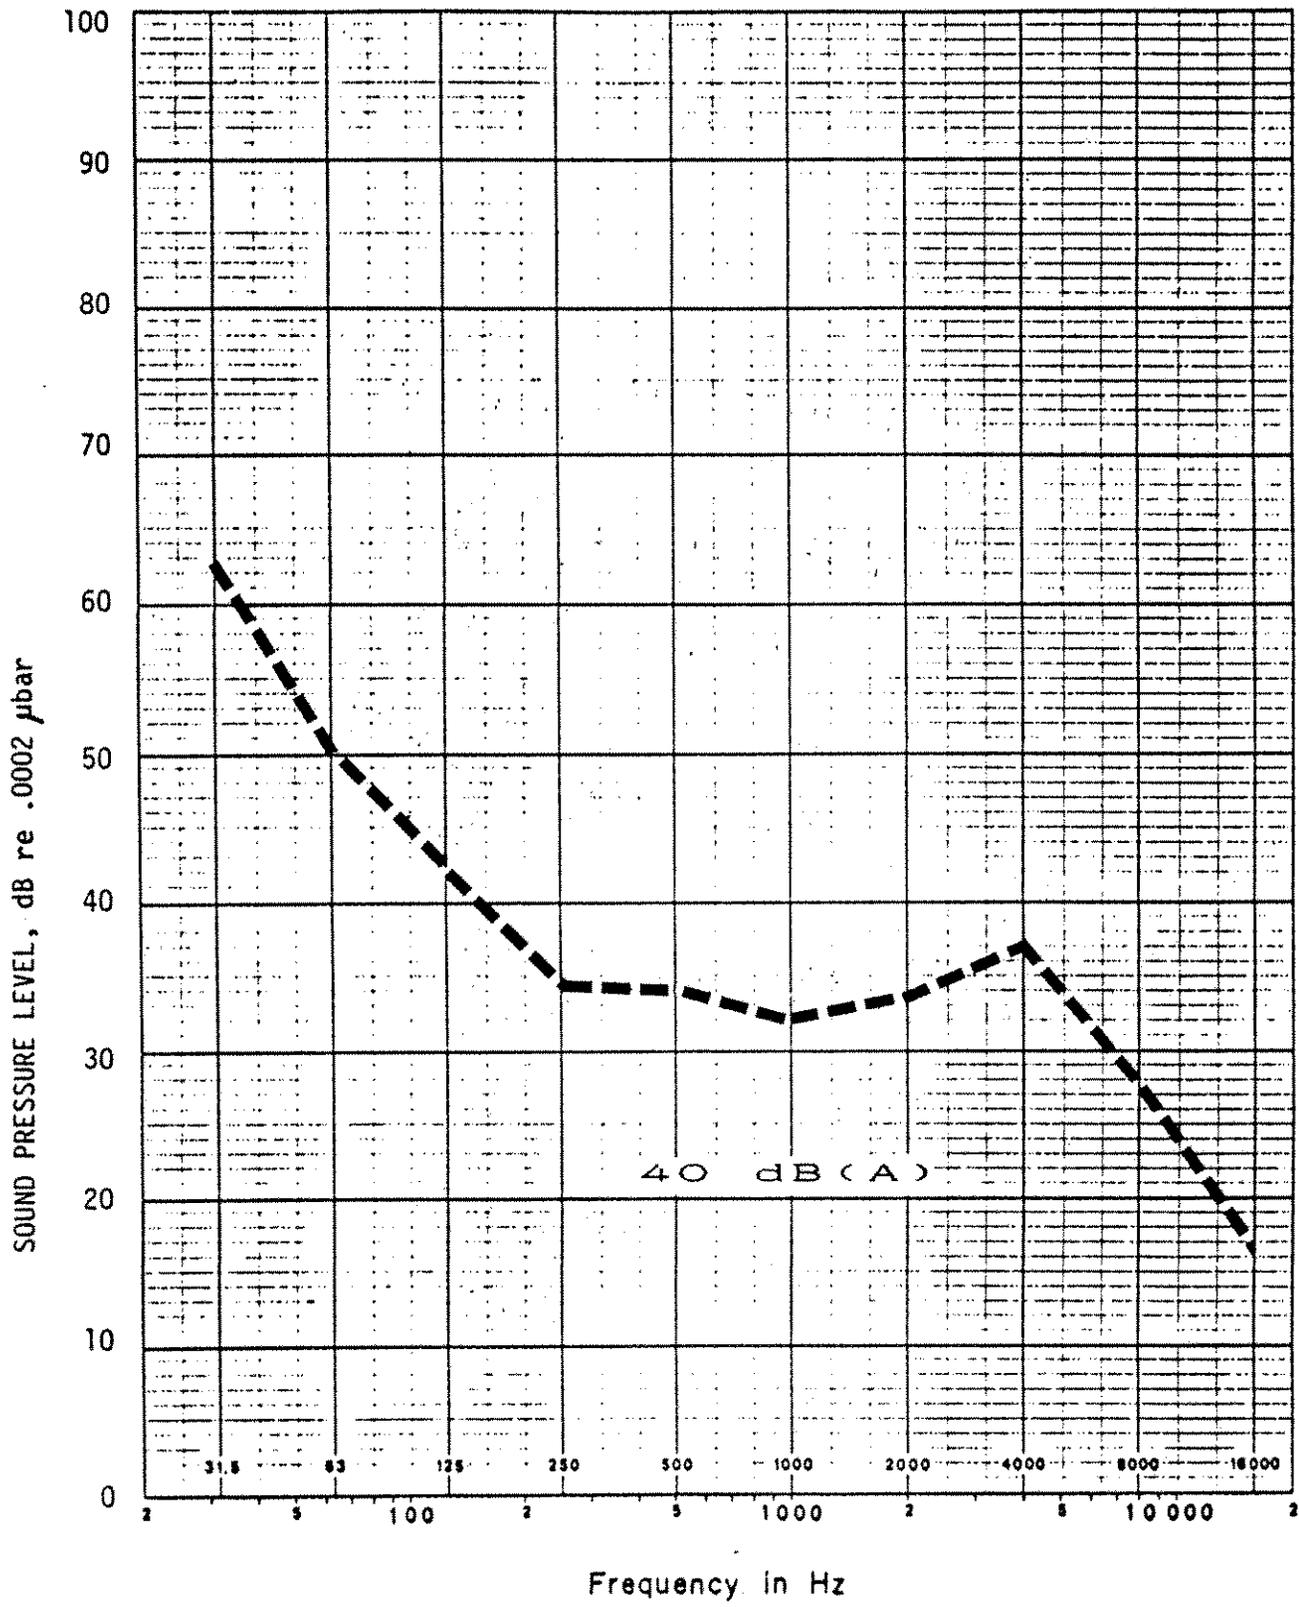
FIGURE 3C. AMBIENT OCTAVE
 FREQUENCY MEASUREMENT
 POSITION 6
 WIND: NE, 5-10 KNOTS

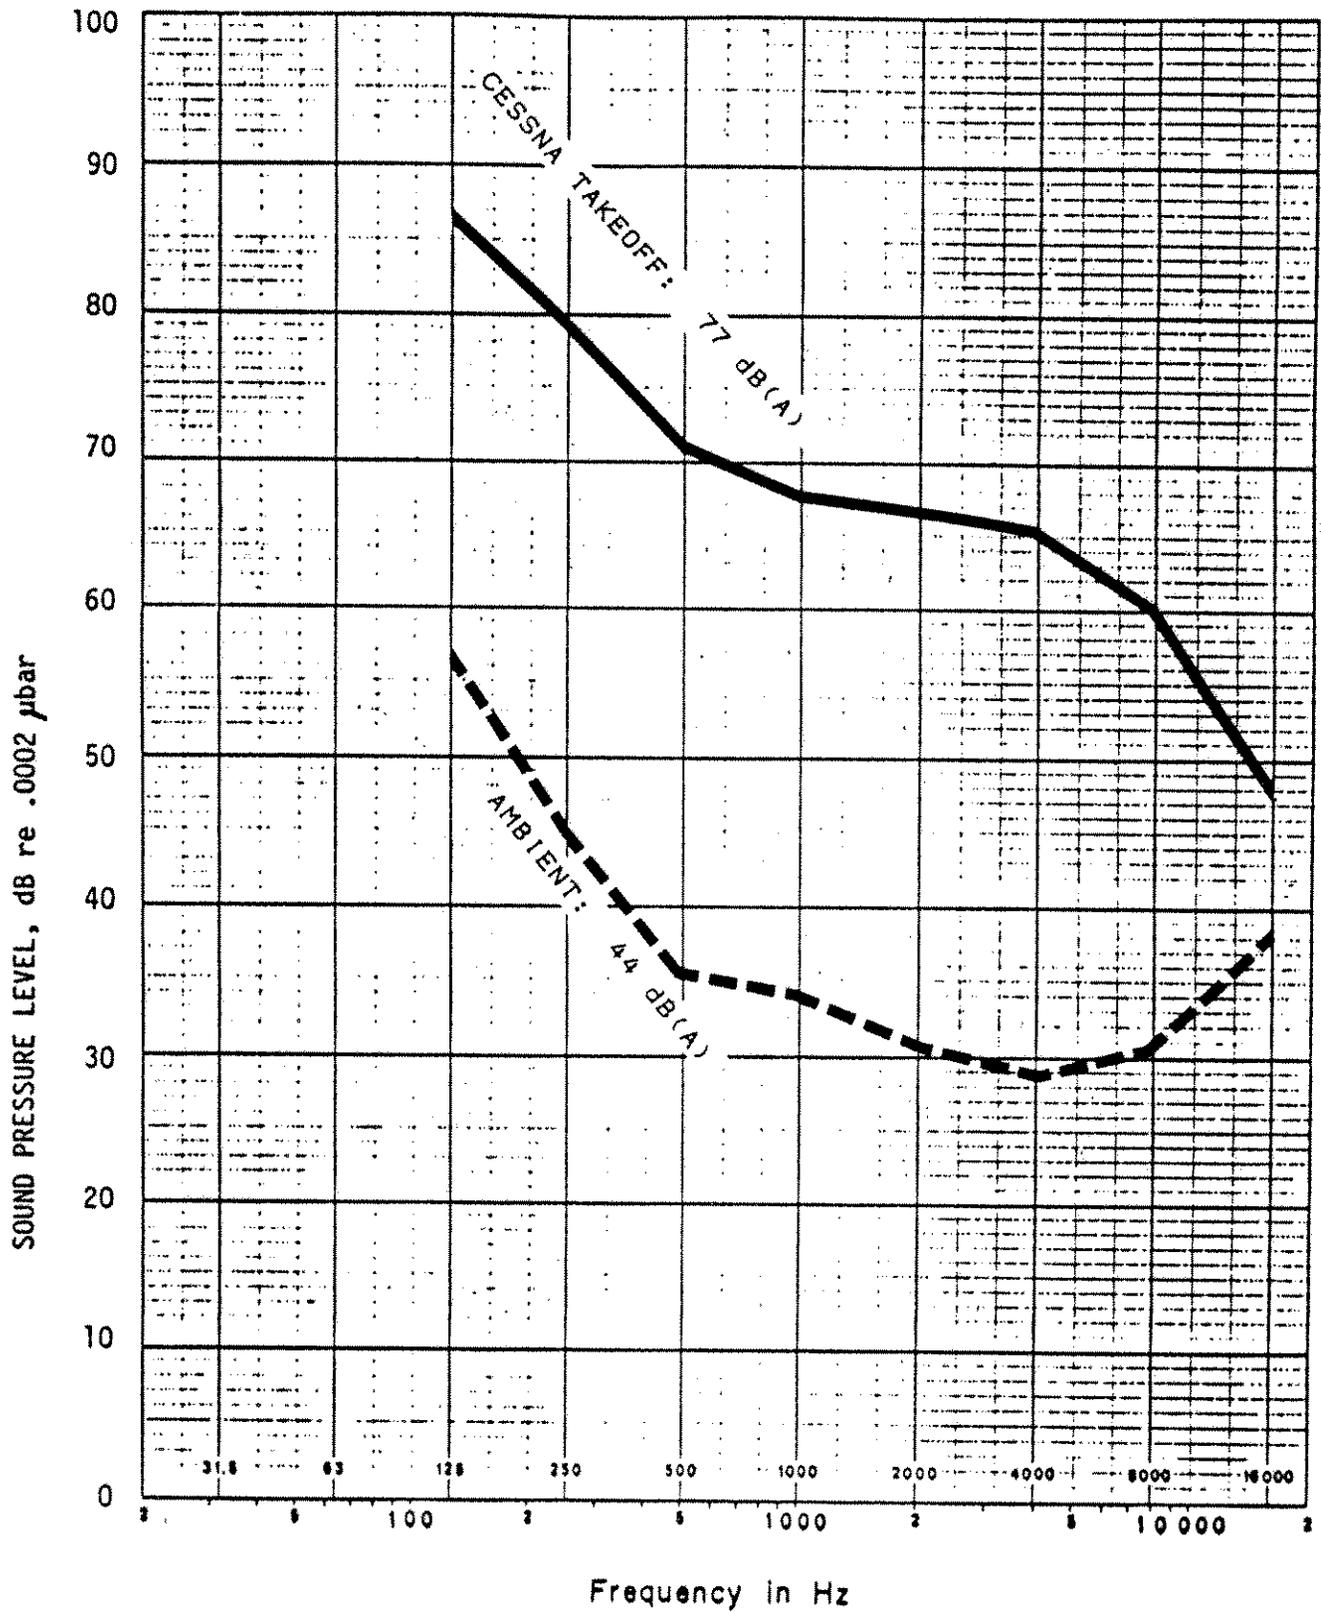
FIGURE 4A. CESSNA 402 TAKEOFF AND AMBIENT OCTAVE FREQUENCY MEASUREMENT POSITION 2

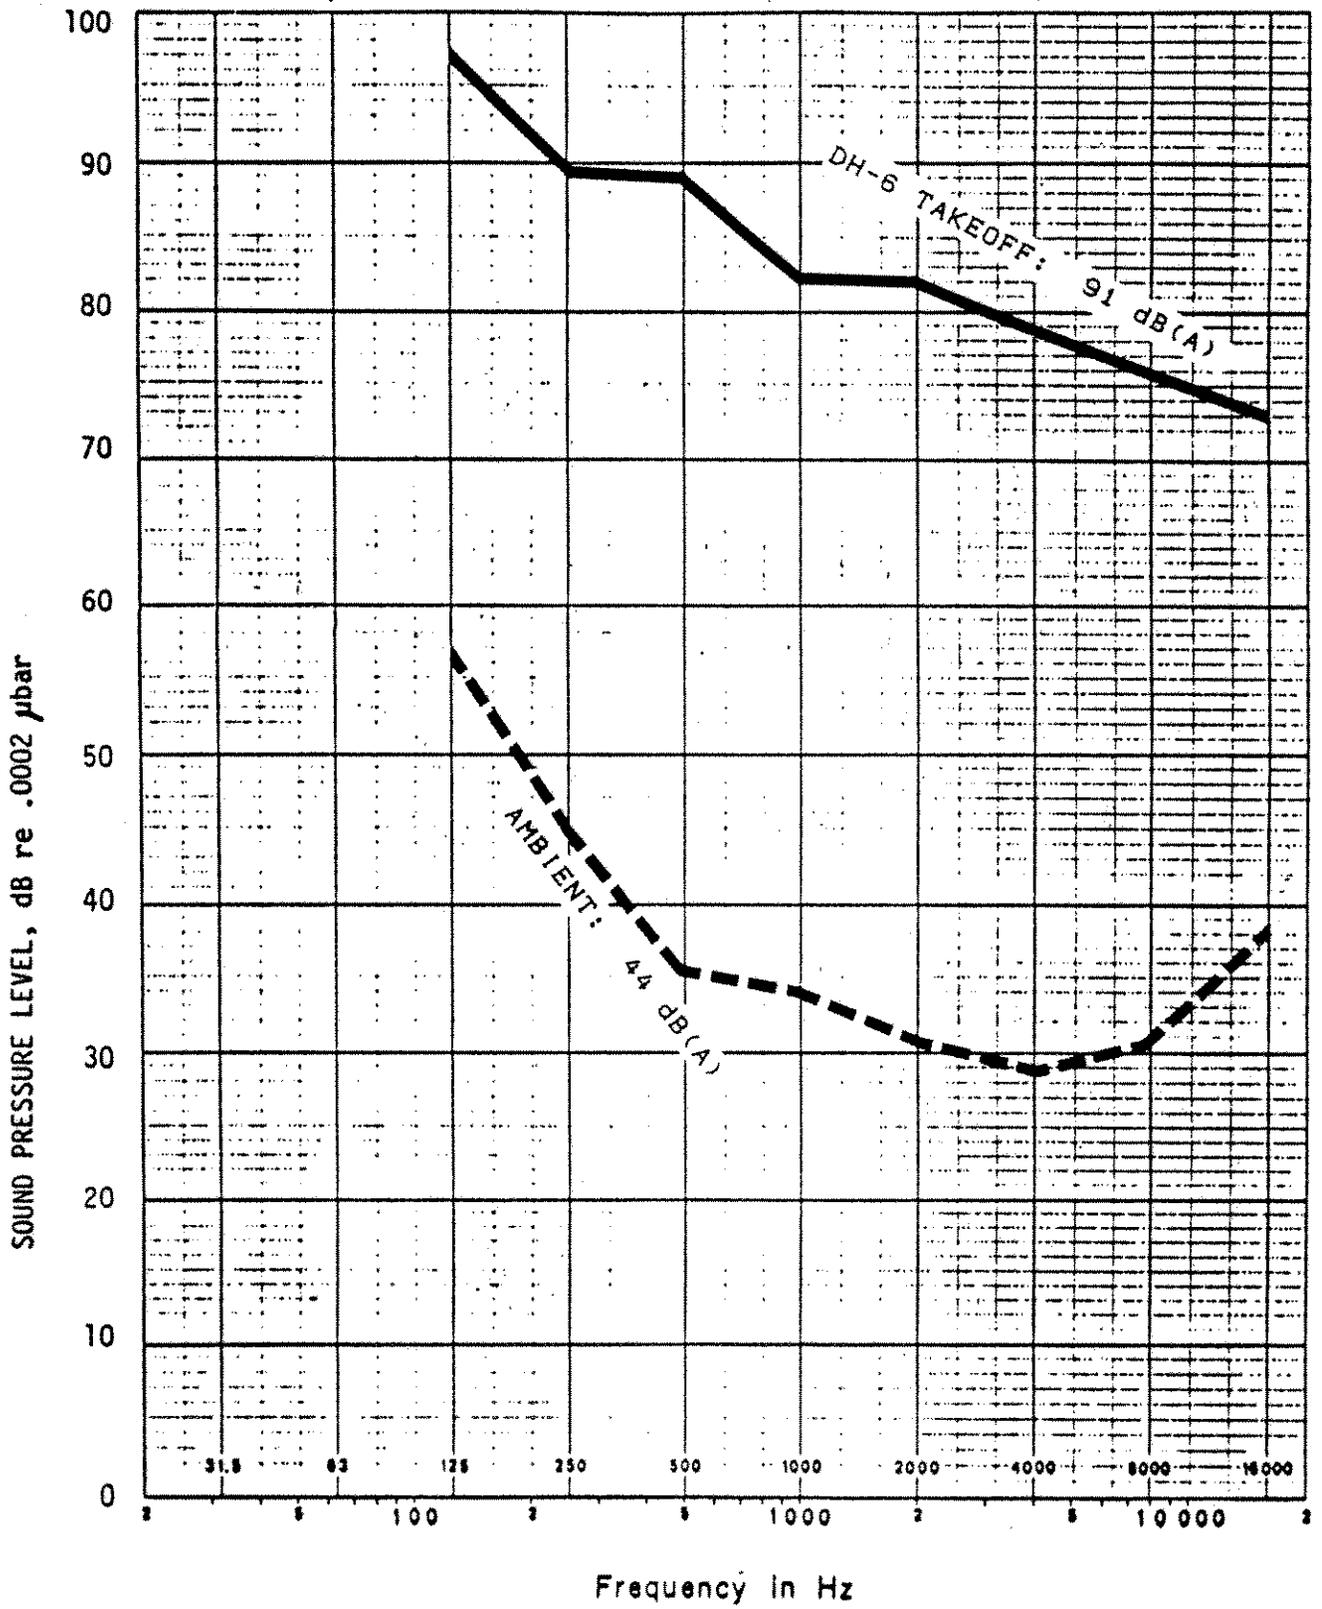
FIGURE 4B. DH-6 TAKEOFF AND AMBIENT OCTAVE FREQUENCY MEASUREMENT POSITION 2

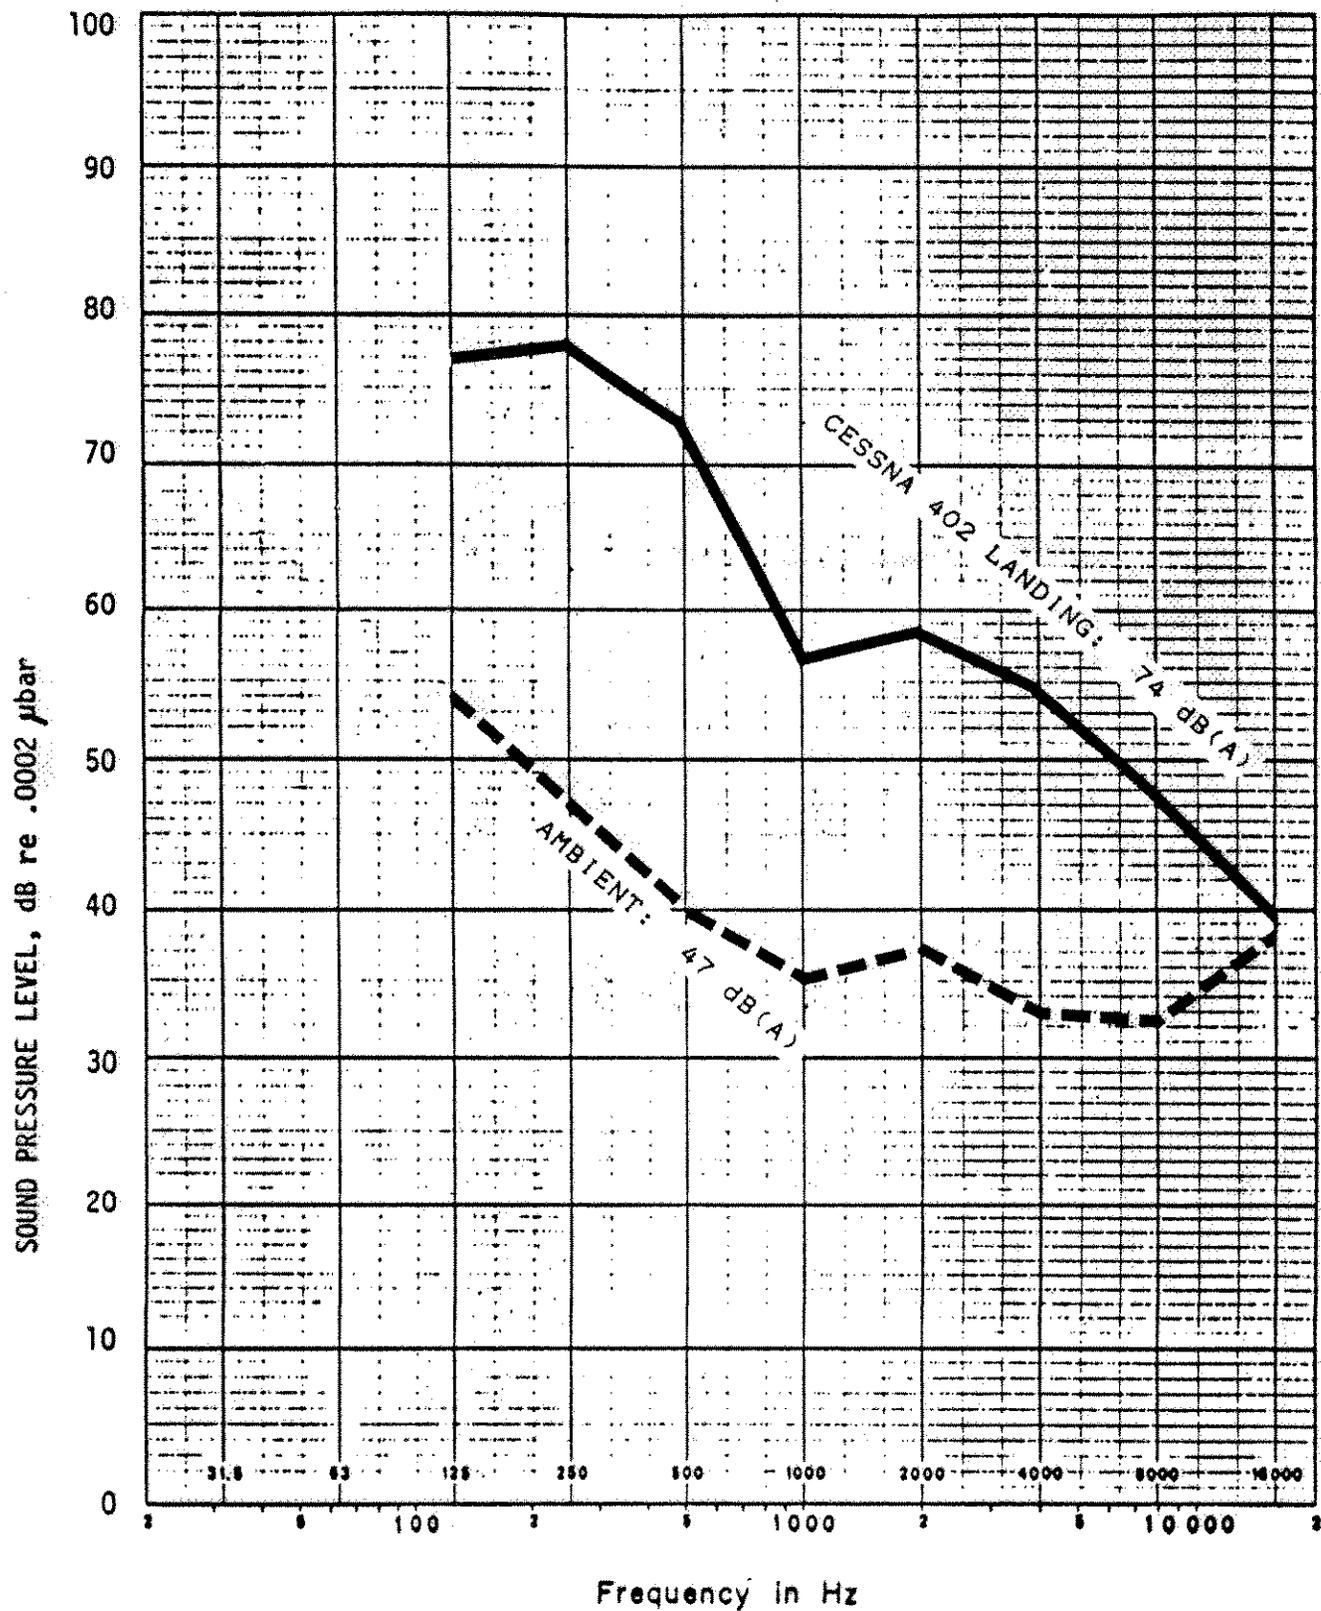
FIGURE 4C. CESSNA 402 LANDING AND AMBIENT OCTAVE FREQUENCY MEASUREMENT POSITION 3

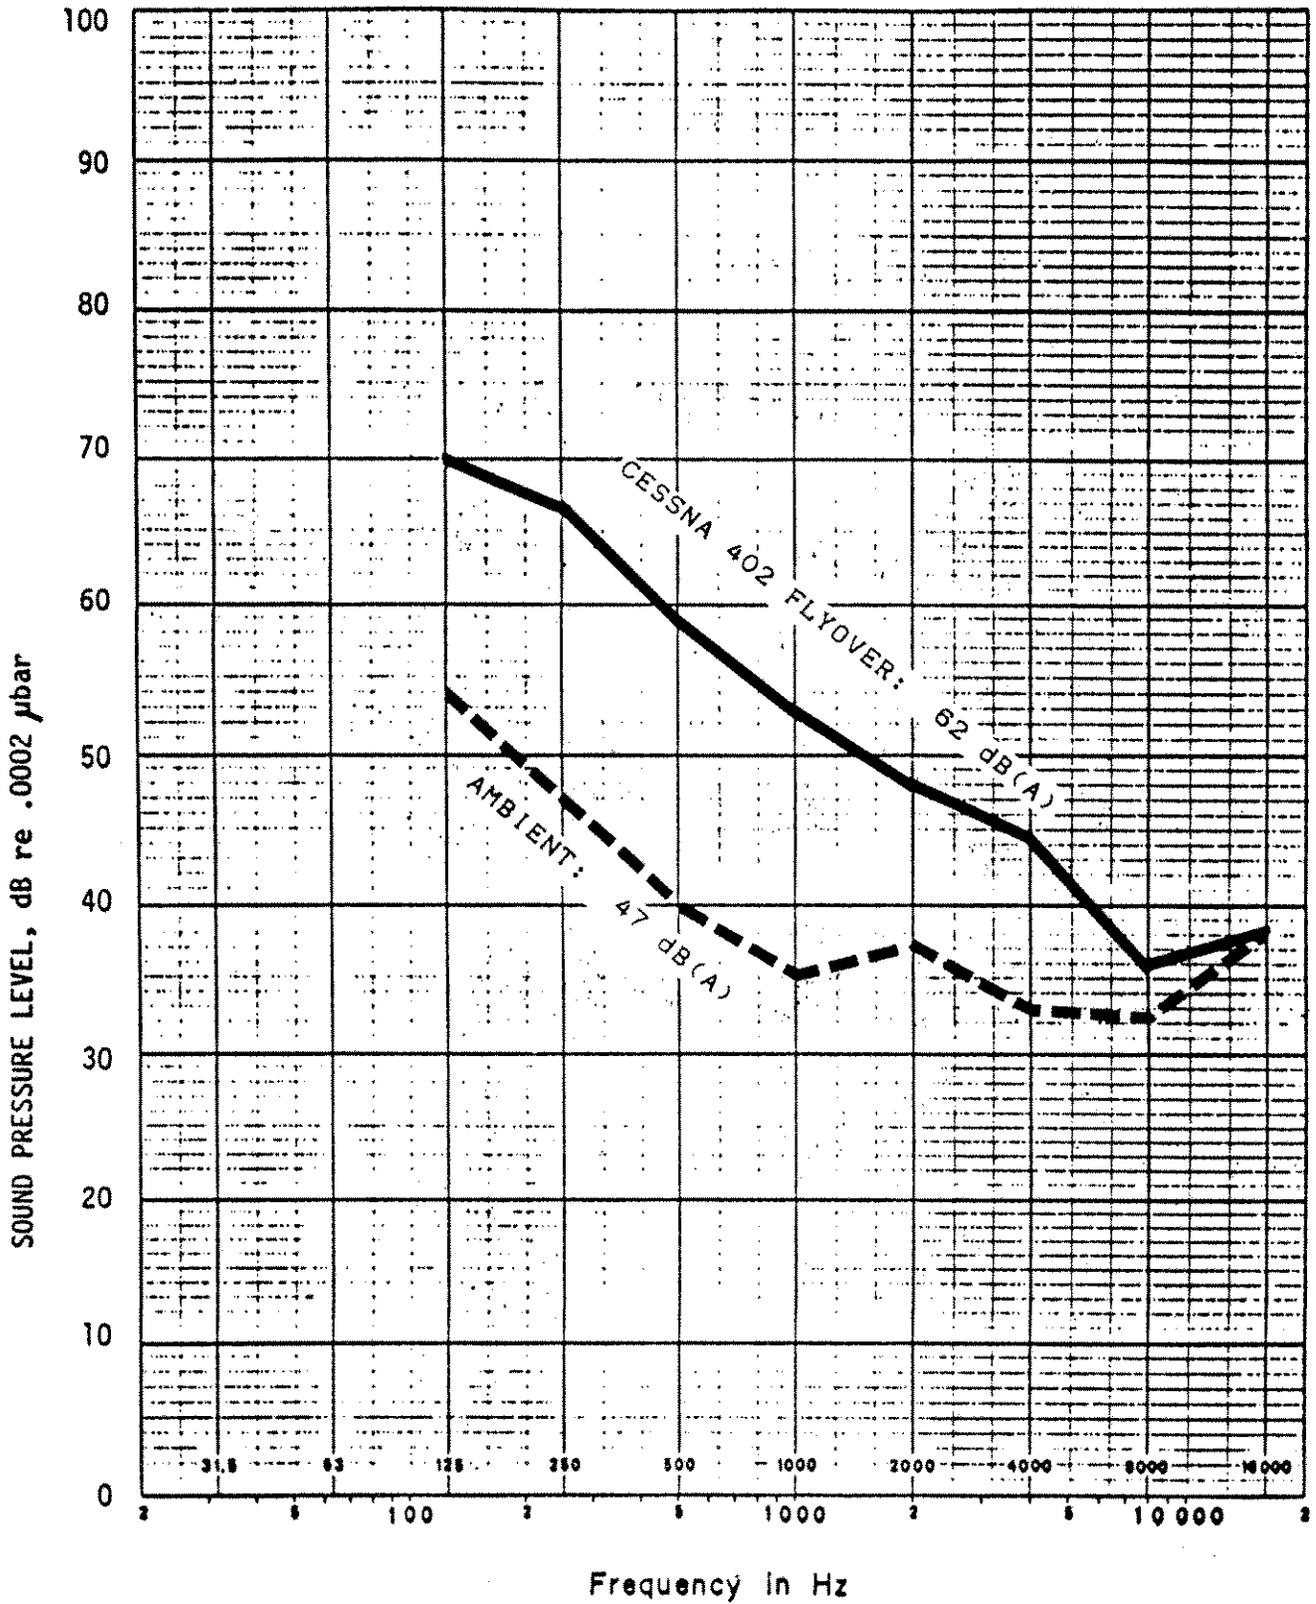
FIGURE 4E. CESSNA 402 FLYOVER AND AMBIENT OCTAVE FREQUENCY MEASUREMENT POSITION 3

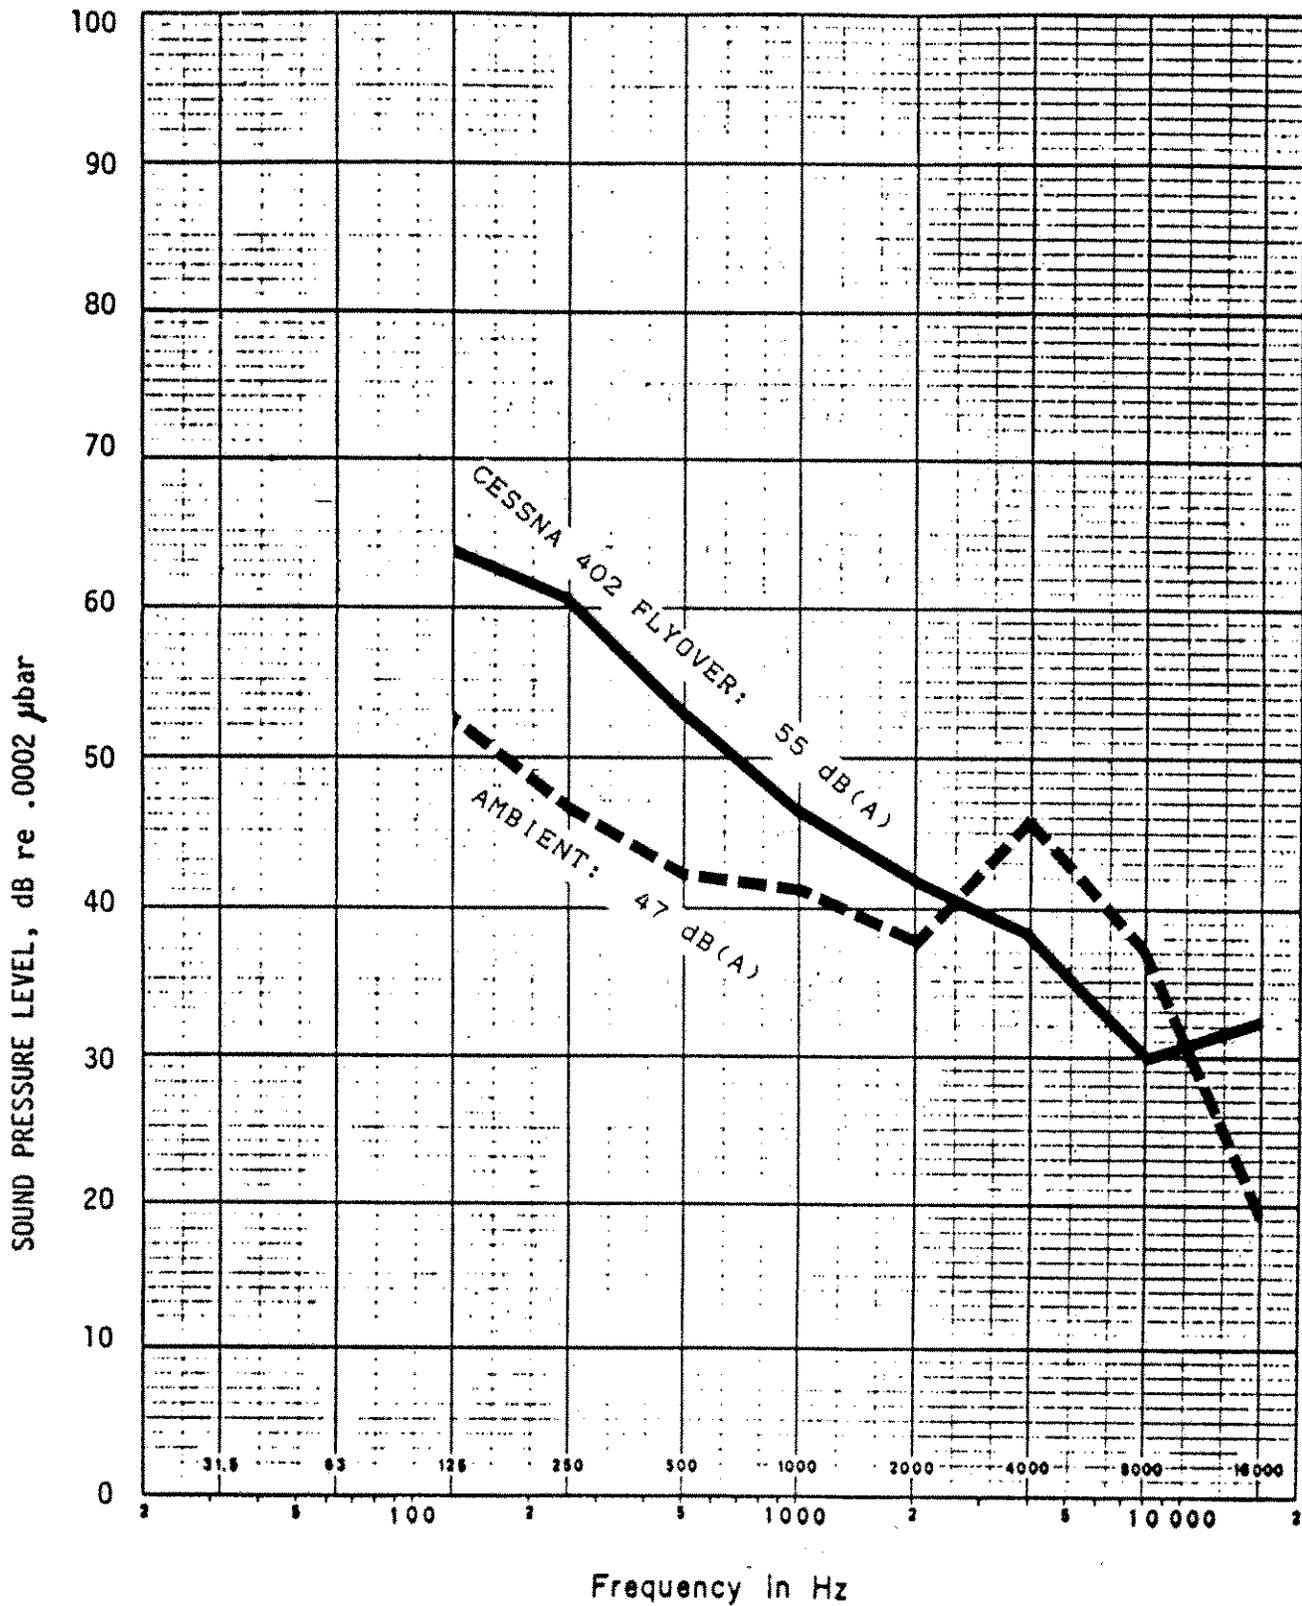
FIGURE 4F. CESSNA 402 FLYOVER AND AMBIENT OCTAVE FREQUENCY MEASUREMENT POSITION 5, WIND 5-10 KNOTS

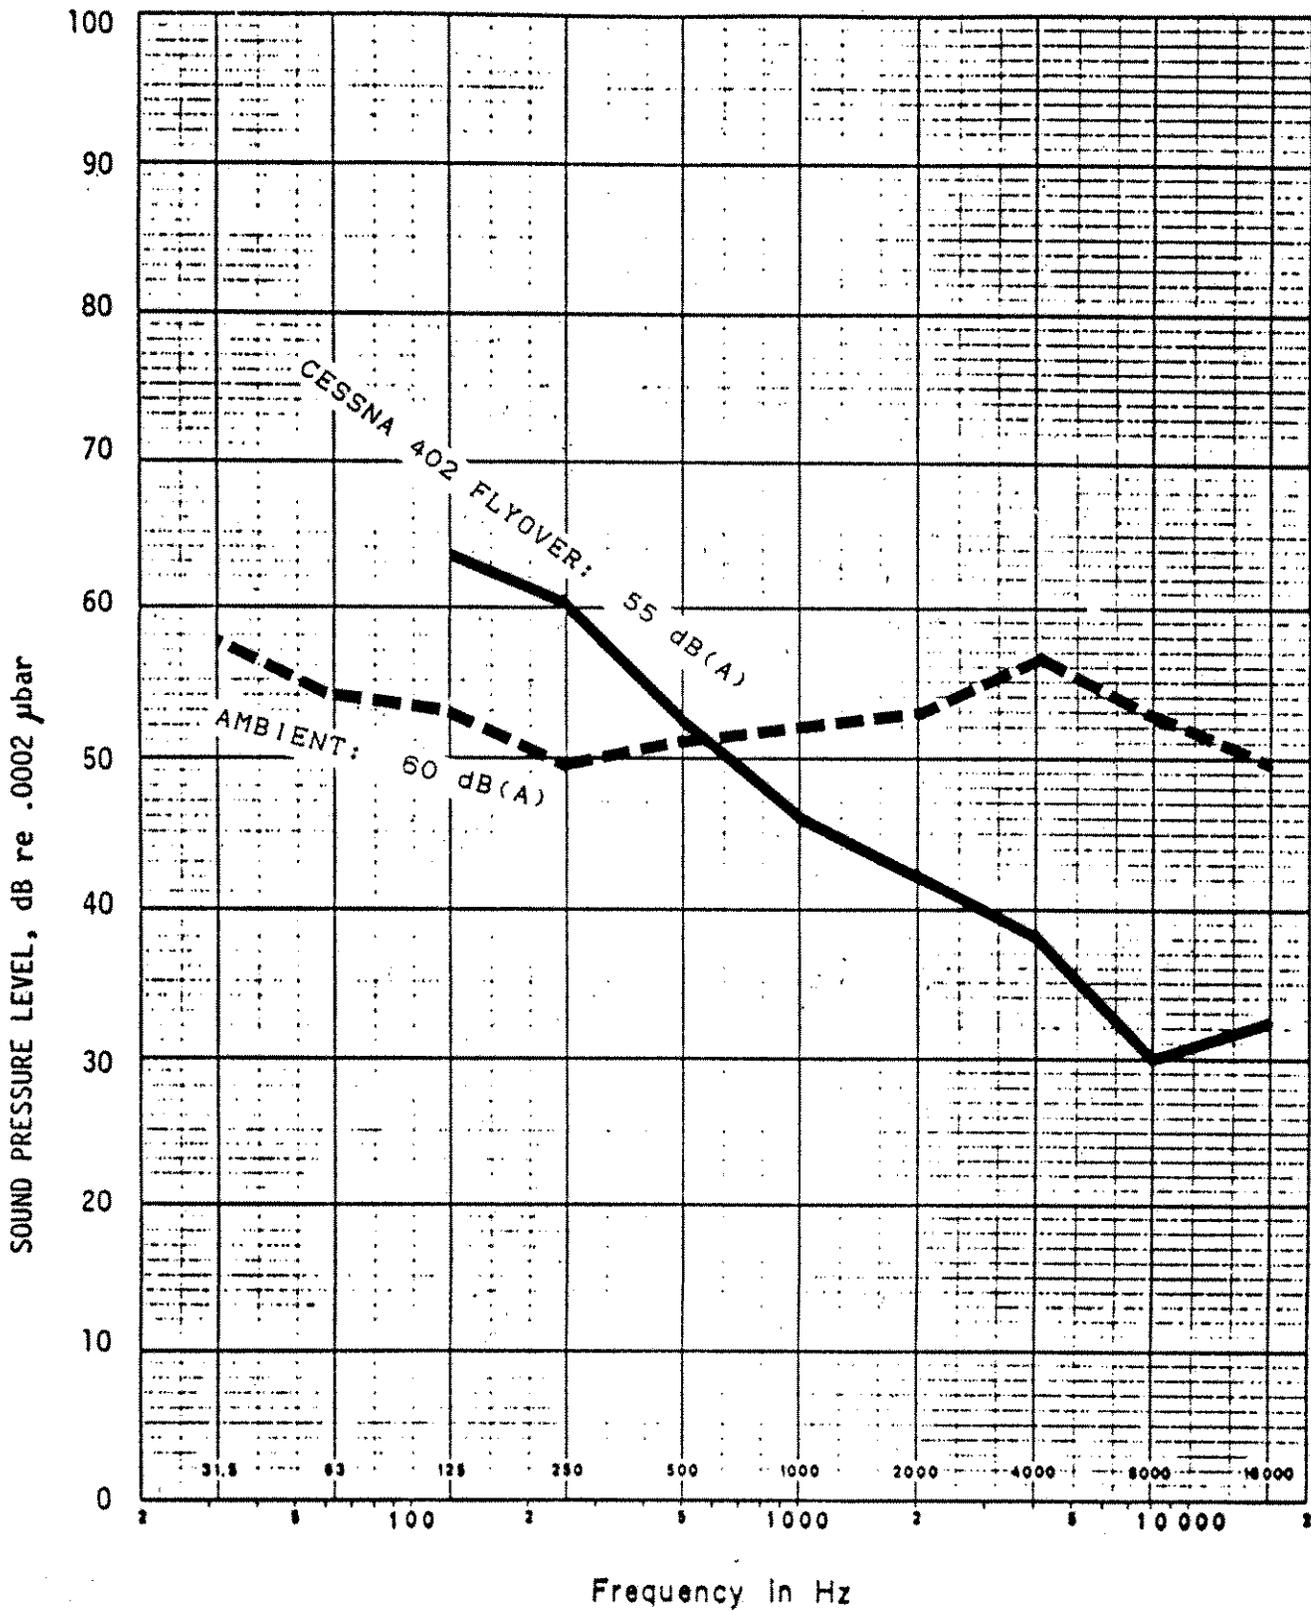
FIGURE 4G. CESSNA 402 FLYOVER AND AMBIENT OCTAVE FREQUENCY MEASUREMENT POSITION 5, WIND 15-20 KNOTS
