**DEPARTMENT OF THE AIR FORCE
50TH SPACE WING (AFSPC)**

ATTACHMENT 1 SECTION 106 CONSULTATION

**PROPOSED UNDERTAKING:
MULTIPLE SUSTAINMENT, RESTORATION, AND MODERNIZATION
(SRM) PROJECTS
at
KAENA POINT SATELLITE TRACKING STATION
U.S. AIR FORCE SPACE COMMAND (Proponent)
NATIONAL HISTORIC PRESERVATION ACT COMPLIANCE REQUEST
FOR SECTION 106 REVIEW AND CONCURRENCE**

- A. TITLE OF UNDERTAKING: Building 10 at USAF Kaena Point Satellite Tracking Station (KPSTS), Multiple Sustainment, Restoration, and Modernization (SRM) Projects
- B. PROPOSED START DATE: September 1, 2011
- C. LOCATION: Tax Map Key for this undertaking is 6-9-003: 005. The project site is within and upon KPSTS Building 10.
- D. DESCRIPTION OF PROPOSED UNDERTAKINGS:

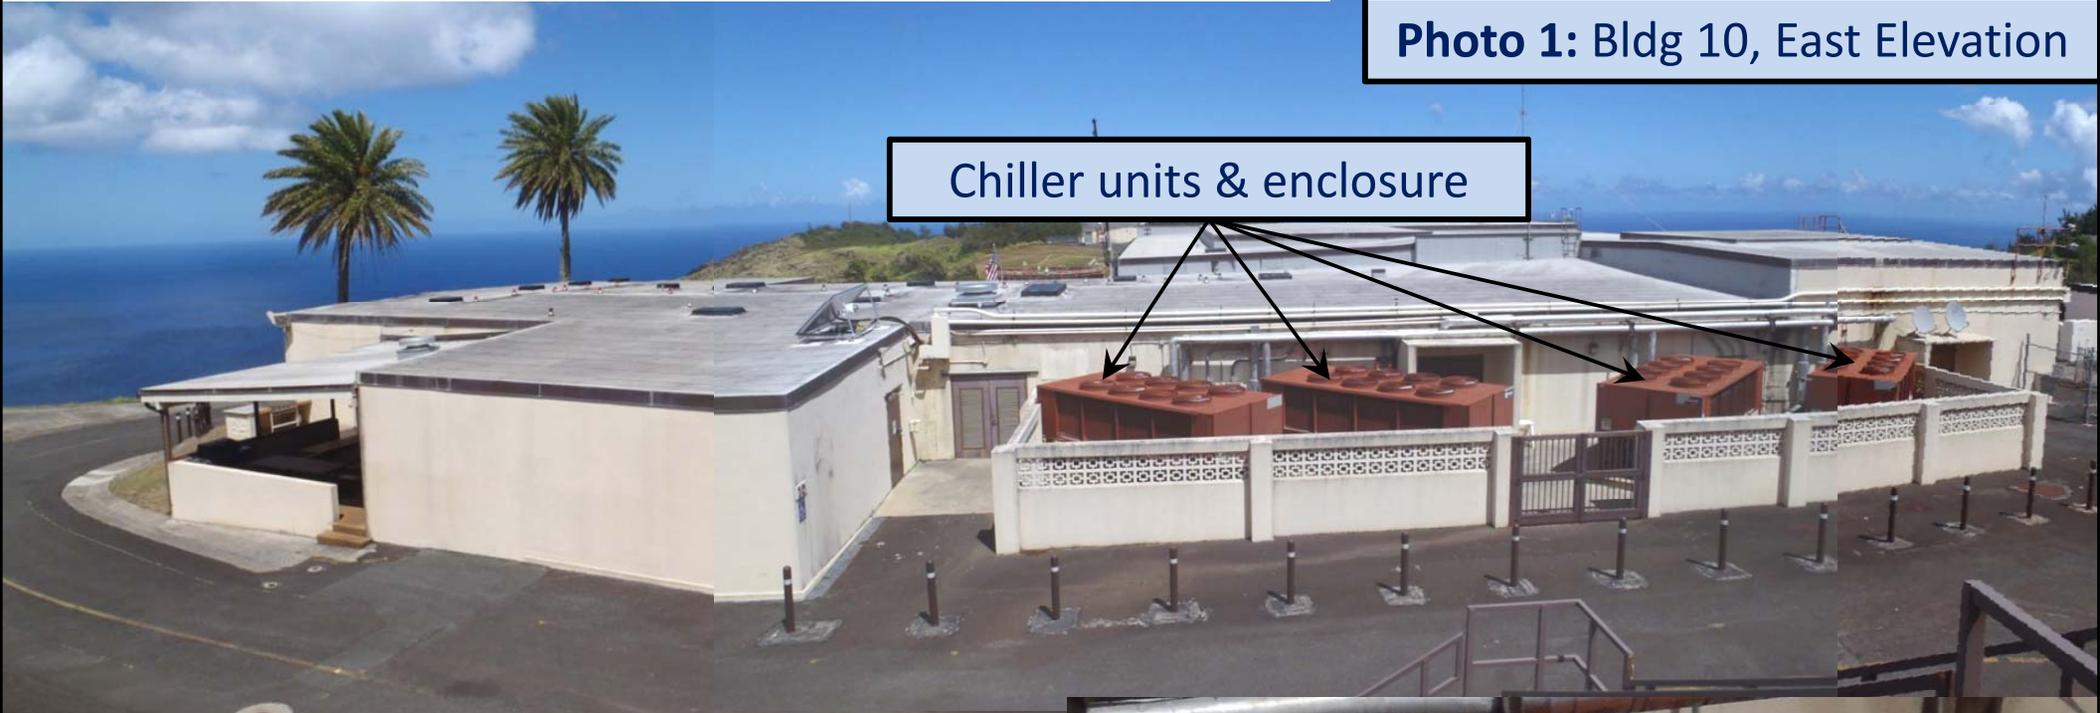
Photo 1: Bldg 10, East Elevation

Chiller units & enclosure

REPLACE CHILLER PLANT (Attachment 3, Photos 1-3)

Description: Install two (2) air cooled chillers to replace four (4) existing deteriorating and

- a. Retrofit air distribution (ductwork, terminal units) to meet load based on solar heat gain.
- b. Configure to provide redundant chilled water to system using 410A refrigerant
- c. Reuse existing pumps.
- d. Remove existing four (4) chillers and install two (2) chillers, electrical and chilled water connections, valves, meters, pipe supports. The new chiller dimensions are 89" x 93" x 79" and would be installed in the existing chiller enclosure.
- e. Reconfigure 4" chilled water return and supply lines. Remove unused exterior chilled water lines and support hangers.
- f. Remove and replace chilled water line insulation.
- g. Remove/replace properly sized ductwork, terminal units and registers.
- h. Patch and finish all wall penetrations associated with demolition work to match existing.

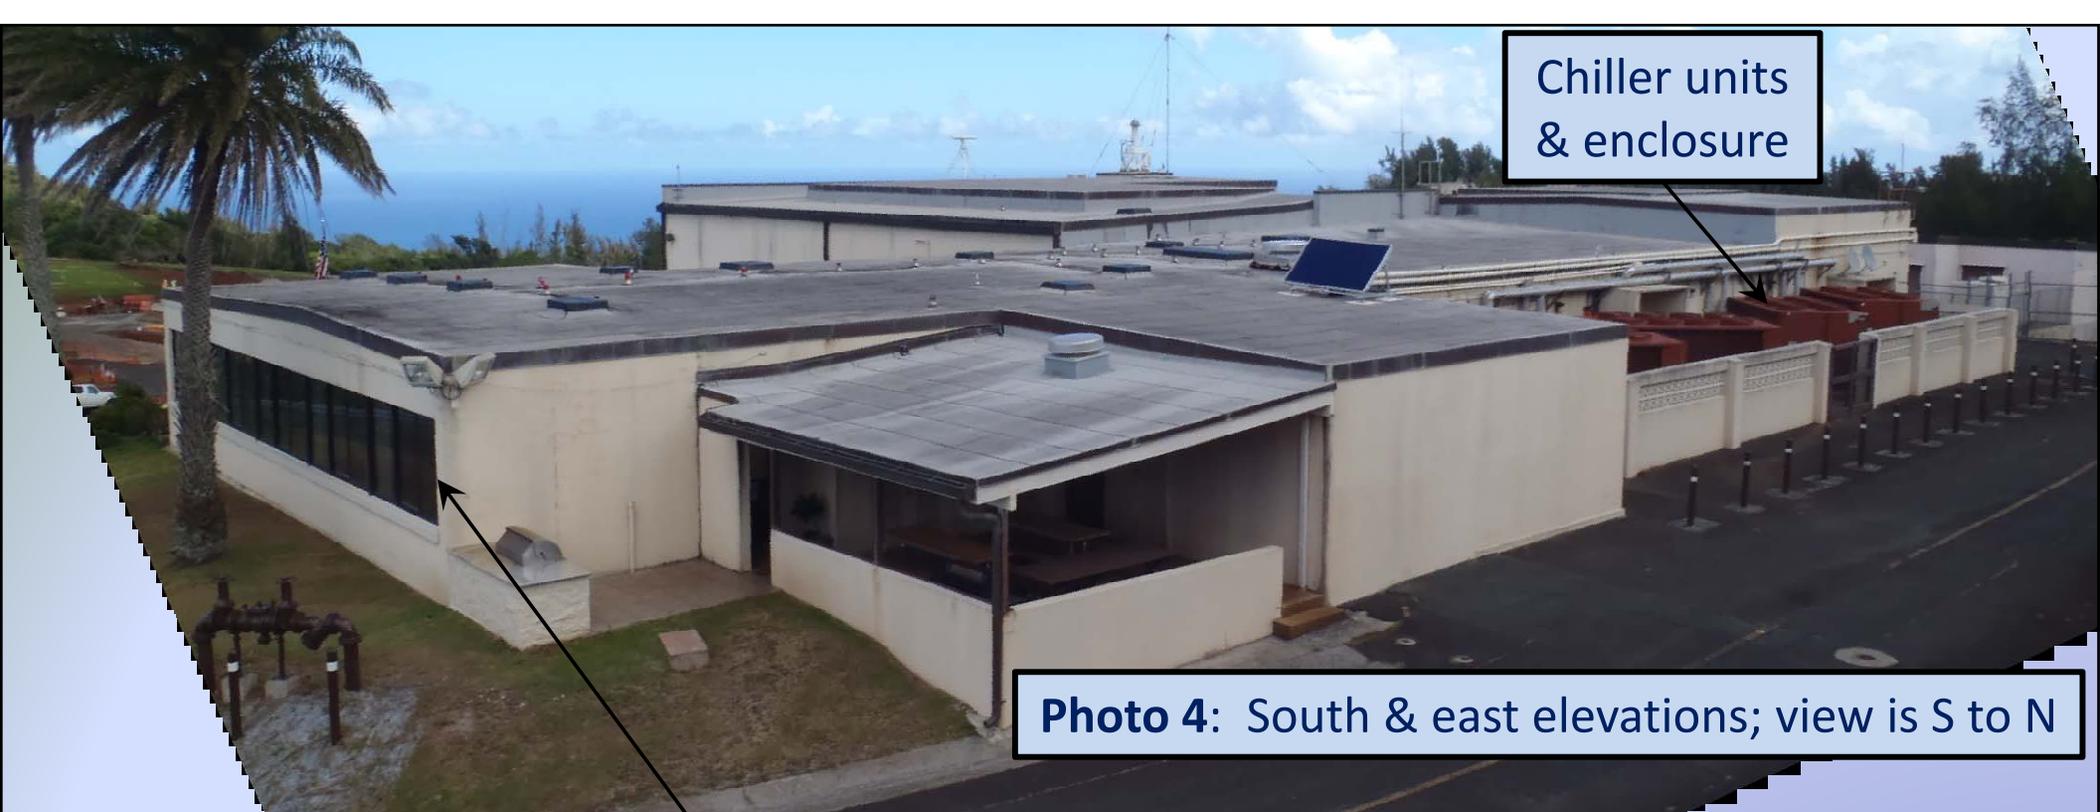
Photo 4: South & east elevations; view is S to N

Chiller units
& enclosure

REPLACE COMMAND SECTION WINDOWS, ROOMS 119, 121, 123

- a. Remove existing exterior windows to offices
- b. Existing windows consist of horizontal sliding, aluminum framed anodized with dark brown finish (Glenwood, Series 510C, Marine Grade, Fleetwood).
- c. Remove window frames
- d. Restore finishes to original as needed.
- e. Install new window frames and glazing in existing window openings.
- f. New insulated glazing specification will minimize solar heat gain from the south facing exposure, but maintain an adequate level of visible transmittance.
- g. Install new aluminum frames to match existing frame finish (anodized dark brown). Match vertical mullion layout.
- h. Seal around frame and rough opening.
- i. Caulk interior frame to abutting drywall.

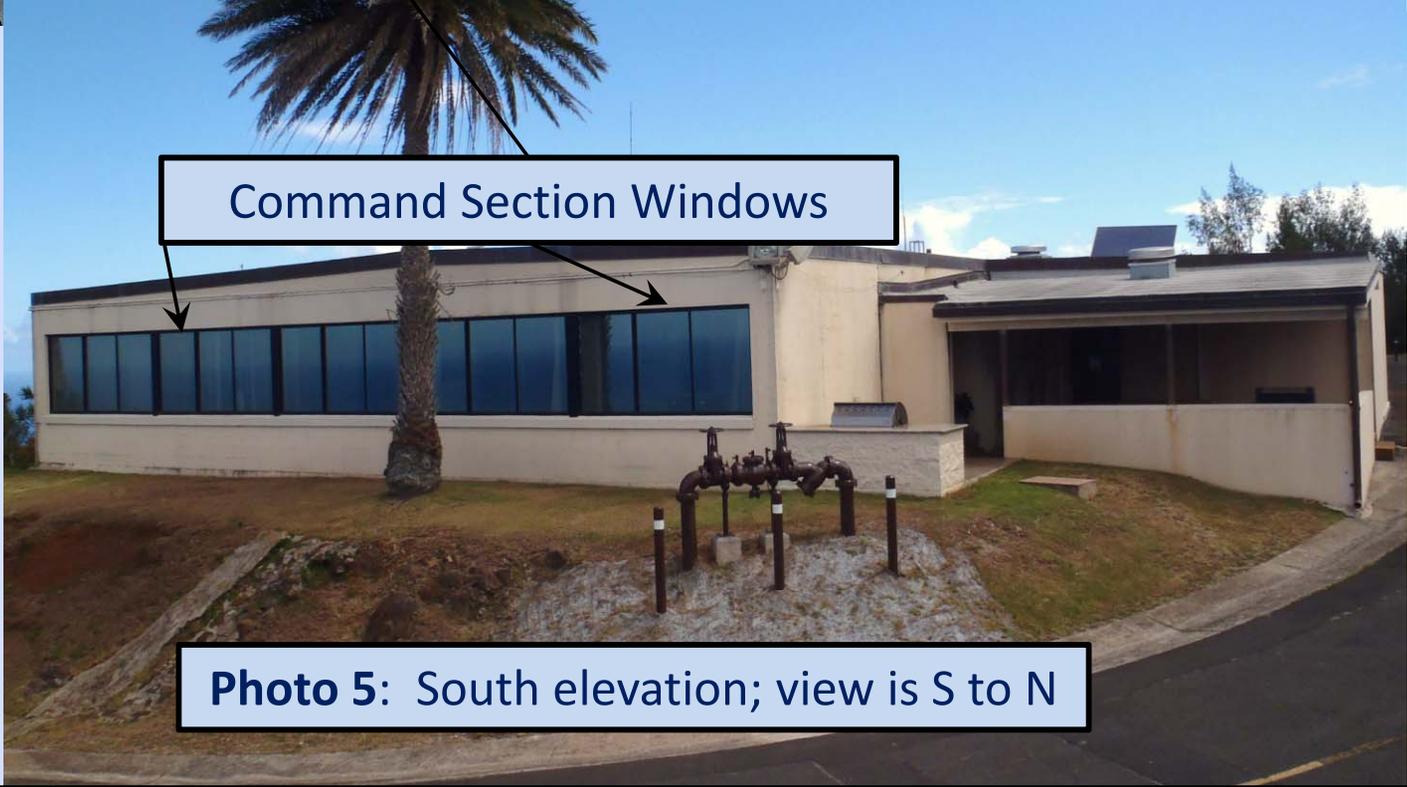
Photo 5: South elevation; view is S to N

Command Section Windows

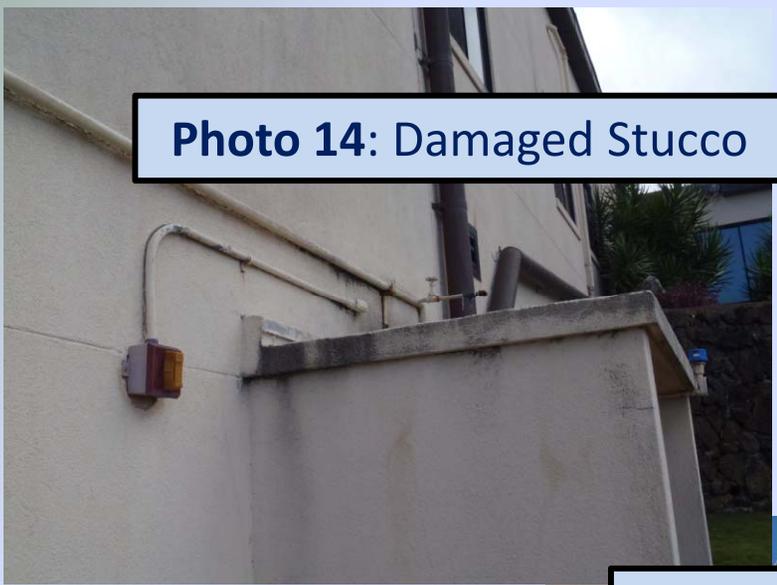
Photo 14: Damaged Stucco

II. PERFORM EXTERIOR REPAIRS (Attachment 3, Photos 12-24; Attachment 5 contains drawings and specifications)

- a. Remove and replace sections of stucco plaster from exterior per drawings/plans
- b. New stucco color and texture to match existing.
- a. Skim coat and/or paint remaining undamaged stucco plaster to match new.
- b. Caulk or seal all exterior wall penetrations encountered.
- c. Repair cracked and failing masonry lintel above window on south elevation, basement level.

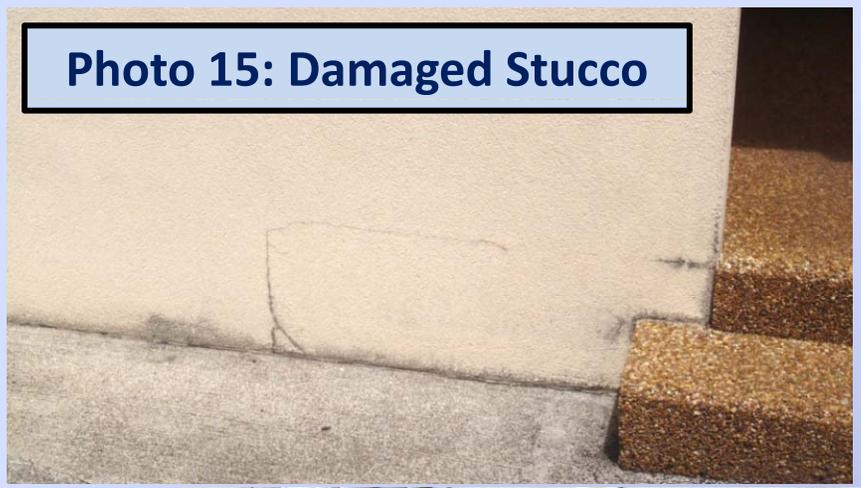
Photo 15: Damaged Stucco

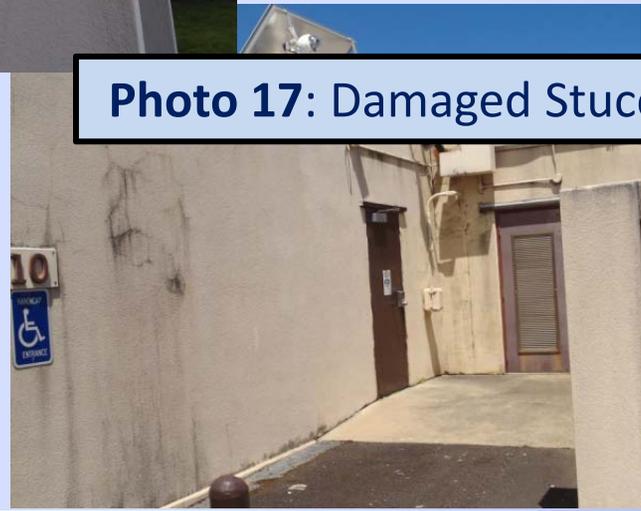
Photo 17: Damaged Stucco

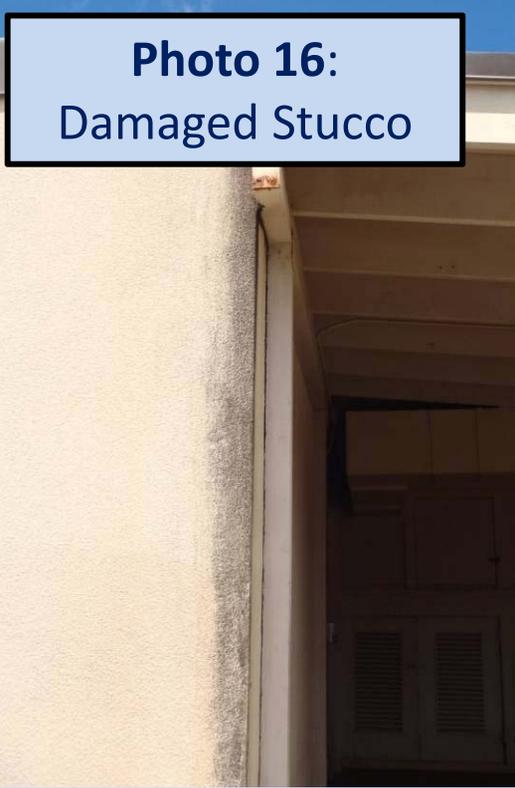
Photo 16: Damaged Stucco

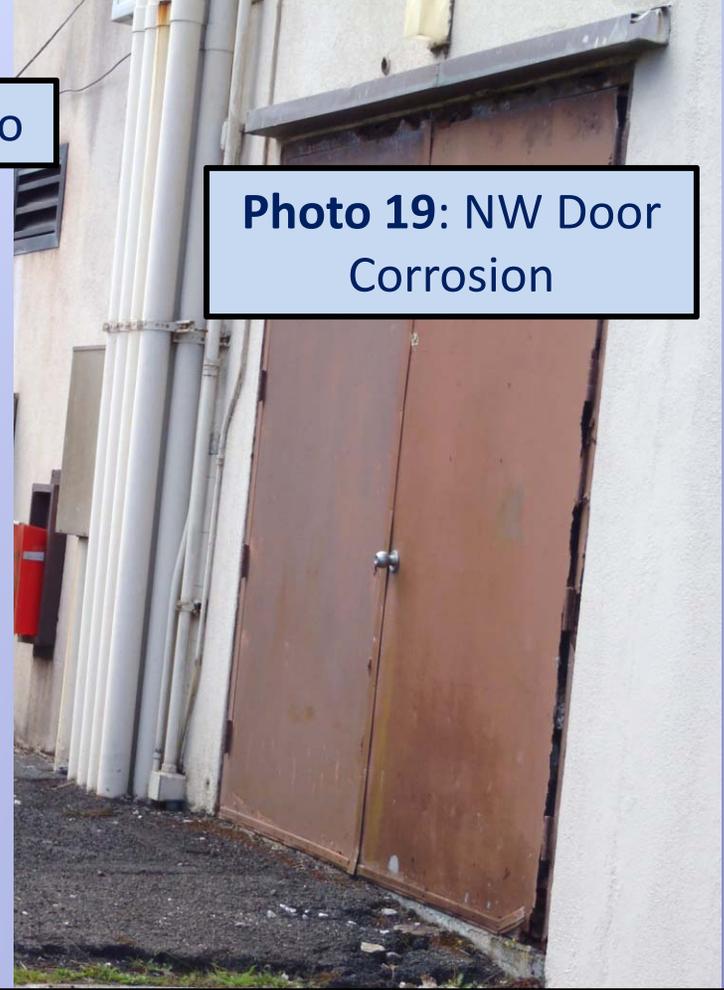
Photo 19: NW Door Corrosion

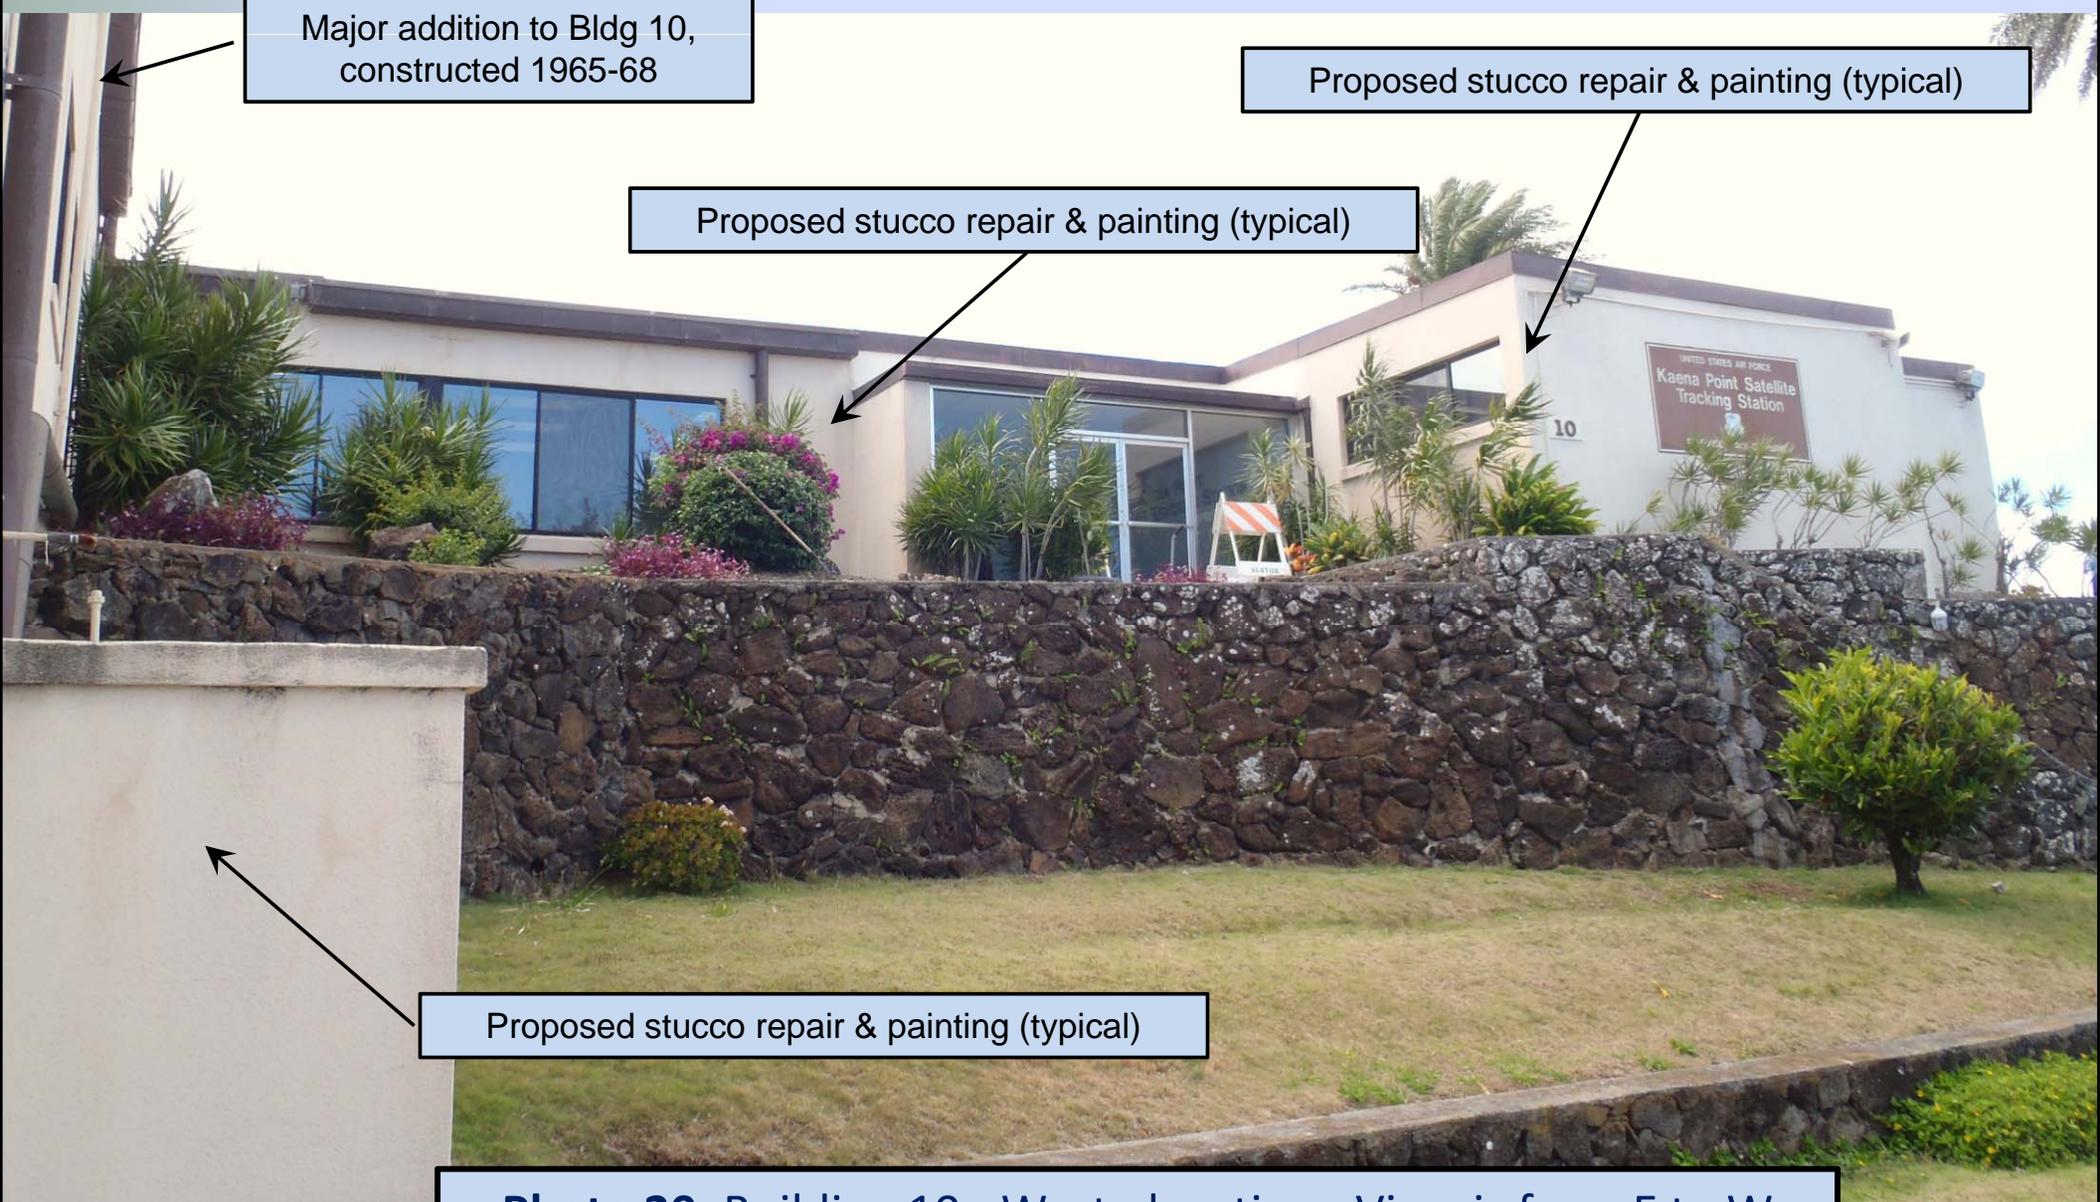
Photo 20: Building 10 - West elevation. View is from E to W

Major addition to Bldg 10, constructed 1965-68

Proposed stucco repair & painting (typical)

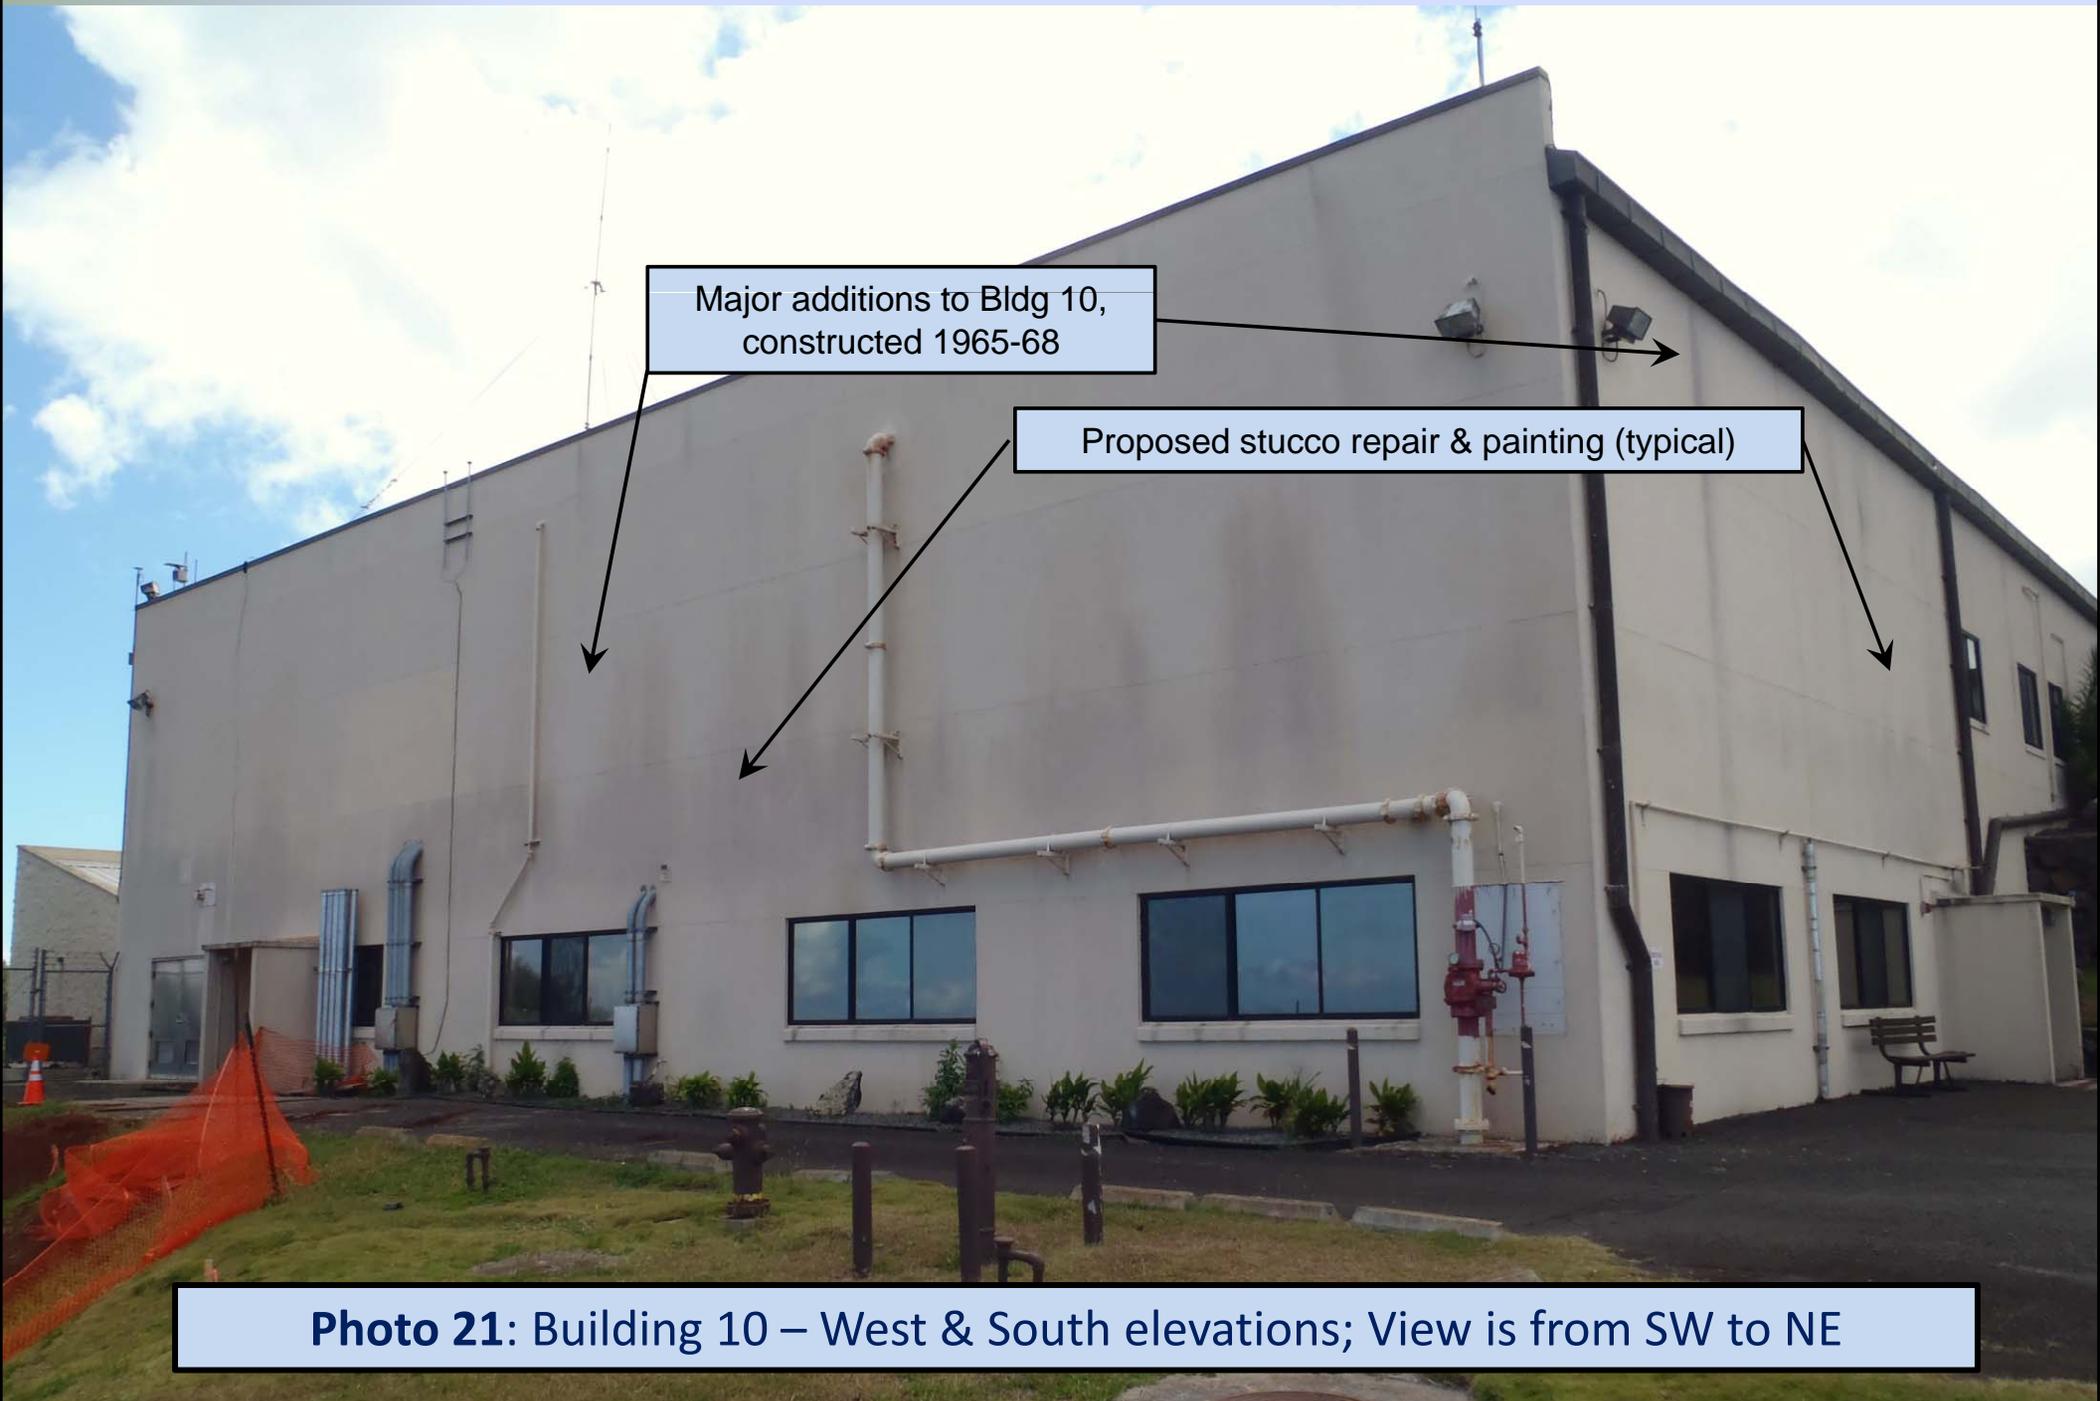
Photo 21: Building 10 – West & South elevations; View is from SW to NE

Major additions to Bldg 10,
constructed 1965-68

Proposed stucco repair & painting (typical)

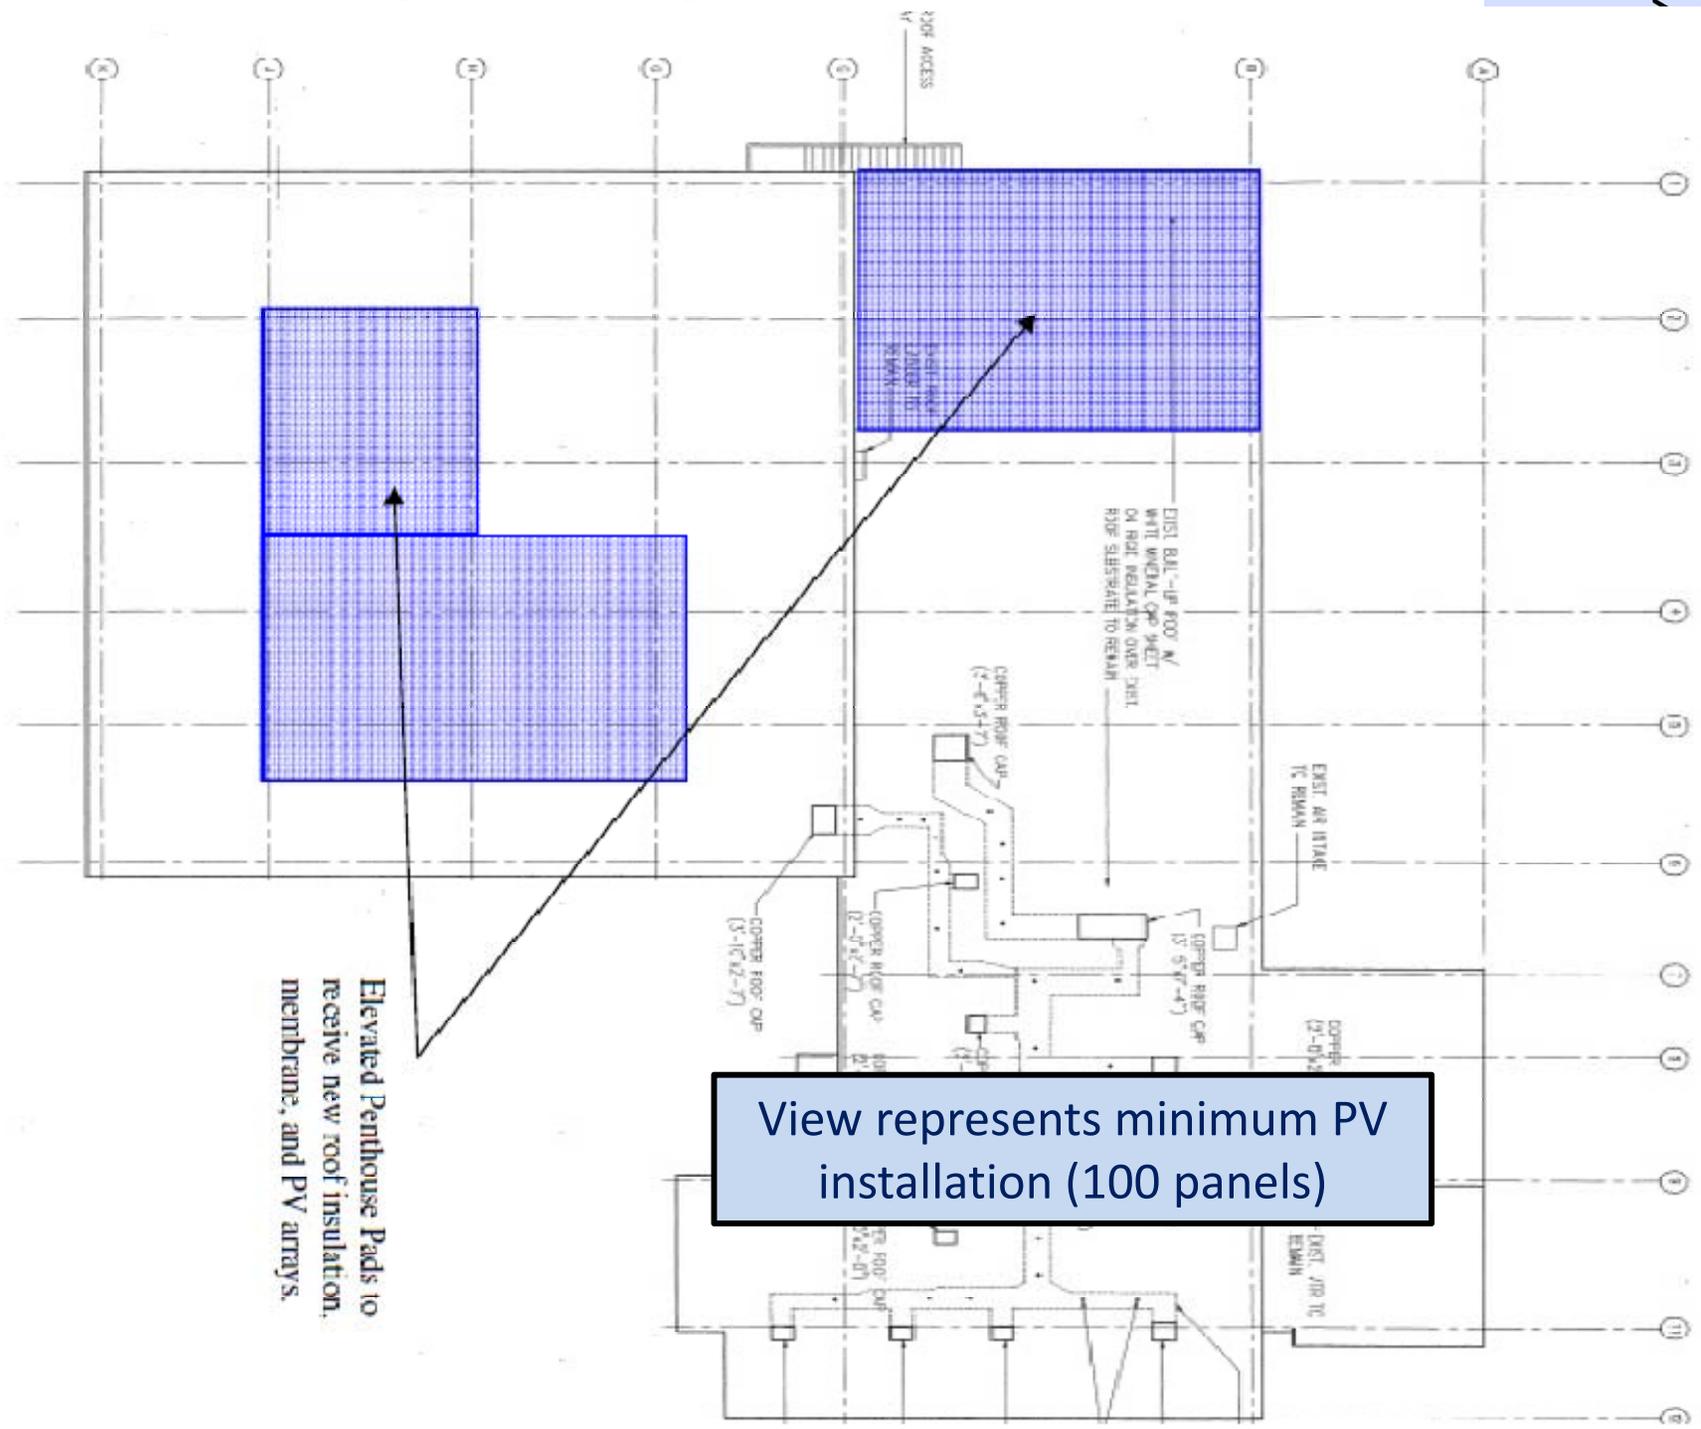
ROOF PLAN - BUILDING 10
SCALE 1/8" = 1'-0"

Elevated Penthouse Pads to receive new roof insulation, membrane, and PV arrays.

View represents minimum PV installation (100 panels)

- a. New array is to be roof mounted on building 10 at the penthouse pads identified on attachment "Schematic Roof Plan".
- b. Provide PV array and power conditioning system for Building 10 in a turn-key fashion; array and inverter(s) will operate as an integrated element in the facility electrical system upon completion.
 - a. Install between 100 and 430 of rectangular (41" x 61") PV panels
 - b. Maintain minimum profile and footprint as is practicable
 - c. Install inverter(s) and disconnect(s)

- d. Replace Penthouse Roof Pads for PV Roof Mounting System;
- e. Remove and replace existing rolled roof membrane and roof deck insulation at the penthouse pads identified in the "Schematic Roof Plan".
- f. Replace existing flashing as necessary.
- g. Furnish and install PV array mounting system to roof deck. Mounting system shall be compatible with selected panels. Mounting system shall be installed to maximize the available space of the penthouse pads and allow for array growth.
- h. Install flashing or boots to weatherproof the roof mount penetrations as necessary.

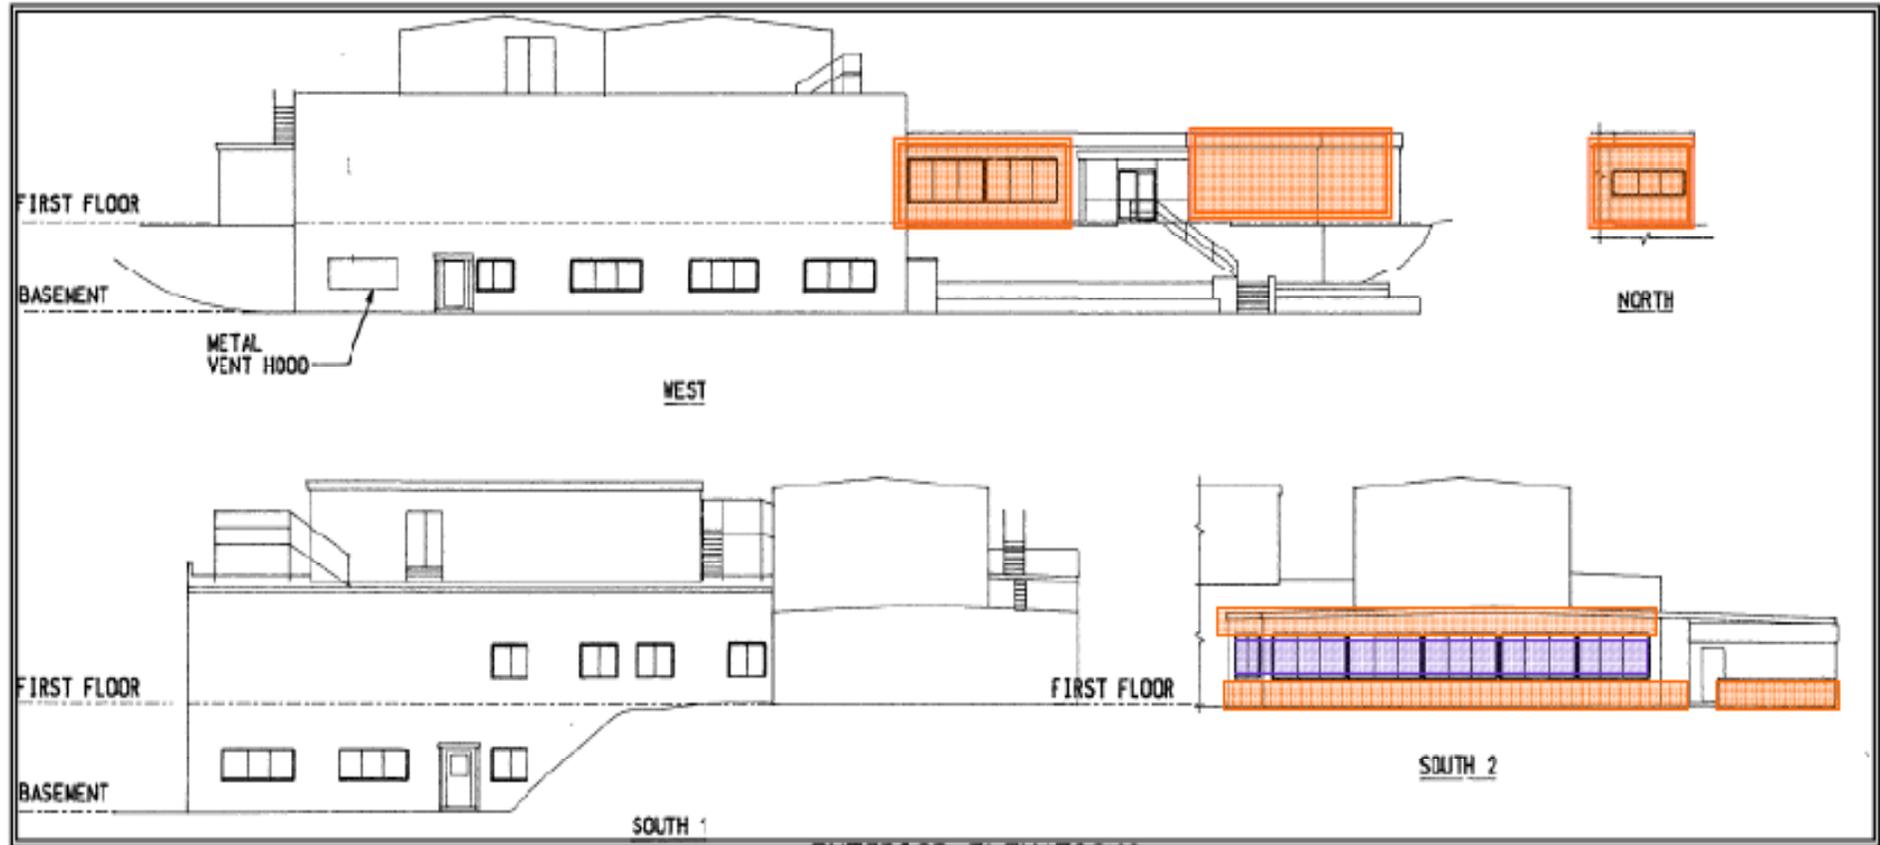
Building 10 (Elevation Views)

Remove and replace stucco finish.
-

Remove and replace windows.

Repair work (examples)
