SUBJECT: Chapter 25, Revised Ordinances of Honolulu  
Draft Environmental Assessment  
Project: Punaluu Stream Restoration Project  
Applicant: Kamehameha Schools  
Agent: ICF International  
Location: Punaluu Watershed – Koolauloa  
Tax Map Keys: 5-3-1: 41 and 52, and 5-3-3: 1

**Project Name:** Punalu'u Stream Restoration Project, EA

Appendix C Biological Assessment Punalu'u Stream, O'ahu, Hawai'i with Recommendations for  
Stream Enhancement

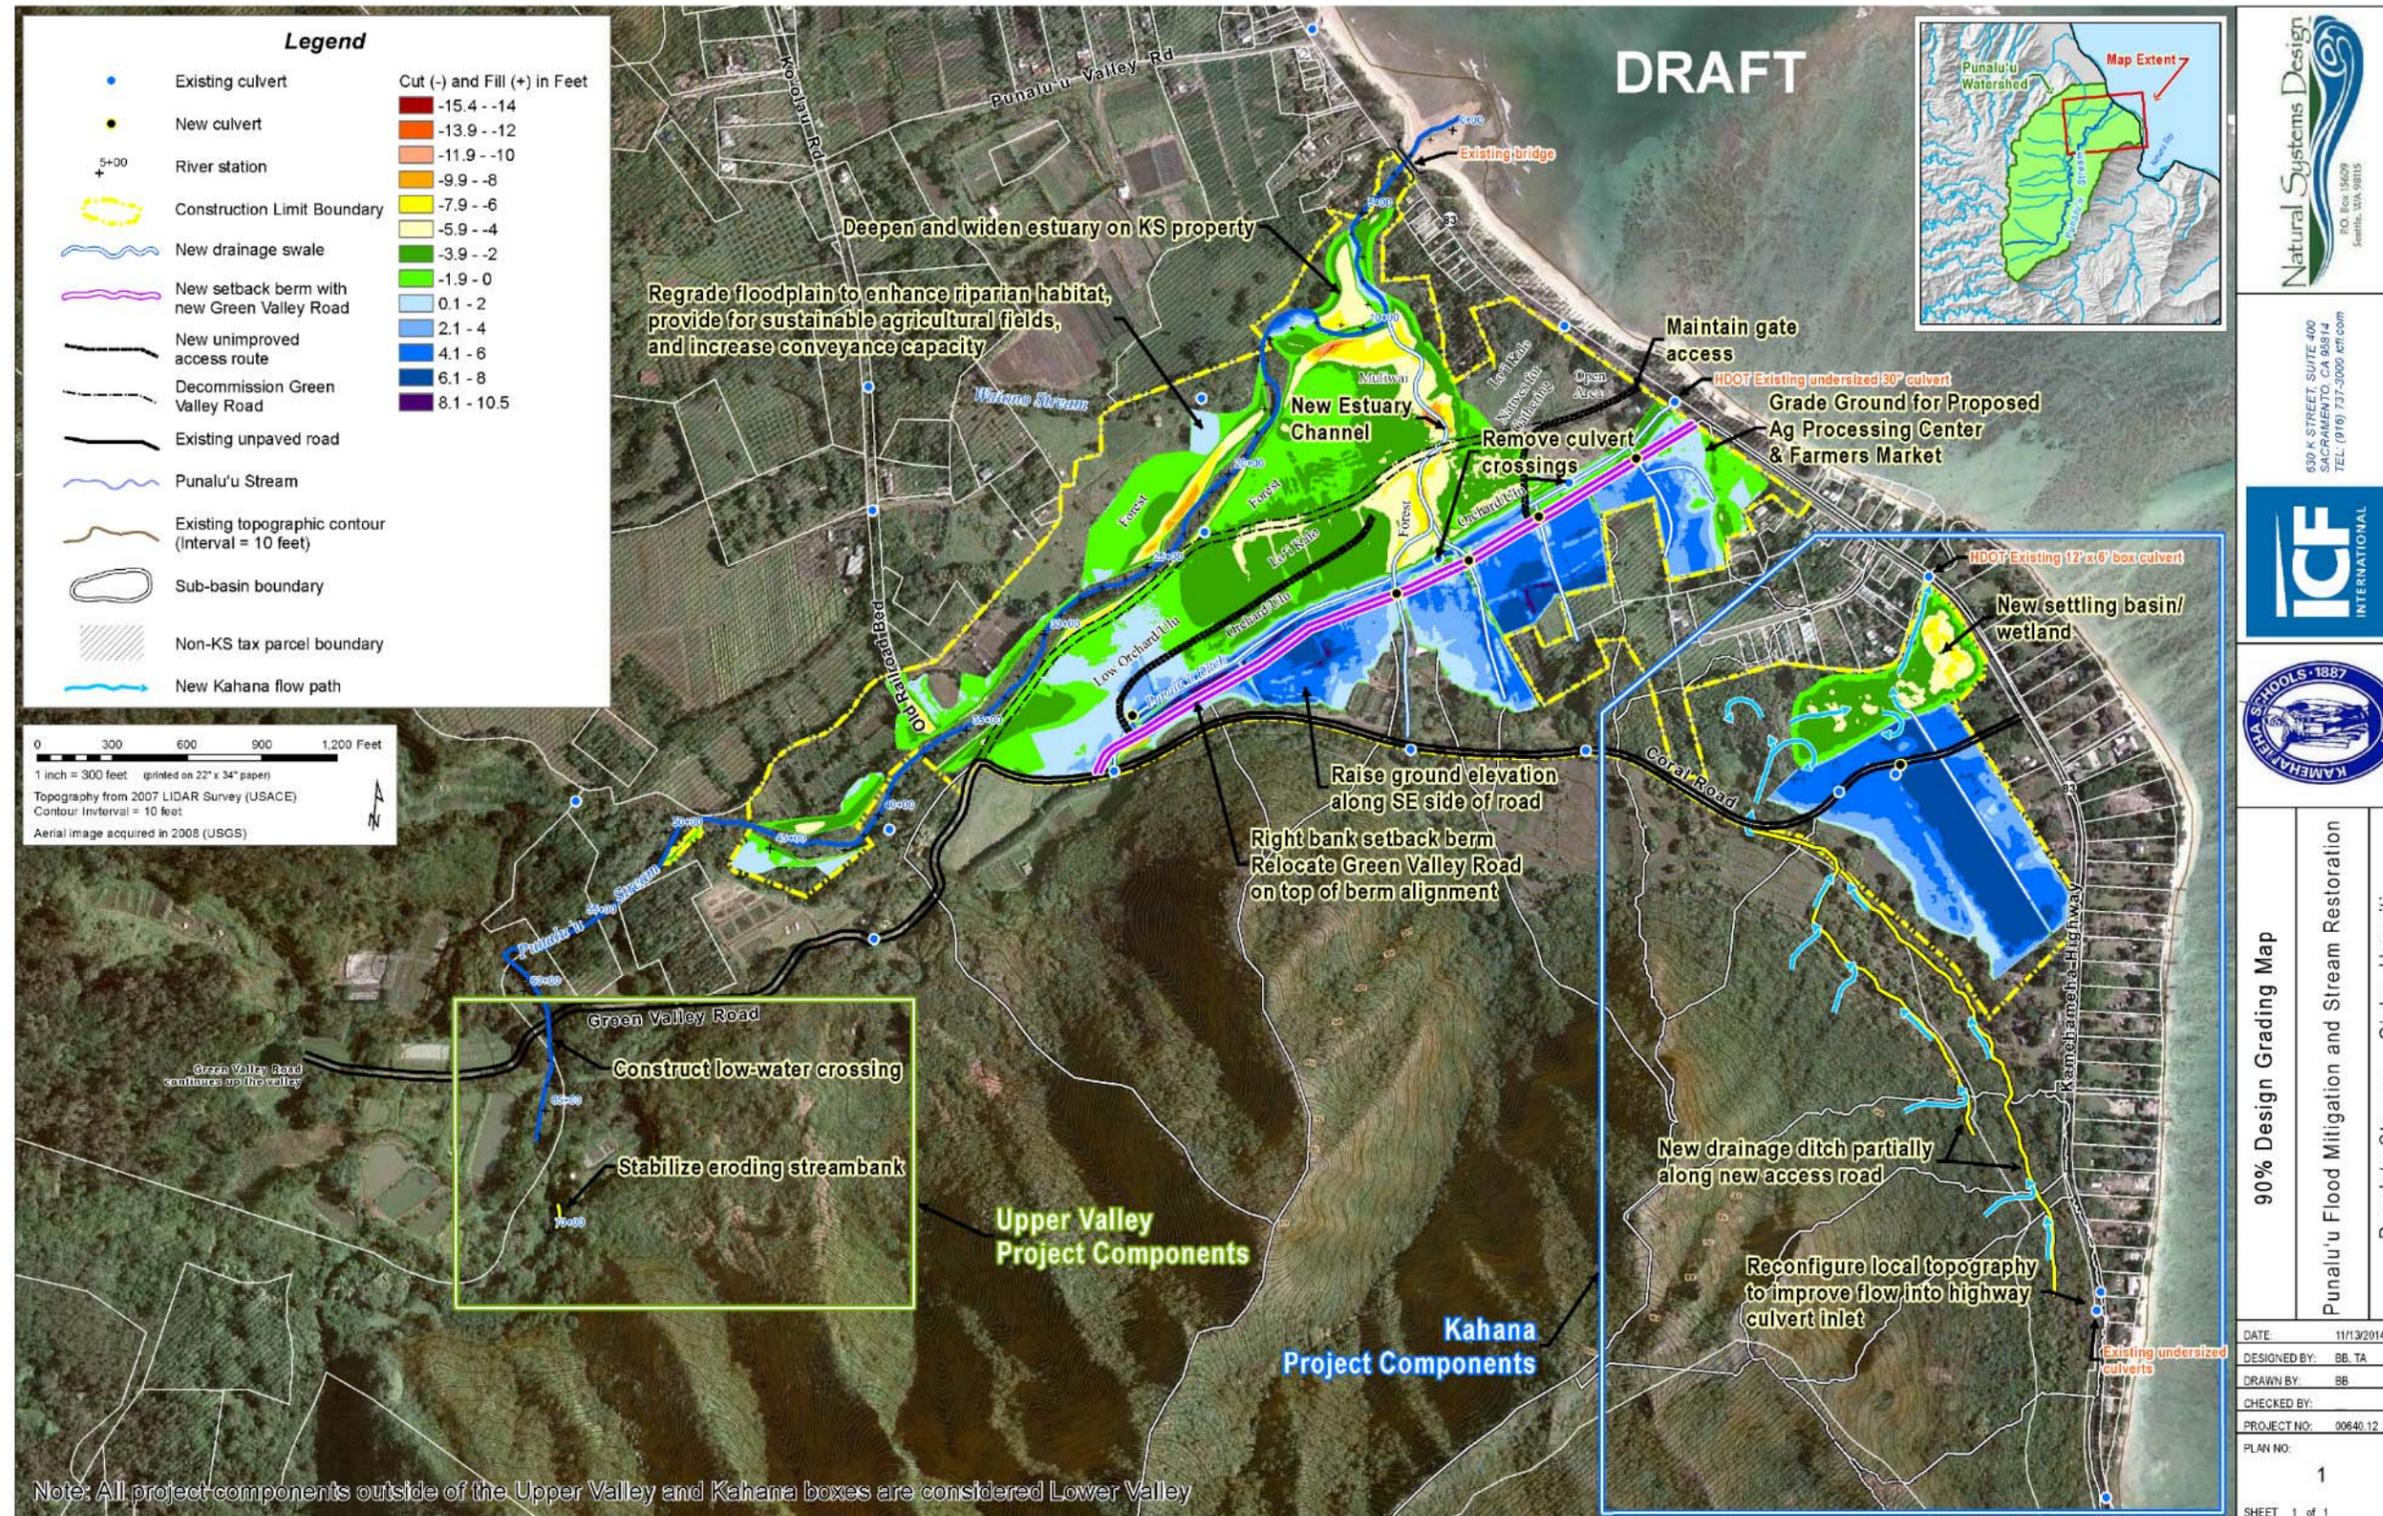
**Exhibit 3-2. Cut and Fill Areas for Punalu'u Flood Mitigation and Stream Restoration.** Note the Footprint of the Proposed New Settling Basin/Wetland Feature has been updated since the 90% Grading Plan was developed (see Exhibit 3-1 for Update). Cut and Fill Calculations for the Revised Boundary will be Determined in the Final Design.

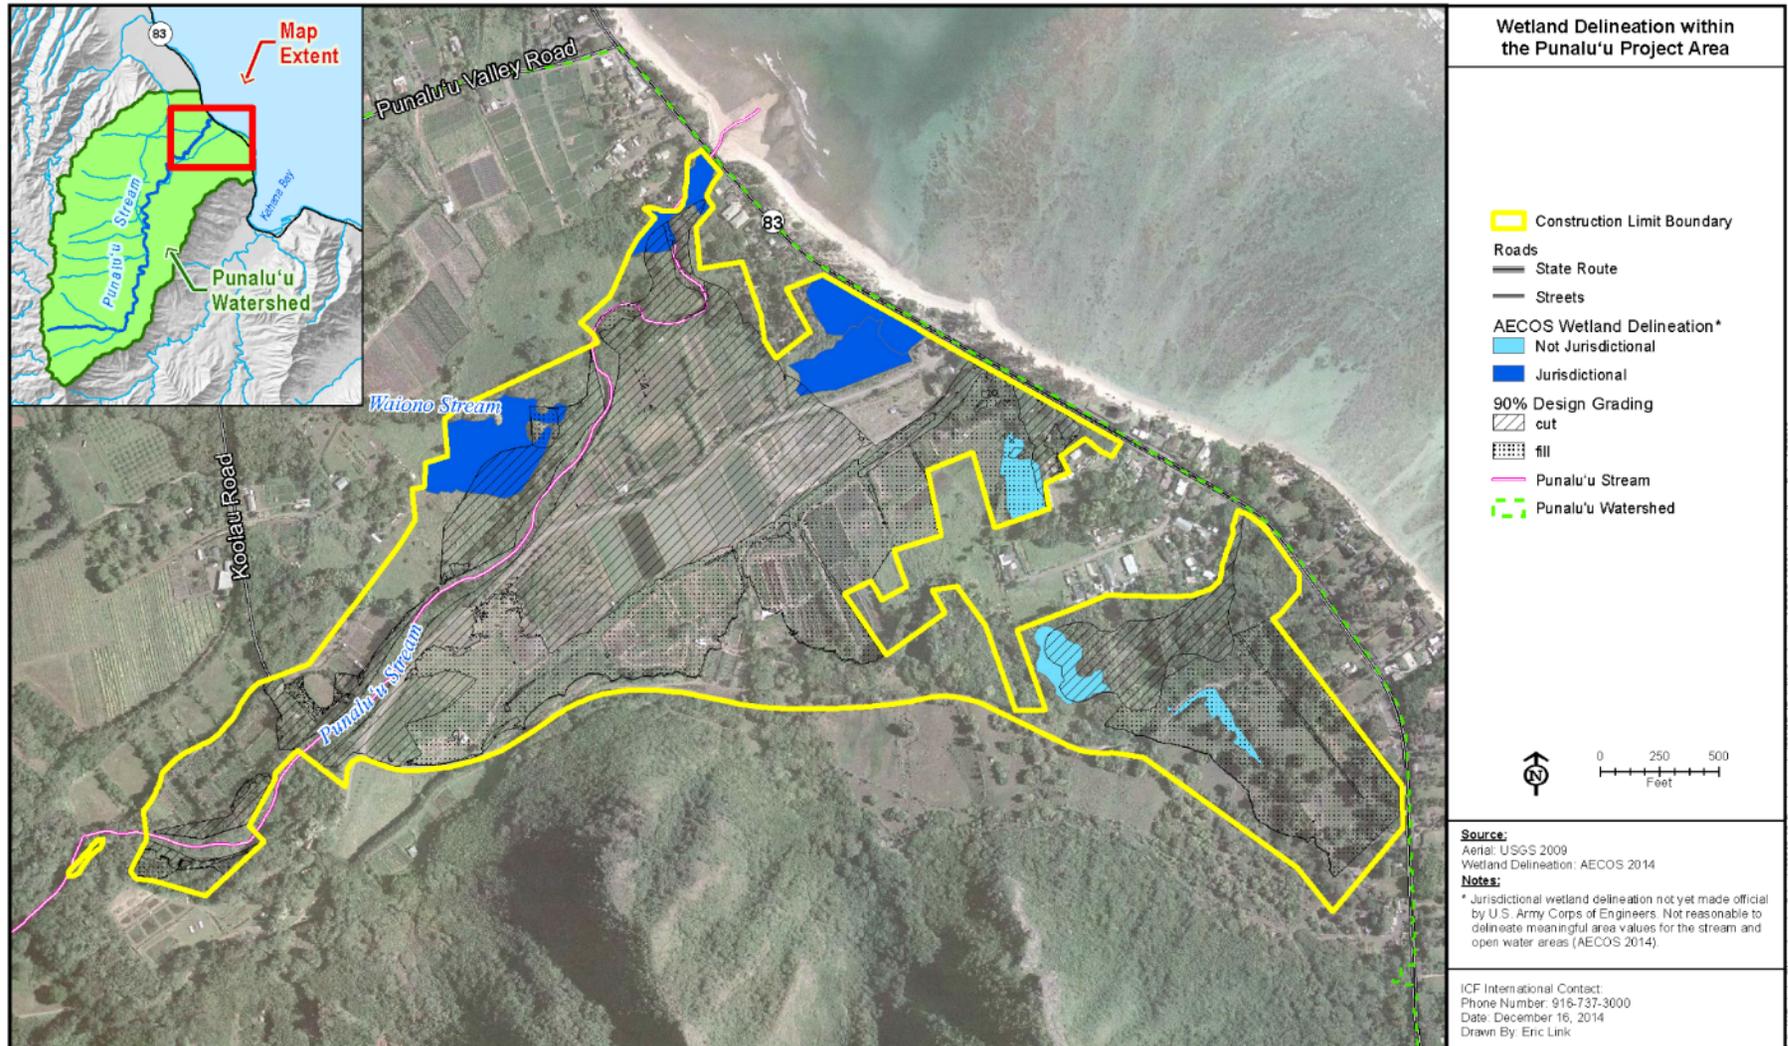
Exhibit 4-8. Wetland Delineation of the Project Area

A wetland delineation was performed for the project by wetland biologists with AECOS, Inc. in September 2014 (AECOS 2014). The wetland delineation report provided in Appendix B includes details on the site history, field methods, and results with accompanying maps. The delineation covered the 140 acre project area and also included a survey of the ordinary high water mark (OHWM). AECOS found three types of open water features and 6 “types” of wetlands in the project area. Open water features include: estuary, stream, and agriculture ditch. Wetlands are all palustrine wetlands (inland marshes and swamps) and include: temporarily flooded with broad-leaved evergreen trees (PFO3A), semi permanently flooded with broad-leaved evergreen scrub-shrub vegetation (PSSF), temporarily flooded with persistent, emergent vegetation (PEM1A), seasonally flooded with persistent, emergent vegetation (PEM1C), actively artificially flooded, diked and/or impounded with persistent, emergent vegetation (active PEM1Kh), and formerly artificially flooded, diked and/or impounded with persistent, emergent vegetation (relict PEM1Kh).

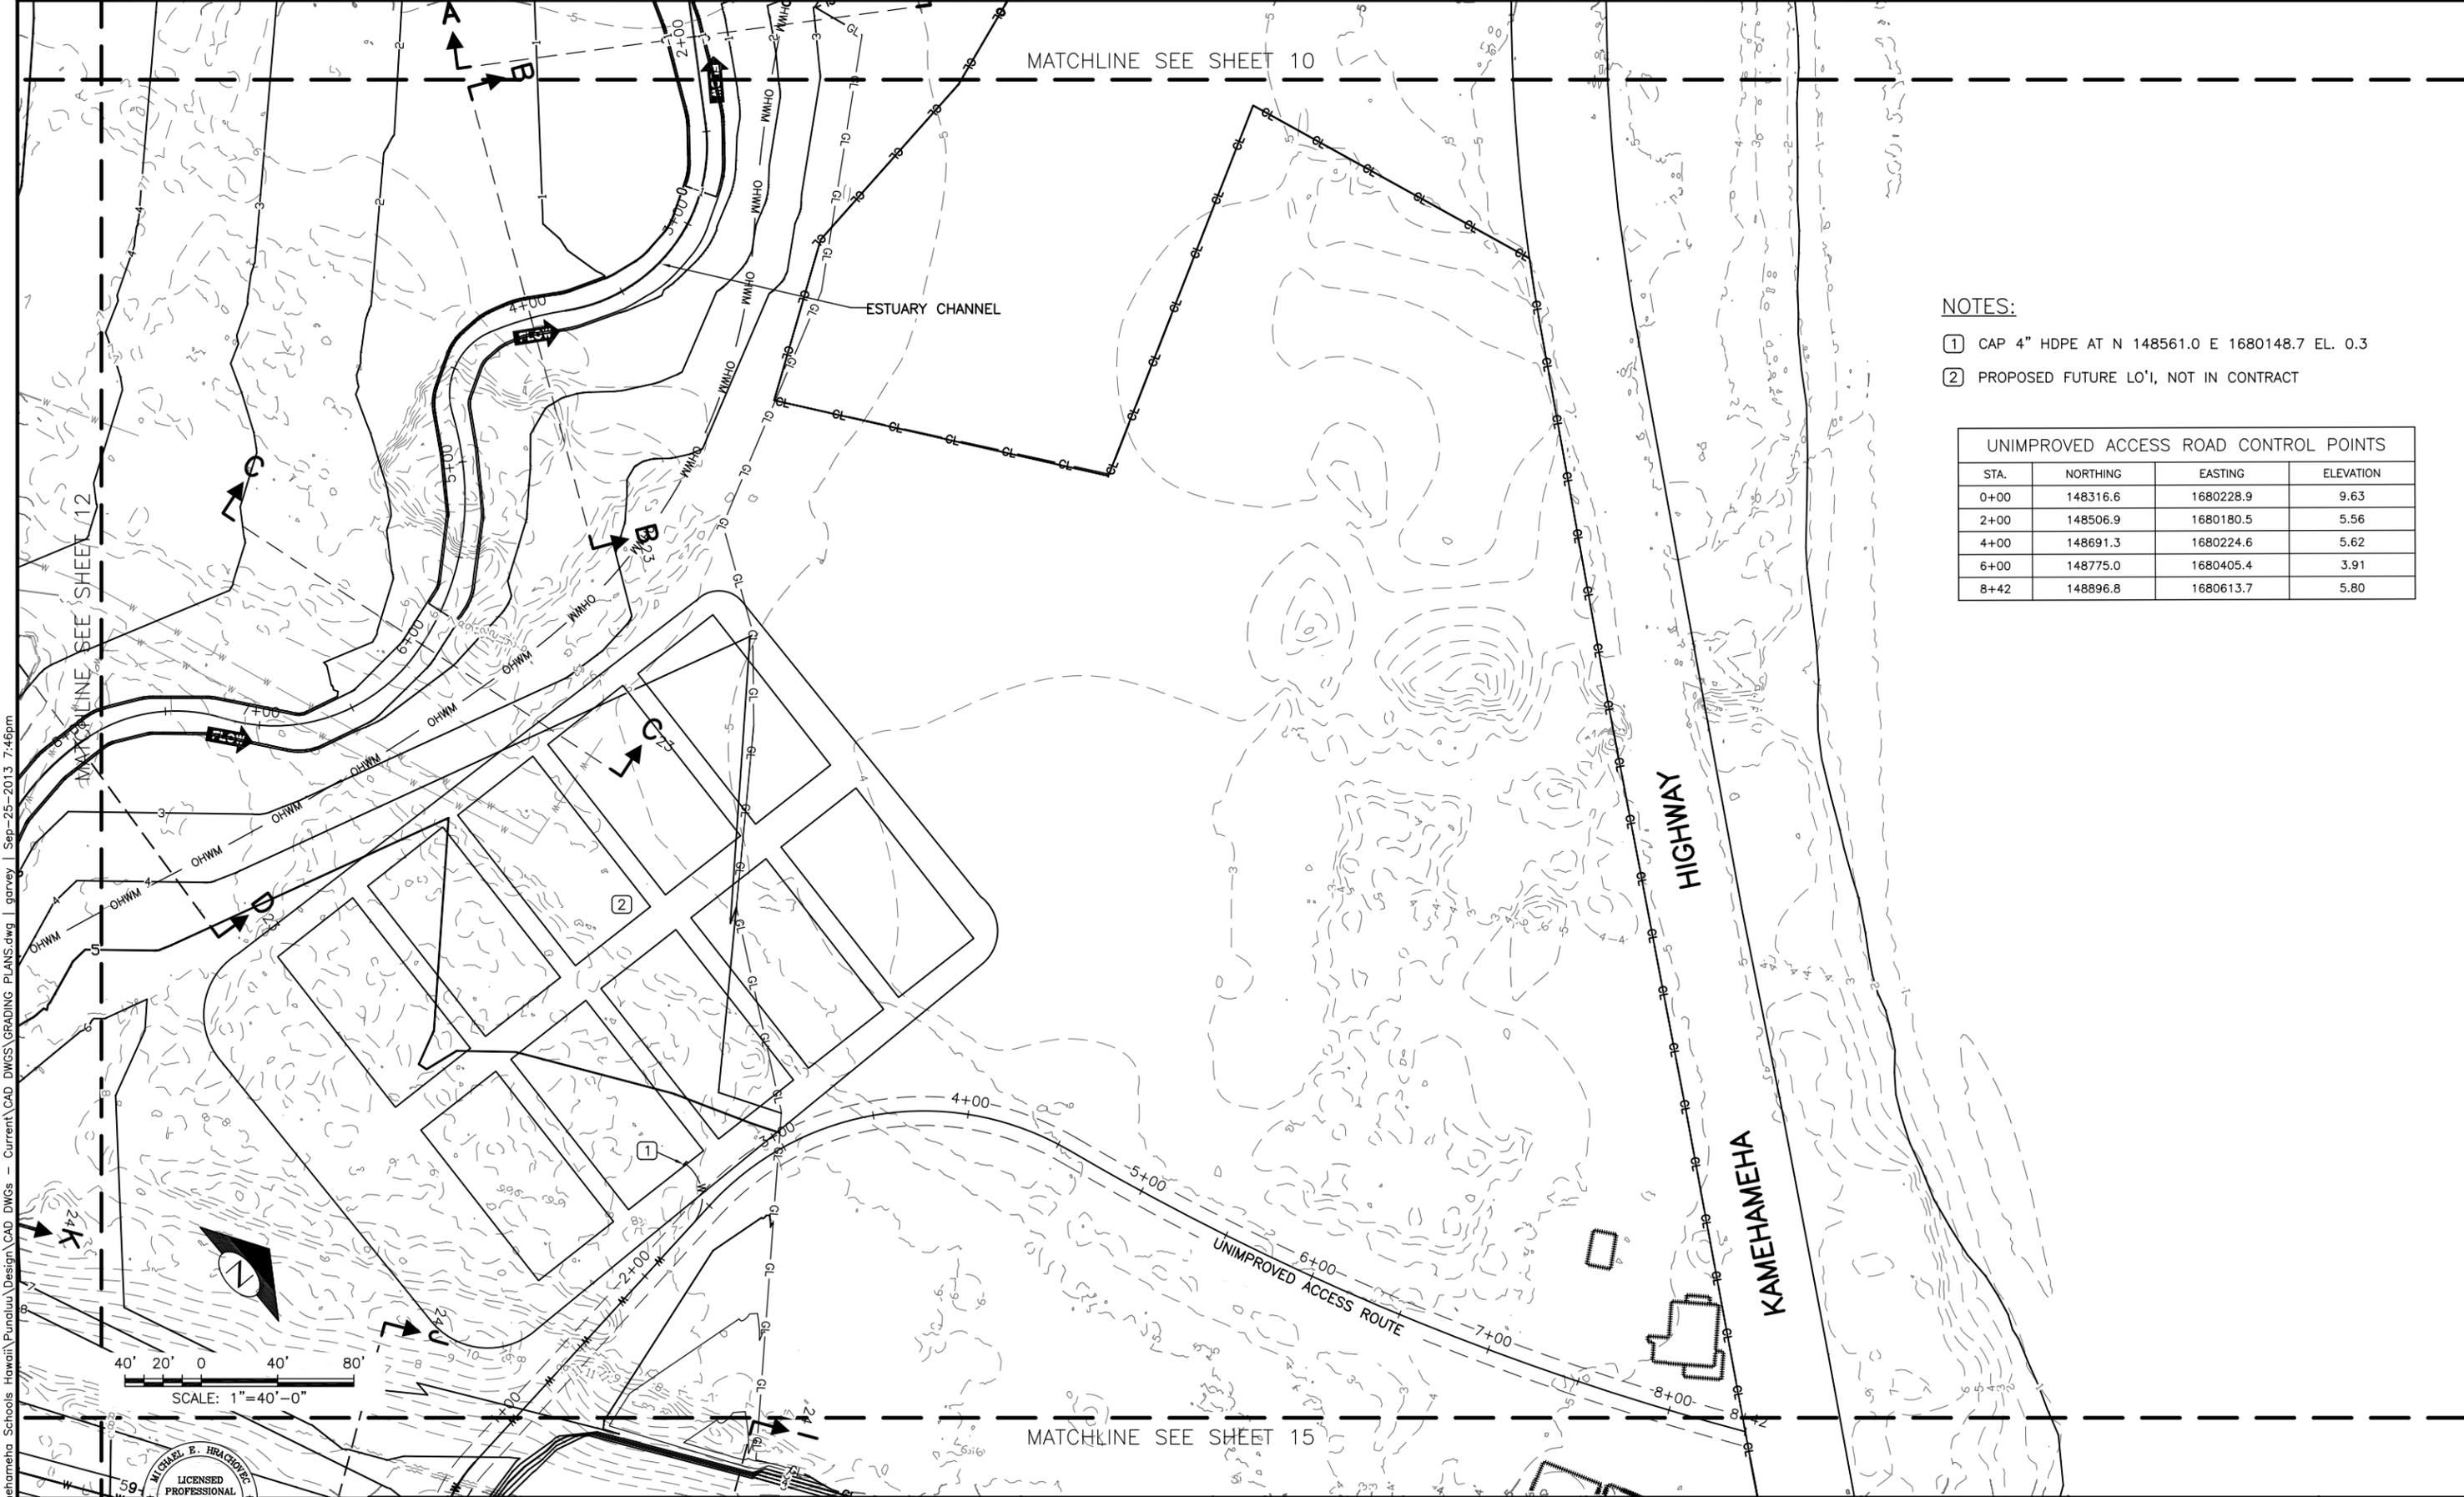
**GRADING PLAN 6**

- ① CAP 4" HDPE AT N 148561.0 E 1680148.7 EL. 0.3
- ② PROPOSED FUTURE LO'1, NOT IN CONTRACT

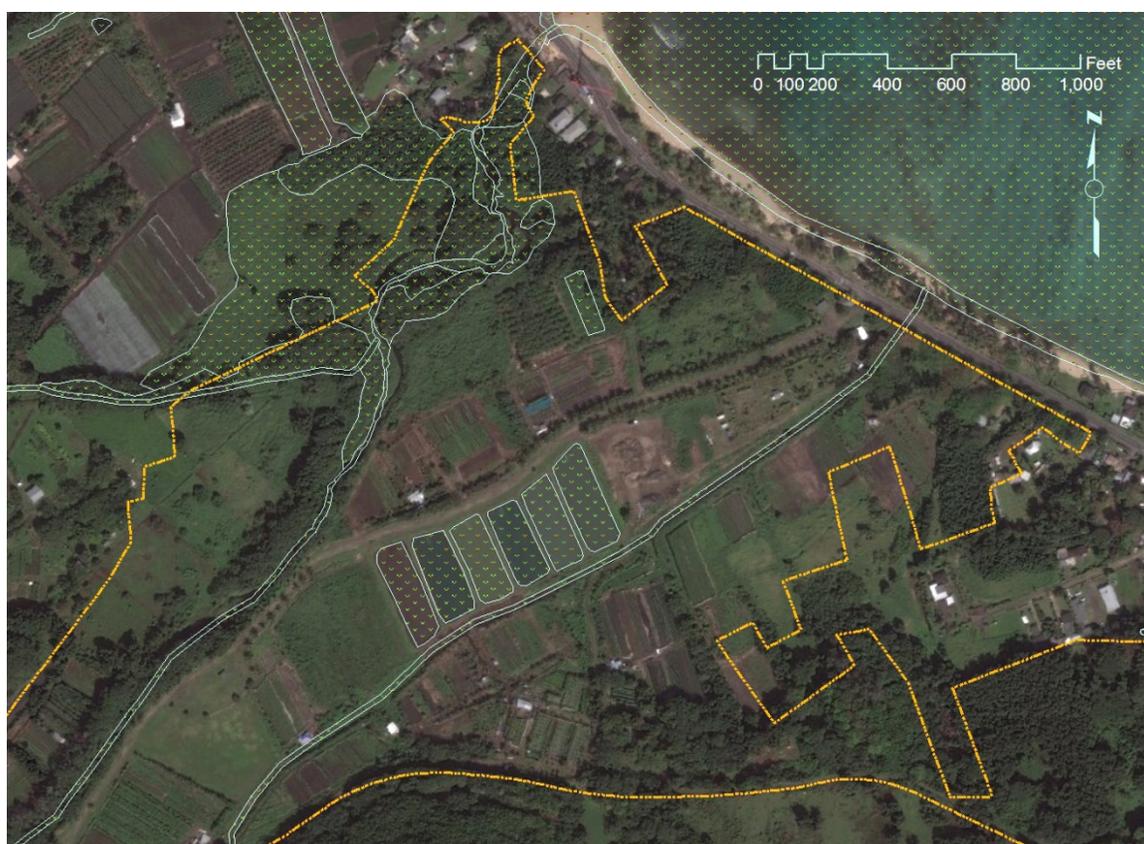
Figure 2. Aquatic features identified on National Wetlands Inventory (NWI) map in Plan Area of Punalu'u watershed. Note that the NWI includes marine areas.

The U.S. Fish and Wildlife Service (USFWS) definition of wetlands is different than that used to regulate wetlands under the CWA—only a single wetland characteristic (hydrophytic vegetation, hydric soils, or wetland hydrology) is required by USFWS for an area to be considered a wetland. The National Wetlands Inventory (NWI; USFWS, 2006), a mapping of all aquatic environments (not just wetlands), indicates aquatic features are present within the Plan Area of Punalu'u watershed (Figure 2).

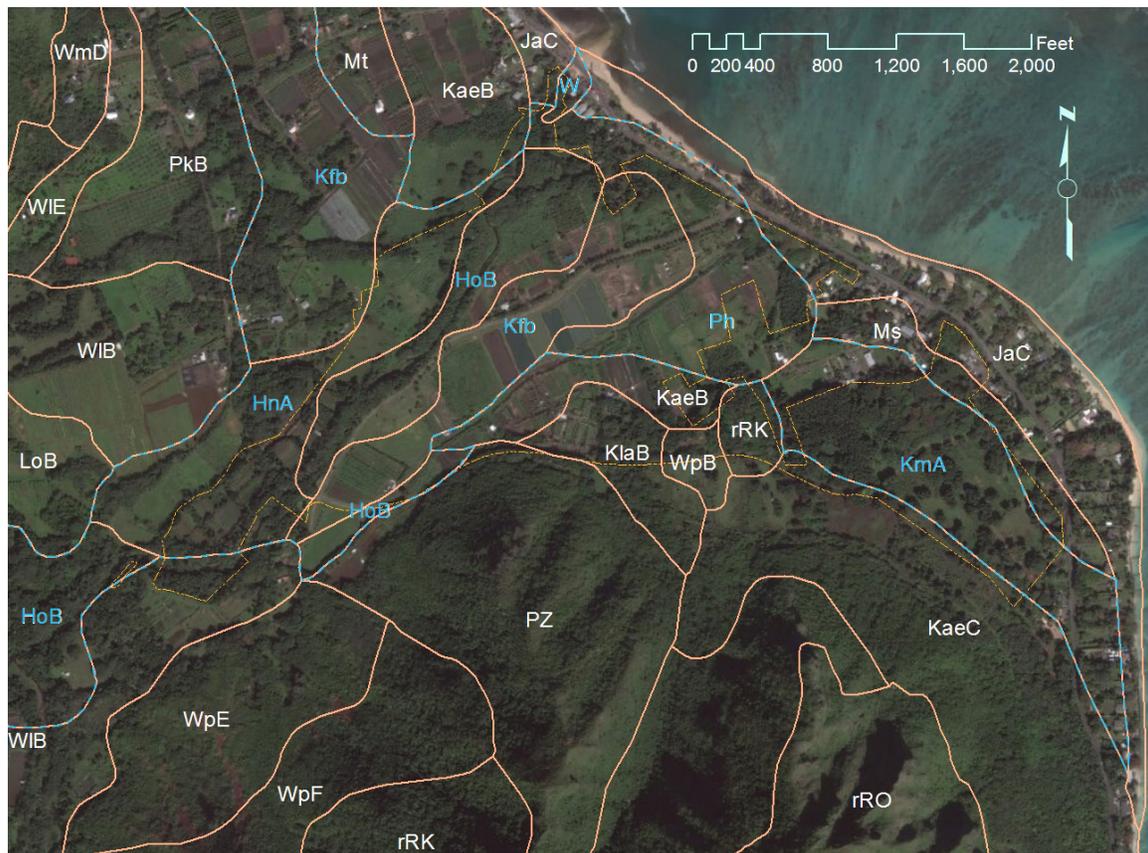
Figure 3. Soil survey including the Plan Area of Punalu'u watershed. Hydric soils (in blue type; named in text) are HnA, HoB, Kfb, and Ph.

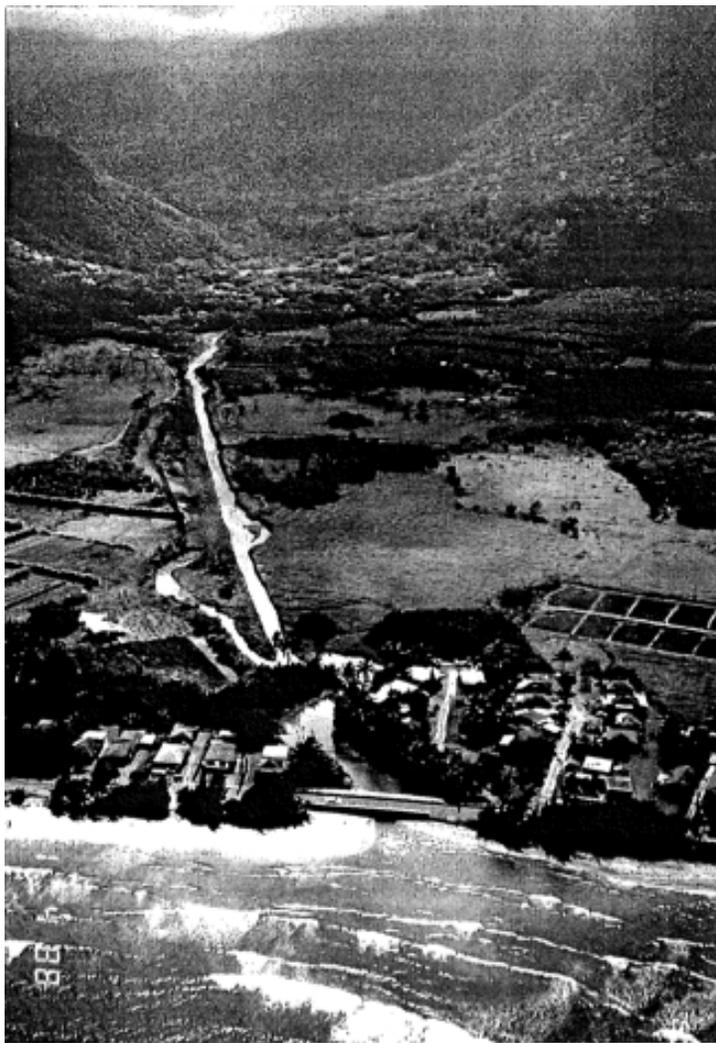
Figure 4. 1988 oblique aerial photo of the lower reach of Punalu'u Stream, redirected to a straightened channel.

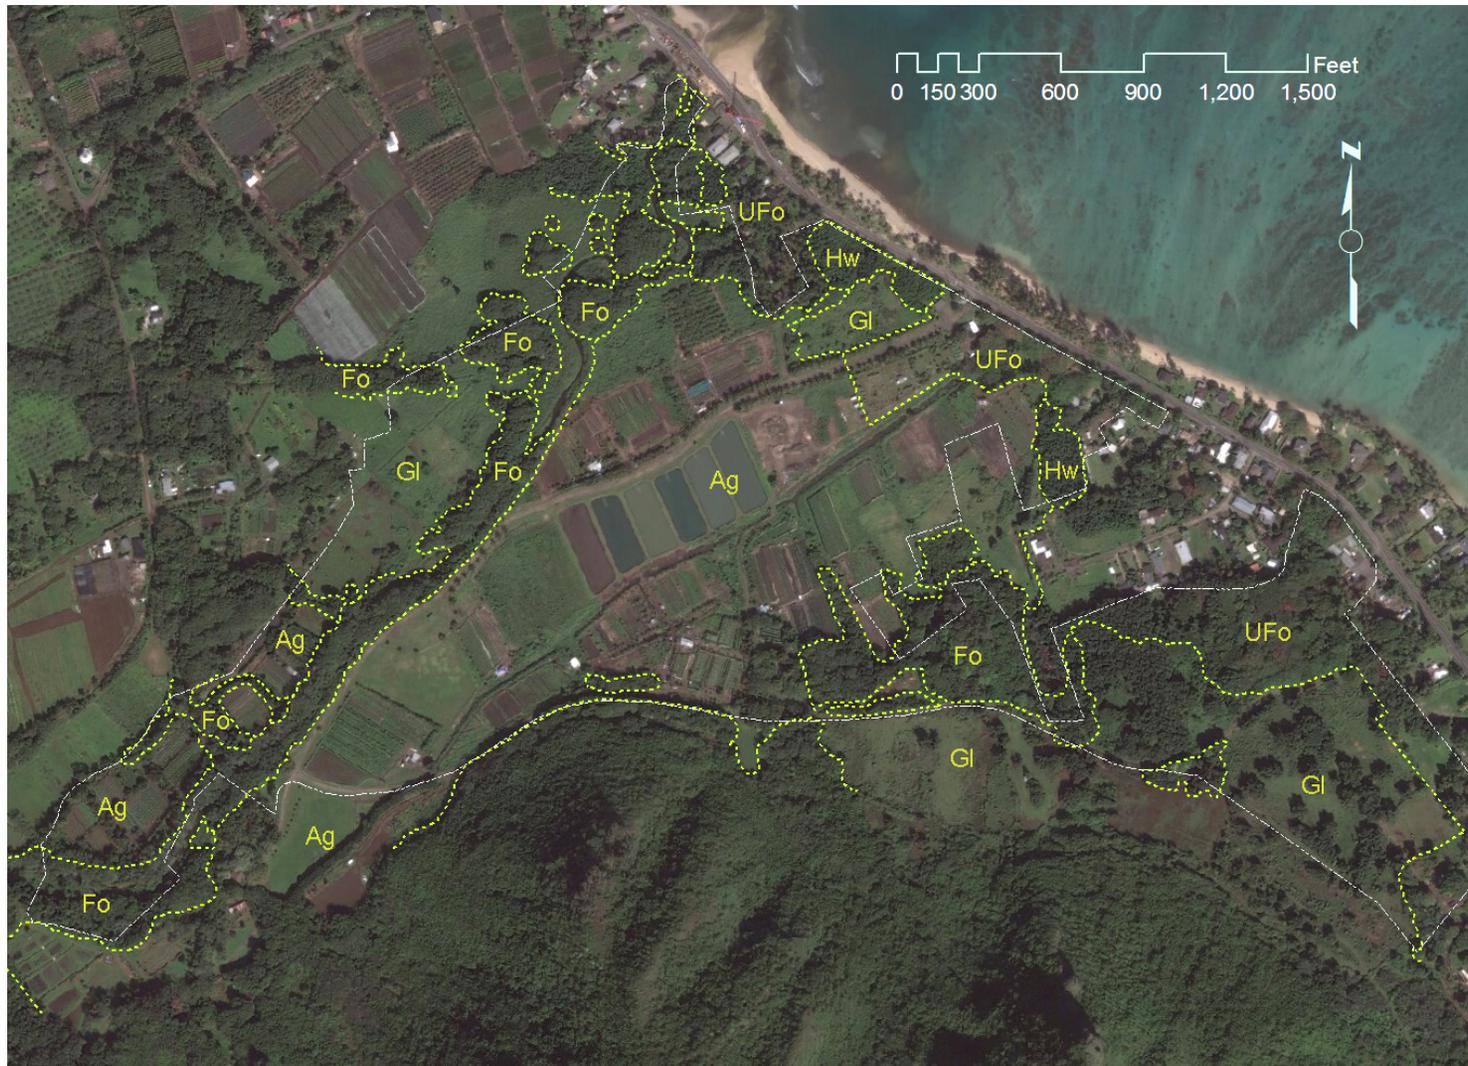
Figure 5. Vegetation map for Plan Area (see text Table 2 for definitions).

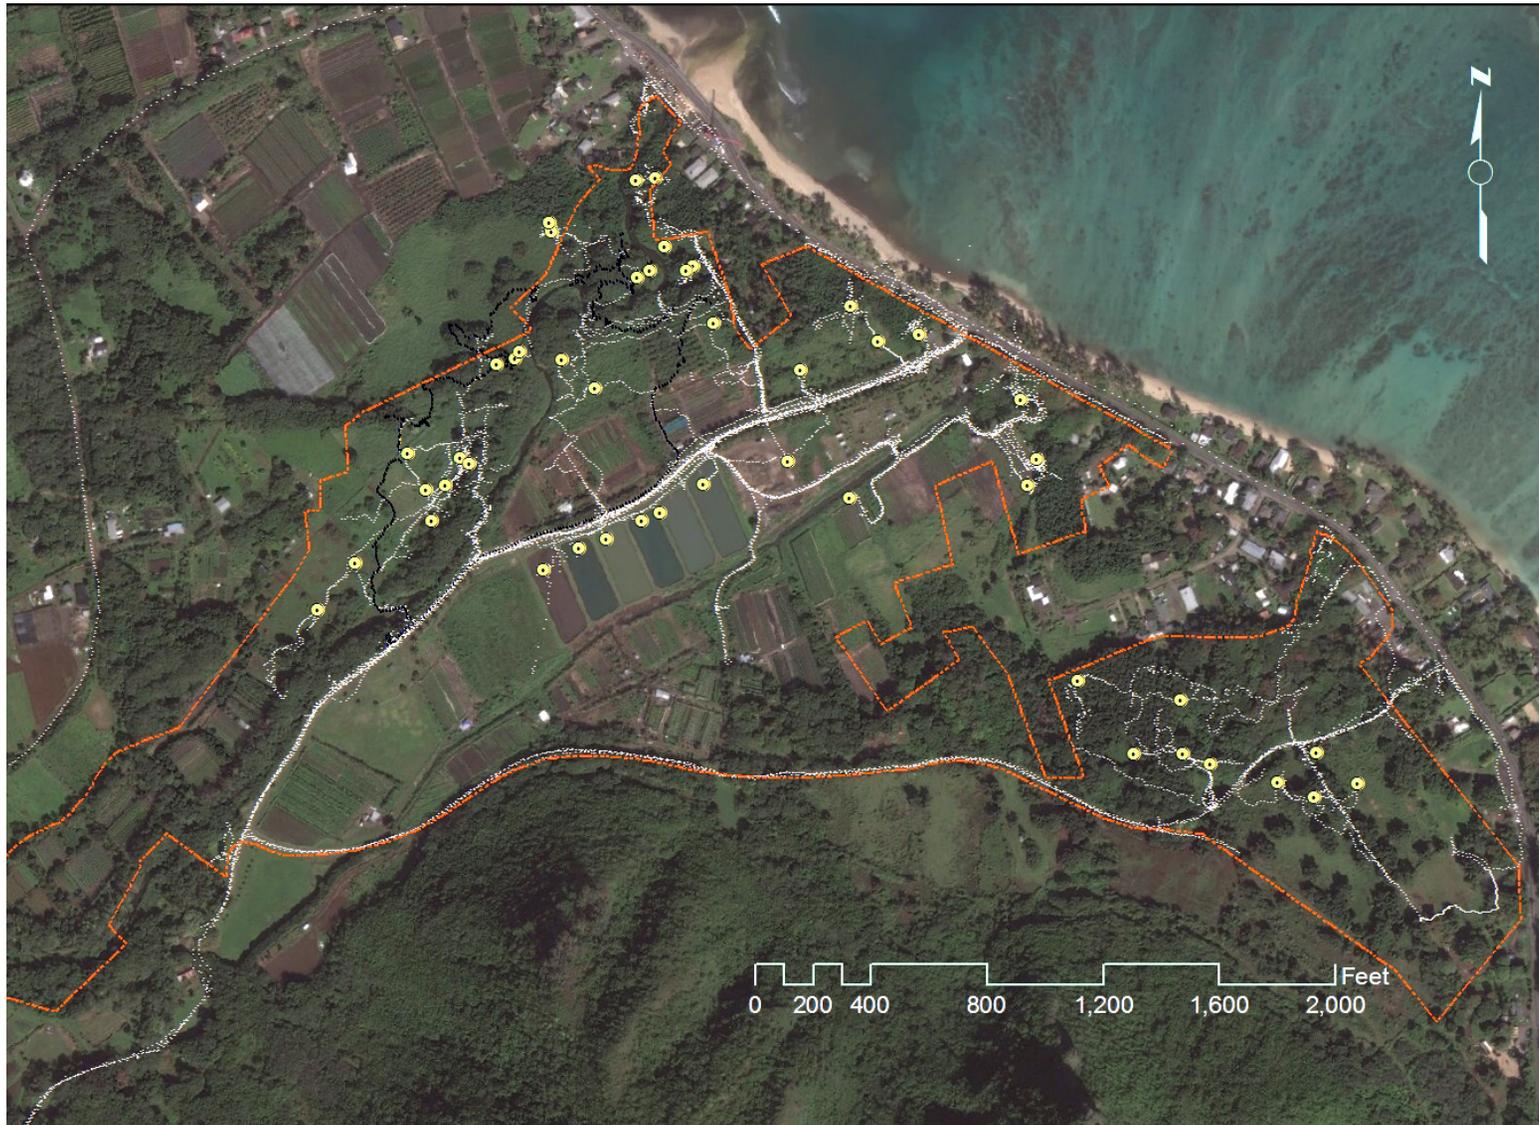
Figure 6. Distribution of the 47 sampling points (yellow circles) and recorded tracks of biologists (white dots) in the Plan Area.

provide submeter accuracy of a recorded location (position). The GNSS units also recorded the biologists’ movements around the survey area (also shown in Fig. 6).

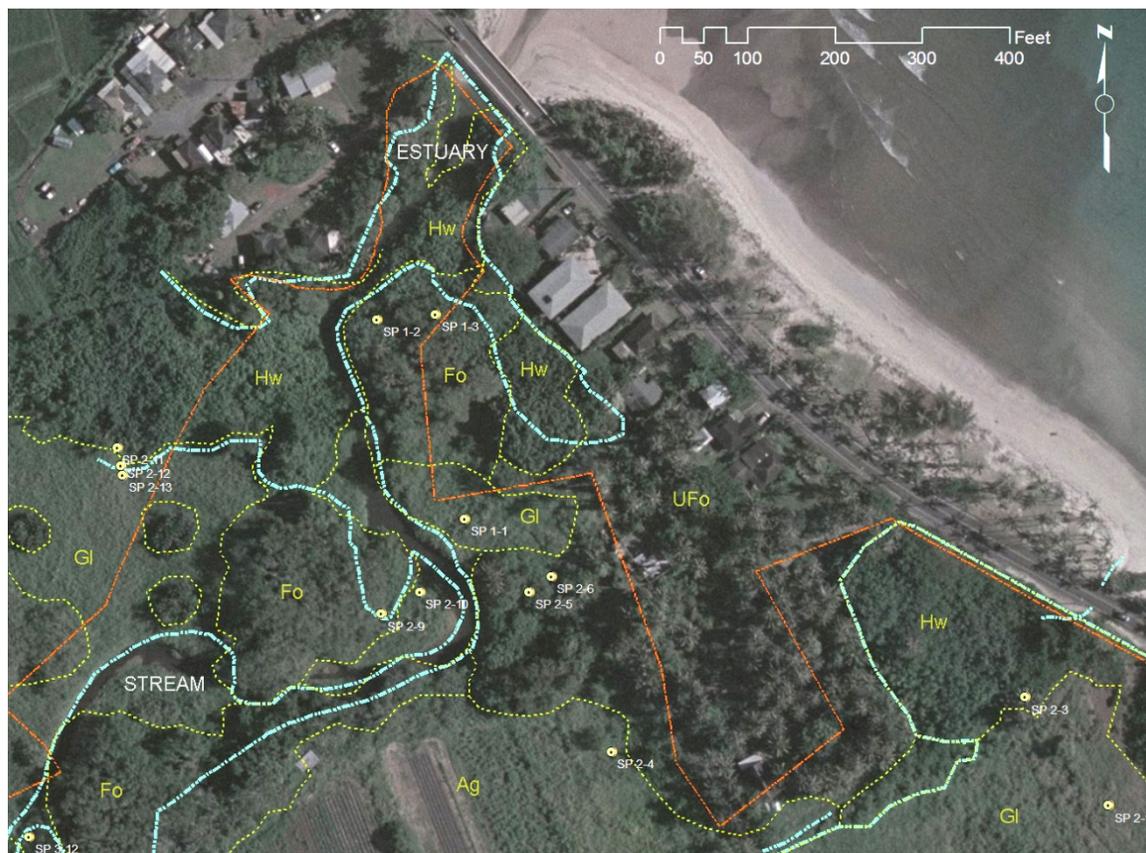
Figure 7. Jurisdictional estuarine waters are present at the mouth of Punalu'u Stream and in low areas *mauka* of the highway. Map shows both vegetation zones (yellow, with symbols) and wetland boundaries (light blue). Sampling points (yellow dots) are labeled.

hydrology at sampling points near the margins, confirming the entire plant assemblage is wetland (see Figs. 7 and 11). The largest *hau* wetland occurs along Punalu'u Stream and estuary (SP 2-11, SP 2-8) and extends behind houses on Kamehameha Highway east of the Punalu'u Stream bridge (outline here based on LIDAR). Another, more extensive *hau* wetland, borders the *mauka* side of Kamehameha Highway west of the main entrance to the Plan Area (SP 2-2, SP 2-3). This wetland is connected to the ocean shore through a culvert under the highway as indicated in Fig. 7. These areas would be classified as temporarily flooded, palustrine wetlands with broad-leaved evergreen trees (PFO3A). Adjacency to Punalu'u Stream established that the largest *hau* wetland is jurisdictional and the connection via an outflow culvert establishes jurisdiction for the other *hau* forest. A small area of American mangrove (*Rhizophora mangle*), an obligate wetland species, is present just upstream of the culvert, demonstrating tidal (and marine) influence.

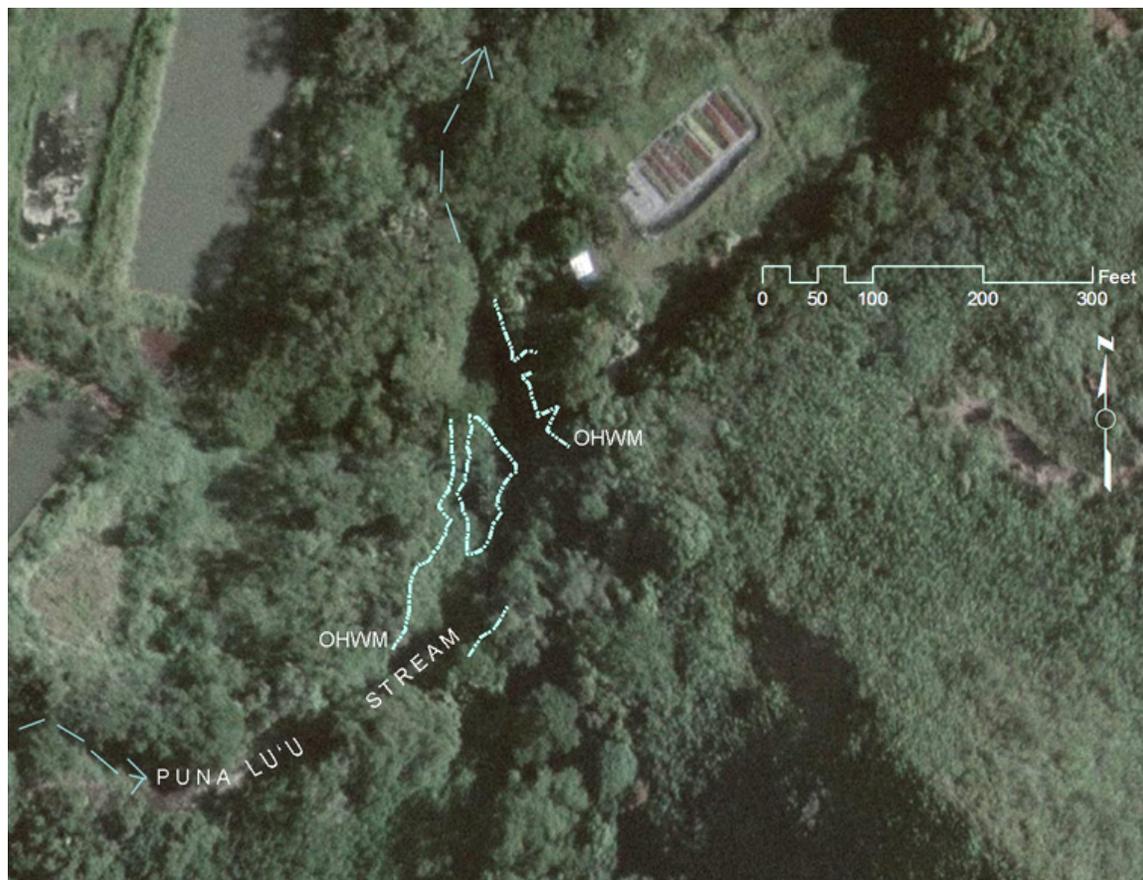
Figure 8. OHWM at stream segment proposed for restoration of eroding right bank.

A levee lines both banks along most of Punalu'u Stream through the middle of the Plan Area. The side of the bank facing the stream provides a good estimate of where the OHWM would be located. We were provided with 1- and 2-ft contours of the Plan Area based on LIDAR (Light Detection and Ranging) data, and these areas of steep contours were used to draw the rough jurisdictional boundary bordering lower Punalu'u Stream. Although LIDAR data can see through vegetation to a certain extent, presumably providing a contour map of the ground surface, this ability to penetrate dense vegetation varies from place to place. We found the LIDAR contours to be of limited use in defining low areas or basins for wetland boundaries, but the levees showed up clearly in the LIDAR image. Determination by this method is a planning level designation of the jurisdictional boundary, and not an OHWM determination.

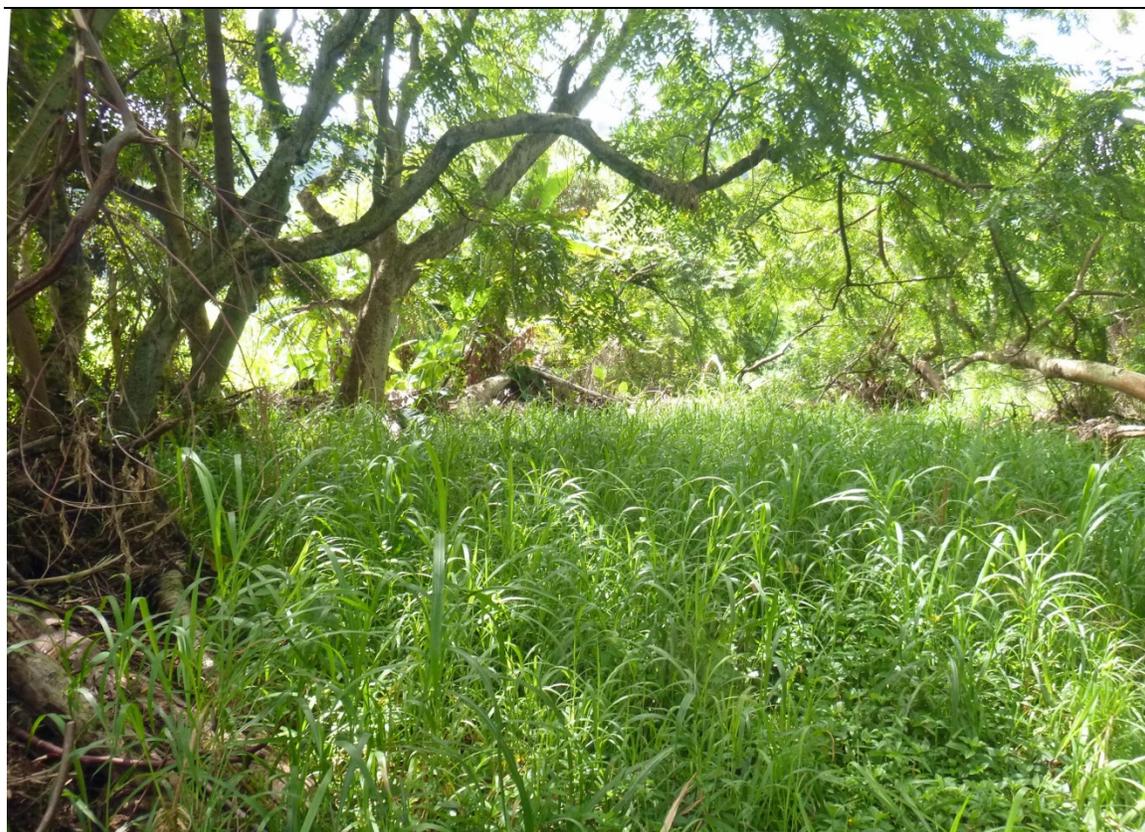
Figure 10. This unnamed intermittent tributary to Punalu'u Stream does not have obvious and continuous bed, banks, or OHWM but is associated with a grass-covered wetland.

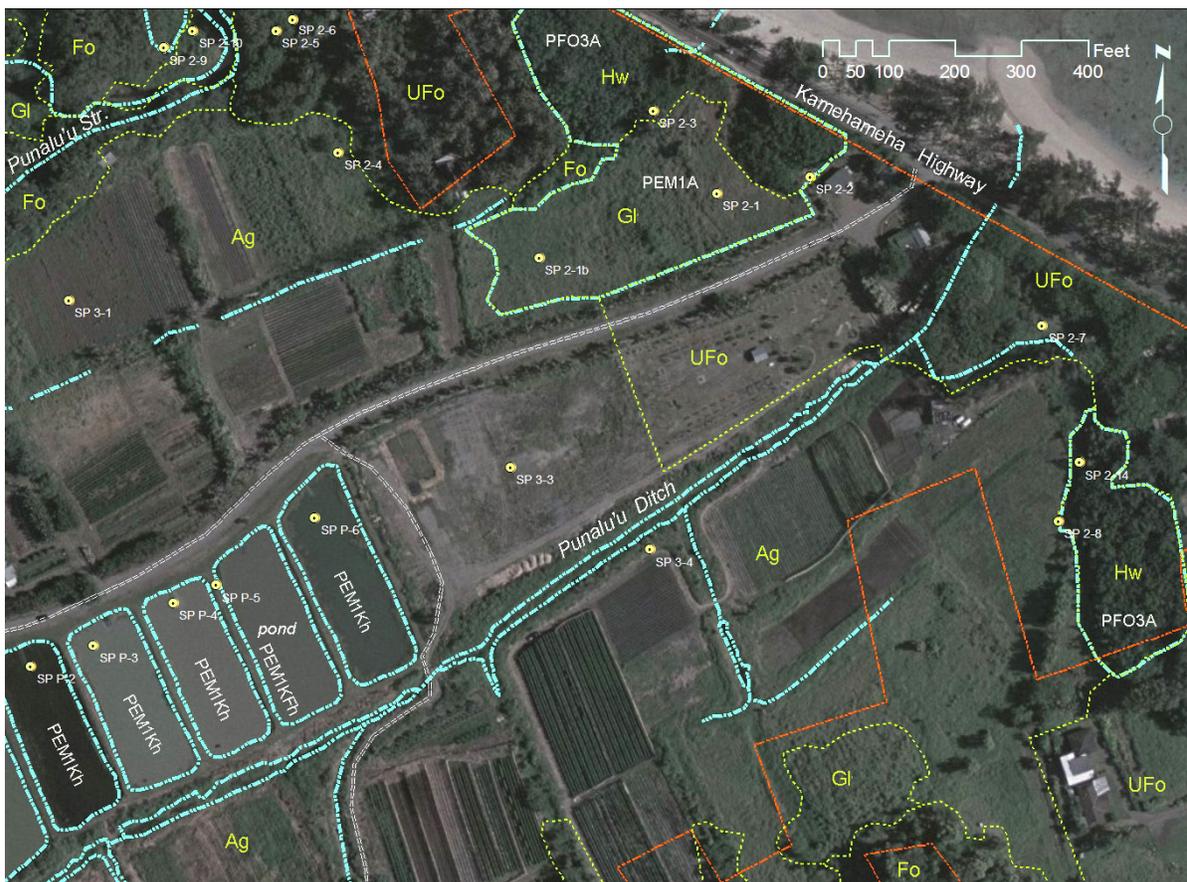
Figure 11. Middle *makai* part of Plan Area around entrance road and Punalu'u Ditch showing vegetation and wetland boundaries.

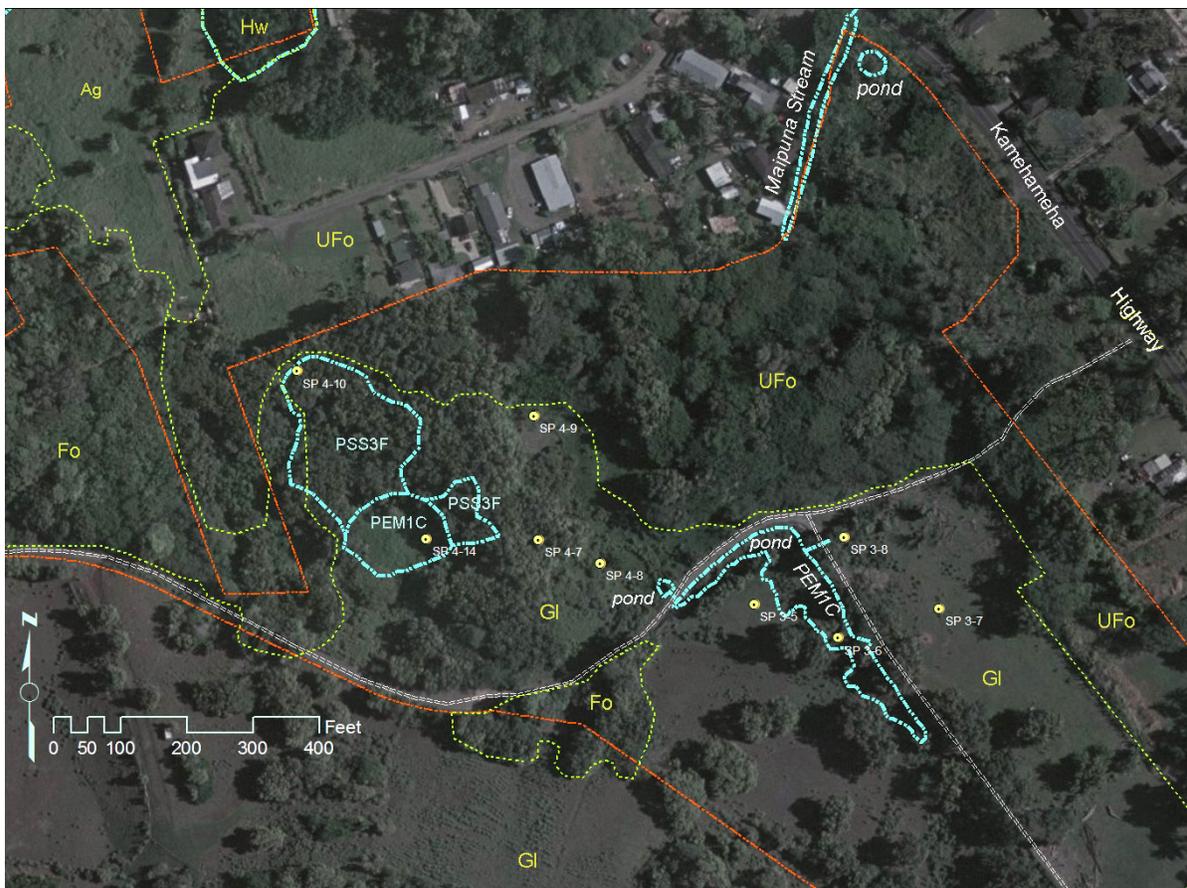
Figure 12. Southeast Plan Area showing the several aquatic features.

PSS3F and PEM1C – A variety of aquatic features occur in the southeast part of the Plan Area (see Figure 12). Two are marshlands dominated by herbs or small shrubs. We attempted to establish a connection between them, but could not find any, although the more northern wetland basin would, at times of high runoff from rainfall, overflow into the southern wetland via a culvert under the farm road.
