SUBJECT: Chapter 25, Revised Ordinances of Honolulu  
Draft Environmental Assessment  
Project: Punaluu Stream Restoration Project  
Applicant: Kamehameha Schools  
Agent: ICF International  
Location: Punaluu Watershed – Koolauloa  
Tax Map Keys: 5-3-1: 41 and 52, and 5-3-3: 1

**Project Name:** Punalu'u Stream Restoration Project, EA

Appendix C Biological Assessment Punalu'u Stream, O'ahu, Hawai'i with Recommendations for  
Stream Enhancement

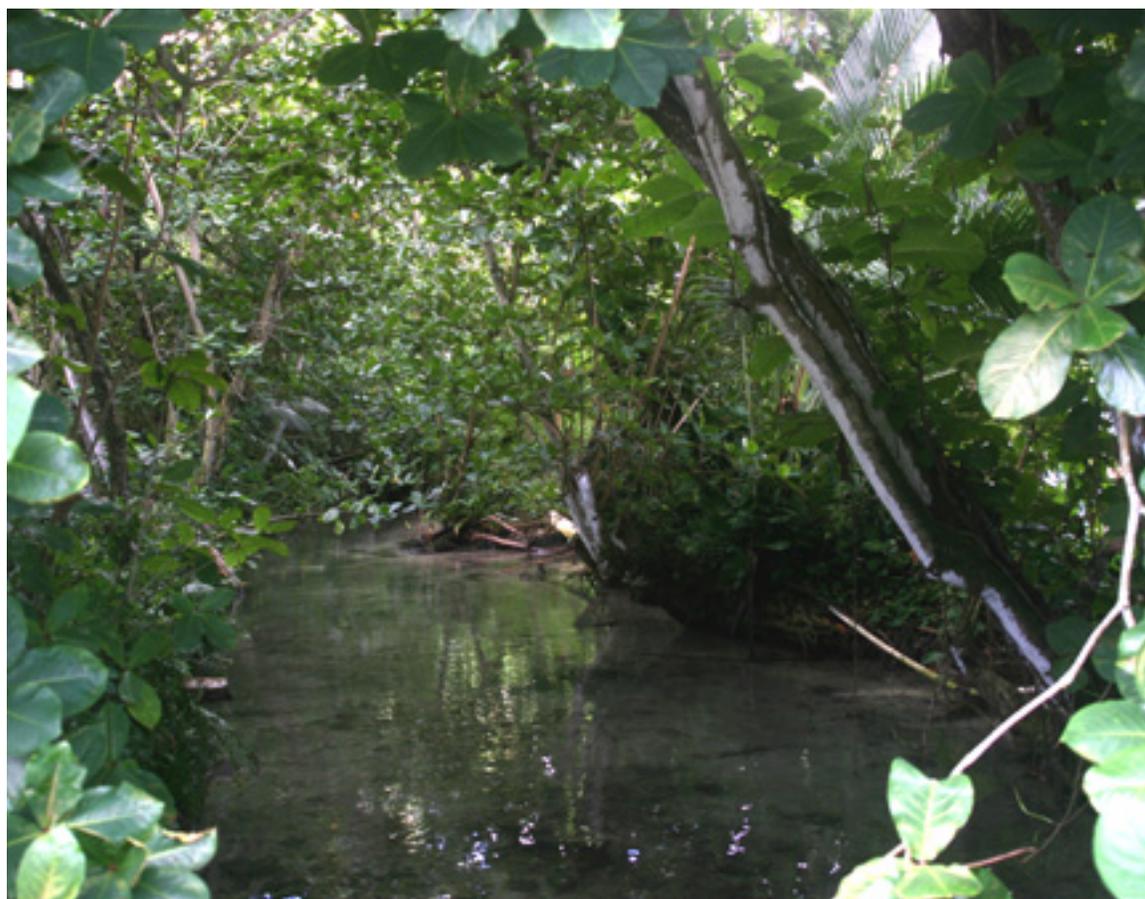
Figure 13. The estuarine “ditch” thought to be Maipuna Stream.

There is no apparent direct surface connection between the above described wetland and waters of the U.S. The closest point of the wetland is at least 3000 ft (910 m) from the Pacific Ocean shore and 610 ft (190 m) from a ditch located to the northeast along the Plan Area boundary. This ditch is probably Maipuna Stream (Figs. 12 and 13) and extends some 650 ft (200 m) inland from the ocean shore, but ends abruptly. There is a culvert under Kamehameha Highway. This feature is possibly tidal up to the end: waves were observed translated this far inland. While this stream or ditch may drain the developed lands on the north side, a low berm separates the ditch from Plan Area wetlands in the interior.

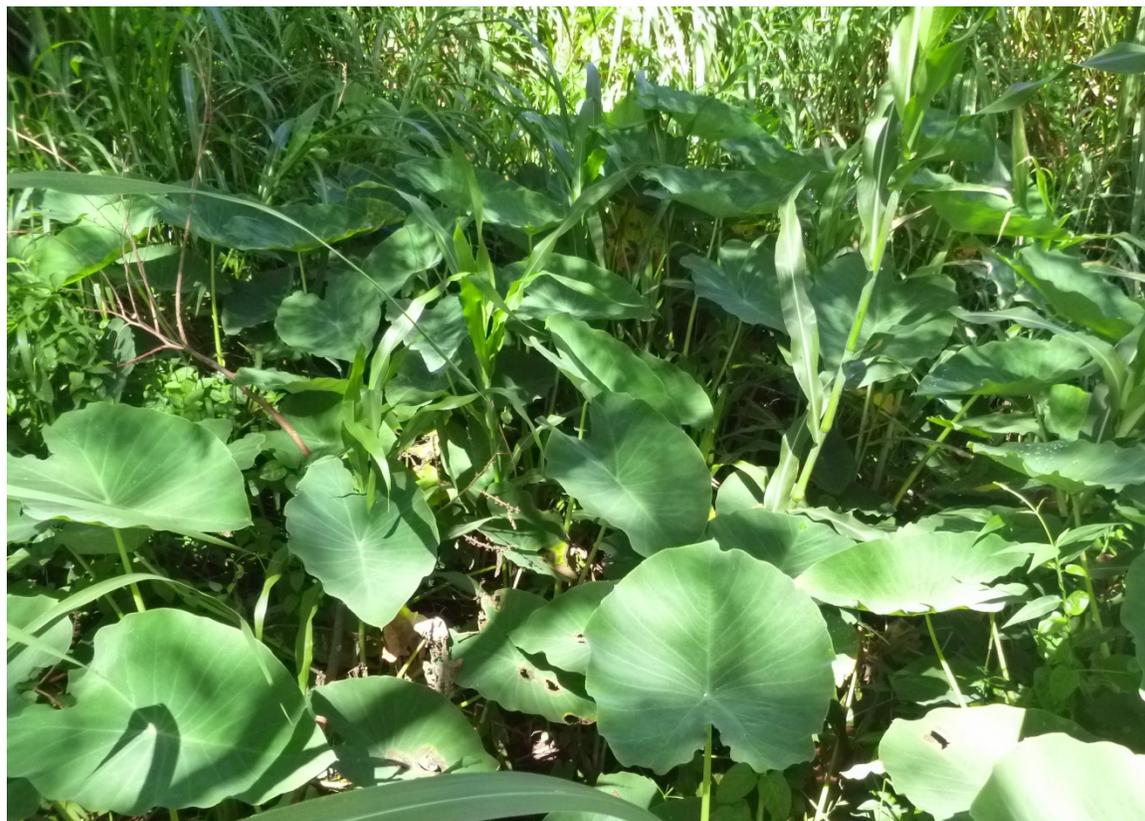
Figure 15. Punalu'u Stream floodplain PEM11C wetland appears to have been managed in the past as a *lo'i kalo*.

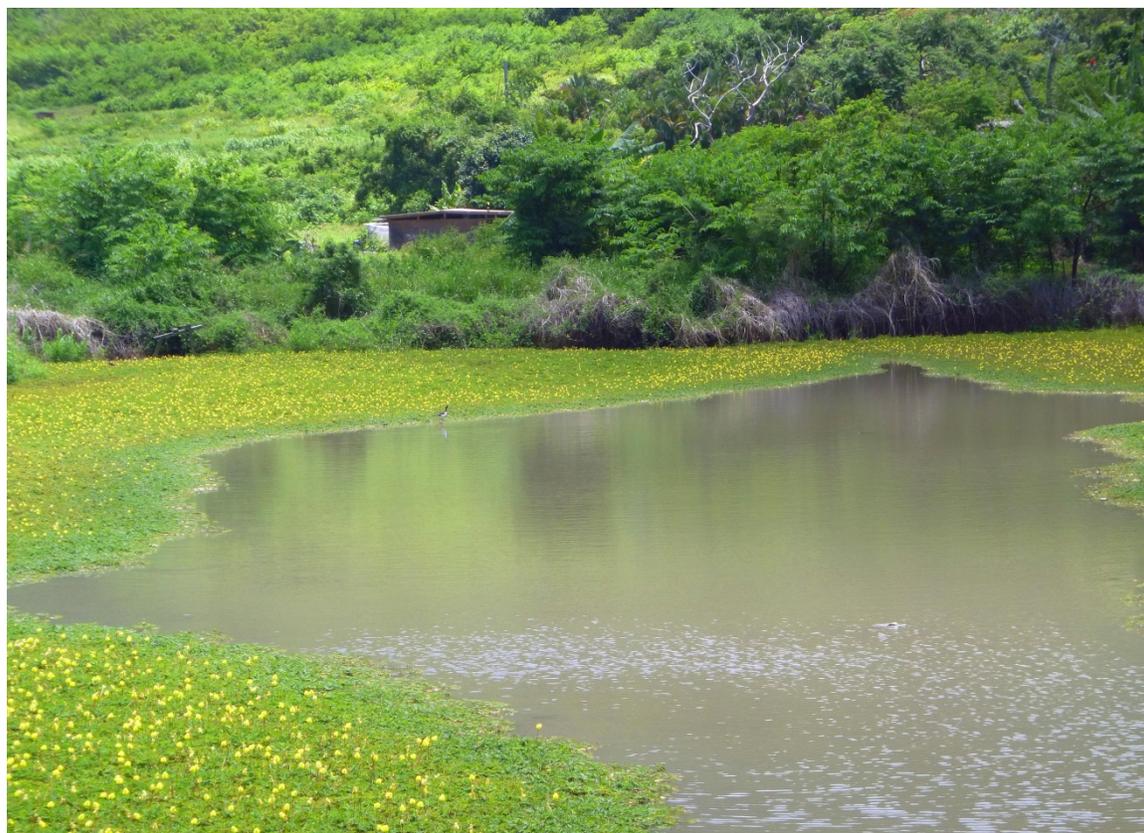
Figure 16. Only Pond “P-5” is presently utilized as an aquaculture pond field.

Active PEM1KFh - At the time of our sampling, only Pond at P-5 was in active aquaculture (Figs. 11 and 14). This pond is a diked and/or impounded wetland that is semi permanently artificially flooded with persistent, emergent vegetation (PEM1KFh). An edible aquatic plant, water mimosa (*Neptunia oleracea*; Fig. 16), is growing in the pond. This cultivar is not in the 2012 National Wetland Plant List (USACE, 2012b) or the 2014 update (Lichvar, et al., 2014), it is an obligate hydrophyte. At the time of our survey, water was flowing via a pipe into the pond. This pond is isolated and not jurisdictional, but the open water is visited by the endangered Hawaiian stilt (*Himantopus mexicanus knudseni*; see Fig. 16).

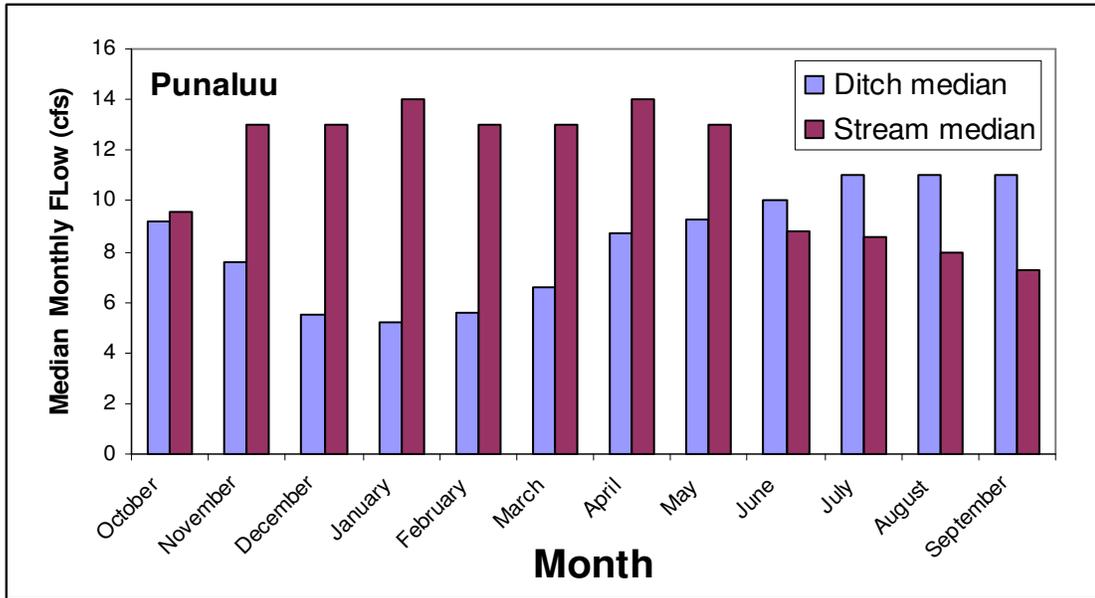
**Figure 5. Monthly median flows in Punalu'u Stream and the Punalu'u Ditch based on mean daily flow records.**

Oki et al. (2006) also derive estimates of base flow. Based on calculation, their study found that mean base flow (as defined using the computerized base-flow separation model of Wahl and Wahl 1995) for the combined flows from 1954 to 2004 was 18.2 cfs (11.8 mgd), suggesting that base flow in Punalu'u Stream was about 73 percent of the total flow. This was attributed to groundwater discharge, while the remaining 27 percent was attributed to direct runoff.

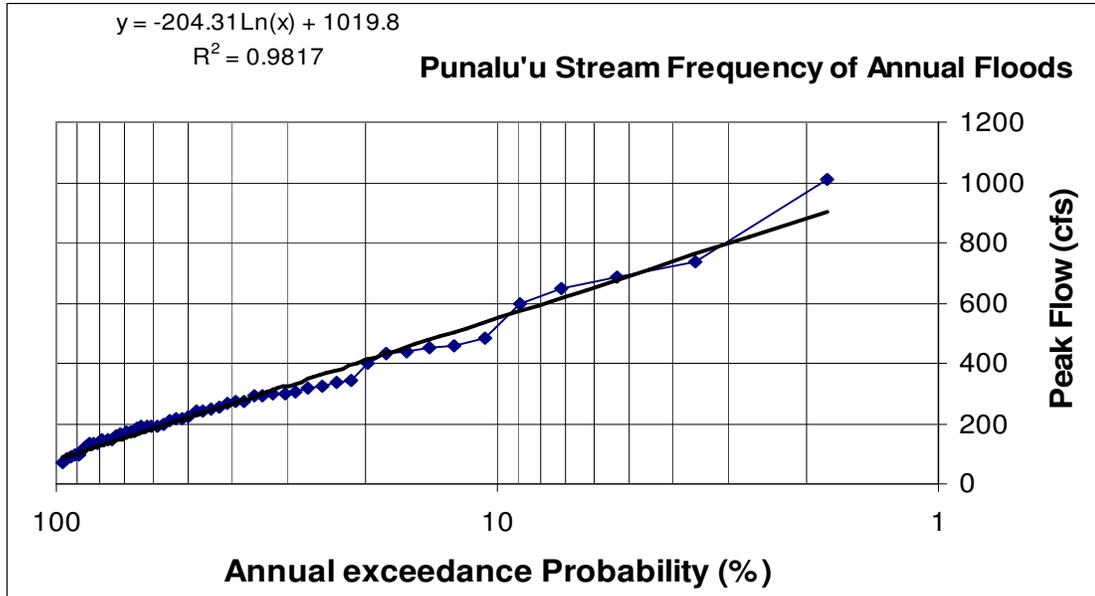
**Figure 8. Annual exceedance flood probability for Punalu'u Stream (station 16303000). The straight line is a fitted logarithmic estimate.**

With these caveats in mind, it is still of some value to use the existing data for Punalu'u Stream to investigate the chances of a flood occurring. Figure 8 presents the probability of exceedance for floods of a given magnitude using the Weibull plot (Dalrymple 1960). With this analysis, a year with a maximum flood flow as great as 200 cfs (129.3 mgd) could be expected in about 6 out of 10 years, while only 3 percent of all years would be expected to have a peak annual flood of 800 cfs (517 mgd). Note that this graph represents data from the stream only, not the combined total flow.

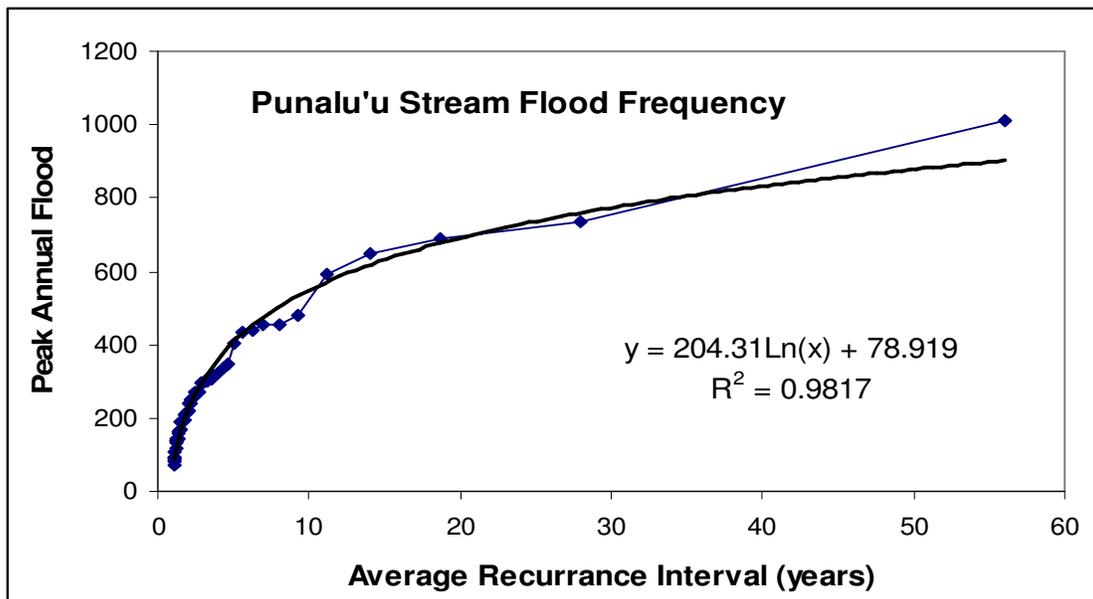
**Figure 9. Flood frequency analysis for Punalu'u Stream. The fitted curve is a logarithmic estimate.**

A more direct way of examining the same data is to plot the average flood frequency (Figure 9). In such a plot, the mean recurrence interval is plotted against the magnitude of the flood. For example, in Punalu'u Stream a flood peak of about 540 cfs (349 mgd) could be expected on average every 10 years. Oki (2004) studied and analyzed long term trends in many Hawaiian streams, including Punalu'u Stream. He found that trends in annual total and base flow in Punalu'u Stream had decreased significantly over the 49 year period of record.

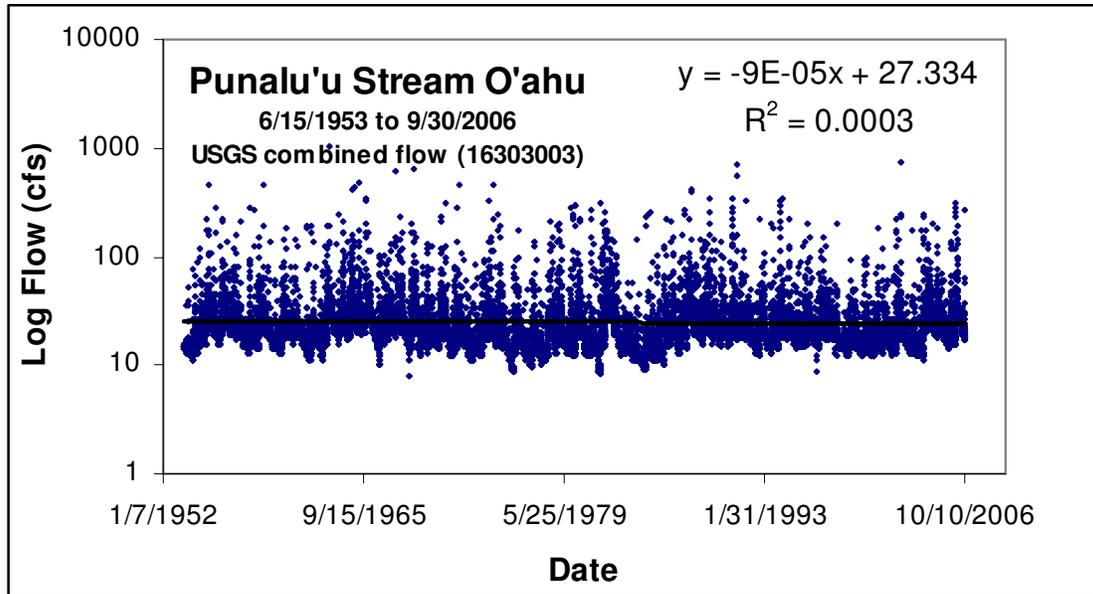
**Figure 10. Daily mean flow for Punalu'u Stream plus ditch flow.**

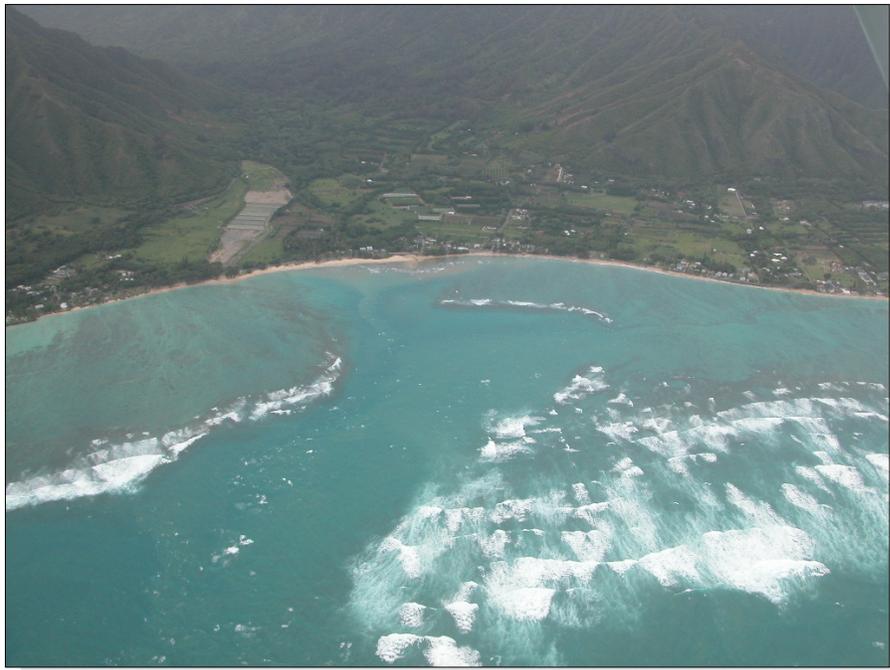
**Figure 12. Oblique photo of Punaluu Beach, reef, and channel.**

Along the windward coast of O'ahu from Ka'oiio Point to Mokuauia there is a reef structure about 800 m (0.5 mi) offshore (Figure 12). This reef is fairly continuous and provides some degree of protection to the shoreline areas (Anon 1954, Balder 1992). A cross section at Hau'ula indicates a sandy-bottomed lagoon structure with a maximum depth of 20' extending 1200' off shore where the shallow reef reaches the surface (Anon 1954). SHOALS Lidar imagery available from the University of Hawaii (<http://www.soest.hawaii.edu/coasts/data/oahu/shoals.html>) provides visual details of this nearshore reef bathymetry.

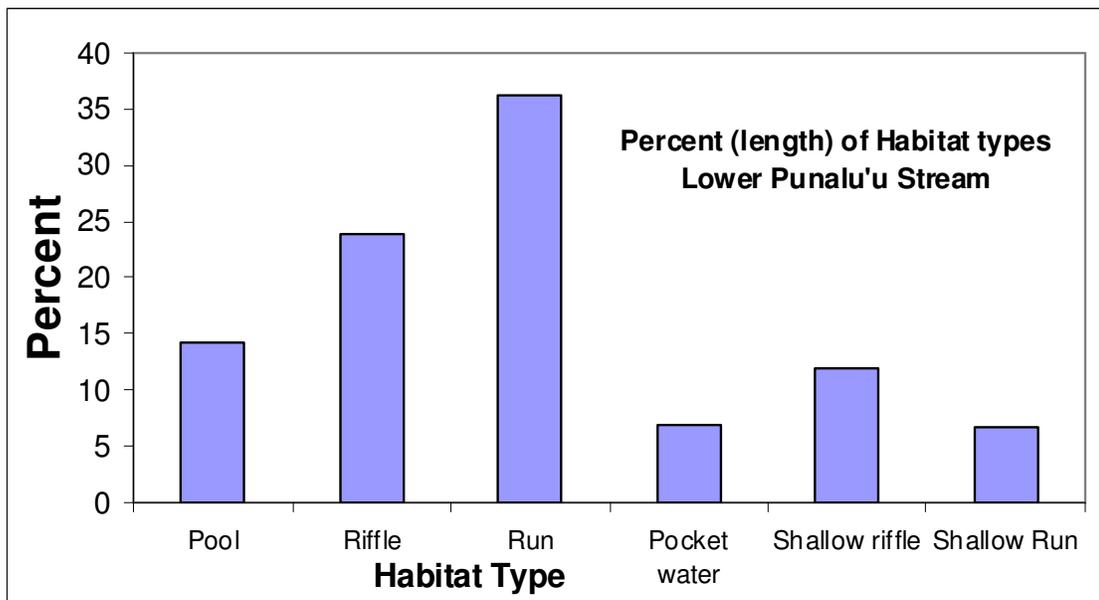
**Figure 13. Percent of habitat types in lower Punalu'u Stream.**

Runs, riffles and pools are the dominant habitat type in this reach (Figure 13). Pools within this reach were typically large. The mean length and estimated width of all pools in the study reach were 21.7 and 9.3 m (71.2 and 30.5 ft), respectively. Mean estimated depth of all pools in the reach was 0.87 m (2.9 ft). Common of low gradient stream, such as the reach surveyed in lower Punalu'u, valley cascades and falls were not observed; however, such habitat types are common in Punalu'u at higher elevations where the gradient is steeper.

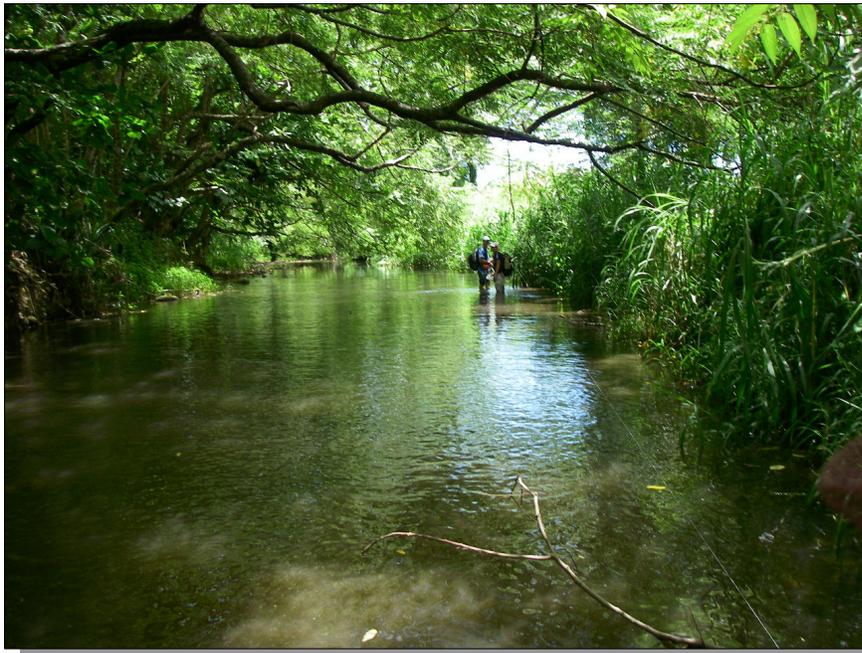
**Figure 14. Shallow pool in the lower reach of Punalu'u Stream.**

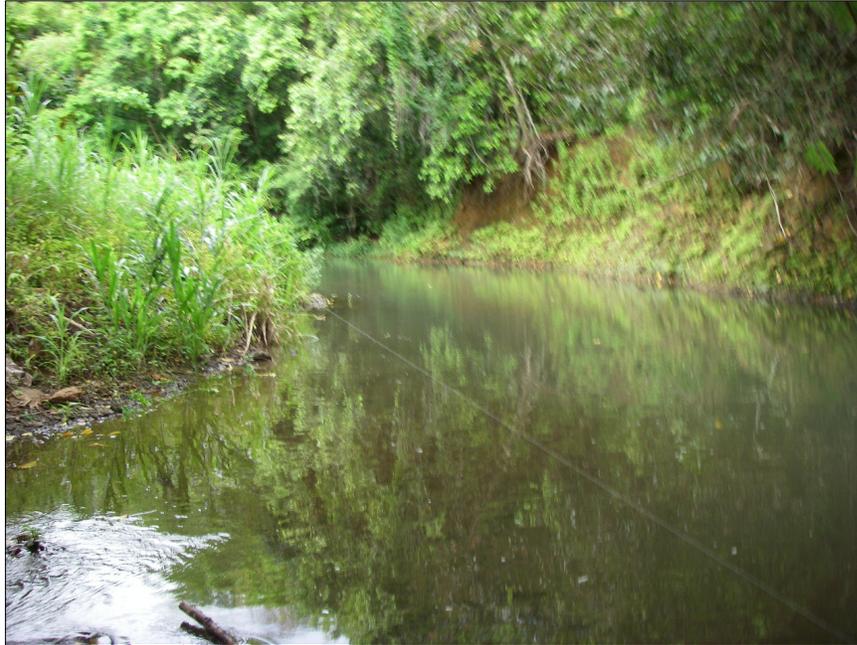
**Figure 15. Deep pool in the lower reach of Punalu'u Stream.**

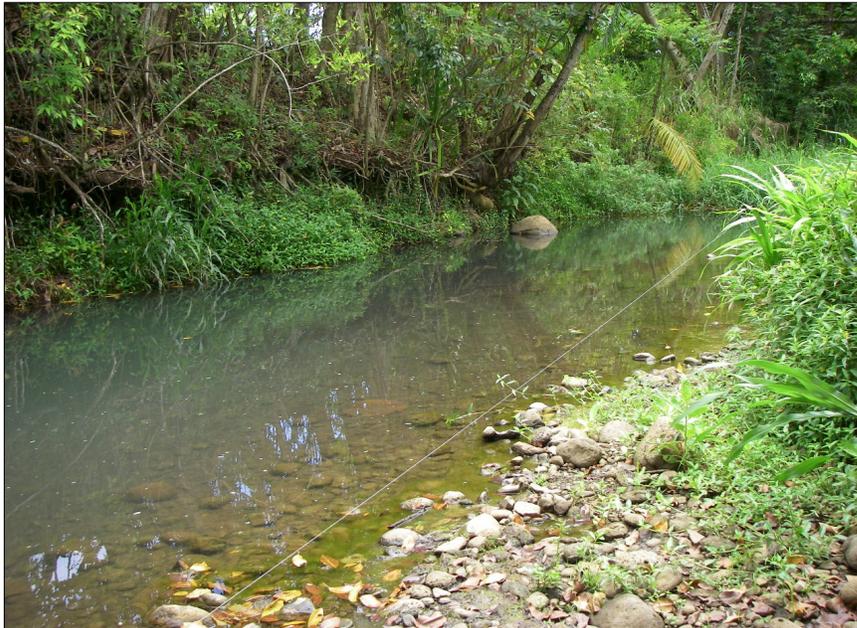
Table 2. Vegetation code legend for maps in this report.

The amount of silt observed within the stream bed may reduce habitat quality for native species. There were few places in the study reach where the cobble and boulder substratum was not covered by a thick layer of flocculent material (Figure 16). Continuous, high-gradient streams draining forested watersheds are generally free of benthic fine sediment accumulation in their upper and middle reaches.

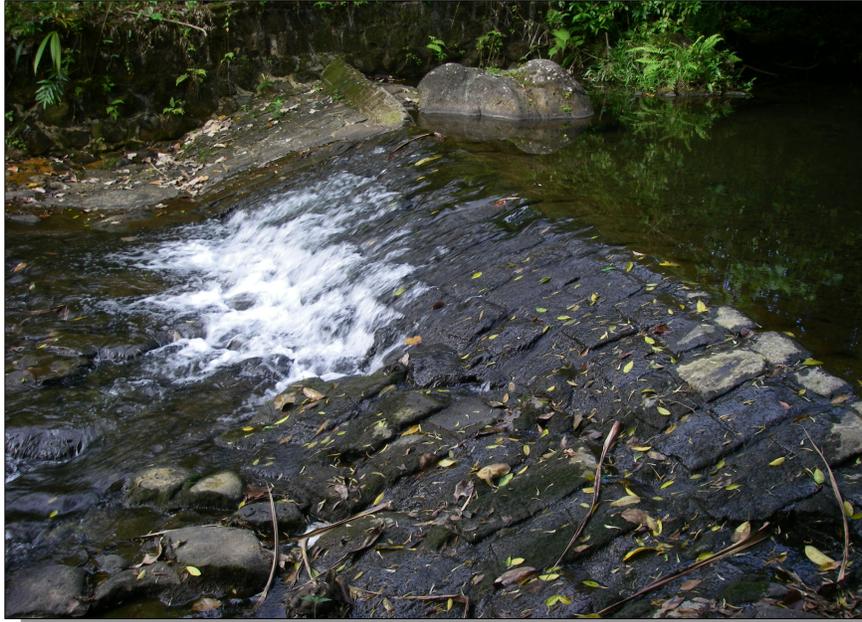
**Figure 17. The Punalu'u diversion dam showing the sloping downstream face.**

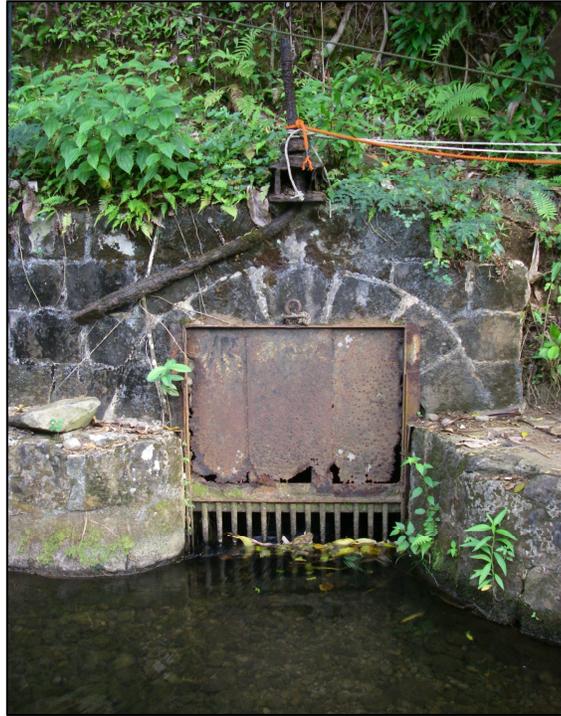
**Figure 18. The opening into the diversion system showing the grate.**

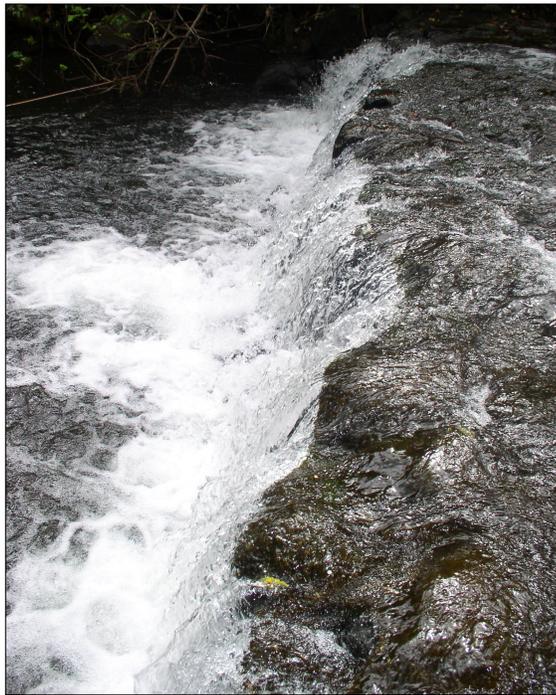
**Figure 19. Showing the drop below the face of the dam.**

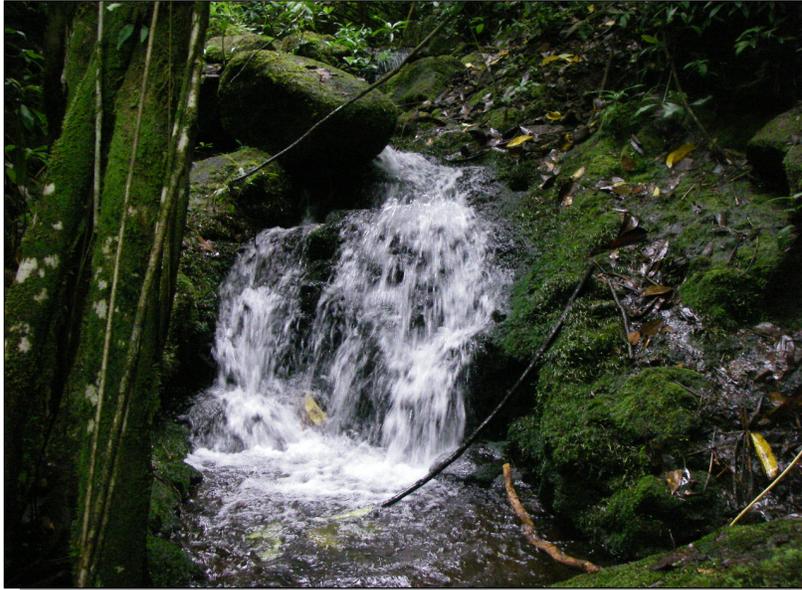
**Figure 21. Small perennial tributary just above the 4X4 road.**

At roughly the same elevation as the dam, there are several tributaries mostly along the western side of the valley. SWCA personnel surveyed these small streams (Figure 21). Because they were too small for snorkeling, only net sampling was done. The endemic 'opae kala'ole was common in the larger of the two tributaries checked. This small stream ran, for some distance through an old concrete box culvert or ditch remnant. In general, the substratum of these tributaries appeared to be free of fine sediment accumulation. Due to turbid conditions in the lower reaches, SWCA biologists did not conduct snorkeling surveys where the habitat mapping took place. However, observations in shallow water allow some points to be made. First of all, almost the entire lower reach is heavily silted. There are few if any reaches where clean rock surfaces are available. Secondly, as noted by USGS and DAR surveys, this low gradient reach is

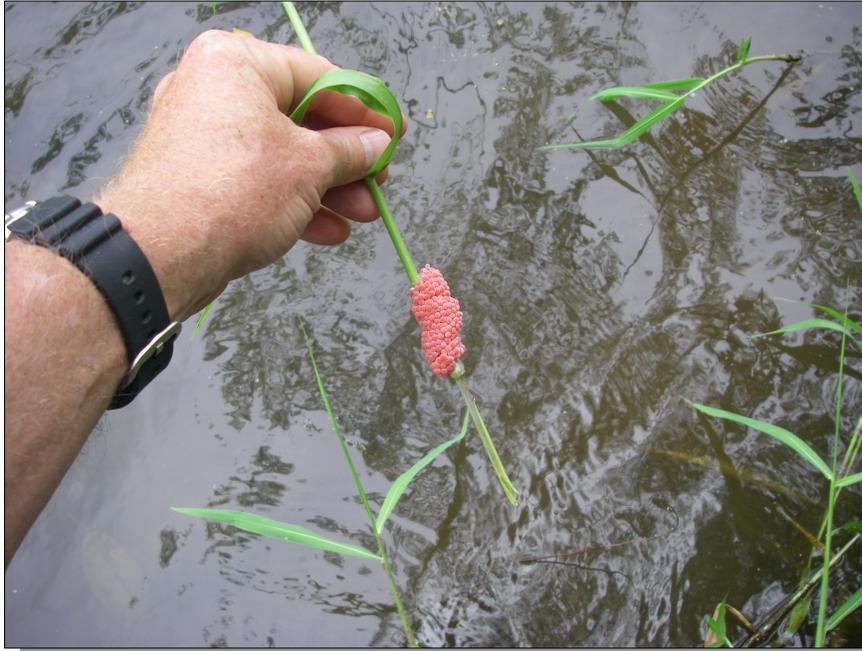
**Figure 23. Eggs of apple snails on vegetation along the stream bank.**

Lach and Cowie (1999) studied the spread of non-native apple snails (*Pomacea canaliculata*) on O'ahu and reported them as being absent from Punalu'u Stream. However, we found abundant eggs masses of this species throughout the lower reaches of the stream above the estuary (Figure 23). While they are not known to directly harm native stream species, their presence is of concern to taro growers since floods could transport these pests into active lo'i.

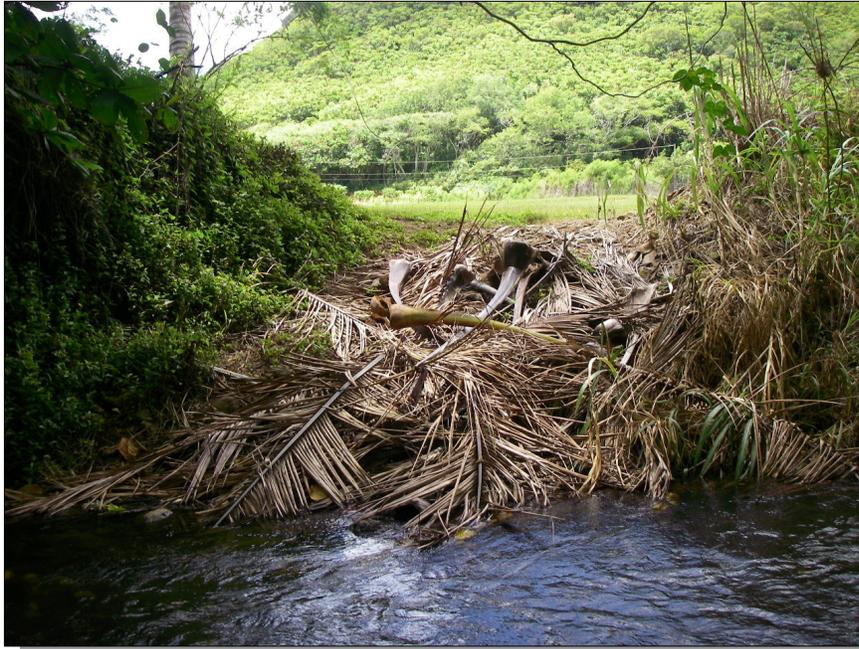
**Figure 24. Palm fronds discarded into lower Punalu'u Stream.**

The riparian vegetation along the lower reaches was almost entirely alien. In many sections of the study reach, the channel was almost blocked by streamside vegetation. Riparian vegetation was largely dominated by California grass (*Brachiara mutica*), honohono grass (*Commelina diffusa*), cane grass (*Pennisetum purpureum*), hau (*Hibiscus tiliaceus*), gunpowder tree (*Trema orientalis*), octopus tree (*Schefflera actinophylla*), and java plum (*Syzygium cumini*). Where the stream banks are close to the road there is some dumping of vegetation into the channel (Figure 24). While probably not a major concern in this reach given the more acute problems, this dumping should be discouraged since it traps sediments and can interrupt flow.

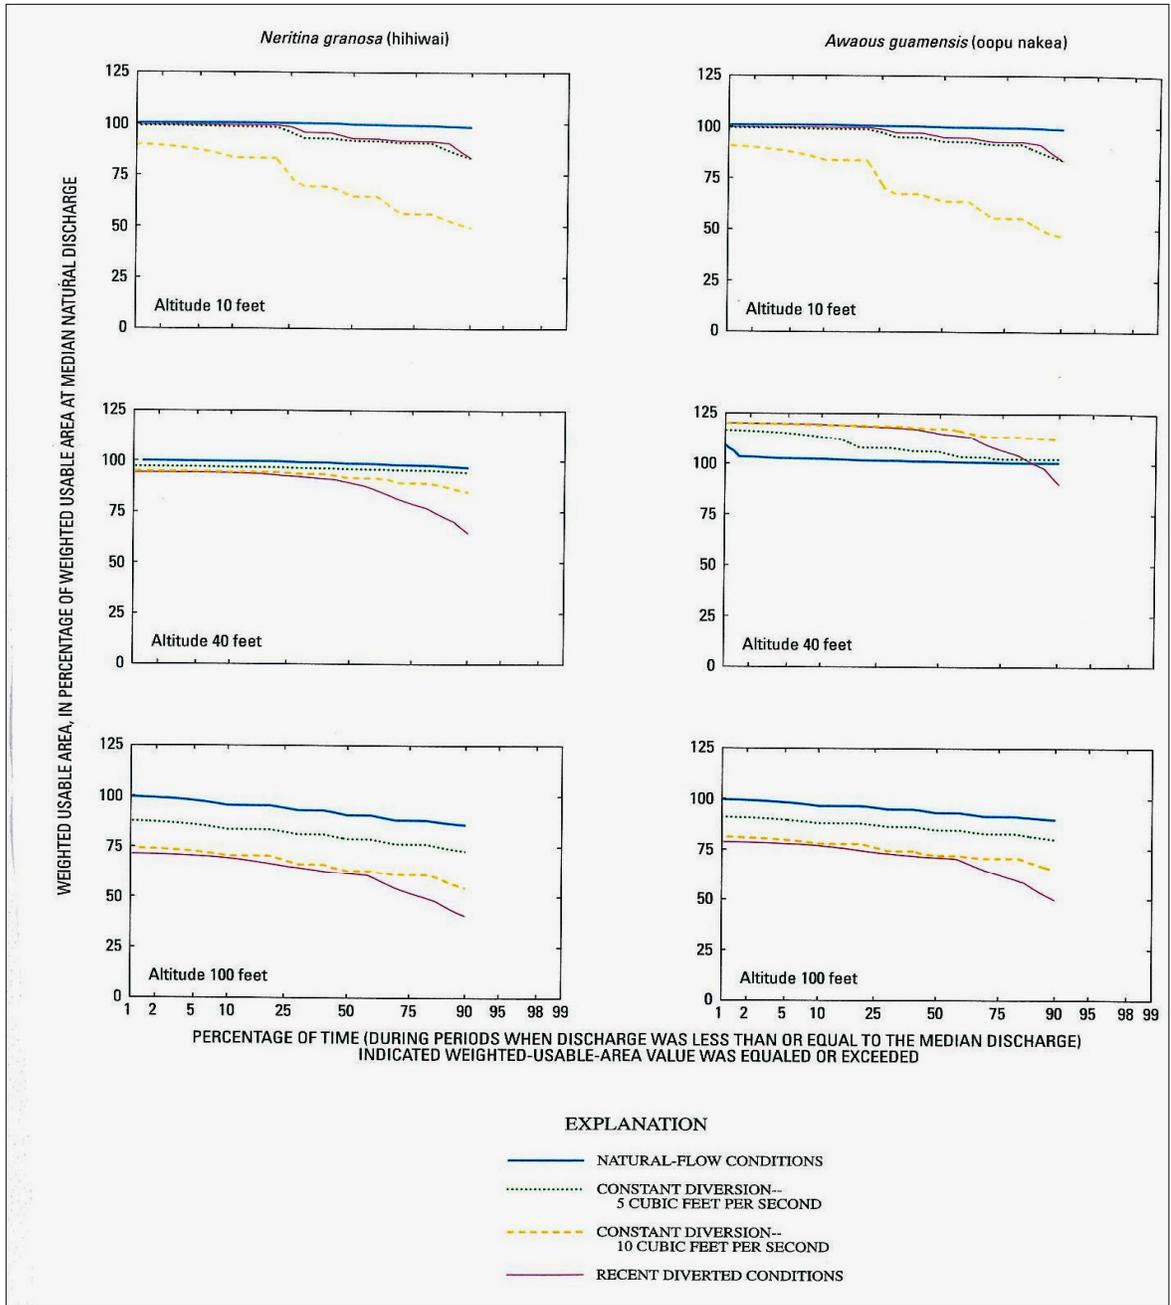
**Figure 26. Plots of WUA as a percentage of undiverted WUA vs. percentage of time the indicated WUA is exceeded. Source: Oki et al. (2006).**

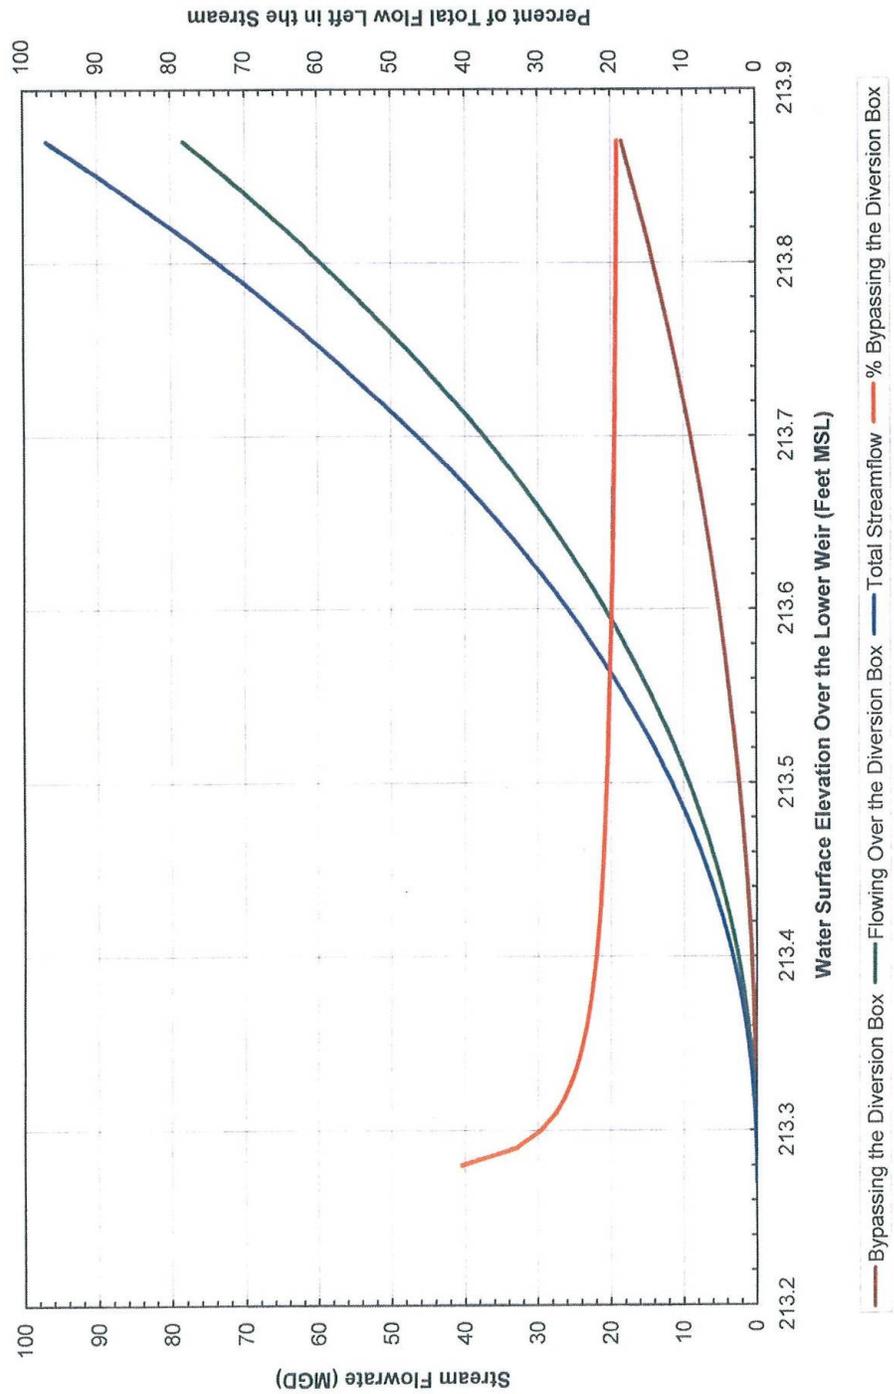
**Figure 28. Distribution of Flow Over the New Punalu'u Weir (Source: Nance 2009, Figure 3).**

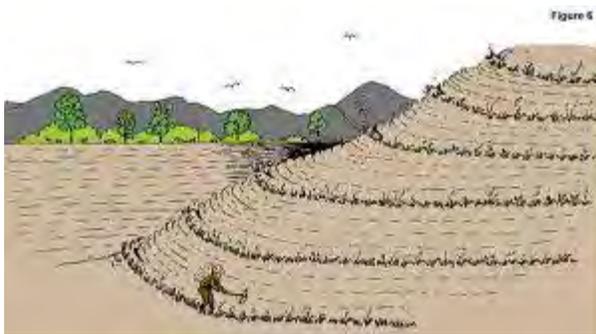
**Figure 10: Illustration depicting contour farming technique**

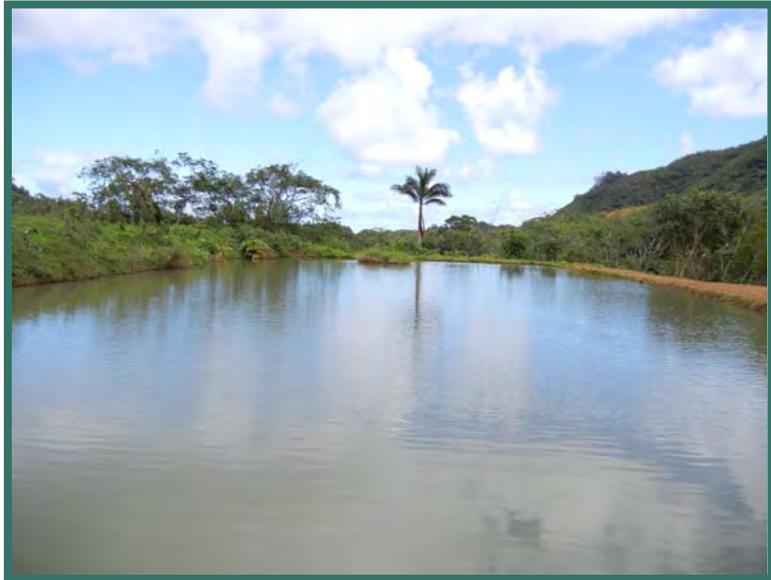
**Figure 11 – Aquaculture within the project area**

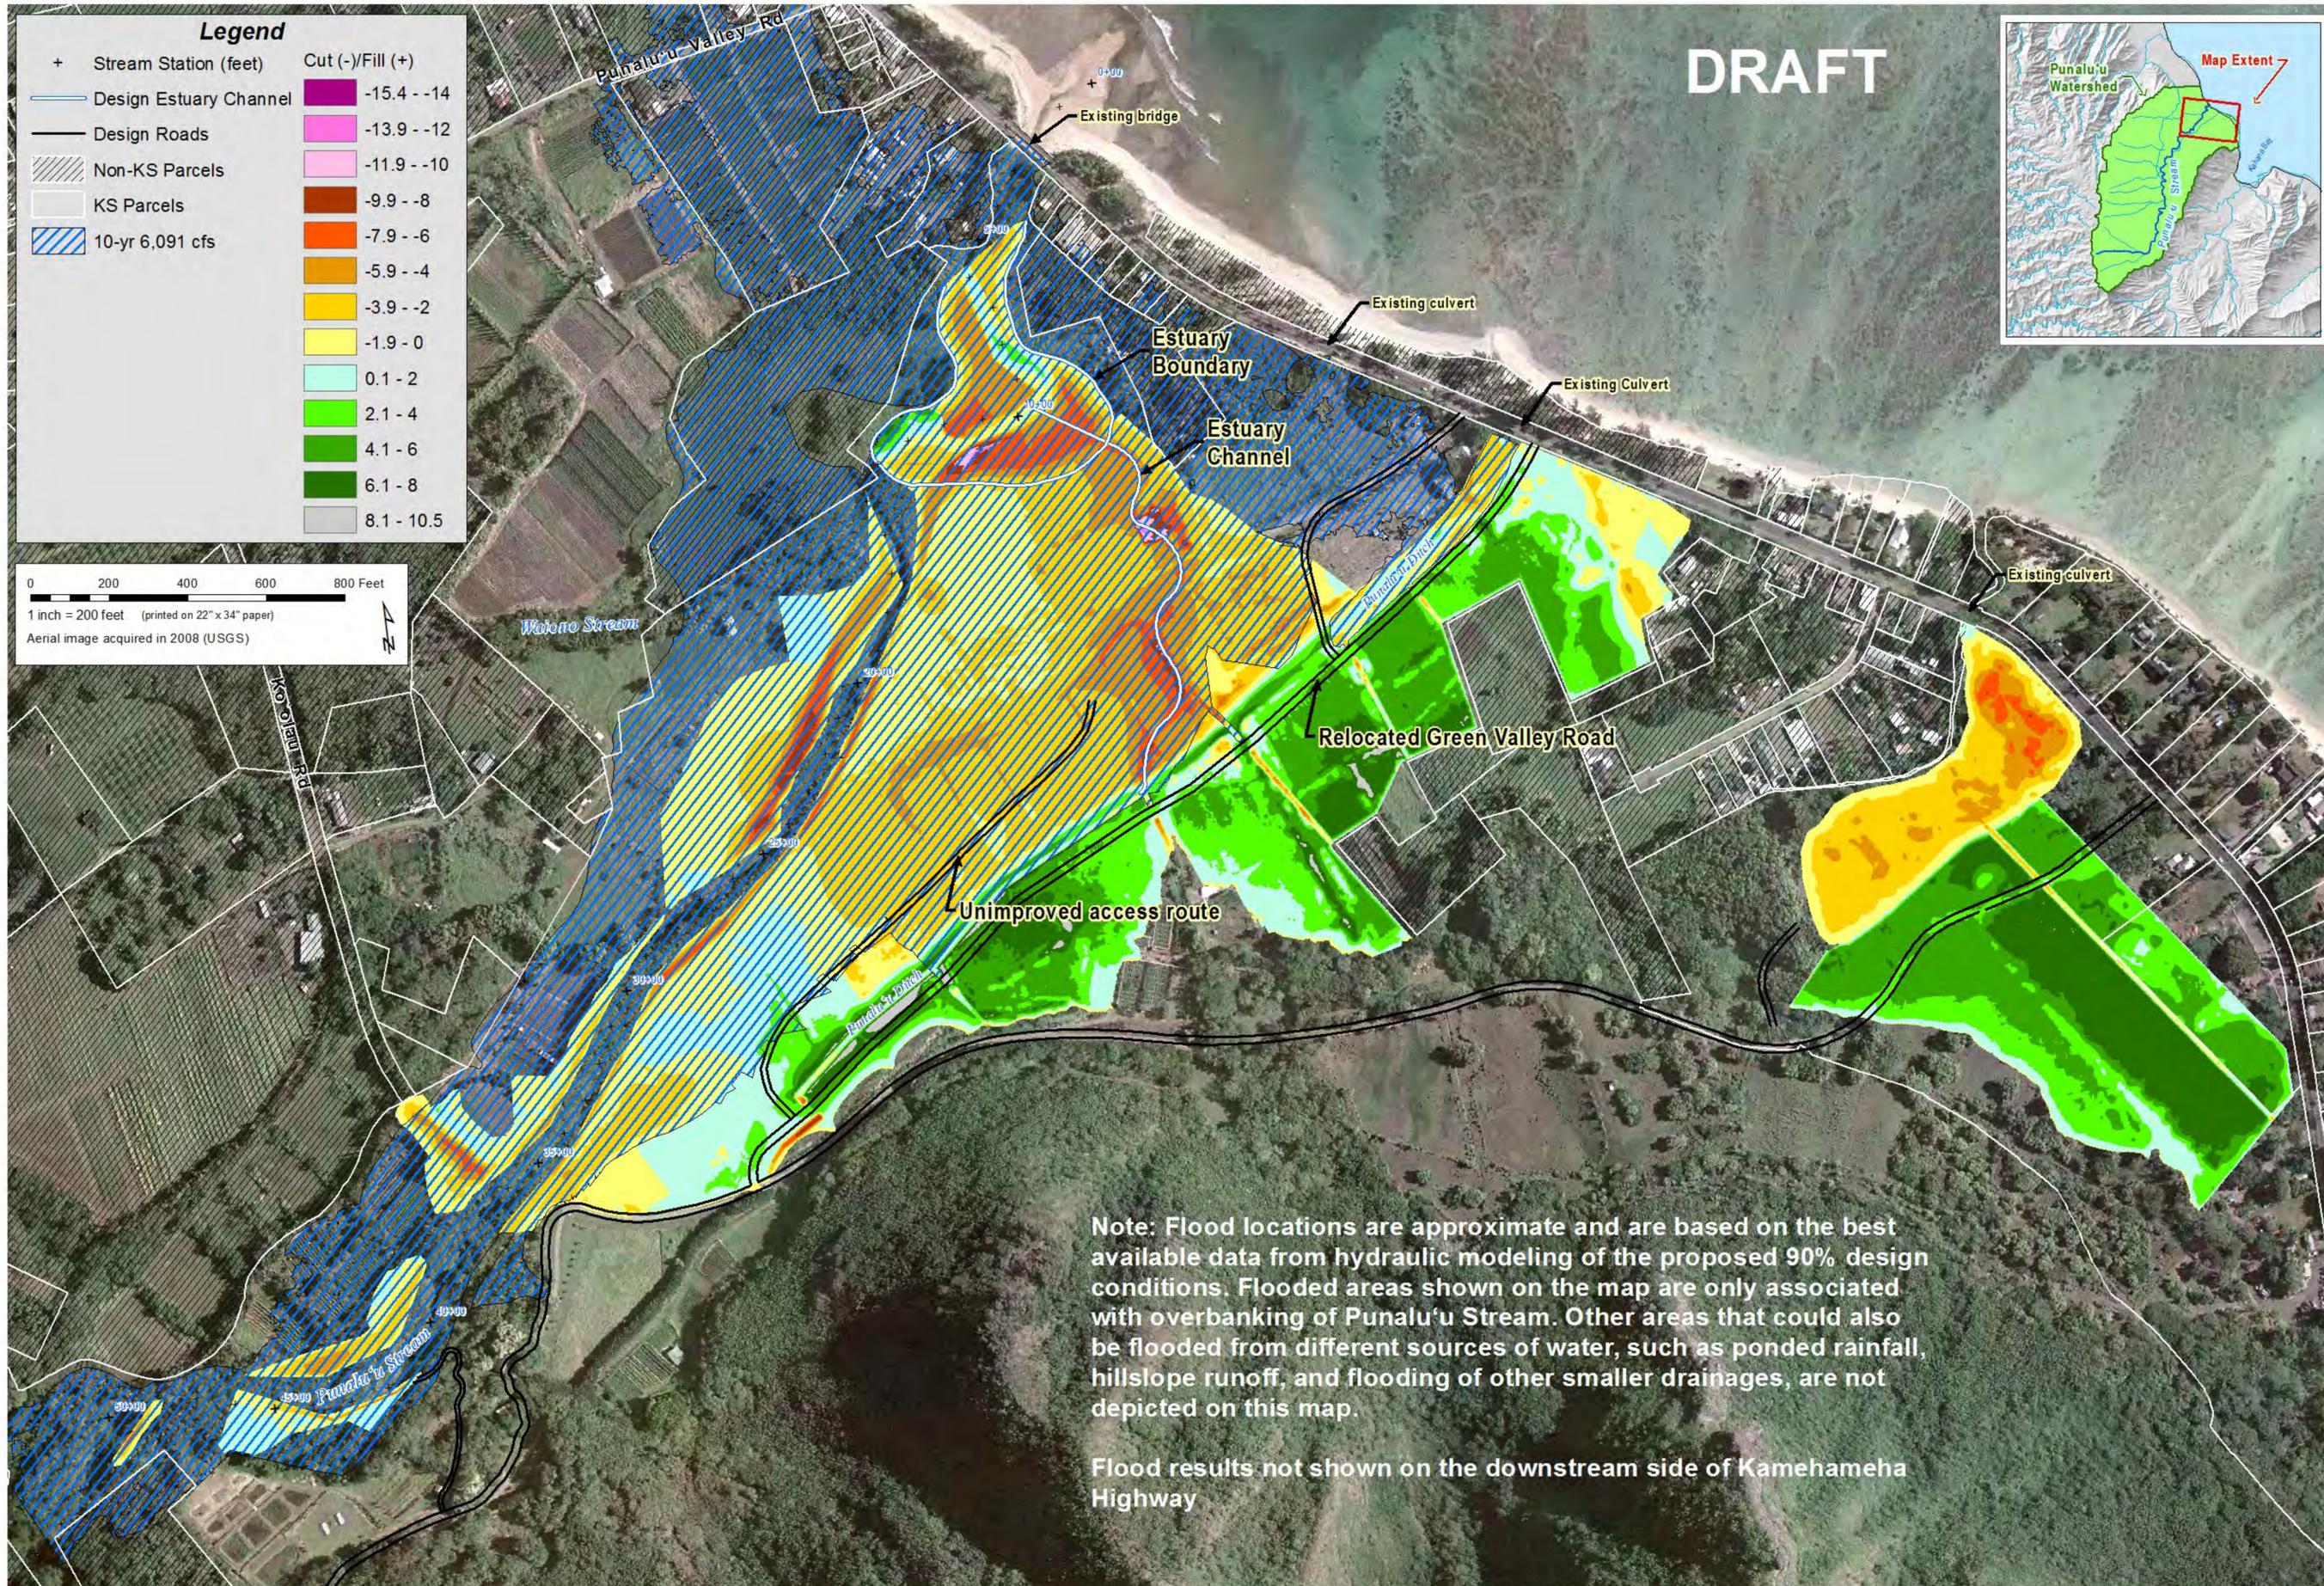
Note: Flood locations are approximate and are based on the best available data from hydraulic modeling of the proposed 90% design conditions. Flooded areas shown on the map are only associated with overbanking of Punalu'u Stream. Other areas that could also be flooded from different sources of water, such as ponded rainfall, hillslope runoff, and flooding of other smaller drainages, are not depicted on this map.
