SUBJECT: Chapter 25, Revised Ordinances of Honolulu  
Draft Environmental Assessment  
Project: Punaluu Stream Restoration Project  
Applicant: Kamehameha Schools  
Agent: ICF International  
Location: Punaluu Watershed – Koolauloa  
Tax Map Keys: 5-3-1: 41 and 52, and 5-3-3: 1

**Project Name:** Punalu'u Stream Restoration Project, EA

Appendix C Biological Assessment Punalu'u Stream, O'ahu, Hawai'i with Recommendations for  
Stream Enhancement

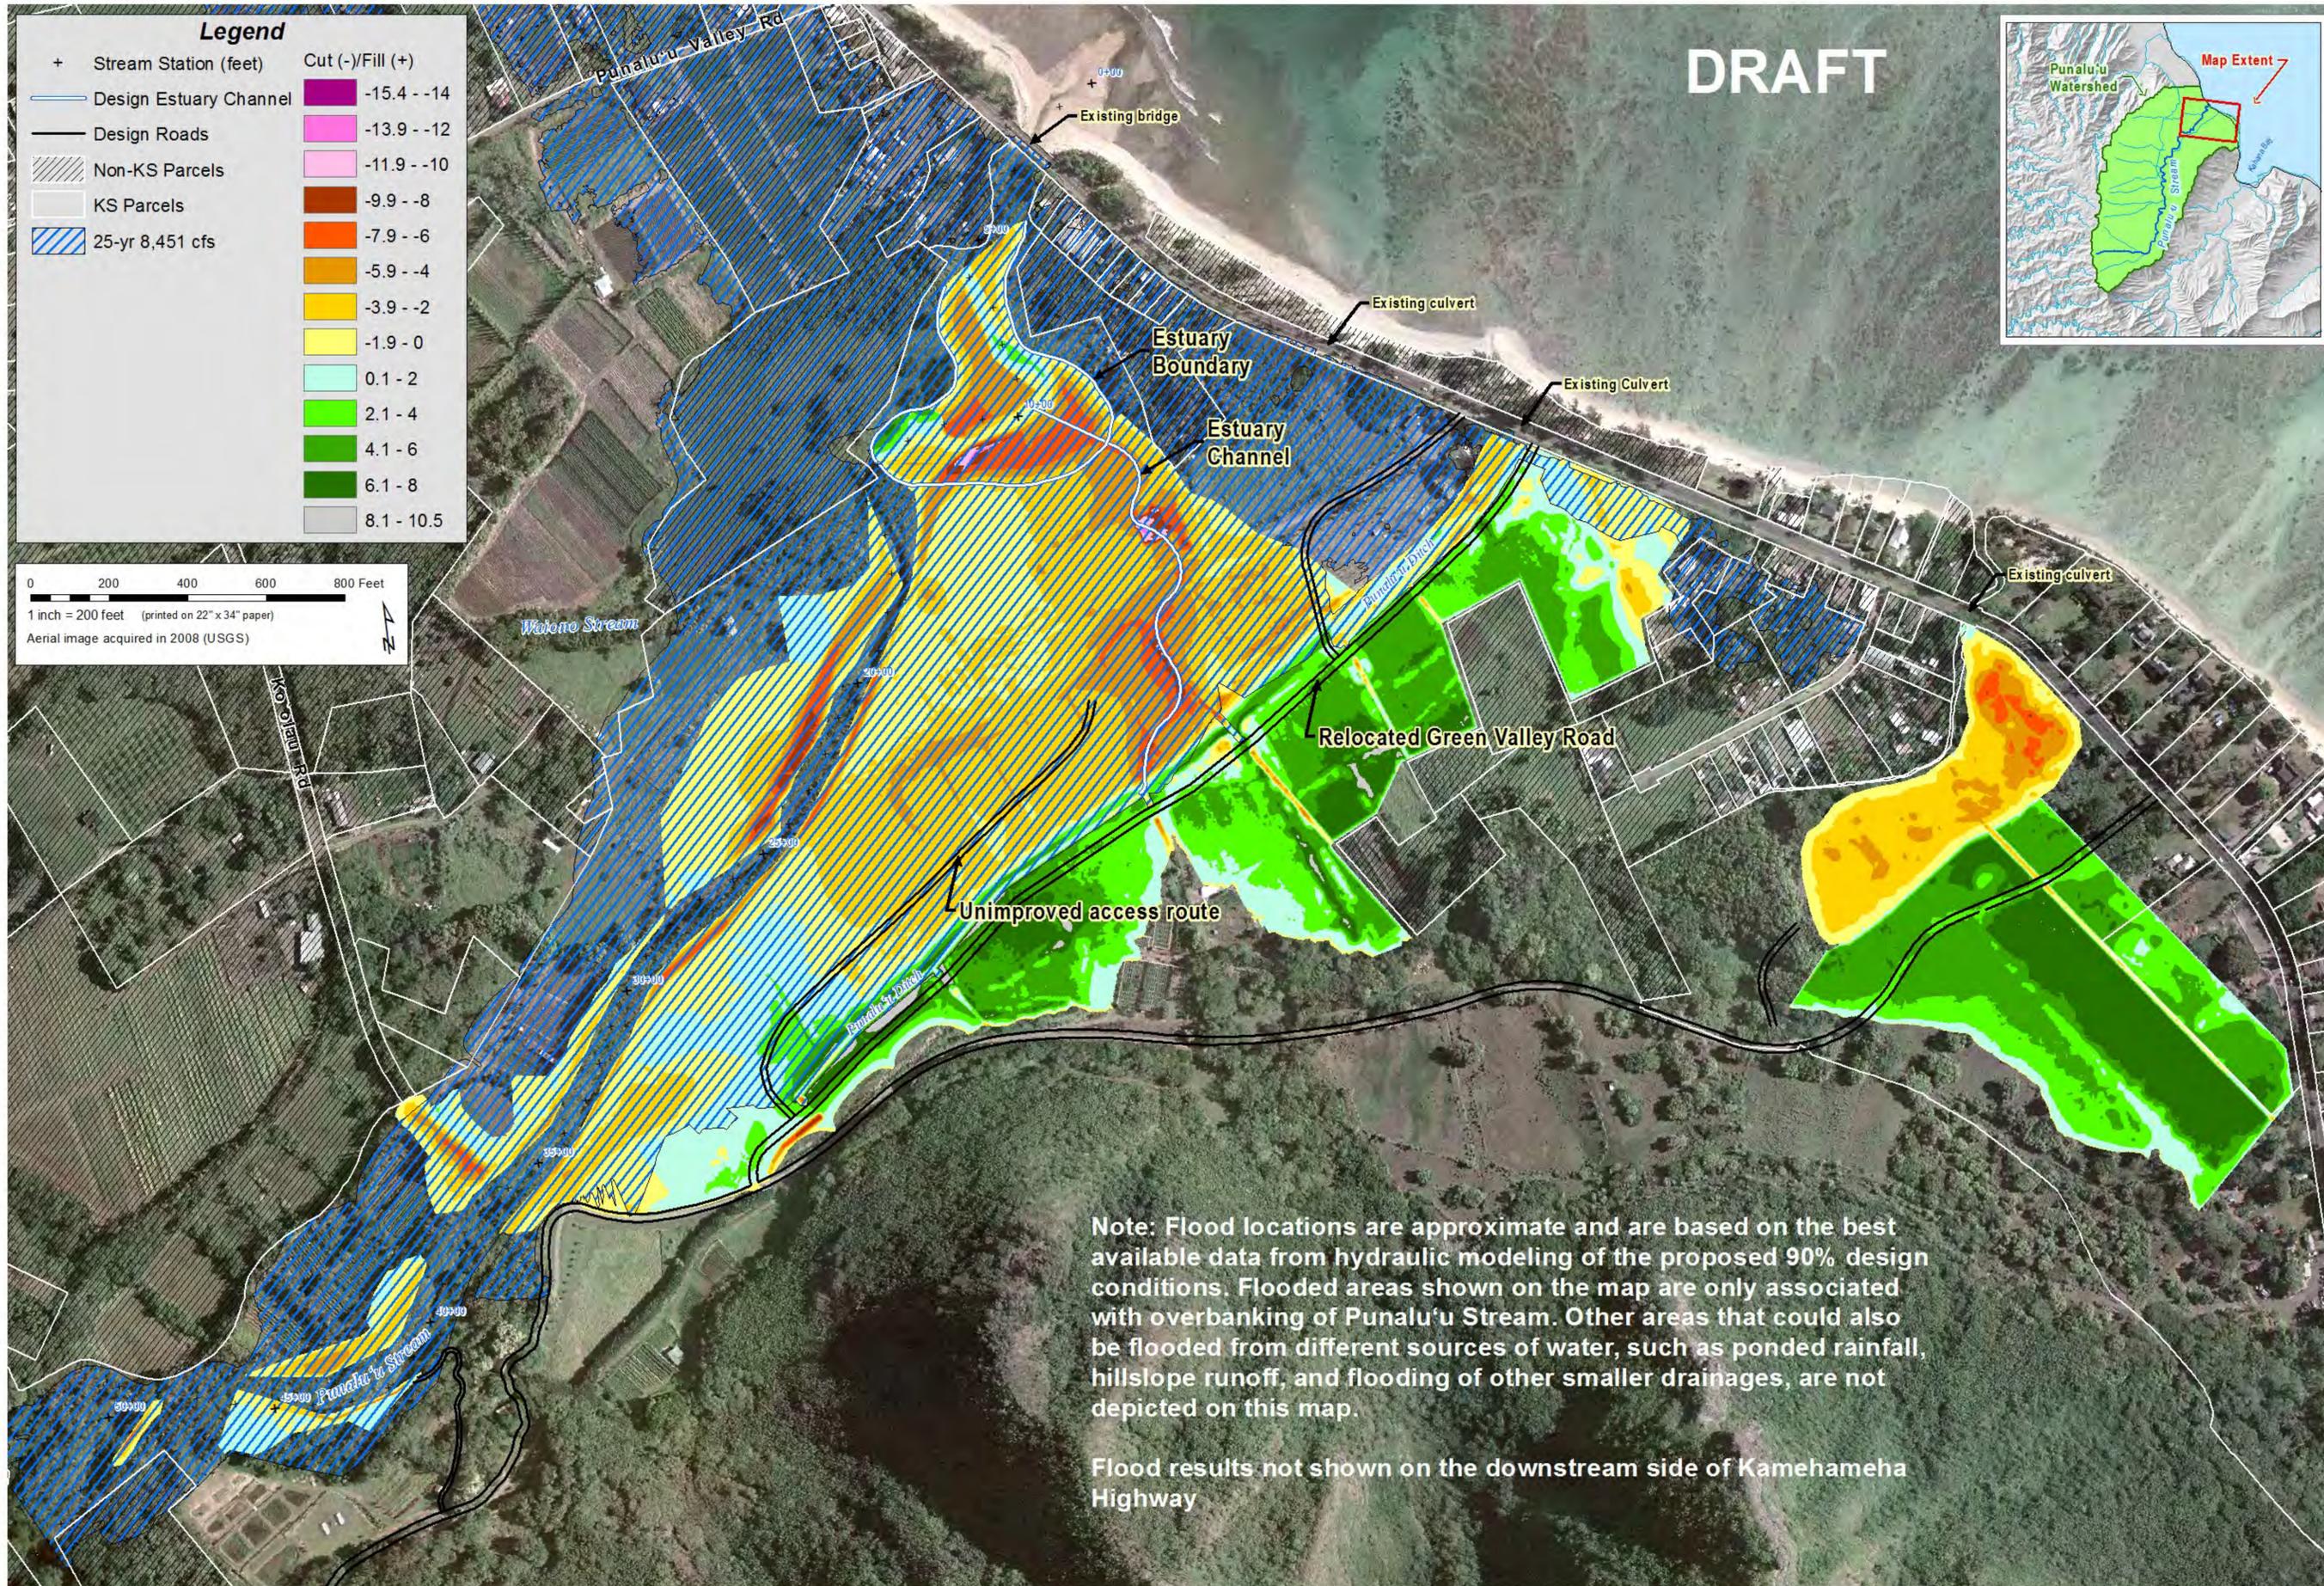
Note: Flood locations are approximate and are based on the best available data from hydraulic modeling of the proposed 90% design conditions. Flooded areas shown on the map are only associated with overbanking of Punalu'u Stream. Other areas that could also be flooded from different sources of water, such as ponded rainfall, hillslope runoff, and flooding of other smaller drainages, are not depicted on this map.

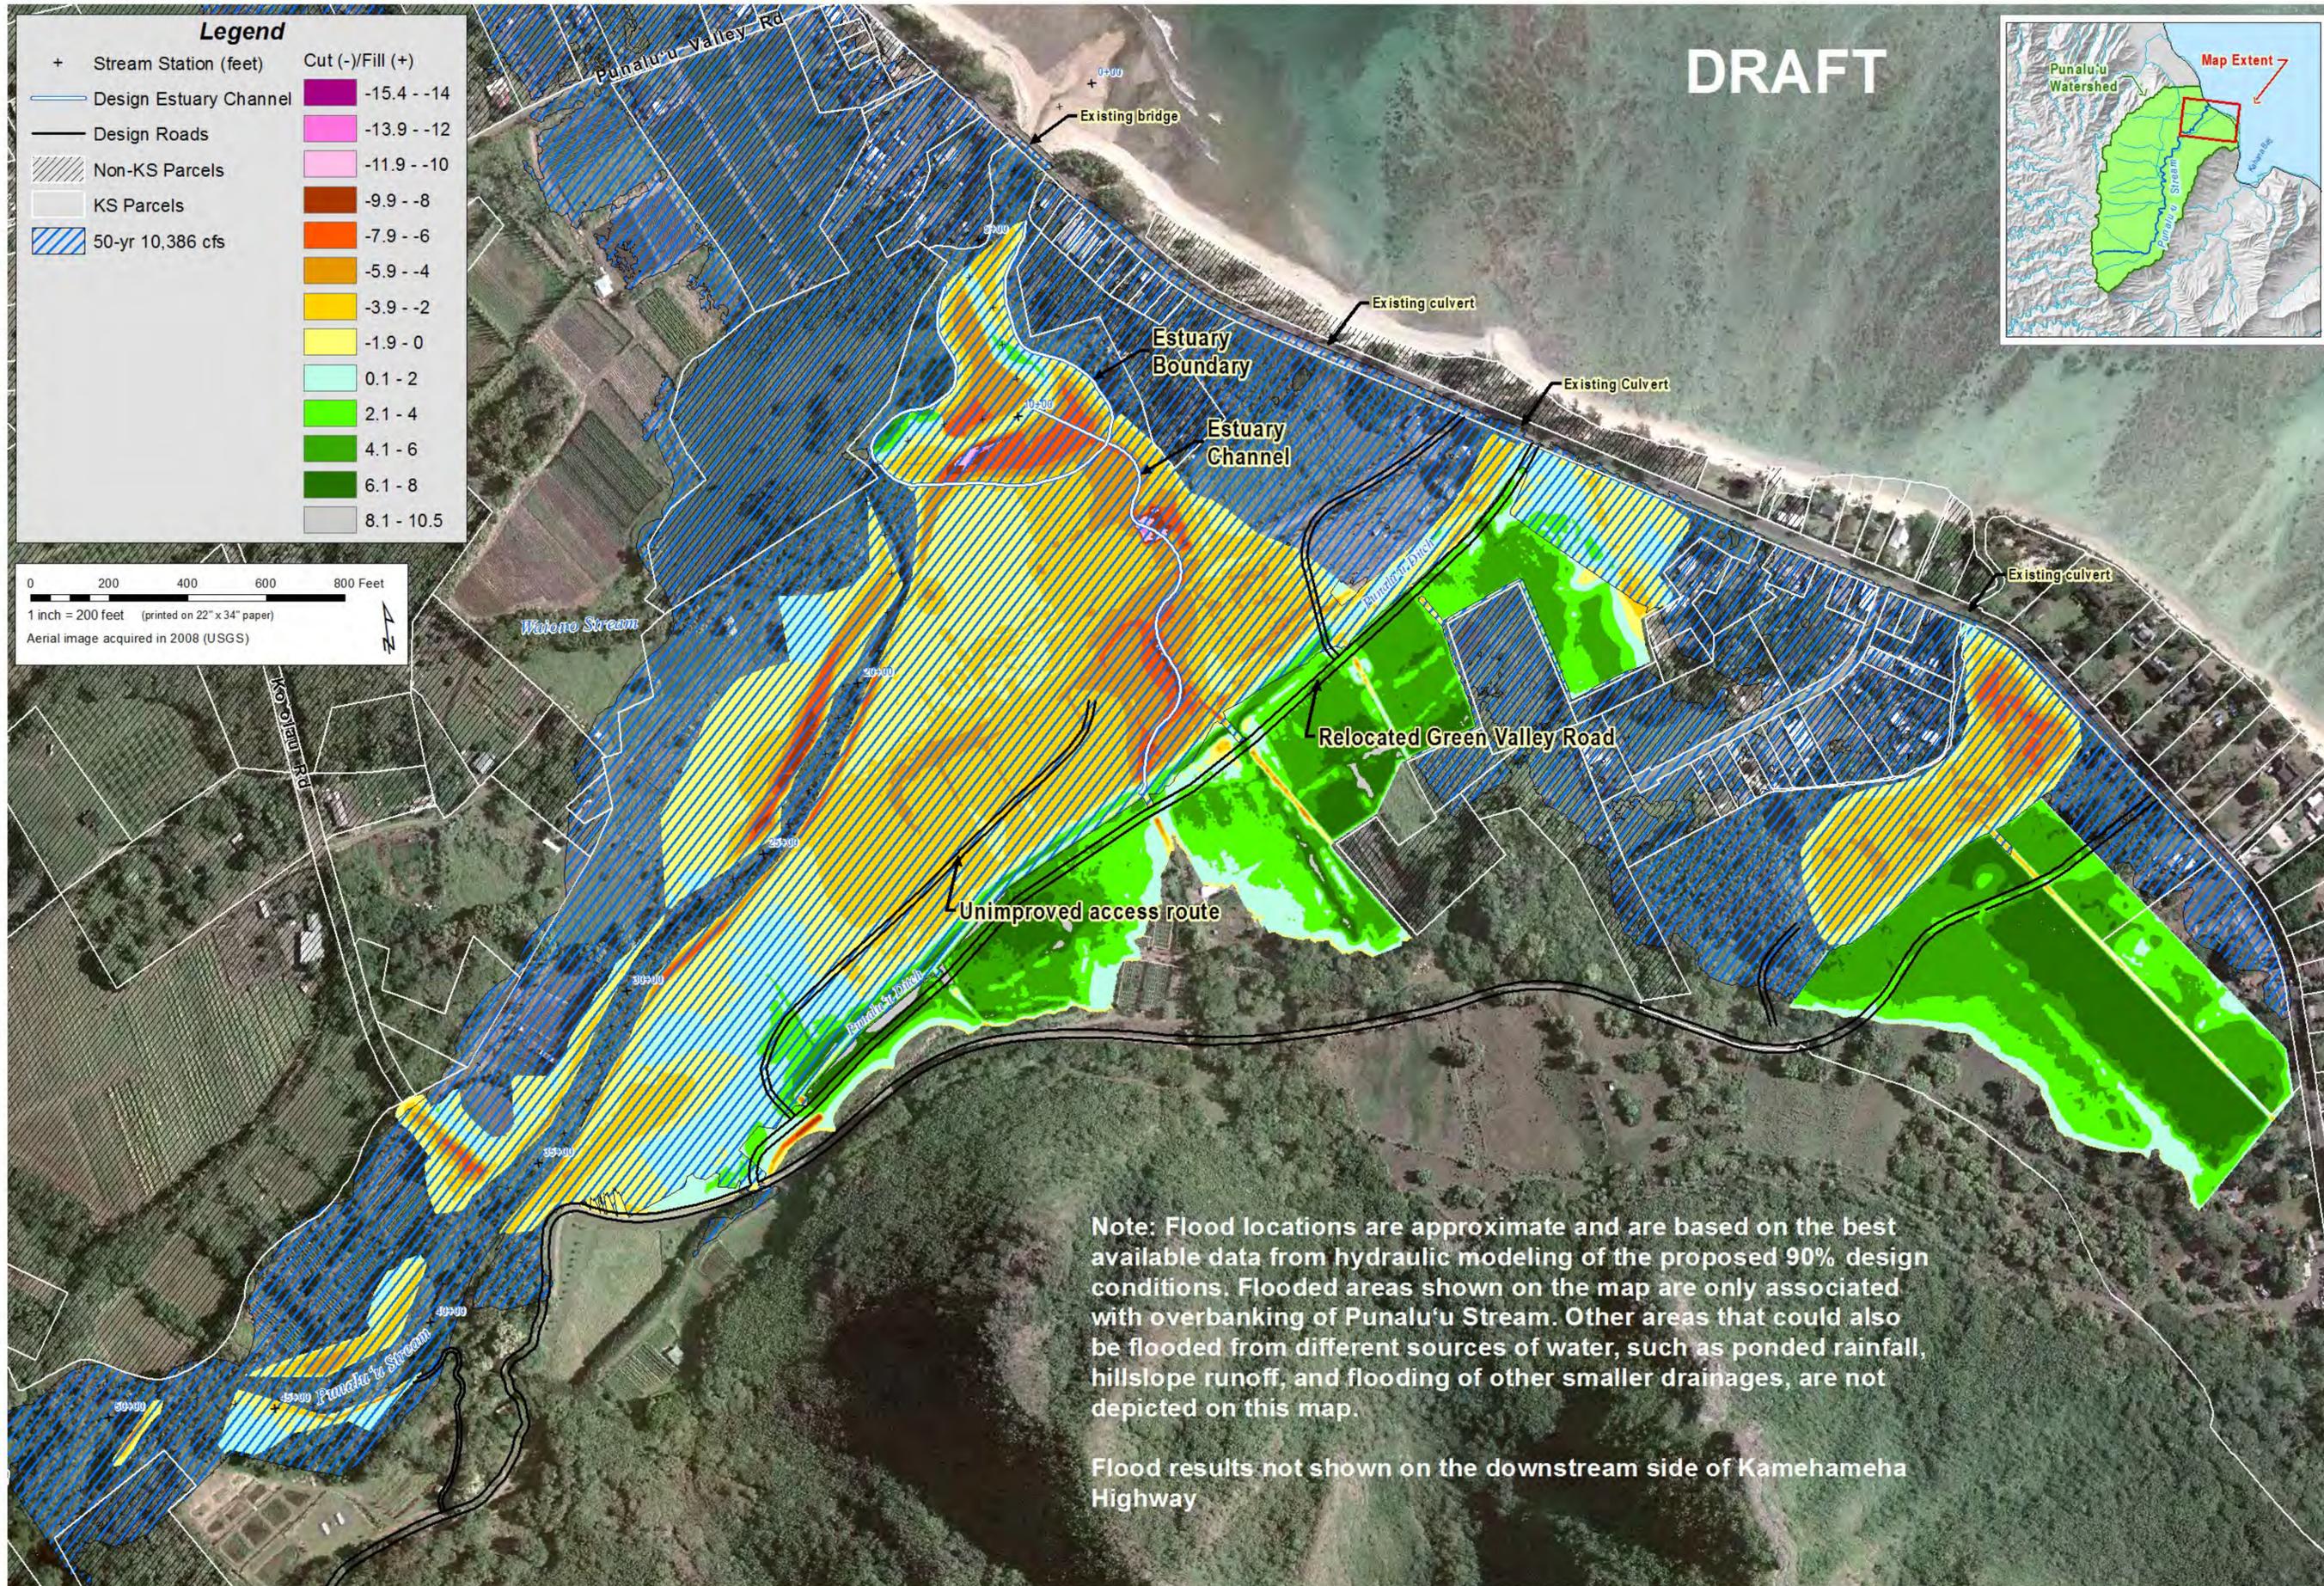
Note: Flood locations are approximate and are based on the best available data from hydraulic modeling of the proposed 90% design conditions. Flooded areas shown on the map are only associated with overbanking of Punalu'u Stream. Other areas that could also be flooded from different sources of water, such as ponded rainfall, hillslope runoff, and flooding of other smaller drainages, are not depicted on this map.

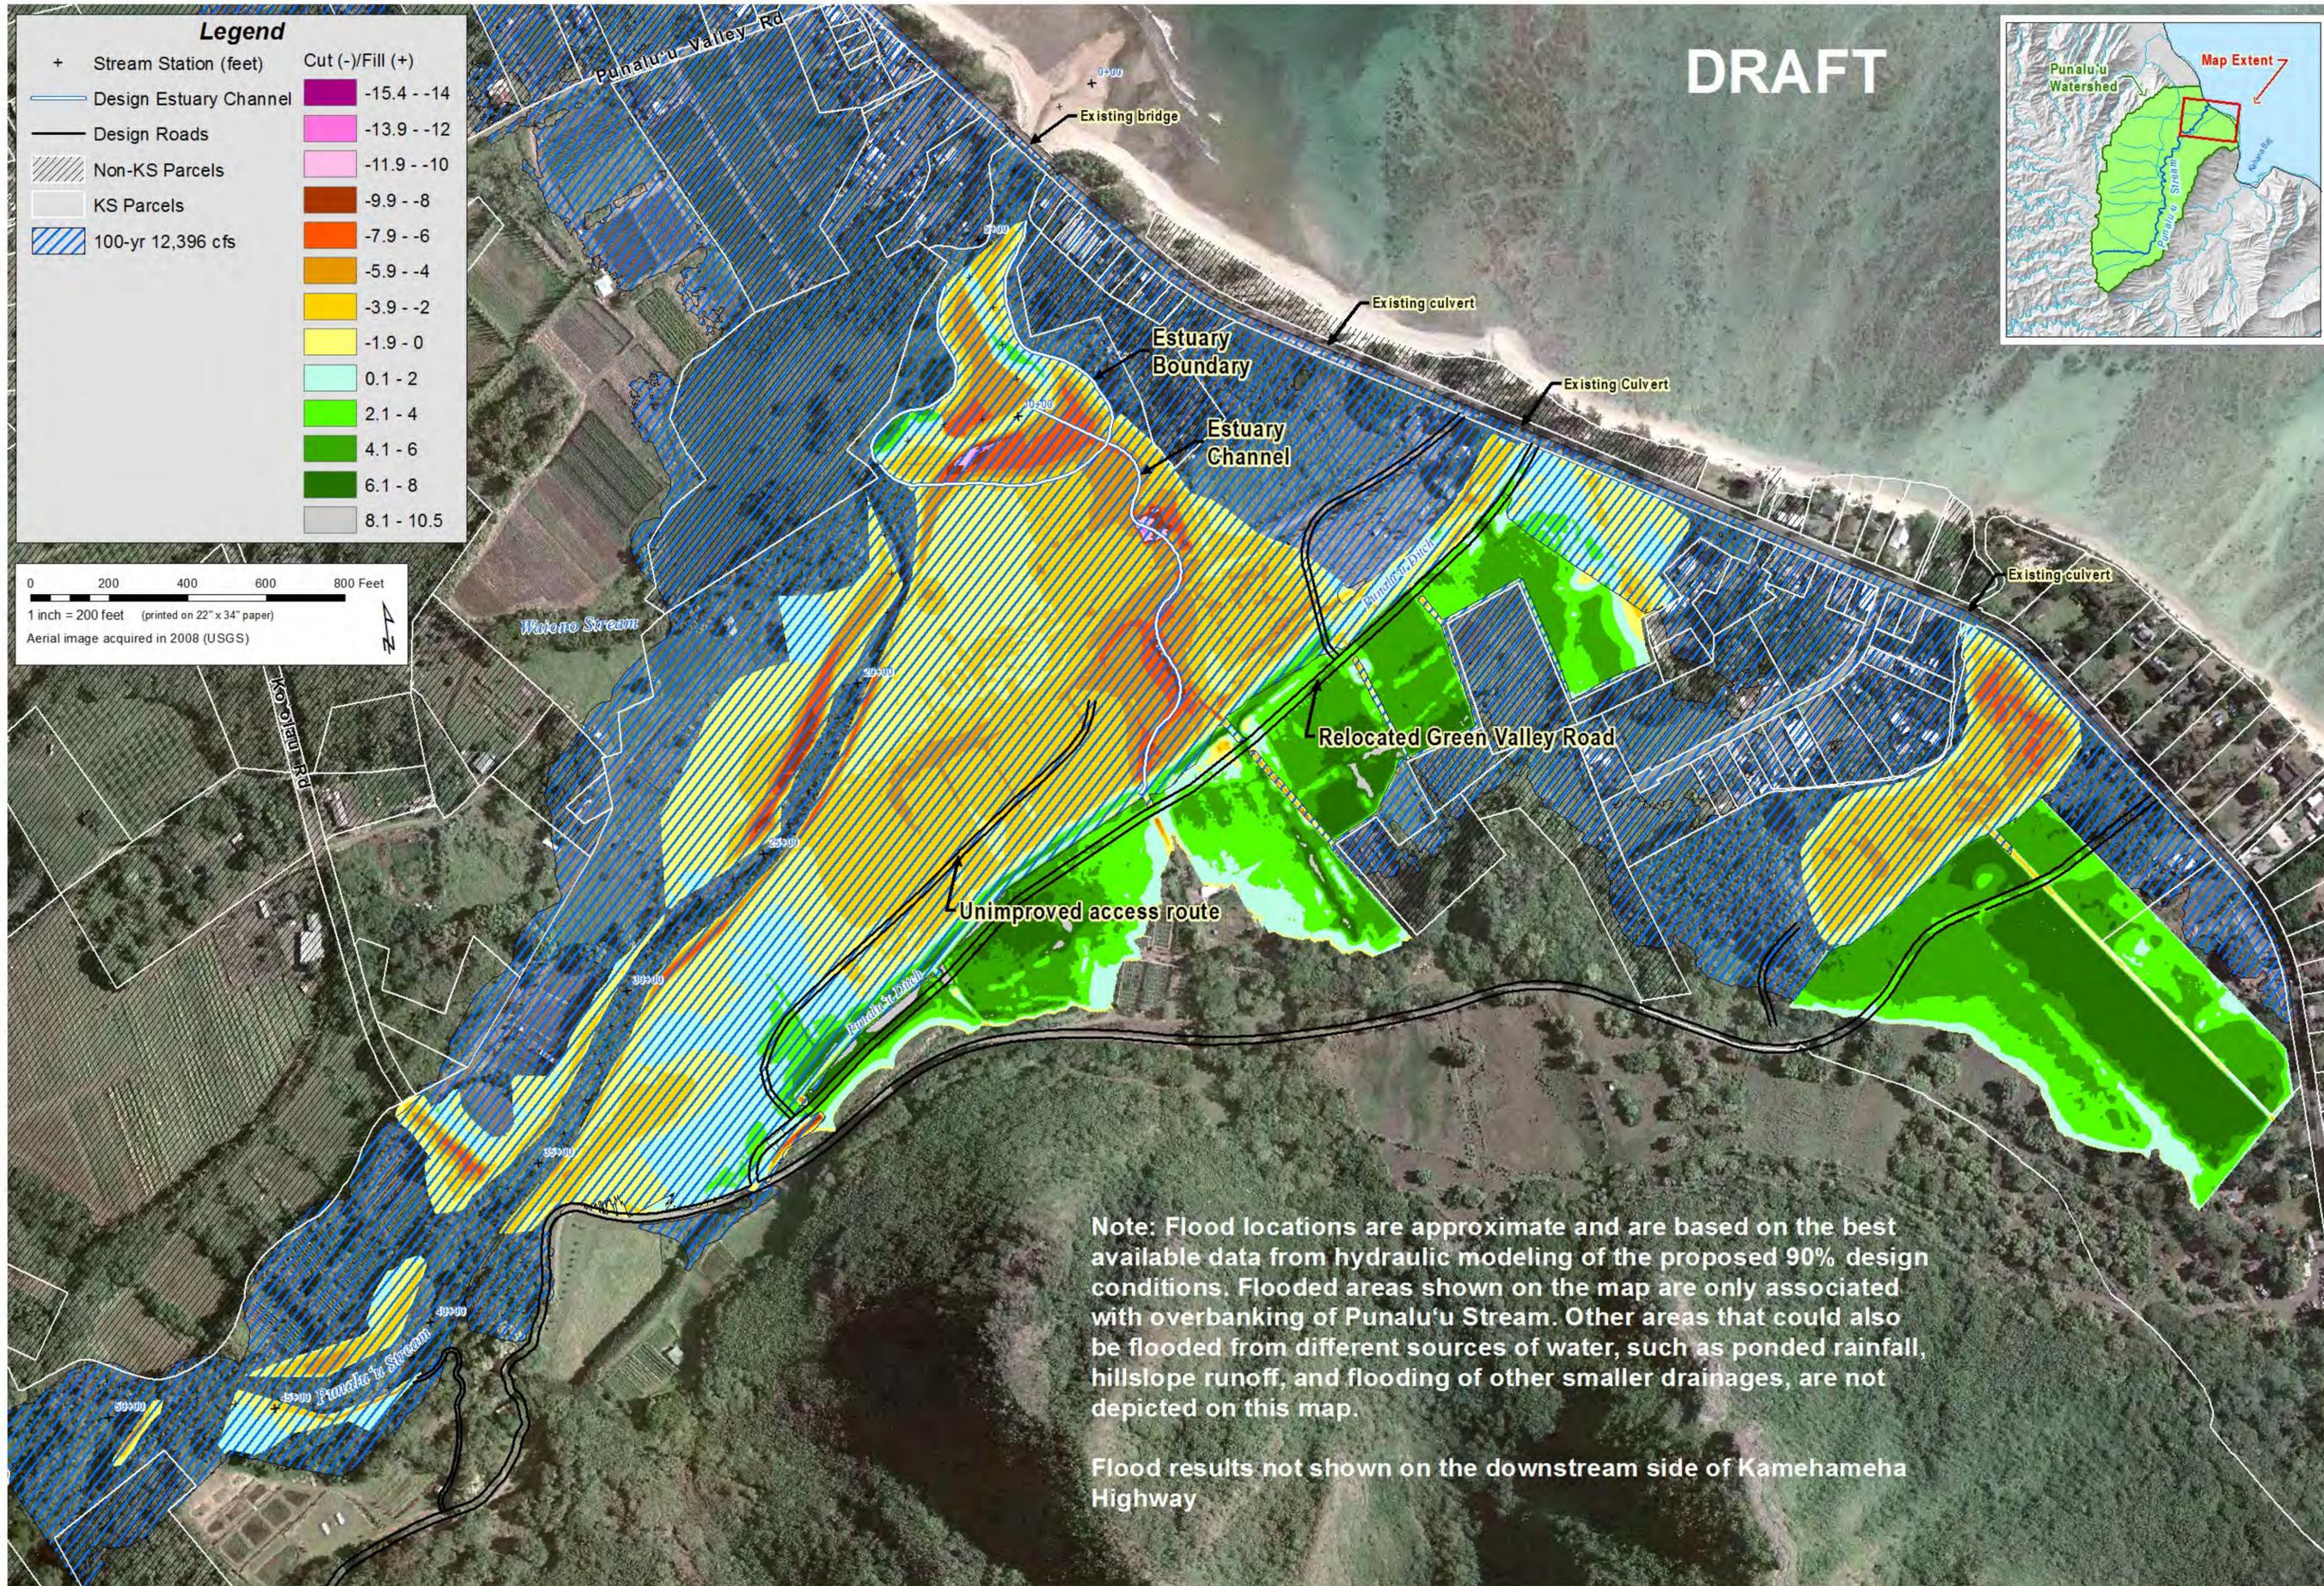
Note: Flood locations are approximate and are based on the best available data from hydraulic modeling of the proposed 90% design conditions. Flooded areas shown on the map are only associated with overbanking of Punalu'u Stream. Other areas that could also be flooded from different sources of water, such as ponded rainfall, hillslope runoff, and flooding of other smaller drainages, are not depicted on this map.

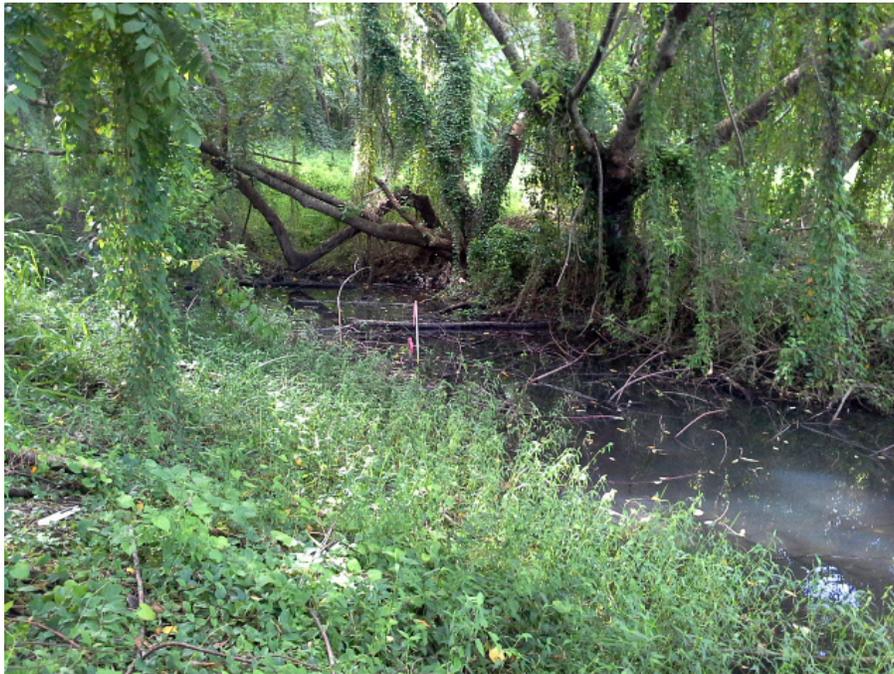
Photo 3. Typical Site 7236 ditch; view to the southeast.

Site 50-80-06-7236 is a network of valley-bottom irrigation ditches (Photos 3-5) running at least 2,344 m in total length. The network is within the valley and is fed principally from Punalu‘u Stream, though it appears to have previously been fed by another major ditch (Site 7223; outside of the current project area). The earthen ditches typically include soil berms on either side without any stone or concrete lining. They vary in width from 0.5-2.0 m and in depth from 0.5-1.0 m. Recently constructed stone dams and metal culverts as well as steel culverts, are found at various locations throughout the network. Three stone dams 2.2-2.5 m long, 0.8-1.4 m wide, and 0.4-0.9 m high were recorded. The dams are recent constructions, being built with stacked basalt rocks atop plastic lining. Four steel culverts measuring 0.3-0.9 m in diameter were recorded at locations where roads crossed over the ditches. Much of the ditch network is still in use, with other recent modifications including diversion ditches and pipes.

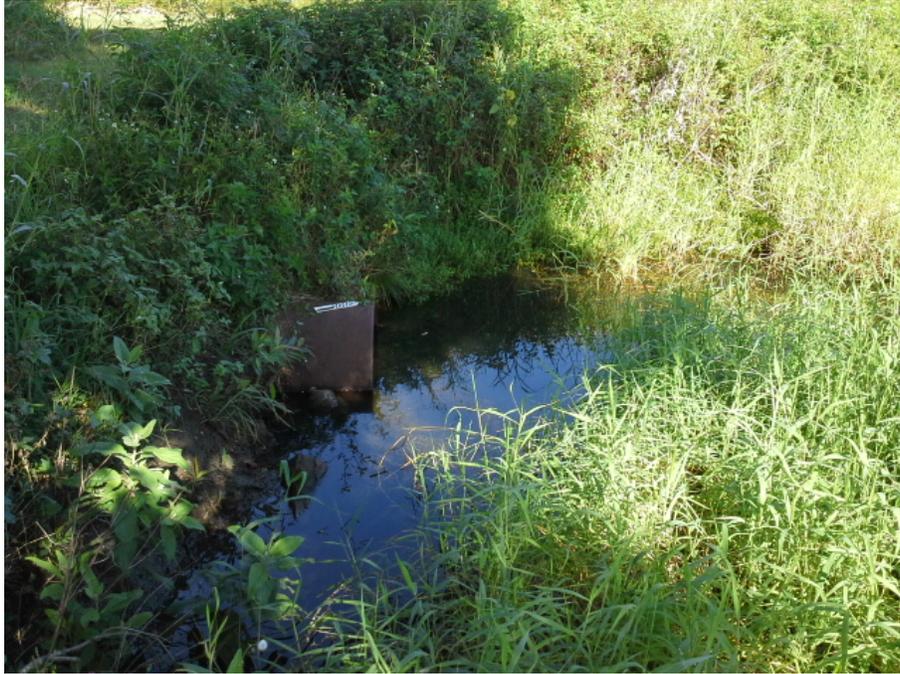
Photo 4. Culvert, part of the Site 7236 ditch network; view to the west.

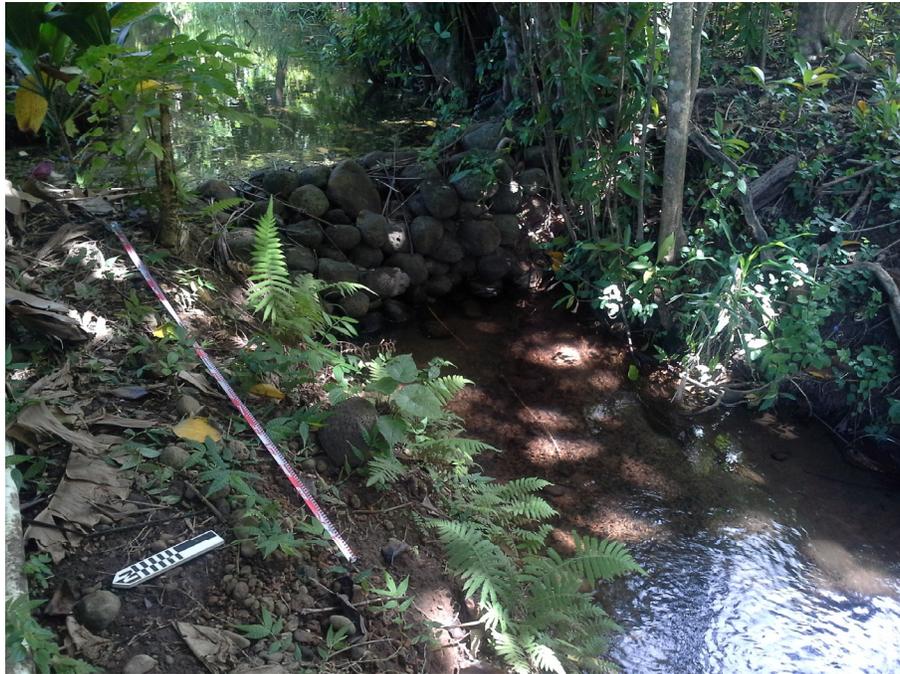
Photo 5. Stone dam, part of the Site 7236 ditch network; view to the east.

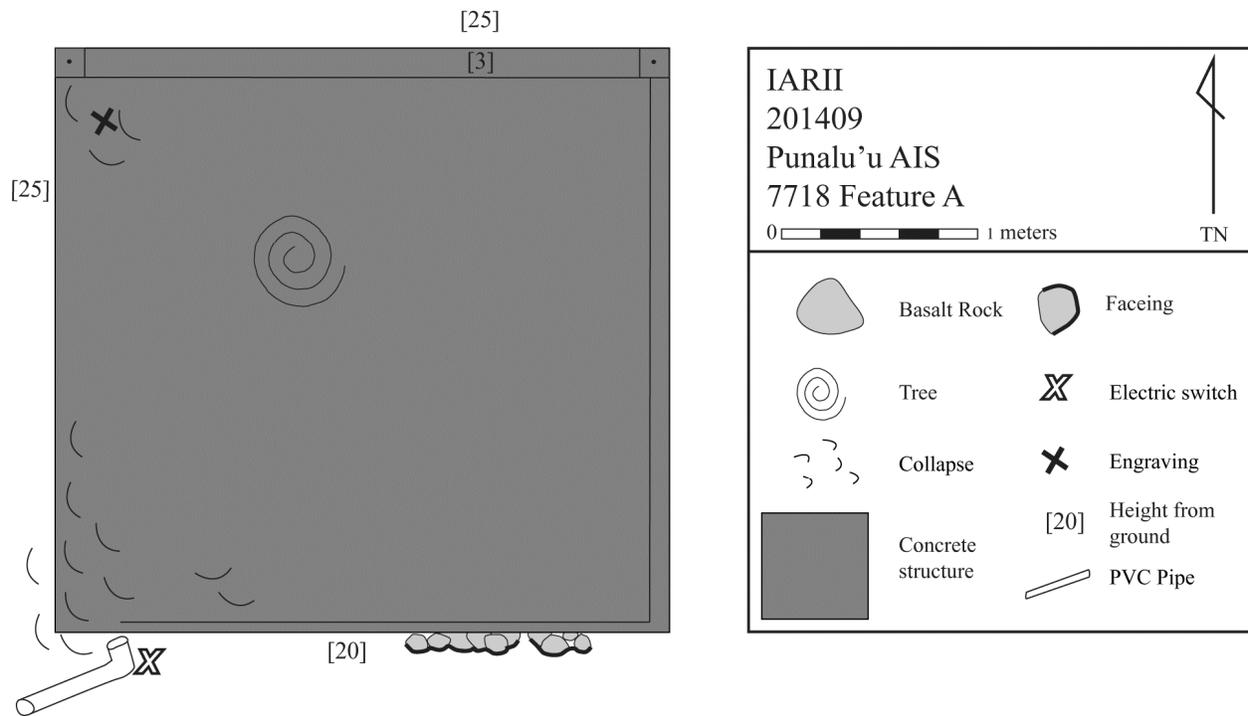
Figure 15. Scaled plan view map of Feature A, Site 7718.

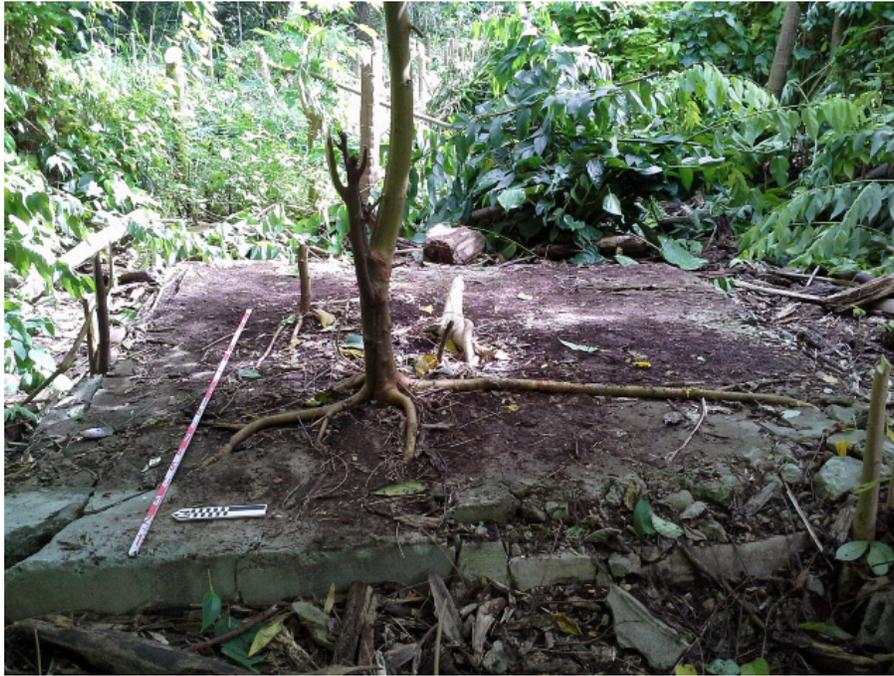
Photo 7. Feature A; view to the west.

Feature A is a square concrete pad with corners oriented roughly to compass points. The foundation is 3.15 m by 3.0 m and 0.25 m in height (Fig. 15; Photo 7). The concrete pad was poured over a layer of subrounded basalt cobbles. In the south corner is a disarticulated section of a metal pipe and a power outlet box. A date inscribed in the concrete at the north corner indicates that the structure was built on September 11, 1953 (Photo 8). The concrete pad is in fair condition. Feature A is interpreted as a building foundation, presumably for an outbuilding since it is smaller than a typical mid-20th century primary residence.

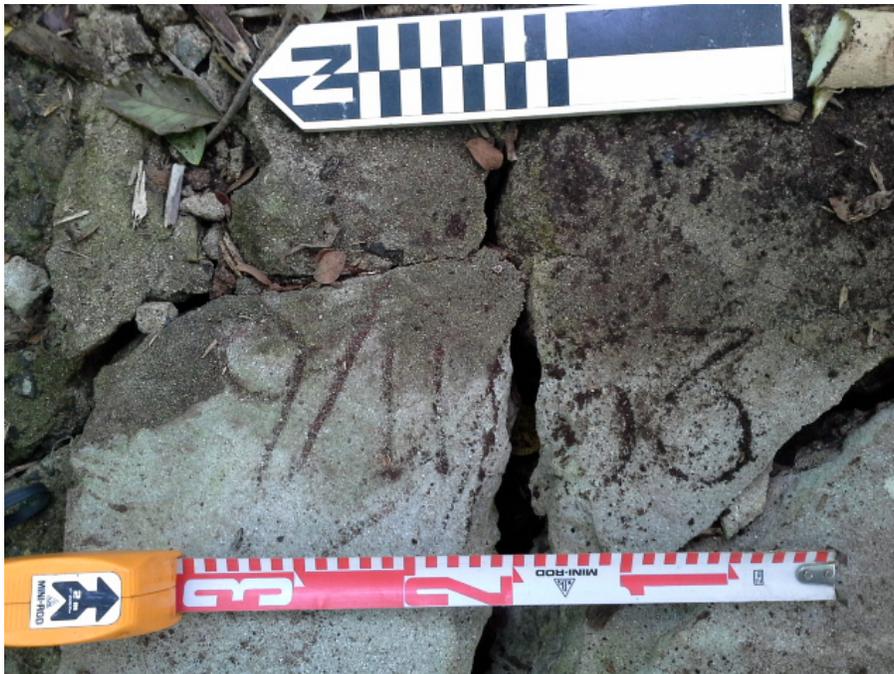
Photo 8. Inscribed date "9/11/53" in the north corner of Feature A.

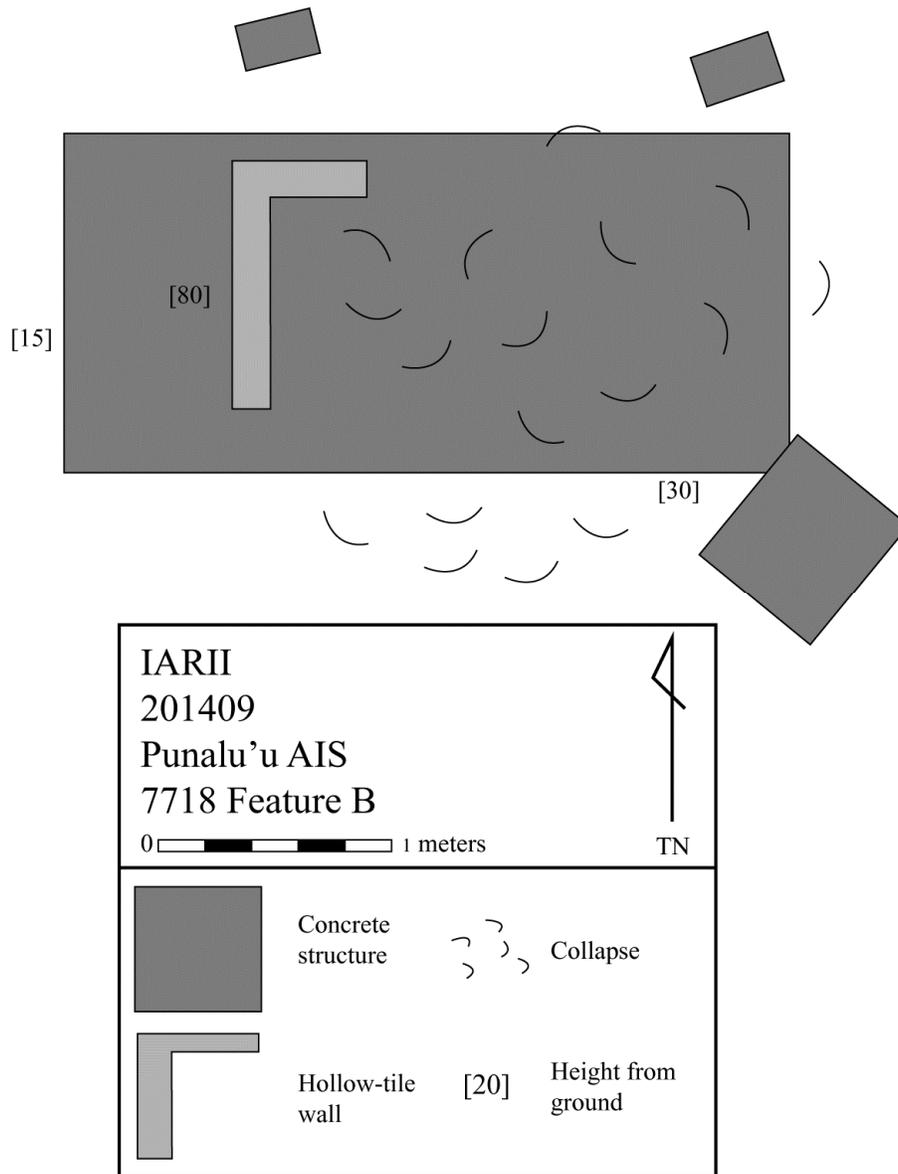
Figure 16. Scaled plan view map of Feature B, Site 7718.

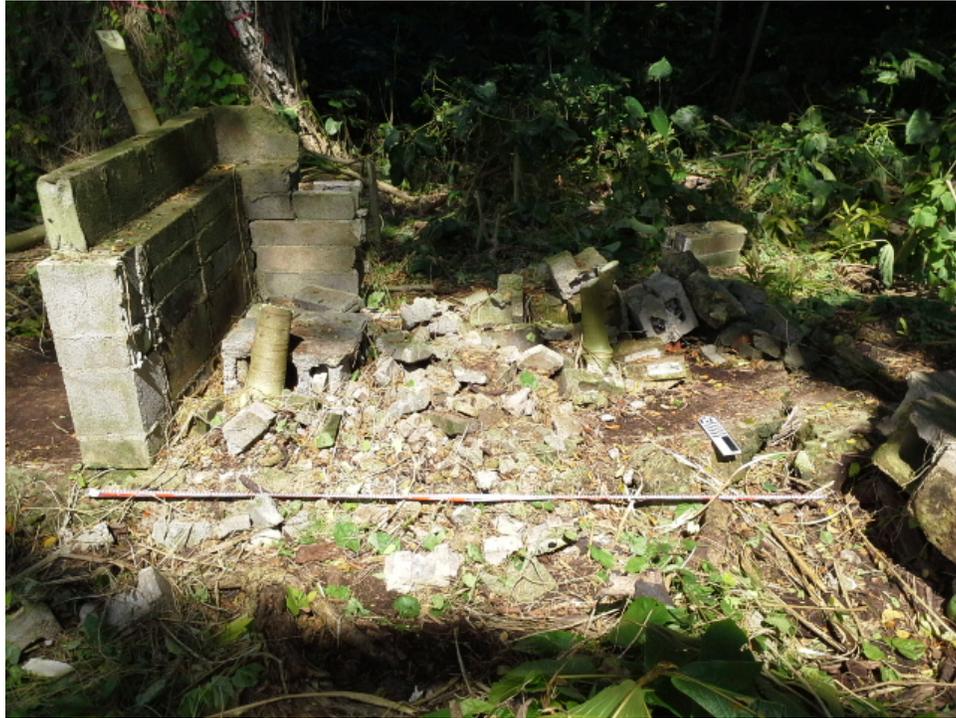
Photo 9. Feature B, showing intact standing wall segment; view to the east.

Feature B is a rectangular concrete pad with the partial remains of a concrete block and mortar superstructure still standing in places (Fig. 16; Photo 9). The feature is located 30 m north northeast of Feature A. The foundation is 3.1 m by 1.1 m and 0.15-0.3 m in height. The standing wall is constructed of concrete masonry units and measures 1.45 m by 0.2 m and 0.85 m in height. Unlike Feature A, the concrete slab foundation does not appear to overlay basalt cobbles, but rests directly on the soil. The feature is in fair condition. As with Feature A, based on its size Feature B is interpreted as an ancillary residential or agricultural structure although its specific function is unclear.

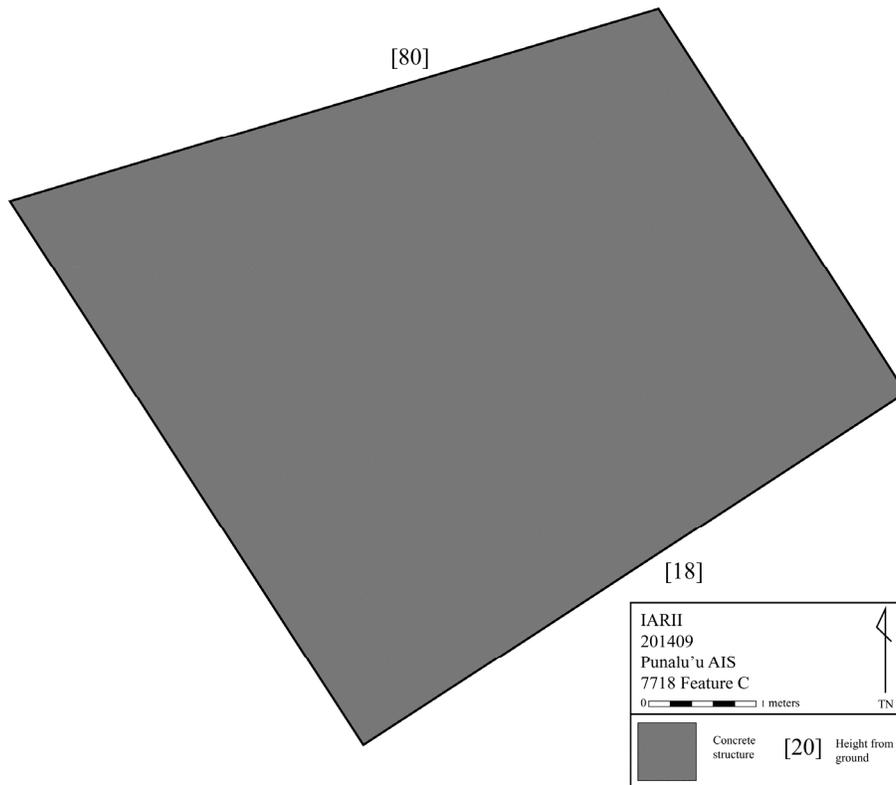
Figure 17. Scaled plan view map of Feature C, Site 7718.

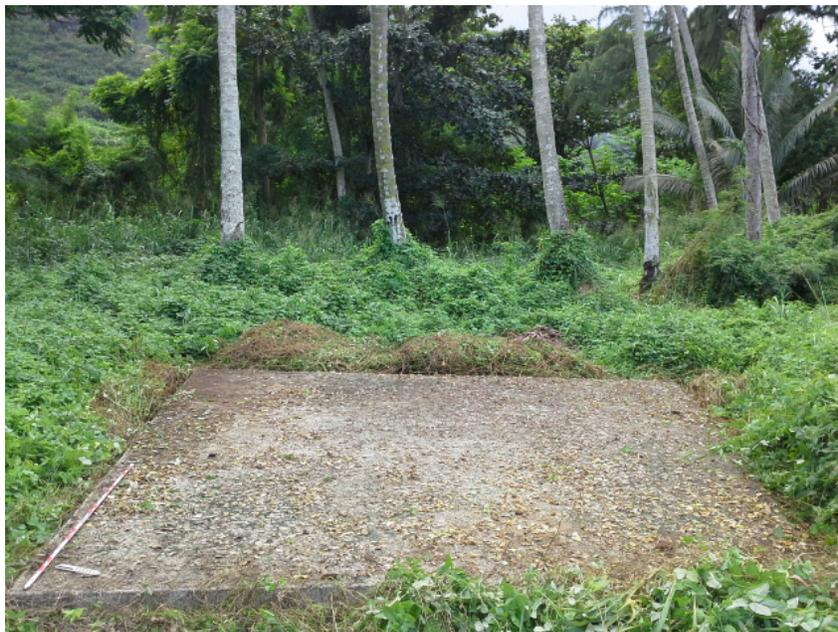
Photo 10. Feature C; view to the west.

Feature C is a concrete slab foundation located 115 m east of Feature B, outside of the current project area. The foundation is 6.1 m by 6.1 m and 0.2 m in height (Fig. 17; Photo 10). The slab is bare, with no discernable internal features. Feature C is the foundation for the largest structure within Site 7718, yet the lack of internal divisions or remnant utilities (e.g., plumbing drain pipe) suggests that it was not the foundation for a primary residence. This does not, however, exclude the possibility that it was the foundation for a house lacking plumbing ( a possibility for a mid-20th century, rural family). Therefore, the function of this feature is unclear. Feature C is in good condition.

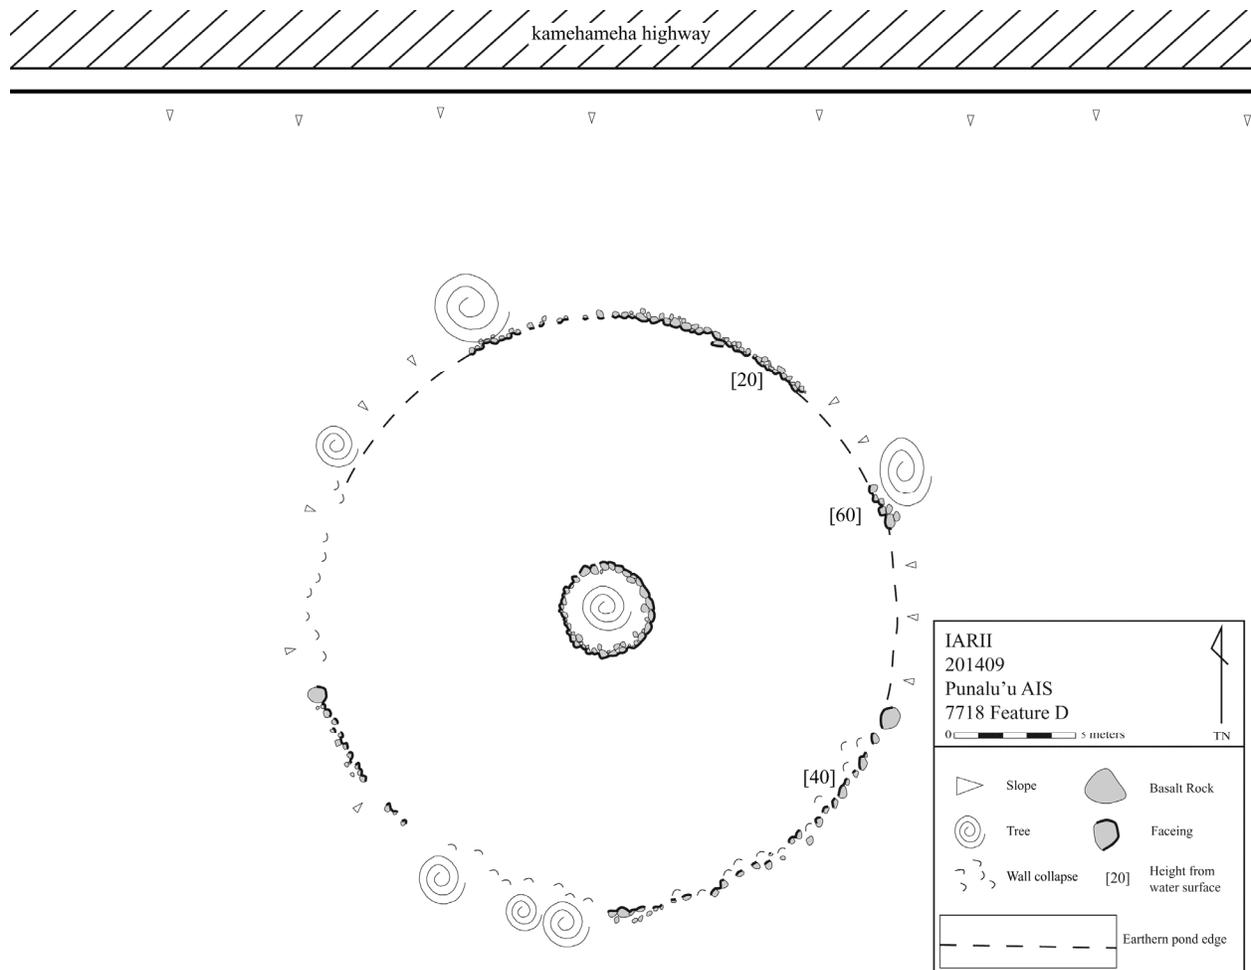
Figure 18. Scaled plan view map of Feature D, Site 7718.

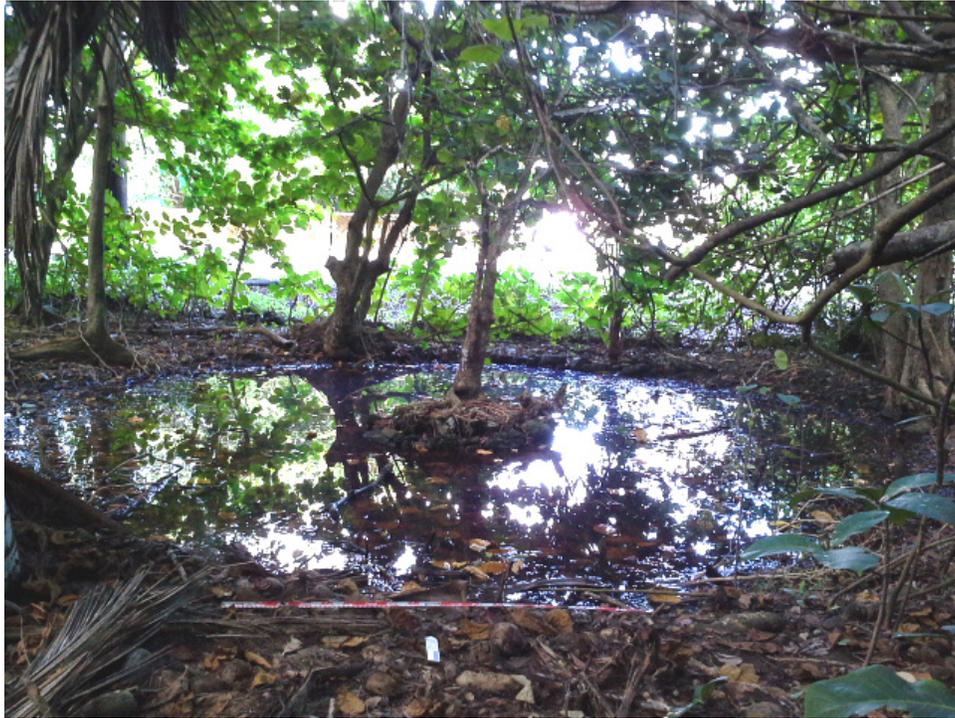
Photo 11. Feature D, showing the islet at the center of the pond; view to the north.

Feature D is a stone-lined pond located along the highway 130 northwest of Feature C, outside of the current project area (Fig. 18; Photo 11). The pond measures 12 m in diameter and is partially lined with dry-stacked basalt cobbles and boulders with some limestone facing; it was holding water at the time of the survey and the depth was not determined. The perimeter of the pond is bounded with an embankment 0.4-0.55 m in height. A small islet 1.75 m in diameter and 0.4 m above the water line is present at the center of the pond. The islet is faced with basalt and limestone cobbles and contains a single tree. The pond is in good condition. A circle interpreted as the pond is depicted on Thoene's (1953) map (see Fig. 13).

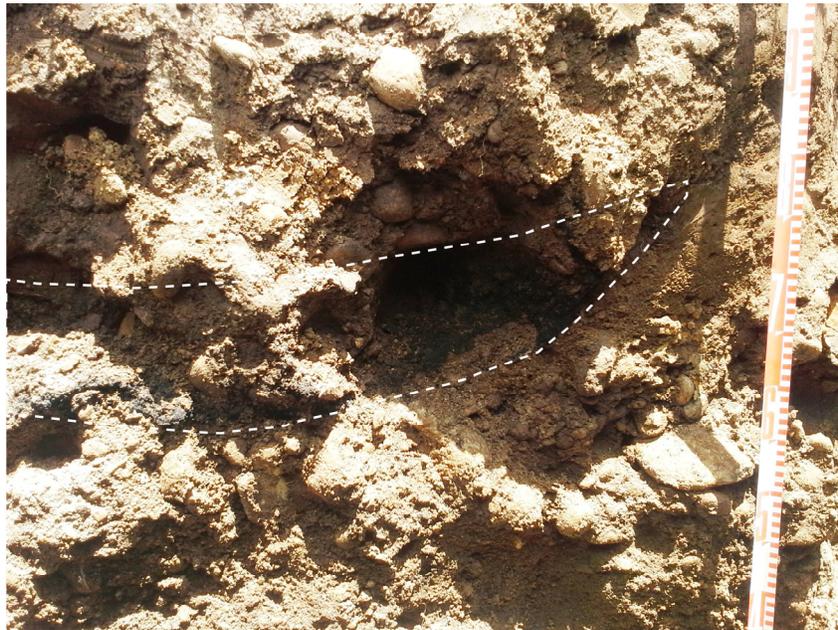
Photo 12. Closeup of the north wall of the trench, with the *imu* highlighted by the dashed line.

Site 50-80-06-7727 is a buried *imu* encountered during excavation of Trench 14, located along Punalu‘u Valley Road (Green Valley Road) approximately 600 m from the highway (Figure 19; Photo 12). The feature was bisected during trenching and the remainder was investigated with the excavation of a controlled test unit. The feature extended from 59-75 cm below surface (bs) and measured 95 cm in diameter. There was no associated cultural deposit present and the stratigraphy documented in the trench indicates that the feature was likely placed in or adjacent to a former stream channel; Punalu‘u Stream is currently approximately 10 m to the northwest. Significant amounts of basalt and charcoal were present within the feature. No other cultural materials were encountered. Charcoal of *alahe‘e* (cf. *Psydrax odorata*) and an unknown woody taxon was recovered from the base of the feature; no historic species were identified in the sample. The *alahe‘e* charcoal provided a conventional radiocarbon age of 200±30 BP (Beta-396329).

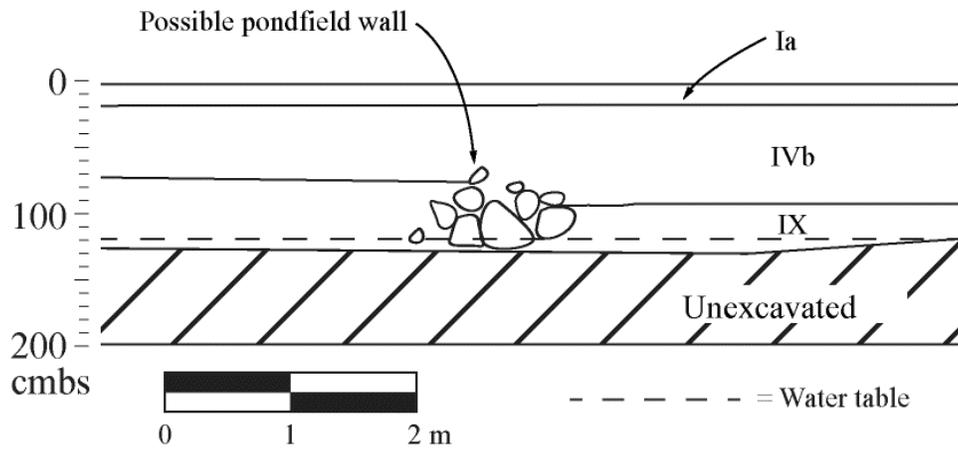
Figure 20. Portion of Trench 18 northwest wall profile, showing the terrace wall; note the thicker deposition of agricultural soil on the upslope (left) side.
