SUBJECT: Chapter 25, Revised Ordinances of Honolulu  
Draft Environmental Assessment  
Project: Punaluu Stream Restoration Project  
Applicant: Kamehameha Schools  
Agent: ICF International  
Location: Punaluu Watershed – Koolauloa  
Tax Map Keys: 5-3-1: 41 and 52, and 5-3-3: 1

**Project Name:** Punalu'u Stream Restoration Project, EA

Appendix C Biological Assessment Punalu'u Stream, O'ahu, Hawai'i with Recommendations for  
Stream Enhancement

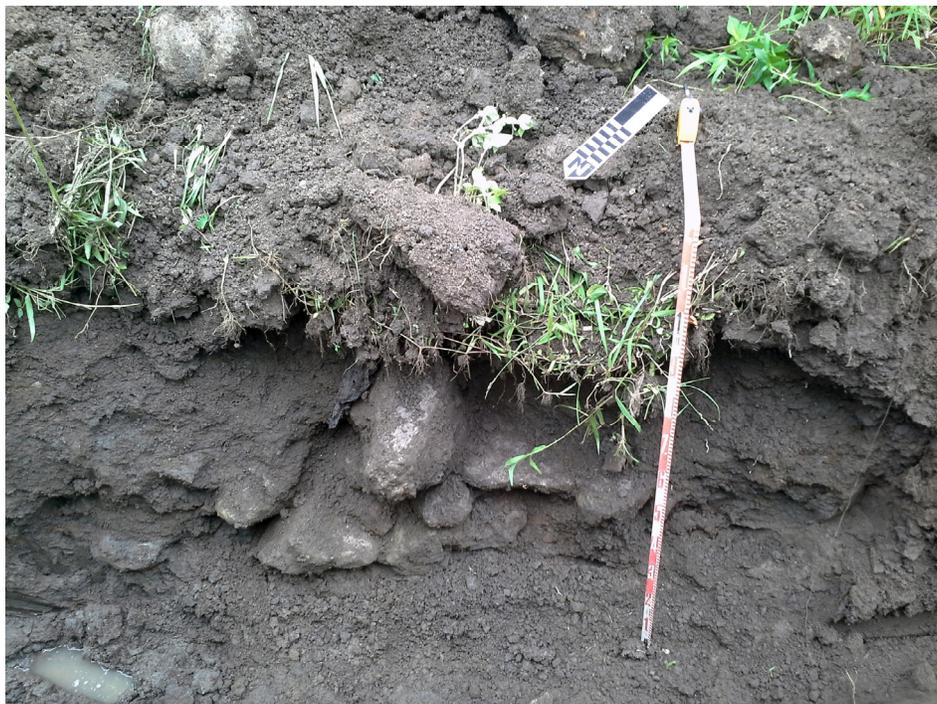
Photo 13. Close up of the southeast wall of Trench 18, showing the buried terrace wall.

Site 50-80-06-7728 is a possible buried terrace retaining wall and associated agricultural soil, which was encountered during excavation of Trench 18 along the southern edge of the valley (Fig. 20; Photo 13). Trenching exposed a concentration of basalt cobbles and small boulders, visible in both sidewalls of the trench. The stones were roughly arranged in 2-4 dry-stacked courses, 10-35 cm tall. In order to examine feature construction, a second backhoe trench, extending from the northwest side of the trench, was excavated parallel to the downslope (northeast) side of the wall. Additionally, the southeast side of the trench was manually excavated around the feature (Photo 14). Integrity of the wall rapidly diminished on both sides and it was no longer intact at 1.2 m from Trench 18. The lack of a well-defined edge or corner suggests that the retaining face was previously damaged, leaving only this small section intact. Although the structural evidence is ambiguous, the presence of a gley agricultural layer (see Fig. 20) in association with the feature supports its interpretation as a pondfield wall. Furthermore, historic maps indicate the area where the wall is located was under rice cultivation in 1907 (Fig. 21) and sugarcane by 1923 (Fig. 22); neither map shows internal terracing of these fields. Charcoal samples were collected from below the wall and between wall stones; however, both samples were too small and degraded for taxonomic identification and therefore were not submitted for radiocarbon dating. No other cultural material was encountered in the trench.

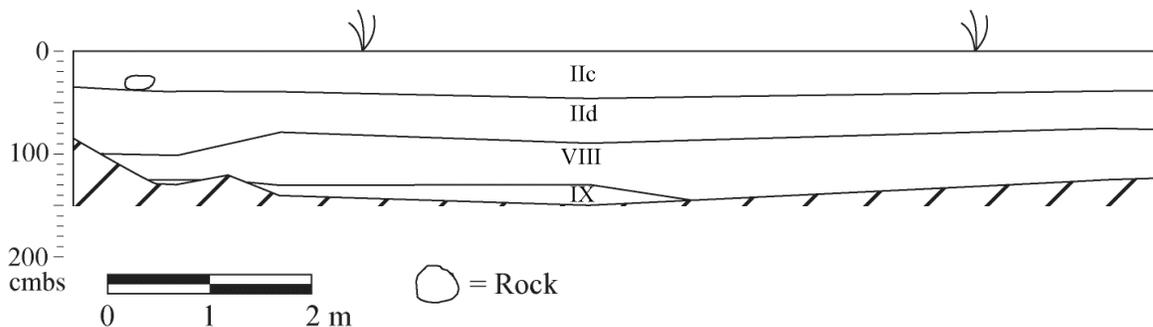
Figure 25. Scaled stratigraphic profile of a portion of the north wall of Trench 17. Layer IX is the Site 7734 agricultural soil correlated with Hahia's *lo'i* (LCA 8172:1).

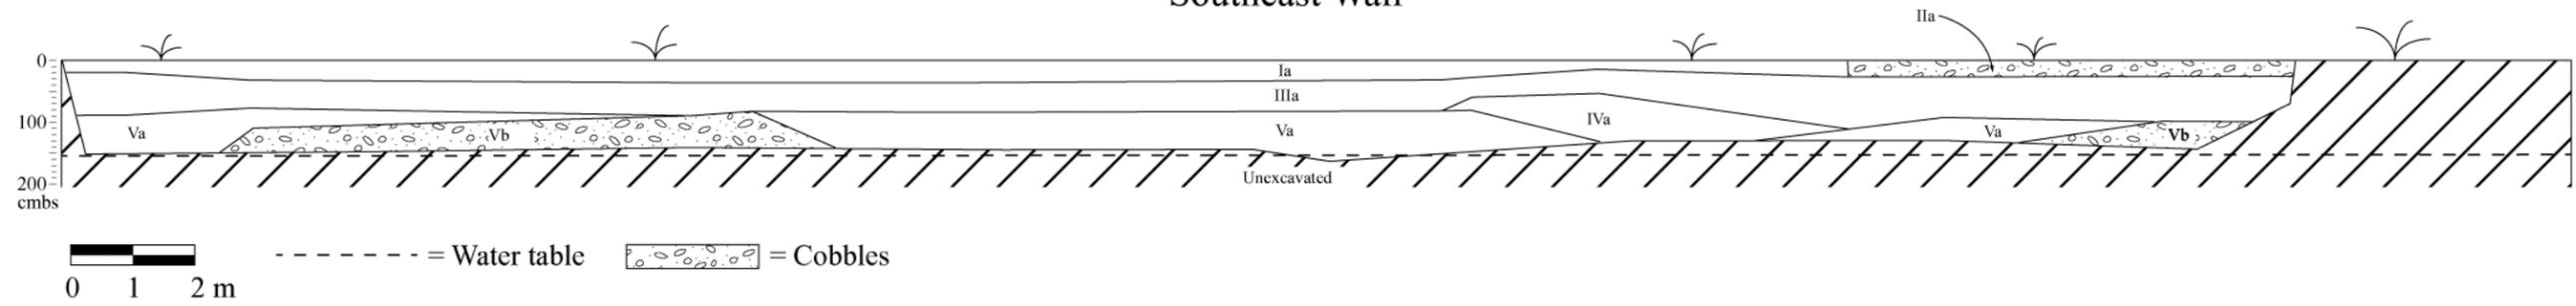
Punalu'u  
Trench 1  
Southeast Wall

Figure 27. East wall of Trench 1.
