CHAPTER 343, HRS
Environmental Assessment/Determination
Negative Declaration

Recorded Owner/ Applicant	:	Wallace Johnston
Agent	:	Oceanit Coastal Corporation
Location	:	870 Mokulua Drive, Lanikai, Oahu
Tax Map Key	:	4-3-8: 50
Request	:	Shoreline Setback Variance
Proposal	:	Construction of a Rubble Revetment
Determination	:	A Negative Declaration Is Issued

**FINAL
ENVIRONMENTAL ASSESSMENT FOR
SHORE PROTECTION AT
870 MOKULUA DRIVE, LANIKAI, OAHU
TMK 4-3-08:50**

NOVEMBER 1994

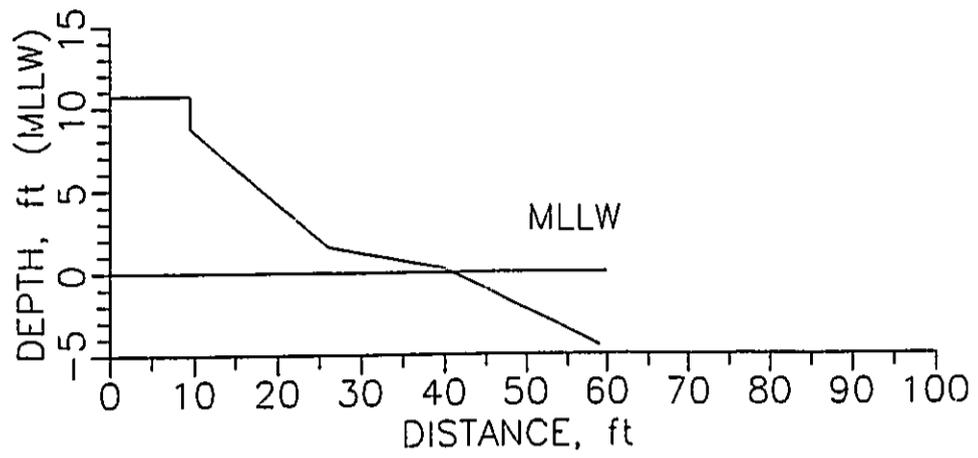
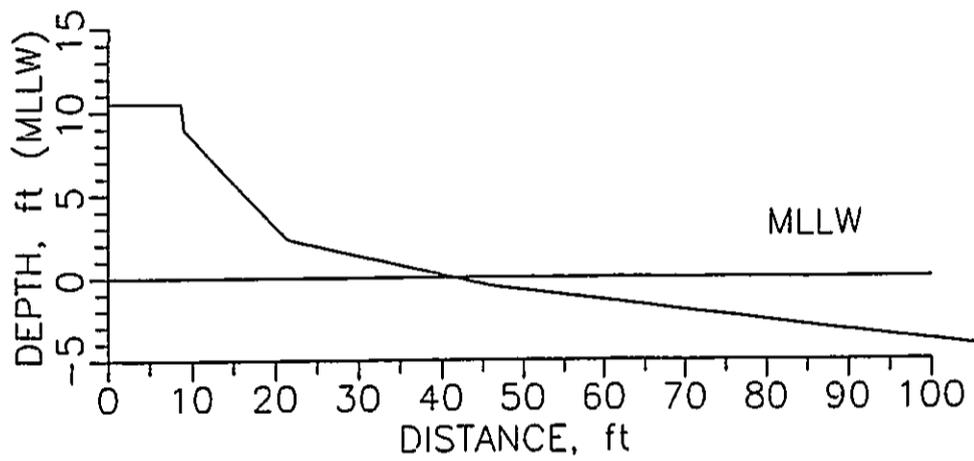
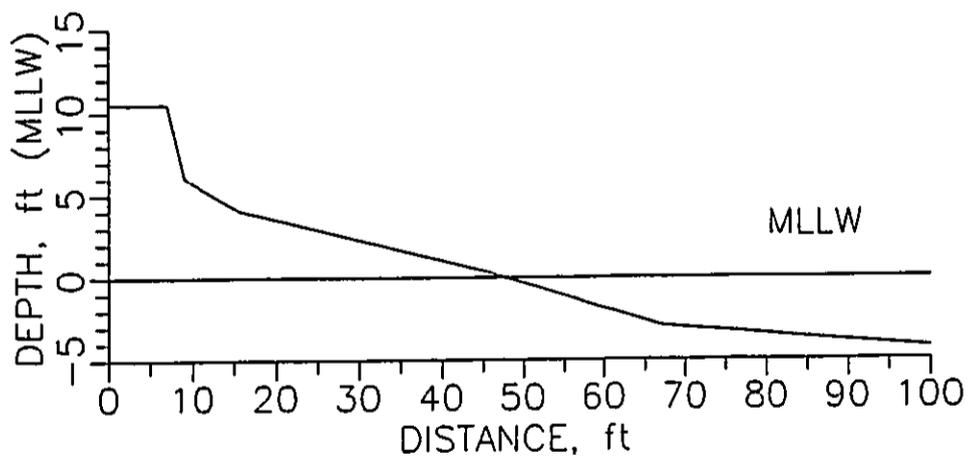
FIGURE 5. SHORELINE PROFILES

the top of the revetment approximately 10.5 feet above sea level. The offshore bottom is flat and consists of mixed sand, rock, and reef material. Water depth is less than 6 feet deep out to a reef approximately 1800 feet offshore. Beach/revetment profiles are shown in Figure 5. These profiles vary seasonally.

BEACH PROFILE NORTH EDGE OF PROPERTY

BEACH PROFILE CENTER OF PROPERTY

BEACH PROFILE SOUTH EDGE OF PROPERTY

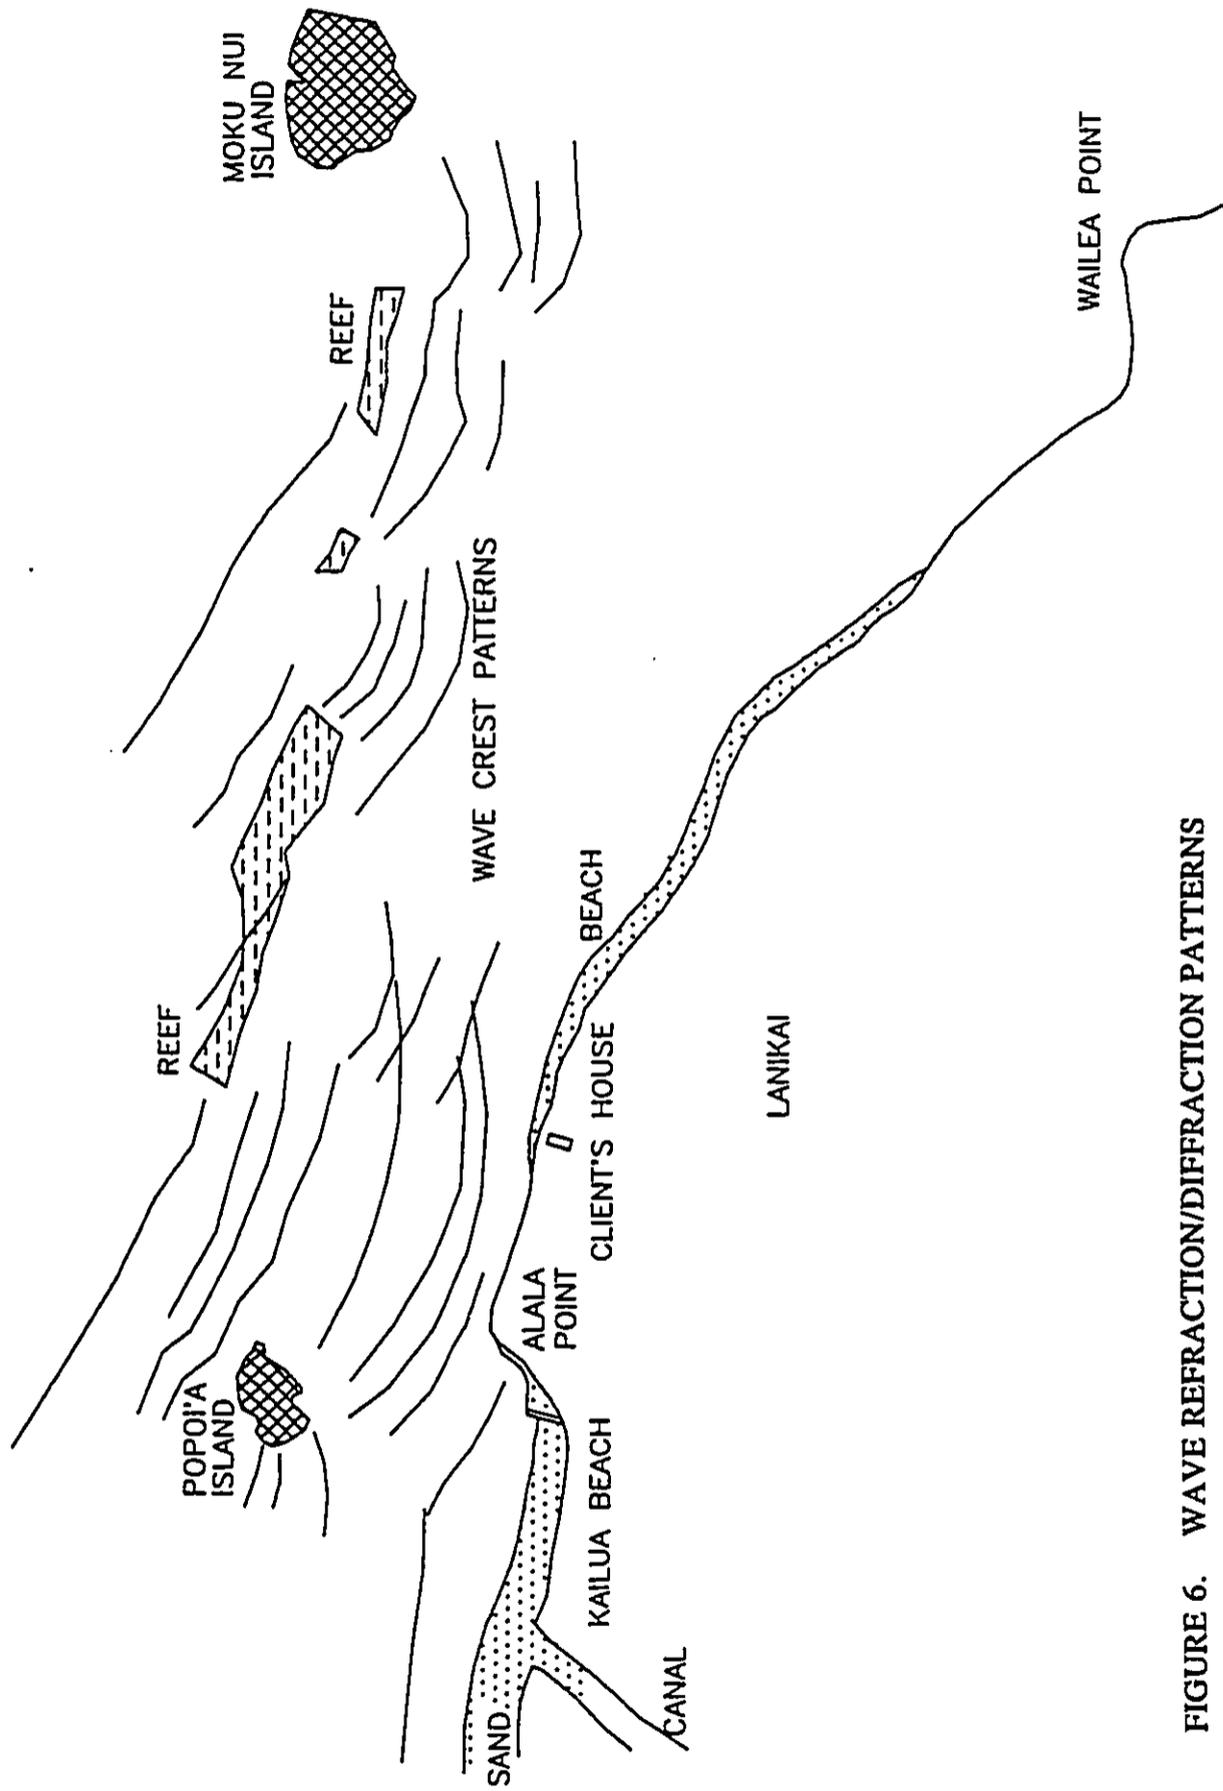
FIGURE 6. WAVE REFRACTION/DIFFRACTION PATTERNS

Based on wave patterns and beach shape, the property appears to be located near a beach node where sand transport can move in either direction along the coast. Wave refraction/diffraction patterns taken from an aerial photograph indicate why this occurs as wave fronts can be seen to move in both directions along the coast (Figure 6). The bi-directional movement of sand has also been observed by local residents. During a site visit, a slow current was observed moving to the north. Waves are generally small with larger waves breaking on the offshore reef.

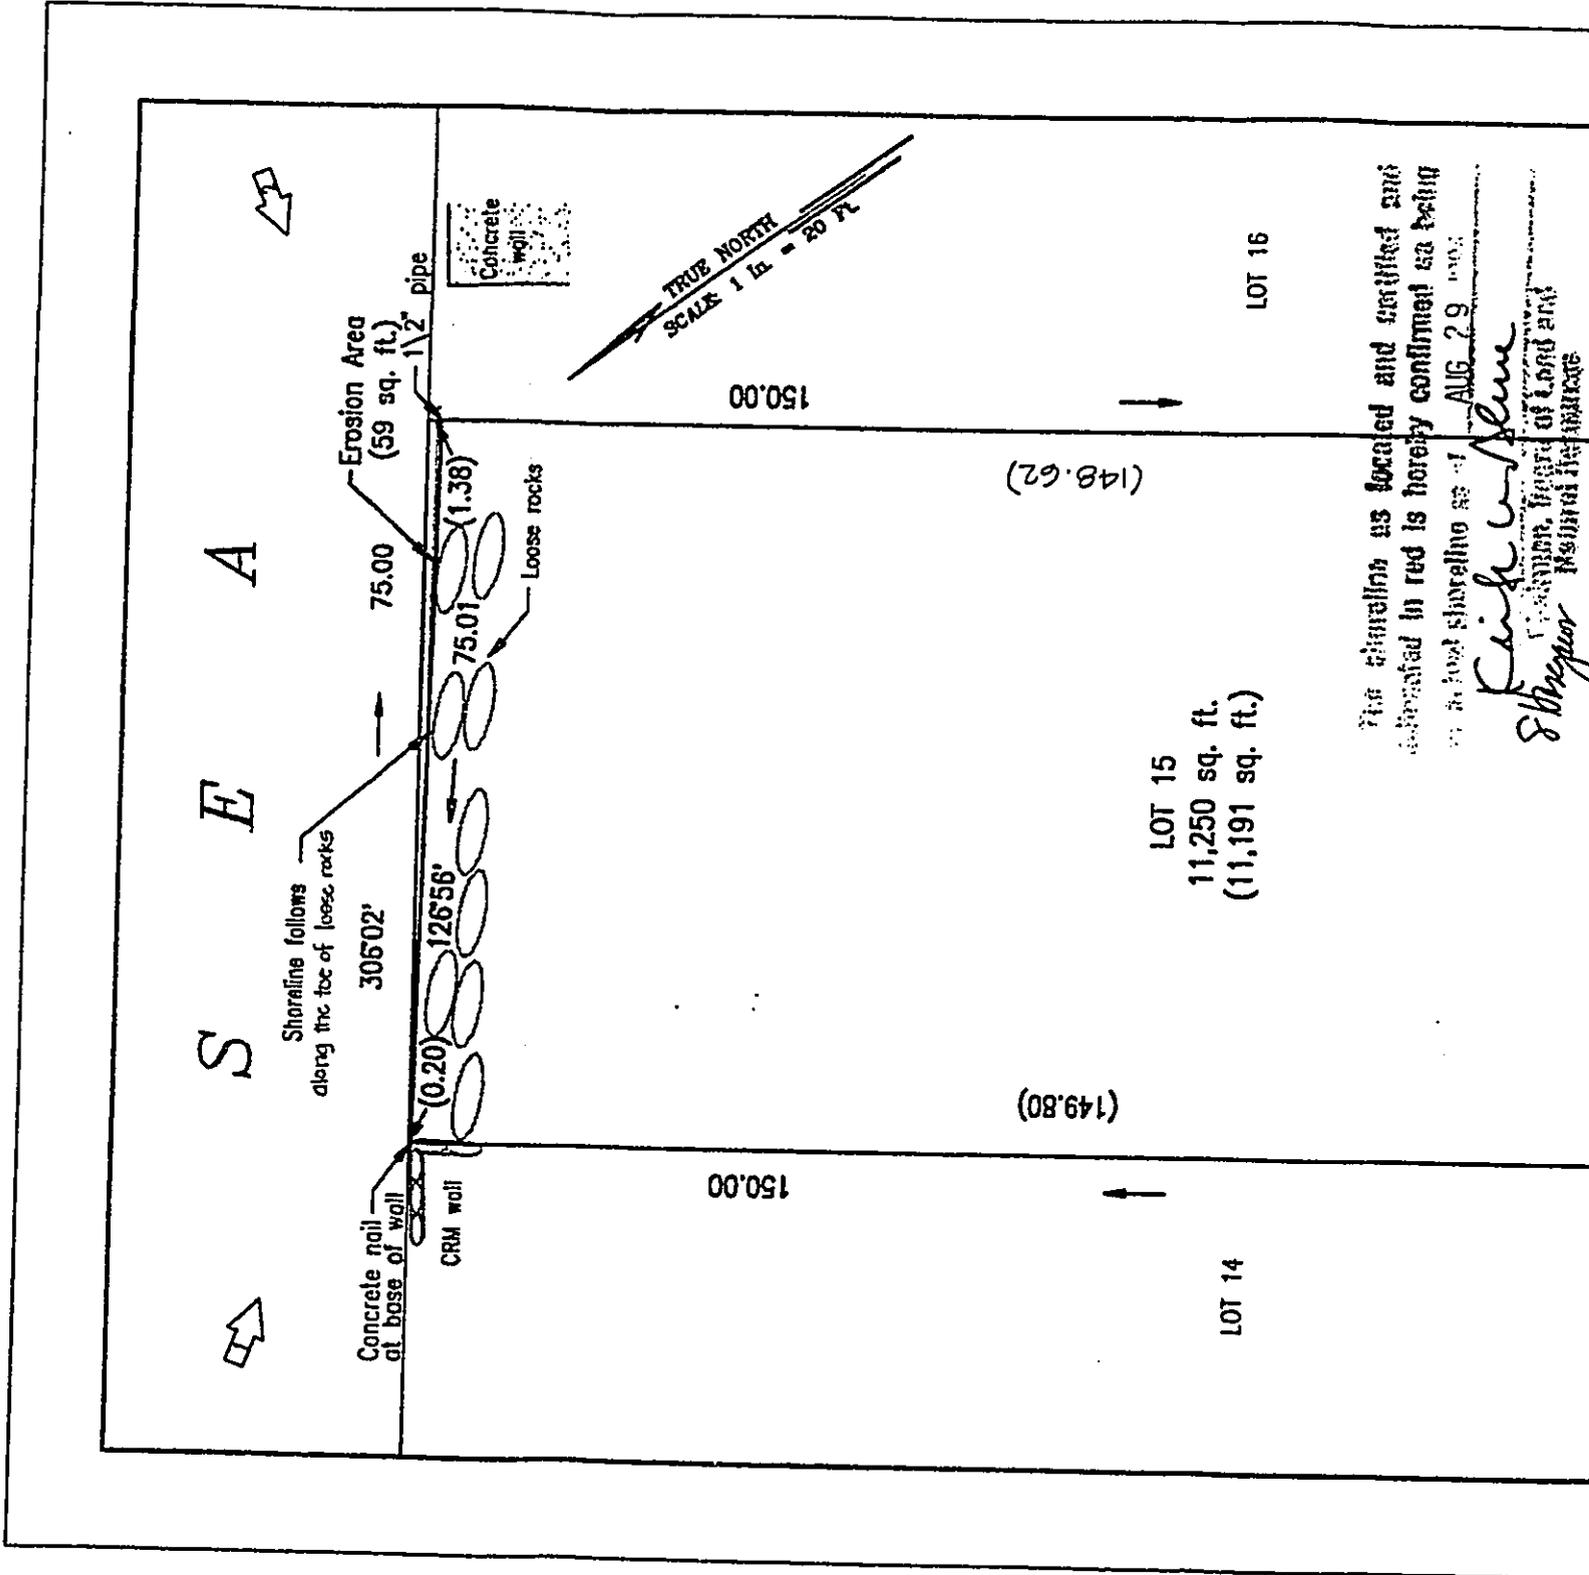
SHORELINE MAP
LOT 15

Shoreline follows along the toe of loose rocks

Erosion Area (59 sq. ft.)

A shoreline survey map is included in Appendix A. The site plan is shown in Figure 2.

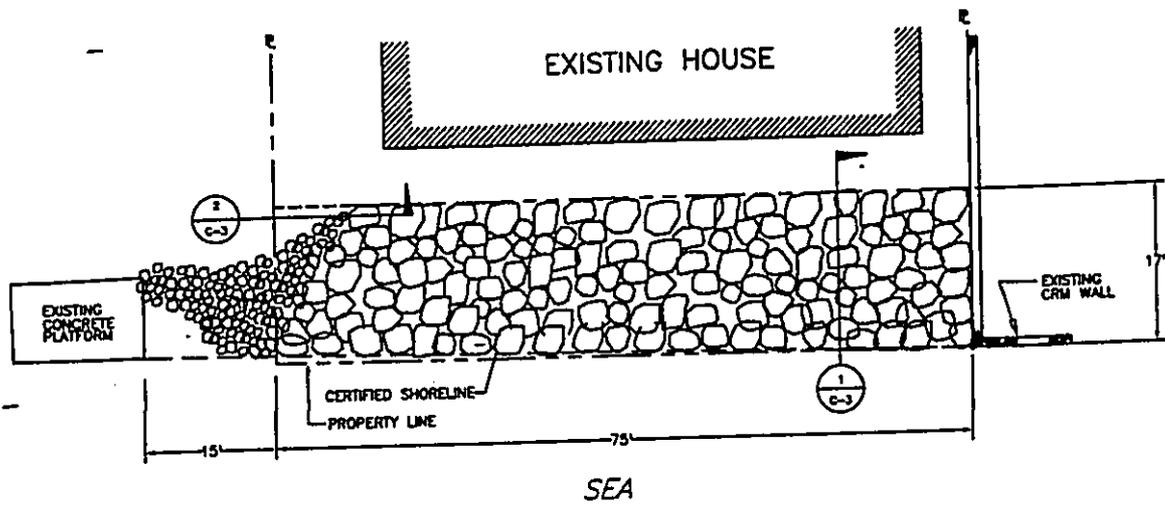
1 PROPOSED REVETMENT PLAN
 C-2 SCALE: 1" = 10'

CERTIFIED SHORELINE
 REVETMENT TOE SHALL NOT EXTEND
 SEAWARD OF CERTIFIED SHORELINE

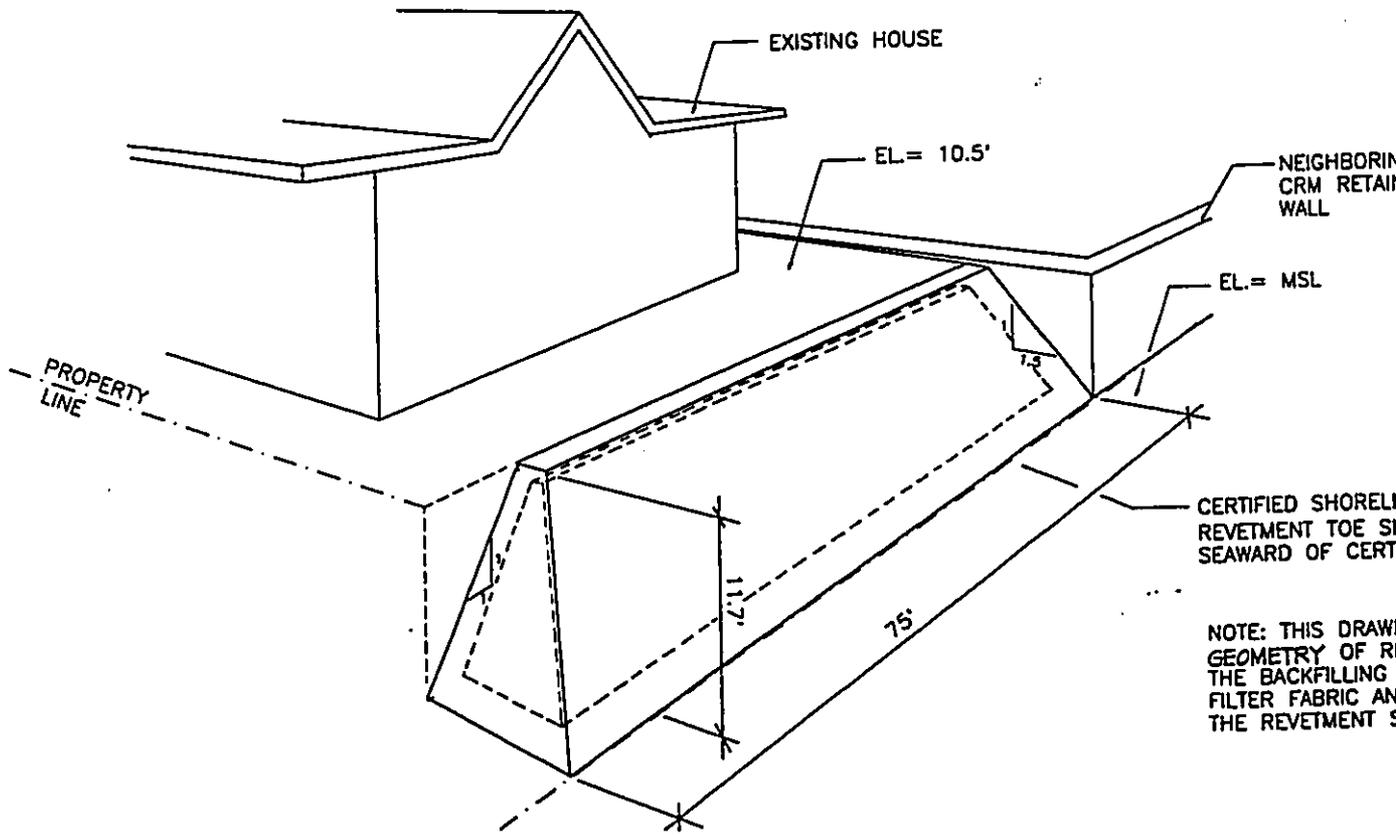
3 REVETMENT WALL PERSPECTIVE
 C-2 SCALE: 1" = 10'

NOTE: THIS DRAWING SHOWS THE GEOMETRY OF THE REVETMENT WALL. THE BACKFILLING, FILTER FABRIC AND THE REVETMENT S...

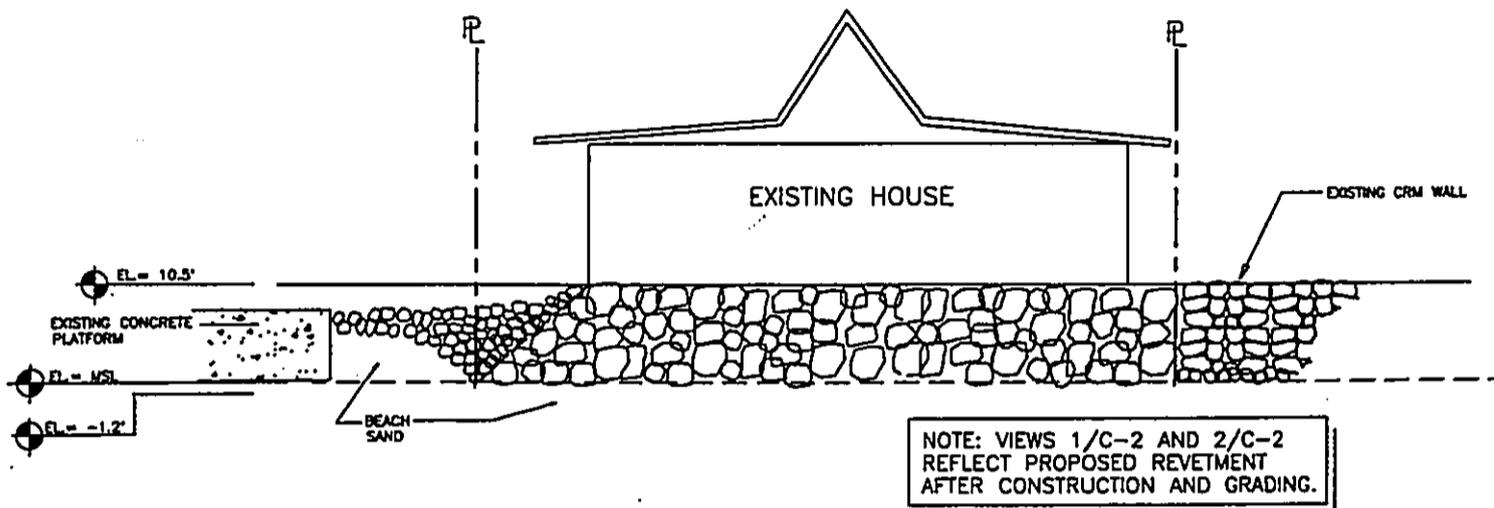
2
C-2
PROPOSED REVETMENT FRONT VIEW
 SCALE: 1" = 10'

NOTE: THIS DRAWING SHOWS THE
 GEOMETRY OF REVETMENT.
 THE BACKFILLING OF SAND AND PLACEMENT OF GEOTEXTILE
 FILTER FABRIC AND STONE LAYERS SHOULD FORM
 THE REVETMENT SHOWN IN OTHER DRAWINGS

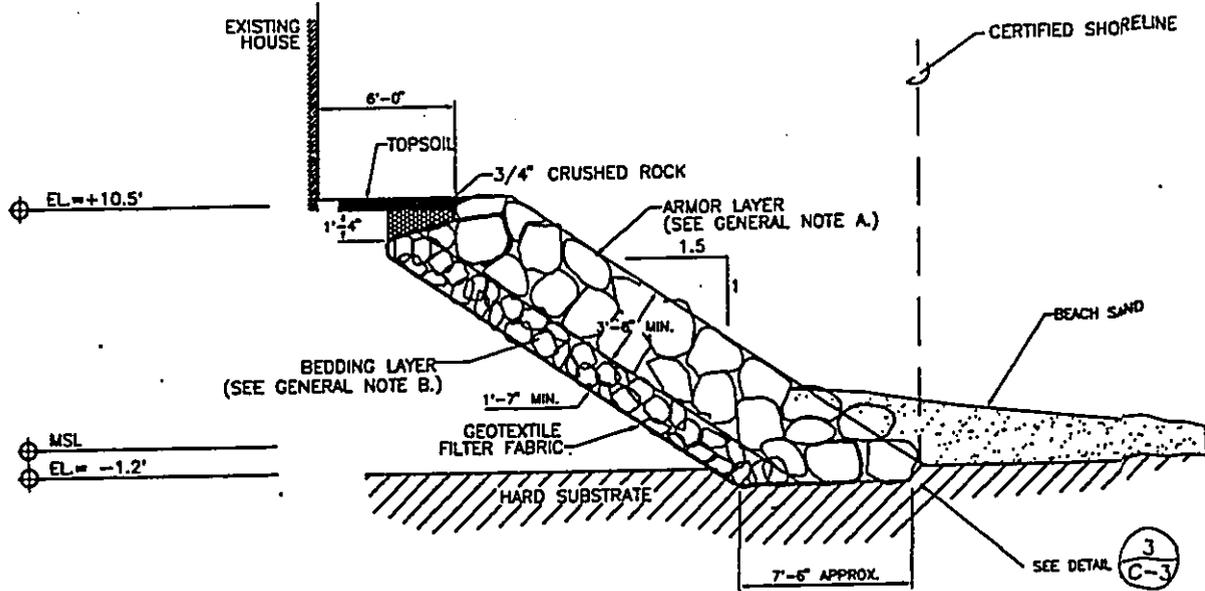
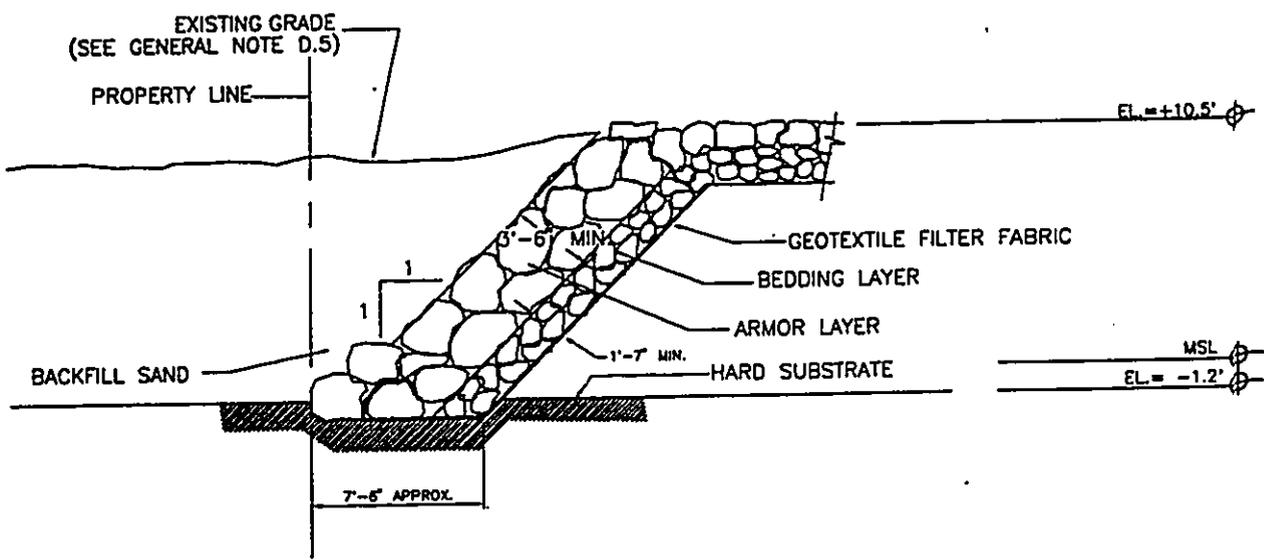
1 CROSS SECTION
 C-3 SCALE: 1" = 4'

The proposed shore protection structure is a rubble revetment with a slope of 1:1.5. Design drawings are included in Appendix B. The revetment has been designed according to Corps of Engineers guidelines. The top of the revetment is at elevation +10.5 feet MSL. The toe of the revetment follows the certified shoreline. The toe stones will be placed on hard substrate and keyed into the bottom for stability. Armor stones will range from 700 to 1200 pounds with 50 percent greater than 900 pounds. Nominal size of this stone ranges from 1.9 to 2.2 feet diameter. Two layers of armor stones will be placed on a bedding layer of 1/10 size stone.

Filter fabric will be placed between the bedding layer and existing soil to prevent piping. The revetment is flanked on the north by a neighboring CRM wall. The south end of the revetment will be flanked by placing armor stones on a 1:1 slope at the end of the revetment. This slope will be backfilled with sand and smaller stone to blend with the neighboring property. This flanking slope will only be exposed if severe erosion occurs. Under normal conditions, it will be buried.

BEDDING STONE
 GEOTEXTILE
 FILTER FABRIC

With a design wave of 3.5 feet, runup on the revetment will be approximately 6-8 feet. Therefore, some overtopping may occur during high wave conditions. The revetment has been designed with a gravel filter to allow overtopping water or rain runoff to drain back into the sea.

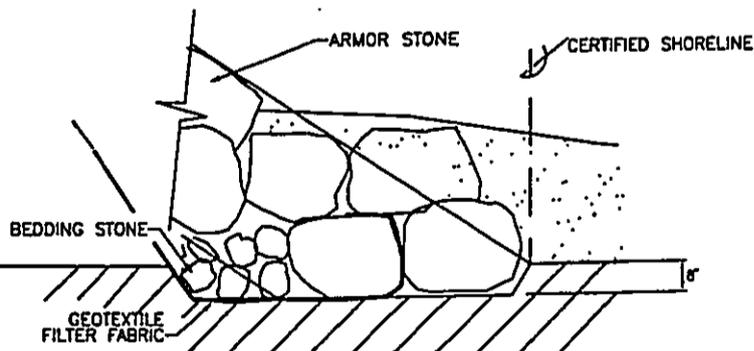
3 TOE STONE KEY DETAIL
C-3 SCALE: NOT TO SCALE

3. The largest armor stones will be used as toe stones. Toe stones must be placed on hard substrate. No stones shall be placed seaward of the certified shoreline.
