Thompson Seawall

Daniel Thompson
Feb. 1997 Final
Environmental Assessment
TMK 9-1-07:014

COASTAL ENGINEERING EVALUATION
AND ENVIRONMENTAL ASSESSMENT
FOR A SEAWALL AT
EWA BEACH, OAHU, HAWAII
(TMK: 9-1-07: 014)

SEAWALL INVESTIGATION
91-045 PARISH DRIVE
PUULOA BEACH, OAHU, HAWAII

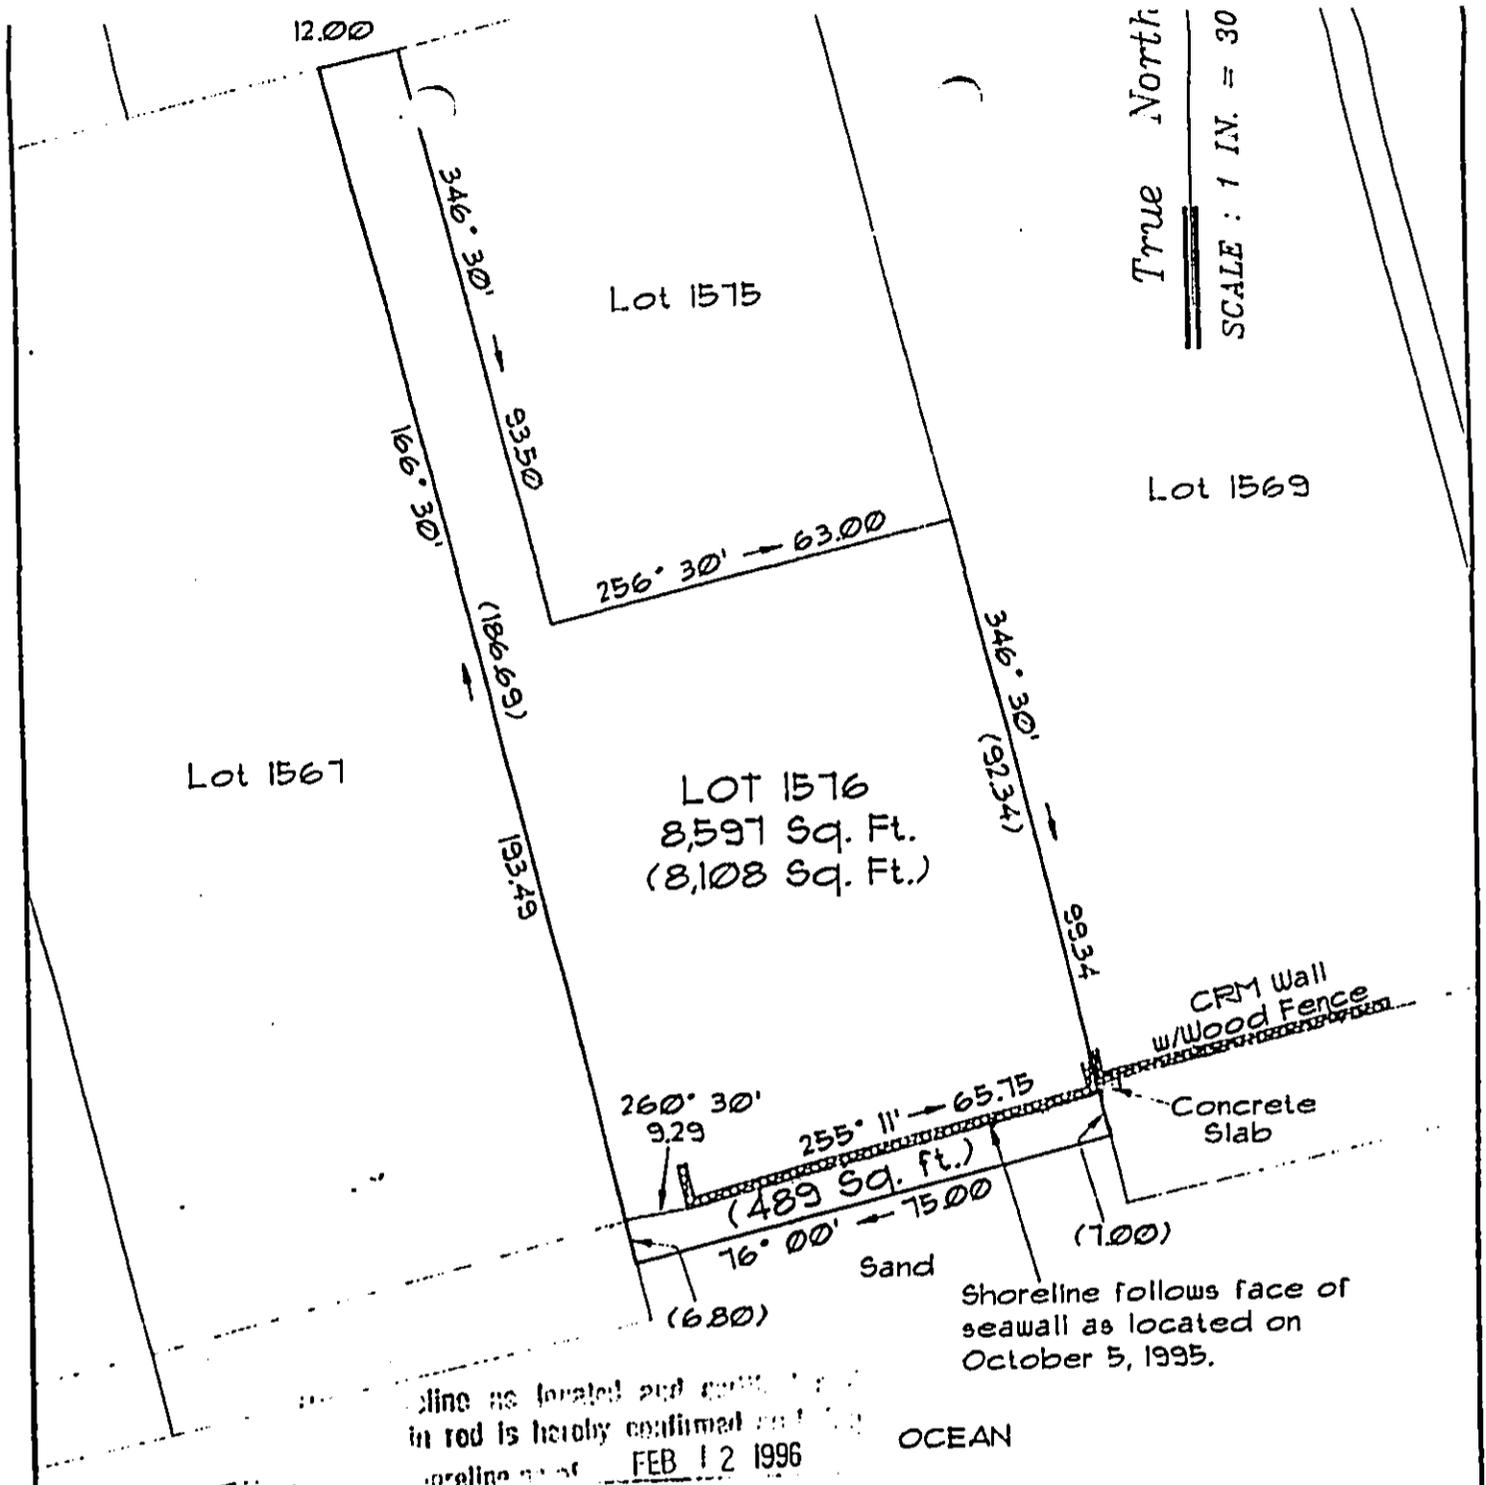
FIGURE 4

Shoreline Survey
of Lot 1576
of Land Court Application 242 (Map 216)
at Ewa, Honolulu, Oahu, Hawaii
T.M.K. : 9-1-07 : parcel 14

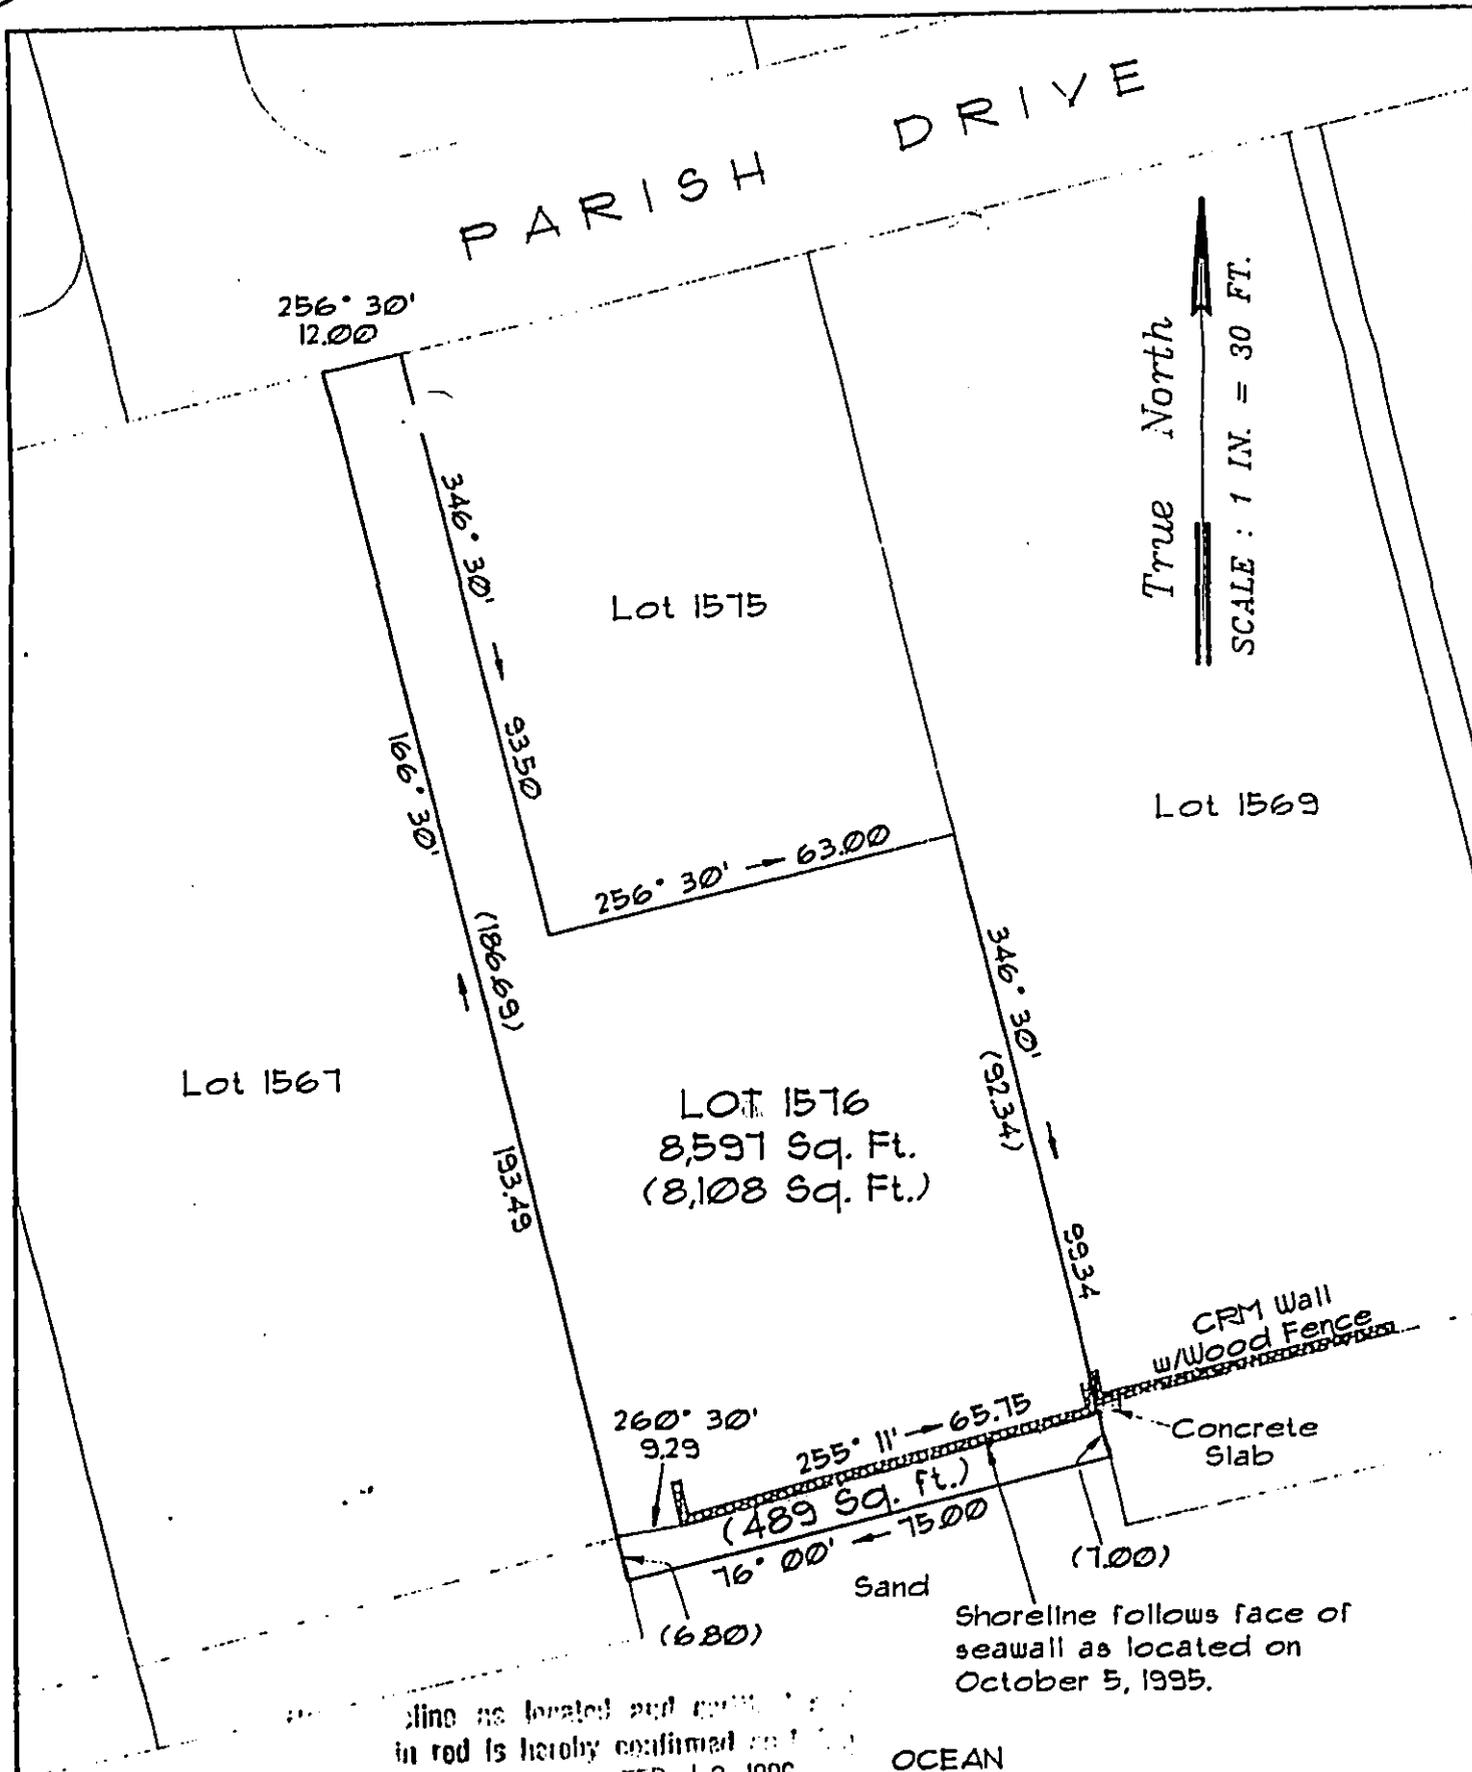
FIGURE 4

Shoreline as located and confirmed in red is hereby confirmed as of FEB 12 1996

Shoreline Survey
 of Lot 1576
 of Land Court Application 242 (Map 216)
 at Ewa, Honolulu, Oahu, Hawaii
 T.M.K. : 9-1-07 : parcel 14

The existing seawall was constructed after a severe storm occurred in December 1984, which caused significant erosion and wave overtopping damage to this shorefront. A shoreline survey on file with the State Surveyor shows the shoreline following the face of the seawall as located on August 19, 1986 (Figure 3). The current certified shoreline also follows the face of the seawall as located on October 05, 1995 (Figure 4). At the time the 10/95 survey was taken, the surveyor was aware the seawall was built without a variance/permit. The seawall is located about 6.52 feet landward of the seaward property boundary (effectively reducing the usable property area by about 489 square feet).

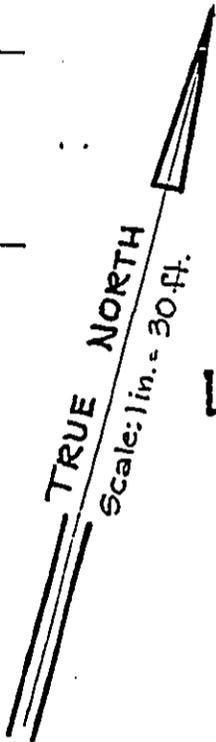
FIGURE 5

EROSION TO LOT 1568
AND SUBDIVISION OF SAID LOT 1568
LESS EROSION
INTO LOTS 1575 AND 1576
AT PUULOA, EWA, OAHU, HAWAII

(NOTE: The applicants acquired interest in this property in 1973. At this time, the applicants property was one lot, numbered 1568. The applicants desired to subdivide the property, and acquired a Shoreline Survey on October 18, 1974. In August 1975, the property was subdivided into two lots, numbered 1575 and 1576. Lot number 1576 is now the beach front property. The 1974 survey used for the subdivision showed the beach front property to have eroded 9.93 linear feet from original property line, totaling 745 square feet. See Land Court Application 242, filed on August 1, 1975 and certified by State Land Surveyor on September 17, 1975 (Figure 5). Seawall is located approx. 16.5 feet landward of the original property line. EHT)

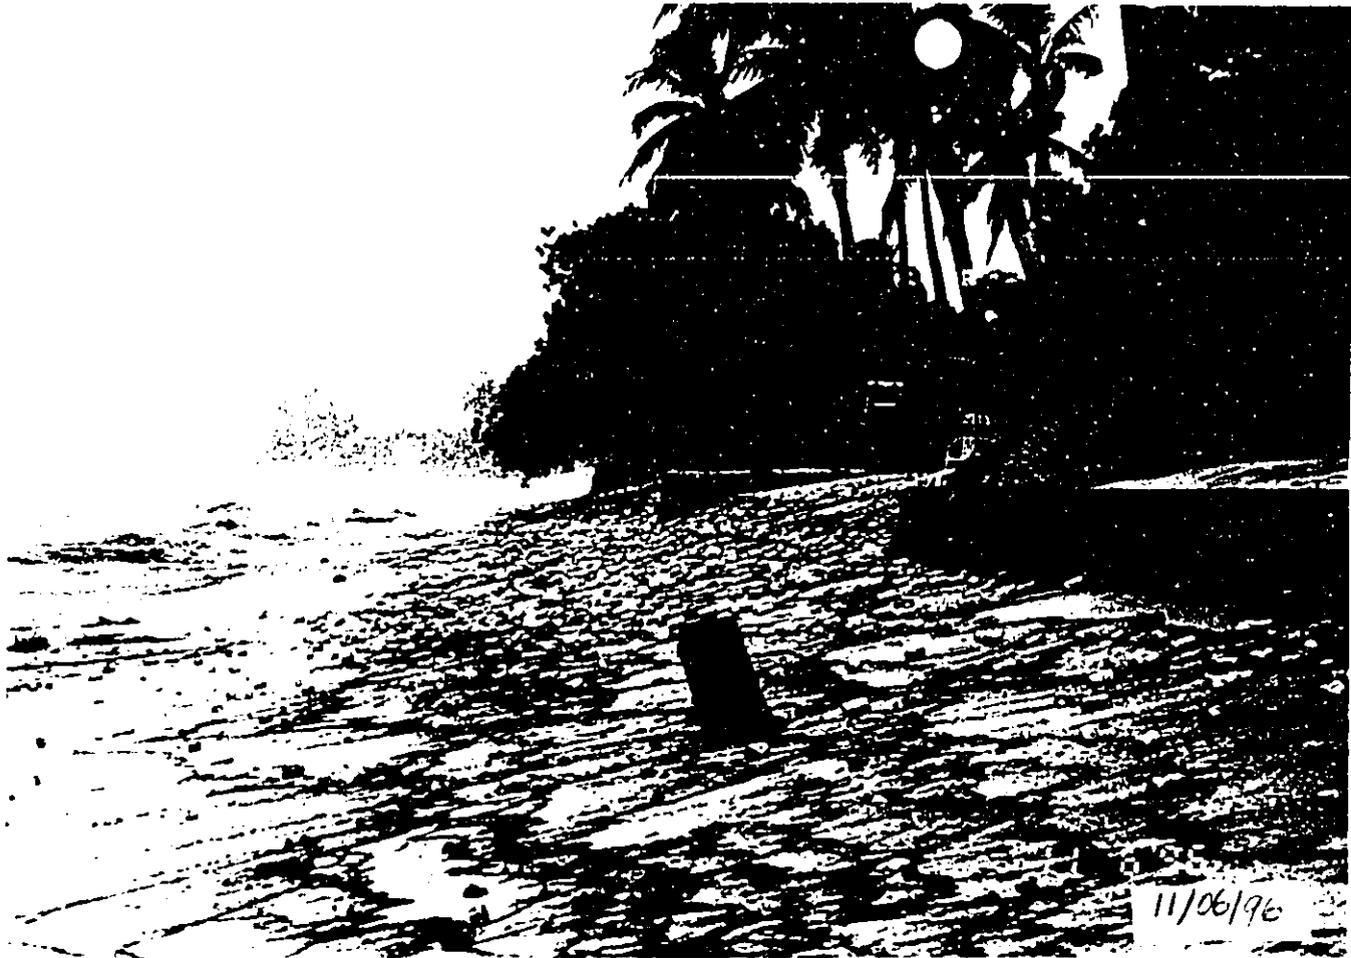
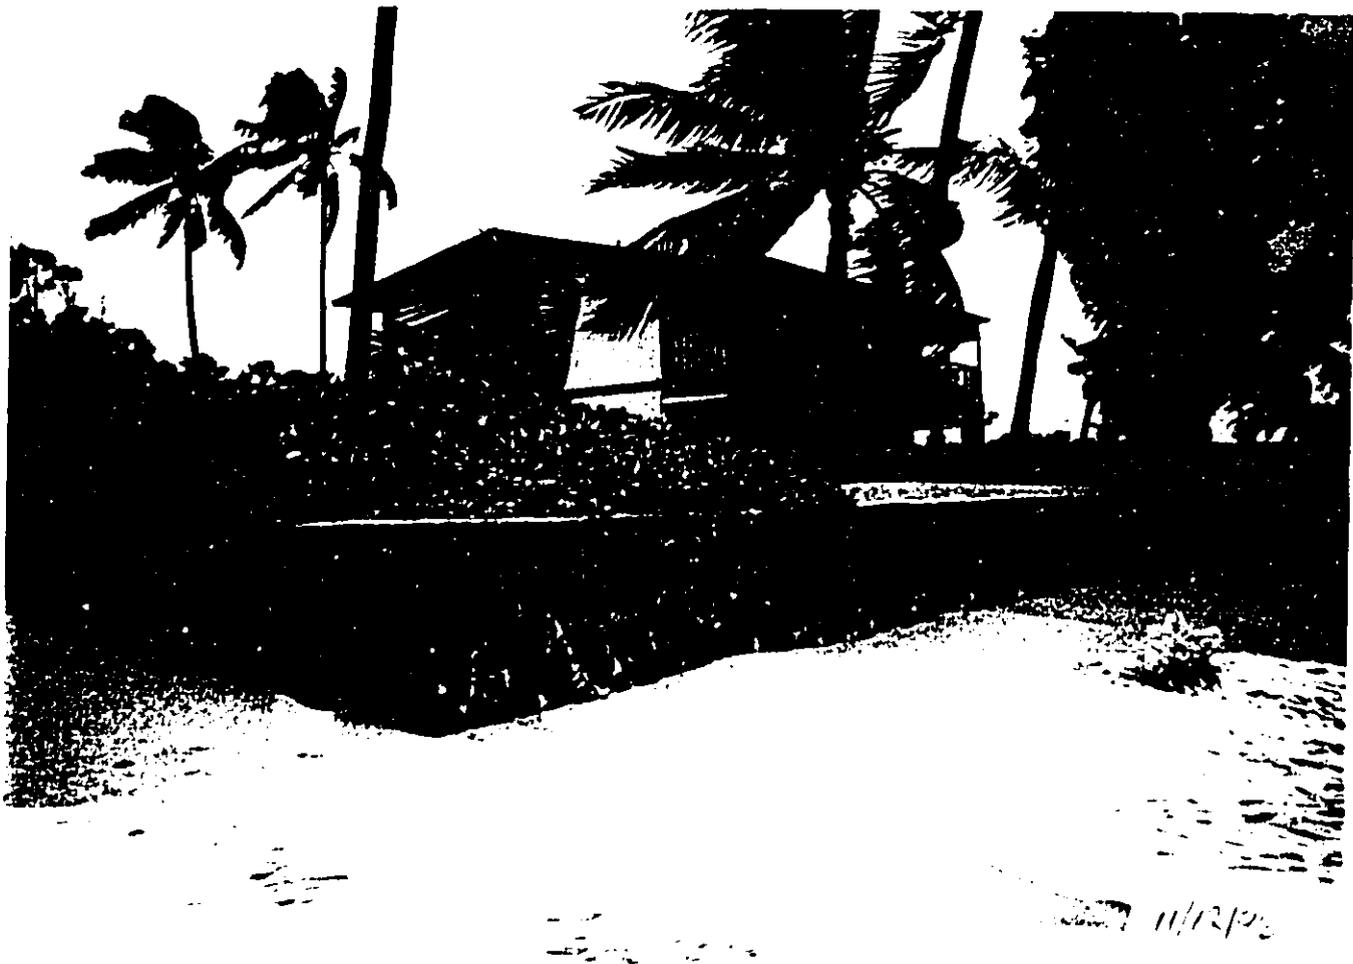
Photo 1(A) - Above photo taken on Nov. 6, 1996. Rubbish on beach is from drainage channel. Below photo taken on Nov. 12, 1996.

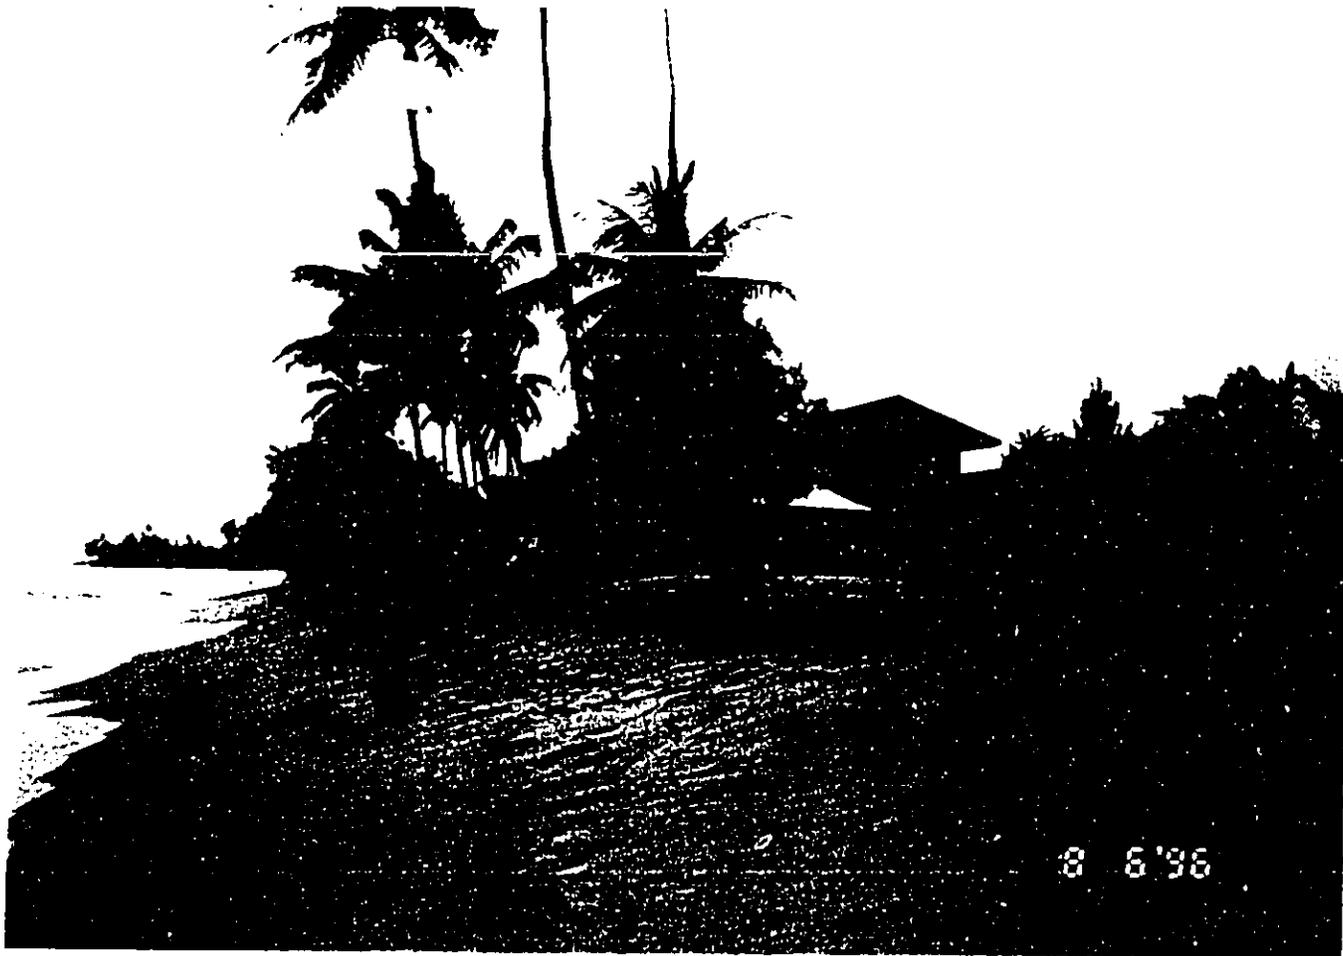
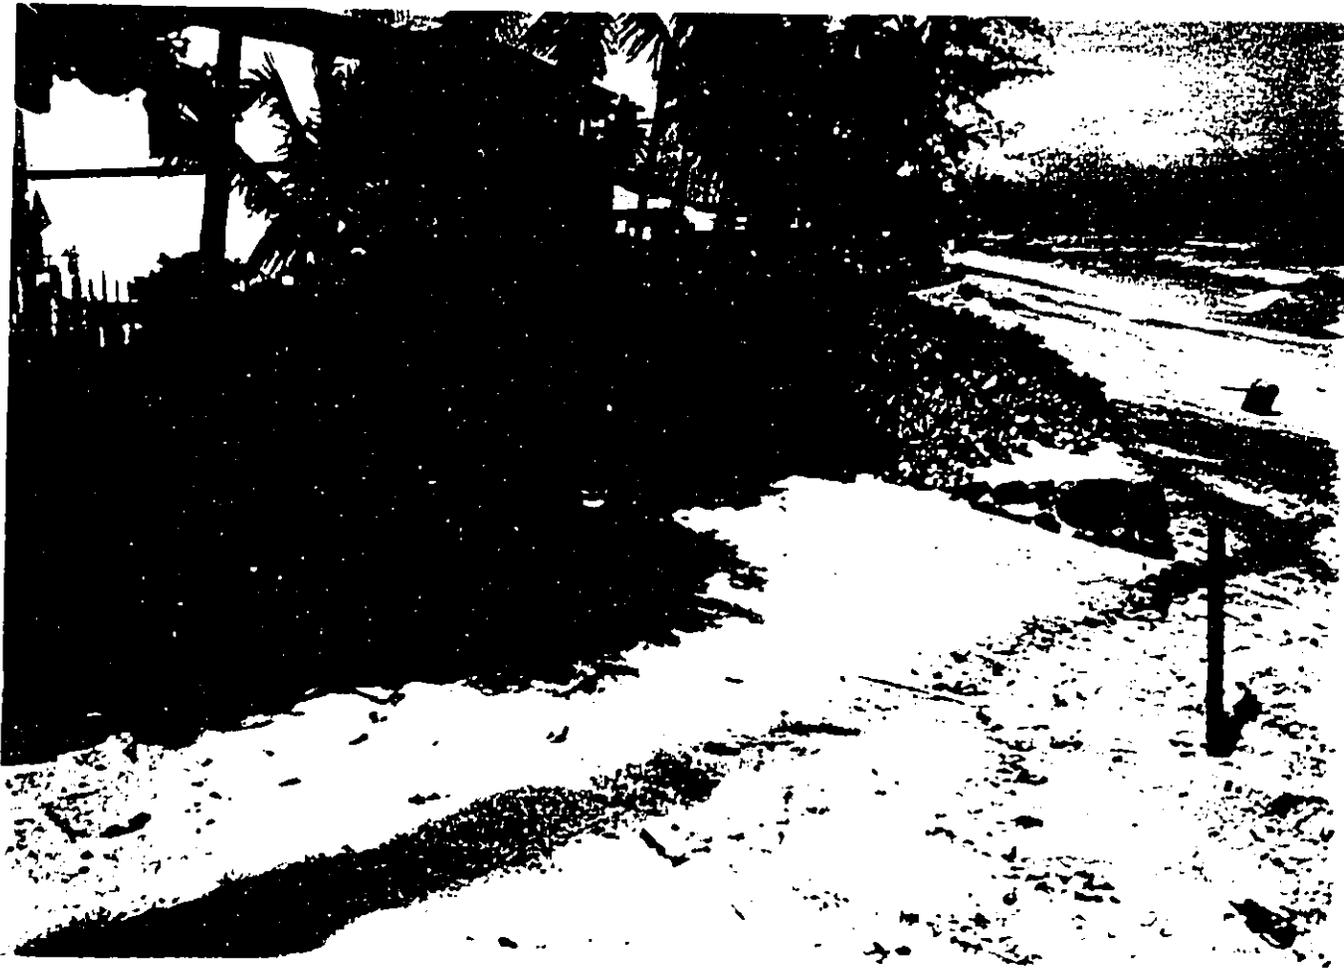
PHOTO 3 Conditions of beach and seawall in August 1996. Note sand amount mauka of seawall, inside yard.

The structural integrity of the wall is adequate to withstand storm wave runup and overtopping, since much of the wall is usually buried. The footing of the wall, keyed to the limestone platform underlying the beach, will prevent wave scour and undermining of the seawall, should it become exposed during extended duration of storm wave attack. However, the stepped face and low profile of the wall will minimize reflectivity, allowing sand to be redeposited on the beach. Because the seawall is low enough to allow substantial wave overtopping during high water level and large wave conditions, sand is usually washed over the beach crest and seawall, and deposited in the yard. (Photo 3)

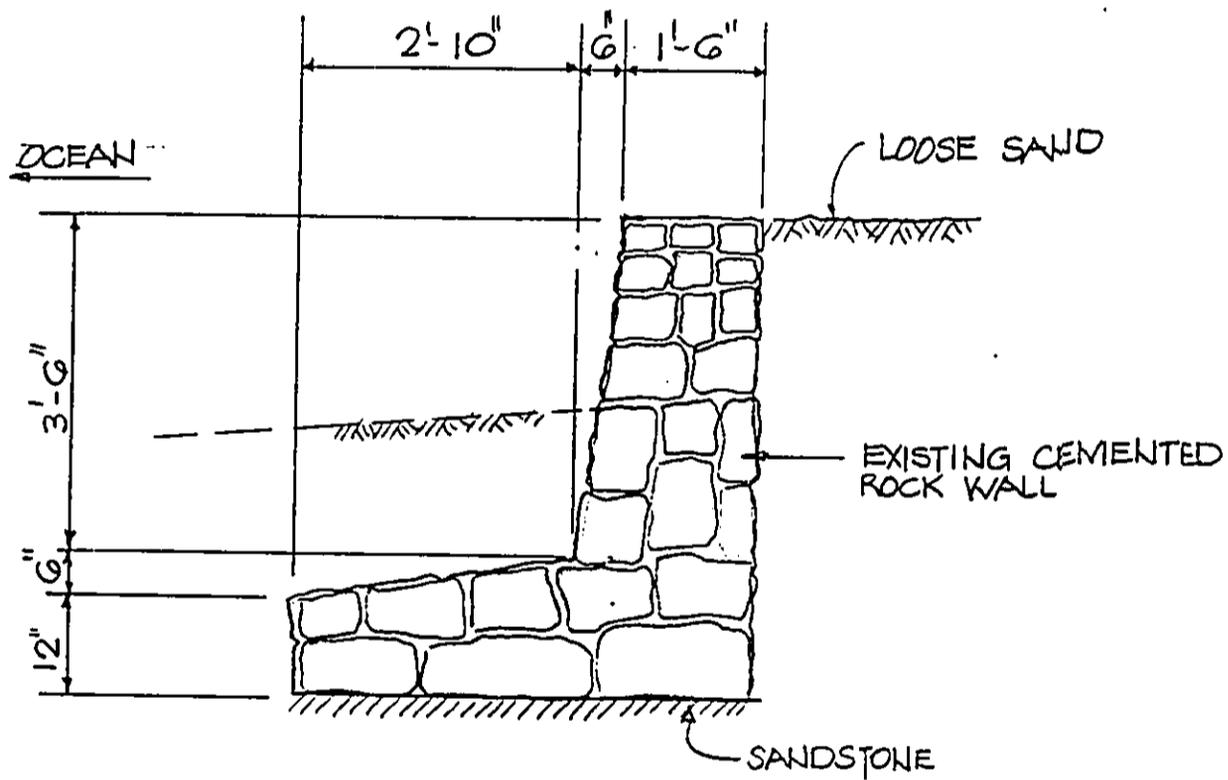
FIGURE 7 (3)

SECTION OF SEAWALL

The seawall was constructed by excavating to place the base of the wall on the coral limestone platform underlying the beach. According to the sketches provided by the owner, the seawall was built in 2 tiers forming a stepped face. This effectively created a "sloping" seaward face to the seawall. The seawall is constructed of rock set with cement mortar, with a crest width of 18 inches. The bottom width of the seawall is estimated to be about 4 feet 10 inches.

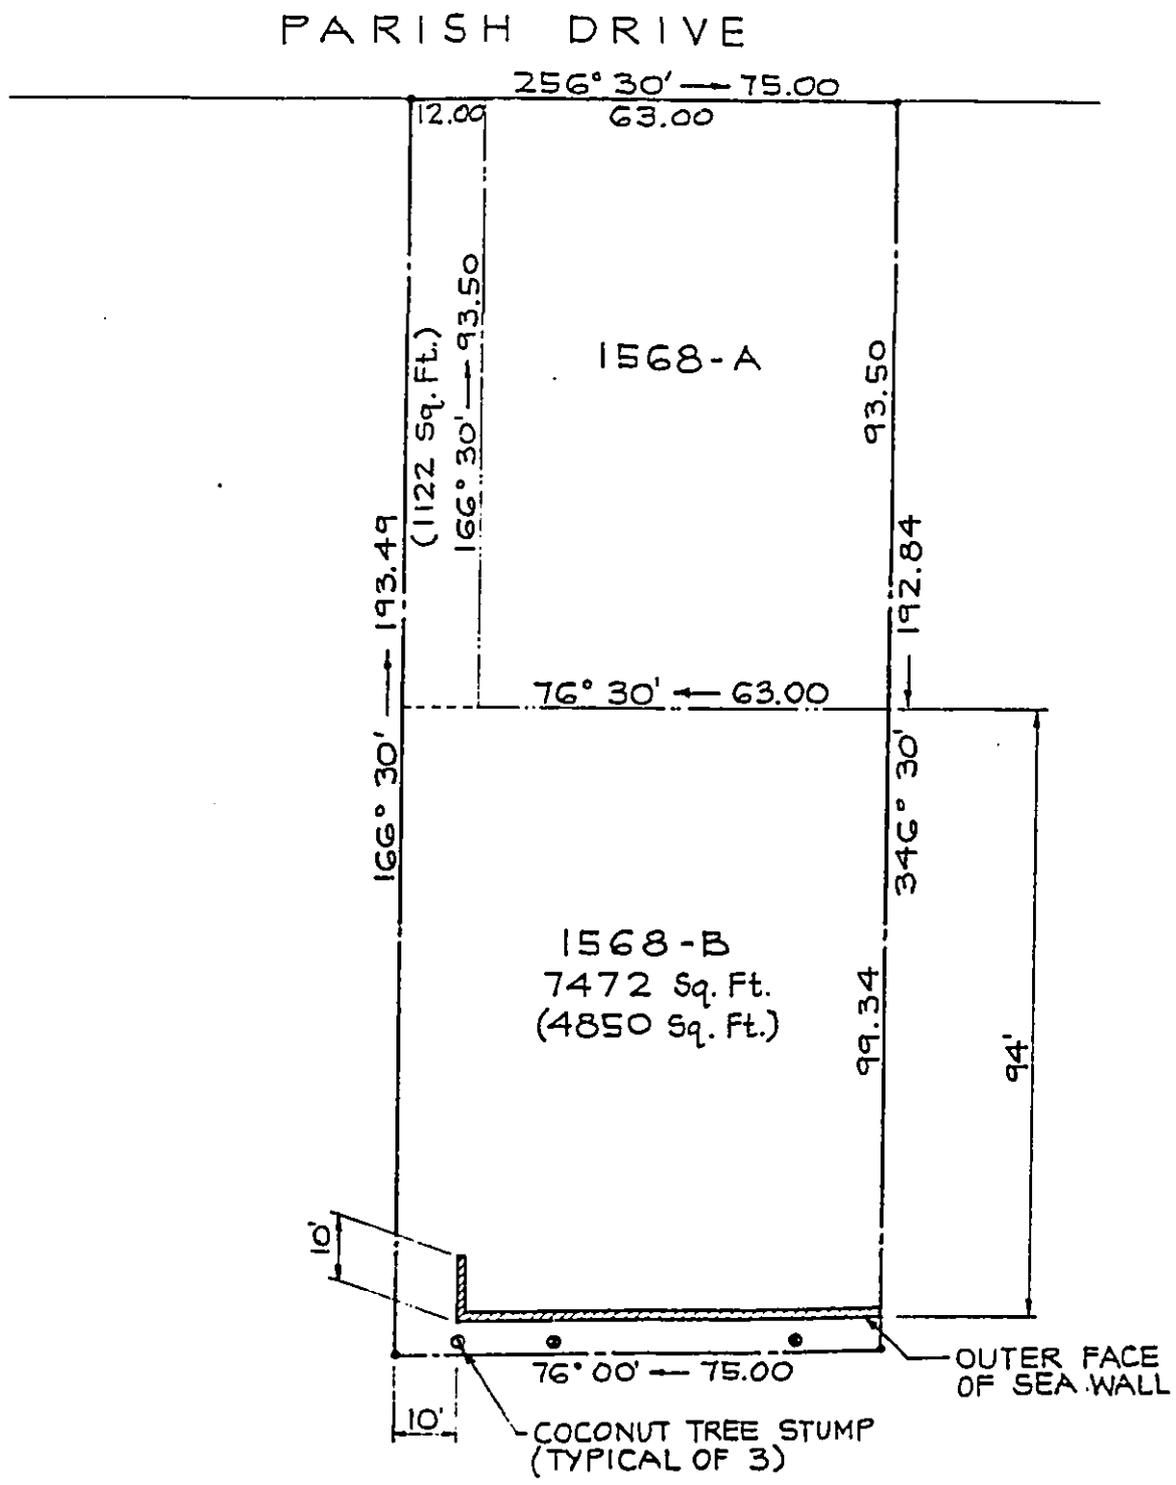
FIGURE 7 (4)

SITE PLAN

The seawall is located along the coastline at Puuloa Beach, Ewa, Hawaii. The seawall is constructed with cemented rocks and was built in 1984. It extends 65.0 feet along the coastline and abuts the neighbor's seawall on one side and terminates with a 90 degree return 10.0 feet from the property line on the opposite end. The portion that remained unprotected is to provide access for the launching of owner's boat. Field measurements of the seawall were made to areas that were exposed and probings were performed to estimate the dimensions of the submerged portion. See sketch below of the approximate cross section of the existing seawall. See the following page for the Plot Plan and the limits of the seawall.

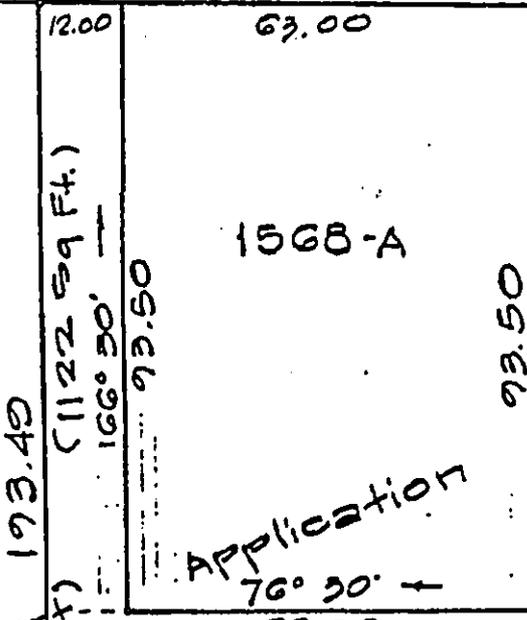
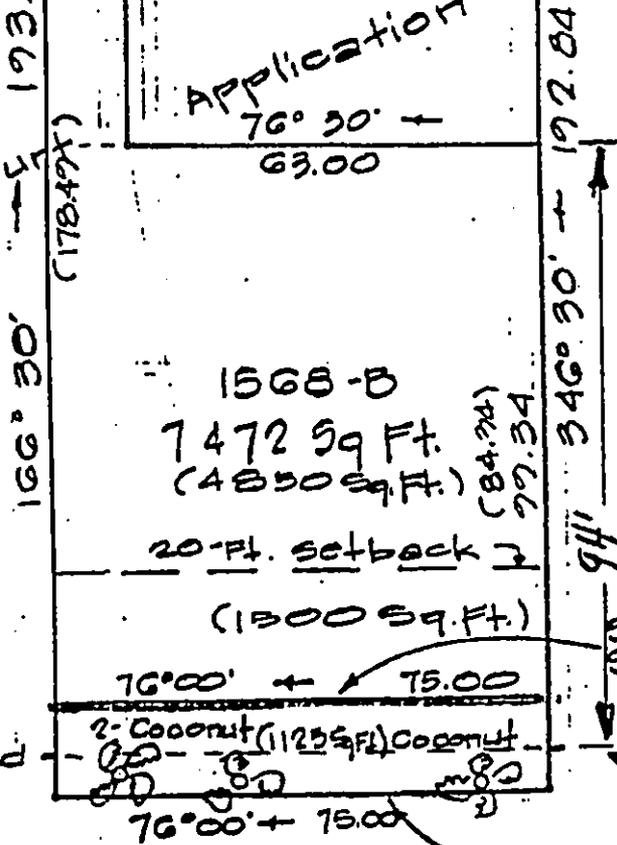
FIGURE 7 (5)

The shoreline as located and certified and delineated in red is hereby confirmed as being the actual shoreline as of OCT 1 1984

Boundary follows along Shoreline Oct. 18, 1974
SHORELINE CERTIFICATION PLAN SHOWING
 lots 1568-A and 1568-B
 Land Court Application 242
 and location of Coconut trees along beach

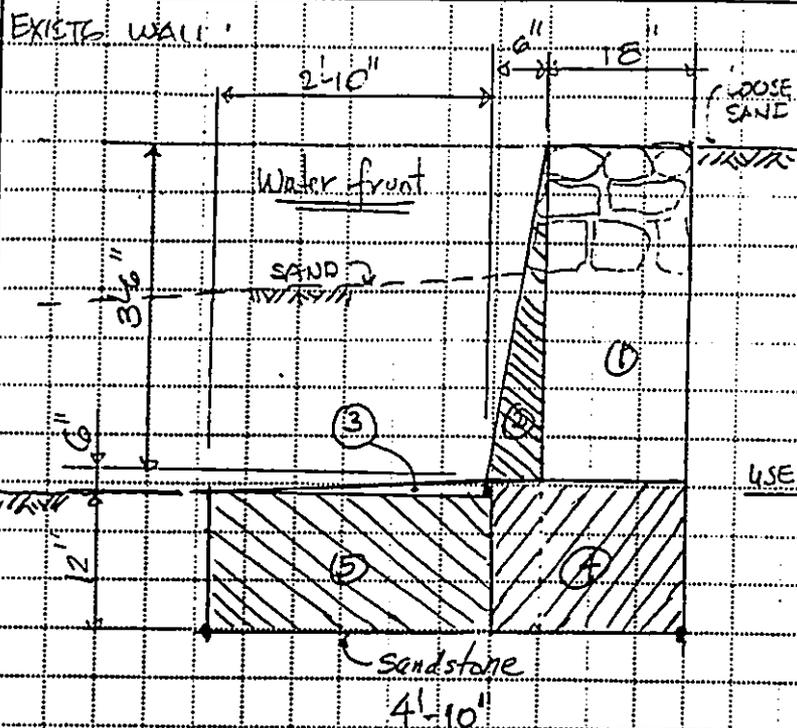
Assume Moss Rock: P_{DC}

- ① $3.5 \times 1.5 \times 1 = .925 K$
- ② $.5(3.5)(3) = .088 K$
- ③ $.5(2.83)(.5) = .071 K$
- ④ $2 \times 1.5(.1) = .300 K$
- ⑤ $1 \times 2.83(.1) = .283 K$

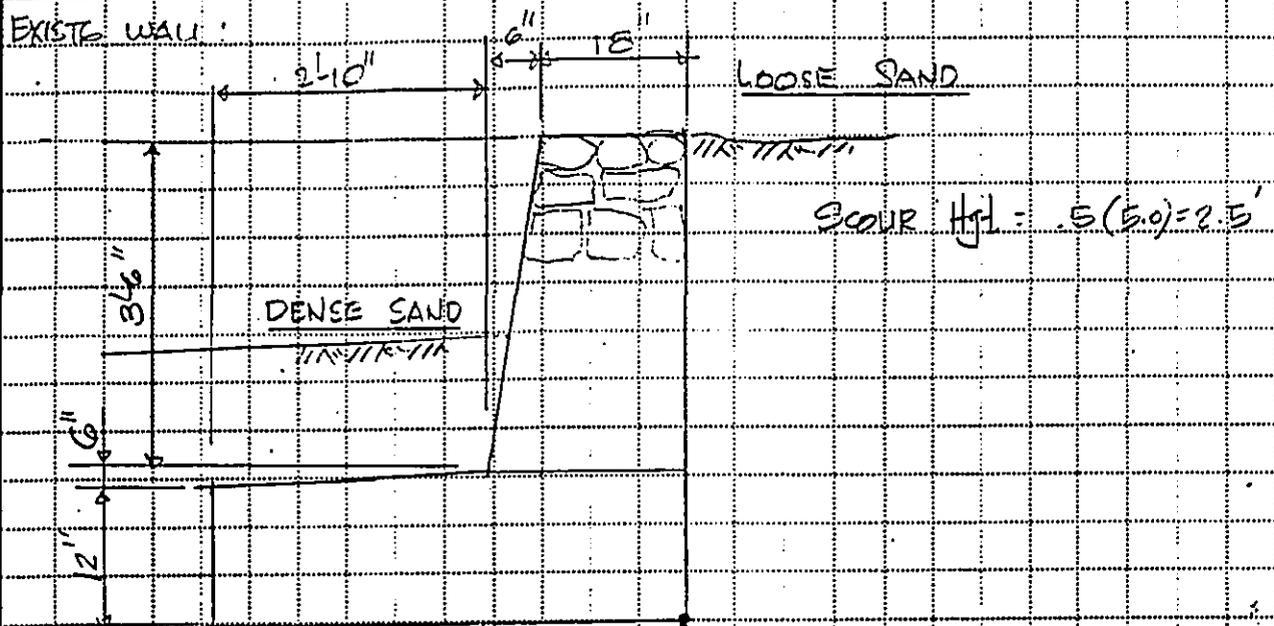
$$\text{HYDROSTATIC FORCE} = \frac{1}{2} \rho g \left[h + \frac{U_D^2}{2g} \right]^2 = \frac{1}{2} (2.0) (32.2) \left[3.5 + \frac{(2.5)^2}{2(32.2)} \right]^2 = 438$$

$$x = \frac{1}{3} \left(h + \frac{U_D^2}{2g} \right) = \frac{1}{3} \left(3.5 + \frac{(2.5)^2}{2(32.2)} \right) = 1.23'$$

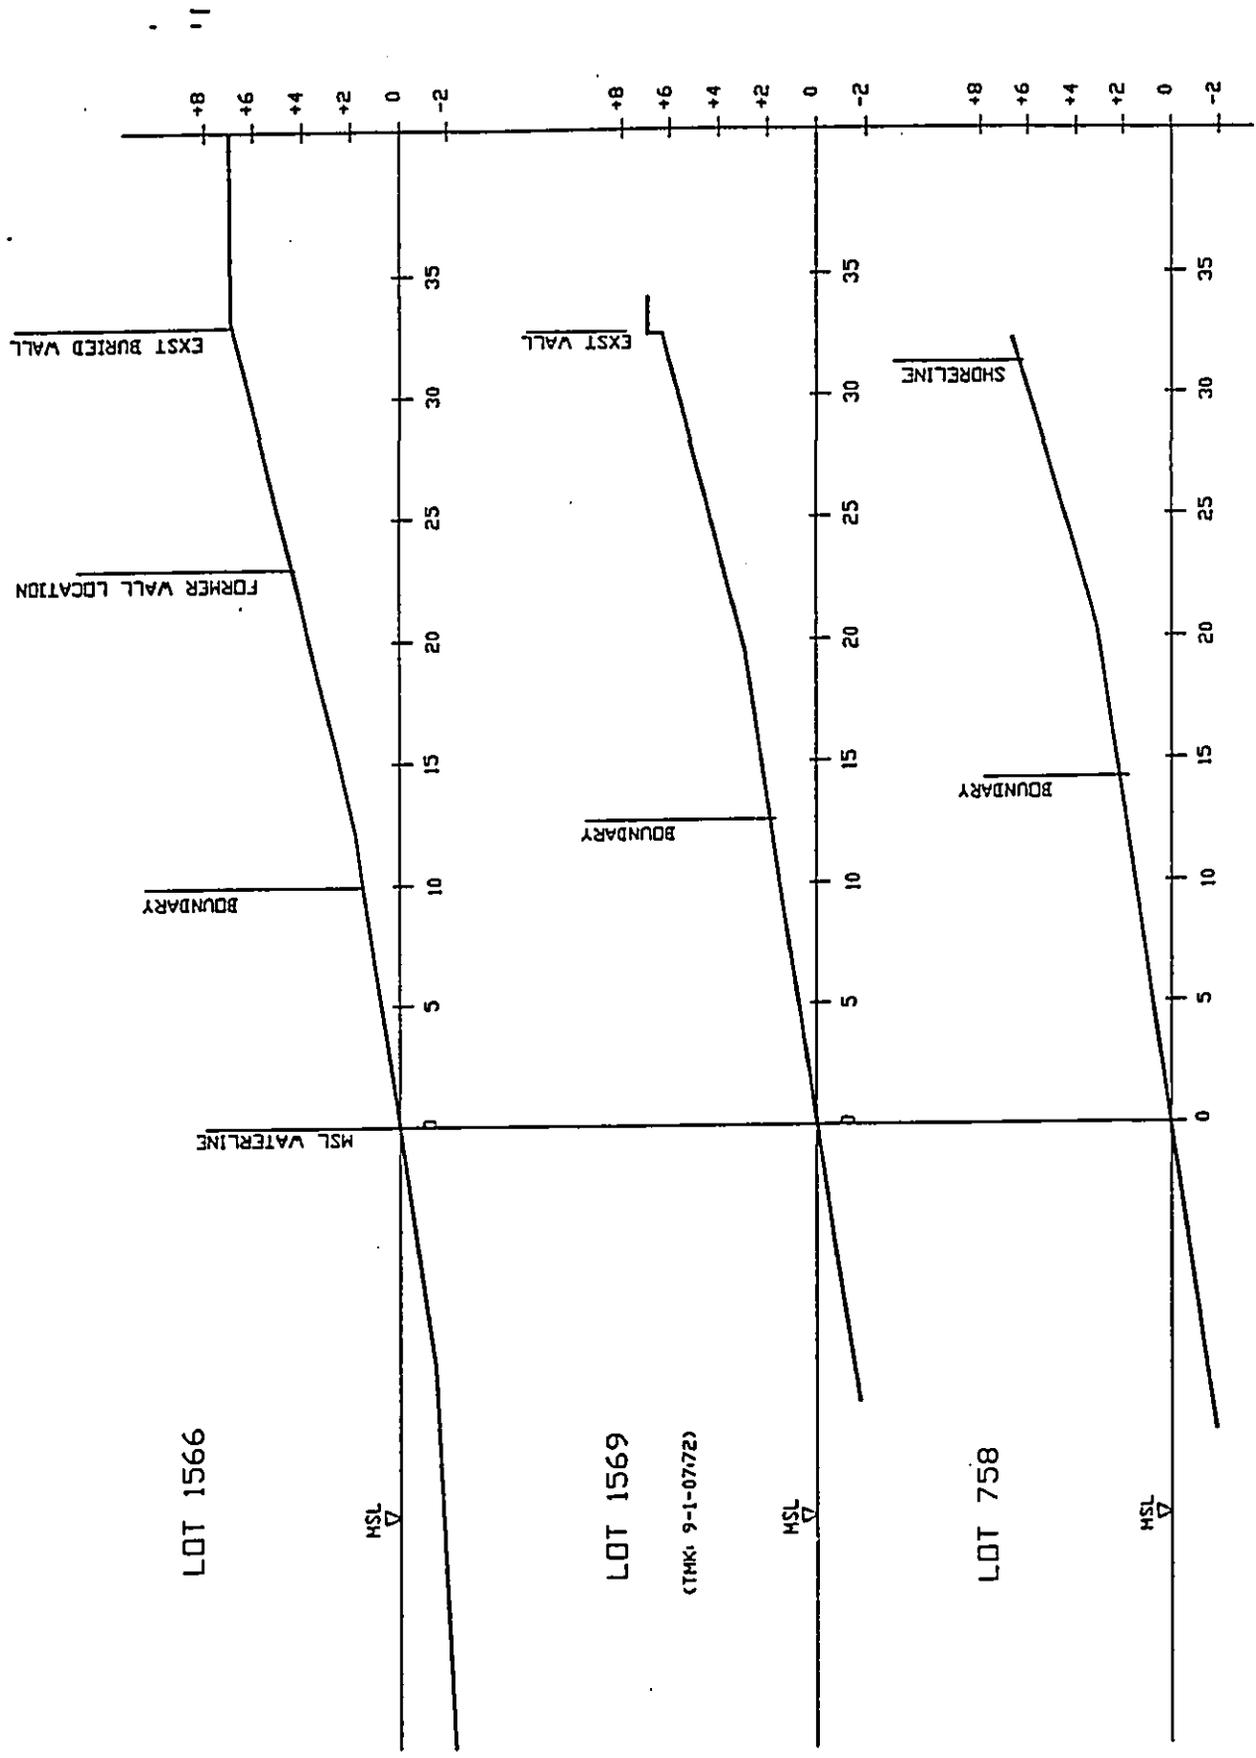
FIGURE 8

BEACH PROFILES COMPARISON

With the demolition and removal of the seaward 40 feet of the drainage channel, the outlet was situated landward of the approximate toe of the beach at about the highwater line. Immediately after demolition of the seaward end of the channel, sand was trucked to the site and placed on the Barbers Point side directly adjacent to the channel to restore the eroded condition of the downdrift shoreline. Over the ensuing years, erosion of the shoreline has continued, but in recent years appears to be less apparent. For example, the existing seawall built 11 years ago on the subject parcel is still mostly buried, for the most part, indicating that the beach width and profile has not changed significantly over the long term.
