Masunaga Seawall

**APPLICATION FOR SHORELINE SETBACK VARIANCE  
AND  
FINAL ENVIRONMENTAL ASSESSMENT**

**Reconstruction of Seawall**

Masunaga Property, TMK (1) 6-8-10:26 (Lot 11 )  
68-705 Farrington Highway, Mokuleia, Oahu, Hawaii

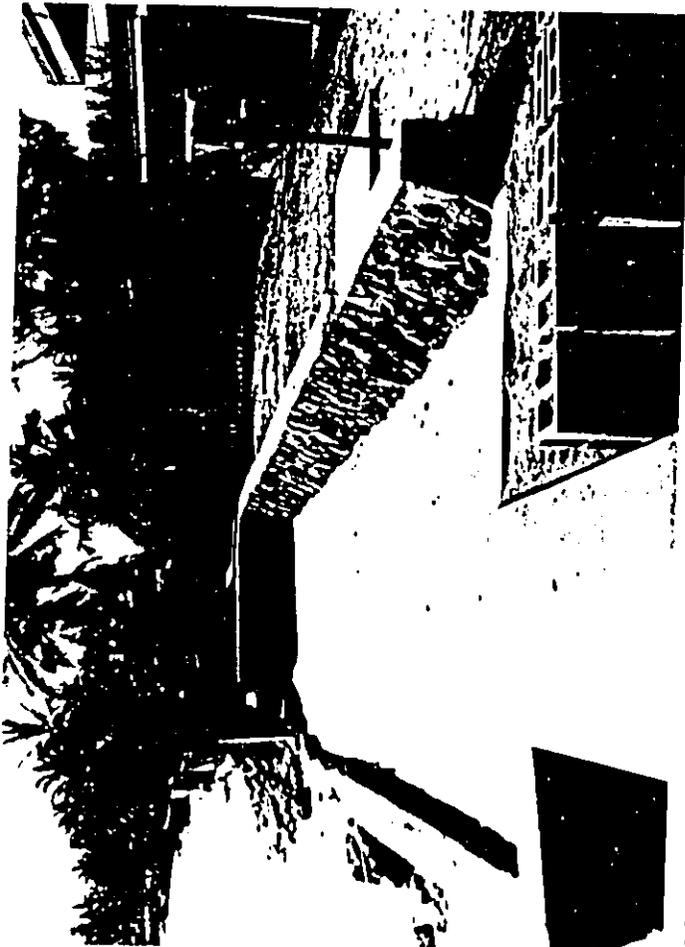
Figure 5

Masunaga: View toward Haleiwa

Masunaga: View toward Kaena

Figures 4, 5 and 6 are photographs of the subject property and existing shoreline structure. The seawall spans the entire shoreline frontage of the Masunaga property.

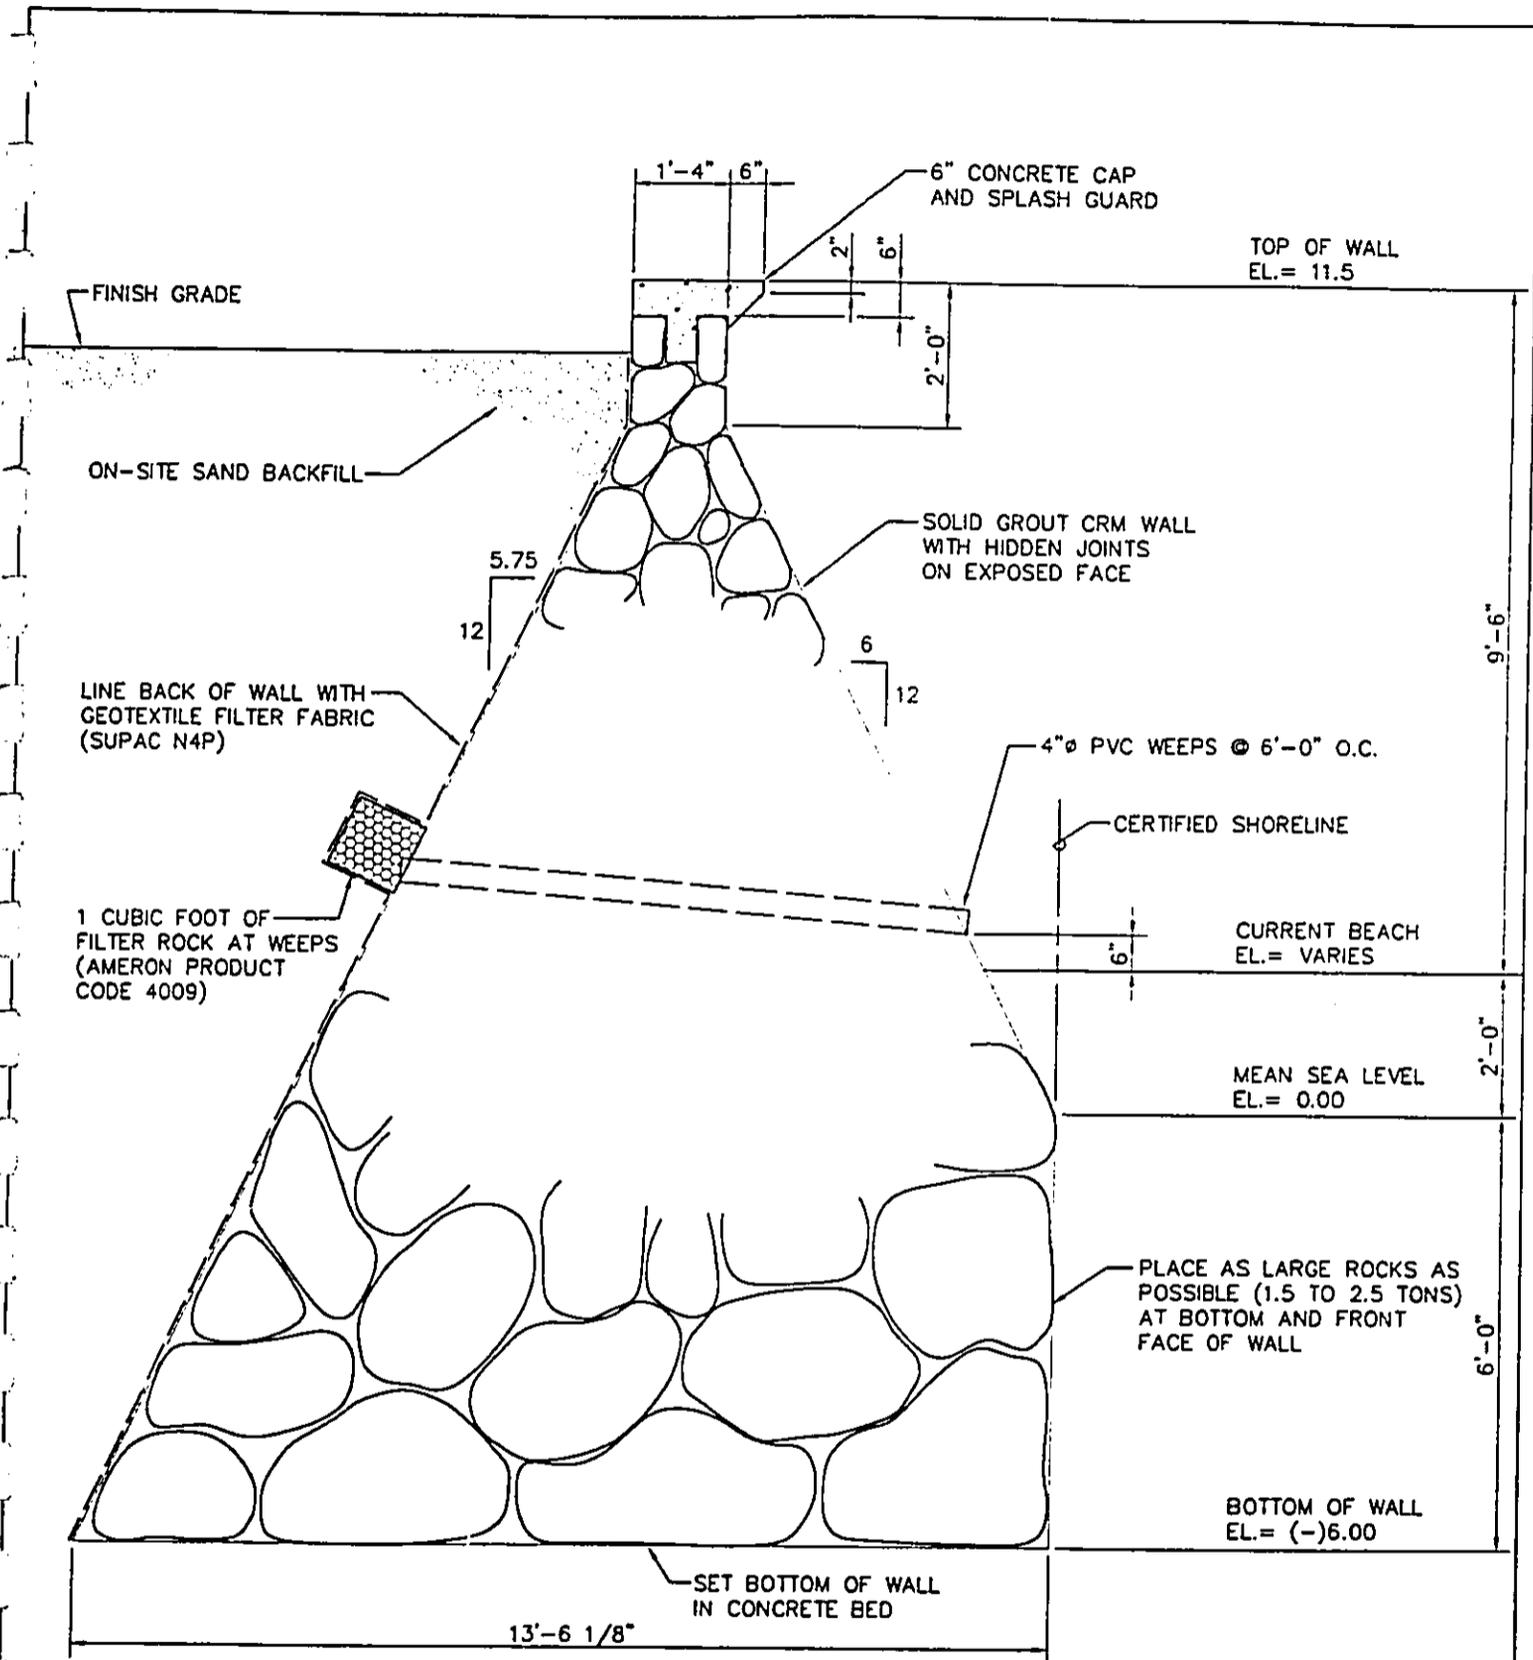
Typical CRM  
Modified Seawall Section  
Source: TNWRE, 1997

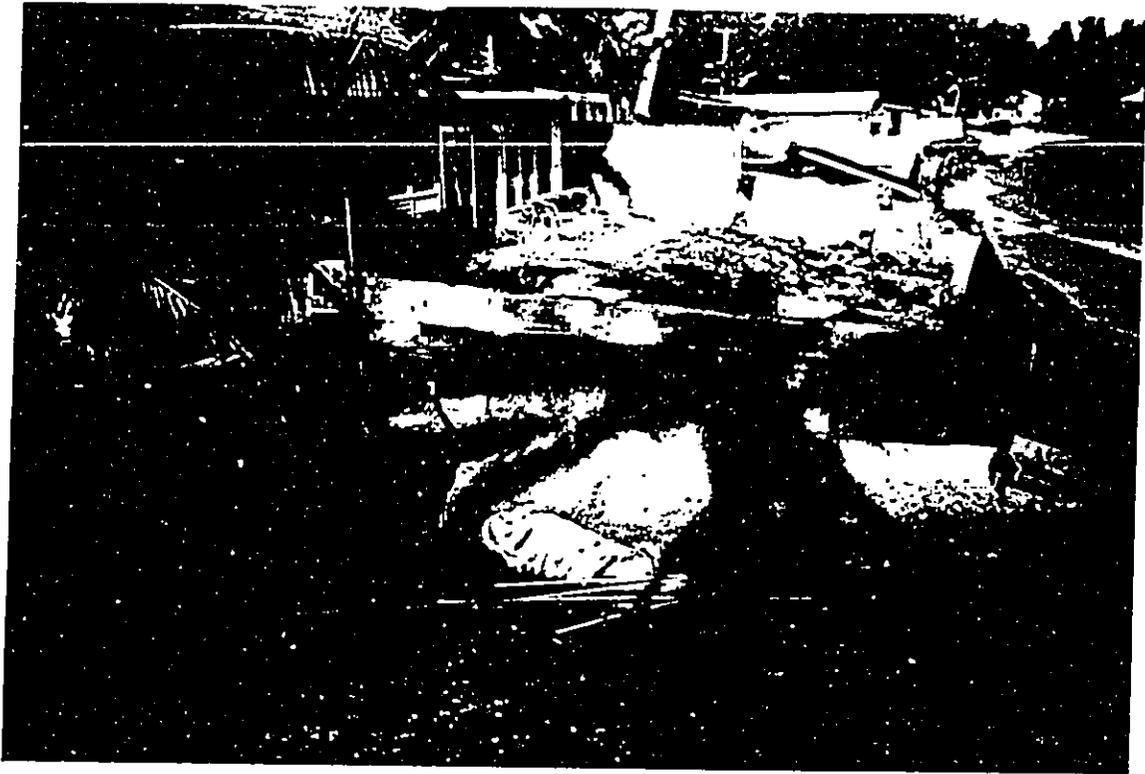
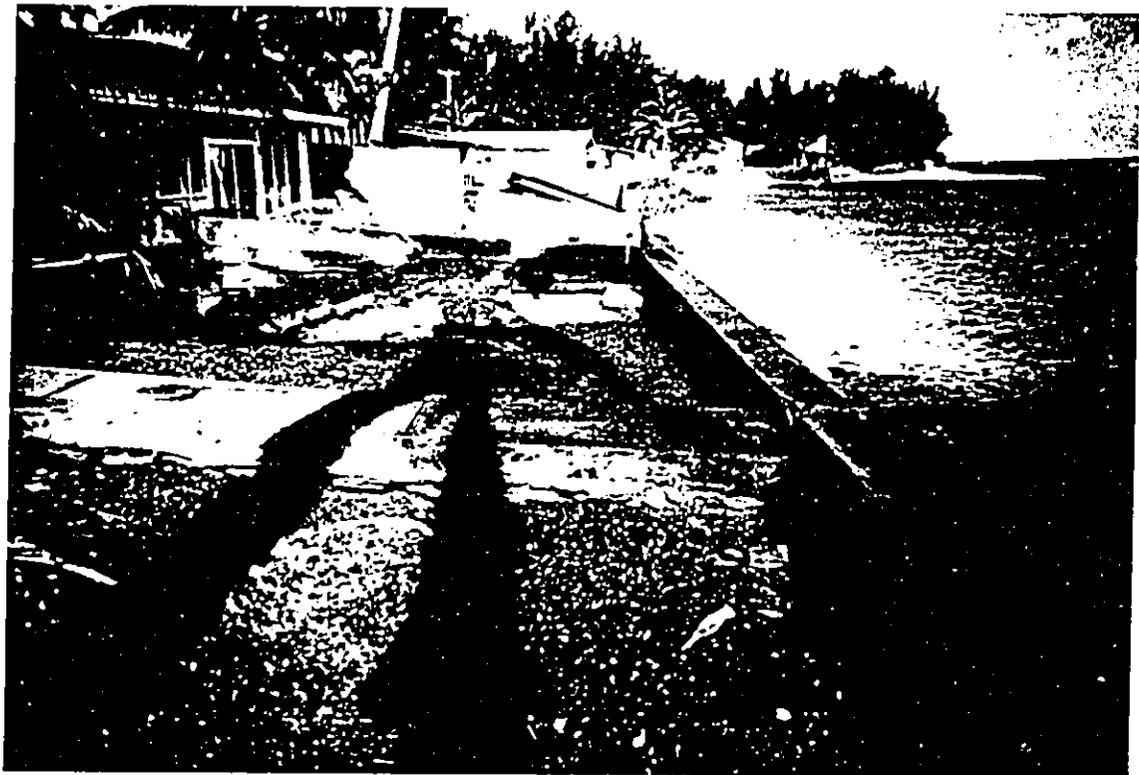
Photo Nos. 3 & 4. These photos illustrate the stop gap measures to stabilize the wall at TMK 6-8-10:23 and counteract the undermining occurring mostly at the west end.

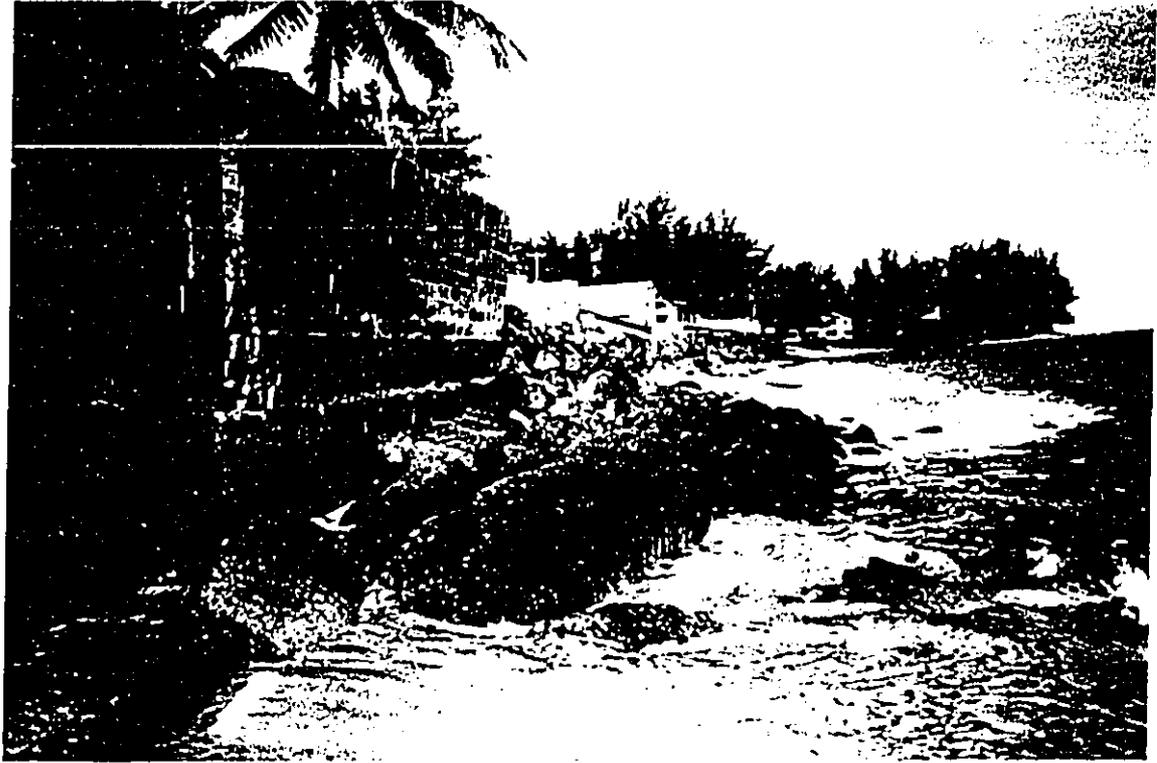
Photo Nos. 7 & 8. The top photo shows the undermining of the footing at TMK 6-8-10:24 and the outward tilt of the remaining portion of the seawall. The bottom photo shows some of the scour that has occurred behind the wall.

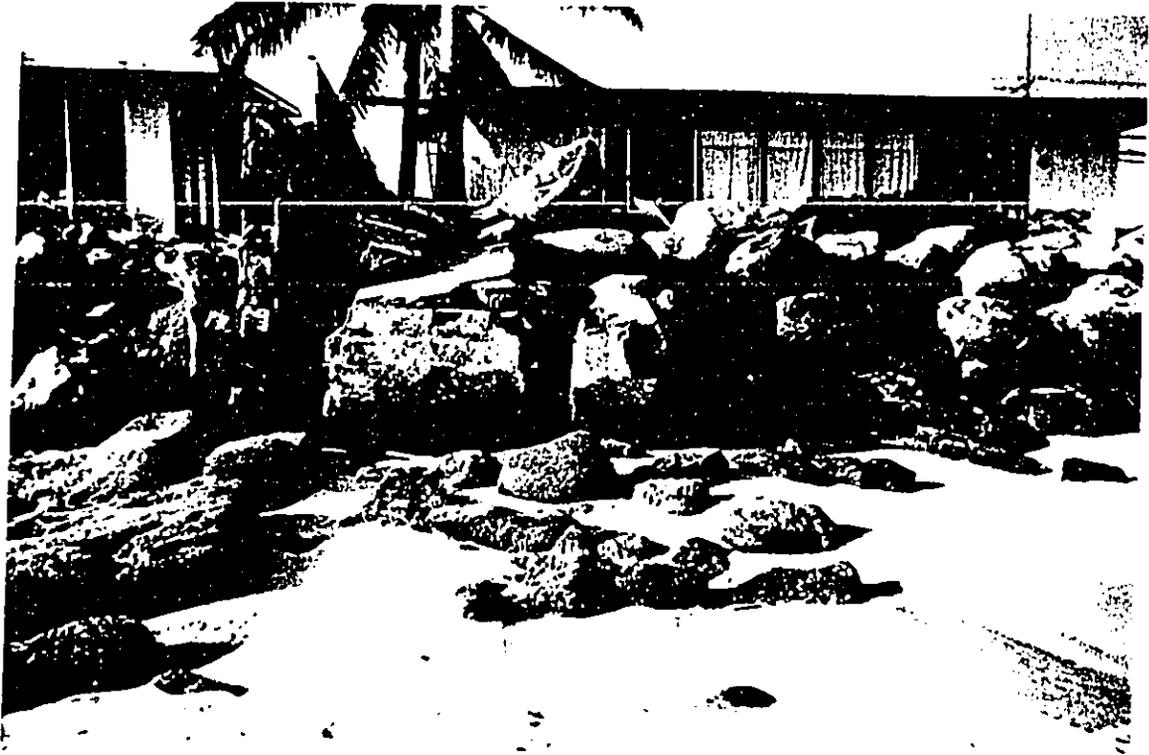
Photo Nos. 11 & 12. These details of the remnants of the seawall at TMK 6-8-10:25 show the top of the foundation to be well above sea level.

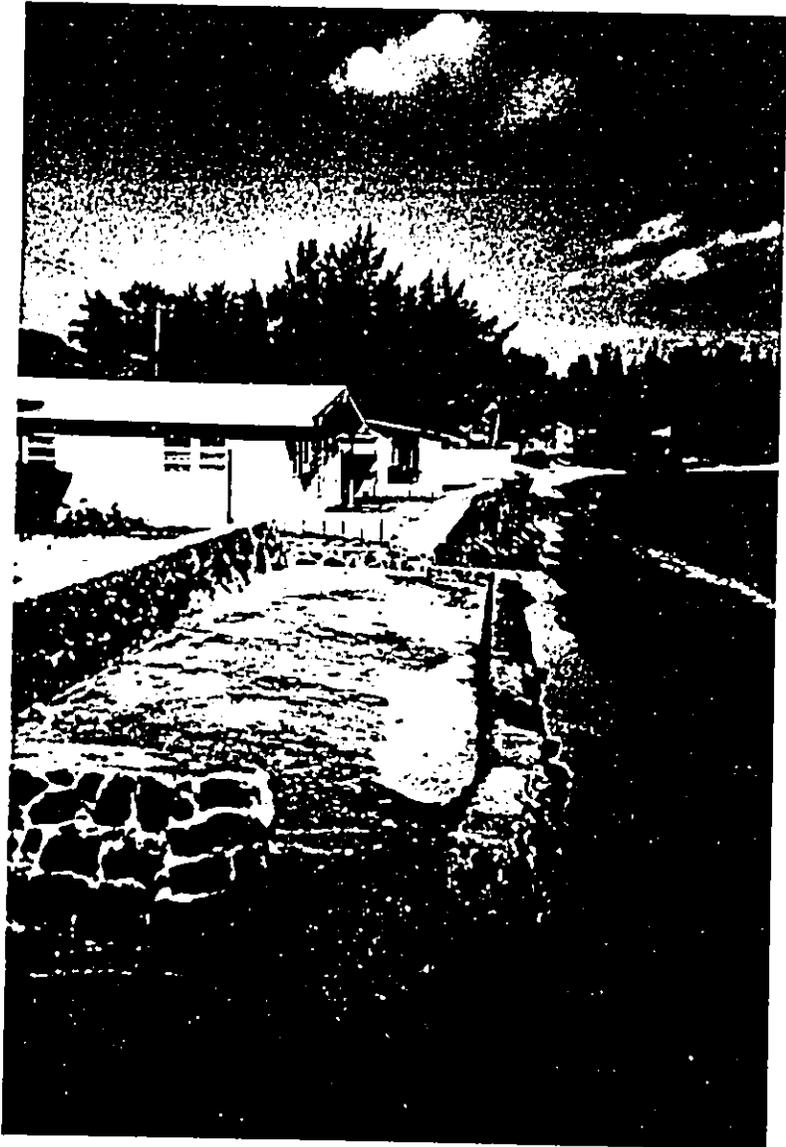
Photo Nos. 15 & 16.

The top photo shows the extent of undermining of the rubble-rock seawall at TMK 6-8-10:26. Concrete has been poured on the landward side to avoid undermining there (photo at right). A second wall set 14 feet behind the seawall has been constructed to contain overtopping waves.

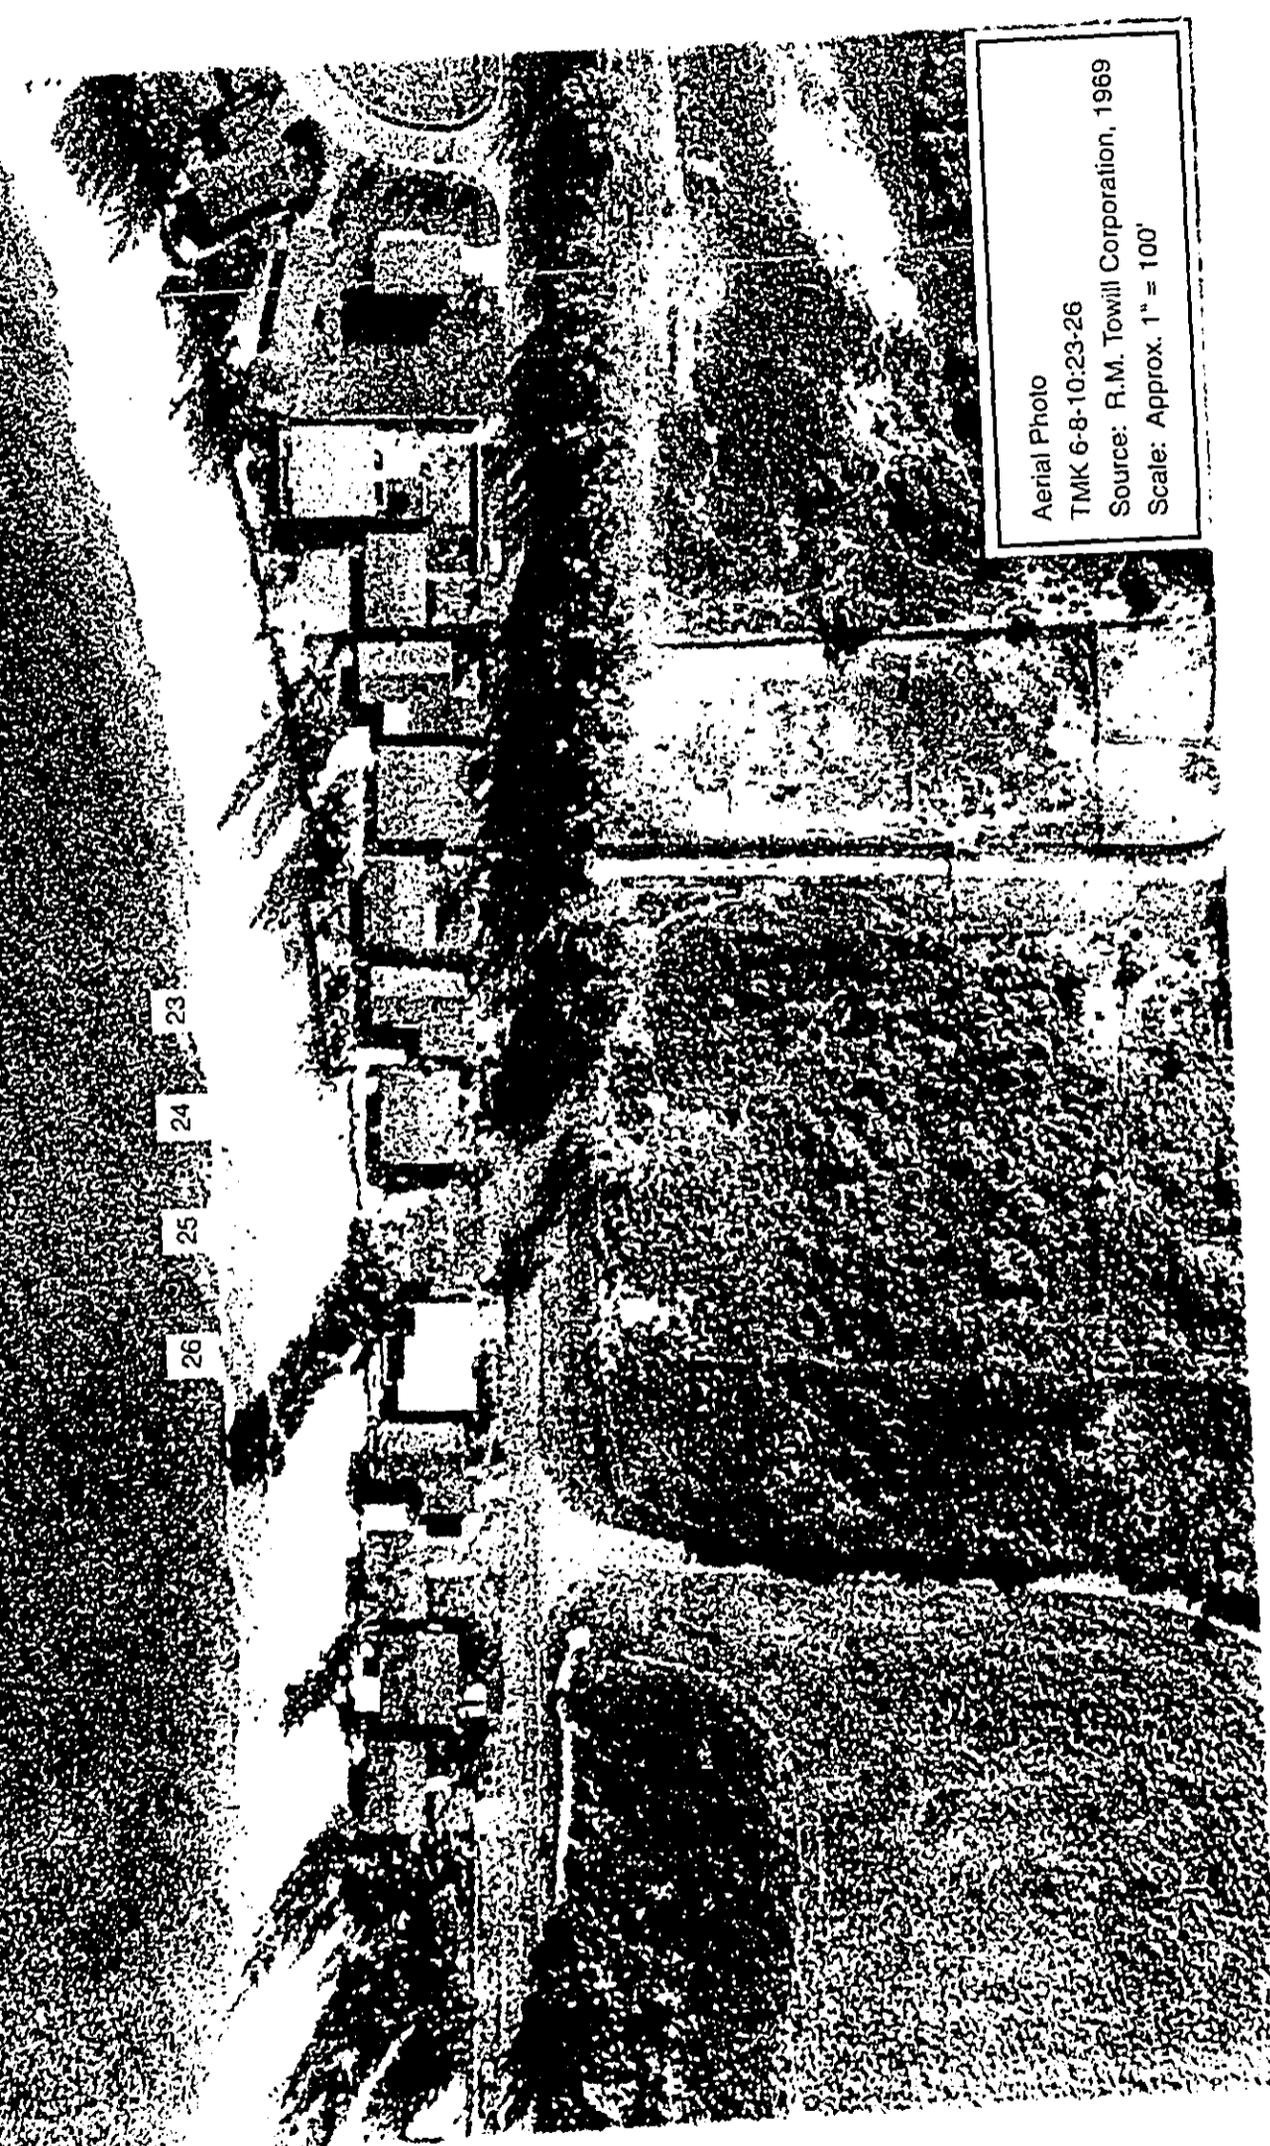
Aerial Photo  
TMK 6-8-10:23-26  
Source: Air Survey Hawaii, 1996  
Scale: Approx. 1" = 100'

Aerial Photo  
TMK 6-8-10:23-26  
Source: R.M. Towill Corporation, 1983  
Scale: Approx. 1" = 100'

Aerial Photo  
TMK 6-8-10:23-26  
Source: Air Survey Hawaii, 1975  
Scale: Approx. 1" = 100'

Aerial Photo  
TMK 6-8-10:23-26  
Source: R.M. Towill Corporation, 1969  
Scale: Approx. 1" = 100'

Aerial Photo  
TMK 6-8-10:23-26  
Source: R.M. Towill Corporation, 1967  
Scale: Approx. 1" = 100'

Aerial Photo  
TMK 6-8-10:23-26  
Source: R.M. Towill Corporation, 1961  
Scale: Approx. 1" = 100'

Aerial Photo  
TMK 6-8-10:23-26  
Source: R.M. Towill Corporation, 1949  
Scale: Approx. 1" = 100'

There has been a diminishing width of beach sand over the 1949 to 1996 period. The width of beach sand is now 18 to 25 feet, which is less than one-third the width that prevailed in 1949. This loss of beach sand width explains the recent failure of a number of seawalls along this embayment shore. In all cases, the walls were built with their foundations above sea level. At the time of their construction, there was a substantial beach sand deposit between these footings and the shoreline. Much of the sand has been eroded, with waves that continually wash beneath the footings to the inland side of the wall. A chronology of house and seawall construction, movement of the vegetation line, and approximate beach widths based on aerial photographs are presented in Exhibits C and D (aerial photos).
