Final Environmental Assessment

Proposed Shore Protection -- Two Residences, Lanikai

Lanikai, Oahu

Prepared by PlanPacific, Inc.

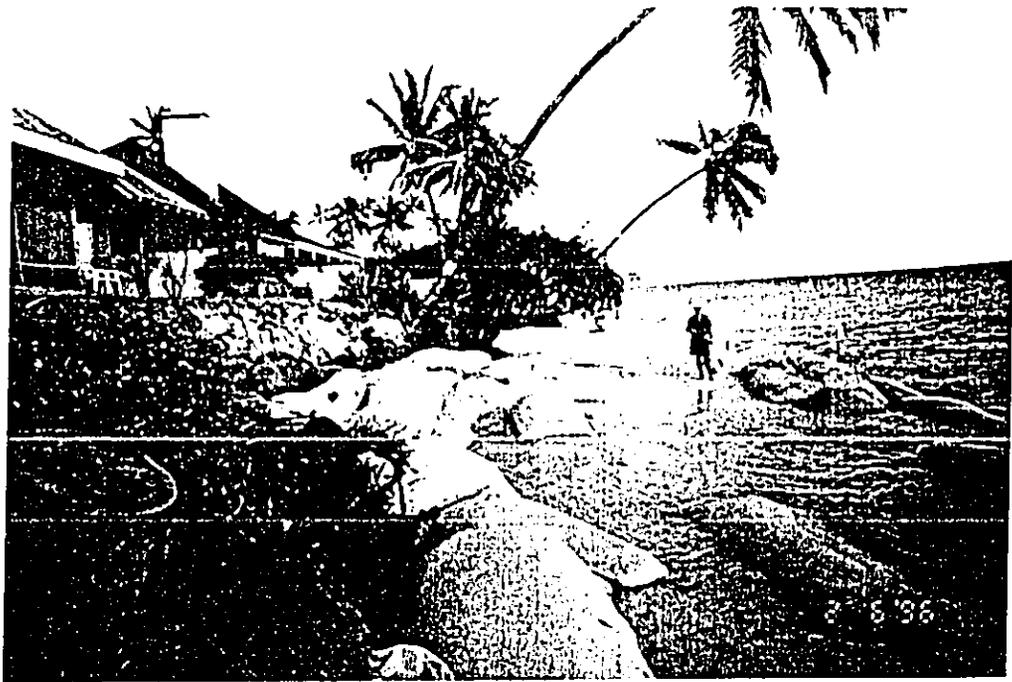
Photo 4: View northward showing damaged condition of sandbags fronting adjacent parcel 98 (Carpenter).

the beach. The SEAbags on the adjacent properties did not survive the 1995-1996 winter season very well. The SEAbag revetment on adjacent parcel 98 had to be rebuilt in February-March 1996, and by that time, the property owner of the two subject parcels had suffered extensive erosion damage. Photos 1 through 8 show the condition of the subject properties and adjacent properties in February-March 1996.

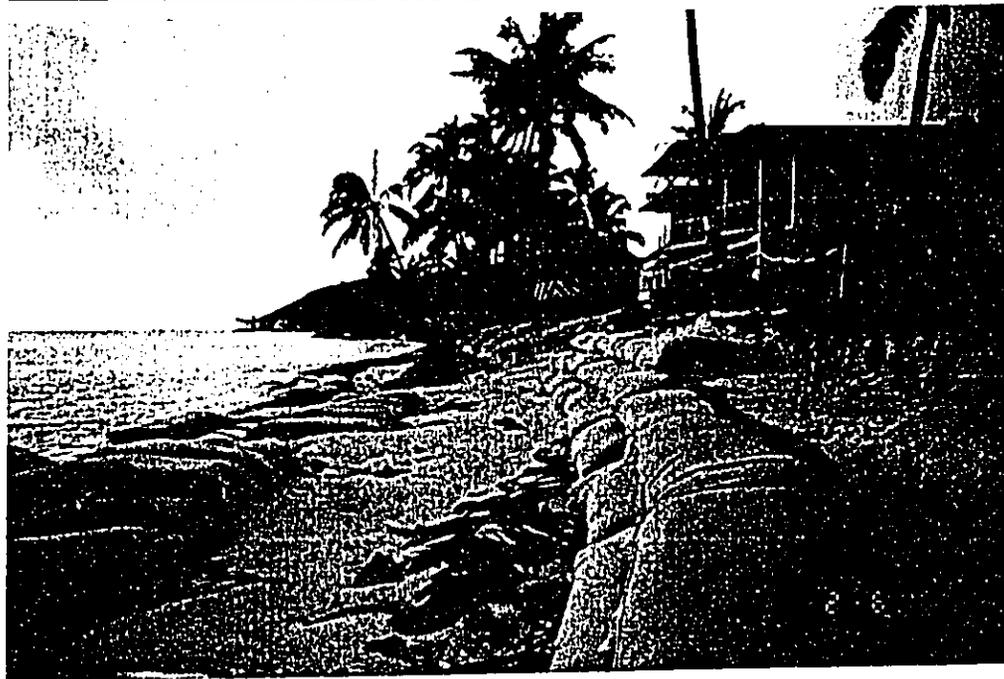
Photo 5: View southward showing sandbags fronting parcels 76 (Olds) and 77 (Davis).

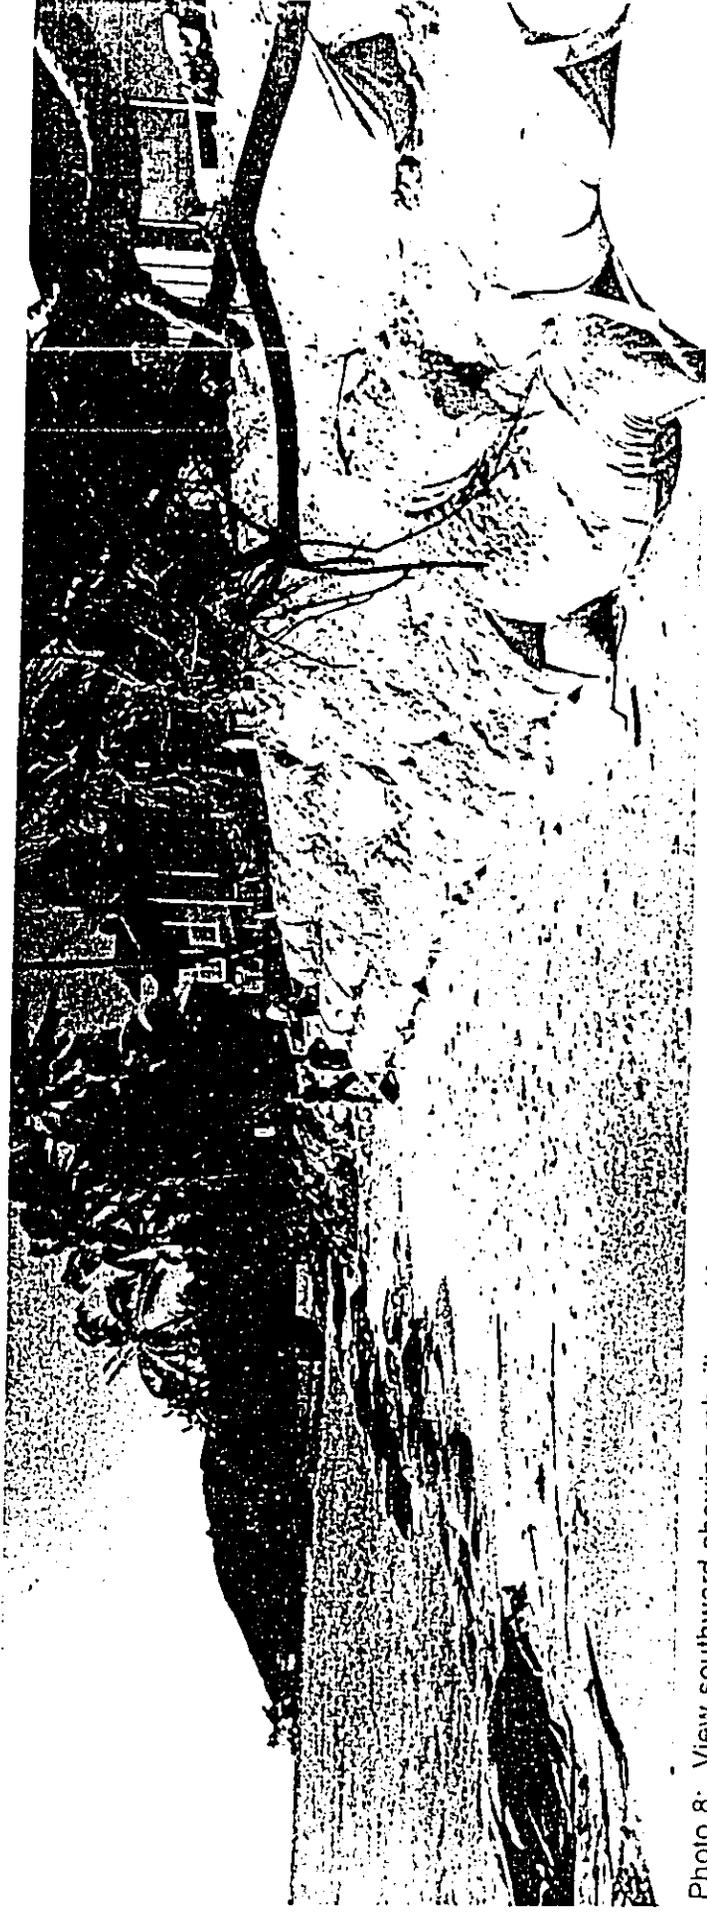
Photo 8: View southward showing rebuilt sand bag revetment on adjacent parcel 98 (Carpenter).

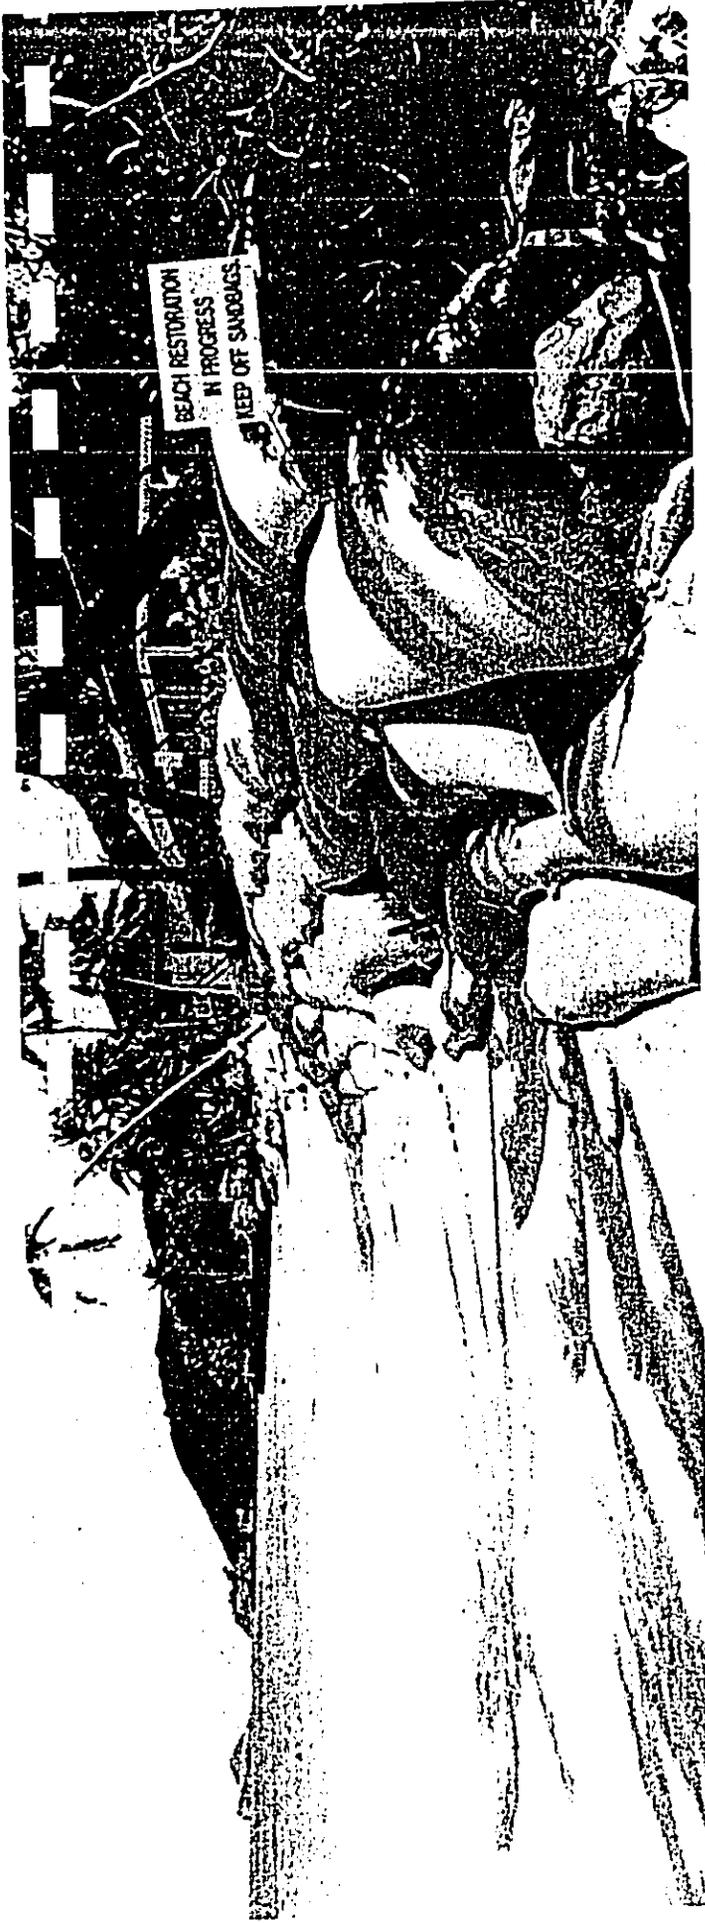
Photo 12: View southward fronting subject property TMK:4-3-5:61 showing condition of sand bag revetment after repairs completed.

Photos 12 through 17, taken in May 1997, show the existing condition of the SEAbag revetment on the subject parcels and the condition of adjacent properties. Note that the shoreline fronting the adjacent properties to the south is continuing to be modified by placement of SEAbags, removal of prior SEAbags that were damaged, placement of additional beach sand obtained from offsite source(s), and possibly mechanical redistribution of sand in the nearshore area. While the details are unclear, apparently the work is being done as part of a demonstration pilot project for beach replenishment by the Lanikai Beach Management Committee.⁴ A Departmental Permit for use within the Conservation District was issued by the Board of Land and Natural Resources on June 3, 1996 for the demonstration beach replenishment project. A condition of the permit was the requirement to perform pre-, during-, and post-construction beach profile monitoring and topographic monitoring for at least a year. The first monitoring report for the "Pilot Research Project" was filed in September 1997 by David Lipp, the coastal engineer who is monitoring the project on a volunteer basis. The report

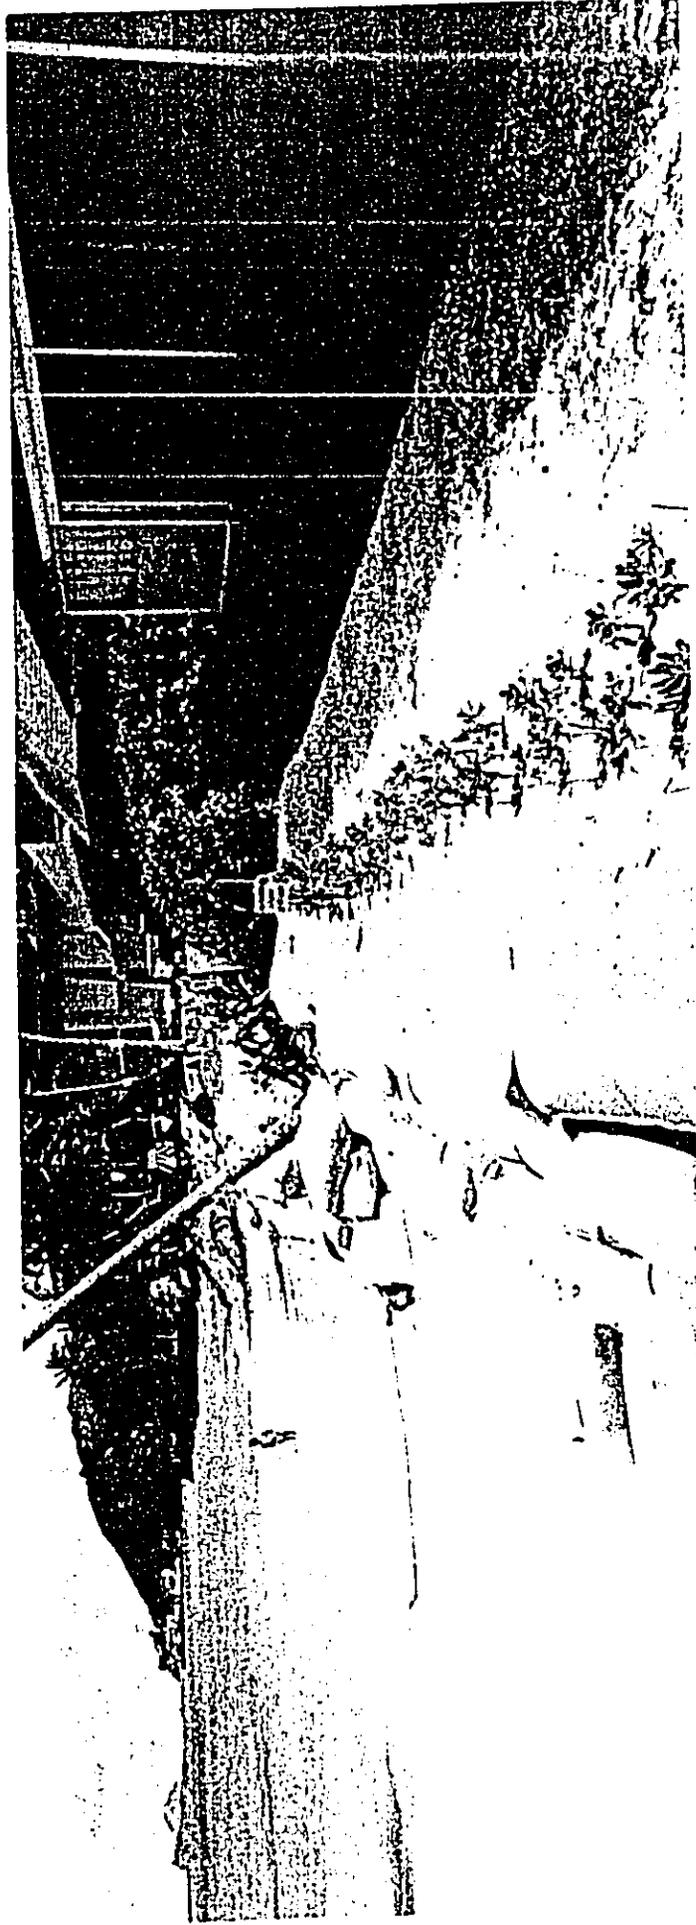
Photo 13: View southward showing shoreline condition in front of the house on subject parcel TMK:4-3-4:74.

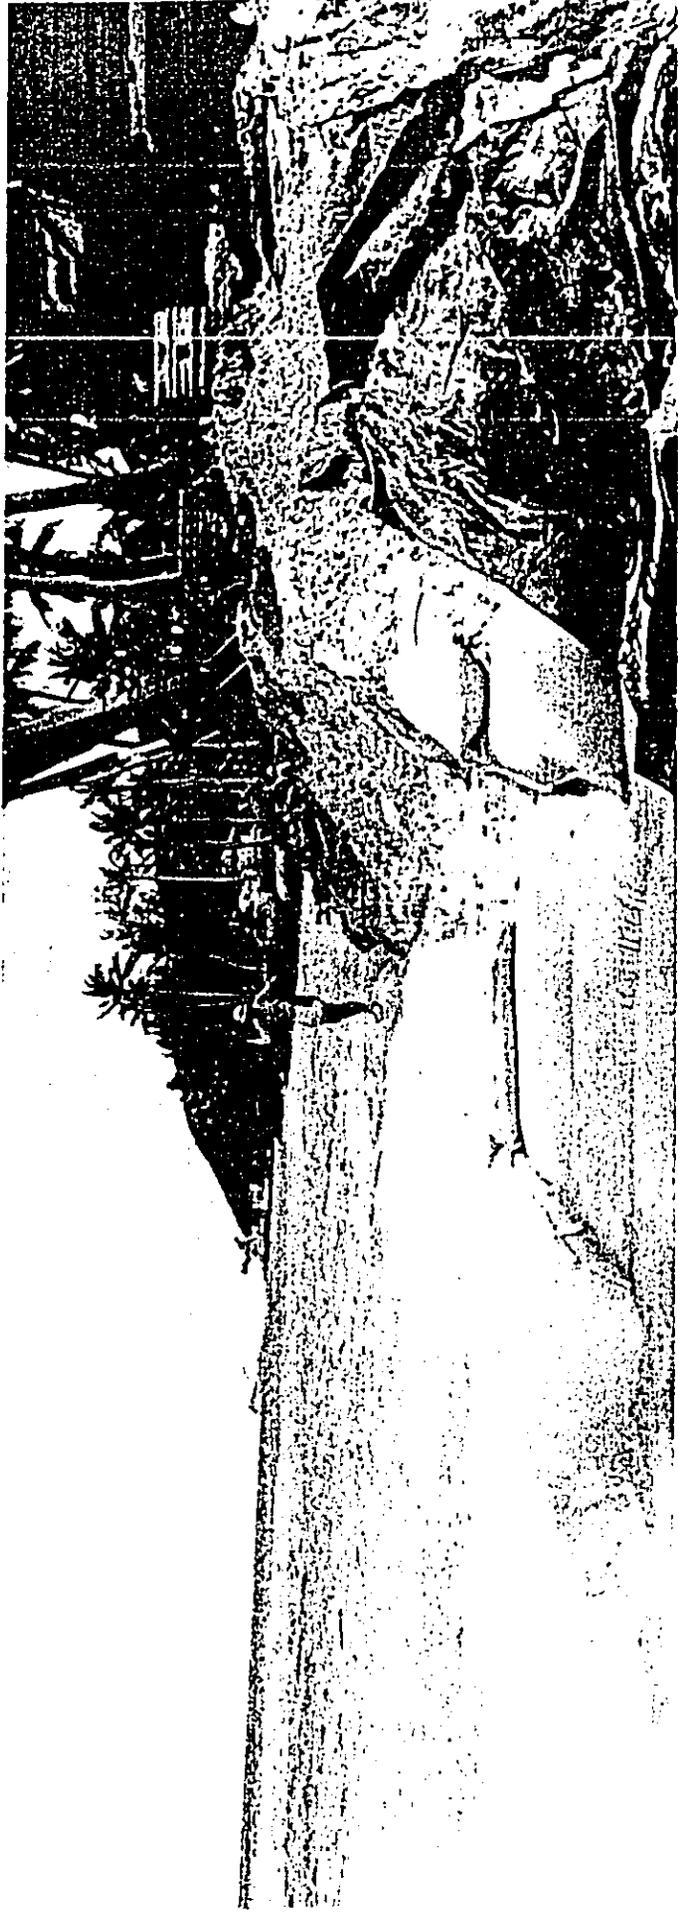
Photo 15: View southward fronting parcel 77 (Davis). Note stockpiled sand and new sand bags on this property.
