2004-12-23 FONSI  
GROSSMAN SEAWALL RECONSTRUCTION AND BOAT  
RAMP REPAIR

# Final Environmental Assessment

## Improvement of Nonconforming Seawall

Lanikai, Oahu  
TMK: 4-3-005: 076

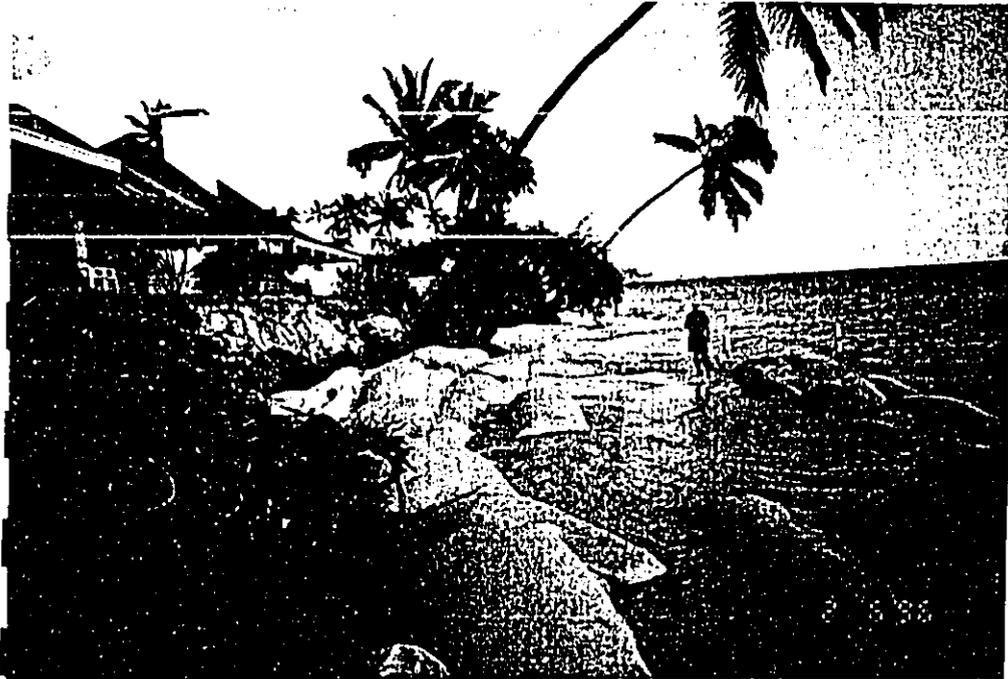
Photo 4: View northward showing damaged condition of sandbags fronting adjacent parcel 98 (Carpenter).

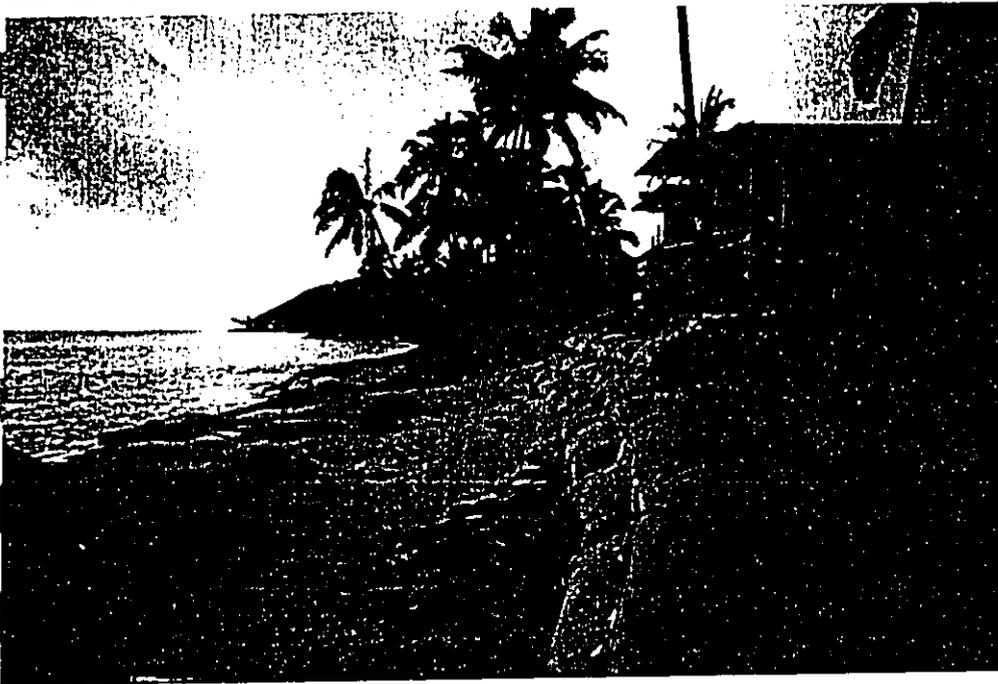
Photo 5: View southward showing sandbags fronting parcels 76 (Olds) and 77 (Davis).

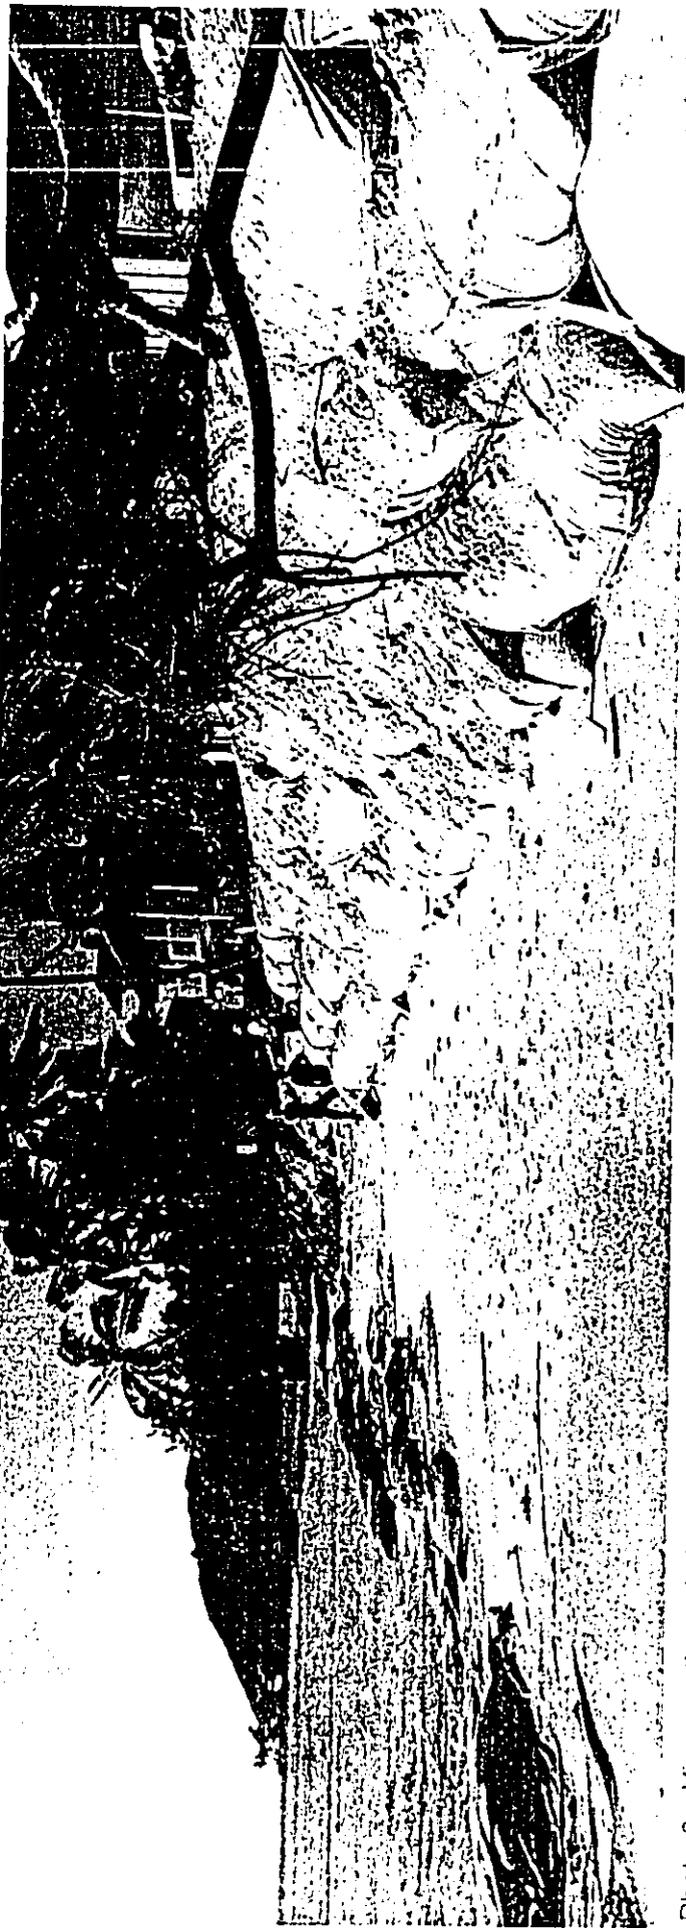
Photo 8: View southward showing rebuilt sand bag revetment on adjacent parcel 98 (Carpenter).

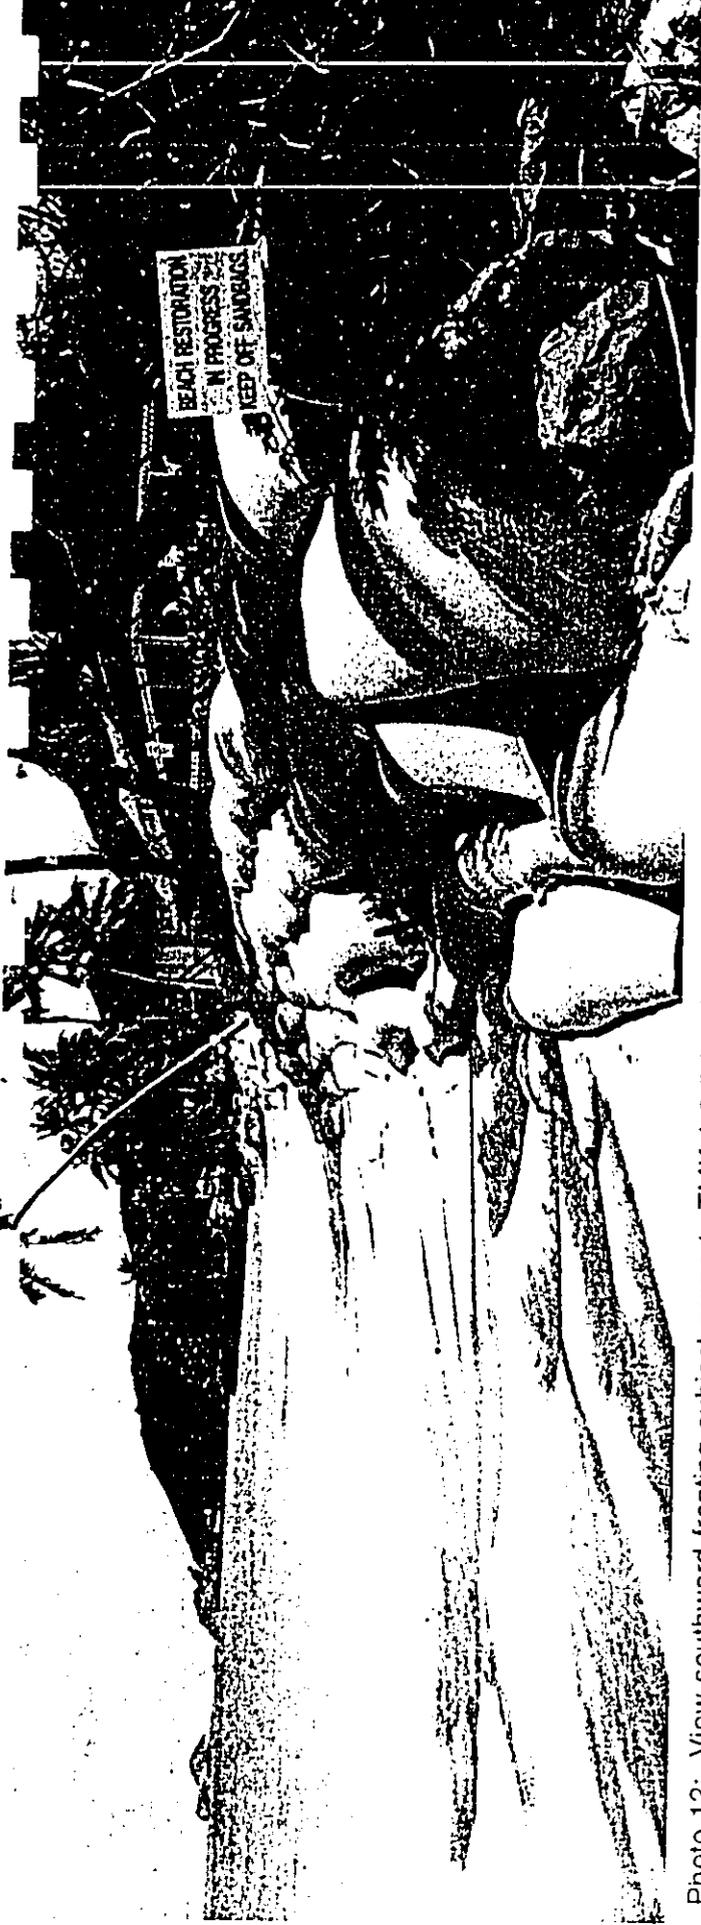
Photo 12: View southward fronting subject property TMK:4-3-5:61 showing condition of sand bag revetment after repairs completed.

Photos 12 through 17, taken in May 1997, show the existing condition of the SEAbag revetment on the subject parcels and the condition of adjacent properties. Note that the shoreline fronting the adjacent properties to the south is continuing to be modified by placement of SEAbags, removal of prior SEAbags that were damaged, placement of additional beach sand obtained from offsite source(s), and possibly mechanical redistribution of sand in the nearshore area. While the details are unclear, apparently the work is being done as part of a demonstration pilot project for beach replenishment by the Lanikai Beach Management Committee.<sup>4</sup> A Departmental Permit for use within the Conservation District was issued by the Board of Land and Natural Resources on June 3, 1996 for the demonstration beach replenishment project. A condition of the permit was the requirement to perform pre-, during-, and post-construction beach profile monitoring and topographic monitoring for at least a year. The first monitoring report for the "Pilot Research Project" was filed in September 1997 by David Lipp, the coastal engineer who is monitoring the project on a volunteer basis. The report

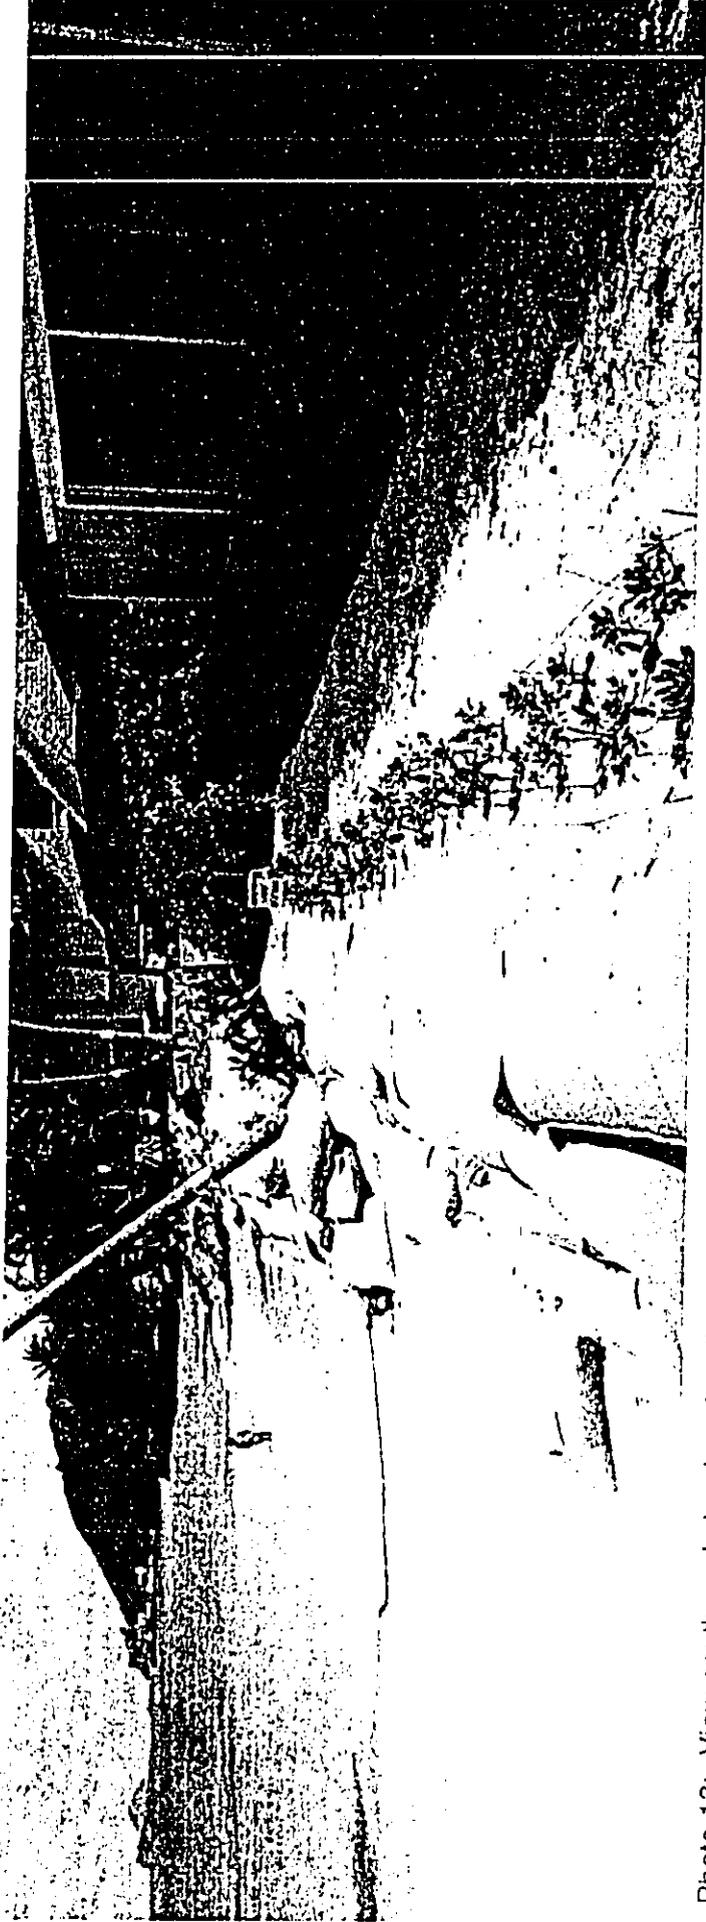
Photo 13: View southward showing shoreline condition in front of the house on subject parcel TMK:4-3-4:74.

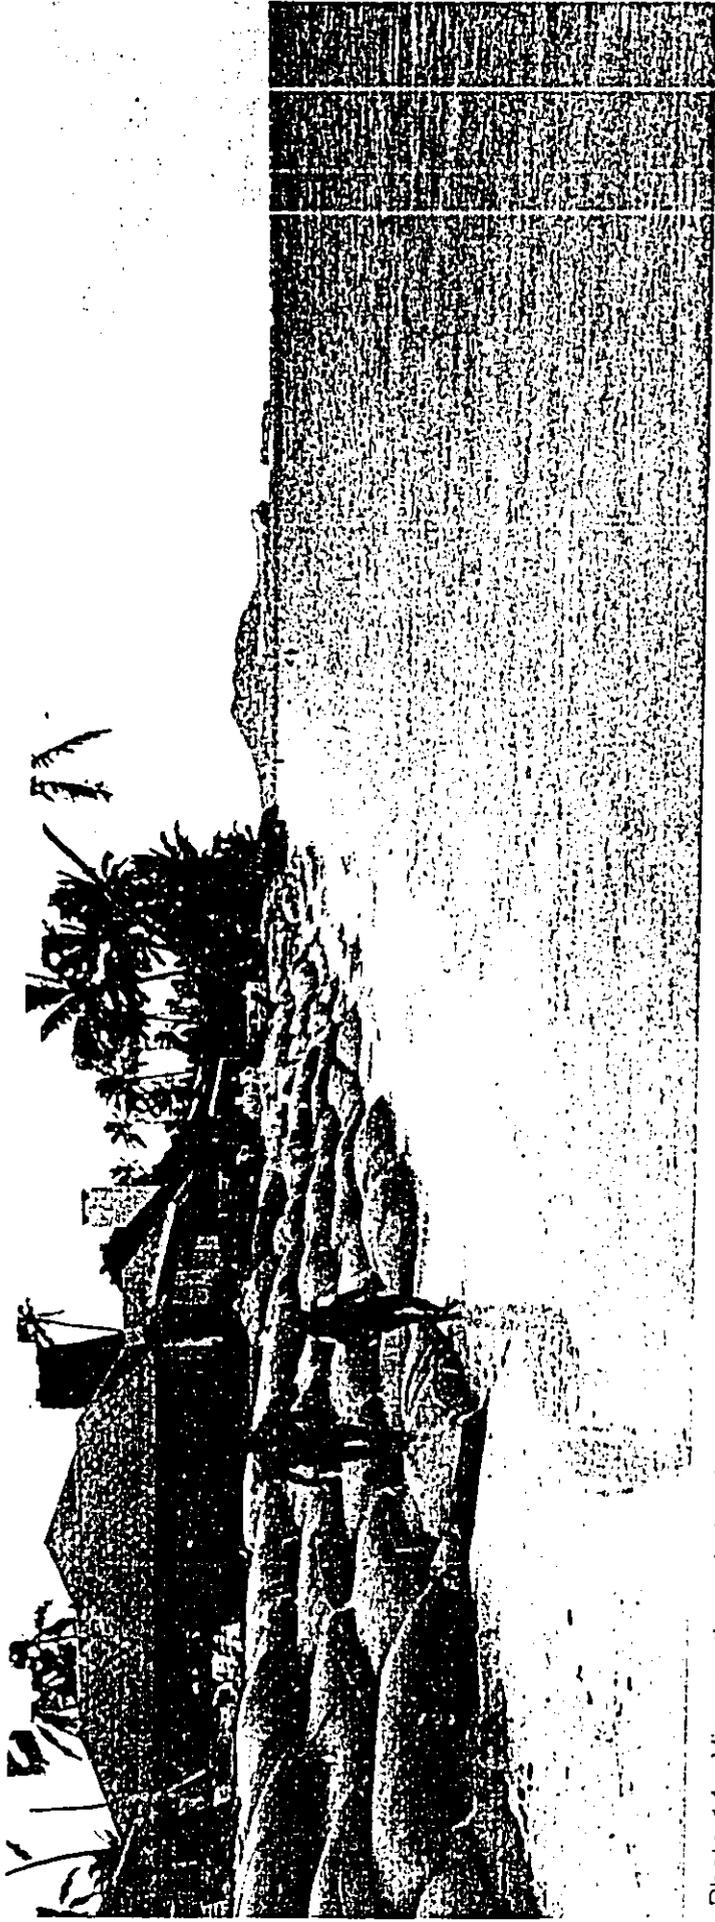
Photo 14: View northward showing condition of shoreline fronting adjacent parcels 76 (Olds) & 98 (Carpenter). Subject parcel is in background.

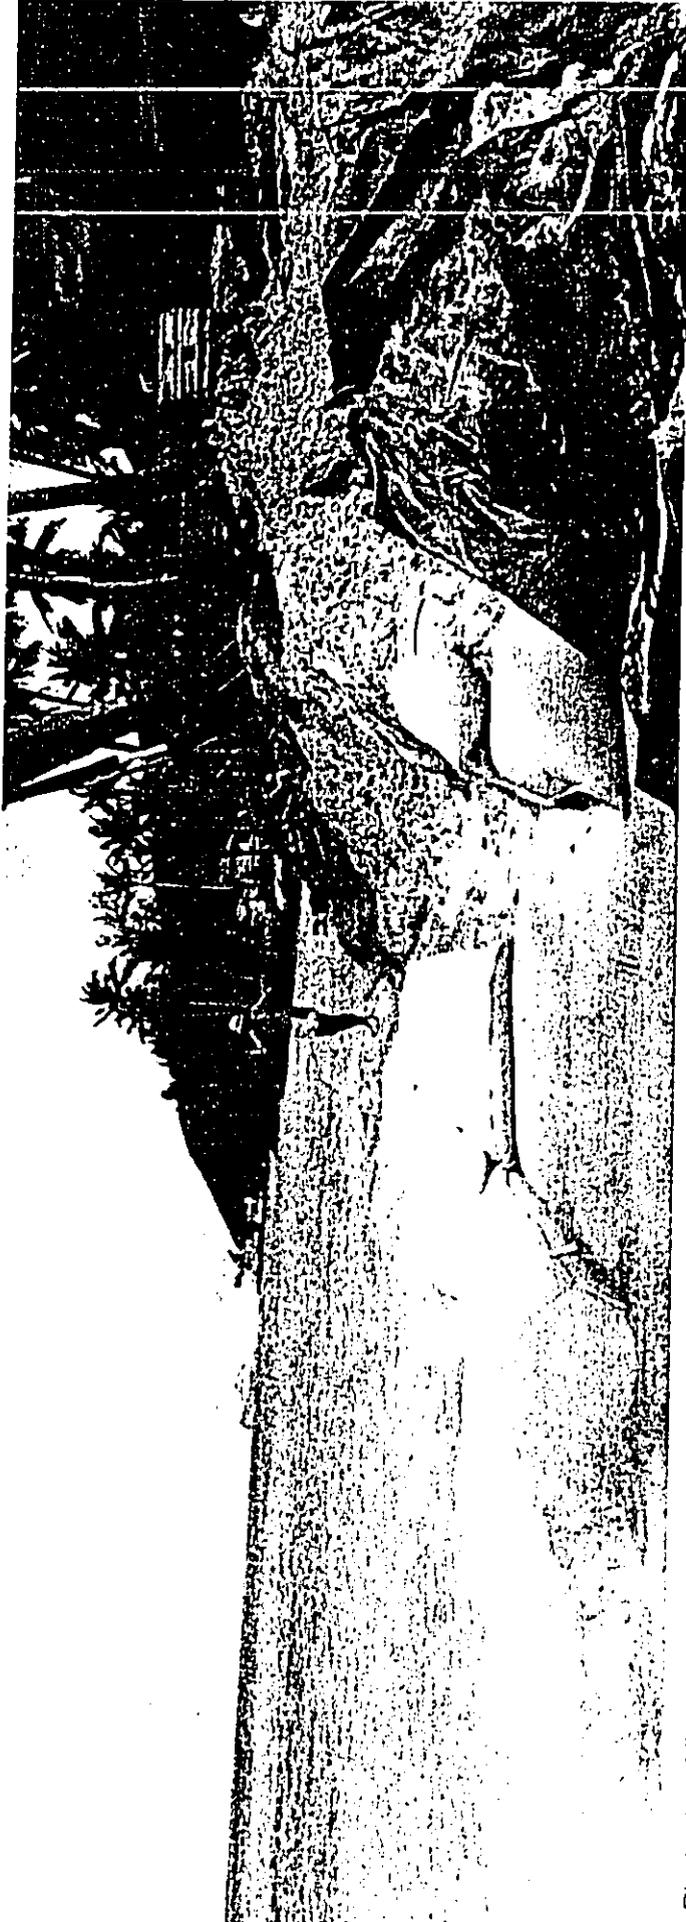
Photo 15: View southward fronting parcel 77 (Davis). Note stockpiled sand and new sand bags on this property.
