Landowner/Applicant: Gary Capo
Agent: Analytical Planning Consultants, Inc.
Location: 68-687 Farrington Highway - Mokuleia
Tax Map Key: 6-8-10: 20
Request: Shoreline Setback Variance
Proposal: To retain a reinforced concrete seawall within the shoreline setback.
Determination: A Finding of No Significant Impact is Issued

FINAL ENVIRONMENTAL ASSESSMENT

SHORELINE SETBACK VARIANCE

TMK: 6-8-10: 020
68-687 Farrington Highway
Mokuleia, Oahu, Hawaii

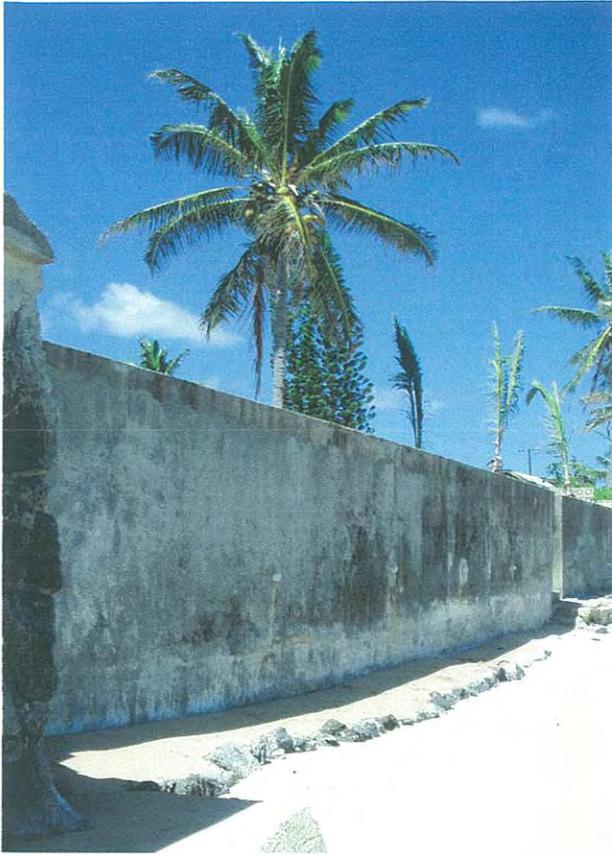
3A.1

Mokuleia TMK 6-8-10: 020
Photo Fall 2004

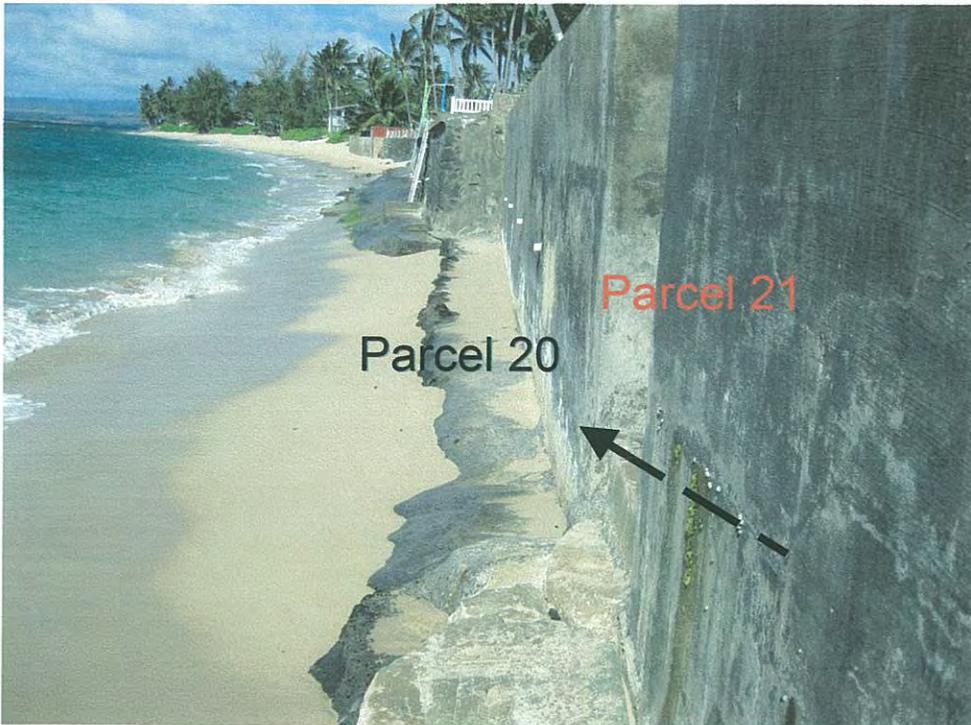
Figure 3A

SUBJECT SEAWALL TMK: 6-8-10: 020
68-687 Farrington Highway, Mokuleia, Oahu, Hawaii

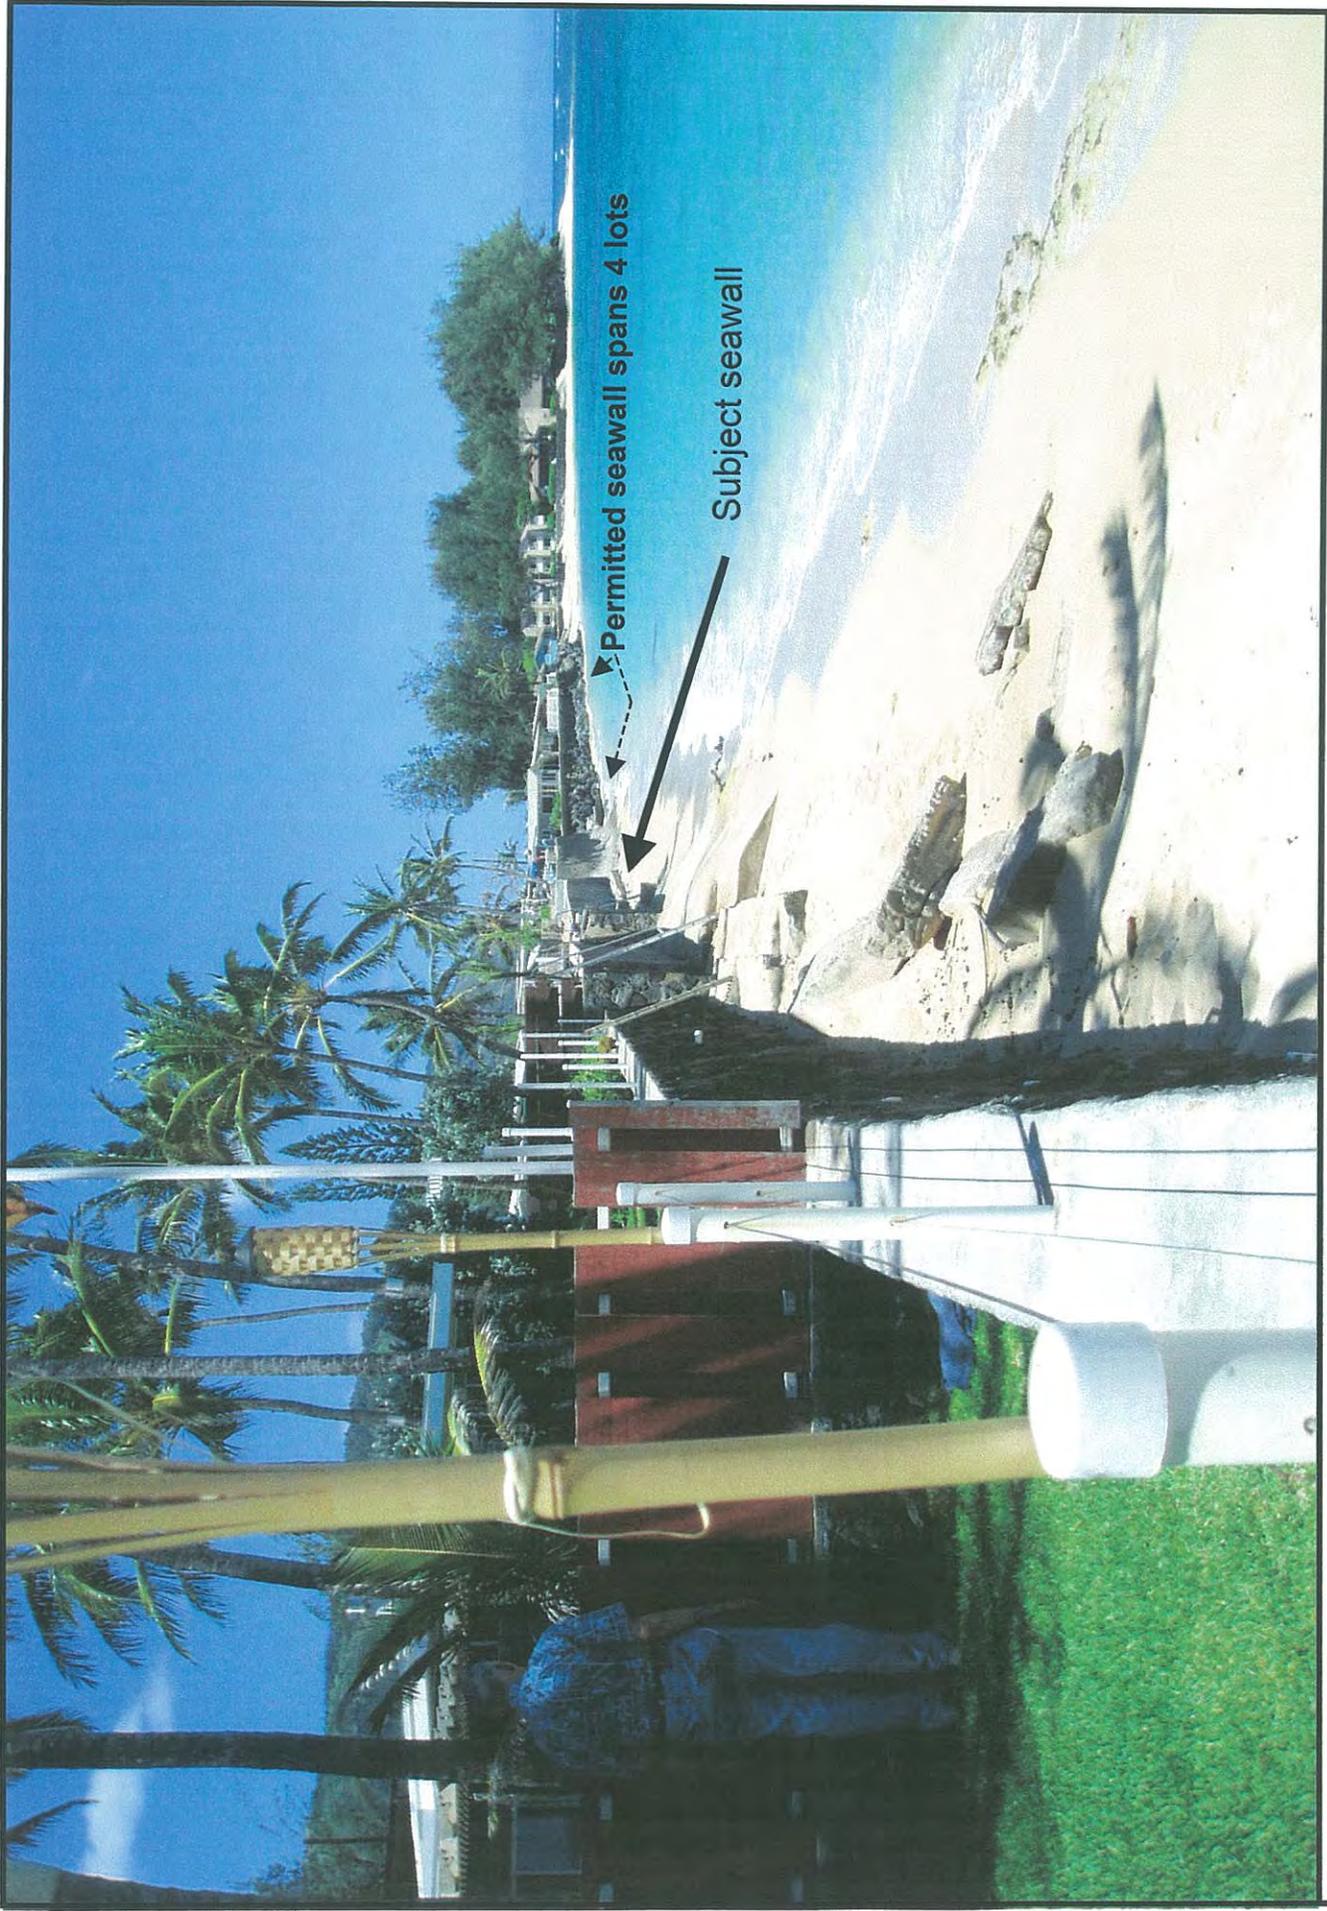
Figure 10

EXISTING CONTINUOUS SEAWALLS ALONG EMBAYMENT

When the wall was reconstructed the original foundation was left to provide additional support and to protect the foundation of the wall from scouring as the elevation of the fronting beach was lowered by continuing erosion. Granting of the Shoreline Setback Variance will allow the property owner to maintain and repair the seawall as needed, otherwise overtime, portions of the wall could collapse should the footings be undermined by wave action. Any mitigation would involve securing the footings to prevent undermining by wave action. The seawall ties into seawalls on both the east and west side of the subject property. The adjacent seawalls located on parcels 21 and 19 were originally constructed in the 1970's without building permits and the owners are in the process of obtaining an after-the-fact shoreline setback variance.

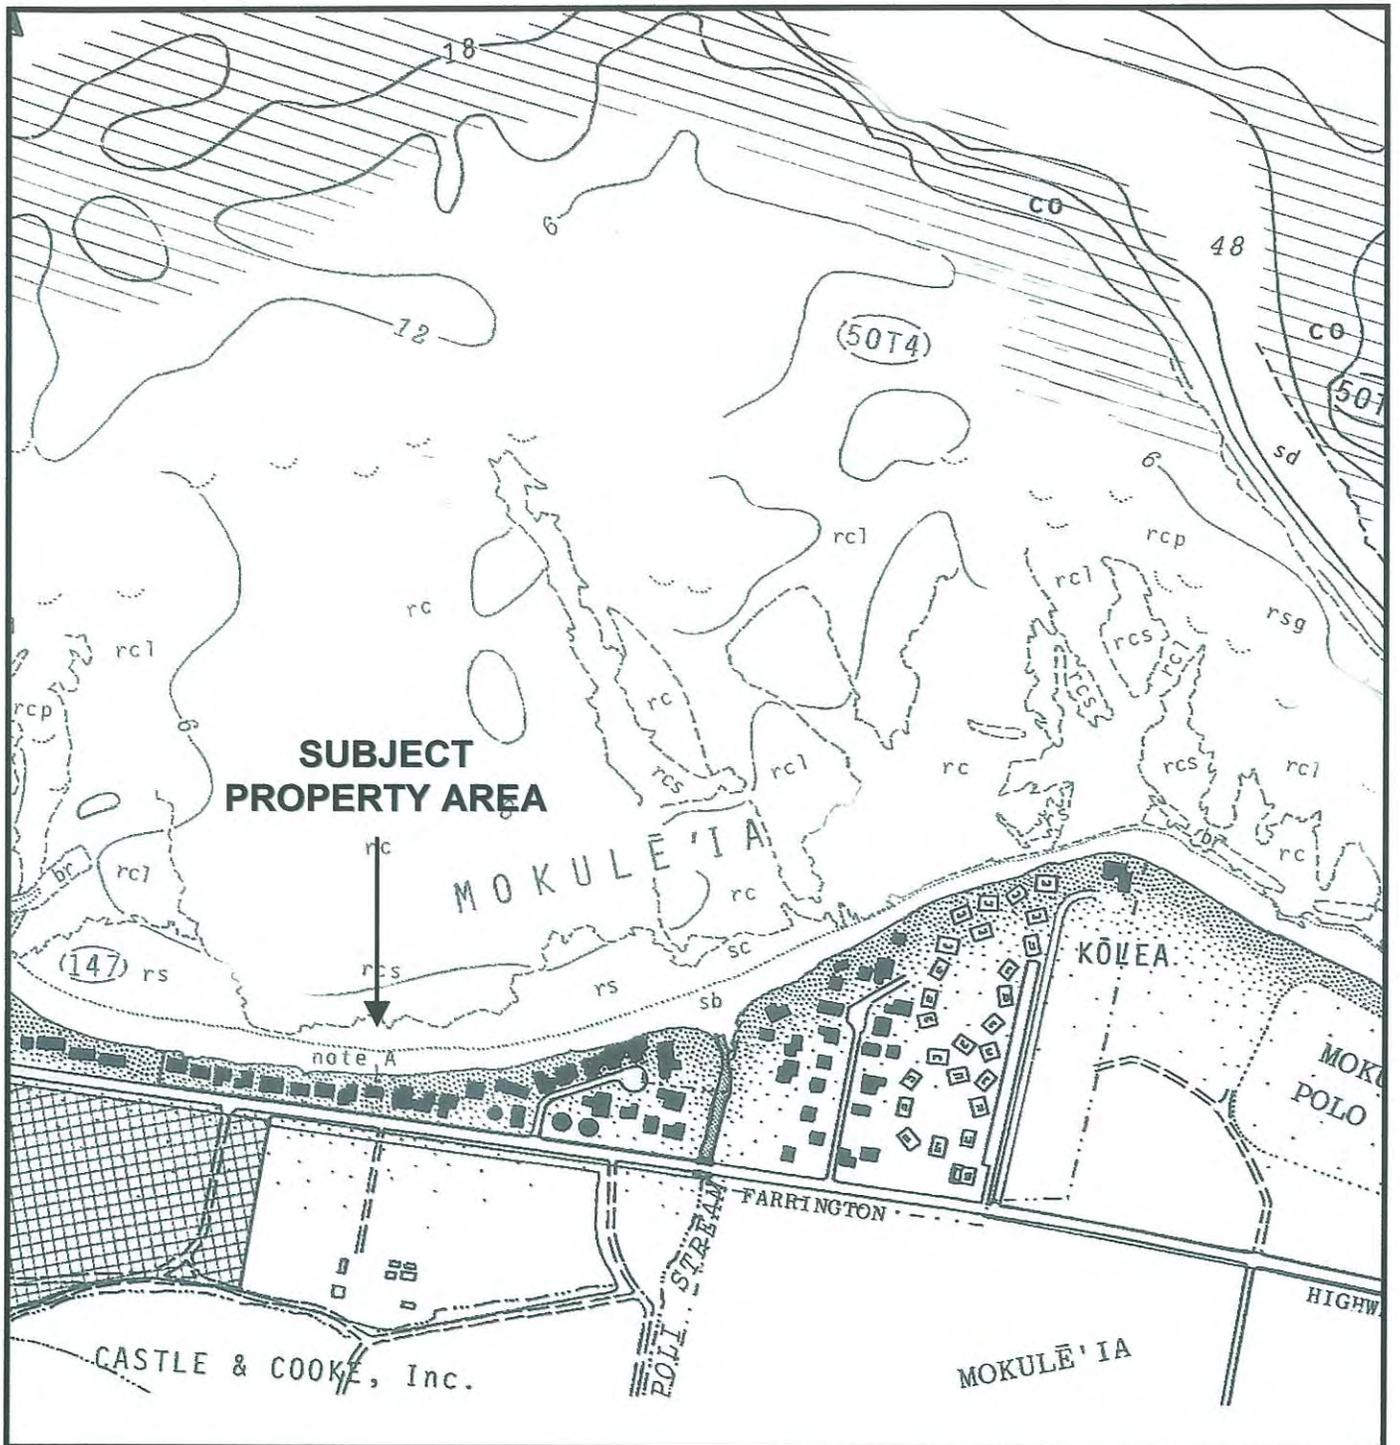
Figure 9
SHORE AND NEARSHORE CHARACTERISTICS
 68-687 Farrington Highway, Mokuleia, Oahu, Hawaii

br	beachrock
rbs	hard bottom with sand pockets
rcl, rcp	consolidated limestone bottom
rc, rcs	complex reef (sand, rubble, hard & soft)
rs	hard bottom with sand pockets
rsg	consolidated grooved limestone with sand
sb	sand beach
sc, sd	sand bottom or patch; also in depths > 30 feet

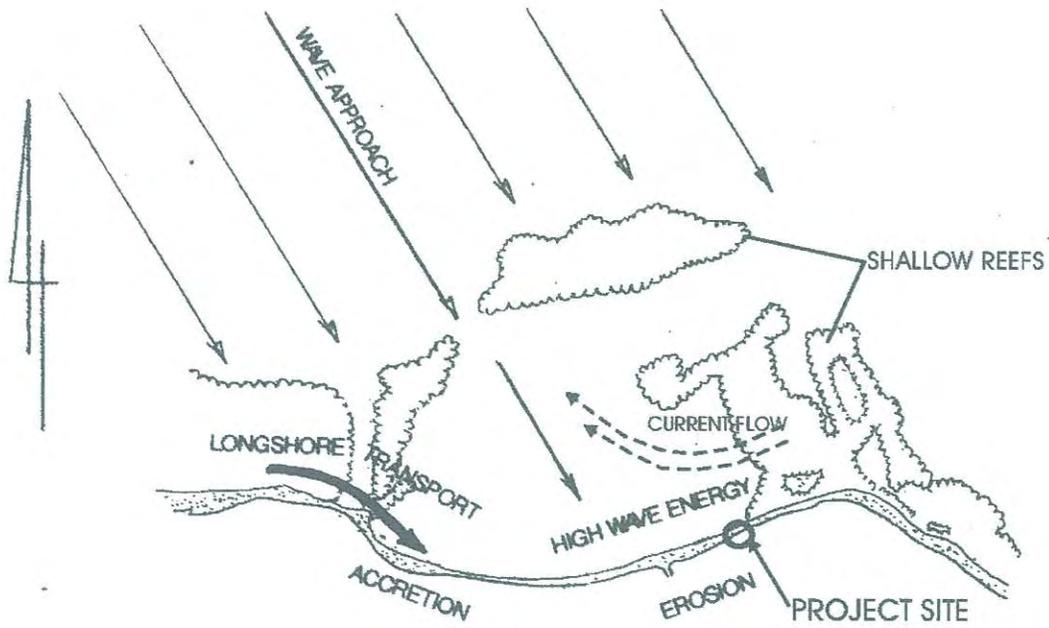
WINTER NORTHWEST SWELL CONDITIONS

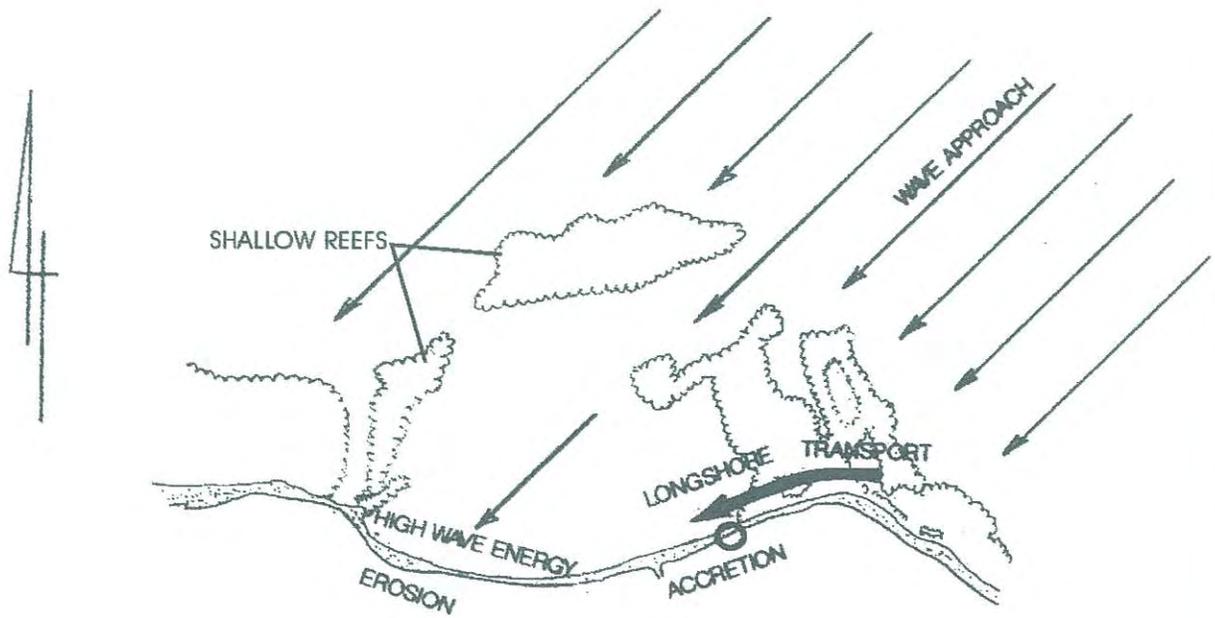
SUMMER NORTHEAST TRADEWIND CONDITIONS

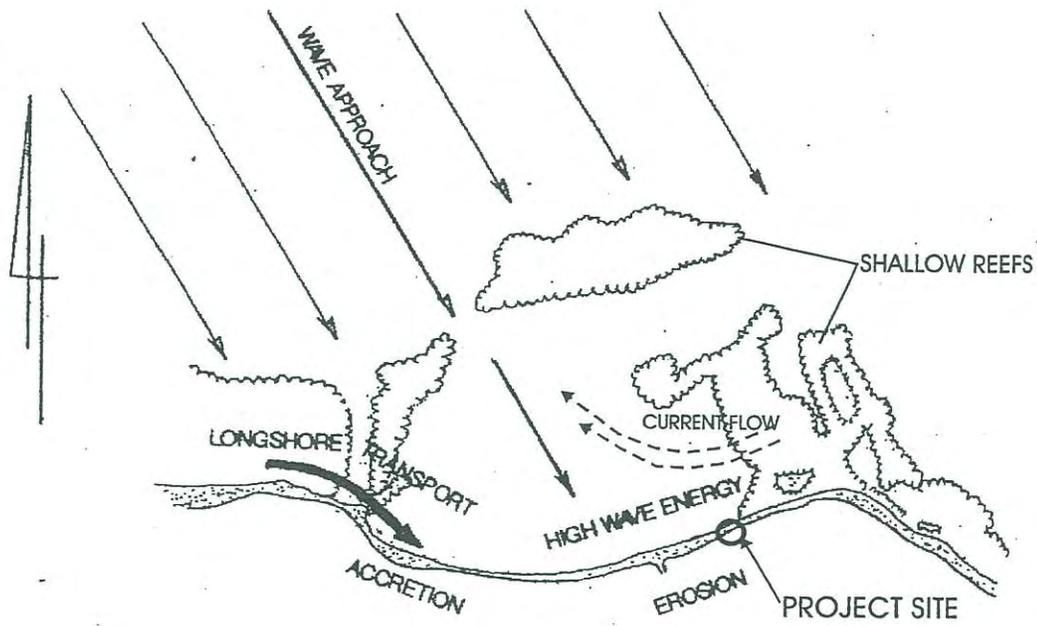
WINTER NORTHWEST SWELL CONDITIONS

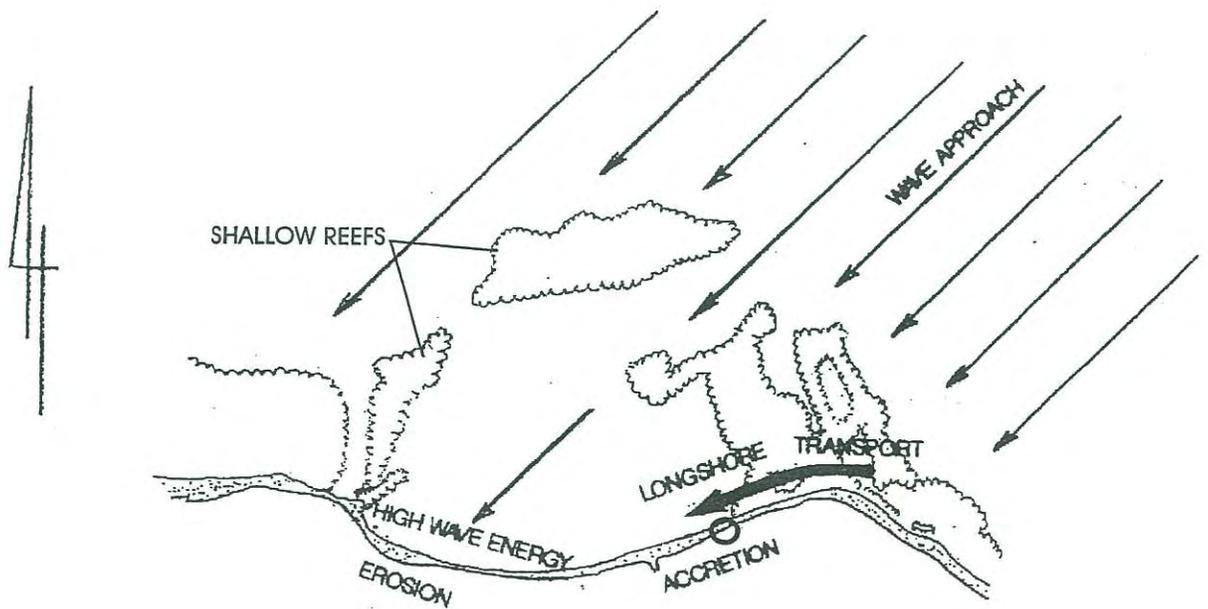
FIGURE 3

SUMMER NORTHEAST TRADEWIND CONDITIONS

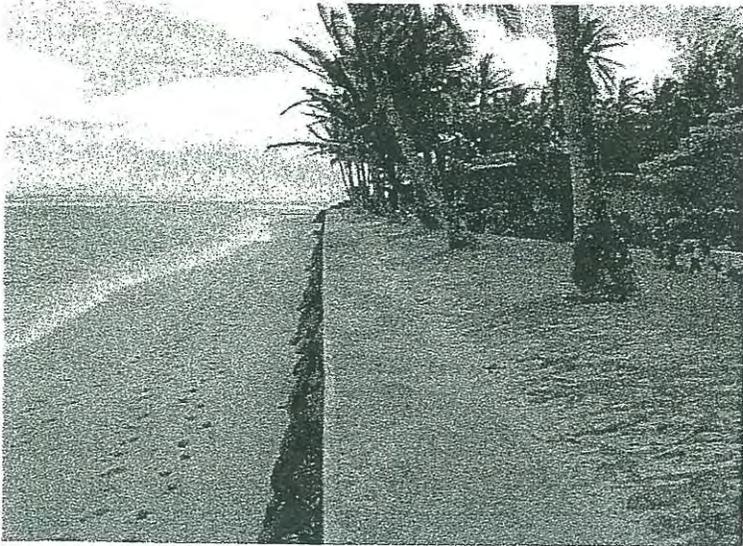
View eastward along the top of the seawall fronting the Mokuleia Beach Colony. Note the narrow beach.

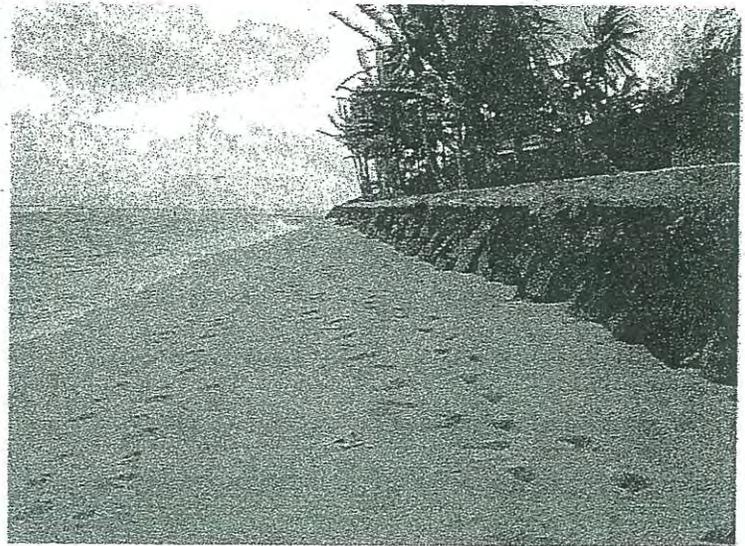
View eastward along the beach fronting the Mokuleia Beach Colony seawall. Note the narrow and steep beach profile.

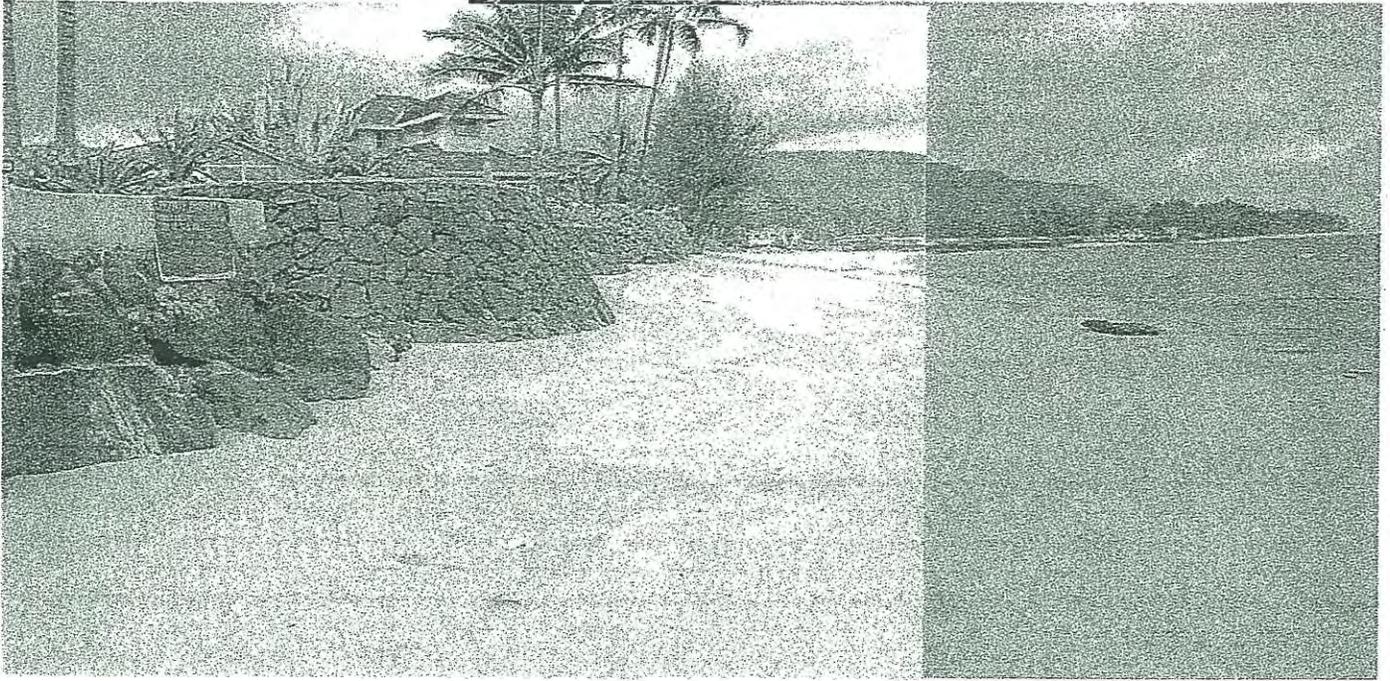
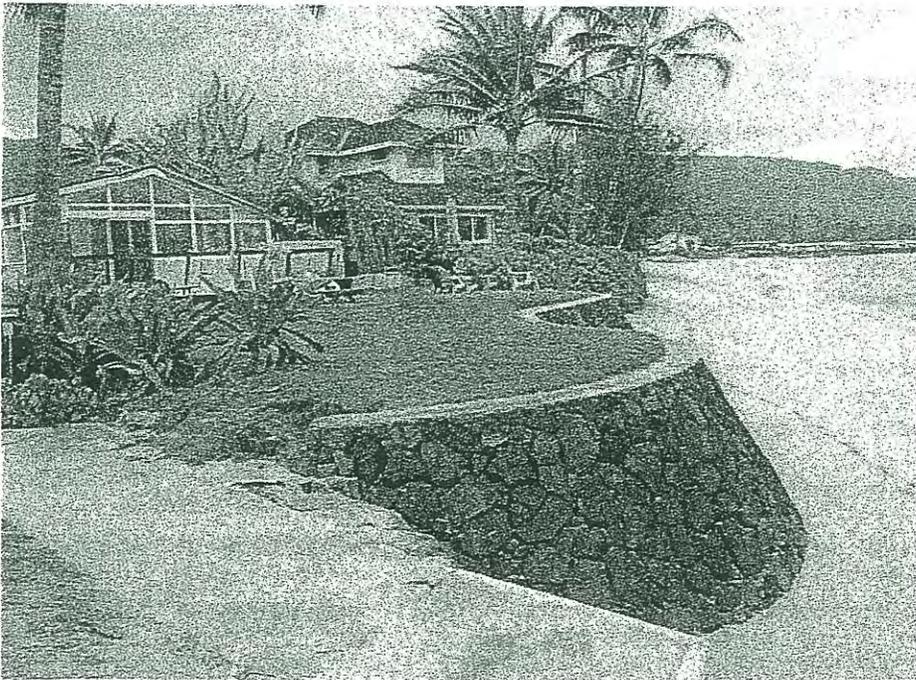
Views westward from west end of Mokuleia Beach Colony seawall. Parcel 10 is in the foreground. Parcel 11 is next to Parcel 10. (Sign is on the west end of the Mokuleia Beach Colony seawall. The sign permits the public to walk on the top of the seawall.)

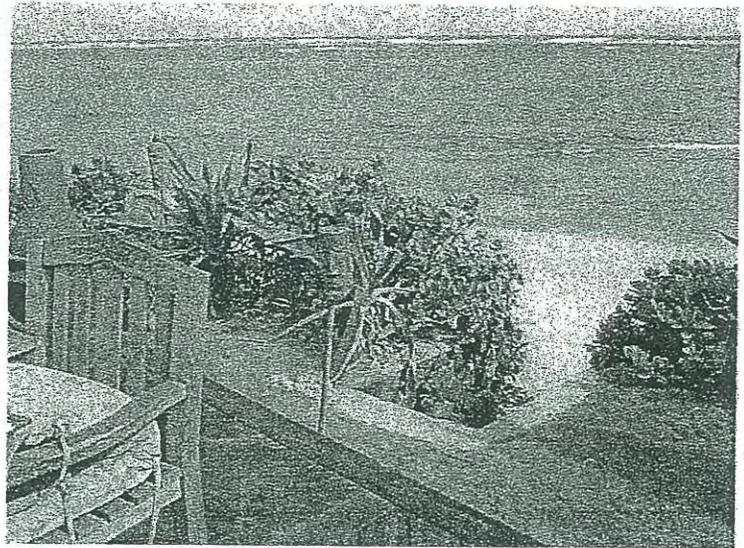
View offshore from porch on Parcel 11.
Steps in seawall lead down to the beach.

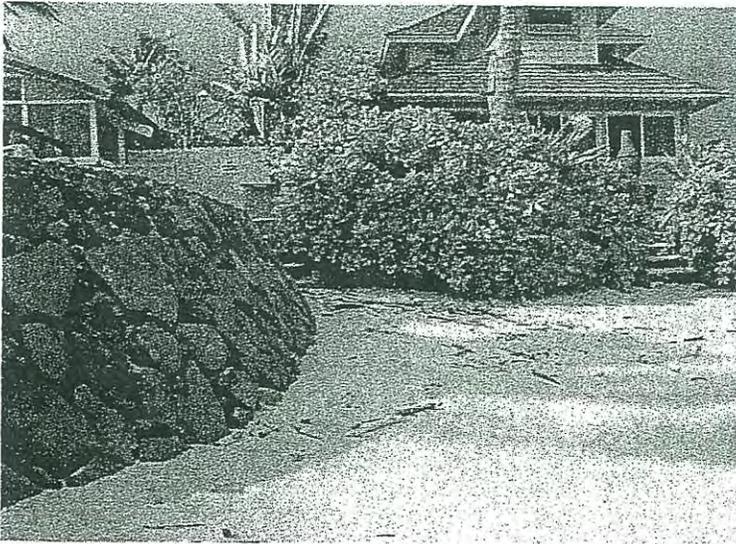
View of Parcel 11 seaward frontage. Seawall is hidden by naupaka vegetation. Curved seawall on left fronts Parcel 10.

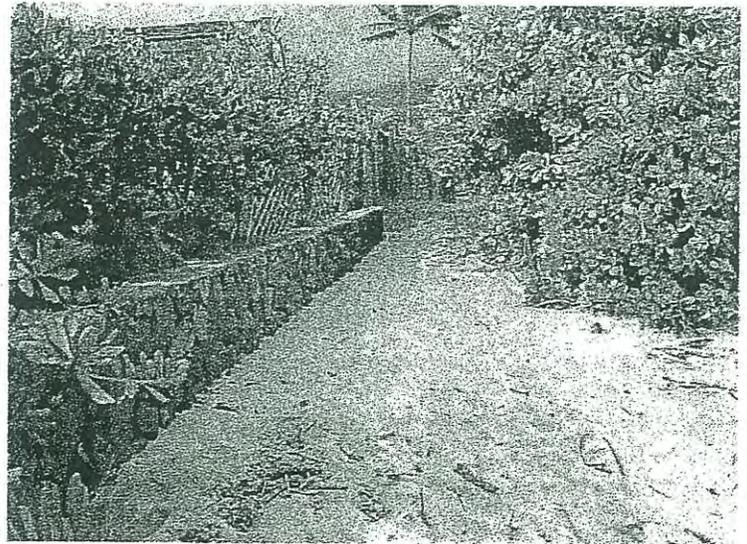
View mauka along private right-of-way. The CRM wall on left is Parcel 11's return wall.

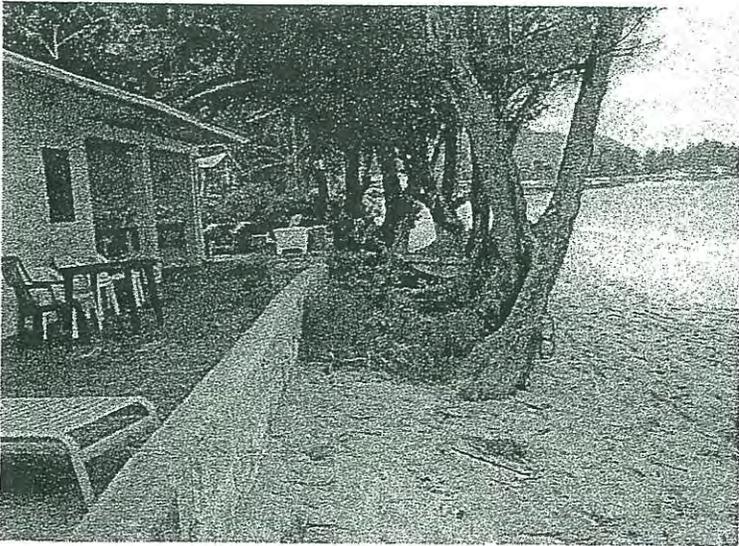
CMU wall fronts Parcel 13 .

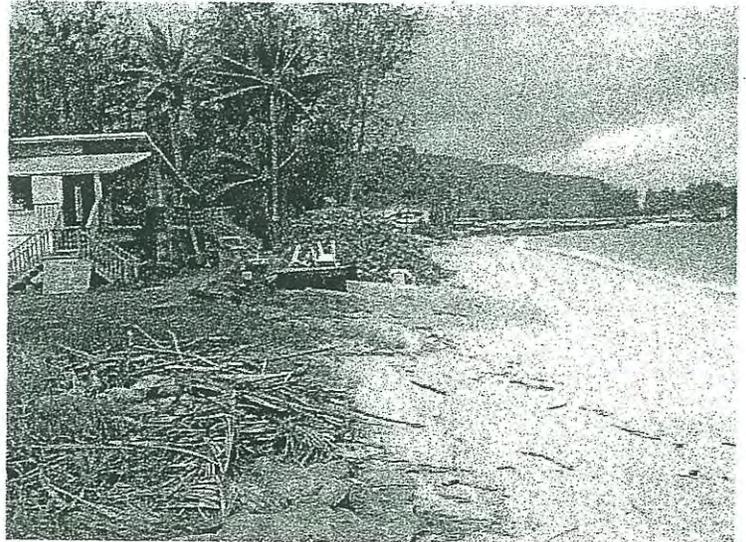
Shoreline fronting Parcel 20 on east side
of stream, Note debris line at edge of
vegetation.
