Final Environmental Assessment and Coastal Engineering Evaluation
for a Shoreline Setback Variance at 91-447 Pupu Street, Ewa Beach,
Hawaii 96706

TMK 9-1-030:008

May, 2008

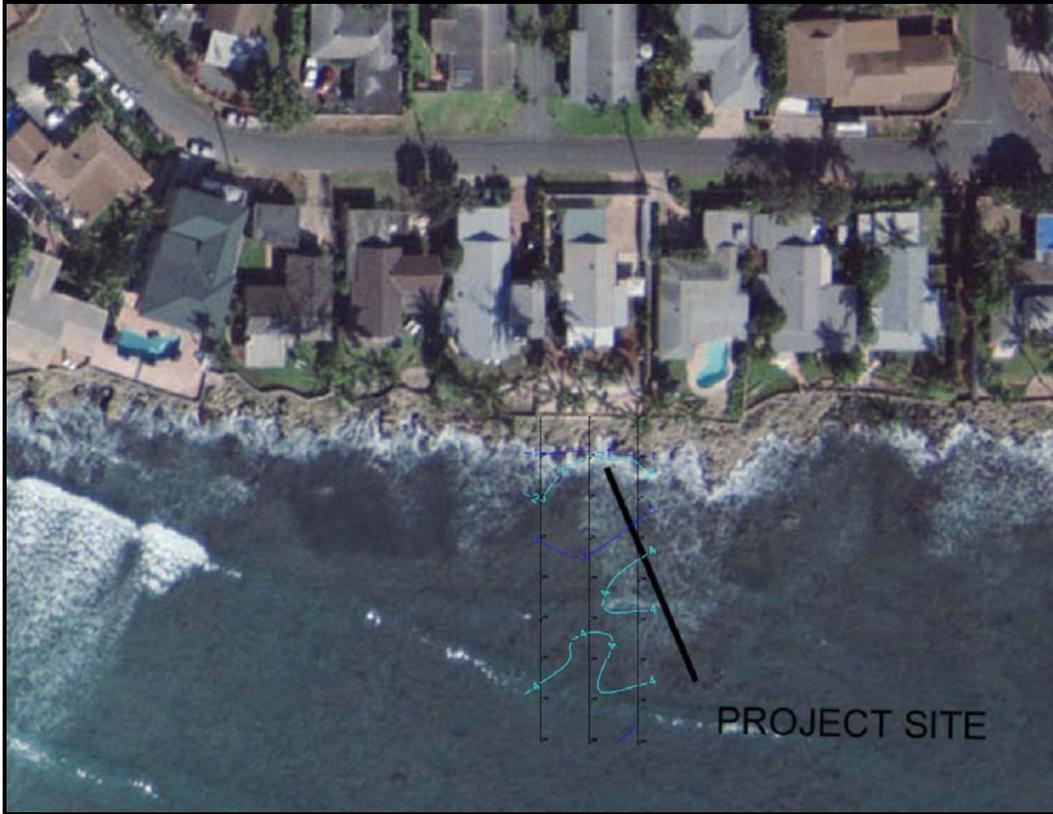
Figure 2-3 Aerial photograph of project site with offshore bathymetry (survey lines are 200 ft)
(photograph courtesy of UH Coastal Geology Group website)

Three beach profiles were taken at the project site at each end and the center of the property. Profiles were measured using a surveyor's tape to a distance of 200 ft offshore, and water depths were measured using a lead line at 25-ft intervals. Contours generated from depth measurements are shown on the aerial photograph in Figure 2-3. The three profiles are virtually identical; the center profile is typical, and is shown in Figure 3-13.

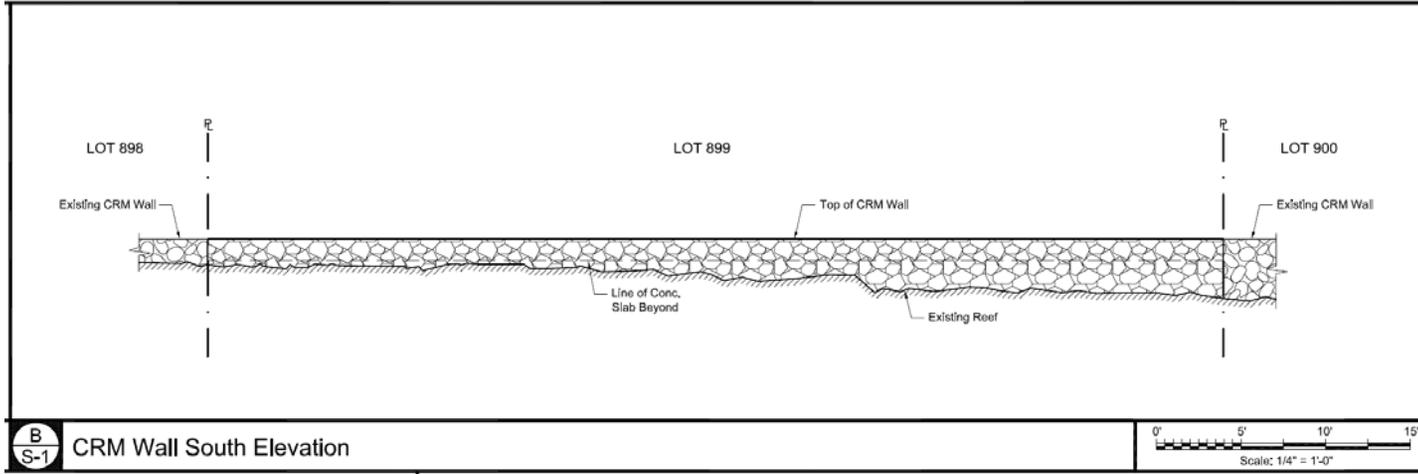
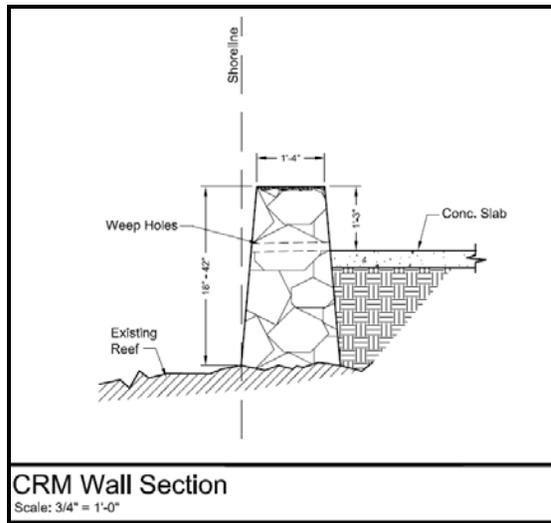
Figure 2-6 Plans and specifications for the new CRM wall

B
S-1 CRM Wall South Elevation

CRM RETAINING WALL

8. Mortar shall be of free flowing consistency and shall fill all voids inbetween stones.
9. Weep holes shall be placed at 6'-0" on centers horizontal and vertical. Add gravel (1.5 Cft) and geotextile fabric over and around the weeper pipe.

The concrete slab extends 11 ft behind the wall and covers the entire 60-ft width of the lot (Figures 2-5 and 2-6). The slab is approximately 4 in thick. As of this writing (approximately one year after construction), there are no visible cracks in the slab.

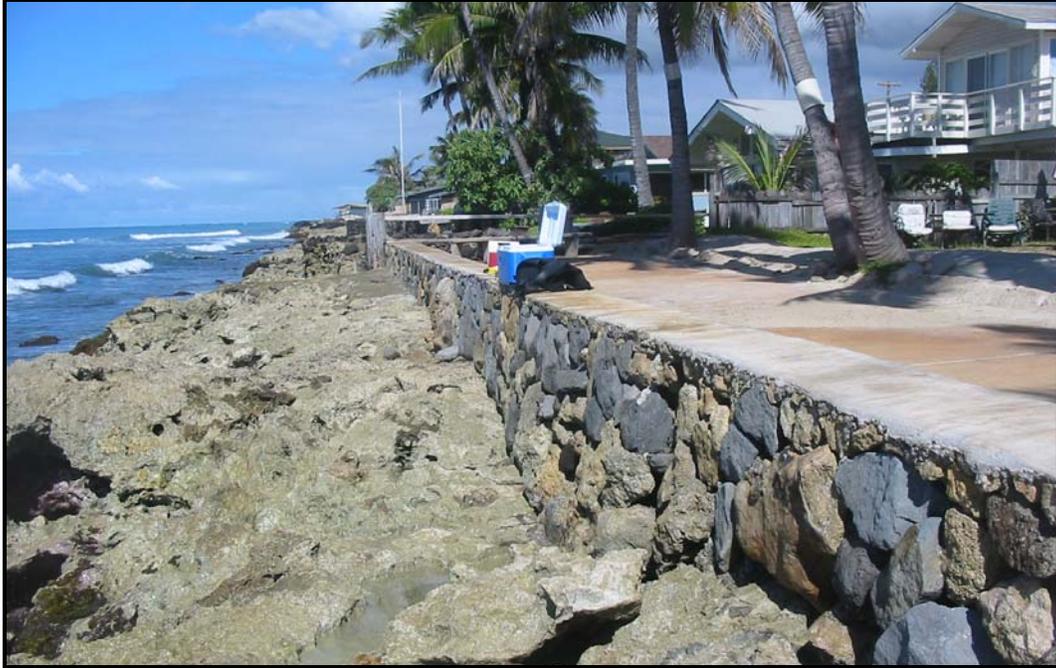
Figure 2-7 View of CRM wall looking west

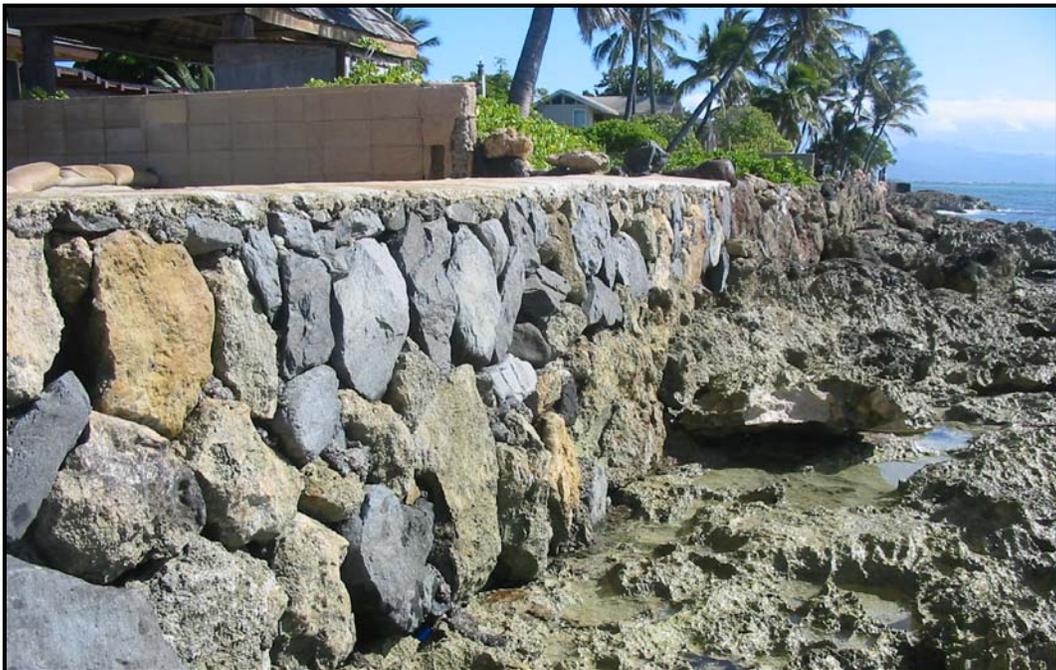
Figure 2-8 View of CRM wall looking east

The shoreline in the project vicinity has a "Zone AE" flood hazard designation on the FEMA Flood Insurance Rate Map (FIRM), with a base flood elevation of 8 ft. The project topographic drawing is shown in Figure 5-1. The average top wall elevation (8.9 to 9 ft) is approximately 1 ft above the regulatory flood elevation. Both adjacent properties have walls equal in height at the property boundaries (see Figures 2-8, 2-10, and 5-1). Therefore, the presence of the wall will not

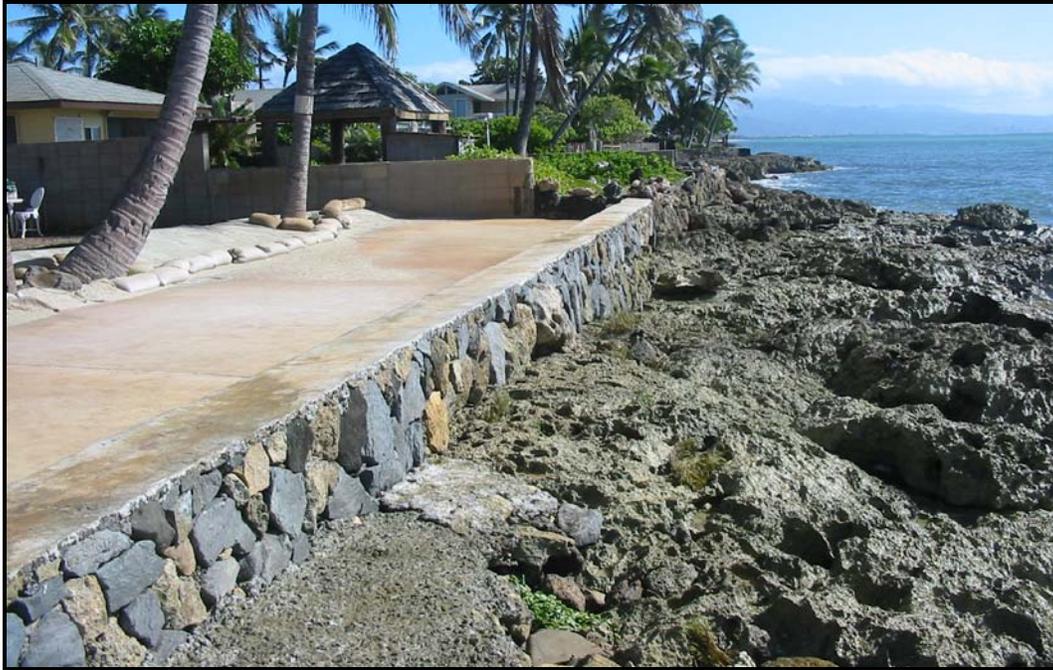
Figure 2-9 View of CRM wall and concrete slab splash apron

The low CRM wall and concrete splash apron act together to 1) prevent the full force of waves from propagating into the property and 2) drain the overtopping and wave splash of wave impact against the wall during high wave conditions. Because of the project construction, the property owner has a safer terrain, has full use of her backyard, and has a better viewplane.

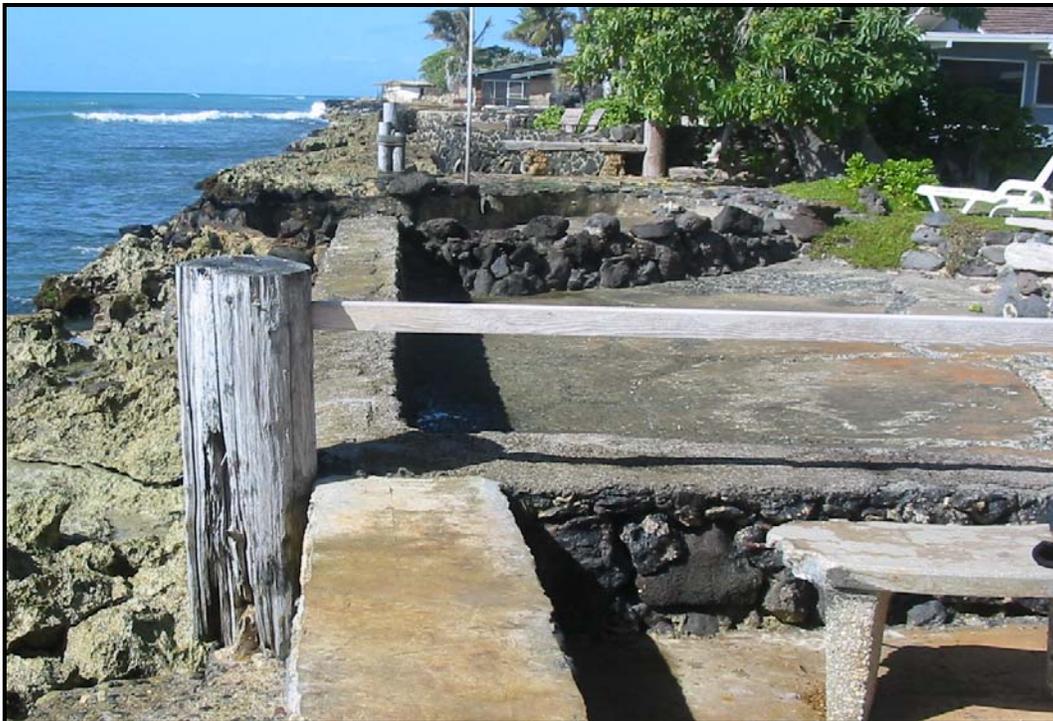
Figure 2-10 Location of wall relative to adjacent property (west)

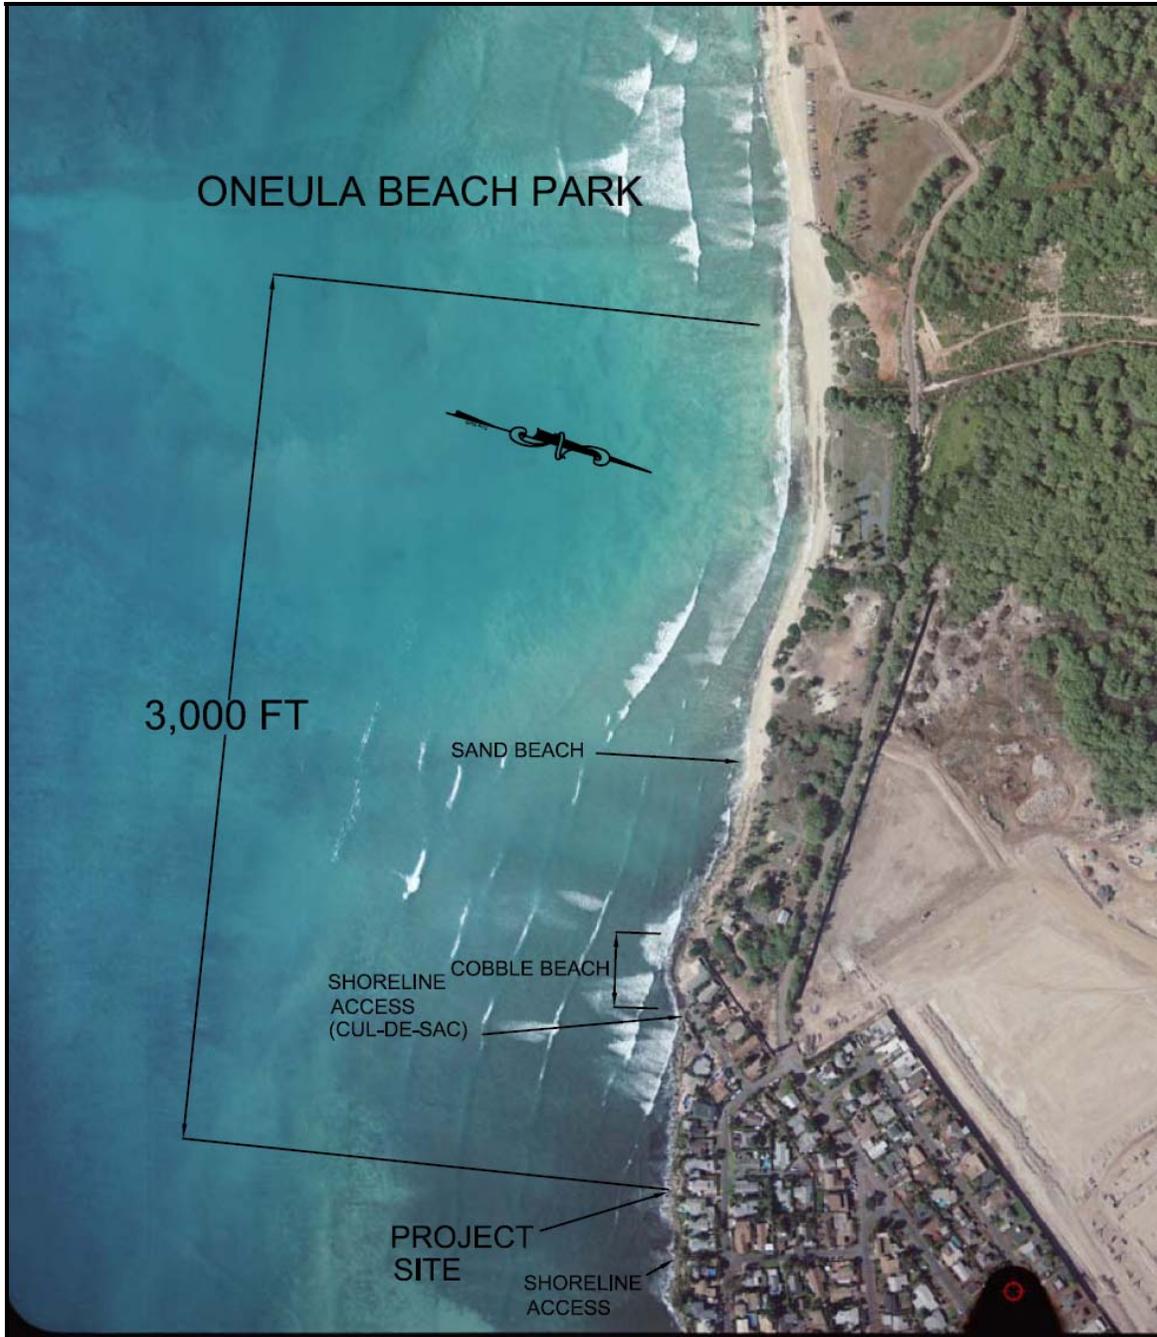
Figure 3-2 Shoreline west of the project site

Figure 3-2 is an aerial photograph that shows shoreline features over a distance of 3,000 ft west of the project site. The elevated limestone platform narrows and is replaced by a basalt cobble and boulder berm approximately 550 ft west of the project, near the cul-de-sac shoreline access (Pupu Place). However, it is likely that the limestone underlies the cobbles and boulders, as it reappears on the shoreline after approximately 500 ft. The basalt cobble and boulder berm is likely a constructed shore protection feature.

A sand beach overlies the limestone approximately 1,500 ft west of the project site and continues into Oneula Beach Park, approximately 3,000 ft from the project.

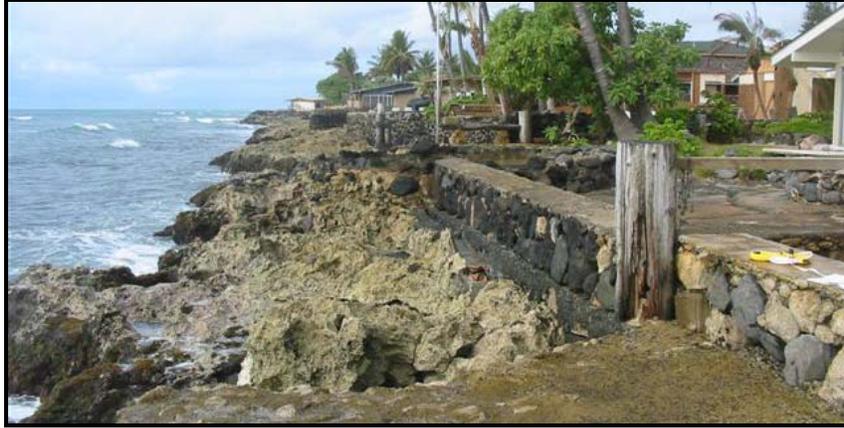
Figure 3-3 Photograph of adjacent property (1)

Photographs of the shoreline at adjacent property, 91-435 Pupu Street, showing seawall and landscaping pool

The adjacent property to the west (91-435 Pupu Street) contains a seawall similar in size and shape to the applicant's (Figure 3-3). The seawall changes into a landscape pool feature at the west side of the property (Figures 3-4 and 3-5).

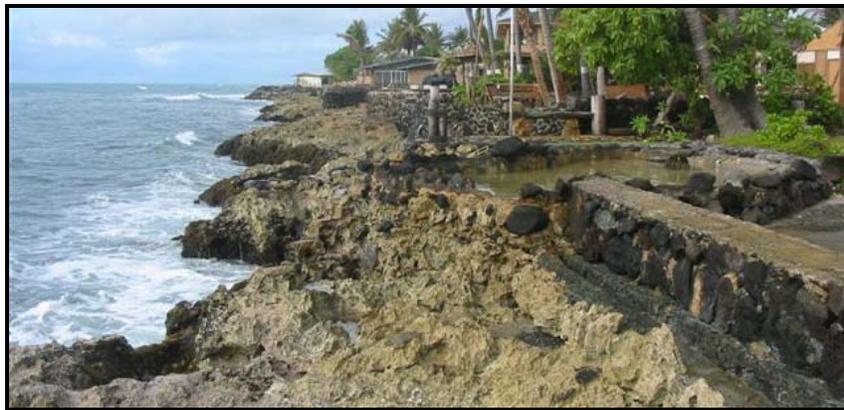
Figure 3-4 Photograph of adjacent property (2)

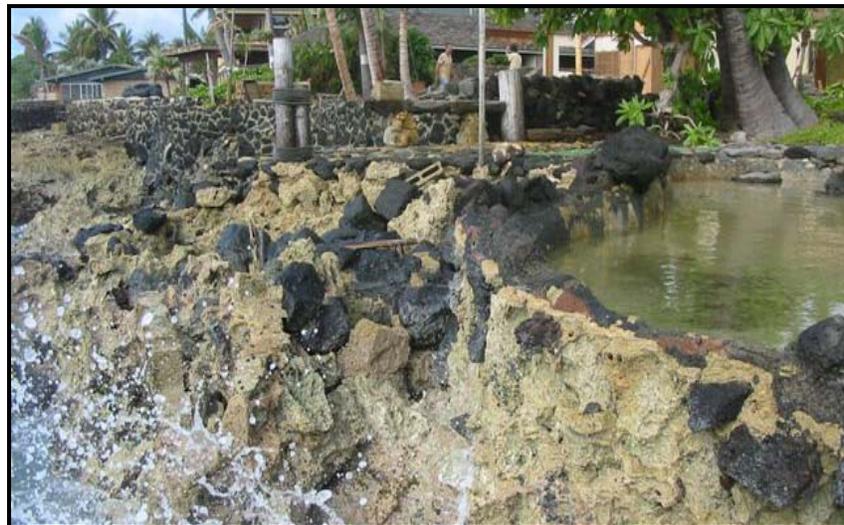
Figure 3-5 Photograph of adjacent property (3)

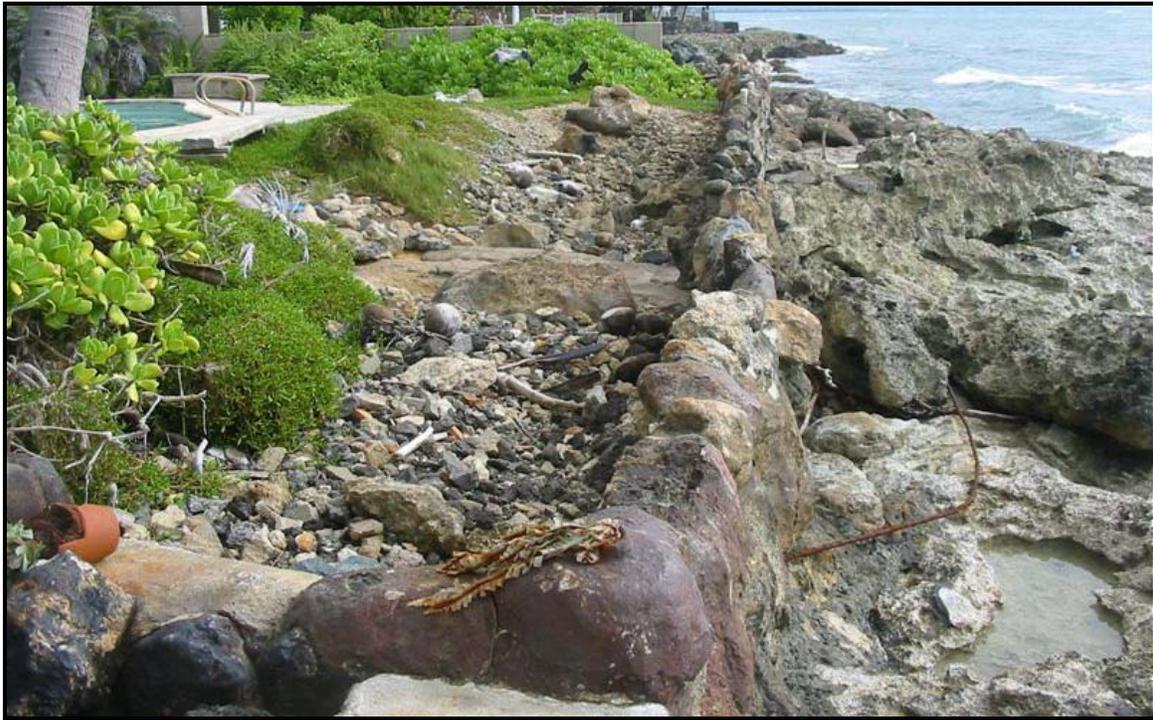
Figure 3-6 Legal non-conforming seawall at 41-453 Pupu Street

The property east of the project property has a legal non-conforming seawall. At the time the applicant's seawall was constructed, this property used the same contractor to repair and rebuild the non-conforming wall. The construction was done without a permit and the owner was given a notice of violation by the City and County of Honolulu DPP. Because the property owner had the right to repair the wall in kind up to 50% of its value, Sea Engineering wrote letters on behalf of the owner offering justification for the repairs. However, the DPP considered the repairs to have unjustifiably altered the wall. The property owner elected to demolish the repair work rather than go through the extensive permit application and environmental review process as reflected in the current document.

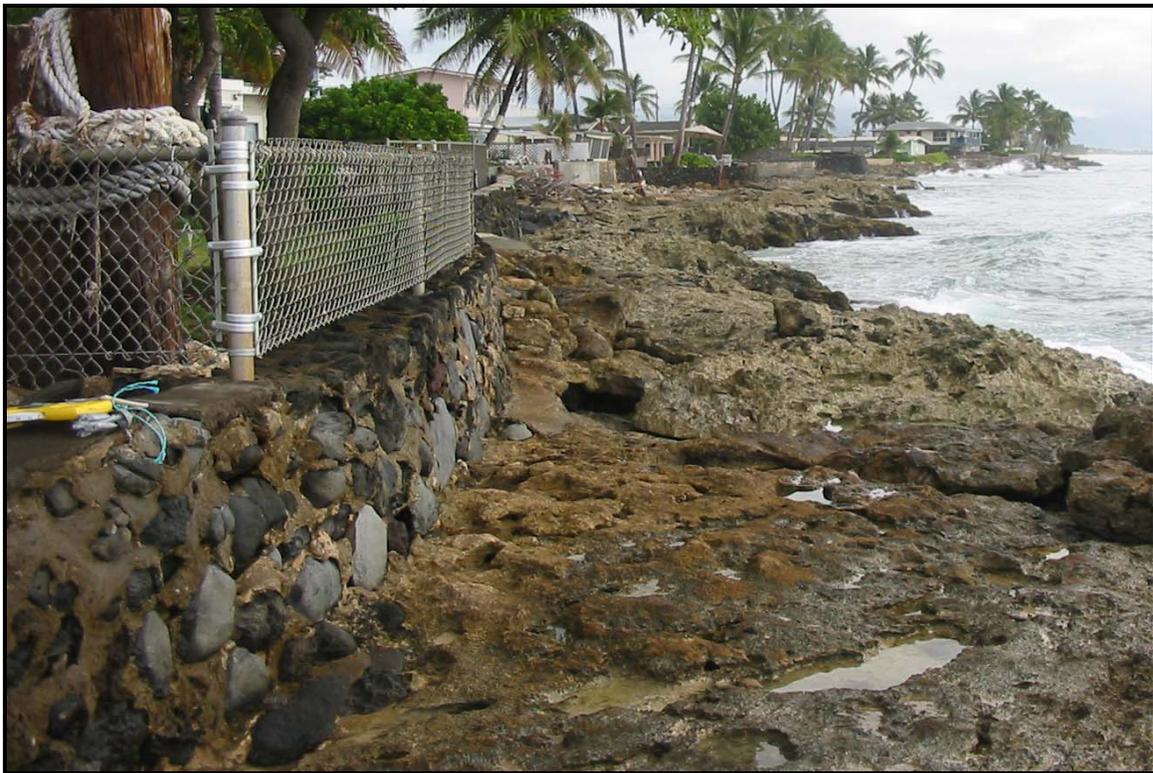
Figure 3-8 Certified shoreline (follows wall), TMK 9-1-30:01

All nearby properties are protected by seawalls for protection from flooding due to wave overtopping during extreme events. A search for certified shoreline records recovered five properties on the applicant's tax map that have had certified shorelines recorded along the seawall. Figure 3-7 shows the five properties on the tax map with the date of shoreline certification. Figures 3-8 through 3-12 are photographs of these shorelines. The photographs also typify the regional shoreline conditions.

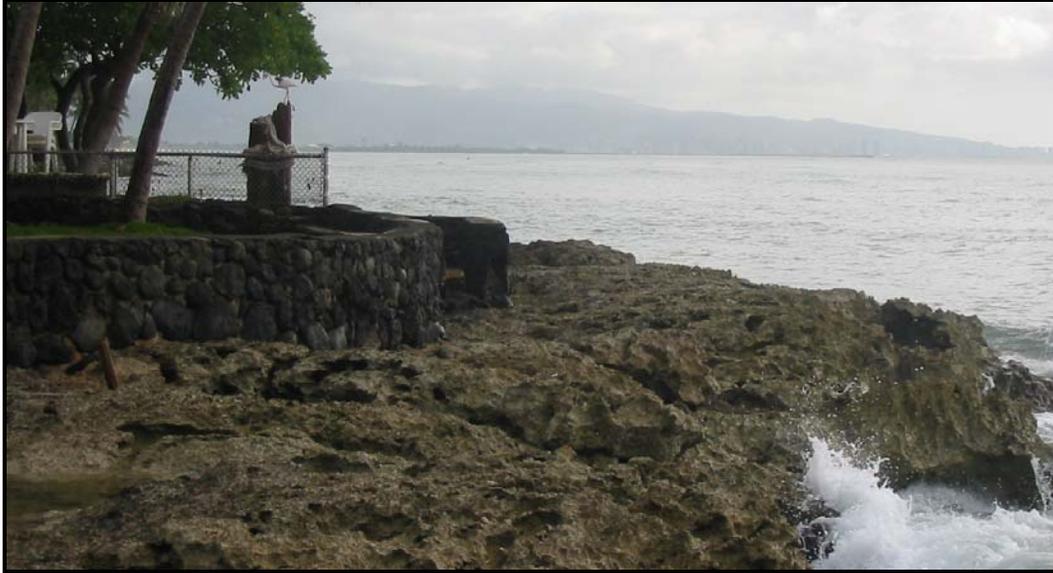
Figure 3-9 Certified shoreline (follows wall), TMK 9-1-30:02

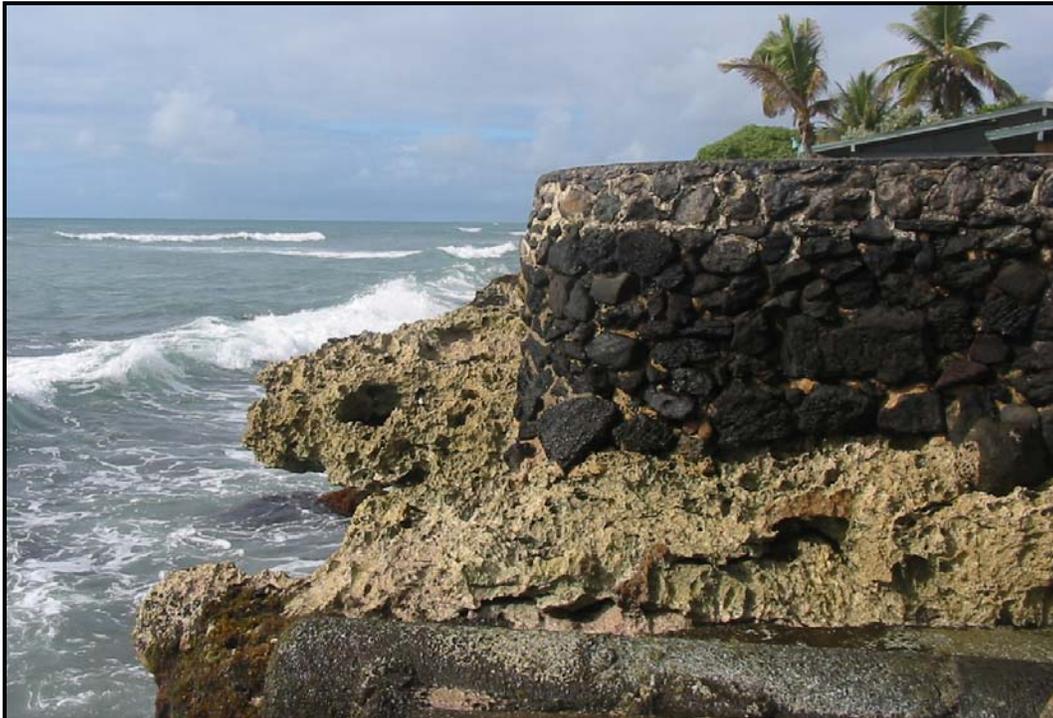
Figure 3-10 Certified shoreline (follows wall), TMK 9-1-30:12

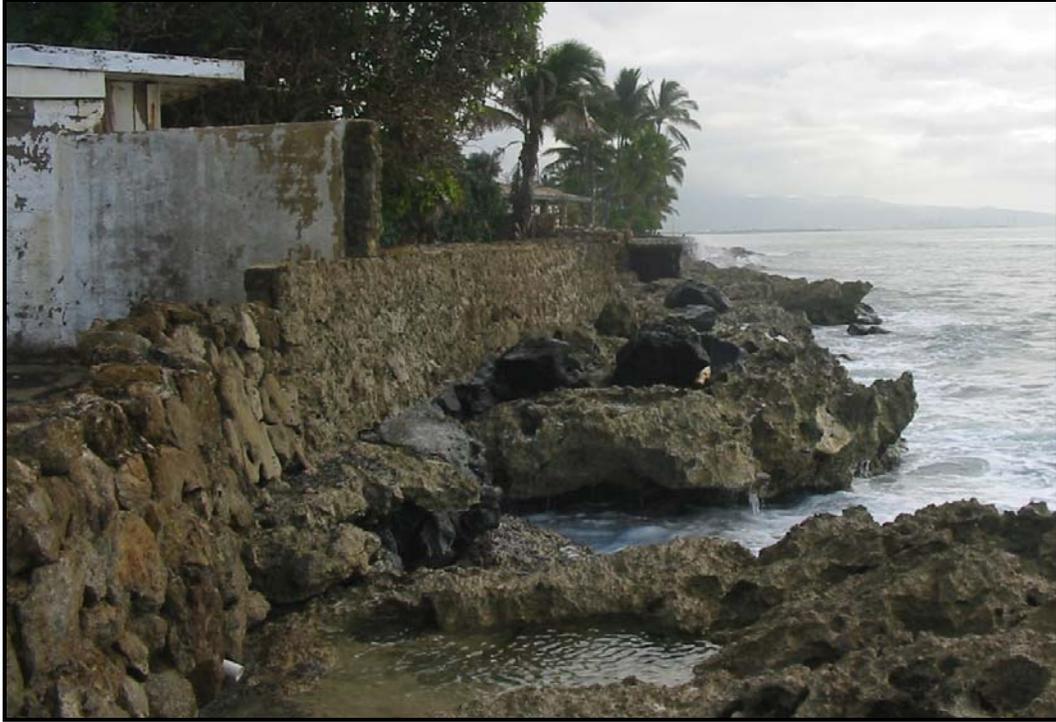
Figure 3-11 Certified shoreline (follows wall), TMK 9-1-30:14

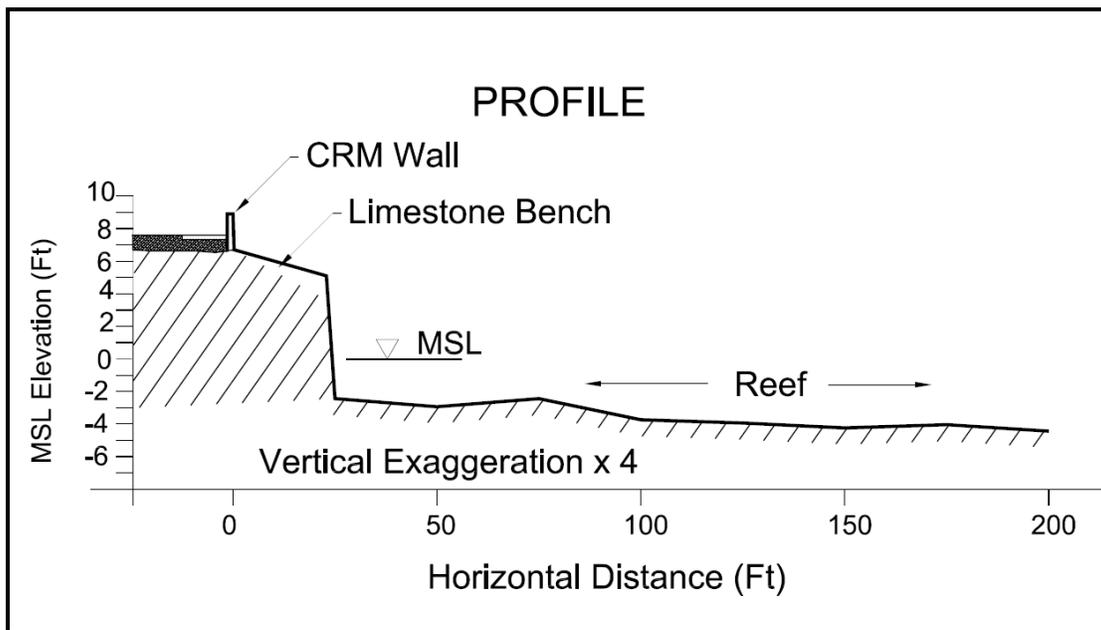
Figure 3-13 Typical profile of the project site

A rocky irregular bottom composed of coralline limestone with limu growth typifies the offshore bottom conditions. No sand pockets or sand channels were observed in the vicinity.

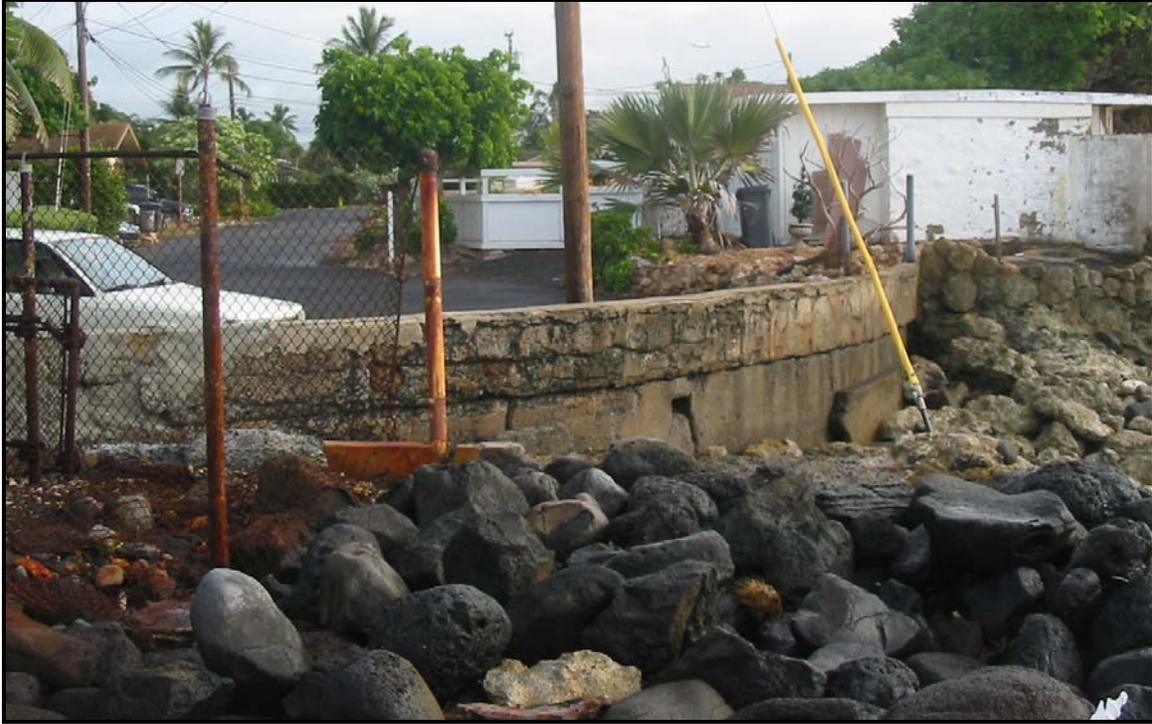
Figure 3-14 Shoreline access west of the project site (Pupu Place cul-de-sac)

A coastal access easement exists approximately 200 ft east of the subject property (see Figure 2-2). Access is also provided approximately 540 ft west of the subject property at the cul-de-sac termination of Pupu Place public street (Figure 3-14). However, access is difficult and unsafe from this direction due to the treacherous rocky shoreline conditions.

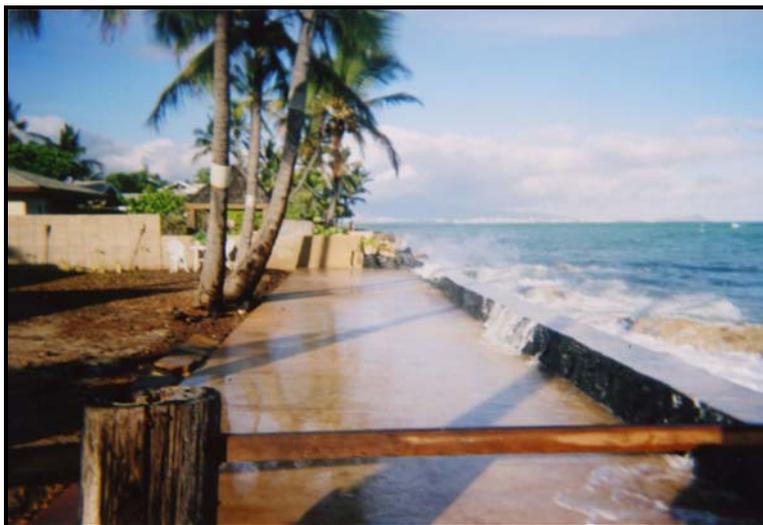
Figure 3-15 Wave overtopping during high tide conditions

Studies conducted by SEI near the project site have indicated that large yearly wave events can be expected to reach the nominal 6 to 7 ft elevation of the base of the wall. More extreme Hurricane waves can be expected to severely overtop the wall, and will likely cause flooding in the home. Figure 3-2 is a photograph of waves overtopping the seawall during high tide and large wave conditions, and shows that the wall is necessary to prevent wave bore propagation into the property.
