*Draft Environmental Assessment*

# **Waterfront Passive Park & Waipahu Depot Road Improvements**

WAIPAHU, OAHU, STATE OF HAWAII

MARCH 2009

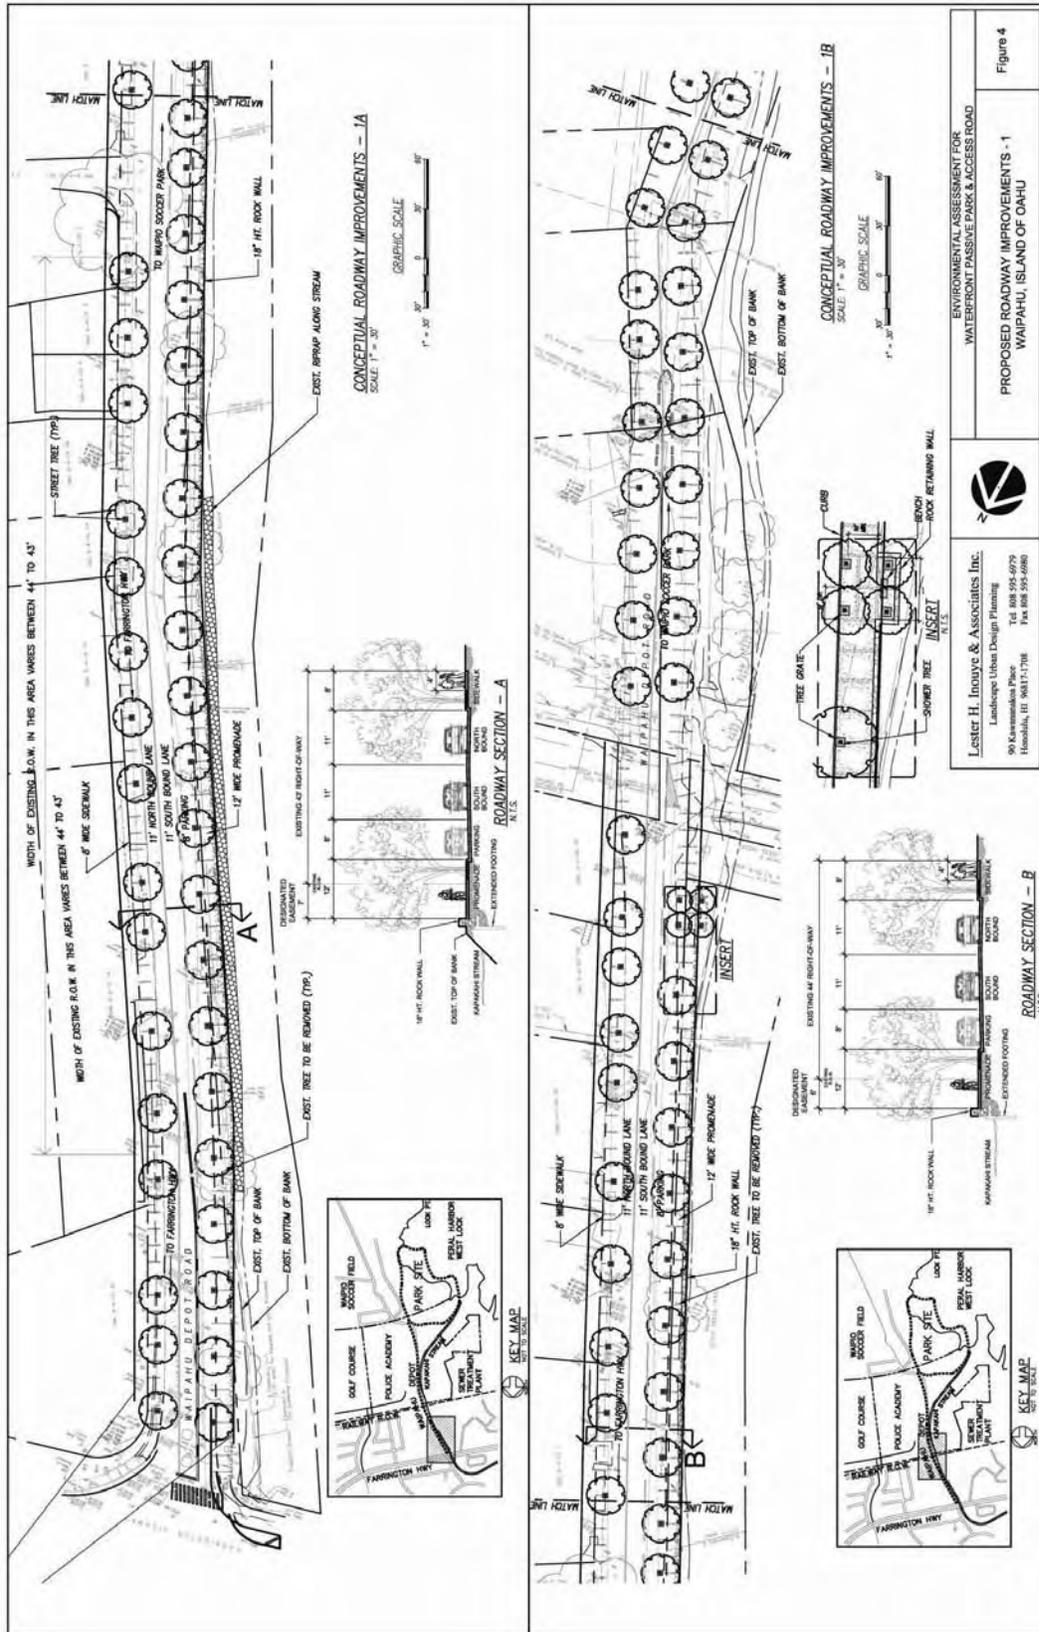
ENVIRONMENTAL ASSESSMENT FOR  
 WATERFRONT PASSIVE PARK & ACCESS ROAD  
 PROPOSED ROADWAY IMPROVEMENTS - 1  
 WAIPAHU, ISLAND OF OAHU

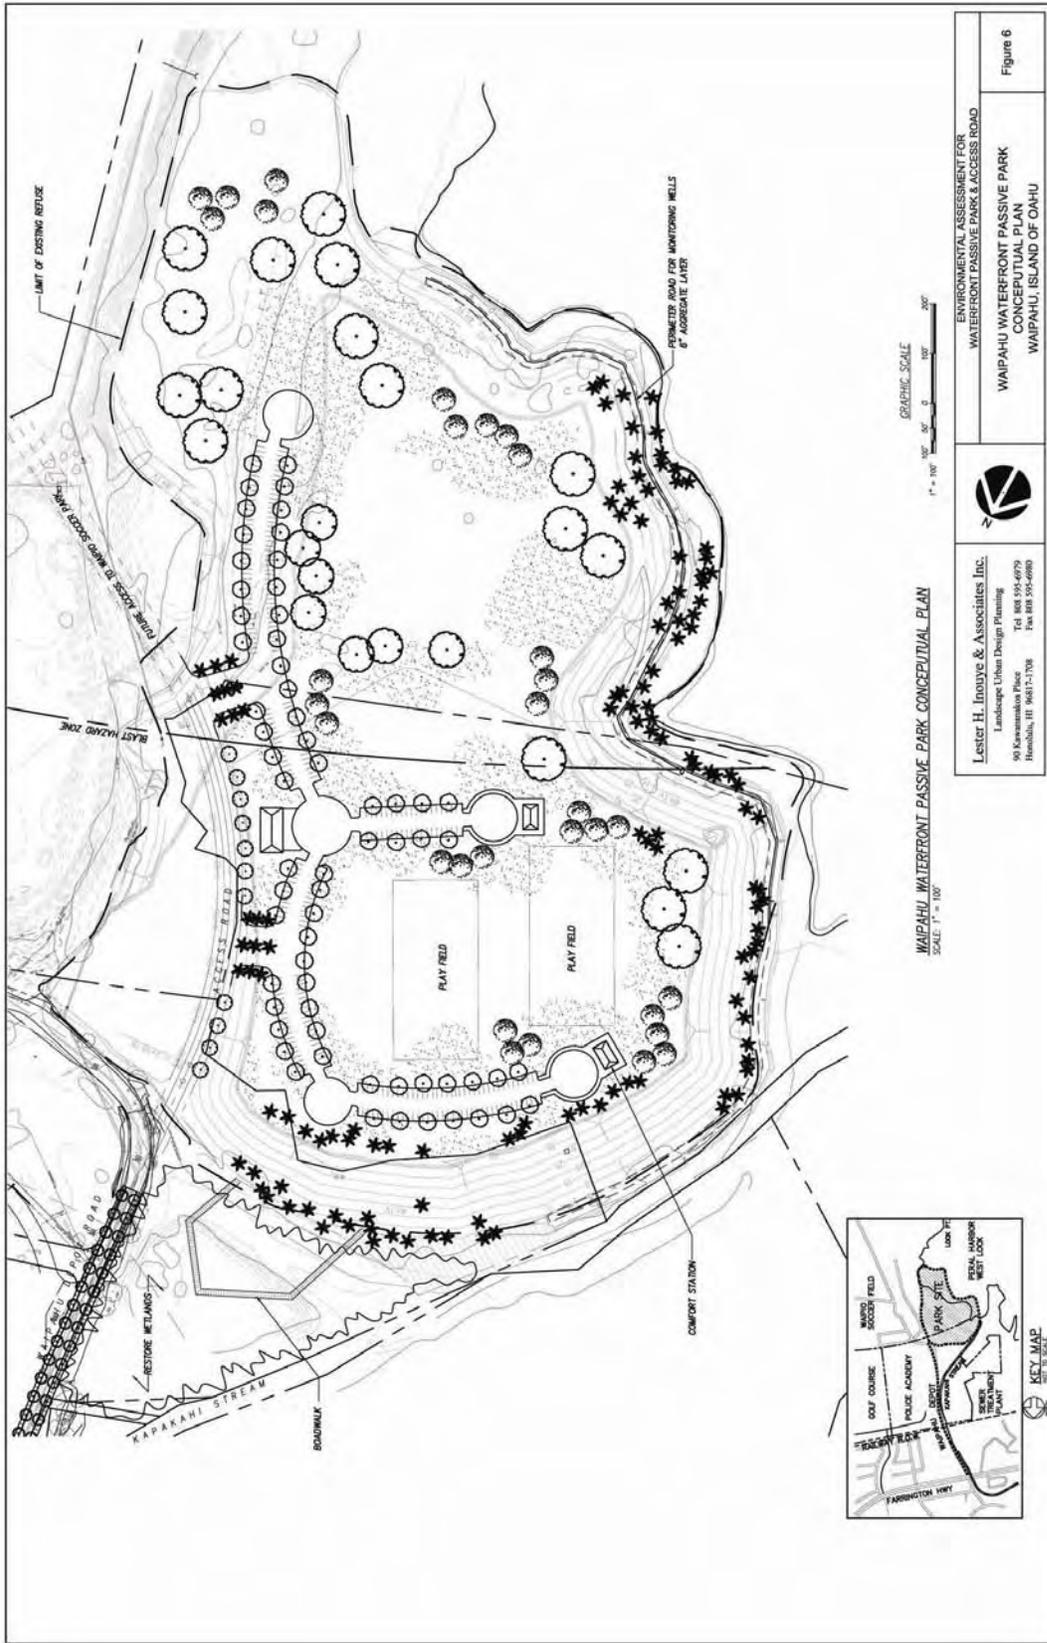
ENVIRONMENTAL ASSESSMENT FOR  
 WATERFRONT PASSIVE PARK & ACCESS ROAD  
 WAIPAHU WATERFRONT PASSIVE PARK  
 CONCEPTUAL PLAN  
 WAIPAHU, ISLAND OF OAHU

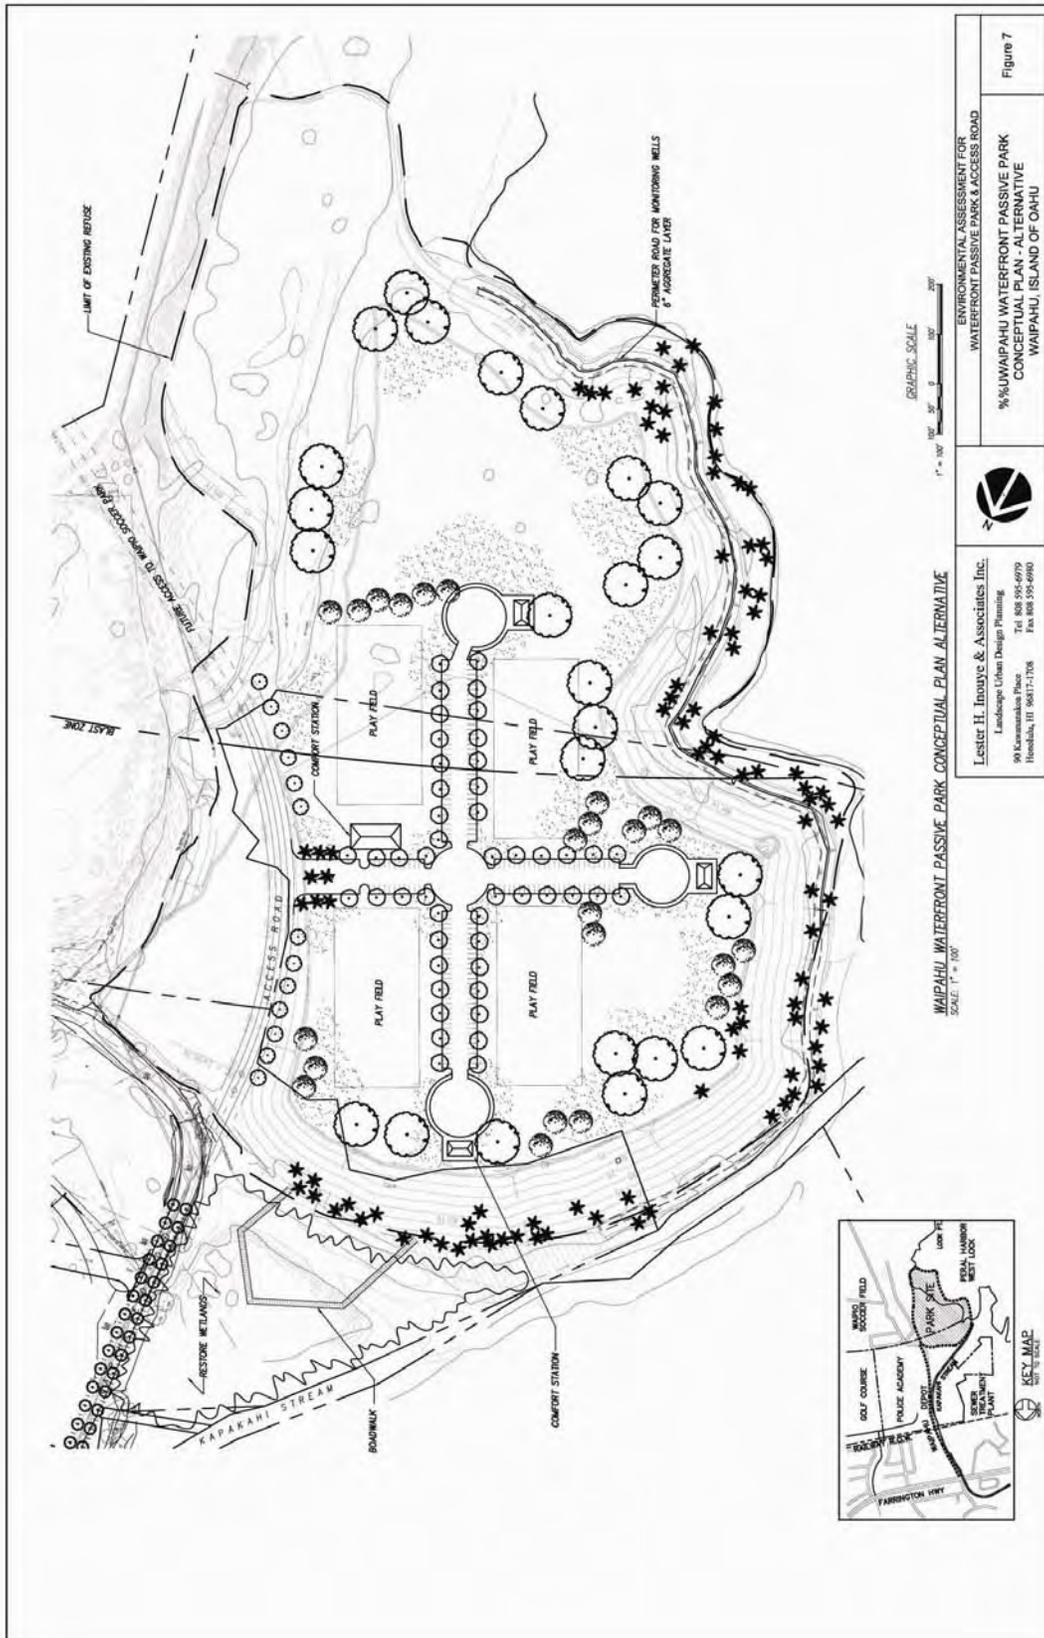
ENVIRONMENTAL ASSESSMENT FOR  
 WATERFRONT PASSIVE PARK & ACCESS ROAD  
 %LUWAIPAHA WATERFRONT PASSIVE PARK  
 CONCEPTUAL PLAN - ALTERNATIVE  
 WAIPAHA, ISLAND OF OAHU

In this alternative, conversion of closed ash landfill to a recreational facility would require precautions be established to protect the integrity of the closed ash landfill. Additional design features may include increased soil layer thickness to allow special turf establishment and accommodate a buried irrigation system. Conversion to a park will also require the City to go through the National Environmental Policy Act (NEPA) review process and gain approvals from the Department of Health, Department of Land and Natural Resources, and the Navy. The post-closure plan would need to be modified as necessary to include any changes to the landfill cap.

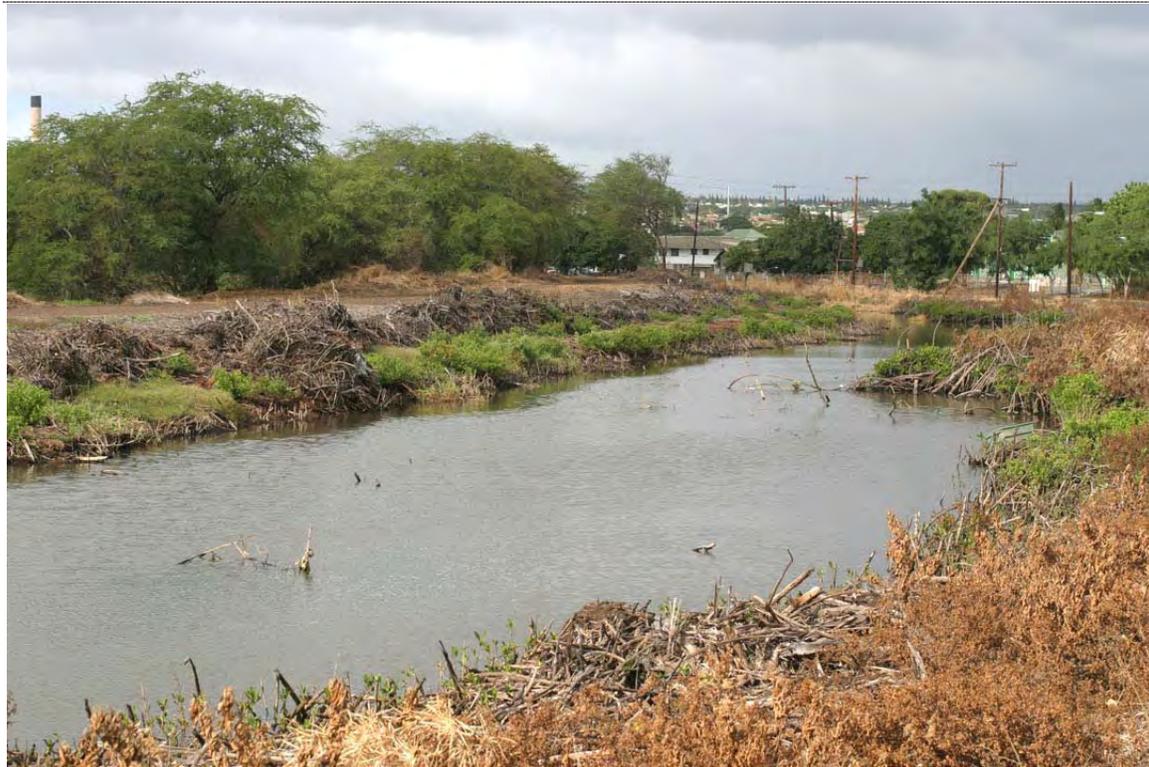
Figure 3. Kapakahi Stream channel (estuarine reach) downstream from the state energy corridor crossing showing banks recently (January 2007) cleared of trees and brush.

were cleared from Kapakahi Stream (ORCDC, 2006; Fig. 3). In early 2007, mangroves (except for widely scattered seedlings) were no longer present in the main channel and a side channel leading eastward and its banks had been covered with chipped mulch. The banks of the channel adjacent to Waipahu Depot Road are low but steep and have very little vegetation (Fig. 4).

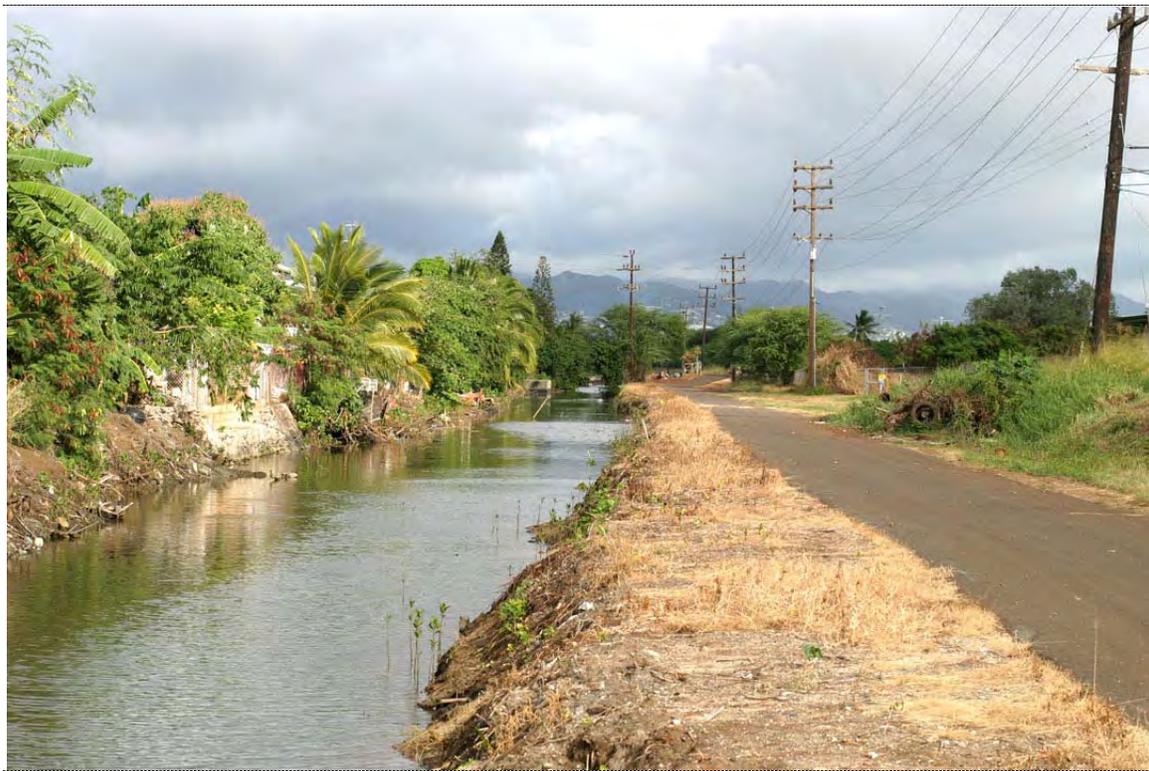
Figure 3. Kapakahi Stream (estuarine reach) looking upstream with Waipahu Depot Road on right.

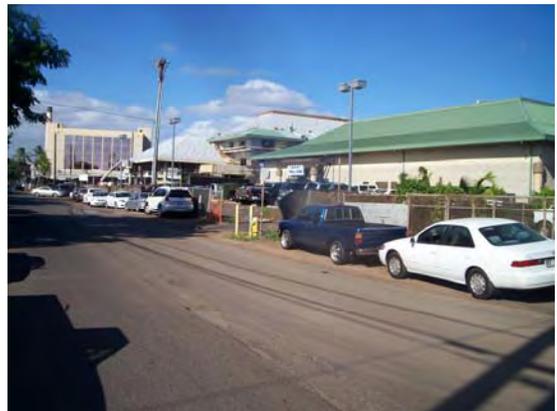
Photo 4: Asphalt surface cuts observed along the southern half of the Site.

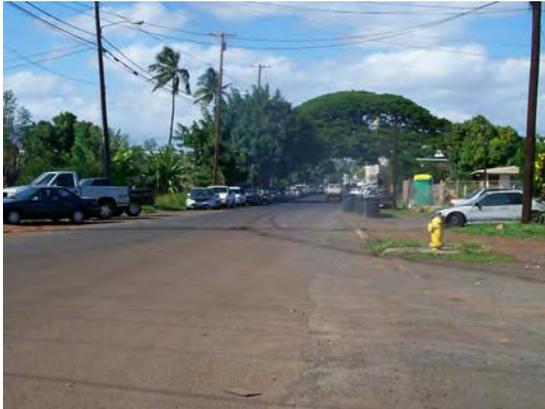
Photo 6: Example of typical wear and tear surface abnormalities observed more on the southern half of the Site.

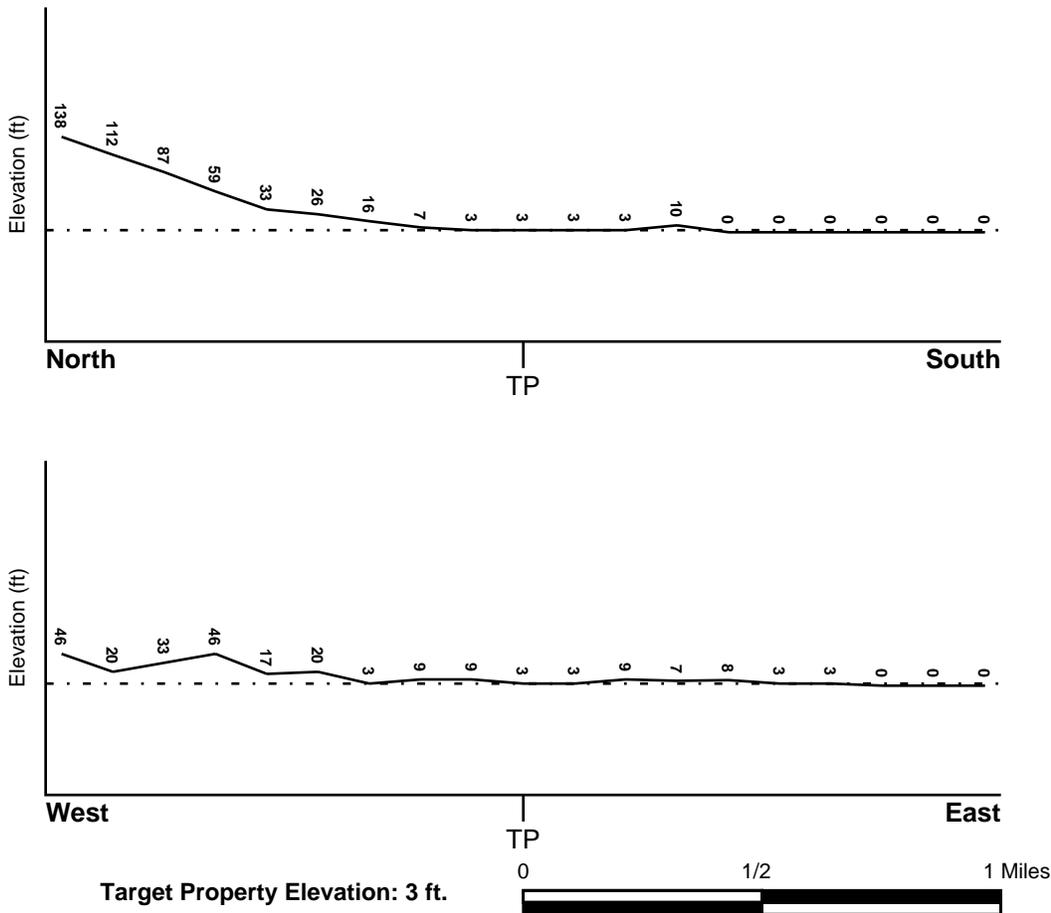
Source: Topography has been determined from the USGS 7.5' Digital Elevation Model and should be evaluated on a relative (not an absolute) basis. Relative elevation information between sites of close proximity should be field verified.

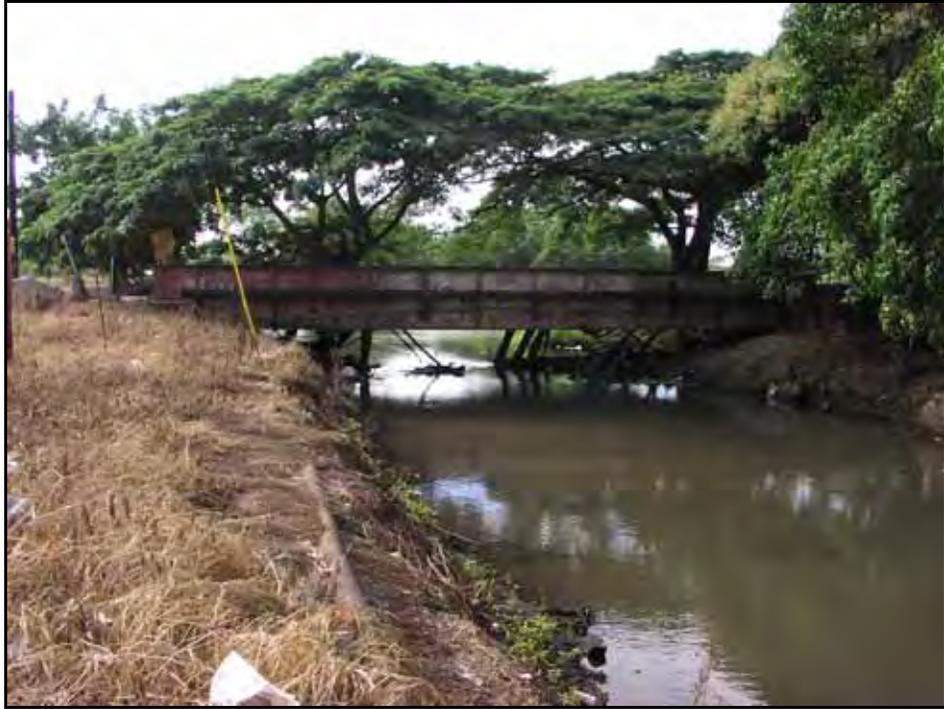
Figure 18. Photograph of the O.R. & L. Bridge across Kapakahi stream, looking south

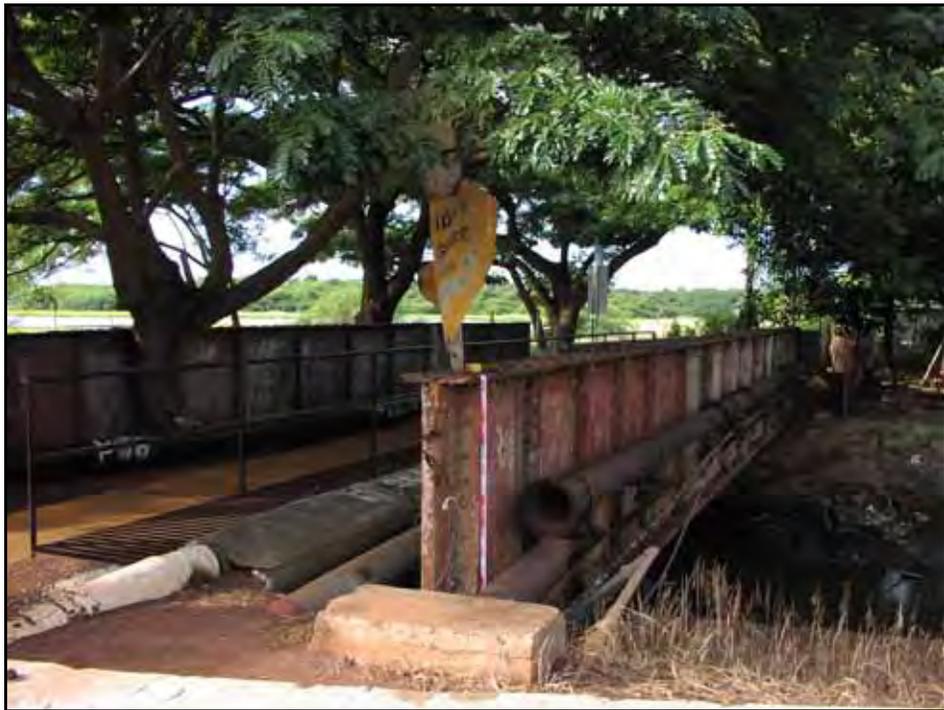
Figure 19. Photograph of the O.R. & L. Bridge looking west at utility lines crossing the bridge.

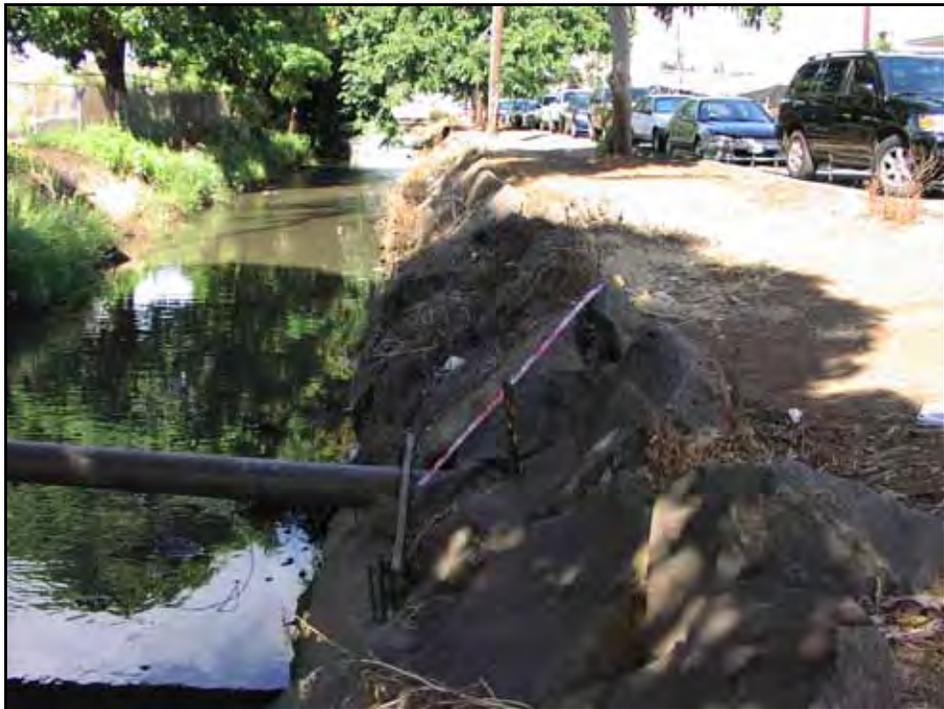
Figure 21. Photograph of a retaining wall and utility pipe along Kapakahi Stream; view to the north

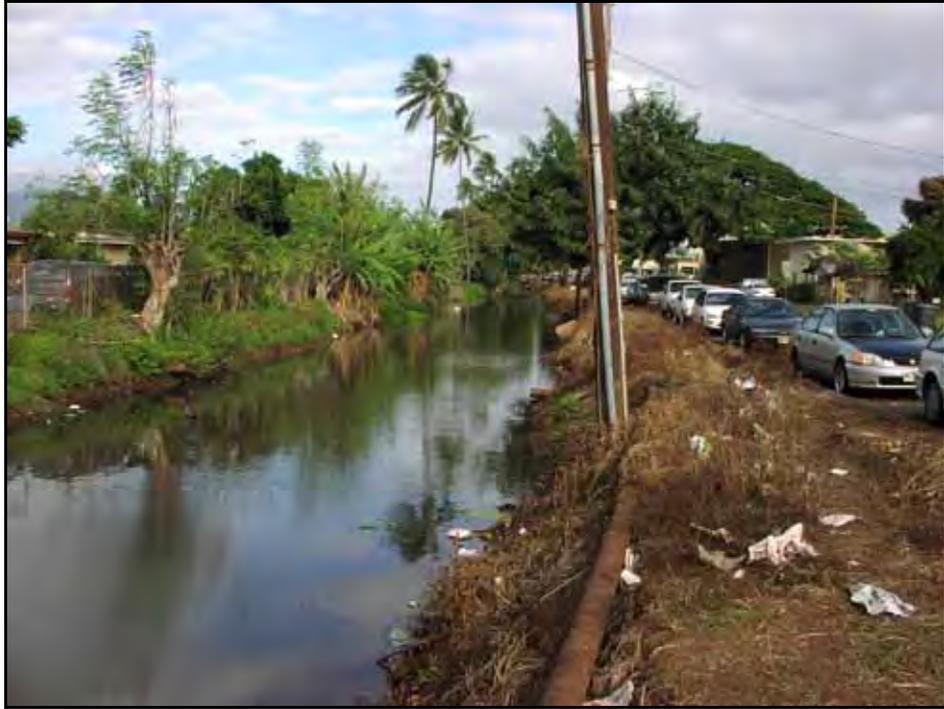
Figure 22. Photograph of the steel pipe visible intermittently along Waipahu Depot Street; view to the north

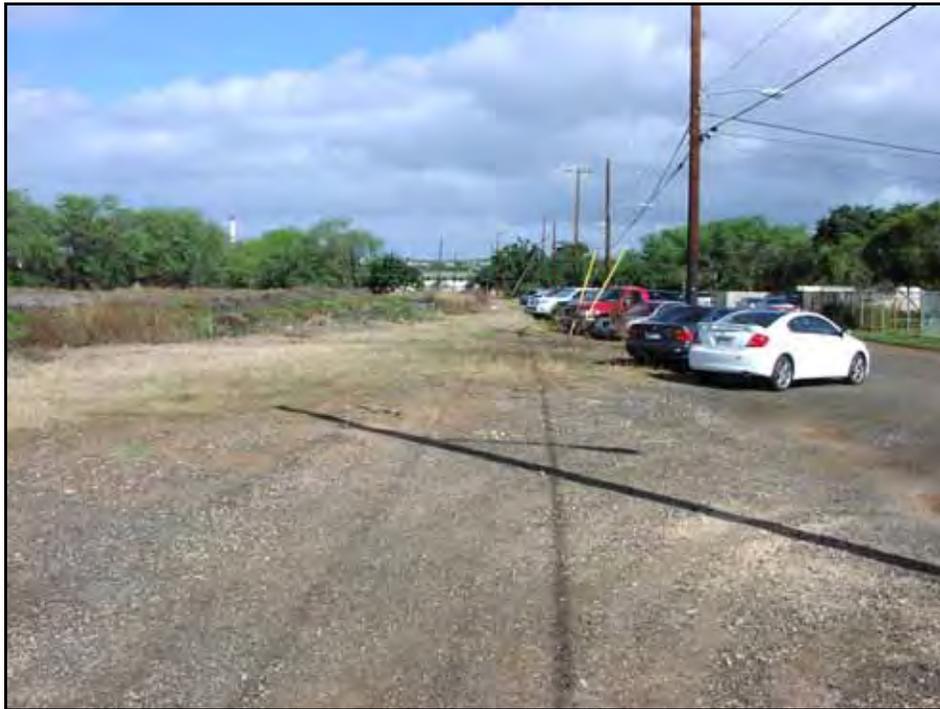
Figure 25. Photograph of Waipahu Depot Road and the graded stream bank across the street from the police academy; view to the northeast

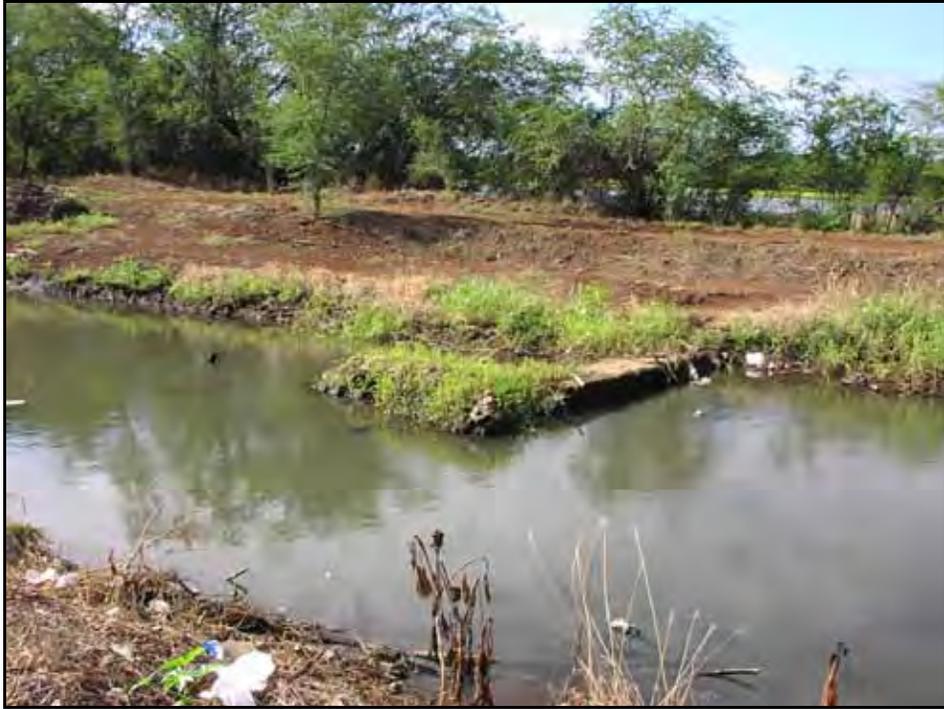
Figure 26. Photograph of concrete blocks in Kapakahi Stream potentially used for water control

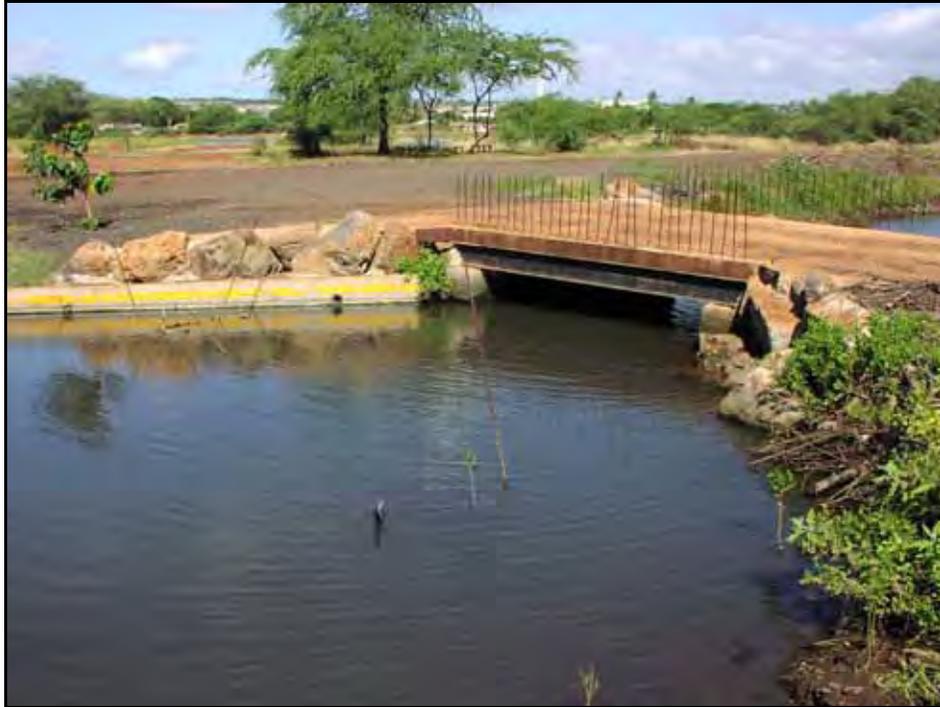
Figure 30. Photograph of modern bridge crossing Kapakahi Stream, photo scale is 1 meter long; view to the northwest
