Subject: Chapter 343, Hawaii Revised Statutes  
Environmental Assessment (EA)/Determination  
Finding of No Significant Impact

**FINAL ENVIRONMENTAL ASSESSMENT**

**SHORELINE SETBACK VARIANCE**

TMK: 6-8-10: 019  
68-683 Farrington Highway  
Mokuleia, Oahu, Hawaii

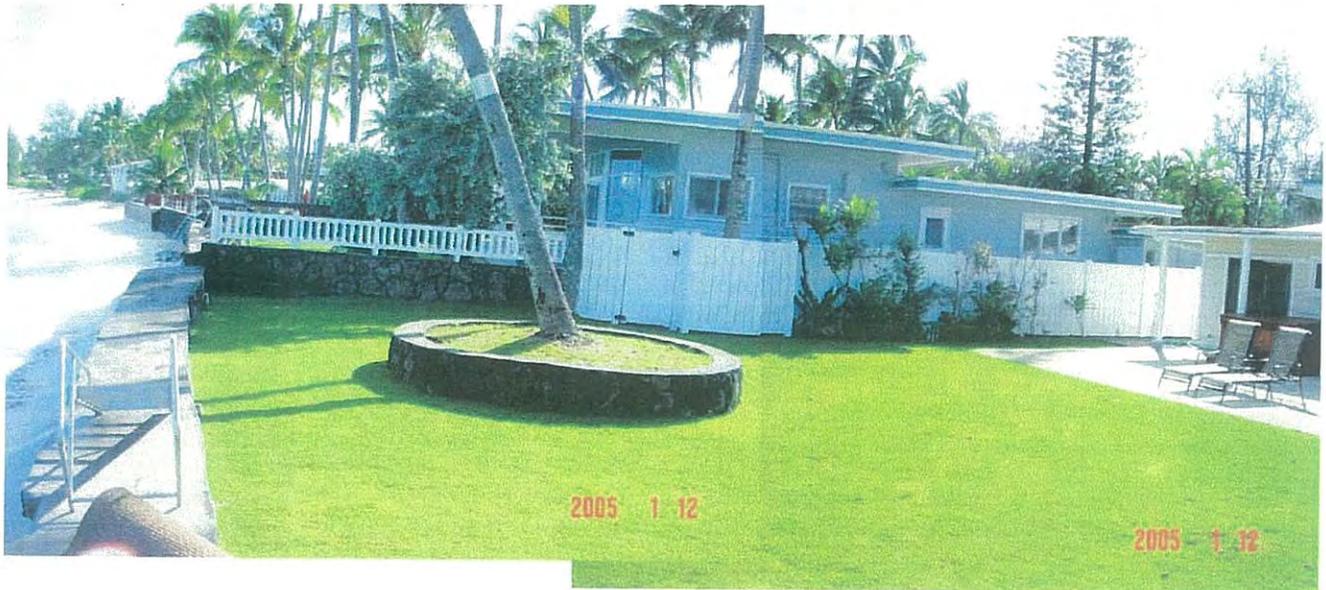
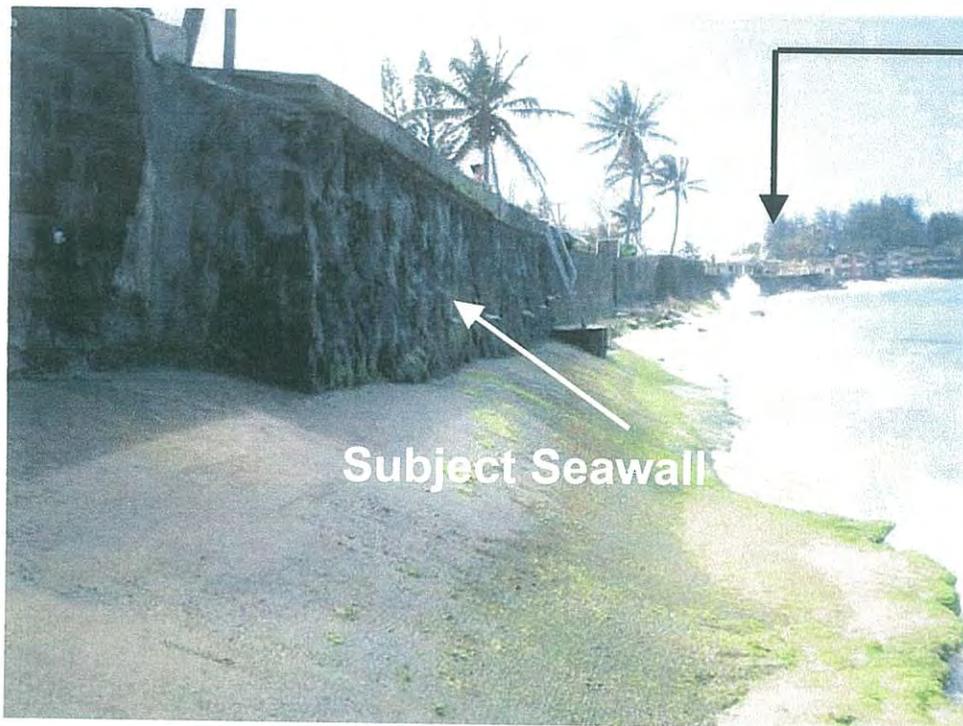
**Figure 3A**  
**SUBJECT SEAWALL TMK: 6-8-10: 019**  
68-683 Farrington Highway, Mokuleia, Oahu, Hawaii

**3A.1** Mokuleia  
TMK: 6-8-10:19  
Photo date 01-12-05  
By Hida, Okamoto & Assoc.

DPP approved  
seawall on 4 lots  
TMK: 6-8-10: 23, 24,  
25, 26

**3A.2**  
Mokuleia  
TMK: 6-8-10:19  
Photo date 04-02-05  
Time 2:00 pm  
By EKNA Services  
Tide approx. 0.1' MLLW

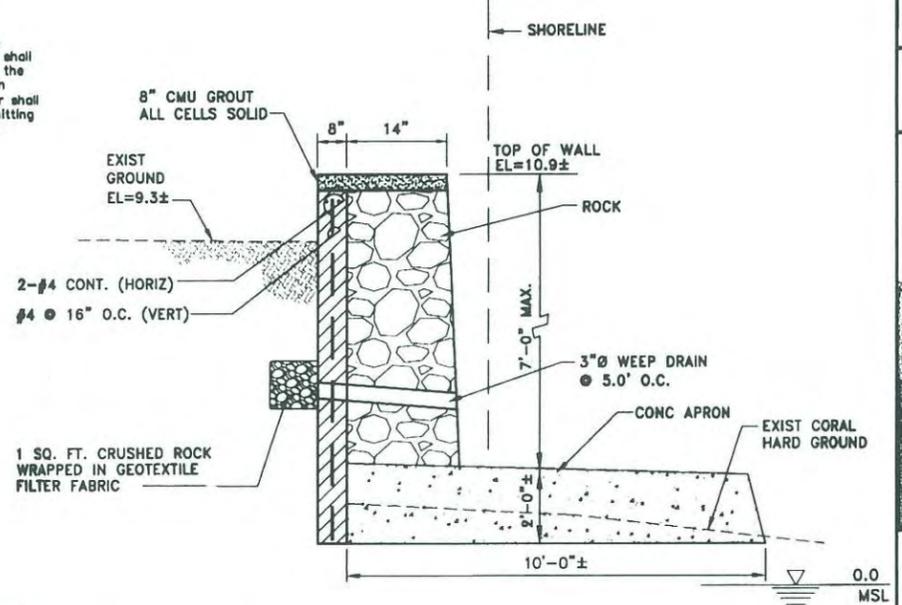
TYPICAL WALL DETAIL  
SCALE: 1/2" = 1'-0"

NOTE: BACKFILL UTILIZED : 27 Cu. Yd.

- For Bench Mark, see sheet C-1.
  - Assumed Life expectancy for Seawall is 30 years.

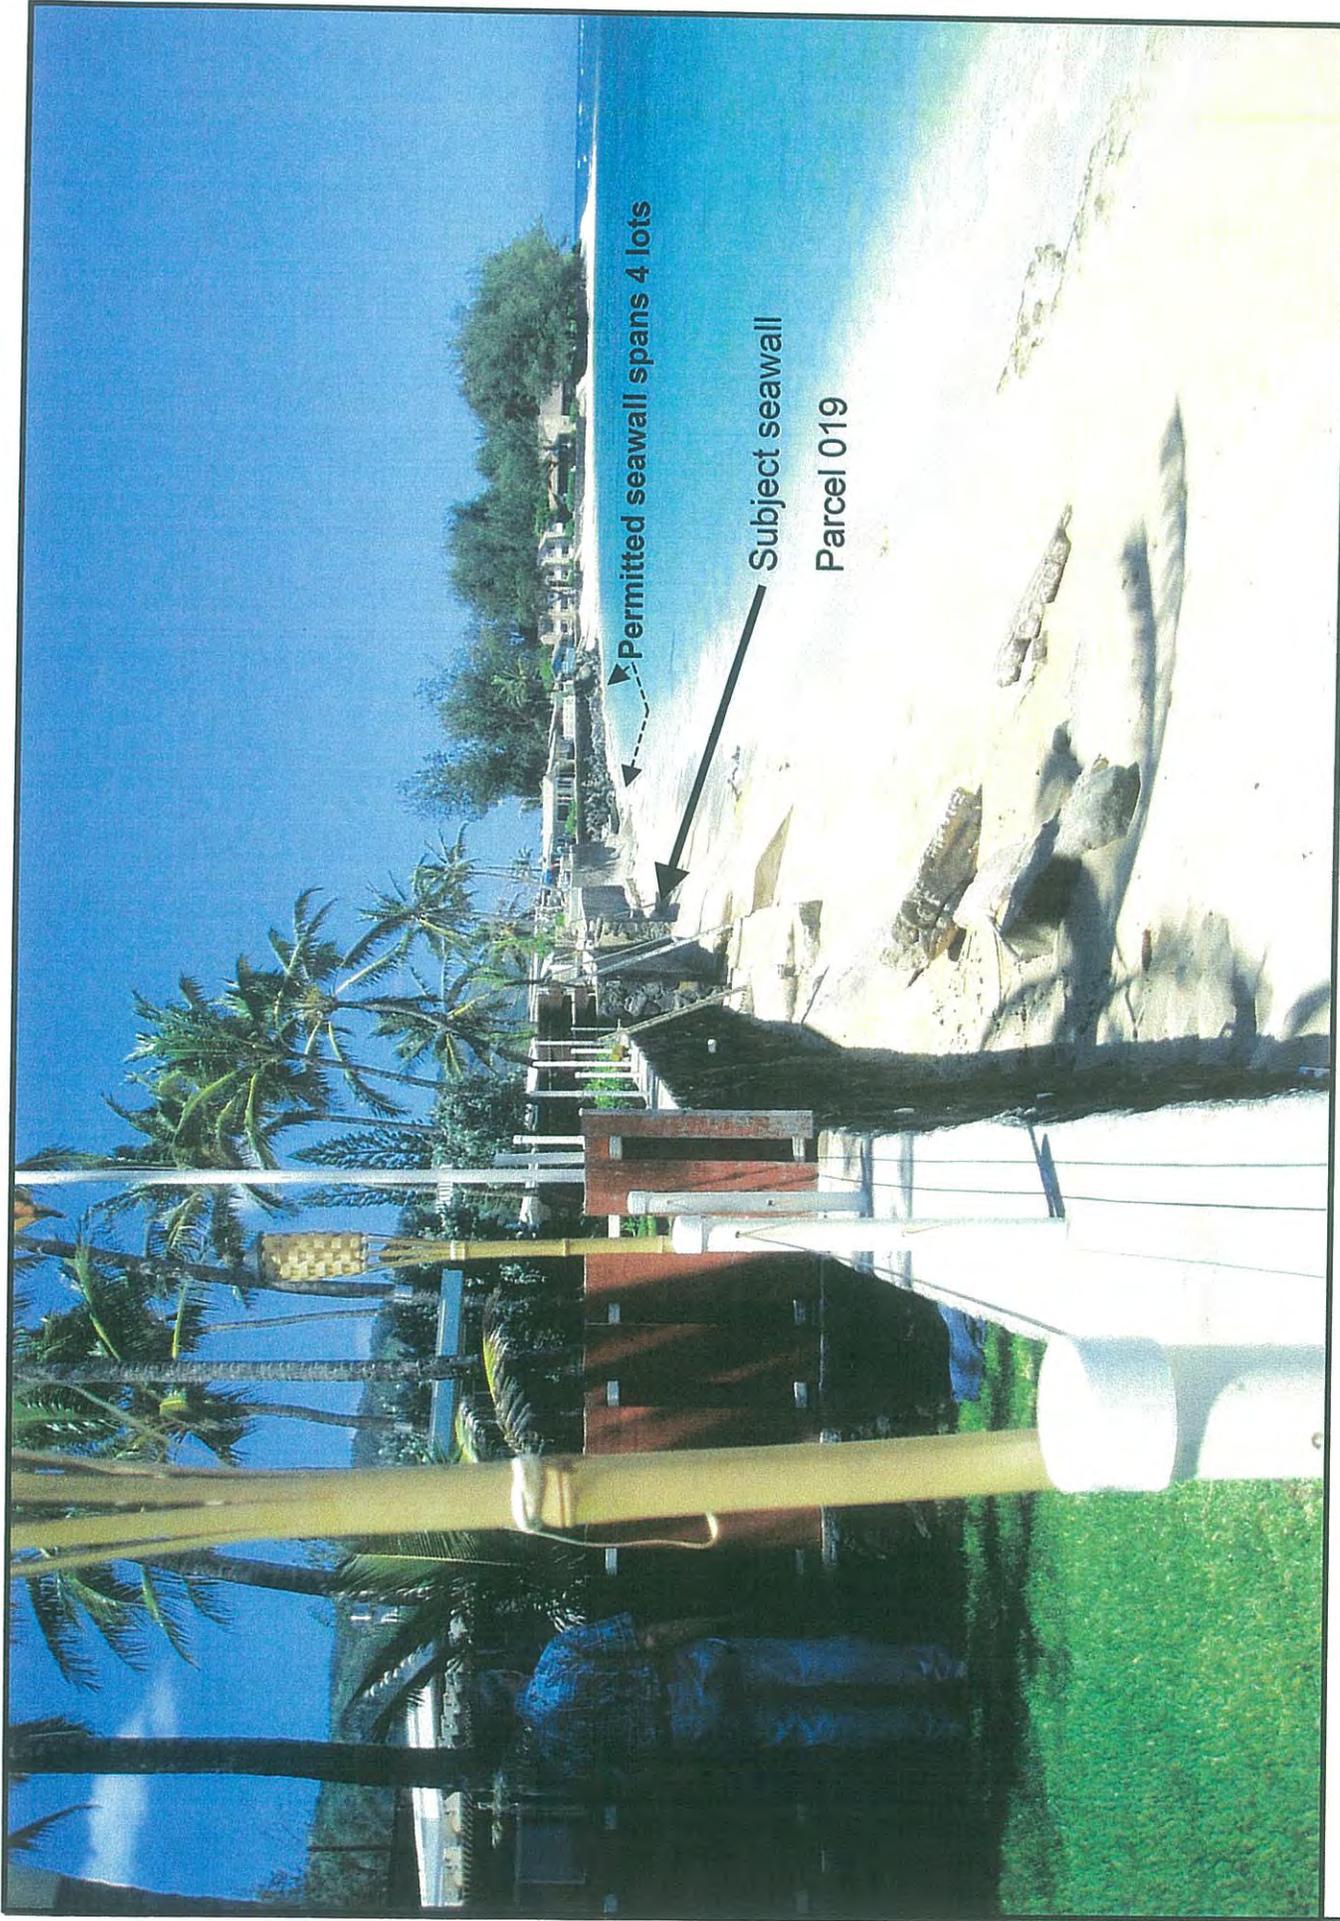
Figure 9

**EXISTING CONTINUOUS SEAWALLS ALONG EMBAYMENT**

The subject seawall ties into concrete seawalls on both sides of the subject property. A public right-of-way (ROW) is located east of the subject property. Properties further eastward of the ROW to the Poli Stream mouth are protected with structures, and properties westward of the ROW within the embayment are protected by seawall – about 1,000 linear feet or so. There is no “dry beach” fronting the seawalls extending westward within the embayment. **Figure 3A** contains photos which depict the condition of the shoreline in the vicinity of the subject property.

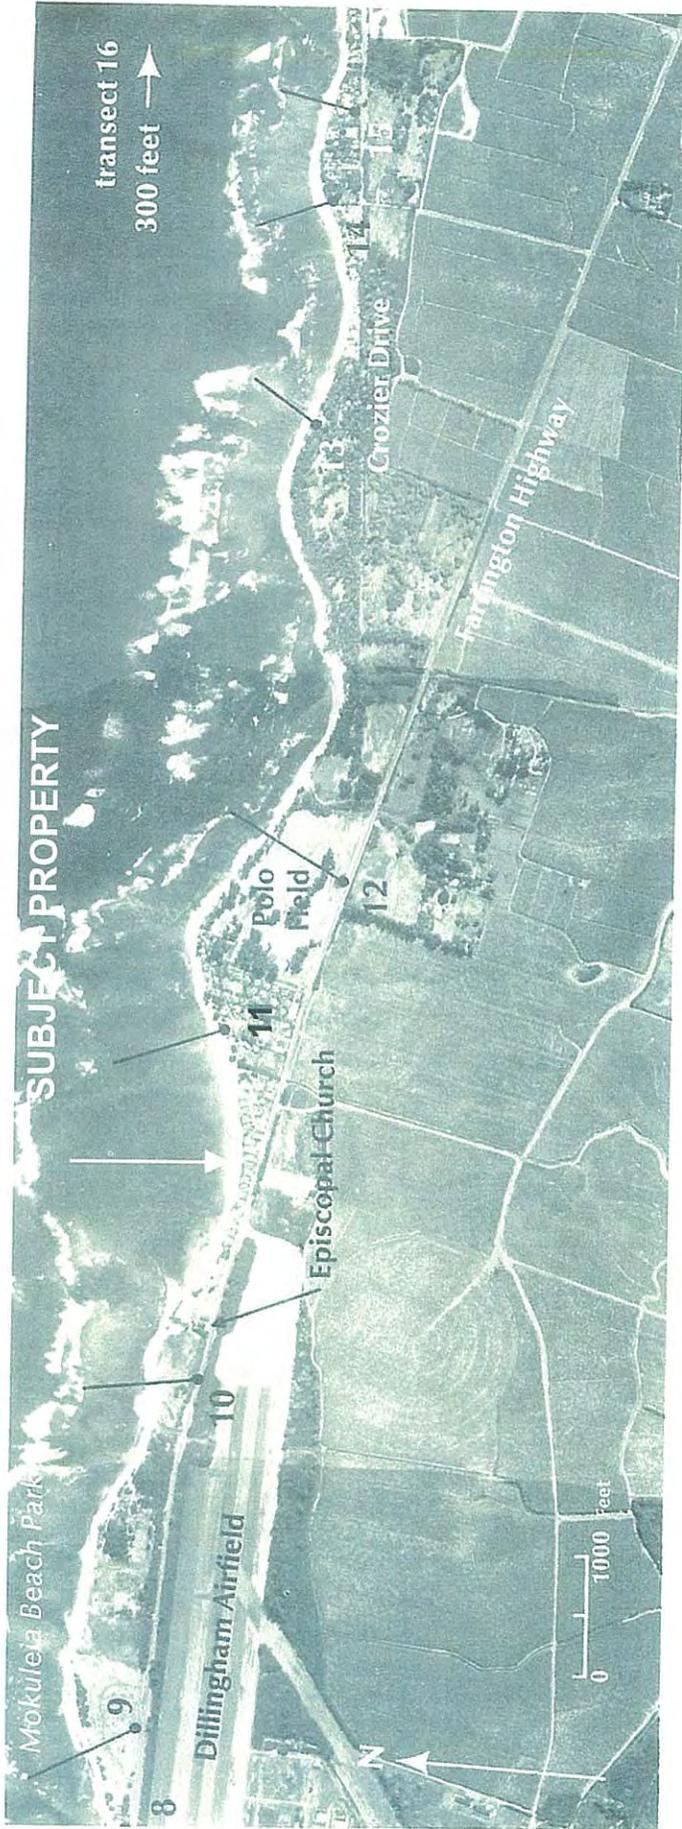
**Photomap 2. Mokuleia Beach (Middle Section)**

Photographs by Air Survey Hawaii: March 1971

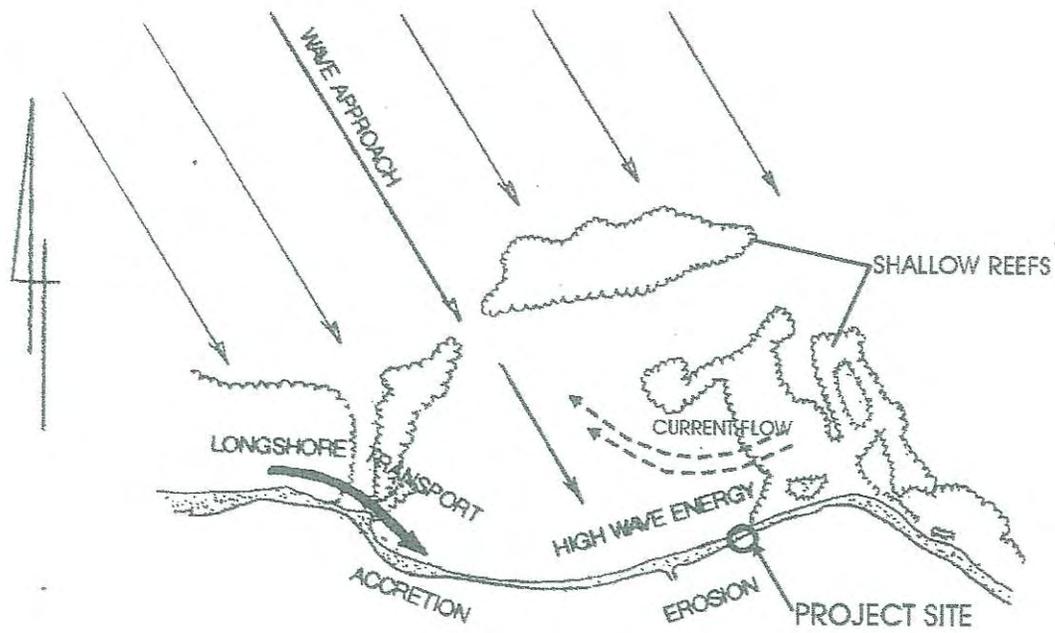
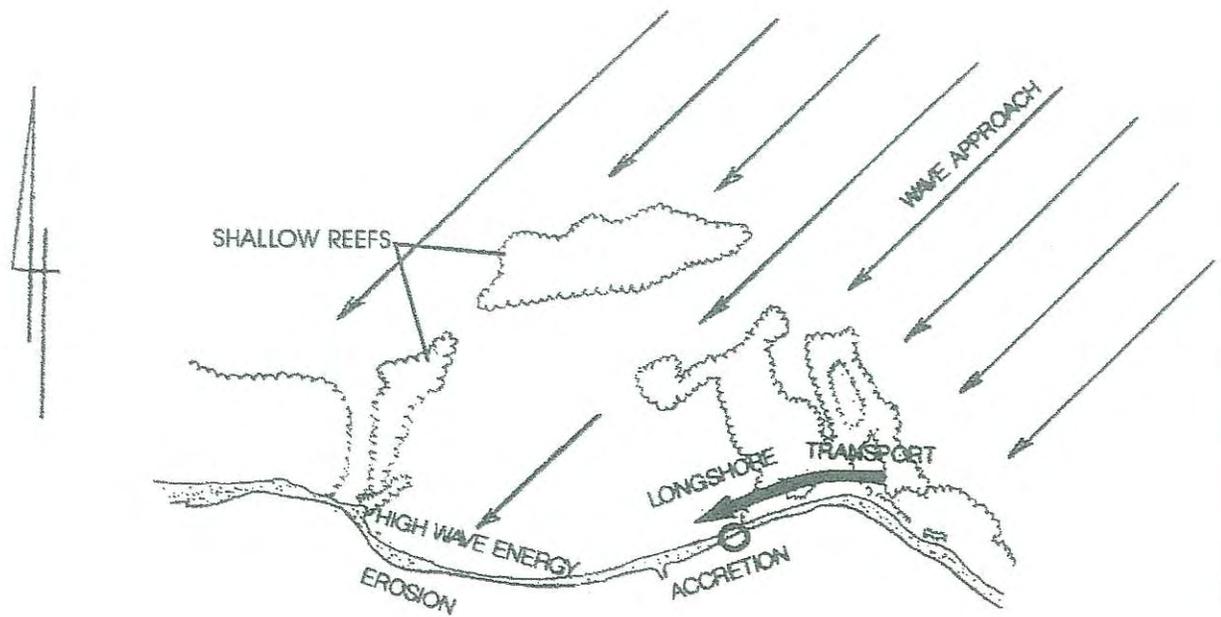
WINTER NORTHWEST SWELL CONDITIONS

SUMMER NORTHEAST TRADEWIND CONDITIONS

According to a prior report by EKNA Services for the Mokuleia area, residents have noted that shoreline currents within this embayment flow towards the west during high winter swell activity, which may be hydraulically driven due to the bathymetric contours within the embayment rather than wave-driven. Water that accumulates within this embayment during large swell or storm wave activity seeks to flow towards the deeper water depth areas on the west side of the embayment, or areas of hydraulically least resistance. Thus, the water drains towards deeper areas within the embayment and those deeper water depths exist on the west side of the embayment.

The shallow reef structure offshore of the eastern headland – closer to the Mokuleia Beach Colony – is broader and extends further in the embayment than the shallow reef structure offshore of the western headland. The configuration of the shallow reef structure and the presence of an apparent “channel” through the offshore reef near the western end of the embayment, along with hydraulically-driven circulation, are probably the basis for the westerly-flowing shoreline current that residents have noted.

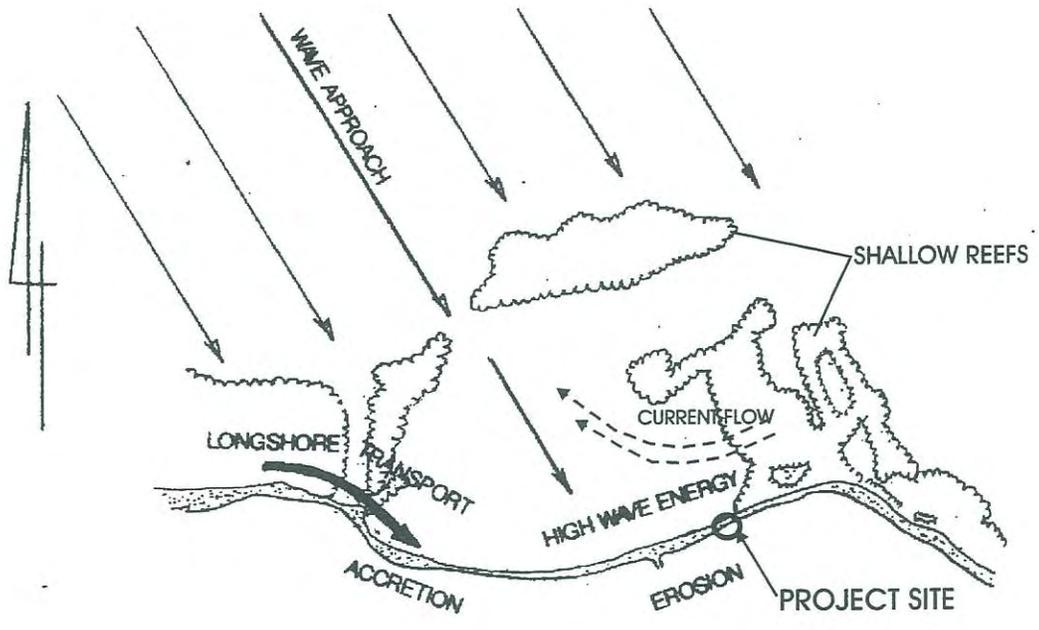
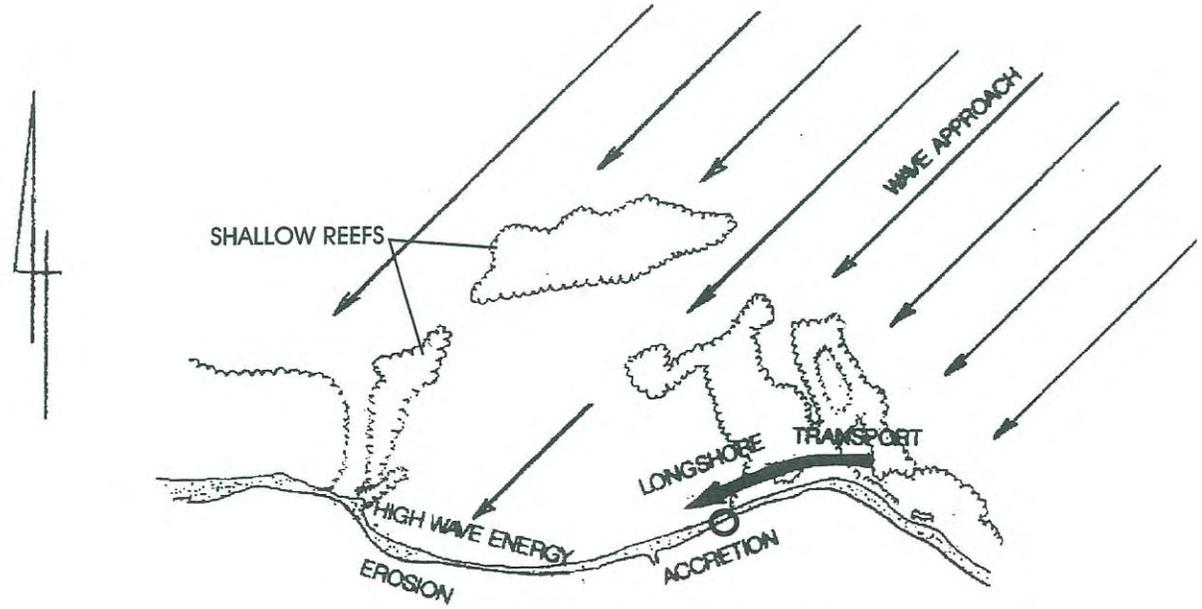
FIGURE 3

WINTER NORTHWEST SWELL CONDITIONS

SUMMER NORTHEAST TRADEWIND CONDITIONS

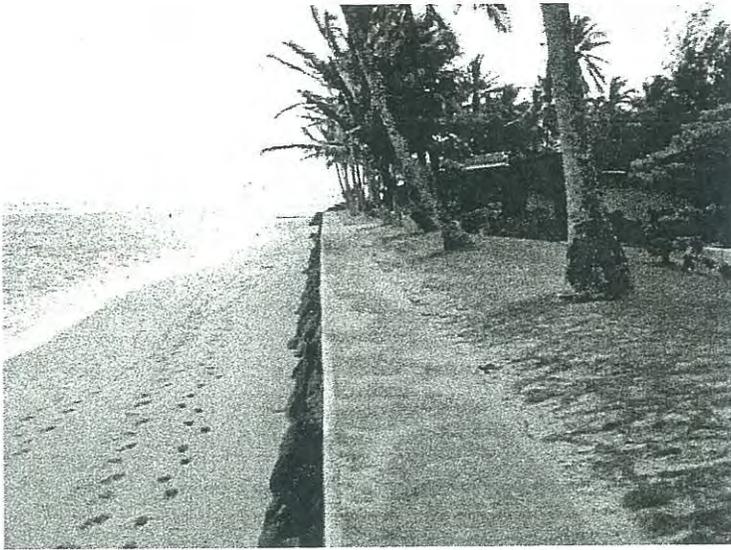
View eastward along the top of the seawall fronting the Mokuleia Beach Colony. Note the narrow beach.

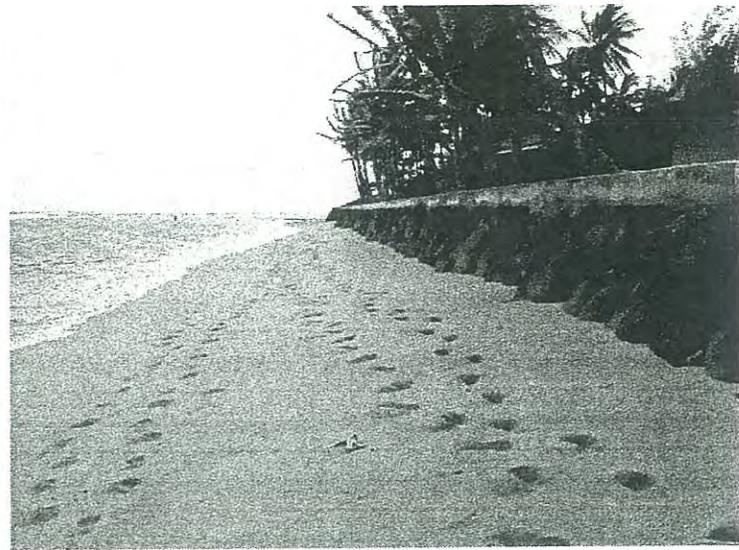
View eastward along the beach fronting the Mokuleia Beach Colony seawall. Note the narrow and steep beach profile.

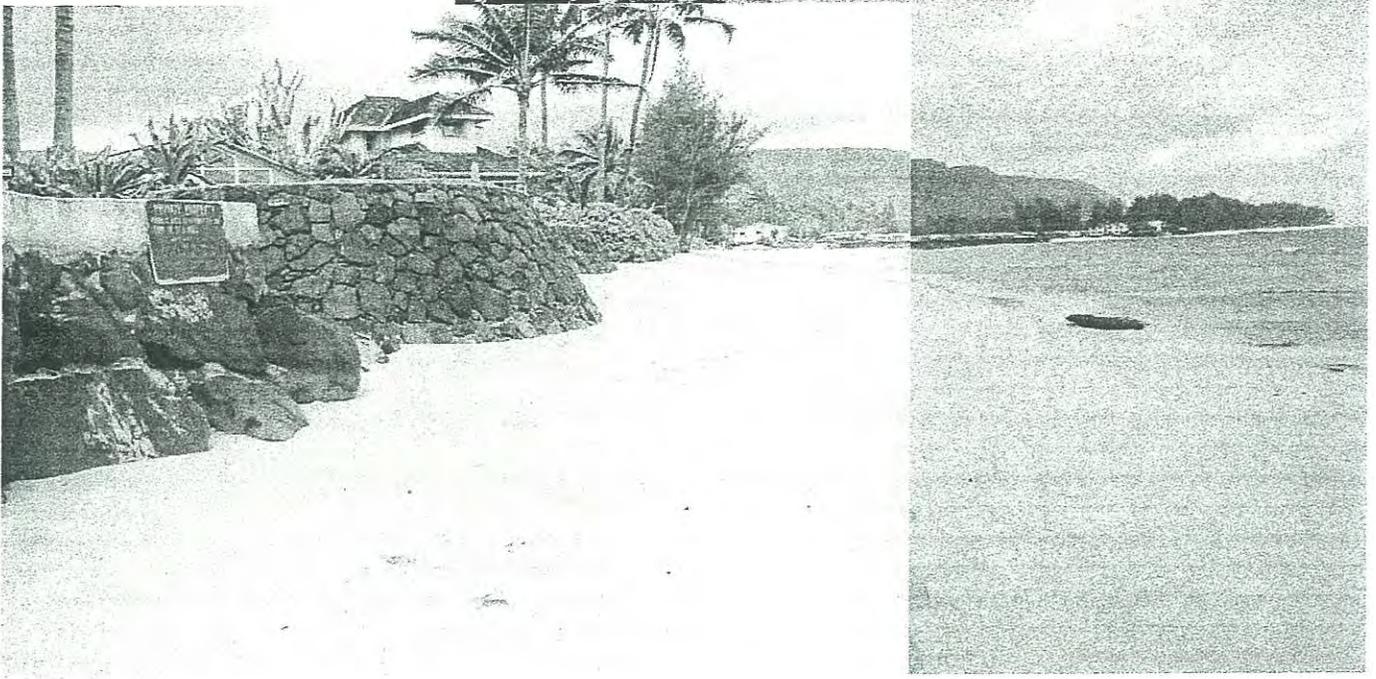
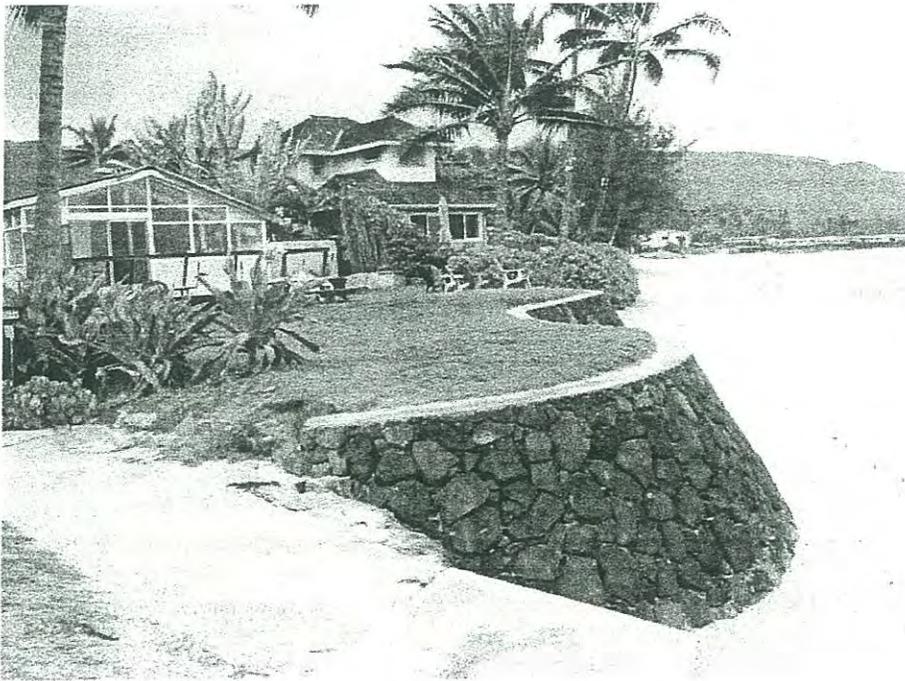
**PHOTO page-2**

Views westward from west end of Mokuleia Beach Colony seawall. Parcel 10 is in the foreground. Parcel 11 is next to Parcel 10. (Sign is on the west end of the Mokuleia Beach Colony seawall. The sign permits the public to walk on the top of the seawall.)

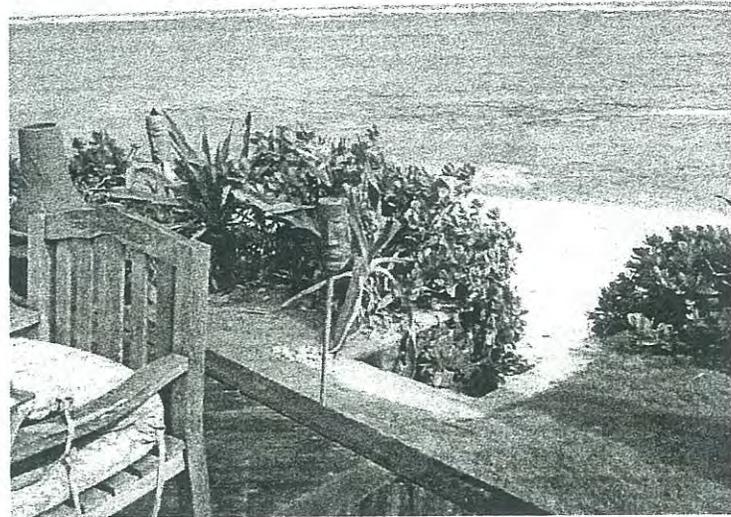
View offshore from porch on Parcel 11.  
Steps in seawall lead down to the beach.

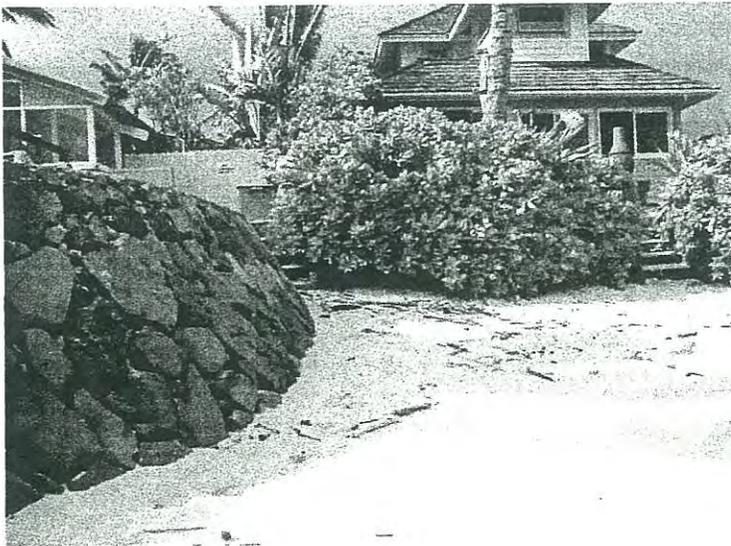
View of Parcel 11 seaward frontage. Seawall is hidden by naupaka vegetation. Curved seawall on left fronts Parcel 10.

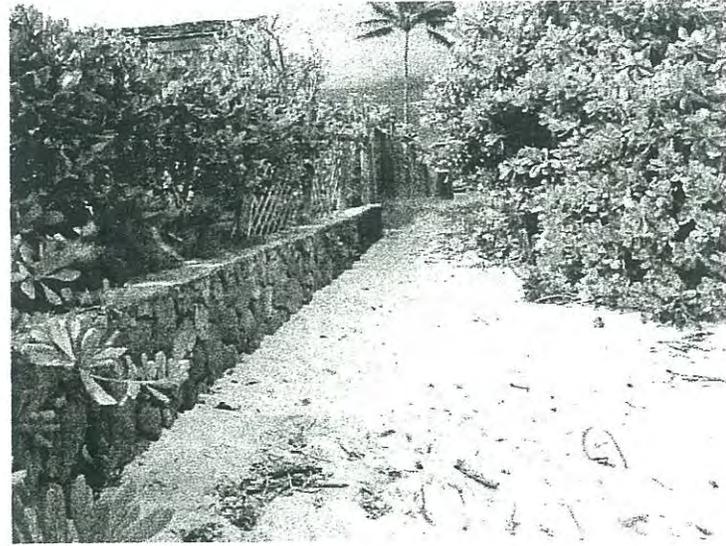
View mauka along private right-of-way. The CRM wall on left is Parcel 11's return wall.

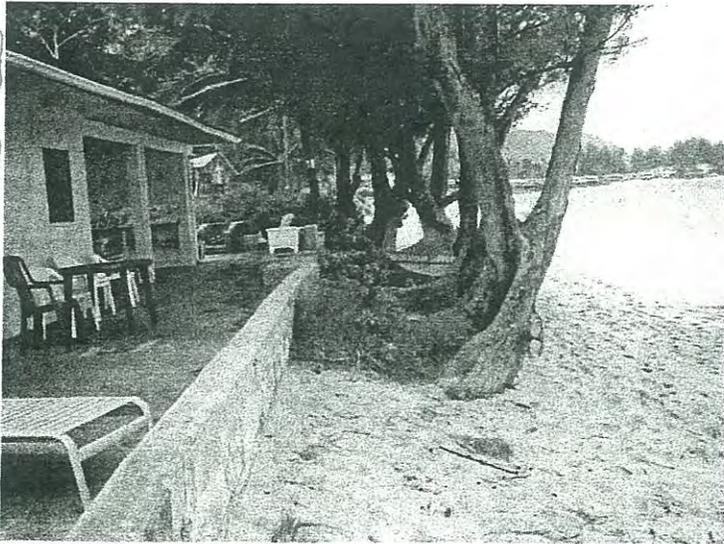
CMU wall fronts Parcel 13 .

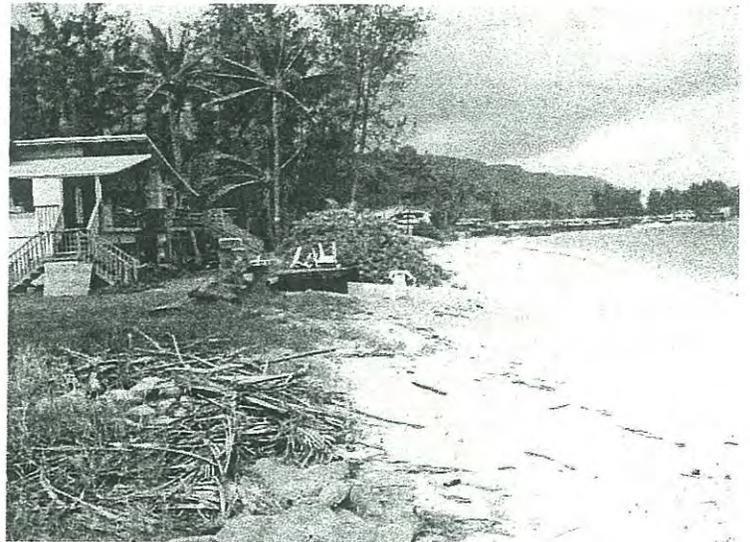
Shoreline fronting Parcel 20 on east side  
of stream. Note debris line at edge of  
vegetation.

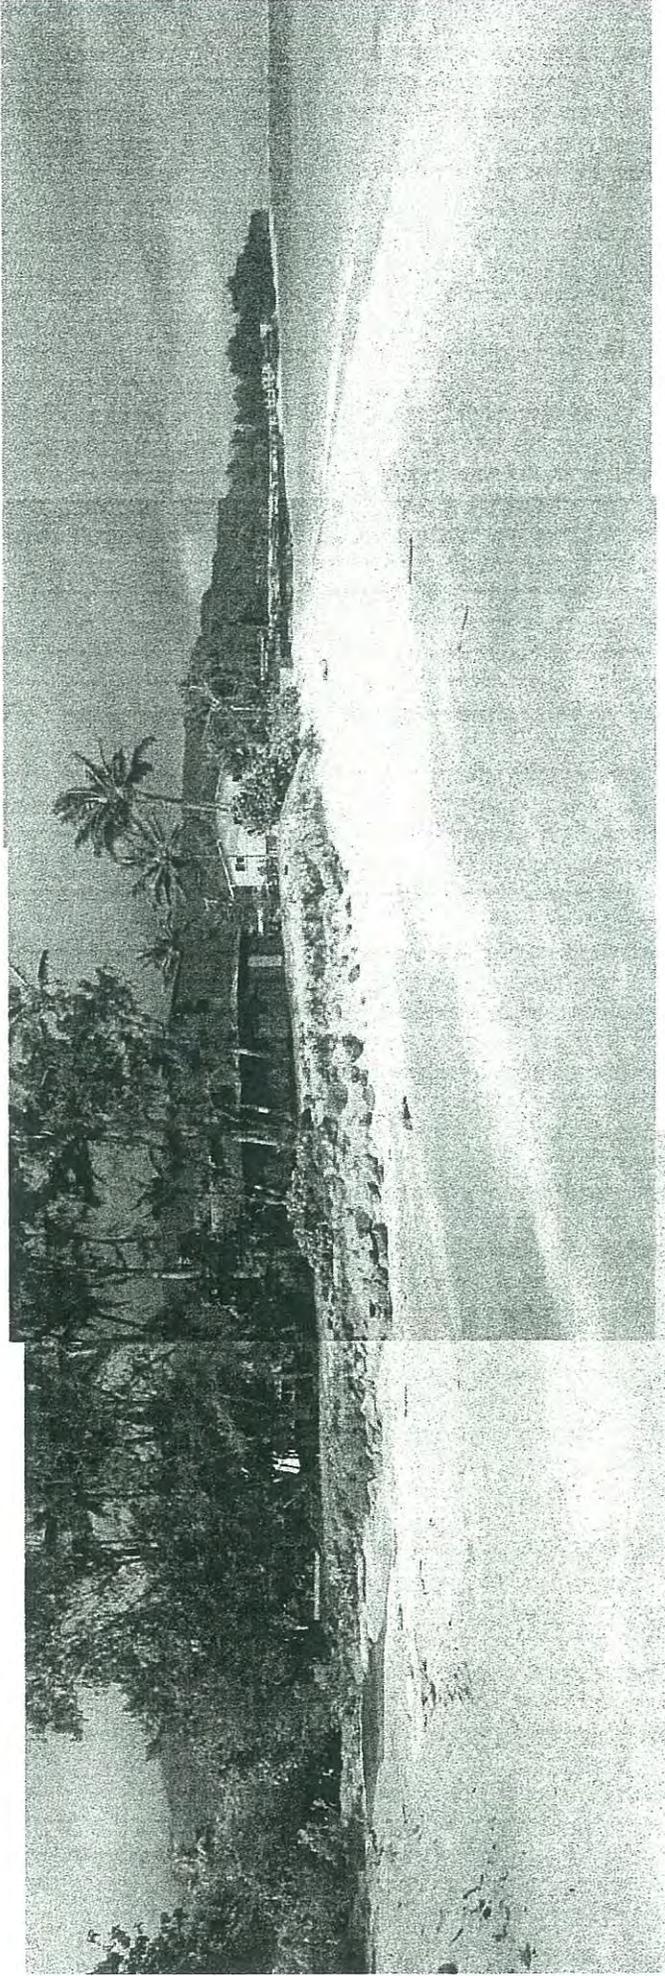
View westward from stream mouth. Note eroded condition of embankment on west side of the stream. Continuous line of seawalls protect entire central shore frontage within the embayment.
