Retaining Wall TMK: 4-7-019-049, 47-079 Kamehameha Hwy, Kaneohe, Hawaii

**FINAL
ENVIRONMENTAL ASSESSMENT FOR SHORELINE
SETBACK VARIANCE APPLICATION**

**After-the-fact Concrete Deck and
Slope and Shoreline Stabilization**

**PREPARED BY:
Joseph and Kristen Souza
(808) 236-2480
April 2006
Revised September 2008
Revised April 2009**

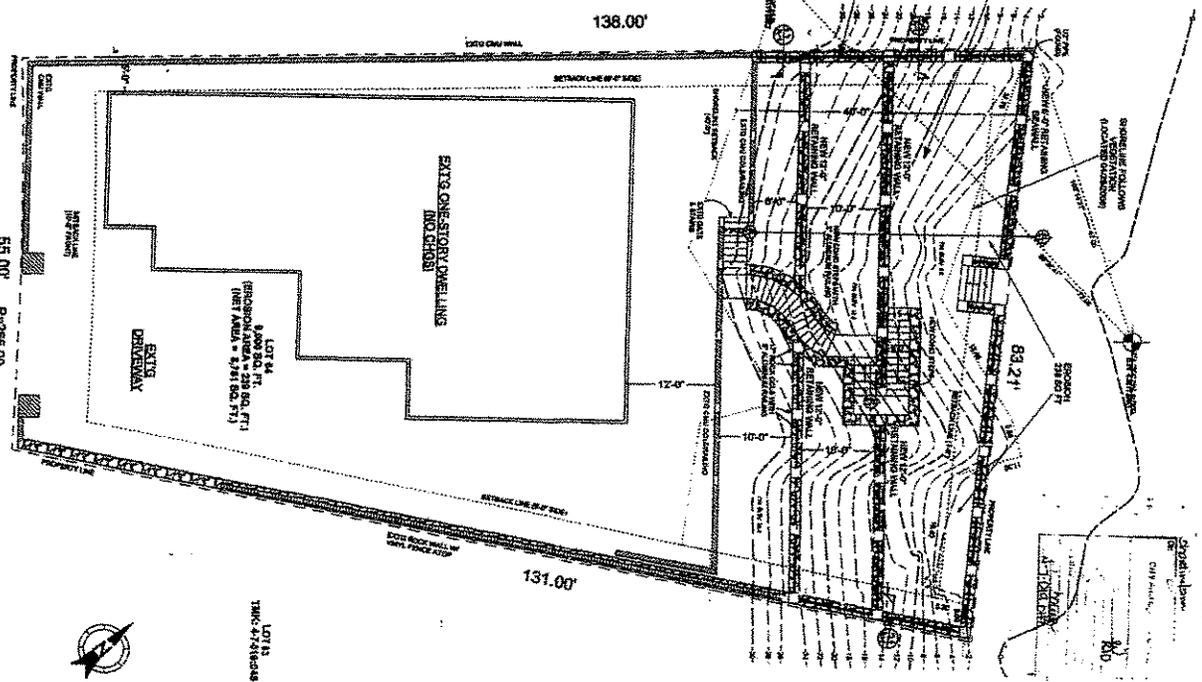
PLAN
 (SC. 1/4" = 1'-0")

PROJECT SITE
 Location enclosed showing. Provide concrete and retaining walls to protect from further erosion.

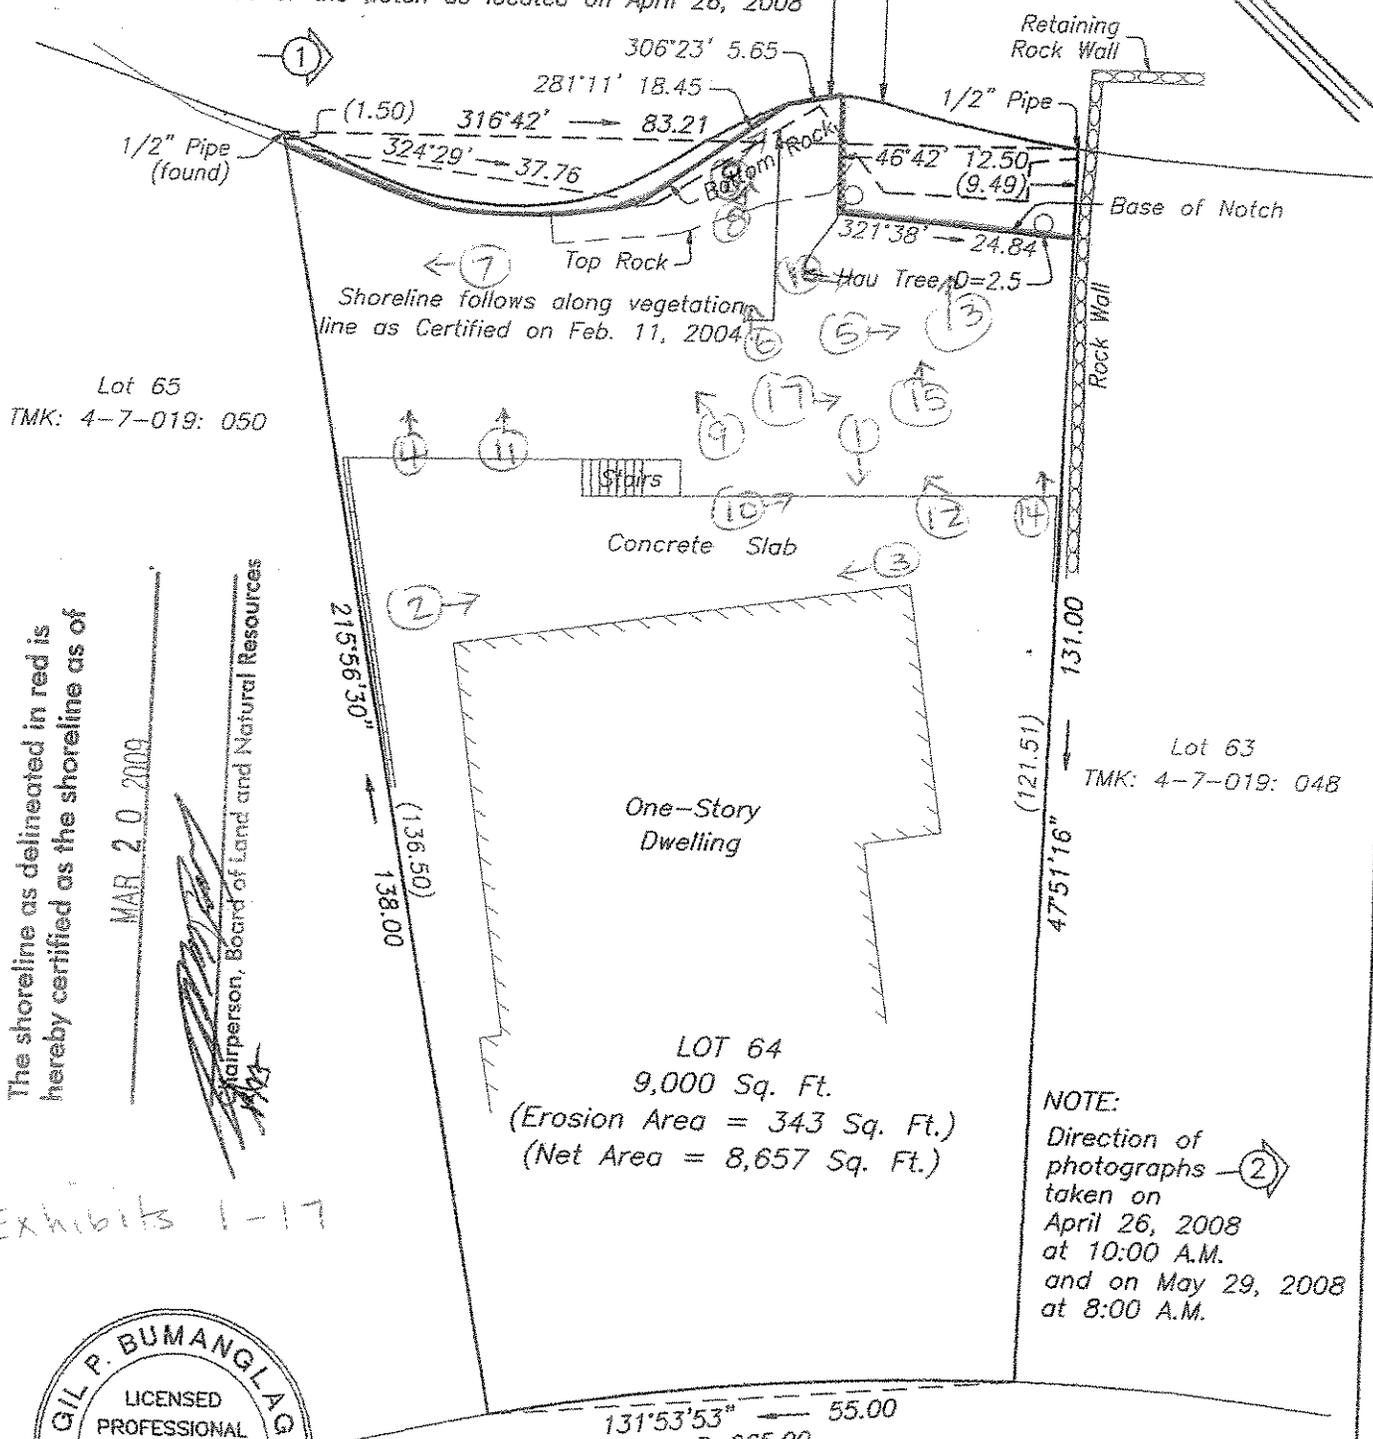
TRUE NORTH
 Scale: 1 in = 20 ft

Shoreline follows along mauka edge of mud flat at bottom
 of rock and base of the notch as located on April 26, 2008

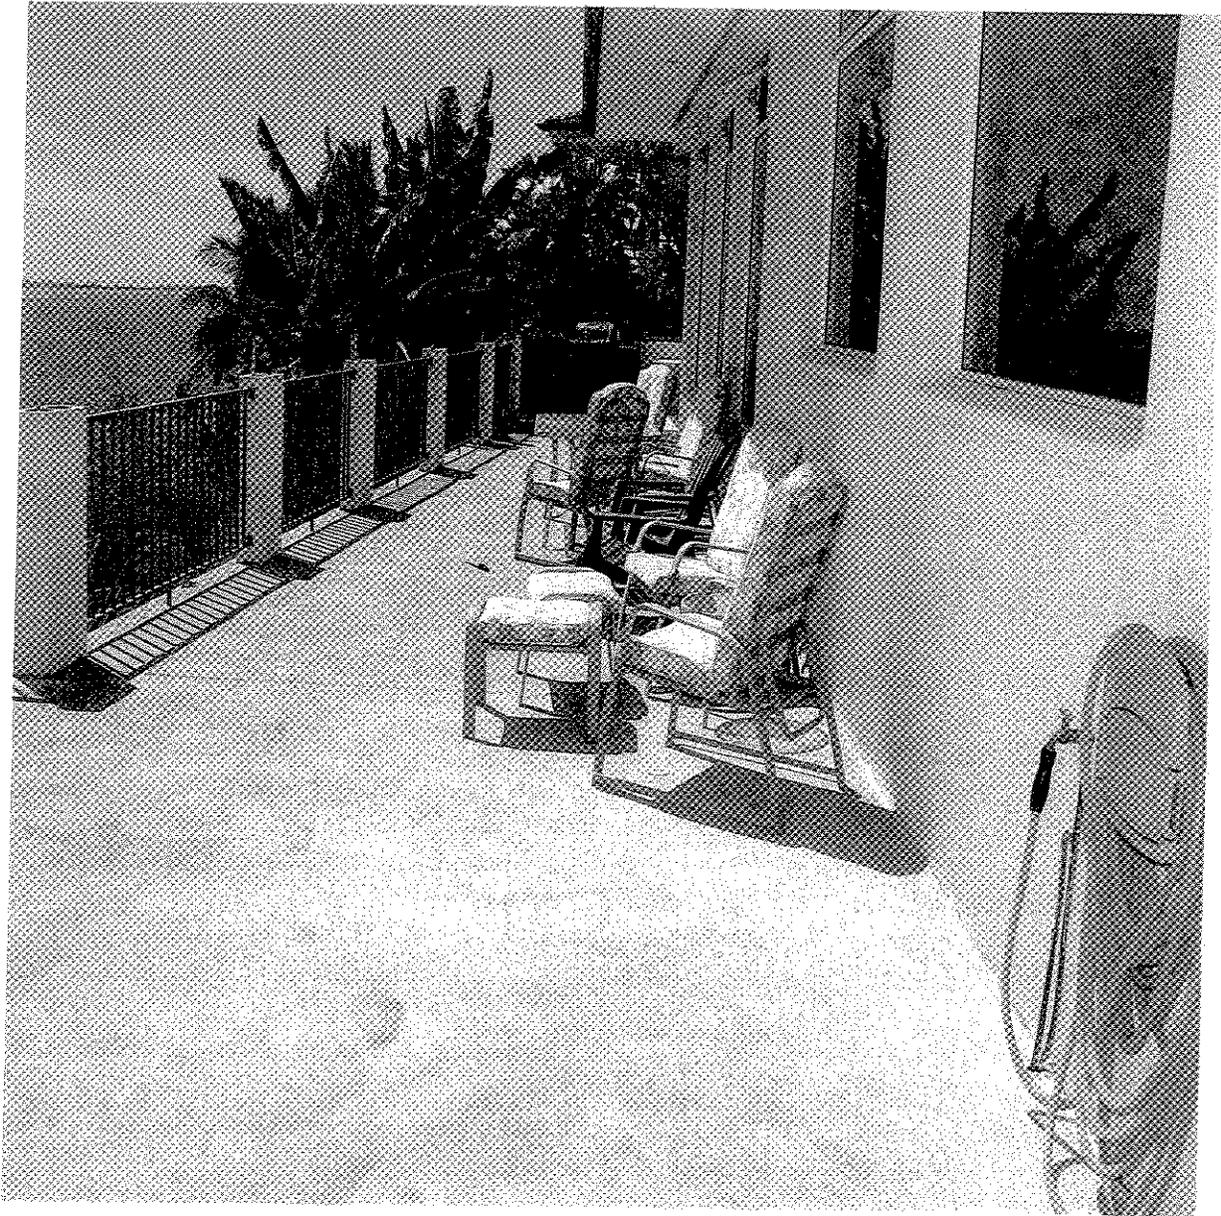
Exhibit 1

CMU wall with gutter system. Below this structure is dirt and weeds. There is about 2 feet some areas are less and some are a bit bigger of dirt and weeds before the cliff to the water.

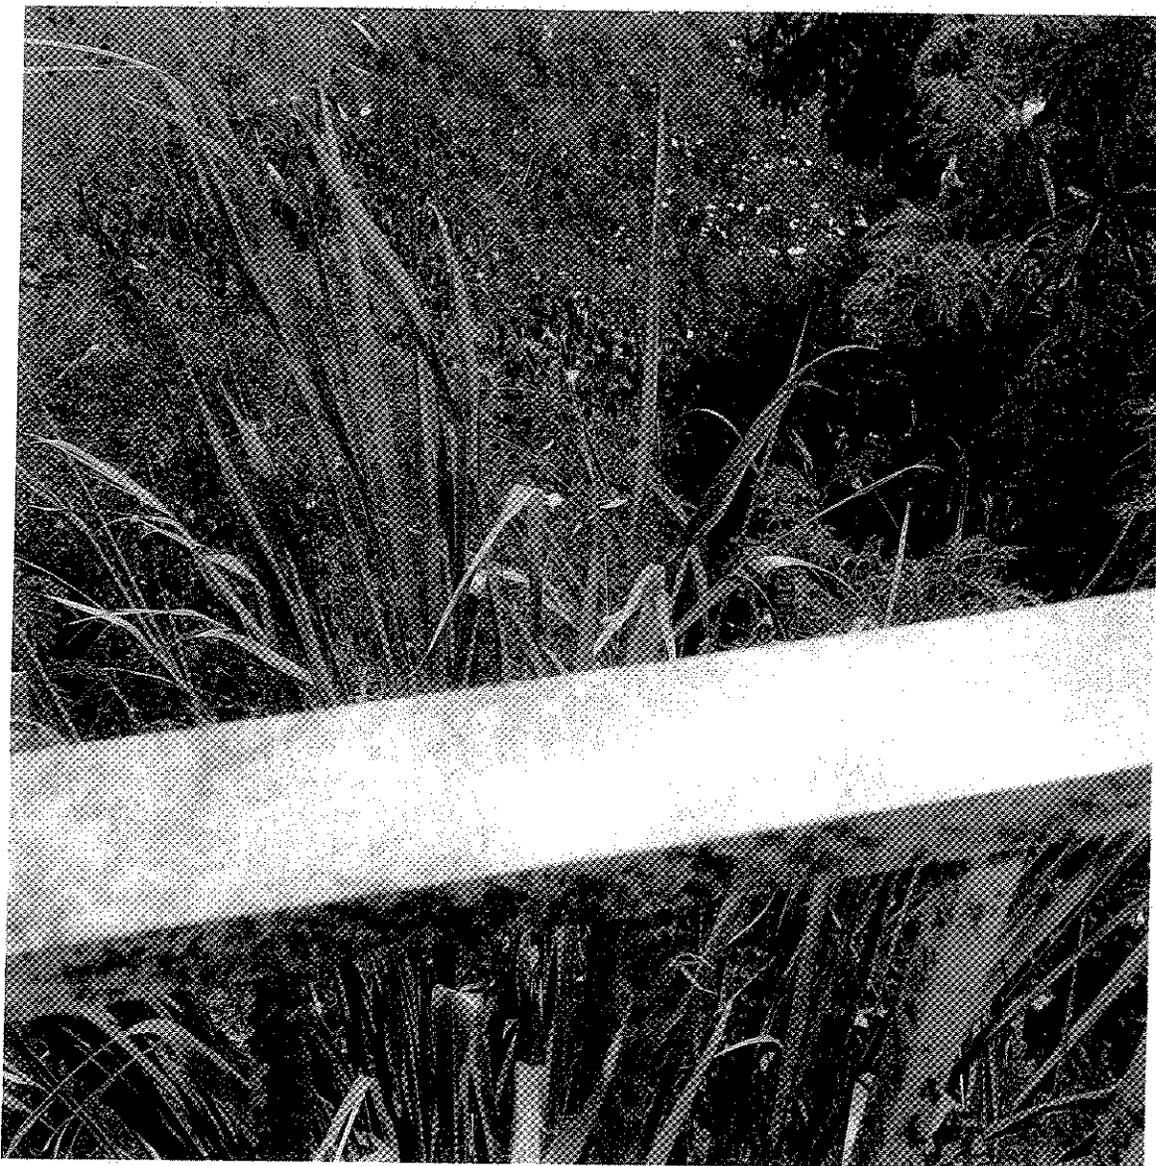
Exhibit 3

Proposed retaining wall with back fill and concrete

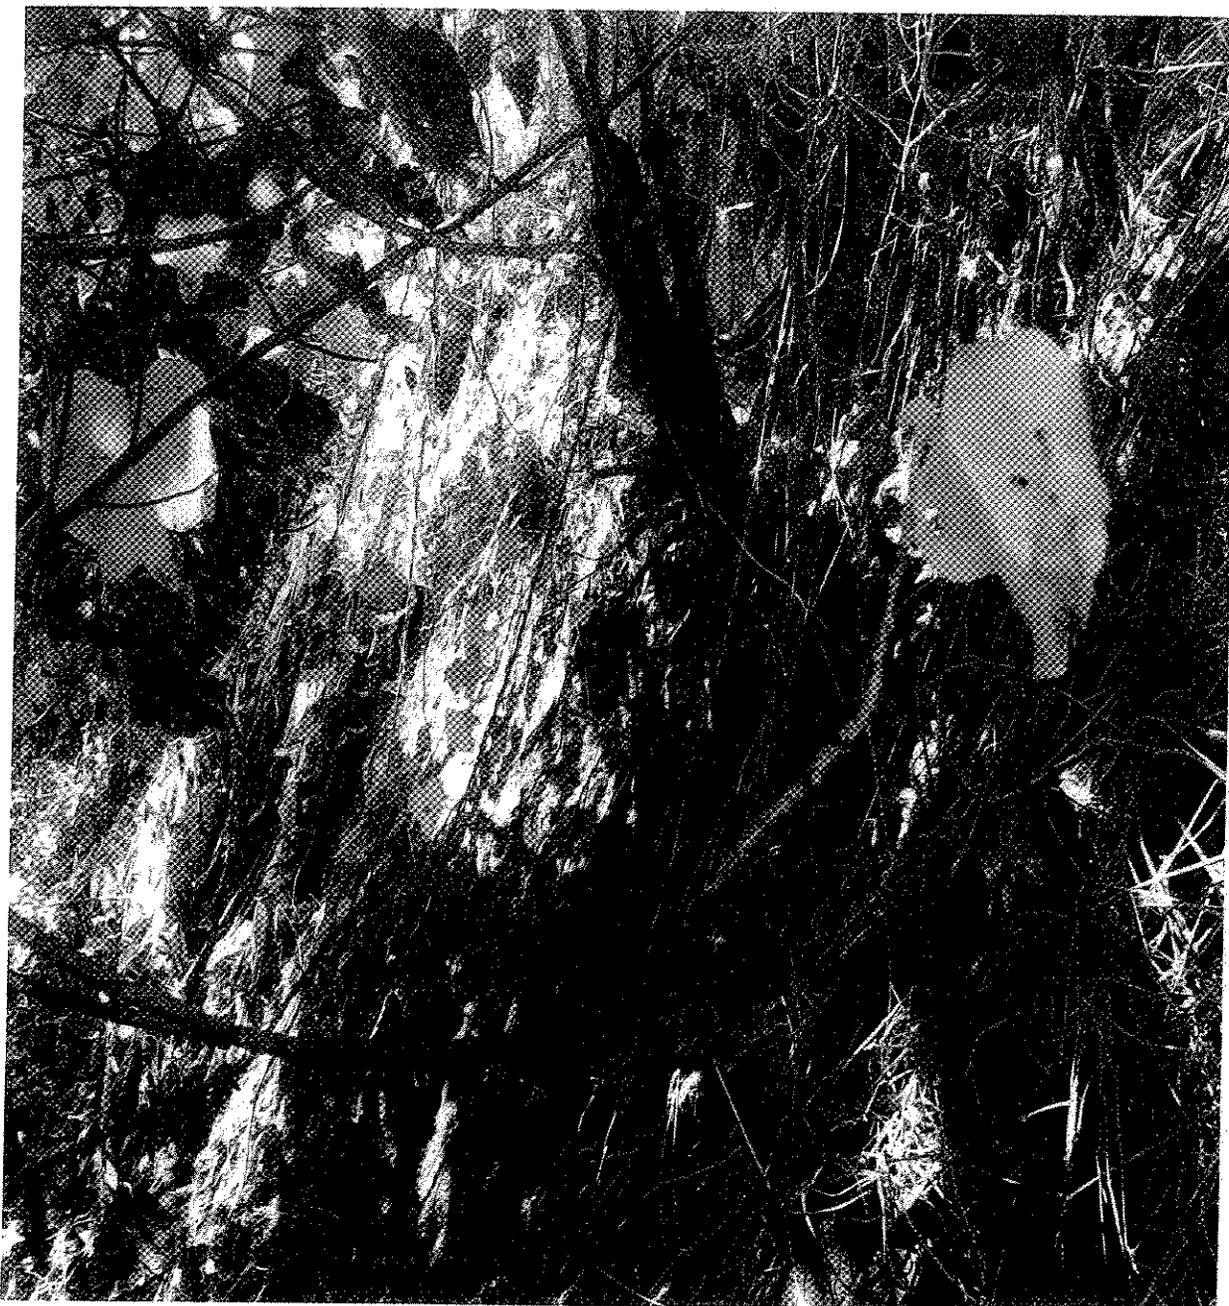
Exhibit 4

This is a photo of the cliff looking down from the retaining wall. Please take note on how dangerous it could be if there was no type of railing or retaining wall.

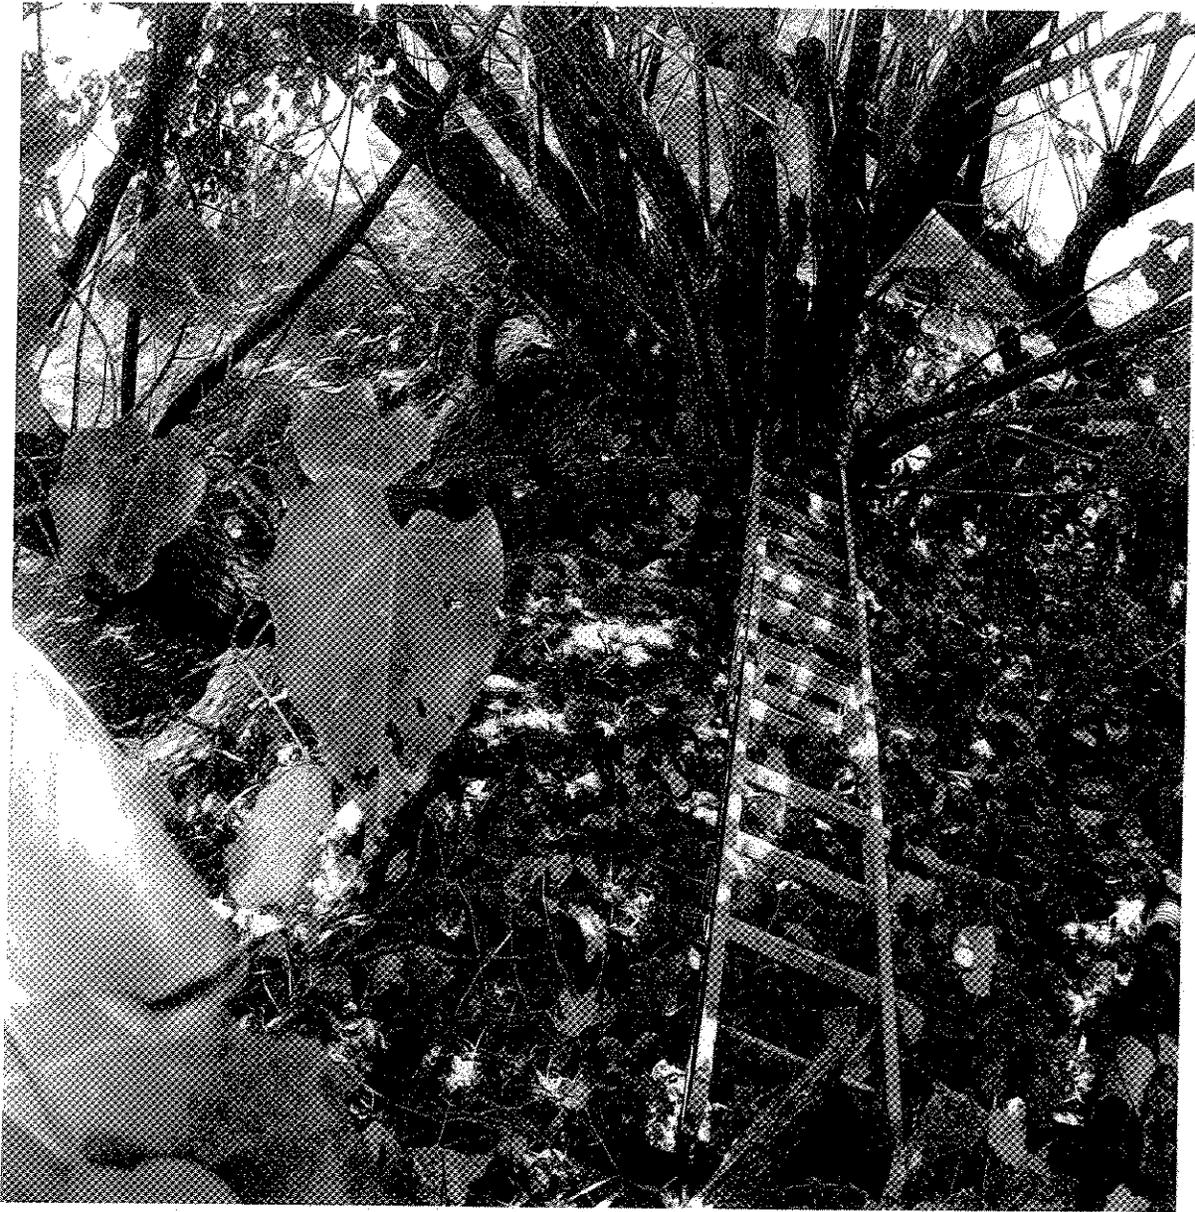
Exhibit 5

Photo of cliff (right side) below the CMU retaining wall. Please take note how the cliff is straight down. Also you are able to see the erosion which has taken place over the last year.

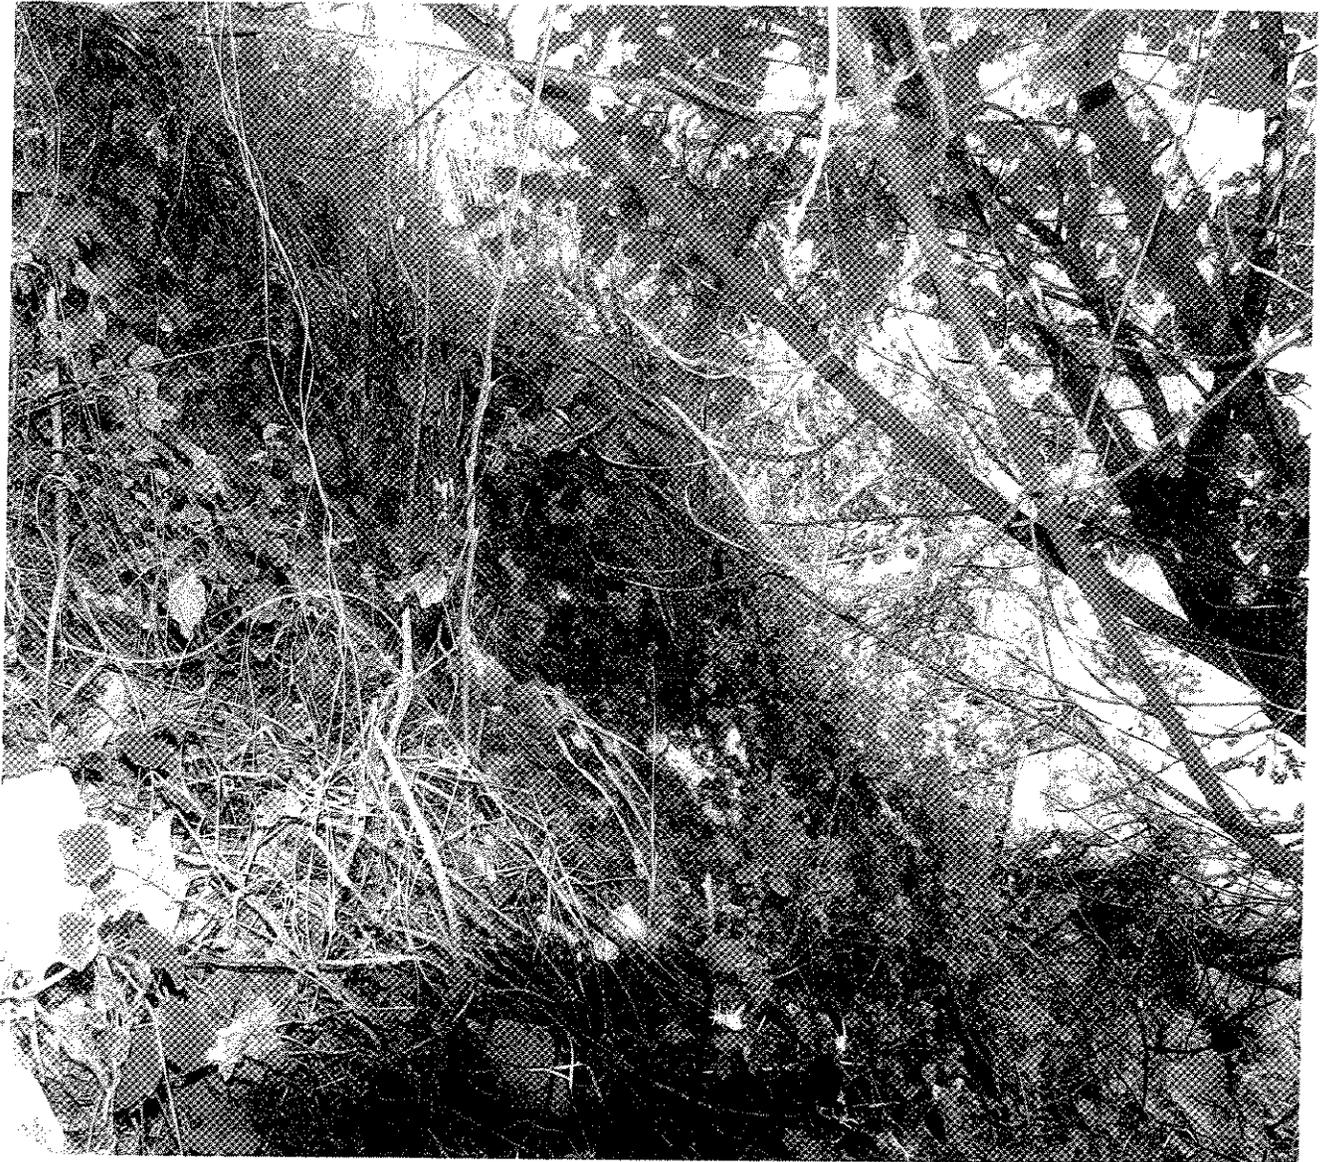
Exhibit 6

Front view of cliff from about half way up to the retaining wall from the water line. The erosion as you are well aware of will not stop until we control the slope and situation. Any large rains just create more danger and eat away at our property.

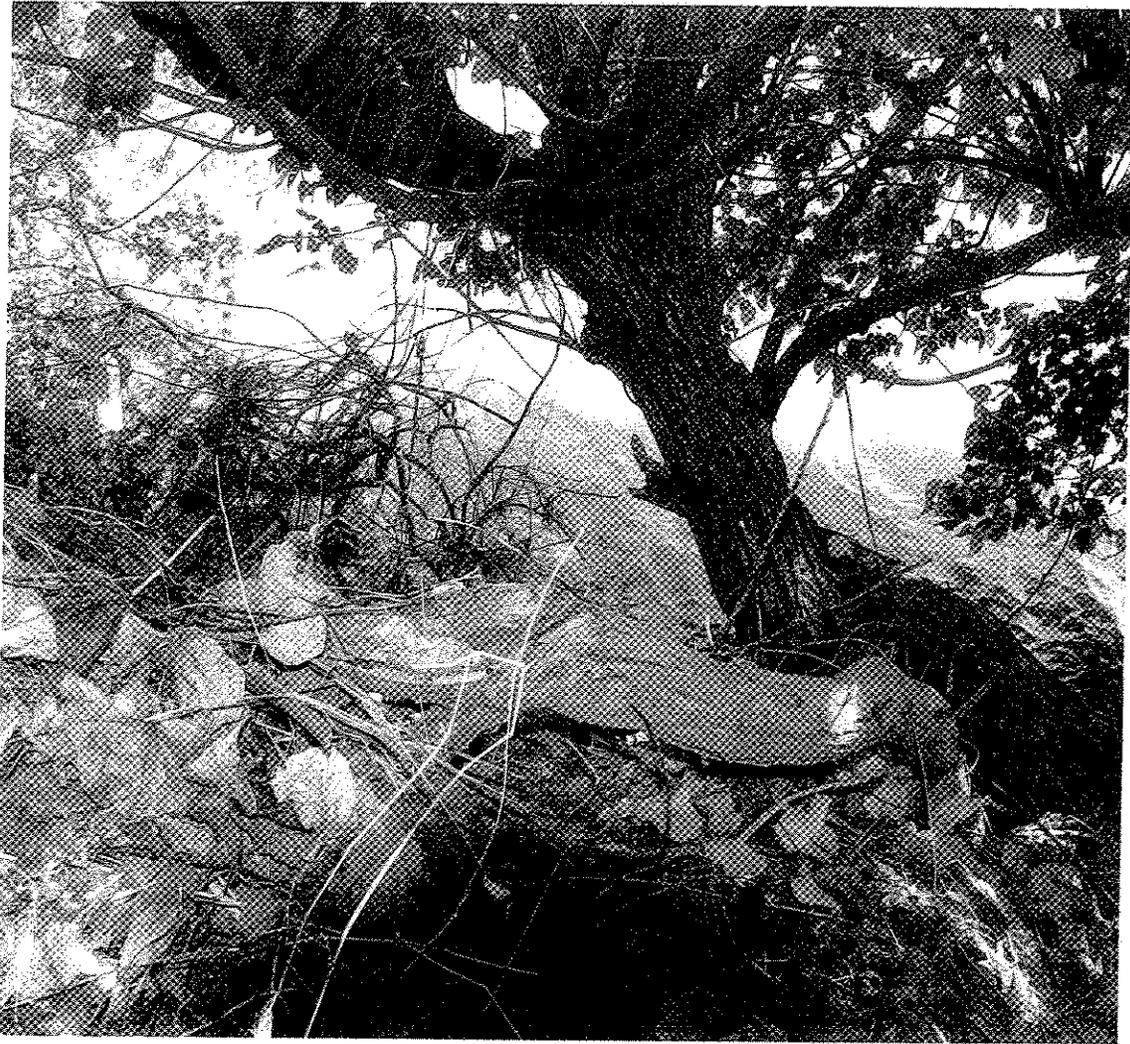
Exhibit 7

Photo of cliff on the left side of the property. The dirt area that you are viewing is one of many land slides. To the left (facing water) of this land slide our neighbors Milo tree has fallen in to the water bringing down majority of our hillside.

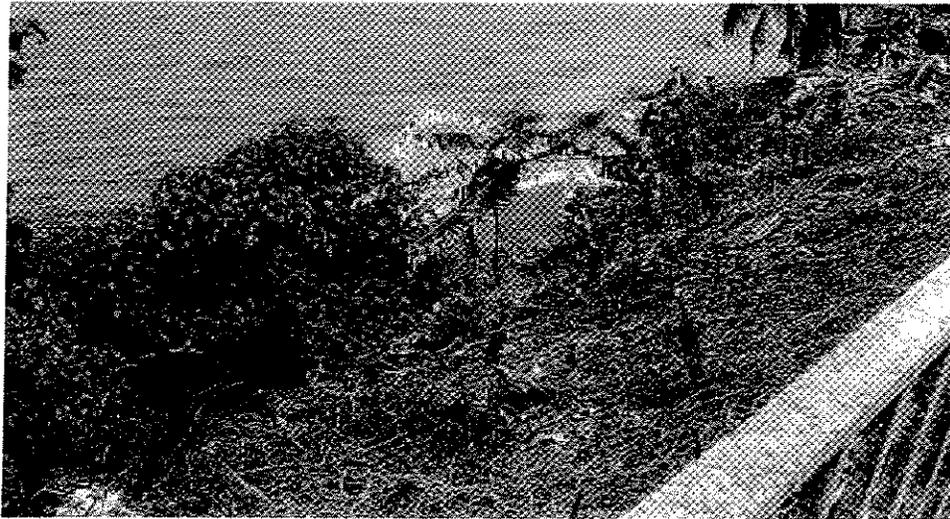
Exhibit 10

Looking right from the existing deck area down towards the water Kaneohe direction.
Please note the grass area on the lower area is our neighbor, Wallace Ho. Their property
is approximately 10 feet further out than ours. They have a lease with the City for the
property gained.

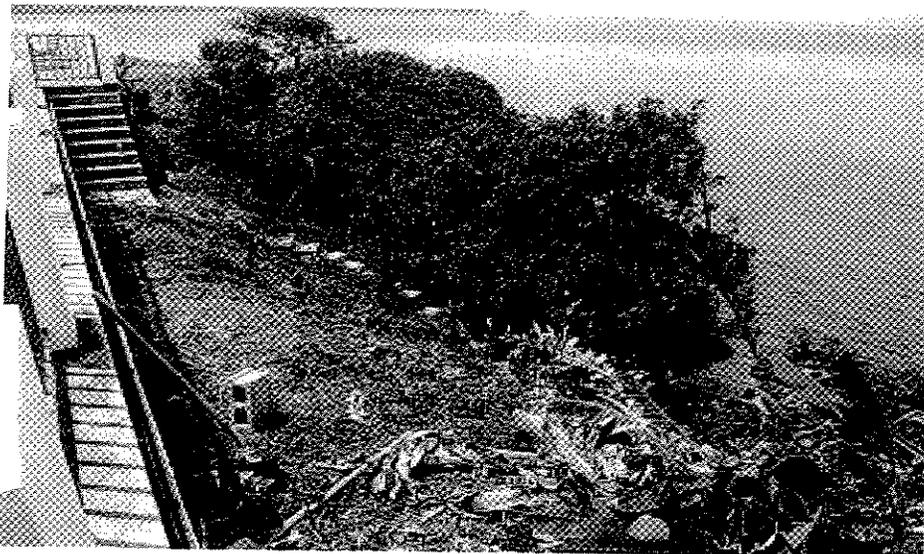
Exhibit 12

This photo is taken from the right side of our property on the existing deck. The view is looking north. The large trees are our neighbor's property, Joseph Meyer.

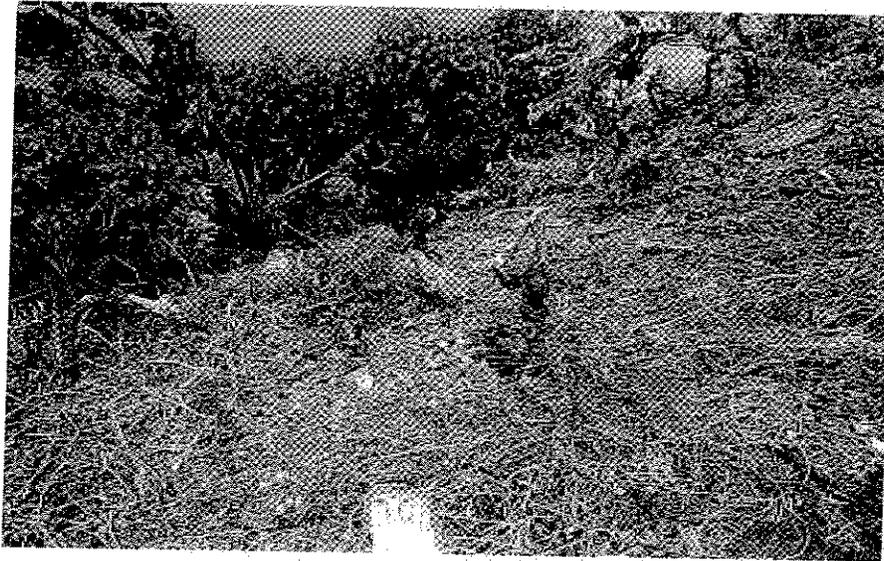
Exhibit 14

The photo is taken from the far right (Kaneohe side) of our property next to Wallace Ho. The white fence and rock wall is their property. Please note the severity of height elevation. This is 35' high.

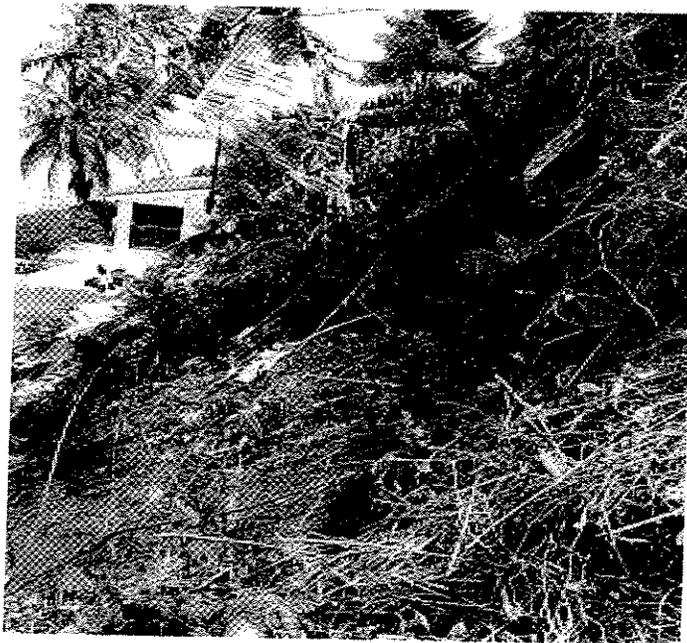
Exhibit 15

Photo from mid/upper left side section looking down towards water.

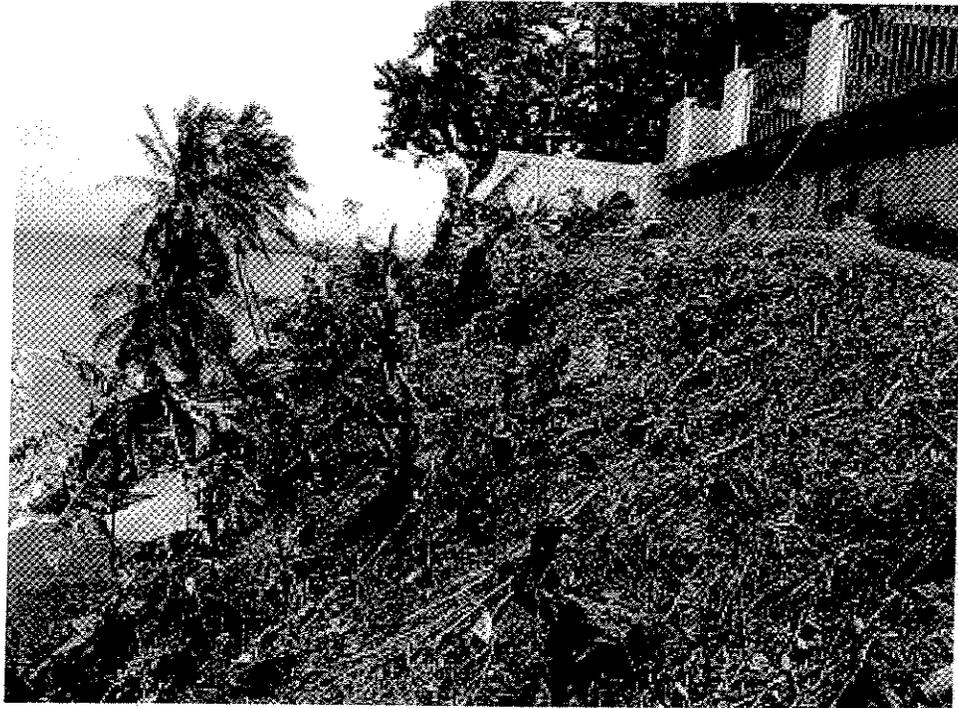
Exhibit 16

Photo taken from about ½ way down hillside looking towards the right, Kaneohe direction. This is one of the many land slides which occur annually. This part of the hillside is just below exhibit 17.

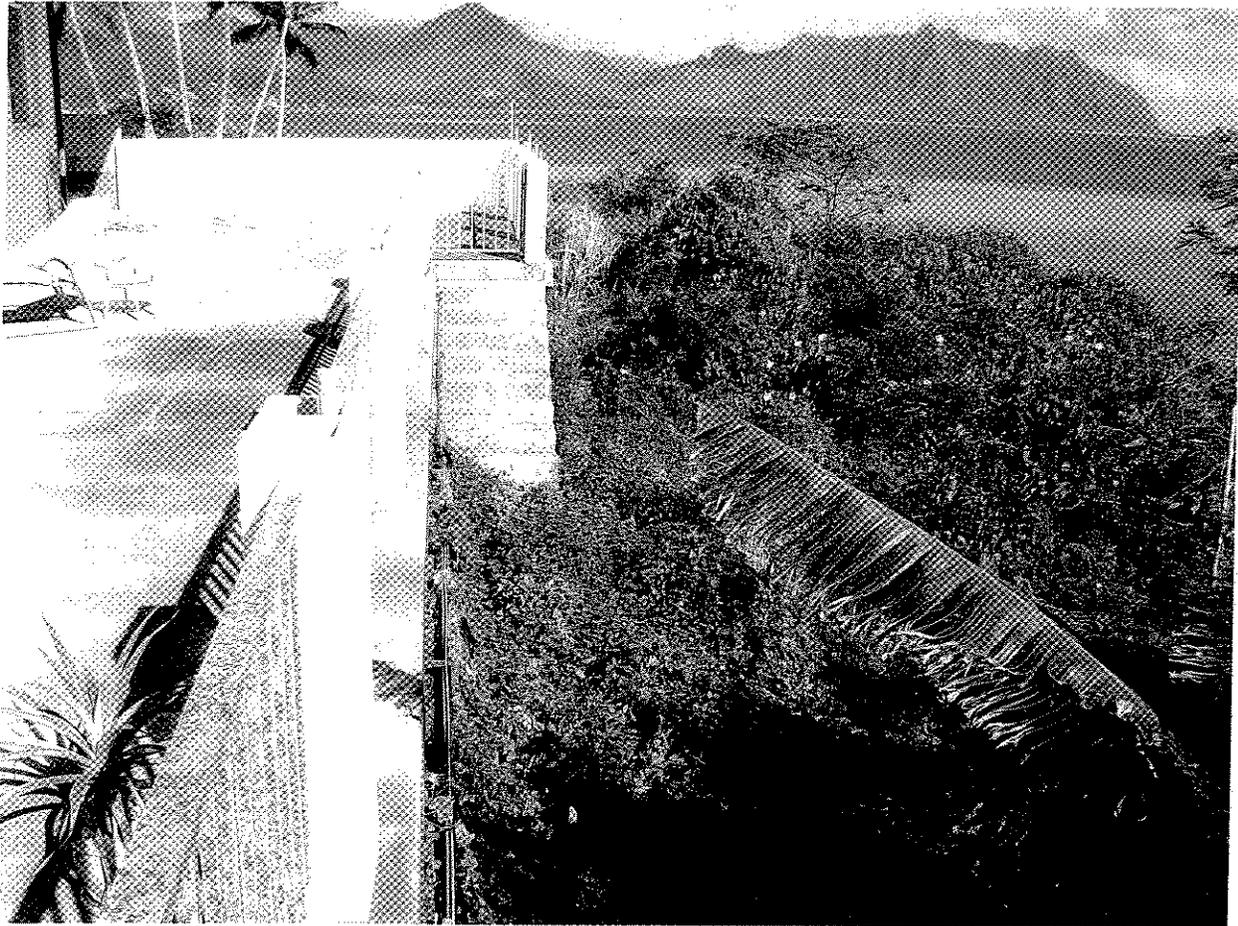
Figure 2. Rear portion of property with steep seaward cliff on the right.

The property stretches from Kamehameha Highway to the Kaneohe Bay shoreline. The lot grades downward gently from street level to the edge of the seaward cliff. The cliff itself descends sharply from about 32 feet elevation to sea level at an average slope of approximately 45°. A residence occupies the majority of the lot and includes a rear concrete porch extending to within about 5 feet of the head of the steep shorefront slope. A set of narrow stairs leads partly down to the ocean. The steep slope is overgrown with trees and low-laying vegetation (Figure 2).

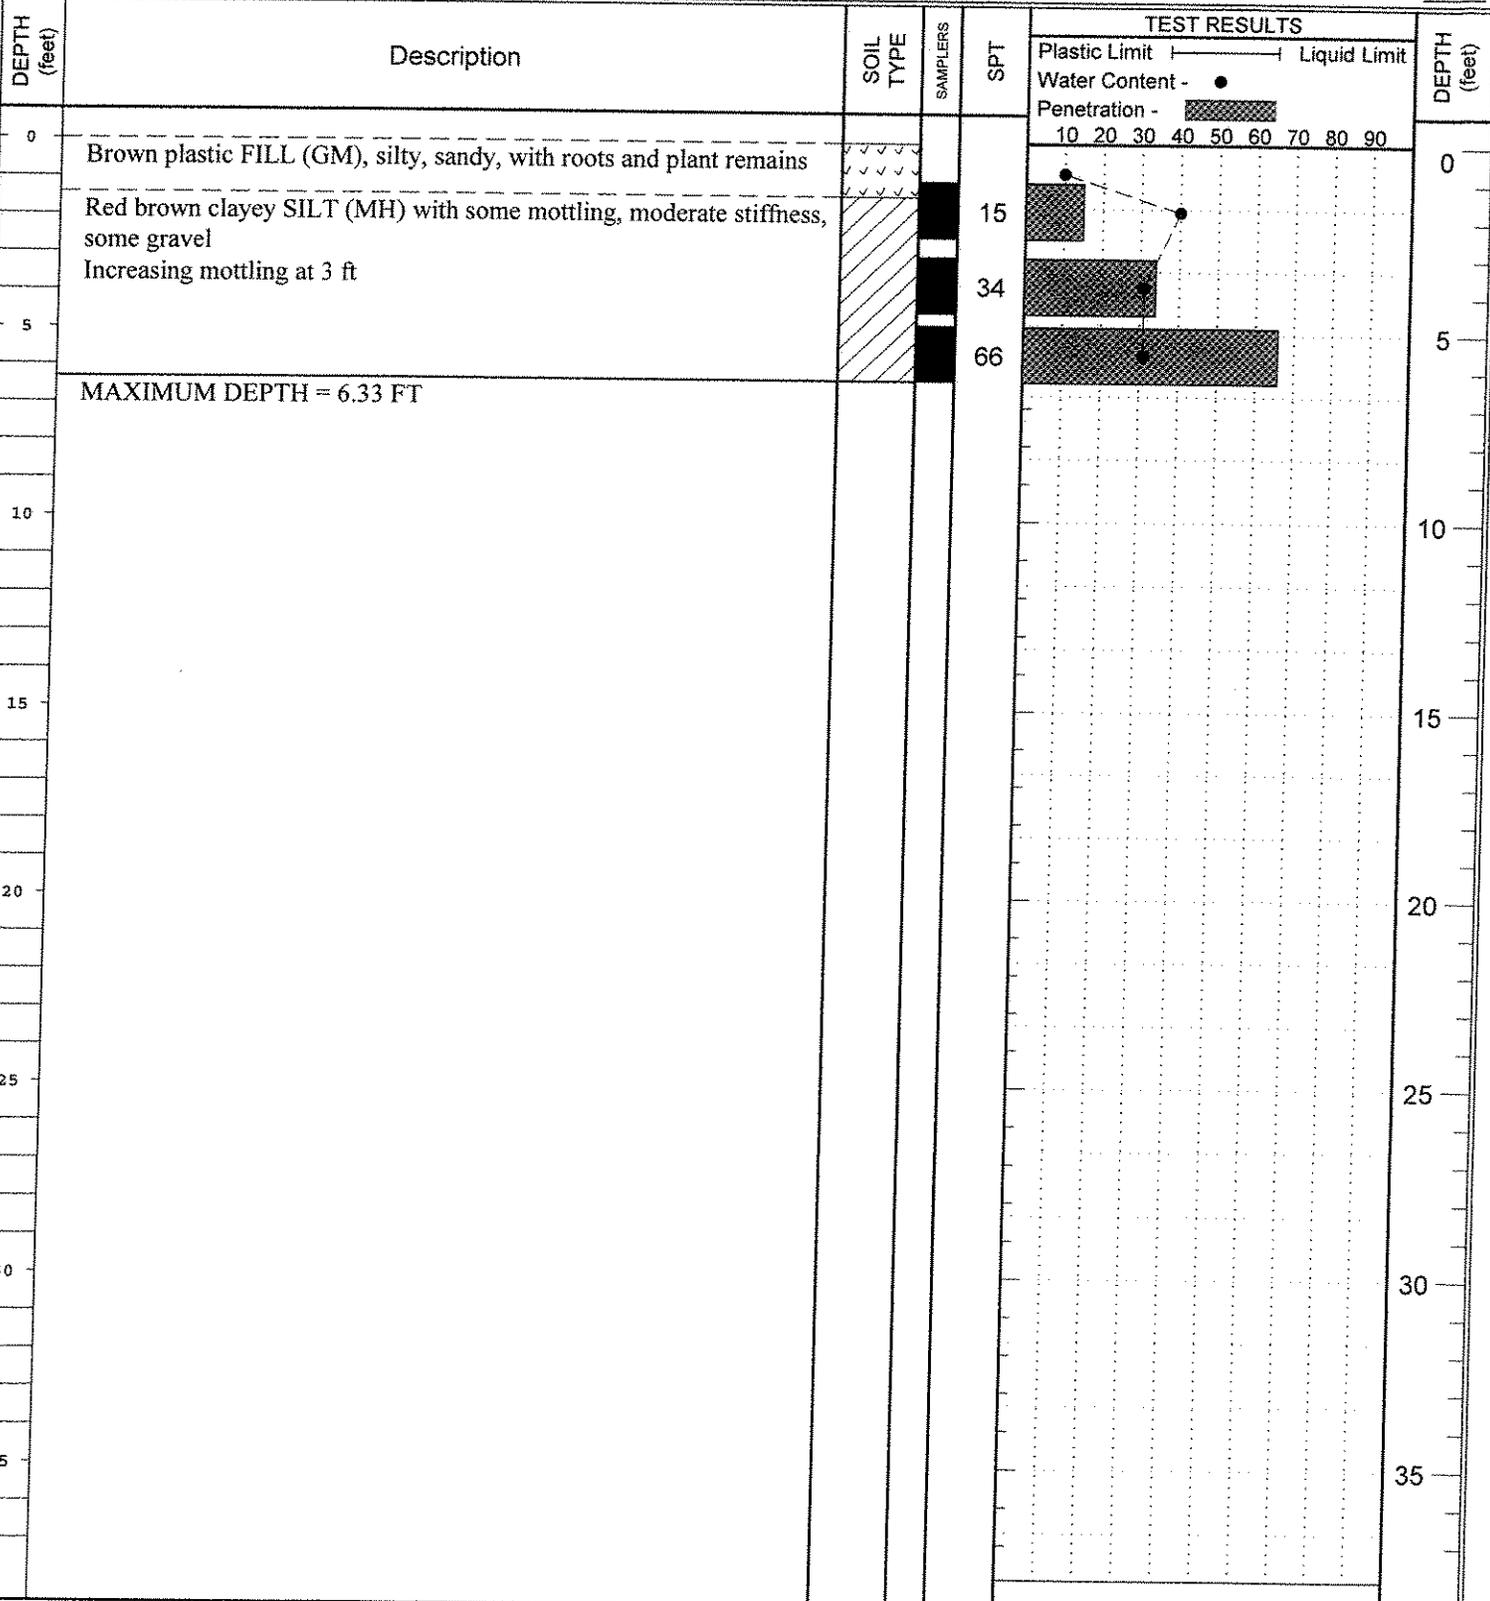
BORING NO. B2

Hand-held drilling rig with 35-lb hammer dropping a distance of 48"

The subsurface conditions at the project site were explored by drilling and sampling three borings, designated as B1 through B3.

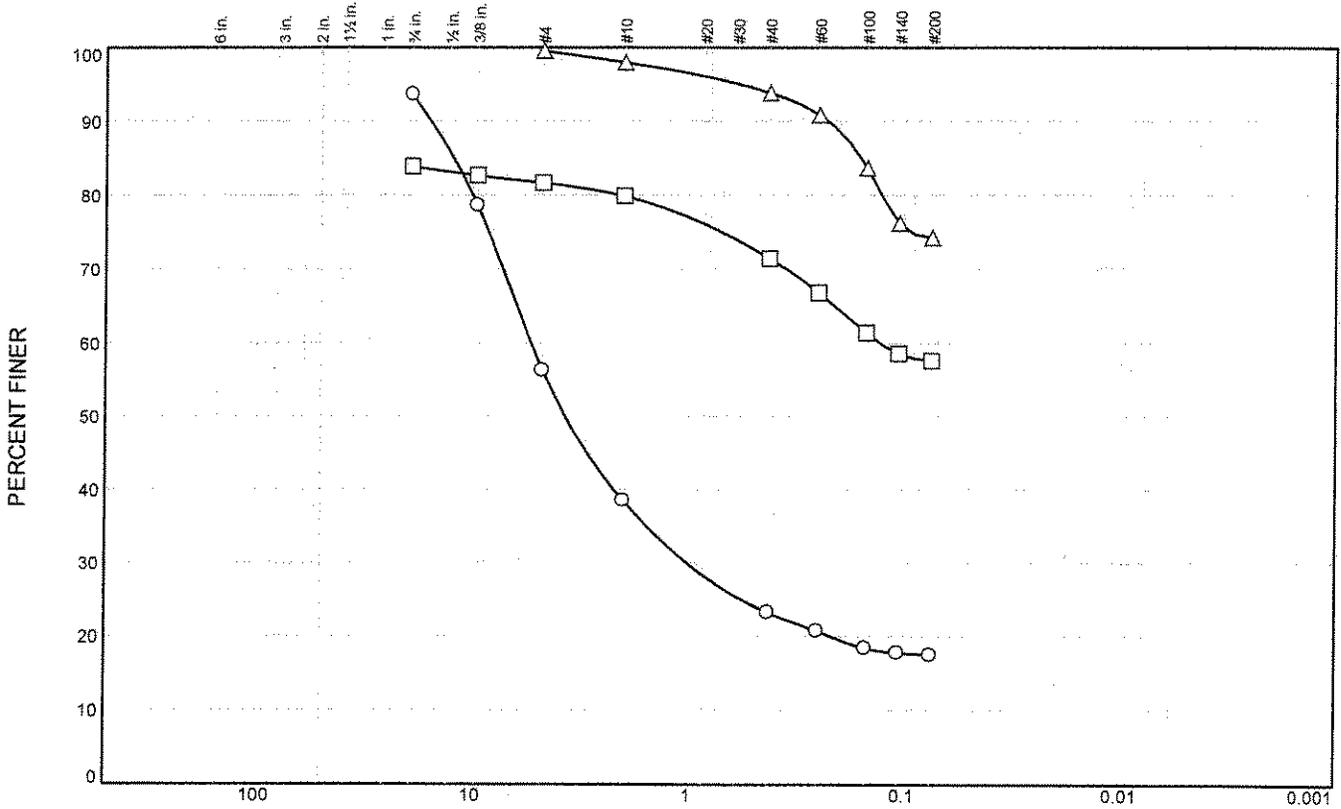
Figure B1

Particle Size Distribution Report

% +3"	% Gravel		% Sand			% Fines	
		Coarse	Fine	Coarse	Medium	Fine	Silt	Clay
○			37.3	17.8	15.2	5.8	17.5	
□			2.2	1.8	8.4	13.9	57.6	
△				1.6	4.1	19.5	74.3

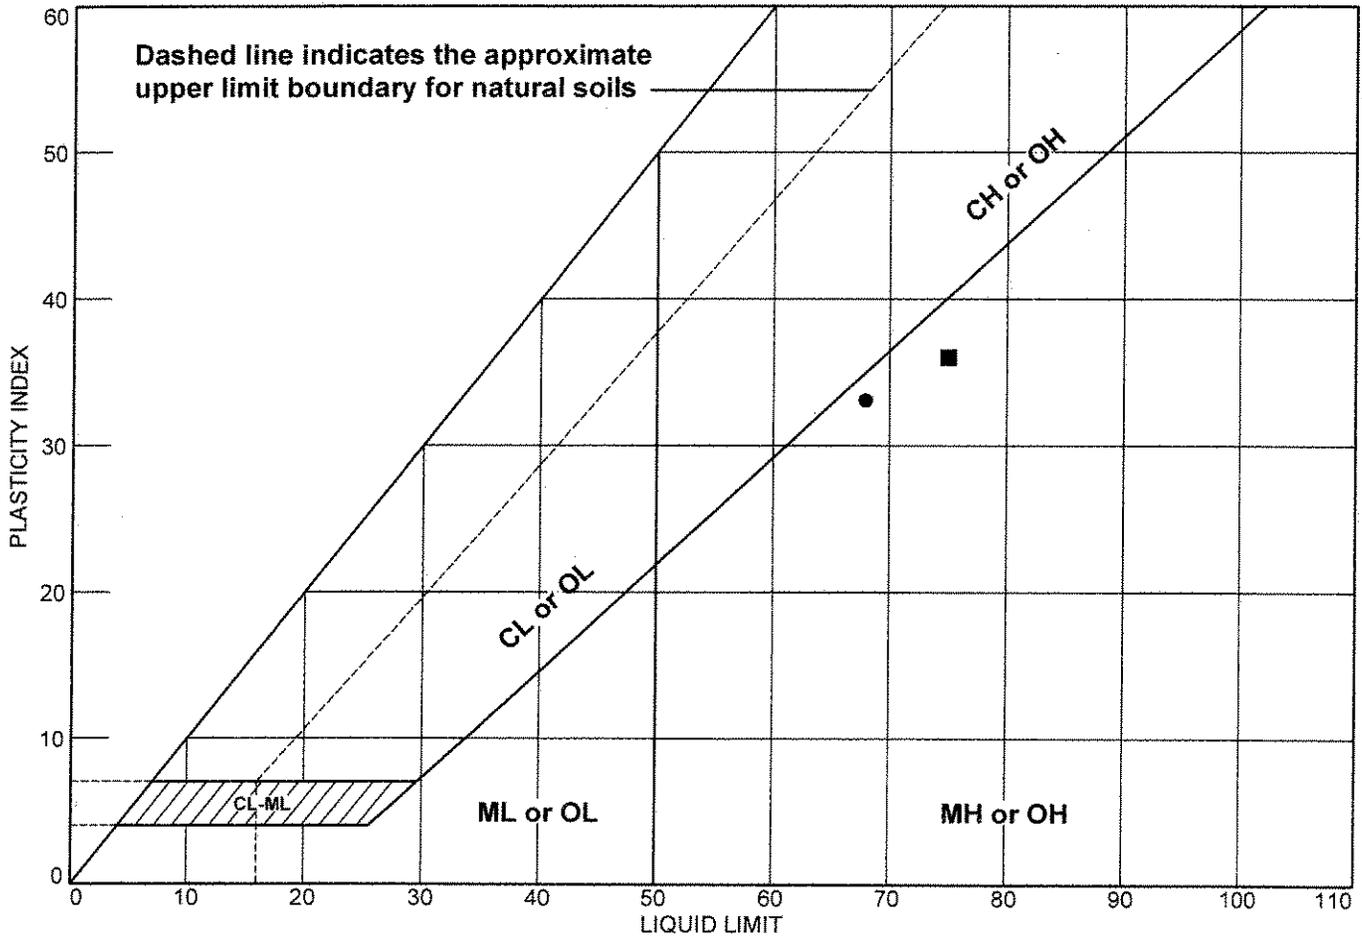
Figure B2

LIQUID AND PLASTIC LIMITS TEST REPORT

SYMBOL	SOURCE	SAMPLE NO.	DEPTH	NATURAL WATER CONTENT (%)	PLASTIC LIMIT (%)	LIQUID LIMIT (%)	PLASTICITY INDEX (%)	USCS
●	B2		2.25	30	35	68	33	MH
■	B3		6.75	38	39	75	36	MH

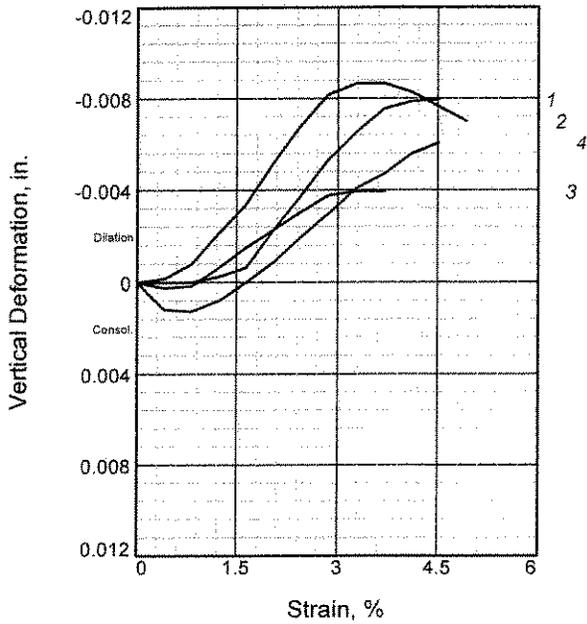
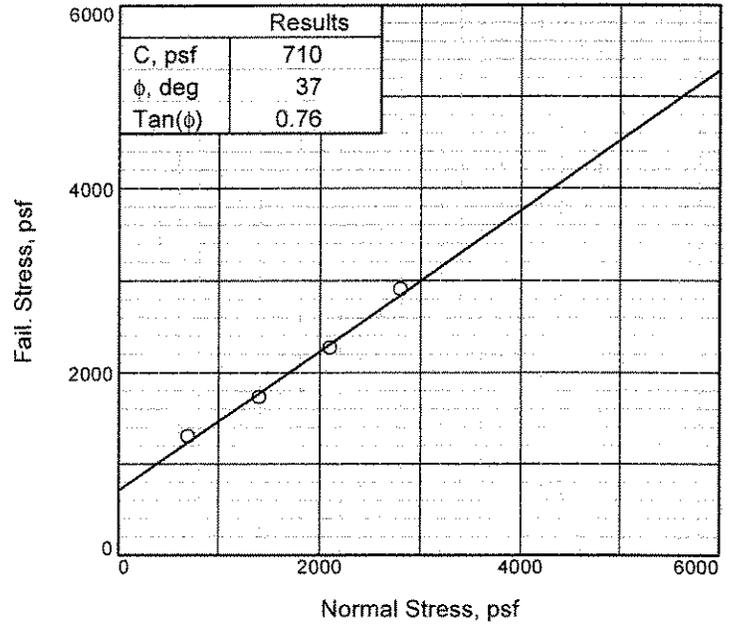
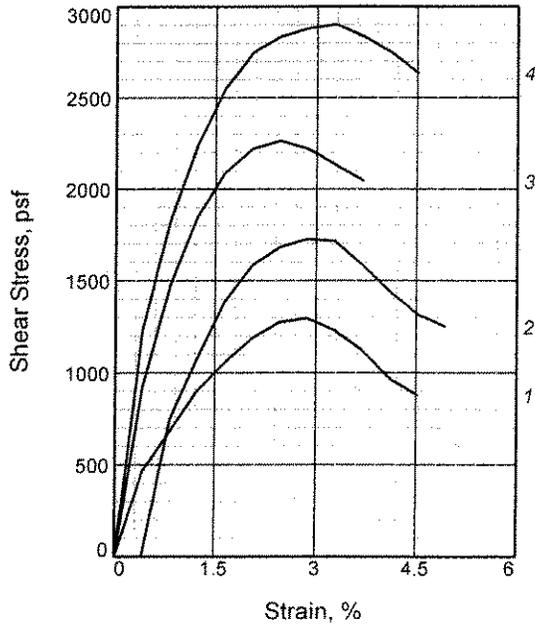
Direct Shear Tests: B3 @ 6'

Sample No.		1	2	3	4
Initial	Water Content, %	41.0	40.0	38.7	38.2
	Dry Density, pcf	80.9	83.2	83.9	84.8
	Saturation, %	91.4	93.5	91.9	92.4
	Void Ratio	1.3915	1.3267	1.3059	1.2813
	Diameter, in.	2.40	2.40	2.40	2.40
	Height, in.	1.00	1.00	1.00	1.00
At Test	Water Content, %	44.2	42.6	41.3	41.0
	Dry Density, pcf	81.6	84.0	84.8	85.9
	Saturation, %	99.9	101.3	99.8	101.4
	Void Ratio	1.3723	1.3034	1.2828	1.2539
	Diameter, in.	2.40	2.40	2.40	2.40
	Height, in.	0.99	0.99	0.99	0.99
Normal Stress, psf		701	1403	2105	2807
Fail. Stress, psf		1298	1727	2266	2903
Strain, %		2.9	2.9	2.5	3.3
Ult. Stress, psf					
Strain, %					
Strain rate, in./min.		0.04	0.04	0.04	0.04
