Retaining Wall TMK: 4-7-019-049, 47-079 Kamehameha Hwy, Kaneohe, Hawaii

**FINAL
ENVIRONMENTAL ASSESSMENT FOR SHORELINE
SETBACK VARIANCE APPLICATION**

**After-the-fact Concrete Deck and
Slope and Shoreline Stabilization**

**PREPARED BY:
Joseph and Kristen Souza
(808) 236-2480
April 2006
Revised September 2008
Revised April 2009**

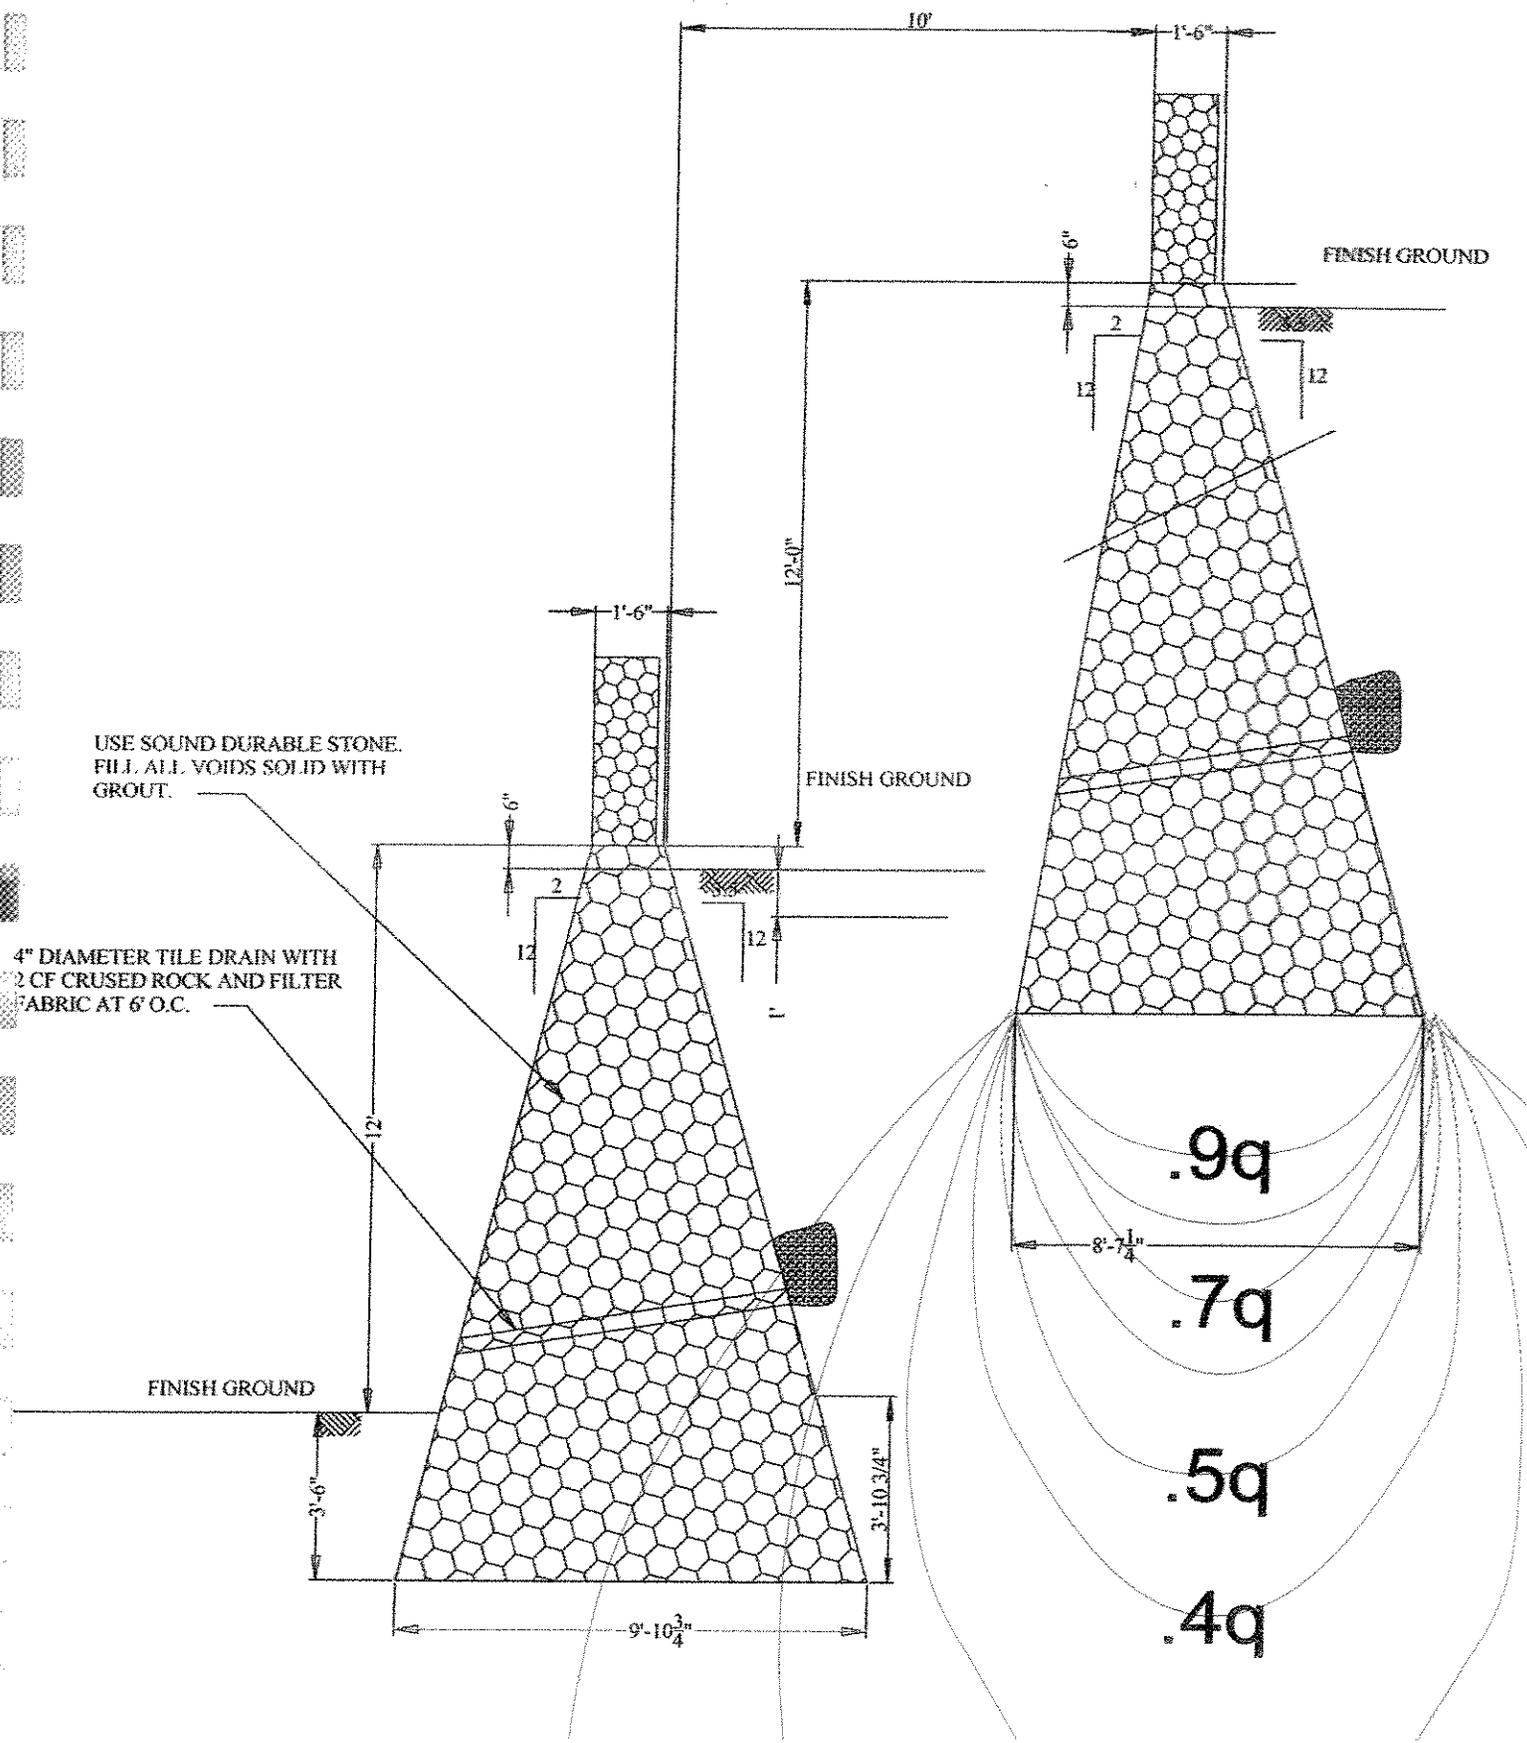
USE SOUND DURABLE STONE.
FILL ALL VOIDS SOLID WITH
GROUT.

4" DIAMETER TILE DRAIN WITH
2 CF CRUSHD ROCK AND FILTER
FABRIC AT 6" O.C.
