# 'Aiea Intermediate School Erosion Control

## Draft Environmental Assessment

Job No. Q71009-07

Prepared for:  
State of Hawai'i,  
Department of Education

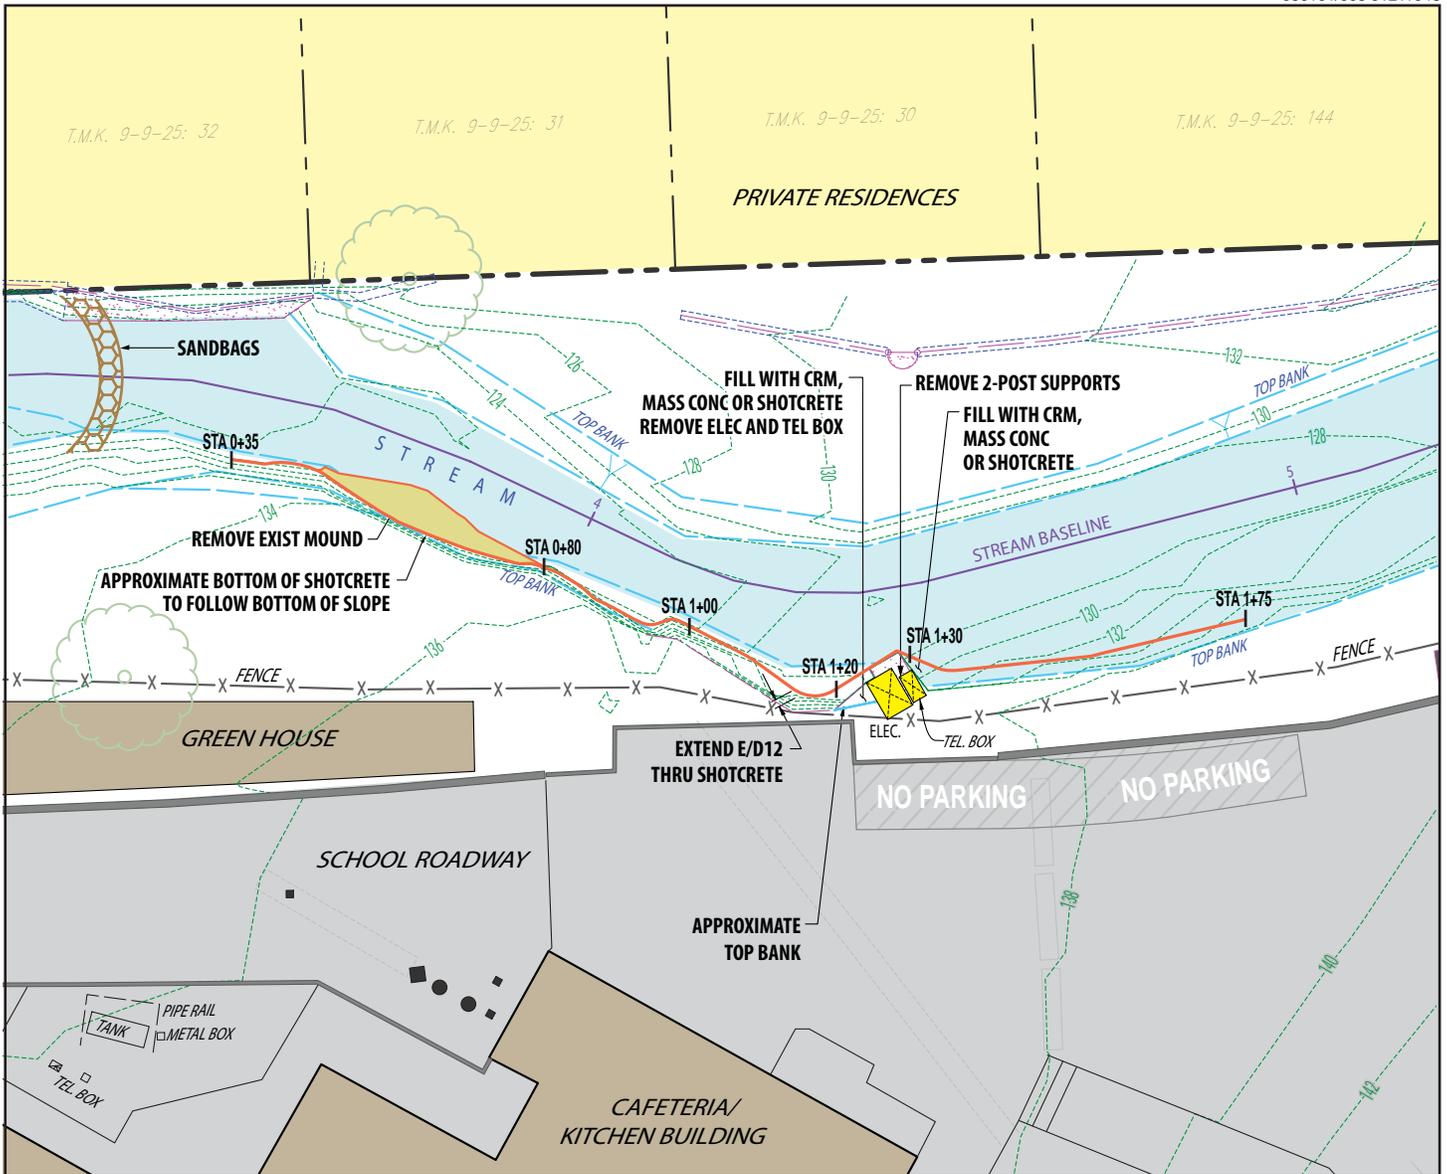
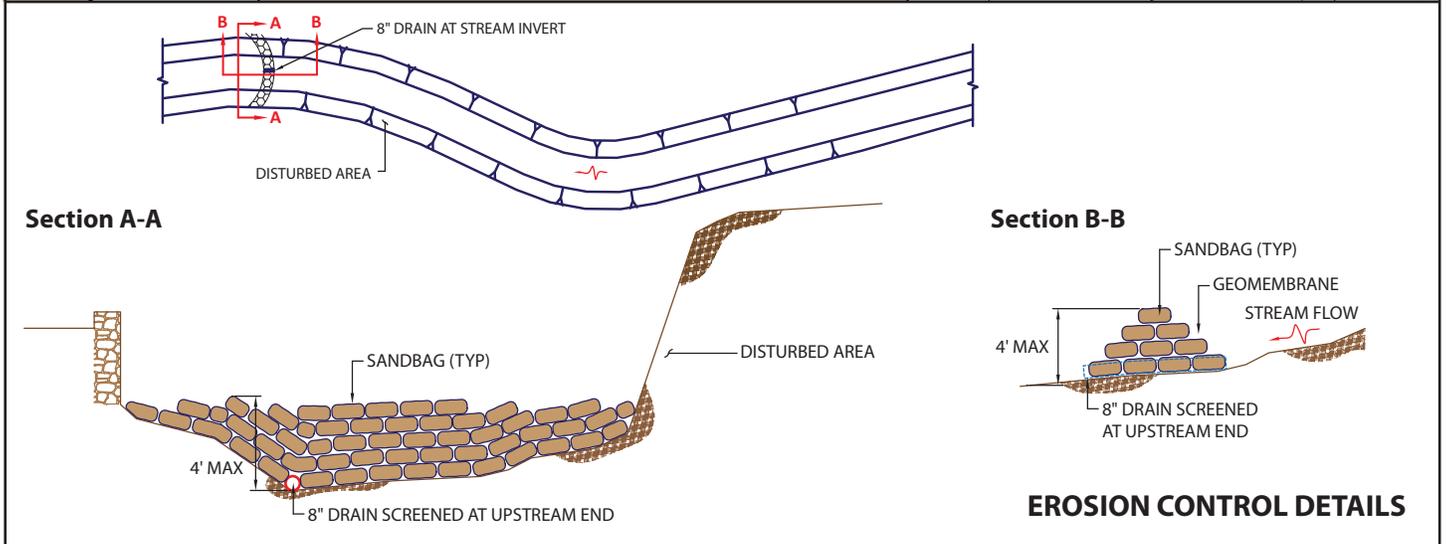
**Figure 3**  
**SITE PLAN**  
 'Aiea Intermediate School Erosion Control EA

The proposed project will protect and stabilize a 150-foot segment of the eroding stream bank in this area, as shown in Figures 3 and 4. Sections of the stream bank which have already been undermined will be supported with grouted rip rap or mass concrete and unstable outcrops and overhangs will be trimmed or removed. Wire reinforced shotcrete will then be applied over the entire eroding and distressed stream bank to prevent further sloughing and retreat of the stream bank caused by stream scour and erosion. Shotcrete is a concrete mixture which is sprayed at high velocity through a hose and nozzle. This application process allows the concrete mixture to be placed on steep slopes. Prior to the application of the shotcrete, the bank surface will be prepared by the removing loose debris and vegetation and placing geocomposite sub-drainage strips on the slope.

At the toe of the slope near the stream, the bottom three (3) feet below grade will also be excavated, reinforced with reinforcing steel, and backfilled with shotcrete. This will protect against scour caused by the stream flow.

A sub-drain system in the shotcreted area of the stream bank will prevent infiltrated surface water from building up behind the slope face protection. Water will be released through weep holes or small pipes at the bottom of the slope.

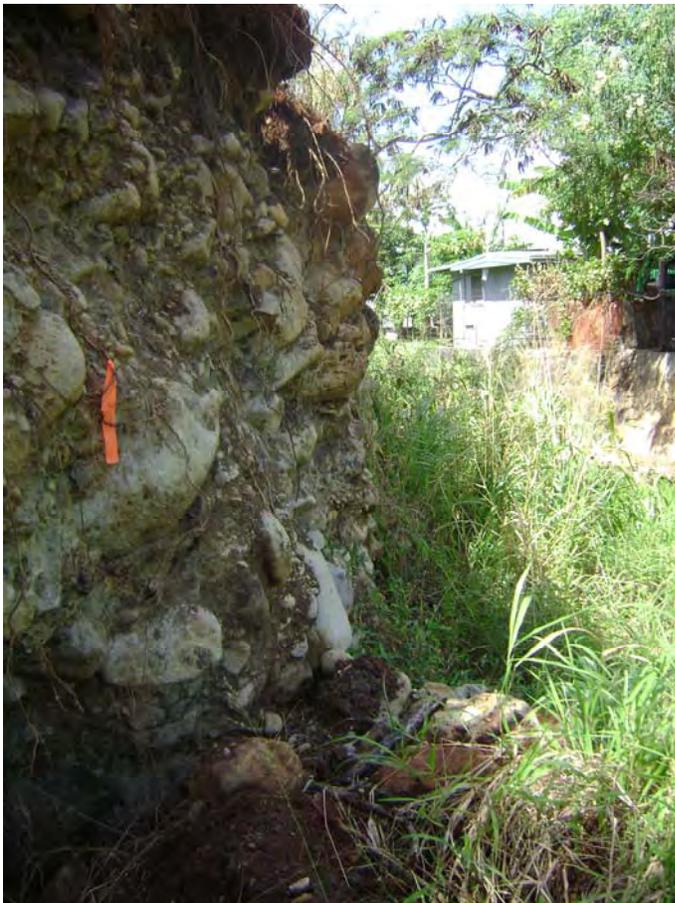
The Geotechnical Exploration and Evaluation Report found the stream bank bluff is severely scoured and undermined at the toe of the slope near the stream. This has resulted in overhanging outcrops and exposed boulders and cobbles. Vertical tension cracks were observed on the bank adjacent to the overhanging outcrops. The scour and erosion have also undermined an electrical hand hole box leaving a large cavity beneath the box. The electrical lines were relocated in 2009.

Eroded stream bank and residence on the other side of the stream. (photo courtesy of YKE)

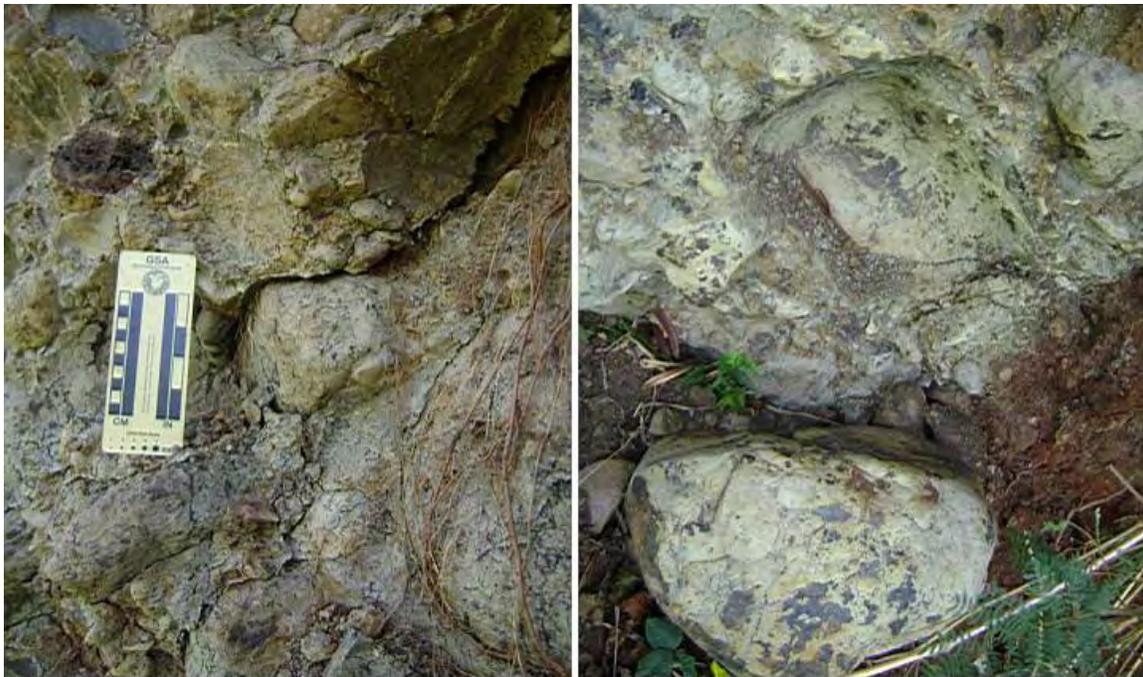
Figure 12: Vertical Tension Cracks and Spalled Boulders

The vertical tension cracks observed in the vicinity of the overhanging outcrops substantiates this pattern of scour, spall, and progressive retreat of the stream bank as shown in the following photographs (Figure 12).

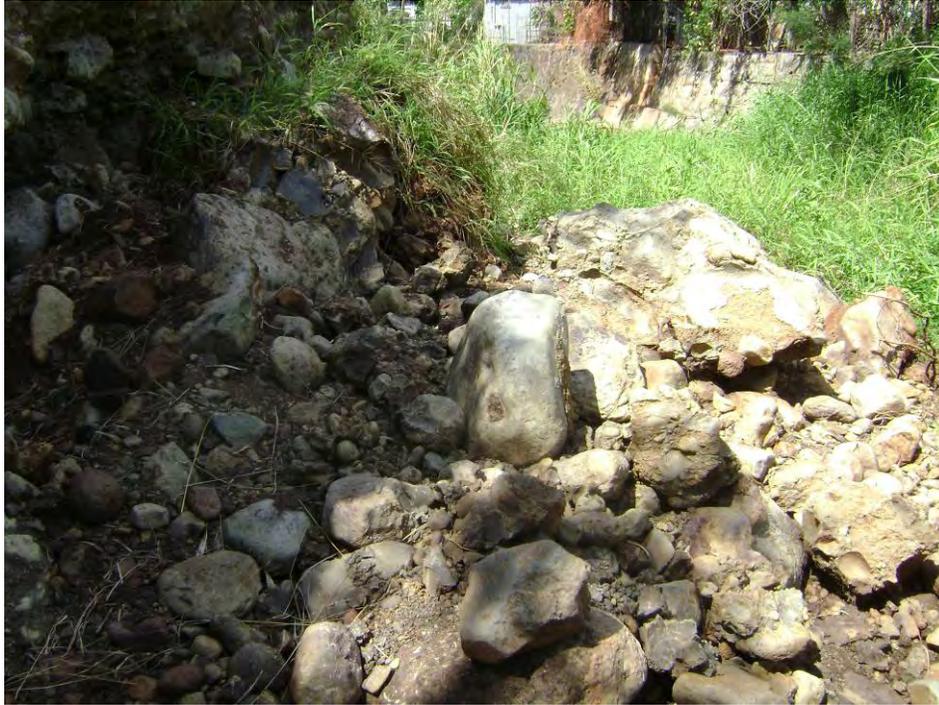
Figure 13: Recent Stream Bank Spall Debris and Local Failures

Recent spall debris consisting of boulders and cobbles partly embedded in a matrix of silts and clays were also observed lying in the stream bed in the vicinity of the undermined vertical stream bank as shown in Figure 13 below.

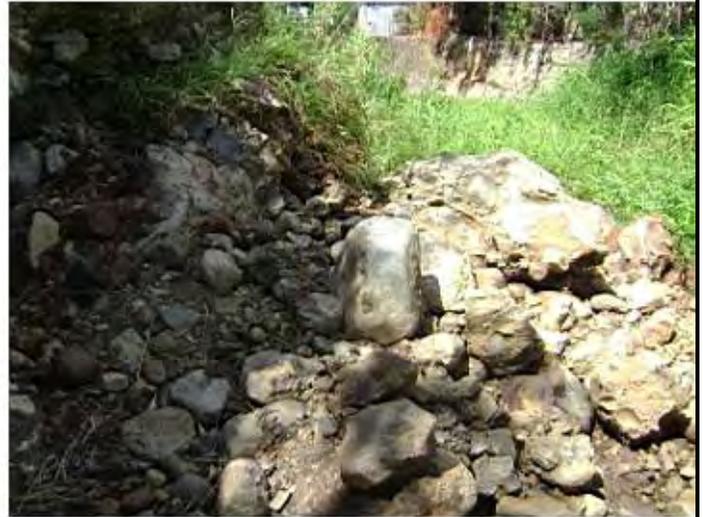
Scour at the Base of the Stream Bank

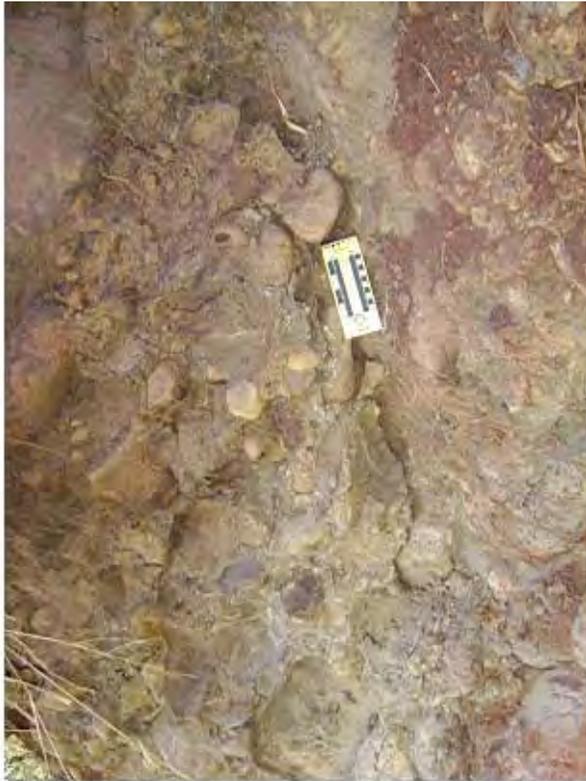
Tension Cracks Observed on Vertical Stream Bank

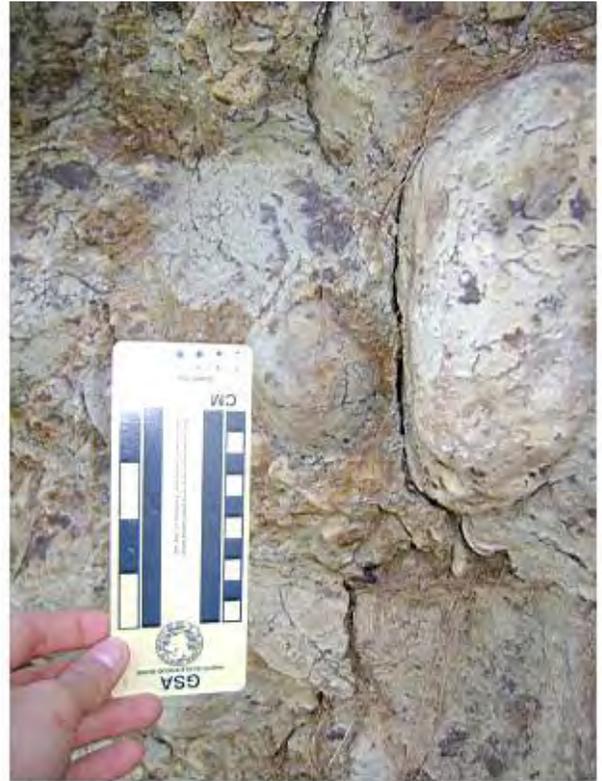
Tension Cracks Observed on Vertical Stream Bank

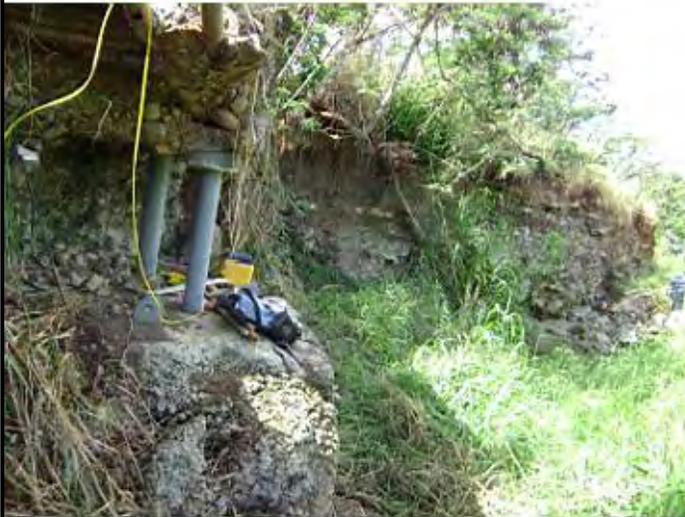
Undermined Electrical Box and Vertical Stream Bank  
Downstream

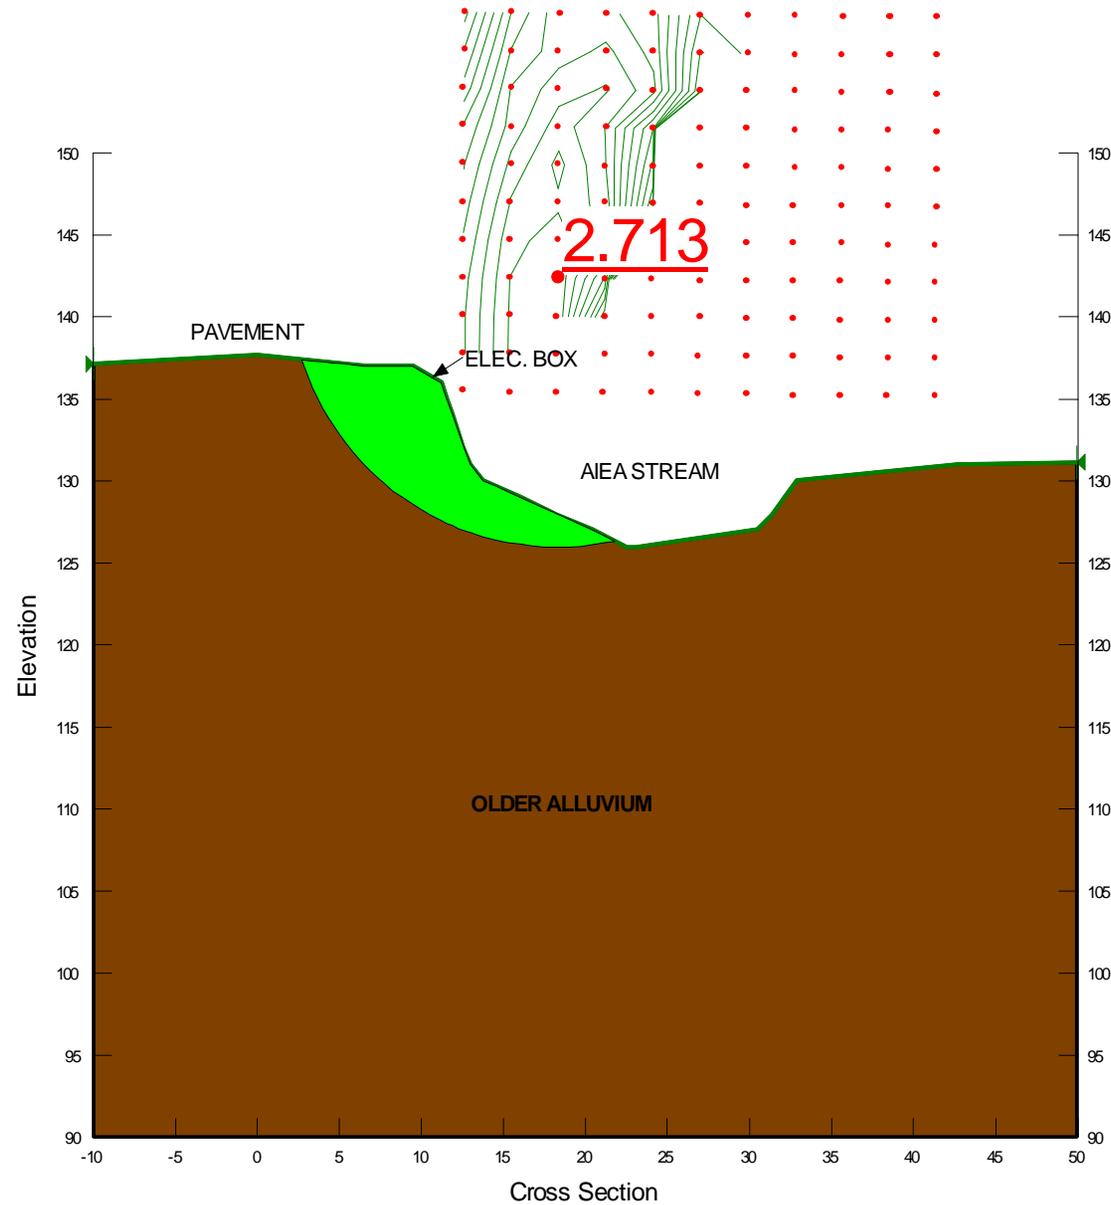
OLDER ALLUVIUM  
Unit Weight = 125 pcf  
Cohesion = 350 psf  
Phi = 26.6 degrees  
SEISMIC LOADING:  
Horizontal = 0g  
Vertical = 0g

### SLOPE STABILITY ANALYSIS: EFFECTIVE STRENGTH – STATIC & UNSATURATED CONDITION

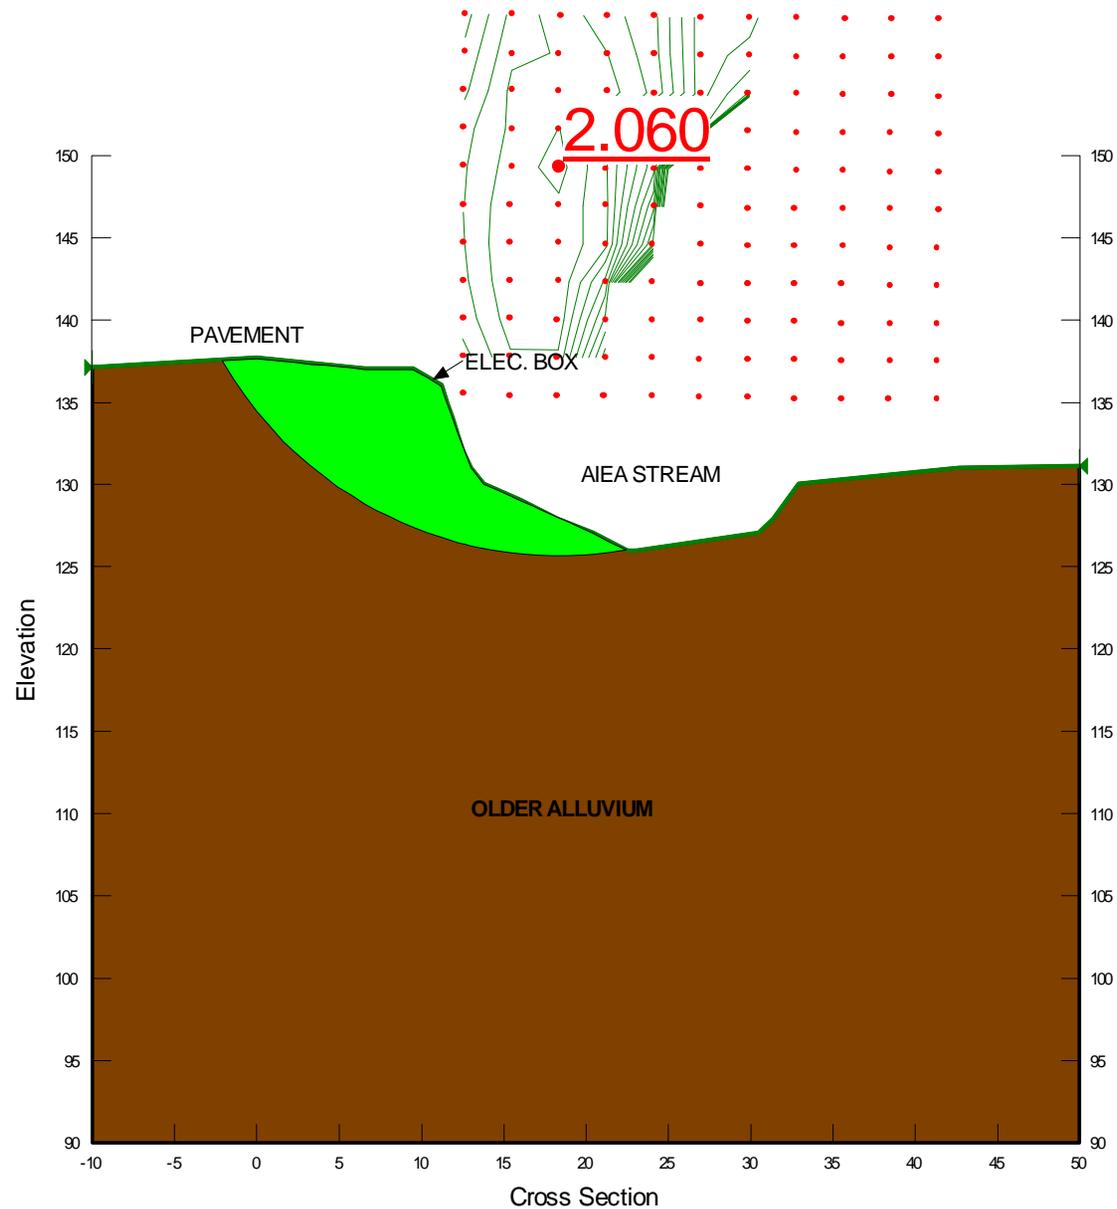
SEISMIC LOADING:  
Horizontal = 0.15g  
Vertical = 0.1g

**SLOPE STABILITY ANALYSIS: EFFECTIVE STRENGTH – UNSATURATED CONDITIONS WITH PSEUDOSTATIC SEISMIC LOADING**  
Stream Bank Assessment and Roadway Support  
Aiea Intermediate School, Aiea, Oahu, Hawaii

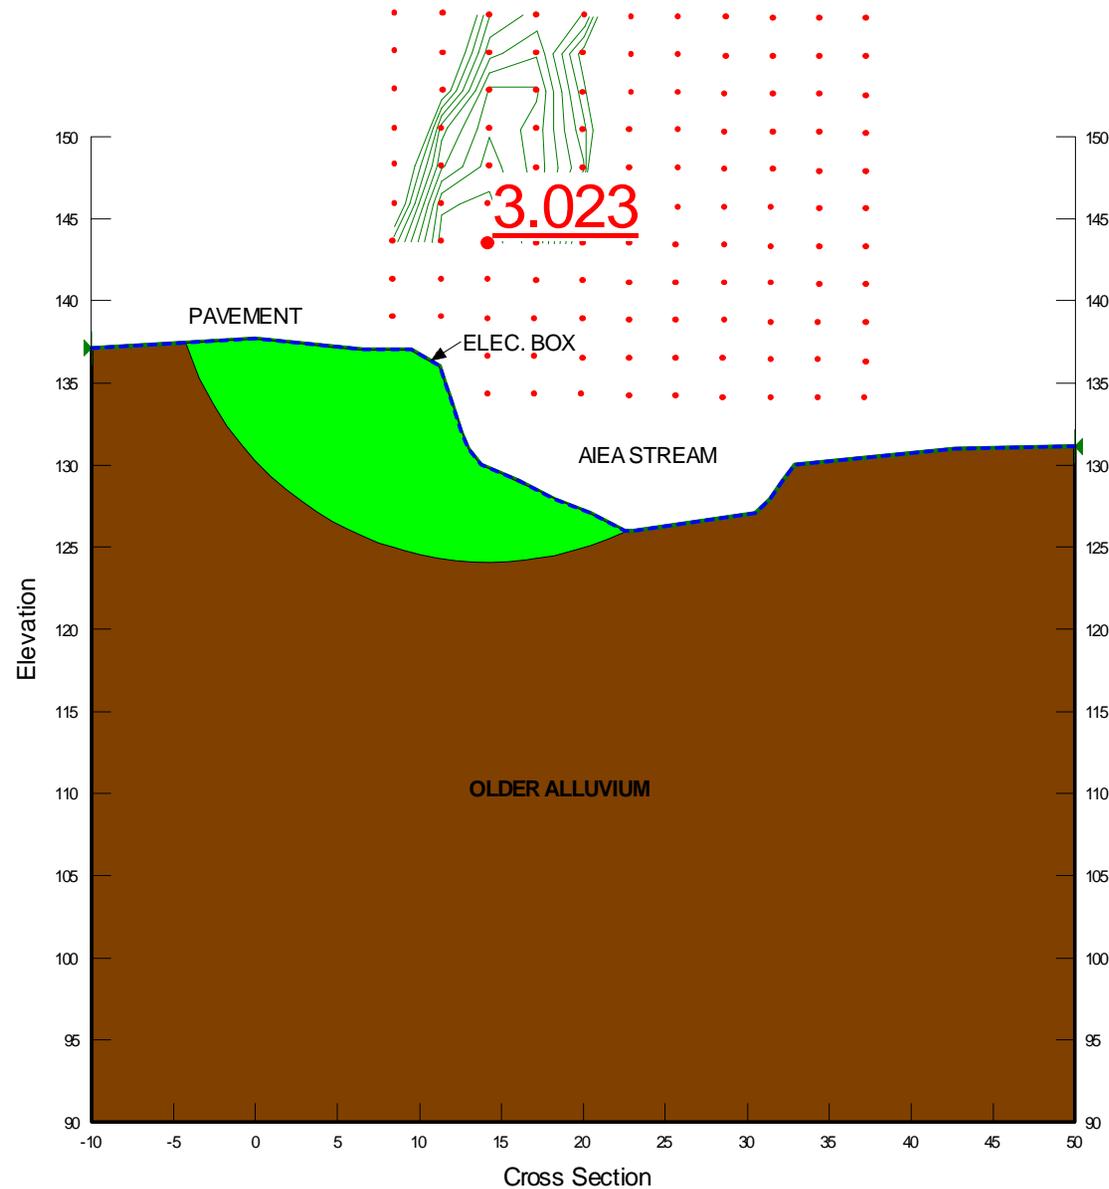
OLDER ALLUVIUM  
Unit Weight = 125 pcf  
Saturated Unit Weight = 130 pcf  
Cohesion = 750 psf  
Phi = 0 degrees  
SEISMIC LOADING:  
Horizontal = 0g  
Vertical = 0g

**SLOPE STABILITY ANALYSIS: TOTAL STRENGTH – STATIC WITH SATURATED RAPID  
DRAWDOWN CONDITIONS**

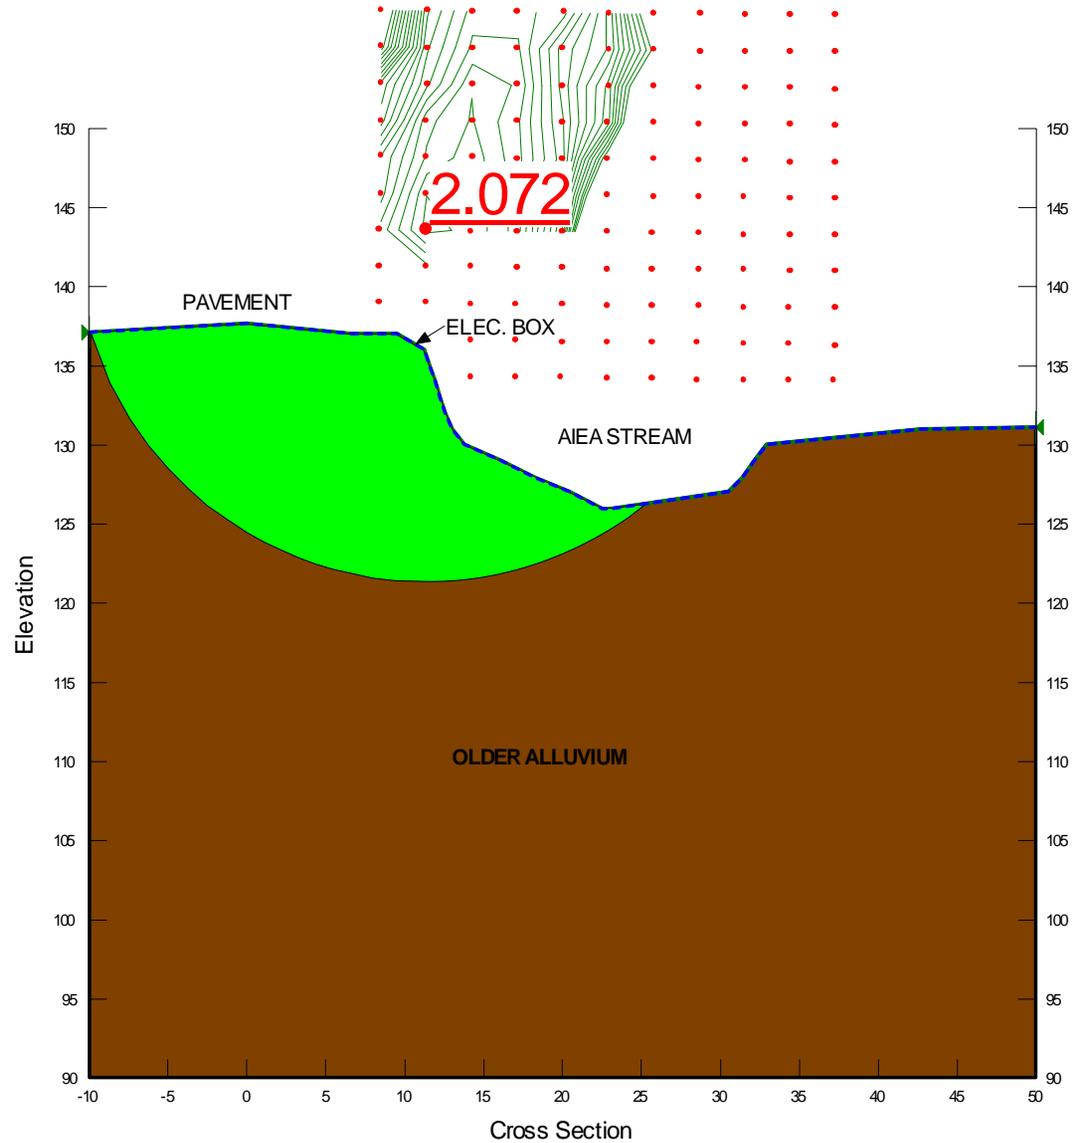
OLDER ALLUVIUM  
Unit Weight = 125 pcf  
Saturated Unit Weight = 130 pcf  
Cohesion = 750 psf  
Phi = 0 degrees  
SEISMIC LOADING:  
Horizontal = 0.15g  
Vertical = 0.1g

**SLOPE STABILITY ANALYSIS: TOTAL STRENGTH – SATURATED RAPID DRAWDOWN  
CONDITIONS WITH PSEUDOSTATIC SEISMIC LOADING**  
Stream Bank Assessment and Roadway Support  
Aiea Intermediate School, Aiea, Oahu, Hawaii

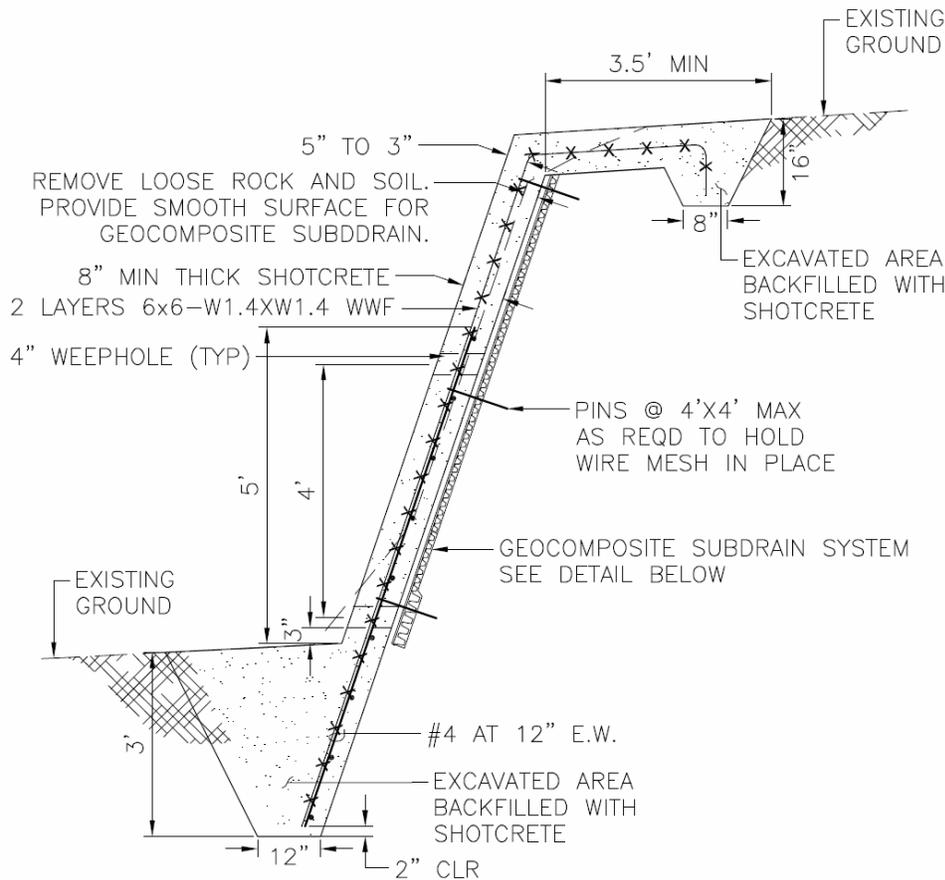
1-4 | Typical Section Detail

be reinforced with reinforcing steel. The additional reinforcing will minimize sections of the shotcrete from breaking off.

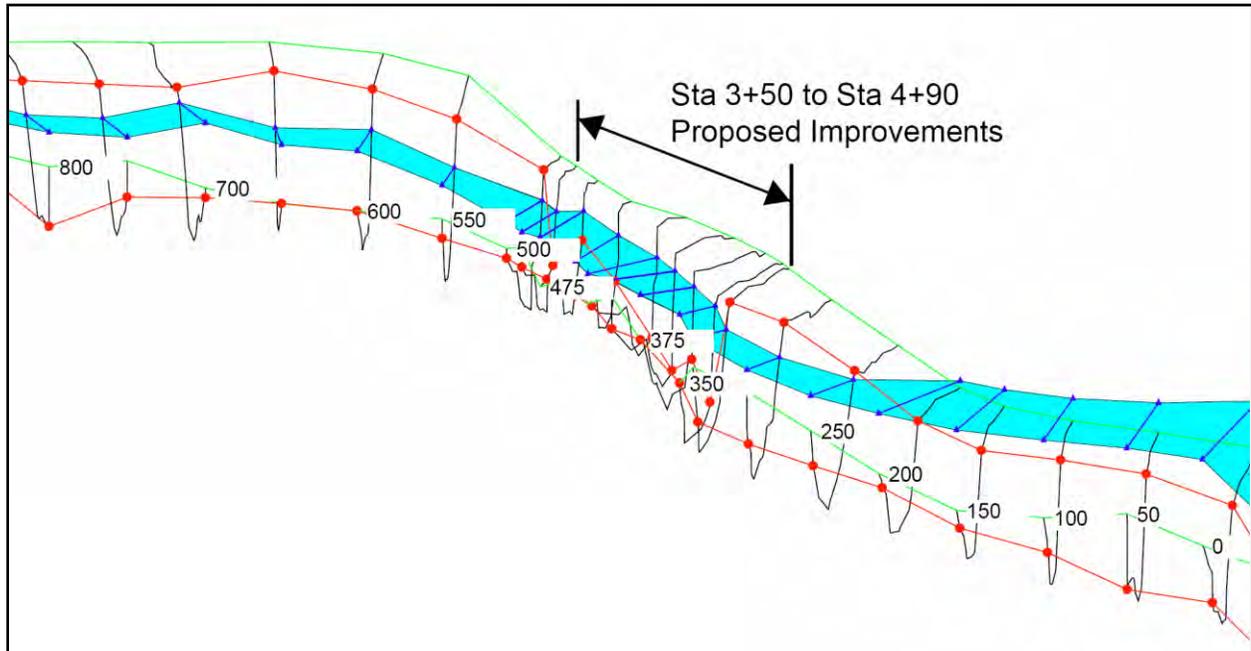
3-2 | 3-D View of Water Surface and Stream at Sta 0+00 to Sta 8+00

Water surface elevations did not change significantly between existing conditions and with the construction of the slope protection measures. Water level changes ranged from (+)0.07 to (-) 0.07 feet. Input data and results for the HEC RAS Version 4 hydraulic program is included in Appendix D.

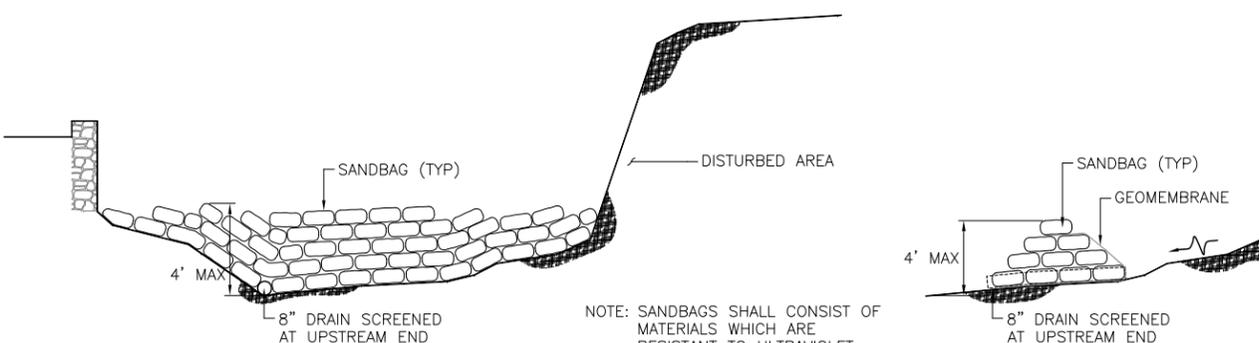
**SECTION A-A**  
SCALE: 1/4" = 1'-0"

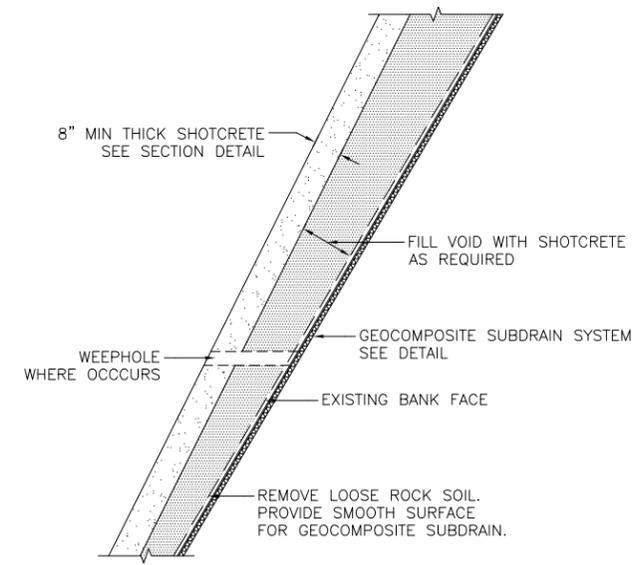
**CONDITION FOR FILL**  
 SCALE: 1/2" = 1'-0"

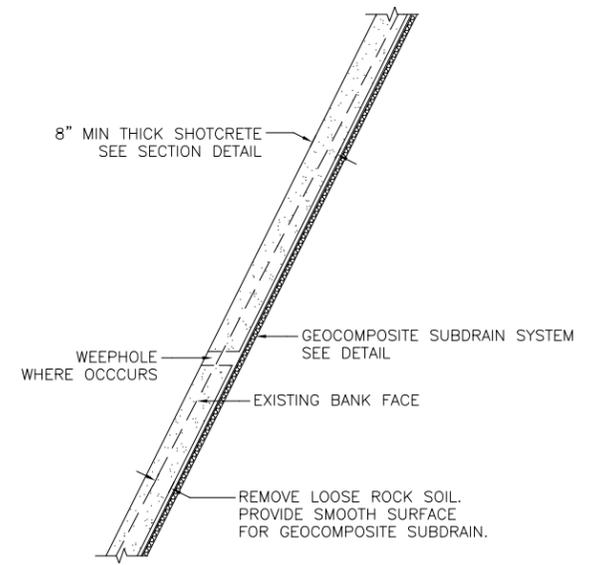
**CONDITION FOR EXC**  
 SCALE: 1/2" = 1'-0"

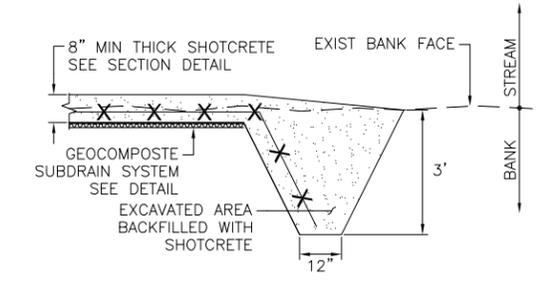
**CONDITION AT BEGIN/END**  
 SCALE: 1/2" = 1'-0"
