# Draft Environmental Assessment

## Mauna Lahilahi Beach Park Shore Protection Wai'anae, O'ahu, Hawai'i

## Mauna Lahilahi Beach Park Shore Protection

### Draft Environmental Assessment

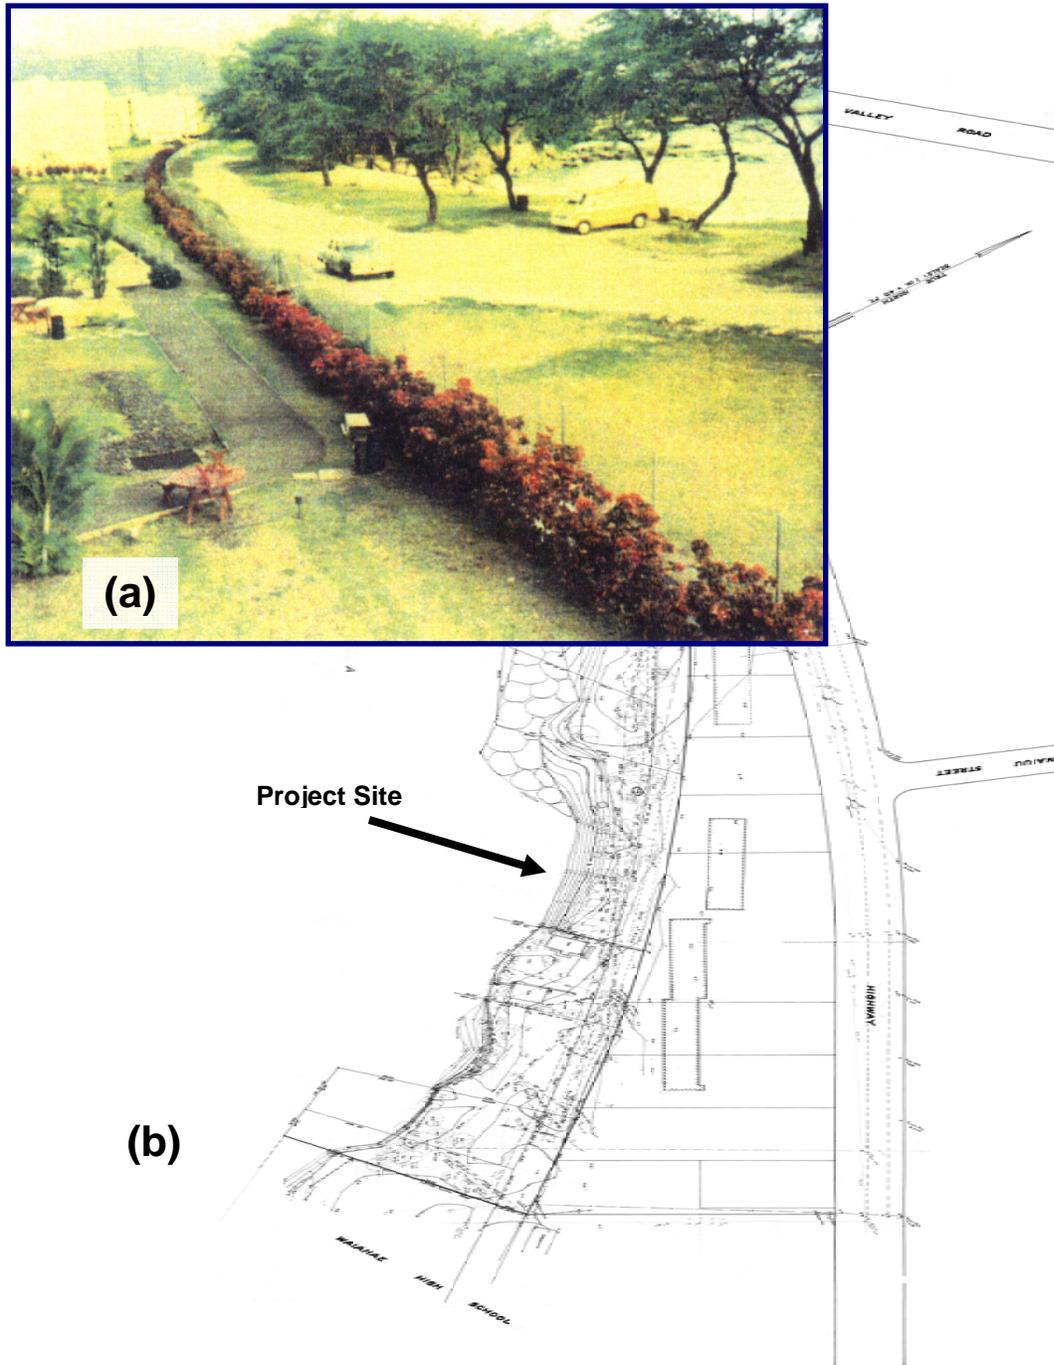
Figure 3-1 (a) Beach View of Mauna Lahilahi Cove in 1970. (b) Topographic Map of Mauna Lahilahi Cove, 1972 (Division of Land Survey & Acquisition); Oriented WNW Along Shoreline

The cove at Mauna Lahilahi Beach was relatively stable until some time after 1949 when the beach toe began receding shoreward. The beach was still relatively wide in 1970 as shown in Figure 3-1, which provides a photo and topographic map of the beach area. However, the beach continued to erode in the 1970s. Hurricanes Iwa in 1982 and Iniki in 1992 caused nearly \$2 million in damage to the Mākaha Surfside Apartments and eroded much of the shoreline fronting the property (Figures 3-2, 3-3, and 3-4). Overall, the shoreline within the pocket beach project area receded nearly 200 feet between 1949 and 1996 as can be seen in Figure 3-5. Aerial photos (Figures 3-6, 3-7, and 3-8) show progressive shoreline changes. An estimated 48,900 square feet of City & County park land presently valued at approximately \$248,700 was lost to shoreline erosion between the early 1970s and 1996. The commercial value of the lost land is about \$2 million. The top of the bank eroded through the fence into the Mākaha Surfside property before a sandbag revetment was constructed during the late 1990s. The existing breakwater was constructed and 10,000 cubic yards of beach sand were placed in 2003 (Figures 3-8, 3-9, and 3-10). The sandbag revetment was removed when the beach was nourished. Since 2003, the nourished sand has been pushed to the south between the breakwater and the shoreline embankment leaving the backshore at the cove's northeast corner exposed to further erosion by waves moving through the gap between the existing breakwater and rocky shoreline. An access road that formerly ran along the edge of the park property was entirely lost to

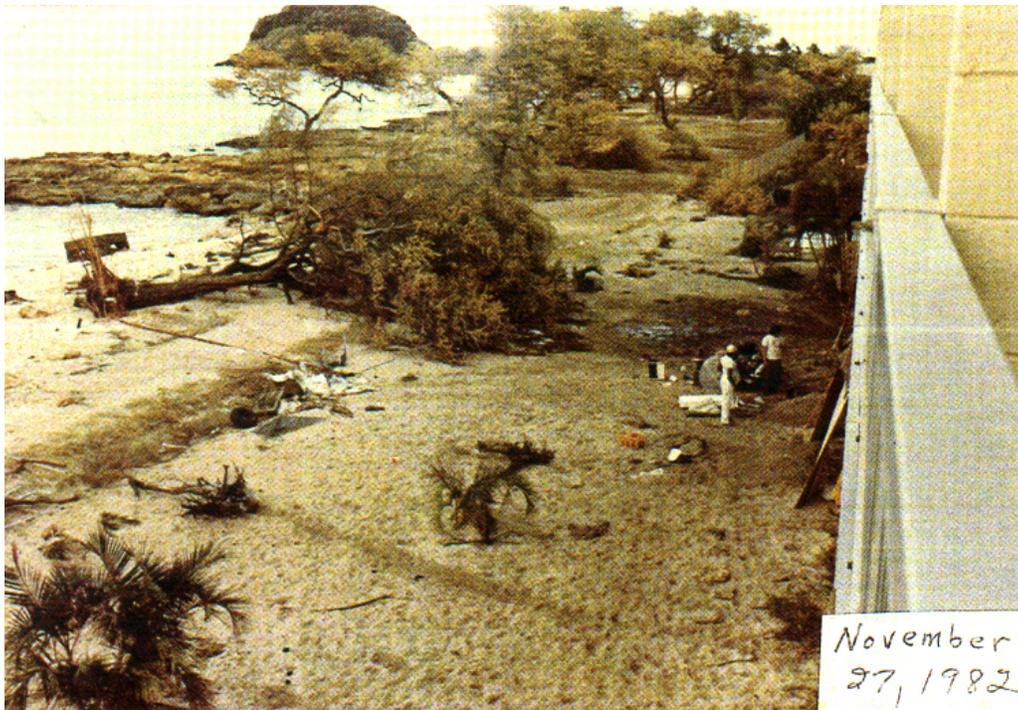
Figure 3-2 Photo of Mauna Lahilahi Project Area in November 27, 1982 Following Hurricane Iwa; Oriented NW Along Shoreline.

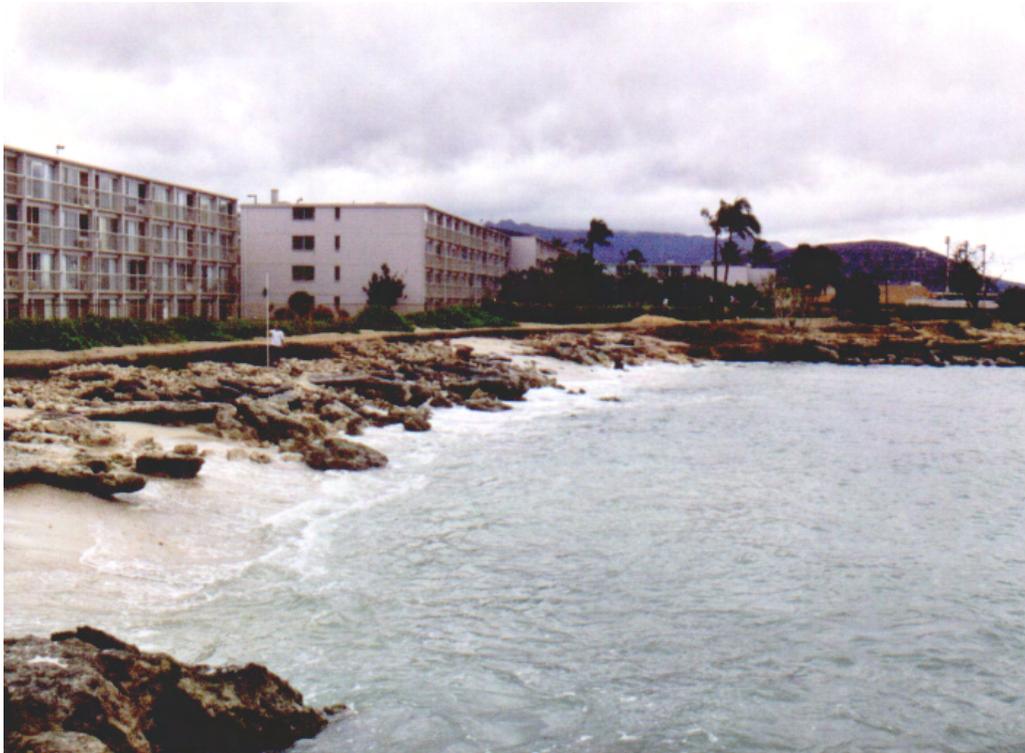
Figure 3-3 Photo of Mauna Lahilahi Project Area in 1998; Oriented SE along Shoreline

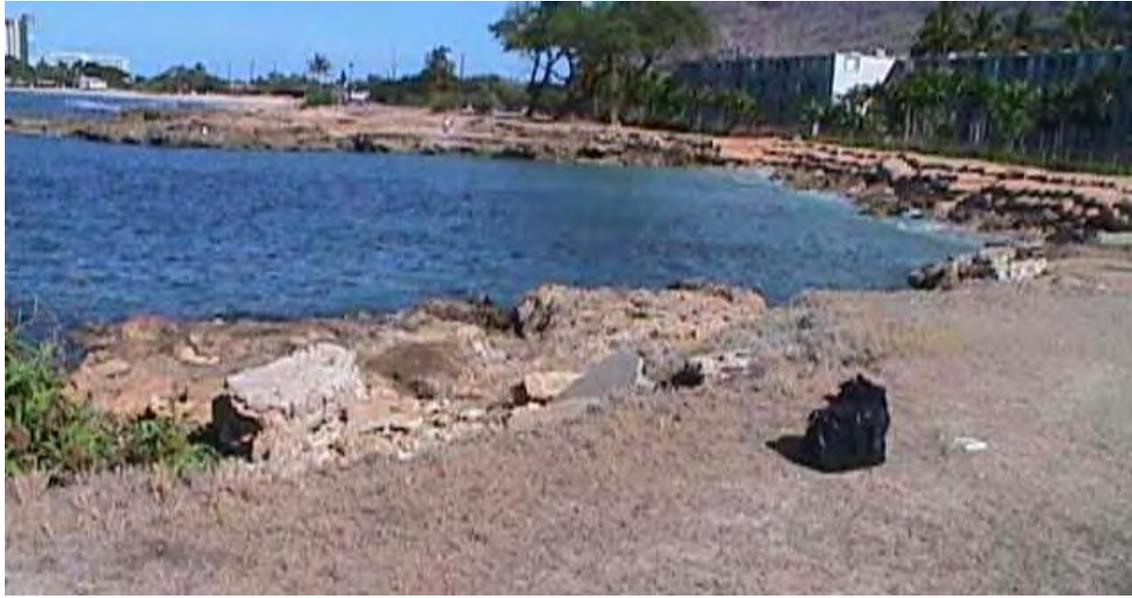
Figure 3-4 Photo of Mauna Lahilahi Project Area with Sandbags in 2000

There is a temporary sandbag revetment built along the shoreline to minimize erosion of the lateral access path and the Mākaha Surfside property. An alternative is to replace the sandbag revetment with a properly designed rock revetment. To be effective, a rock revetment would have to be moved seaward and built higher. Otherwise waves would overtop the revetment and run into the private property causing erosion and flooding. Another risk from this alternative is that a usable recreational beach would not stay on the seaward side of a revetment because of wave reflection and turbulence from incoming waves.

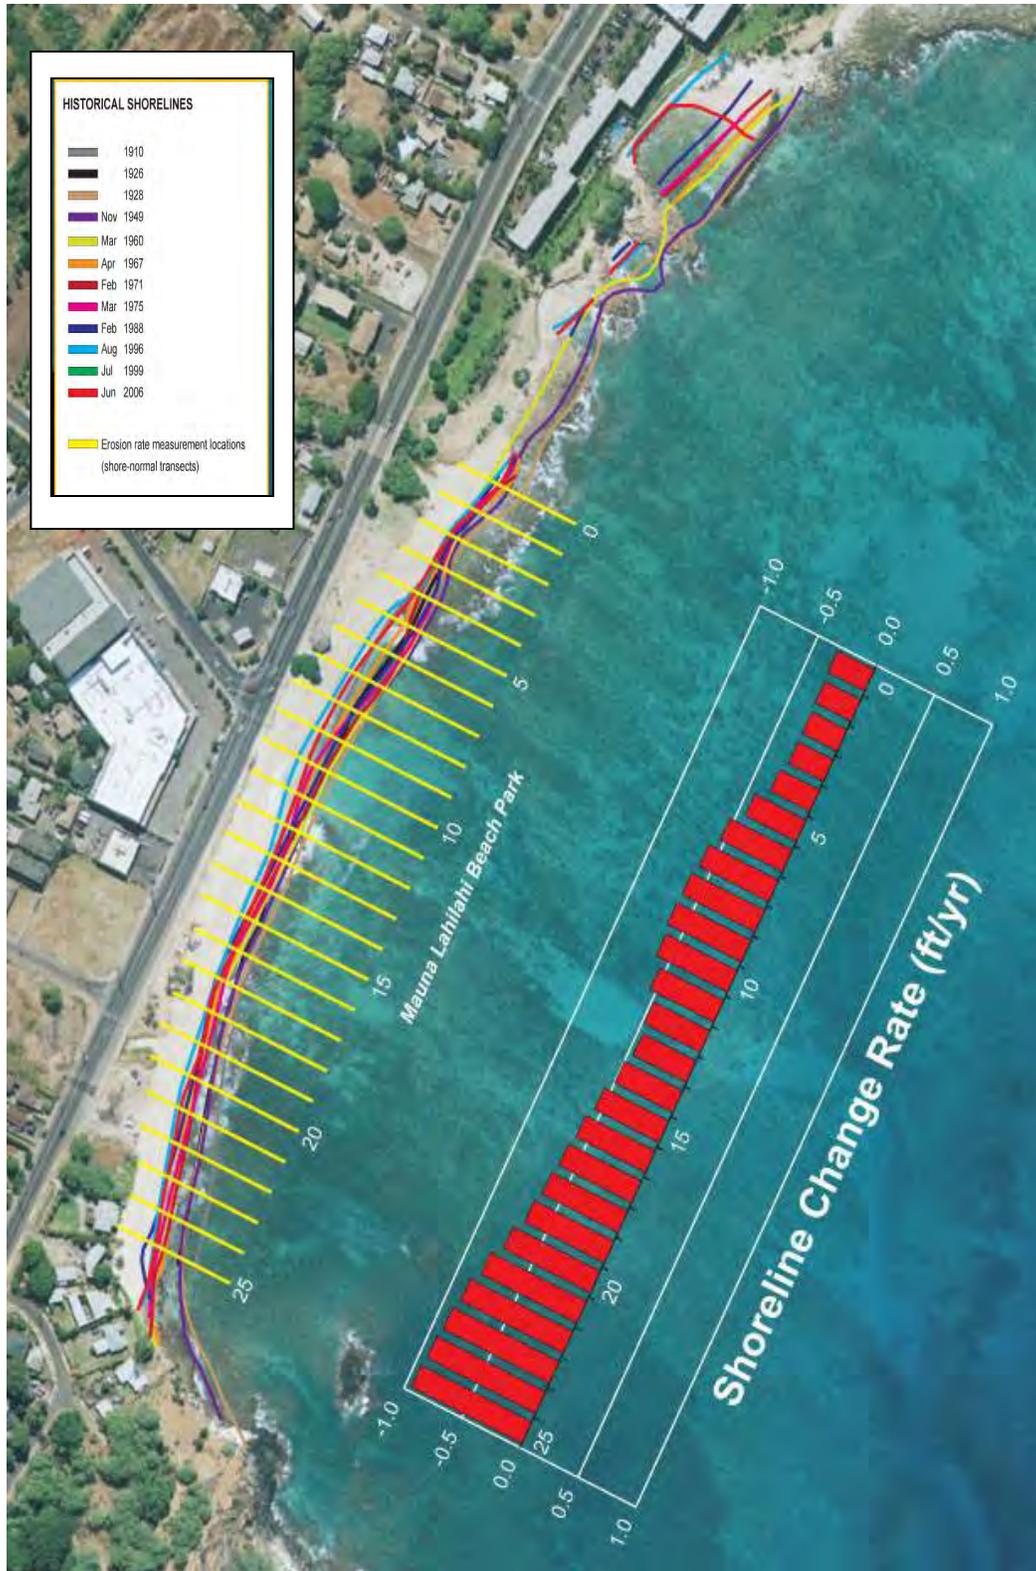
Figure 3-5 Shoreline Erosion Rates

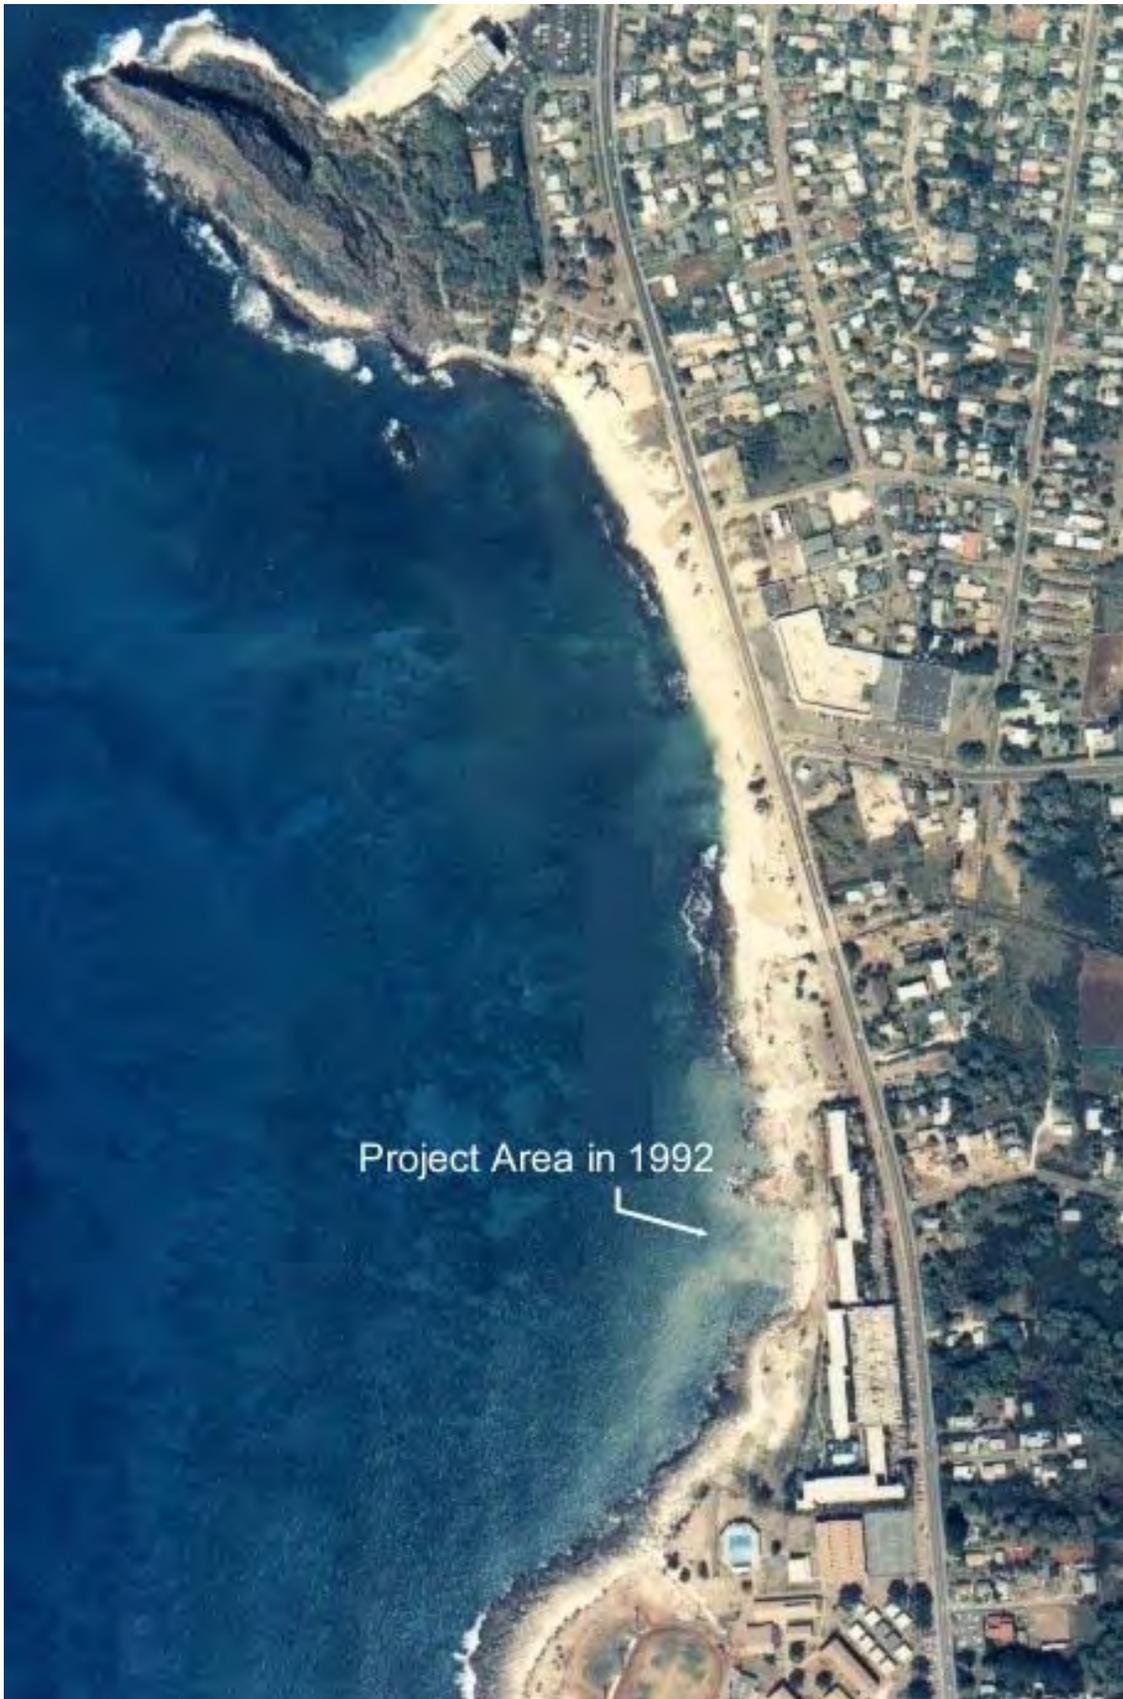
Figure 3-6 Aerial Photo of Mauna Lahilahi Beach Area Following Hurricane Iniki in 1992

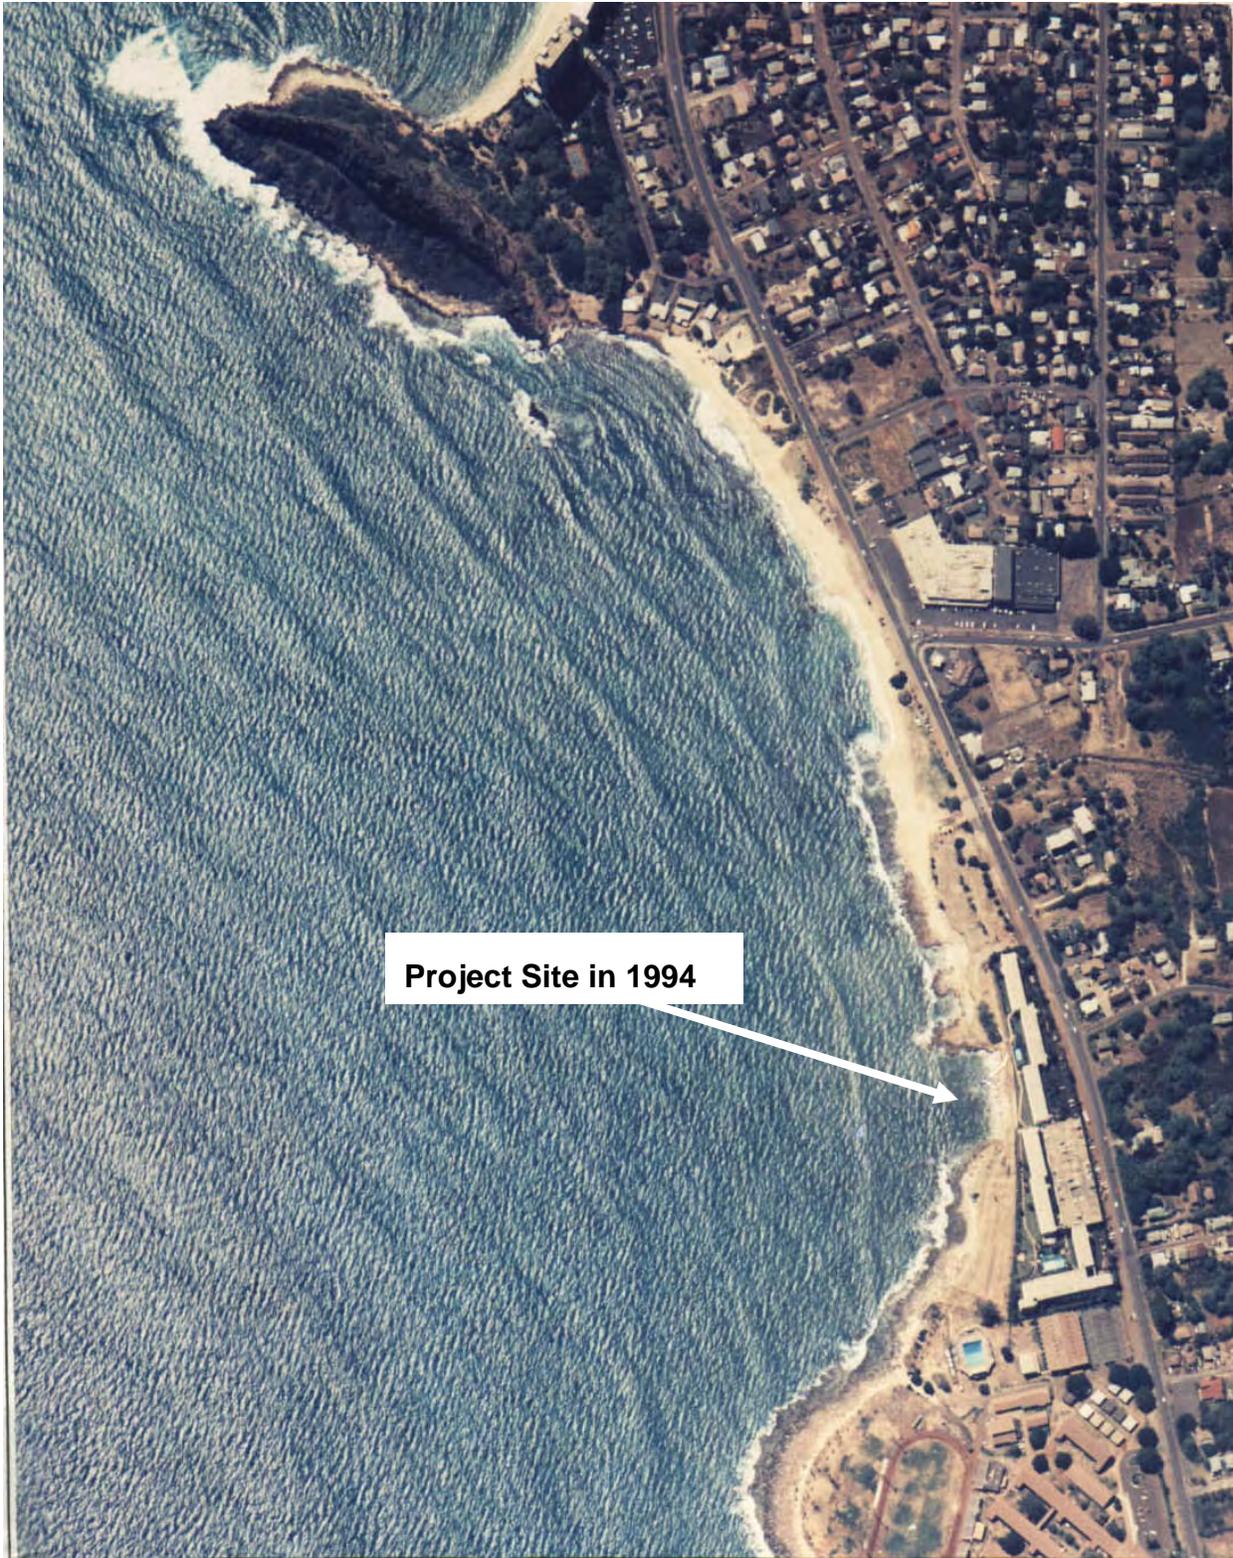
Figure 3-7 Aerial Photo of Mauna Lahilahi Beach Area from 1994

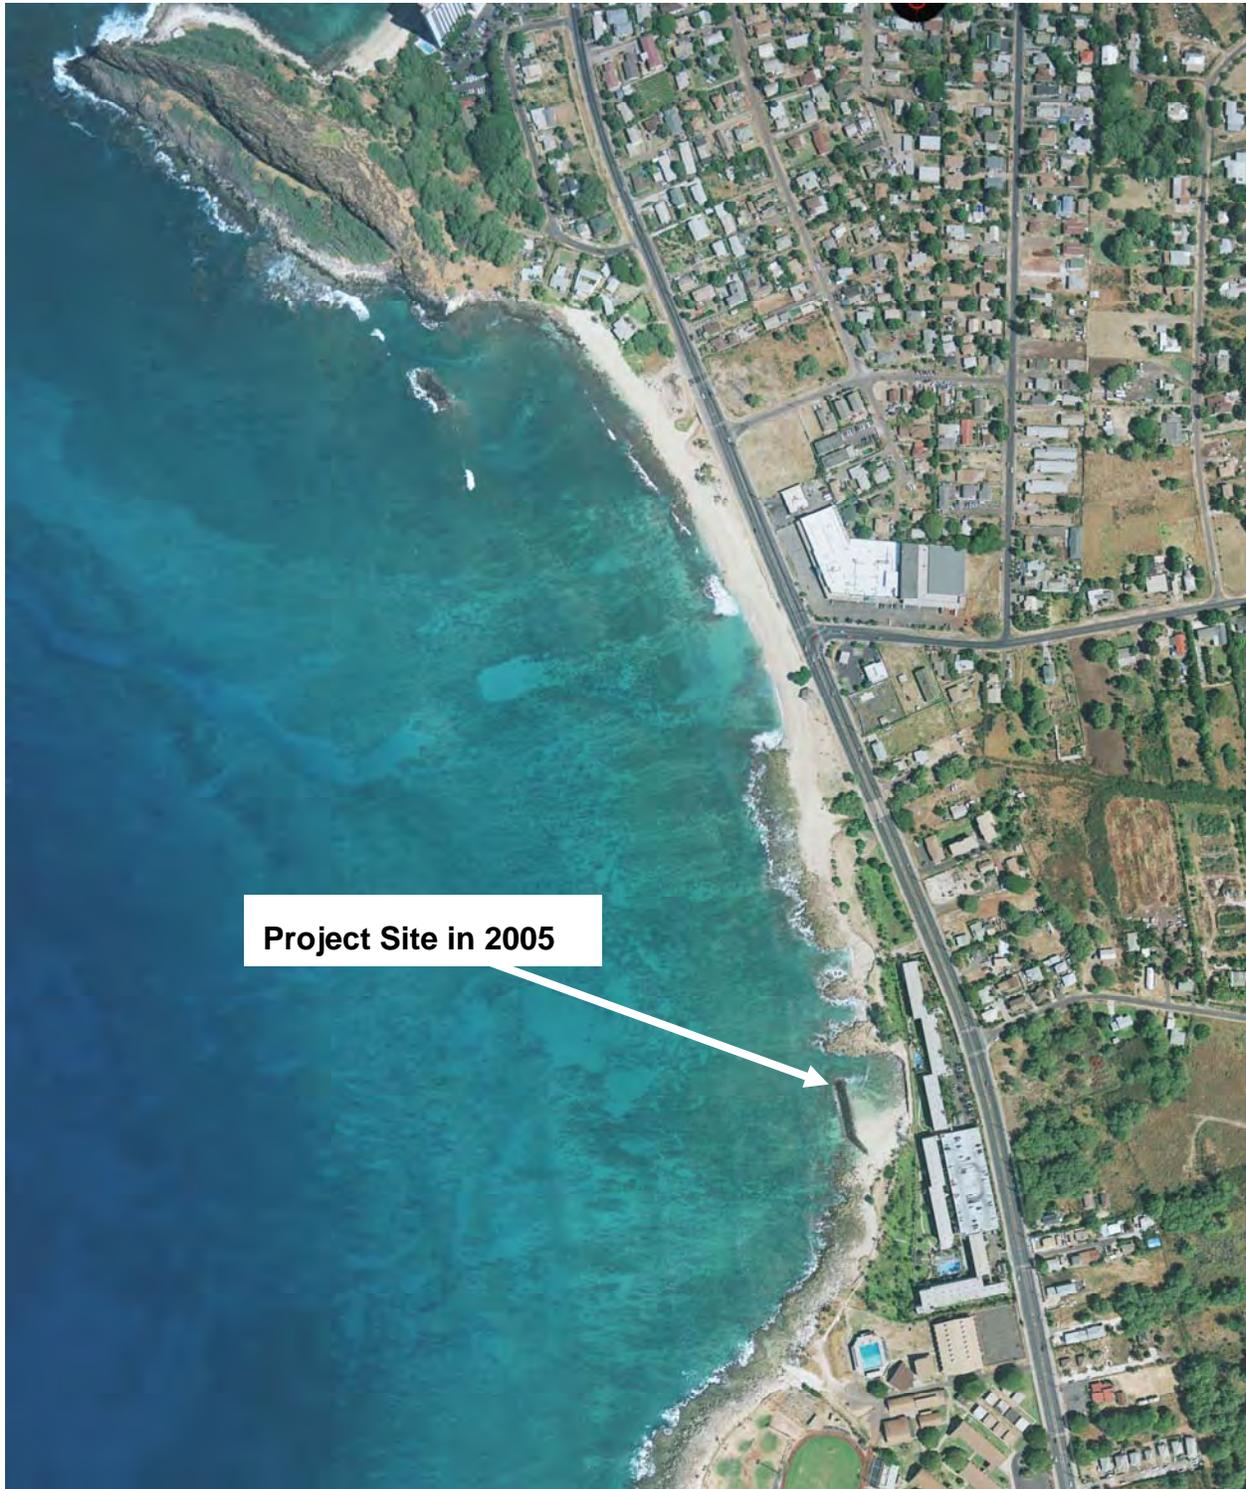
Figure 3-8 Aerial Photo of Mauna Lahilahi Beach Area in 2005 after Outer Breakwater Construction (University of Hawai'i, 2005); Oriented NNW, Along Shoreline

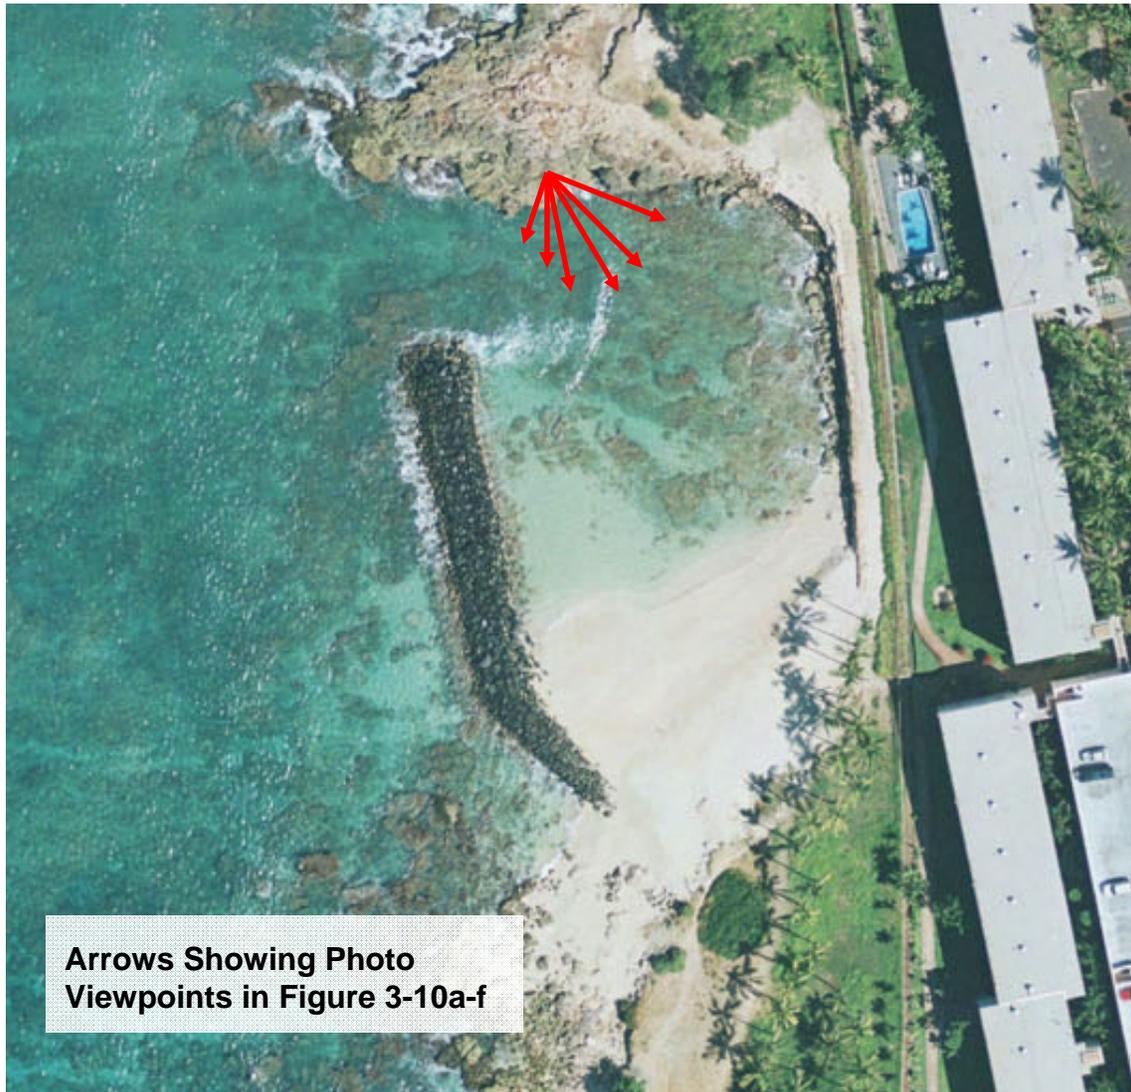
Figure 3-9 Aerial Photo from 2005 showing Beach Transformation in the Lee of the Breakwater

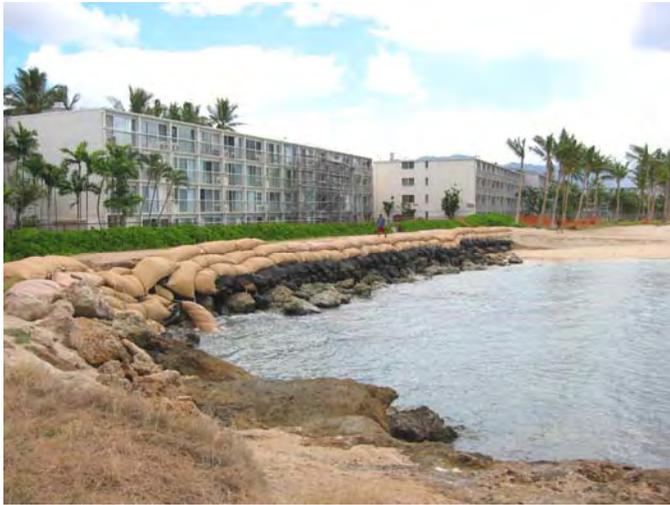
Figure 3-10a. View from North End in 2006; Sandbag Revetment

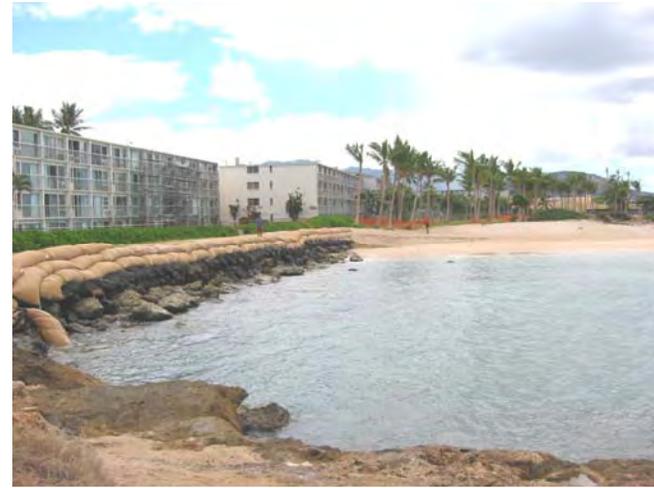
Figure 3-10b. View from North End in 2006; Sandbag Revetment

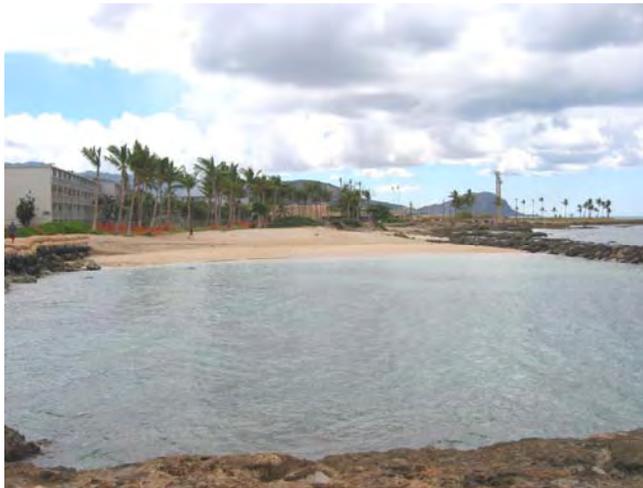
Figure 3-10c. View from North End in 2006; Migrated Beach Nourishment

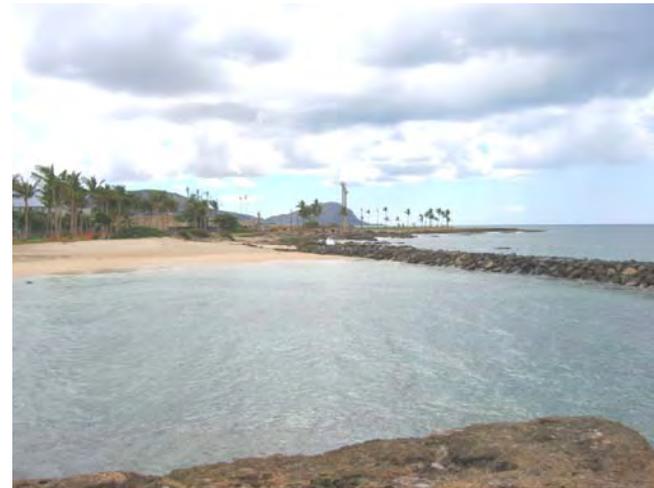
Figure 3-10d. View from North End in 2006; Breakwater Connection

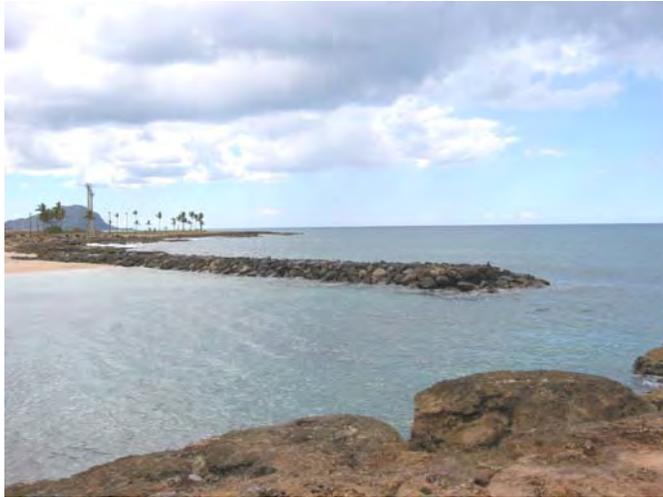
Figure 3-10e. View from North End in 2006; Existing Rock Breakwater

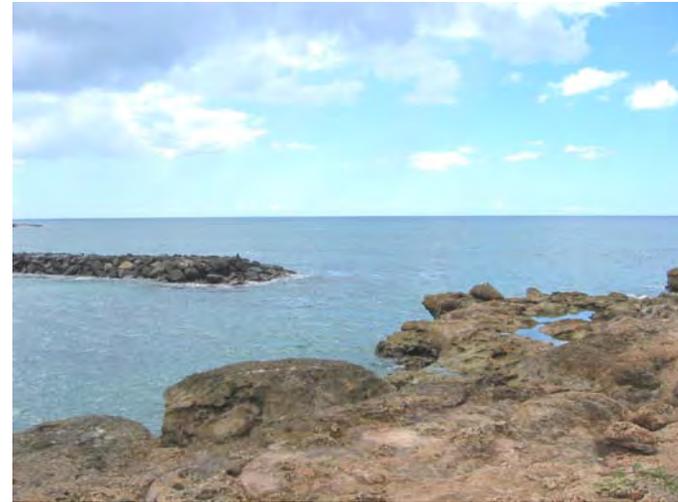
Figure 3-10f. View from North End in 2006; Breakwater Gap

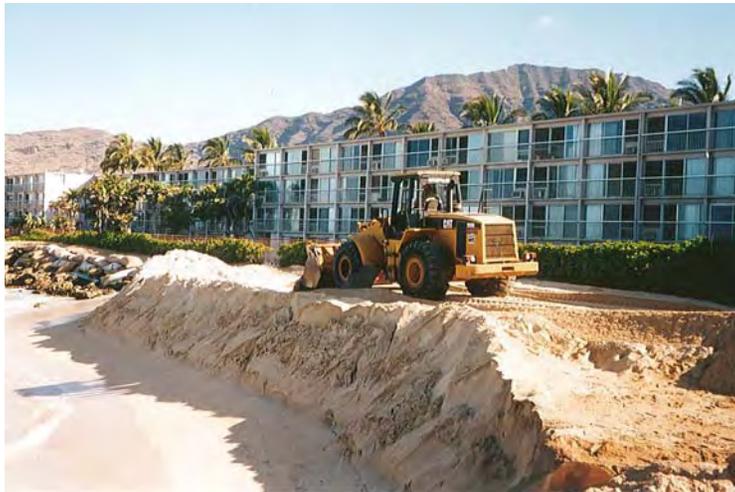
Figure 3-10g. Placement of Beach Nourishment in 2003

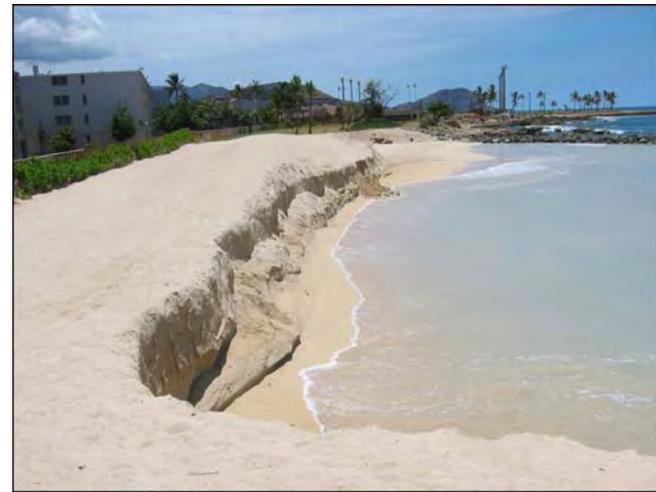
Figure 3-10h. Beach Nourishment Shortly after Placement

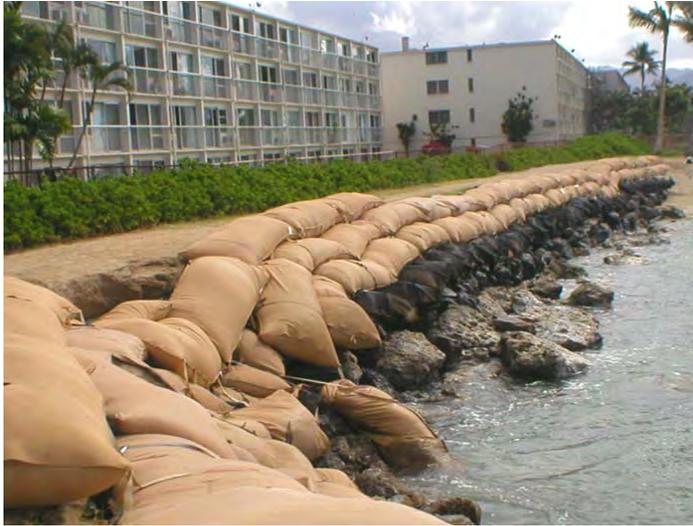
Figure 3-10i. Beach Erosion & Sandbag Revetment at North End in November 2005 (Courtesy of Jeanne Marx)

erosion, and the sandbag revetment had to be rebuilt. From 2003 through 2008, high winter waves damaged the sandbag revetment requiring extensive repairs several times (see Figures 3-10i and 3-10j). Some of the sand at the south end migrated through the porous rock breakwater and moved offshore or onto the shoreline farther south.

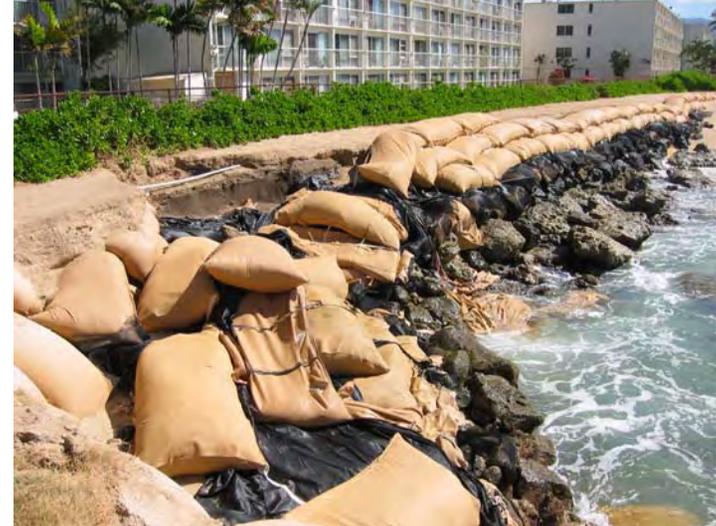
Figure 3-10j. Beach Erosion & Sandbag Revetment at North End in January 2006

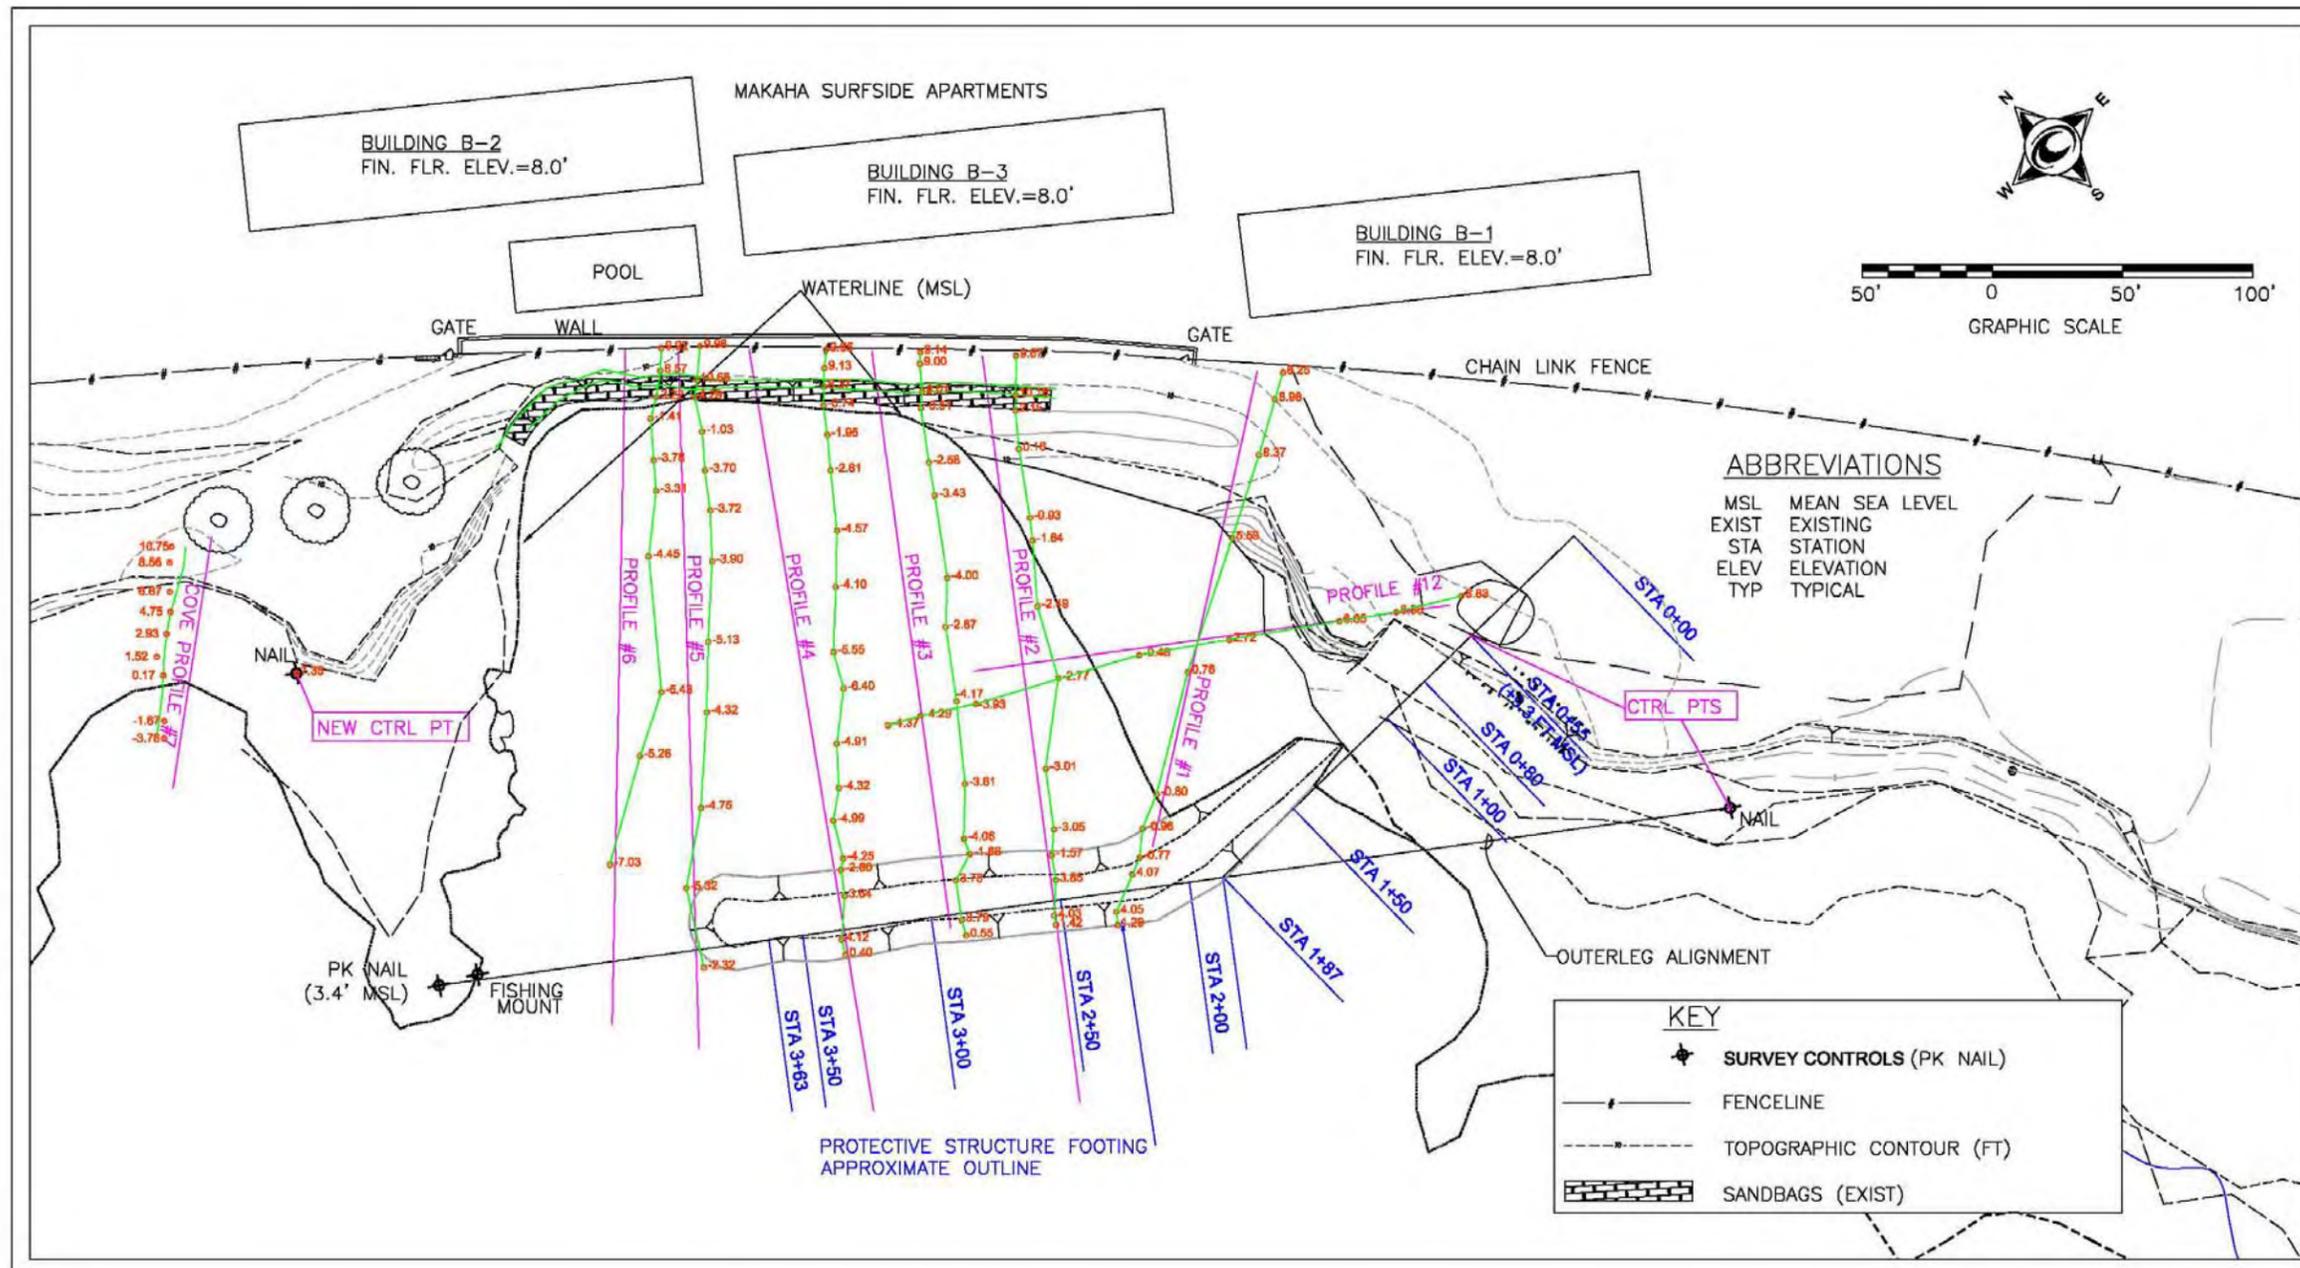
From 2003 through 2008, the beach and breakwater were monitored and surveyed periodically to record transformation and condition. The final monitoring run was in October 2008. Surveyed transects through the beach and breakwater showing depth measurements are shown in Figure 3-11.

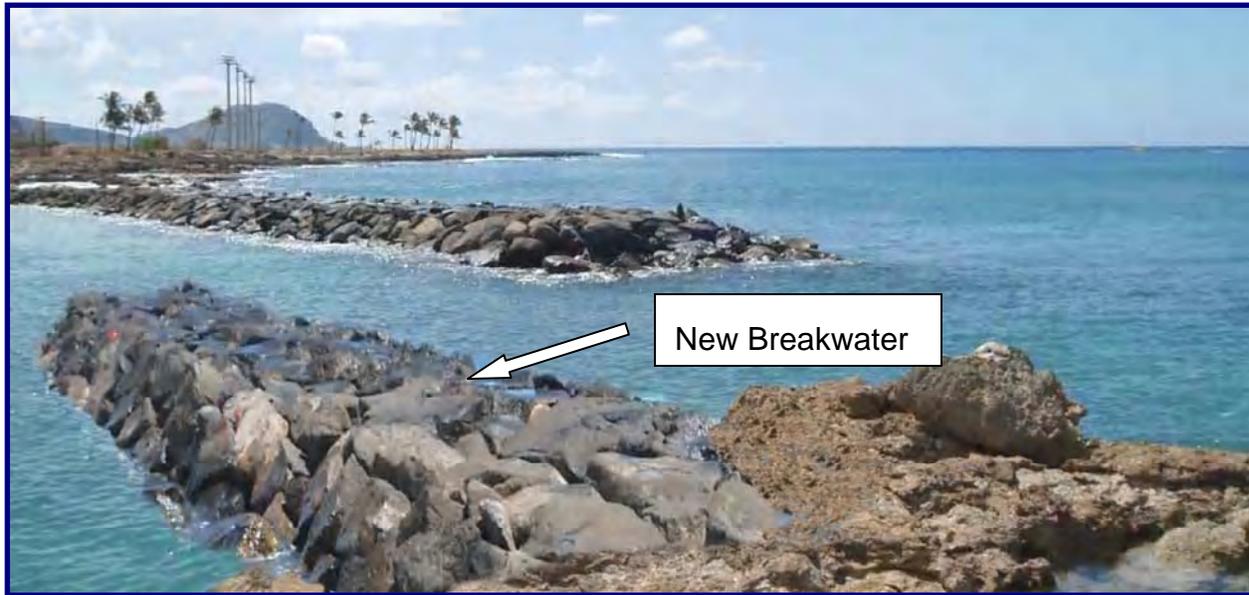
Figure 3-12 Rendering of New Breakwater

Several breakwater alternatives were evaluated with the coastal computer model, CEDAS. The selected alternative is a 90-foot rock breakwater that will run parallel to and inside the existing breakwater across the gap where waves currently enter the cove. The breakwater will be oriented perpendicular to the dominant nearshore wave direction. Figure 3-12 provides a graphic rendering of the proposed breakwater.

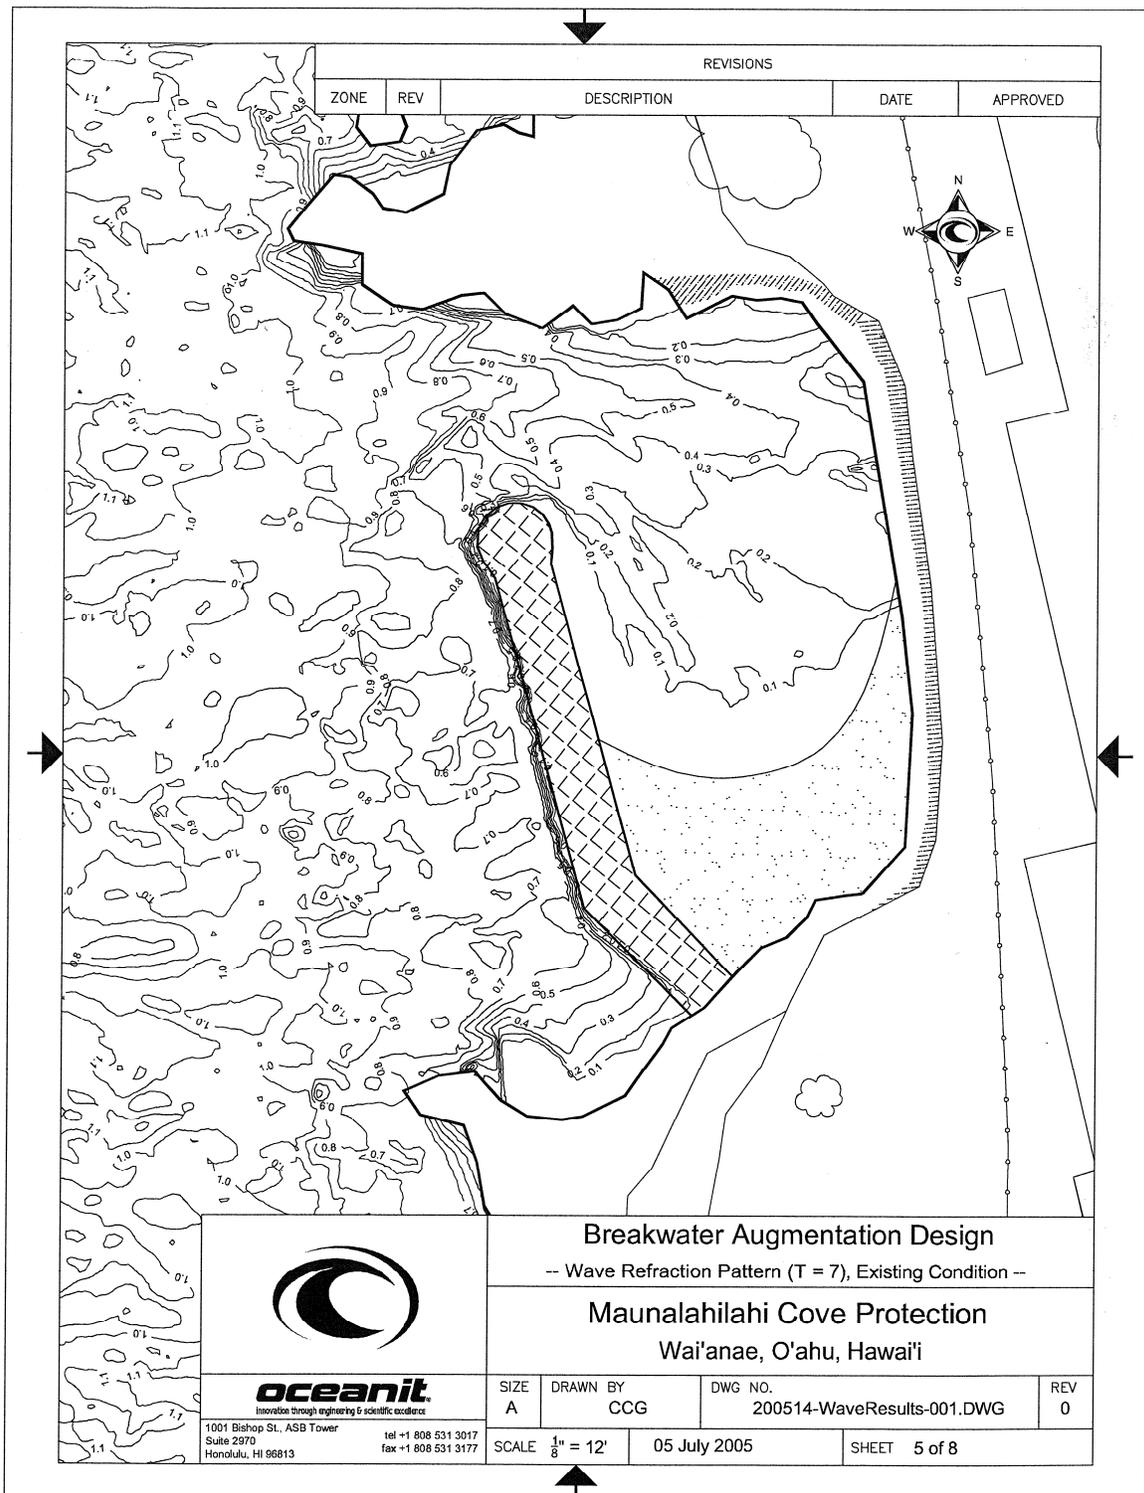
Figure 3-13 Unit Height Wave Transformation Contours around Existing Breakwater
