# Draft Environmental Assessment

## Mauna Lahilahi Beach Park Shore Protection Wai'anae, O'ahu, Hawai'i

## Mauna Lahilahi Beach Park Shore Protection

### Draft Environmental Assessment

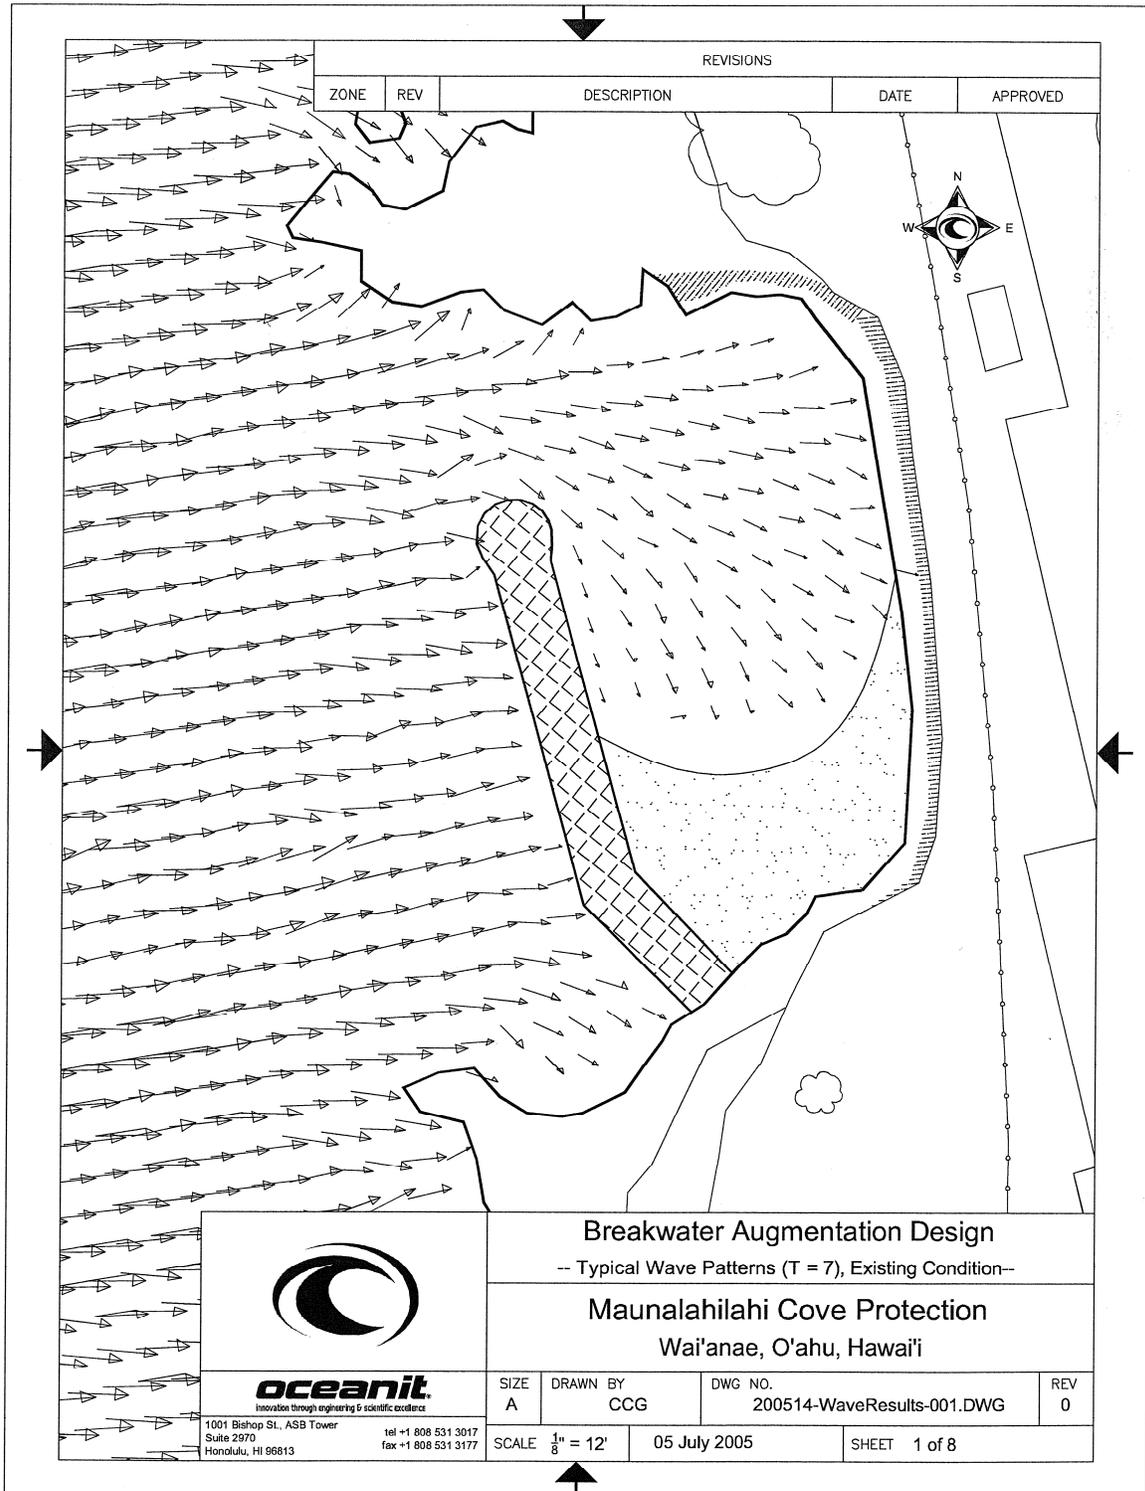
Figure 3-14 Unit Height Wave Transformation Direction Vectors for Existing Conditions

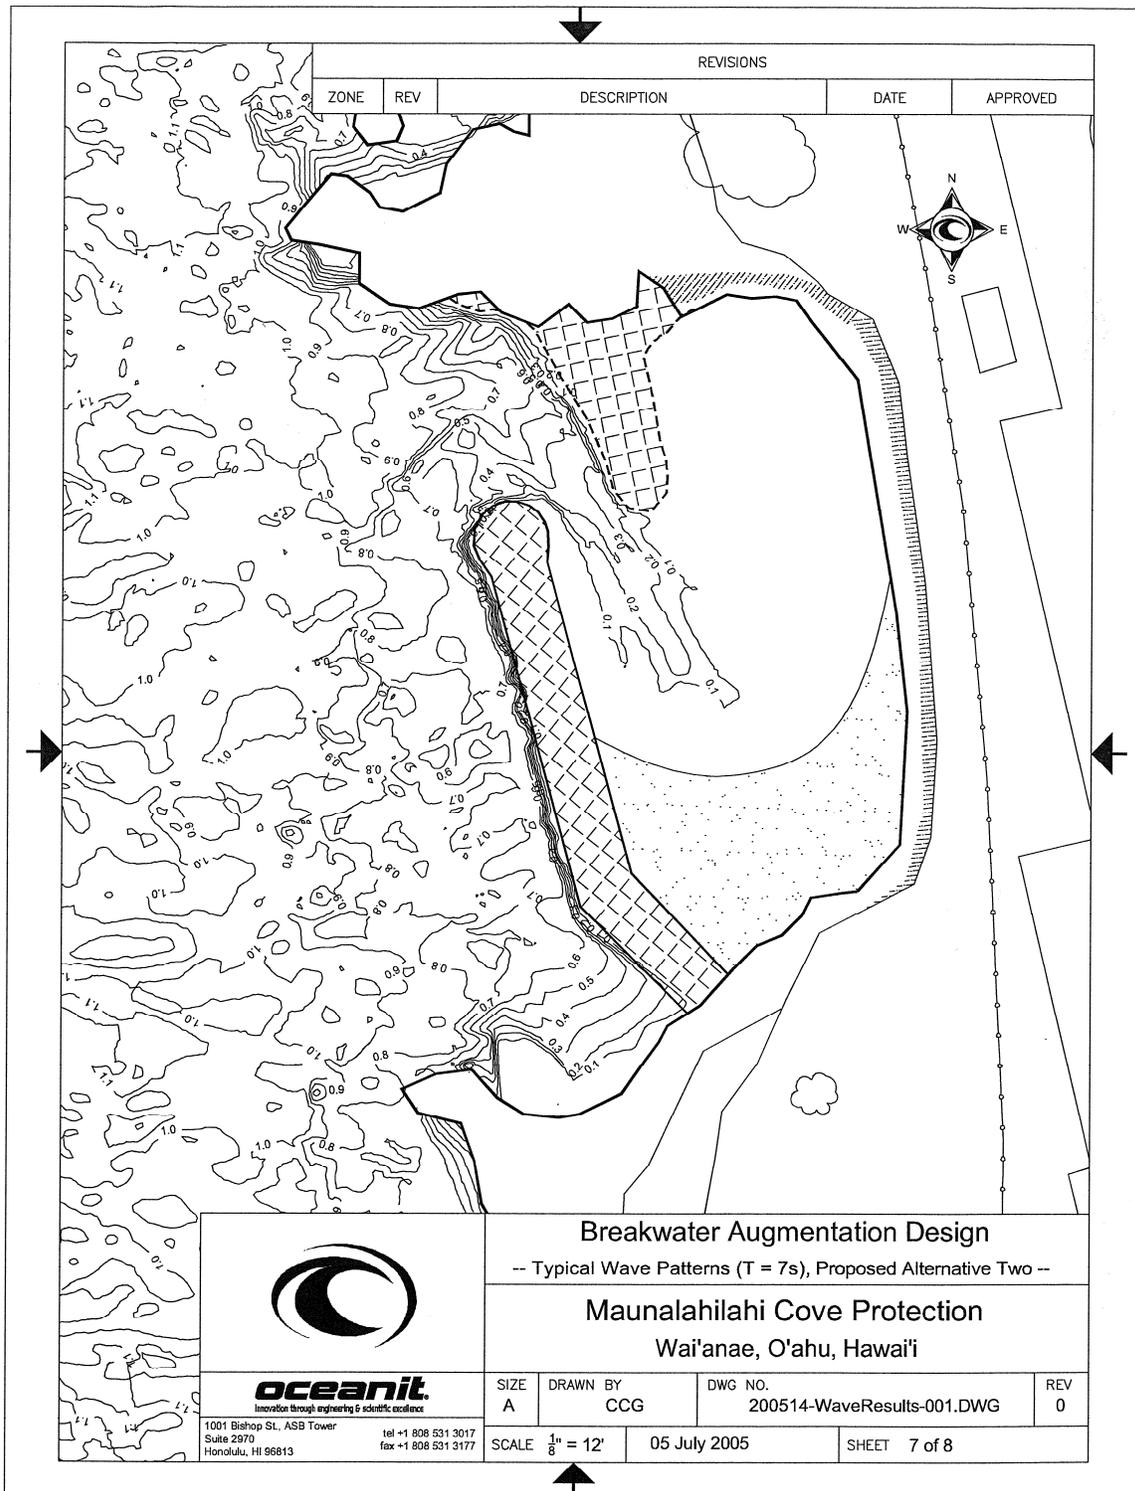
Figure 3-15 Unit Height Wave Transformation Contours with Proposed Inner Breakwater

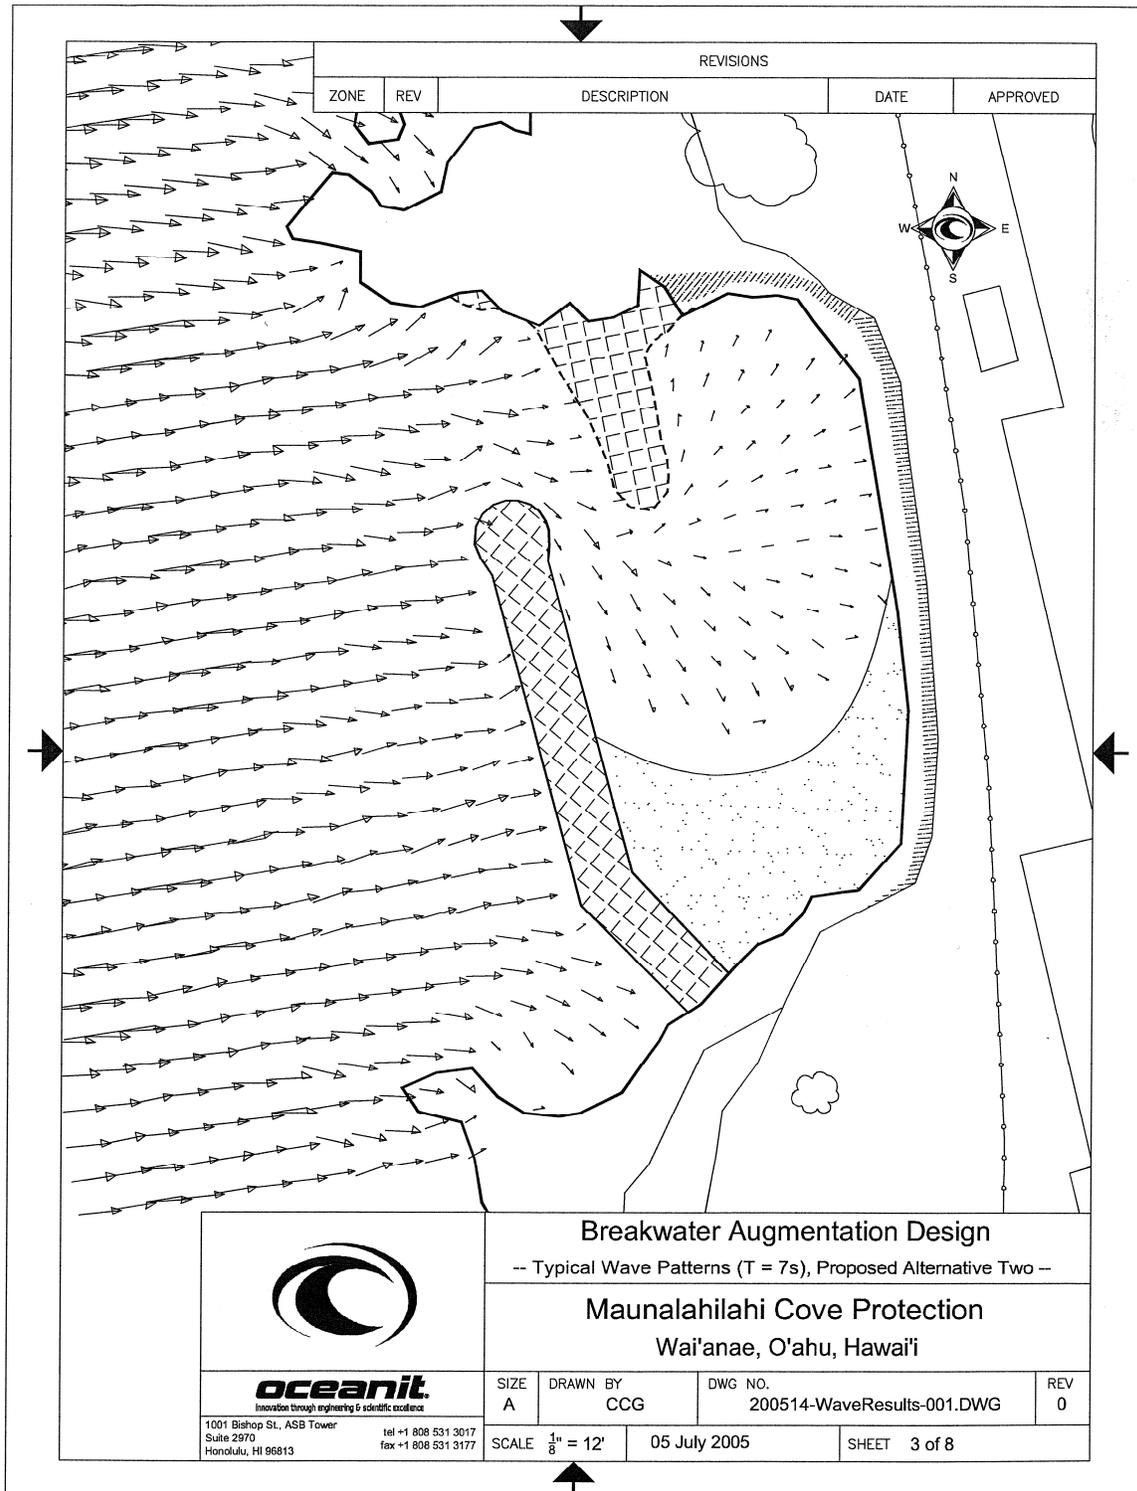
Figure 3-16 Unit Height Wave Transformation Direction Vectors for Selected Alternative

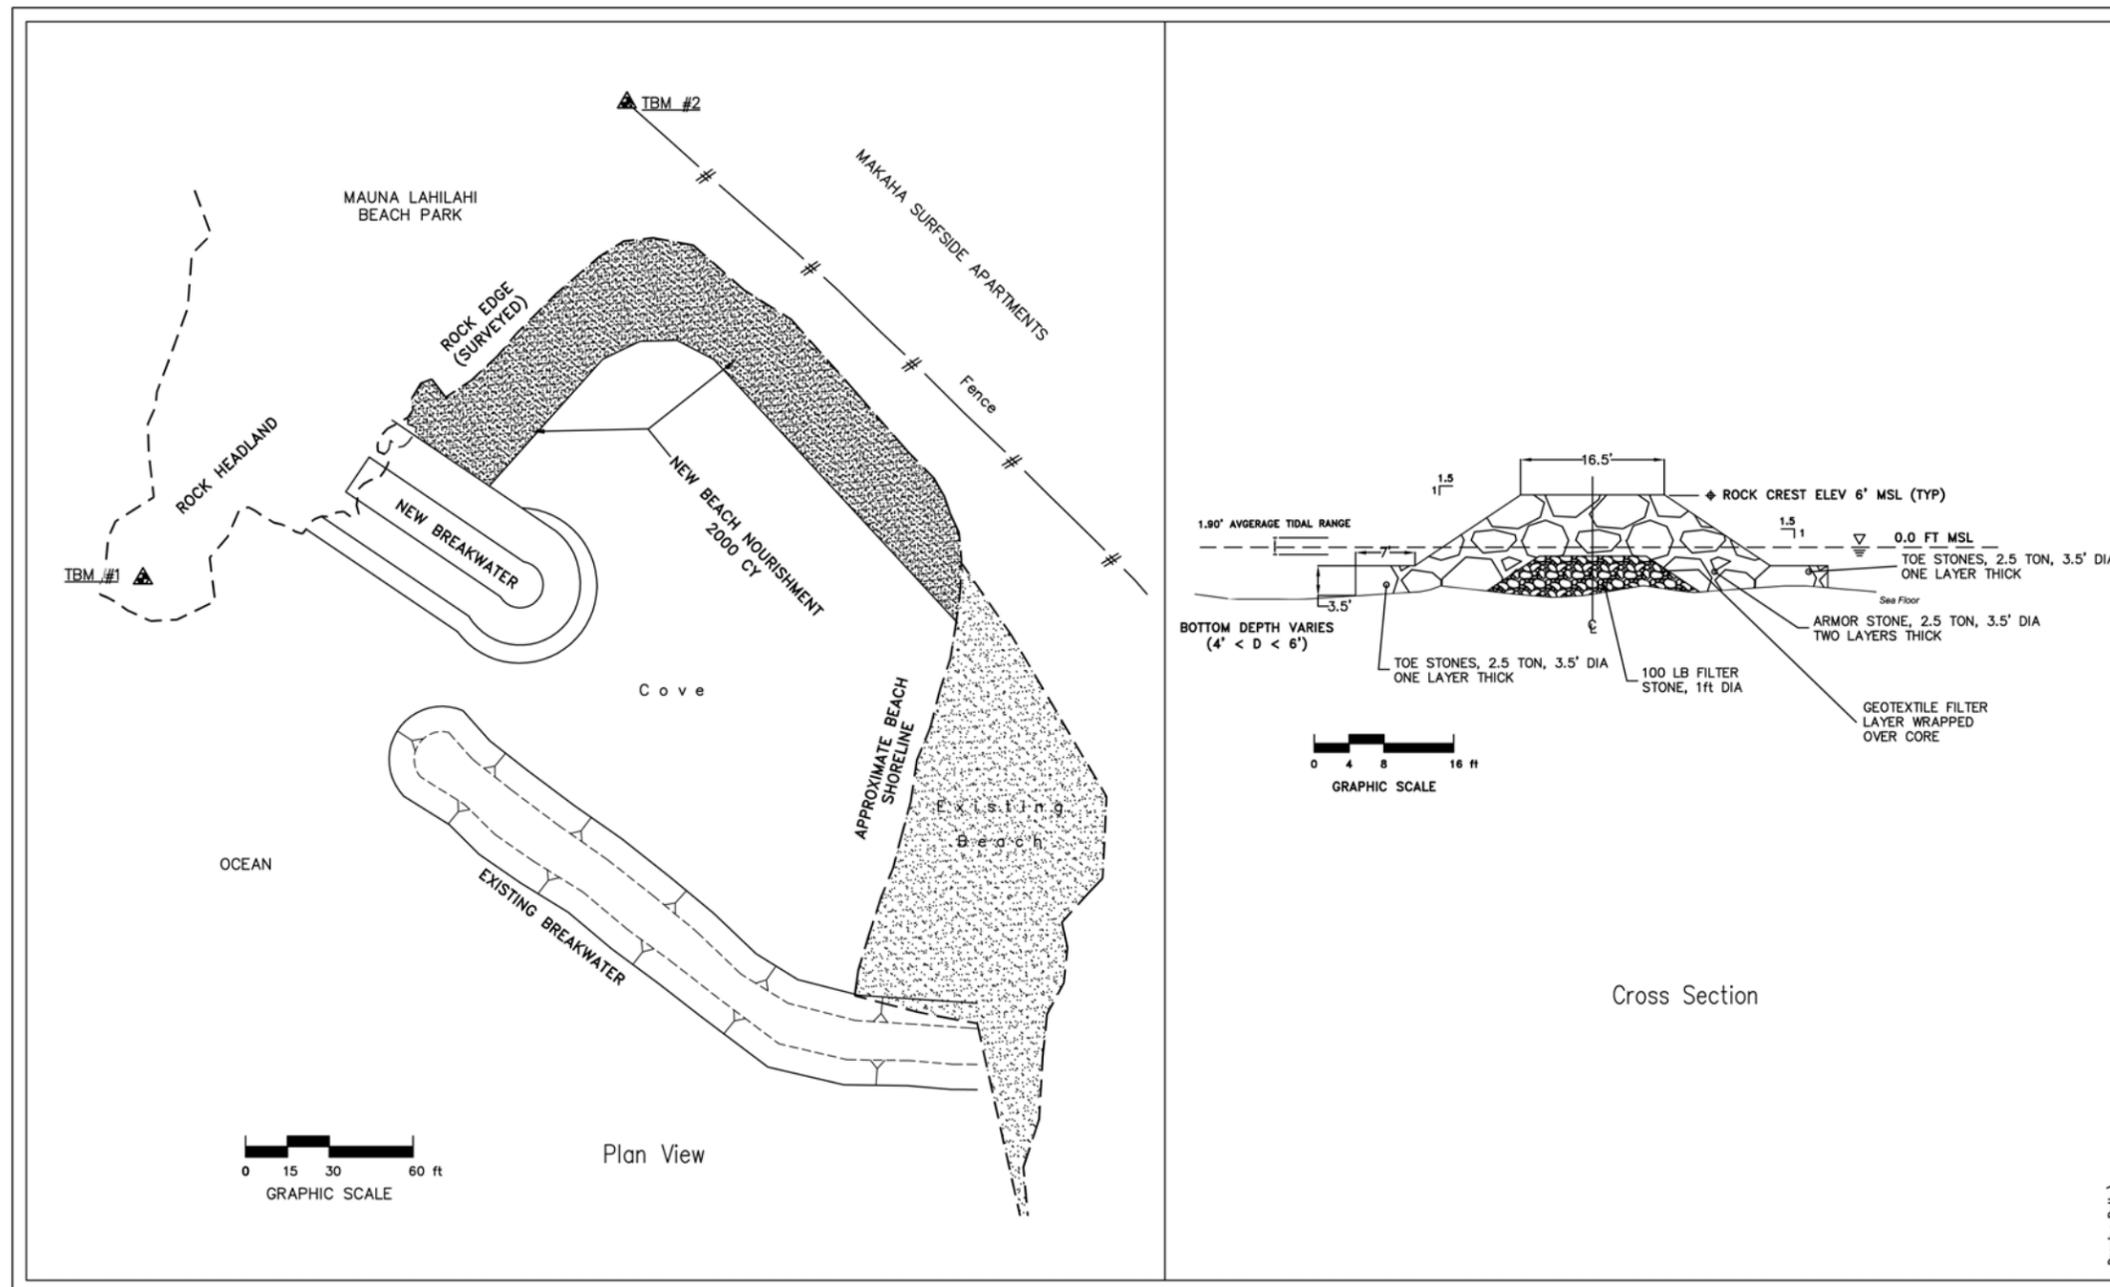
Figure 3-17 Proposed Inner Breakwater Plan, Cross Section, and Beach Nourishment

Water depth at the opening of the cove is approximately 6 feet below mean sea level (MSL). Design water level for the structure was determined to be 2.9 feet MSL. This water level was calculated by adding the highest anticipated tide (1.9 feet MSL), potential wave setup (0.5 feet), and estimated sea level rise over the 50 year design life of the structure (0.5 feet). These conditions were used to calculate a design wave height of 7.0 feet, which is the maximum non-breaking wave that would reach the structure. This wave height was used to calculate breakwater rock size.

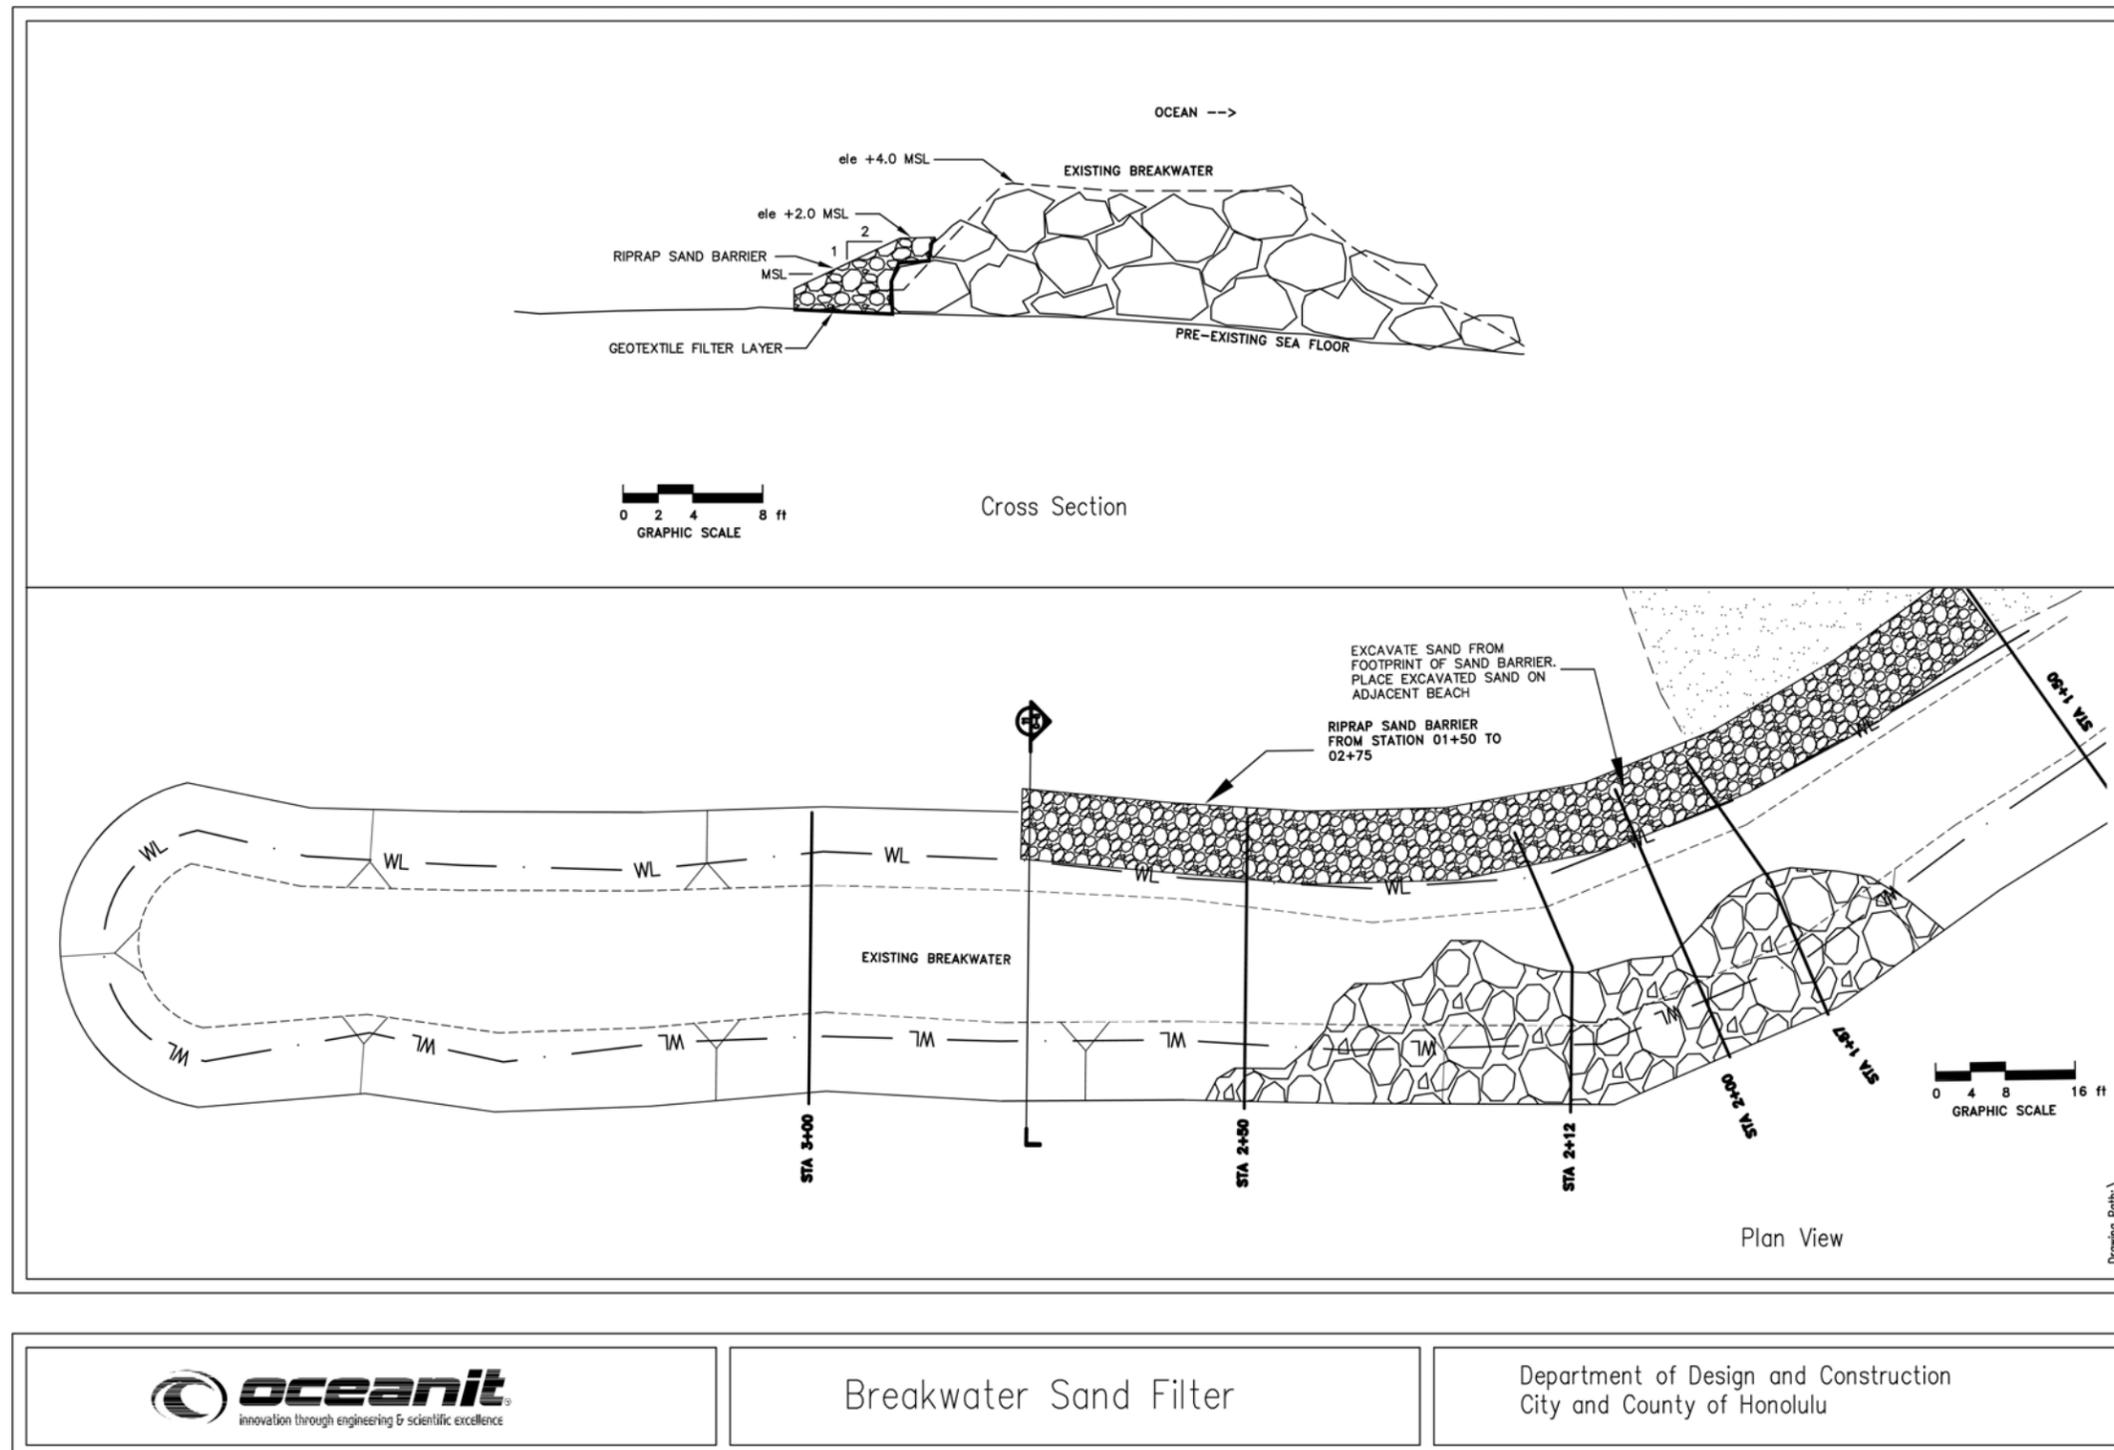
Figure 3-18 Proposed Sand Filter on Existing Breakwater

Waves now wash sand through the existing breakwater to the outside bottom. Some of this sand is then carried up onto the rock shoreline to form a new beach to the south. Sand also passes around the landward end of the existing breakwater and moves south. To minimize sand loss, a rock and fabric filter system will be constructed along the inner face of the existing breakwater as shown in Figure 3-18. Approximately 81 cubic yards of graded rock will be placed for the sand filter.

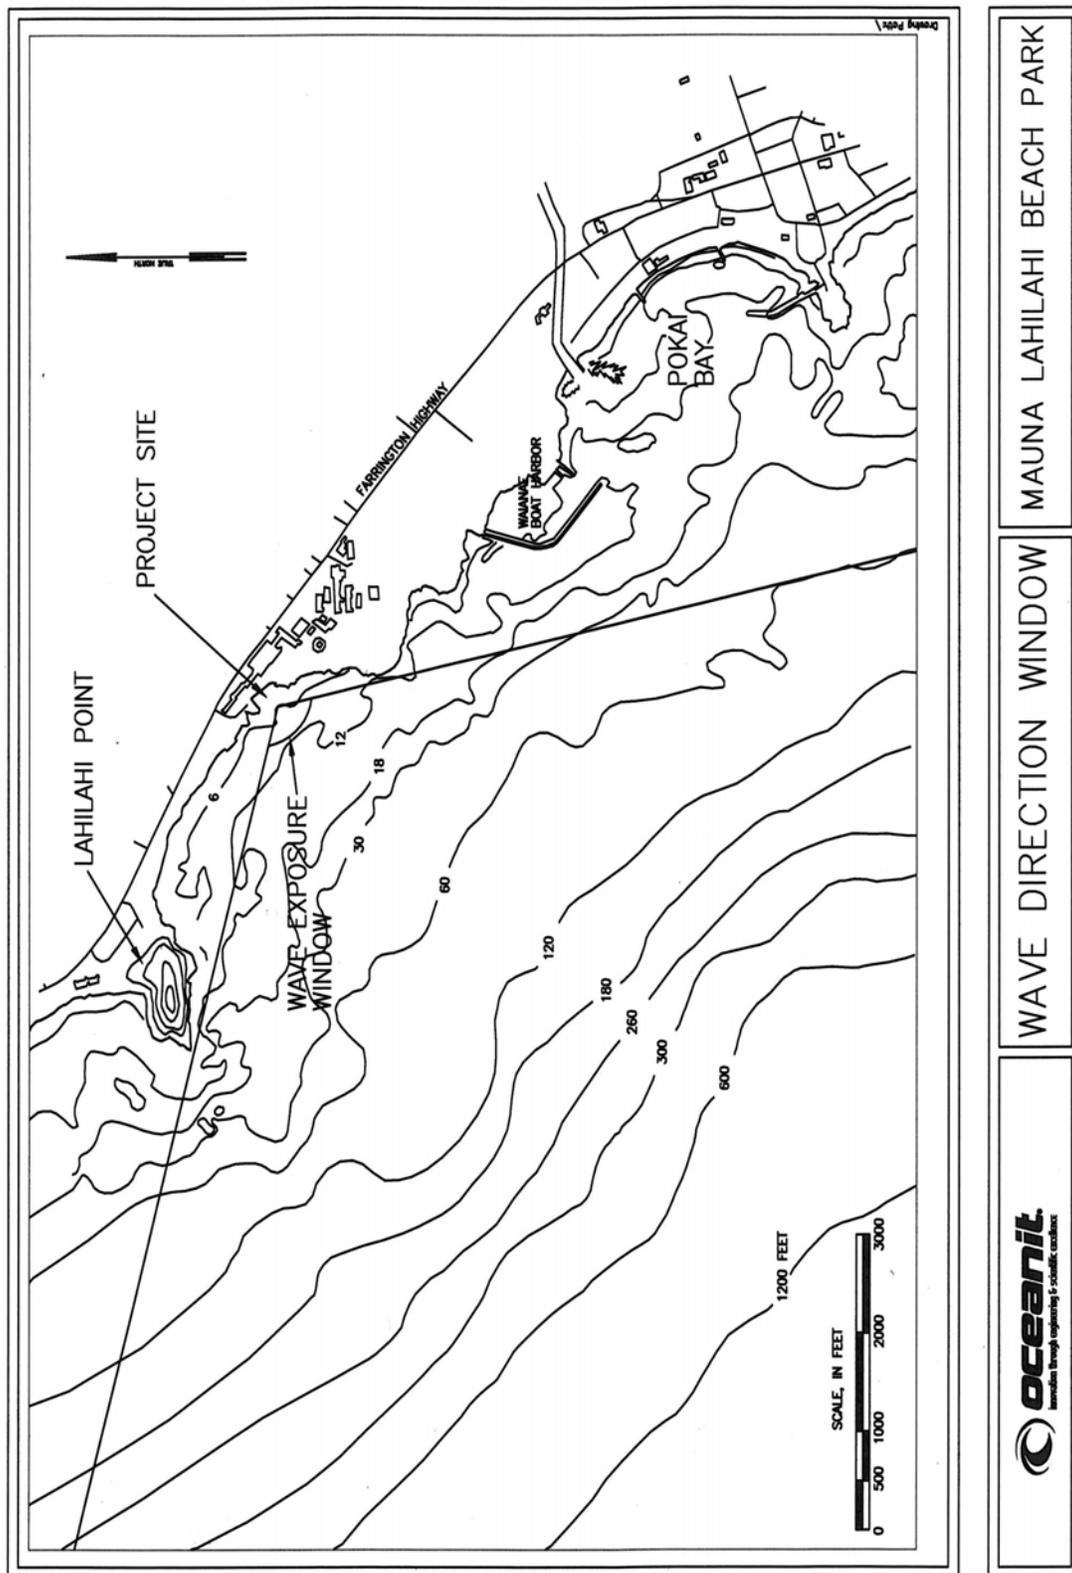
Figure 5-1 Wave Direction at Project Site

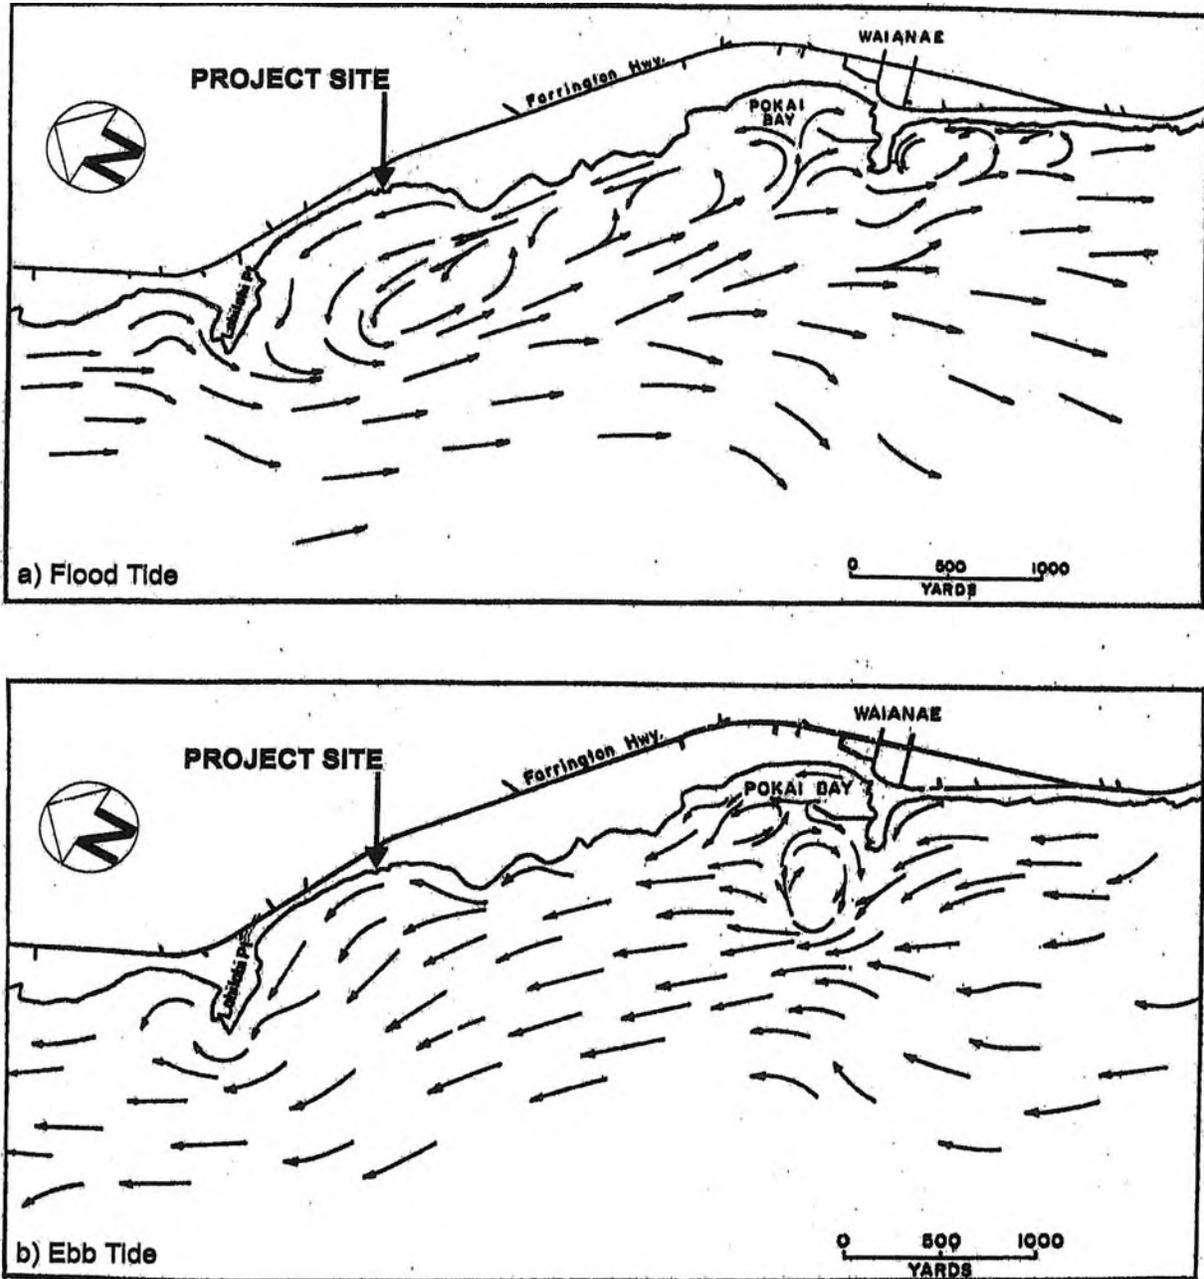
Figure 5-2 Current Patterns Mauna Lahilahi Beach Park

shore in the vicinity of the project site generally flow to the northwest during both flood and ebb tides. This is caused by eddies that form down-current from Lahilahi point. Measured current speeds were typically near 0.25 knots (Wai`anae Boat Harbor Final EIS, 1976).

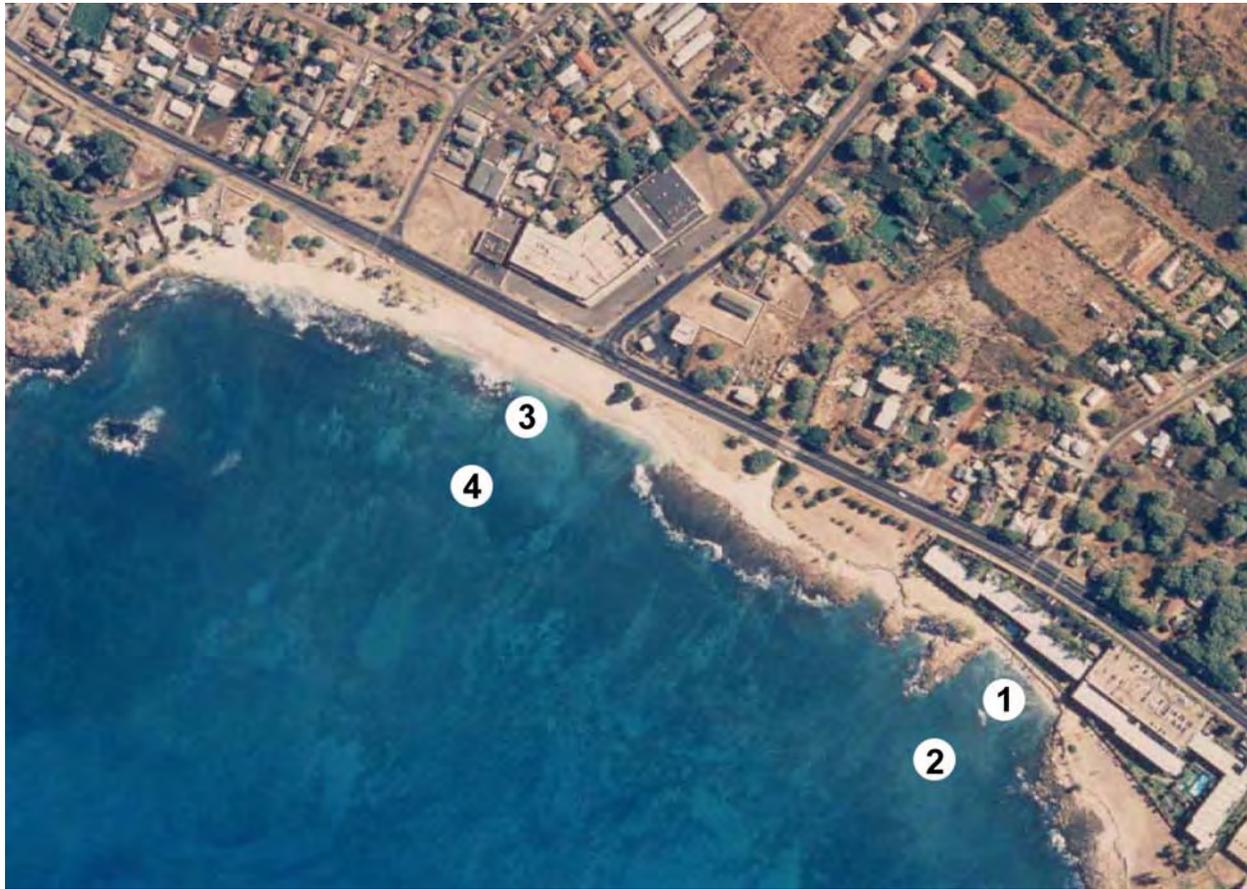
Figure 5-3 Water Quality Sample Locations

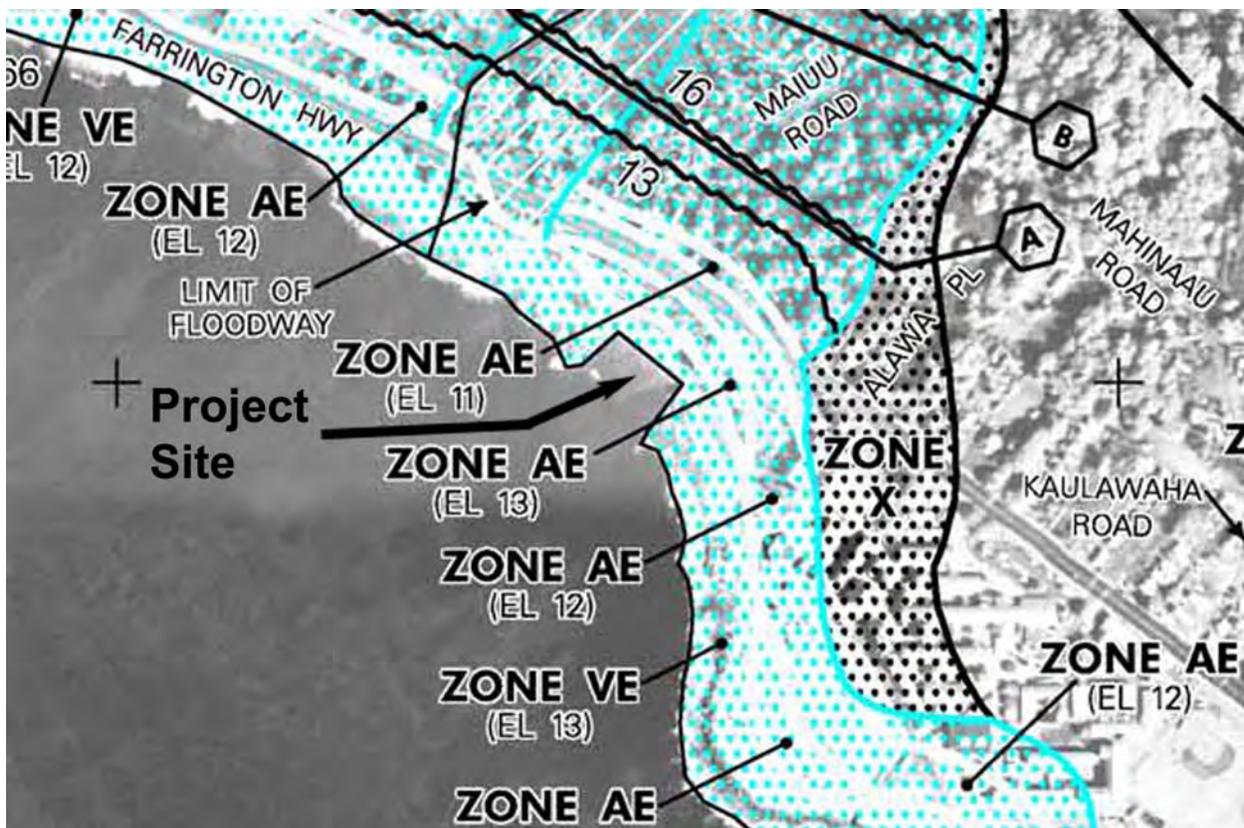
Figure 5-4 FEMA Flood Map

The Mākaha Surfside is located in flood zones VE and AE, an area subject to tsunamis or other velocity hazards, with a base flood elevation of 13 feet. Figure 5-4 is the Flood Insurance Rate Map for the project area.
