## HAWAII KAI MARINA AND ENTRANCE CHANNEL MAINTENANCE DREDGING

**FINAL ENVIRONMENTAL ASSESSMENT  
HAWAII KAI MARINA AND ENTRANCE  
CHANNEL MAINTENANCE DREDGING**

## PROJECT SUMMARY

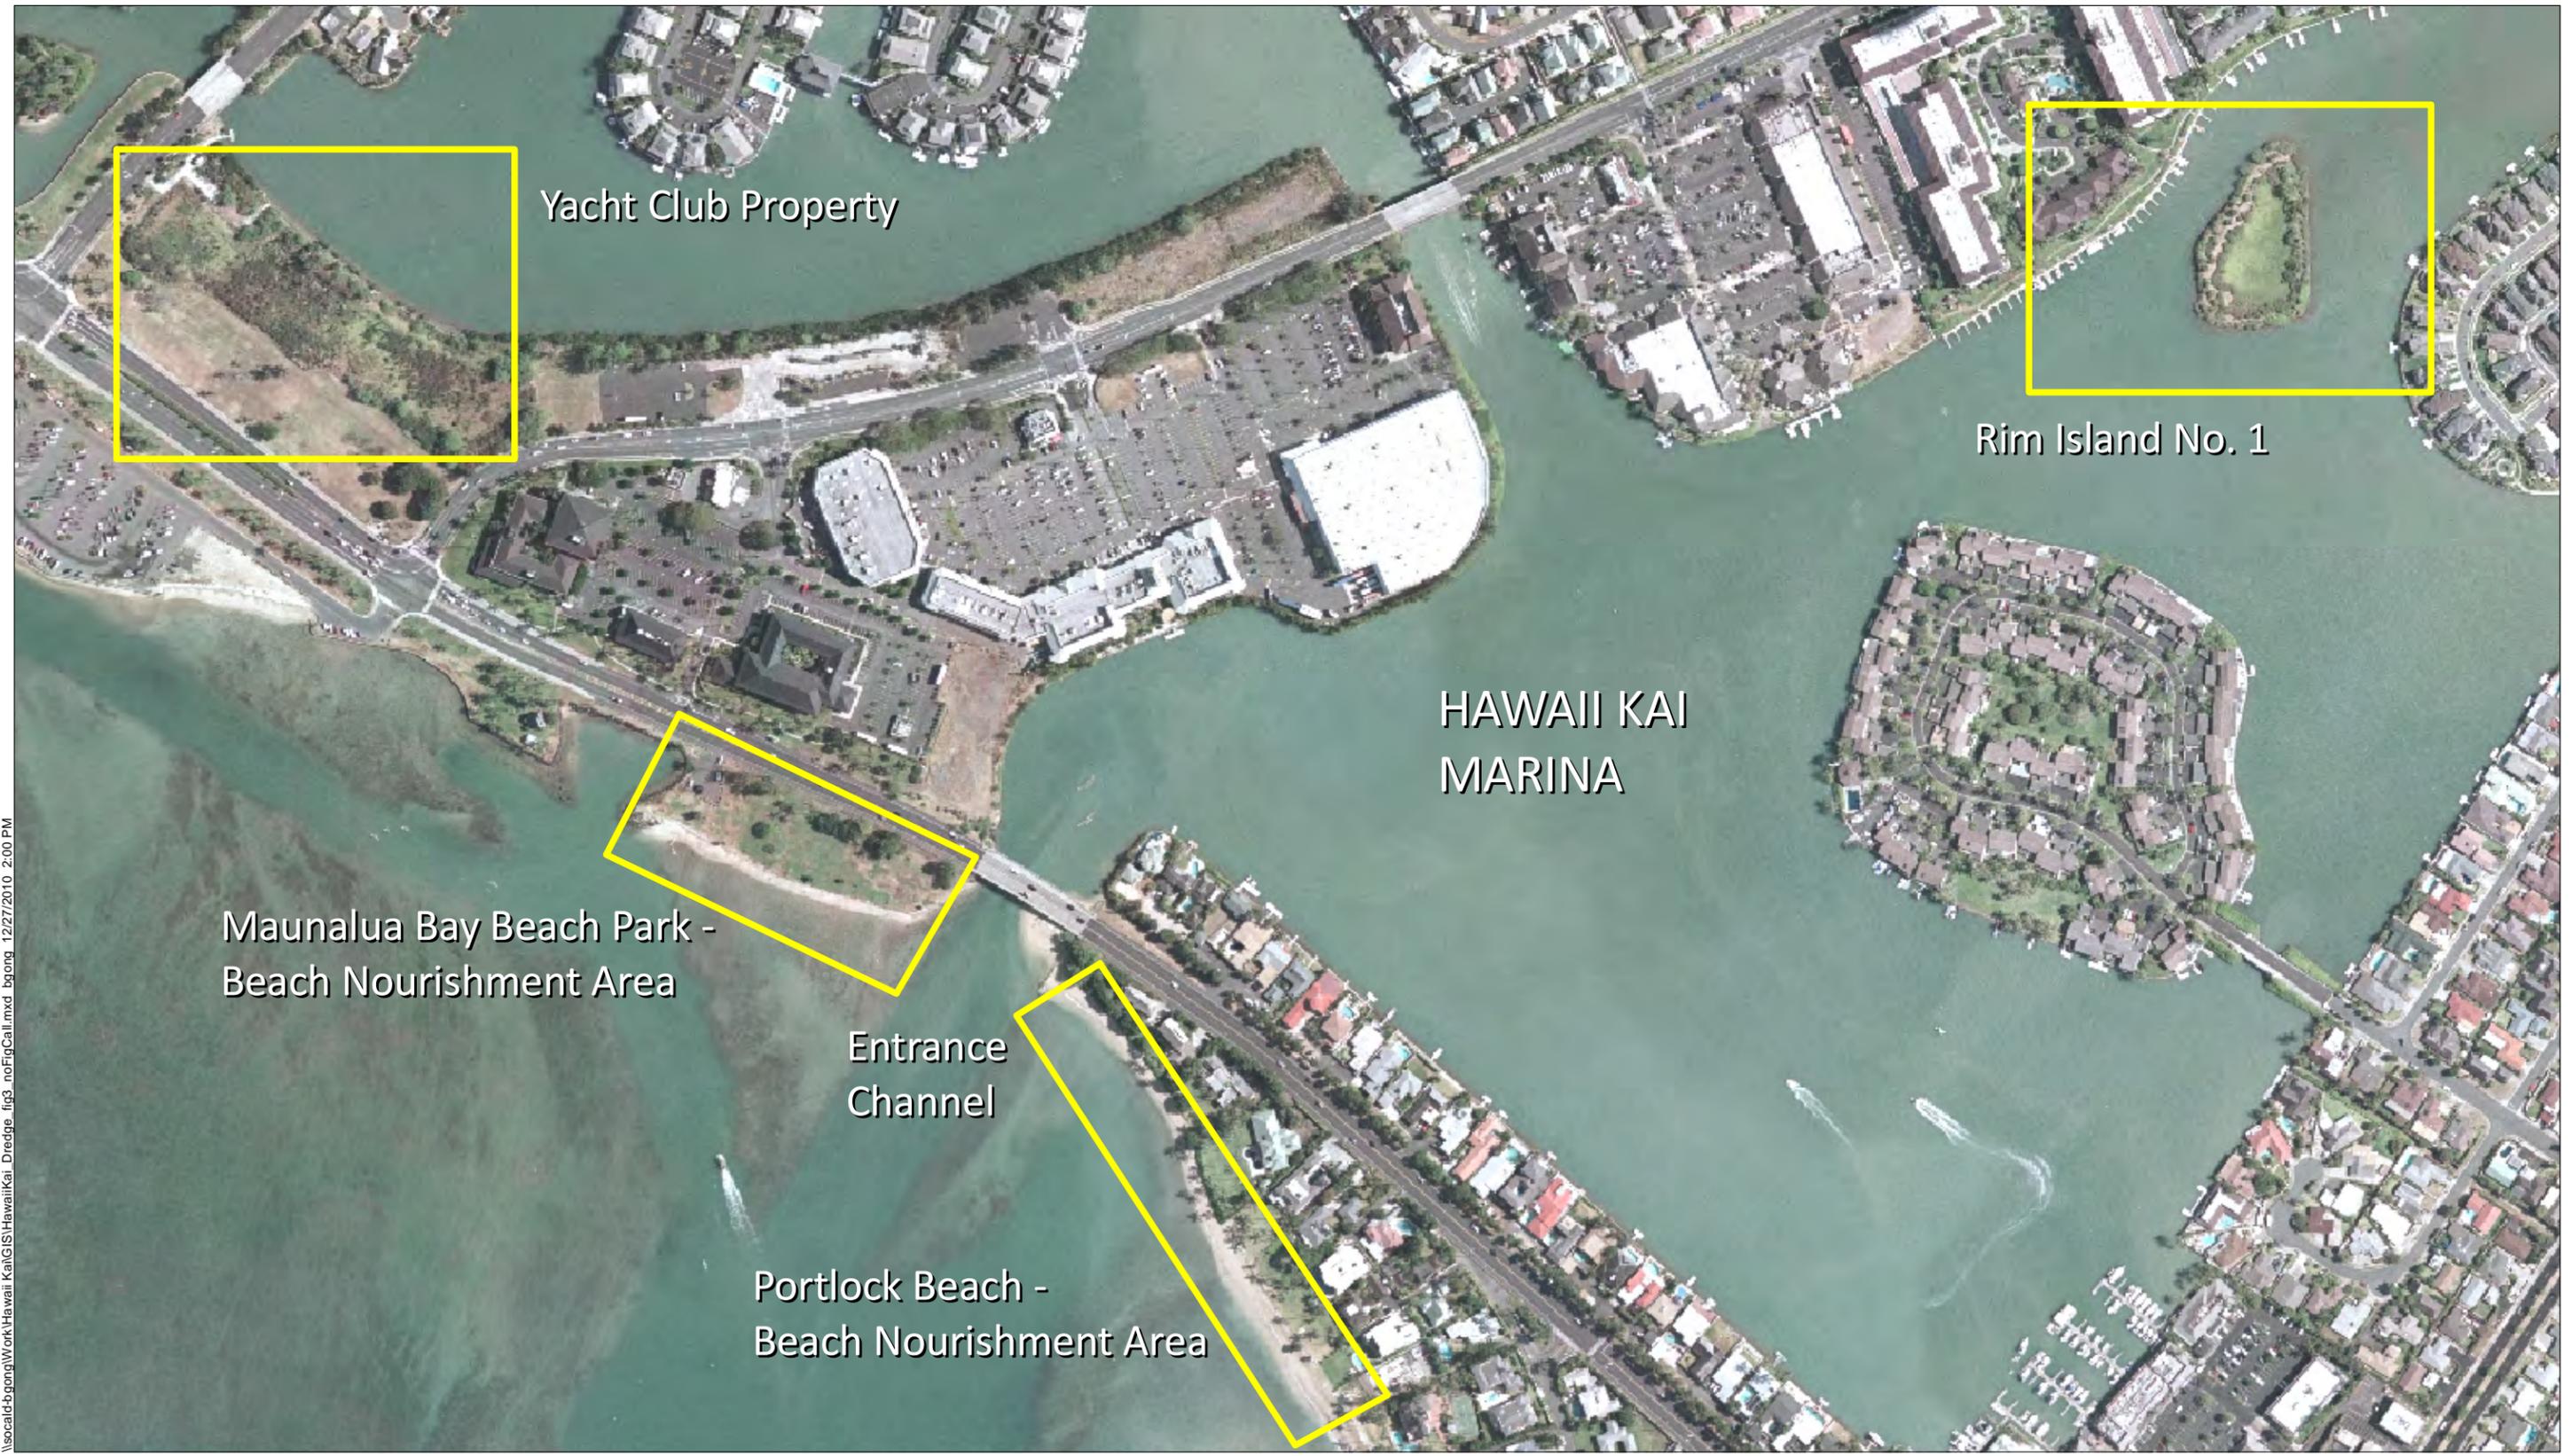
Much of the sediment to be dredged from the marina does not appear to contain a suitable percentage of sand to qualify for beach nourishment. To accommodate a portion of this sediment, upland disposal within the marina will include filling Rim Island No. 1 to its full capacity as well as placing fill material on the Yacht Club Property (see Section 2.4), which is owned by the HKMCA. These upland fill locations are identified on Figure 3.

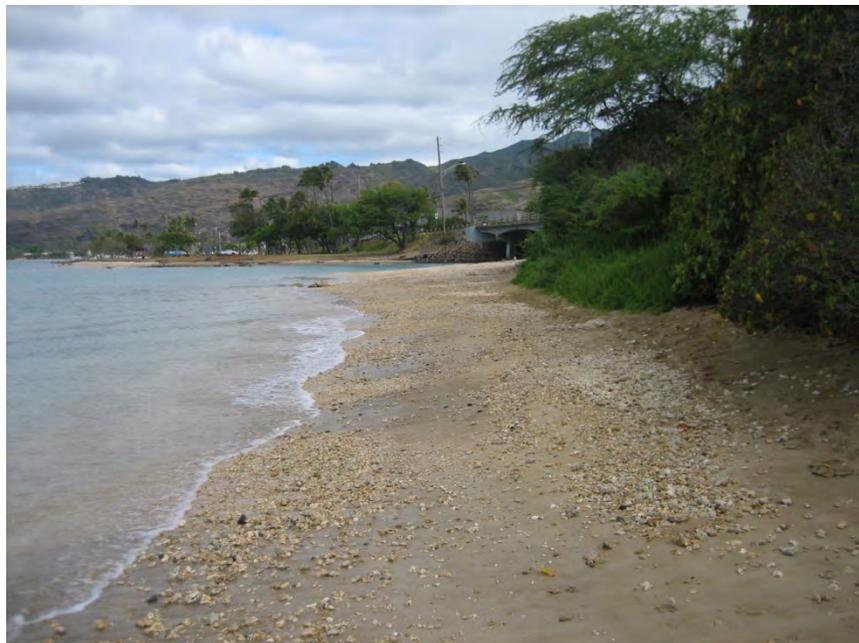
**Photograph 1**

**Portlock Beach proposed beach nourishment location (east of entrance channel)**

The project proposes to use the coarser-grained sandy material within the entrance channel shoaling area for placement along the adjacent shorelines of Portlock Beach (Photograph 1) and Maunalua Bay Beach Park (Photograph 2). This beneficial reuse alternative is preferred to upland or offshore disposal options, because it returns sand to the littoral system. The resulting beach nourishment also offers benefits of increased habitat, protection of existing shoreline infrastructure, and enhancement of public recreation opportunities by replacing sand in highly eroded shoreline areas of Maunalua Bay.

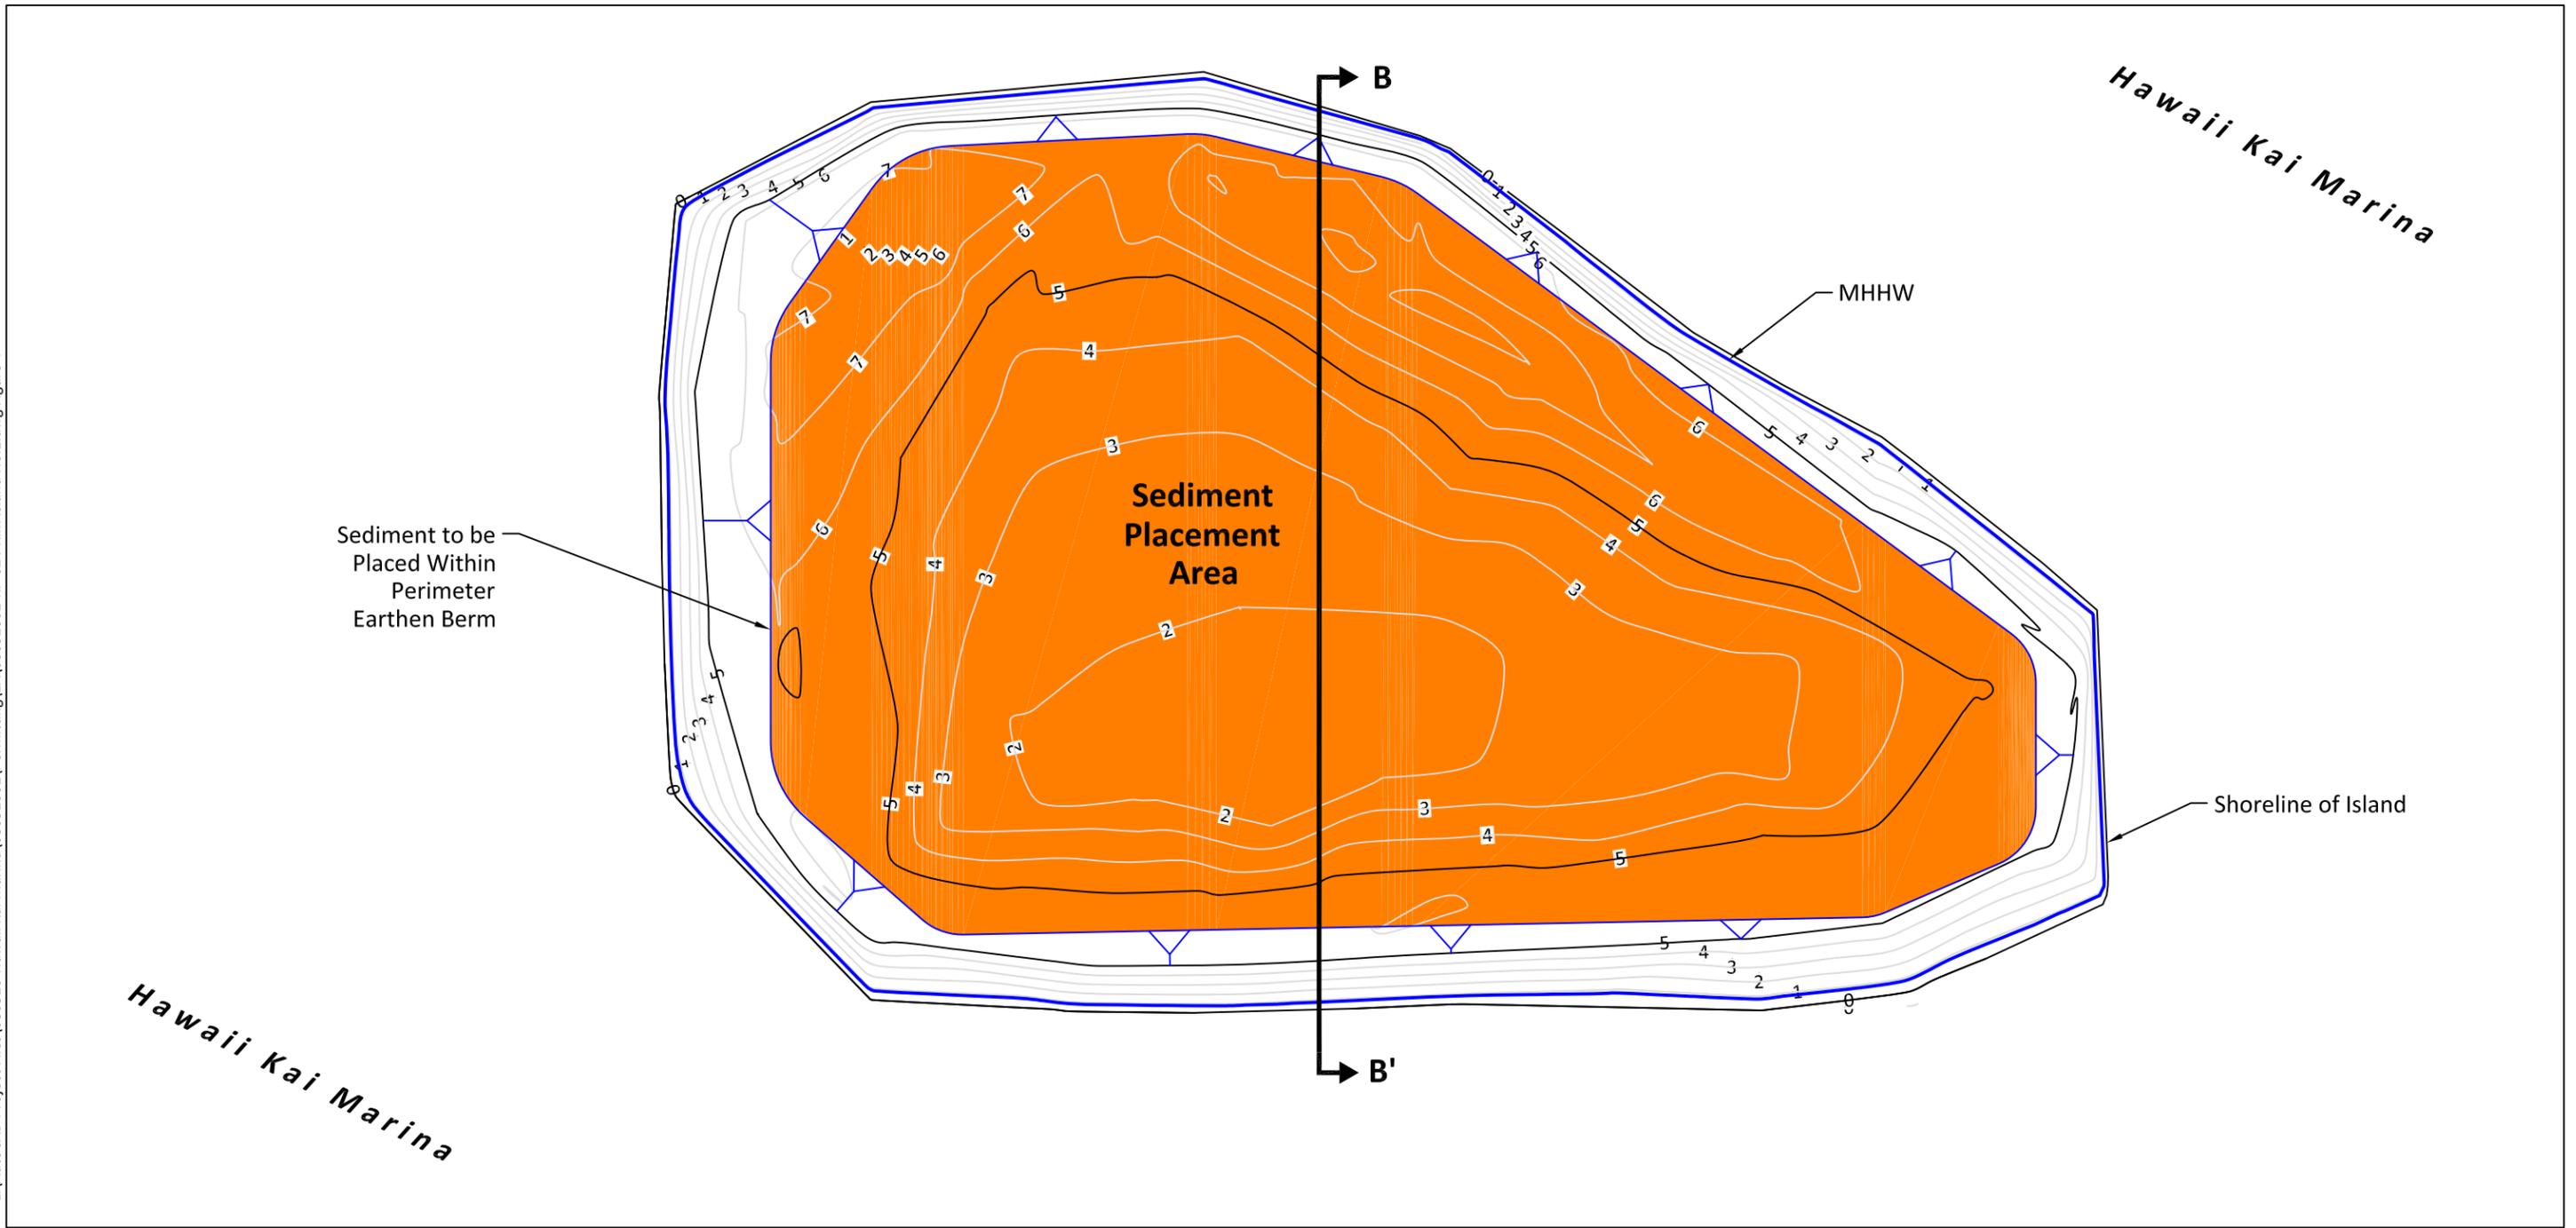
L:\AutoCAD Project Files\080520-Hawaii Kai Marina\08052001\Permitting\EA\08052001-RP-024-Rim Island No.1.dwg Figure 4

**SOURCE:** Drawing prepared from Austin, Tsutsumi & Associates, Inc., file named, "09-15.dwg" dated March 23, 2009.  
**HORIZONTAL DATUM:** All azimuths are referred to Government Survey Triangulation Station "KOKO HEAD3."  
**VERTICAL DATUM:** Elevations referred to Benchmark L-11, (Elev. = 16.00) mean sea level (MSL).

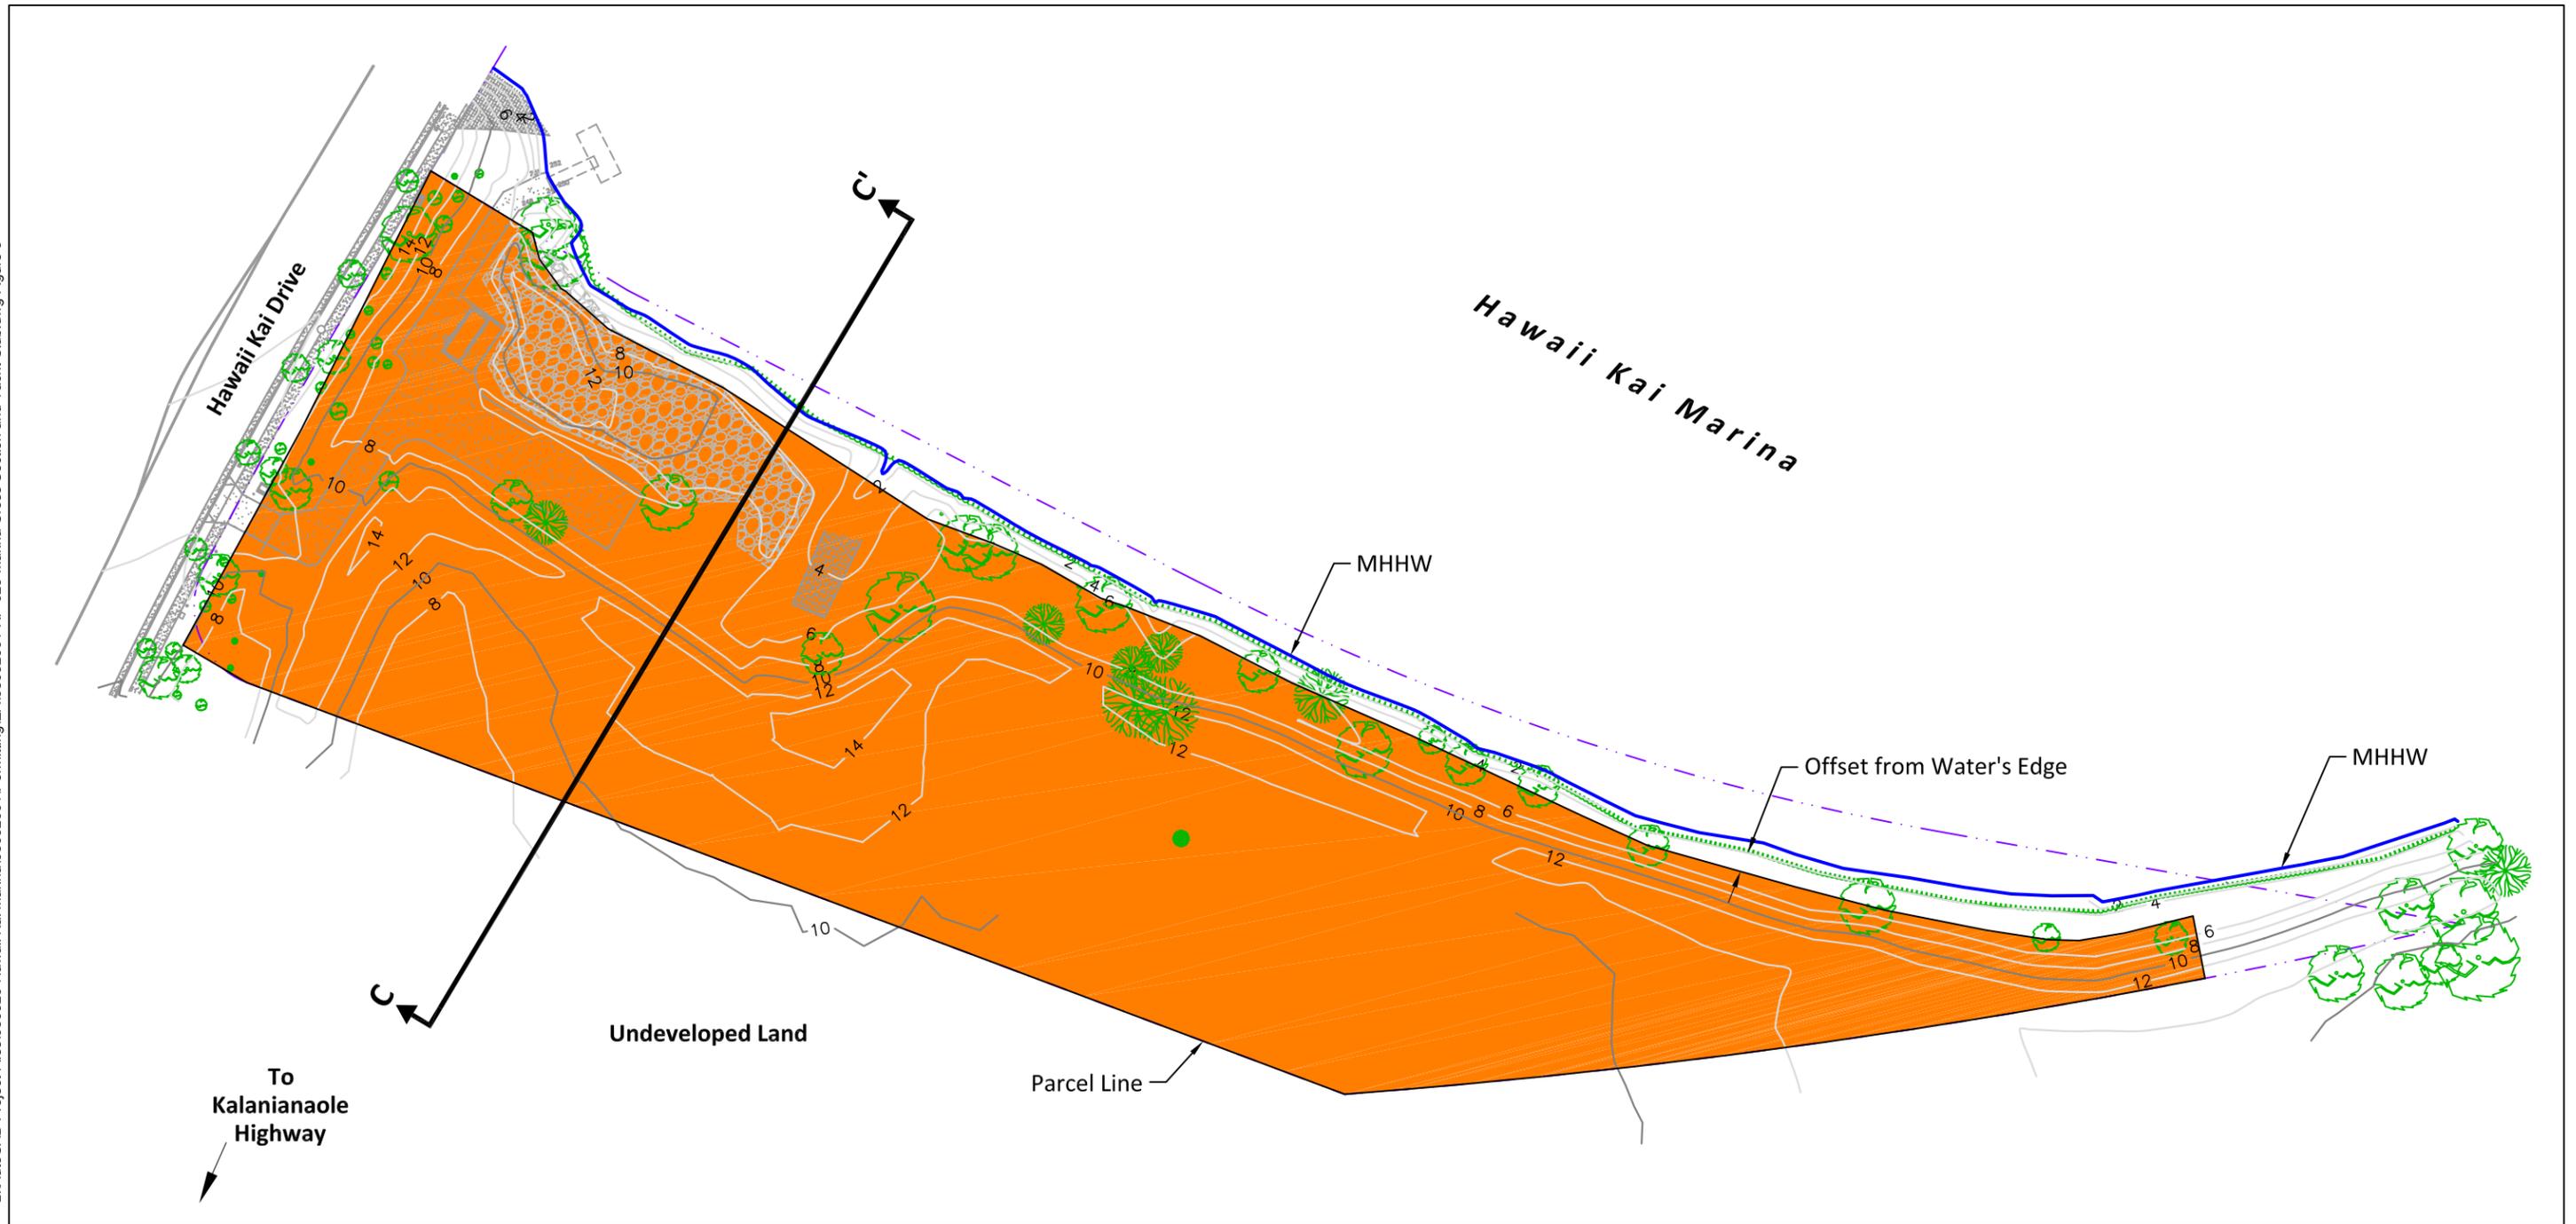
L:\AutoCAD Project Files\08052001\Permitting\EA\08052001-RP-025-Marina Cross Section and Yacht Club.dwg Figure 5

**SOURCE:** Drawing prepared from electronic file provided by Towill, Shigeoka & Associates Inc., dated September 17, 2004.  
**VERTICAL DATUM:** mean sea level (MSL).

approximate elevation of +13 feet MLLW. Figure 5 depicts a topographic survey displaying existing site conditions.

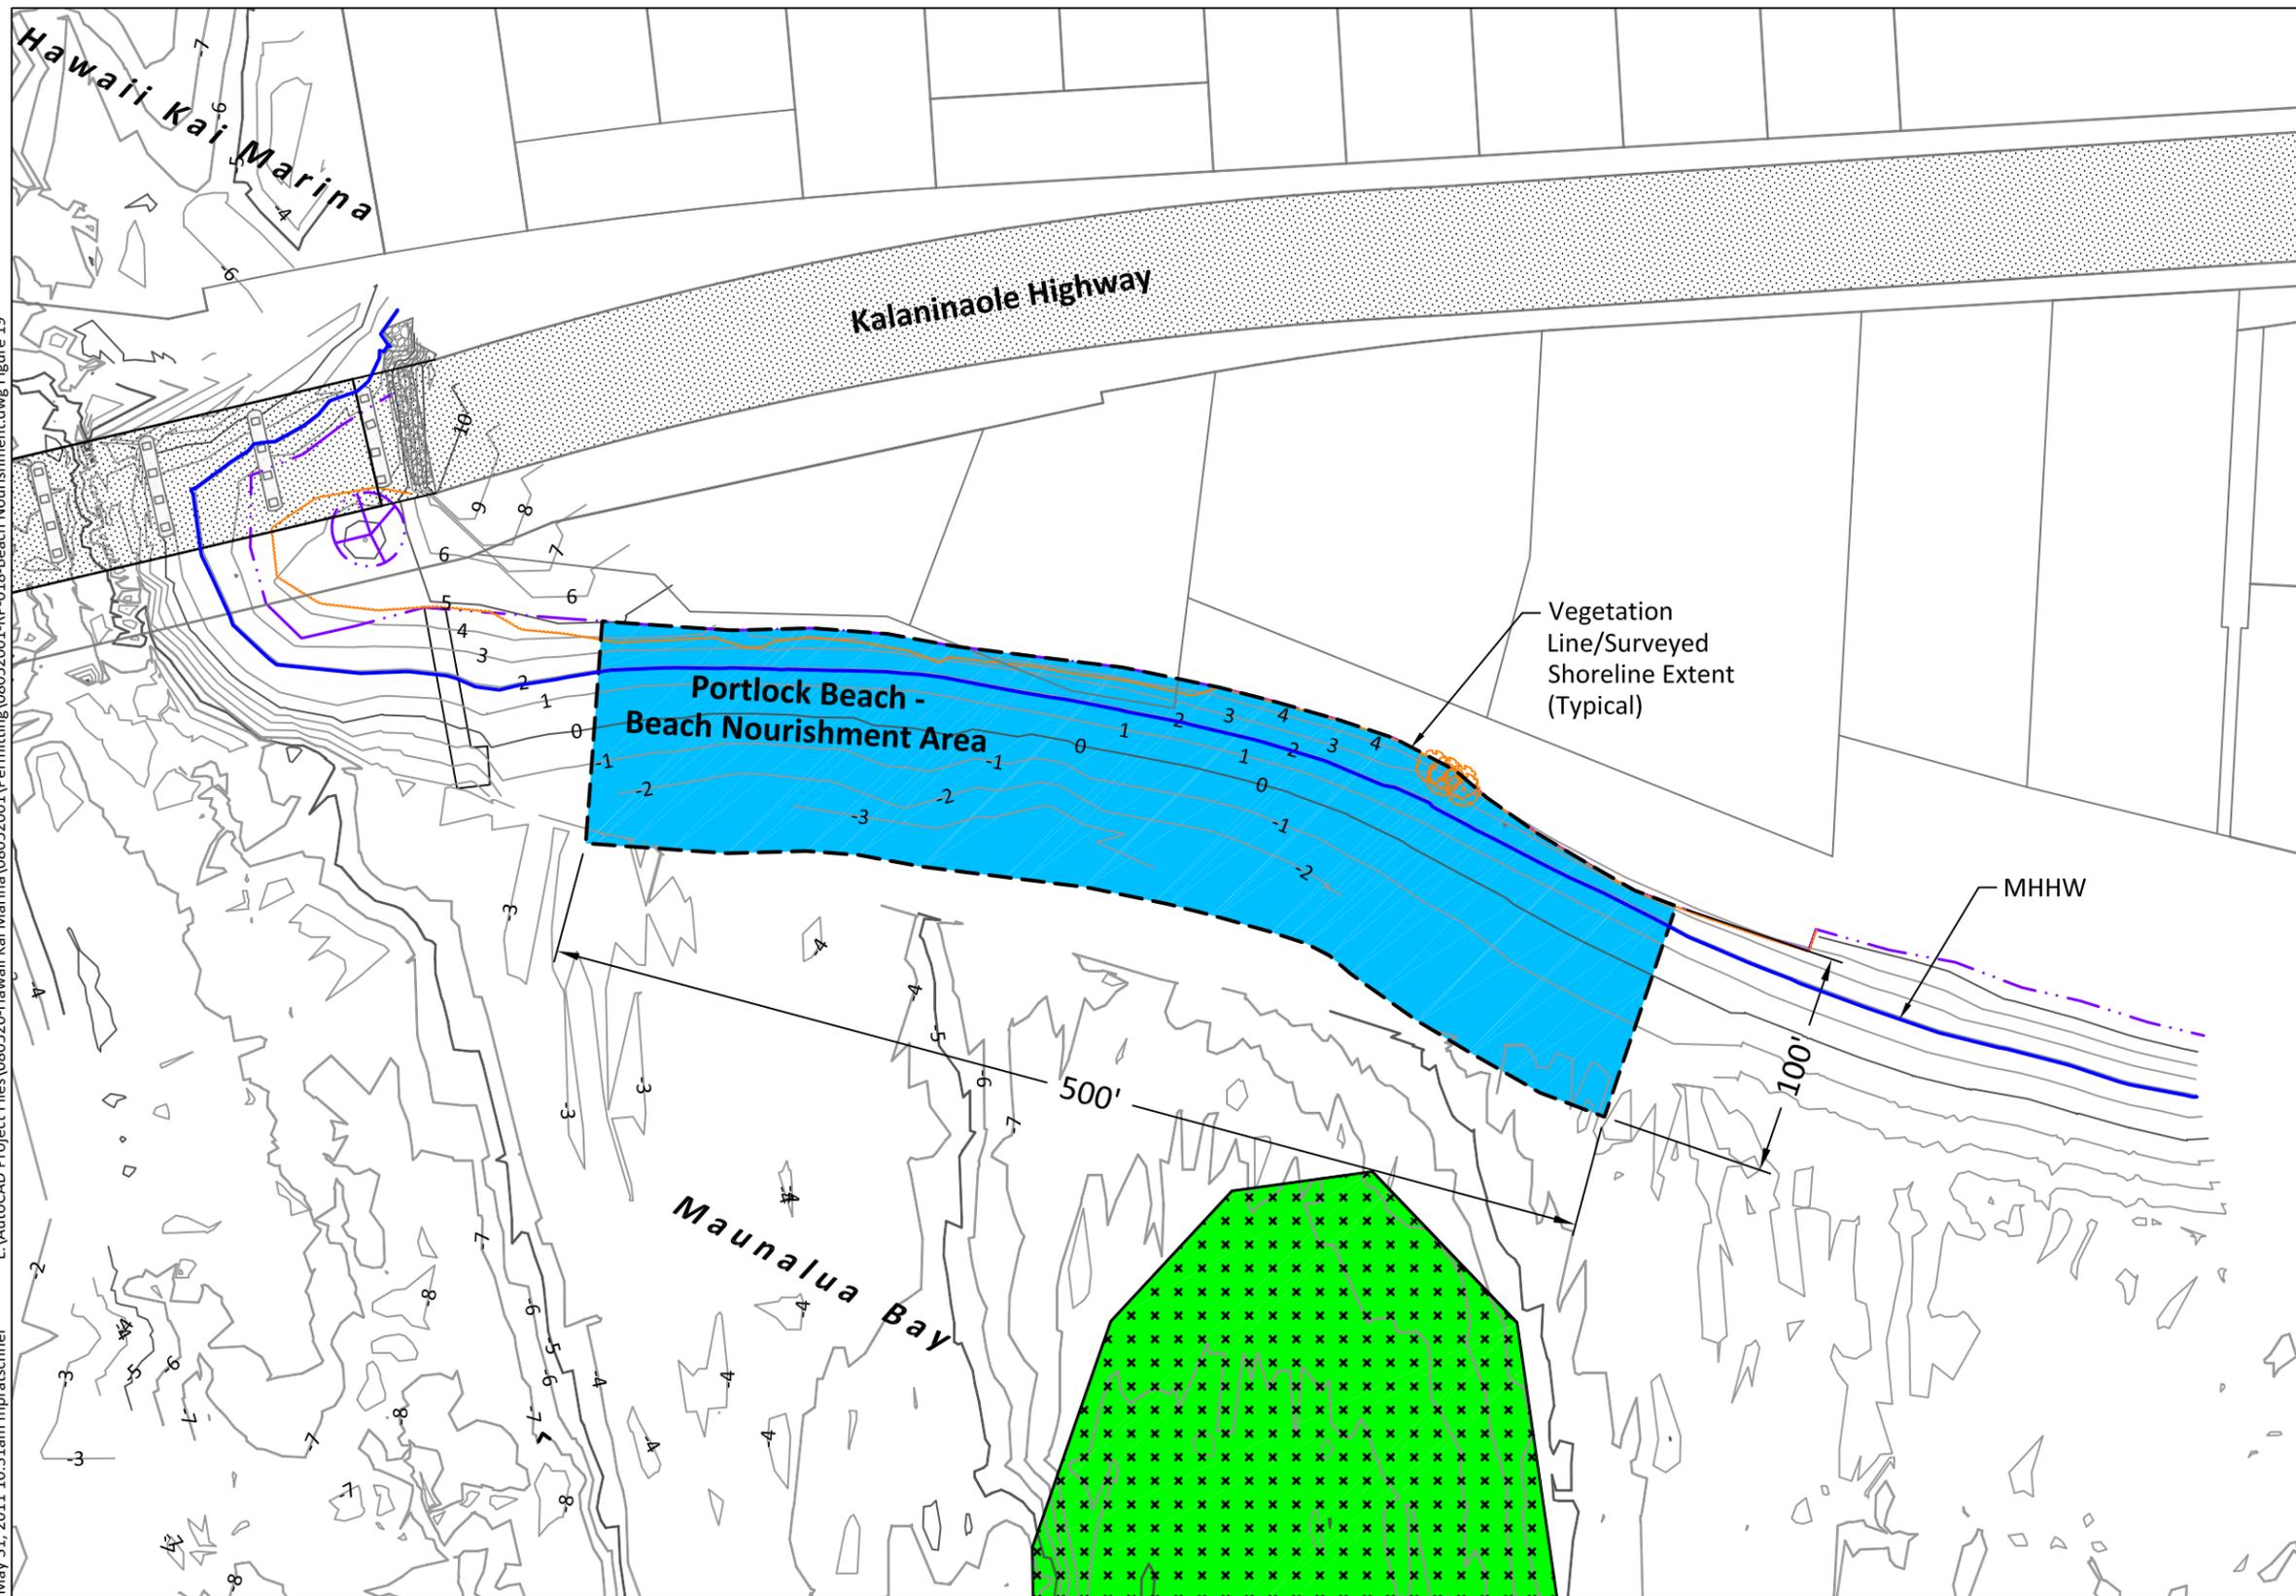
L:\AutoCAD Project Files\080520-Hawaii Kai Marina\08052001\Permitting\08052001-RP-018-Beach Nourishment.dwg Figure 19  
 May 31, 2011 10:31am mpratschner

**Figure 7**  
 Beach Nourishment Area - Portlock Beach  
 Hawaii Kai Marina and Entrance Channel Maintenance Dredging

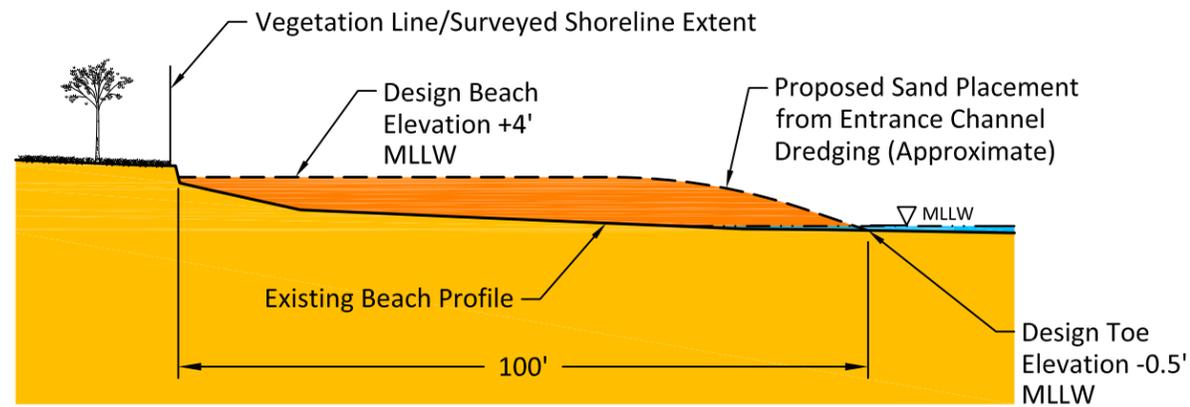
### Maunalua Bay Beach Park (Typical)

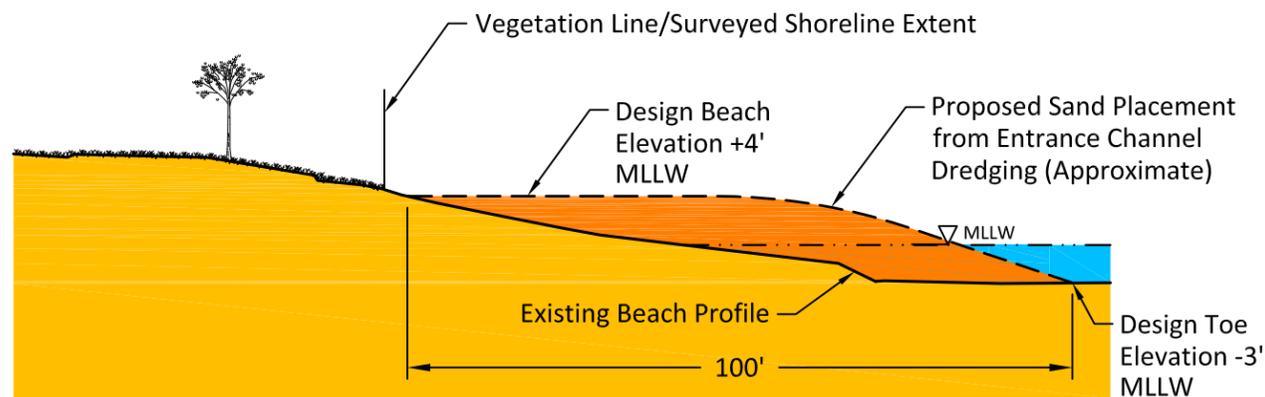
### Portlock Beach (Typical)

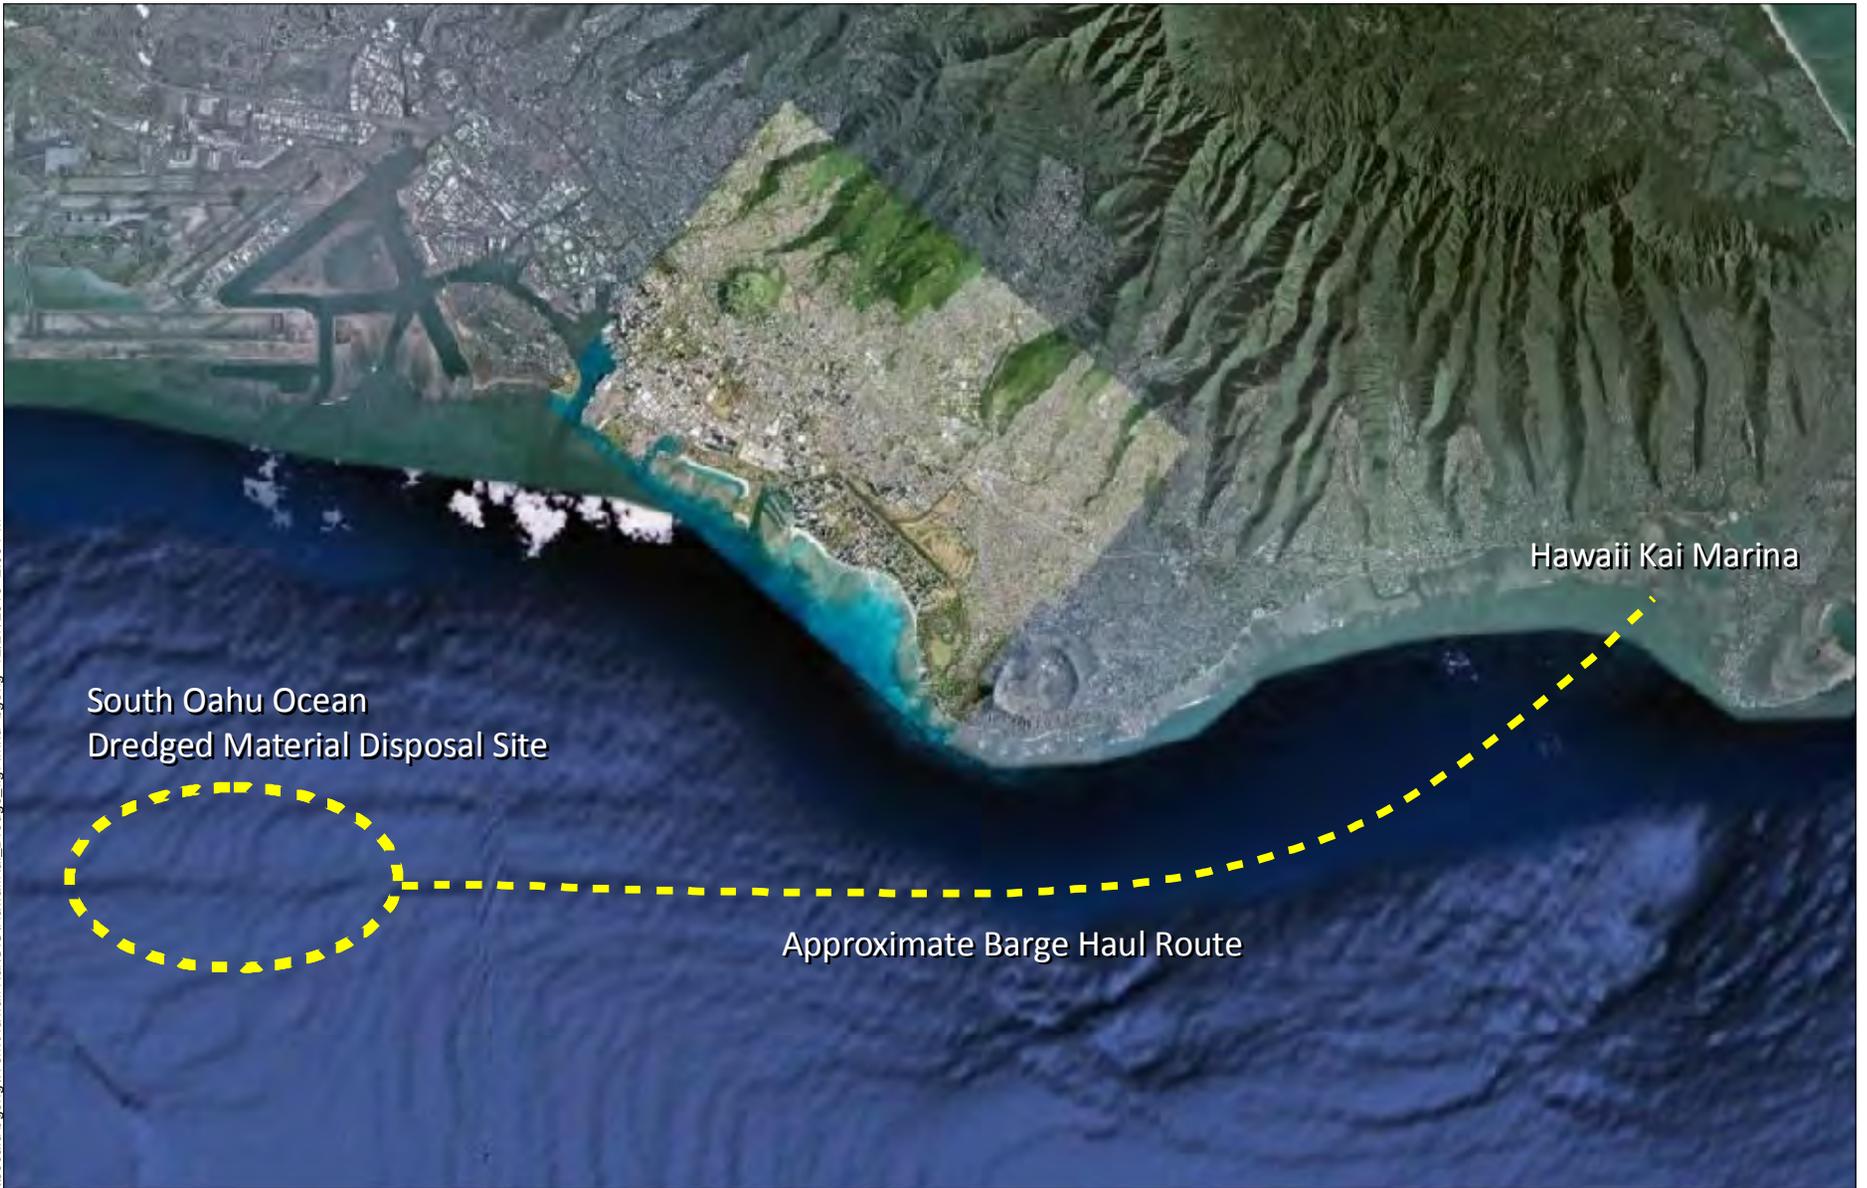
**Figure 9**  
Approximate Location of South Oahu Ocean Dredged Material Disposal Site  
Hawaii Kai Marina and Entrance Channel Maintenance Dredging

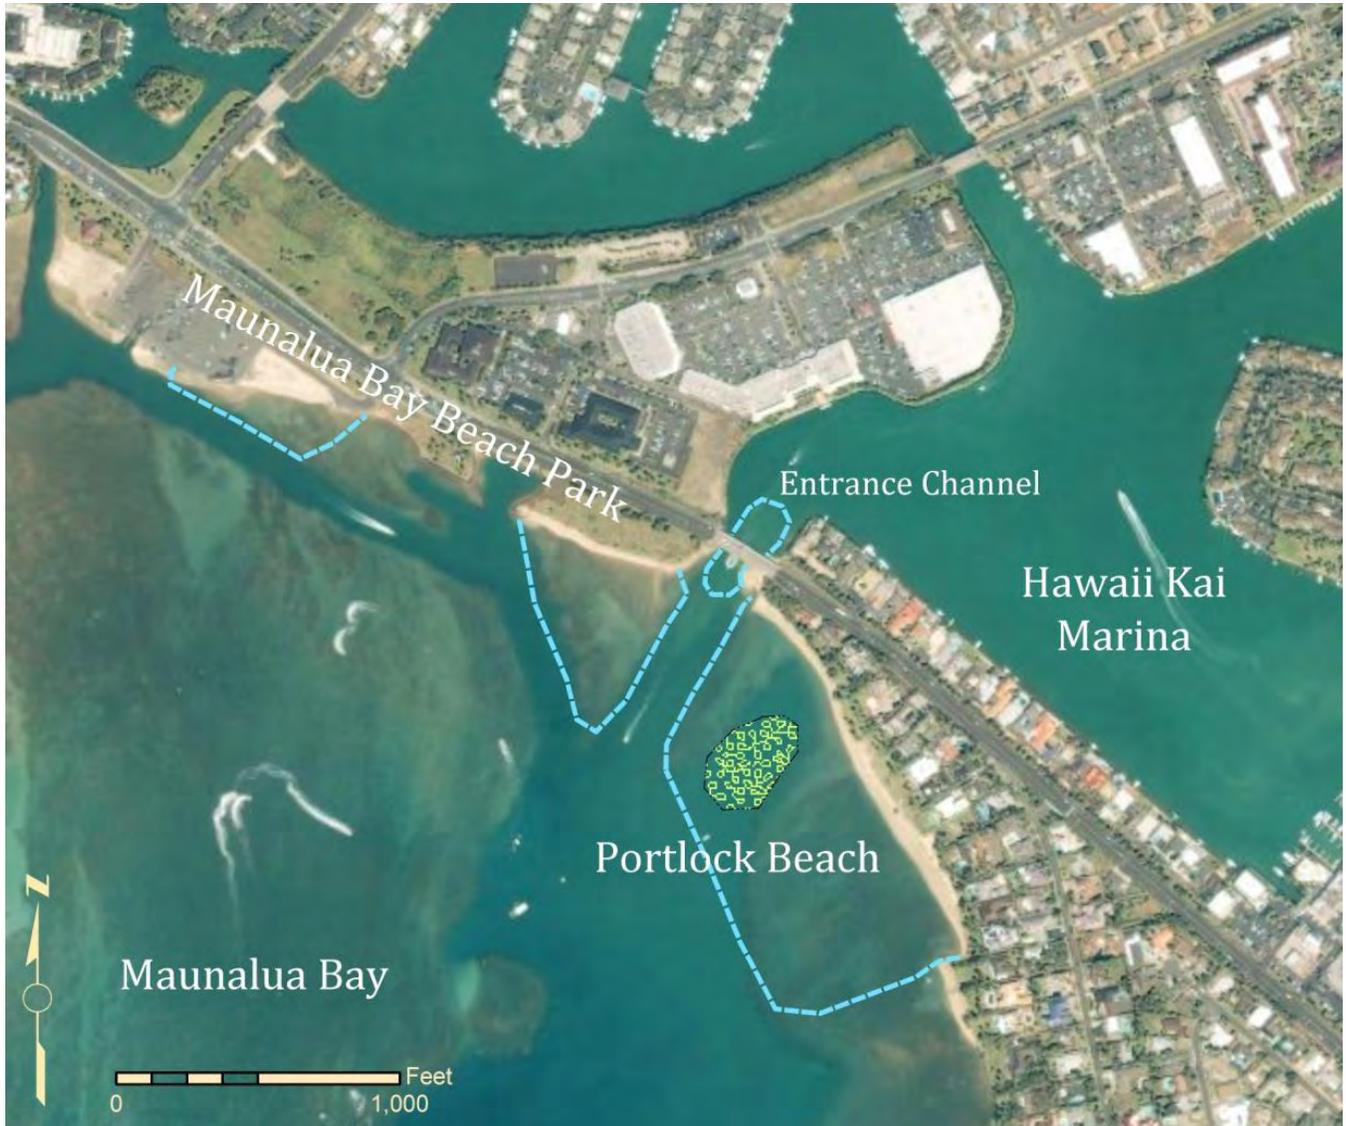
Notes: Areas surveyed (outlined by blue dashed lines) in channel and on nearshore reef remnant November 2007 and October 2009. Approximate area of seagrass bed (green) off Portlock Beach also shown.

The reef flats off Maunalua Bay Beach Park (located to the north of the entrance channel) and off Portlock Beach (located to the south) were surveyed by AECOS biologists in November 2007 and October 2009 (Figure 911). Table 6 presents a list of organisms observed by AECOS biologists on the reef flat in these surveys.

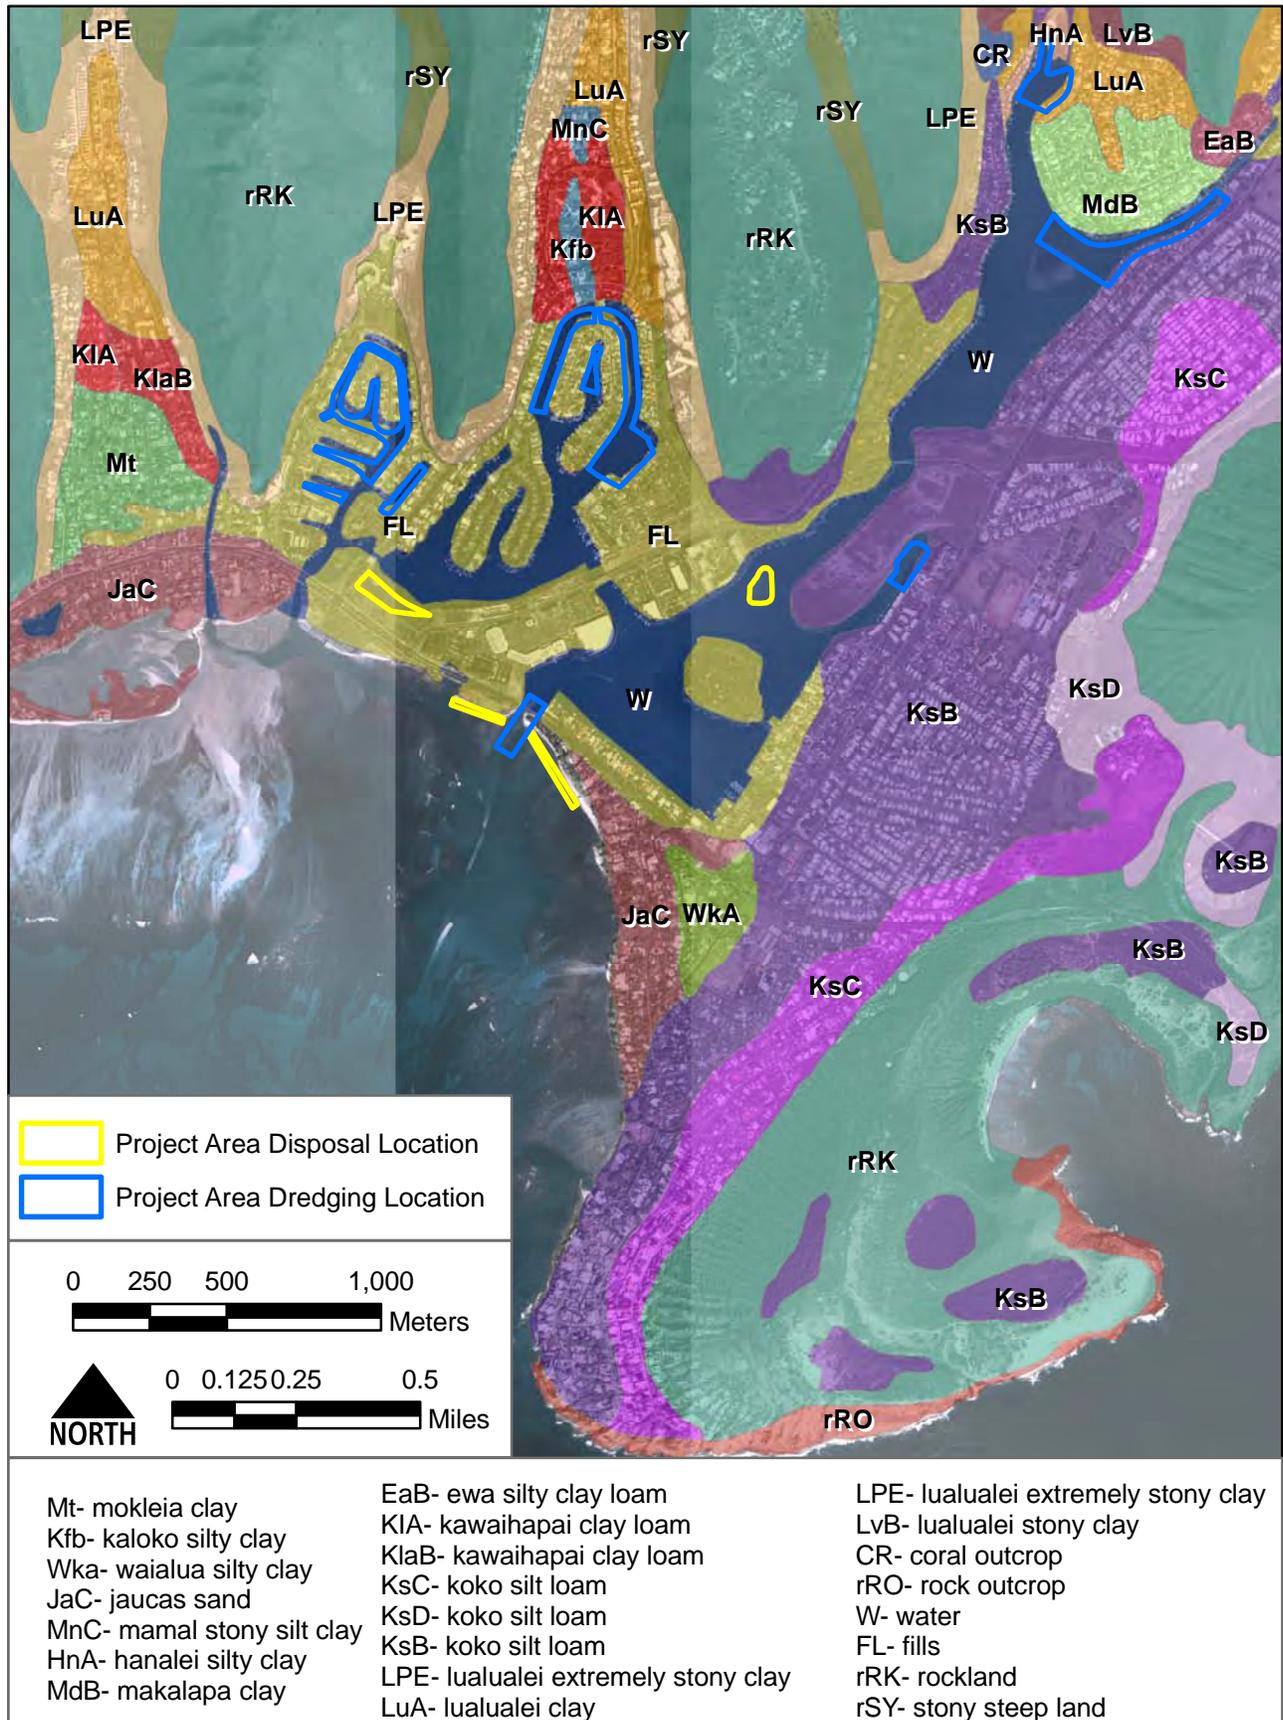
Figure 3. Soil reference map; National Cooperative Soil Survey data accessed 9.16.2010 from Geocommunity, aerial photograph (U.S. Department of Agriculture 2/7/2001), project location data georeferenced (Anchor QEA, LP, 2010).

Most natural soils in the area weather on alluvial sediments eroded from volcanic ash, cinders, and tuff. Foote et al. (1972:72, Map sheets 67 and 68) describe the majority of the soils in the marina area as water and landfills, but areas surrounding the fishpond and the APE are dominated by natural silty and clayey soils formed on diverse alluvial sediments (Figure 3). Generally stated, the clayey soils are actively eroding into valleys from the Ko‘olau Range or are weathering on fine sediments eroded from the Ko‘olau, while the silty soils weather on fine sediments eroding from Koko Head.

In summary, the fishpond area generally contains soils composed of mainly clay and silt. Rock outcrops are common on the surrounding slopes, and many stony, gravelly soils are associated with these outcrops. As indicated, the majority of the fishpond is now classified as either water or fill. The soils in the fishpond itself may, uncertainly, once have included wetland taro pondfield (*lo‘i kalo*) soils around pond margins, as was true for many *loko* (ponds).
