## HAWAII KAI MARINA AND ENTRANCE CHANNEL MAINTENANCE DREDGING

**FINAL ENVIRONMENTAL ASSESSMENT  
HAWAII KAI MARINA AND ENTRANCE  
CHANNEL MAINTENANCE DREDGING**

## PROJECT SUMMARY

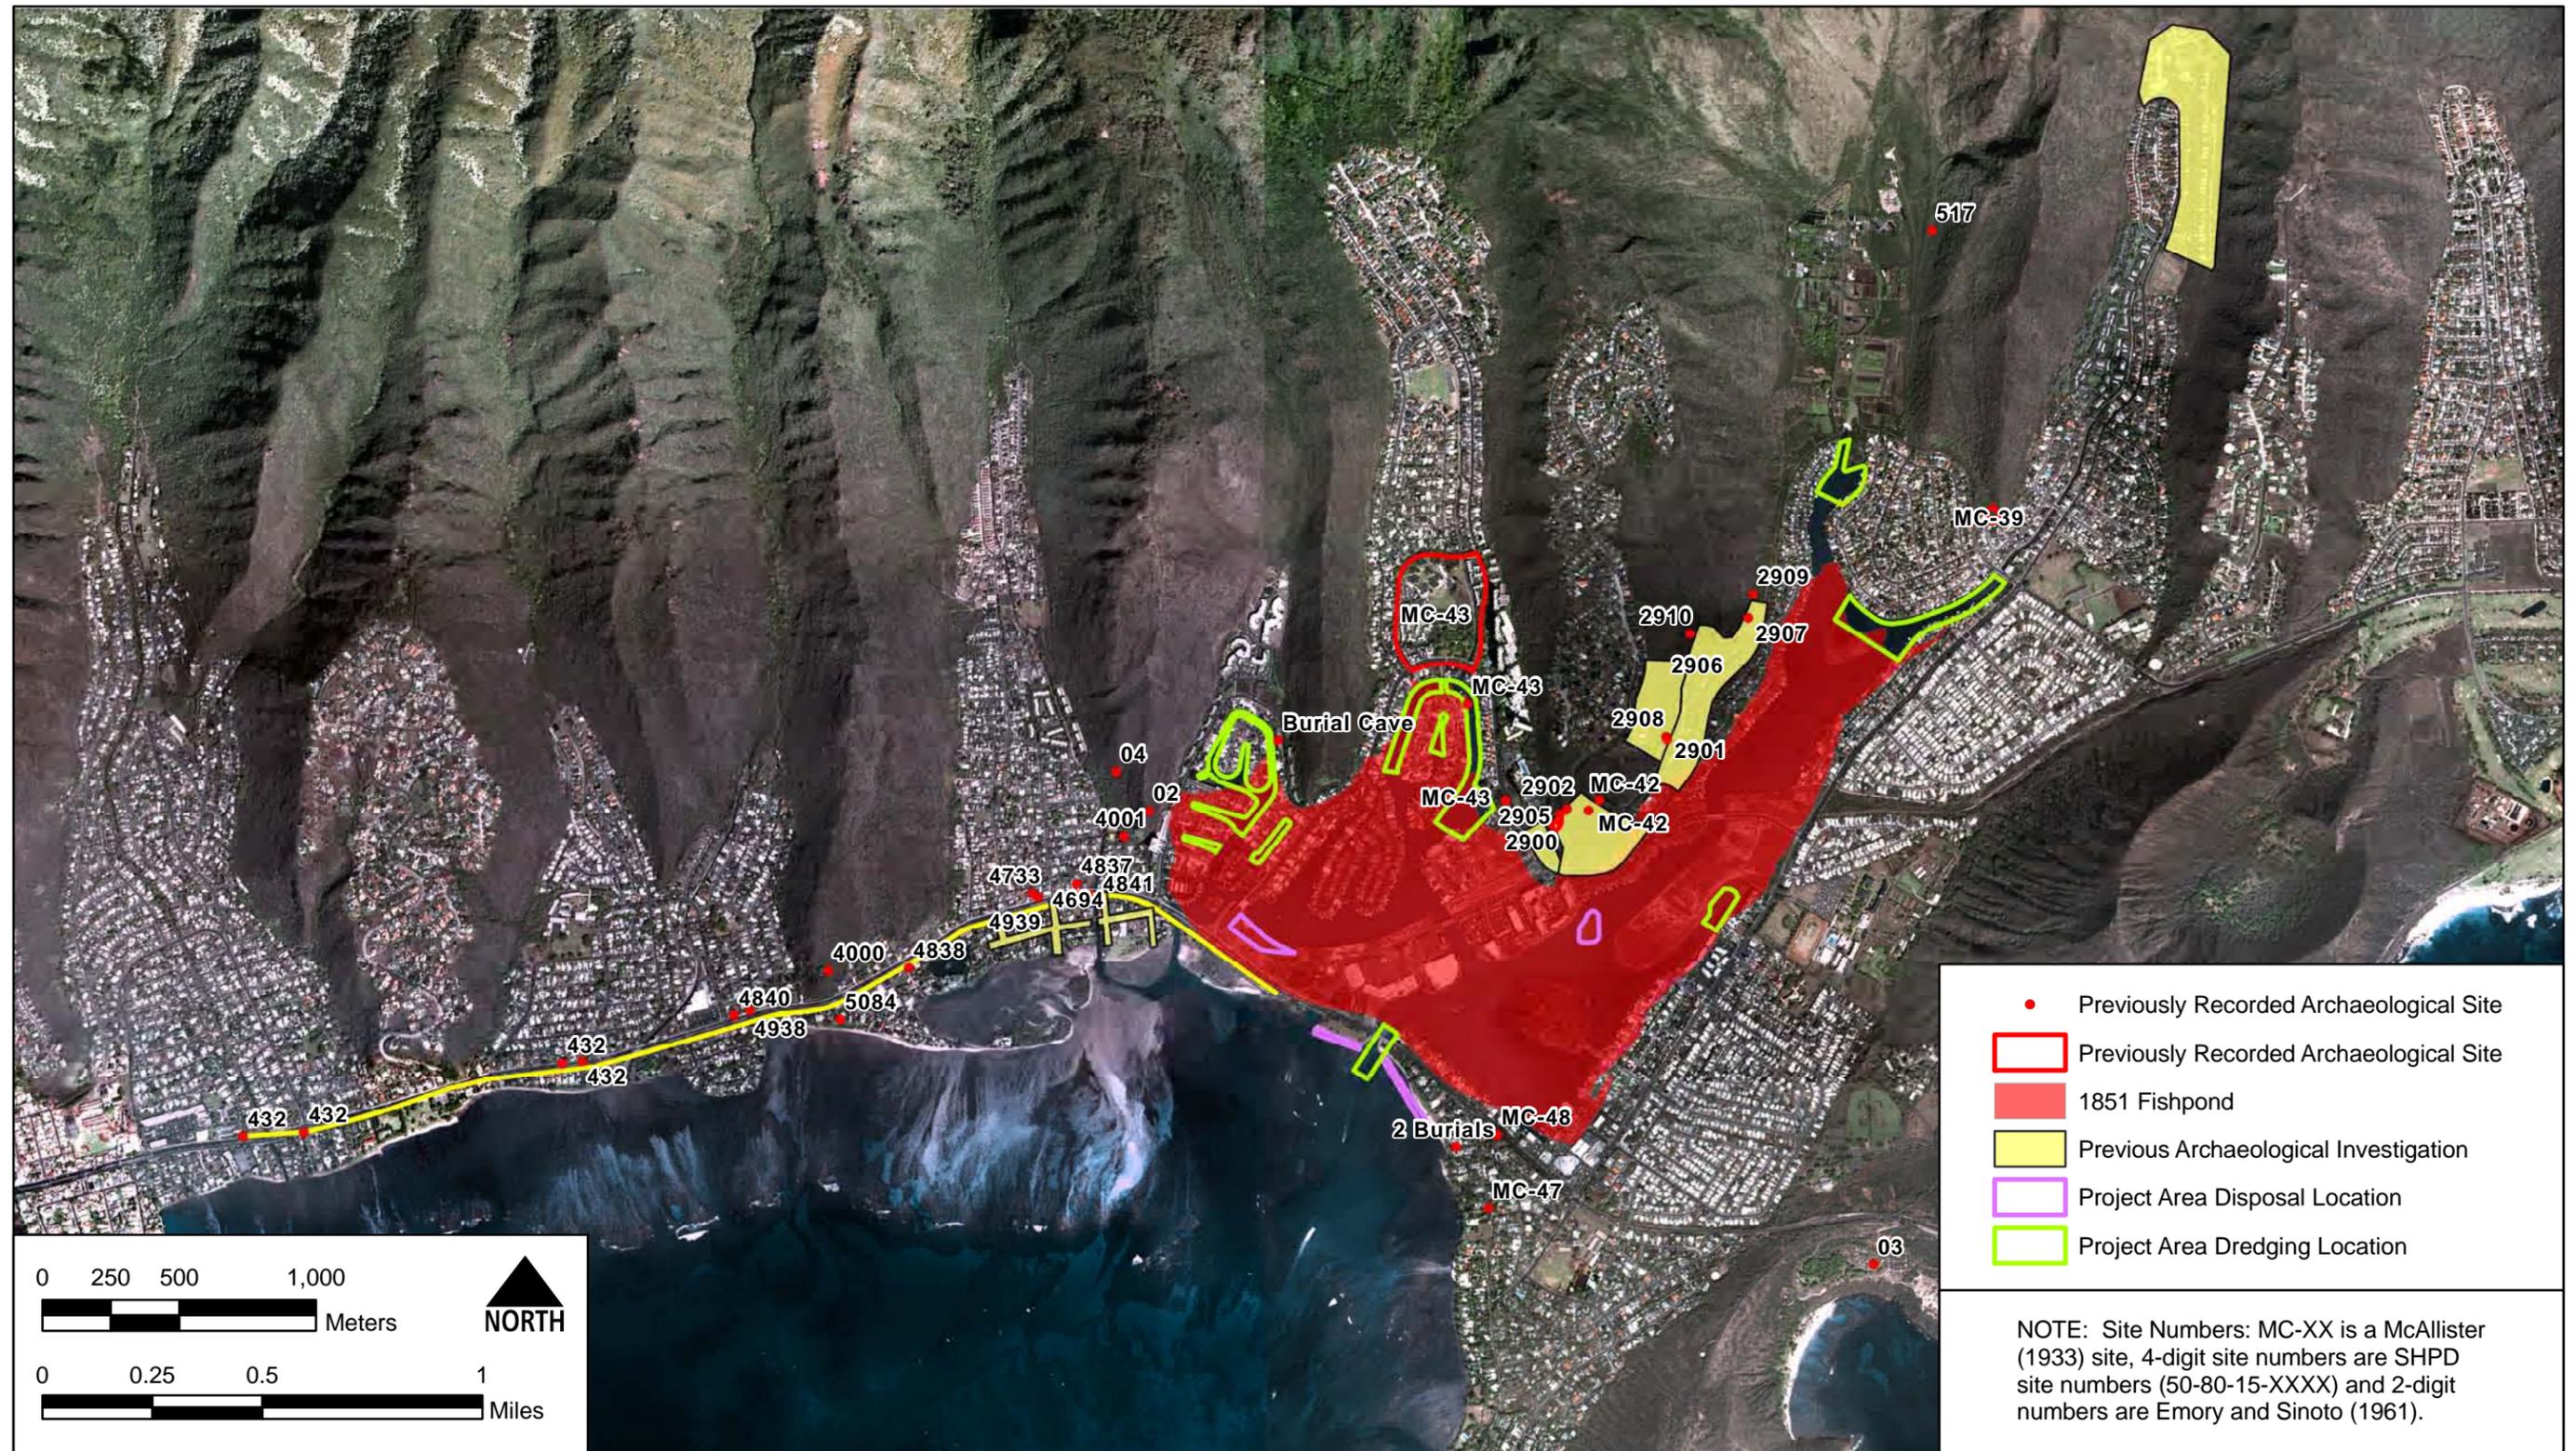
Figure 12. Previous archaeological sites and studies; base map (U.S. Department of Agriculture 2/7/2001), project location data georeferenced (Anchor QEA, LP, 2010).

Information concerning the locations of previous project areas and specific resources is recorded in Table 4 and illustrated in Figure 12. The exact locations of some of these resources are not well documented. Since the sites were observed in the 1930s, there has been a substantial amount of development in the area that has further obscured the locations. Residential development in Hawai‘i Kai Marina has definitely masked the surface expressions of many early sites and has most likely destroyed others. Recent researchers have attempted to relocate McAllister’s sites, in some cases without being certain that they are documenting the same sites McAllister recorded. Fortunately, archaeologists excavated two of the sites, so that much more information is available for these two – McAllister’s Sites 39 and 43. Site 43, the large habitation site, was excavated by Bayard (1967) in 1966; Pahua Heiau (Site 39) was excavated and reconstructed by Davis in 1985. As is often the case, however, each researcher from McAllister on has mapped the location of each resource slightly differently, which leaves several locations for a single resource. Site 43 includes three locations; Site 42 has two (see site descriptions, below).

Table 4 details the results of the literature search conducted to determine the locations of known archaeological sites in the area. Figure 12 illustrates the locations of these resources, showing multiple locations where necessary (e.g., Sites 42 and 43).

Figure 12 includes three Site 43 plots to reflect the different areas plotted by the three researchers. Bayard's (1967) large northern site area in the valley, the outlined area in Figure 12, is located outside the APE. One of the other two Site 43 locations (red dots in Figure 12), was mapped by McAllister and is probably slightly inaccurate, since it falls within an area scheduled for dredging and is therefore within the fishpond (see the more northerly of the two red dots in the figure). The actual location is likely adjacent to the fishpond; it could have involved a fishpond wall. Another possibility is that this location is really the one mapped by Davis (1985) (the southern of the two red dots), just east of the east boundary of the main proposed Haha'ione Valley dredging area. McAllister's (1933) and Davis's (1985) site locations are both located either immediately next to the easternmost dredging area or within it; they are considered possibly located in the APE.

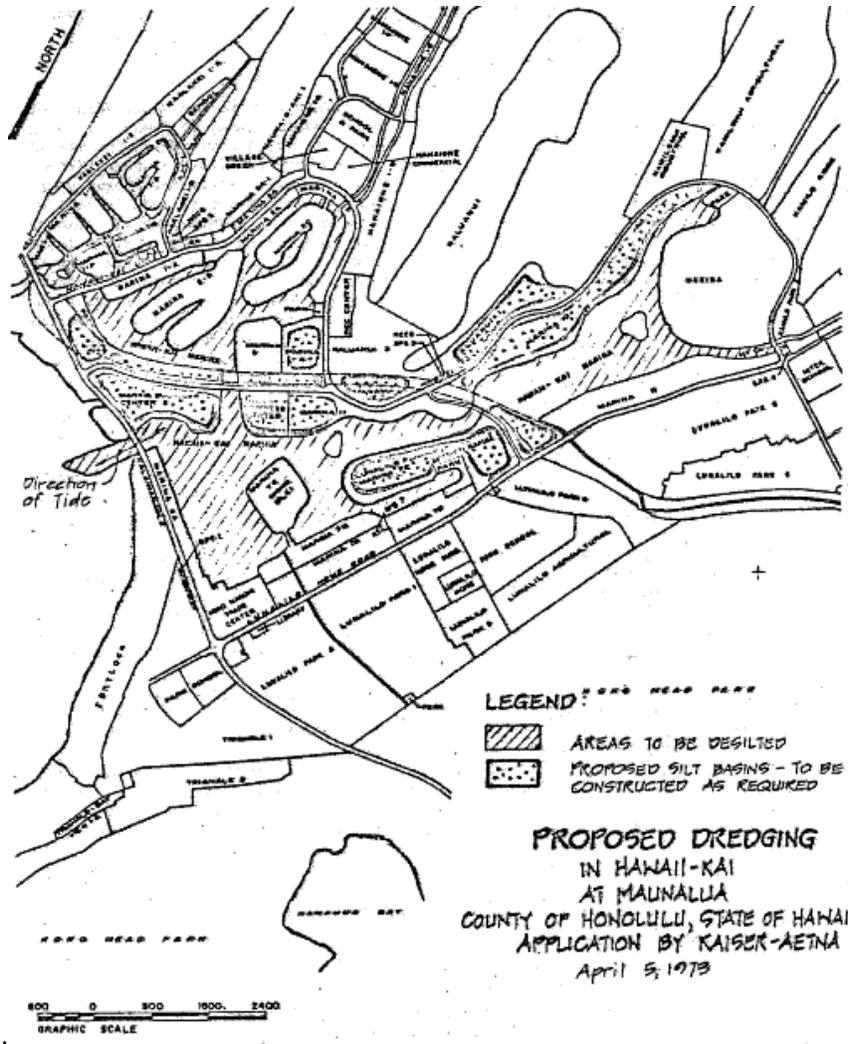
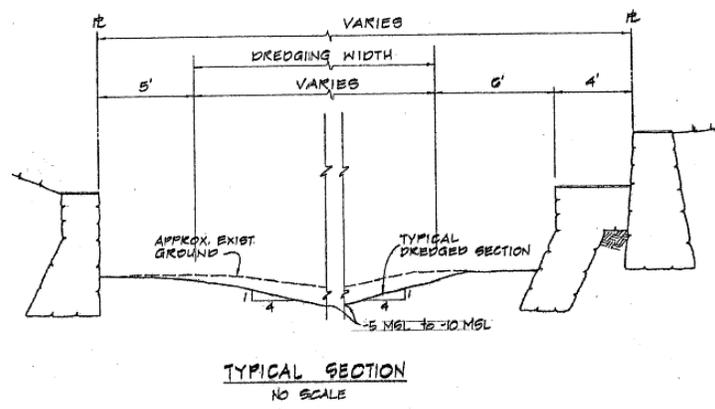
Figure 17. Proposed dredging areas in Hawai'i-Kai, 1973 (adapted from U.S. Army Corps, Engineer, 1975).

**PROPOSED DREDGING  
IN HAWAII-KAI  
AT MAUNALUA  
COUNTY OF HONOLULU, STATE OF HAWAII  
APPLICATION BY KAISER-AETNA  
APRIL 5, 1973**

After this initial dredging phase is completed "Kaiser-Aetna anticipates that future maintenance dredging requirements in the marina will be concentrated in areas under bridges; at the closed ends of the marina channels, and in areas where drainageways enter the marina from upland tributaries. The amount of the material needed to be dredged for these purposes is estimated not to exceed 215,000 CY...", totaling 400,000 CY (U.S. Army Corps, Engineer, 1975:2). Figure 17 includes the figure detailing construction activities throughout the marina and a cross section.

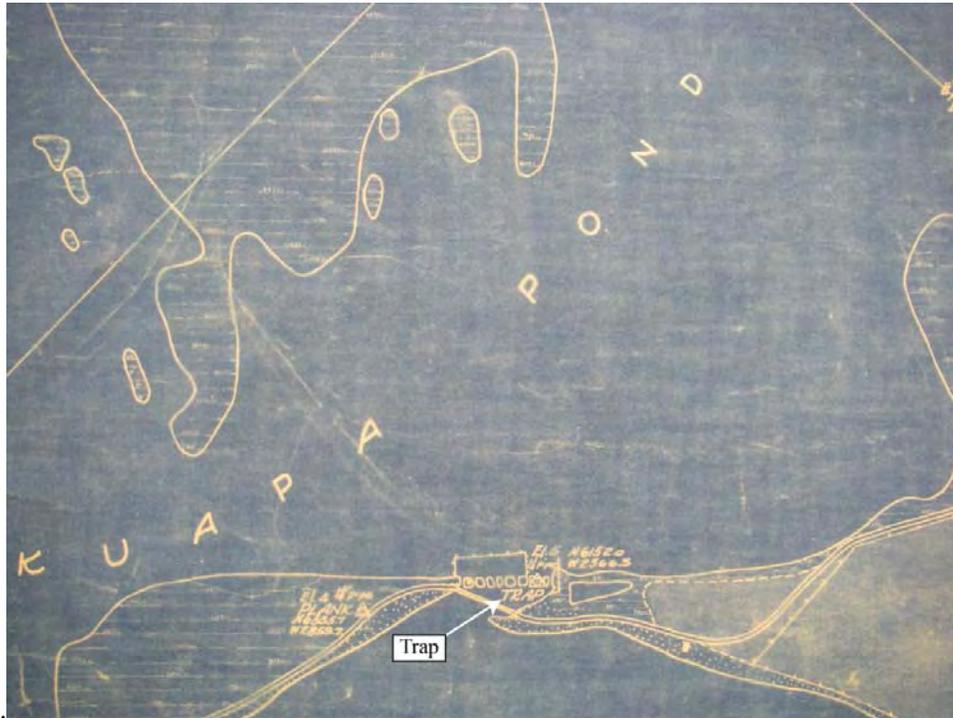
Figure 19. Close-up of Figure 6 (1921 Portion of Maunalua Apana 30, LCA 7713 R.P. 4475, Koolaupoko, Oahu - Surveyor Jas. B Mann) which illustrates the location of the “TRAP” and *loko pu’uone* at Keahupua-o-Maunalua Fishpond.

Surveyor James B. Mann’s (1921) map (Figure 19, below) of Loko Keahupua-o-Maunalua illustrates another, much smaller cultural feature that has not been described in any other available source. The 1921 map shows a “TRAP” located in the entrance/outlet from the *loko* into Maunalua Bay. “TRAP” likely refers to a fish trap, which, at that relatively early date, may have been a traditional Hawaiian fish trap. Fish traps include several types, including the *loko ‘ume ‘iki*, a shore fishpond with lanes (Kikuchi 1973:229-230), and many smaller types including *pā*, *umiki*, *‘ūmi‘i* and others Pukui et al. 1986:210, 548). The *loko ‘ume ‘iki* is a complex trap type that is described by Kikuchi (1973:9-10) as similar in form and construction to the *loko kuapā*, with numerous stone-lined lanes that lead fish into netting areas with the ebbing and flowing tide. A *pā* is a simpler trap, built out into a channel with an opening and a single lane to guide fish at high or low tide, but not both.

The trap's integrity remains in question. It will not be known until the project takes place whether the feature still remains, in the entrance-outlet between the fishpond and Maunalua Bay.

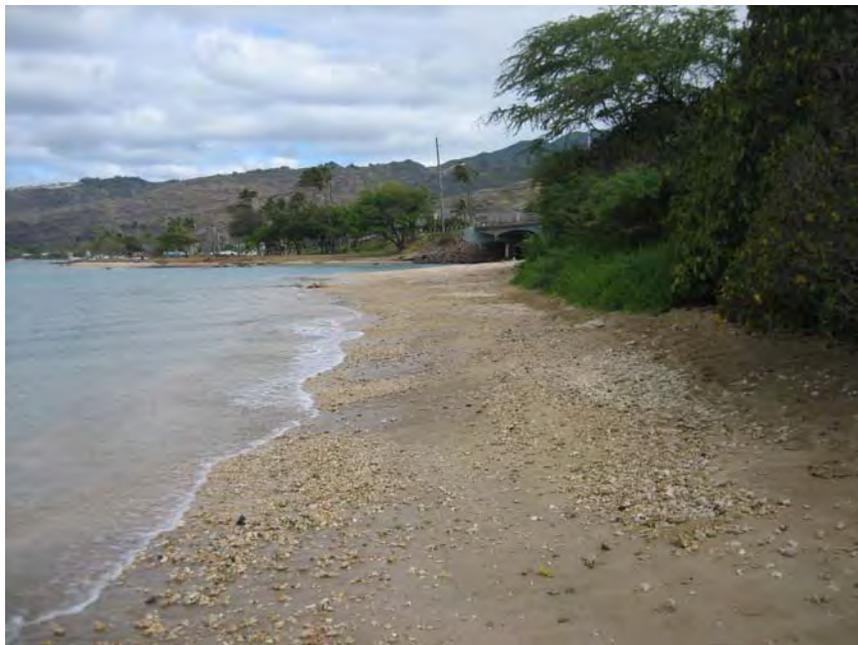
**Photograph 1**

**Portlock Beach proposed beach nourishment location (east of entrance channel)**

The Project proposes to utilize the coarser-grained sandy sediment within the entrance channel shoaling area for placement along the adjacent shorelines of Portlock Beach (Photograph 1) and Maunalua Bay Beach Park (Photograph 2). This beneficial reuse alternative is preferred to upland or offshore disposal options as it returns needed material to the littoral system. The resulting beach nourishment offers benefits of increased habitat, protection of existing shoreline infrastructure, and a public recreation area to the eroding shorelines of Maunalua Bay.

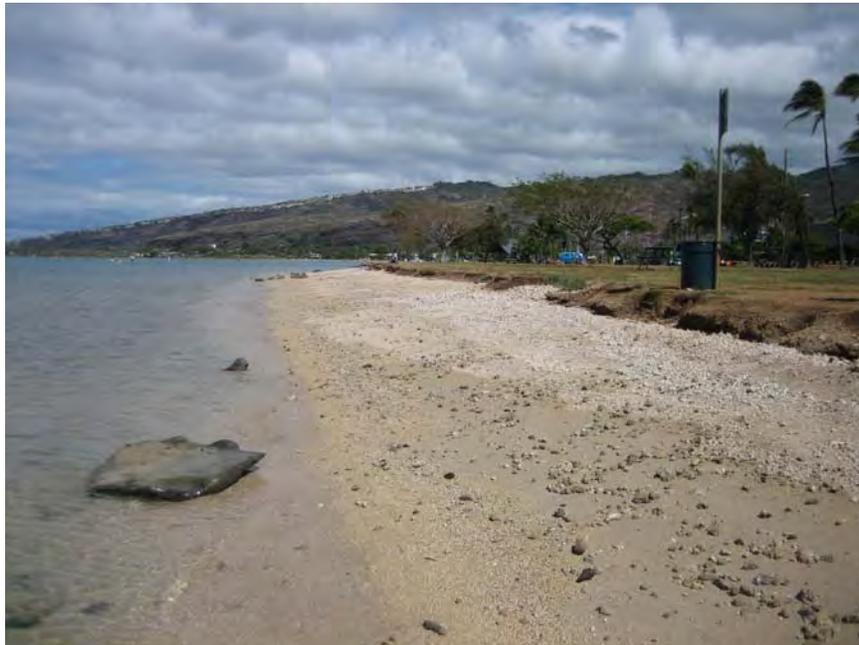
**Photograph 2**

**Maunalua Bay Beach Park proposed beach nourishment location (west of entrance channel)**

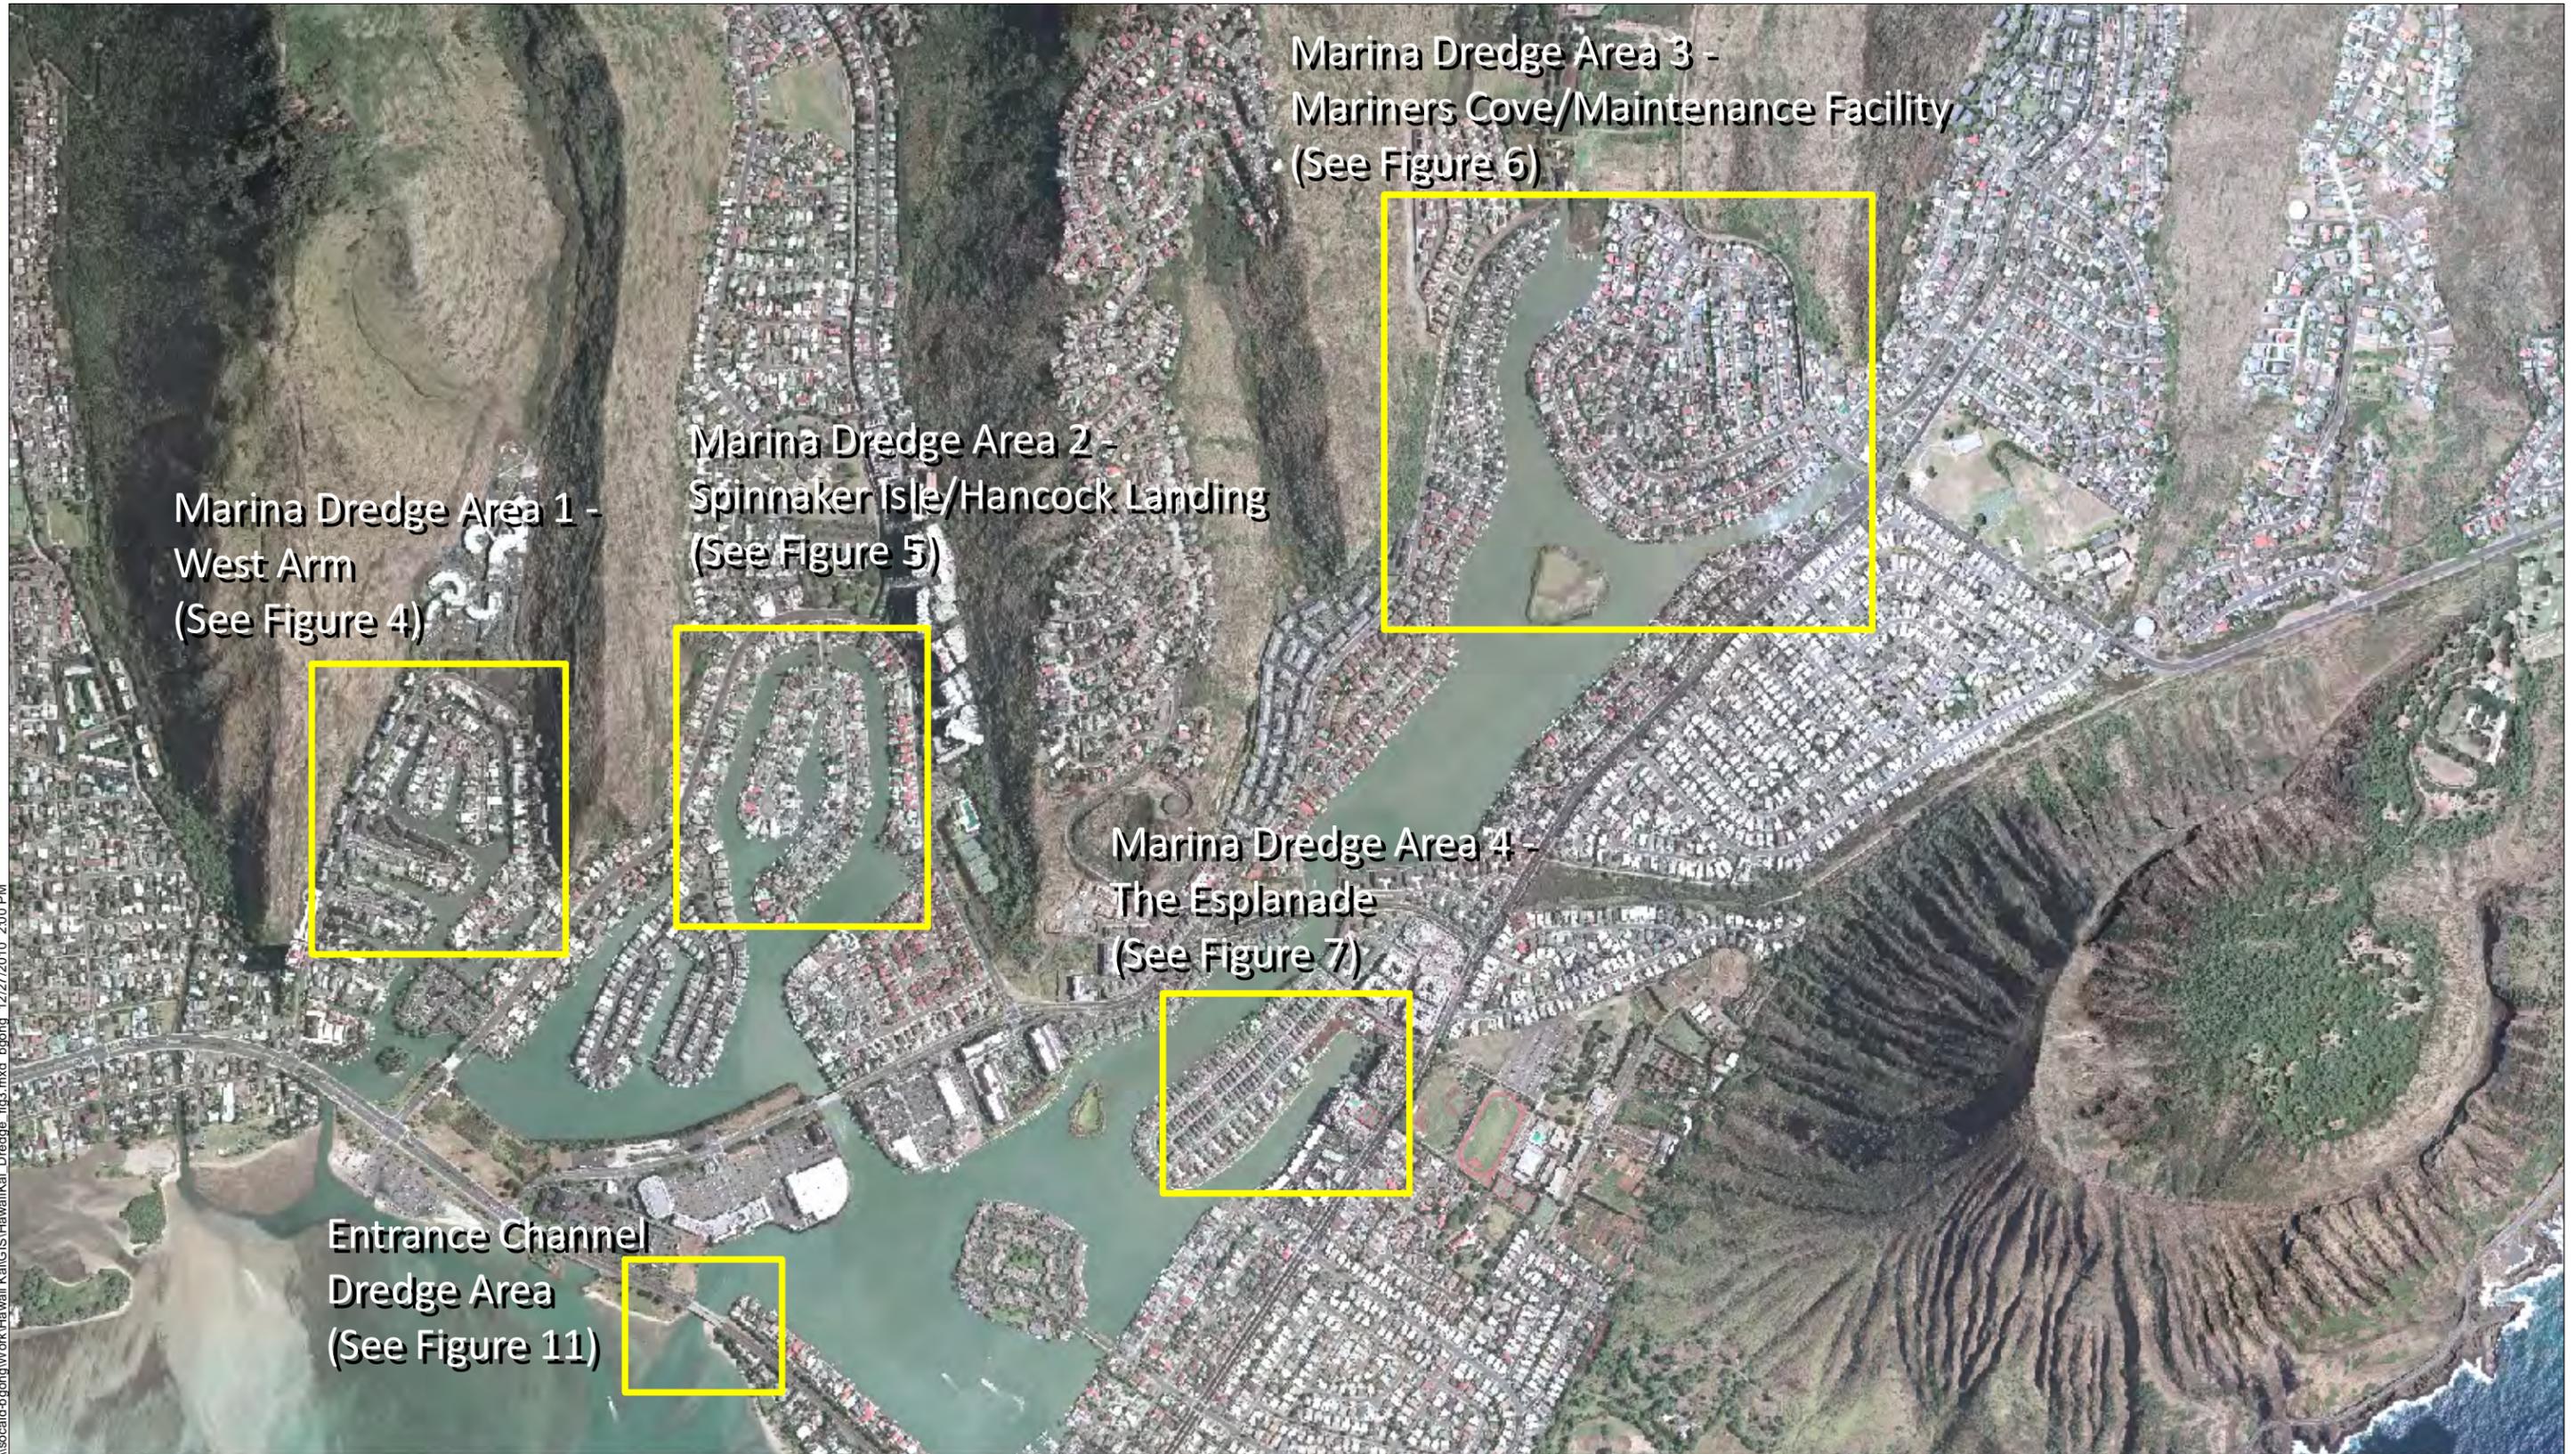
Marina Dredge Area 1 -  
West Arm  
(See Figure 4)

Marina Dredge Area 2 -  
Spinnaker Isle/Hancock Landing  
(See Figure 5)

Marina Dredge Area 4 -  
The Esplanade  
(See Figure 7)

Entrance Channel  
Dredge Area  
(See Figure 11)

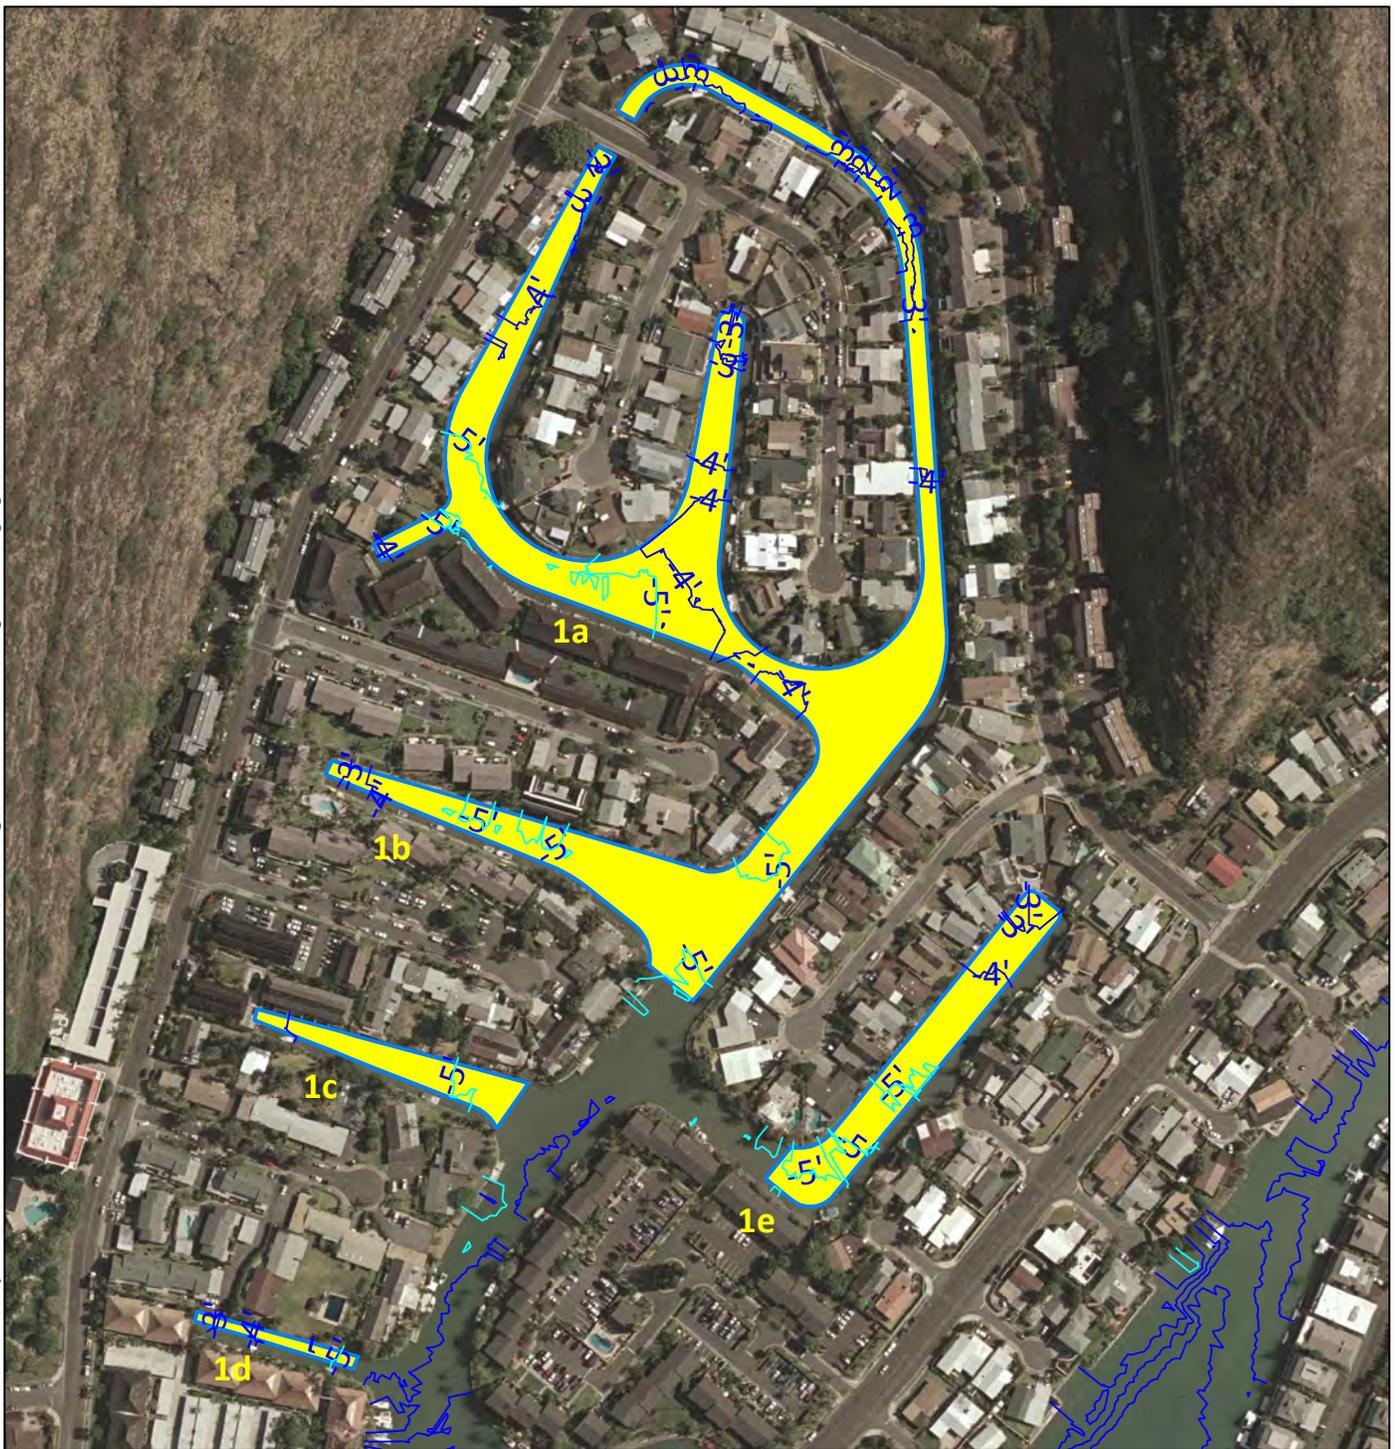
L:\AutoCAD Project Files\080520-Hawaii Kai Marina\08052001\Permitting\08052001-RP-004-Dredge Areas.dwg Figure 4

**SOURCE:** Drawing prepared from GIS files from the City of Honolulu and bathymetric survey performed by Northwest Maritime Industrial in January 2009.  
**HORIZONTAL DATUM:** Hawaii State Plane 3, NAD 83 HARN.  
**VERTICAL DATUM:** mean lower low water (MLLW).

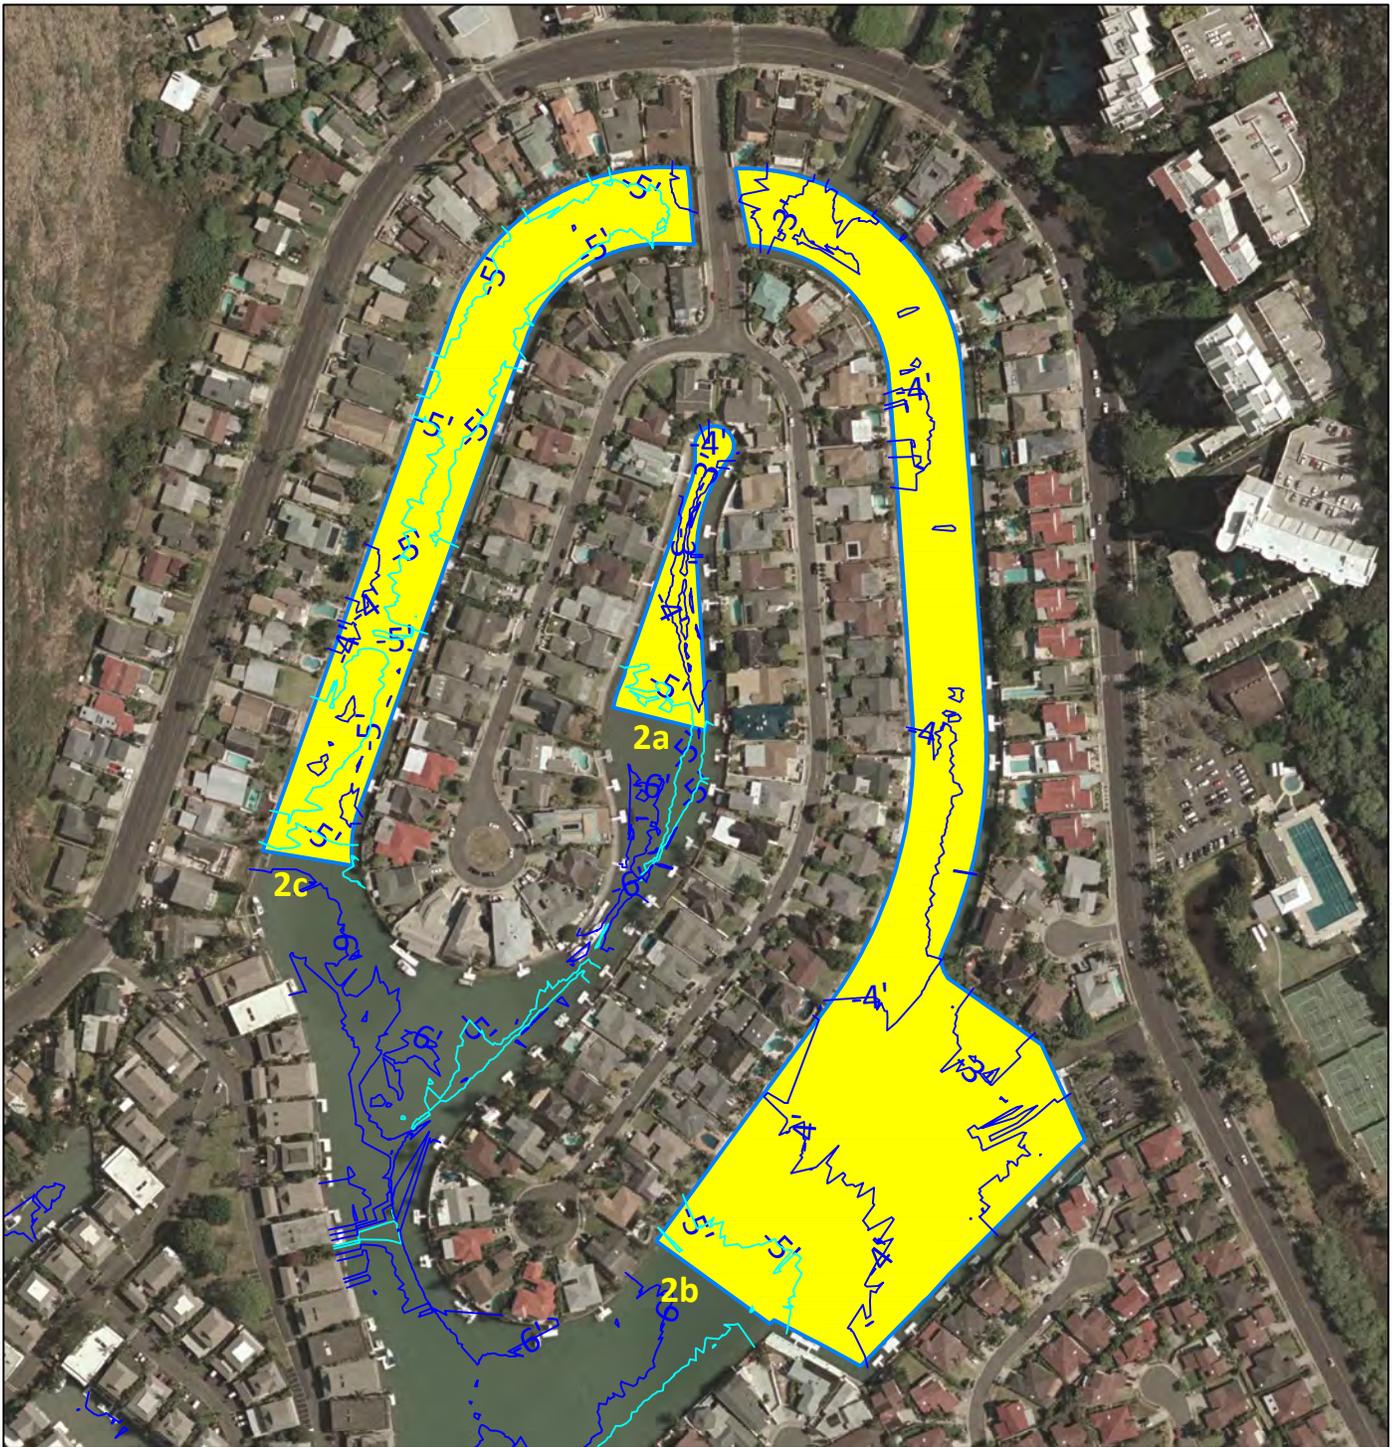
L:\AutoCAD Project Files\080520-Hawaii Kai Marina\08052001\Permitting\08052001-RP-004-Dredge Areas.dwg Figure 5

**SOURCE:** Drawing prepared from GIS files from the City of Honolulu and bathymetric survey performed by Northwest Maritime Industrial in January 2009.  
**HORIZONTAL DATUM:** Hawaii State Plane 3, NAD 83 HARN.  
**VERTICAL DATUM:** mean lower low water (MLLW).

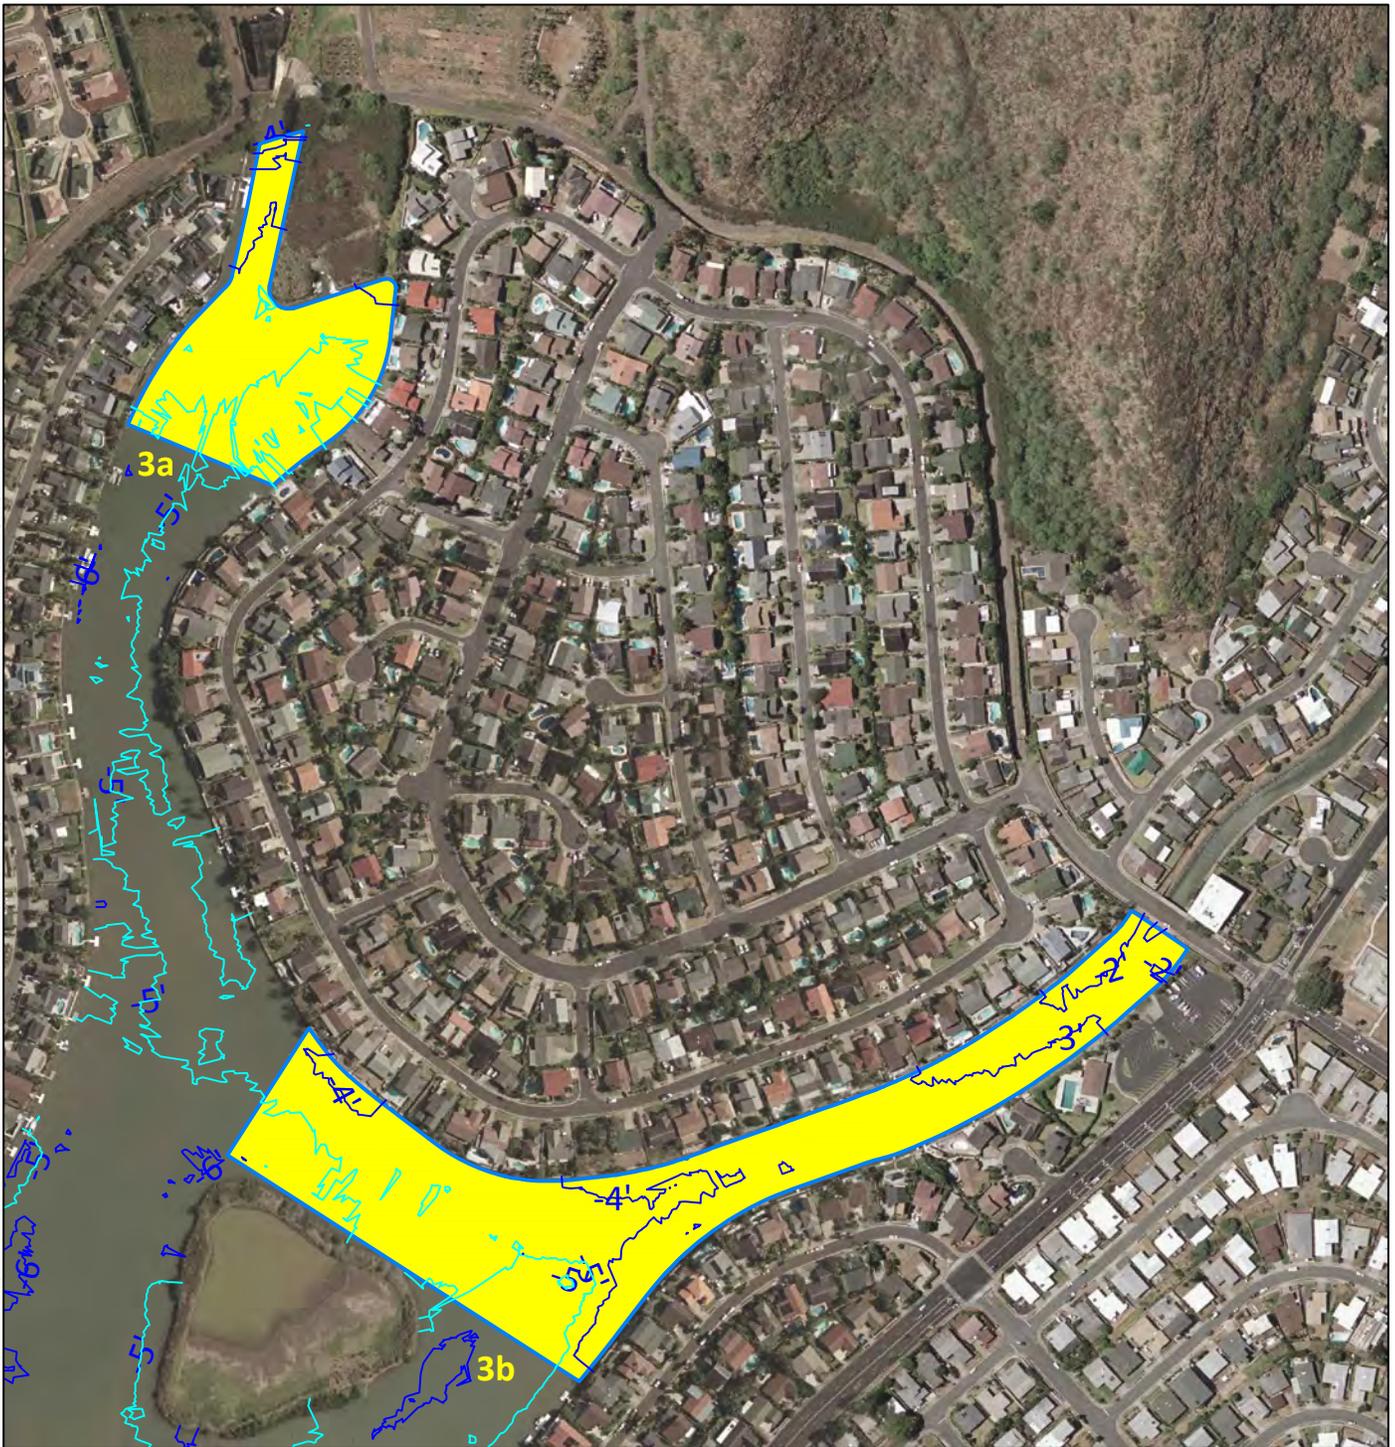
L:\AutoCAD Project Files\080520-Hawaii Kai Marina\08052001\Permitting\08052001-RP-004-Dredge Areas.dwg Figure 6

**SOURCE:** Drawing prepared from GIS files from the City of Honolulu and bathymetric survey performed by Northwest Maritime Industrial in January 2009.  
**HORIZONTAL DATUM:** Hawaii State Plane 3, NAD 83 HARN.  
**VERTICAL DATUM:** mean lower low water (MLLW).

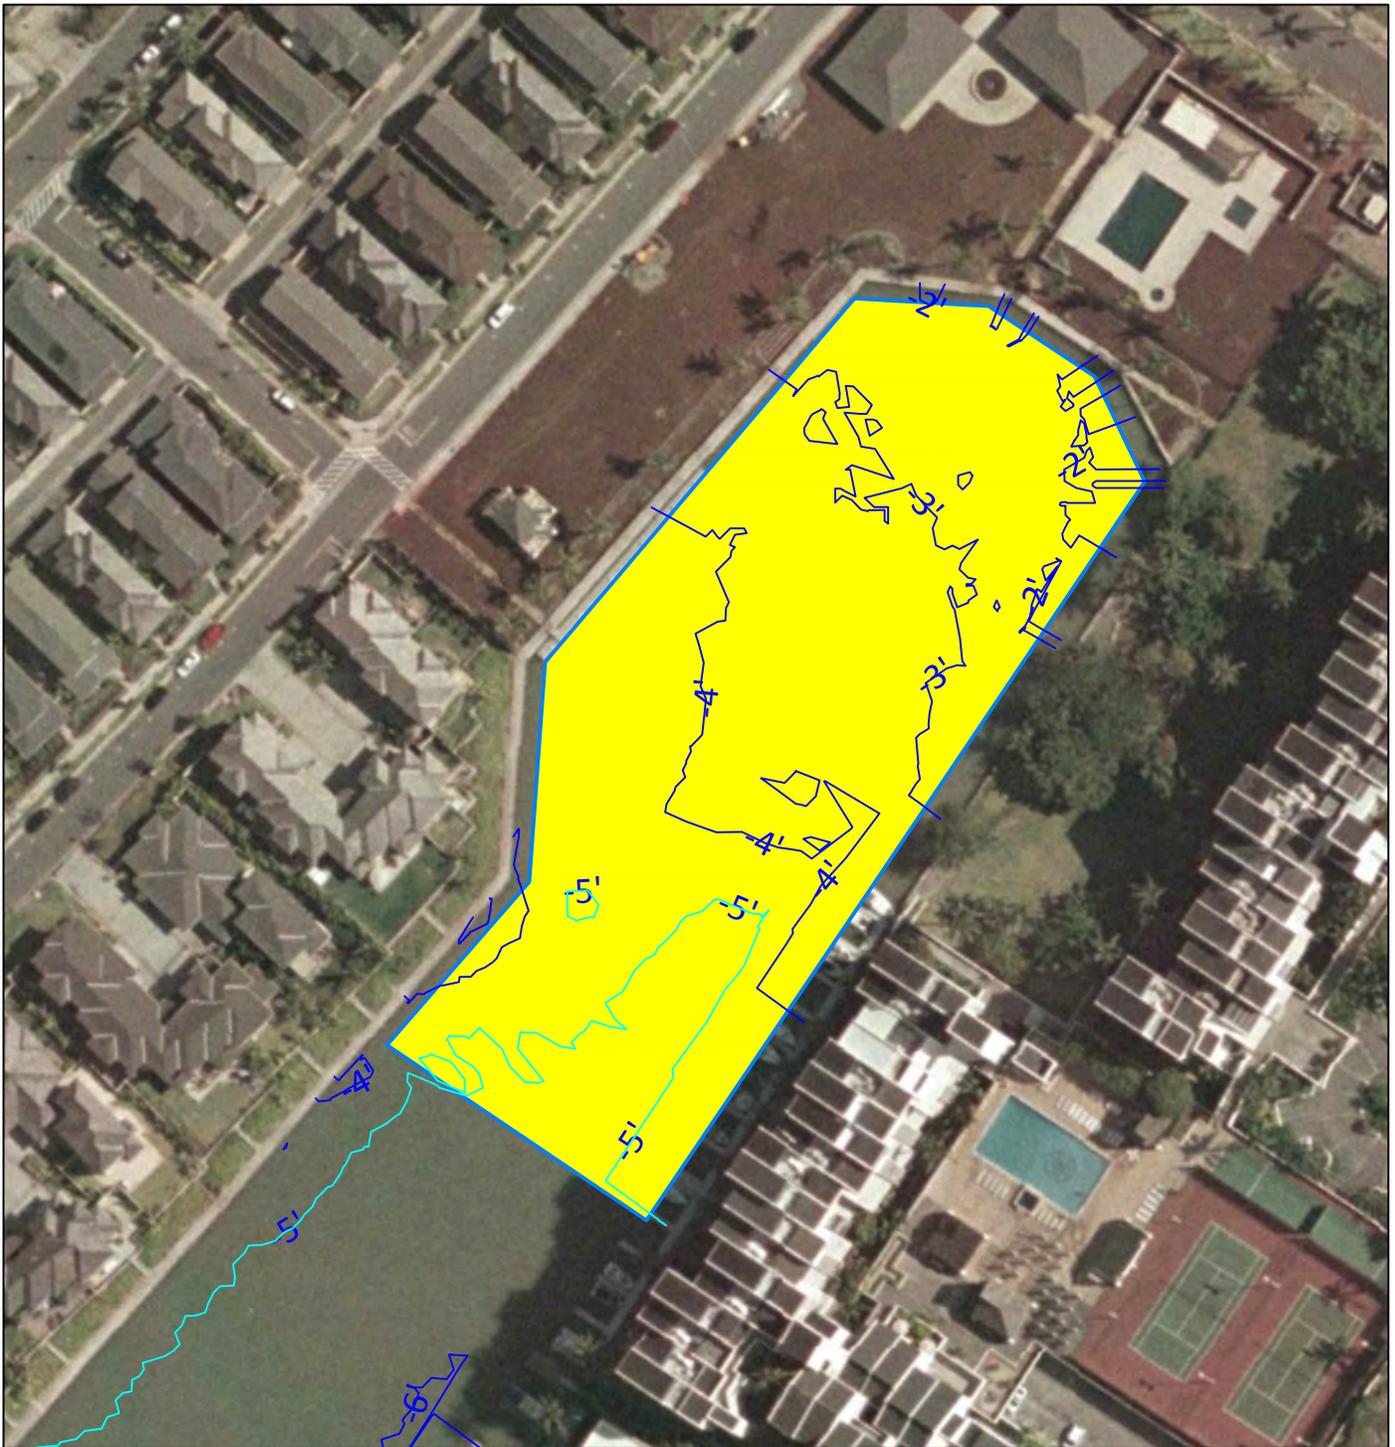
L:\AutoCAD Project Files\080520-Hawaii Kai Marina\08052001\Permitting\08052001-RP-004-Dredge Areas.dwg Figure 7

**SOURCE:** Drawing prepared from GIS files from the City of Honolulu and bathymetric survey performed by Northwest Maritime Industrial in January 2009.  
**HORIZONTAL DATUM:** Hawaii State Plane 3, NAD 83 HARN.  
**VERTICAL DATUM:** mean lower low water (MLLW).

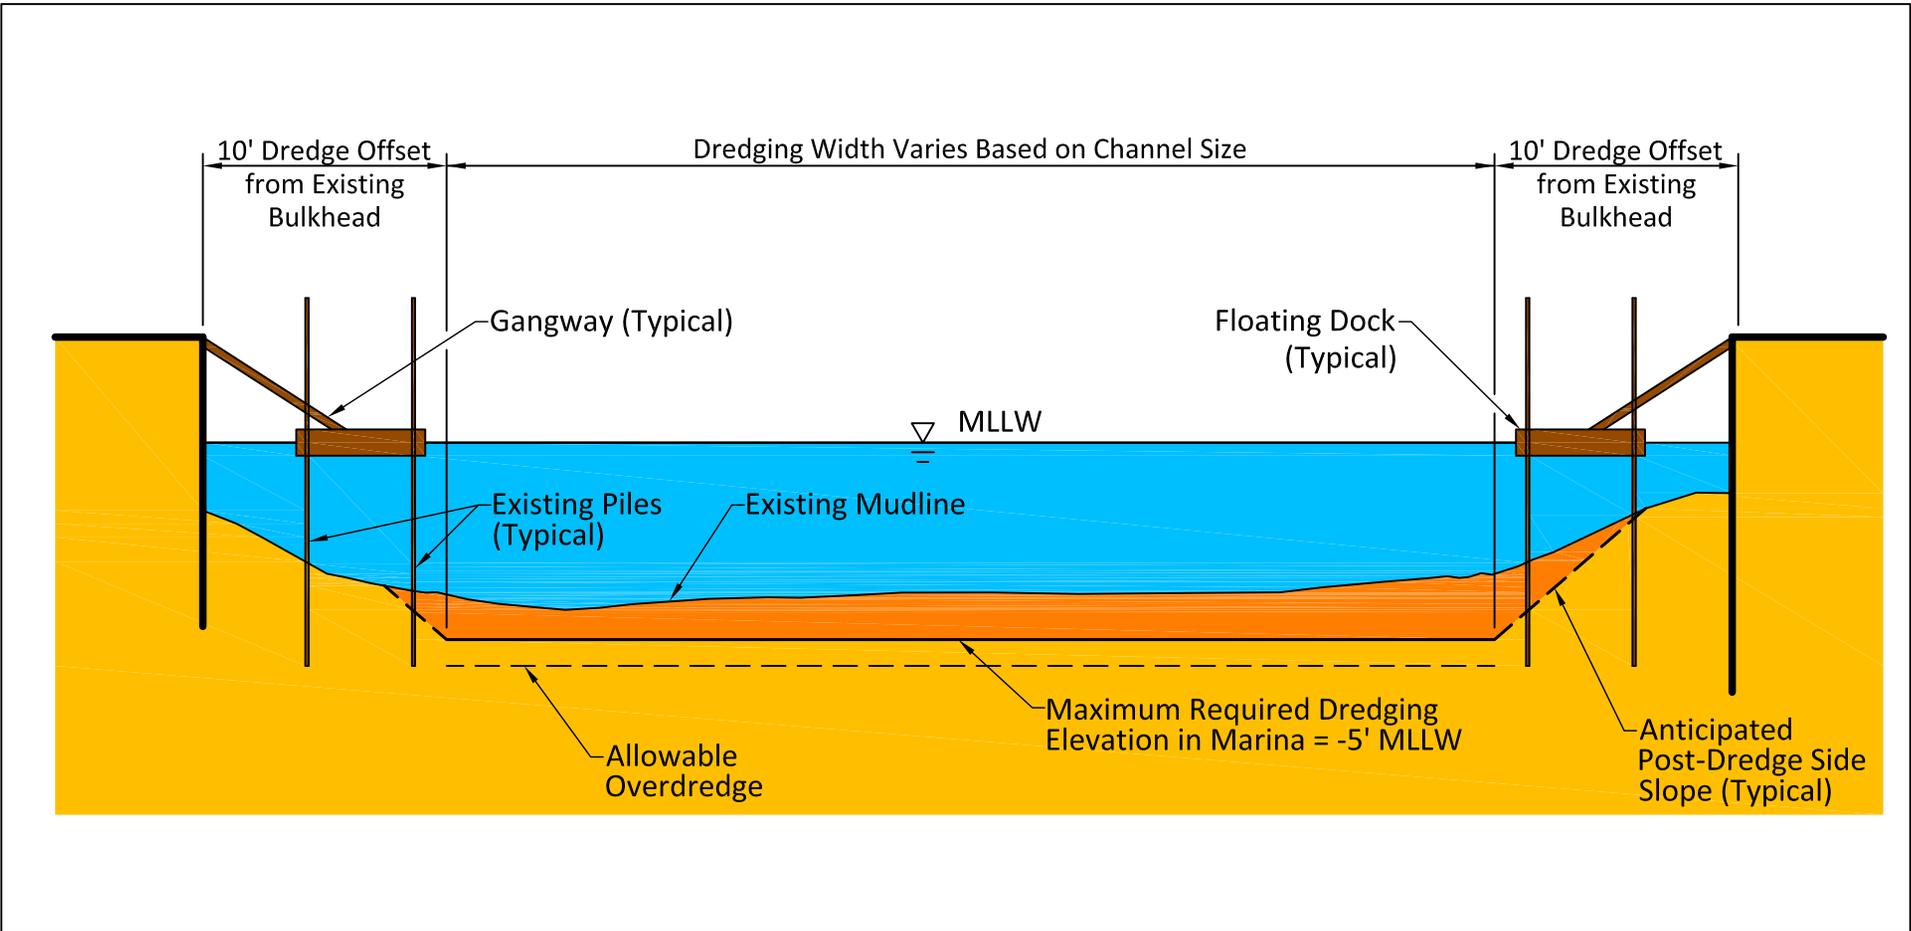
L:\AutoCAD Project Files\080520-Hawaii Kai Marina\08052001\Permitting\08052001-RP-008-Marina Cross Section and Yacht Club.dwg Figure 8

**VERTICAL DATUM:** mean lower low water (MLLW).

**Figure 8**  
Marina Dredging - Typical Cross Section  
Hawaii Kai Marina and Entrance Channel Maintenance Dredging
