## HAWAII KAI MARINA AND ENTRANCE CHANNEL MAINTENANCE DREDGING

**FINAL ENVIRONMENTAL ASSESSMENT  
HAWAII KAI MARINA AND ENTRANCE  
CHANNEL MAINTENANCE DREDGING**

## PROJECT SUMMARY

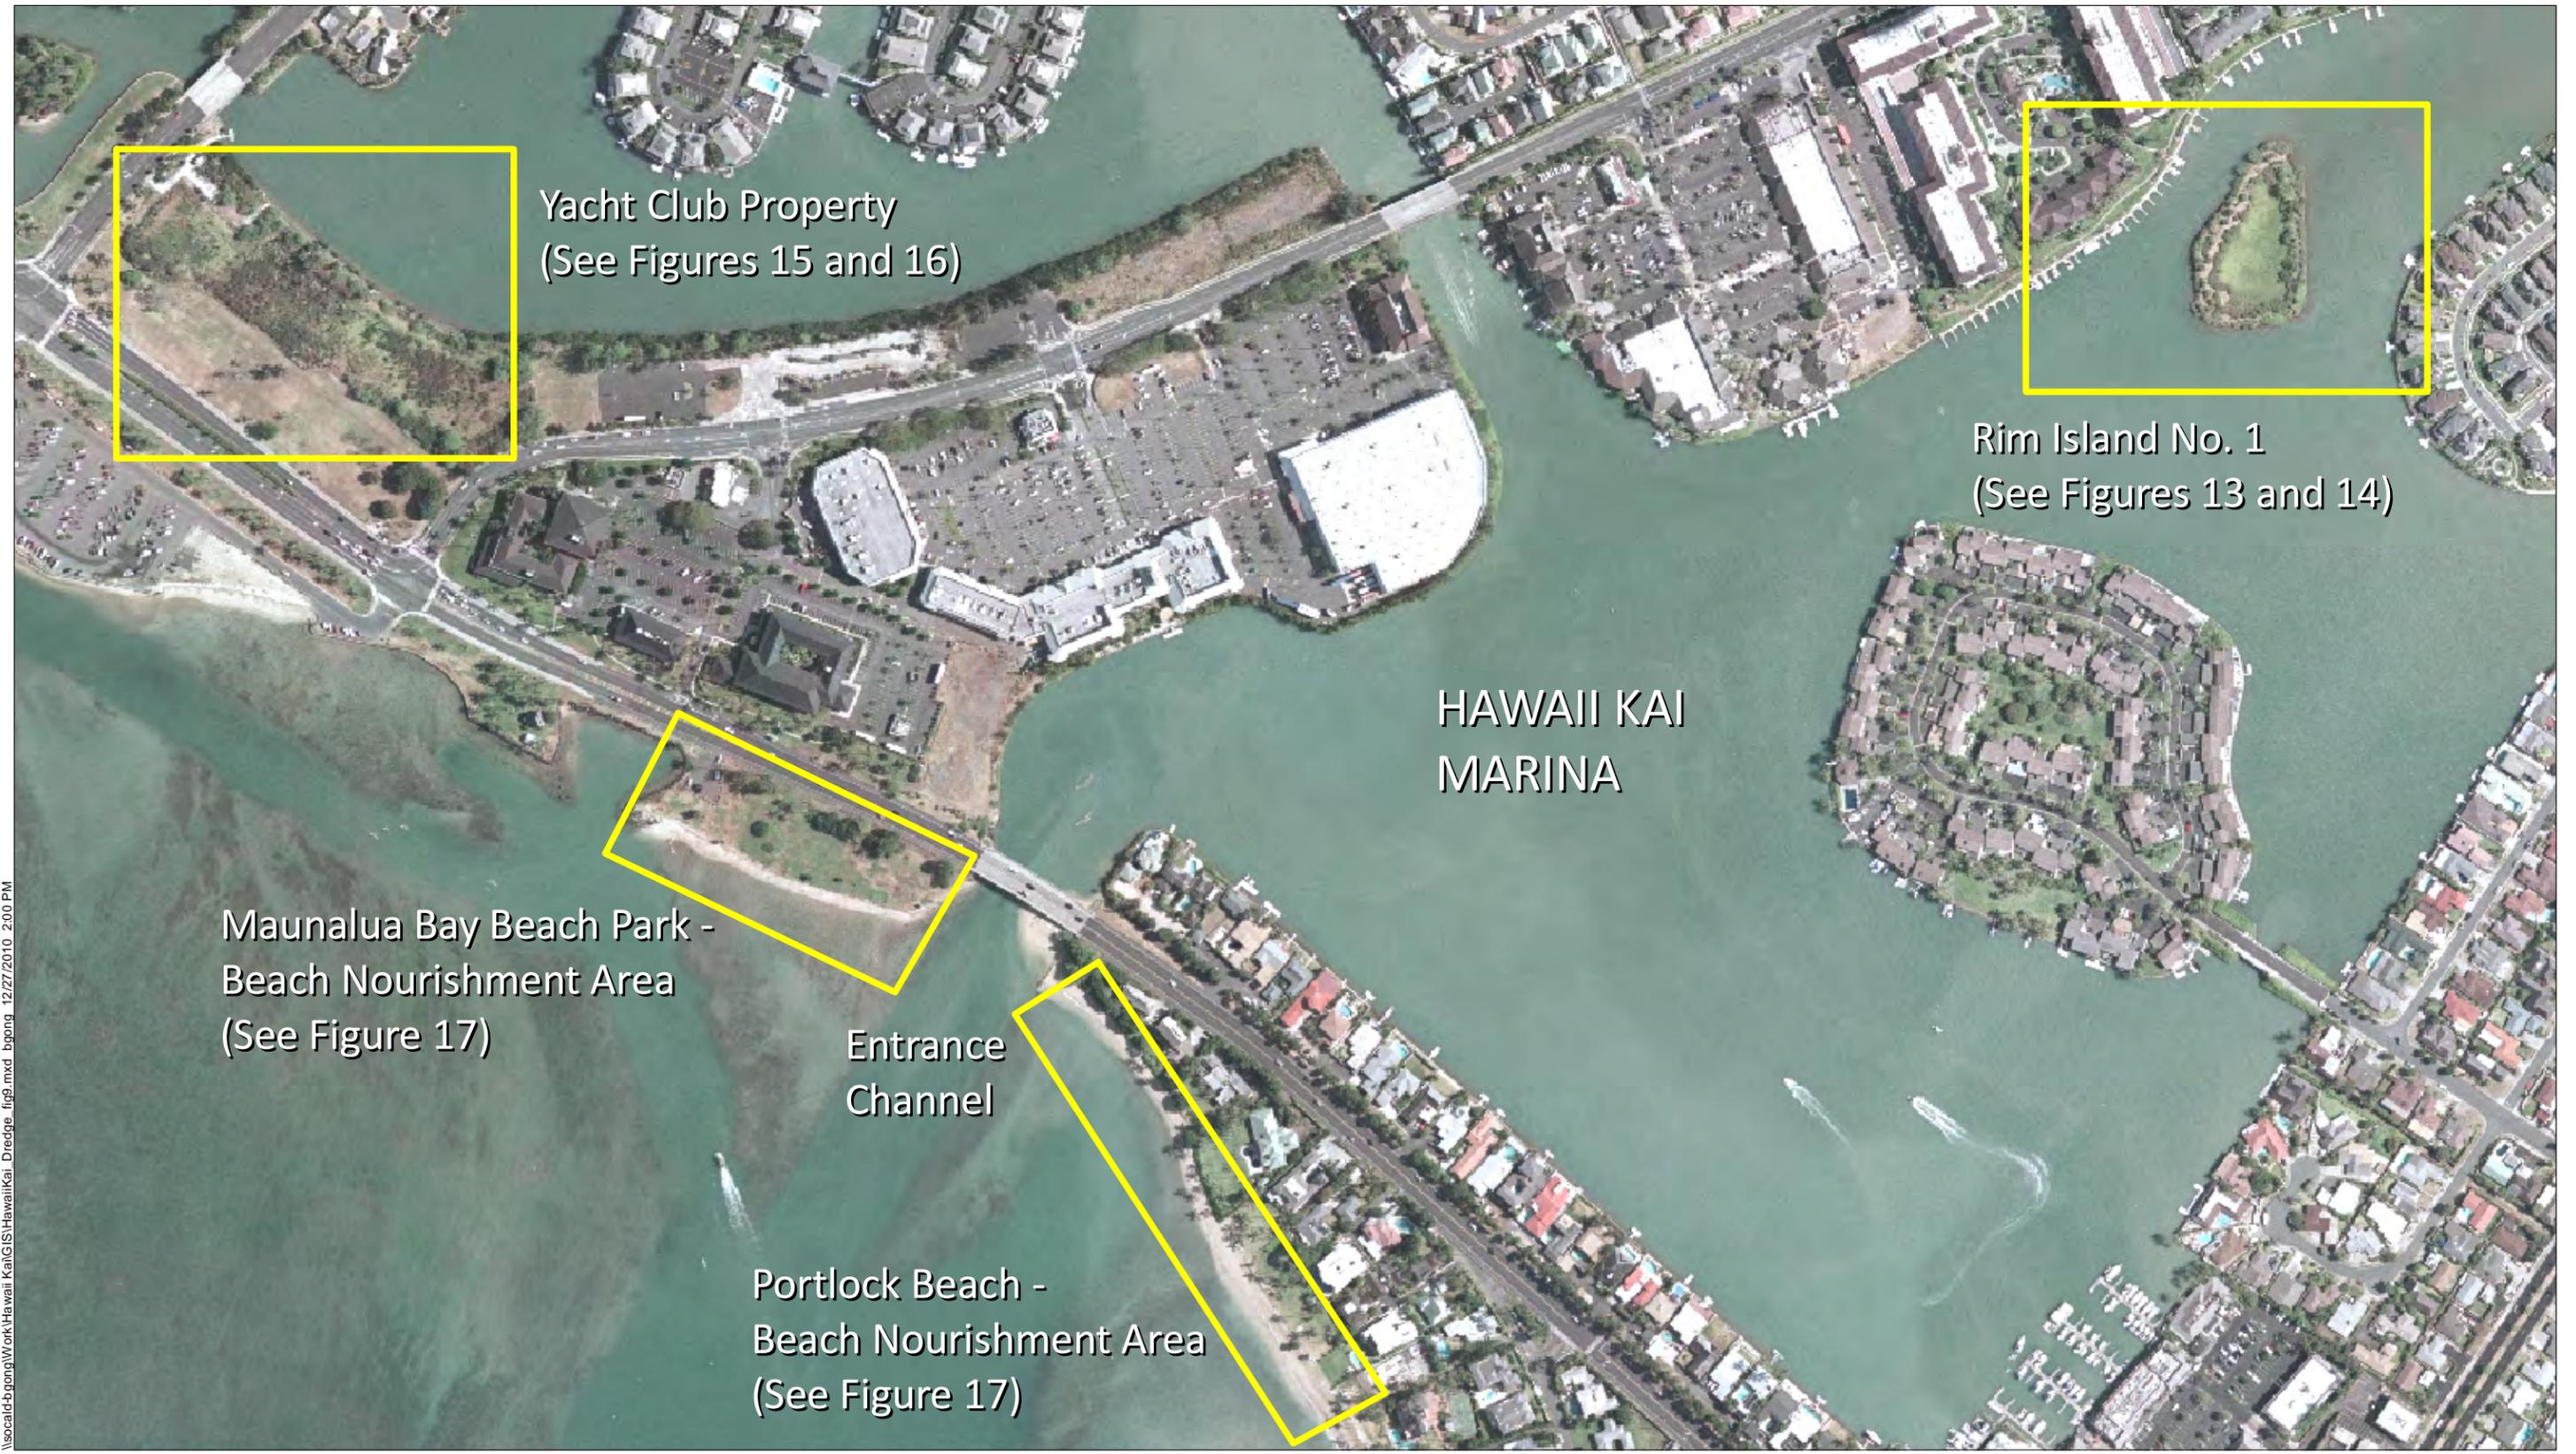
Yacht Club Property  
(See Figures 15 and 16)

Rim Island No. 1  
(See Figures 13 and 14)

Maunaloa Bay Beach Park -  
Beach Nourishment Area  
(See Figure 17)

Portlock Beach -  
Beach Nourishment Area  
(See Figure 17)

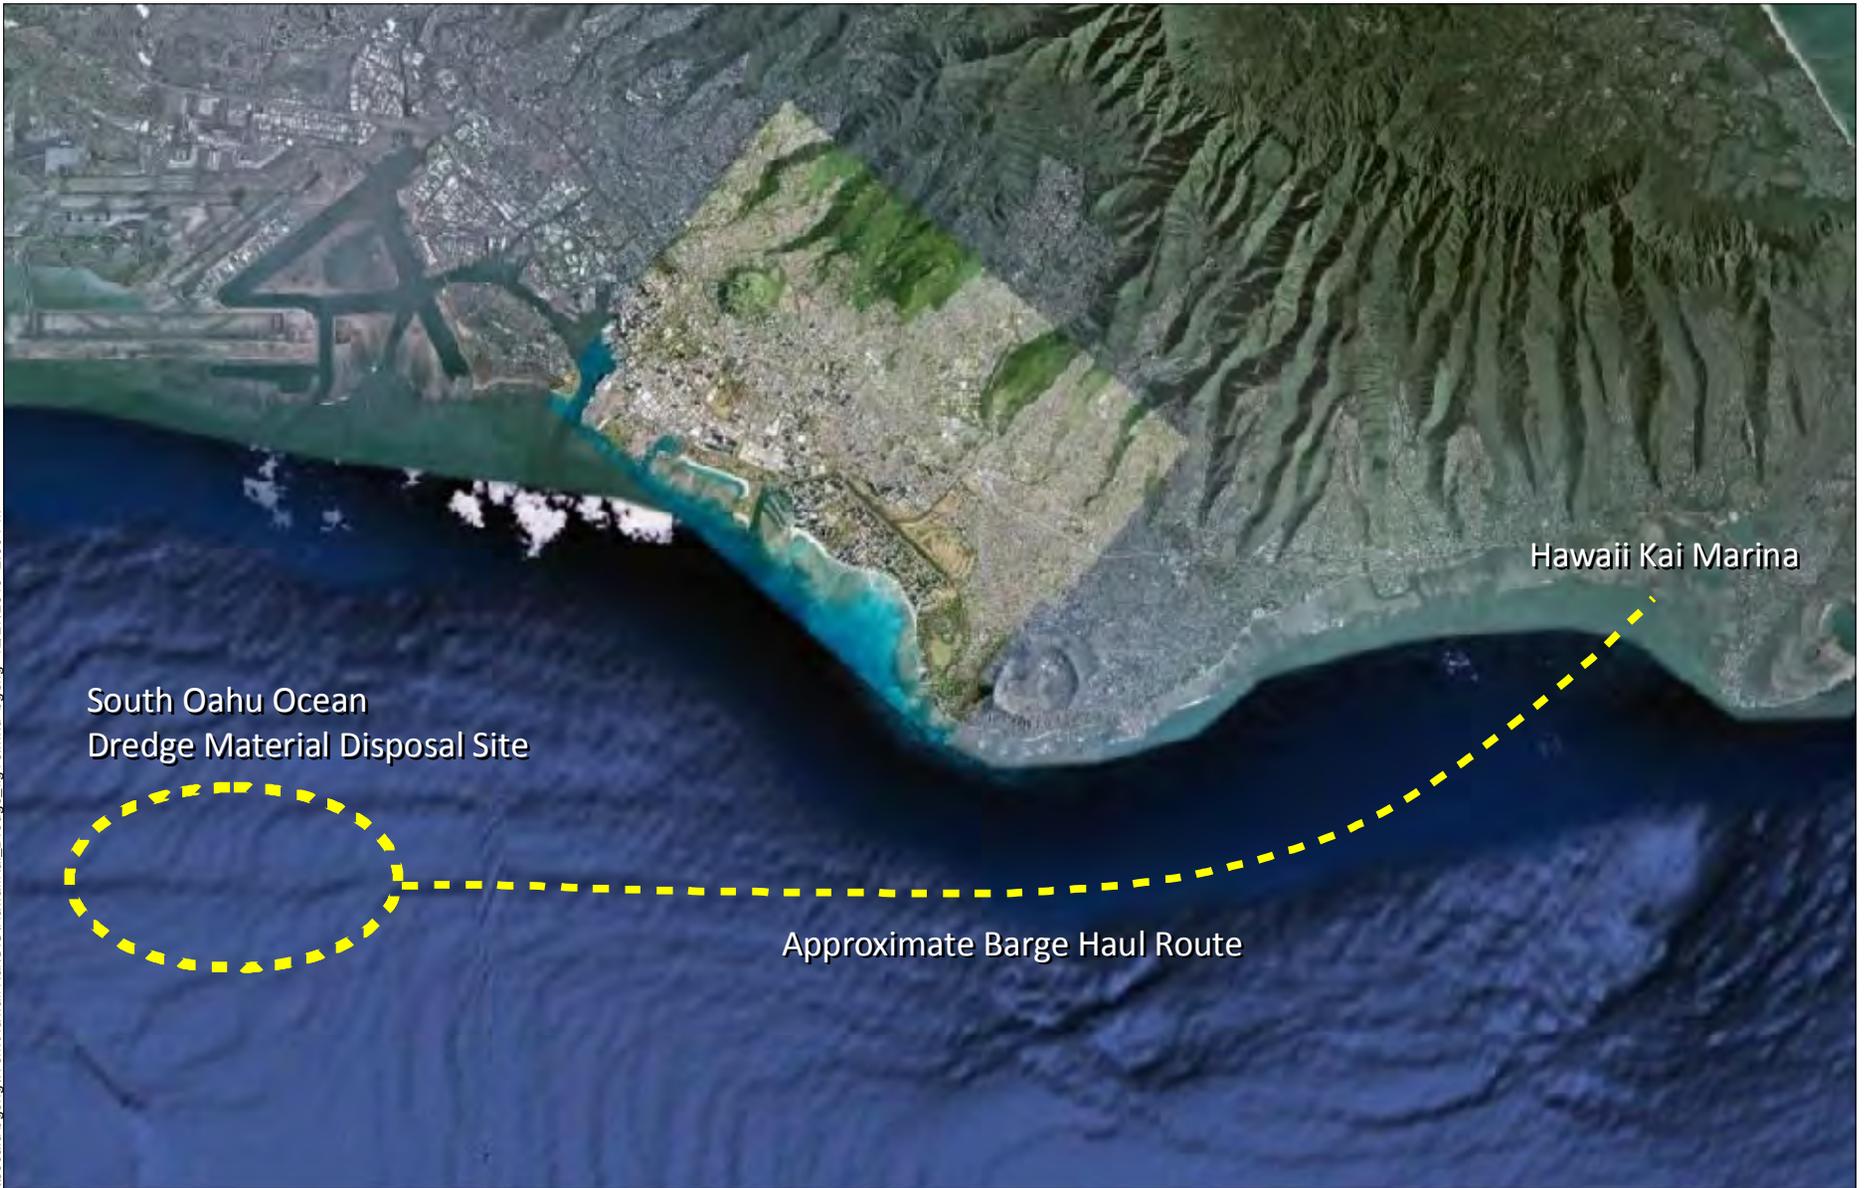
**Figure 10**  
Approximate Location of South Oahu Ocean Dredged Material Disposal Site  
Hawaii Kai Marina and Entrance Channel Maintenance Dredging

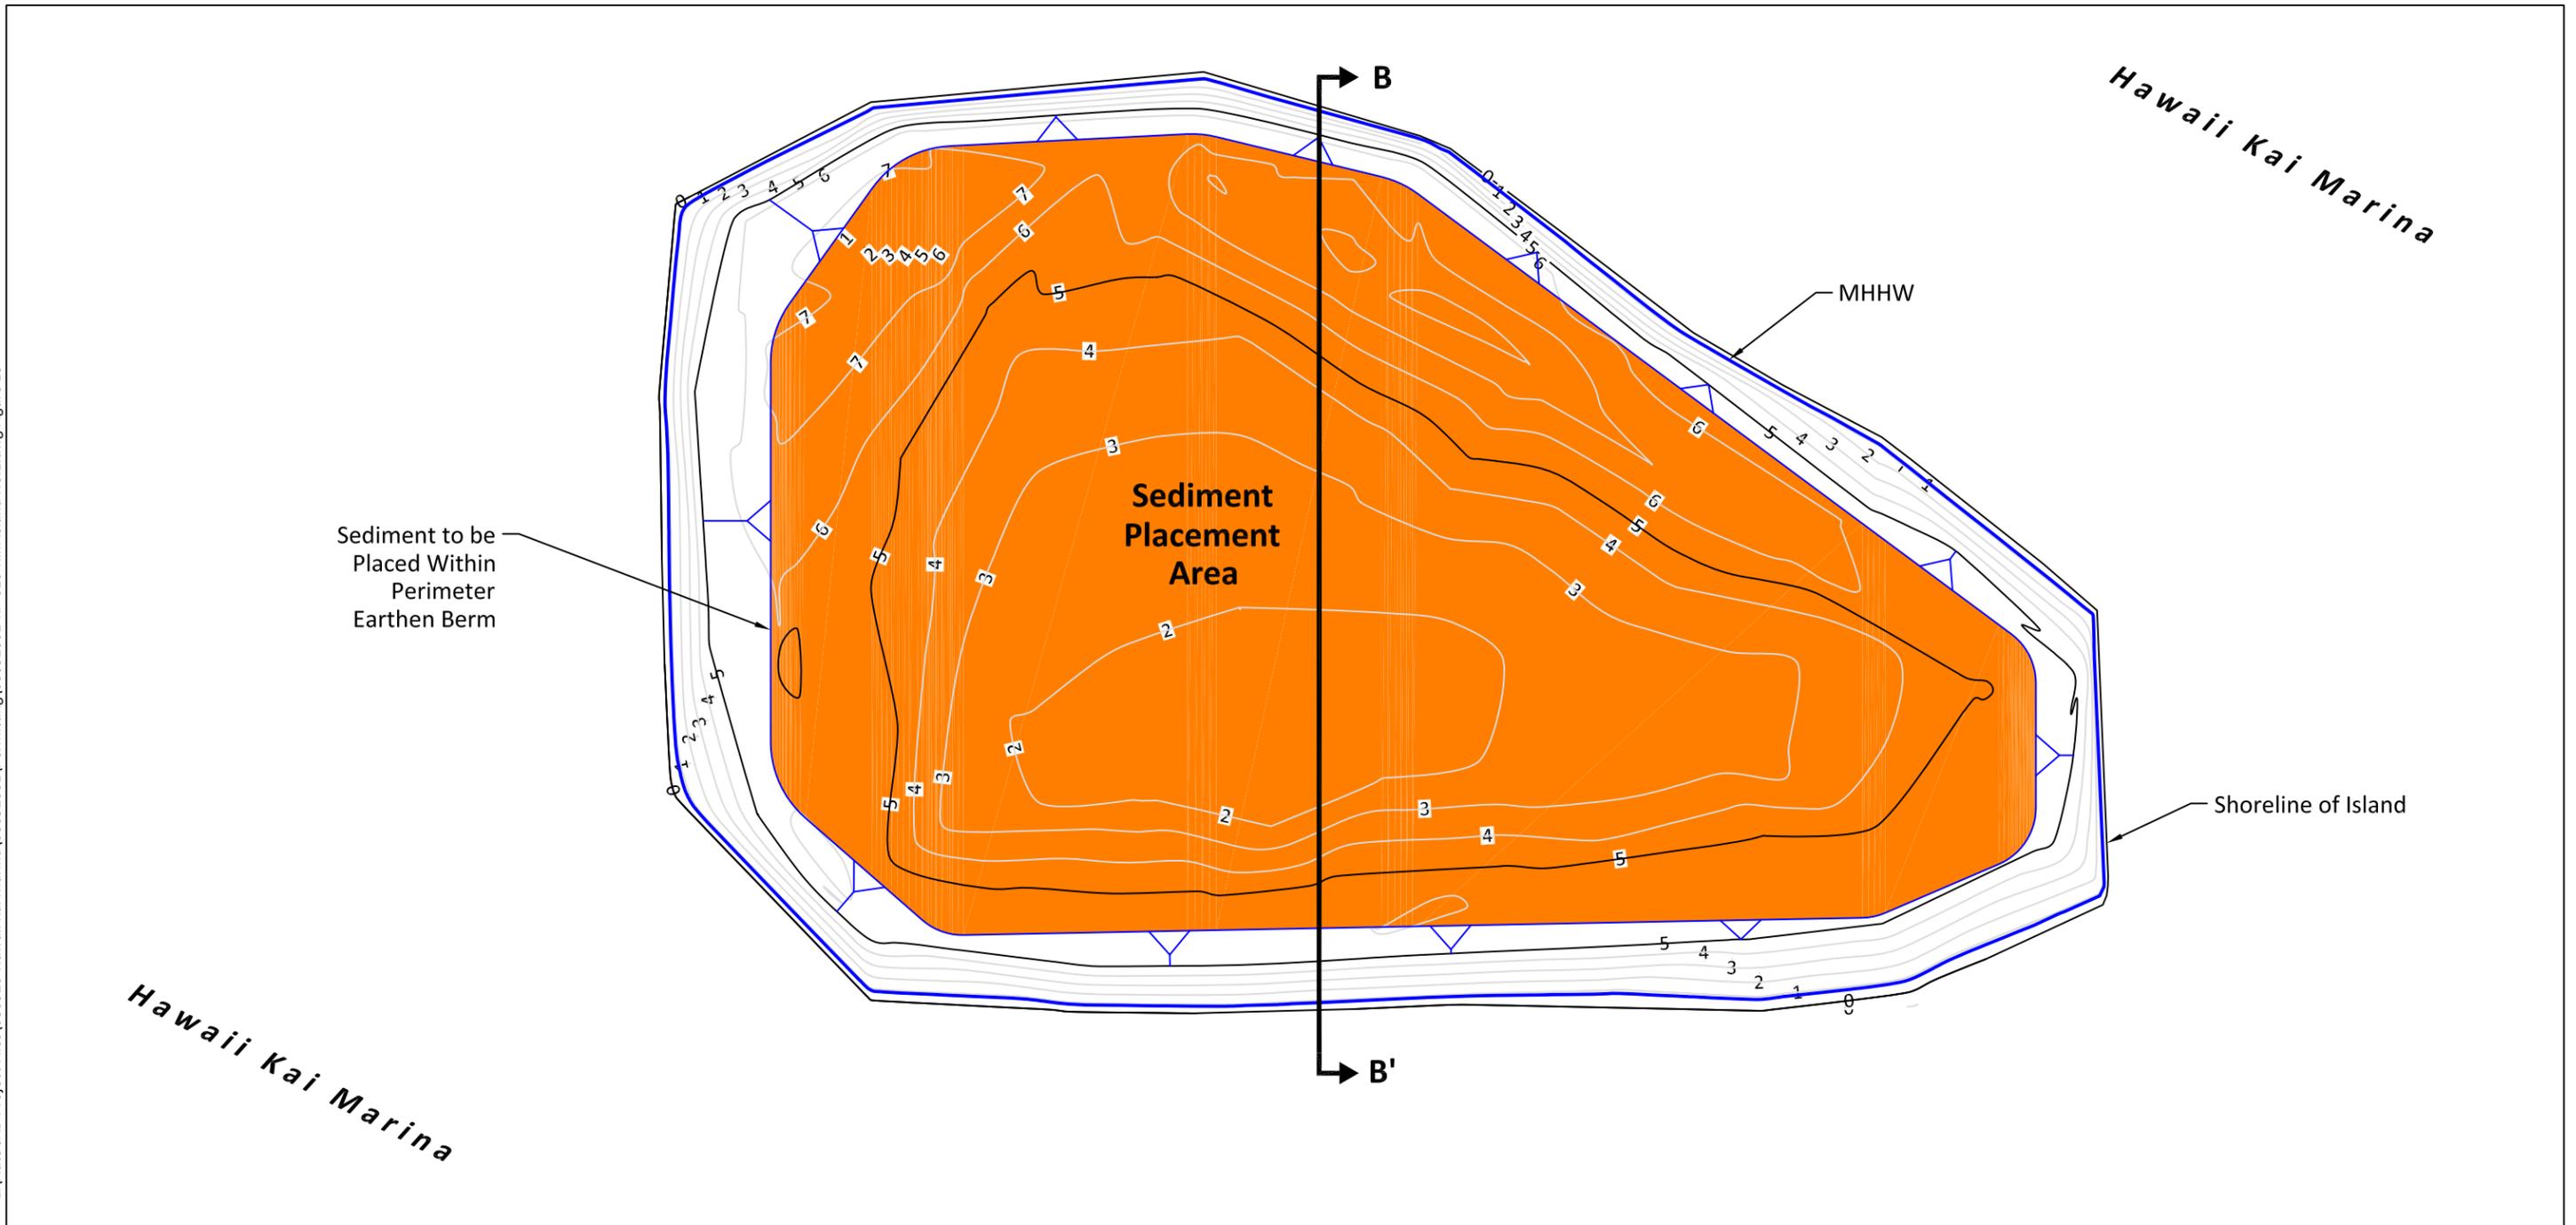
L:\AutoCAD Project Files\080520-Hawaii Kai Marina\08052001-Permitting\08052001-RP-013-Rim Island No.1.dwg Figure 13

**SOURCE:** Drawing prepared from Austin, Tsutsumi & Associates, Inc., file named, "09-15.dwg" dated March 23, 2009.  
**HORIZONTAL DATUM:** All azimuths are referred to Government Survey Triangulation Station "KOKO HEAD3."  
**VERTICAL DATUM:** Elevations referred to Benchmark L-11, (Elev. = 16.00) mean sea level (MSL).

**NOTES:**  
 1. MHHW determination (+0.82' MSL) based on NOS Station 1612340 (Honolulu) for the 1983-2001 tidal epoch.

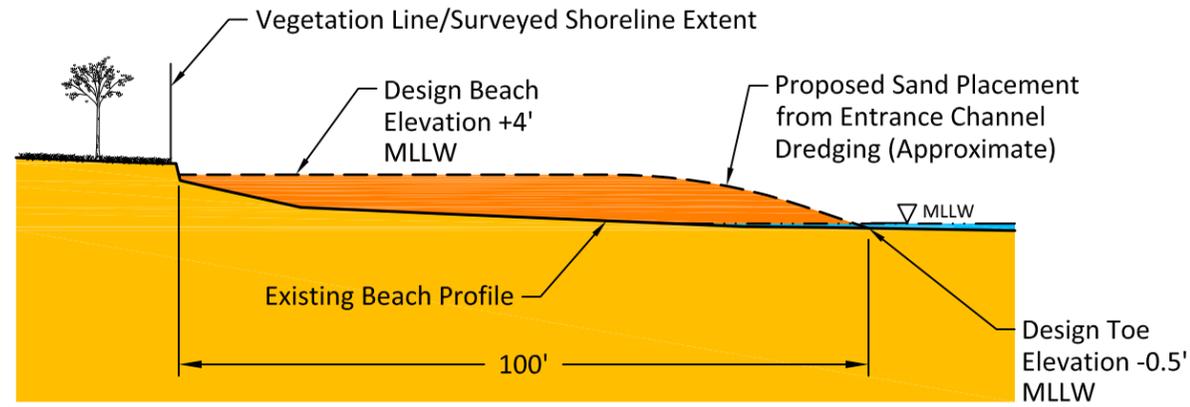
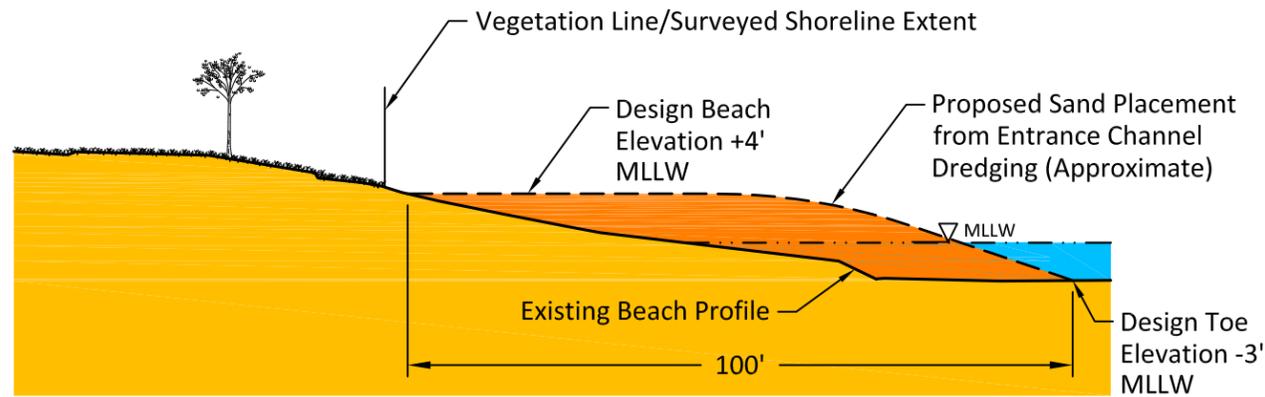
L:\AutoCAD Project Files\080520-Hawaii Kai Marina\08052001\Permitting\08052001-RP-017-Beach Nourishment Sectionst.dwg Figure 17

**Maunalua Bay Beach Park (Typical)**

**Portlock Beach (Typical)**

**HORIZONTAL DATUM:** Hawaii State Plane, Zone 3, NAD83 HARN.  
**VERTICAL DATUM:** mean lower low water (MLLW).

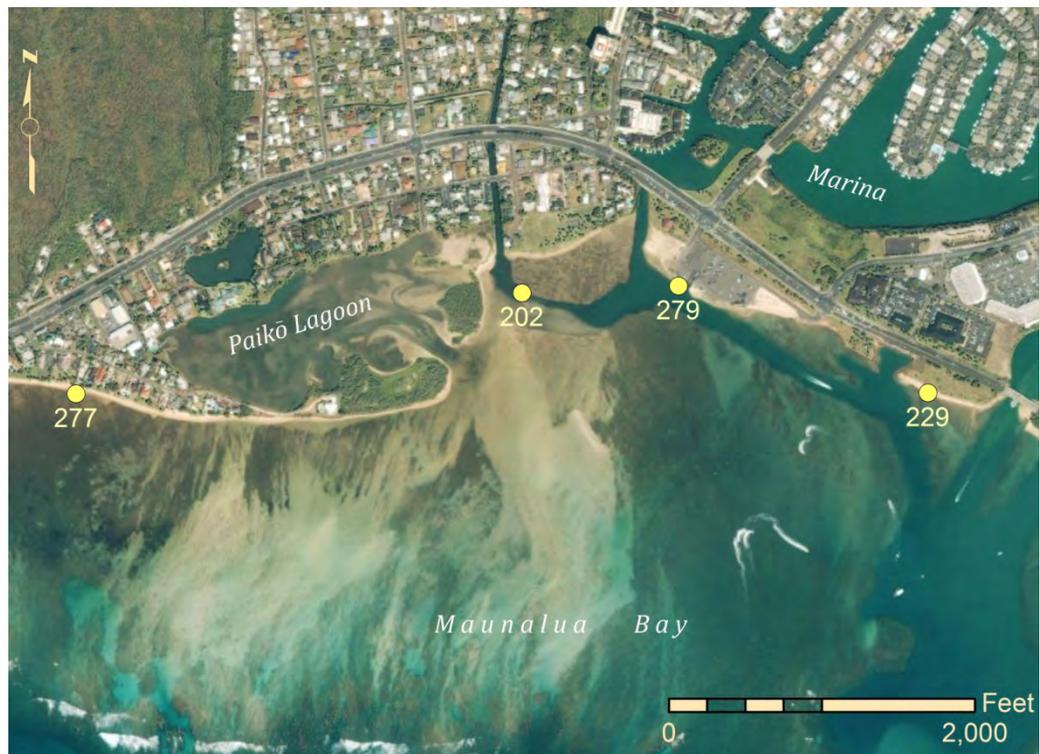
Figure 3. Satellite image showing approximate locations of HDOH nearshore water quality sampling stations in Maunalua Bay near Hawai'i Kai Marina (USEPA, 2009).

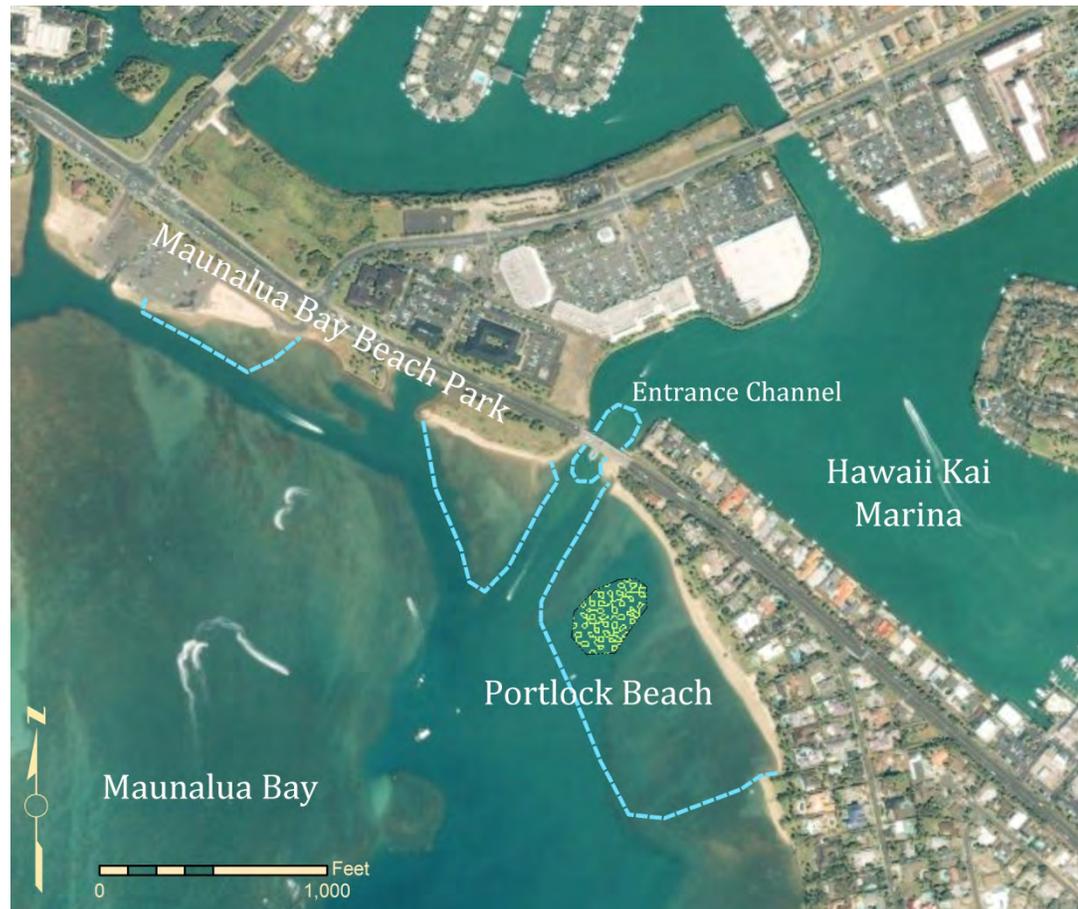
Figure 4. Areas surveyed (outlined by blue dashed lines) in channel and on nearshore reef remnant November 2007 and October 2009; approximate area of seagrass bed (green) off Portlock Beach also shown.

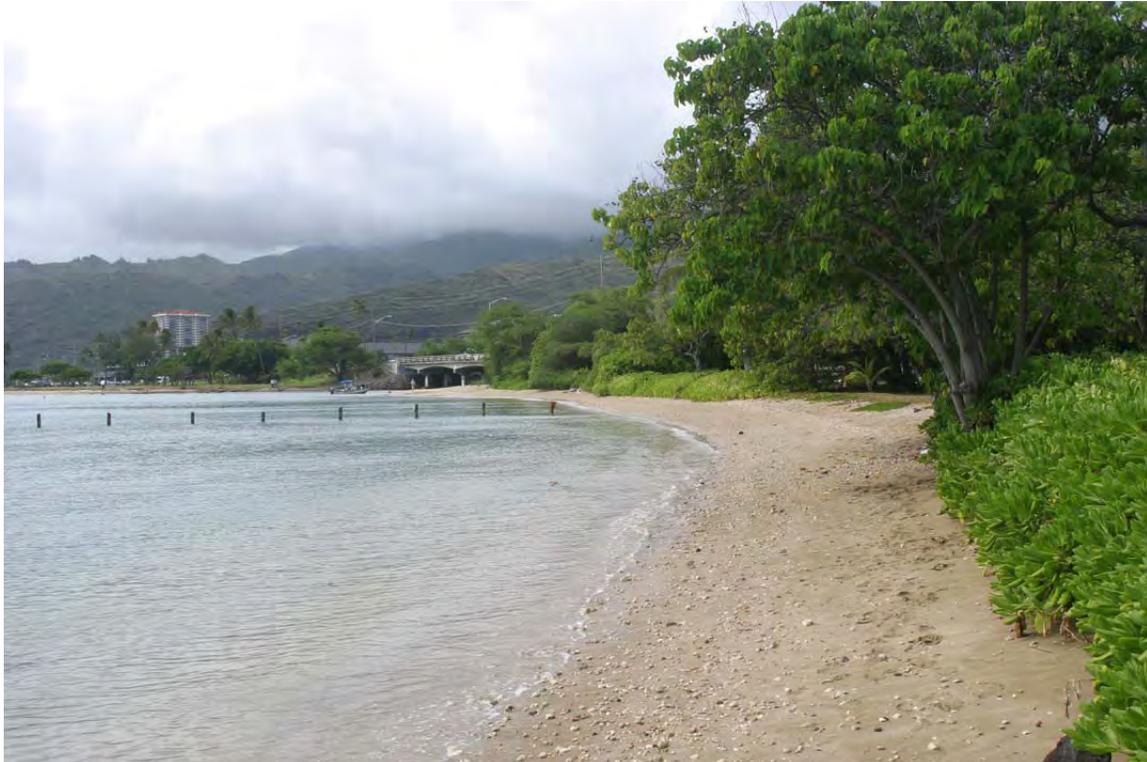
Figure 5. Portlock Beach looking northwest towards the main entrance channel to the Hawaii Kai Marina (under highway bridge).

According to WOA (1988), when Kalaniana'ole Highway was built in the late 1930s, the main entrance channel from Kuapā Pond to Maunalua Bay was widened to 12 m (40 ft) and another channel to the west arm of the marina constructed to provide better water exchange. The entrance channel was built at a natural break in the reef, probably a drainage channel for the brackish water of Kuapā Pond initially formed during a lower stand of the sea (AECOS, 1979). The entrance channel was again dredged in the 1940s to facilitate landing craft operations and to service the military installation during World War II. As part of the development of the Hawai'i Kai community, the entrance channel was widened to 76 m (250 ft) and dredged to 1.9 m (6.2 ft) to accommodate potential runoff from a 100-year storm (PODCO Permit 820D issued 04/14/67). At that time, an access channel from Kuli'ou'ou Stream to the entrance channel was dredged parallel to the shore and the second channel to the west arm of the marina was dredged. The material from this dredging project was used to construct Maunalua Bay Beach Park and the boat launching area. Since the 1960s, the entrance channel has largely filled in and, despite

maintenance dredging once every ten years, now more closely resembles the 12 m- (40 ft-) wide channel that was first created in the 1930s.

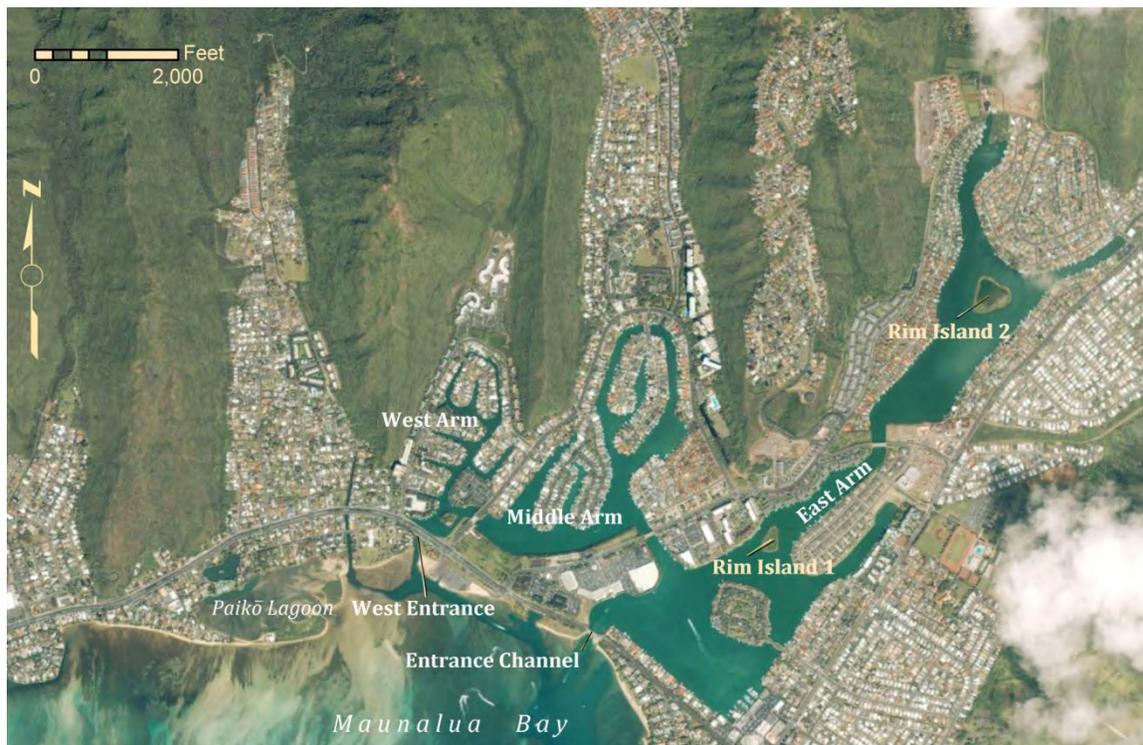
Figure 6. Satellite photograph of Hawai'i Kai Marina and environs showing the three arms, two rim islands, and two channel openings to Maunalua Bay.

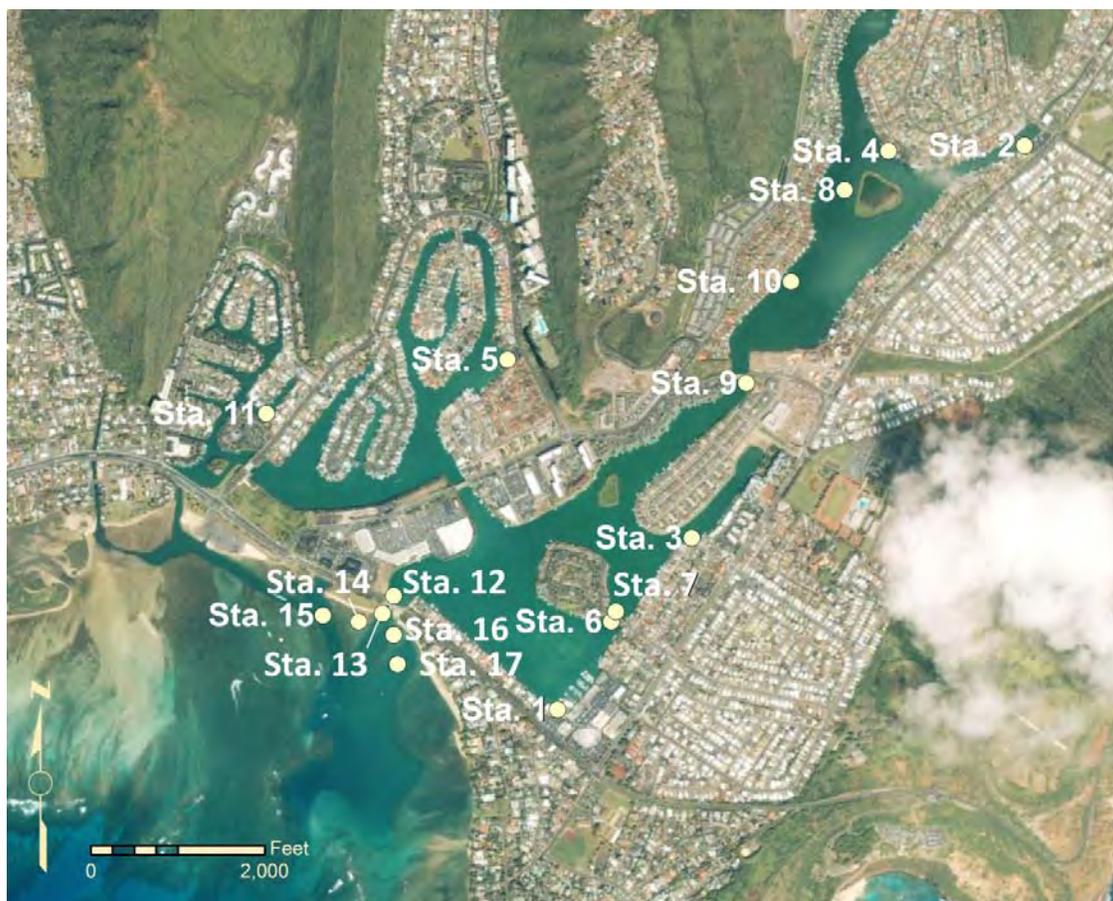
Figure 7. Locations of water quality stations, November 13, 2007 sampling event.

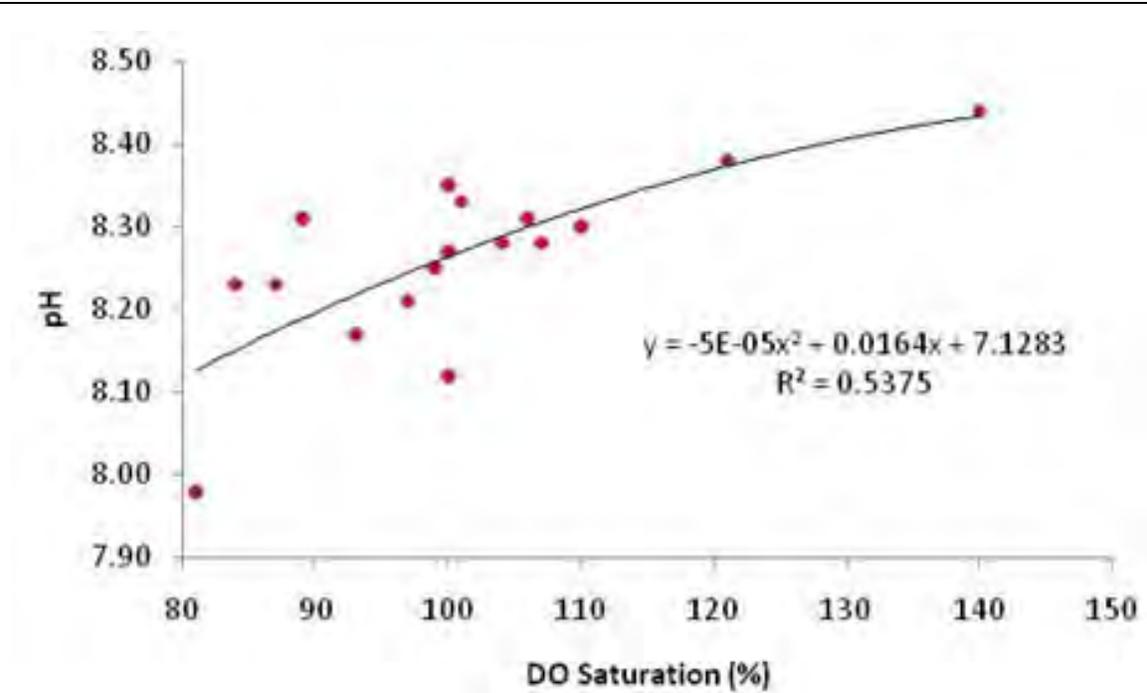
Figure 8. Trend showing correlation between increasing pH and DO for the November 13, 2007 sampling event.

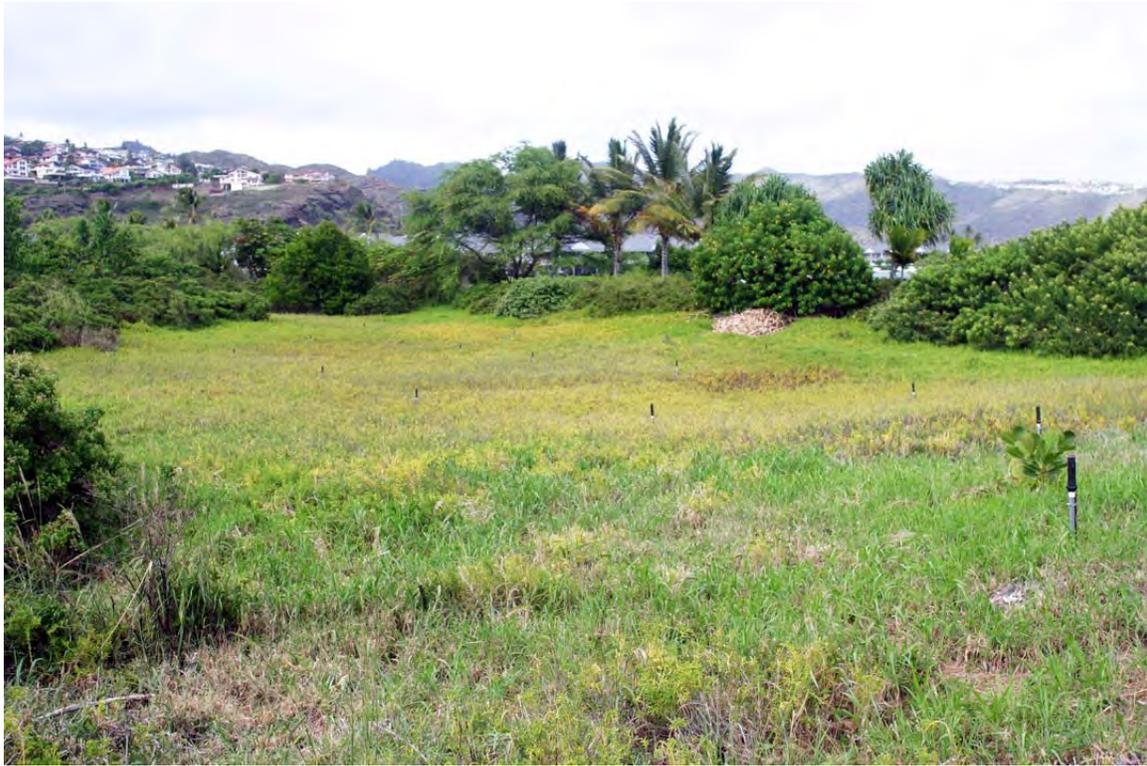
Figure 9. Central part of Rim Island 1 (note sprinkler heads) supporting yellowish-green *Batis* in low areas.

Rim Island 1 was originally created by stockpiling dredged material from the surrounding marina. The island initially consisted of a berm surrounding an interior depression, but the depression was partially filled in with dredged material in 1995 and 1996. The central part of the islet remains a depression with pickleweed (*Batis maritima*; Fig. 9) and potentially a wetland. However, open, standing water is not present. The islet is maintained (including watering) as a picnic destination for marina users.

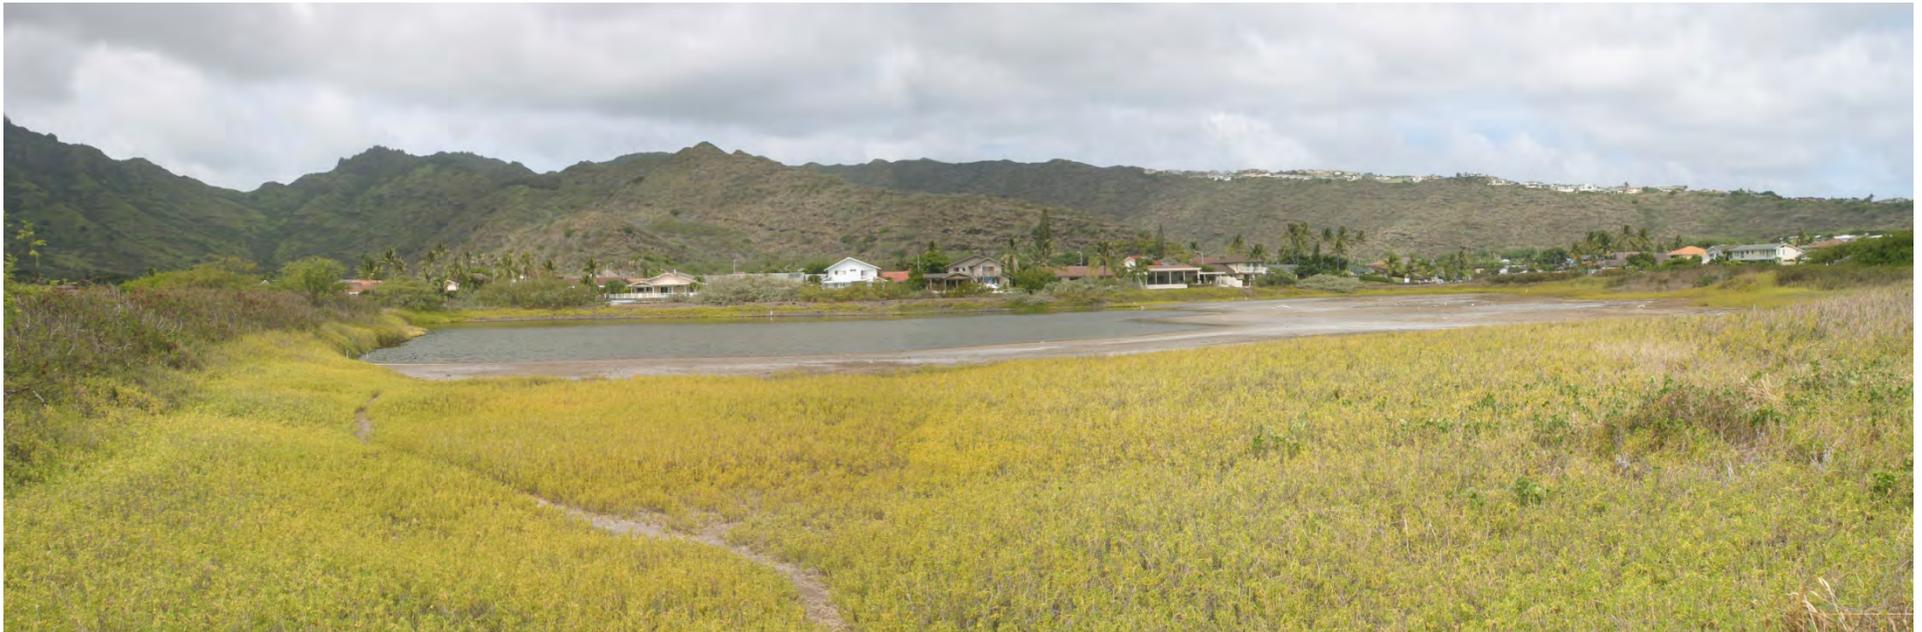
Figure 10. Rim Island 2 showing central depression with open water and mud flats. Houses behind are separated by marina waters beyond the rim at far sides of pond.

Rim Island 2 was created by stockpiling dredged material from the surrounding marina. The perimeter of the island is a berm some 2 m (6 ft) high, which surrounds a depression that is near, and in places below, sea level and intermittently contains standing water in an open flat, surrounded by a pickleweed flat (Fig. 10).
