SUBJECT: Final Environmental Assessment (FEA)/Finding of No Significant Impact,
Conservation District Use Application OA-3589

The Department has reviewed Conservation District Use Application OA-3589 and the Final Environmental Assessment (FEA) for the proposed repairs of the Kainalu Seawall at Kaluahole, Waikiki, Honolulu, TMK (1) 3-1-033:001. The Draft Environmental Assessment (DEA) for CDUA OA-3589 was published in OEQC's May 8, 2011 *Environmental Notice*.

KAINALU APARTMENTS SHORELINE PROTECTION
 WAIKIKI-DIAMOND HEAD, OAHU, HAWAII
 TMK: (1) 3-1-033-001
TANIMURA & ASSOCIATES, INC.
 CONSULTING STRUCTURAL ENGINEERS
 925 Bethel Street, Suite 309 • Honolulu, Hawaii • 96813
 Phone (808) 536-7692 • Fax: (808) 537-9022

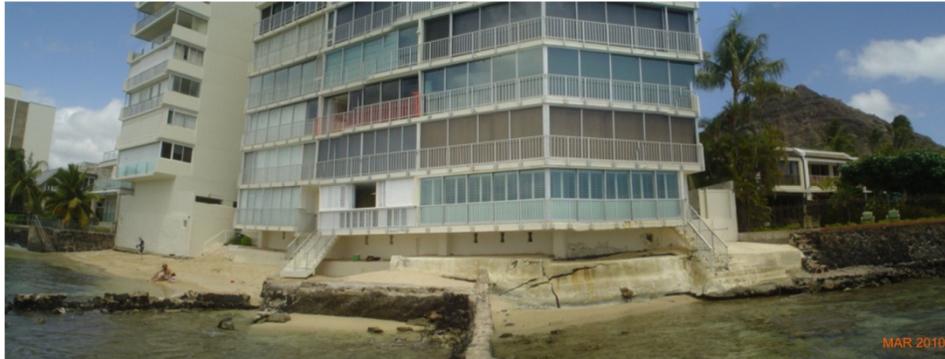
Figure 3. Shoreline Photos

Shoreline along Southern property boundary.

Eroded section in 2009 during high tide wave action.

The continued erosion of sand appears to be causing differential settling, which in turn, is causing the wall and gunite to crack and pull away from the apartment building. It is feared that if erosion continues, the wall will collapse and seawater inundation of the Kainalu support pilings may cause the building to become unstable and collapse.

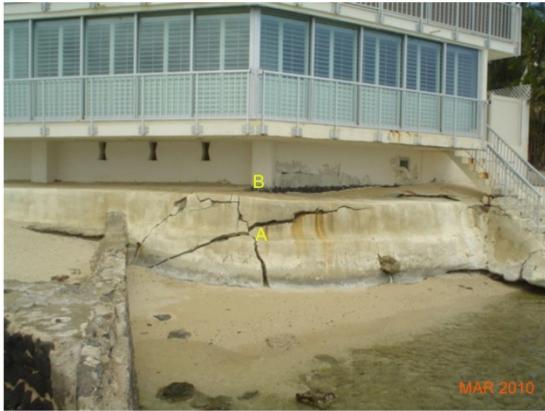
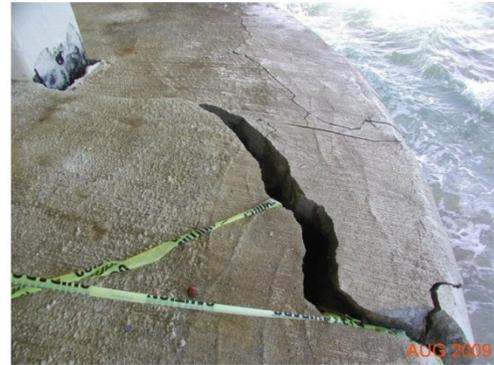
Figure 4. Photos of Wall Damage

Crack on top surface. Wall is hollow under surface.

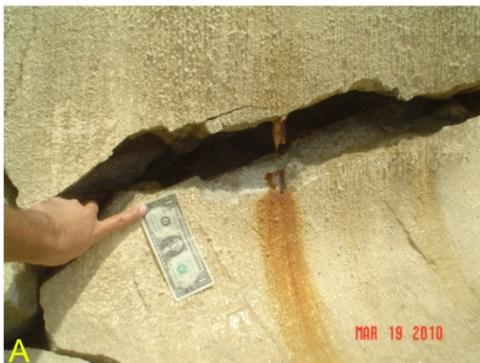
A Cracking in gunnite coating. Wall is hollow behind surface.

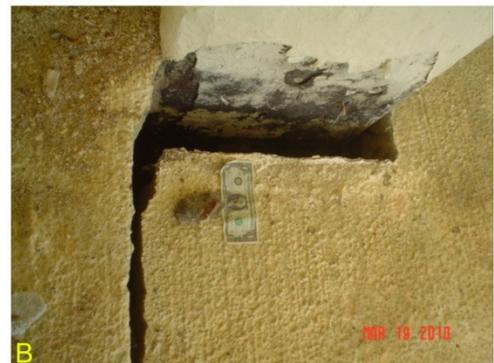
B Separation from building face.

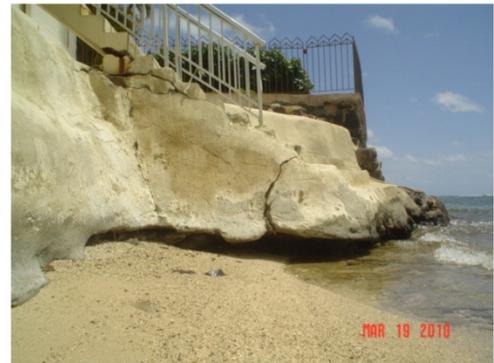
Erosion under encroaching section to be removed

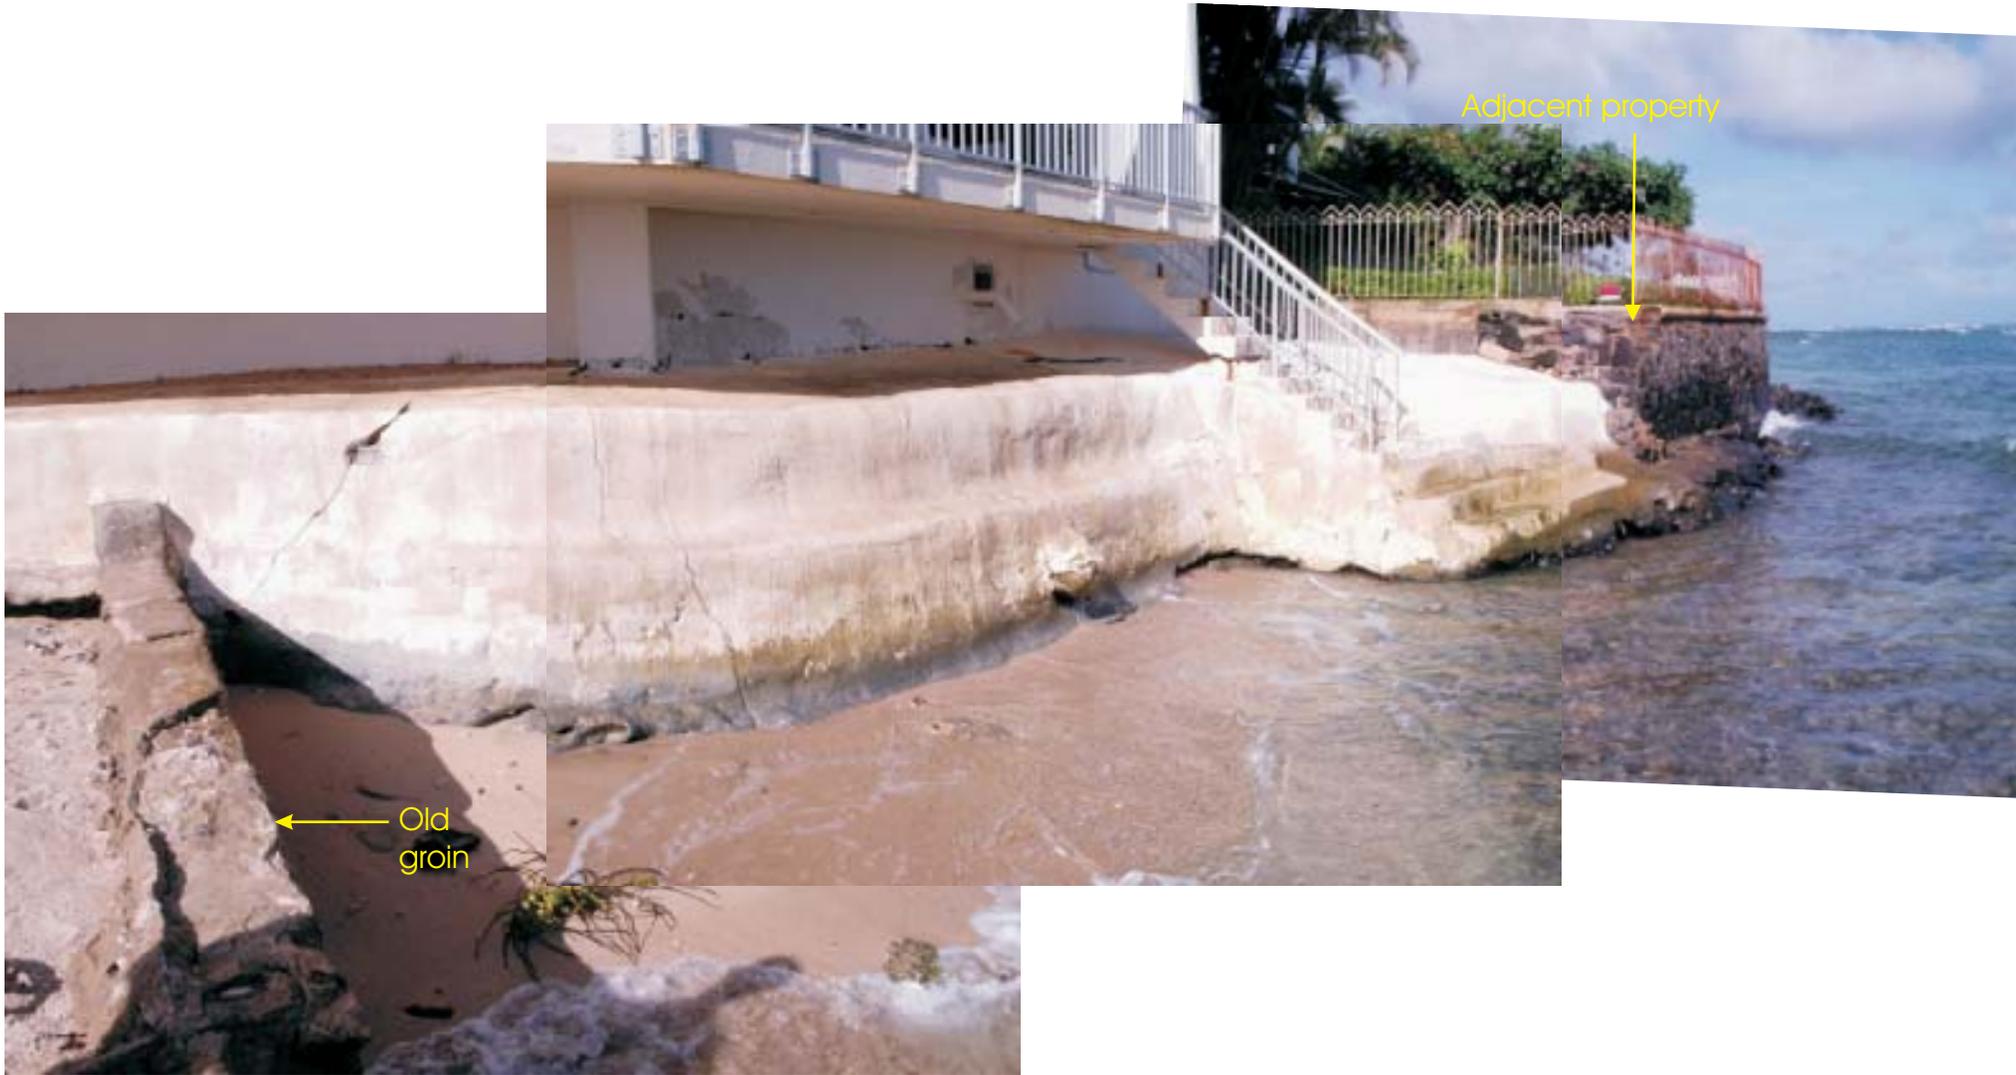
Property shorefront on south side of old groin. Gunitite covers old planter boxes adjacent to the building, formerly fronted by a narrow beach. Stairs lead to first floor apartment.

Portions of the gunite cap on the south side of the groins encroach into the shoreline area seaward of the property boundary. Therefore, the gunite cap must be removed to address this encroachment problem. The continuing erosion fronting this portion of the property is also causing the gunite to crack because of differential settlement of the planter box structure (Photo page-4). Major structural damage to this gunite-covered structure can result in a safety issue for the residents and the general public who access this popular shoreline area. The gunite-covered structure is also causing wave reflection and splash that enters the residential unit directly above.

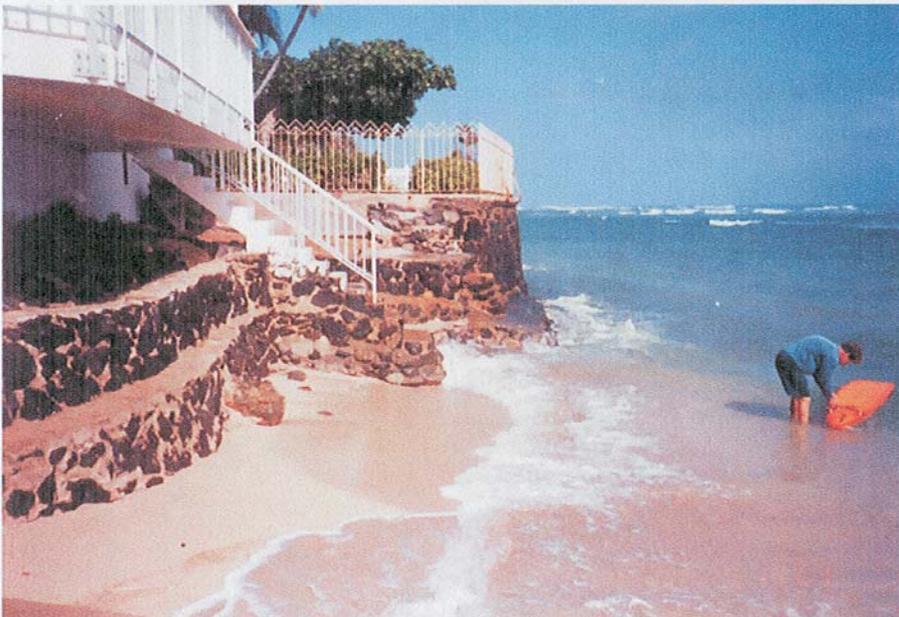
Eastern stairs - 1980

Eastern stairs - 2004

Photos showing the original rock masonry planter boxes and stairs prior to encapsulation by gunite.

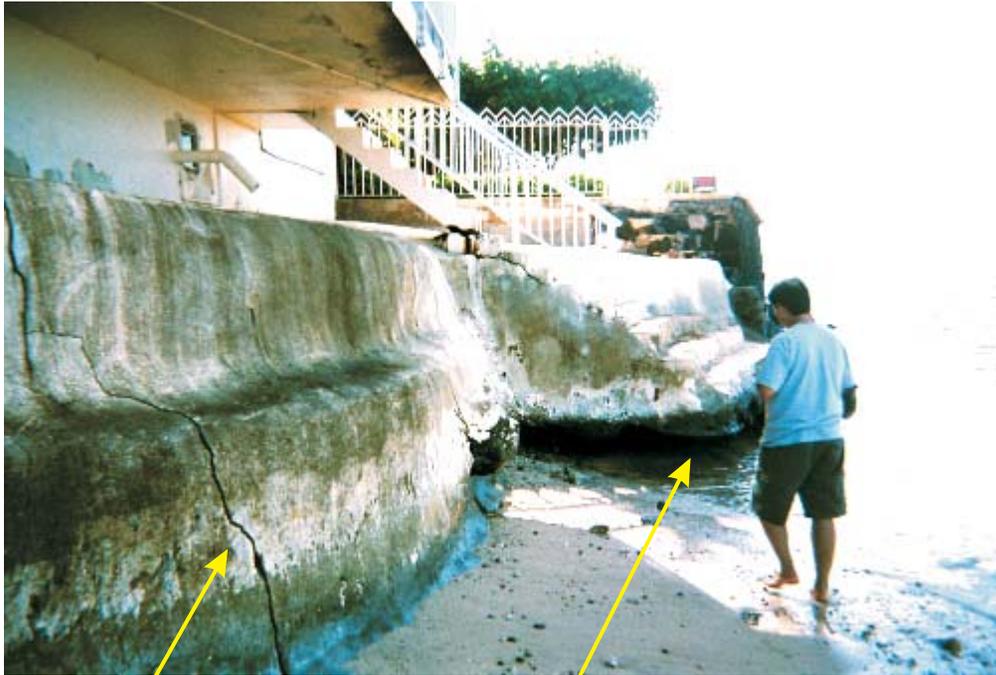
Erosion of the remaining sand covering the reef flat fronting the building is causing continued damage to the gunite-covered structures. There is presently a scoured gap between the limestone reef and the base of the gunited stairs, and large cracks are developing in the gunite surface covering the planter boxes due to differential settlement.

Cracks in gunite
