Subject: Rock Slide Potential Inspection and Mitigative Improvements
Along Round Top Drive in the Vicinity of Puu Ualakaa State Park
Draft Environmental Assessment for Round Top Drive Rockfall
Mitigation, Oahu, Hawaii

Project Name: Round Top Drive Rockfall Mitigation Project, Honolulu, O'ahu, Hawai'i

Applicable Law: HRS Chapter 343
Type of Document: Environmental Assessment
Island: Oahu
District: Honolulu

The City and County of Honolulu proposes the Rockfall Mitigation project to reduce the potential for rockfall hazards on state lands adjacent to Round Top Drive by implementation of slope stabilization measures. The existing slope has a multitude of potentially hazardous rocks, creating a high potential for rockfalls and landslides to reach the roadway. Rockfall mitigation and slope stabilization measures are needed to reduce these identified risks to public health and safety for users of the road corridor.

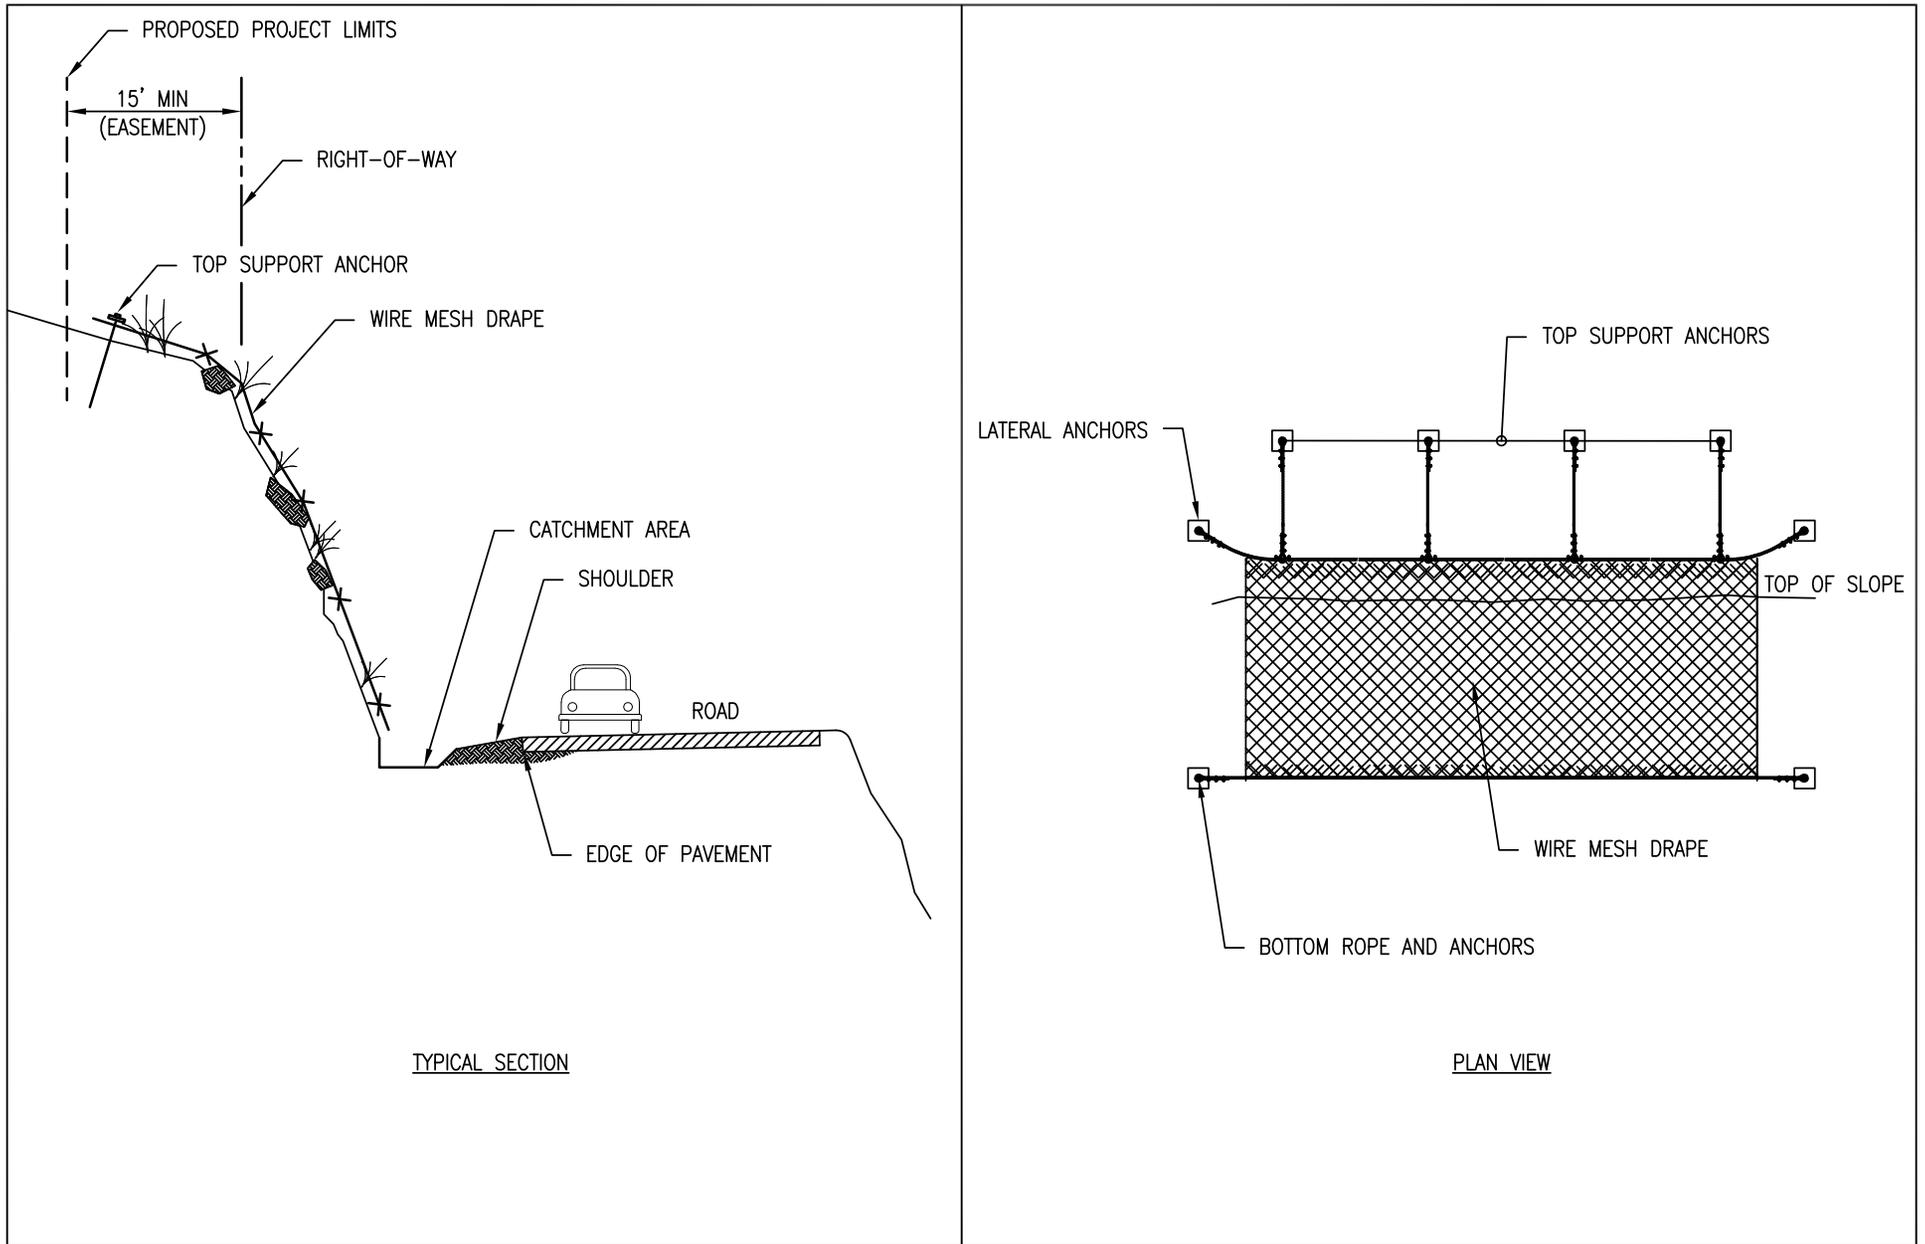
Figure 2-1
Typical Section and Plan View of Proposed Action
Wire Mesh Drape System
Round Top Drive Rockfall Mitigation
Honolulu, HI

Alternative 1 provides for the installation of anchored wire mesh over the entire cut slope that could otherwise send falling rocks onto affected structures. After clearing, scaling, and leveling, the terrain surface is covered by a high strength steel wire mesh and tensioned with pre-installed anchors that are typically spaced 8 to 10 feet apart throughout the coverage area. The anchors pull the wire mesh tightly against the slope to prevent rockfalls by restraining the loose material in place.

The proposed wire mesh drape system would require periodic inspection and maintenance. The mesh would be inspected for corrosion and damage from falling debris, and steel components may need to be repaired or replaced periodically. Additionally, clearing of rockfall debris from behind the wire mesh and from the roadway shoulder would be required.

The Proposed Action involves mitigation of the present slope condition using a wire mesh drape system to contain the potential slope failure and/or rockfall events. The proposed project would involve scaling and vegetation clearing on the hillside. The wire mesh would blanket the hillside, thus containing soil and rocks. Vegetation would be allowed to grow through the mesh, which would provide erosion protection of the unconsolidated soil. Therefore, implementation of the Proposed Action is expected to have positive long-term effects on geology and soils.

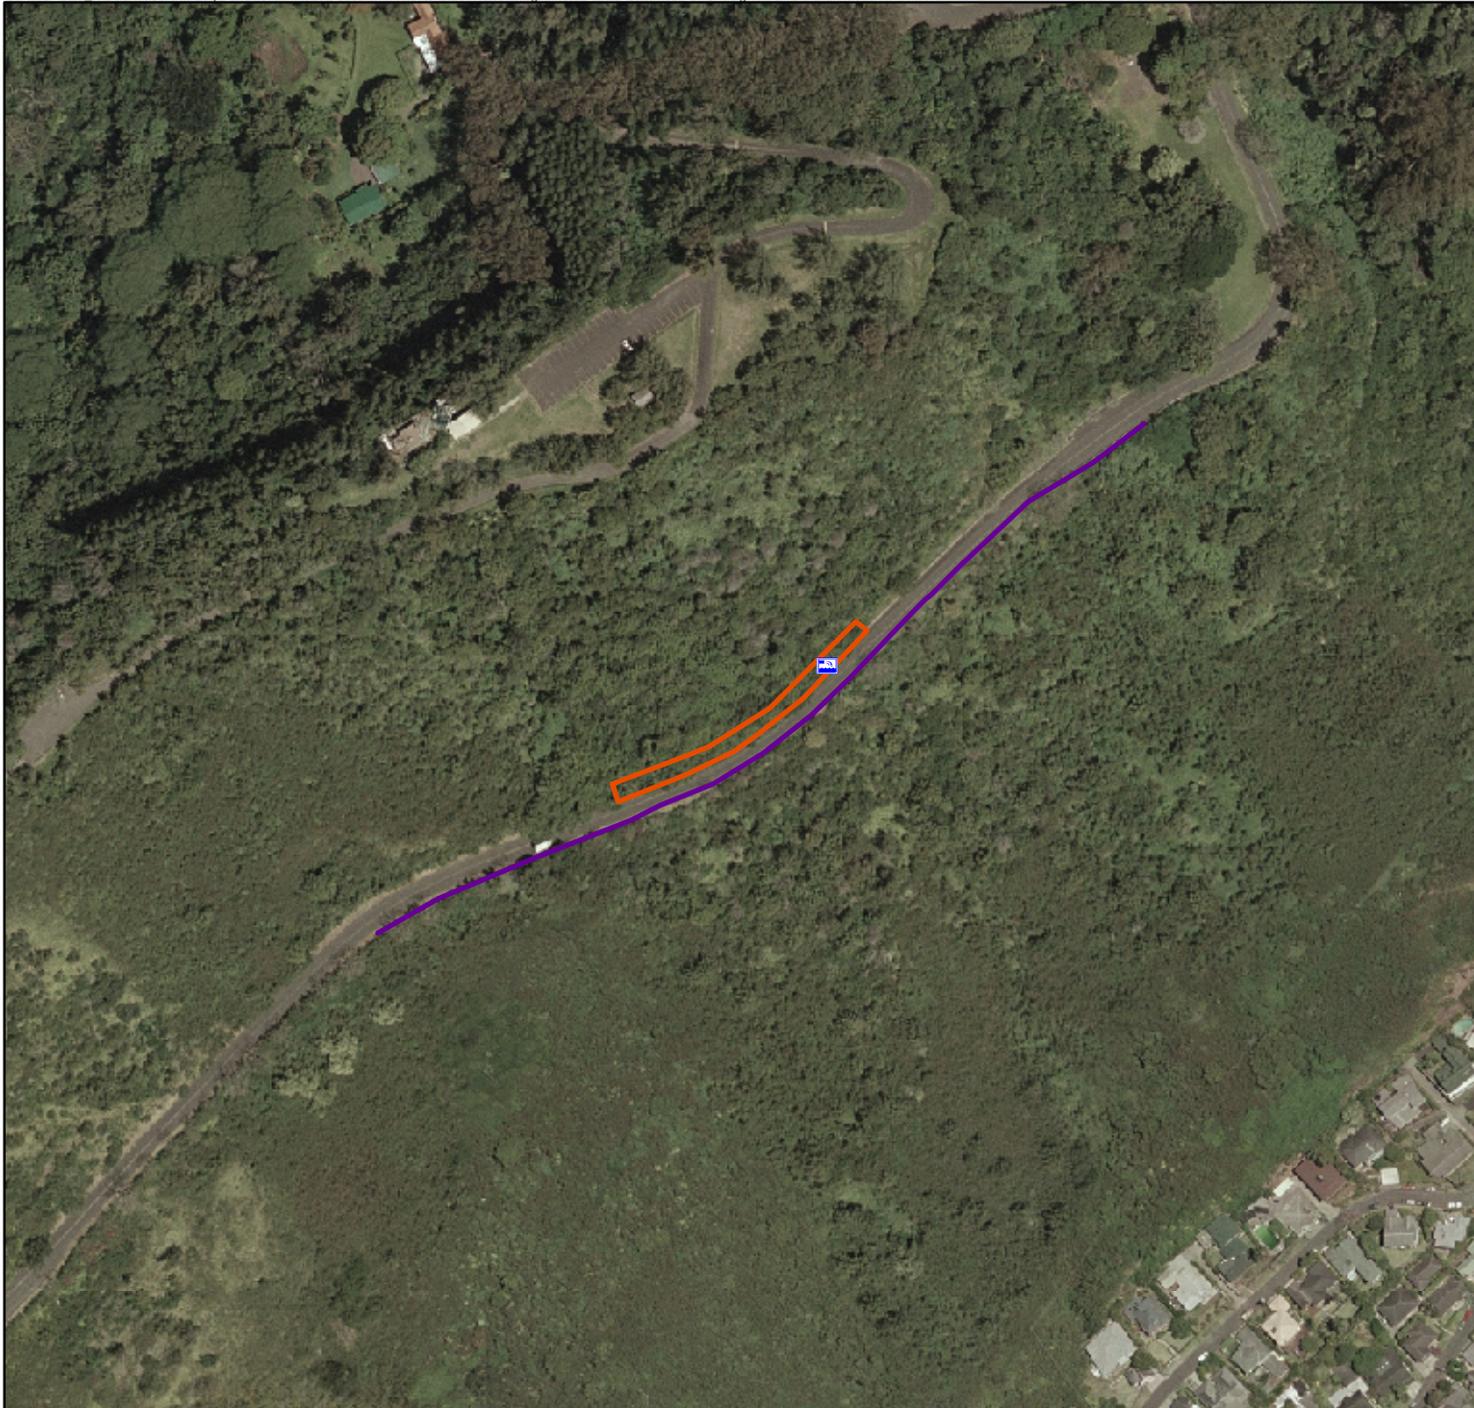
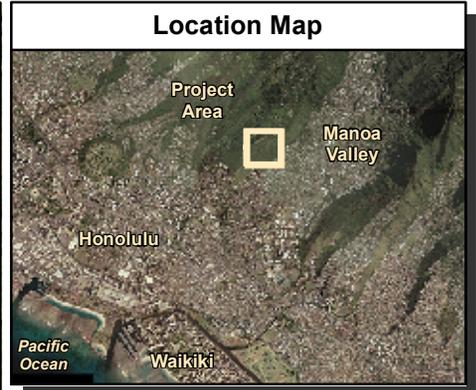
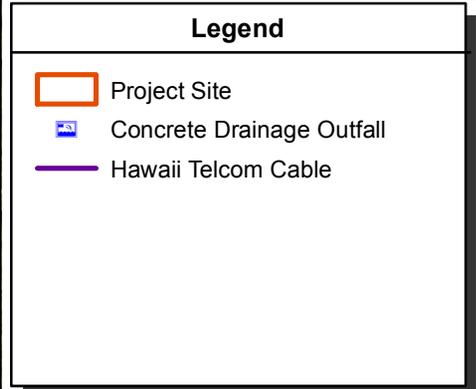
Figure 3-5
Utilities and Infrastructure
Round Top Drive
Rockfall Mitigation
Honolulu, HI

There is one Hawai'ian Telcom cable located on the makai side of the existing roadway. Additionally, there is an existing concrete rubble masonry drainage structure within the proposed project area that drains to the makai side of Round Top Drive. Both of these facilities are identified on Figure 3-5.

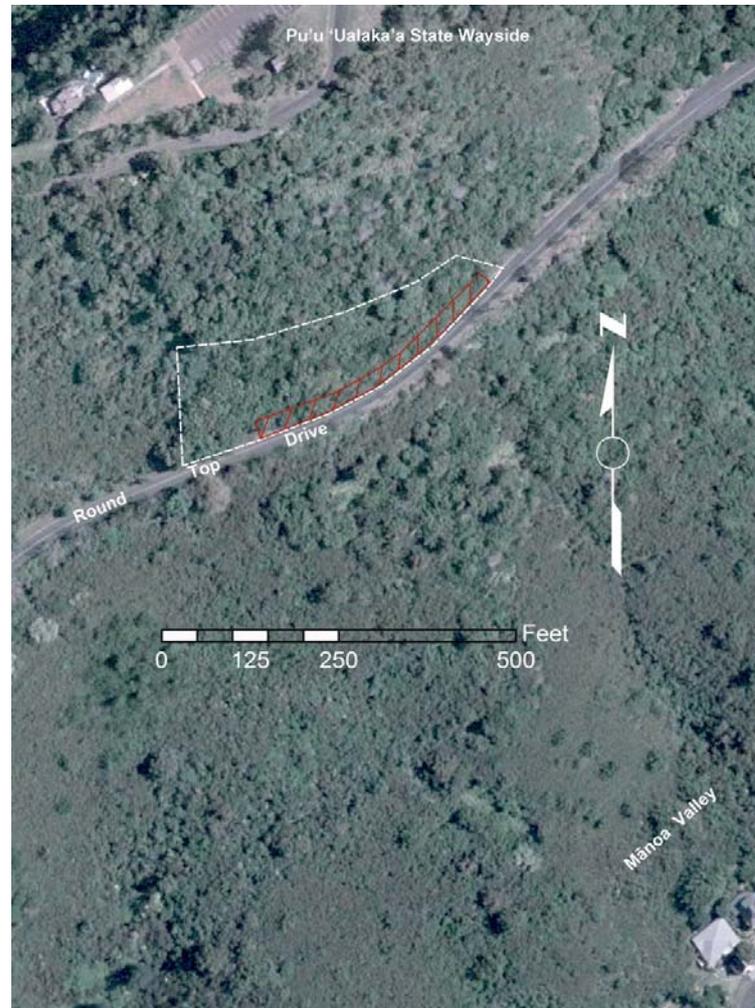
Figure 2. Aerial view of the southeast slope of Round Top (Pu'u 'Ualaka'a) with October 19 survey area outlined in white (based upon GPS record) and approximate project area outlined in red.

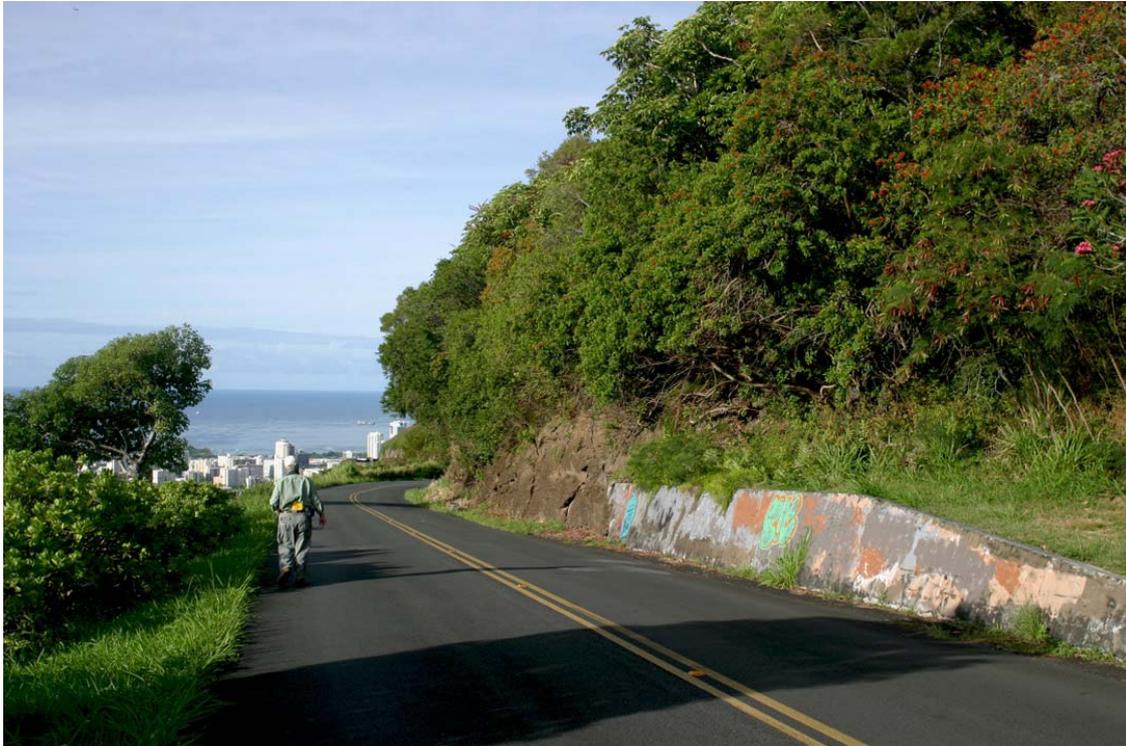
Figure 3. Project site to right of road, starting at end of graffiti-on-concrete wall and extending around corner beyond.

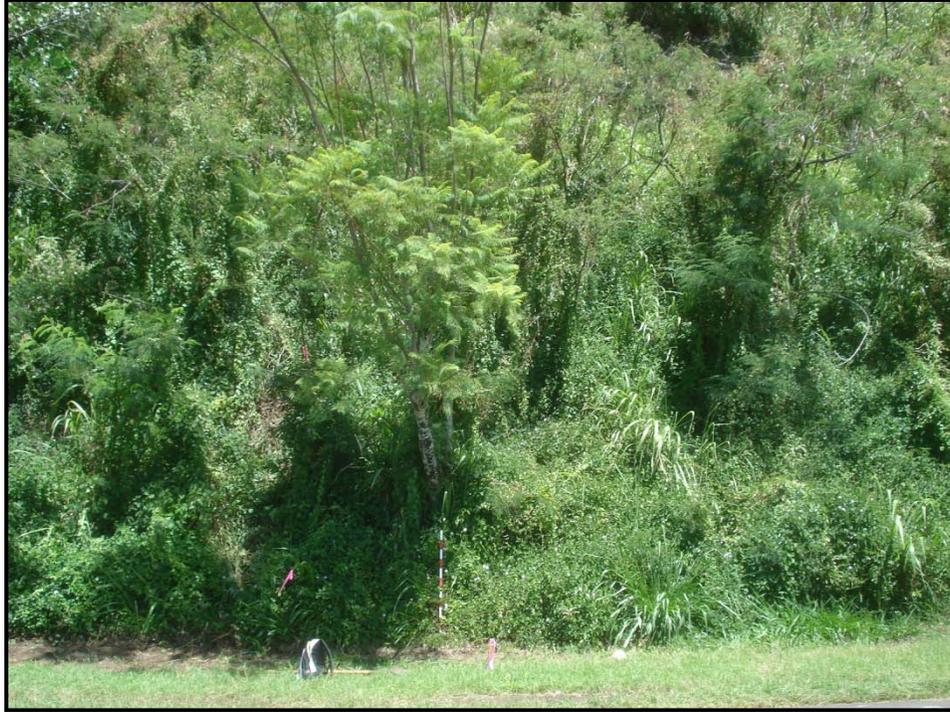
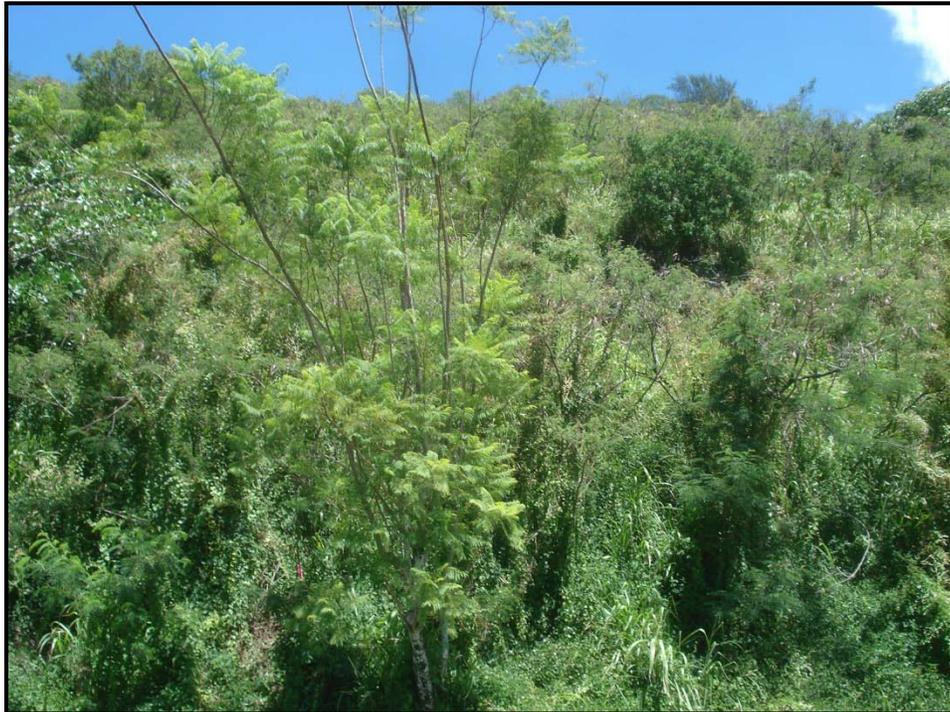
Figure 4. Photographs Showing the Southwest Portion of the Project Area.

The archaeological reconnaissance survey revealed no traditional or historical surface archaeological materials or features. The steepness of the hillside in the parcel vicinity appears to have precluded traditional and historical residential or agricultural pursuits. The survey concluded that no surface archaeological sites or other historic properties were present within the project area. Figures 4 through 6 present photographic overviews of the project area.
