Subject: Mauna Lahilahi Beach Park Rock Revetment
Draft Environmental Assessment
TMK: 8-5-017:005 (and portions of parcels 4, 6, and 7)

Mauna Lahilahi Beach Park Rock Revetment

Prepared for:
City and County of Honolulu
Department of Design and Construction

Prepared by:
Oceanit Laboratories, Inc.
828 Fort Street Mall, Suite 600
Honolulu, Hawaii 96813

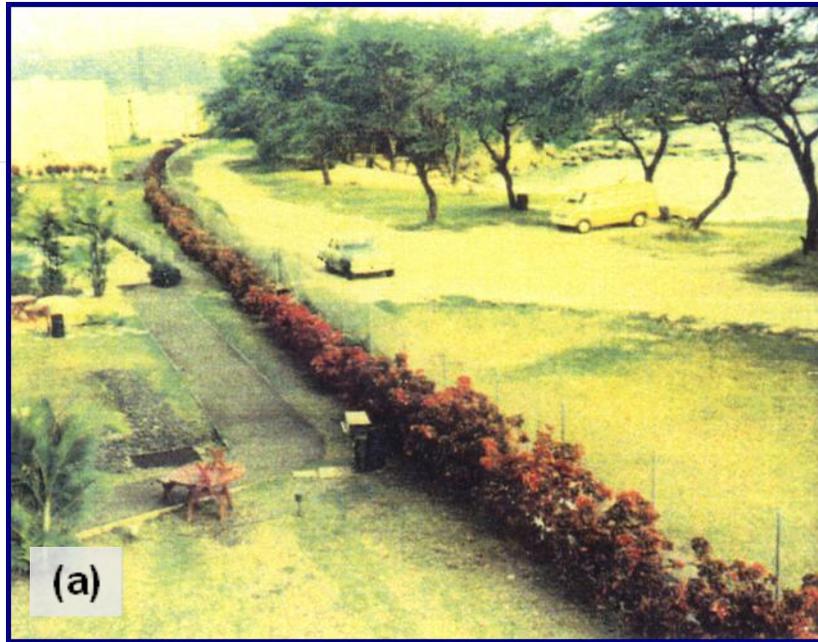
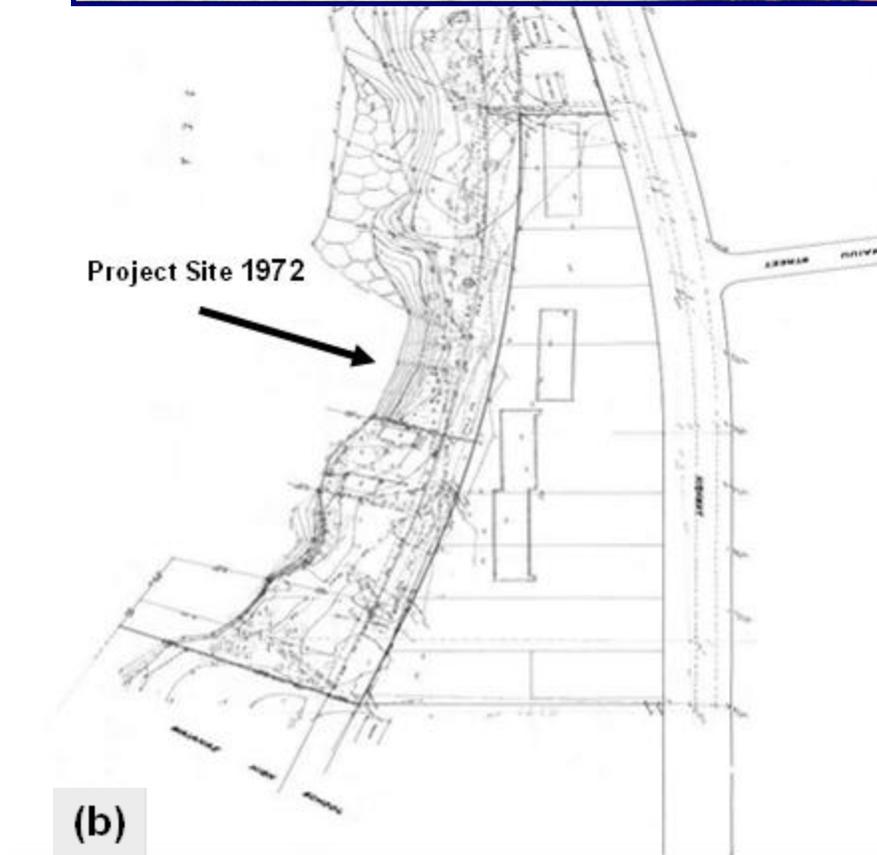
Figure 3-1. (a) Mauna Lahilahi Cove Beach in 1970, (b) Topographic Map in 1972

(Division of Land Survey & Acquisition);
Oriented WNW Along Shoreline

The cove at Mauna Lahilahi Beach was relatively stable until some time after 1949 when the beach began receding shoreward. The beach was still relatively wide in 1970 as shown in Figure 3-1, which provides a photo and topographic map of the beach area. However, the beach continued to erode in the 1970s. Hurricanes Iwa in 1982 and Iniki in 1992 caused nearly \$2 million in damage to the Mākaha Surfside Apartments and eroded much of the beach fronting the property (Figures 3-2, 3-3, and 3-4). Overall, the shoreline within the pocket beach project area receded nearly 200 feet between 1949 and 1996 as can be seen in Figure 3-5. Aerial photos (Figures 3-6, 3-7, and 3-8) show progressive shoreline changes. An estimated 48,900 square feet of City & County park land (Preservation land) presently valued at approximately \$248,700 was lost to shoreline erosion between the early 1970s and 1996. The commercial value of the lost land, if it could be used for apartments, would be about \$2 million. The top of the bank eroded through the fence into the Mākaha Surfside property before a sandbag revetment was constructed during the late 1990s. The existing breakwater was constructed and 10,000

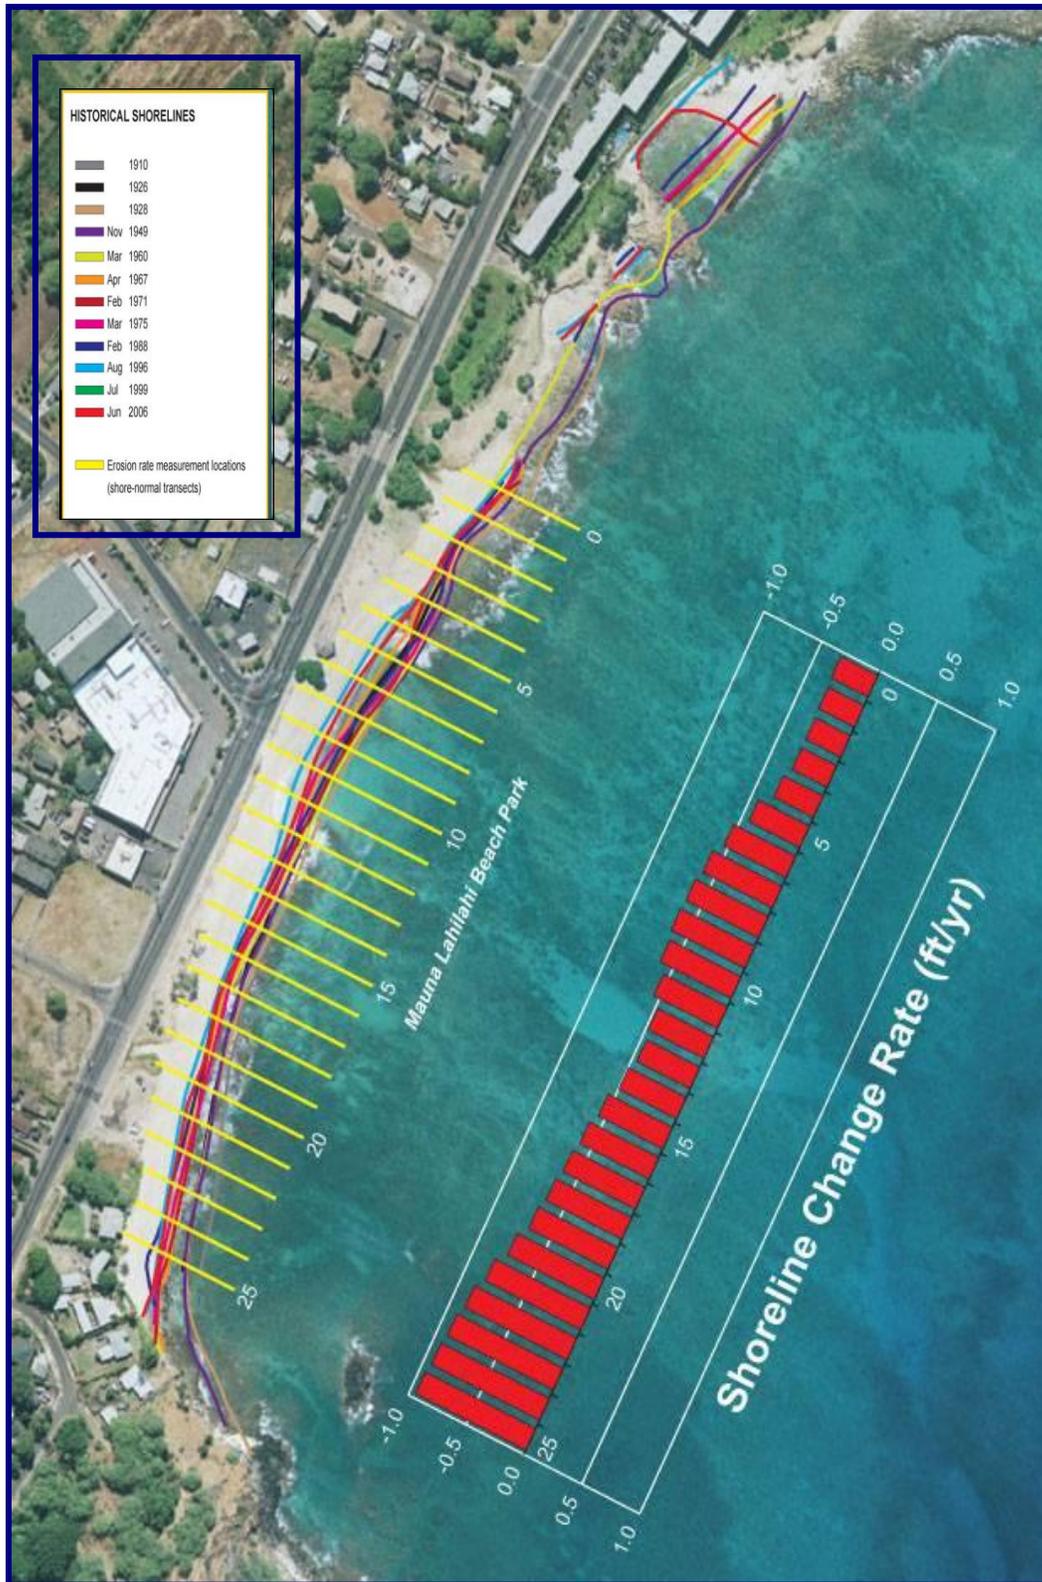
Figure 3-5. Shoreline Erosion Rates

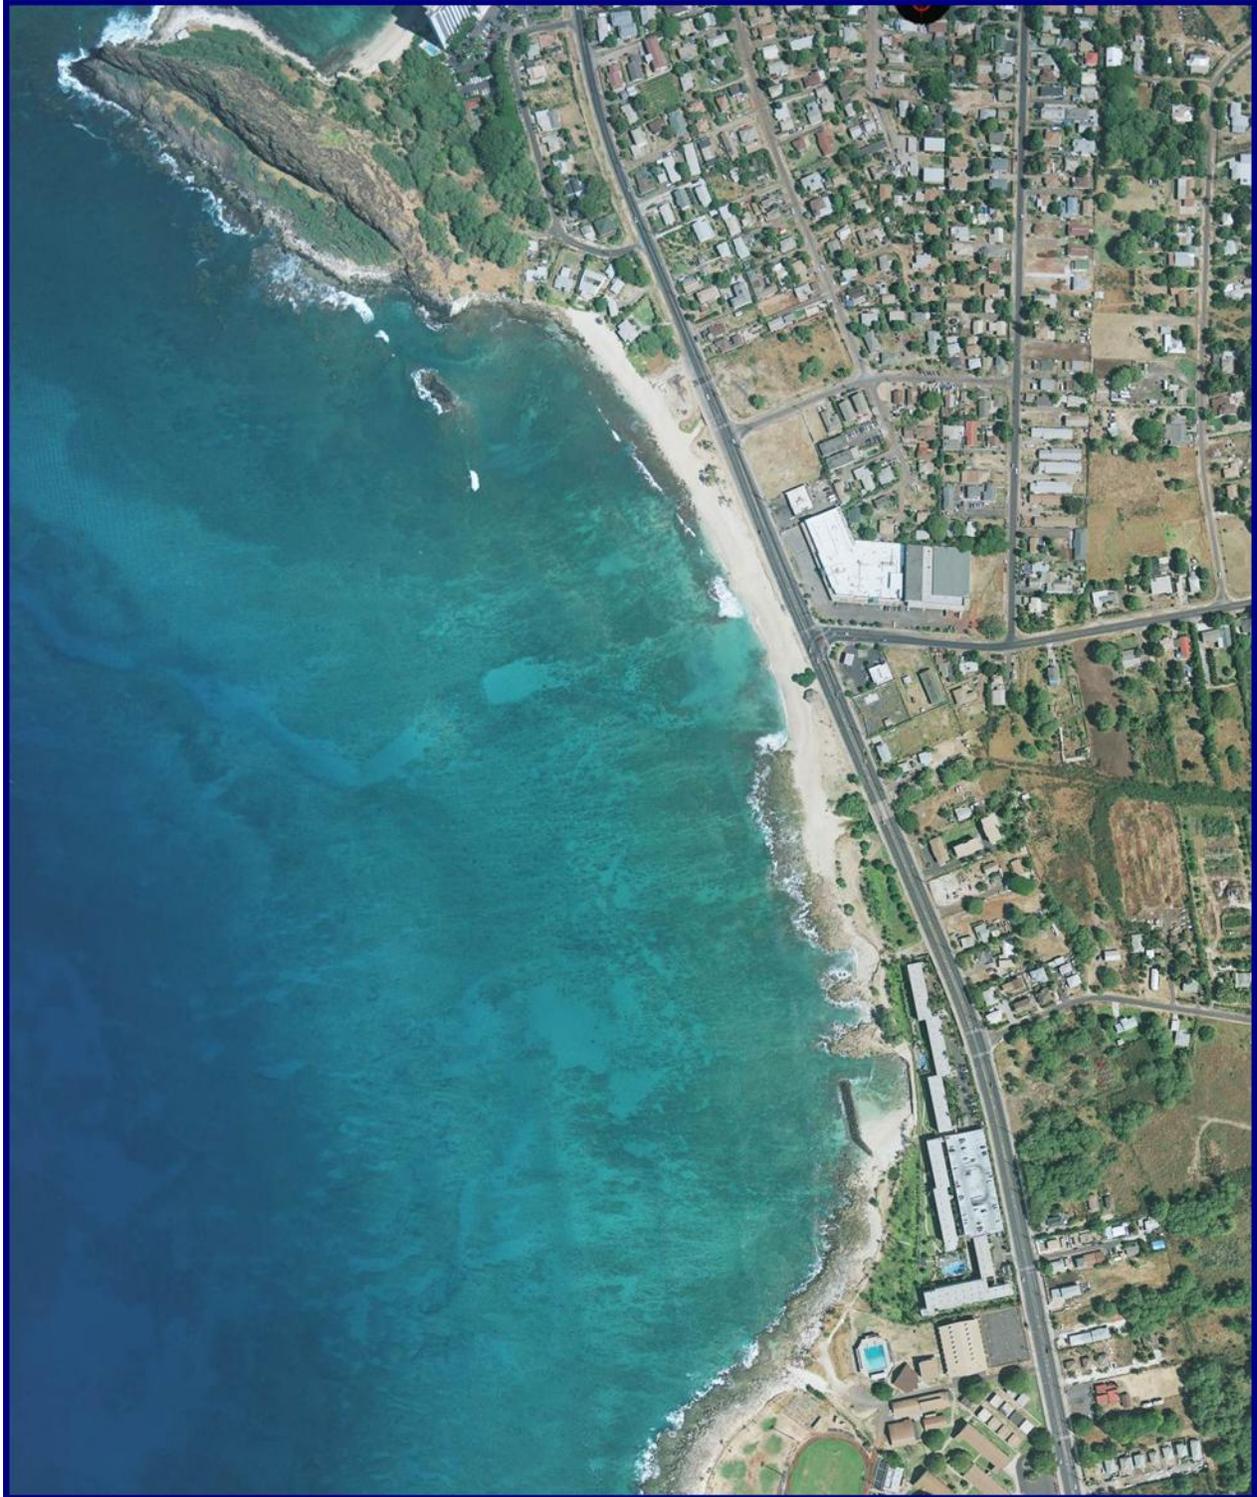
Figure 3-8. Mauna Lahilahi Beach Area in 2006 after Outer Breakwater Construction
(University of Hawai'i, 2006)

cubic yards of beach sand were placed in 2003 (Figures 3-8, 3-9, and 3-10). The sandbag revetment was removed when the beach was nourished. Since 2003, the nourished sand has been pushed to the south between the breakwater and the shoreline embankment leaving the backshore at the cove’s northeast corner exposed to further erosion by waves moving through the gap between the existing

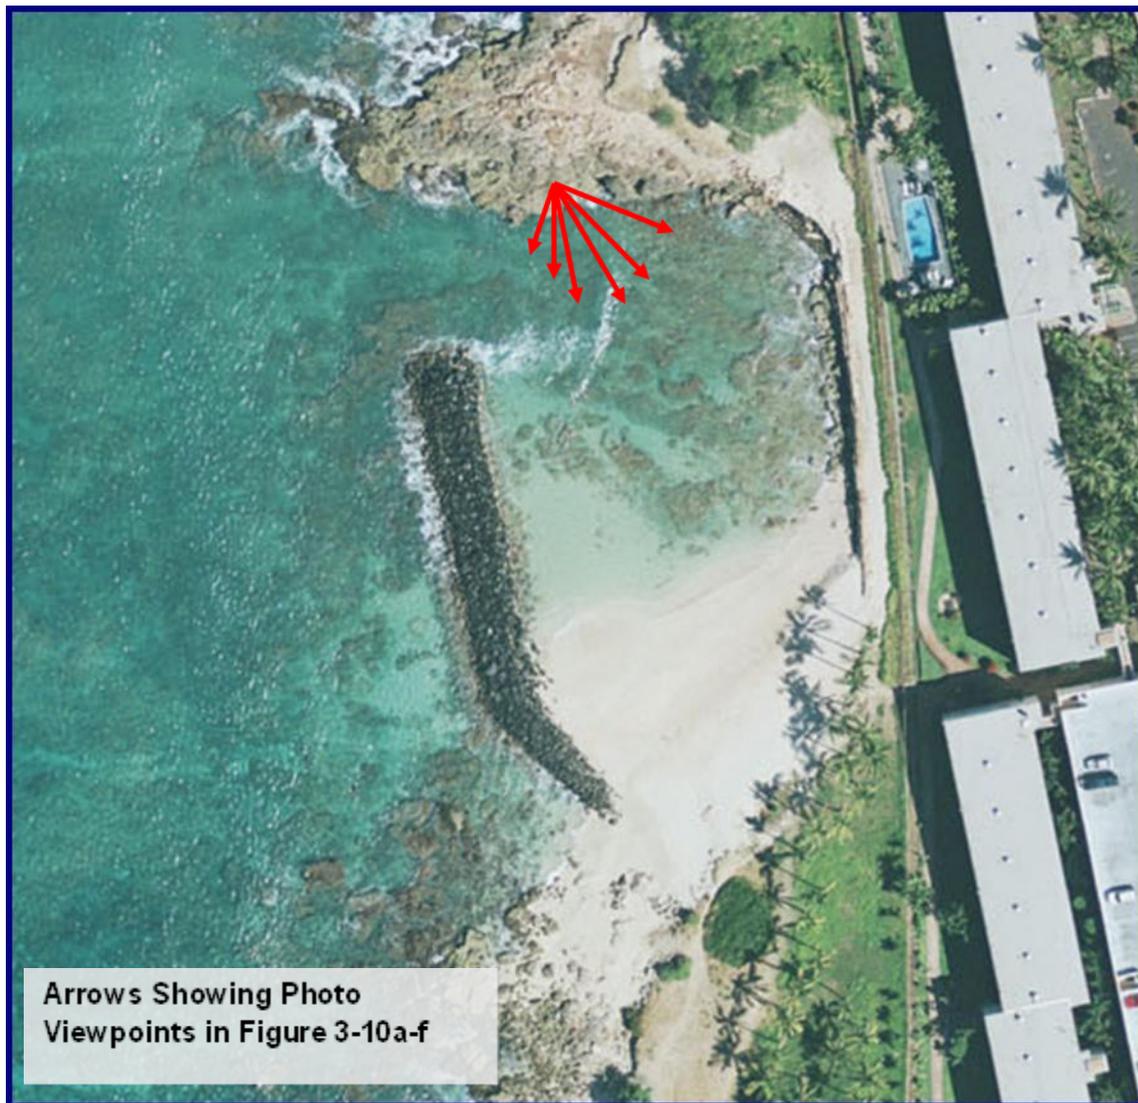
Figure 3-9. 2006 Aerial Photo Showing Beach Transformation in the Lee of the Breakwater

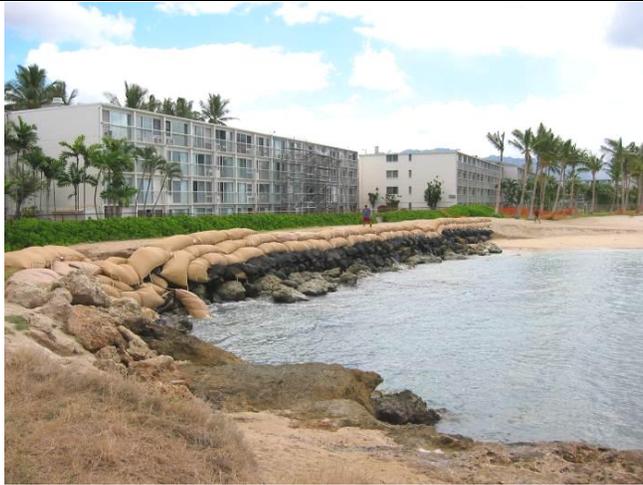
Figure 3-10a. View from North End in 2006; Sandbag Revetment

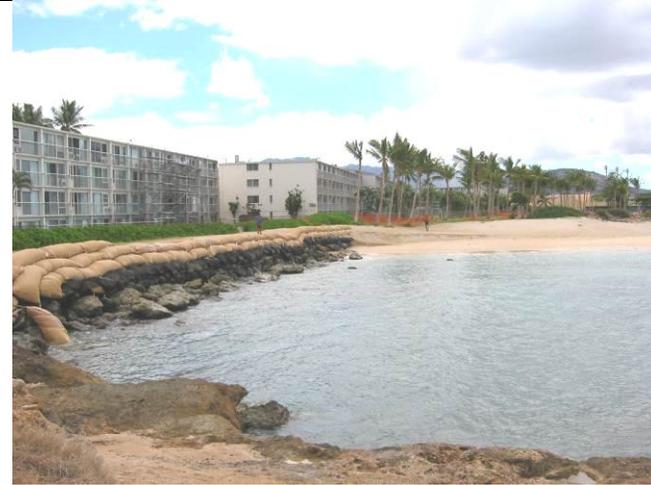
Figure 3-10b. View from North End in 2006; Sandbag Revetment

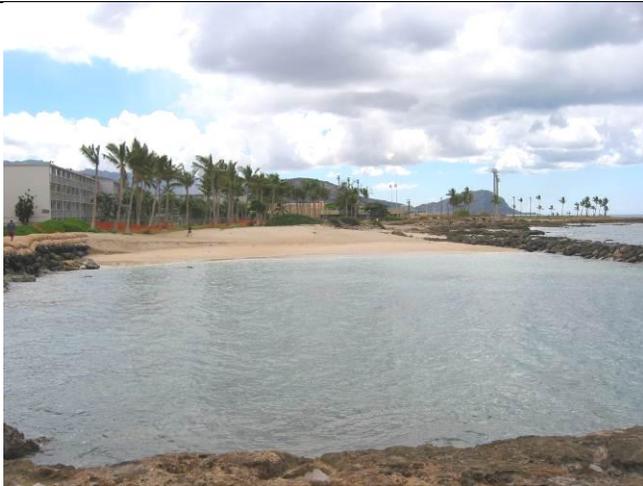
Figure 3-10c. View from North End in 2006; Migrated Beach Nourishment

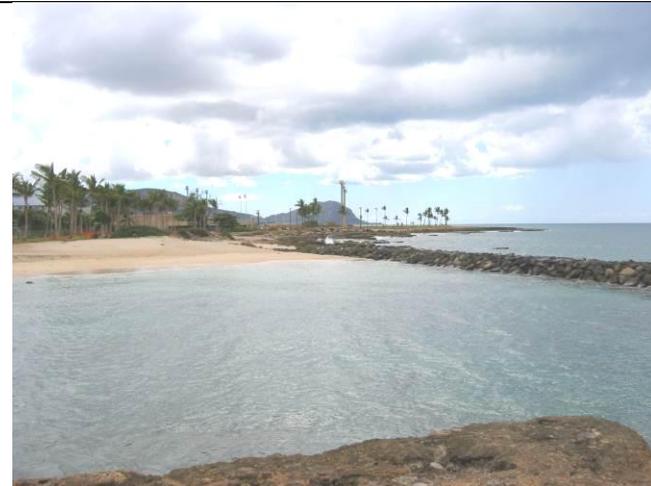
Figure 3-10d. View from North End in 2006; Breakwater Connection

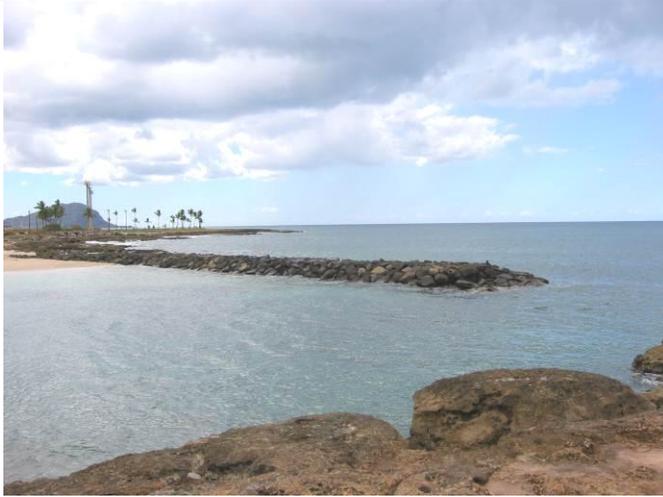
Figure 3-10e. View from North End in 2006; Existing Rock Breakwater

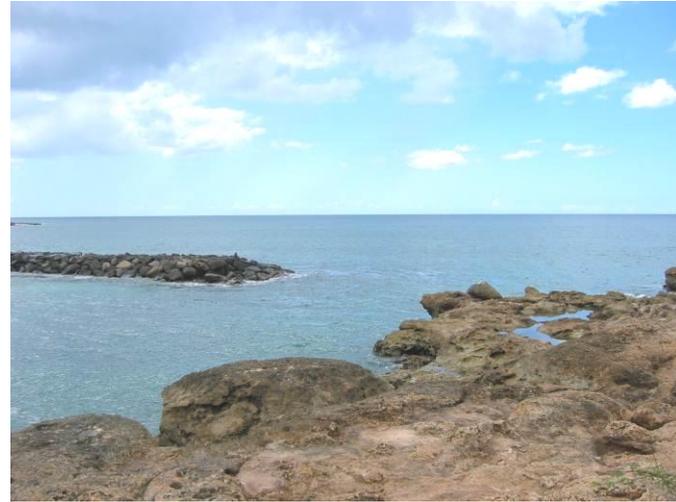
Figure 3-10f. View from North End in 2006; Breakwater Gap

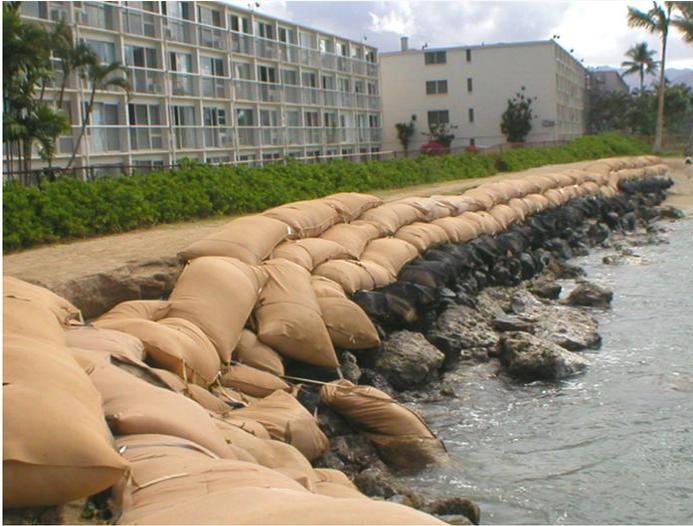
Figure 3-10i. Beach Erosion & Sandbag Revetment at North End in November 2005 (Courtesy of Jeanne Marx)

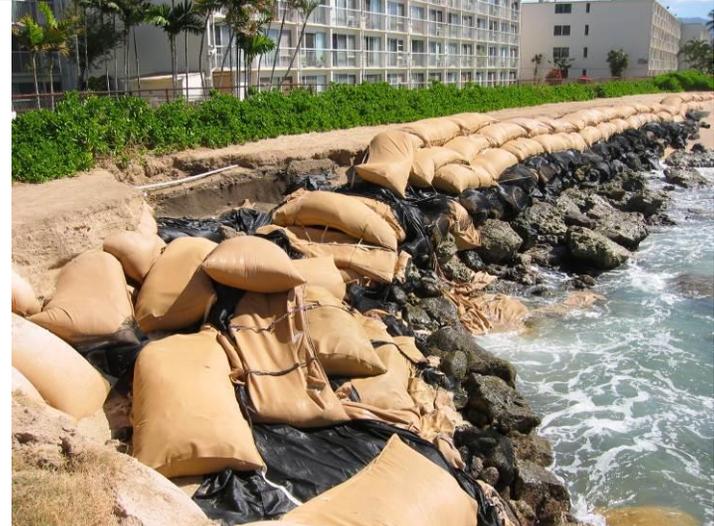
Figure 3-10j. Beach Erosion & Sandbag Revetment at North End in January 2006

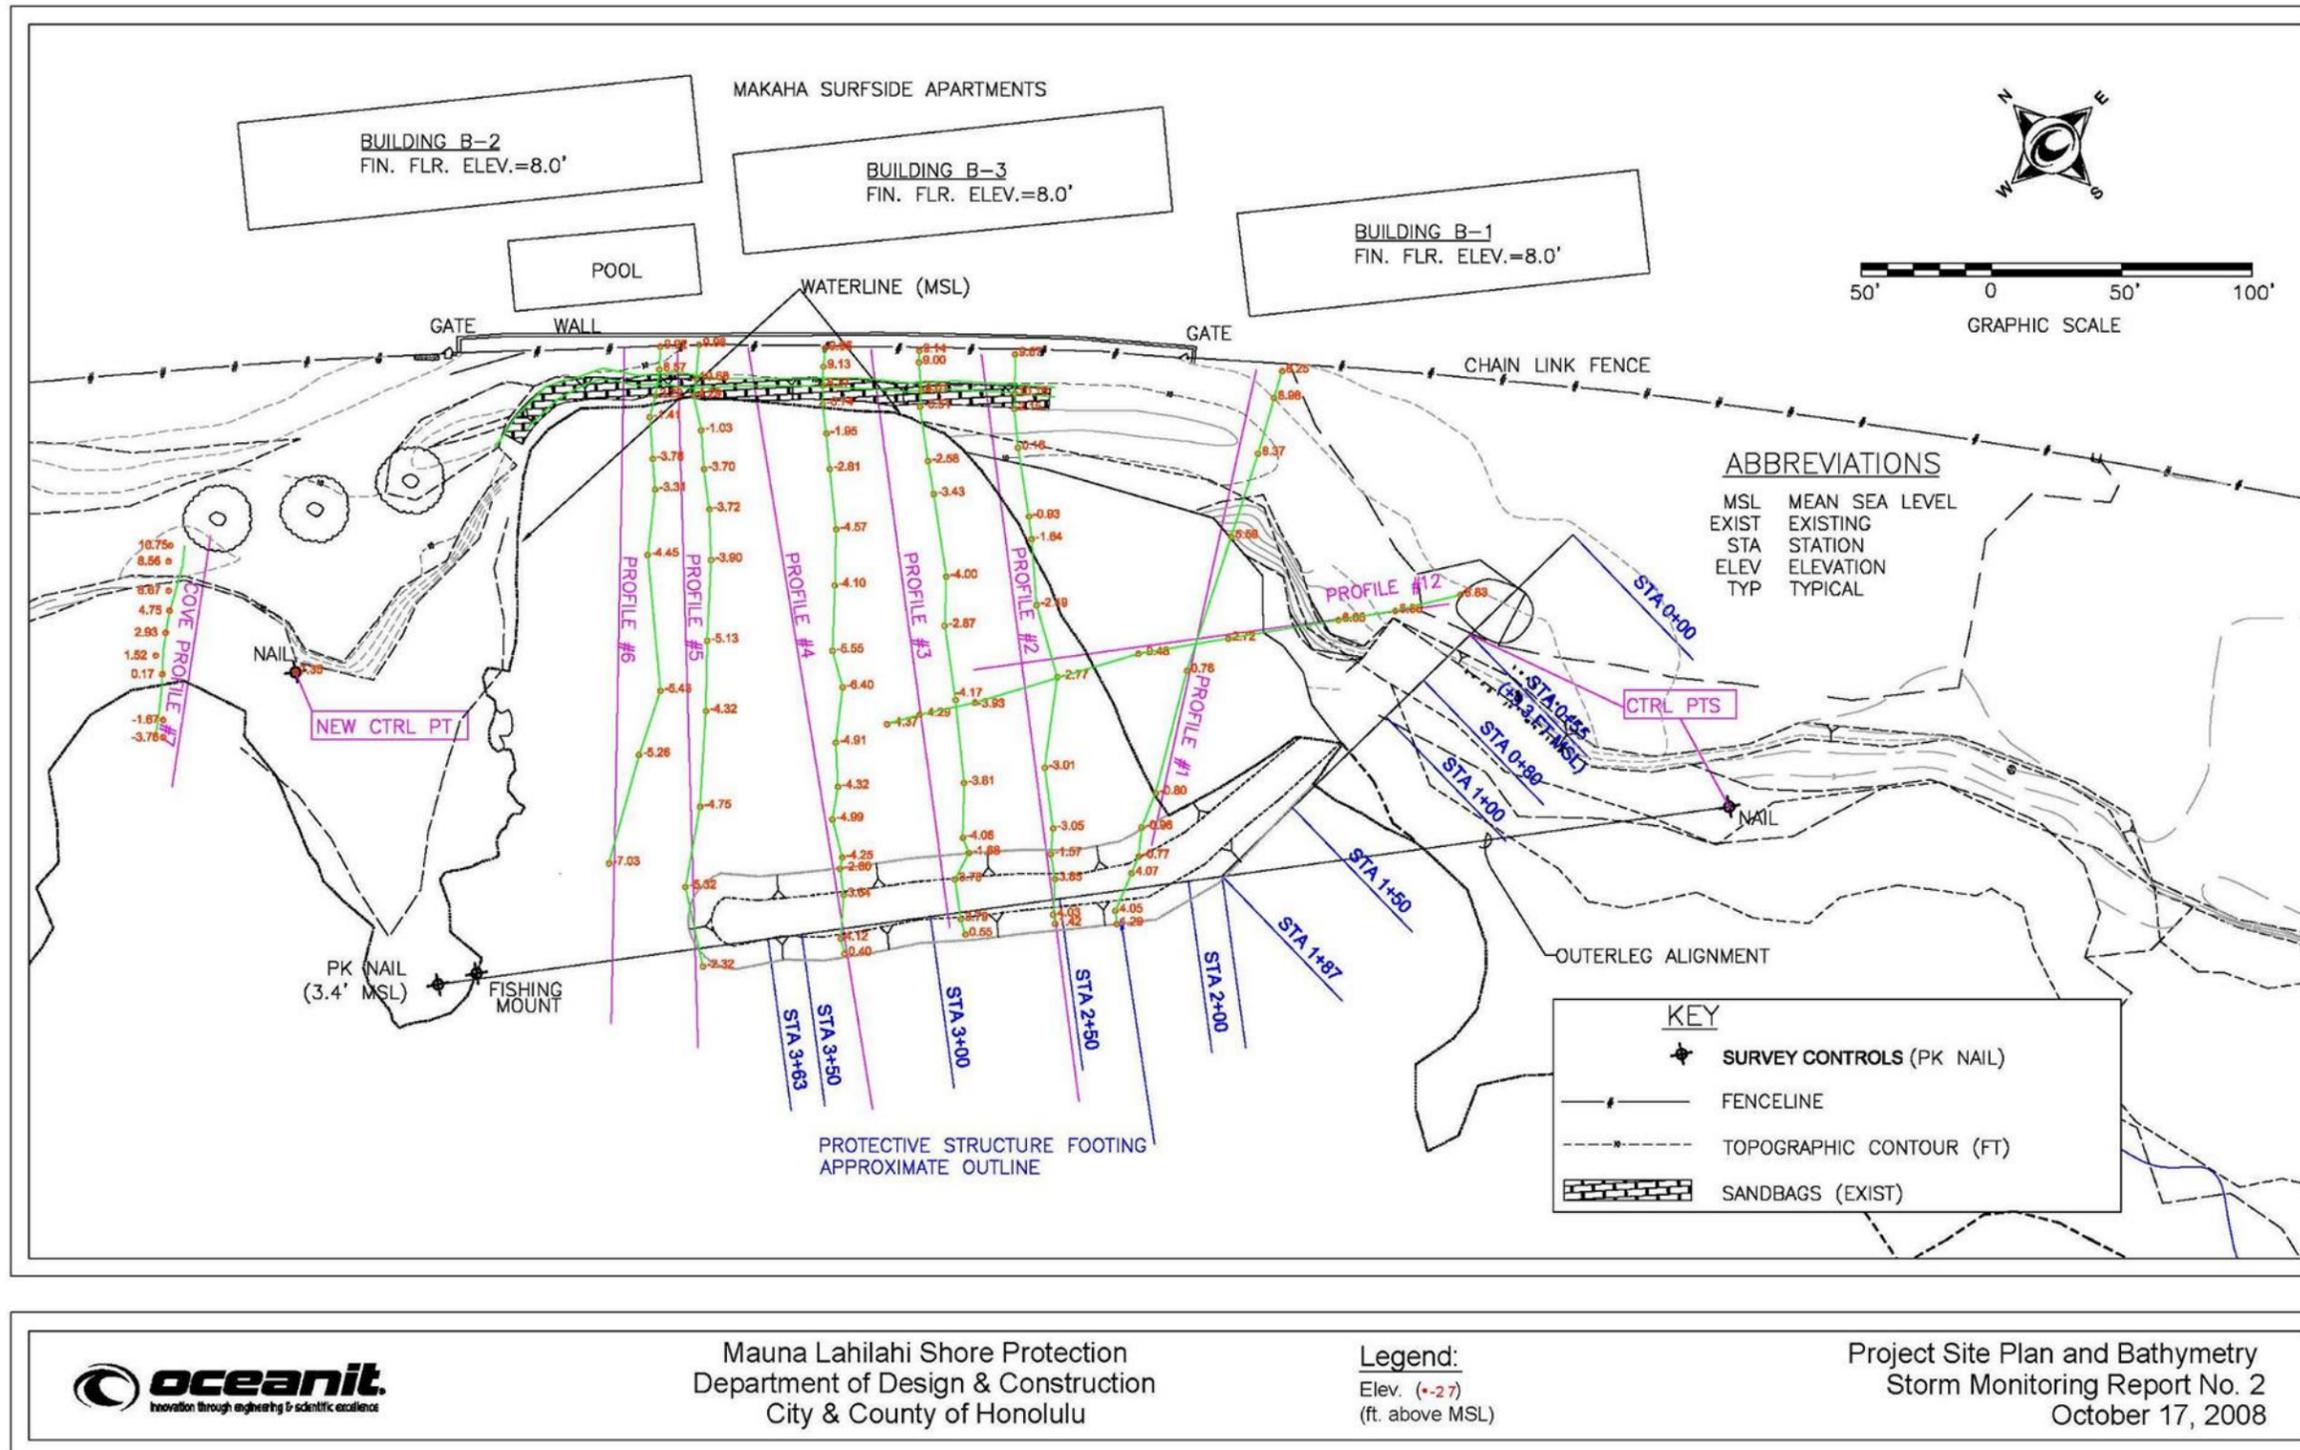
Figure 3-11. Project Site Plan and Bathymetry

From 2003 through 2008, the beach and breakwater were monitored and surveyed periodically to record transformation and condition. The final monitoring run was in October 2008. Surveyed transects through the beach and breakwater showing depth measurements are shown in Figure 3-11.

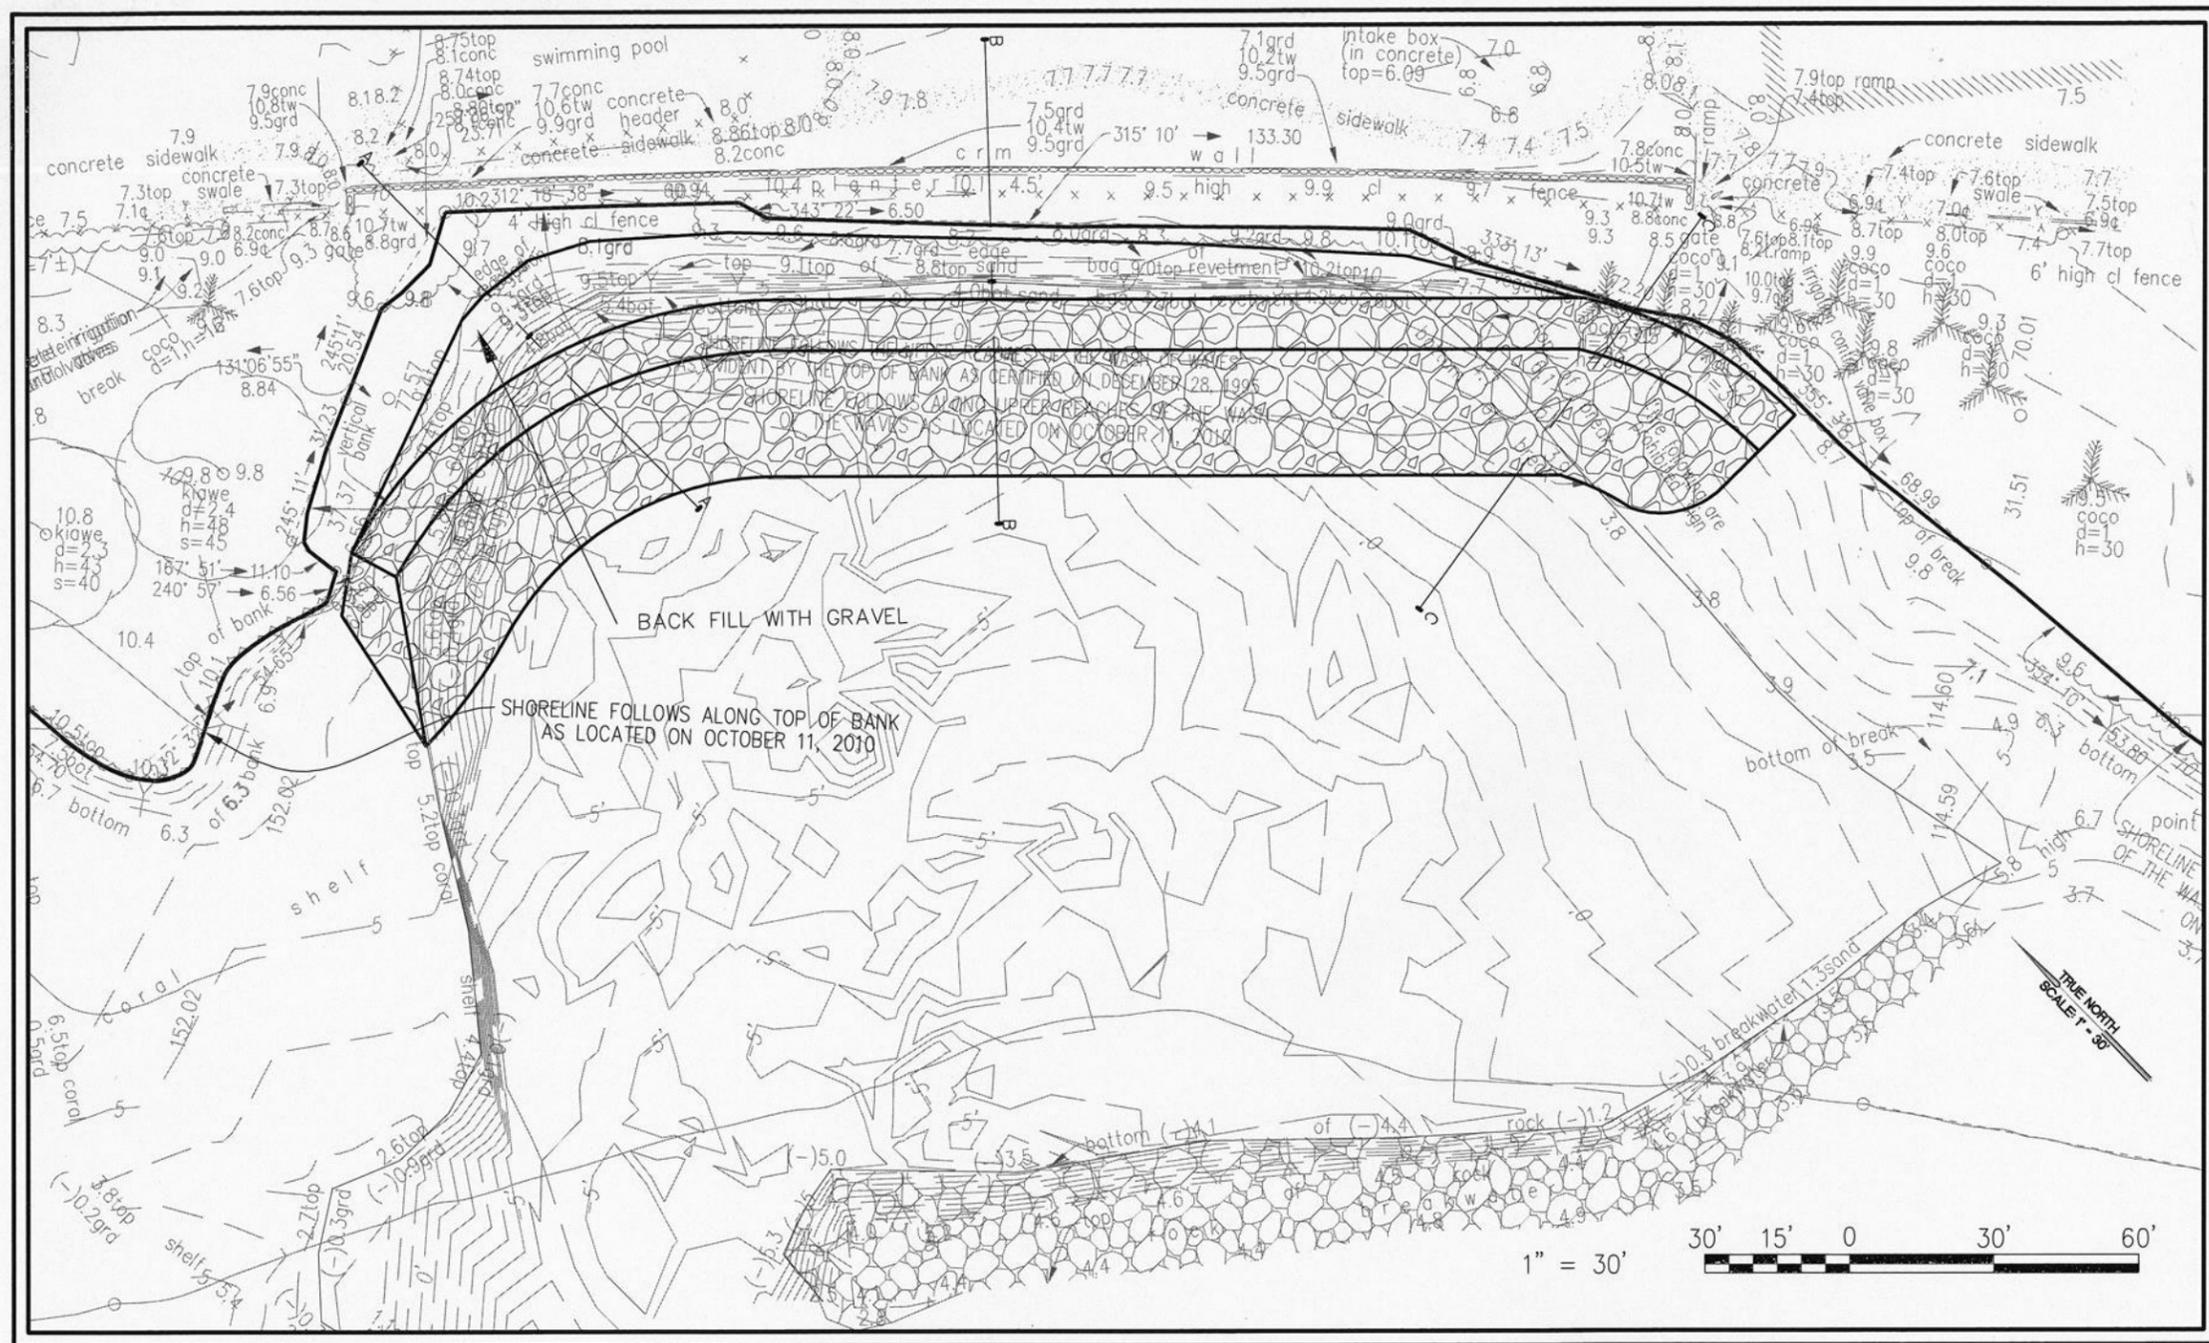
ROCK REVETMENT PLAN VIEW

Figure 3-12. Proposed Revetment Plan

The revetment will be wider at the north end where waves entering through the breakwater gap have overtopped and damaged the sandbags and eroded the backshore area (Figures 3-12 and 3-13). By moving the revetment seaward and building a rock and gravel drainage or splash area behind the revetment, overtopping waves can drain back into the ocean with minimal damage to the backshore property.

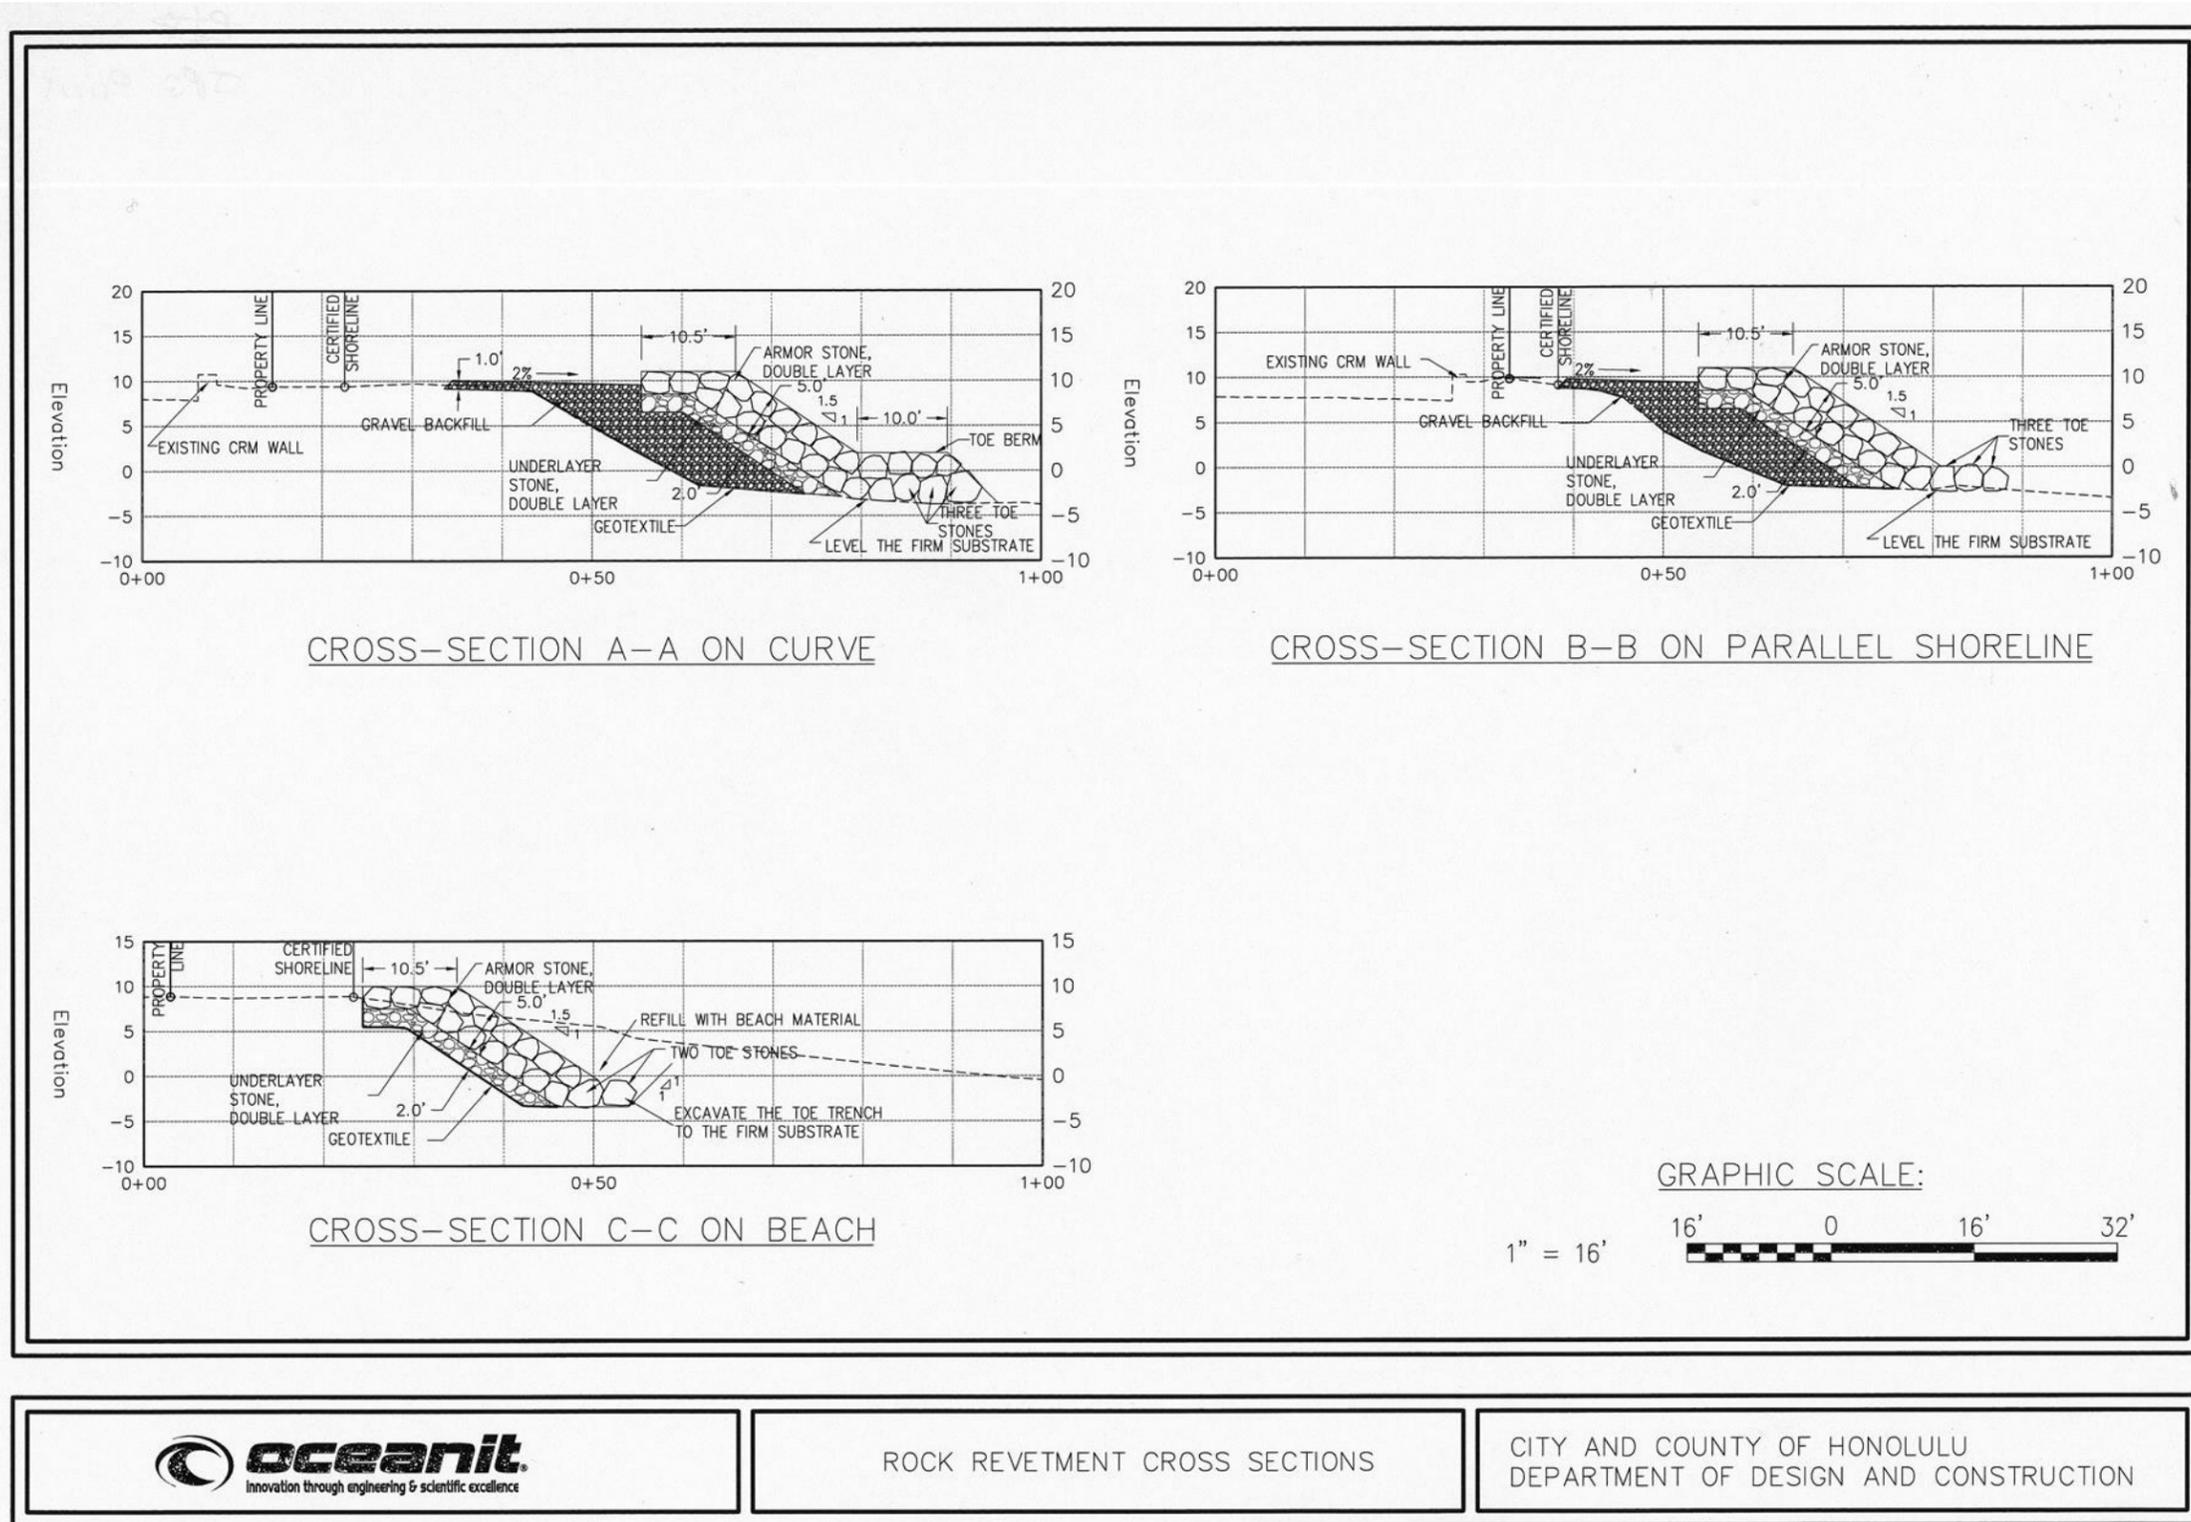
Figure 3-13. Proposed Revetment Cross Section

Water depth at the opening of the cove is approximately 6 feet below mean sea level (MSL). Design water elevation for the revetment was determined to be 6.2 feet MSL. This water level was calculated by adding the highest anticipated tide (1.9 feet MSL), potential wave setup (4.8 feet), and estimated sea level rise over the 50 year design life of the structure (0.3 feet) to find the water depth (5 feet). These conditions were used to calculate a design wave height from a hurricane of 5.5 feet (assuming the breakwater was gone). This wave height was used to calculate breakwater rock size with USACE formulas.

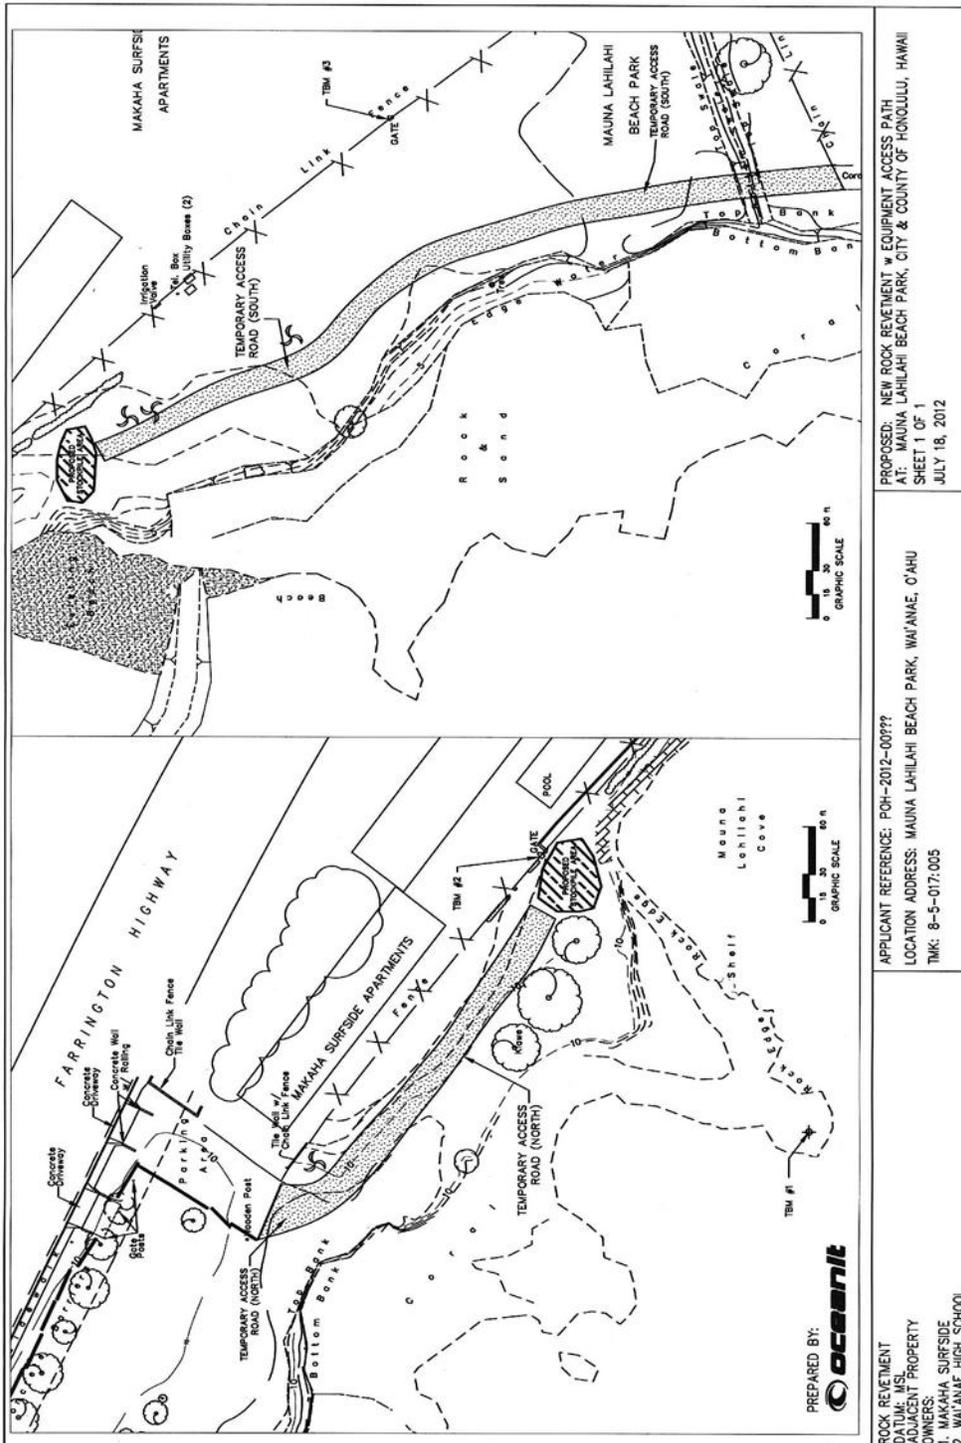
Figure 3-14. Construction Equipment Access

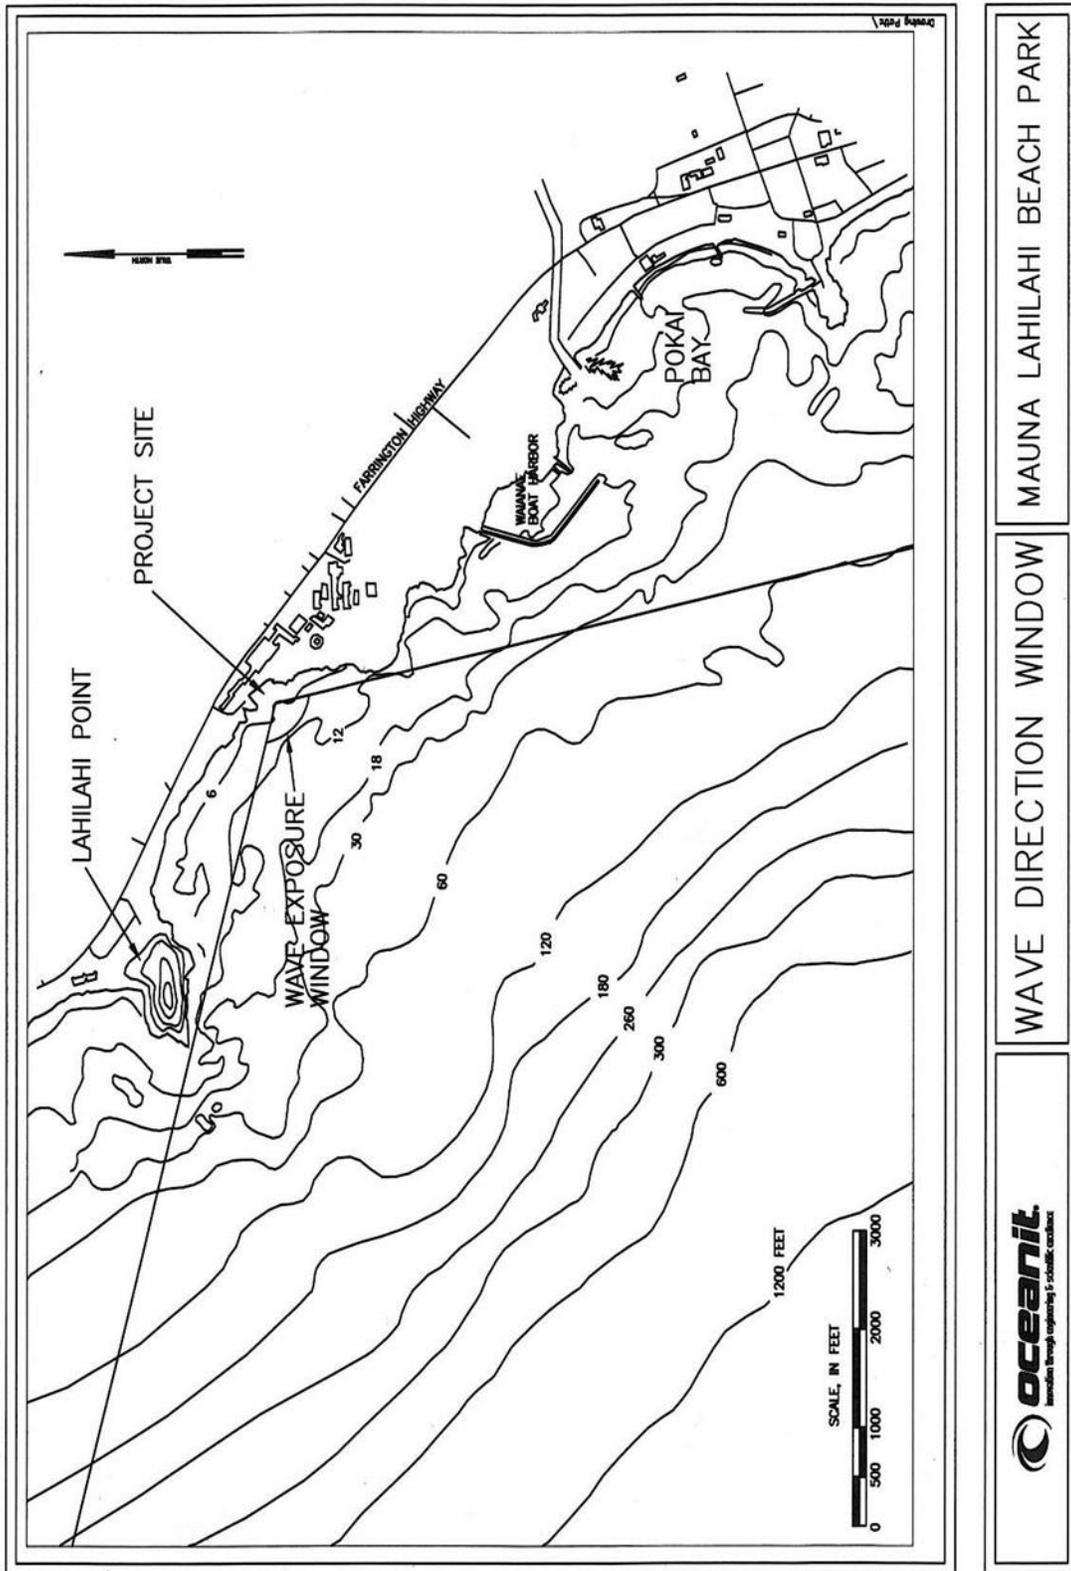
Figure 5-1. Wave Direction at Project Site
