Subject: Mauna Lahilahi Beach Park Rock Revetment
Draft Environmental Assessment
TMK: 8-5-017:005 (and portions of parcels 4, 6, and 7)

Mauna Lahilahi Beach Park Rock Revetment

Prepared for:
City and County of Honolulu
Department of Design and Construction

Prepared by:
Oceanit Laboratories, Inc.
828 Fort Street Mall, Suite 600
Honolulu, Hawaii 96813

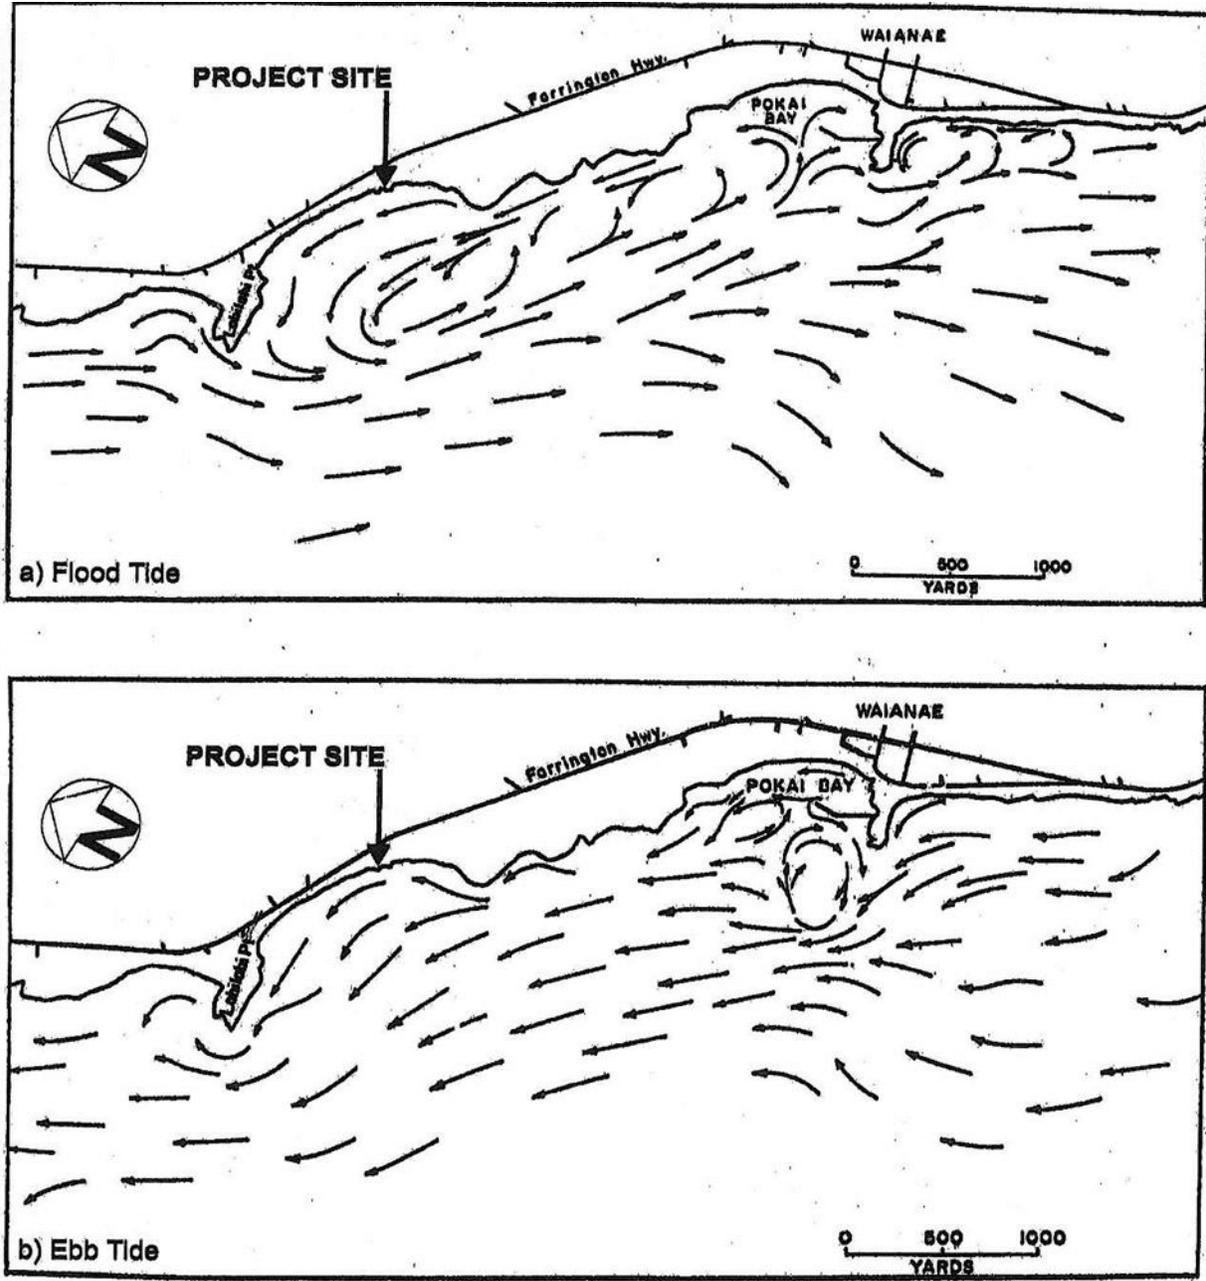
Figure 5-2. Current Patterns Mauna Lahilahi Beach Park

Currents on the Wai‘anae coast are weak and dominated by the tides. Figure 5-2 shows the general offshore flow patterns during flood and ebb tides. Offshore currents show a reversal over the tidal cycle, flowing southeast during ebb tide and northeast during flood tide. The currents closer to shore in the vicinity of the project site generally flow to the northwest during both flood and ebb tides. This is caused by eddies that form down-current from Lahilahi point. Measured current speeds were typically near 0.25 knots (Wai‘anae Boat Harbor Final EIS, 1976).

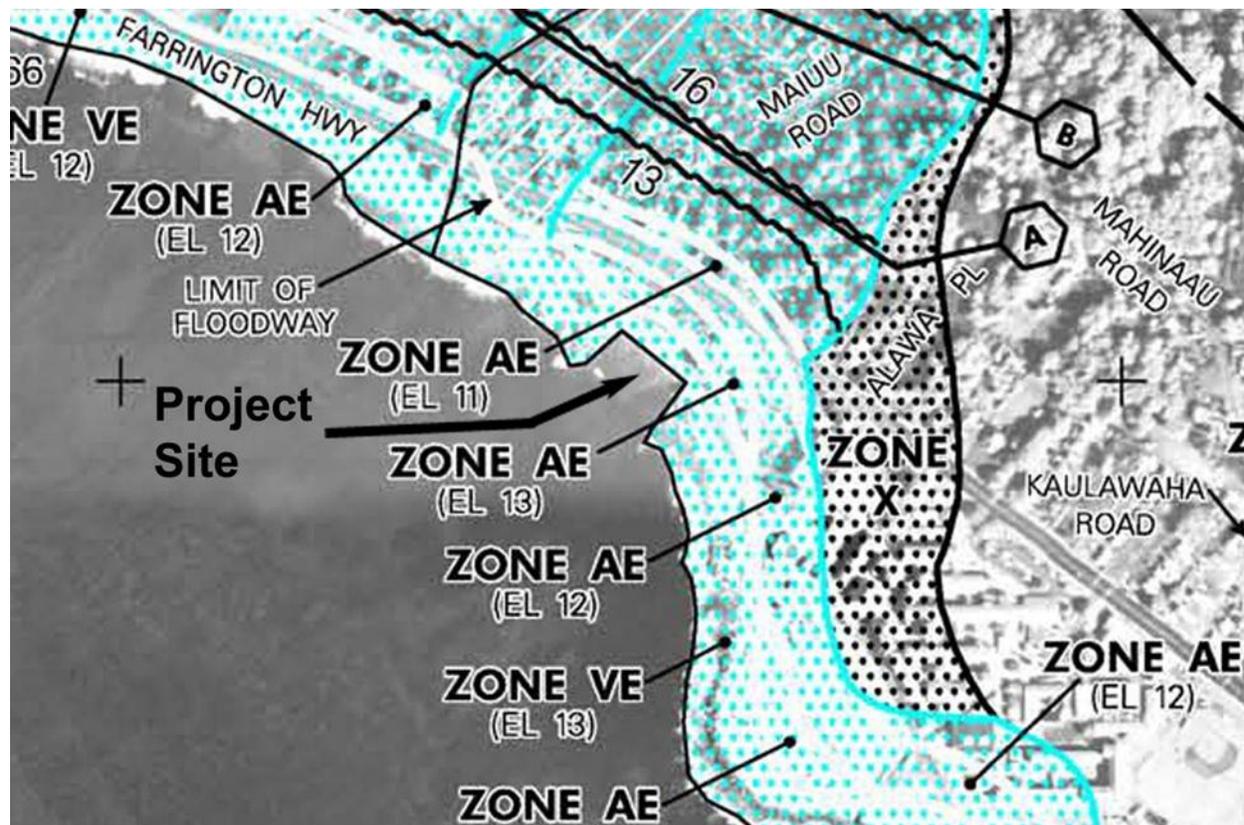
Figure 5-4. FEMA Flood Map

The Mākaha Surfside is located in flood zones VE and AE, an area subject to tsunamis or other velocity hazards, with a base flood elevation of 13 feet. Figure 5-4 is the Flood Insurance Rate Map for the project area.

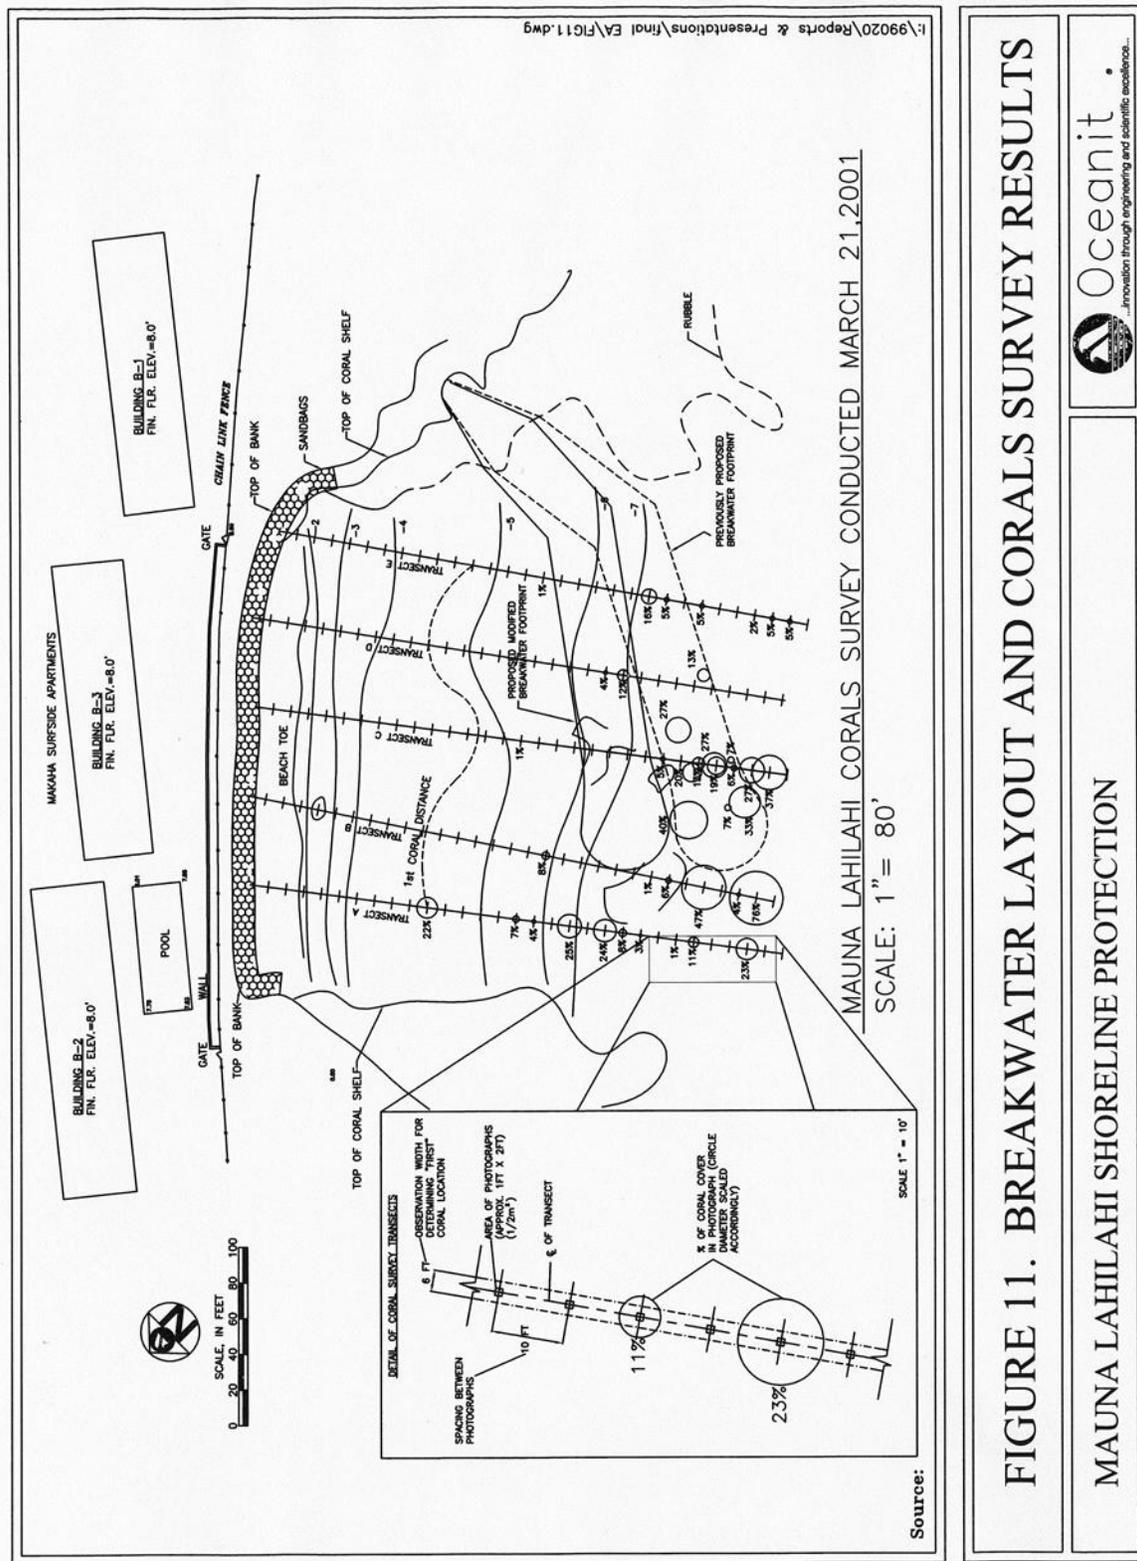
Figure 1. Breakwater Layout and Corals Survey Results

During a third visit to the site water conditions were much better, with no swell and much improved water clarity. On this occasion five transects, each roughly 300 feet long, were surveyed. The five transects were set perpendicular to the beach at 50 foot intervals across the beach. Each transect began at the edge of the lowest sand bag and ended in approximately 8-feet of water well beyond the area of the proposed breakwater. Photographs were taken at 10 foot intervals of a 1/4 square yard quadrant frame held against the substrate. In addition, the distance was recorded along each transect from shore to the first coral within one yard to the left or right of the transect tape. This provided an estimate of the absolute inner limit of coral growth in the cove. Photographs were taken to document the general condition of the reef beyond the breakwater at 300' to 700' off shore. Graphical results of the survey are shown in Figure 1.

As can be seen in Figure 1 there is isolated coral growth from about 100 feet off shore to about 200 feet off shore, but significant coral growth only begins to occur about 220 to 250 feet off shore. While none of these coral heads are very large and do not contribute significantly to the structure of the benthic habitat, they do account for up to 1/3 of the bottom coverage in certain areas. To avoid these areas of high coral coverage, the tip of the initial breakwater design has been moved shoreward approximately 50 feet from the original design.

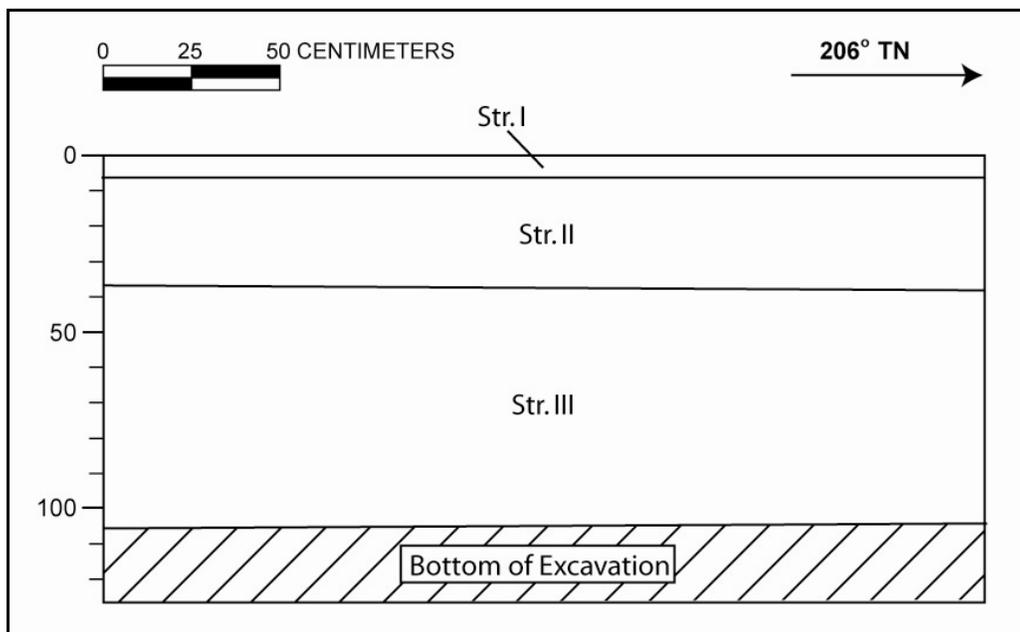
Figure 9. Representative profile of the dominant (Type A) stratigraphic sequence in the project area.

The primary stratigraphic sequence documented throughout the project area (designated as Type A stratigraphy) (Figure 9) consisted of three layers; Stratum I, a very dark gray sandy clay characterized by the mixing of marine sediment (i.e. sand) and terrestrial sediment (dark grayish clay loam) which can be related to the wave action that routinely floods the area and to wind distribution of beach sand; Stratum II, a very dark grayish brown clay loam; and Stratum III, a very dark brown clay matrix with few inclusions as well as generally hard to very hard consistency. These observations agree with the USDA soil data for the project area and its vicinity (Foote et al. 1972).

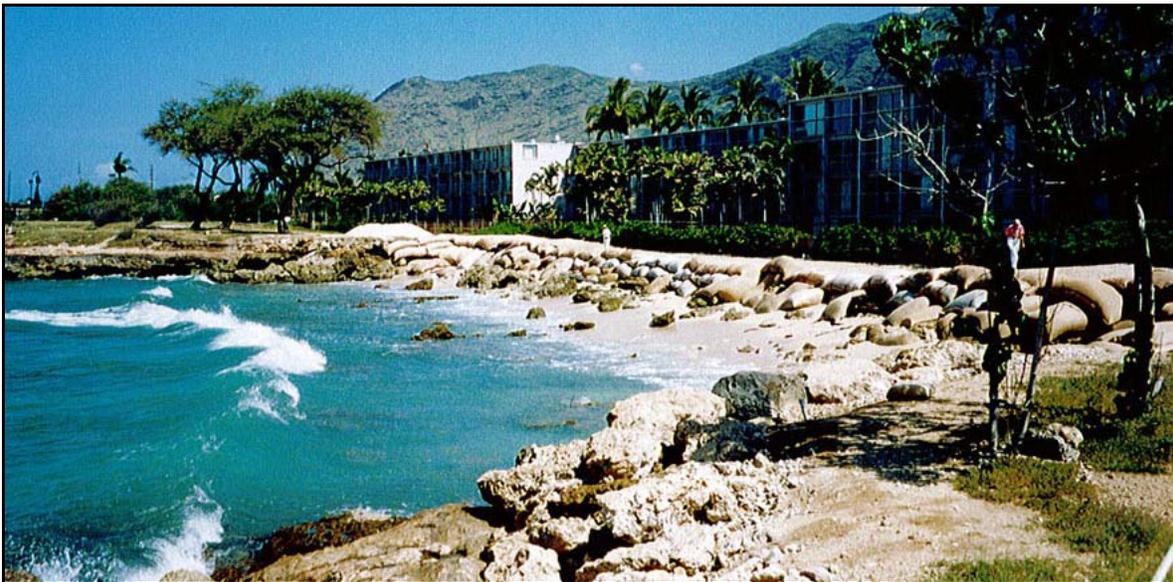
Figure 10. Photograph of the sandbag revetment installed in 1999 to stop beach erosion near the Makaha Surfside apartments, view to north.

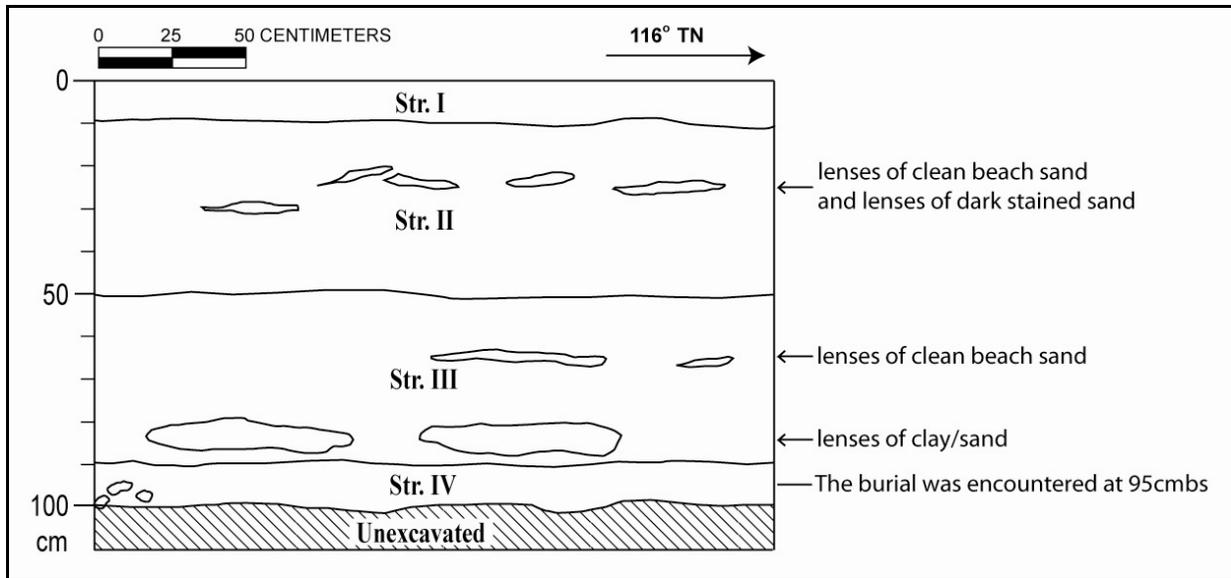
Figure 12. Profile of Type D stratigraphic sequence, from an excavation on the northwest side of the project area, near the construction zone fence.

Stratum IV (90 cmbs-BOE) 10 YR 3/2 Very dark grayish brown clay; weak, fine crumb structure with moist very firm consistency; plastic; terrestrial sediment. Lenses of pale brown beach sand and silty clay/sand were identified in this layer. (Burial site SIHP # 50-80-07-6705 was discovered in this stratum).

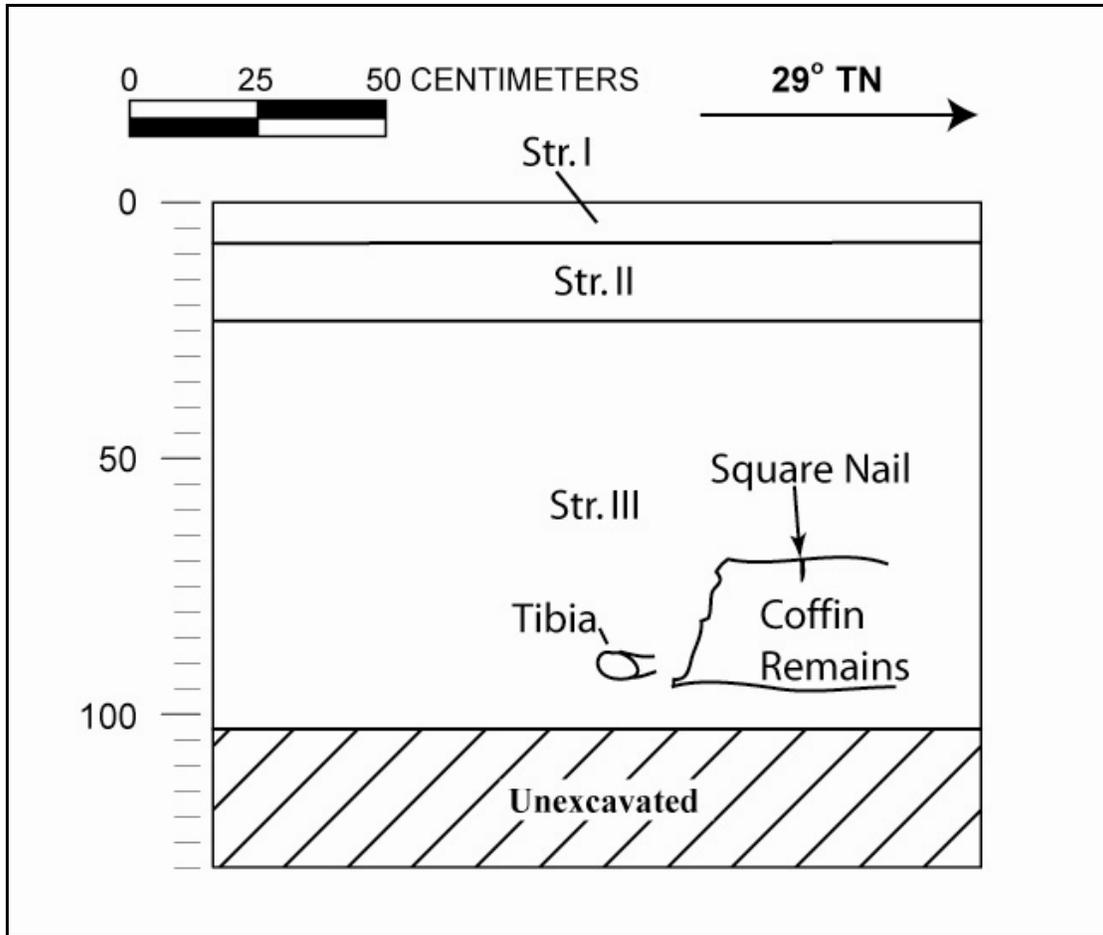
Figure 15. Stratigraphic profile of SIHP # 50-80-07-6704.

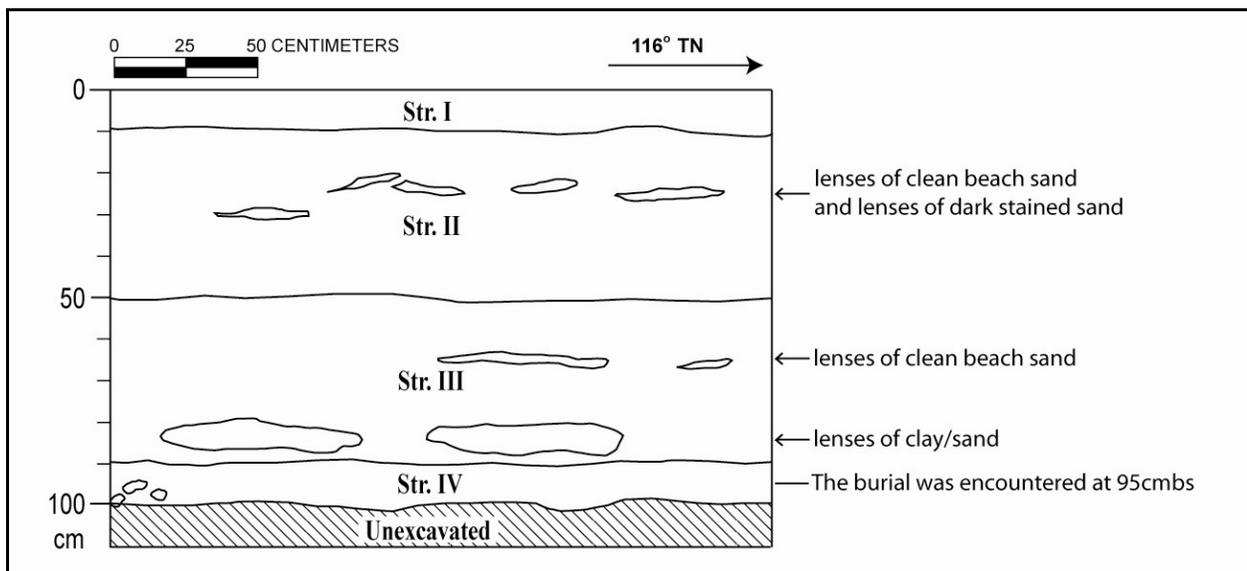
Figure 17. Stratigraphic profile of Site 50-80-07-6705 showing the stratigraphic sequence in the vicinity of Site 50-80-07-6705.
