SUBJECT: Chapter 343, Hawaii Revised Statutes
Draft Environmental Assessment
Shoreline Setback Variance

Project: After-the-fact Deck and Retaining Wall
Applicant: Kristen and Joseph Souza
Agent: Structural Hawaii
Location: 47-079 Kamehameha Highway - Kahaluu
Tax Map Key: 4-7-19: 49
Request: Shoreline Setback Variance
Proposal: To retain an unauthorized concrete deck/retaining wall and to construct an additional wooden/composite stairway within the 40-foot shoreline setback.

Project Name: Souza Residence concrete deck and stairway in the 40-foot shoreline setback
 Island: Oahu
 District: Kahaluu
 TMK: 4-7-19: 49
 Permits: After-the-fact Shoreline Setback Variance
 Approving Agency: Department of Planning and Permitting,
 City and County of Honolulu
 650 South King Street,
 Honolulu, Hawaii 96813
 Steve Tagawa, (808)768-8024
 Applicant: Joseph and Kristen Souza
 47-079 Kamehemeha Highway
 Kaneohe, Hawaii 96734
 Consultant: Structural Hawaii
 1255 Kuala Street #2
 Pearl City, Hawaii 96782
 Riza Gatlula, (808)488-5000

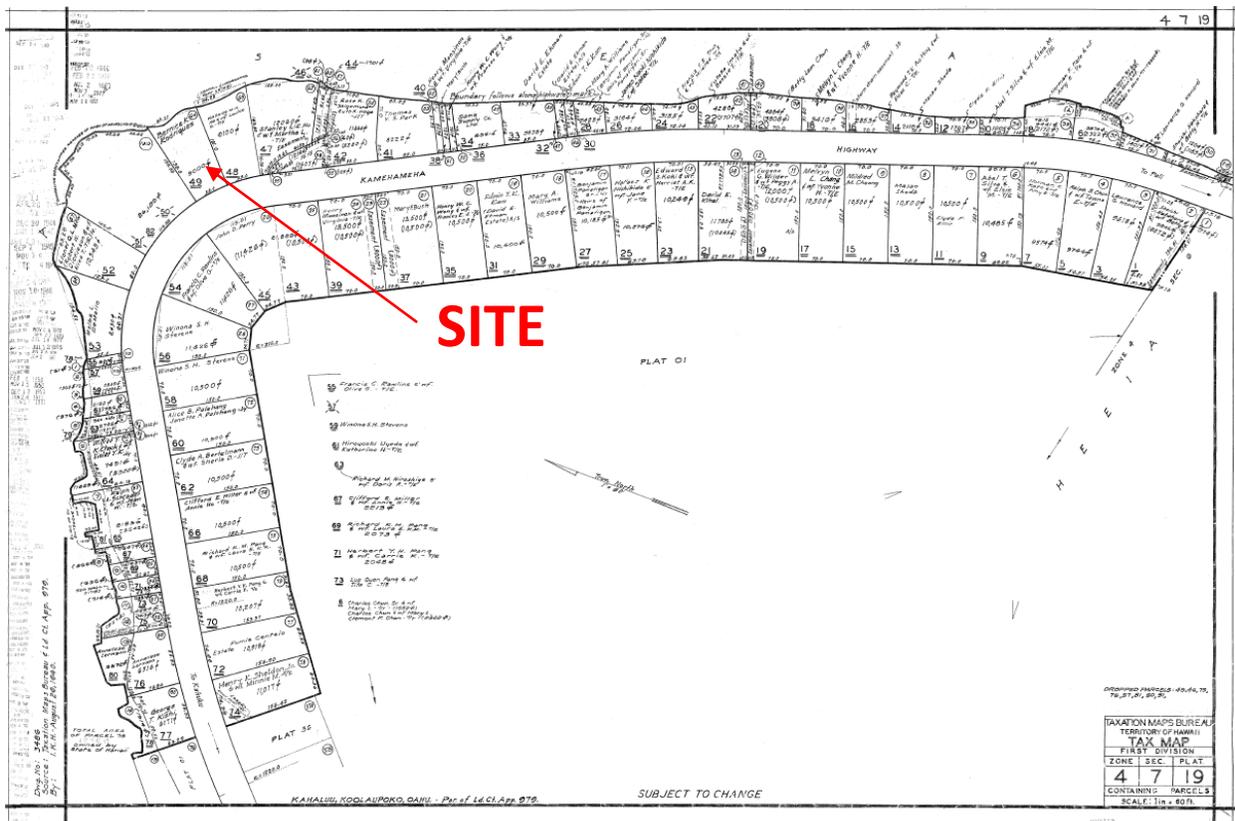
Figure 2-1: Plat Plan

The project site, with TMK 4-7-017:049, is located on 47-079 Kamehameha Highway Kaneohe, Hawaii, within a residential neighborhood along the shore of Kaneohe Bay. The site is 9000 square feet (0.21 acres) and sits about thirty feet above Kaneohe Bay. See project plat plan on Figure 2-1.

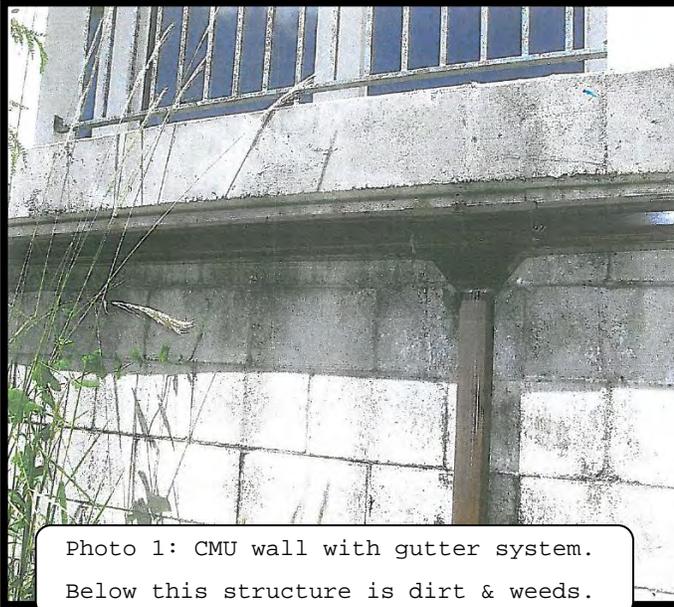
Photo 1: CMU wall with gutter system. Below this structure is dirt & weeds.

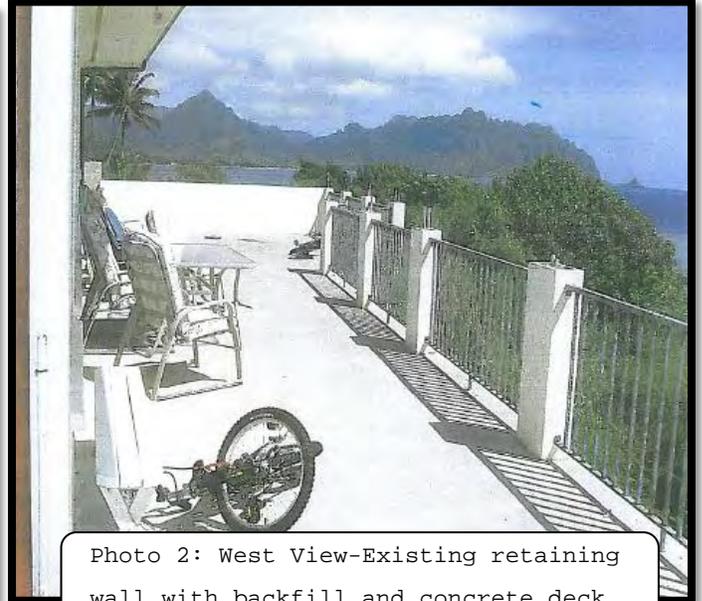
Photo 2: West View-Existing retaining wall with backfill and concrete deck.

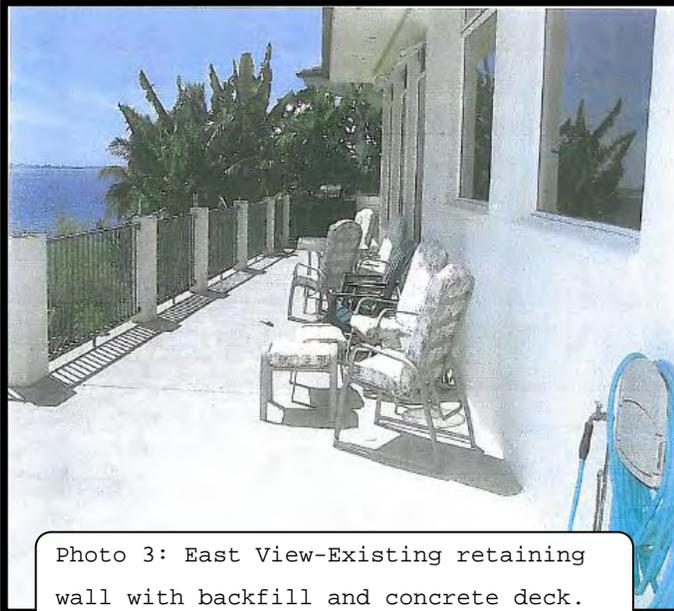
Photo 3: East View-Existing retaining wall with backfill and concrete deck.

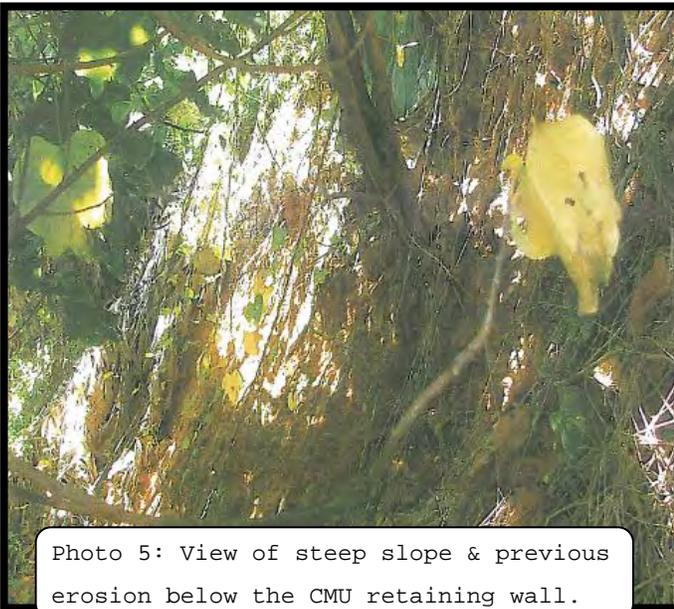
Photo 5: View of steep slope & previous erosion below the CMU retaining wall.

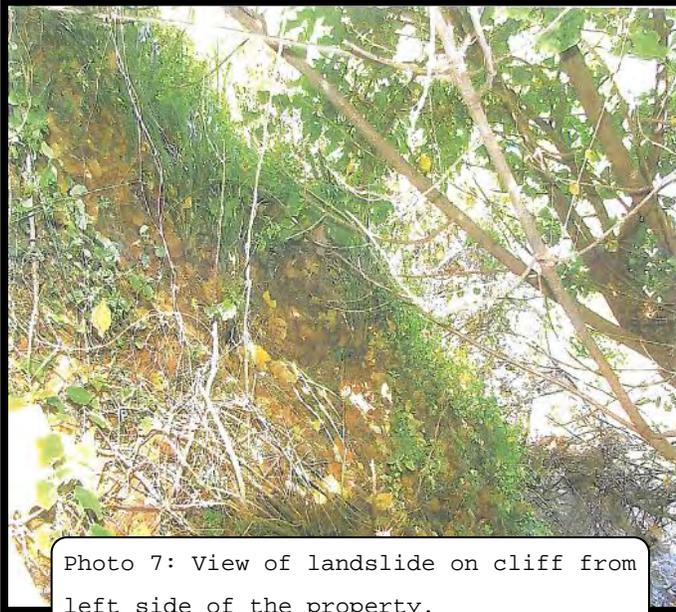
Photo 7: View of landslide on cliff from left side of the property.

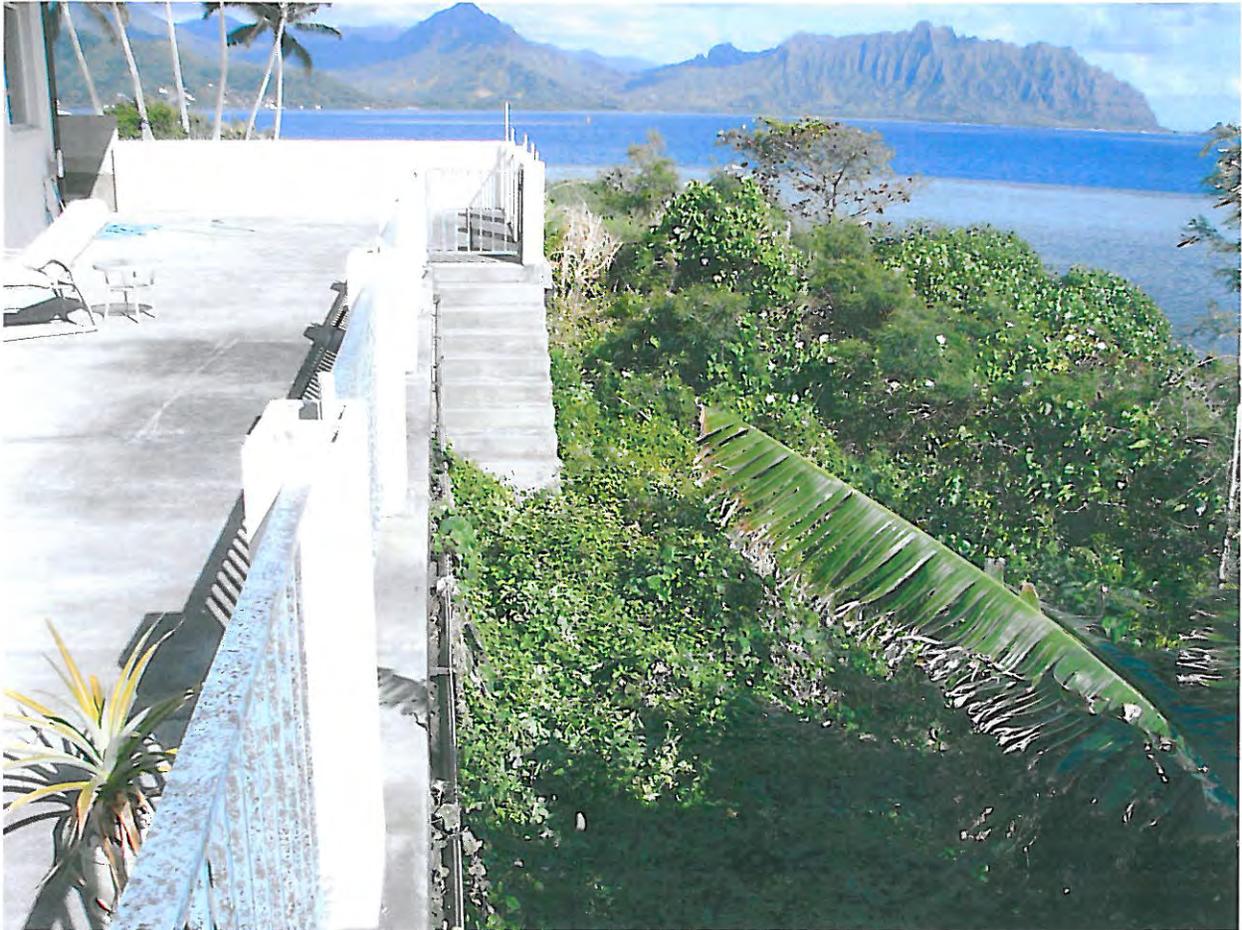
The property stretches from Kamehameha Highway to the Kaneohe Bay shoreline. The lot grades downward gently from street level to the edge of the seaward cliff. The cliff itself descends sharply from about 32 feet elevation to sea level at an average slope of approximately 45°. A residence occupies the majority of the lot and includes a rear concrete porch extending to within about 5 feet of the head of the steep shorefront slope. A set of narrow stairs leads partly down to the ocean. The steep slope is overgrown with trees and low-laying vegetation (Figure 2).

Figure 2. Rear portion of property with steep seaward cliff on the right.

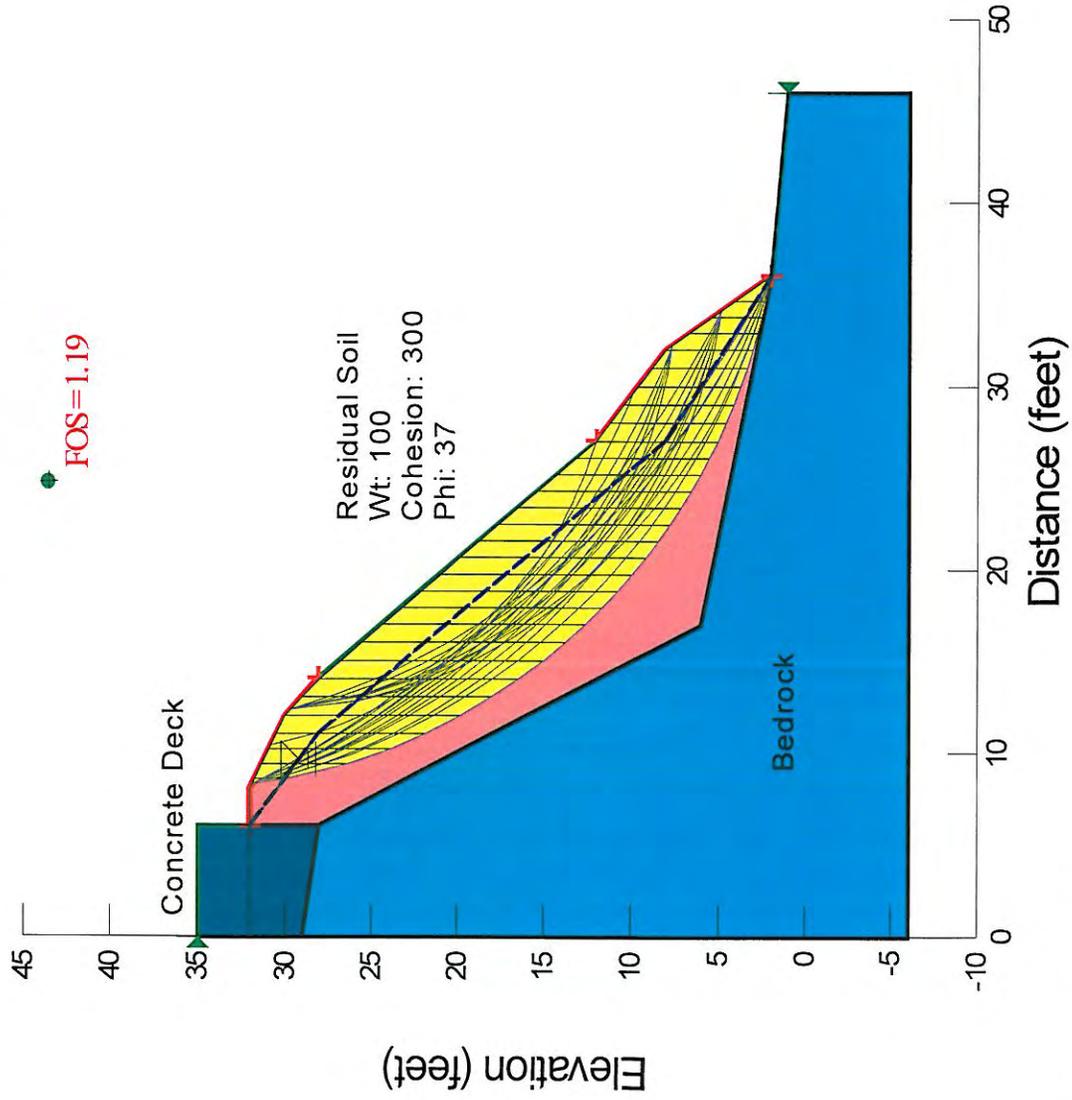
Figure 4

Stability Analysis - Line AA

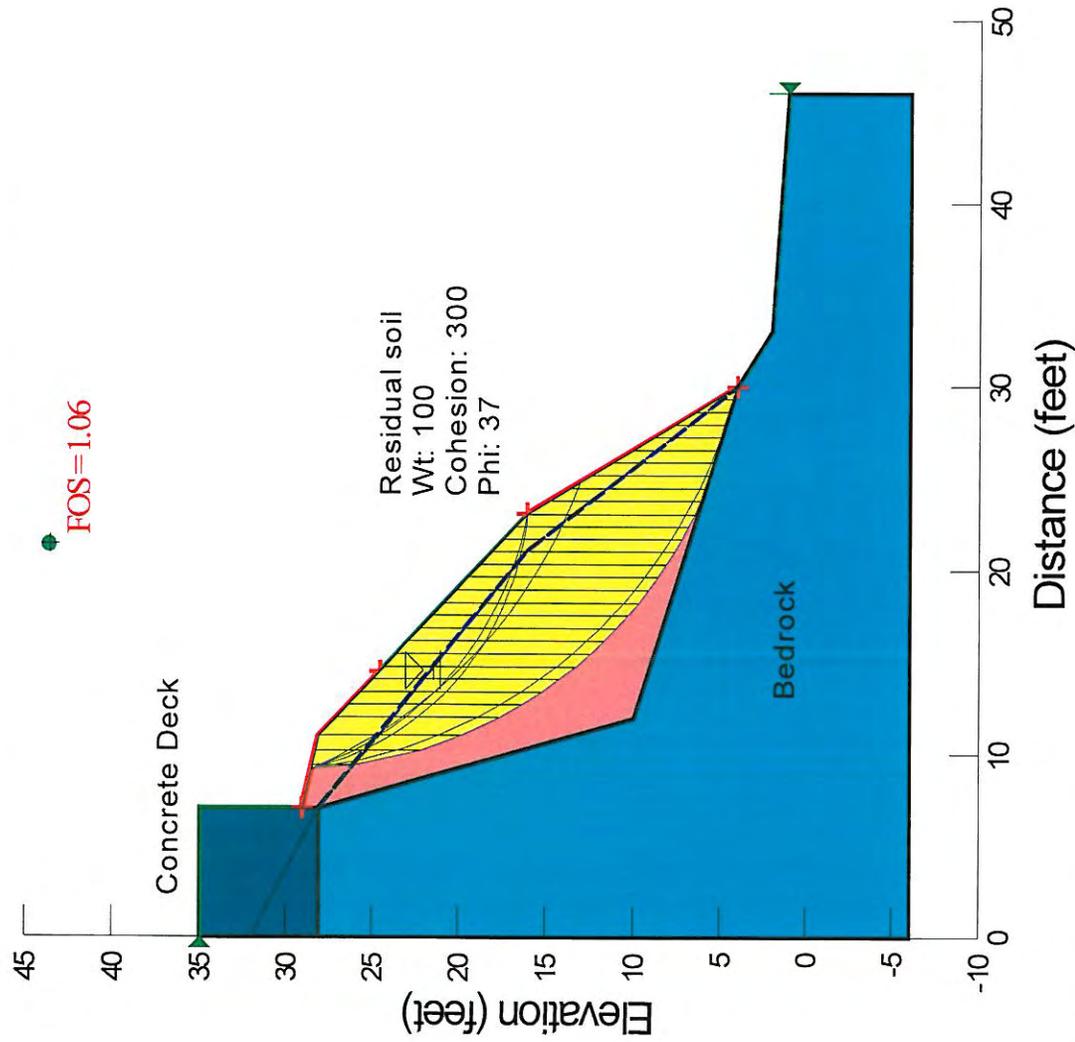
Stability Analysis - Line BB

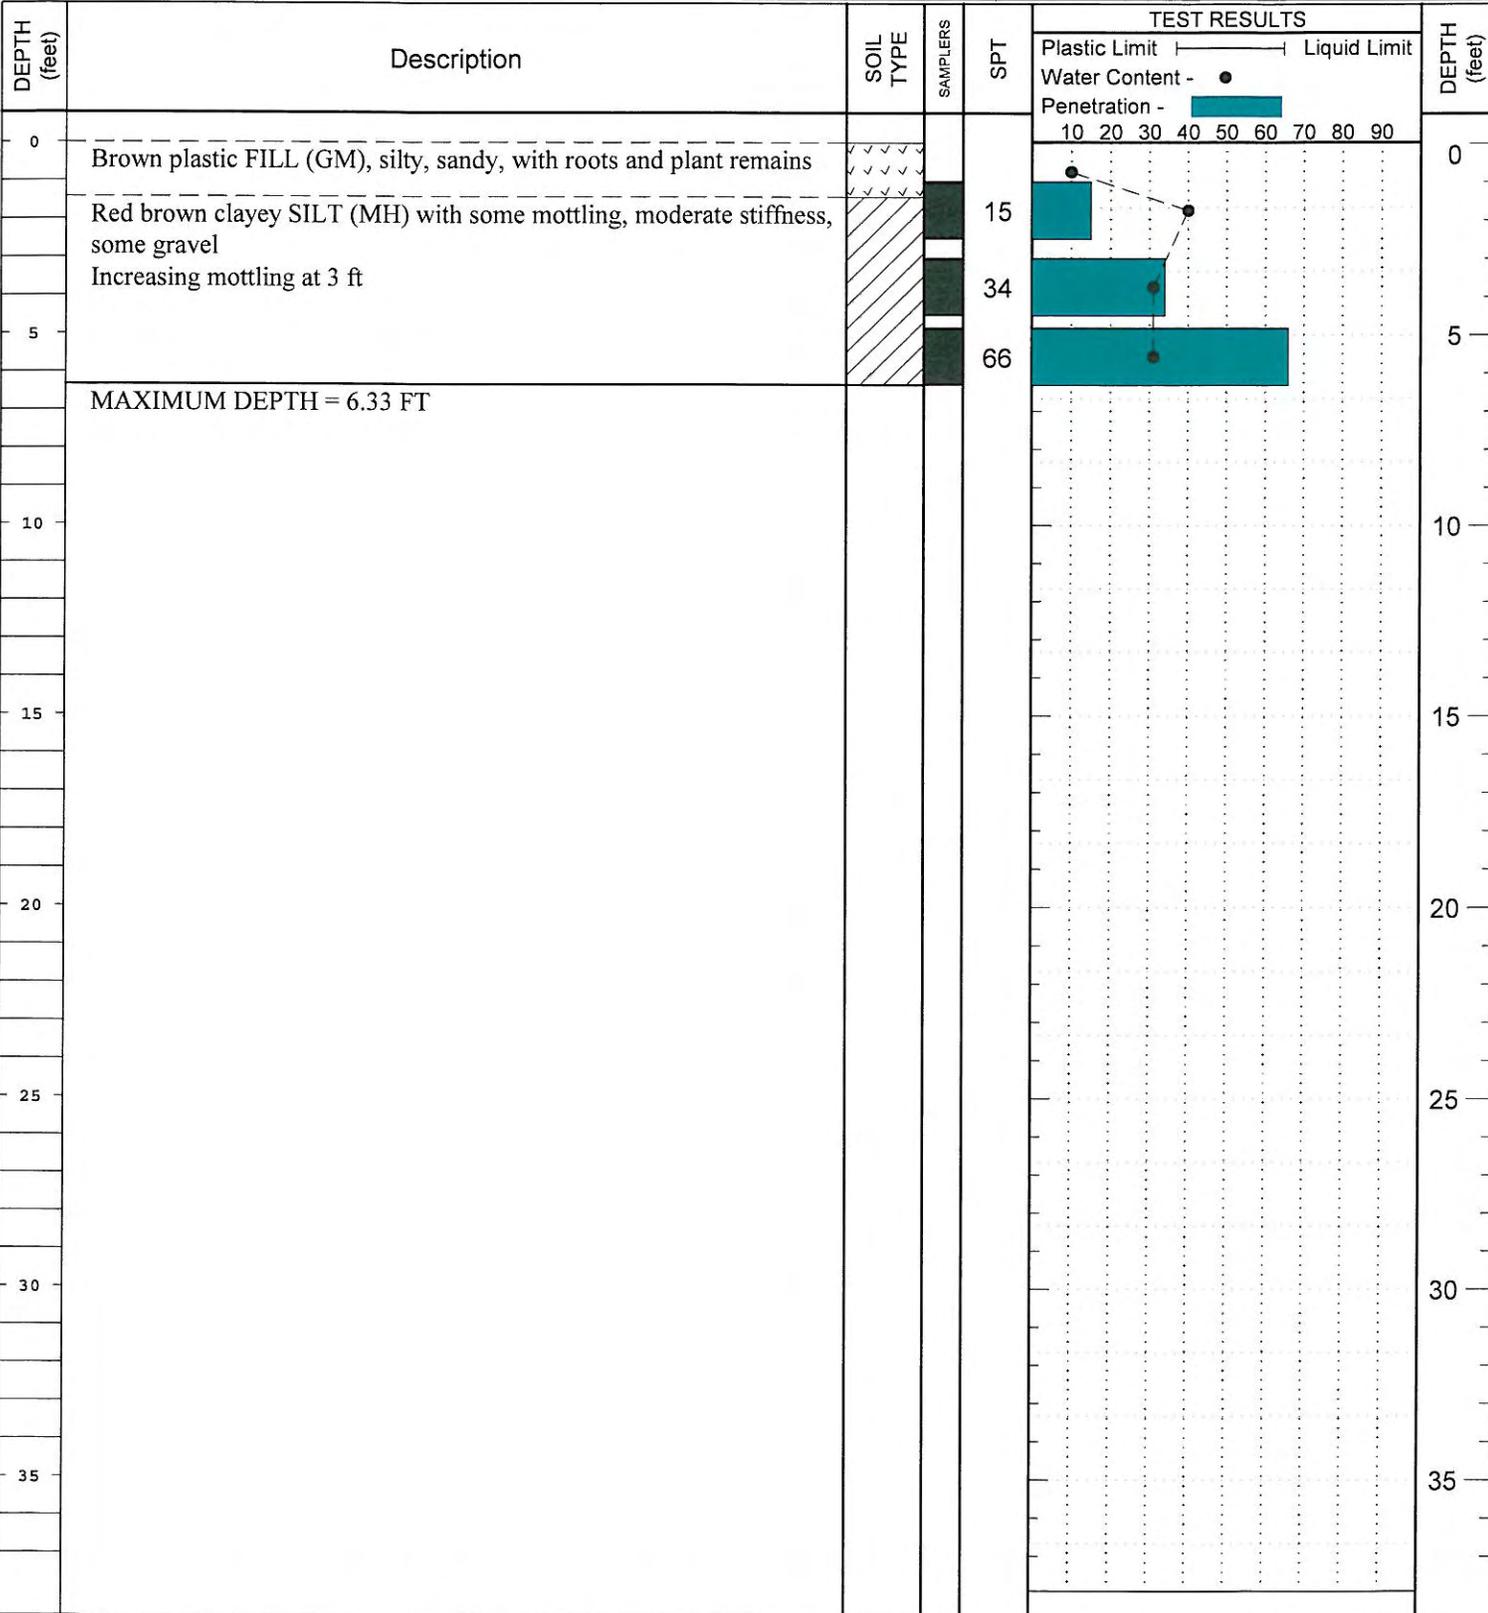
Hand-held drilling rig with 35-lb hammer dropping a distance of 48"

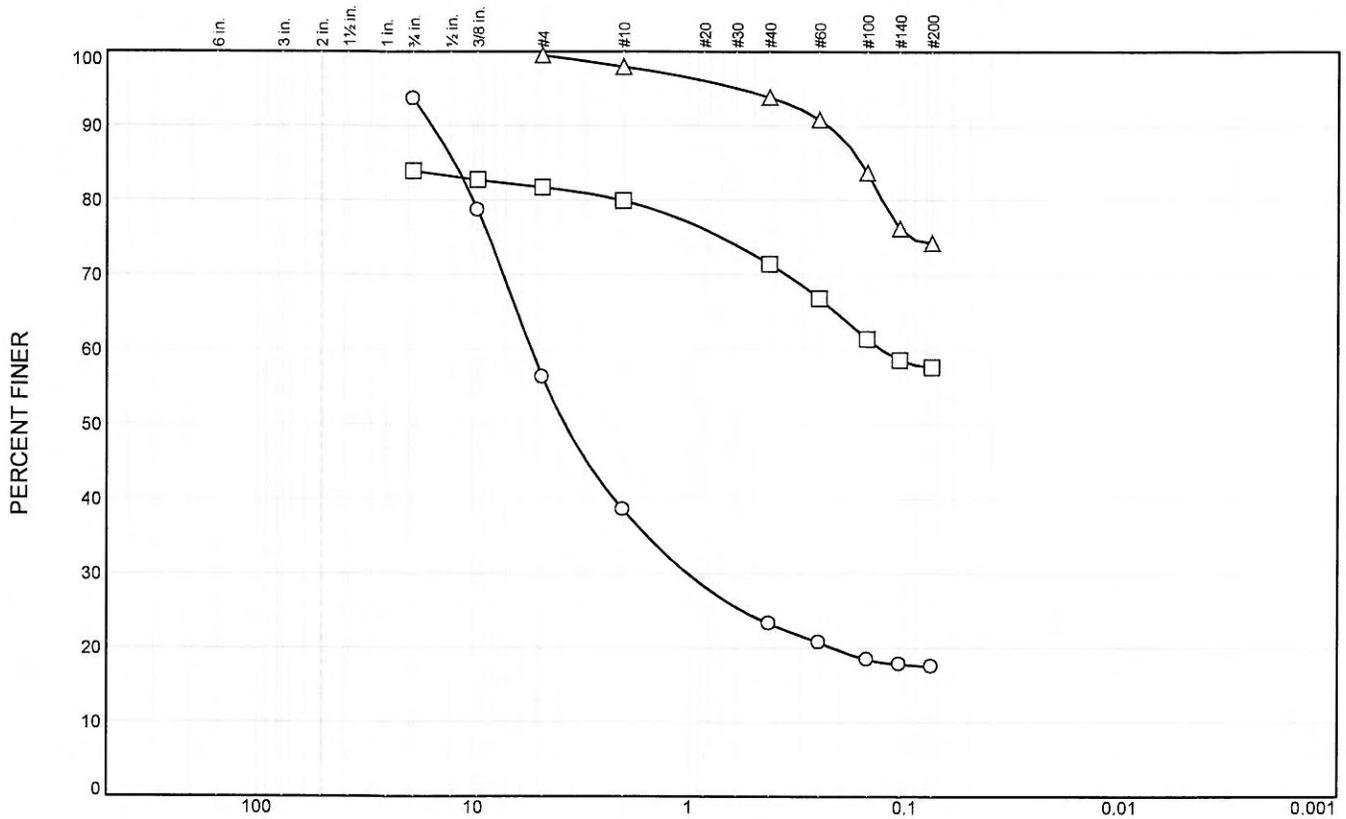
Figure B1

Particle Size Distribution Report

% +3"	% Gravel		% Sand			% Fines	
		Coarse	Fine	Coarse	Medium	Fine	Silt	Clay
○			37.3	17.8	15.2	5.8		17.5
□			2.2	1.8	8.4	13.9		57.6
△				1.6	4.1	19.5		74.3

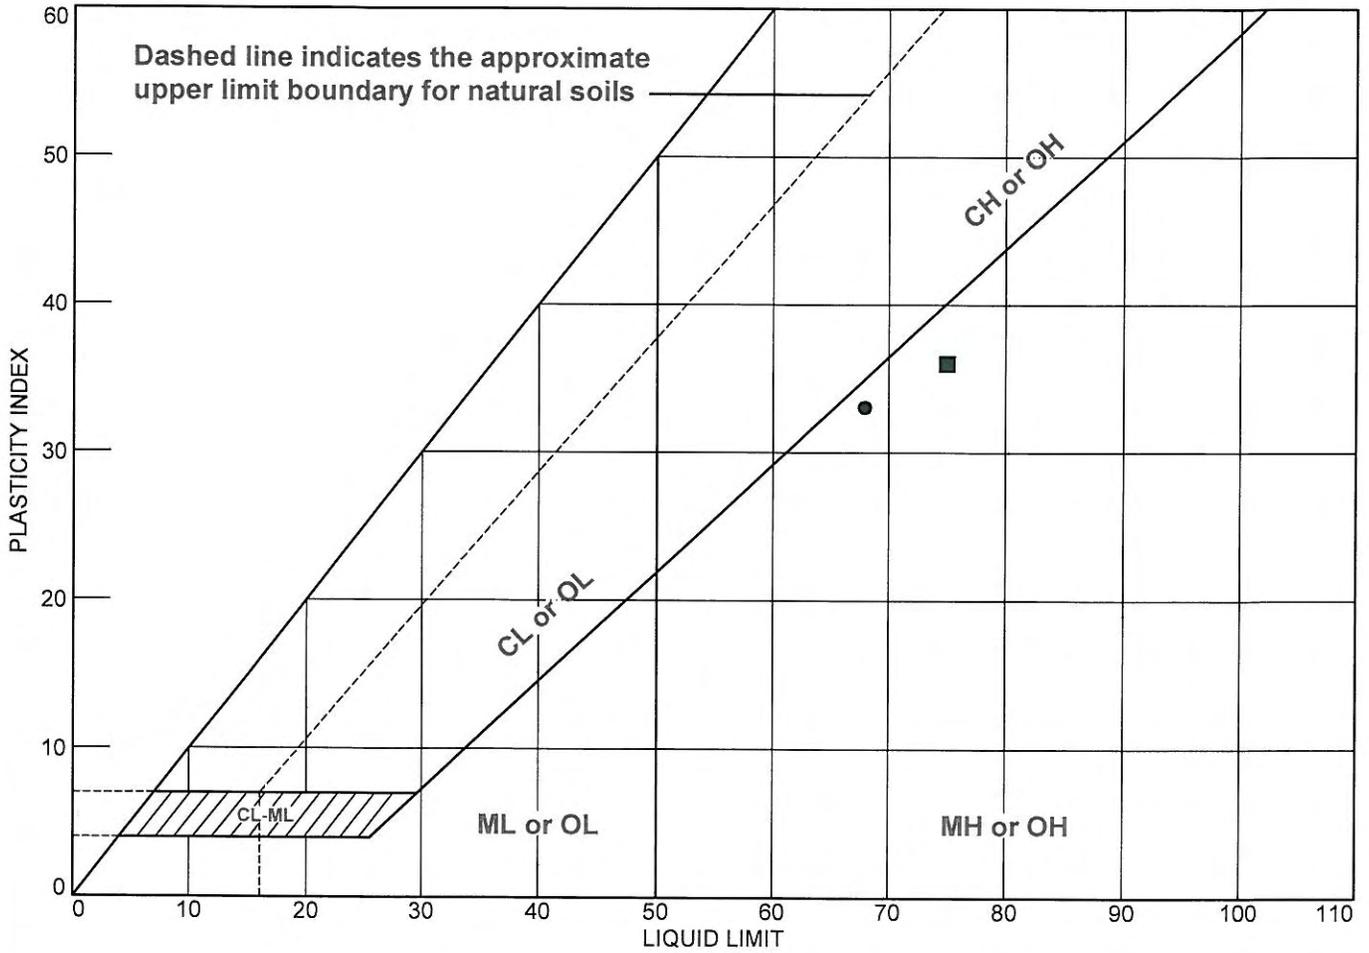
Figure B2

LIQUID AND PLASTIC LIMITS TEST REPORT

SOIL DATA								
SYMBOL	SOURCE	SAMPLE NO.	DEPTH	NATURAL WATER CONTENT (%)	PLASTIC LIMIT (%)	LIQUID LIMIT (%)	PLASTICITY INDEX (%)	USCS
●	B2		2.25	30	35	68	33	MH
■	B3		6.75	38	39	75	36	MH

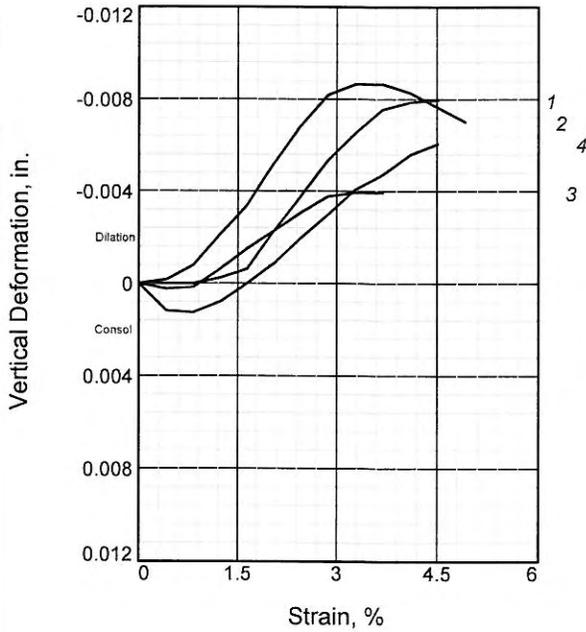
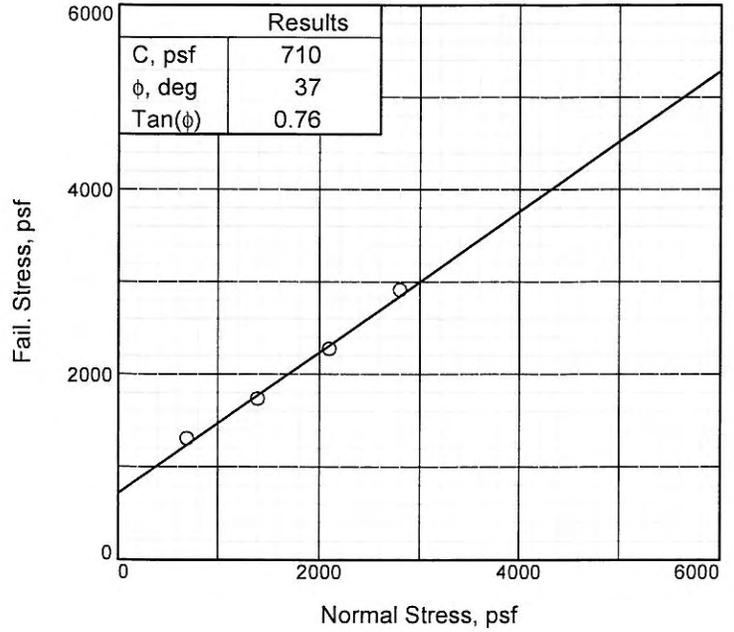
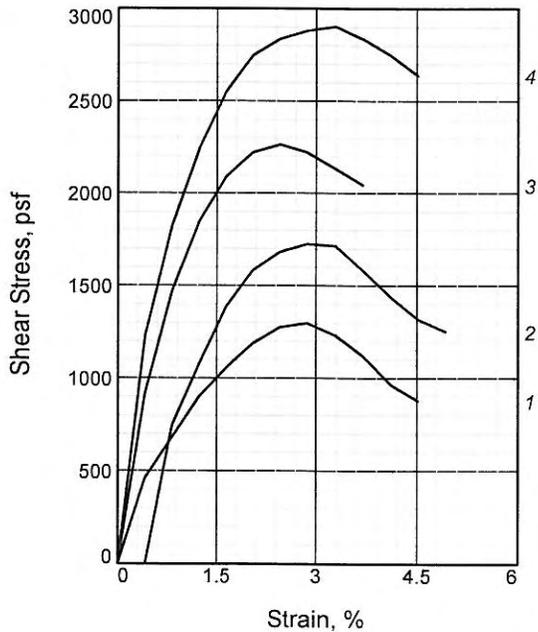
Direct Shear Tests: B3 @ 6'

Sample No.	1	2	3	4	
Initial	Water Content, %	41.0	40.0	38.7	38.2
	Dry Density, pcf	80.9	83.2	83.9	84.8
	Saturation, %	91.4	93.5	91.9	92.4
	Void Ratio	1.3915	1.3267	1.3059	1.2813
	Diameter, in.	2.40	2.40	2.40	2.40
	Height, in.	1.00	1.00	1.00	1.00
At Test	Water Content, %	44.2	42.6	41.3	41.0
	Dry Density, pcf	81.6	84.0	84.8	85.9
	Saturation, %	99.9	101.3	99.8	101.4
	Void Ratio	1.3723	1.3034	1.2828	1.2539
	Diameter, in.	2.40	2.40	2.40	2.40
	Height, in.	0.99	0.99	0.99	0.99
Normal Stress, psf	701	1403	2105	2807	
Fail. Stress, psf	1298	1727	2266	2903	
Strain, %	2.9	2.9	2.5	3.3	
Ult. Stress, psf					
Strain, %					
Strain rate, in./min.	0.04	0.04	0.04	0.04

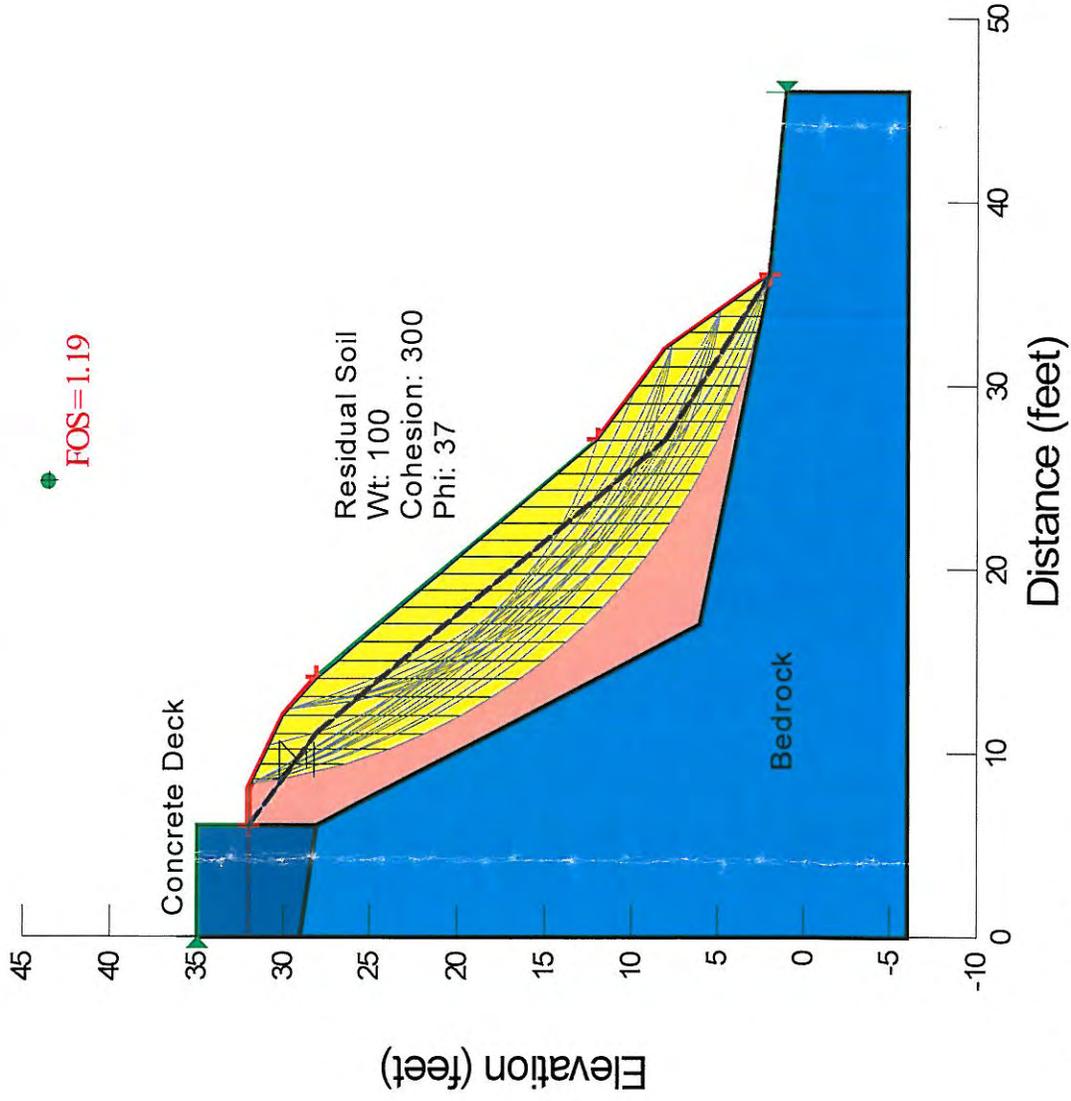
Stability Analysis - Line AA

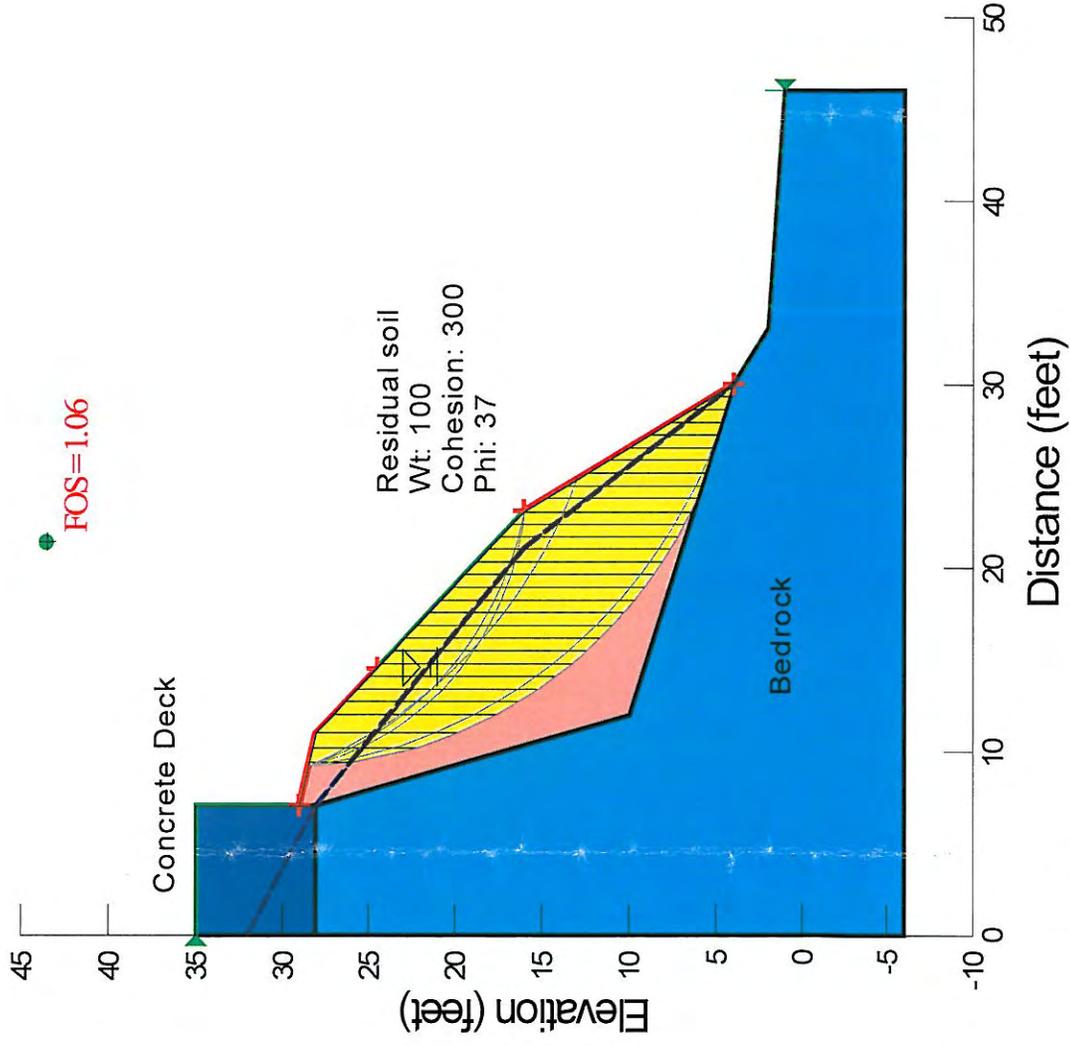
Stability Analysis - Line BB

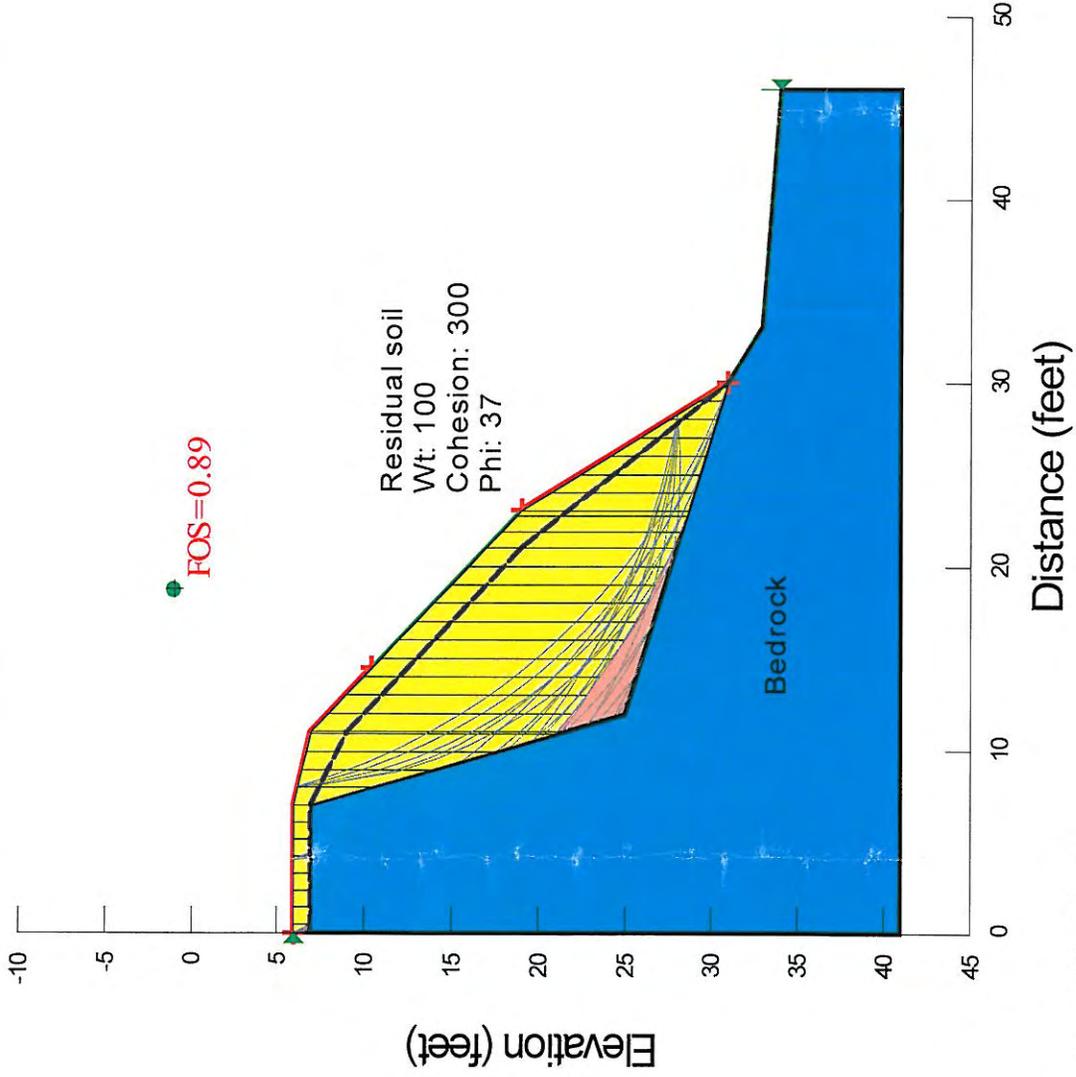
Stability Analysis Without Concrete Deck - Line BB

According to extended analysis made by Applied Geosciences, LLC, removal of the concrete deck would expose critical areas in the back of the slope to additional infiltration from rainfall, and hence would result in a much higher likelihood of mass erosion. This would cause a negative impact on the bay and therefore, undesirable from an environmental perspective. Large-scale slope instability could also compromise the safety of individuals if it were to be substantial enough to place the main house in jeopardy. Therefore, the concrete deck has played an important role in reducing the potential for slope instability and soil erosion and should remain.
