SUBJECT: Chapter 343, Hawaii Revised Statutes
Draft Environmental Assessment
Special Management Area Use Permit and
Shoreline Setback Variance

Project: Lee Residence and Seawall Reconstruction
Applicant: Kyoung-Su Im
Agent: Group 70 International, Inc. (Jeffrey Overton)
Location: 4465 and 4469 Kahala Avenue - Waialae Kahala
Tax Map Key: 3-5-3: 2 and 3
Request: Special Management Area Use Permit (SMP) and
Shoreline Setback Variance (SV)
Proposal: New Residence and Seawall Reconstruction within the 40-foot
shoreline setback.

KĀHALA RESIDENCE AND SHORELINE STRUCTURE

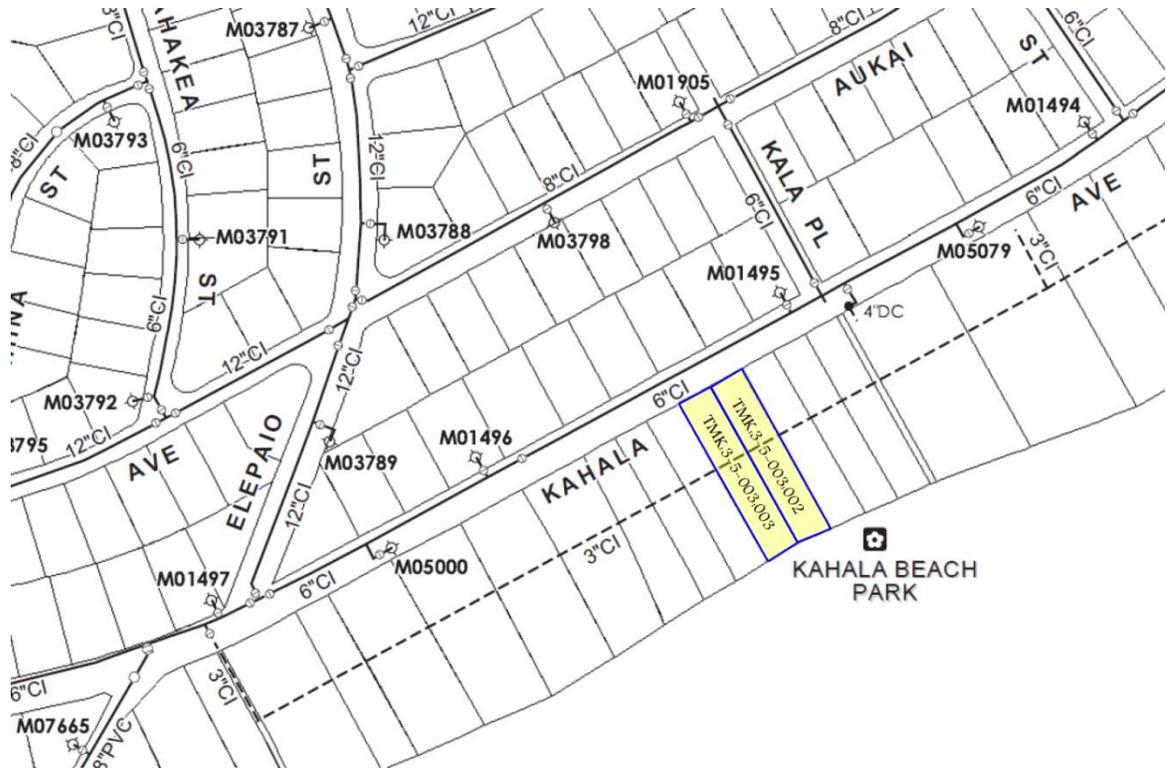
- A 12-inch diameter BWS CI water line in Elepaio Street approximately 800 feet west of the site and connecting to the 6-inch in Kāhala Ave.
- A 6-inch diameter BWS CI water line in Kala Place approximately 170 feet east of the site and connecting to the 6-inch in Kāhala Ave.
- A 6-inch diameter BWS CI water line in Uliuli Street approximately 750 feet east of the site and connecting to the 6-inch in Kāhala Ave.

FIGURE 3-4: EXISTING BWS WATER DISTRIBUTION MAP (NOT TO SCALE)

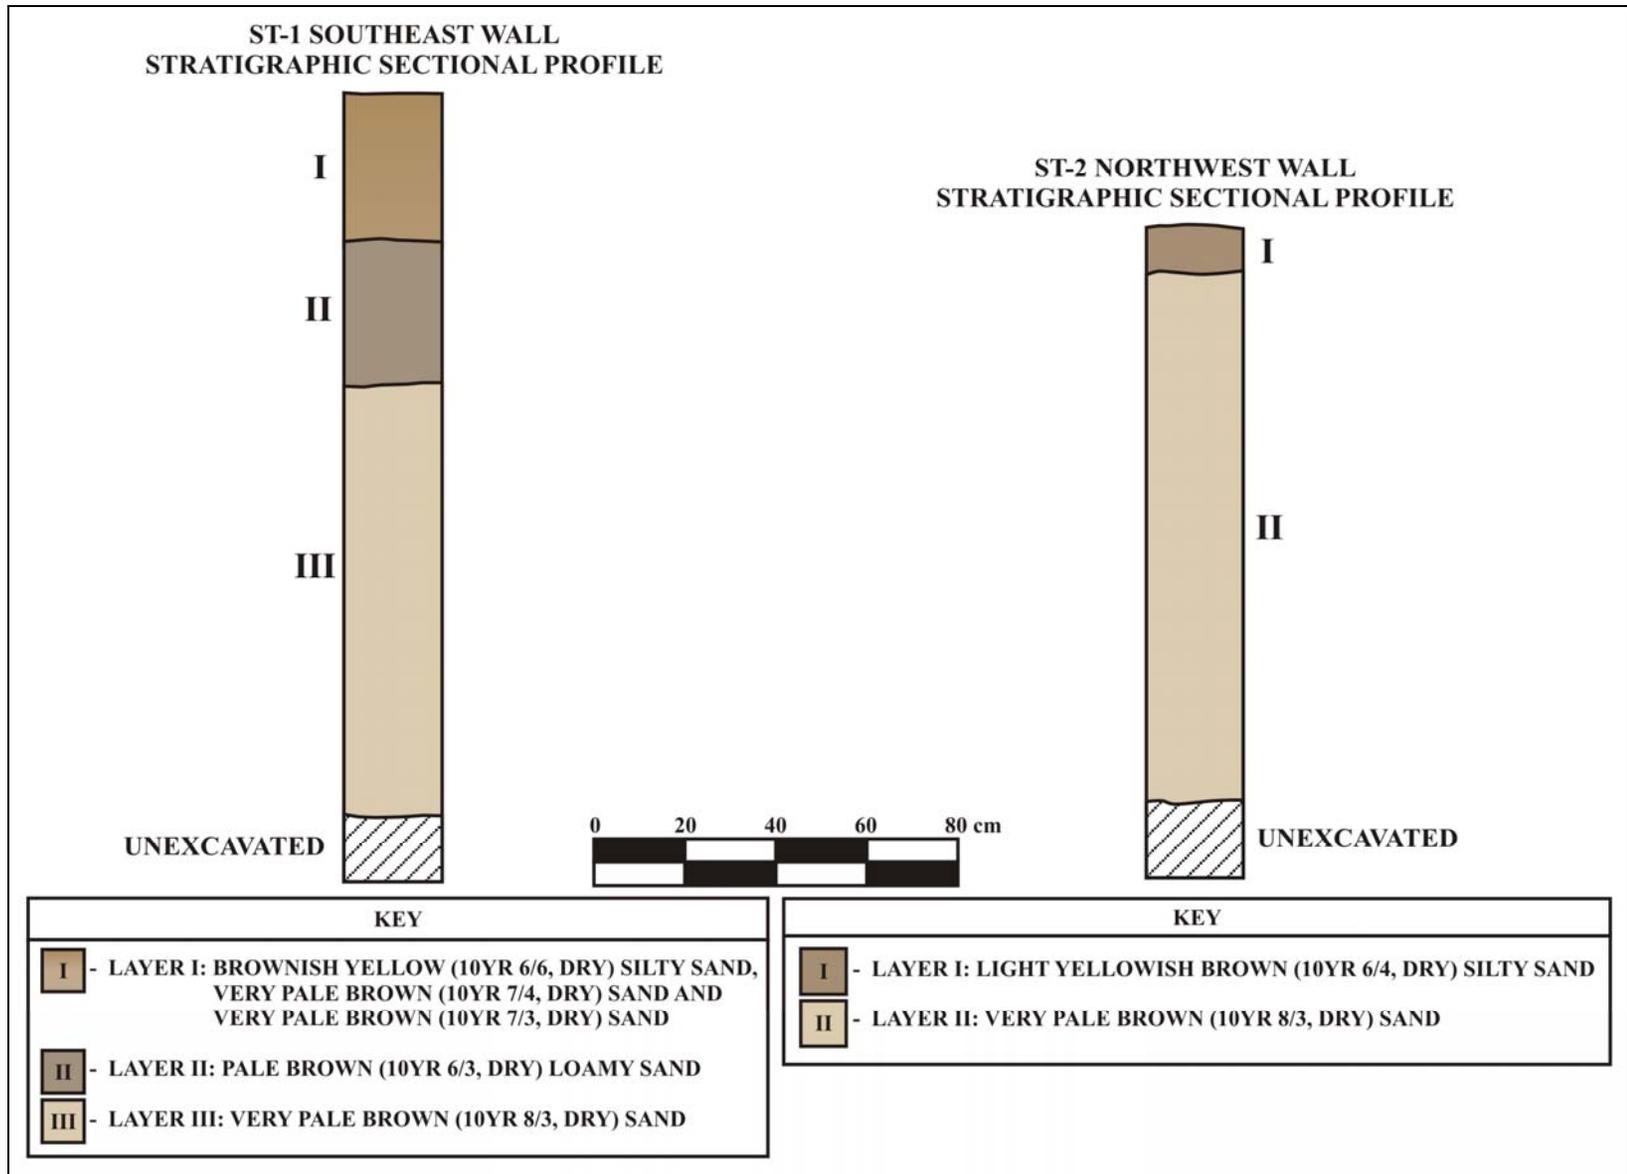
Figure 11: Stratigraphic profiles for Test Trenches ST-1 and ST-2.

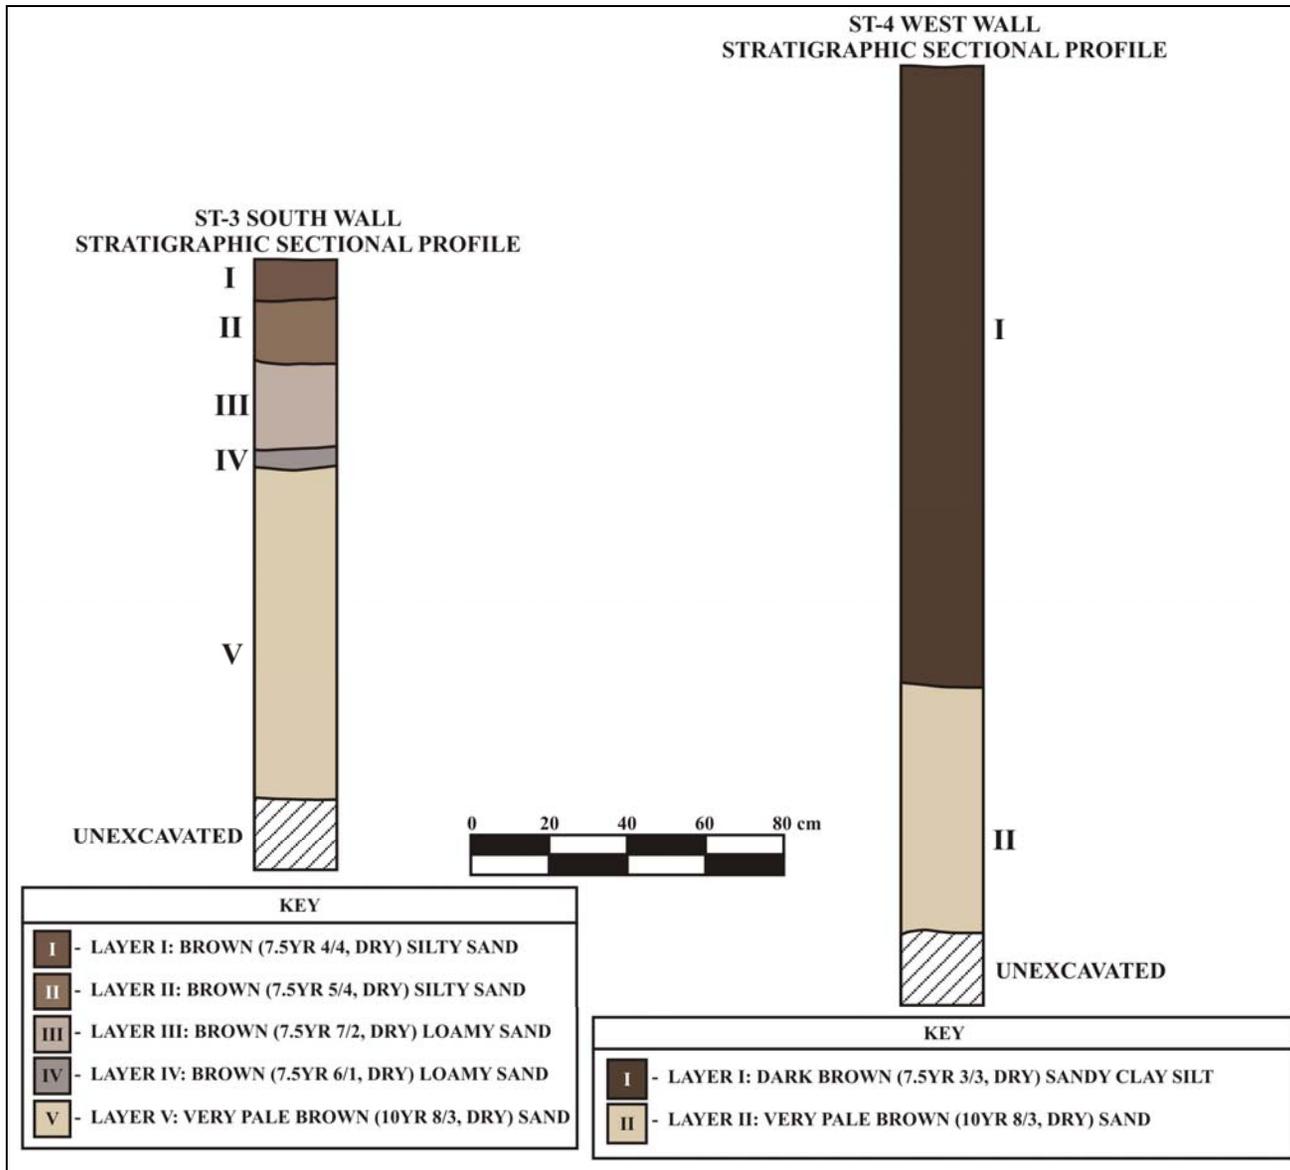
Figure 14: Stratigraphic profiles for Test Trenches ST-3 and ST-4.

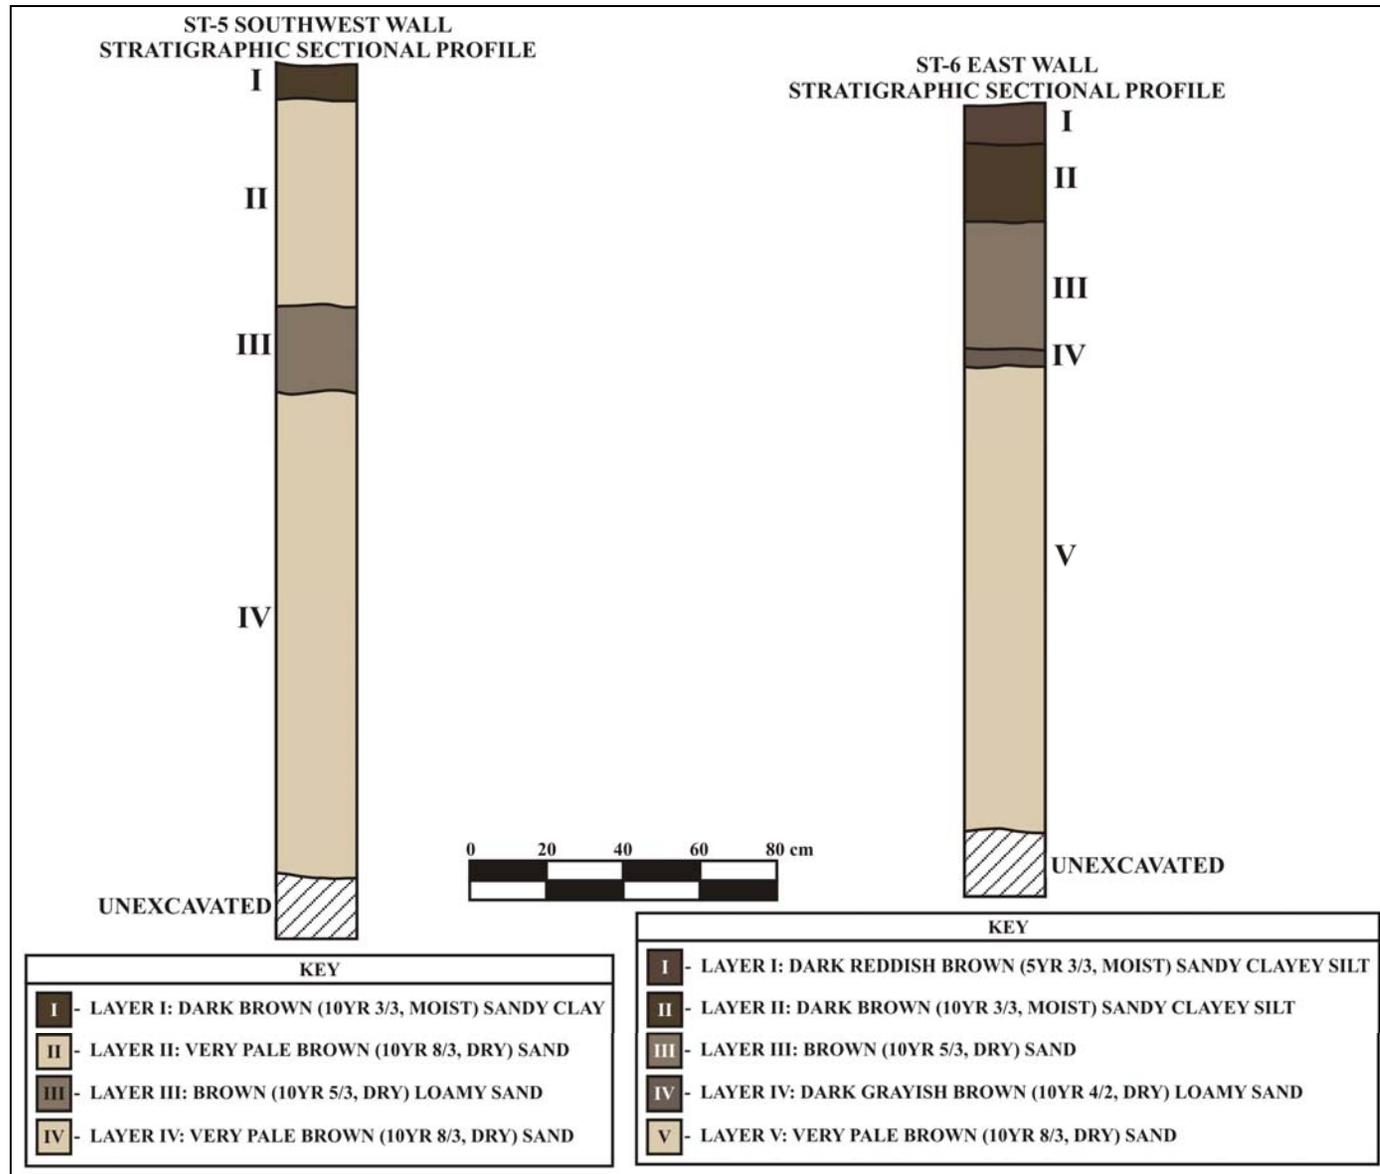
Figure 17: Stratigraphic profiles for Test Trenches ST-5 and ST-6.

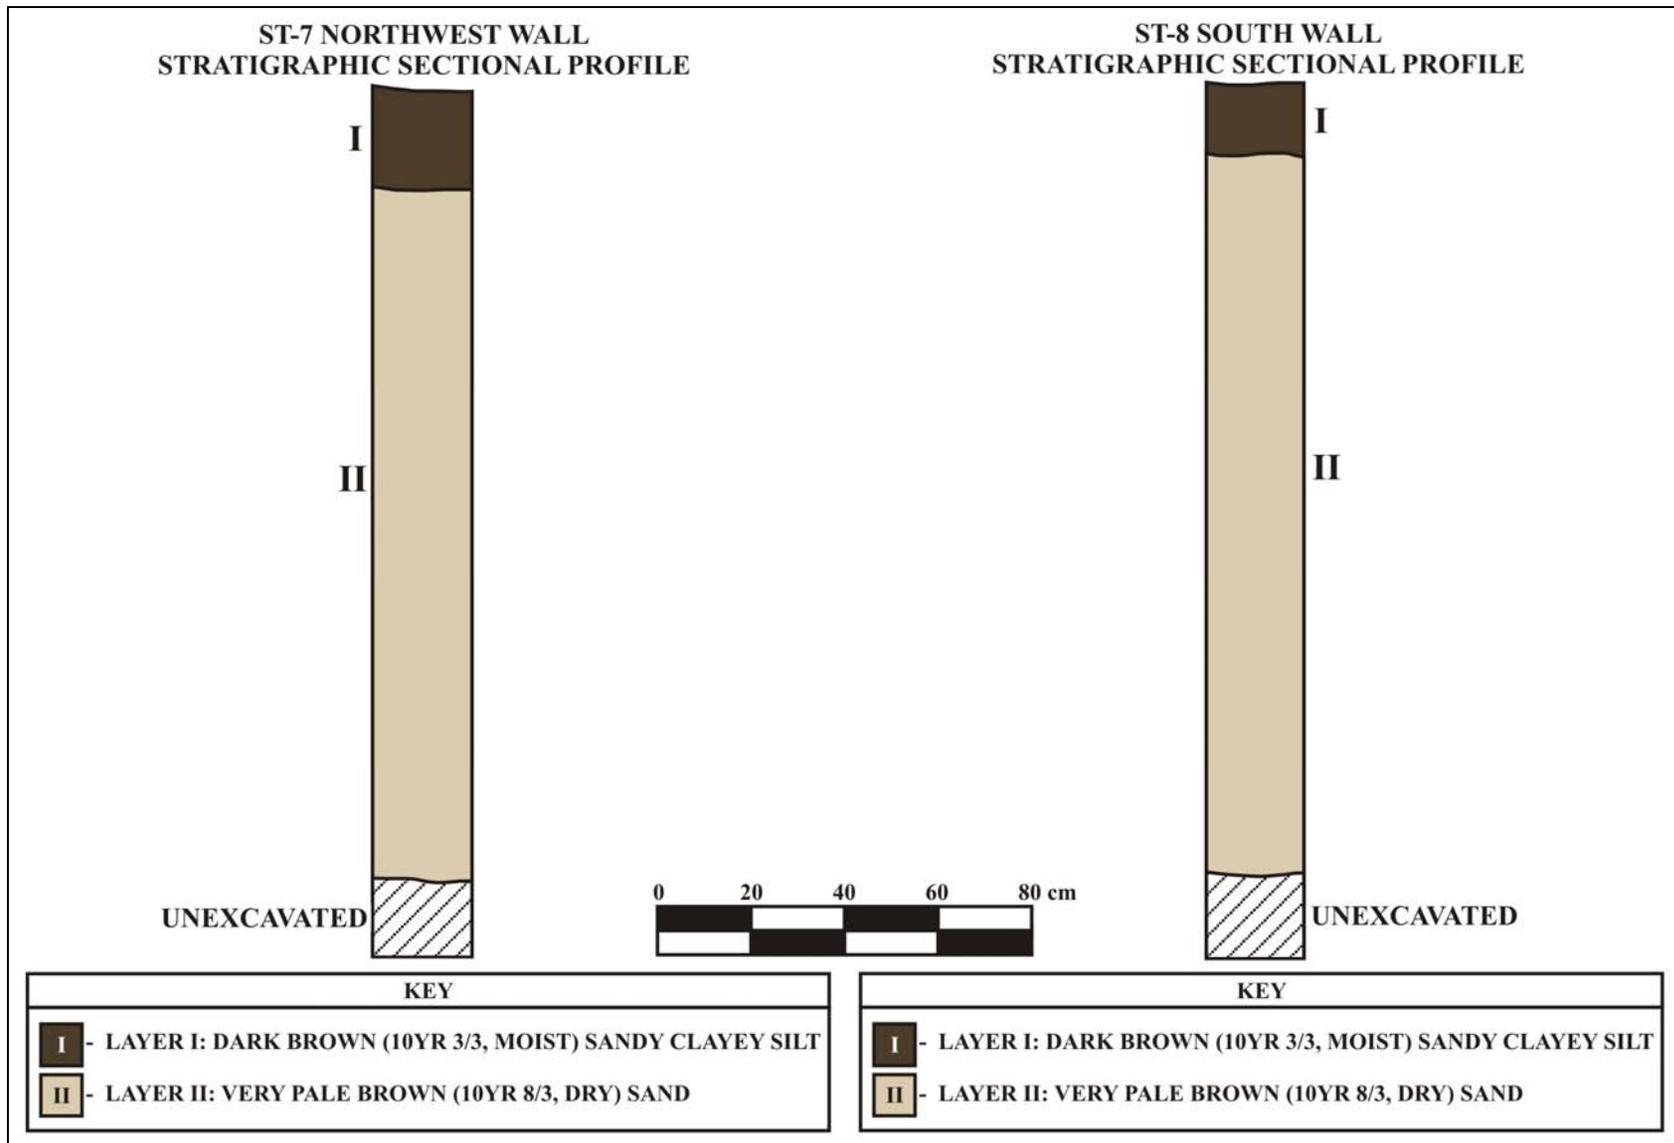
Test Trench-8 (ST-8) 6.2 m long by 0.8 m wide and 1.9 m deep) was placed northwest of ST-7, oriented East-West, near the driveway that ran along the northeast edge of the project area (see Figure 10). ST-8 contained two stratigraphic layers which are described below (Figure 20, Figure 22).

Figure 20: Stratigraphic profiles for Test Trenches ST-7 and ST-8.

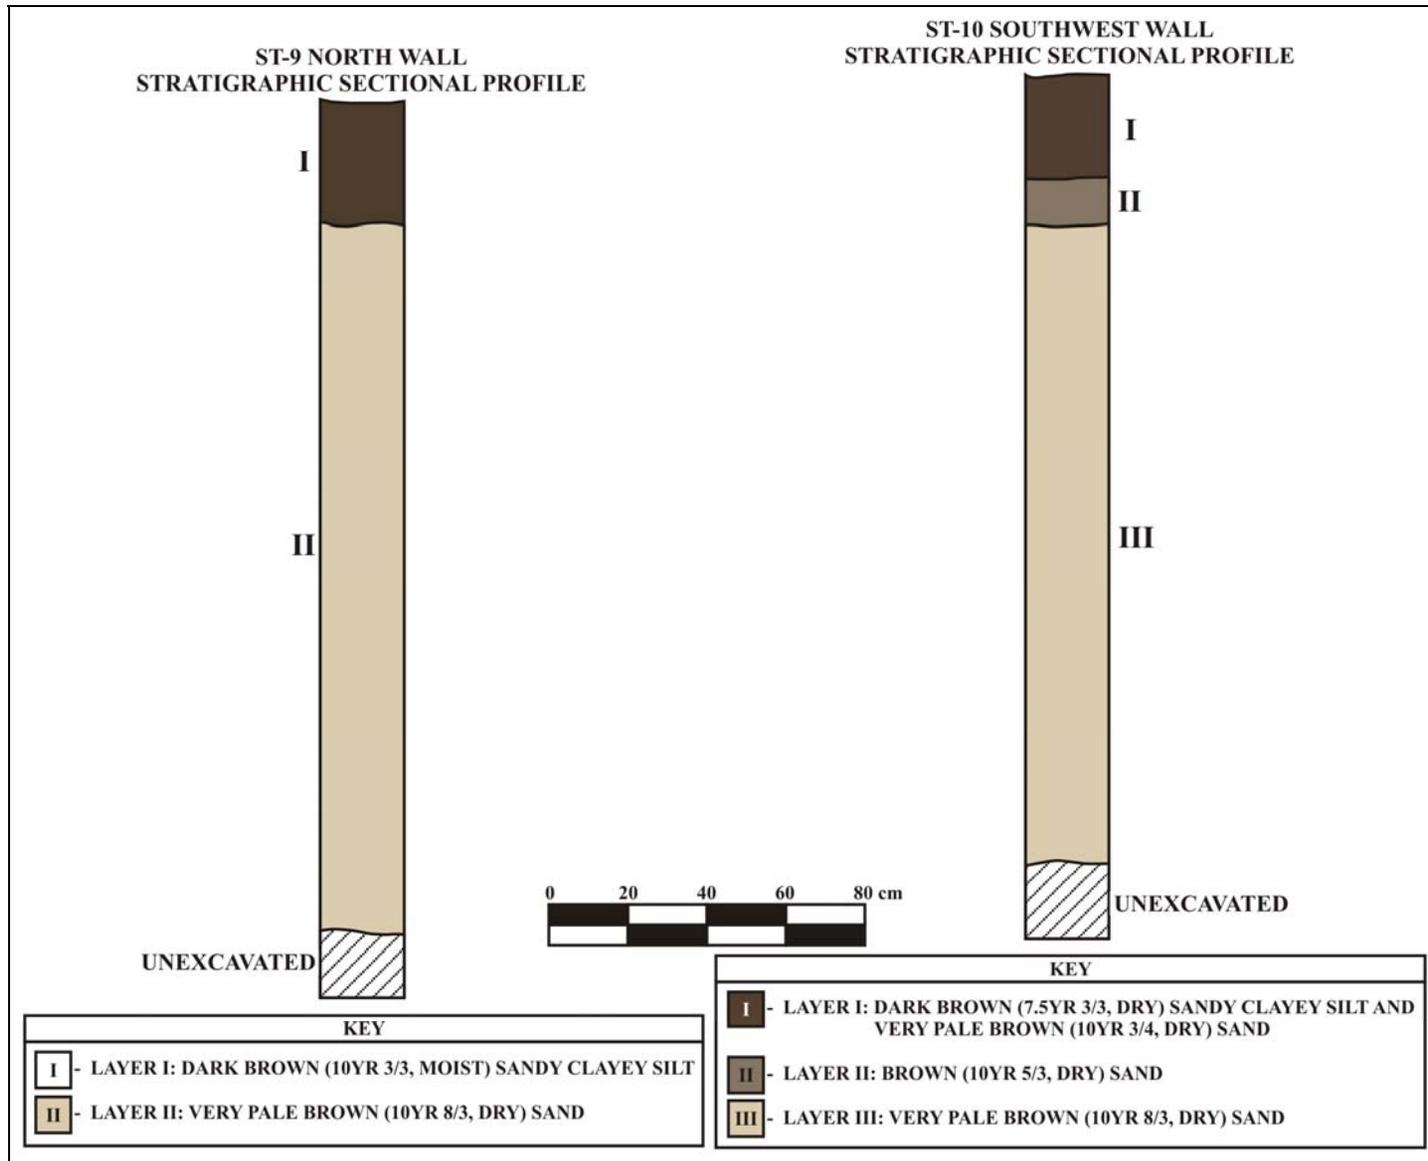
Figure 23: Stratigraphic profiles for Test Trenches ST-9 and ST-10.

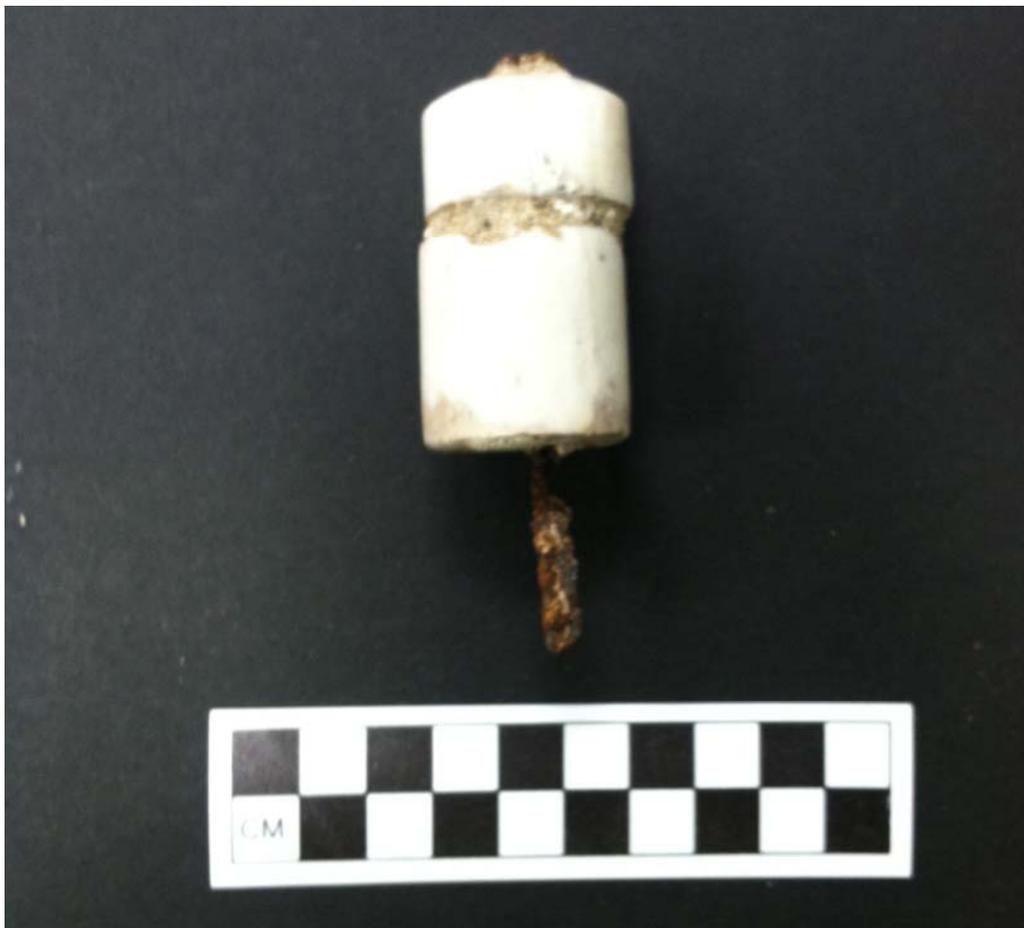
Three artifacts were collected for analysis; after cleaning in the laboratory the ceramic and glass sherds did not contain any diagnostic features. Analysis of the ceramic insulator (Figure) indicated that it was a porcelain "knob and tube" insulator commonly used from the 1880s until the 1940s. Based on its location (in a layer of fill sediment) it could not be determined whether the insulator was associated with a previous structure in the project area or if it had been introduced with the fill sediment.

Figure 26: Ceramic "knob and tube" insulator found in Layer I of ST-2.

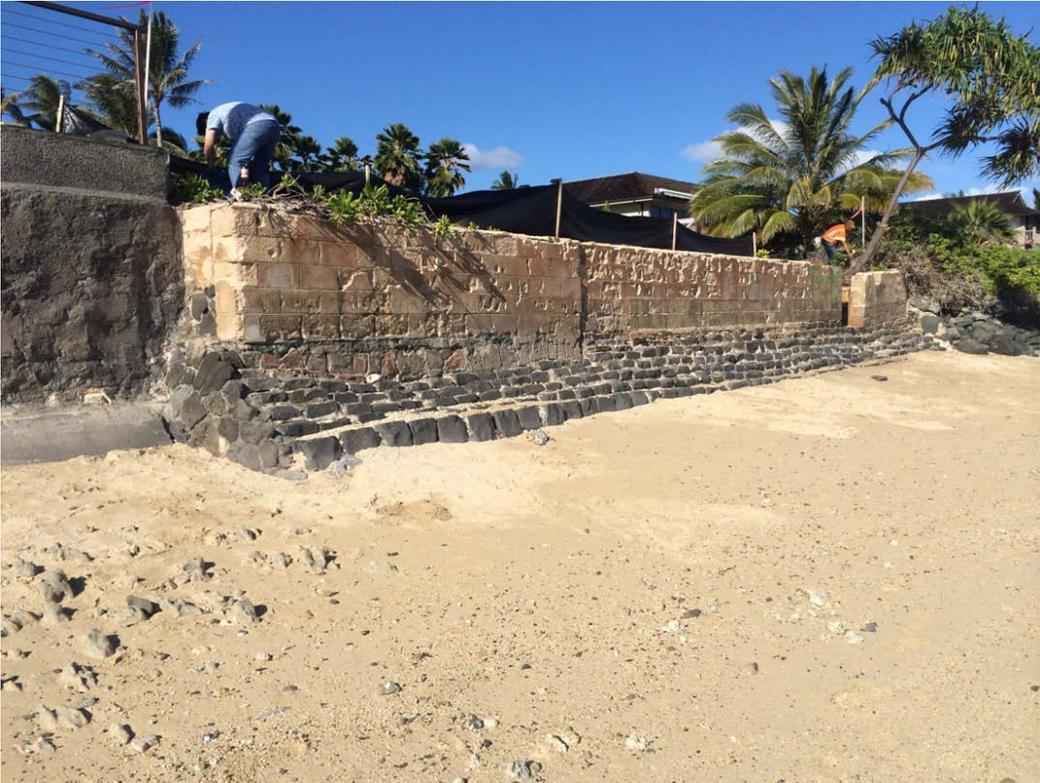
Figure 2-1 Seawall along western lot

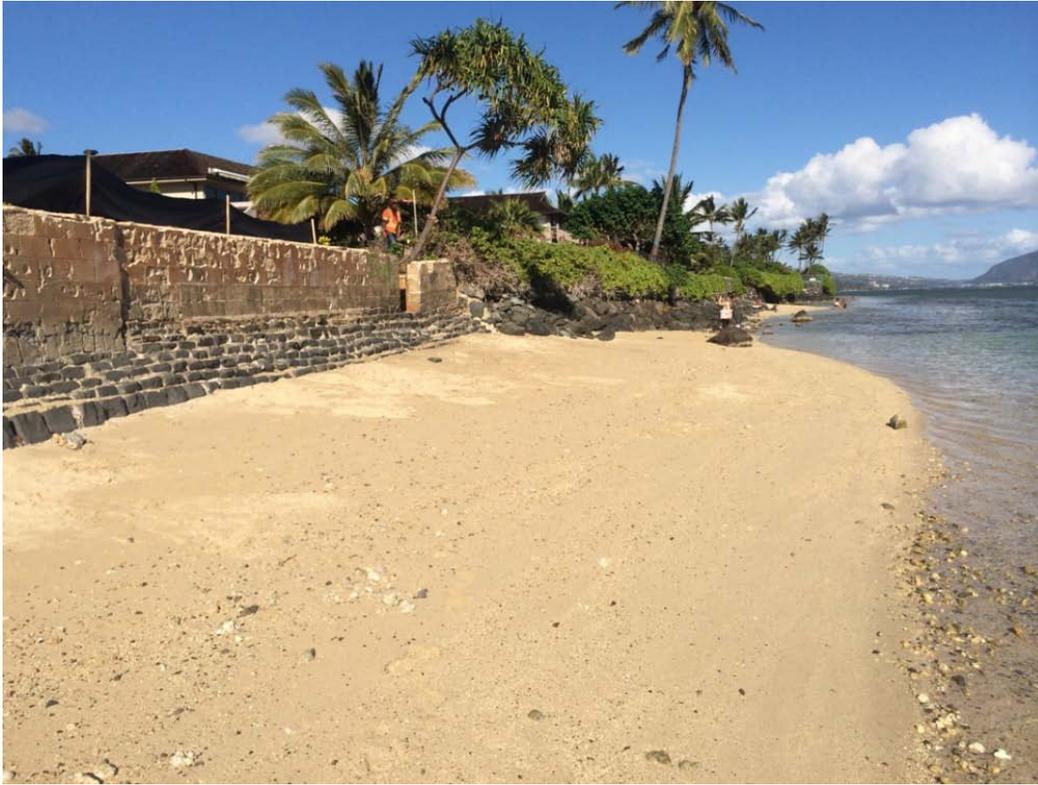
Figure 2-3 Narrow sand beach at project site

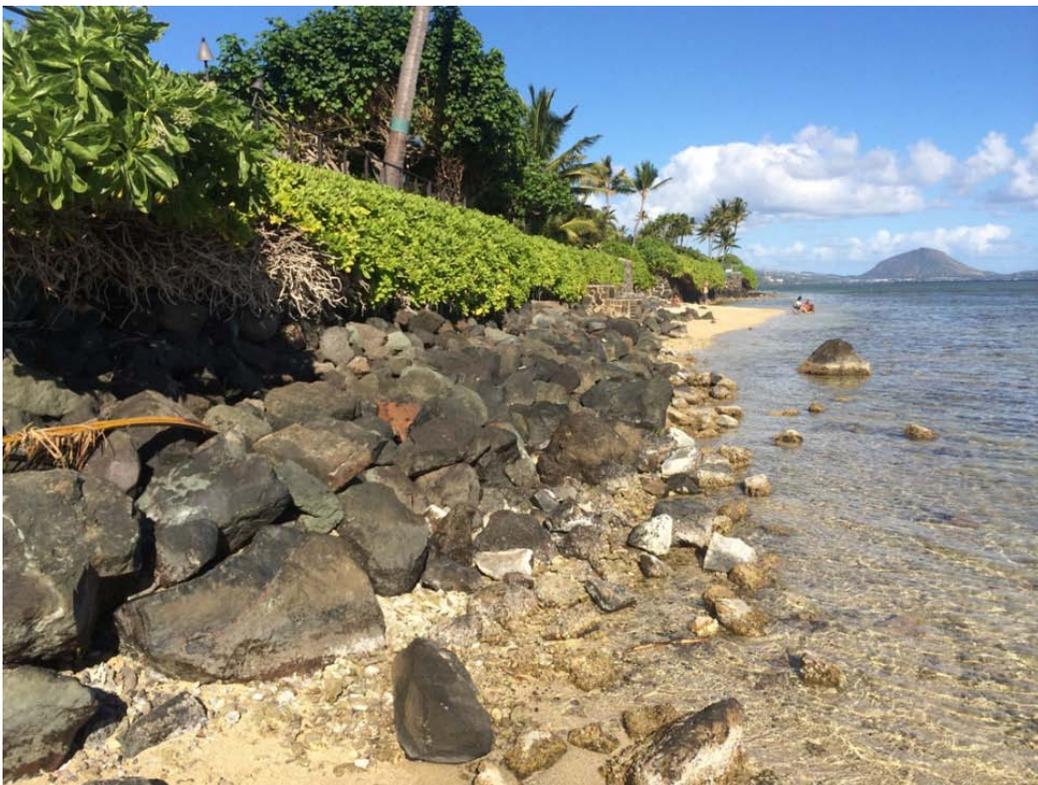
Figure 2-4 Revetment protecting adjoining property to the east

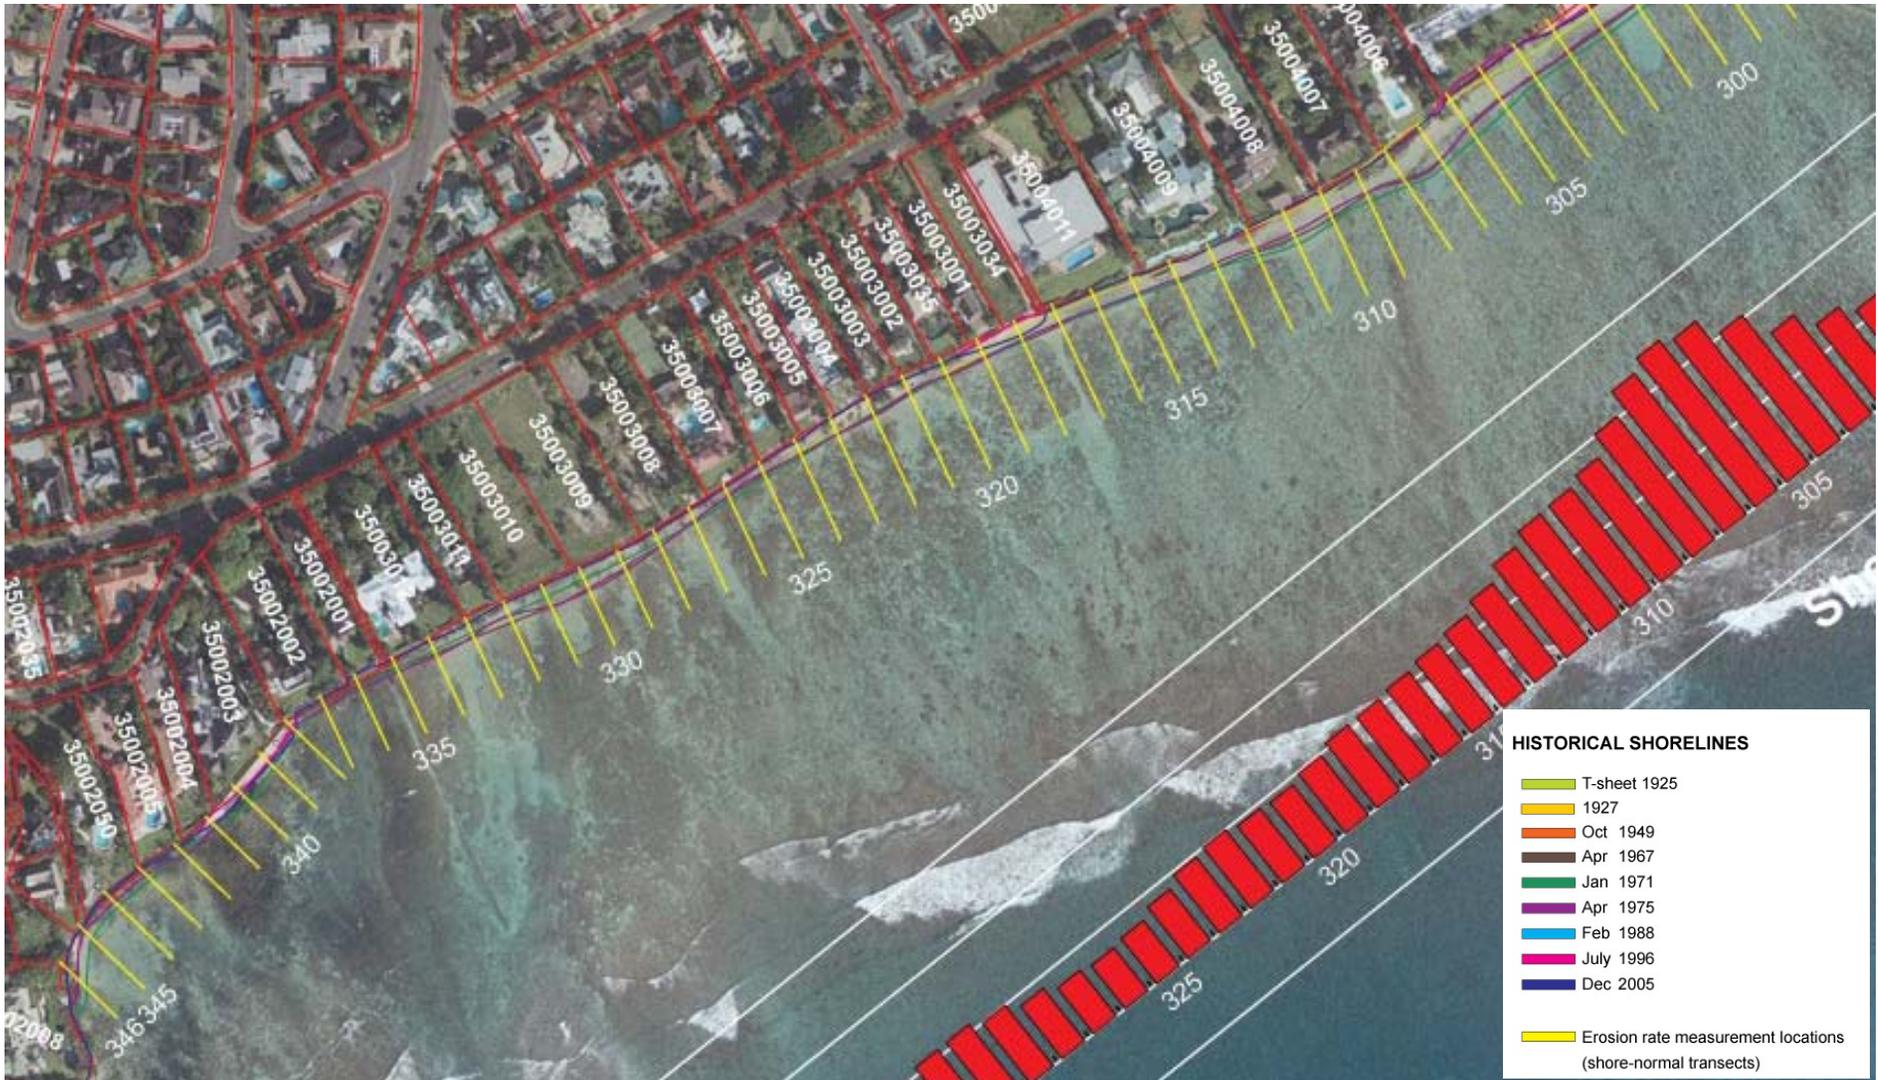
The project site corresponds to Transects 320, 321, and 322. The study indicates that the project shoreline was eroding at a rate of approximately 1 ft/yr. The erosion rate was calculated only to the time that seawalls first appeared at the site and fixed the shoreline position. Seawalls at the project site were presumed to have been built prior to the late 1980s.

Figure 2-7 Historical shoreline change analysis (UH Coastal Geology Group). Yellow lines indicate transect locations spaced 66 ft apart. Red bar graph indicates annual erosion rate calculated for each transect location. White lines through bar graph represent 1ft/yr erosion rate increments.

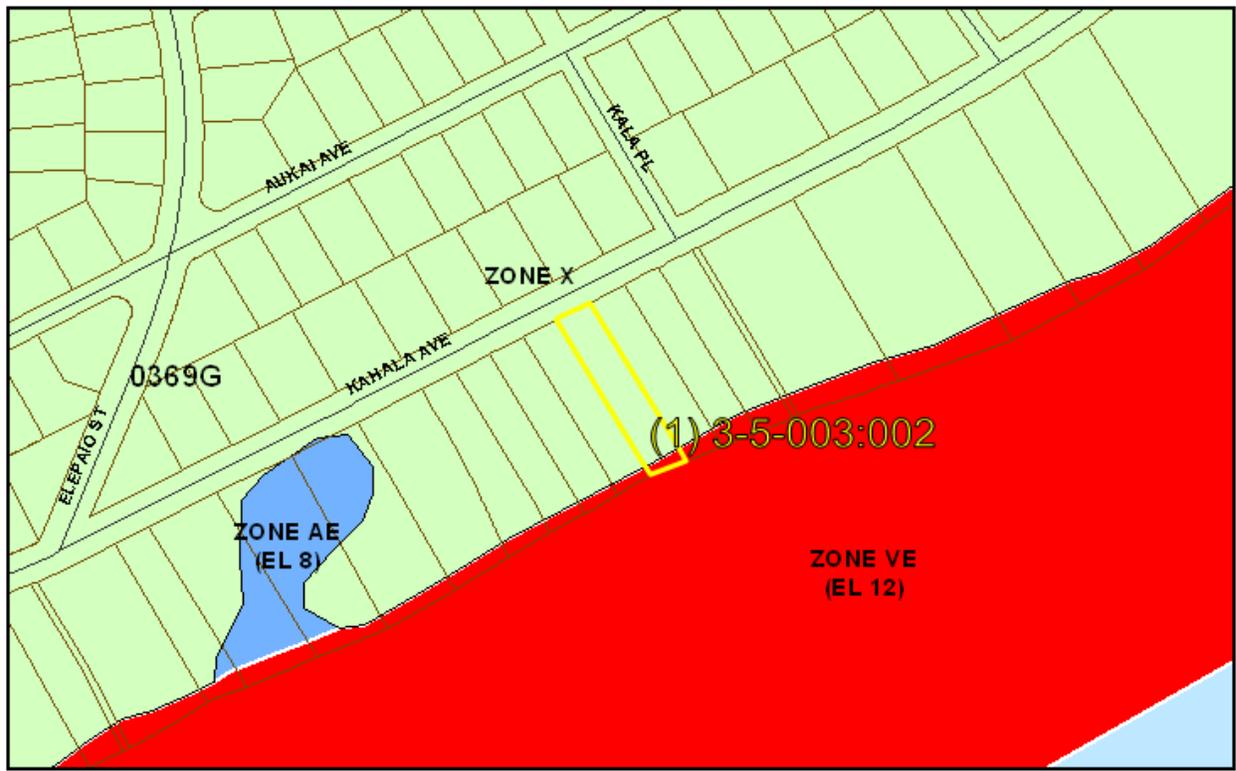
The National Flood Insurance Program, administered by the Federal Emergency Management Agency (FEMA) produces maps identifying flood hazards and risks. Figure 4-1 shows the flood hazard map for the project properties. The map indicates that the properties are rated as Flood Zone X. Zone X is an area determined to be outside of the 0.2% annual chance floodplain. The map indicates that the reef flat offshore is rates as Zone VE (elevation 12). This designates an area along the coast subject to the 1% flood event and velocity wave action. The flood elevation is 12 feet.

Figure 4-1 Flood hazard designation for the project site

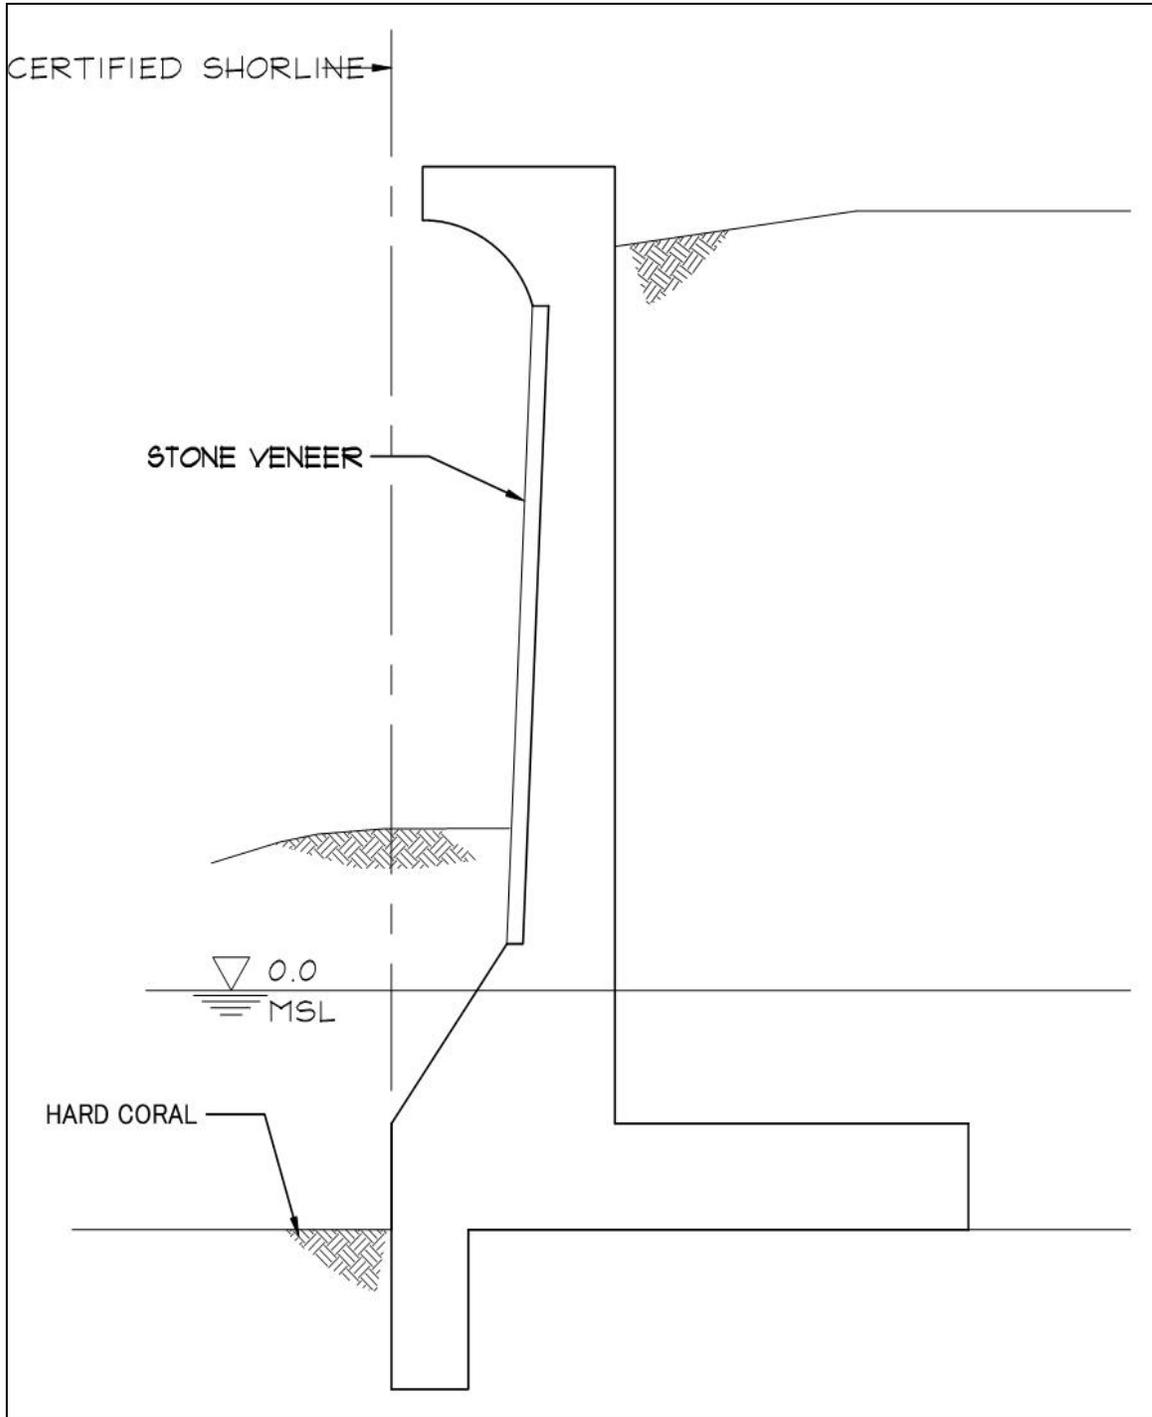
The project plan is to remove the non-permitted revetment and seawall currently located along the project shoreline, and replace these structures with a properly engineered seawall located behind the certified shoreline. Figure 5-1 presents a cross-section showing the seawall design, while Figure 5-2 shows the lot plan with the wall location and certified shoreline position. The proposed wall is a CRM gravity seawall founded on solid non-erodable limestone substrate located at the approximate water line. The seawall will rise to an elevation between +8.0 and +10.5 feet MSL, and will tie into the existing vertical seawall to the west, and the revetment to the east. The wall will be located approximately 5 feet inland of the present wall location.

Figure 5-1 Wall cross-section

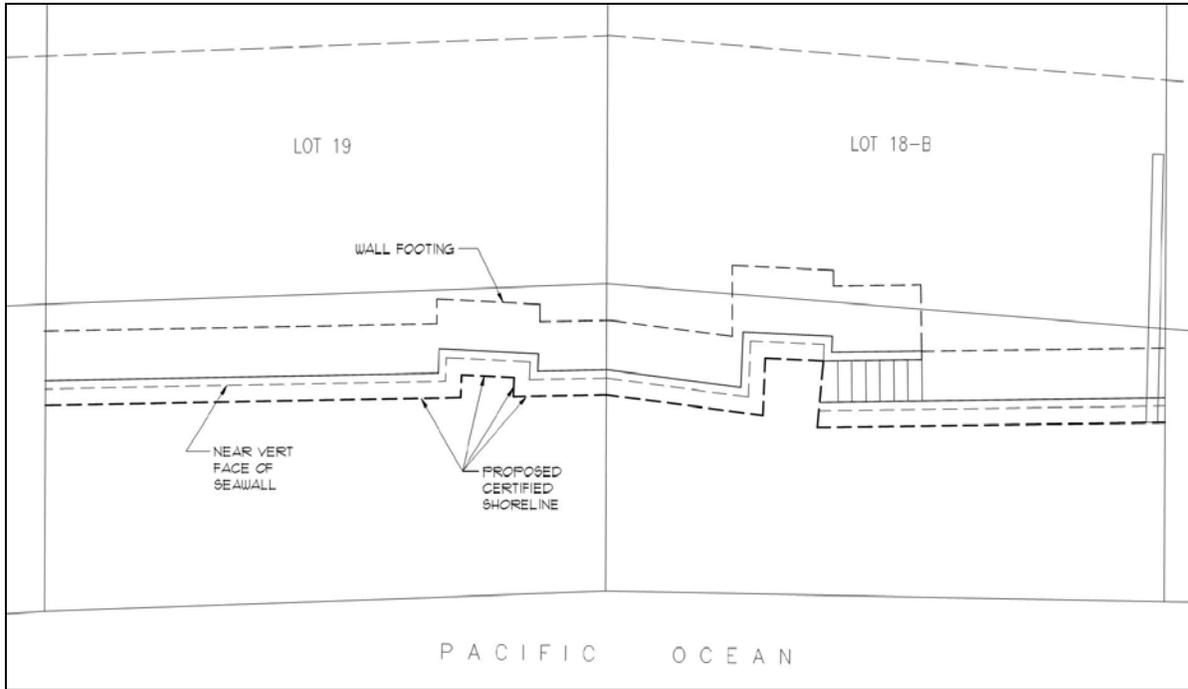
Figure 5-2 Proposed shoreline location for certification and seawall location
