Project: Lee Residence and Shoreline Protection Structure
Applicant: Kyoung-Su Im
Agent: Group 70 International, Inc. (Jeffrey Overton)
Location: 4465 and 4469 Kahala Avenue - Waialae Kahala
Tax Map Key: 3-5-3: 2 and 3
Request: Special Management Area Use Permit (SMP) and
Shoreline Setback Variance (SV)
Proposal: New Residence over 7,500 square-feet and Shoreline Structure within
the 40-foot shoreline setback.

**Subject: Kāhala Residence and Shoreline Structure
Accepted Final Environmental Assessment/FONSI**

Final Draft Environmental Assessment

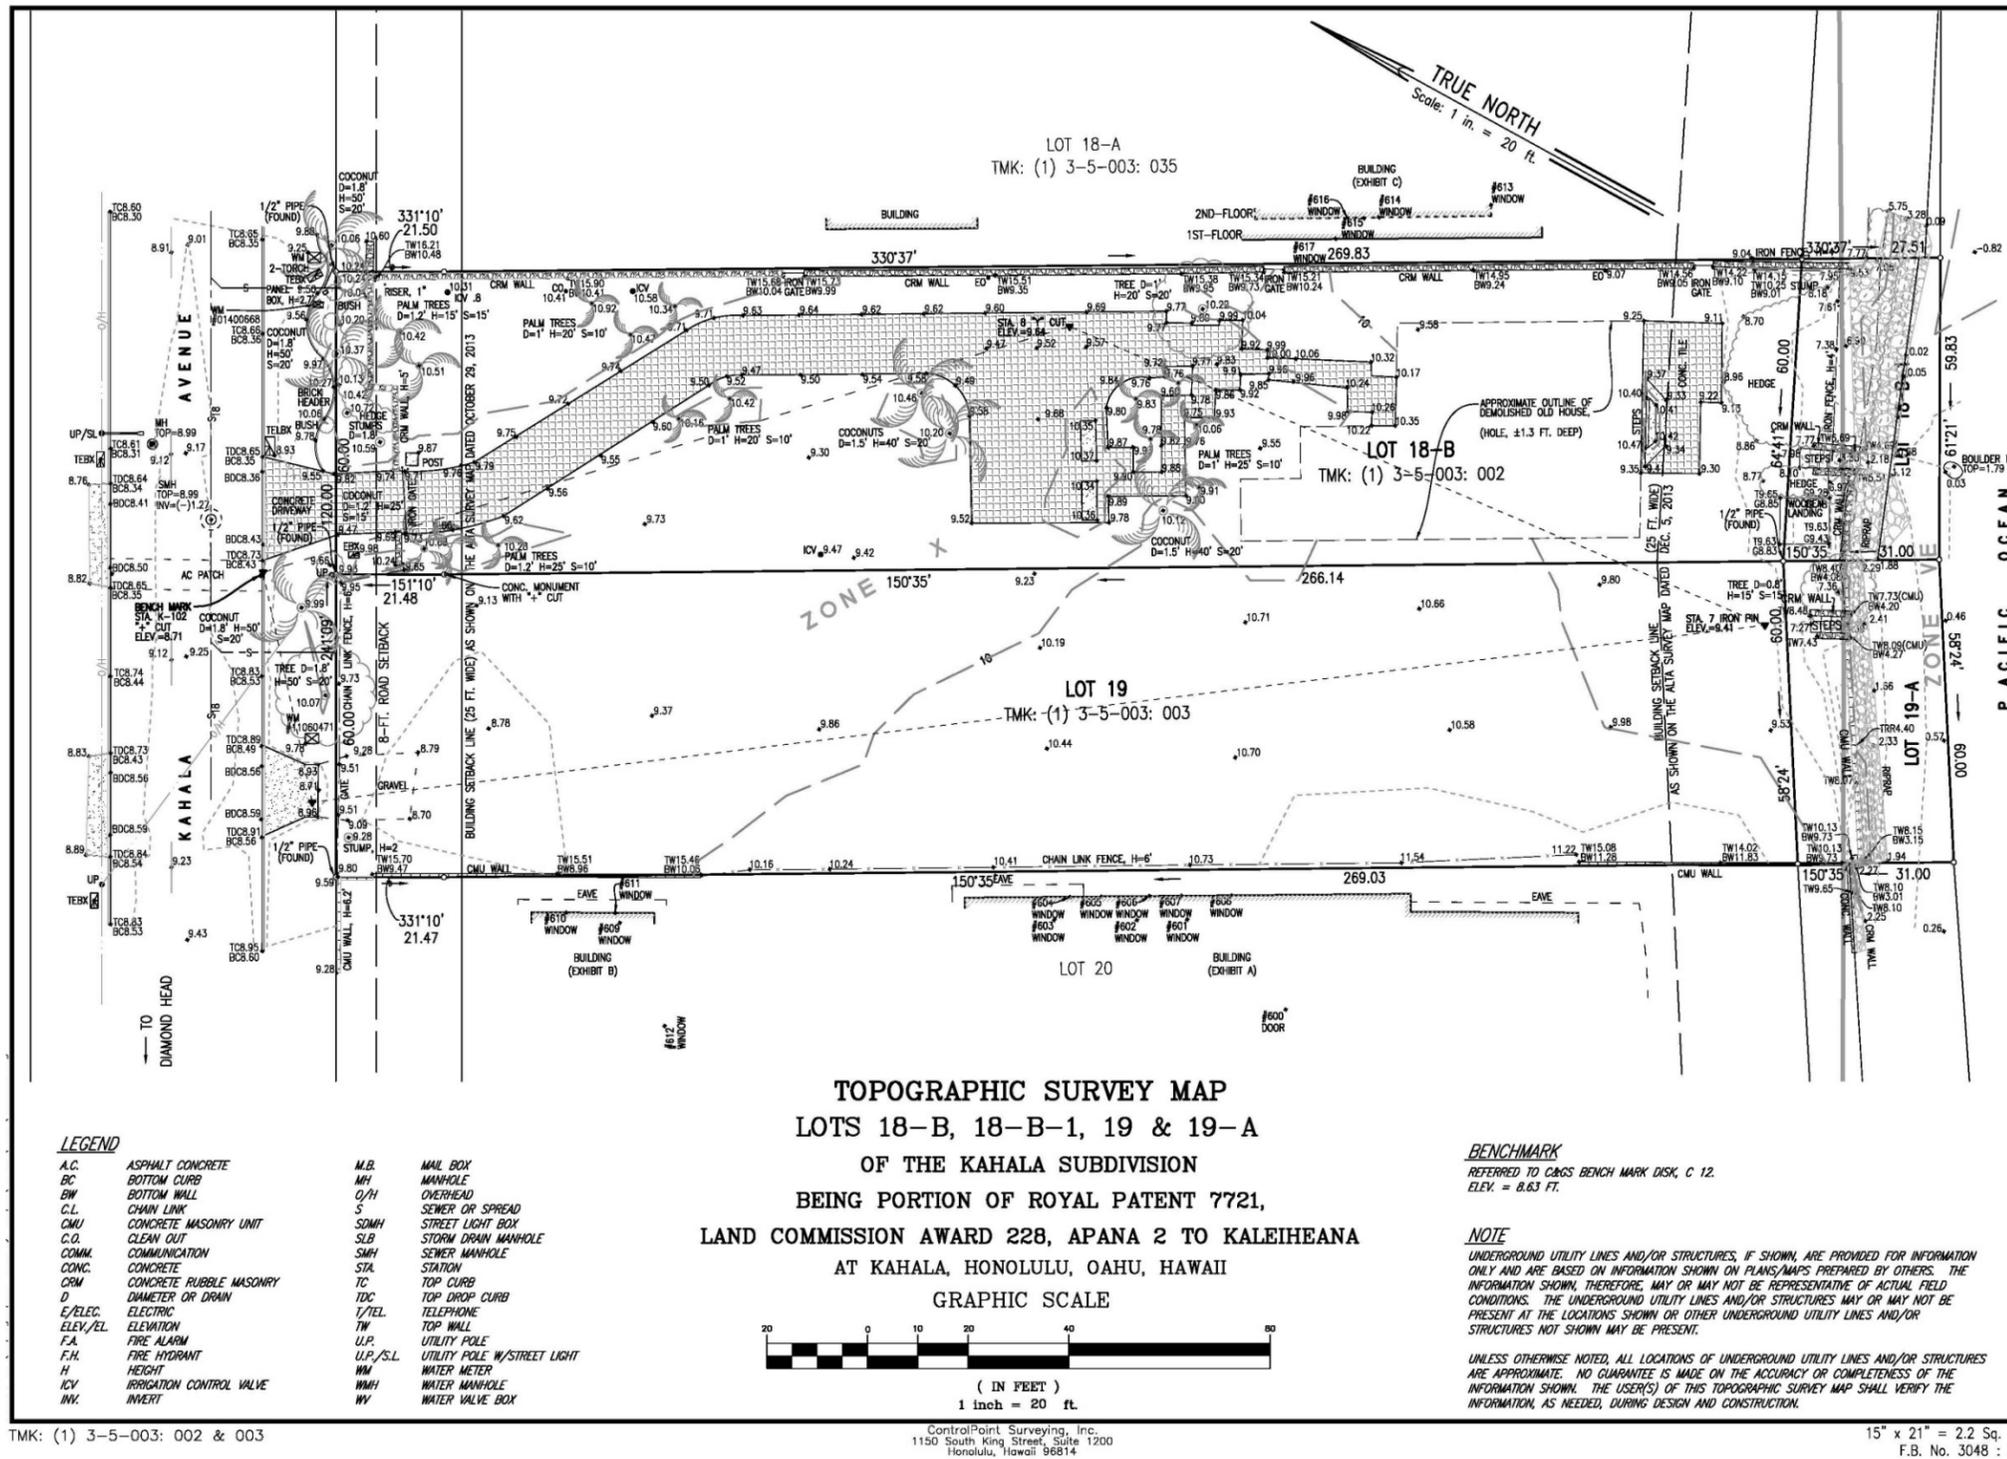
FIGURE 2-1: TOPOGRAPHIC SURVEY MAP (2/18/14 4/10/14) (Note: Seawall removed May 2014.)

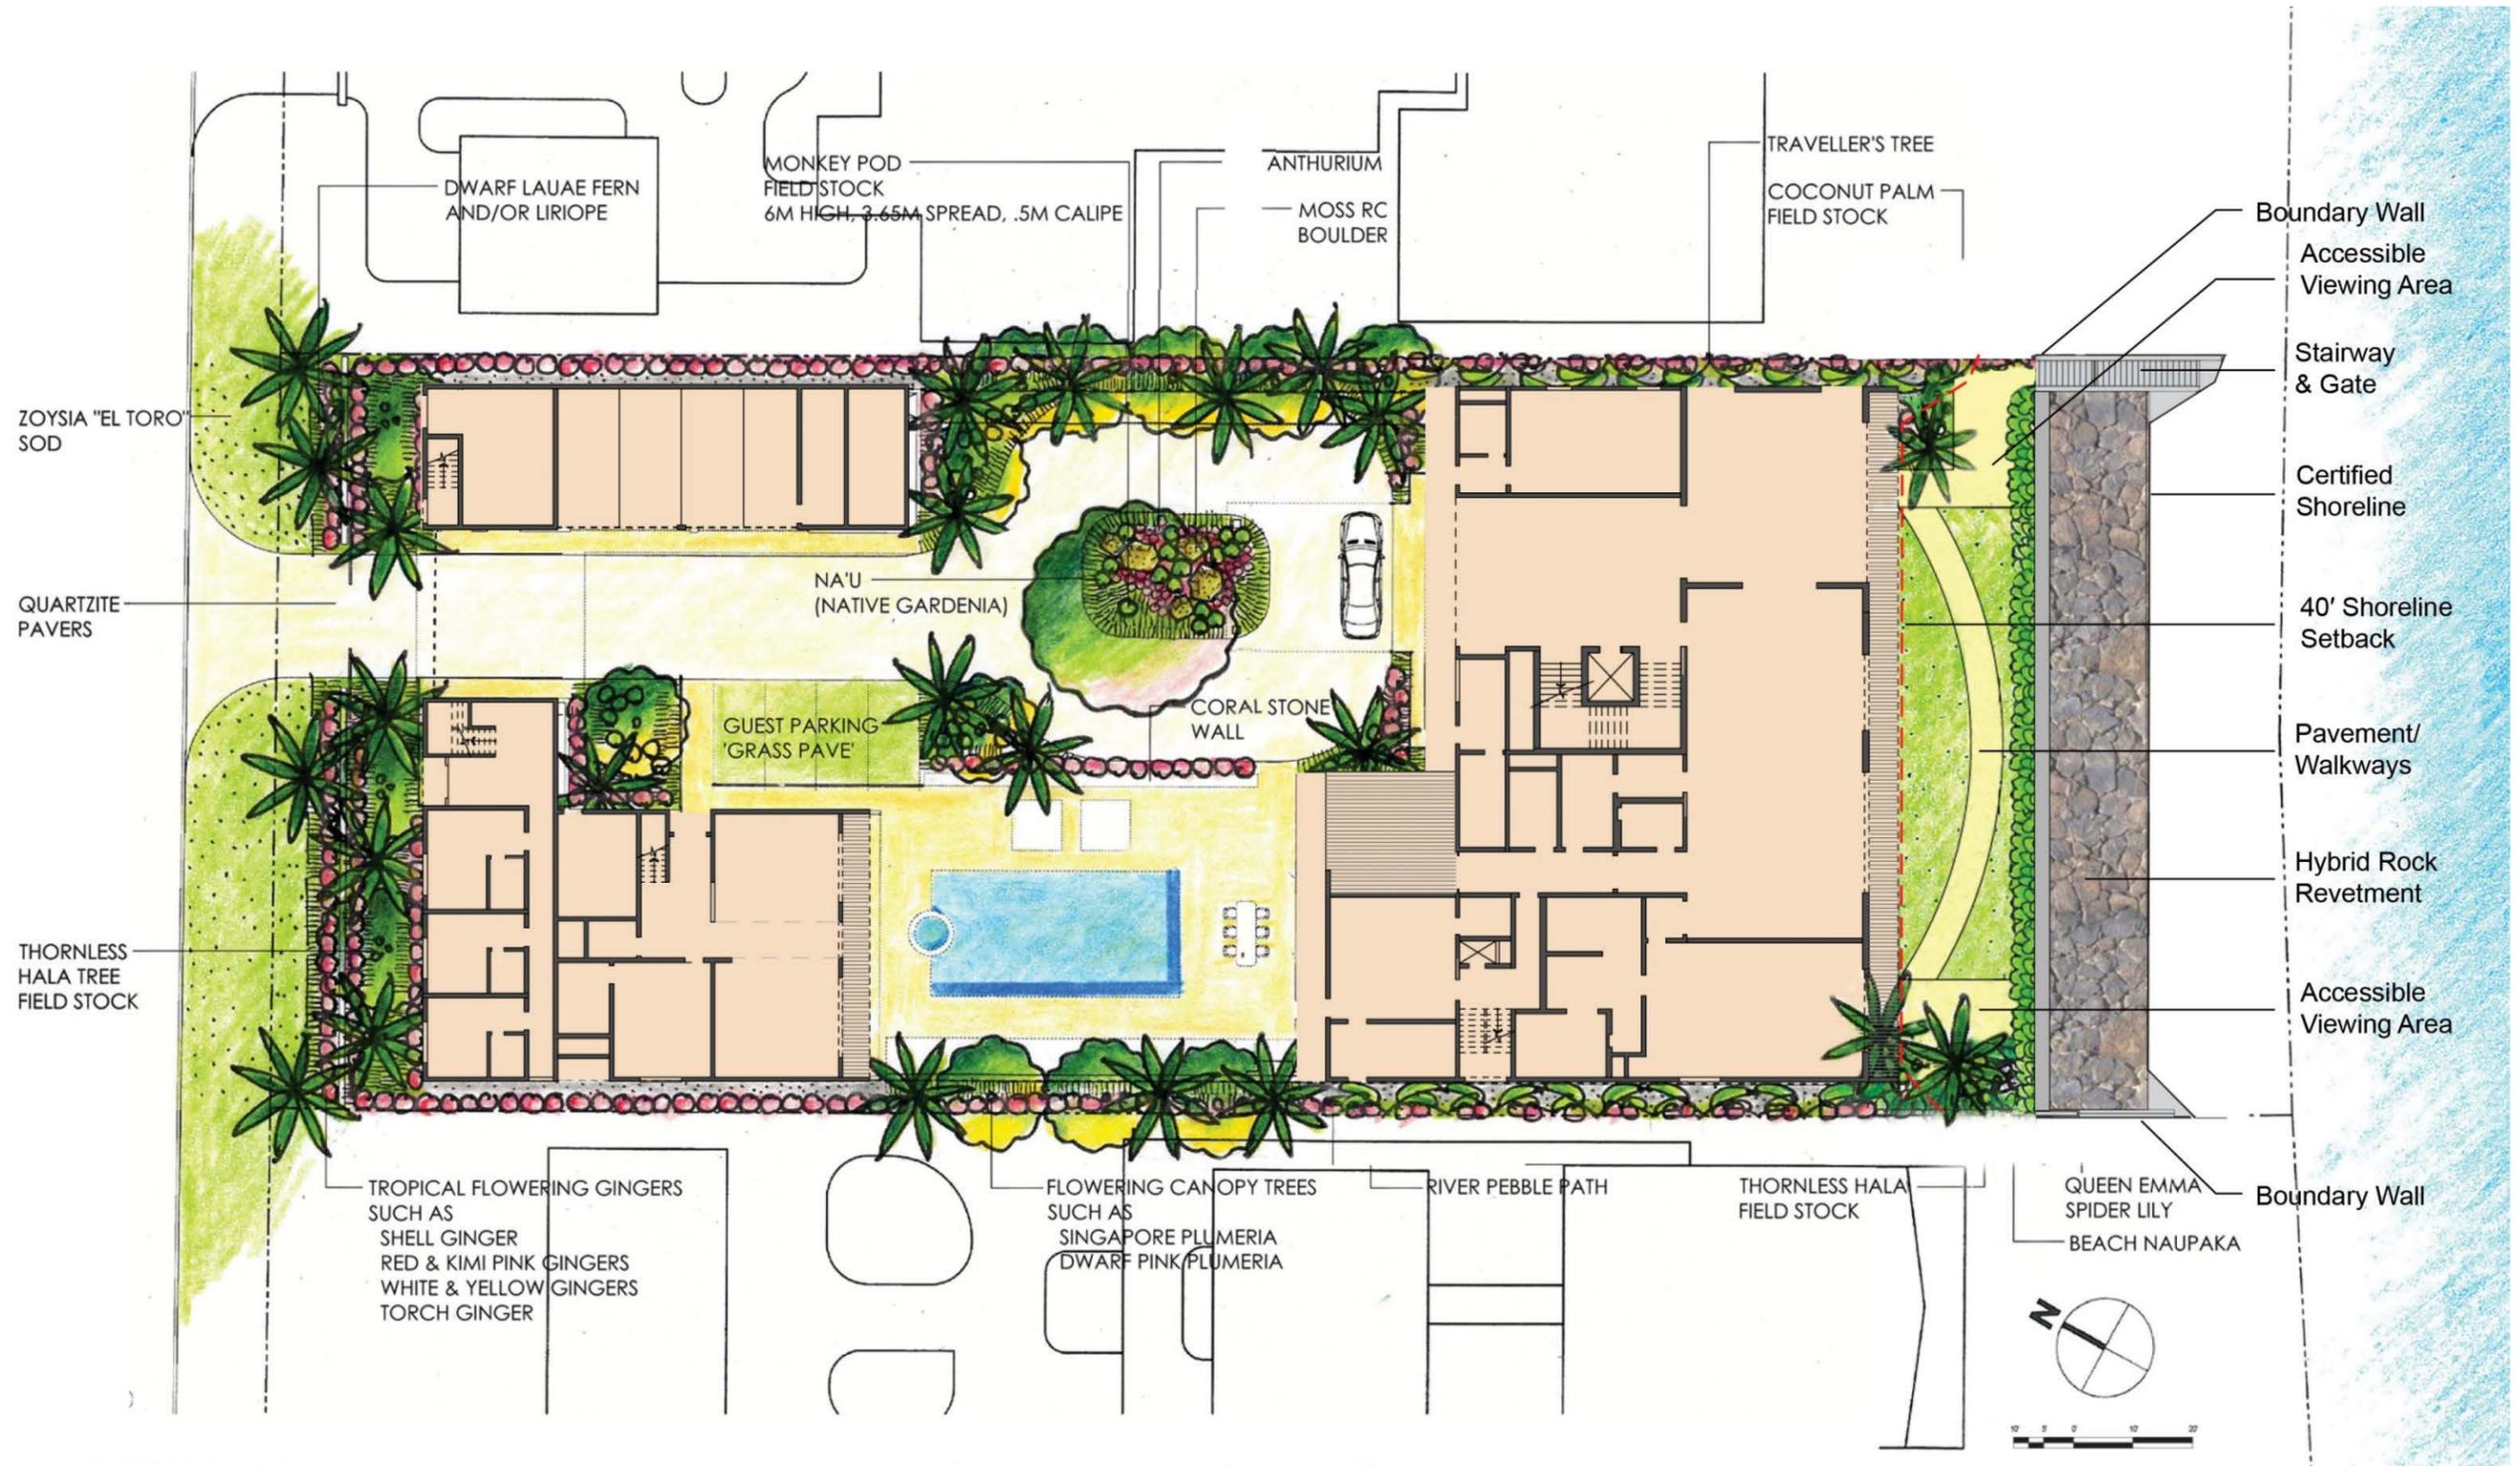
FIGURE 2-2: GROUND LEVEL, SITE PLAN AND LANDSCAPE PLAN (NOT TO SCALE) (2/7/14) (7/02/14)

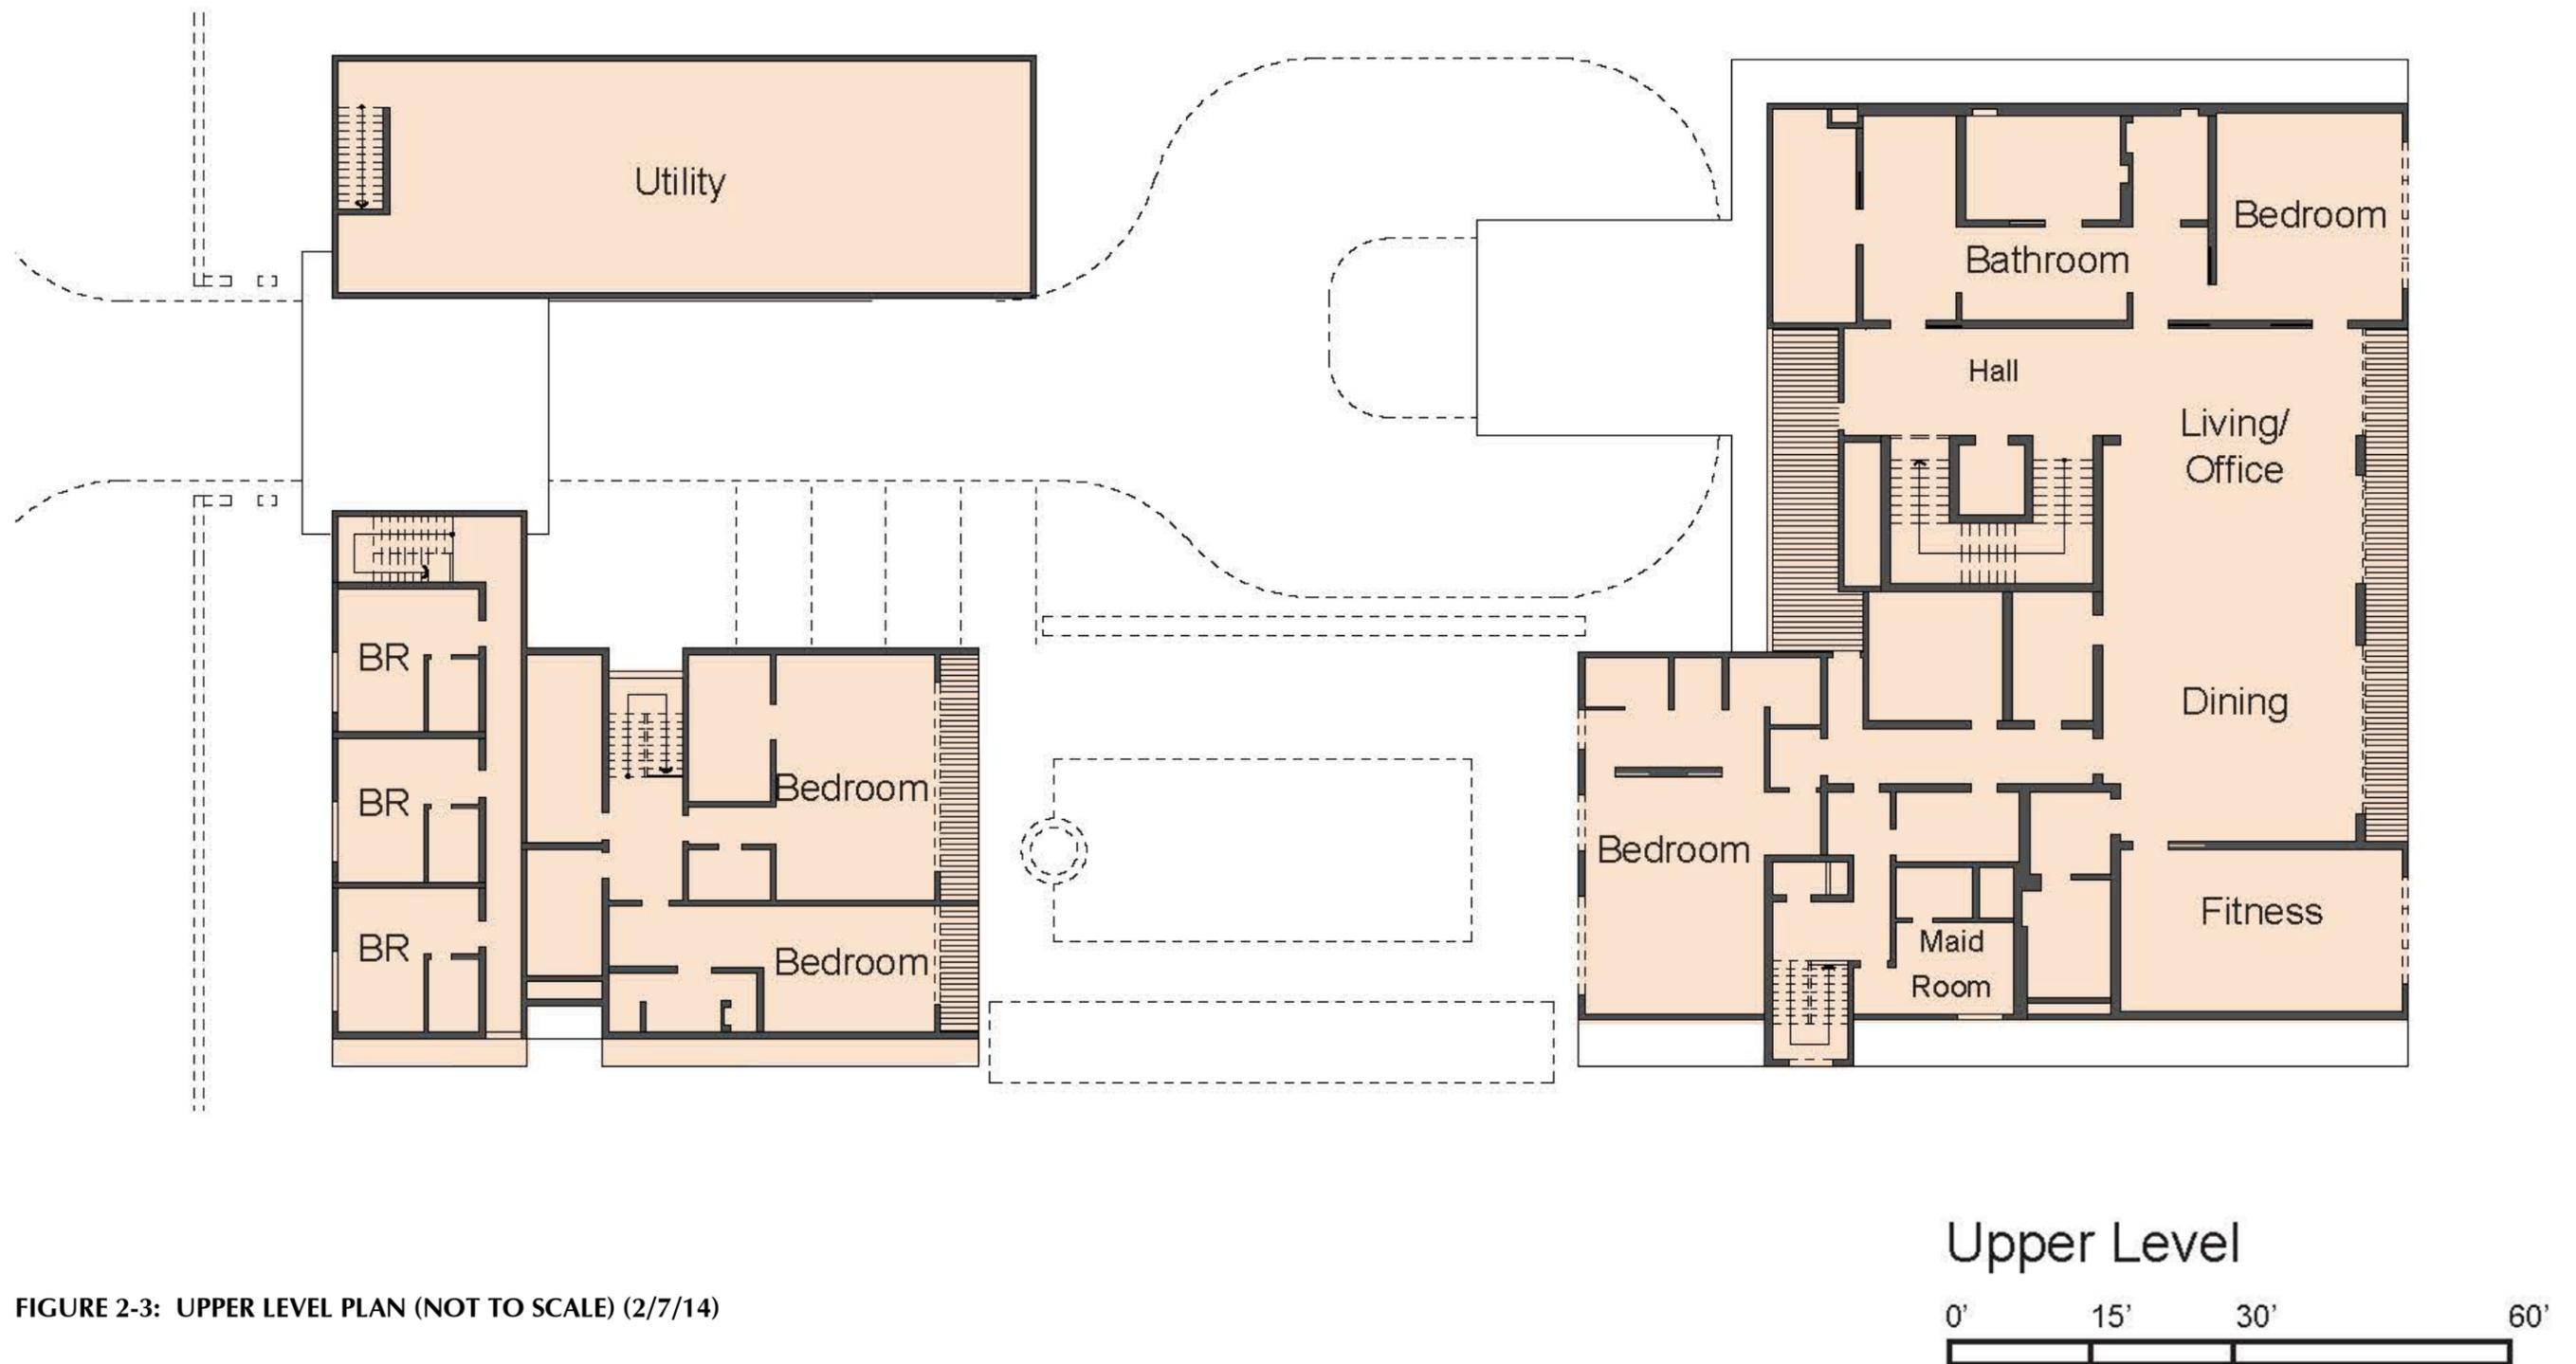
FIGURE 2-3: UPPER LEVEL PLAN (NOT TO SCALE) (2/7/14)

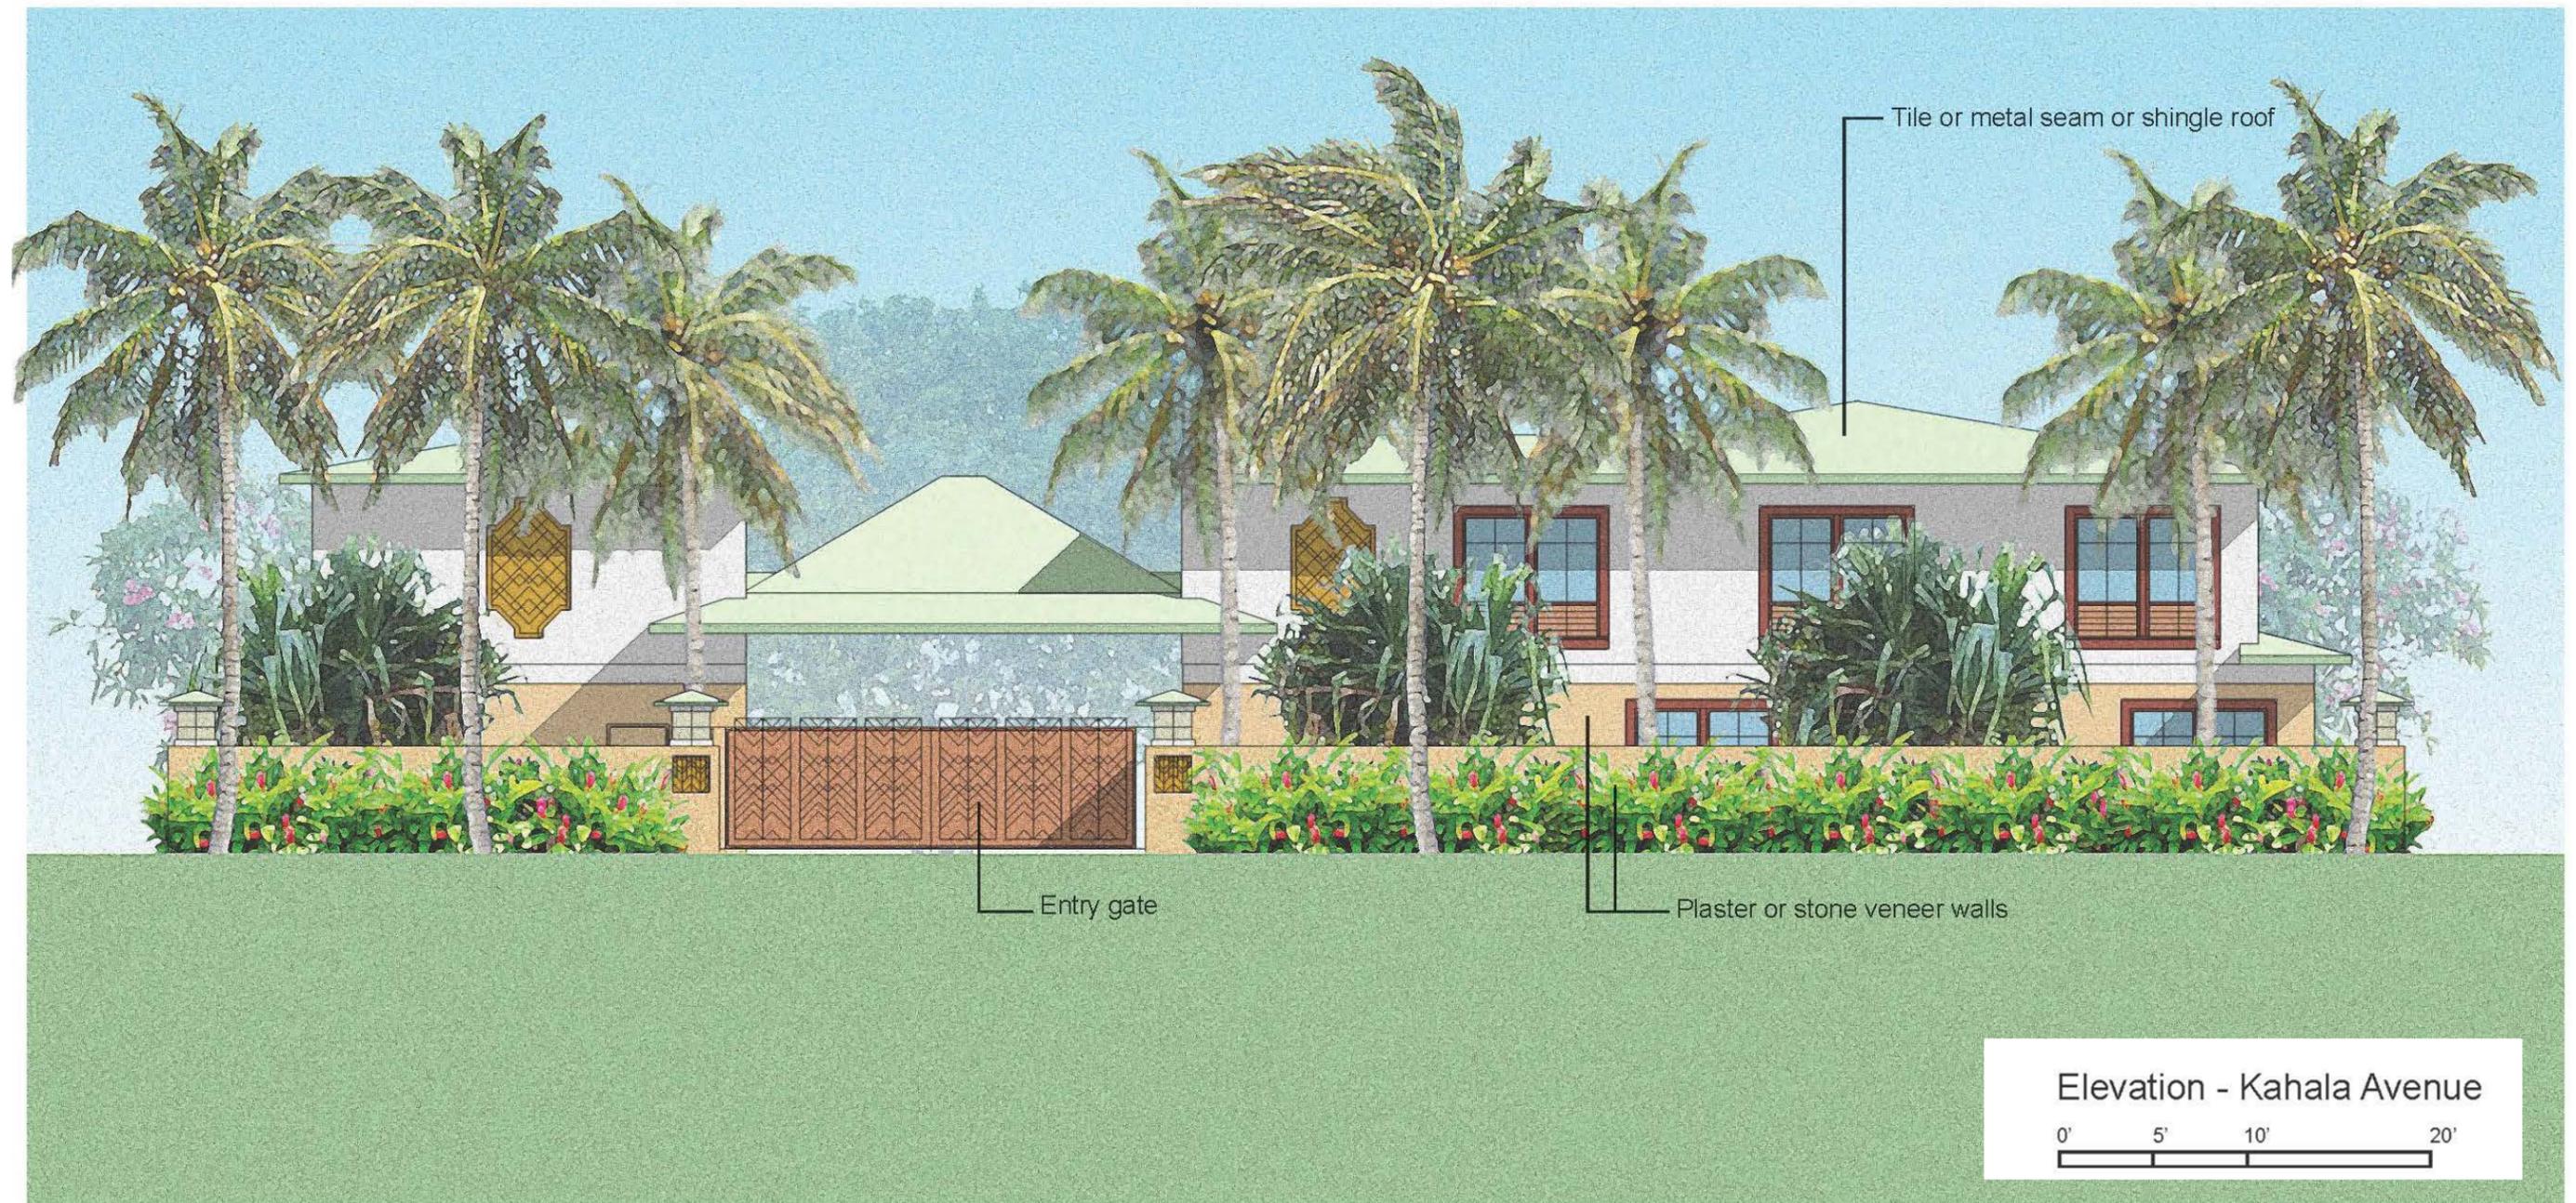
FIGURE 2-5: ELEVATION – KĀHALA AVENUE (NOT TO SCALE) (2/7/14)

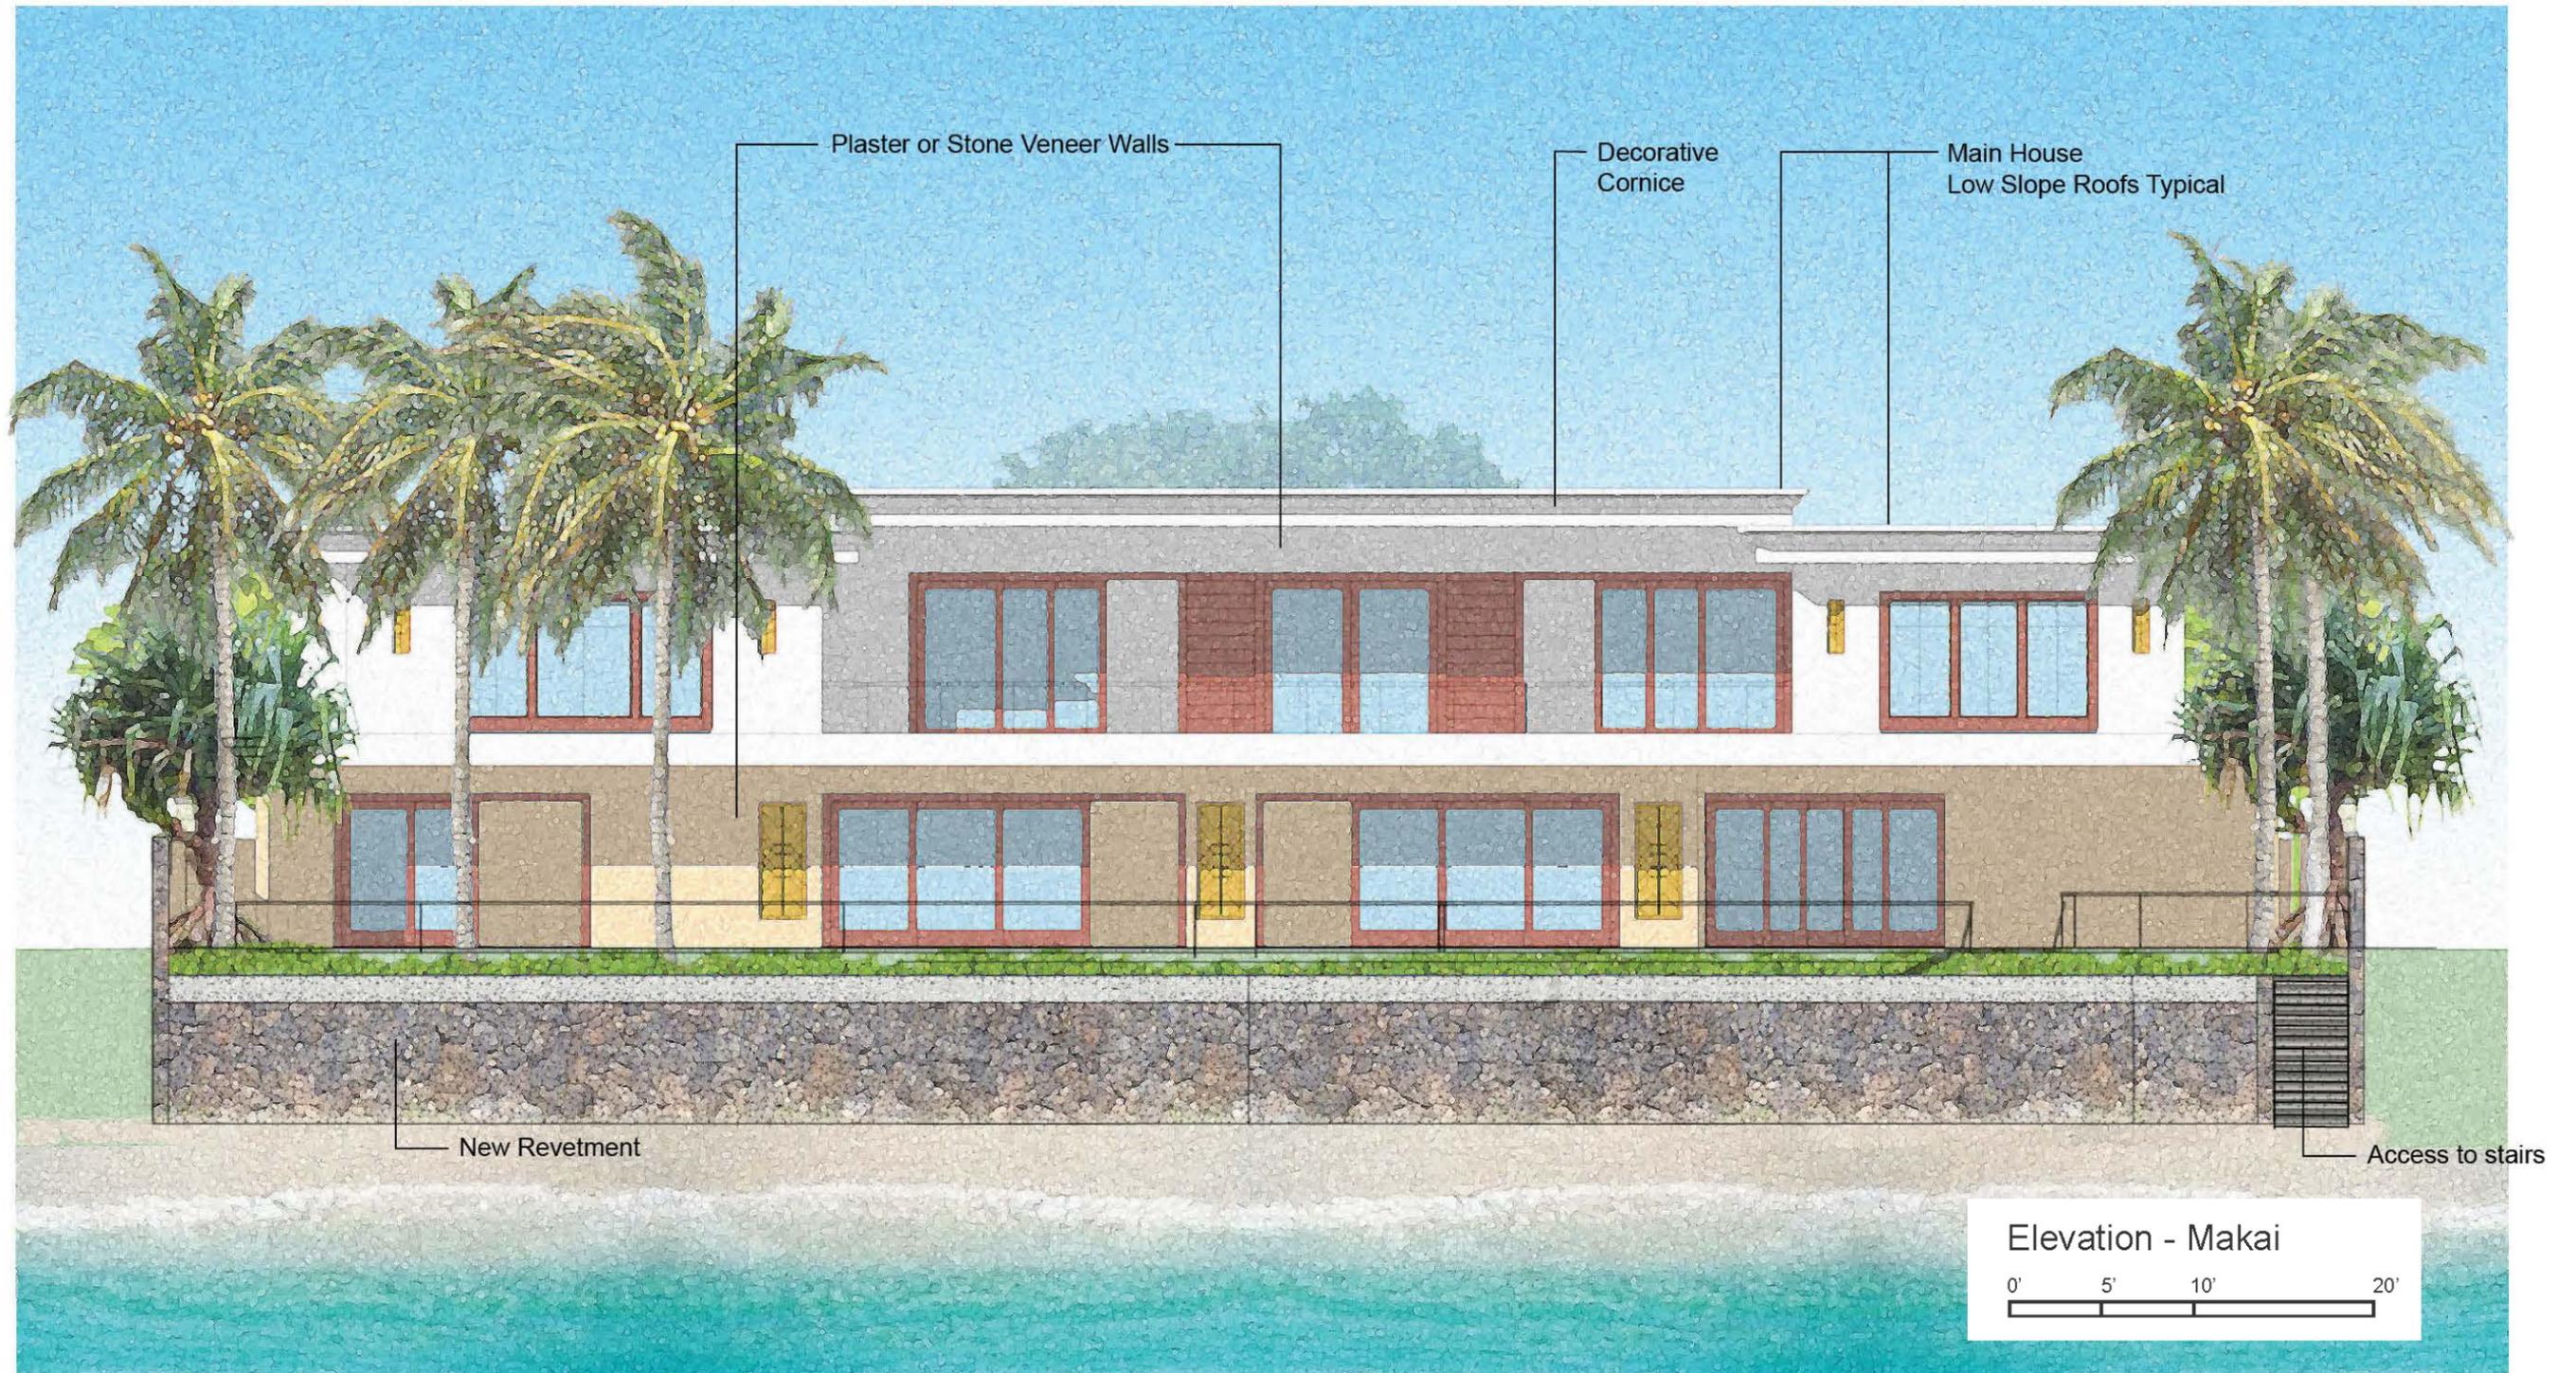
FIGURE 2-6: ELEVATION – MAKAI (NOT TO SCALE) (2/7/14) (7/2/14)

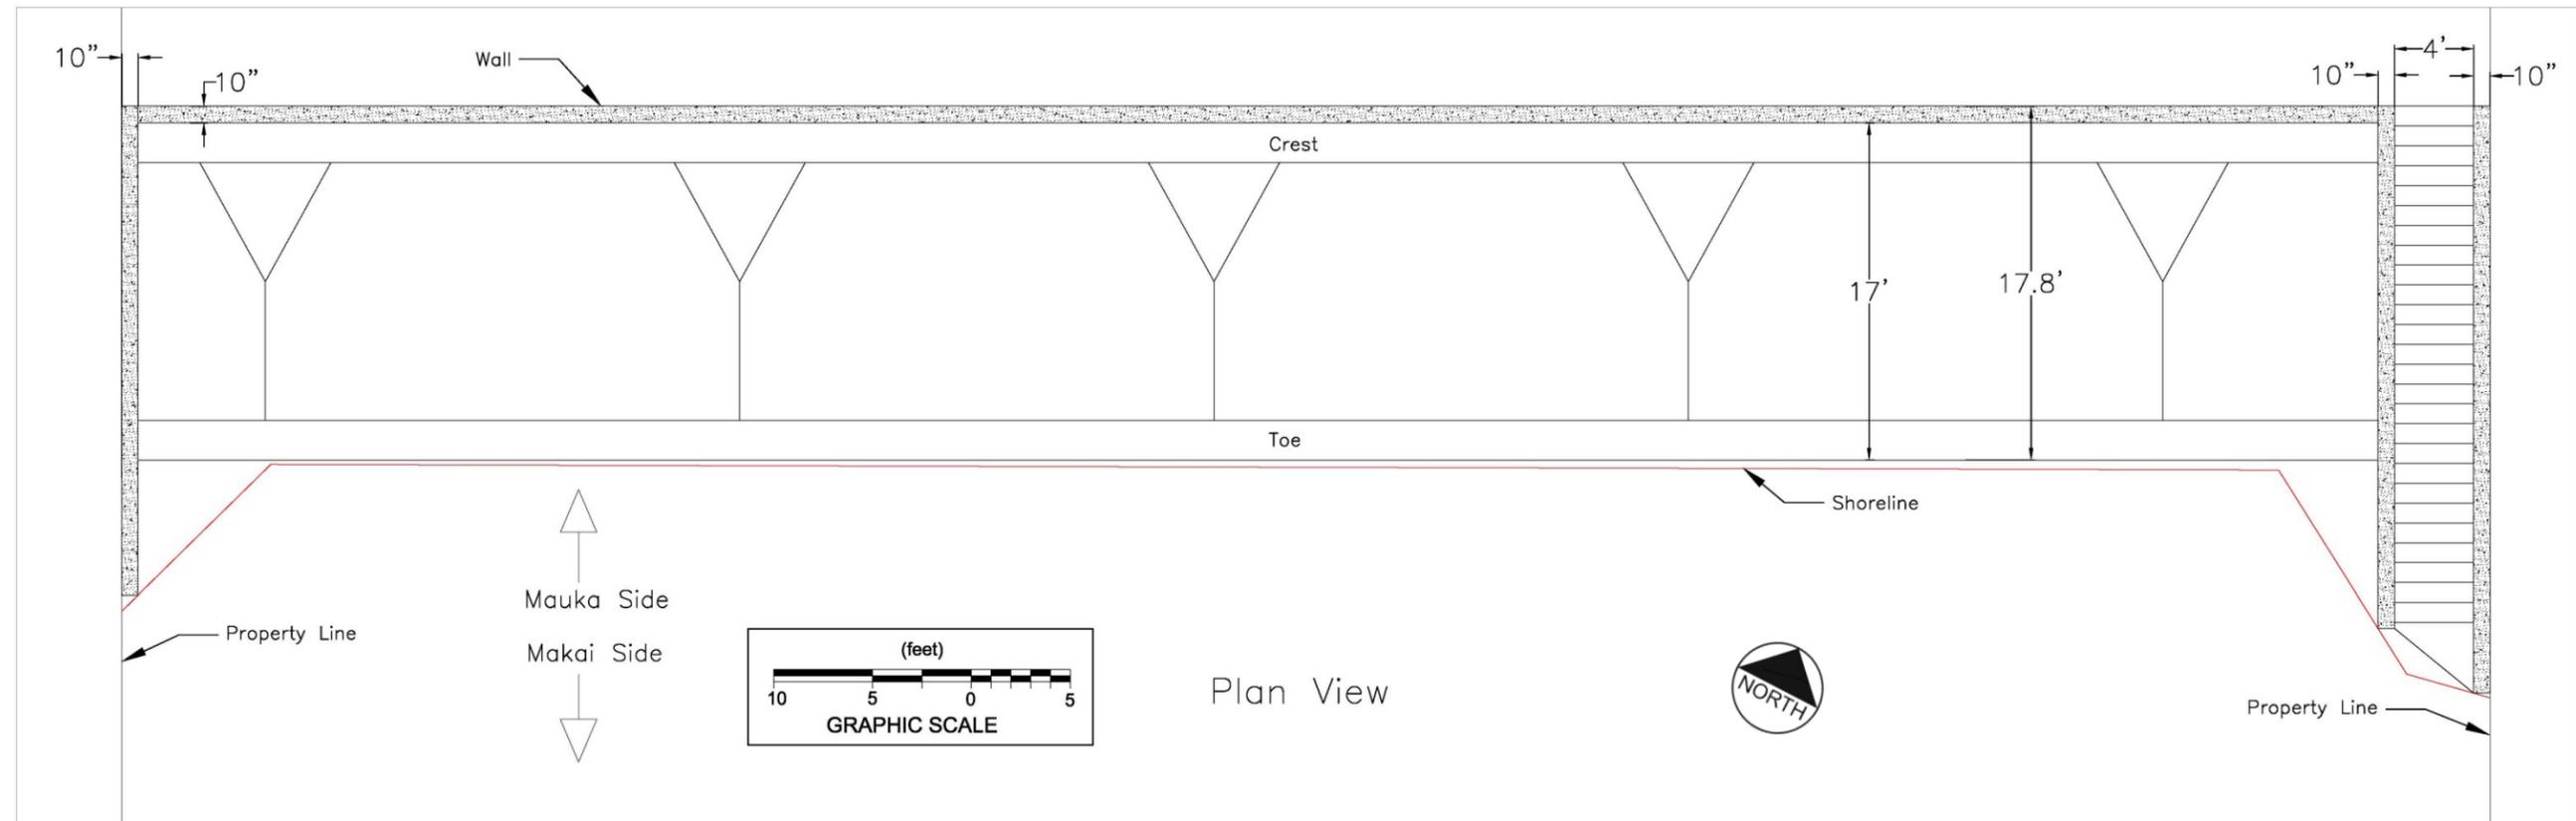
FIGURE 2-9: PROPOSED PRELIMINARY SHORELINE REVETMENT STRUCTURE: PLAN AND SECTION VIEWS (NOT FOR CONSTRUCTION) (2/26/14) (7/02/14)

Summary: The Applicant seeks a Shoreline Setback Variance for the construction of a hybrid sloping rubble revetment, which includes a three-foot vertical concrete section at its crest, which will replace an unauthorized vertical seawall and rubble revetment which were removed along the 120-foot long makai boundary of the site. The Applicant has worked with the State Office of Conservation and Coastal Lands to remove the illegal structures and to establish a shoreline which was certified by the State on August 1, 2014 (File No.: OA-1573). The proposal includes an integrated concrete stairway accessing the shoreline, open steel cable, safety fencing, paved walkway with view area, and concrete fencewalls along both left and right boundaries.

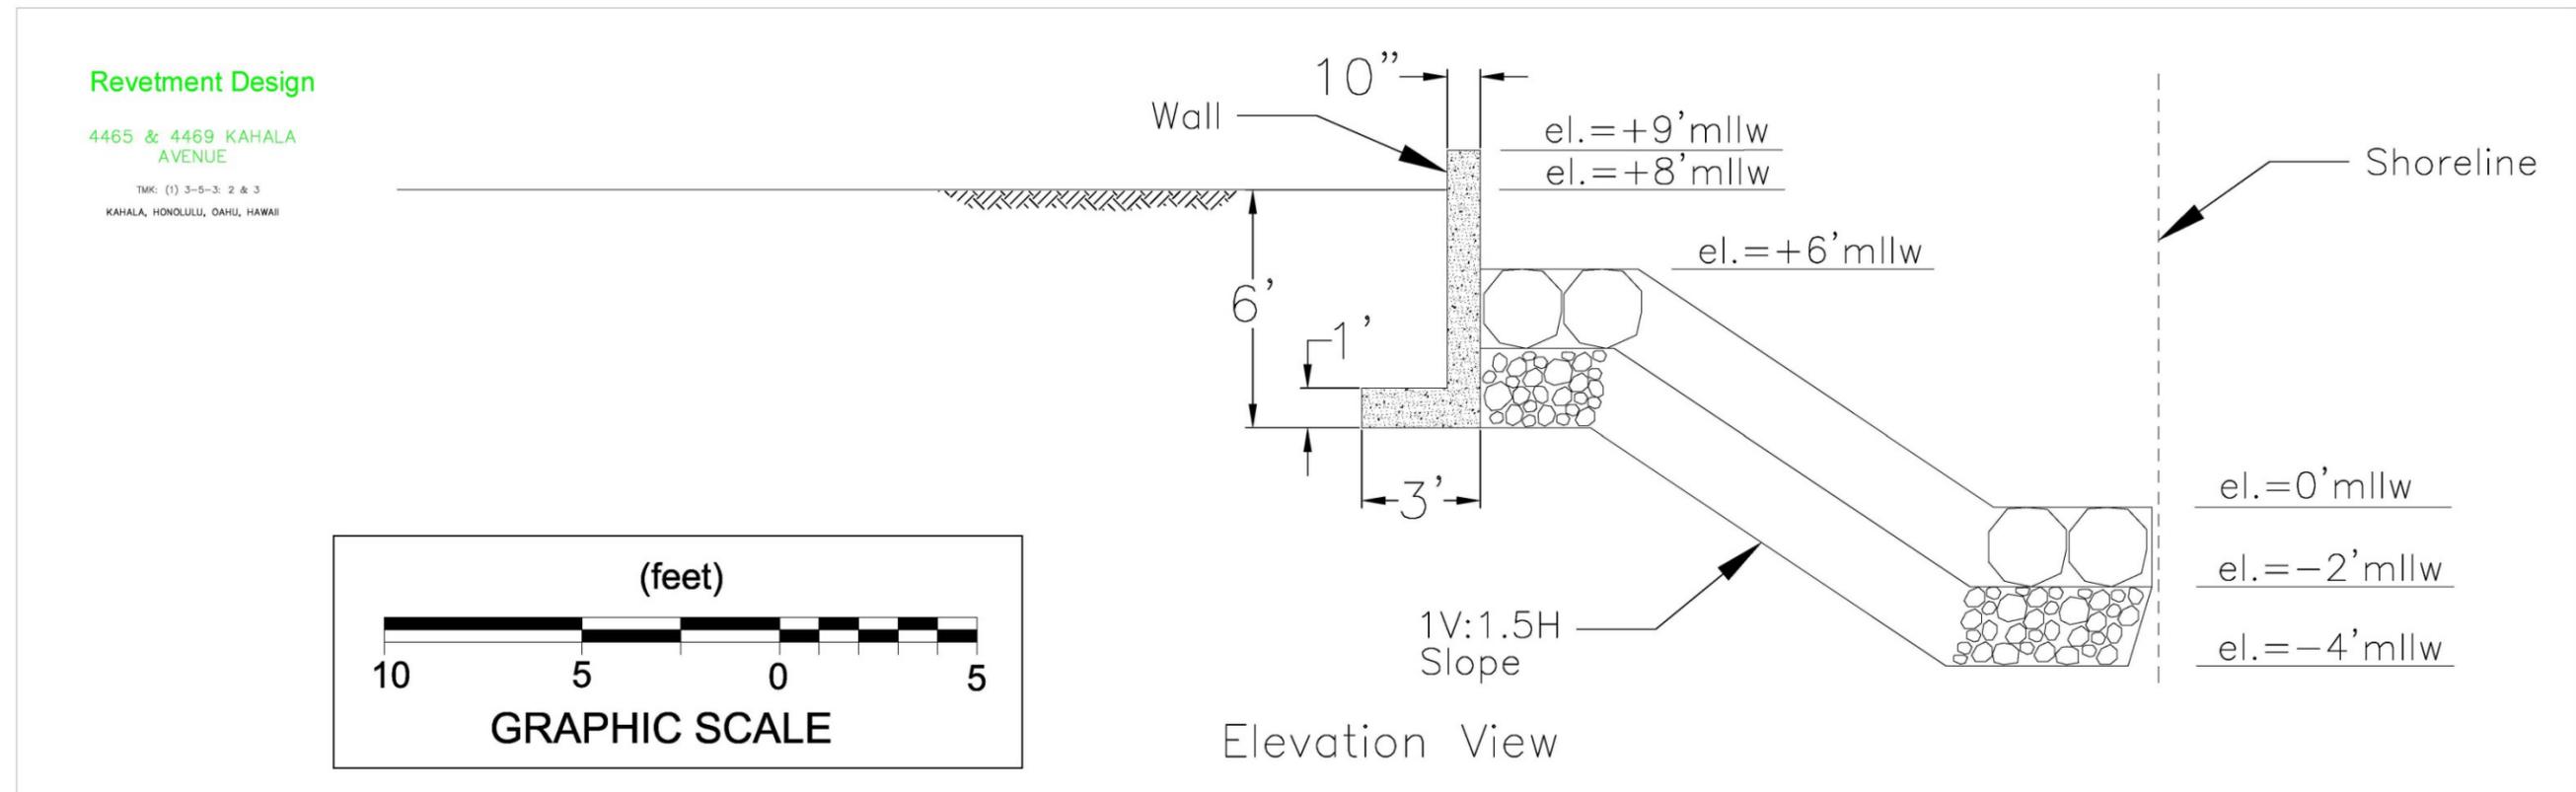
FIGURE 2-10: PROPOSED SHORELINE REVETMENT STRUCTURE: SECTION VIEW I (NOT FOR CONSTRUCTION) (7/02/14)
